Review of the Practice on Slope Surface Drainage Management

GEO Report No. 359

R.W.H. Lee & R.H.C. Law

**Geotechnical Engineering Office
Civil Engineering and Development Department
The Government of the Hong Kong
Special Administrative Region**

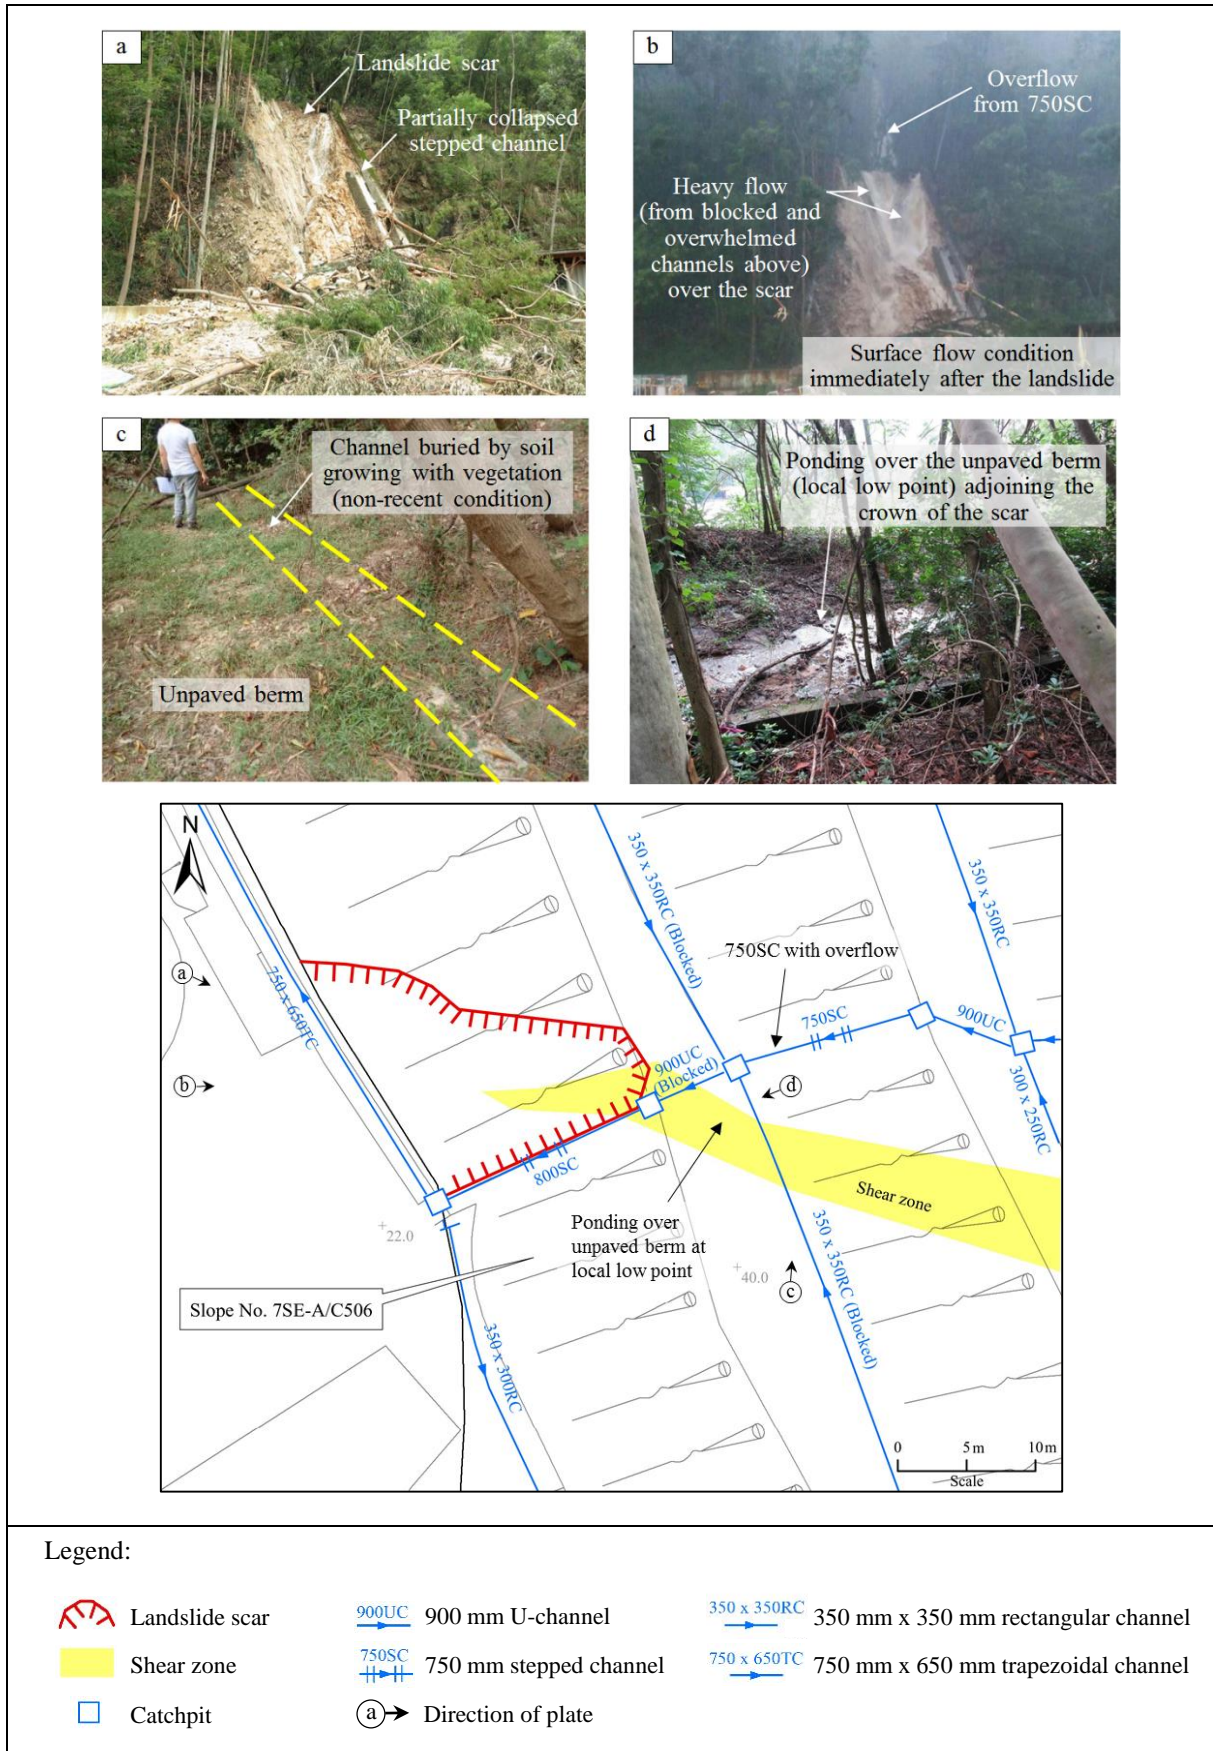
Figure 3.1 Rockslide at Ex-Turret Hill Quarry in August 2015

A major rockslide with a failure volume of about 150 m³ occurred on a rehabilitated rock cut slope (Feature No. 7SE-A/C506) at the ex-Turret Hill Quarry, Shatin (Figure 3.1). The debris partially inundated an industrial training site at the slope toe. The rainstorm that triggered the landslide was severe with a return period of about 170 years, representing the record highest 1- to 3-hour duration rainfall experienced by the slope since the quarry rehabilitation was completed in 1994. The landslide involved the lowest 60° inclined slope batter being traversed by a shear zone and was associated with blocked and overwhelmed slope surface drainage.

According to the eye-witness, there was continuous heavy surface flow overtopping the failure location. The slope comprises ten batters and is sizeable, viz. 620 m long by 180 m high. No maintenance access was available. A post-landslide inspection over limited accessible areas observed substantial blockage of channels and notably many channel sections were buried by soil with vegetation which suggested that the channels had been silted up for some time. The heavy surface flow at the time of the landslide was likely the runoff from the upslope catchment overtopping the blocked berm channels. Besides, overflow was observed from the 750 mm stepped channel above the failure location which was overwhelmed, attributable to the aeration under rapid flow leading to bulking of the flow volume that was not accommodated in the design requirement prevailing at the time. Apart from infiltration through the slope surface, the overflow from the blocked and overwhelmed drainage rendered ponding over the unpaved berm at the crown of the scar where it was a local low point along the berm and coincided with the shear zone. The ponding promoted enhanced infiltration into the shear zone elevating the water pressure within the highly permeable fractured rock mass and consequently resulted in the landslide.

The incident highlights that inadequate drainage management in combination with other unfavourable factors, viz. adverse geological conditions and site settings, can lead to sizeable landslides. The importance of providing proper maintenance access over the slope and regular maintenance to drainage services cannot be over-emphasised. Besides, the incident serves as a reminder of the possible insufficient drainage capacity of stepped

channels designed in the early days when aerated flow was not considered (GEO, 2006). Where opportunities arise such as in Engineer Inspections, necessary preventive maintenance works can be recommended to improve any deficiency in the drainage measures and maintenance access.

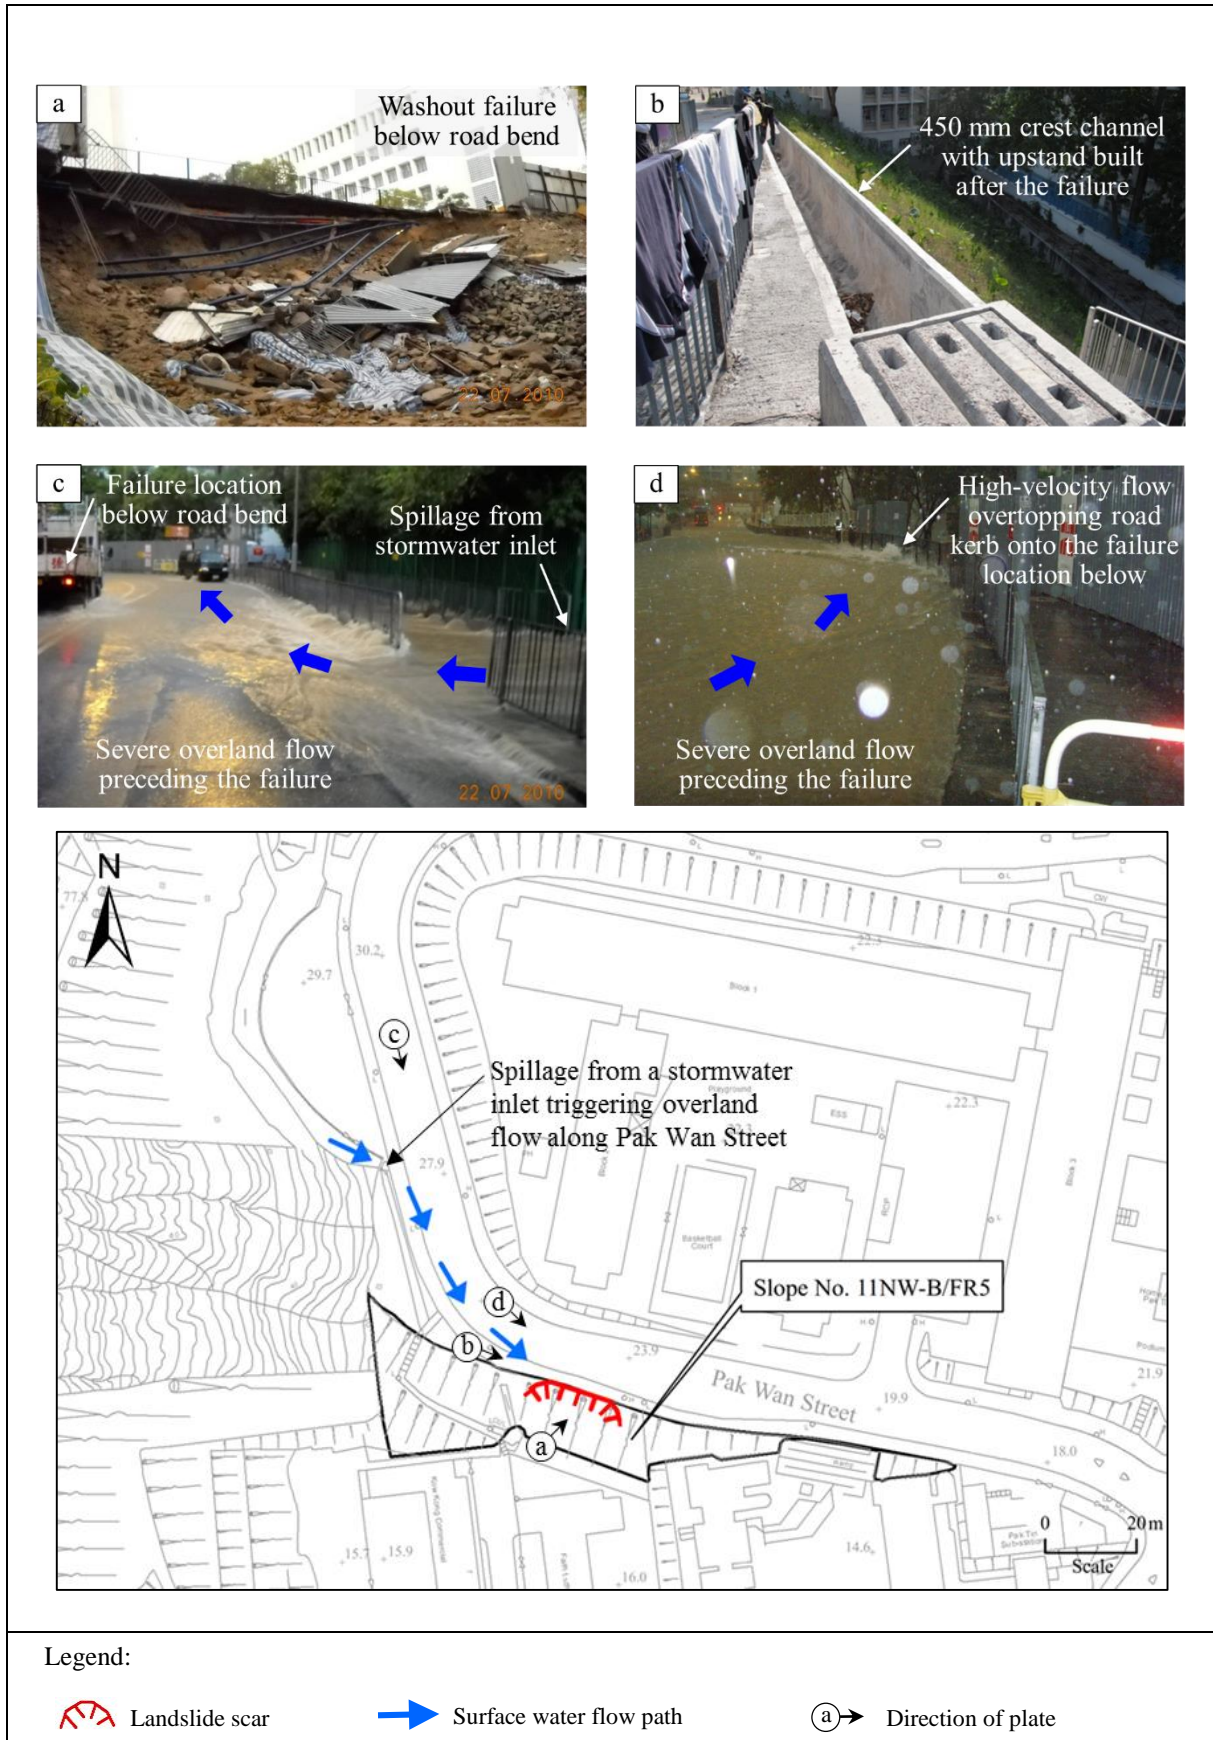
Figure 3.2 Washout below Pak Wan Street in July 2010

A major washout with a failure volume of about 150 m³ occurred on a fill slope (Feature No. 11NW-B/FR5) at Pak Wan Street, Sham Shui Po (Figure 3.2). The incident undermined a section of pedestrian pavement and resulted in temporary closure of one lane of Pak Wan Street. The rainstorm that triggered the incident was severe with a return period of about 100 years for a 2-hour duration. At the time of the incident, upgrading works was in progress on the slope and a temporary 60° cut covered with tarpaulin sheets and shotcrete was formed at the failure location.

The permanent drainage as part of the upgrading works for the subject fill slope had not been constructed at the time of the incident. Although the drainage performance was yet to be tested, the designer had taken the opportunity to review the adequacy of the drainage design. From the review, it was noted that the original design had underestimated the catchment area for the crest channel design. Eventually, the size of crest channel was increased from 300 mm to 450 mm wide. While the drainage capacity of the channel was not to accommodate the subject severe overland flow, an upstand was incorporated in the crest channel to guard against possible overshooting of flow onto the slope in light of this incident.

The incident showcases an example of cascading failures under the dense urban settings where severe overland flow could trigger a sizeable landslide. The incident also highlights the importance of appreciating adverse topographical settings and their implications, e.g. sloping roads acting as conduits channelising high-velocity flow and possible spillage at road bends, which may warrant particular attention in slope drainage design. Where a slope could be subjected to the impact of overland flow fed by surface catchment well beyond the immediate upslope area, precautionary measures such as the provision of upstand or baffle wall at the slope crest should be recommended. Moreover, the incident serves to remind that the catchment area for surface channel design should be cautiously assessed.

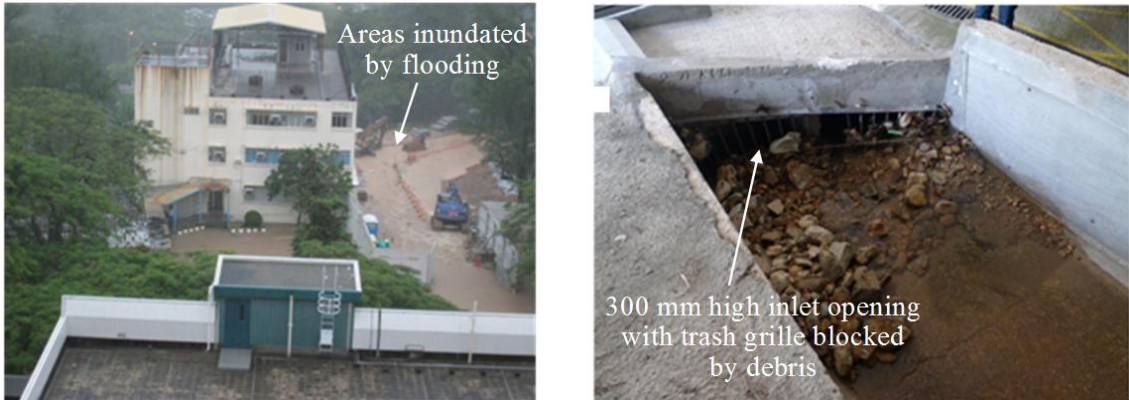
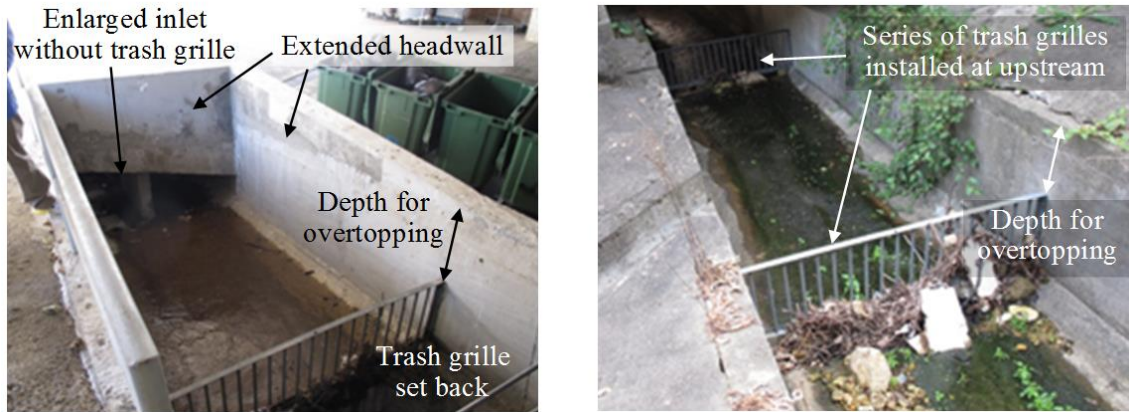
Figure 3.3 Flooding at Haven of Hope Hospital in July 2010

Flooding Arising from Overflow at a Blocked Culvert Inlet

Post-incident Drainage Improvement Measures

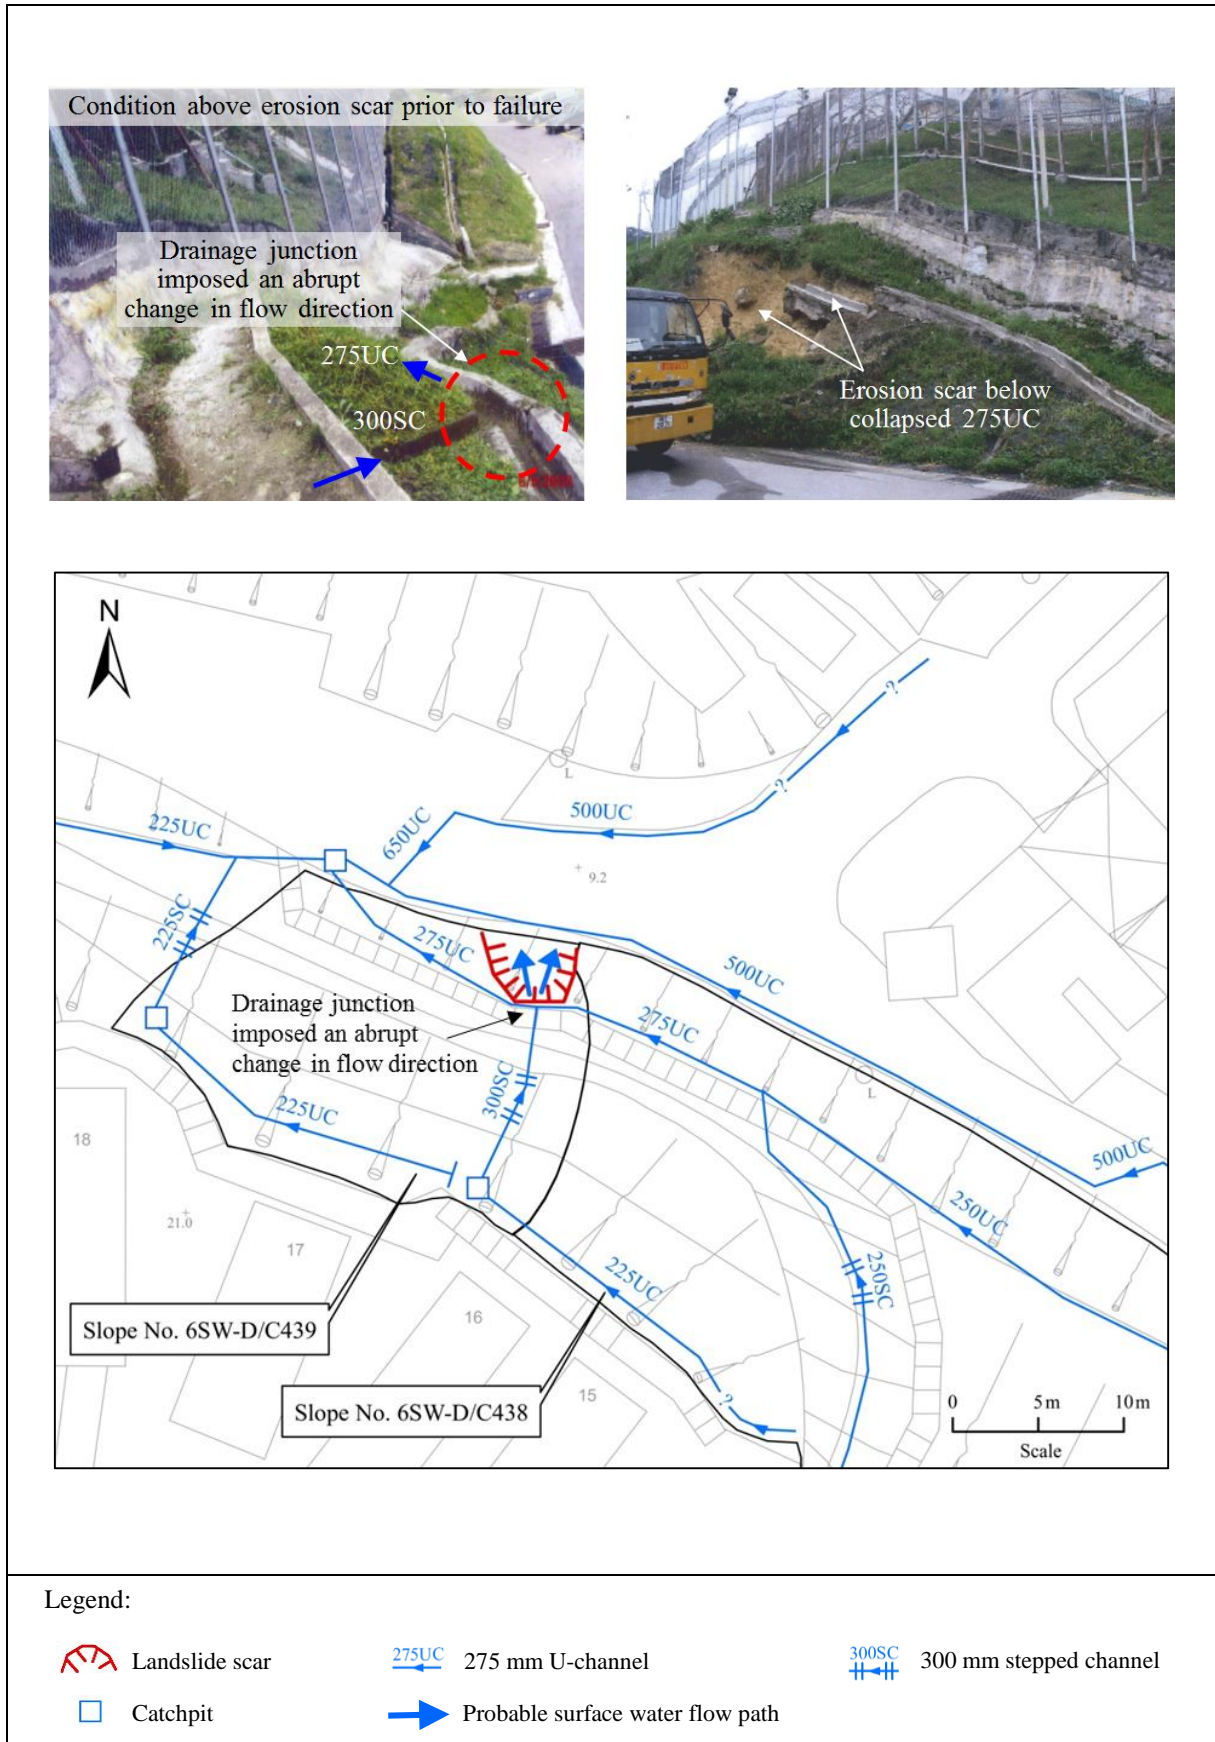
Figure 3.4 Washout at Tai Lam Correctional Institution in April 2009

A minor washout with a failure volume of about 10 m³ occurred on a soil cut slope (Feature No. 6SW-D/C439) at Tai Lam Correctional Institution, Tuen Mun (Figure 3.4). The rainfall preceding the incident was not intense, with a return period of less than 2 years. The slope was upgraded in 2004 and the failed portion, being 50° inclined, was installed with soil nails and covered with erosion control mat and wire mesh.

diverted from outside the slope. The incident also emphasises that even engineered slopes provided with robust structural support and adequate surface protection measures are liable to failure if there is deficiency in drainage detailing.

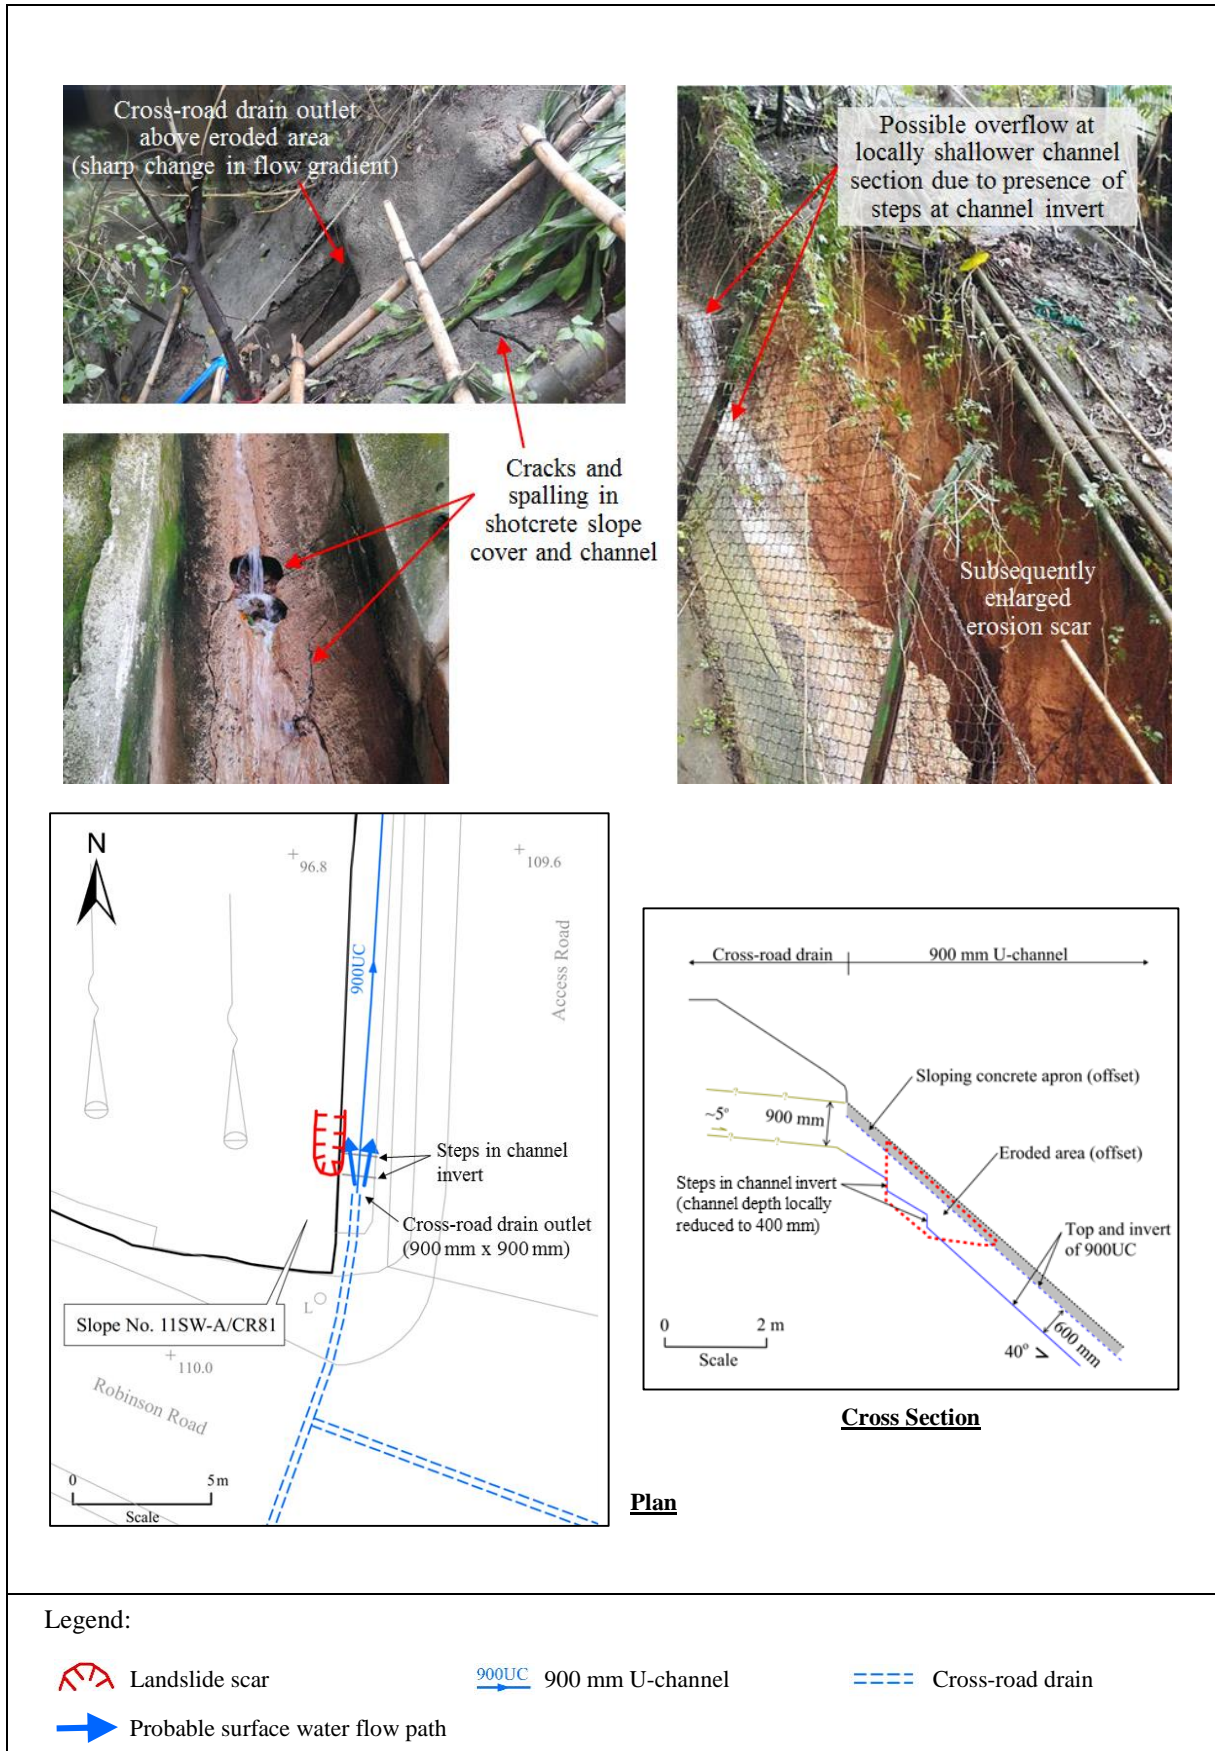
Figure 3.5 Washout below Robinson Road in June 2017

A minor washout with a failure volume of about 1 m³ occurred on a soil cut slope (Feature No. 11SW-A/CR81) below Robinson Road, Mid-levels (Figure 3.5). The rainfall preceding the incident was not particularly intense, with a return period of about 5 years. The slope was upgraded in 1989 and 2013. The failure occurred on the locally unsupported portion near the slope crest, being 40° inclined, that was covered with shotcrete. At the time of the incident, construction for a school redevelopment project was in progress at the toe area of the slope. Although the scale of failure is small, it could result in notable consequence had the school been in use.

The incident involved erosion of a local strip of ground aside a 900 mm down-the-slope U-channel. The eroded area was immediately below (< 1 m) the outlet of a cross-road drain that conveyed flow largely from the hilly areas above Robinson Road. The cross-road drain had a relatively gentle fall (approx. 5°) while the 900 mm U-channel followed the slope profile with an overall gradient of about 40°. Adjoining the upper part of the eroded area, the channel section was particularly shallow, viz. a depth of 400 mm comparing with the typical depth of 600 mm at other channel sections, given the presence of two isolated steps in the channel invert. As revealed from post-landslide inspections, the shotcrete slope cover in the proximity of the eroded area and the 900 mm U-channel were both in a poor state of maintenance as evidenced by the cracking and spalling. Discharge at high velocity was observed from the cross-road drain outlet. With the sharp change in flow gradient and the reduced channel depth, the section of 900 mm U-channel concerned was susceptible to overshooting and overflow under heavy and high-velocity flow. Despite the said deficiency in drainage detailing, no instability was recorded in the past probably due to the presence of sloping aprons which might have returned any spillage back to the channel. Although the failure location was covered with hard surface, lack of maintenance and deterioration rendered it vulnerable to the washout failure.

The incident highlights the importance of proper detailing at channel sections or junctions involving a sharp change in flow gradient where provision of proper containment measures, e.g. channel covers, may be warranted. Where a step is provided within a channel, it could form a spot vulnerable to overflow if the freeboard is insufficient. The case also reiterates the importance of regular slope maintenance to upkeep the condition of drainage measures as well as slope surface cover against erosion and water ingress.

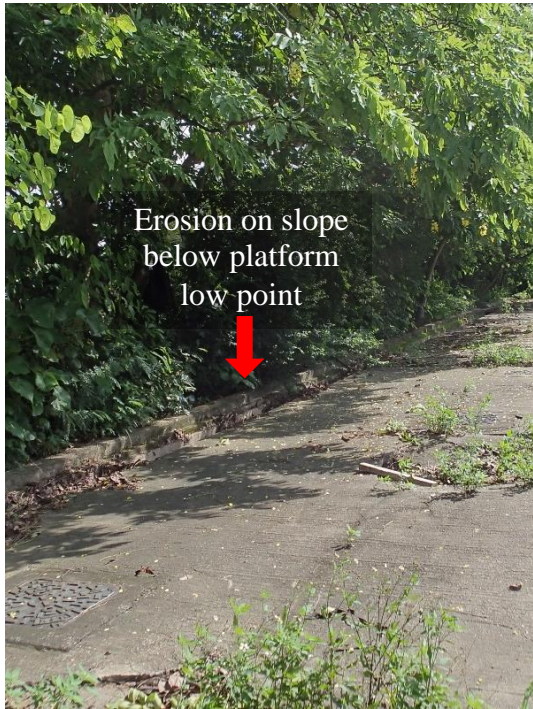
(a) Low Point with Insufficient Measure to Guard against Overflow

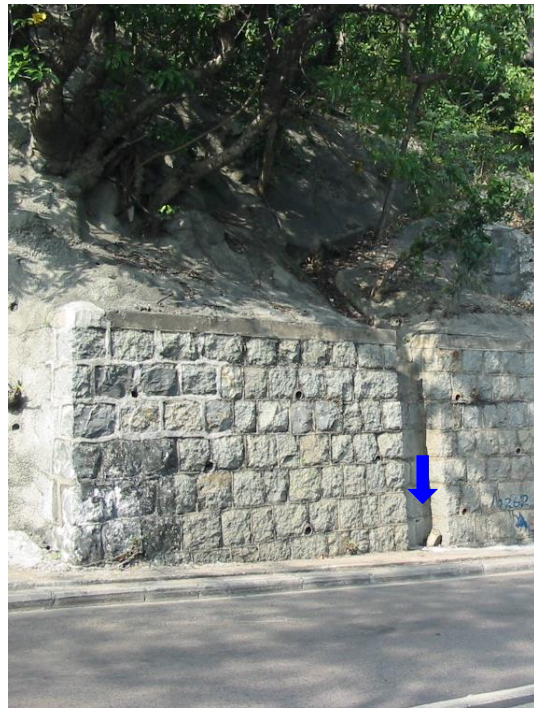
(b) Discharge of Runoff from Slope Directly onto Road Surface

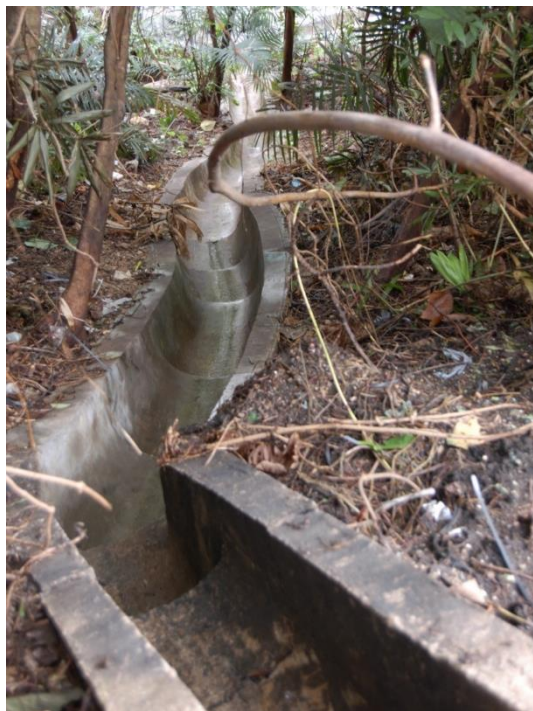
(c) Channel Section with Abrupt Change in Flow Direction being Prone to Spillage

- (a) Inadequate fall or uneven surface hampering the drainage performance and the self-cleansing capability of a channel,
- (b) Abrupt change in flow direction or gradient susceptible to spillage, e.g. modification to suit actual site conditions (also refer to Section 4.2.5 and Figure 4.2(c)),

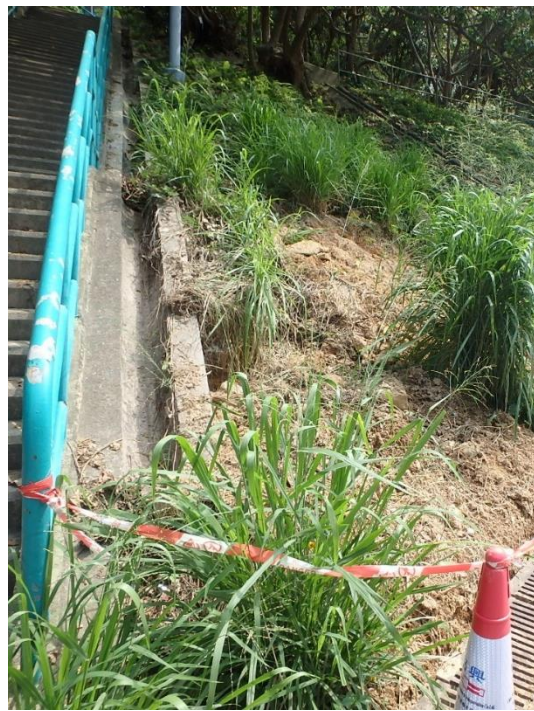
(d) Erosion Adjoining Channel with Apron of Limited Width

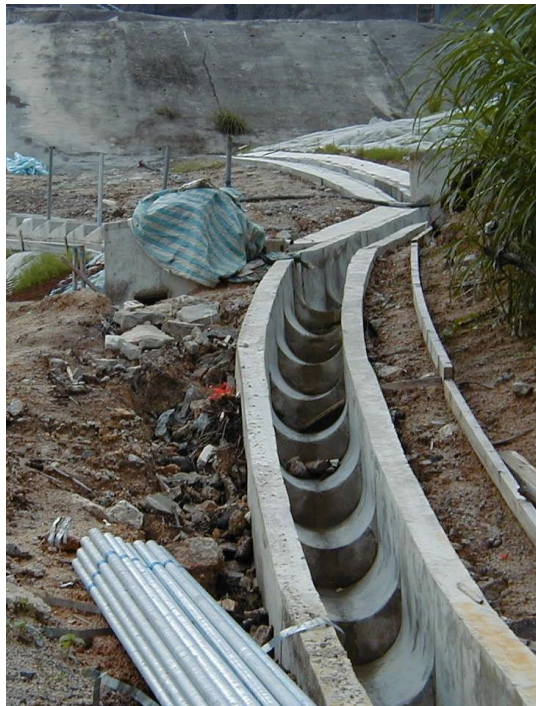
(e) Channel Sidewalls above Adjoining Ground with Erosion along the Side of Channel

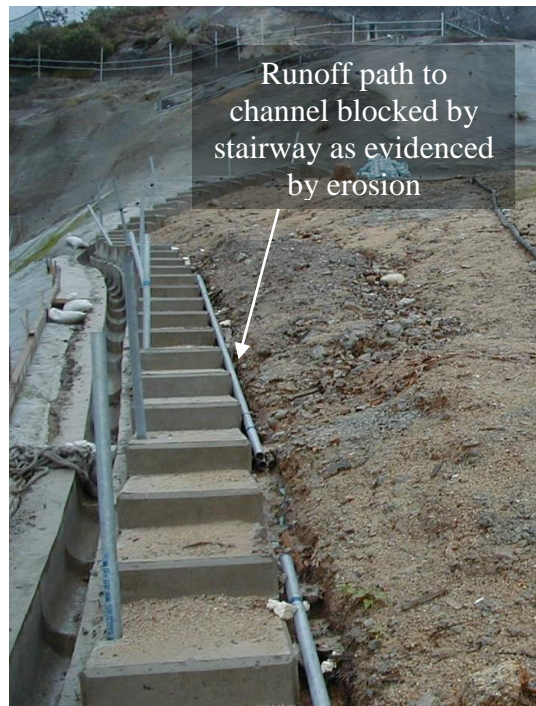
(f) Concrete Stairway Preventing Surface Runoff from Getting into Channel

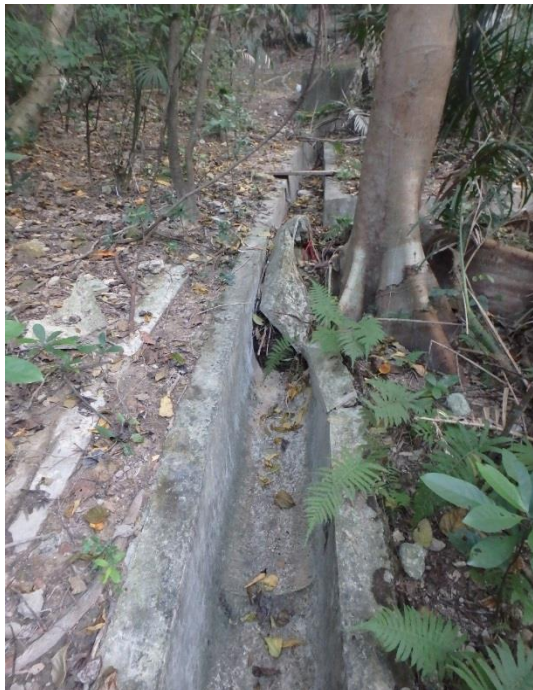
(g) Channel Damaged by the Root Growth of a Tree in Close Proximity

- (e) Channels aligned in close proximity to trees with the potential of damage, blockage or heave by tree root growth (also refer to Section 4.2.5 and Figures 4.2(g) & (h)), and

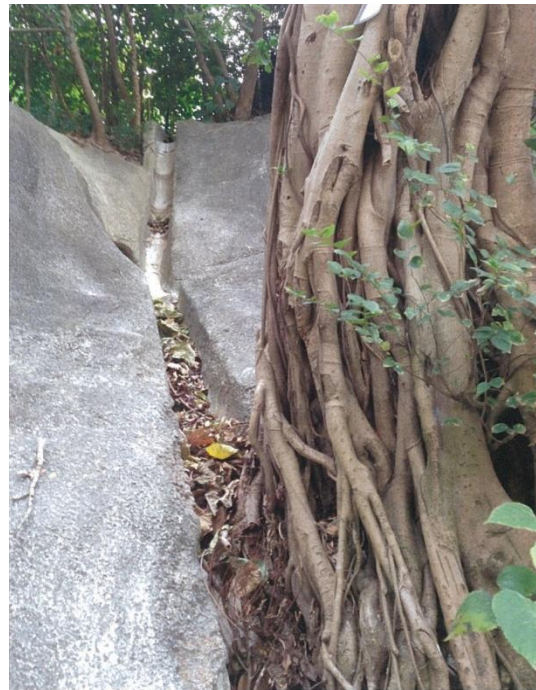
(h) Channel Blocked by the Root Growth of a Tree in Close Proximity

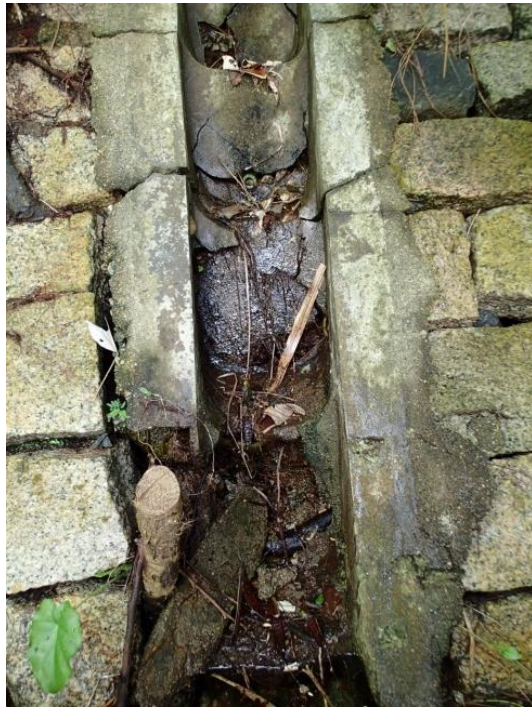
(a) Heavily Cracked Channel

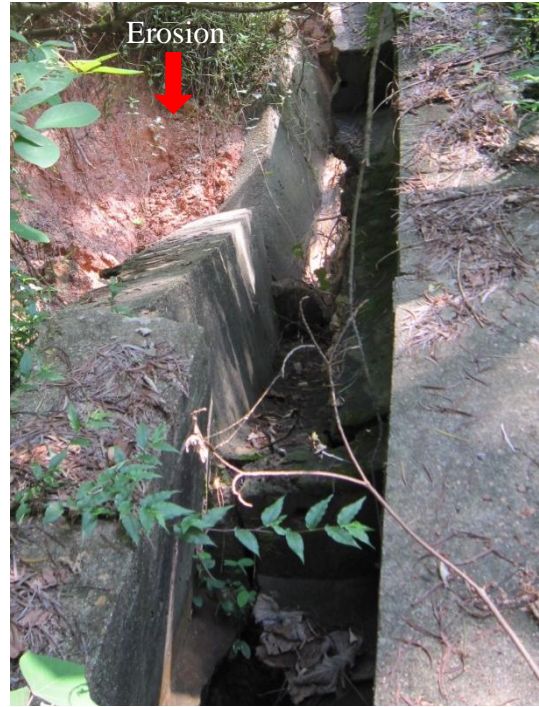
(b) Dislodged Channel Sidewall

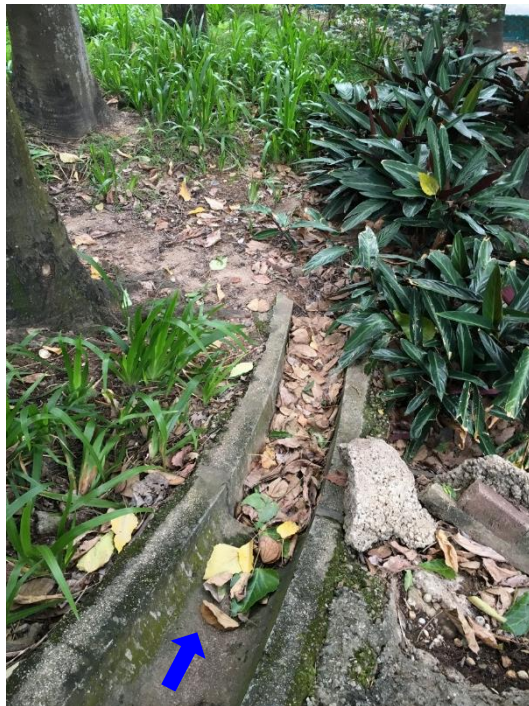
(c) Channel Blocked by Vegetation and Withered Leaves

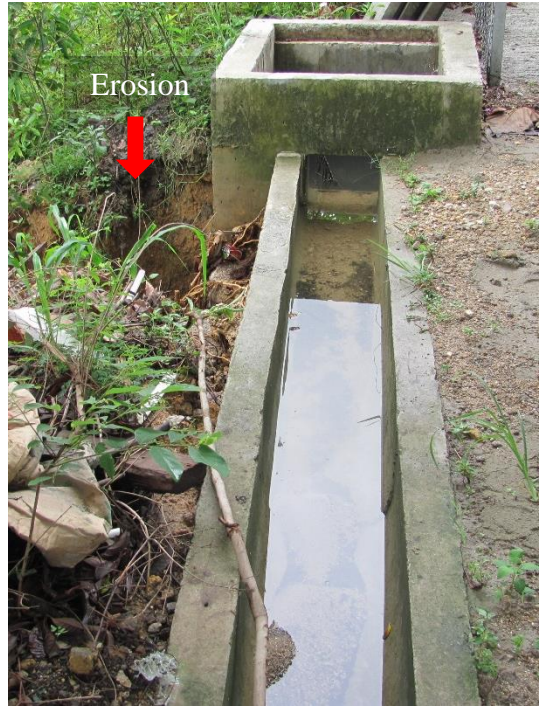
(d) Backing Up of Water within Blocked Channel and Catchpit

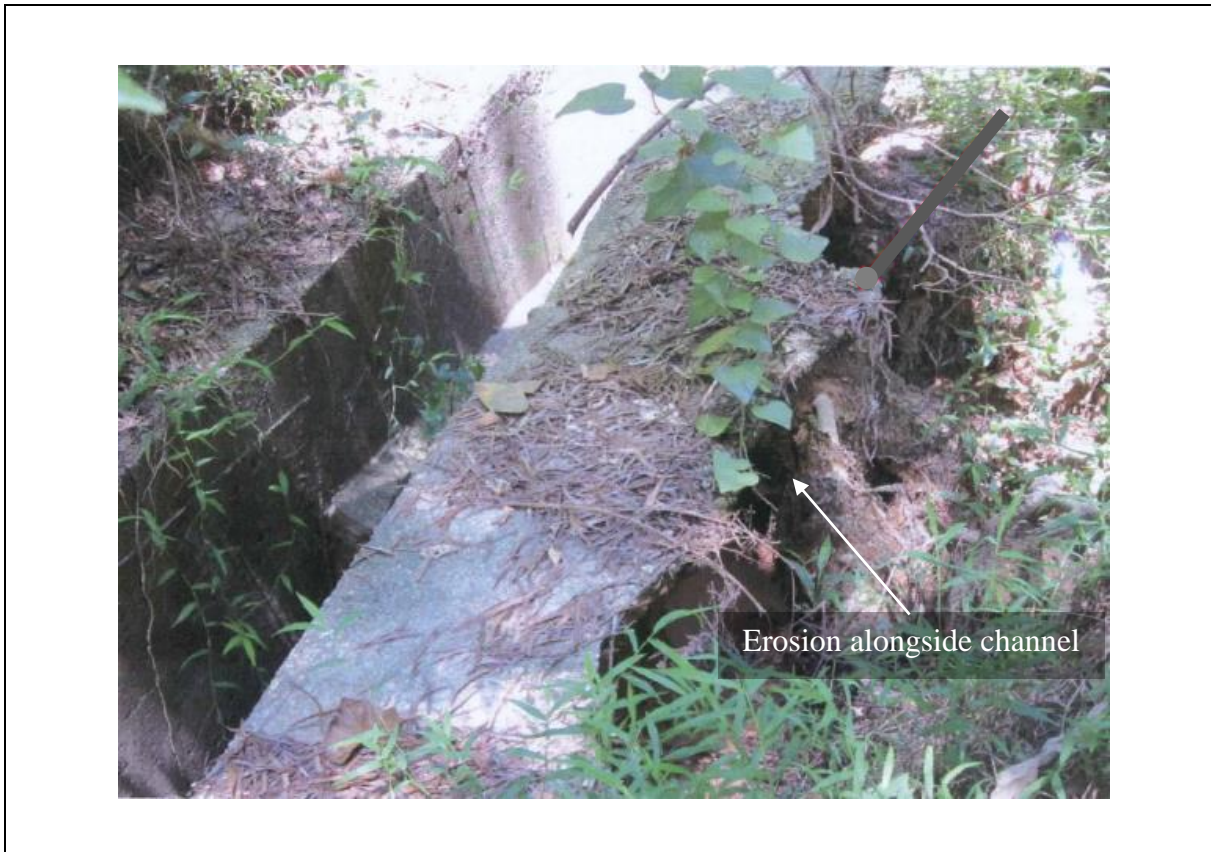
Figure 4.5 Example of Sign of Drainage Deficiency

It is crucial to regularly appraise the drainage performance and the adequacy of the maintenance access provided (also refer to Section 3.3). Apart from blockage and deterioration, maintenance inspections should take note of any probable drainage deficiency particularly during the periodic inspections conducted by professionally-qualified engineers. Signs of drainage deficiency are often noticeable, e.g. water ponding or erosion alongside channels especially if they are clear from blockage (Figure 4.5) may reveal inadequate drainage layout/detailing or undersized channels. If the adequacy of a drainage system is in doubt, inspections may be arranged during rainstorms to ease identification of drainage problems. Maintenance inspections may also be extended to the area beyond the boundary of a slope, e.g. where sign of concentrated flow is observed diverting towards the slope. For sites involving change in surface cover, due attention should be paid to the change in surface runoff characteristics as these may be significantly altered. Apart from field observations, engineers should take opportunity to review the records of maintenance inspections and works, and any reports of recent landslides to examine if these reveal any concern on drainage. Where maintenance works are repeatedly required at a particular location such as the reinstatement of areas of serious erosion, the problems should be investigated. Drainage improvement measures may be implemented to enhance the flow efficiency where necessary.
