# **Detailed Study of the 29 August 2018 Landslides on the Natural Hillside above Fan Kam Road, Pat Heung**

**GEO Report No. 363**

**AECOM Asia Company Limited**

**Geotechnical Engineering Office  
Civil Engineering and Development Department  
The Government of the Hong Kong  
Special Administrative Region**

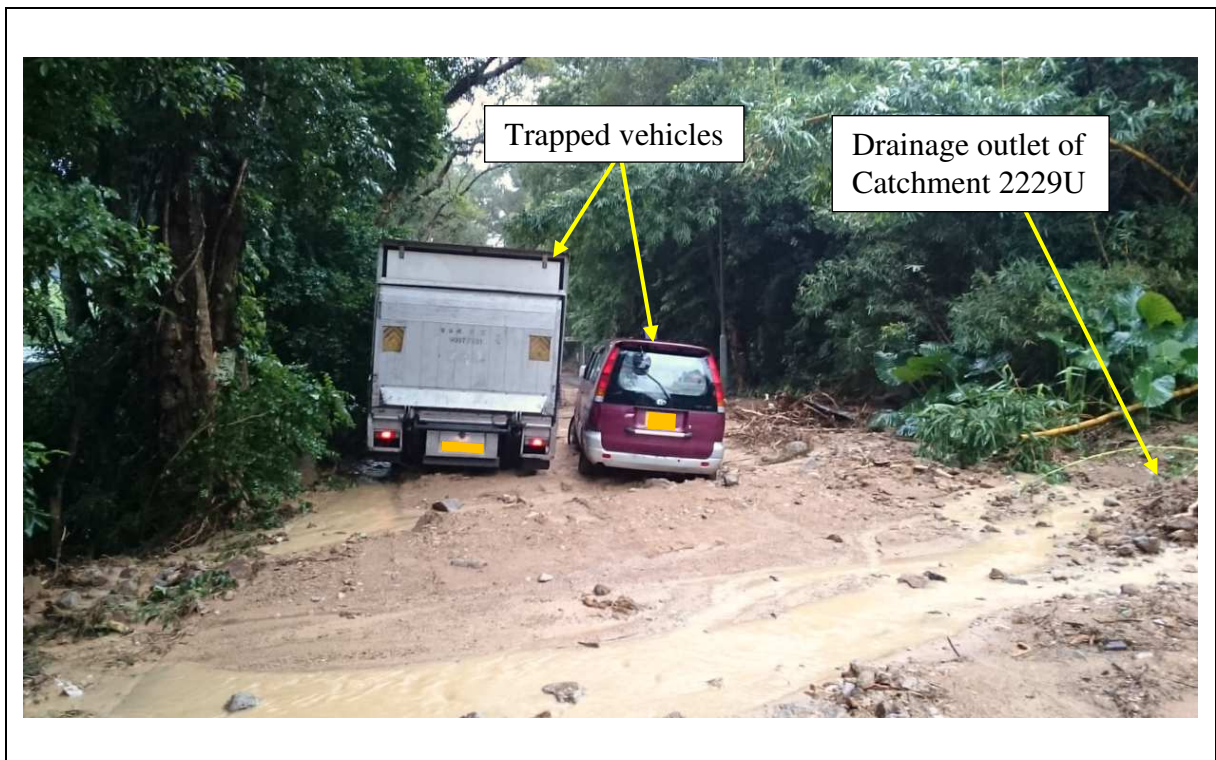
**Figure 3.3 View of Outwash Debris on Fan Kam Road from Landslide Cluster 2229U (Photograph taken on 30 August 2018)**

Outwash debris mainly comprising water sorted silty sand and gravel was observed on Fan Kam Road and further downslope, which had been transported by post-failure fluvial processes (Figure 3.3).

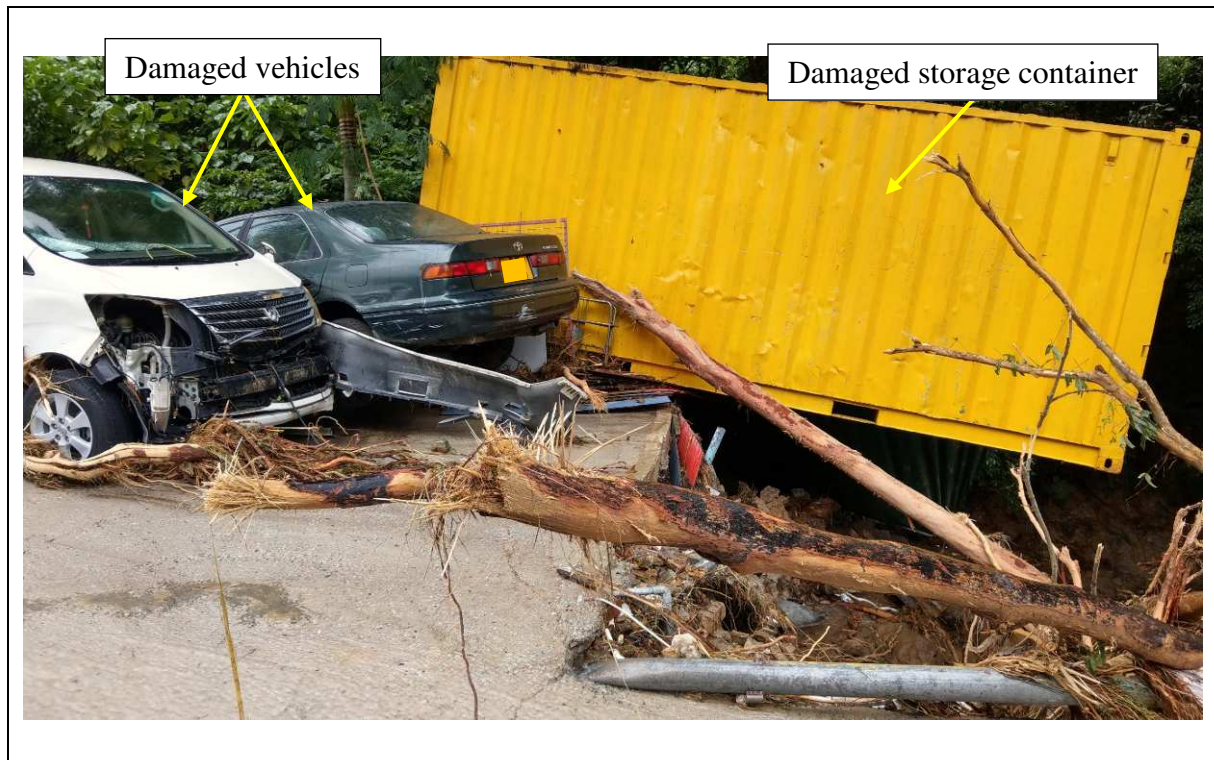
**Figure 3.4 Damaged Vehicles and a Container (Photograph taken on 30 August 2018)**

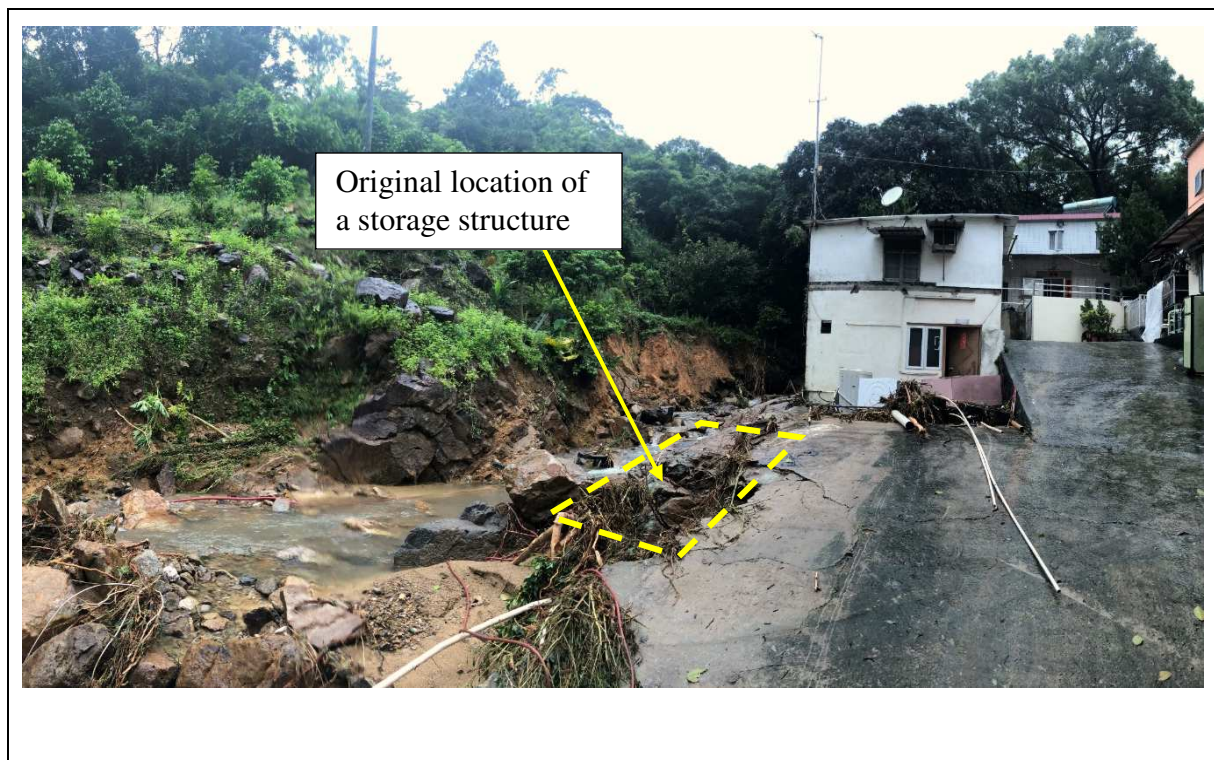
The landslides typically initiated as open hillslope failures from multiple sources areas within the landslide clusters. Debris from most of the source areas at landslide clusters 2228 and 2229U converged into drainage lines and became channelised debris flows descending towards Fan Kam Road, with a runout distance of about 300 m excluding outwash debris. The landslide debris mostly came to rest before reaching Fan Kam Road but outwash debris inundated both lanes of the road resulting in temporary road closure (Figures 3.2 and 3.3). The debris front, containing many boulders, impacted and blocked a cross-road culvert resulting in diversion of stream water and outwash over an access road incurring damage on several vehicles and a container (Figure 3.4). A storage structure adjoining a village house adjacent to the debris trail of landslide cluster 2228 was also reported to have been washed away (Figure 3.5).

**Figure 3.5 A Storage Structure Adjoining to Debris Trail of Landslide Cluster 2228 Reported to have been Washed Away (Photograph taken on 30 August 2018)**

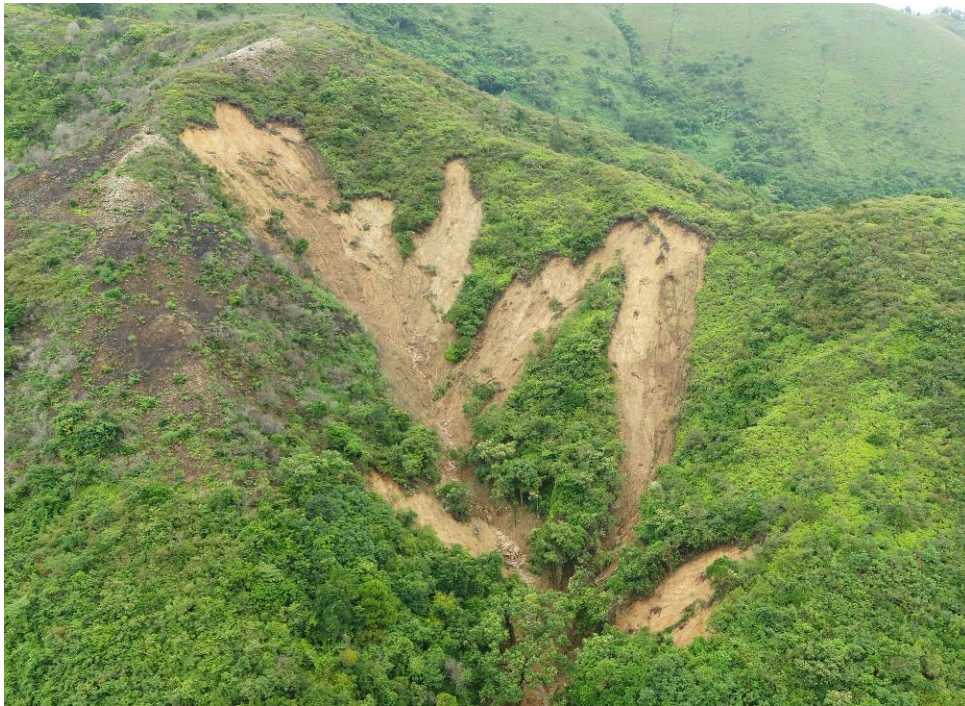
(a) General View of Source Areas of Landslide Cluster 2228

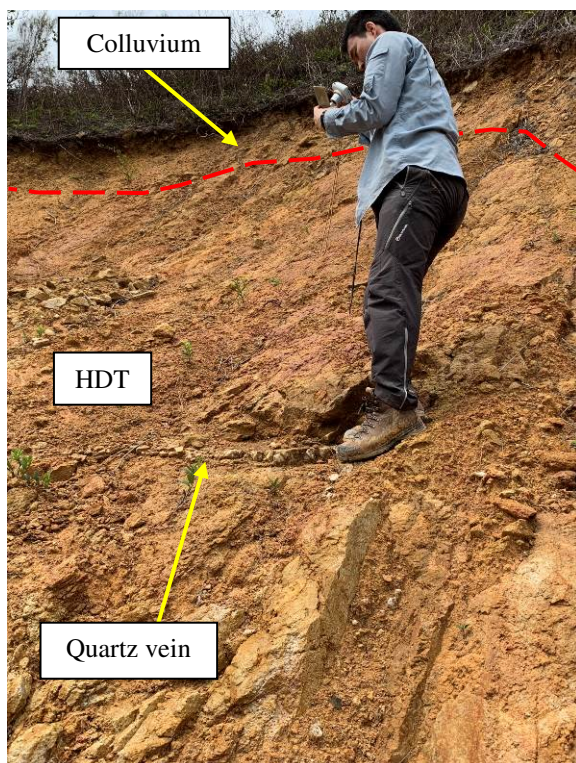
The materials exposed within the main scarps, indicating the detached materials, are mainly colluvium comprising firm to stiff, yellowish brown, sandy silt with some fine to coarse gravel-sized tuff and occasional quartz fragments, overlying minor amounts of C/HDT. Failures generally occurred along the interface between colluvium and underlying weathered tuff (Figure 5.5b). Many source areas have significant proportion of H/MDT exposed in the source floor, where discontinuous joint surfaces were observed, some of which are dipping parallel to the slope (Figure 5.5c), although the persistence is insufficient to control failure. Quartz veins up to 80 mm thick and continuous over two to three meters were observed within some of the source areas which are generally dipping into the slope. Noting that many of the source areas were covered by remoulded debris limiting the exposure, it is anticipated that the actual extent of quartz veins within the source areas could be greater. Soil pipes (generally 25 mm to 100 mm diameter) were observed in many of the main scarps, particularly at the interface of colluvium and weathered tuff. Several minor tension cracks were observed around the main scarps of some of the landslides and could not be traced more than a few metres from the main scarps. These cracks are probably associated with the recent instability since the cracks are free of vegetation.

(b) View of L2 Showing Predominant Materials of the Landslides

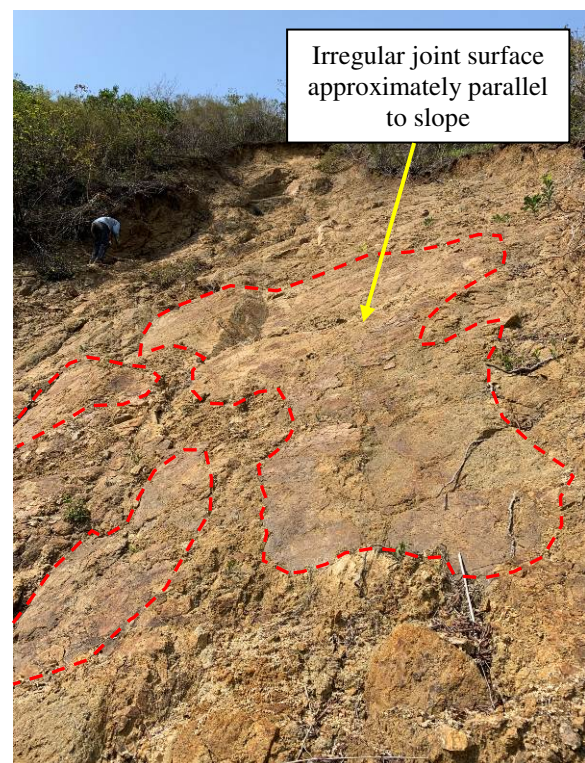
(c) View of L6 Showing Rock Forming Part of Source Floors

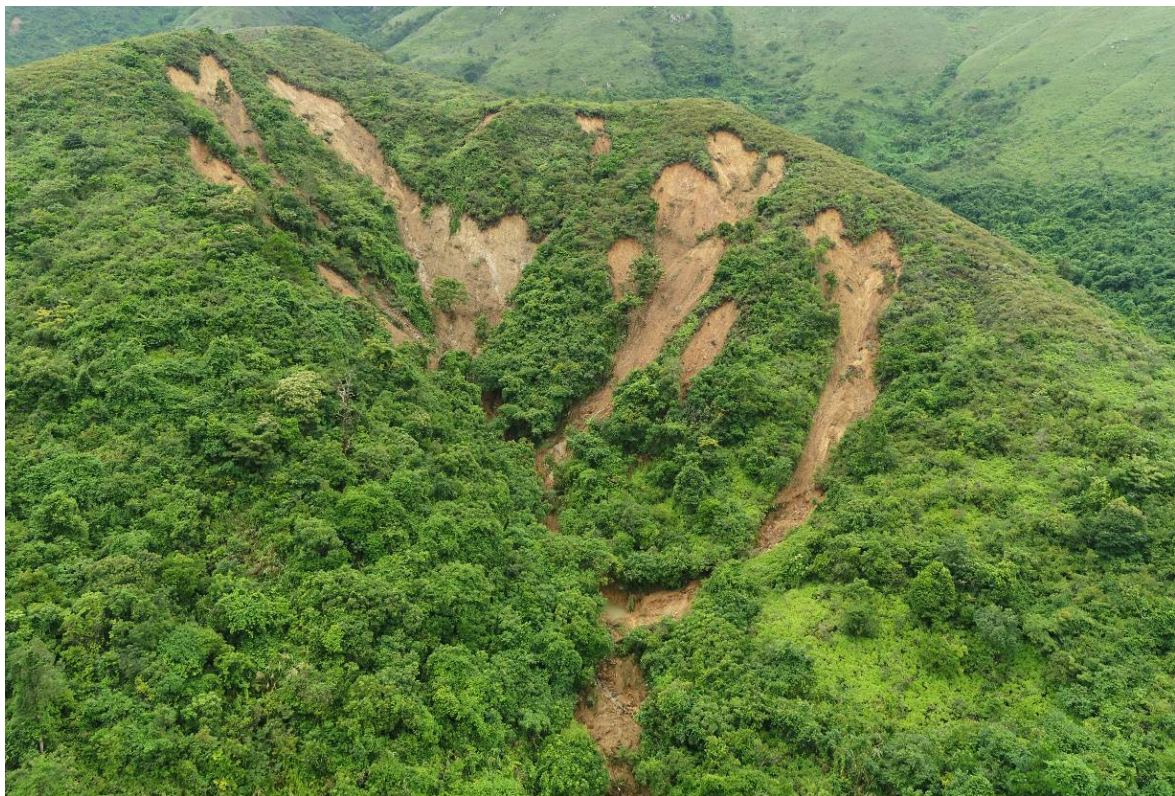
(a) General View of Source Areas of Landslide Cluster 2229

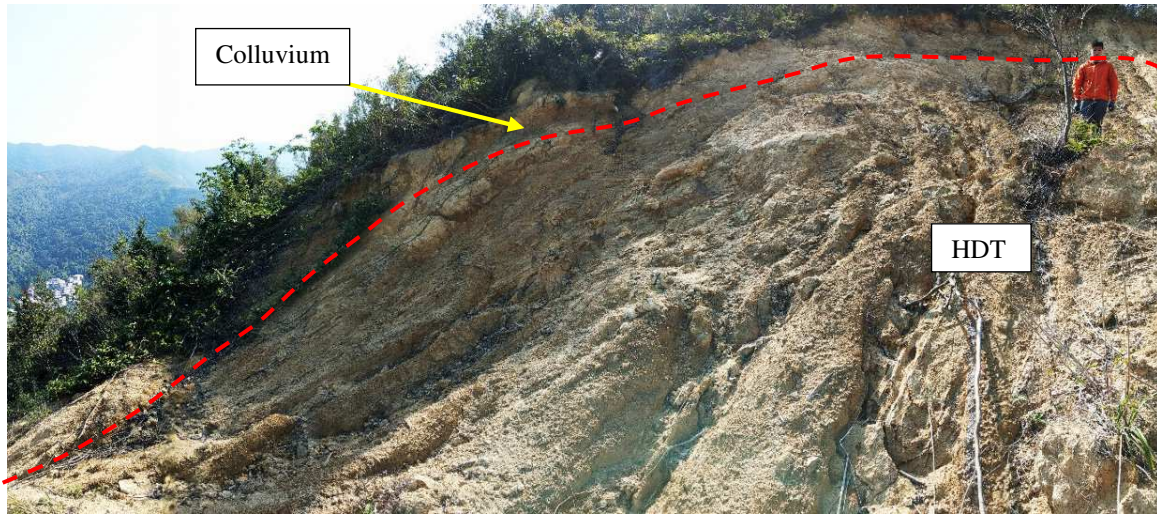
(b) View of L20 Showing Predominant Materials of the Landslides

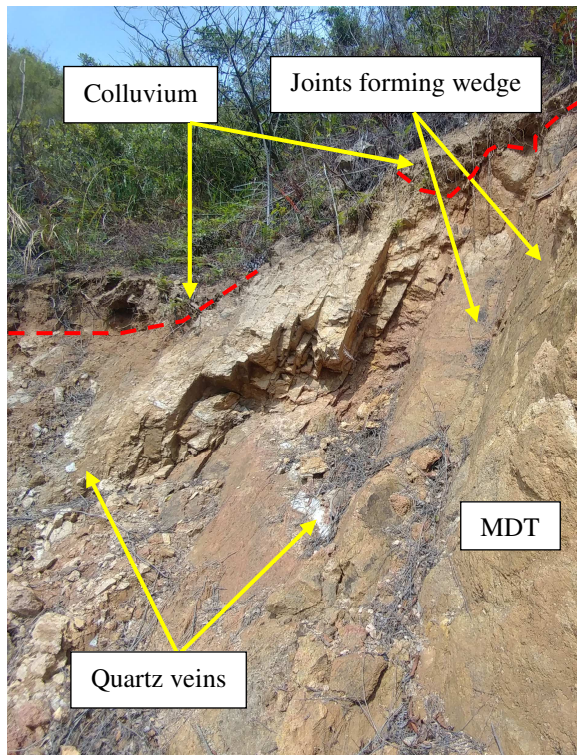
Several bands of persistent quartz veins up to 200 mm thick could be locally observed at source areas L25 and L26, which are generally dipping into the rupture surface (Figures 5.6c). Some quartz veins of about 10 mm thick are also present at source area L31 which are likely to be quartz infill along joints. Similar to landslide cluster 2228, soil pipes (generally 50 mm to 100 mm diameter) with minor infilling of silty sand and several minor tension cracks were occasionally observed in the main scarps of some of the landslides.

(c) View of L25 and L26 Showing Quartz Veins and Rock Joints Forming Wedge

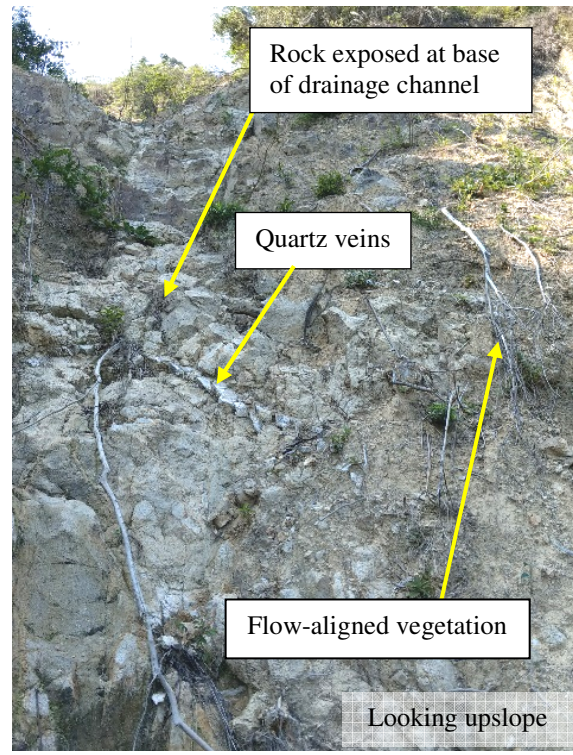
(d) View of Debris Trail from CH60 to CH80 Showing Transportation Process

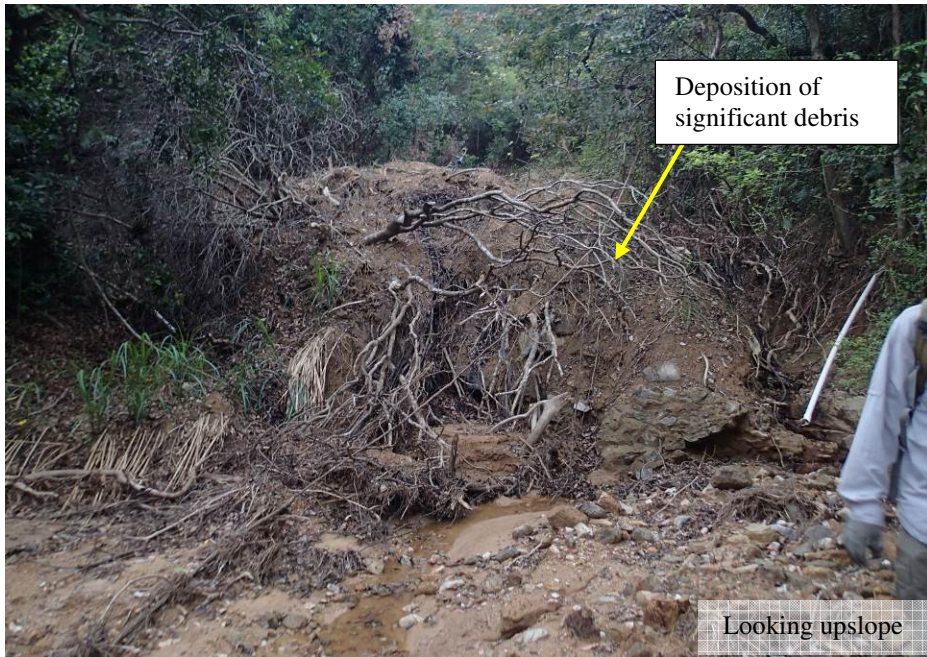
(e) View of Debris Trail from CH190 to CH200 Showing the Deposition Zone

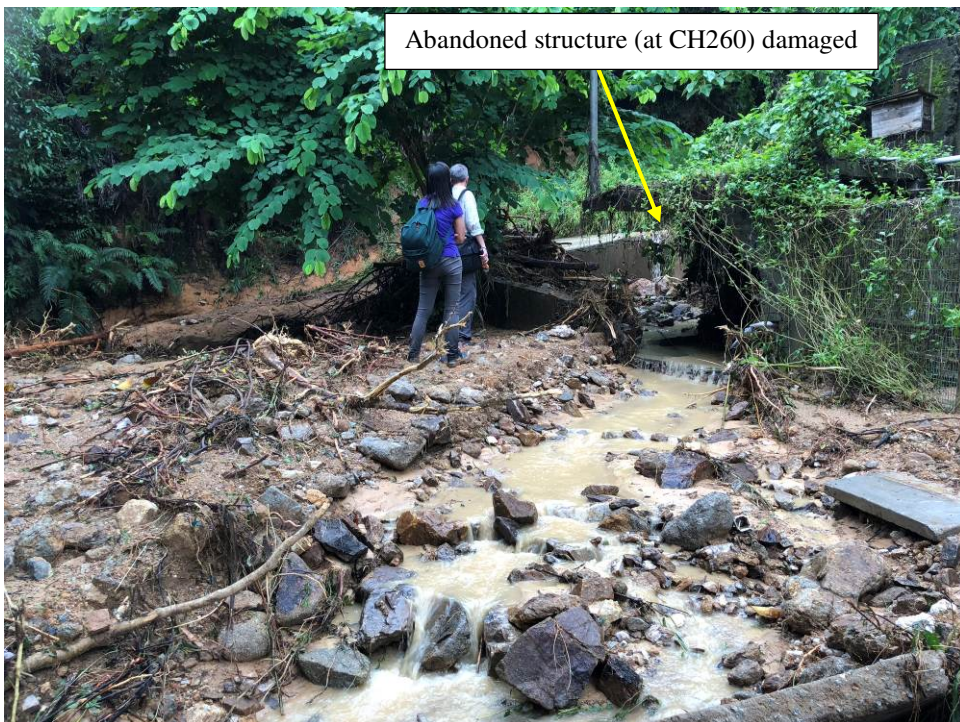
suggest that the amount of entrained materials is relatively modest (about 150 m<sup>3</sup>). With relatively little overall deposition in the debris trail (about 90 m<sup>3</sup>), most of the debris continued downstream. Below Chainage 160, the slope angle reduced to about 10° and the channel becomes less incised, with some relatively flat terrace-like areas along the drainage line. The change in drainage line morphology and slope angle resulted in the onset of significant deposition. Between Chainage 160 and 300, about 450 m<sup>3</sup> of remoulded debris and coarse clastic debris was deposited (Figure 5.6e). Abandoned structures at approximately Chainage 210 and 260 appear to have been destroyed or damaged by the debris flow. At Chainage 300 just before reaching the Fan Kam Road, a significant proportion of cobbles and boulders was observed which likely formed the debris front (Figure 5.6f).

(f) General View Near the End of Debris Trail

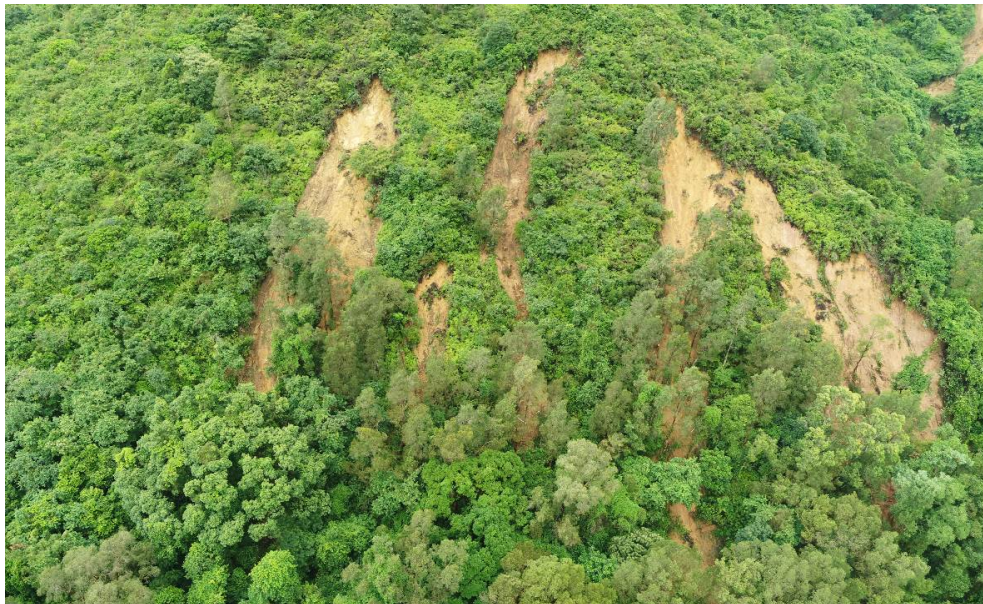
Landslide cluster 2229L comprises three distinct source areas (L14 to L16) and three adjoined source areas (L17 to L19), and being open hillslope failures, most of them appear to spread and coalesce downslope (Figure 5.7a). The source areas are located within a steep open hillslope terrain (typically 35° and 40°) directly above a cut slope (Feature No. 6NE-B/C12) adjacent to Fan Kam Road (Figure 5.2). The source areas are relatively shallow with an average failure depth of about 0.8 m, giving a total estimated volume of detached materials of about 200 m<sup>3</sup>.

(a) General View of Source Areas of Landslide Cluster 2229L

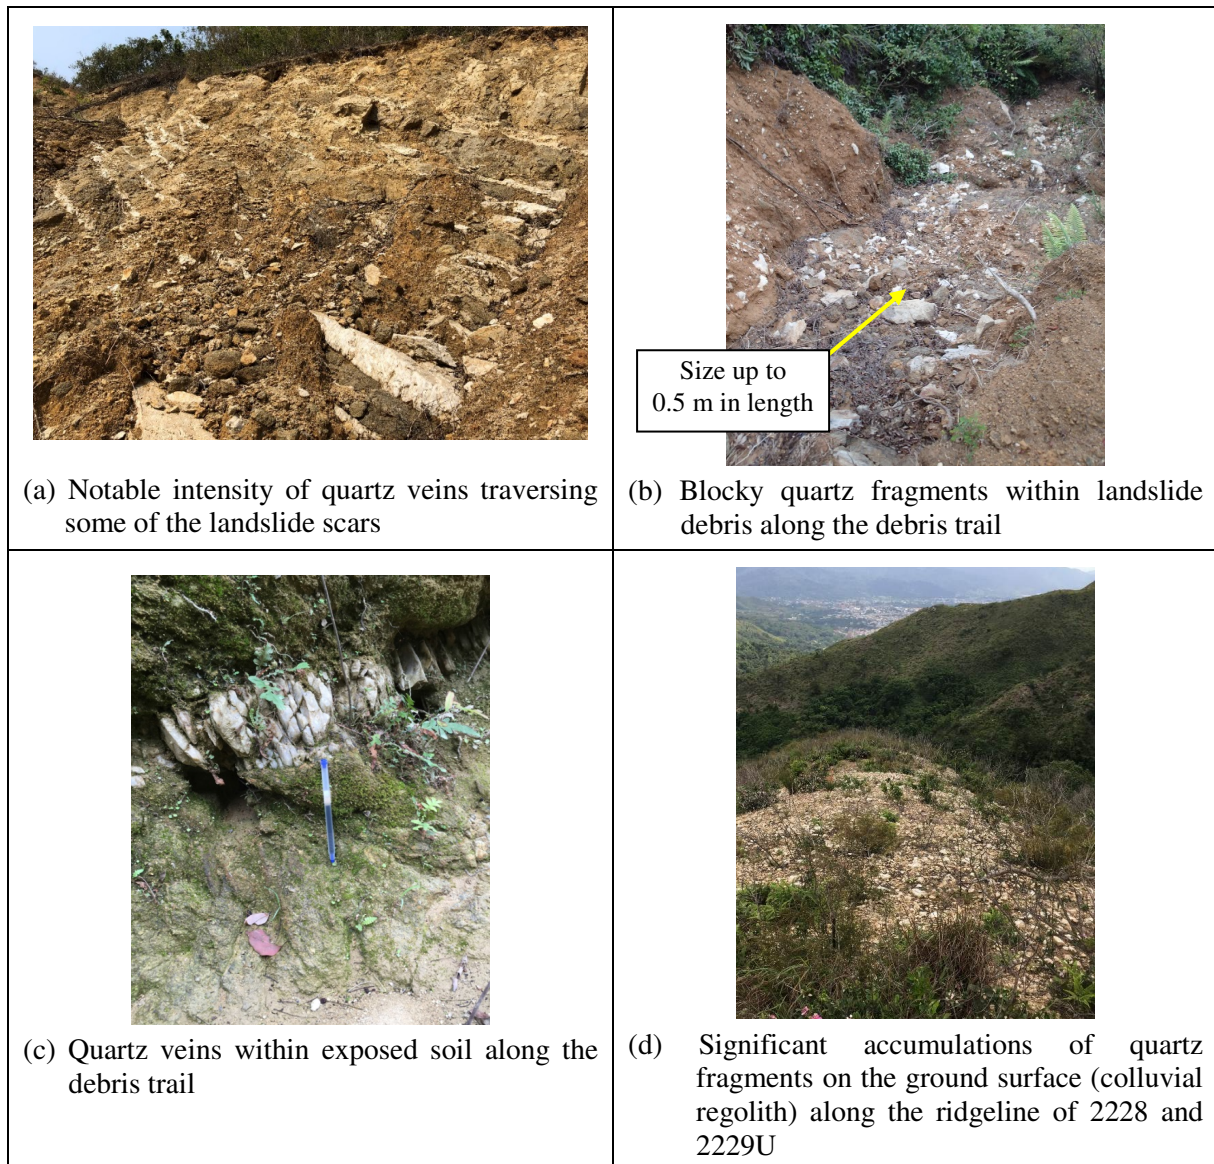
Referring to Section 2.2, the northeast-trending regional Tai Lam Fault is located along Fan Kam Road, adjacent to the three catchments. As revealed by field mapping and a review of existing ground investigation records, the locations of the three landslide cluster areas proximate to Fan Kam Road aligned with the Tai Lam Fault appears to be coincident with a high intensity of persistent quartz veins (up to 200 mm wide) within the landslide source floors and debris trails. In addition, quartz fragments and blocks were observed on the landslide scarps, within the landslide debris and on the ground surface along the ridgeline (Figure 6.4). Some existing ground investigation records also identified quartz fragments in the colluvium in addition to quartz veins in the weathered tuff. The notable intensity of quartz in the insitu weathered materials as well as the superficial deposits may reflect a potentially higher degree of hydrothermal and metamorphic activities in association with the regional Tai Lam Fault along Fan Kam Road. Reference can be made to Sections 2.2 and 5 for other information pertaining to the site geology.

**Figure 6.4 Quartz Veins and Quartz Fragments**

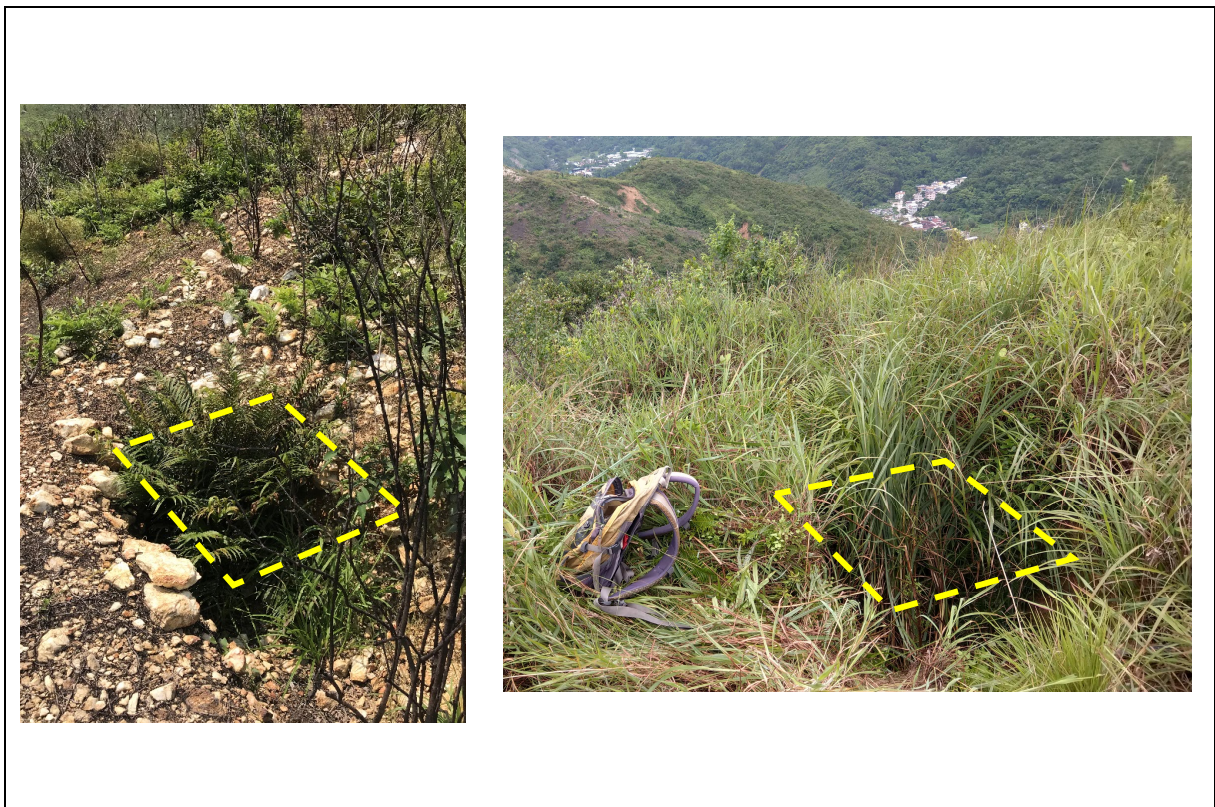
As revealed by API, there are several apparent excavation pits/trenches, considered to be mostly related to past military or mining activities, proximate to the three landslide clusters in particular on the ridgeline above landslide cluster 2229U (Figure 4.1). It is noted that only a few 2018 landslides are situated close to the pits/trenches. The other landslides are several ten metres away from the pits/trenches. With regard the present conditions, the pits/trenches (typically less than 1m in depth) are generally degraded with vegetation growth over time (Figure 7.1). While the edges of the pits/trenches may form oversteepened faces increasing the susceptibility to landsliding, none of the landslides were found to have encroached into any pits/trenches. The pits/trenches may have allowed ponding, promoting enhanced infiltration into the slope which in turn increase the susceptibility to landsliding. It is noted that only about 20% of the landslides are situated at the downslope areas of the pits/trenches. As such, no strong correlation can be deduced between anthropogenic activities and the 2018 landslides.

**Figure 7.1 Conditions of Excavation Pits**
