Review of Landslides in 2021

GEO Report No. 366

C. Lam, V.S.F. Kong & R.W.H. Lee

**Geotechnical Engineering Office
Civil Engineering and Development Department
The Government of the Hong Kong
Special Administrative Region**

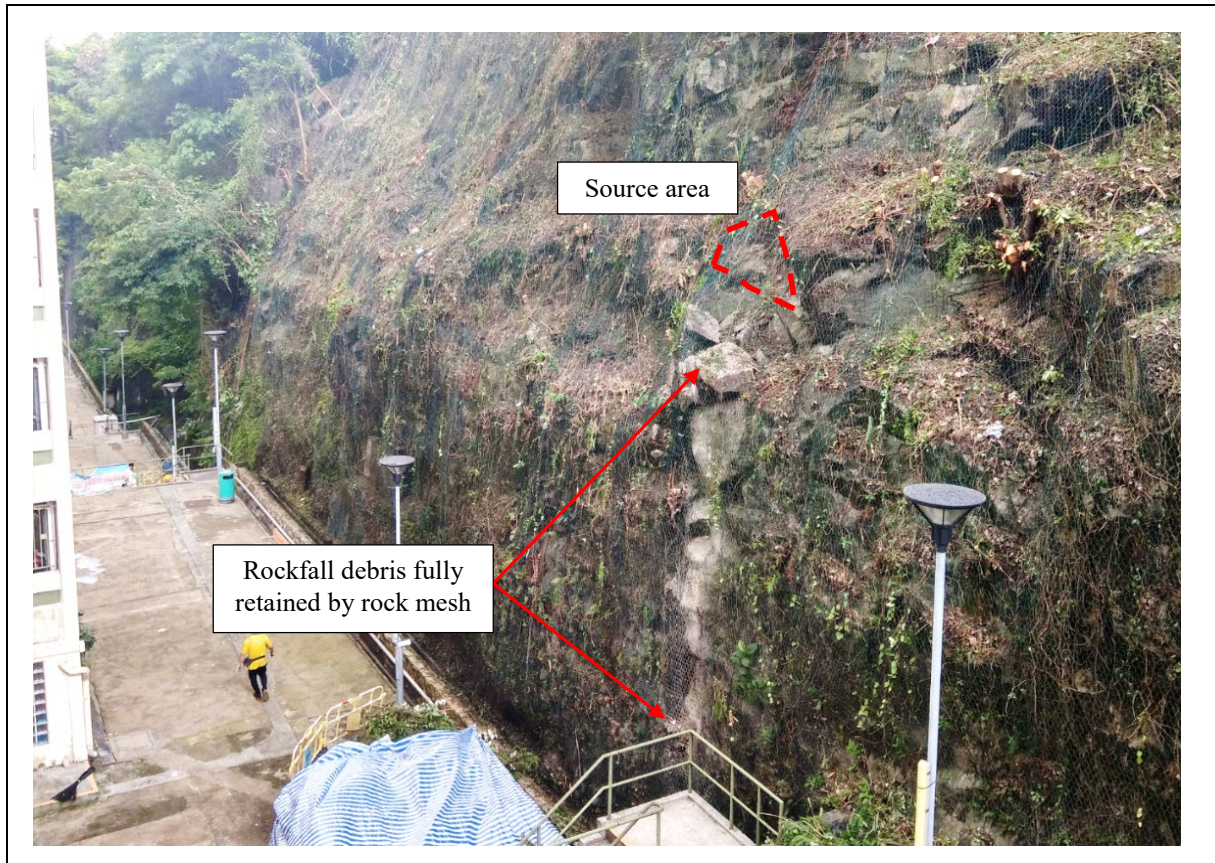
Incident No.	Slope No.	Location	Failure Volume (m ³)	Feature Type	Remarks
1. <u>Slopes Upgraded Under the LPMP/LPMitP</u> ($\Sigma = 4$ nos.)					
2021/07/3005	11NW-D/C44	Behind Lok Fung Lau (Block D), Lok Man Sun Chuen, No. 156 Kau Pui Lung Road, To Kwa Wan	1.7 (Rockfall)	Rock cut	This landslide occurred on a 70° inclined rock cut slope upgraded under the LPMP in 2004. This incident involved a rockfall under dry weather and was primarily due to the presence of adversely orientated rock joints and root wedging action (Figure B1). The rockfall debris was fully retained by a rock mesh.
2021/10/3045	11NW-A/C179	Near Jao Tsung-I Academy, No. 800 Castle Peak Road, Mei Foo	26	Soil cut	This landslide occurred on a soil cut slope upgraded under the LPMP in 1991 by slope cutting, installation of soil nails and provision of surface drainage channels. This incident involved a sliding failure of the topmost unsupported batter which had been cut back to 50° in Grade V materials (Figure B2). Post-landslide inspections revealed defects in the surface drainage channel on the platform beyond the slope crest and immediately above the landslide scar. Water ingress through holes in the channel invert into the slope could have rendered saturation of the groundmass causing the failure.

Figure B1 Rockfall in To Kwa Wan (Incident No. 2021/07/3005)

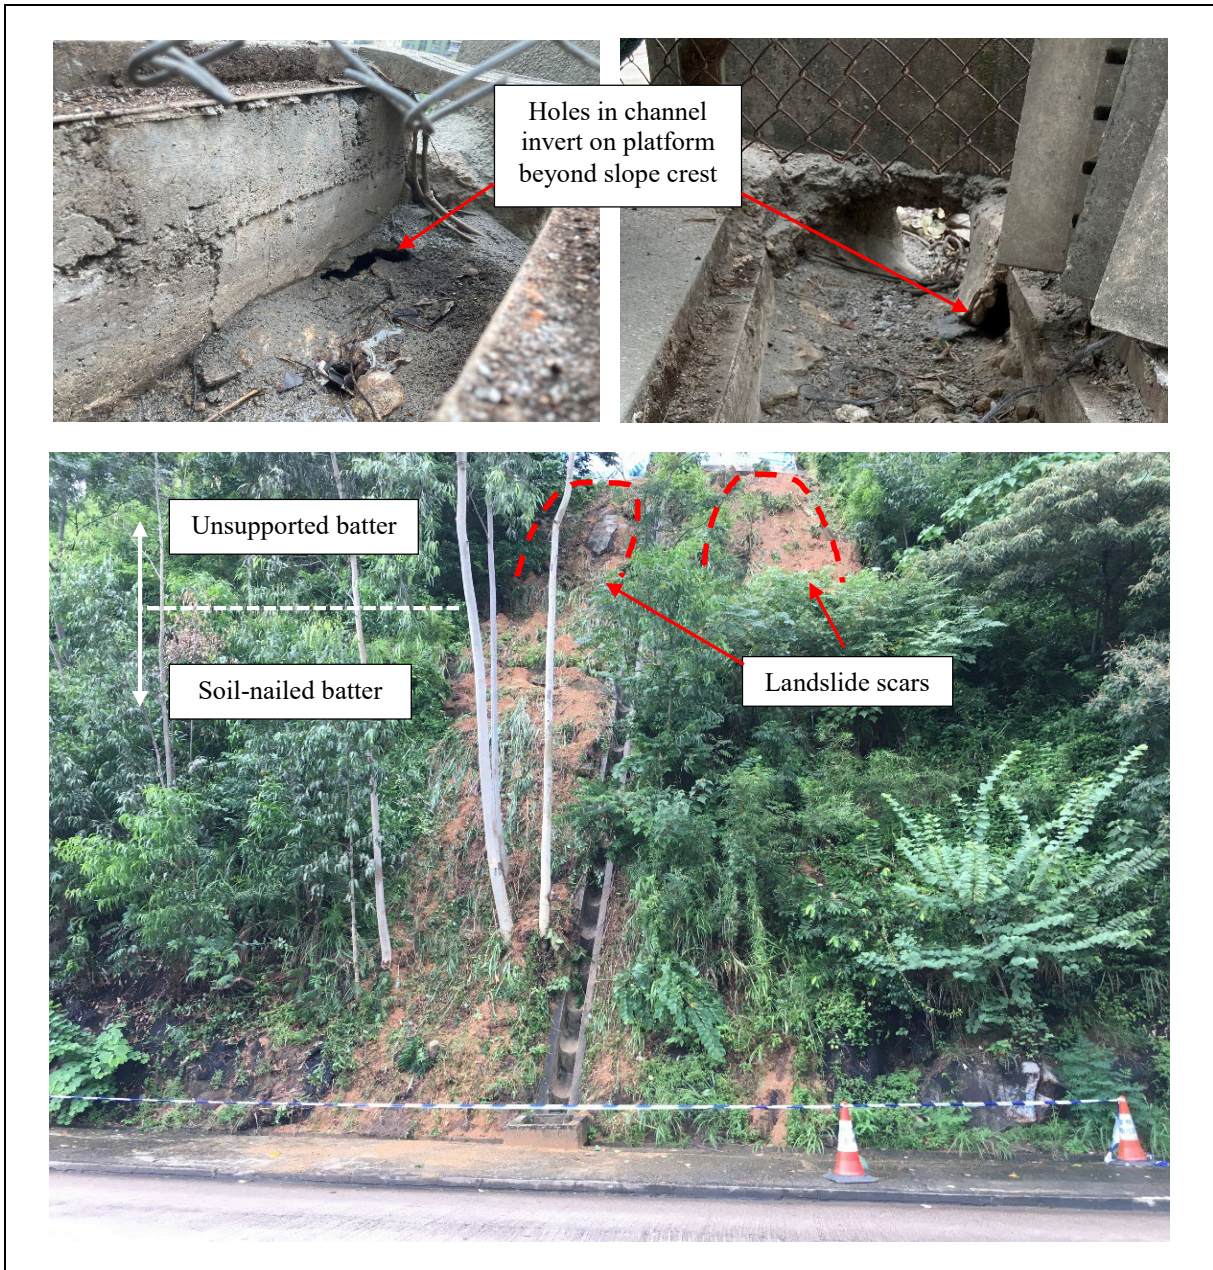
Figure B2 Sliding Failure at Castle Peak Road (Incident No. 2021/10/3045)

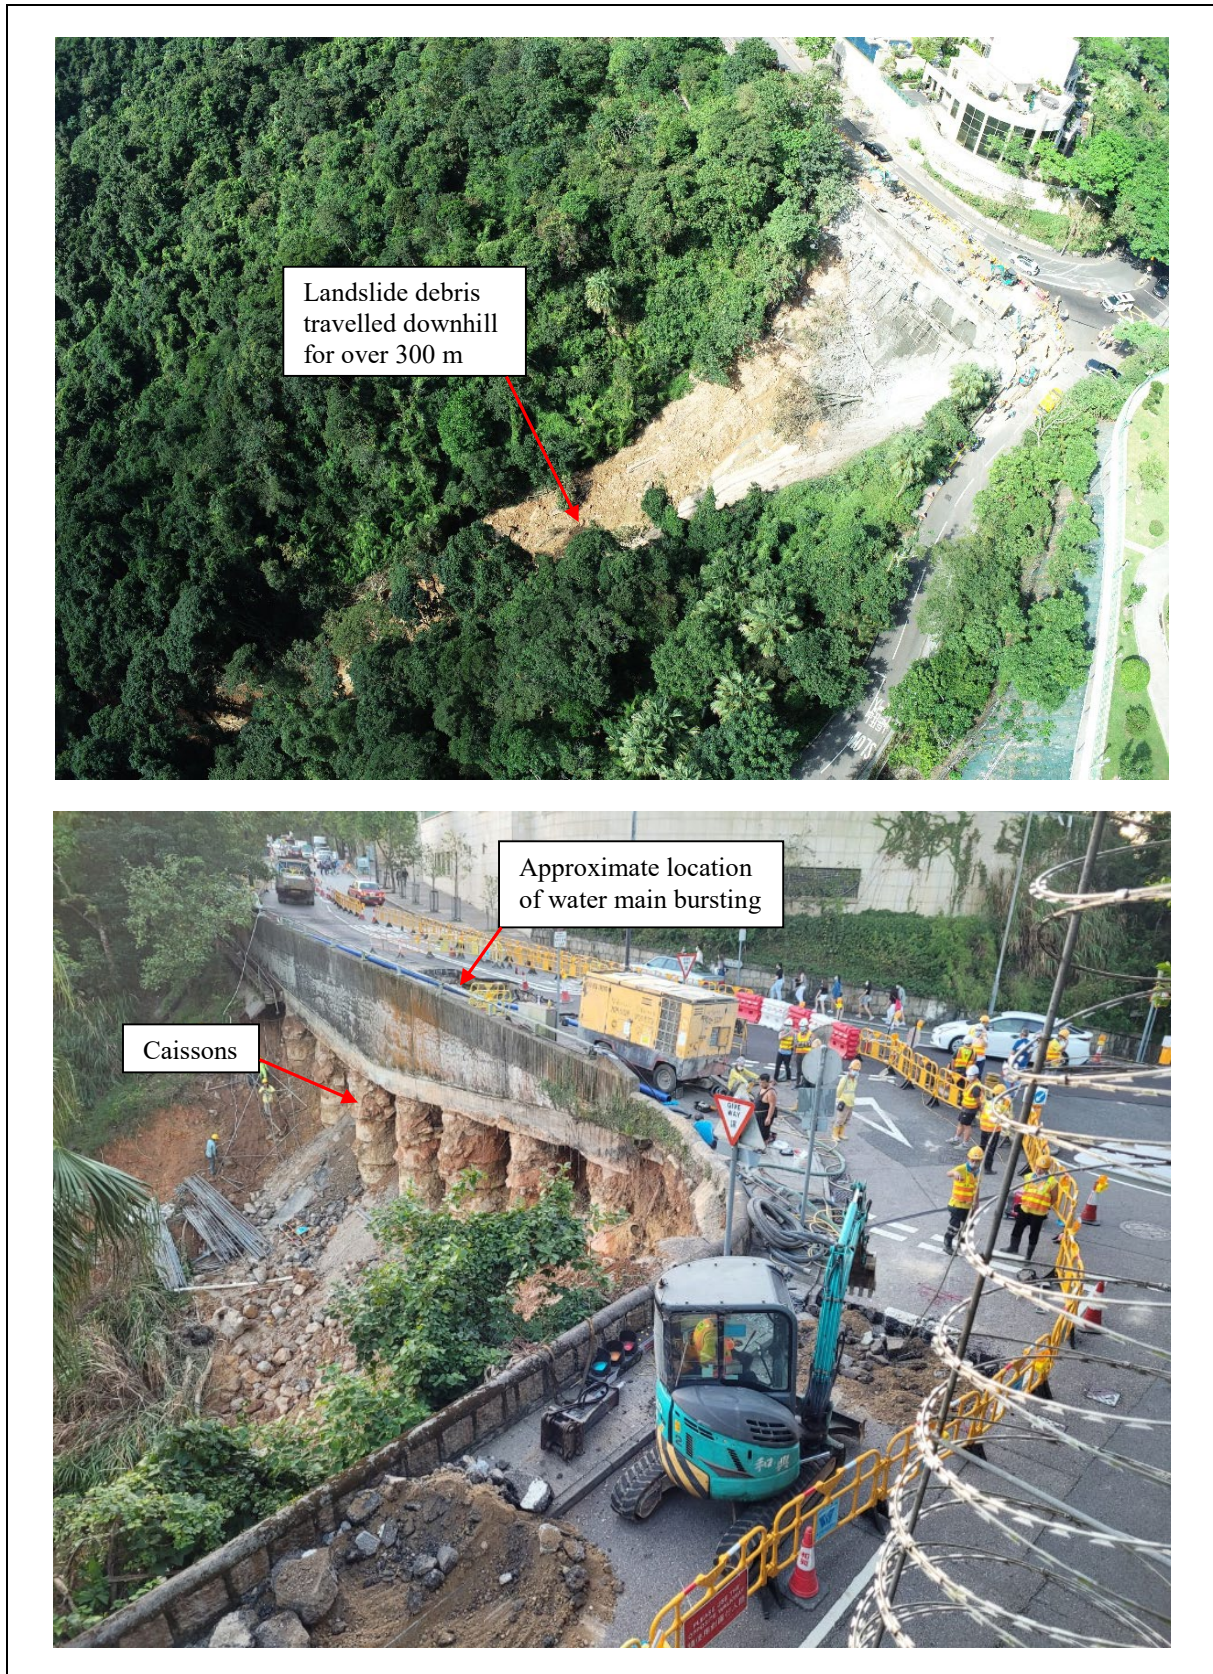
One landslide involved a sizeable failure of the upper portion of a recompacted fill slope below Peak Road (Lam et al, 2022). The failure volume was about 1,600 m³. The incident involved a flowslide that occurred under dry weather. The landslide investigation revealed that the landslide was triggered by the bursting of a buried 250 mm diameter pressurised water main running along the west-bound lane of Peak Road. Water from the burst main probably saturated the uncompacted fill layer underlying the compacted fill cap of 3 m thick, rendering liquefaction of the uncompacted fill which initiated the flowslide. The landslide debris travelled downhill and entered into a natural drainage line. The debris travel distance was over 300 m.

Incident No.	Slope No.	Location	Failure Volume (m ³)	Feature Type	Remarks
2021/11/3089	11SW-D/FR135	Peak Road	1,600	Fill	<p>This landslide occurred on a fill slope below Peak Road. The slope was upgraded under the LPMP in 1988 and the works included recompaction of the top 3 m of soil fill to a slope angle of 30°, construction of a cantilevered reinforced concrete crest retaining wall, construction of a row of hand-dug caissons for supporting the retaining wall and Peak Road, and provision of a vegetated slope surface cover. This landslide involved a sizeable failure of the upper portion of the slope with a scar depth of up to about 6 m (Figure B3). Some of the caissons were exposed after the landslide. The landslide investigation revealed that the failure involved a flowslide triggered by the bursting of a buried 250 mm diameter pressurised water main running along Peak Road. Water from the burst main probably saturated the uncompacted fill layer underlying the compacted fill cap, rendering liquefaction of the uncompacted fill followed by a flowslide. The landslide debris travelled downhill and entered into a natural drainage line. The debris travel distance was over 300 m.</p>

Figure B3 Flowslide at Peak Road (Incident No. 2021/11/3089)

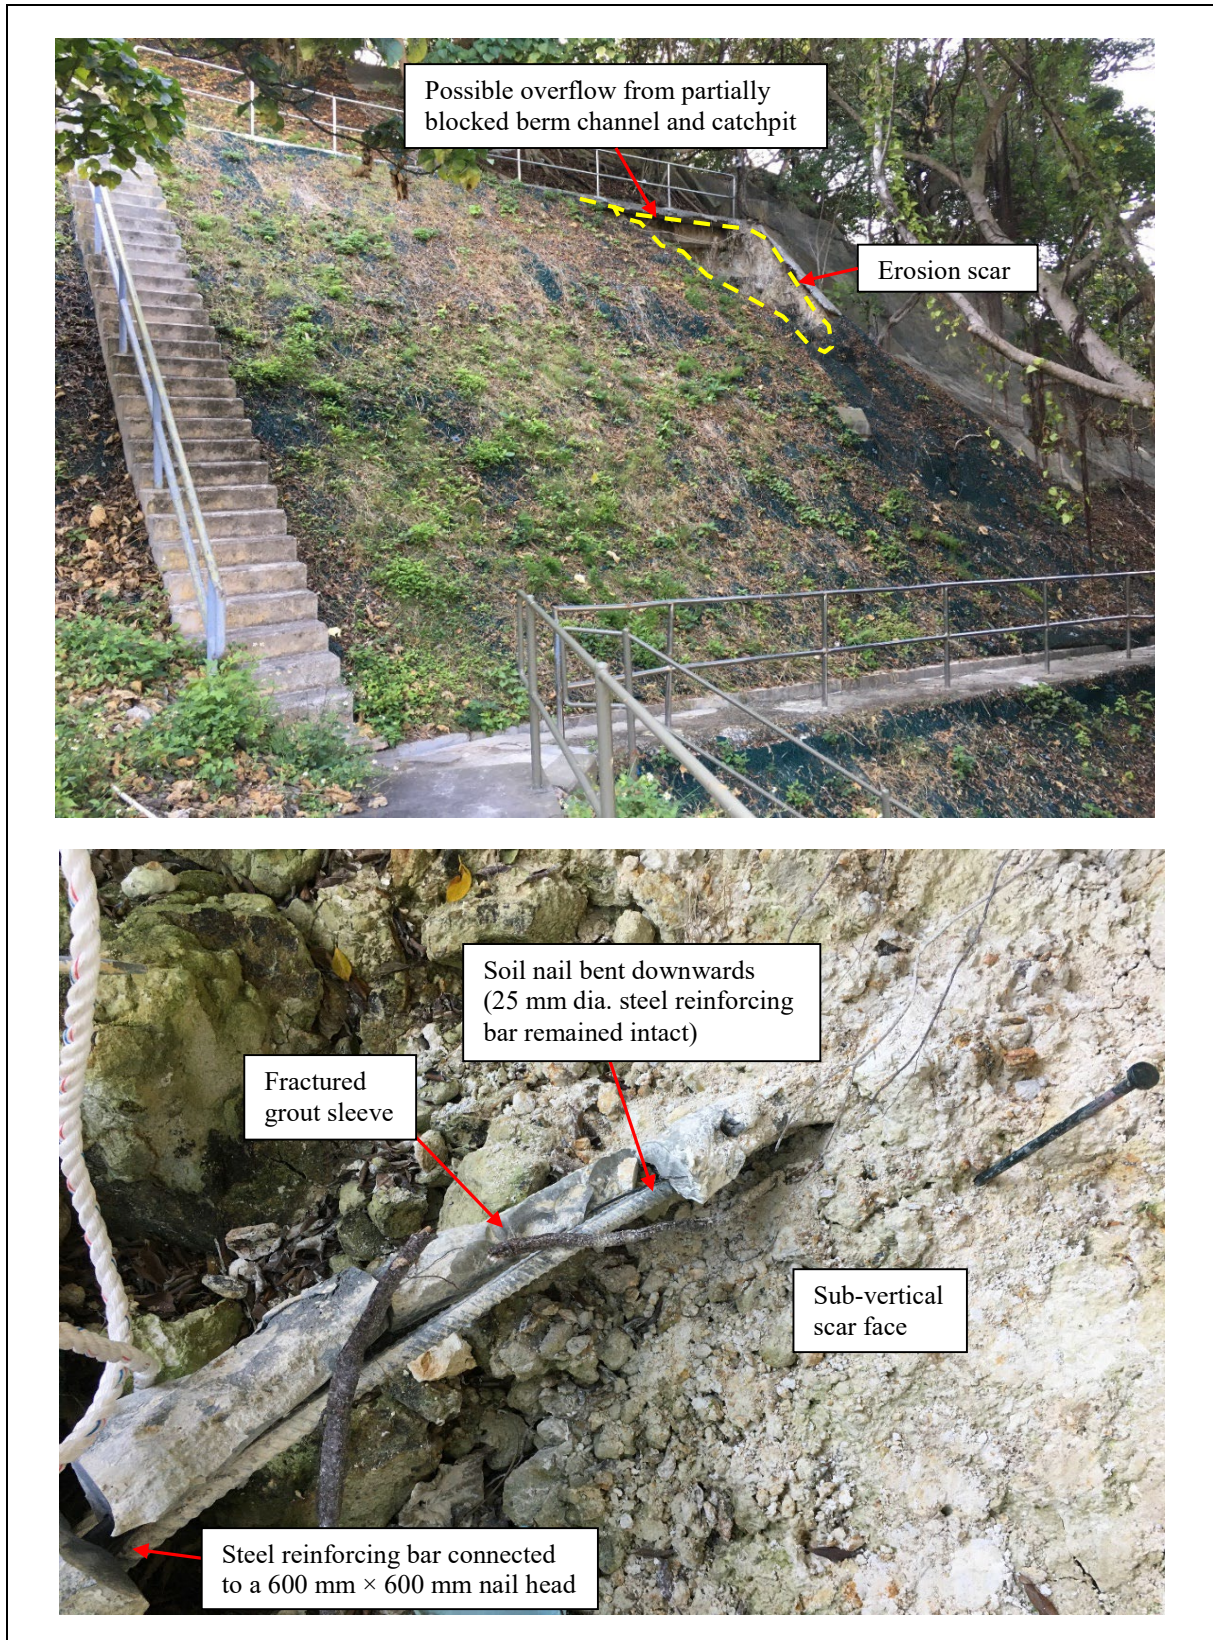
One landslide involved a local washout failure (volume of about 15 m³) within the soil-nailed portion of a soil cut slope. Two soil nails were exposed on the scar face and had bent downwards under their self-weight and the weight of the nail heads. The grout sleeves of the soil nails had fractured while the steel reinforcing bars and the nail heads remained intact. This landslide was probably caused by progressive erosion due to overflow from the partially

Incident No.	Slope No.	Location	Failure Volume (m ³)	Feature Type	Remarks
2022/02/3107	11SW-A/C313	Above Kennedy Town Fresh Water Service Reservoir	15	Soil cut	This landslide occurred on a soil cut slope upgraded under the LPMitP in 2020 mainly by soil nails and placement of compacted rockfill in local areas of the slope. This incident involved a local washout failure within the soil-nailed portion of the slope inclined at about 45° (Figure B4). The slope surface at the failure location was covered with erosion control mat and wire mesh. Two 100 mm diameter soil nails were exposed on the scar face and had bent downwards under their self-weight and the weight of the nail heads measuring 600 mm by 600 mm. The grout sleeves of the soil nails had fractured while the steel reinforcing bars and the nail heads remained intact. This incident was probably caused by progressive erosion due to overflow from the partially blocked surface drainage channel and catchpit on the slope berm immediately above the landslide scar.

Figure B4 Washout Failure below Kennedy Town Fresh Water Service Reservoir (Incident No. 2022/02/3107)

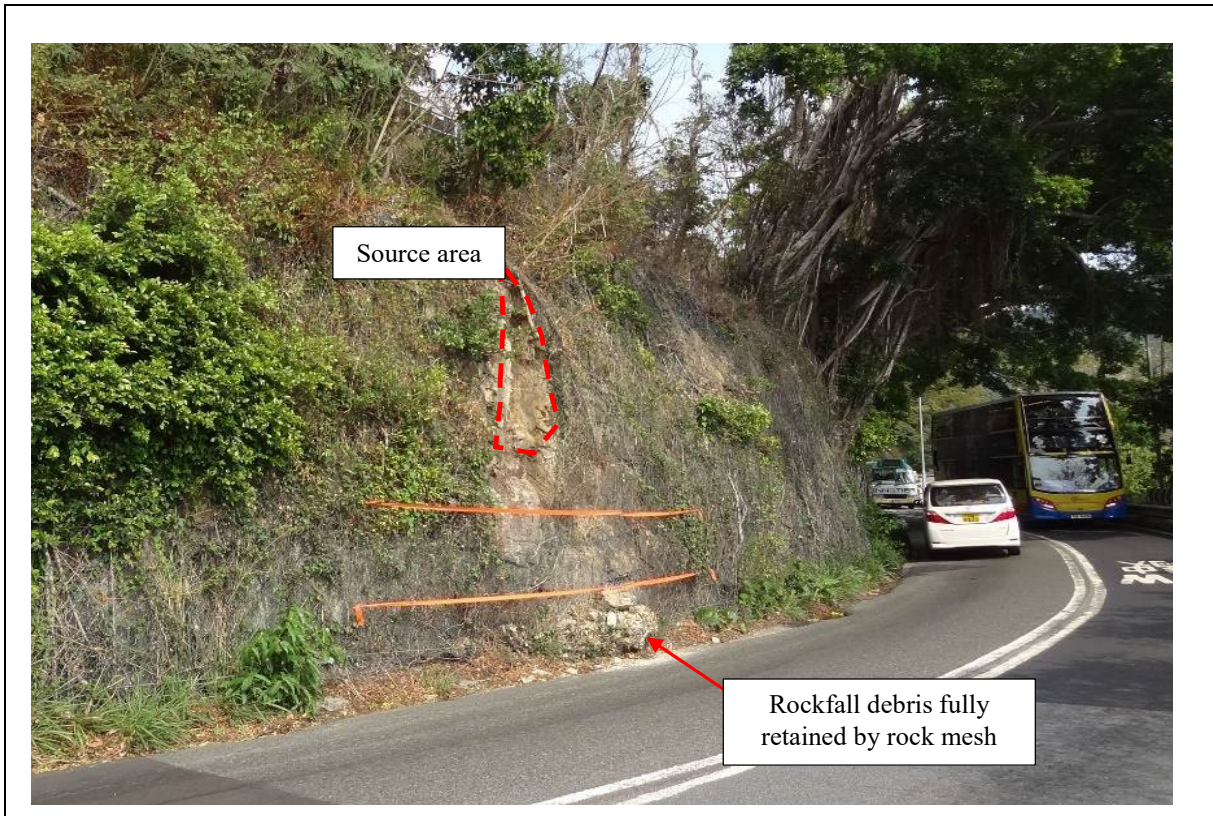
Incident No.	Slope No.	Location	Failure Volume (m ³)	Feature Type	Remarks
6. <u>Slopes Formed or Upgraded by Government Departments and Checked by the GEO</u> ($\Sigma = 2$ nos.)					
2021/03/2869	15NE-A/CR44	Repulse Bay Road (opposite to Lamp Post No. 31628)	0.5 (Rockfall)	Rock cut	The slope was upgraded in 2009 under HyD's Project "Upgrading/Improvement of Roadside Slopes/Retaining Walls on Hong Kong Island (2005 to 2008 Programme)" with the design checked and accepted by the GEO. The landslide occurred under dry weather and involved a rockfall originated from the rock portion of the slope inclined at about 85° and covered with rock mesh (Figure B5). Root wedging action on adversely orientated rock joints could be the key contributing factor to the rockfall. The fallen debris was fully trapped inside the rock mesh and sitting within the road kerb area.

Figure B5 Rockfall at Repulse Bay Road (Incident No. 2021/03/2869)

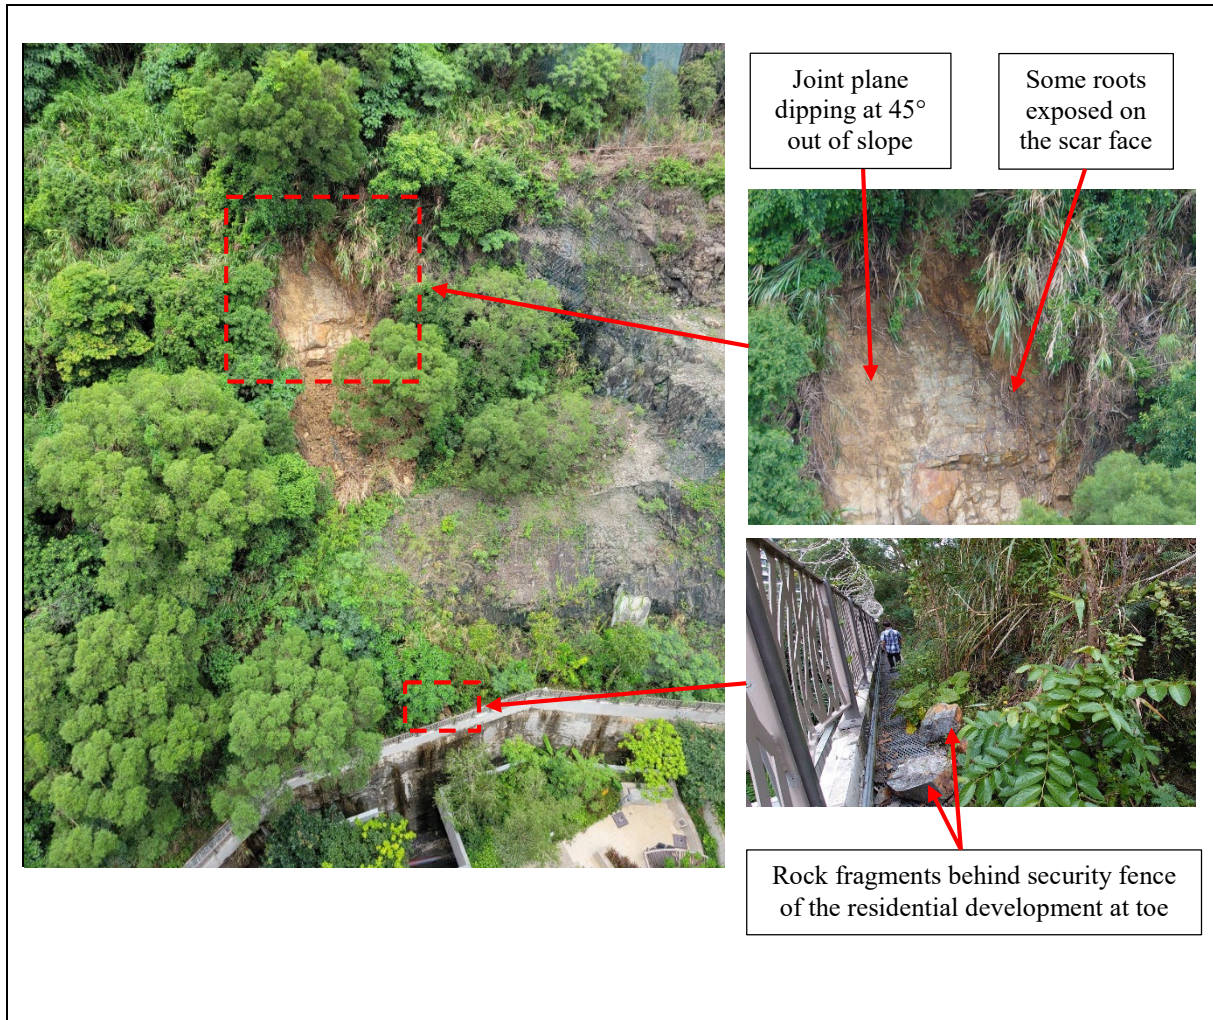
One landslide involved a rockslide (volume of about 15 m³) on the rock portion of a soil and rock cut slope inclined at about 55° and covered by wire mesh. The rockslide involved planar sliding with the scar delineated by a subvertical joint and a 45° daylighted joint forming the back release and sliding surfaces respectively. The failed portion was surrounded by trees and dense vegetation, and a number of roots were noted to have penetrated into the said joints and extended over the scar. The rockslide was probably triggered by rainfall and caused by the development of cleft water pressure within the adversely orientated rock joints, which were opened up by root wedging action.

Incident No.	Slope No.	Location	Failure Volume (m ³)	Feature Type	Remarks
2021/07/3010	7NE-C/C207	Lai Ping Road, Sha Tin	15 (Rockslide)	Rock cut	The slope was upgraded during the site formation works under the “Shatin New Town Stage II” project in 2011. The landslide involved a rockslide on the rock cut portion of a soil and rock cut slope inclined at about 55° and covered with rock mesh (Figure B6). The rockslide involved a planar sliding with the scar delineated by a subvertical joint and a 45° daylighted joint forming the back release and sliding surfaces respectively. The failed portion was surrounded by trees and dense vegetation, and a number of roots were noted to have penetrated into the said joints and extended over the scar. The rockslide was probably triggered by rainfall and caused by the development of cleft water pressure within the adversely orientated rock joints, which were opened up by root wedging action.

Figure B6 Rockslide above Lai Ping Road (Incident No. 2021/07/3010)

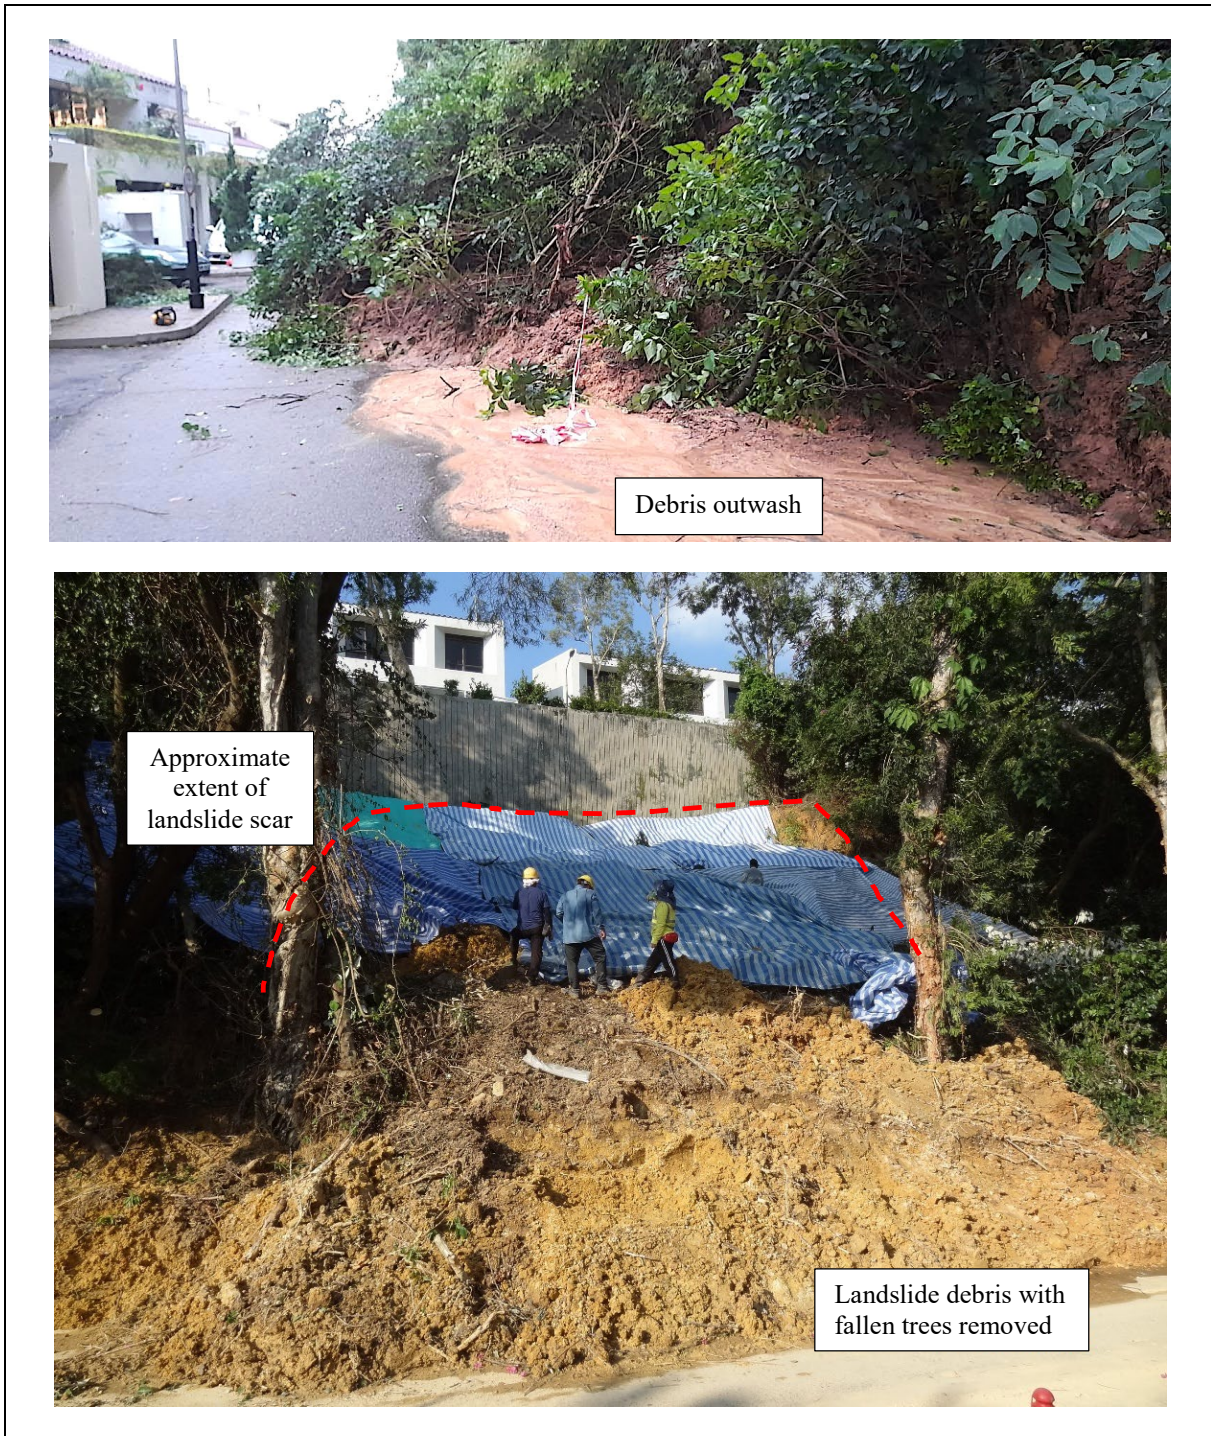
One landslide involved a sliding failure (volume of about 34 m³) within a local fill pocket at the crest of a slope immediately below the toe of a retaining wall. Post-landslide inspections and desk study findings revealed that the fill materials were possibly disturbed as a result of the clearance of a fallen sizeable tree about two months before the incident. Direct infiltration of rainwater through the bare ground surface leading to instability of the disturbed fill materials is considered to be one of the probable causes of the failure.

Incident No.	Slope No.	Location	Failure Volume (m ³)	Feature Type	Remarks
7. <u>Slopes Formed or Upgraded by Private Owners and Checked by the GEO</u> ($\Sigma = 1$ no.)					
2021/10/3066	11SW-D/C1836	Manderly Garden, Deep Water Bay	34	Fill	The slope was constructed between 1984 and 1986 during the site formation works for the construction of Manderly Garden. The slope was formed mainly by cutting with some local fill pockets. The landslide involved a sliding failure of a local fill pocket inclined at 30° at the crest of the slope immediately below the toe of a retaining wall (Figure B7). Post-landslide inspections and desk study findings revealed that the fill materials were possibly disturbed as a result of the clearance of a fallen sizeable tree about two months before the incident. Direct infiltration of rainwater through the bare ground surface leading to instability of the disturbed fill materials is considered to be one of the probable causes of the failure.

Figure B7 Sliding Failure at Manderly Garden (Incident No. 2021/10/3066)

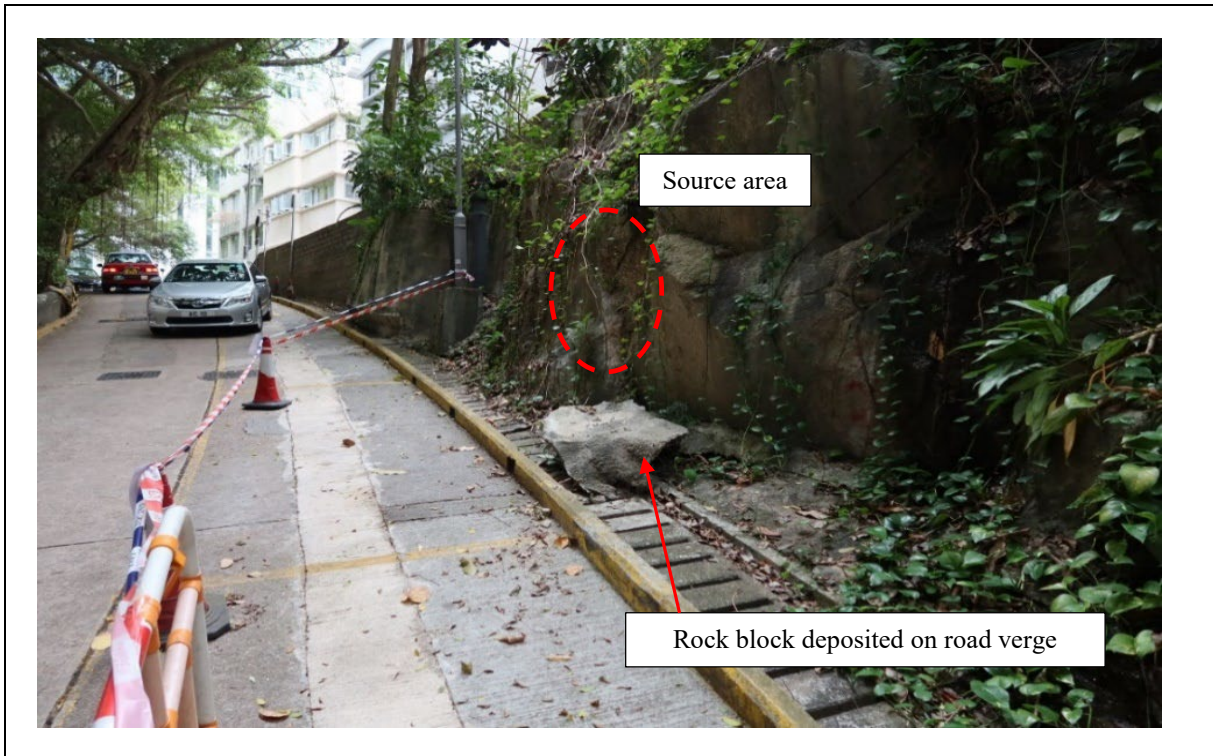
Figure B8 Rockfall in Happy Valley (Incident No. 2021/03/2868)
