**Detailed Study of the
3 August 2021 Landslide on the
Natural Hillside above Block 3,
Middleton Towers,
140 Pok Fu Lam Road**

GEO Report No. 369

Fugro (Hong Kong) Limited

**Geotechnical Engineering Office
Civil Engineering and Development Department
The Government of the Hong Kong
Special Administrative Region**

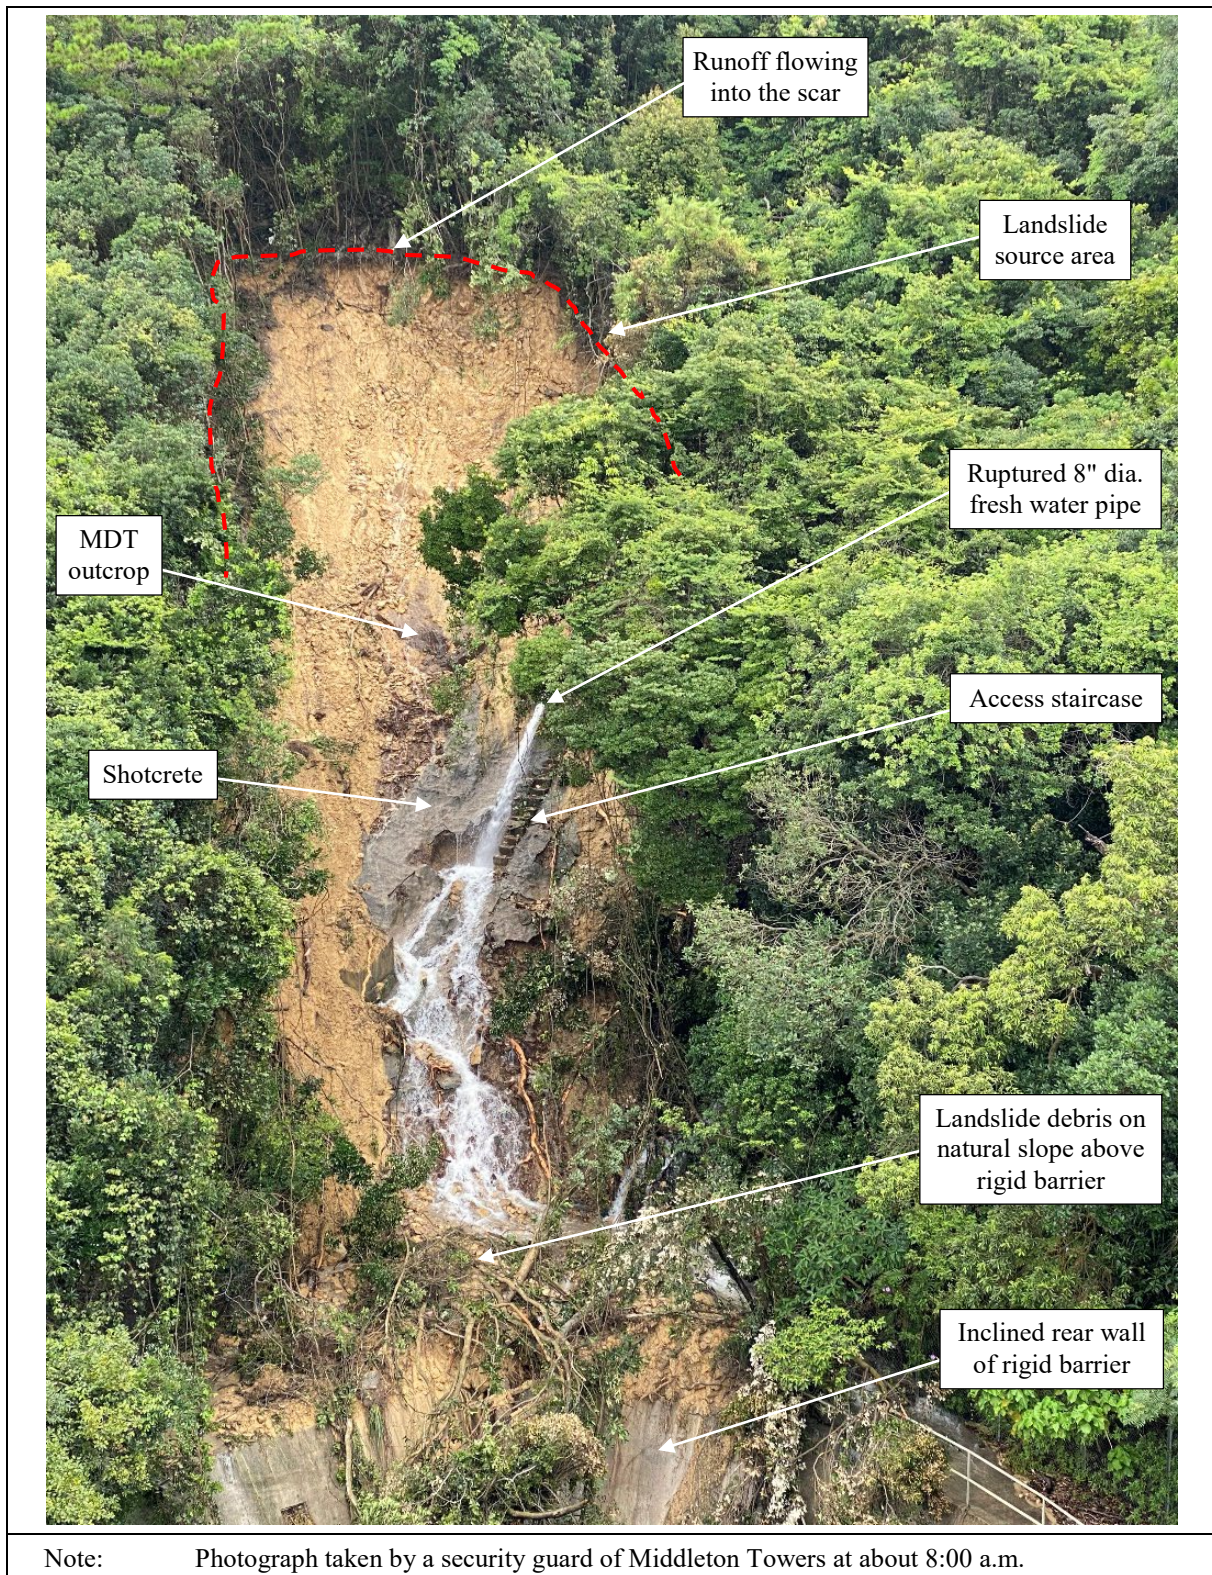
Figure 5.1 General View of the Landslide (Photograph Taken on 3 August 2021)

The 3 August 2021 incident involved an OHF on HLC No. 11SW-C/DF9 above Middleton Towers resulting in the rupture of an exposed 8" diameter fresh water pipe aligned across the catchment (Figure 5.1). Landslide debris had deposited over the lower portion of the natural hillside and within the rigid barrier (Feature No. 11SW-C/ND14) located downslope (Figures 5.2 and 5.3). Middleton Towers was not affected and no casualties were reported as a result of the landslide.

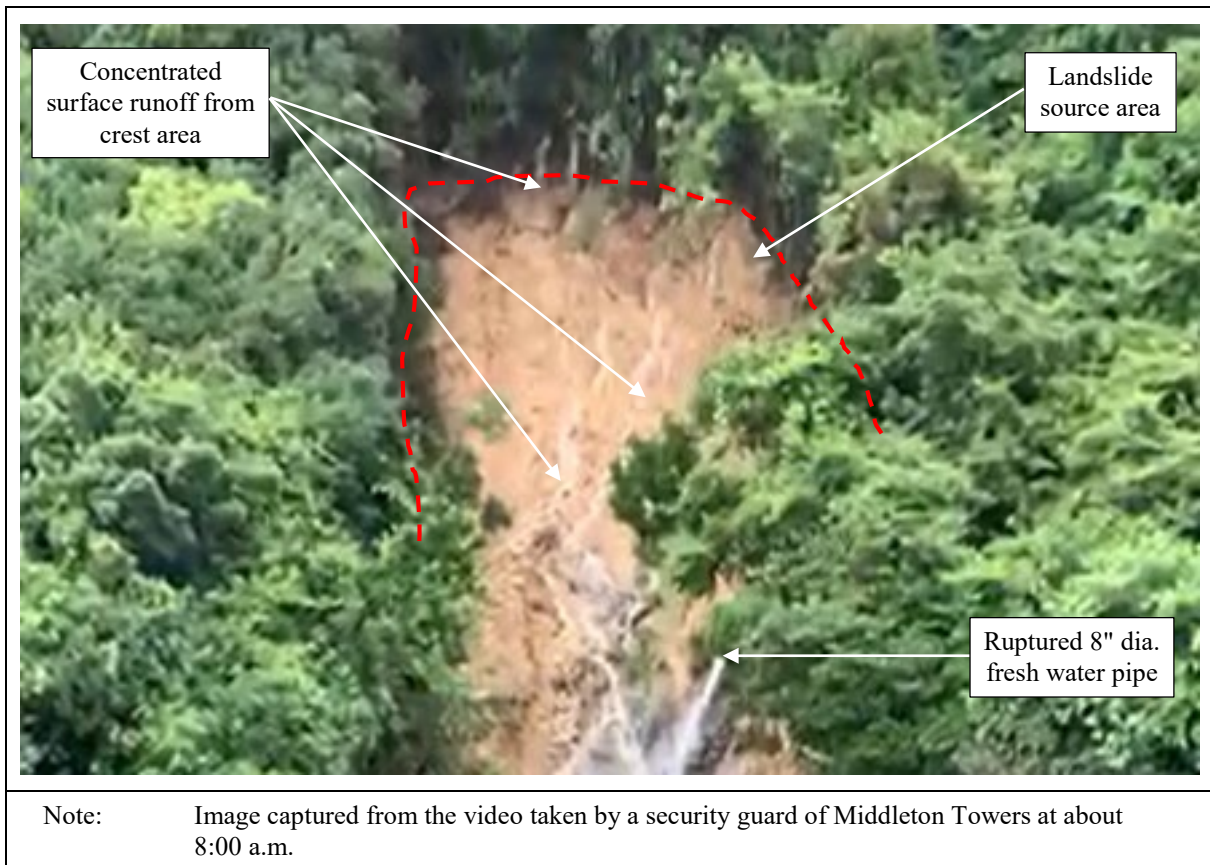
Figure 5.4 Concentrated Surface Runoff from above the Landslide Head Scarp (Video Taken on 3 August 2021)

Based on information from the eye-witnesses, water discharge from the ruptured 8" diameter fresh water pipe and concentrated surface flow over the crest of the landslide scar were observed around the time of the landslide at 6:30 a.m. on 3 August 2021 and such water flow conditions continued until at least 8:00 a.m. By 10:30 a.m. the concentrated surface flow was no longer apparent.

Information from the eye-witnesses has shown that concentrated surface runoff was flowing from above the crest of the landslide into the landslide scar around the time of the landslide on 3 August 2021 (Figure 5.4). With reference to the upslope drainage catchment, a drainage assessment was conducted to estimate the surface runoff that could have reached the landslide location at the time of the landslide in association with rainfall (Appendix D). The runoff could have involved channel overflow from the defective 300UC section on fill slope No. 11SW-C/F64 (Section 5.3.3) and the surface runoff from the natural slope immediately above the landslide location.

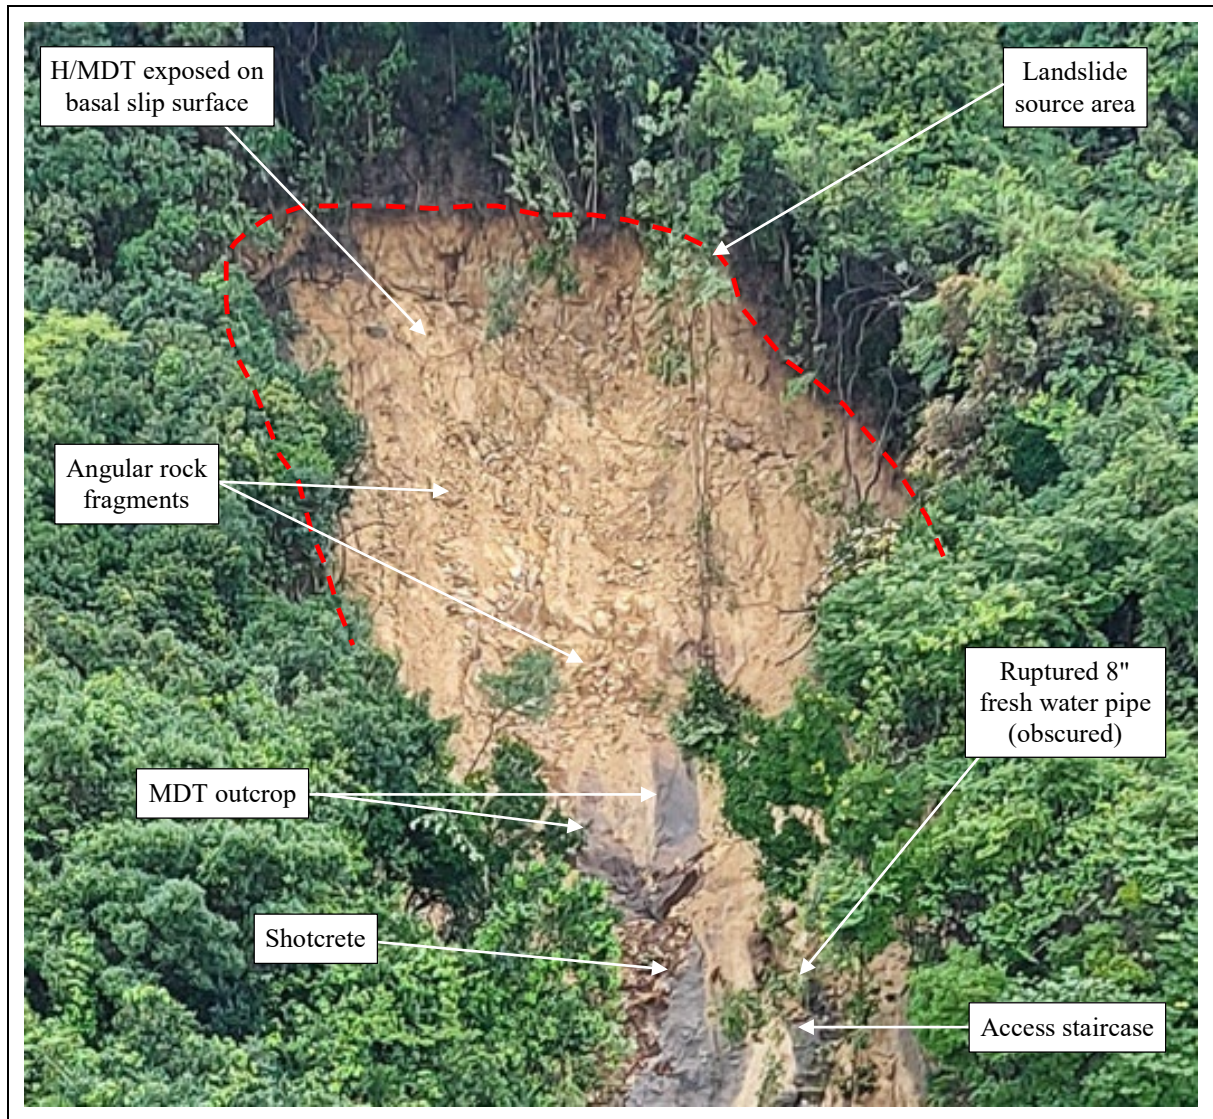
Figure 5.7 General View of the Landslide Source Area (Photograph Taken on 3 August 2021)

The landslide source area (from 188 mPD to 200 mPD) was located on a planar to slightly concave, open hillslope terrain with the lower extent situated immediately upslope of the ruptured 8" diameter fresh water pipe and a shotcreted area (Figure 5.7).

The dimensions of the source area were measured on site as about 14 m long, 10 m wide with a maximum depth of about 1.5 m. Based on the field mapping, the estimated failure volume is about 110 m³ which is generally consistent with the results of the change detection analysis (Figure 5.6).

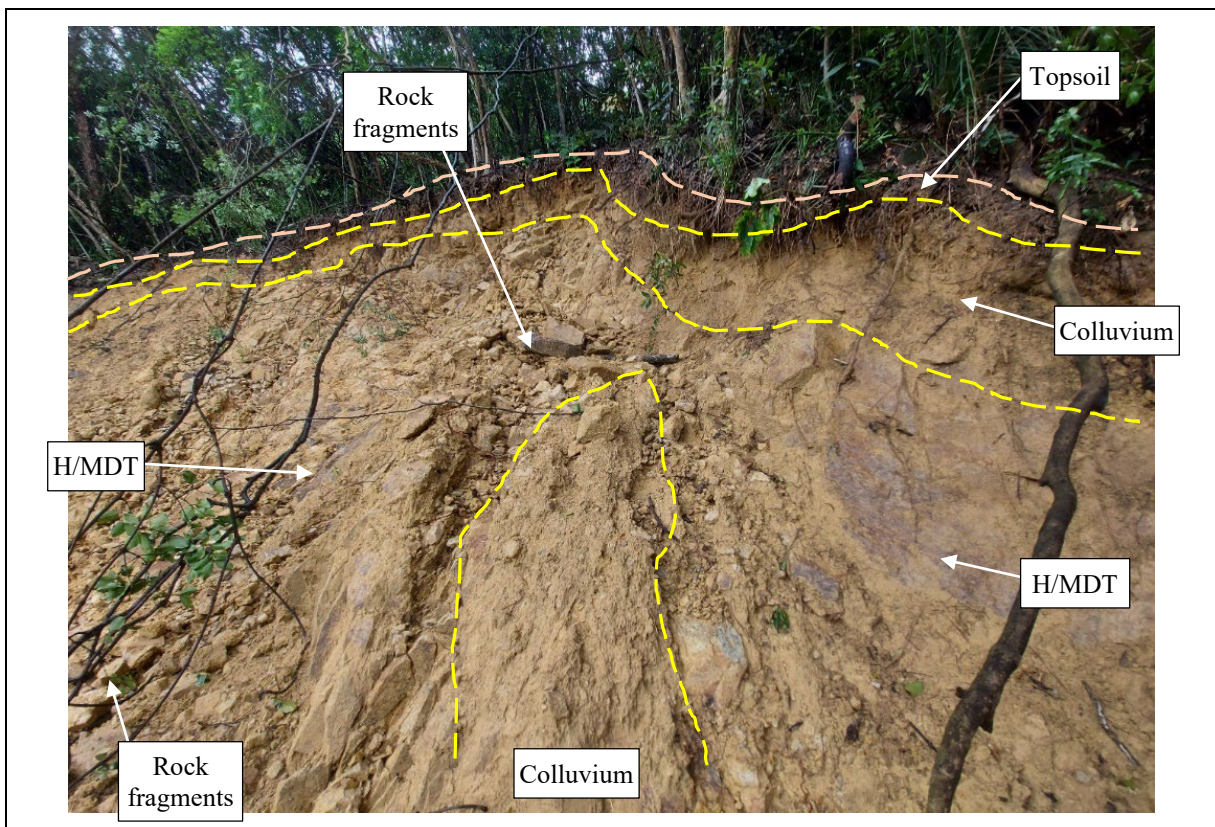
Figure 5.10 Landslide Head Scarp Exposure (Photograph Taken on 4 August 2021)

scar revealed thin superficial layers of topsoil and colluvium up to about 1 m thick overlying sub-vertically and sub-horizontally jointed H/MDT (Figure 5.10). The failed materials predominantly comprised colluvium with some angular rock fragments of the highly fractured H/MDT surface. The observation of thin superficial layers over shallow rockhead is generally consistent with the findings of previous ground investigations. No seepage or soil pipes were observed on the scar at the time of the inspections.

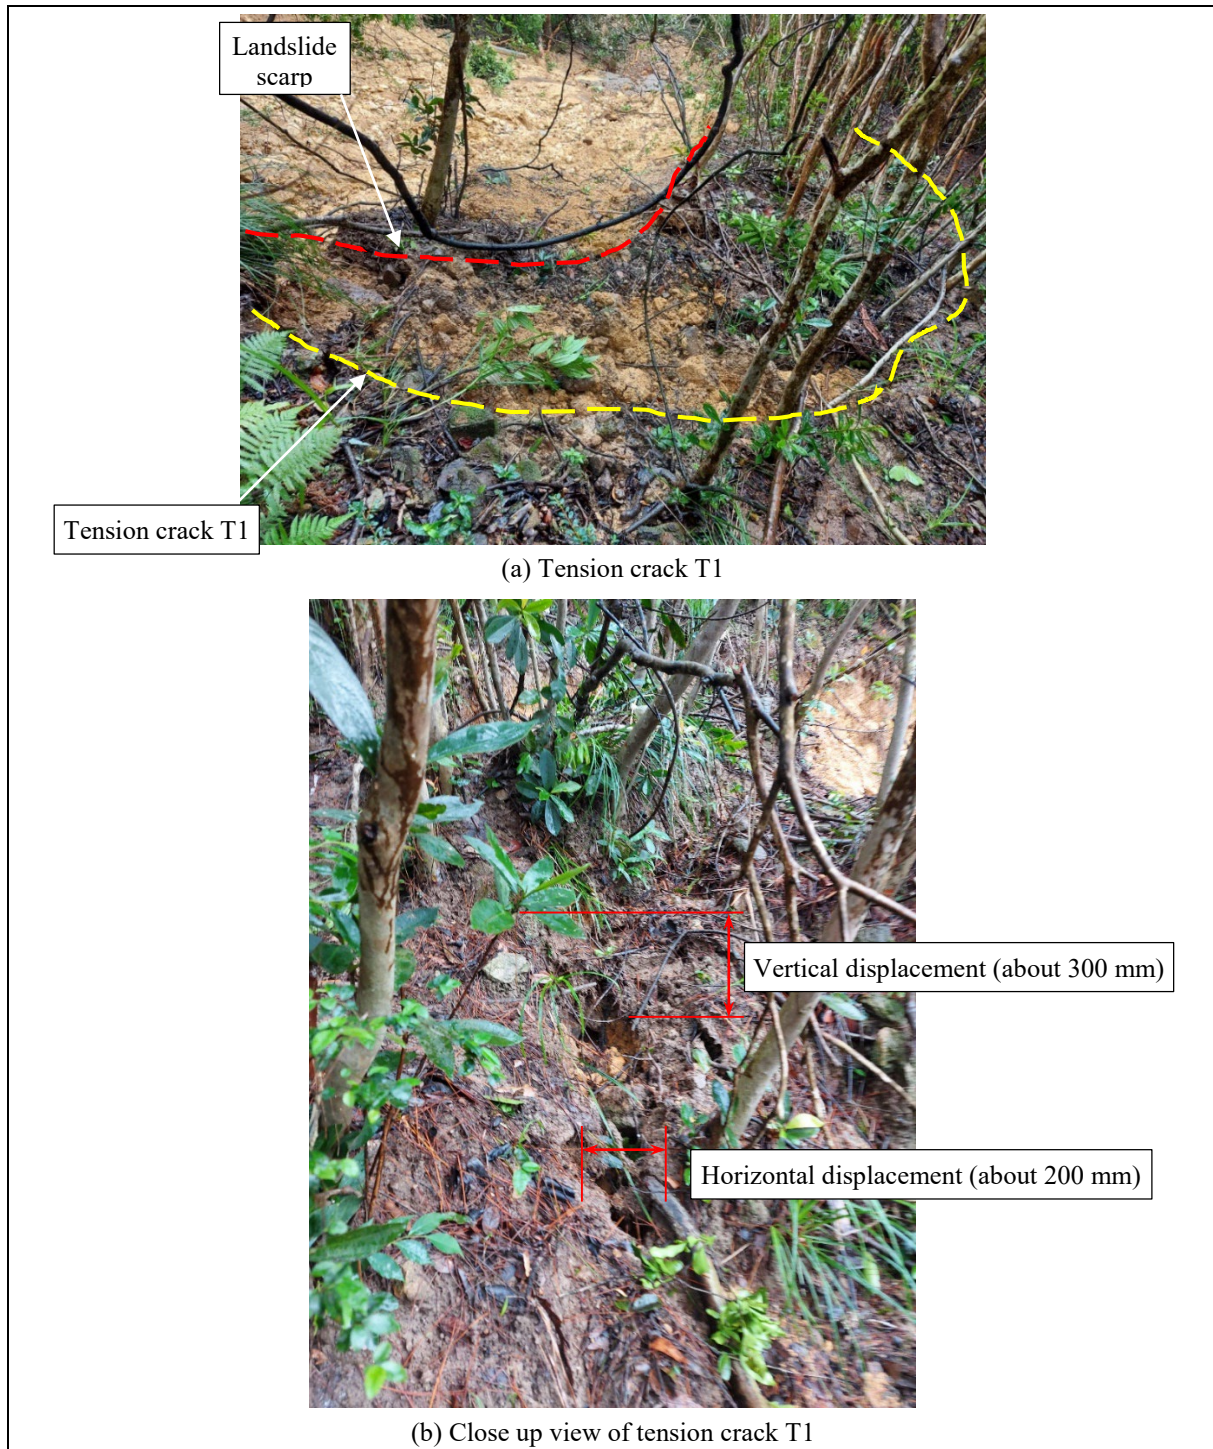
Figure 5.11 Tension Crack T1 Extending from the Northern Side of the Landslide Head Scarp (Photographs Taken on 3 August 2021)

On the northern flank of the landslide, a tension crack (T1) was observed as a continuation of the head scarp with some signs of displacement (Figure 5.2 and 5.11). Tension crack T1 was about 12 m in length and was displaced by about 0.3 m vertically and 0.2 m laterally.

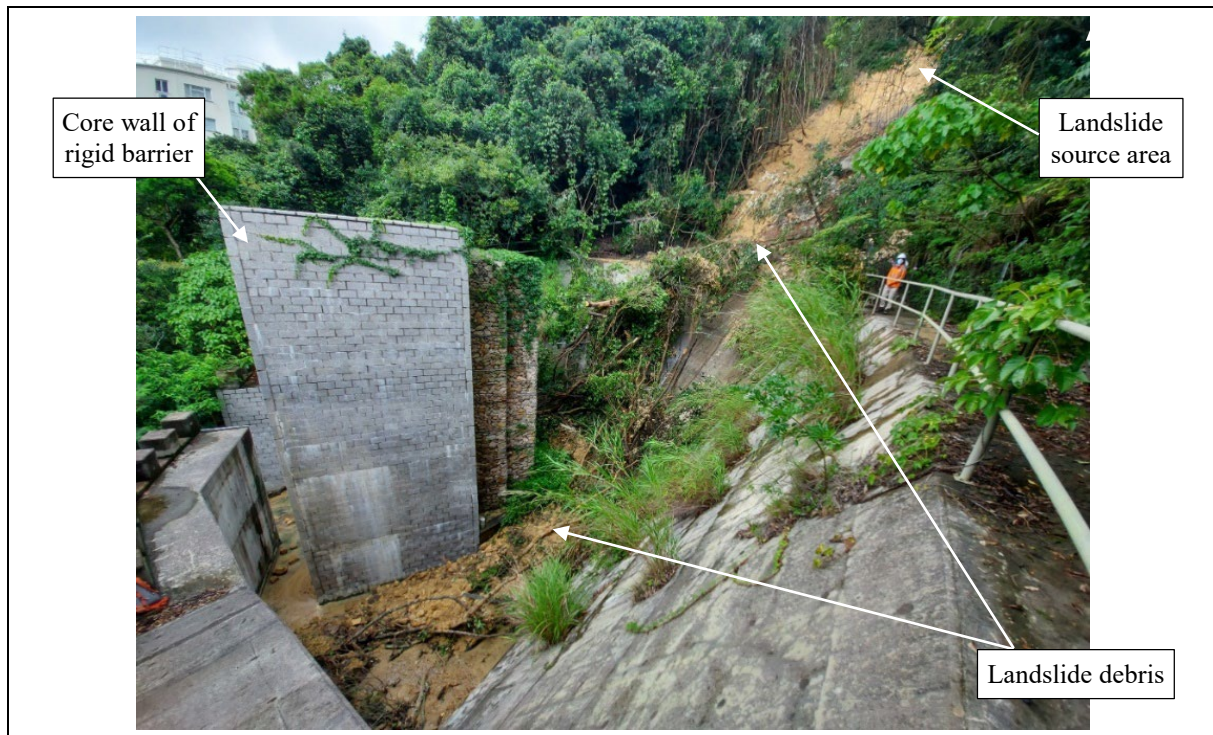
Figure 5.12 View of Landslide Debris Trail (Photograph Taken on 3 August 2021)

The debris had deposited over the lower part of the natural slope and within the rigid barrier (Feature No. 11SW-C/ND14) at the toe of the catchment (Figures 5.3 and 5.12). The barrier had prevented further runout of the debris to Middleton Towers below.

The debris volume was estimated as about 135 m^3 , with approximately half accumulated in the containment basin of the rigid barrier (about 68 m^3) and half deposited on the natural hillside above the crest of the barrier (about 67 m^3) (Figure 5.6). The debris consisted of soil, rock, uprooted trees and a large section of the ruptured 8" diameter fresh water pipe.

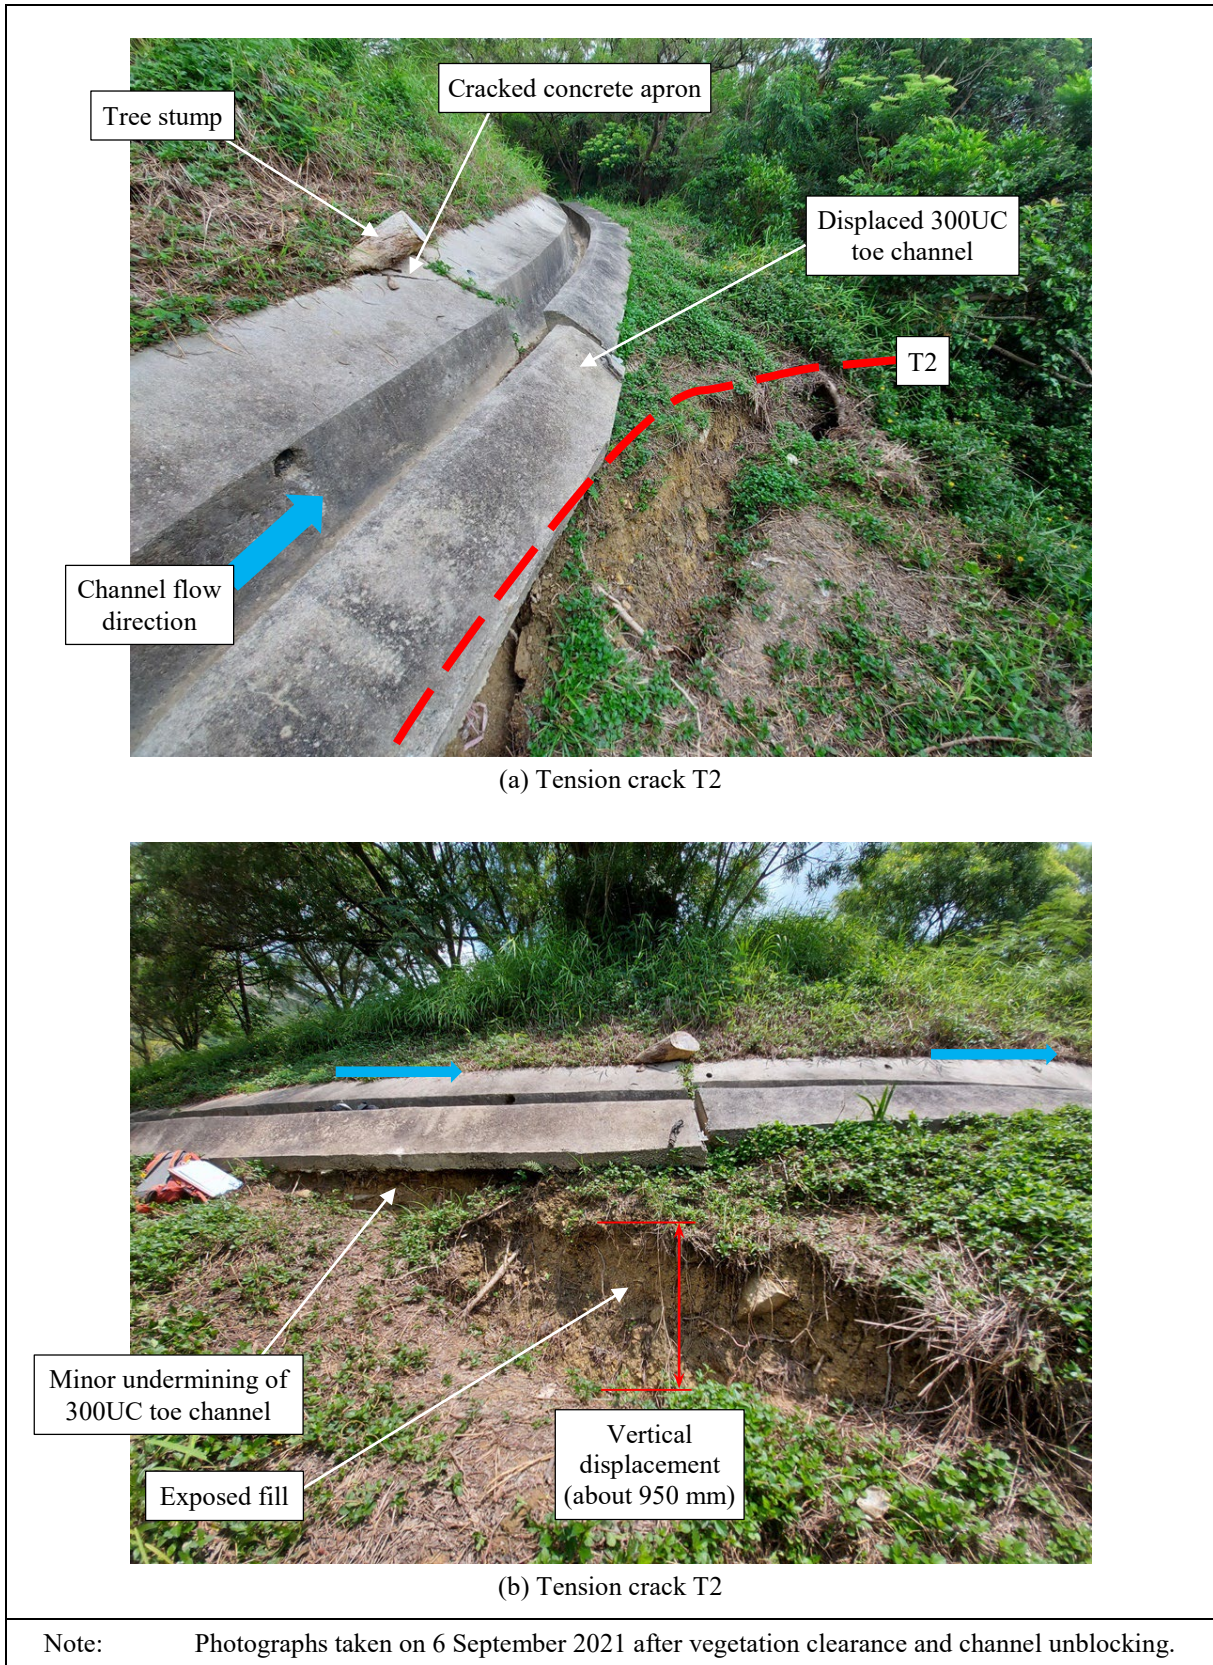
Figure 5.13 Tension Crack T2 (Photographs Taken on 6 September 2021)

The largest tension crack, T2, was measured 10 m in length with a vertical displacement of about 0.5 m exposing fill materials (Figure 5.13). Tension cracks T3 and T4 were located downslope and broadly parallel to tension crack T2. T3 and T4 were measured about 9 m and 6 m in length respectively with a maximum vertical displacement of about 0.1 m (Figure 5.14).

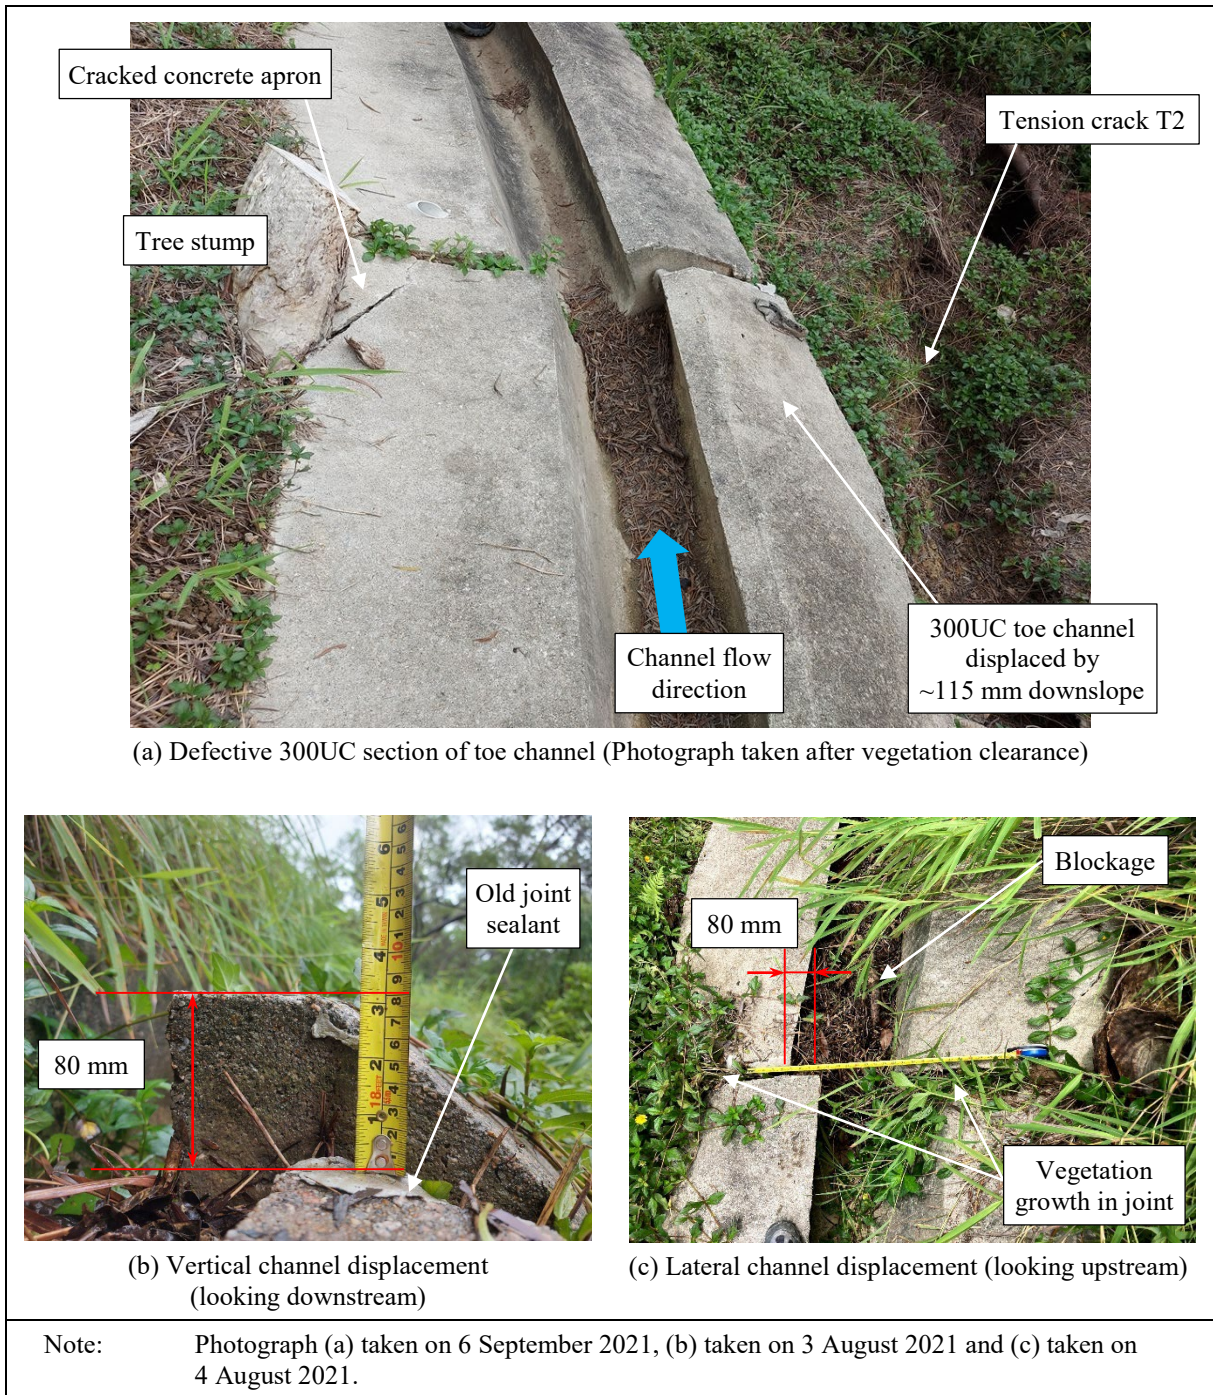
Figure 5.15 Defective 300UC Section (Photographs Taken on 3 August, 4 August and 6 September 2021)

Tension crack T2 had slightly undermined a section of the 300UC toe channel of the fill slope. At this affected section of the channel, a displaced expansion joint and partial blockage of the channel was observed (hereafter referred to as "defective 300UC section") (Figure 5.15). The displaced channel expansion joint had exhibited an overall movement of about 115 mm (80 mm vertically and 80 mm laterally). A tree stump of an apparently previously felled tree

was observed above the displaced joint together with cracking of the concrete apron. It is possible that the joint displacement had resulted from tree root action although the relative timing of the tree felling and joint displacement could not be established. Nevertheless, the joint displacement could have developed some time prior to the incident as evidenced by the vegetation growth within the expansion joint (Figure 5.15).

The defective 300UC section of the fill slope toe channel, the distressed ground below in the form of the three broadly parallel tension cracks (T2 to T4) and evidence of possible overland flow were all observed to be aligned directly above the landslide location indicating the defective 300UC section as a likely point of conveying the observed concentrated surface runoff to the landslide location.

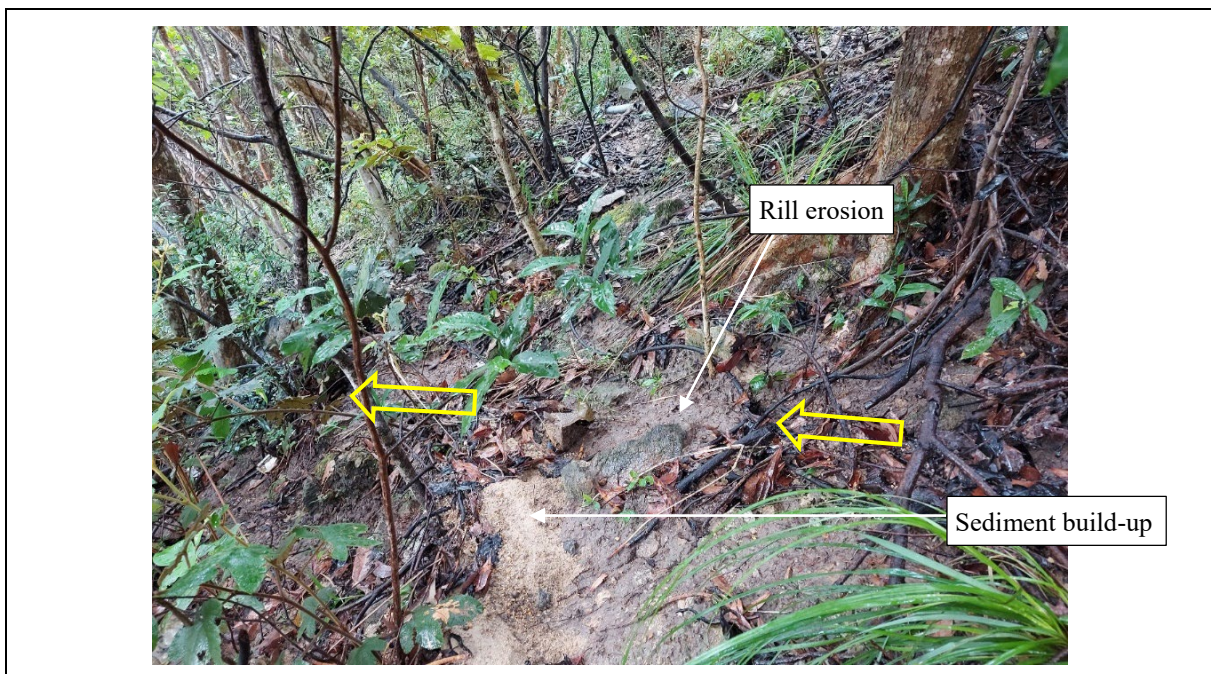
**Figure 5.16 Evidence of Overland Flow Directly above the Landslide Location
(Photograph Taken on 3 August 2021)**

Evidence of vegetation stripping, rill erosion and recent sediment build-up was observed on the hillside area between the tension cracks and the crest of the landslide, indicative of possible overland flow (Figure 5.16).

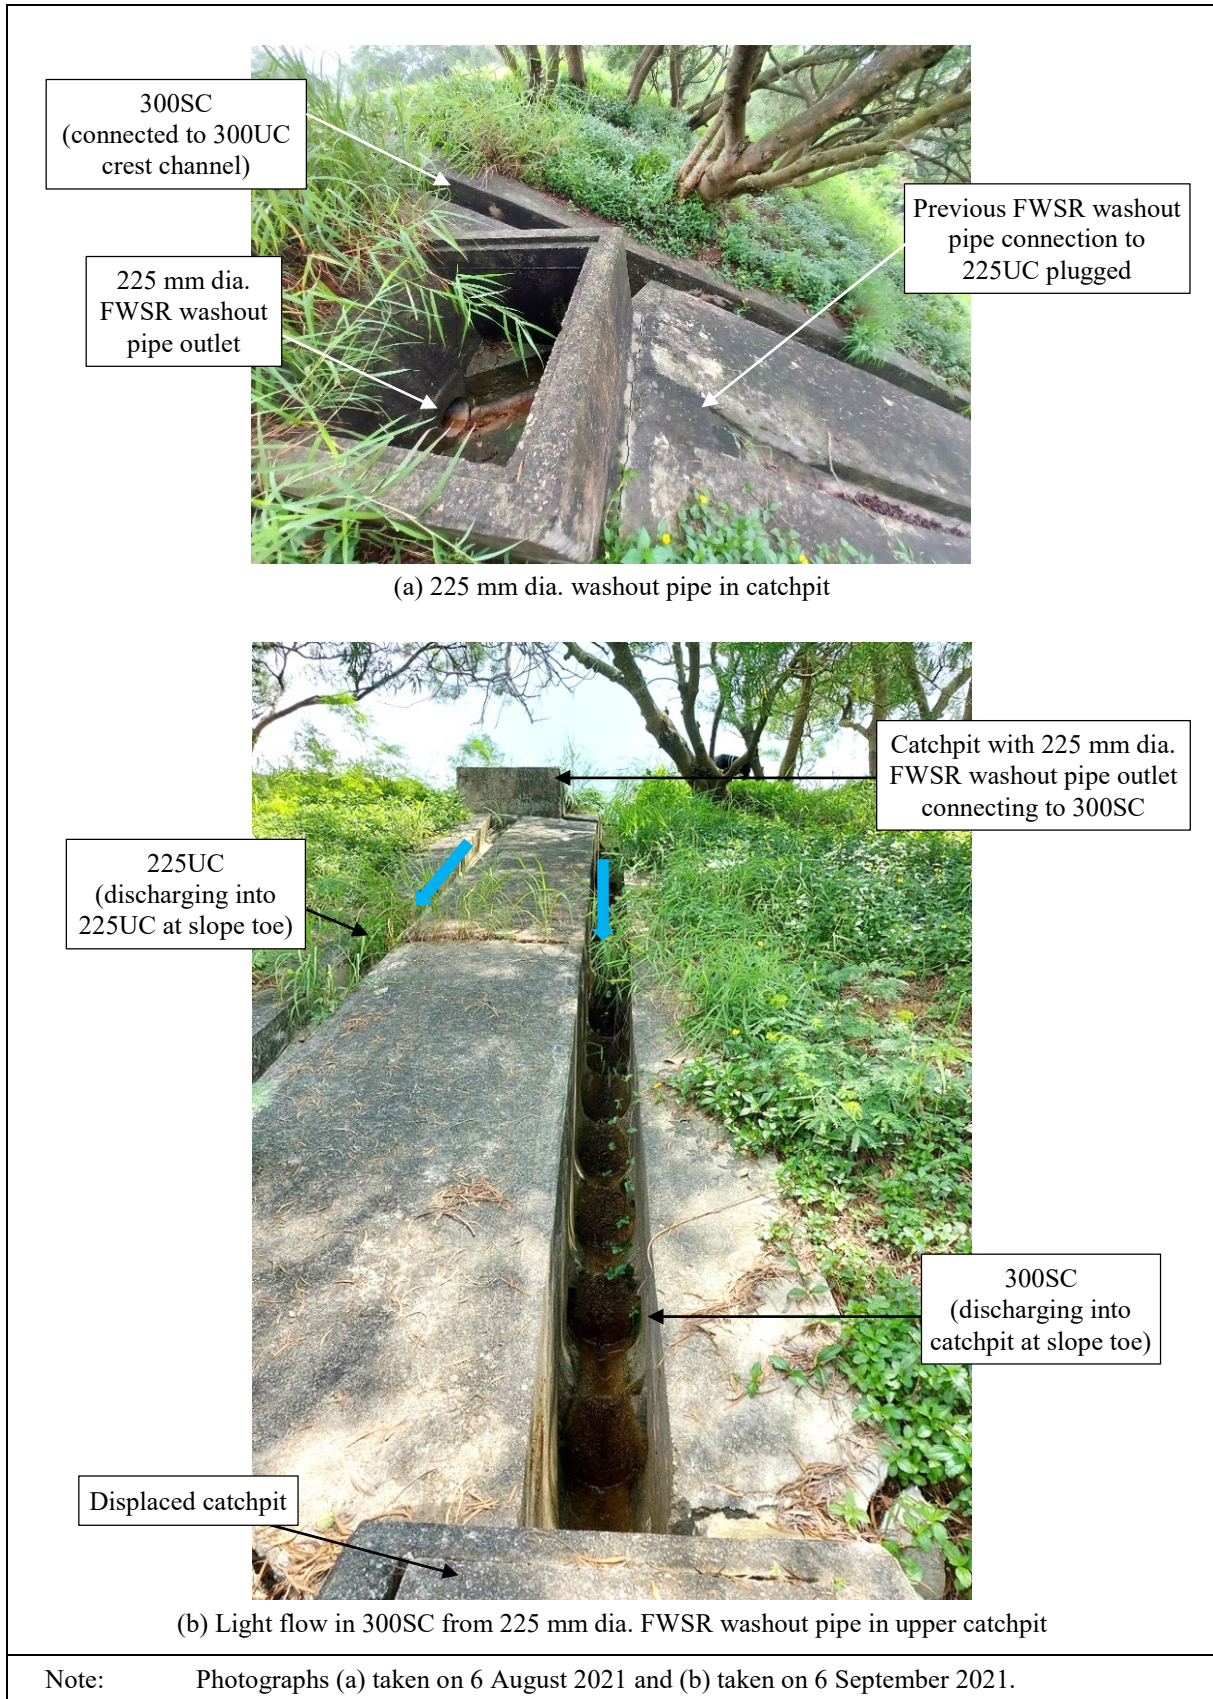
Figure 5.18 Outlet of Northern 225 mm Diameter FWSR Washout Pipe (Photographs Taken on 6 August and 6 September 2021)

The two 225 mm diameter subsurface FWSR washout pipes discharge into the drainage system of the fill slope (see section 2.4). The northern washout pipe discharges into a catchpit about 1.5 m below the slope crest and the flow is diverted to an adjacent 300SC conveying it, via a catchpit, to the 300UC toe channel including the defective 300UC section (Figure 5.18).

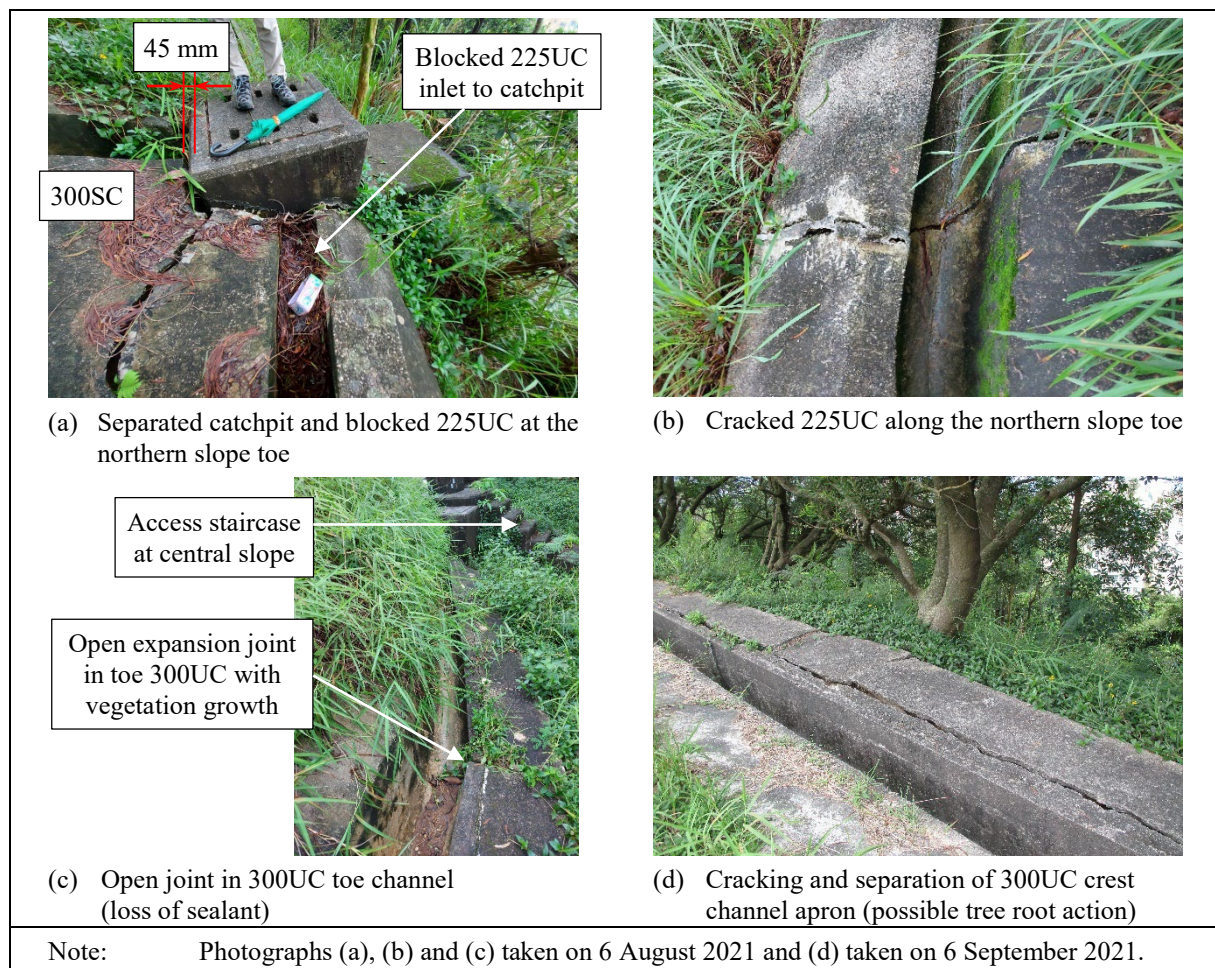
Figure 5.19 Examples of Other Defects in the Surface Drainage on Fill Slope No. 11SW-C/F64 (Photographs Taken on 6 August and 6 September 2021)

Apart from the blockage noted at the defective 300UC section, locally, the 225UC toe channel was heavily blocked at the catchpit inlet at the northern portion of the slope toe (Figures 5.17 and 5.19(a)). The remainder of the fill slope surface drainage system was generally clear. Other defects in the surface drainage system were observed including separation of the aforesaid catchpit from the connecting channels (by up to 45 mm), cracked channels and channel aprons, and loss of joint sealant at an expansion joint in the toe channel (Figure 5.19). Some of the defects appeared to have been present for some time as evidenced by vegetation growth and concrete discolouration. Signs of past repairs on the channels and aprons, possibly associated with previous maintenance works, were also apparent. It is noted that the routine maintenance inspections/works and the Engineer Inspection prior to the landslide were conducted in late 2020 and in April 2021 respectively.

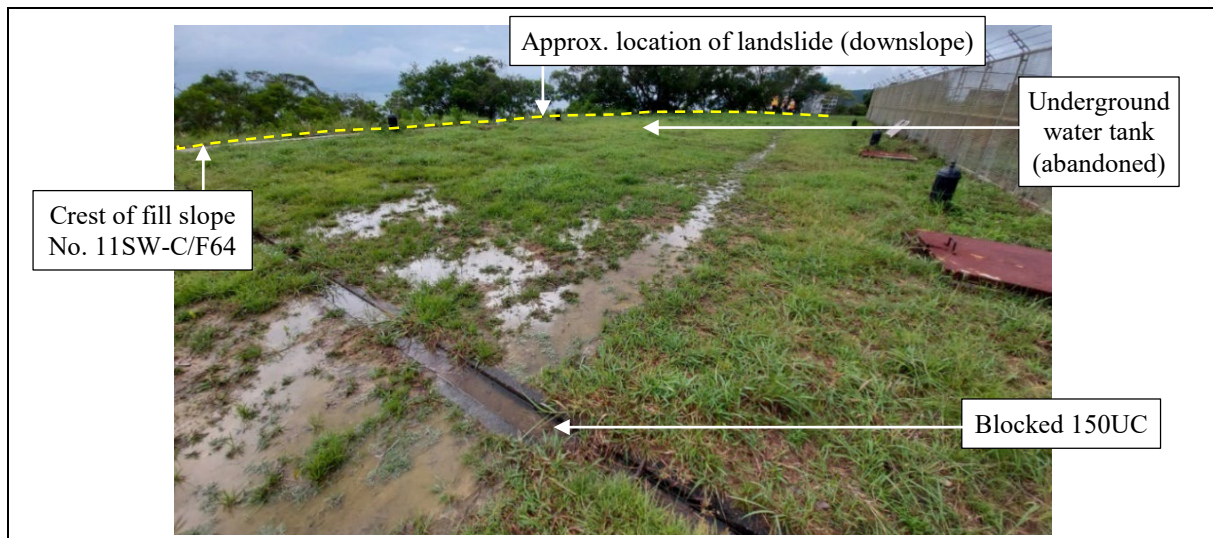
Figure 5.20 Ponding at Crest of Fill Slope No. 11SW-C/F64 (Photograph Taken on 3 August 2021)

Ponding was observed at the crest of the feature, which appeared to be confined to the surface extent roughly above the abandoned underground water tank, probably caused by a lack of gradient and blockage of the 150UCs in the crest platform (Figure 5.20).
