Review of Rockfall Incidents Occurring under Dry Weather

GEO Report No. 370

R.C.T. Wai, K.S.P Lam & R.W.H. Lee

**Geotechnical Engineering Office
Civil Engineering and Development Department
The Government of the Hong Kong
Special Administrative Region**

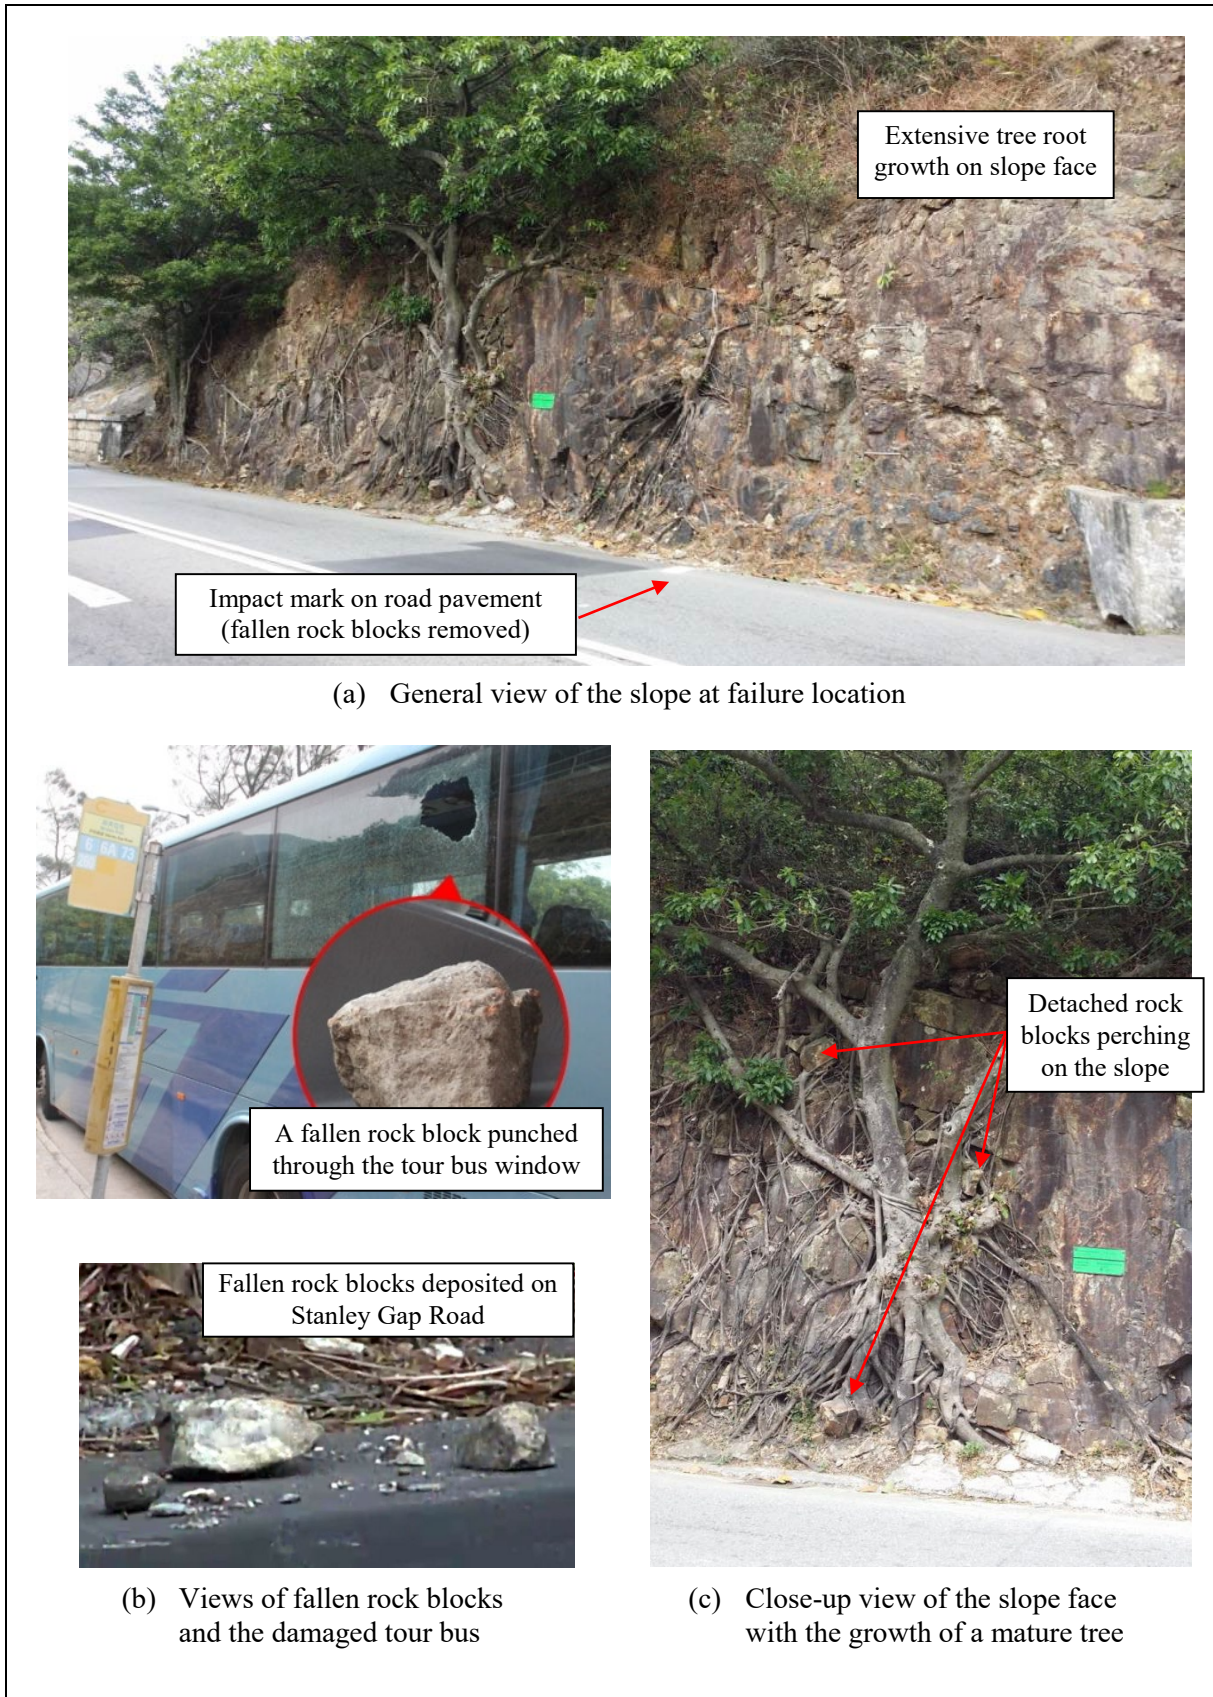
Figure 2.1 Views of the 19 February 2015 Rockfall at Stanley Gap Road near Chung Hom Kok Road, Stanley (Incident No. 2015/02/1659)

At about 5:00 p.m. on 19 February 2015, a rockfall incident occurred on a 6 m high rock cut slope (Feature No. 15NE-A/C425) above Stanley Gap Road near Chung Hom Kok Road (Figure 2.1a). The incident occurred under dry weather and no rain was recorded preceding it. The rockfall, with an estimated failure volume of about 0.05 m³, involved the detachment of several rock blocks. Most of them were deposited on the carriageway while one rock block punched through the window of a tour bus travelling along the road (Figure 2.1b). As a result, four passengers on board were injured by the broken window glass fragments. The incident was reported by the mass media.

The fallen rock blocks originated from the bare rock face of a subvertical rock cut slope above Stanley Gap Road. Along the affected section of the road, there was no pedestrian pavement or footpath. The rockfall debris was largely deposited on the carriageway. As observed from the landslide inspection, mature trees with extensive network of roots were growing over and above the failure location and the progressive tree root growth had penetrated into the apertures of a number of rock joints. It is evident that root wedging action destabilized the rock blocks by opening up the joints of the near-surface rock mass rendering them more susceptible to local detachment. Detached rock blocks were also observed on other parts of the slope, some of which were perching on the rock face adjacent to the failure location (Figure 2.1c).

This incident highlights that rockfalls occurring on slopes adjoining vulnerable facilities (e.g. heavily-trafficked roads) could result in severe consequence, even for failure of small scale. Root wedging action could destabilize the rock blocks on slope face increasing the susceptibility of local detachment.

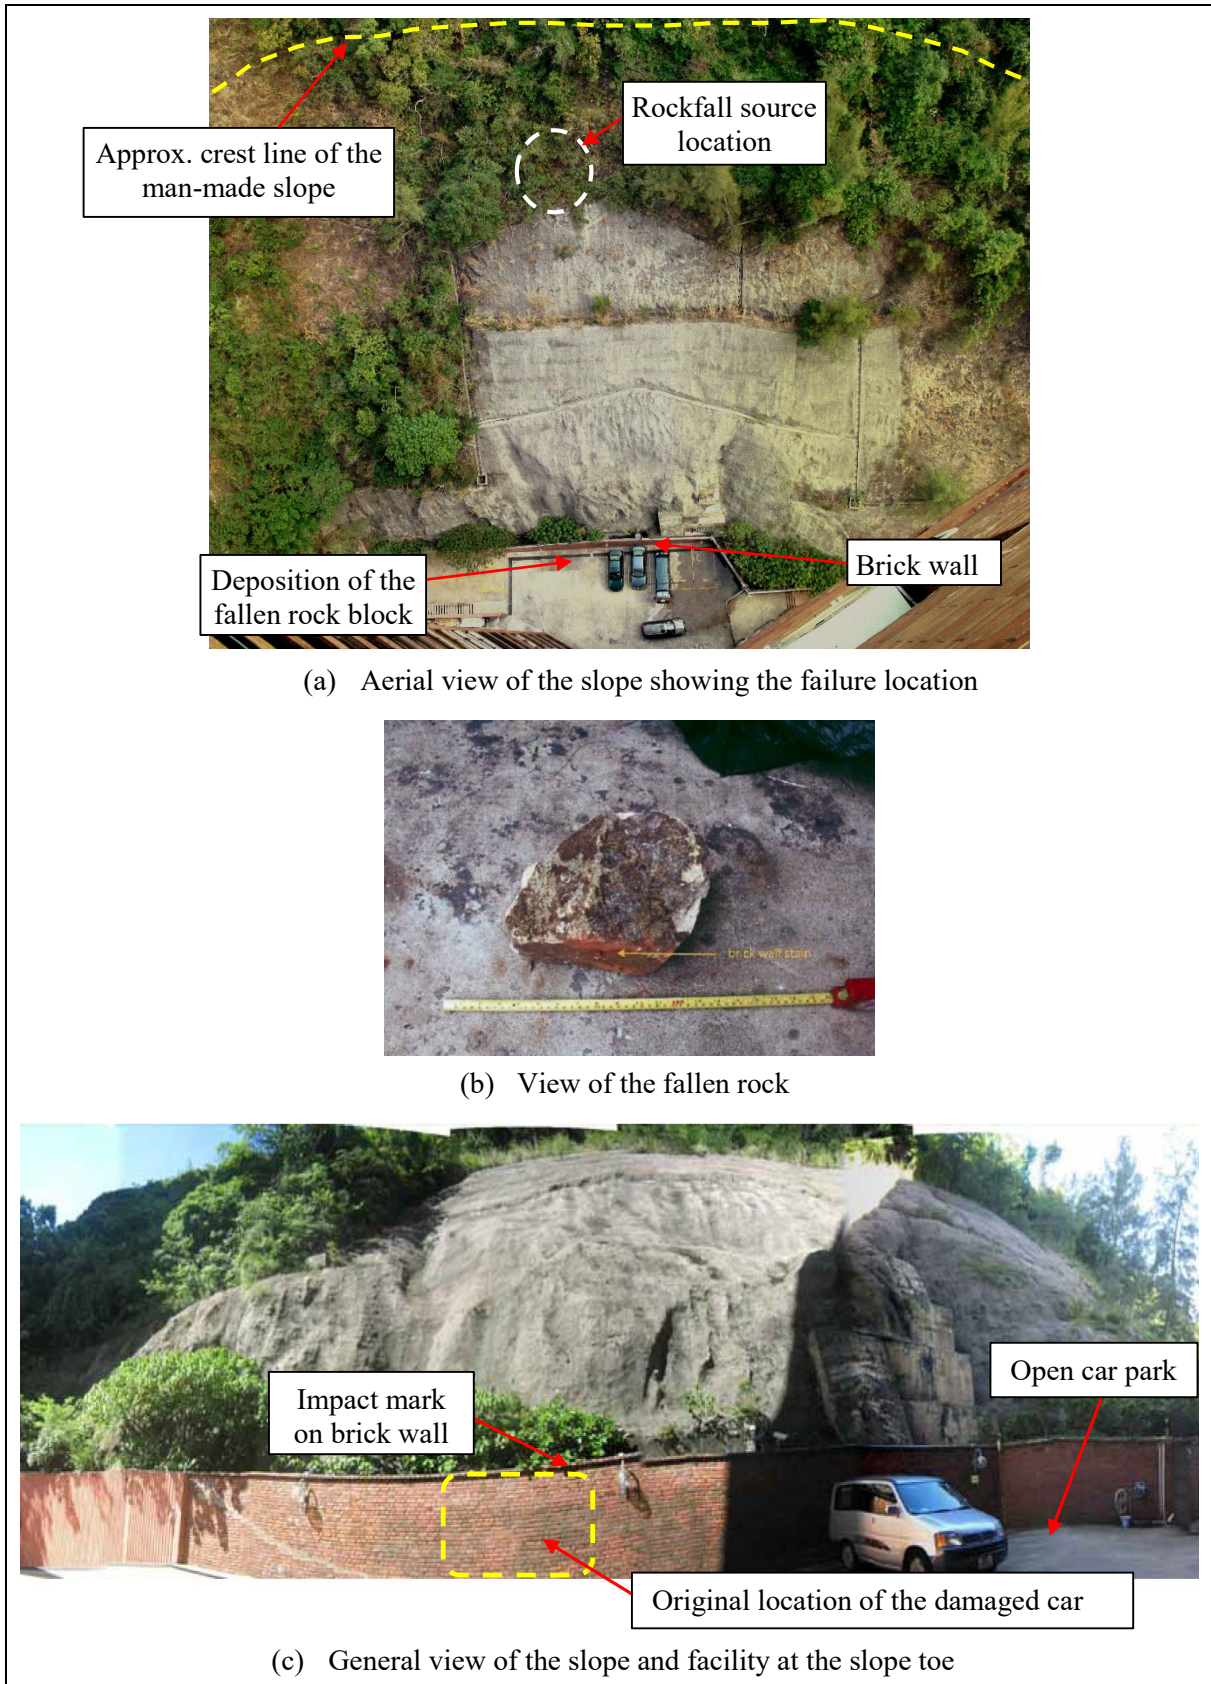
Figure 2.2 Views of the 20 July 2010 Rockfall behind Somerset, No. 67 Repulse Bay Road (Incident No. 2010/07/0968)

At about 11:15 a.m. on 20 July 2010, a rockfall incident occurred on a 40 m high soil and rock cut slope (Feature No. 15NE-A/C233) behind Somerset, No. 67 Repulse Bay Road (Figures 2.2a and 2.2b). The incident occurred under dry weather and no rain was recorded preceding it. The fallen rock block, with an estimated failure volume of about 0.03 m³, dislodged from about 35 m above ground level travelling downslope over a plan

The slope is sizeable and comprises three slope batters. The detached rock block was sourced from a bare rock face, being 45° inclined, near the crest of the slope. Along the trajectory path of the fallen rock block as inferred from the impact marks, the slope surface was primarily covered with shotcrete (Figure 2.2c). From the landslide inspection, closely-jointed weathered rock mass (Grade III/IV) with the growth of mature trees and vegetation were noted over the rockfall source location. This failure was probably attributed to the root wedging action by the nearby trees.

As generally observed from rockfall cases, it is not uncommon that the presence of trees, shrubs and slope furniture (e.g. handrails and fences) may serve as energy dissipators against the motion of rockfalls. In this case, the slope surface along the rockfall trajectory path was primarily covered with shotcrete which in favour the rolling and bouncing of the fallen rock block, as well as the building up of kinetic energy along the fall. Meanwhile, energy dissipators were limited along the rockfall trajectory path. With this setting, the rock block detached from its source area at height travelled over a long distance reaching the open car park at the slope toe.

This incident highlights the possible rendering of long travel distance and high energy of rockfalls associated with source areas at height. Rockfall motion could also be aggravated by the smooth slope surface (e.g. shotcrete cover) and the lack of energy dissipators along its trajectory path.

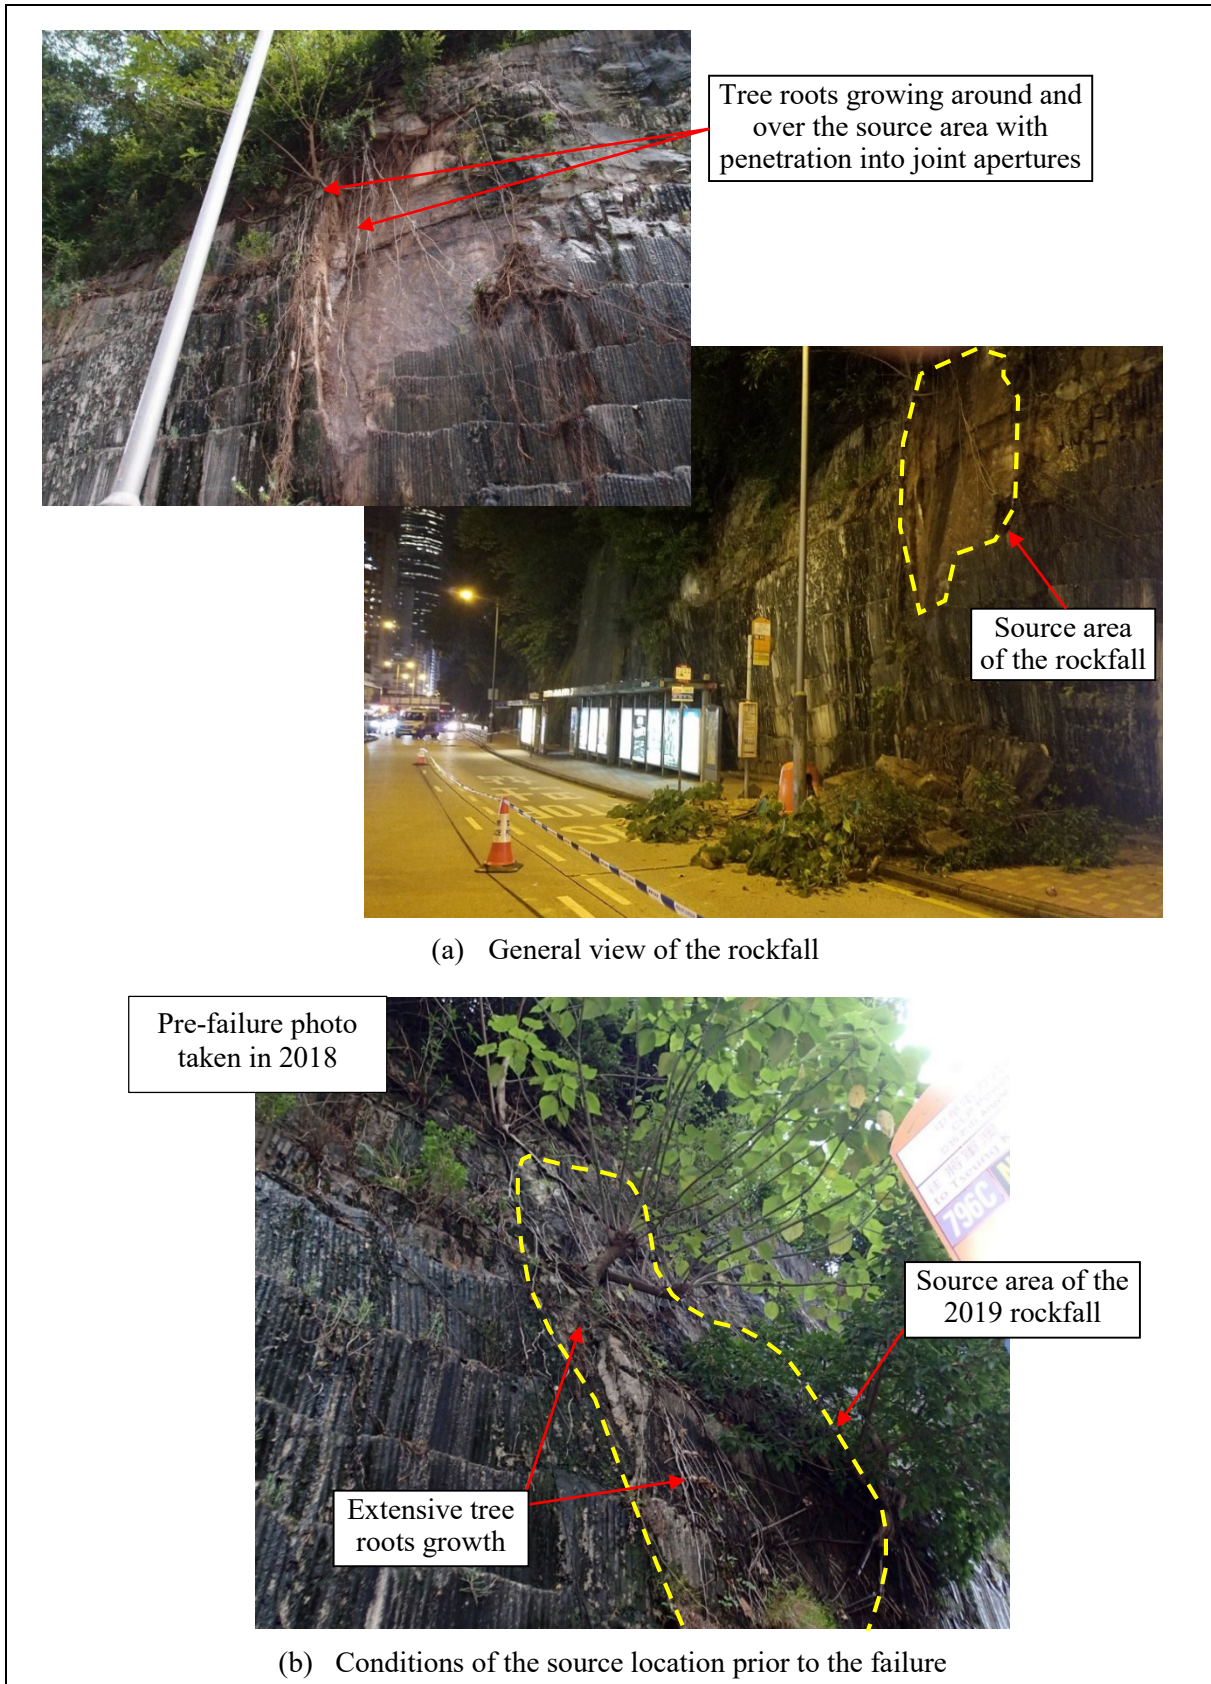
Figure 2.3 Views of the 26 June 2019 Rockfall at Argyle Street, Mong Kok (Incident No. 2019/06/2456)

At about 6:30 p.m. on 26 June 2019, a rockfall incident occurred on a 19 m high soil and rock cut slope (Feature No. 11NW-D/C16) at Argyle Street, Mong Kok (Figure 2.3a). There was no rain at the time of failure. The rockfall with a failure volume of approximately 4 m³ originated from the bare face of the lower rock batter, adjacent to another rockfall incident that occurred in 2018 (Incident No. 2018/08/2208 with a failure volume of about 0.005 m³). The debris, comprising rock fragments and some vegetation, was largely deposited on the pedestrian pavement and some of it covered part of a road lane. Rock fragments with size up to 1.5 m in diameter were recorded. As a result, two road lanes, the pedestrian pavement and the bus stops at slope toe were temporarily closed. No casualty was involved. The incident was reported in the media.

The rockfall involved a planar sliding failure from a sub-vertical rock cut batter over an adversely orientated sliding plane dipping out of the slope at about 75°. Vegetation with extensive root growth was noted at the source area prior to the failure (Figure 2.3b). Post-landslide inspection observed seepage on the failure scar which was probably associated with the precedent heavy rainfall (viz. Amber Rainstorm Warnings were issued in the evening of 25 June 2019 and in the morning of 26 June 2019 and the rolling 2-day rainfall preceding the incident was about 60 mm). The failure was probably caused by the development of cleft water pressure along the sliding plane attributable to the subsurface flow from upslope. The penetration of roots into the joint apertures, as evidenced on the scar, could have progressively

wedged open the adversely orientated rock joints allowing enhanced water ingress.

The incident was notable in that it occurred on a sizeable steep cut slope (19 m high and 85 m long) along a heavily-trafficked road overlooking a number of busy bus stops (located intermittently over a continuous length of about 50 m) during rush hours. Fortunately, the failure did not result in any casualty under such dense urban setting and failure timing. The incident highlights the landslide risk posed by sizeable slopes with the presence of a persistent length of facilities of heavy usage along the slope toe. Given the vulnerable setting, even local failures may lead to severe consequences.

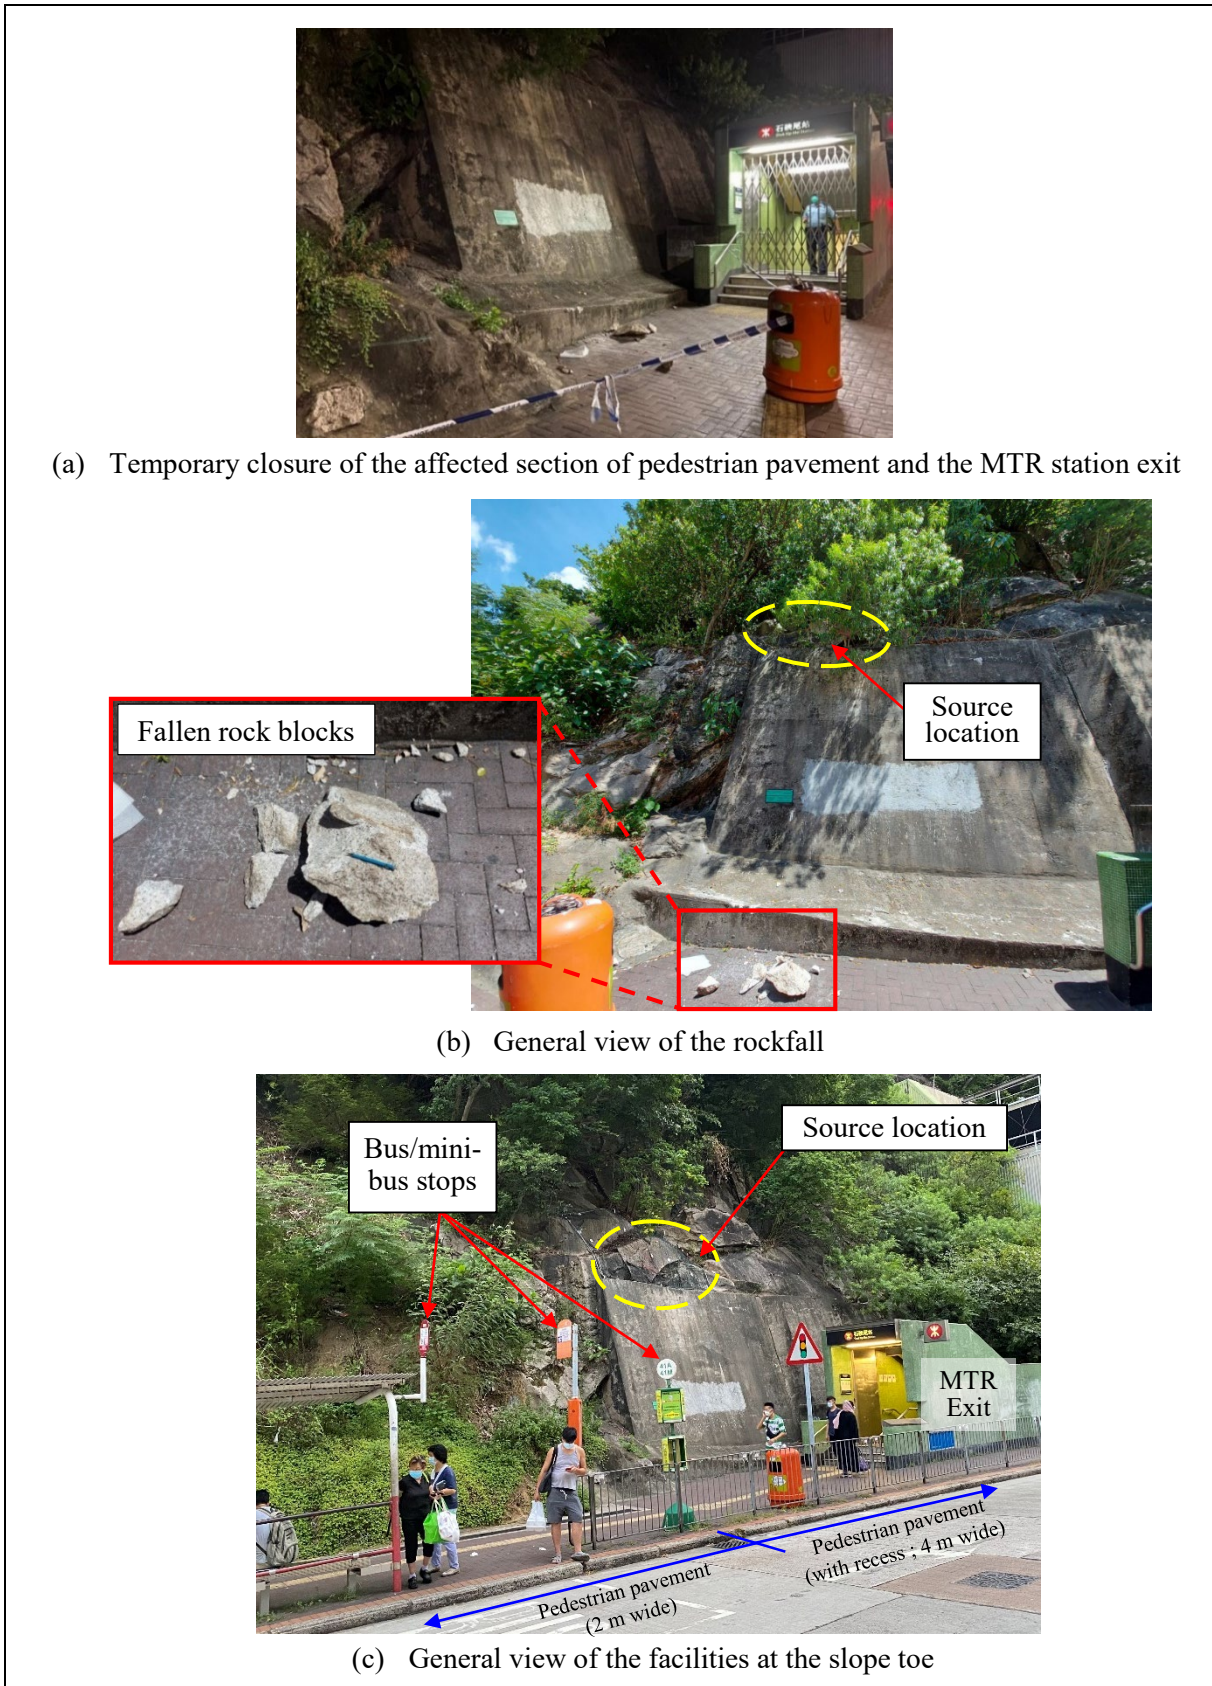
Figure 2.4 Views of the 15 July 2020 Rockfall at Woh Chai Street, Shek Kip Mei (Incident No. 2020/07/2723)

At about 6:20 p.m. on 15 July 2020, a rockfall incident occurred on a 50 m high soil and rock cut slope (Feature No. 11NW-B/C39) at Woh Chai Street, Shek Kip Mei (Figures 2.4a and 2.4b). The incident occurred under dry weather and no rain was recorded preceding it. The rockfall incident, with an estimated failure volume of about 0.06 m³, involved the detachment of small rock blocks from a 50° inclined bare face at the lower rock batter. The rock fragments with a maximum size of about 0.5 m by 0.5 m by 0.25 m were deposited on the pedestrian pavement covering an extent of at about 2.5 m from the slope toe outside an exit of the Shek Kip Mei MTR station. As a result, the affected section of pedestrian pavement and the exit of the MTR station were temporarily closed. No casualty was involved.

Post-landslide inspection revealed that a number of trees and extensive vegetation were growing over and above the failure location (Figure 2.4b) and tree roots were noted on the failure scar. The joints of the rock mass at the failure location could have been opened up by tree root action. Root wedging action had played a key contributory role in this failure.

The subject portion of the slope abuts the pedestrian pavement of varying width (from 2 m to 4 m) with bus stops, a mini-bus stop and an MTR station exit (Figure 2.4c). Although the scale of failure is small, the incident could have resulted in more serious consequences if the rockfall is sourced from a higher slope portion where rock blocks falling with higher energy may reach the carriageways; or if the rockfall is sourced from the area right above the bus/mini-bus stops, located within metres away from the present rockfall location (where a recess rendered a wider pavement at the MTR station exit area), with a narrower pavement. This incident highlights that a slight difference in site settings or rockfall source locations could significantly increase the chance of rendering severe consequences.

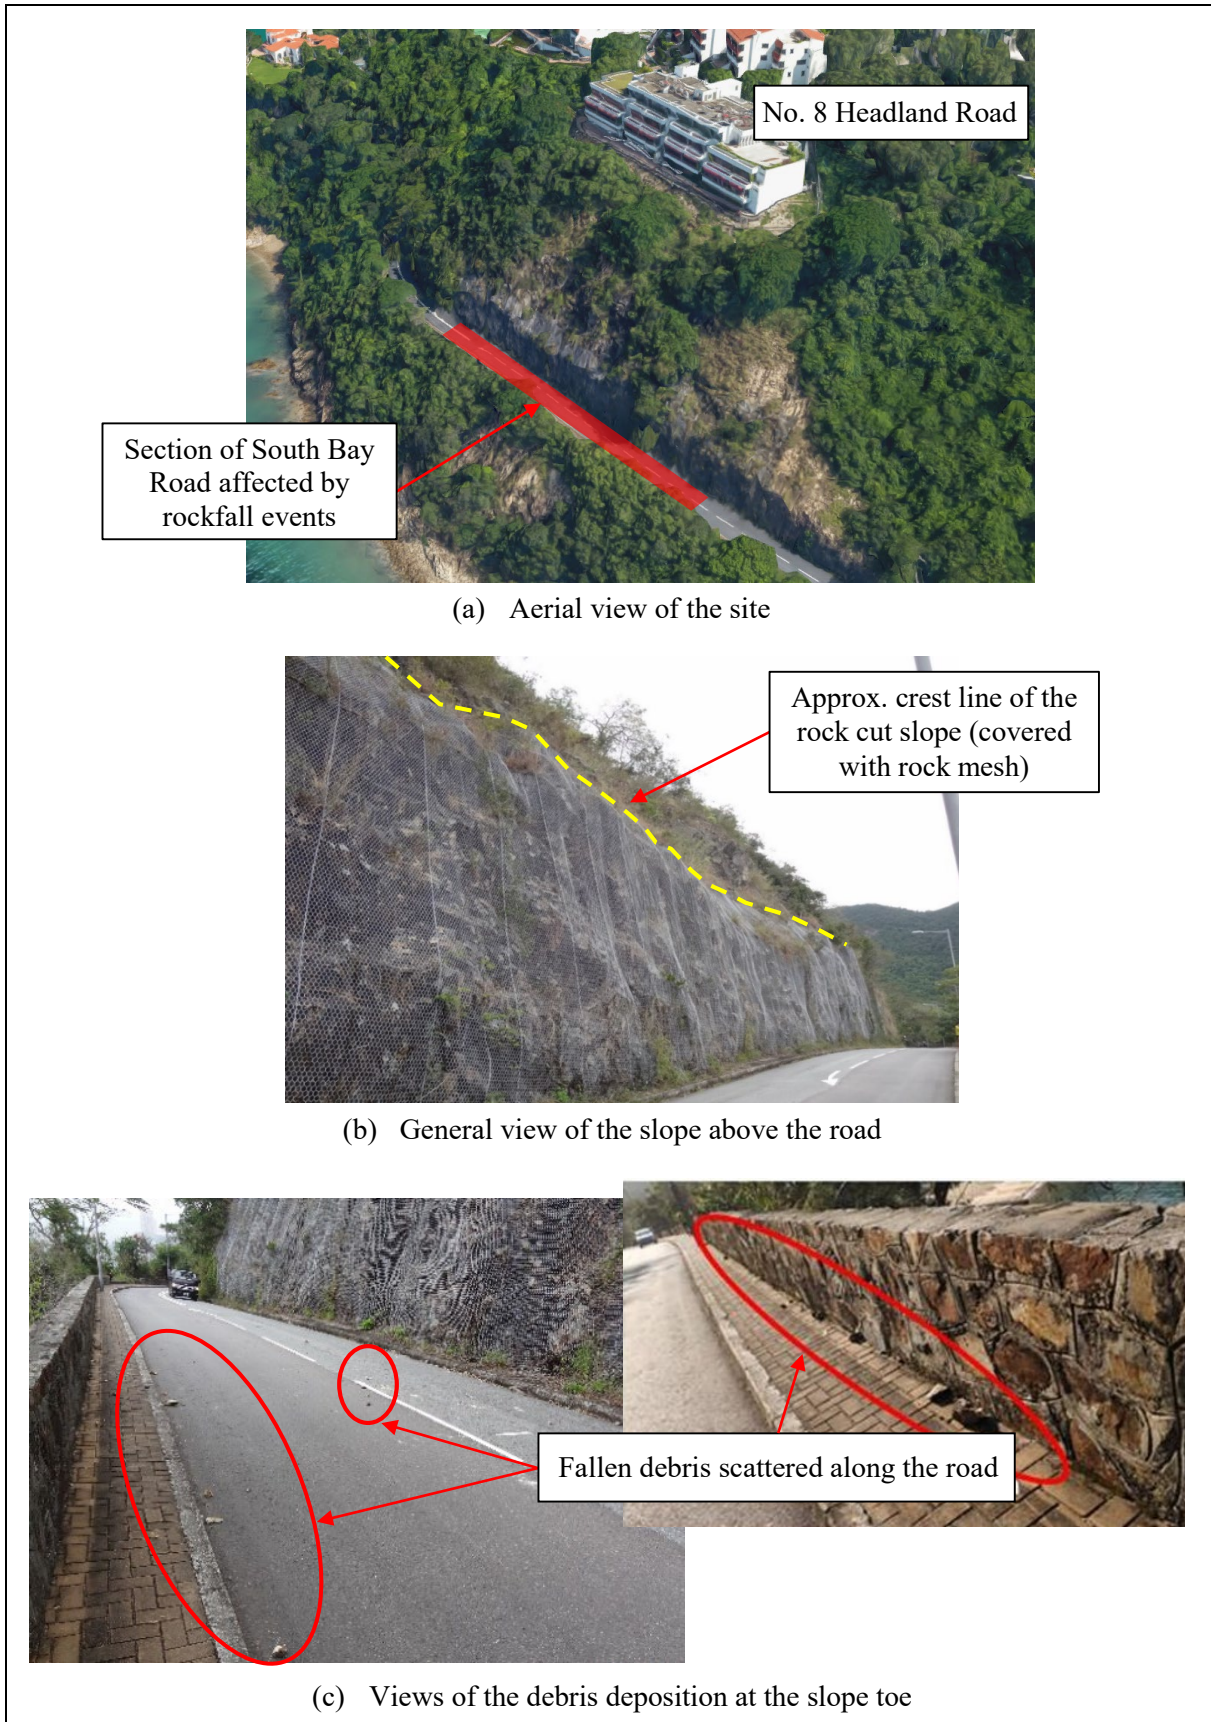
Figure 2.5 Views of the 2018 and 2019 Rockfalls at South Bay Road

Between December 2018 and February 2019, four rockfall events were reported at South Bay Road (Figure 2.5a) with the fallen debris, comprising rock fragments as well as construction and demolition materials, deposited and scattered along a road section of about 80 m long (Figures 2.5b and 2.5c). Though the exact time of failures is not known, the rockfalls were reported under dry weather within the dry season. No significant consequence was resulted from these rockfall events.

The affected section of South Bay Road is abutted by a 10 m high rock cut slope (Feature No. 15NE-A/C100), above which being the natural hillside with a height of about 35 m. A low-rise residential building on a building platform is located at the crest of the hillside. The source locations of the rockfalls are not known. They probably sourced from the hillside with extensive rock outcrops while the cut slope was covered with rock mesh in a fair condition.

The discrete rockfall events affected a substantial length of South Bay Road. In particular, the debris deposited over a 30 m long road section instead of an isolated location in one of the events, differing from the typical observations on rockfall disposition. Wild boars' activities were evidenced on the hillside above the cut slope. Any rock blocks and other materials perched on the hillside could have fallen off with the crossing of the wild boars rendering debris scattered along the road. The activities of wild boars could have constituted to a moving trigger for the rockfalls.

The rockfall events serve as a reminder that rockfall under dry weather may involve other less common triggers, such as the activities of wild animals on slopes.

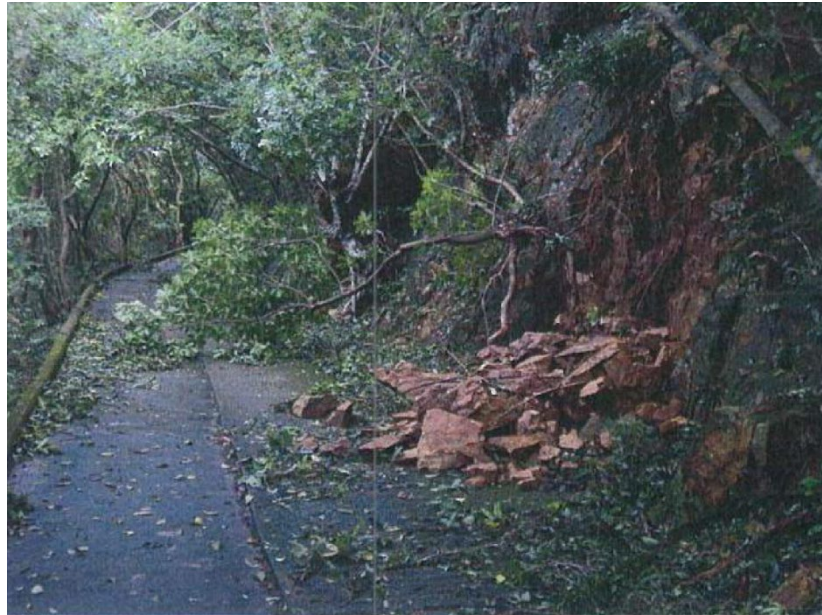
(a) Rockfall on a rock cut slope near Section 4 of Hong Kong Trail, Middle Gap in 2012

Figure 3.5 Examples of Rockfalls Incidents on Bare Rock Faces Probably Triggered by Wedging Action of Tree Roots

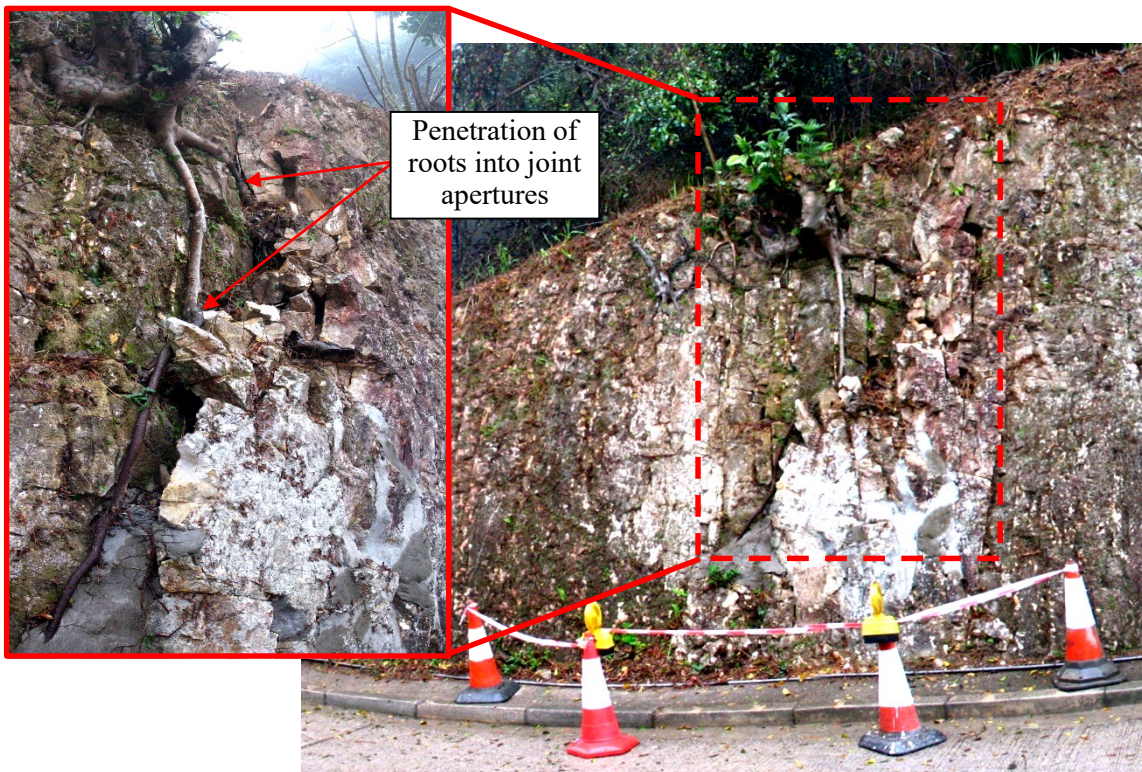
(b) Rockfall on a rock cut slope at the access road leading to 76 Peak Road in 2005

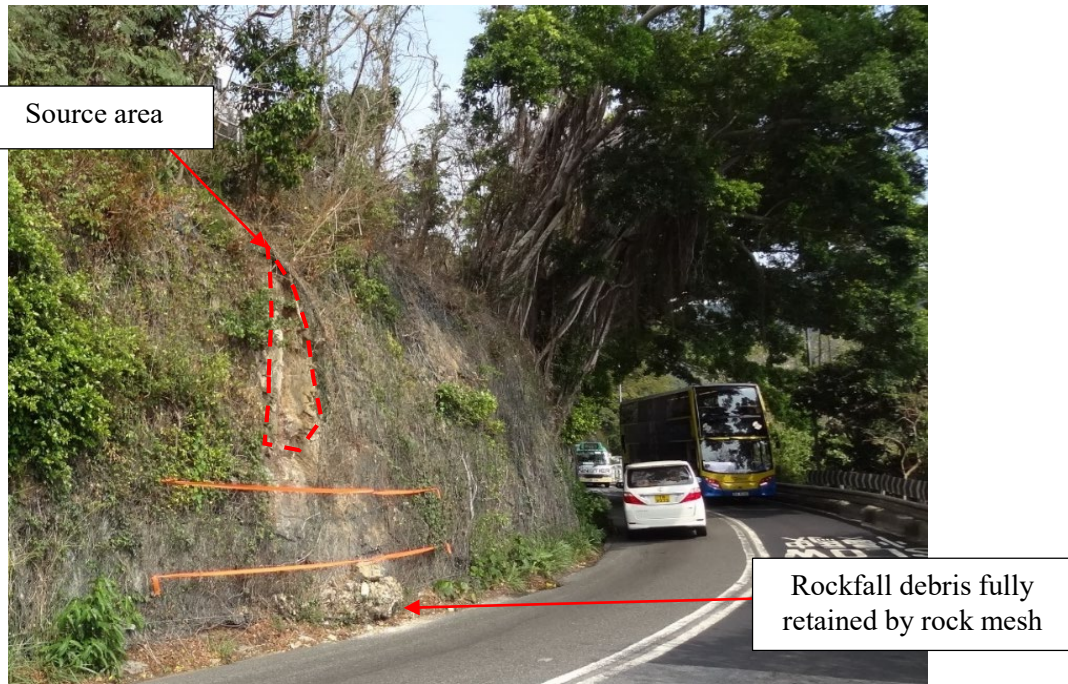
(a) Rockfall on a rock cut slope near the junction of Island Road and Repulse Bay Road in 2021

Figure 4.1 Examples of Rockfall Incidents with Debris Retained by Rock Mesh

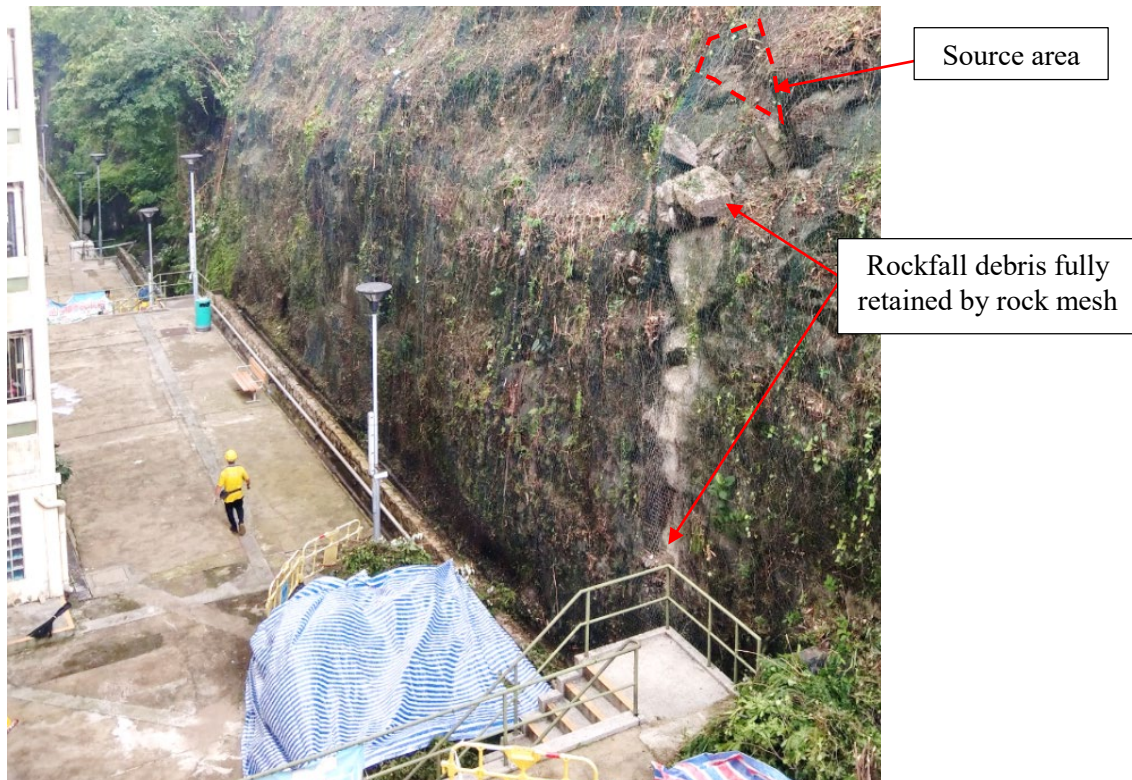
(b) Rockfall on a rock cut slope at No. 156 Kau Pui Lung Road, To Kwa Wan in 2021

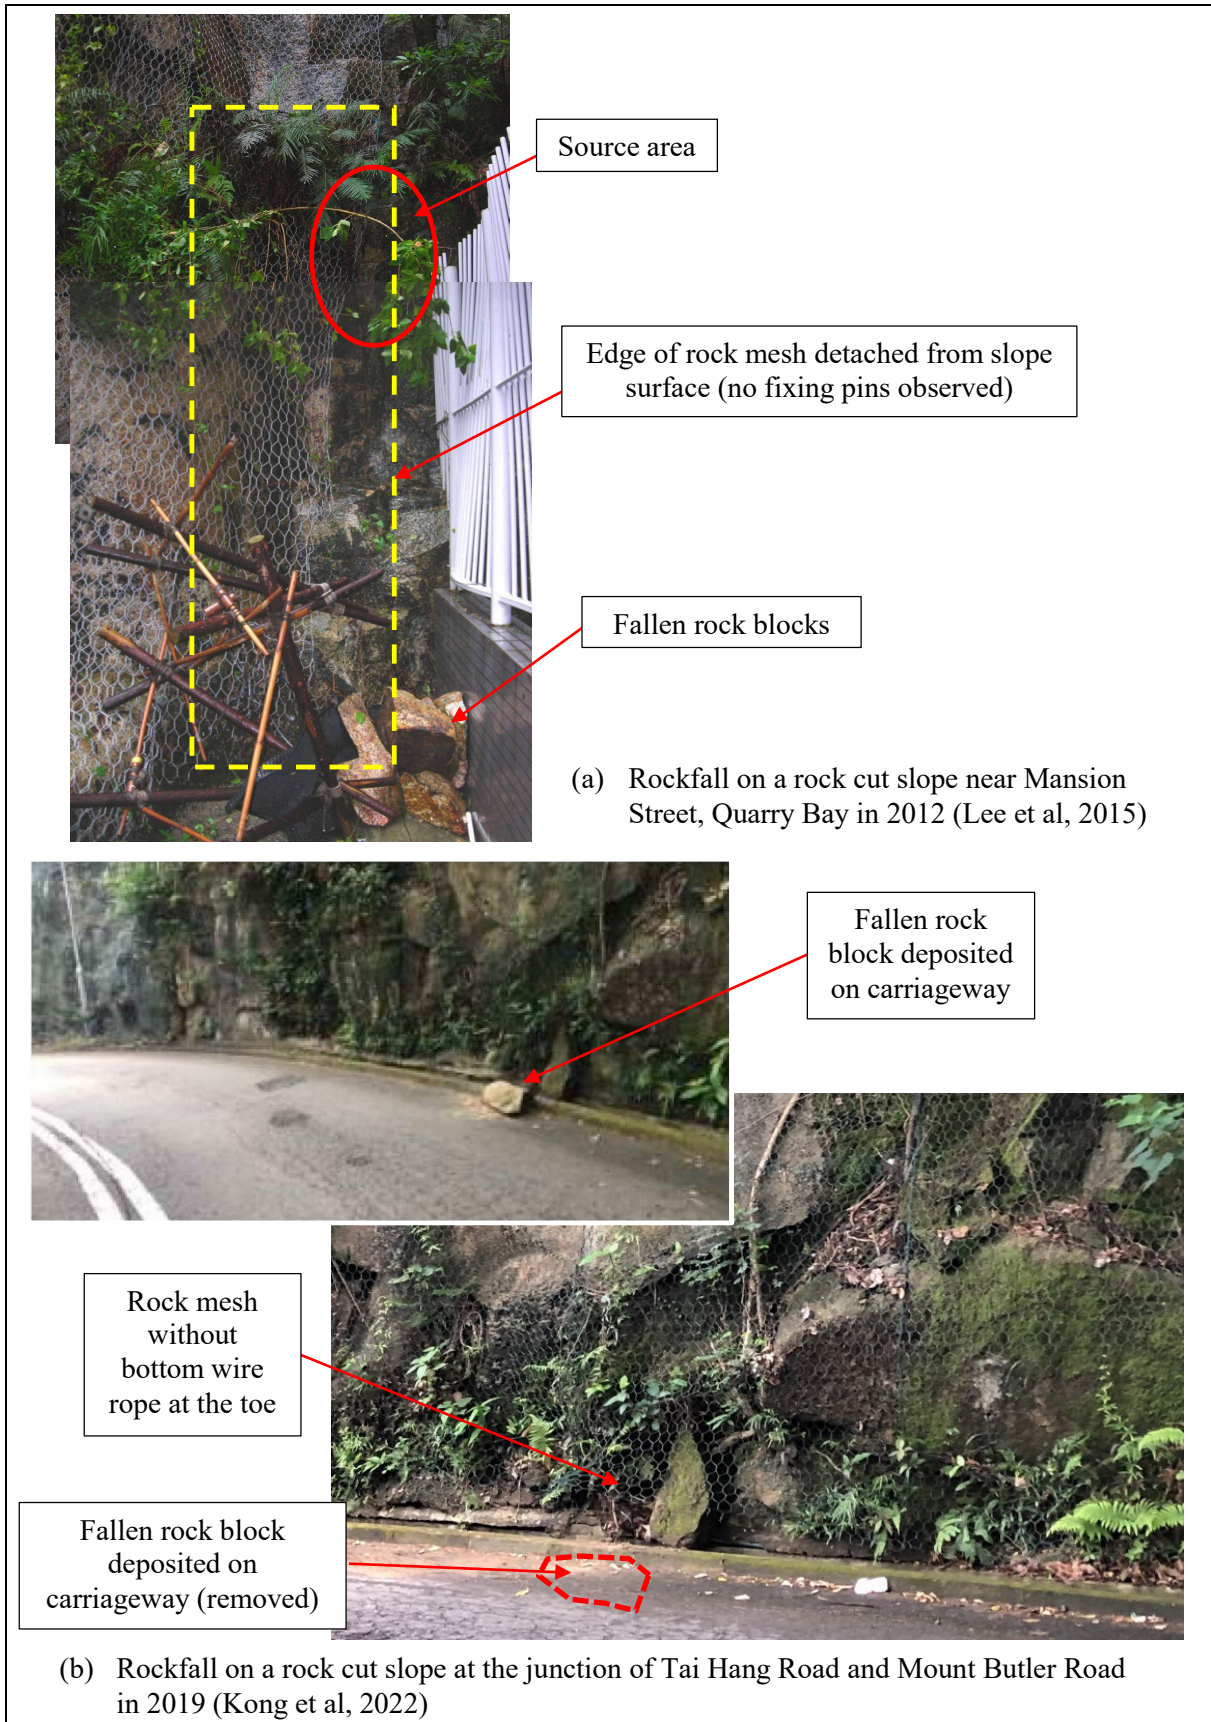
Figure 4.2 Rockfall Incidents with Rock Blocks Falling out of Rock Mesh
