**Detailed Study of the
8 September 2023 Landslides
on the Natural Hillside
above Yiu Hing Road,
Yiu Tung Estate,
Shau Kei Wan**

GEO Report No. 377

Fugro (Hong Kong) Limited

**Geotechnical Engineering Office
Civil Engineering and Development Department
The Government of the Hong Kong
Special Administrative Region**

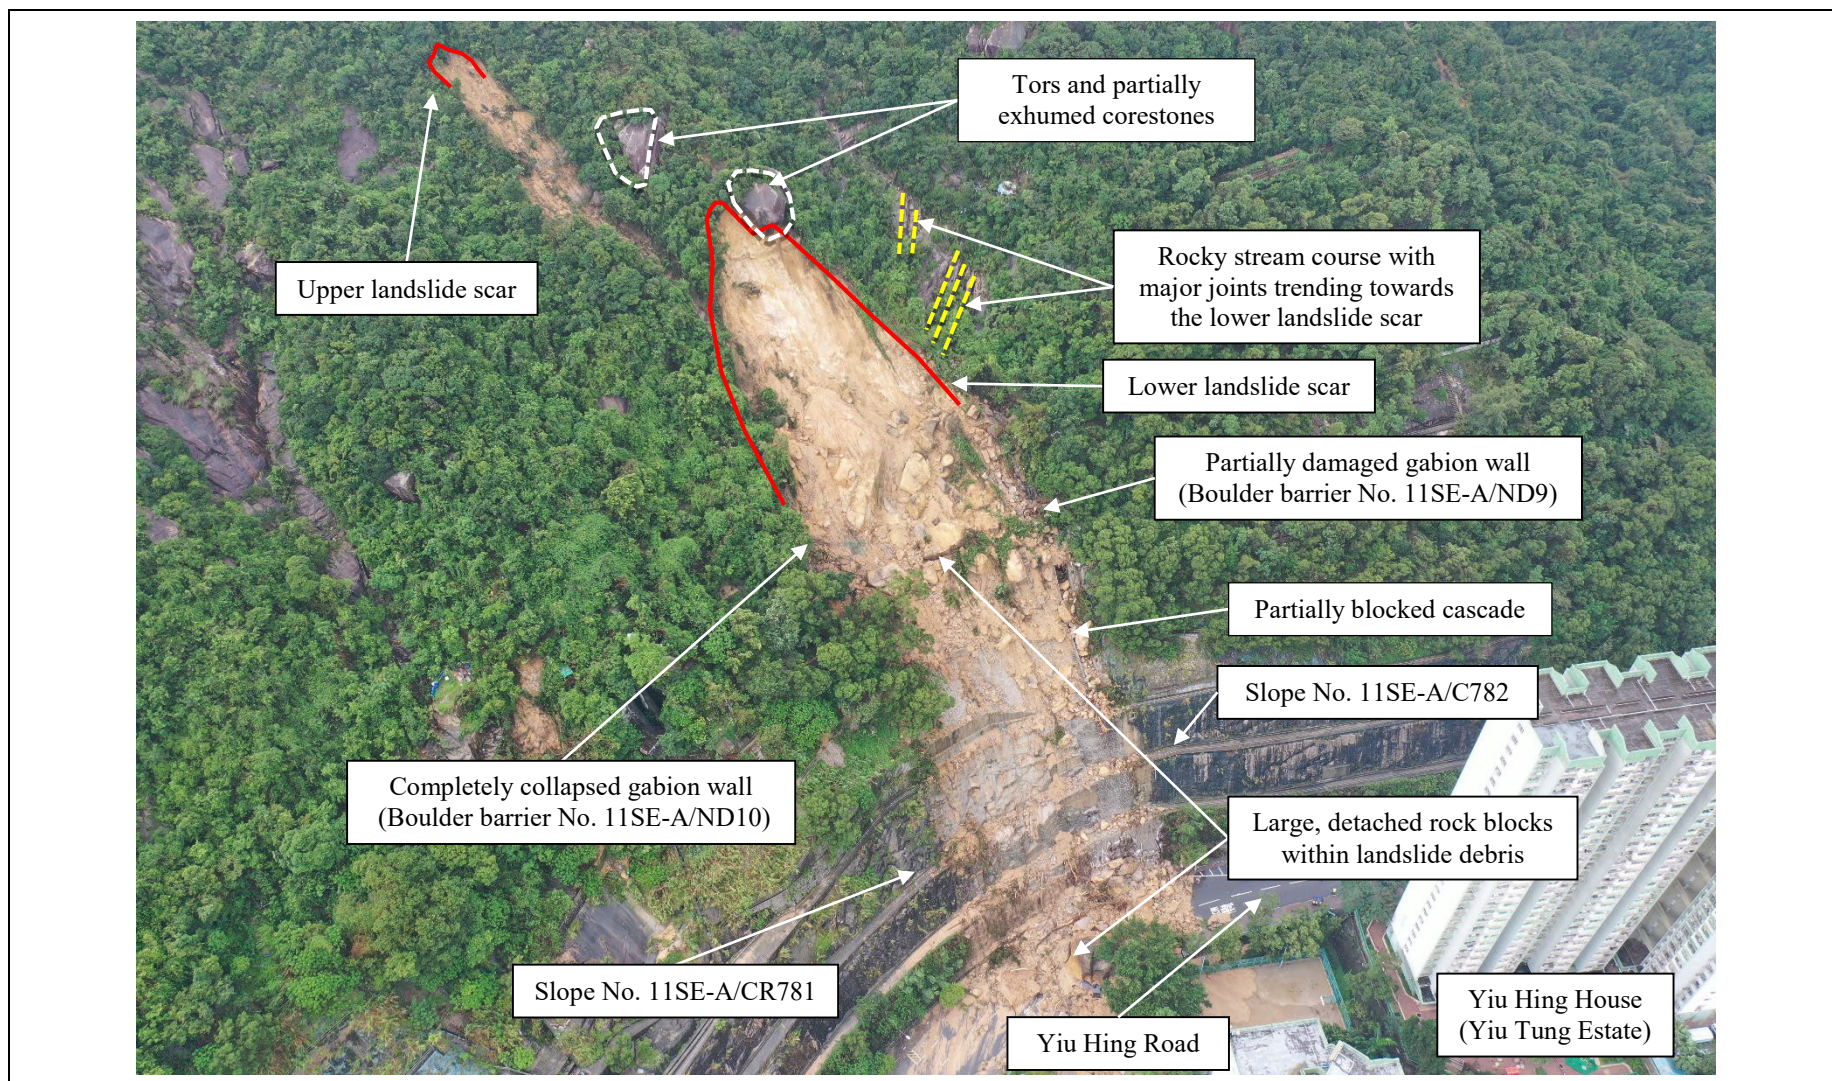
Figure 1.2 General View of the Landslide Site (Photograph taken on 9 September 2023)

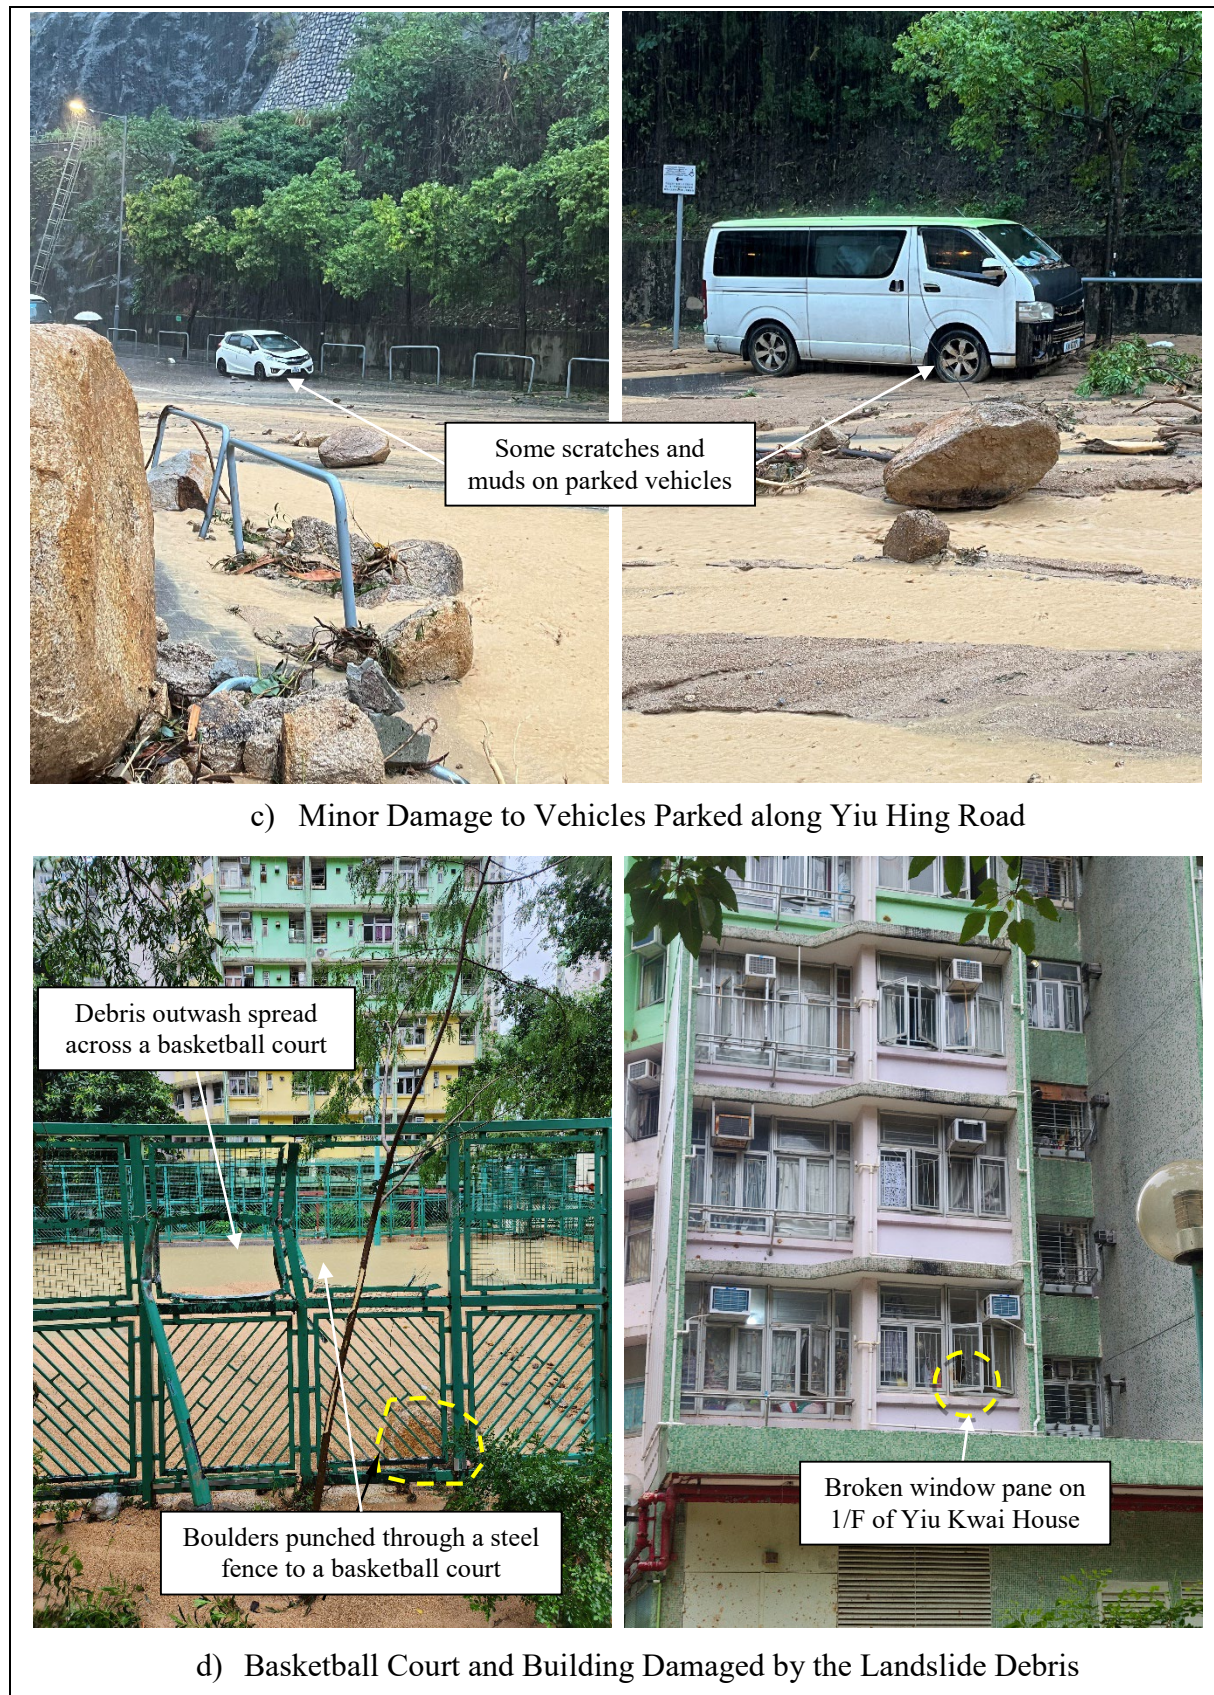
Figure 1.3 Consequences of the Incident (Photographs taken on 8 September 2023)
(Sheet 2 of 2)

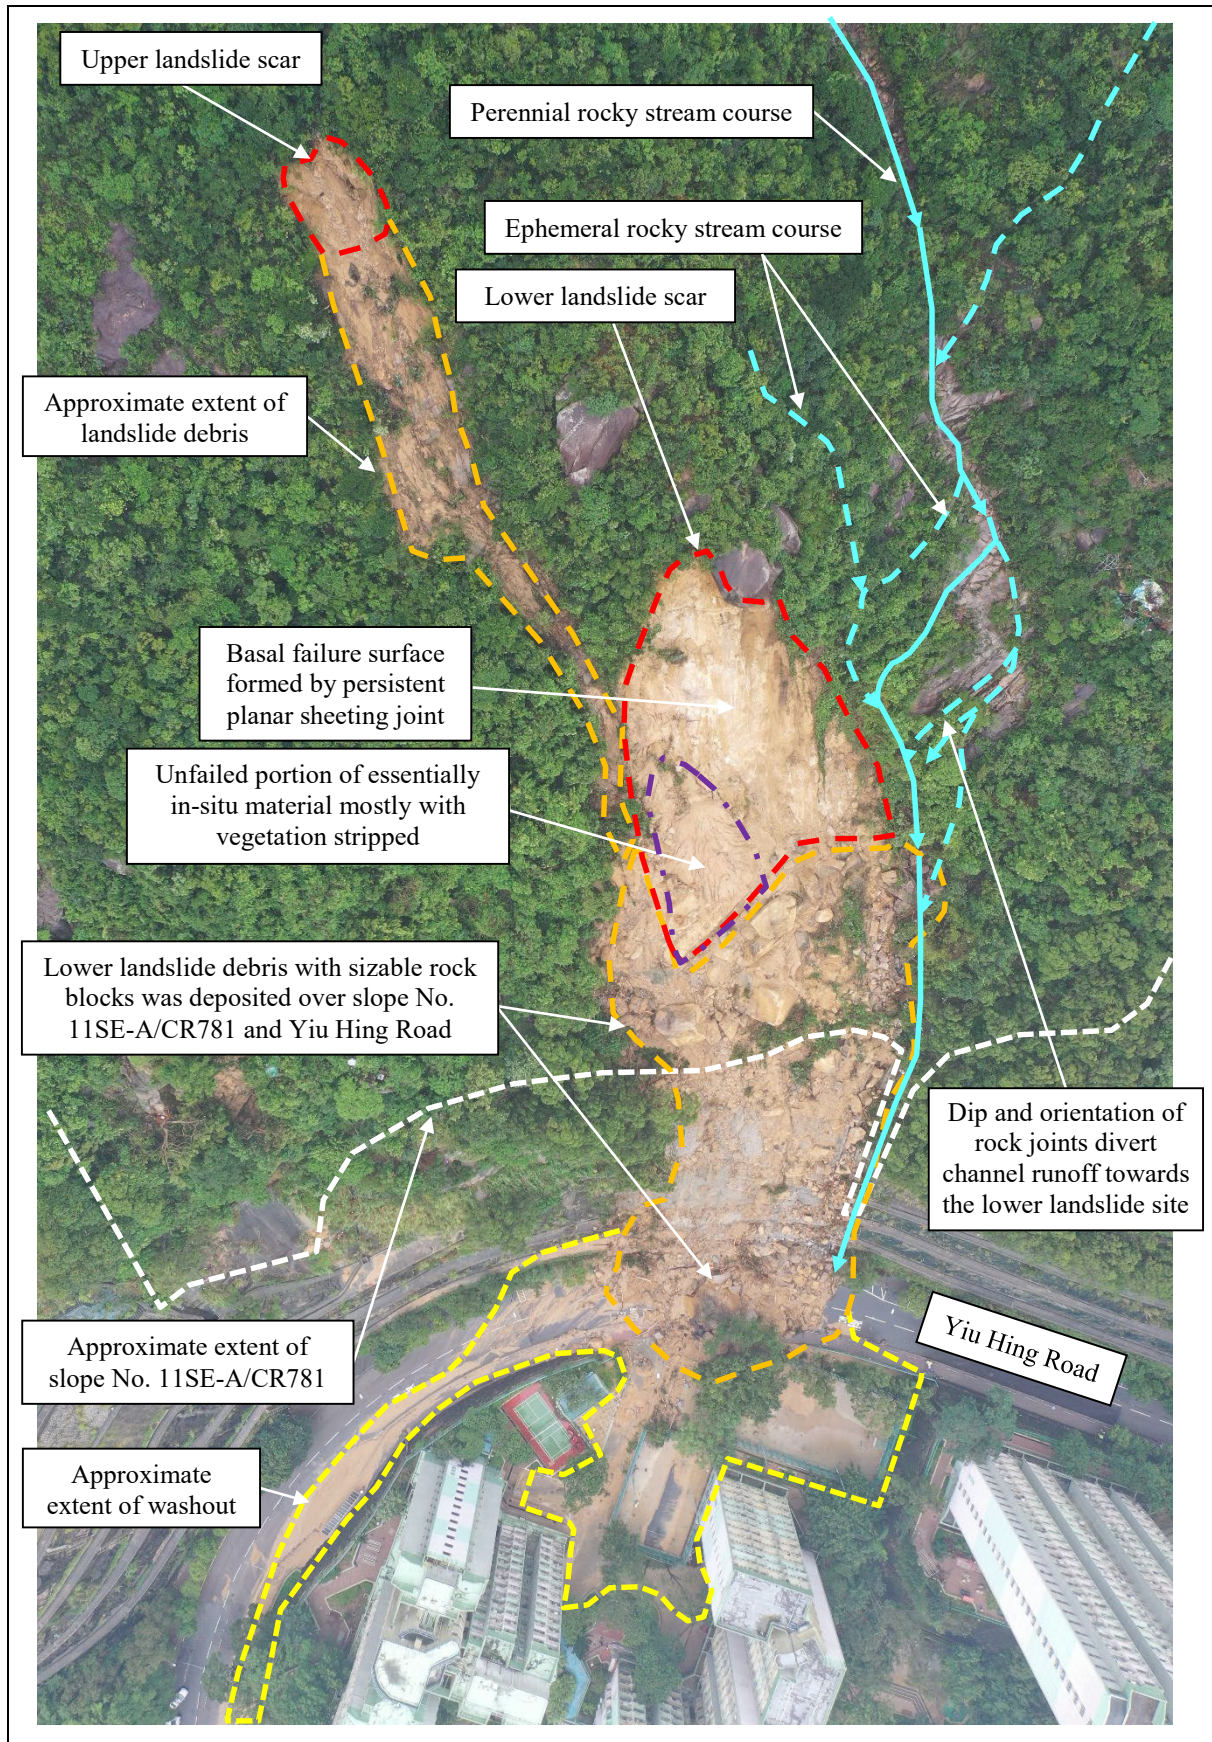
Figure 6.1 Overview of the Landslide Site (Photograph taken on 9 September 2023)

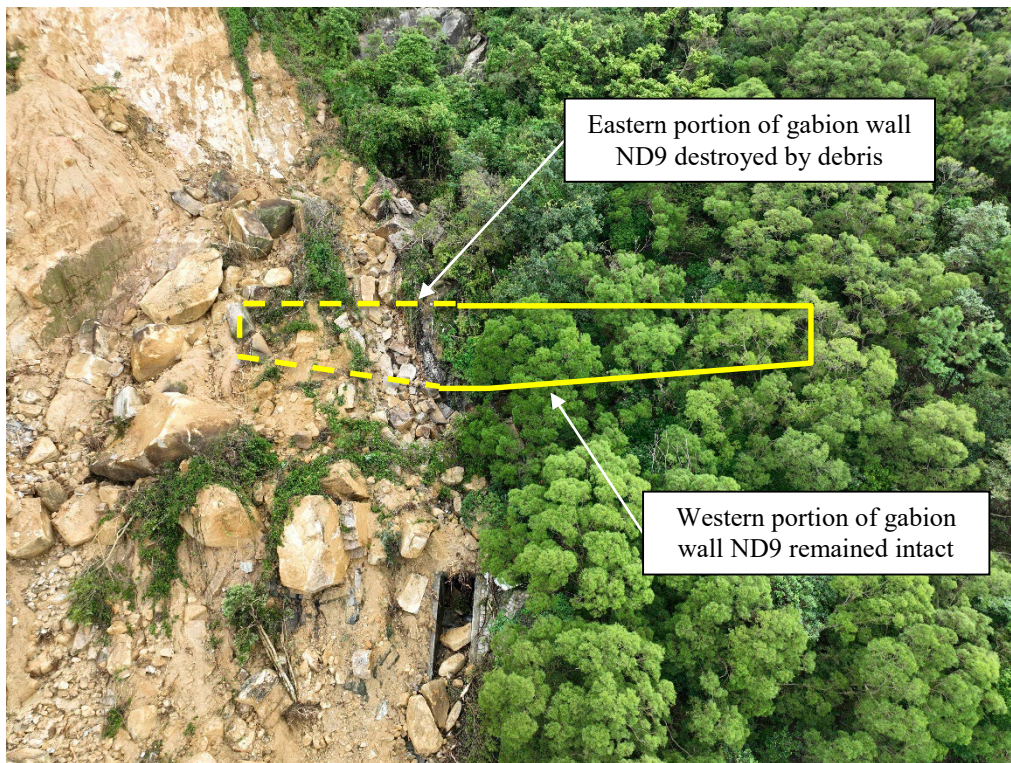
a) Partially Damaged Gabion Wall ND9

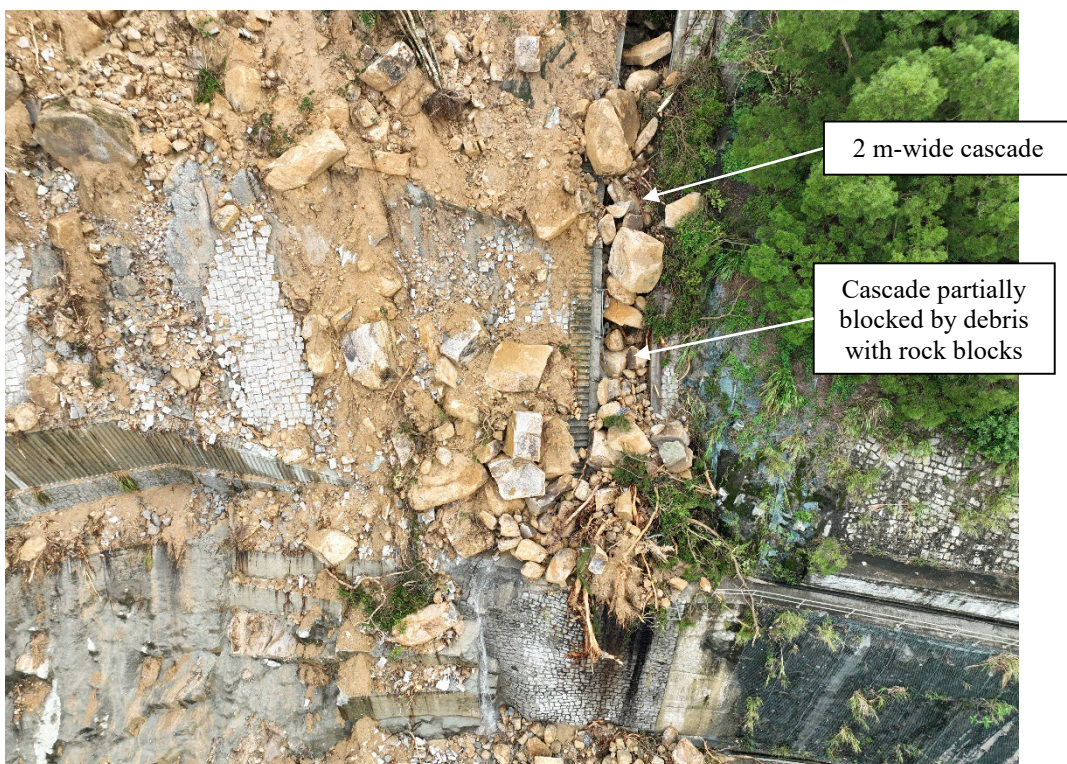
b) Cascade Partially Blocked by Landslide Debris

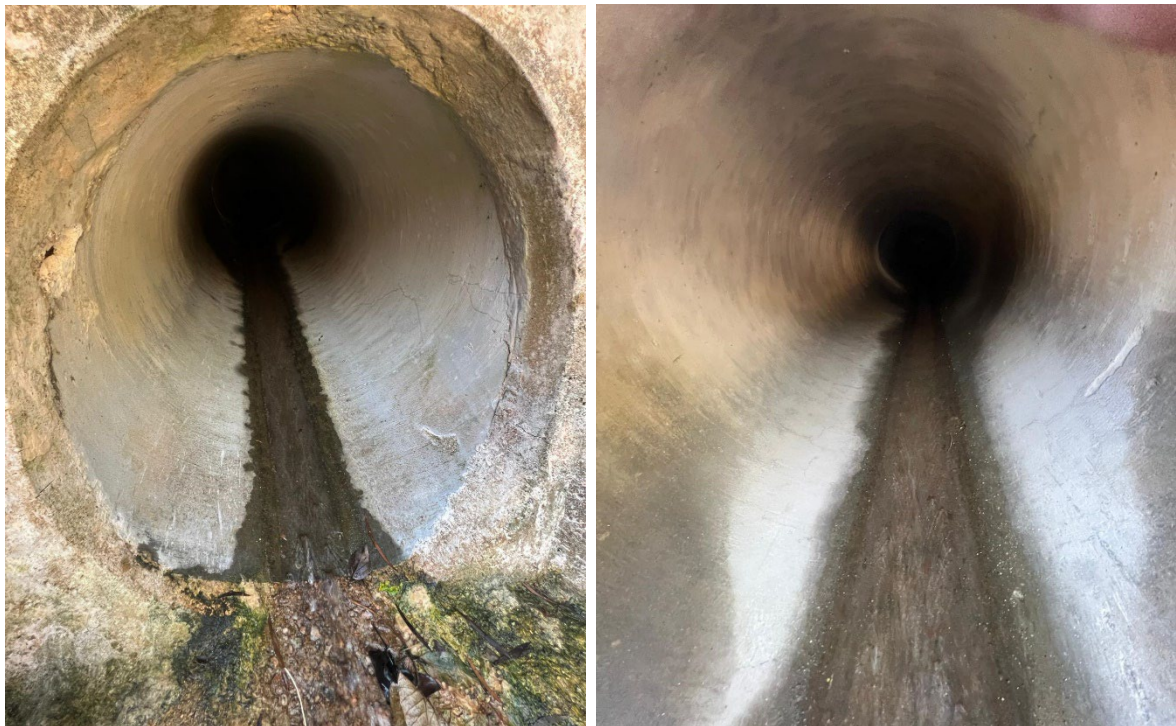
Despite the partial blockage, the post-landslide inspections revealed that channel runoff was still able to flow through two of the drainage pipes. There were no indications of this runoff spreading around the partially damaged gabion wall ND9. The water continued to flow along the cascade below the gabion wall until it reached the blocked area, where it overflowed onto the cut slopes (Figure 6.9). Similar observations were made during a rainstorm on 4 May 2024 (Figure 6.10). No significant water was discharged from the weepholes in the retaining wall of slope No. 11SE-A/CR781.

b) Partially Blocked Inlets of the Other Two Drainage Outlet Pipes

Figure 6.8 Conditions of Drainage Outlet Pipes underneath Gabion Wall ND9 after the Incident (Photographs taken on 12 December 2023)

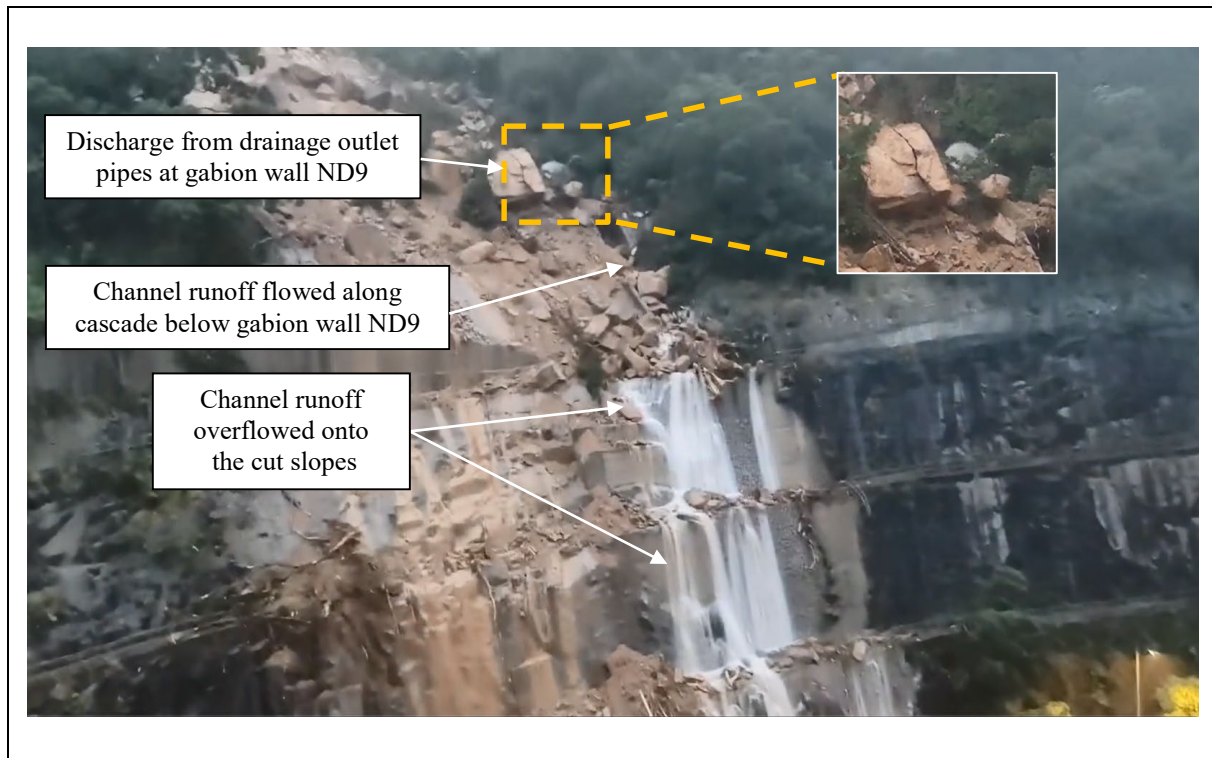
Figure 6.9 Channel Runoff along Cascade below Gabion Wall ND9 (Photograph taken on 8 September 2023)

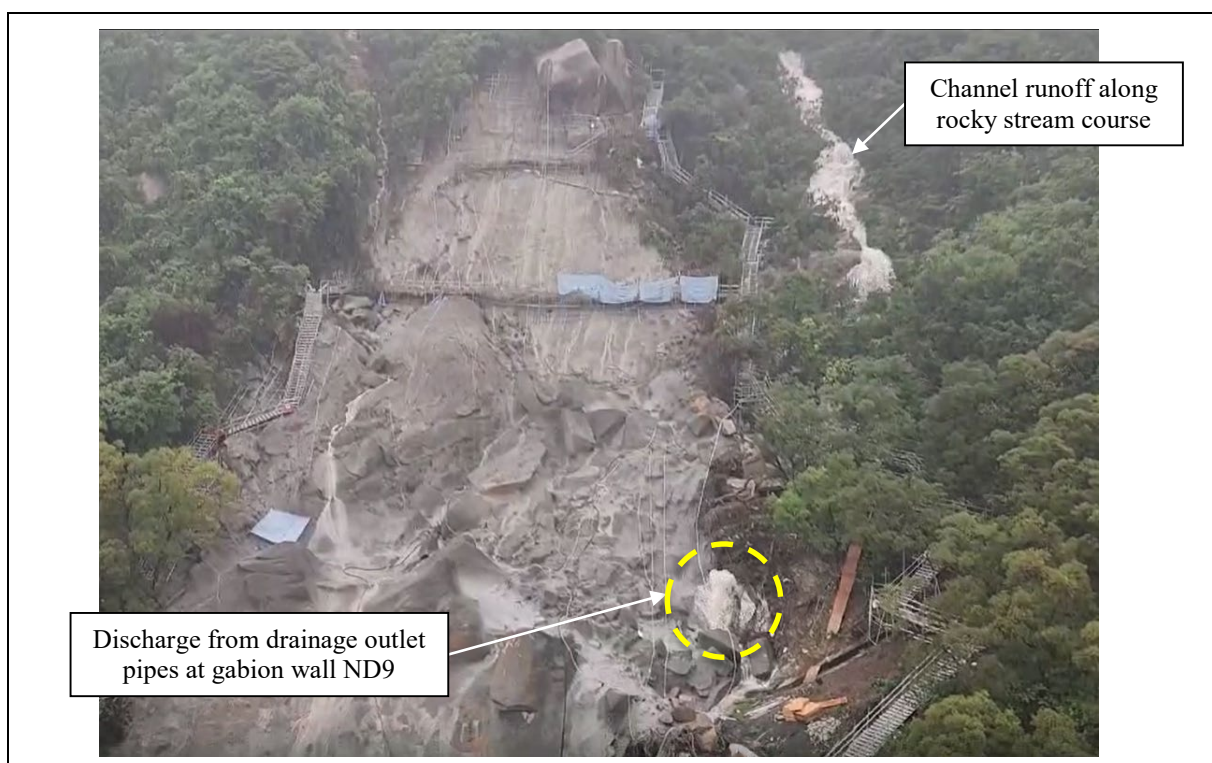
Figure 6.10 Channel Runoff along Cascade below Gabion Wall ND9 (Photograph taken on 4 May 2024)

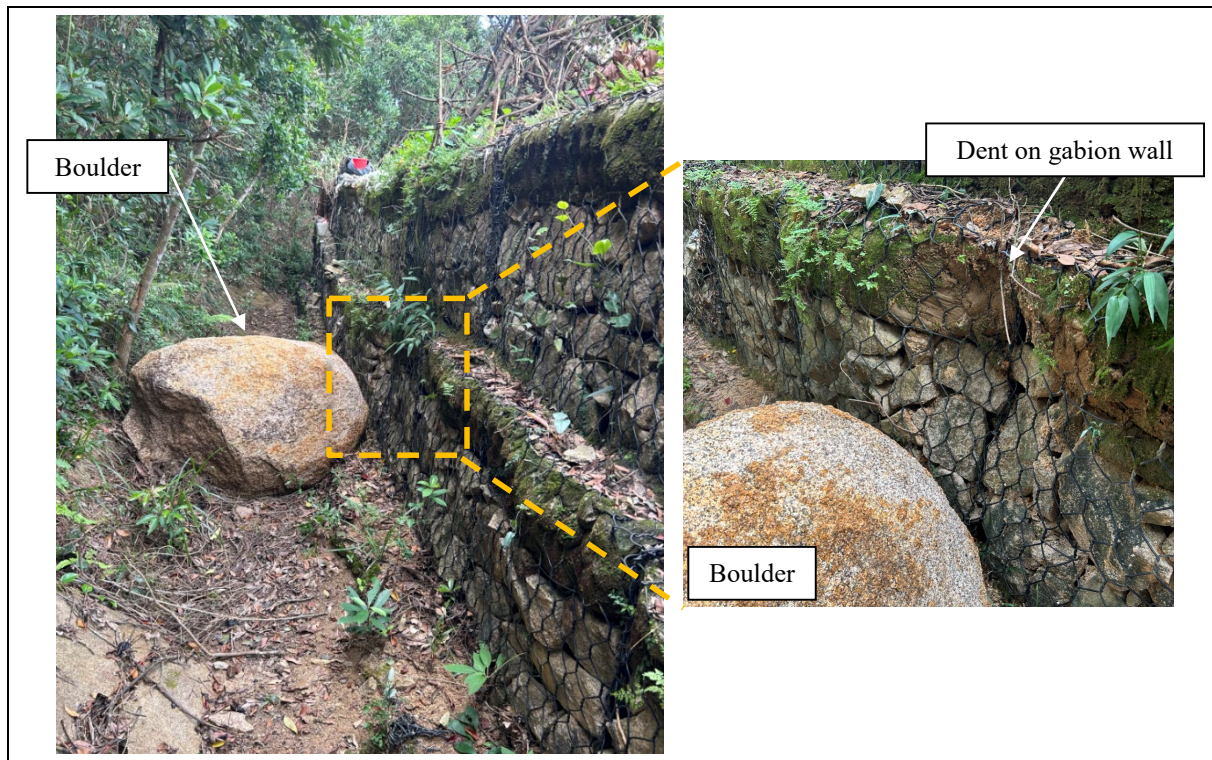
Figure 6.12 Boulder Arrested by Gabion Wall ND8 (Photograph taken on 26 September 2023)

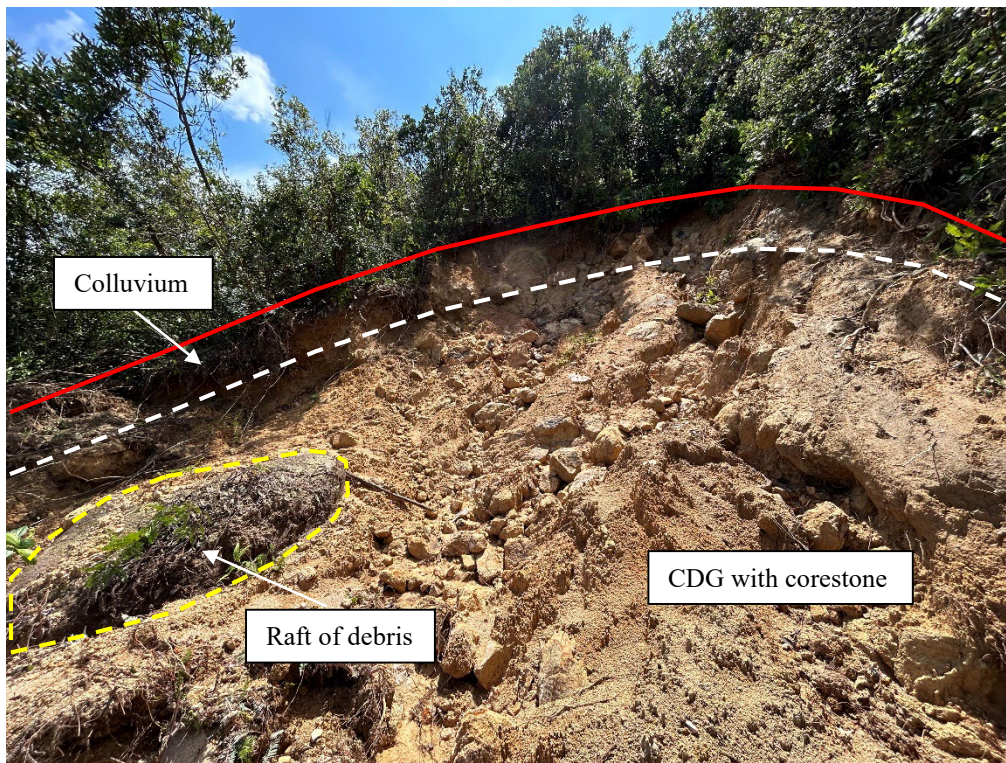
The rupture surface consisted of partially weathered rock with corestones, indicating that the failure occurred at the interface between colluvium and corestone-rich CDG. Some partially exhumed corestones were observed along the debris trail.

Post-landslide inspections revealed no seepage or soil pipes in the landslide scar area.

a) View of the Crest of the Upper Landslide Scar

Figure 6.13 Close-up View of the Upper Landslide Scar (Photographs taken on 19 September 2023)

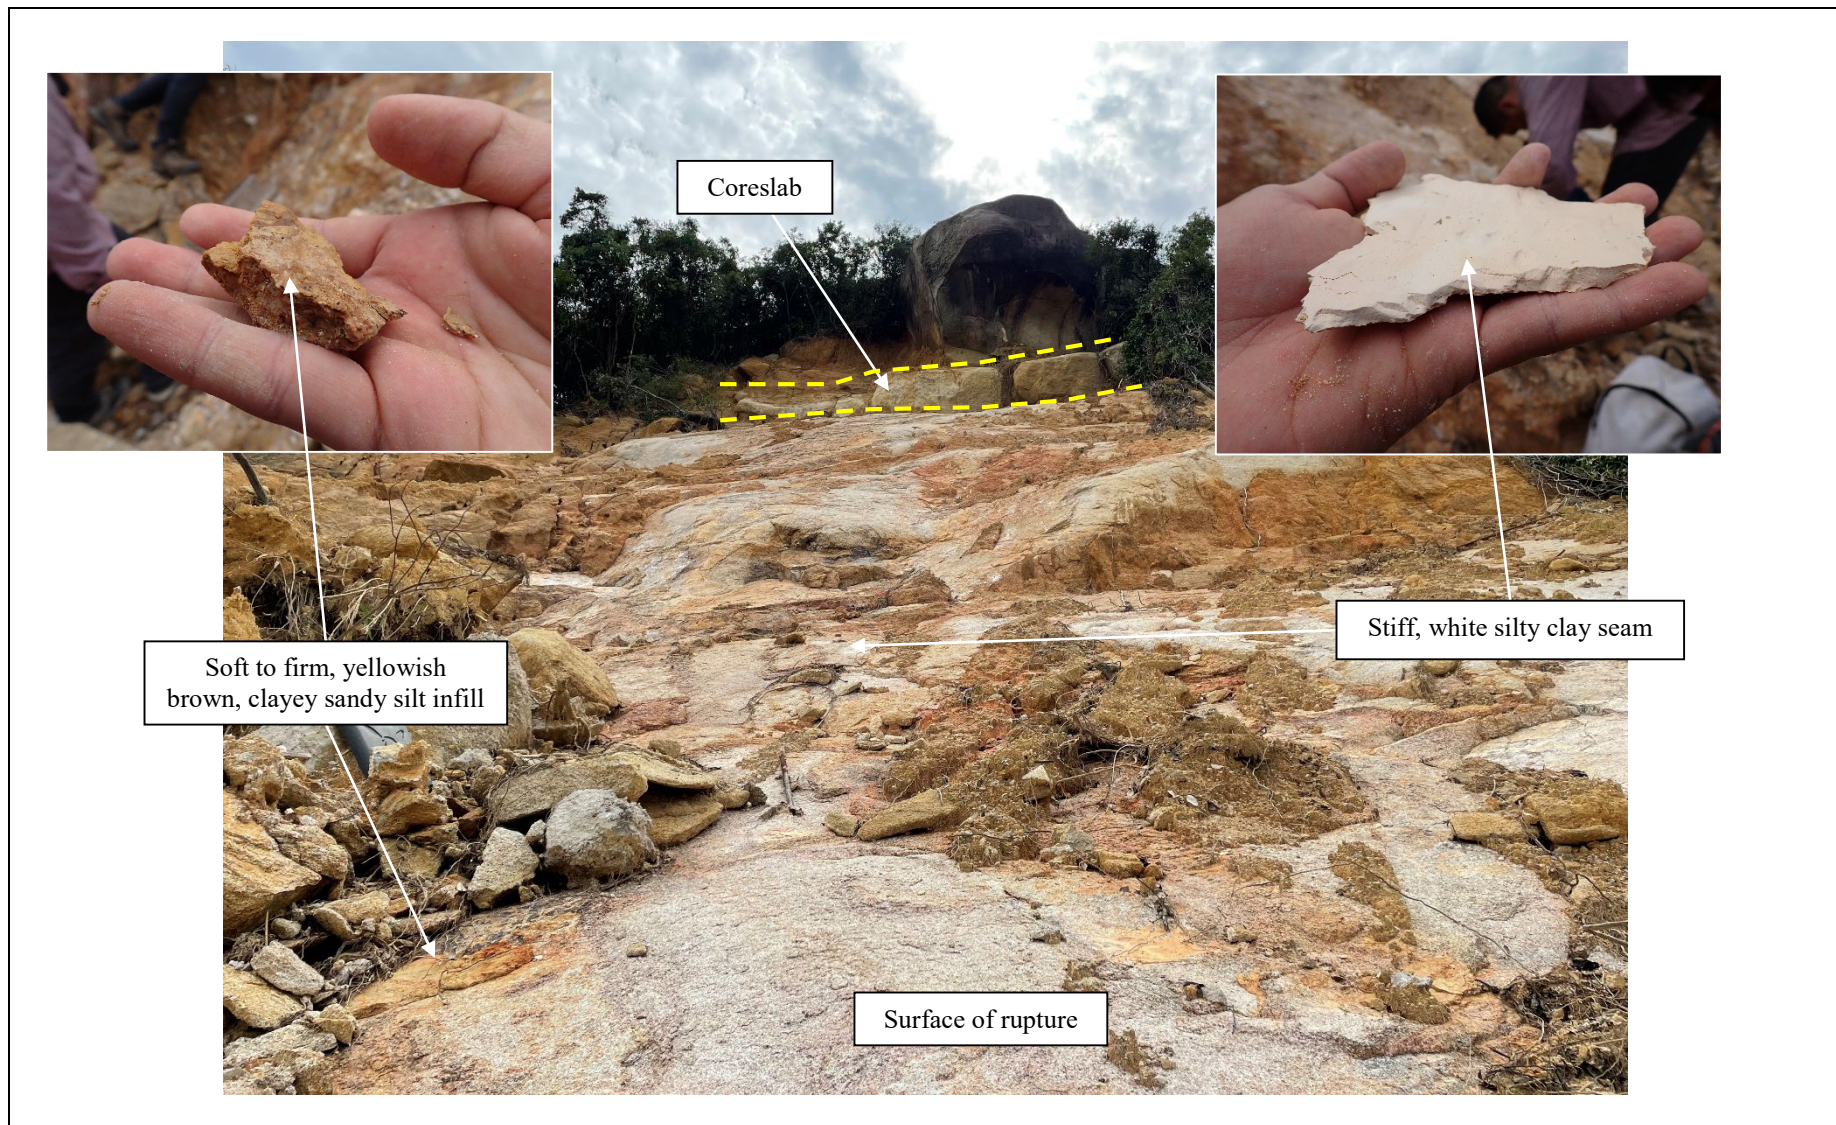
Asperities and undulations along the sheeting joint probably facilitated the formation of locally enhanced apertures and voids, where sediments could accumulate over time following subsurface soil erosion, transportation and deposition processes. Slickensided surfaces, which may have indicated pre-failure movements, were not observed on the basal failure plane. The formation of the sheeting joint is believed to be related to stress relief, with discontinuities developing parallel to the slope surface.

Figure 6.17 Close-up View of the Basal Failure Plane and Infill Materials (Photographs taken on 26 October 2023)

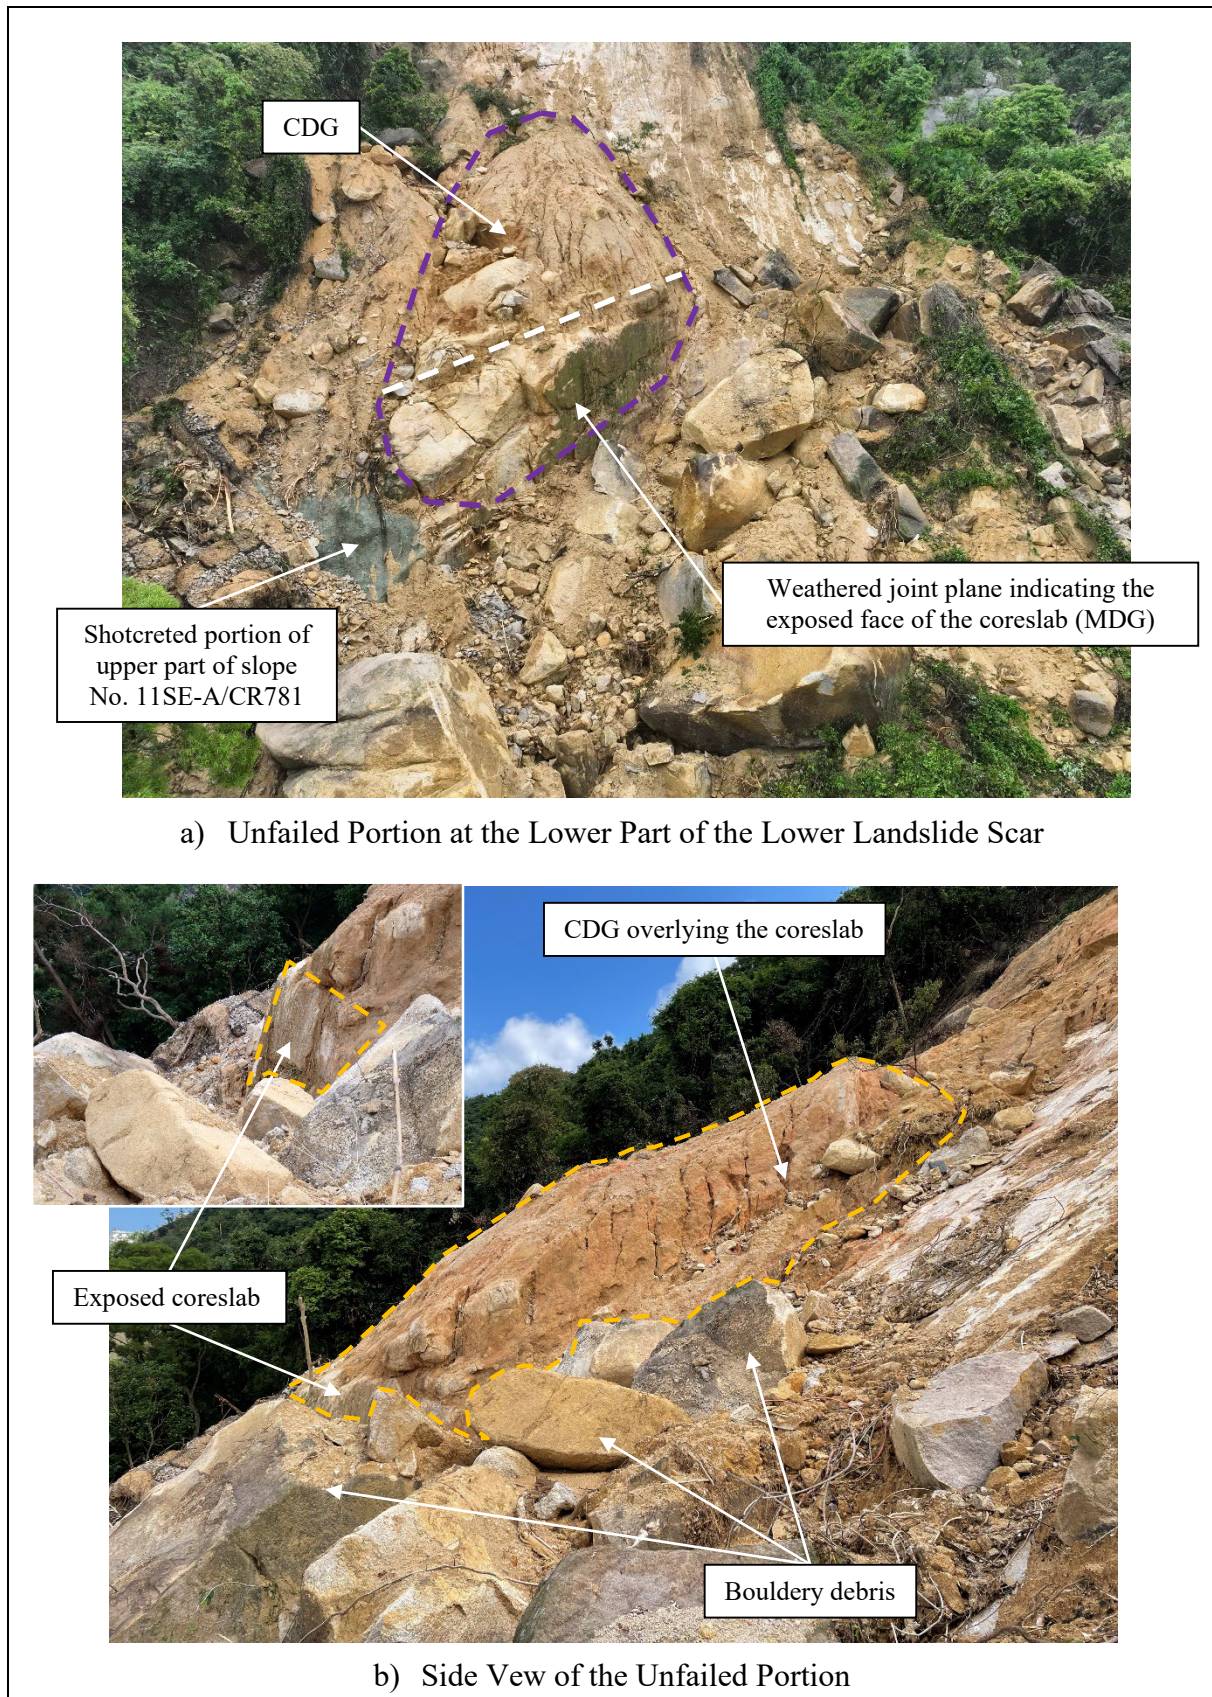
Figure 6.23 Unfailed and Intact Portion at the Lower Landslide Scar (Photographs taken on 9 September 2023 and 26 October 2023)

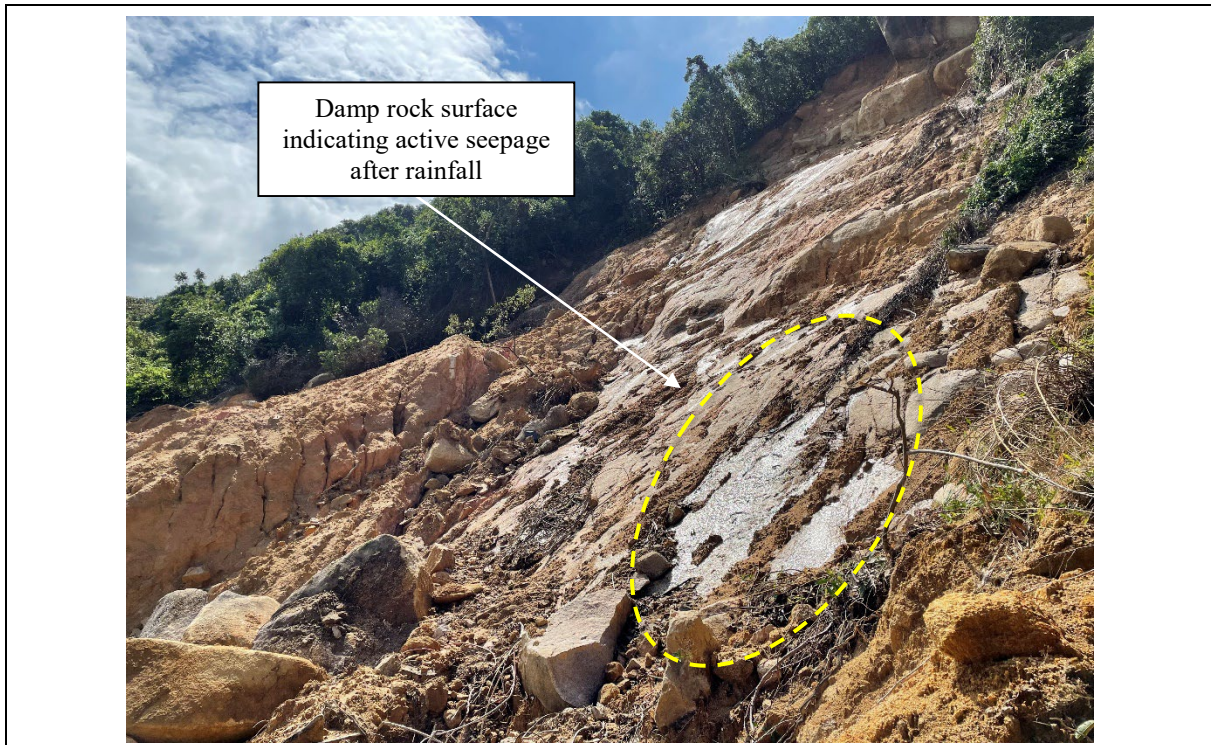
Signs of seepage were observed on the mid-western flank, with seepage becoming more prominent following intense rainfall (Figure 6.24). Minor seepage was observed at the basal failure plane for a few months following the failure.

Figure 6.24 Evidence of Seepage on the Basal Failure Plane (Photograph taken on 11 October 2023)

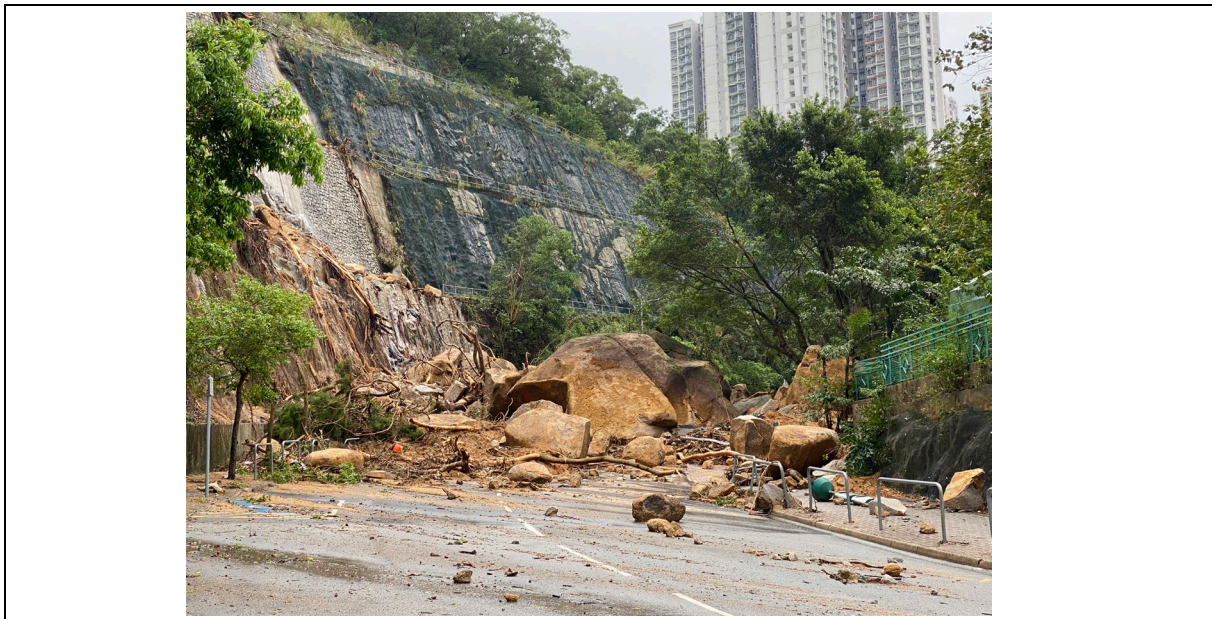
Figure 6.25 General View of the Largest Fallen Rock Block Situated at Yiu Hing Road (Photograph taken on 14 September 2023)

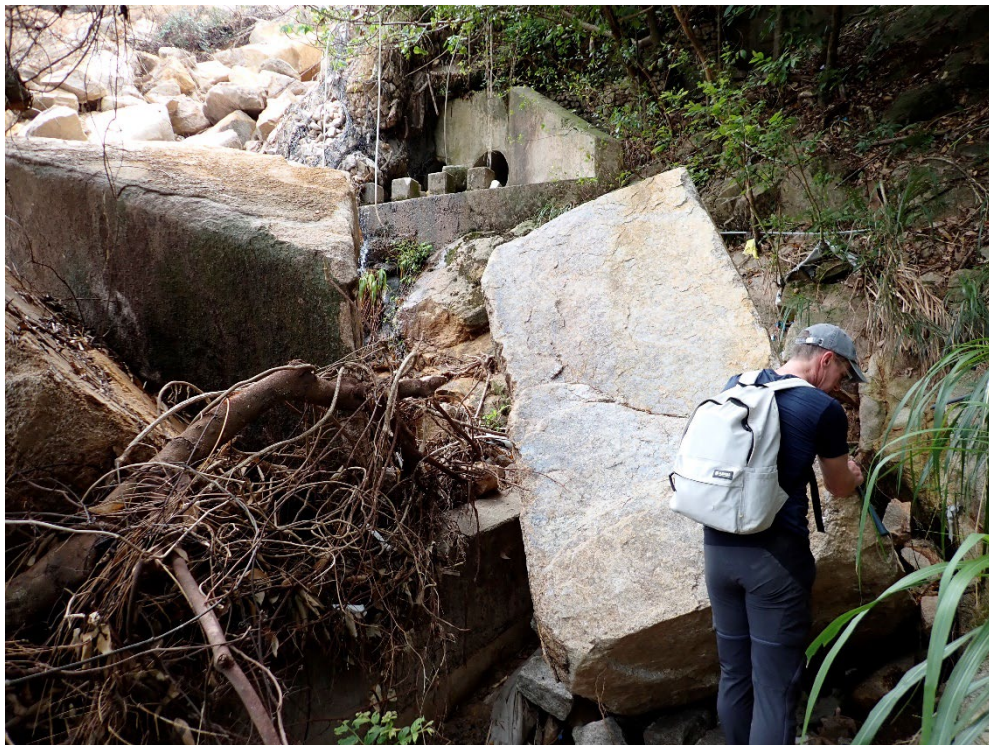
b) Tabular Rock Blocks Probably Slid Down along Basal Failure Plane into the Cascade

Figure 6.26 General View of the Debris deposited at the Toe of the Lower Landslide Scar (Photographs taken on 19 September 2023)

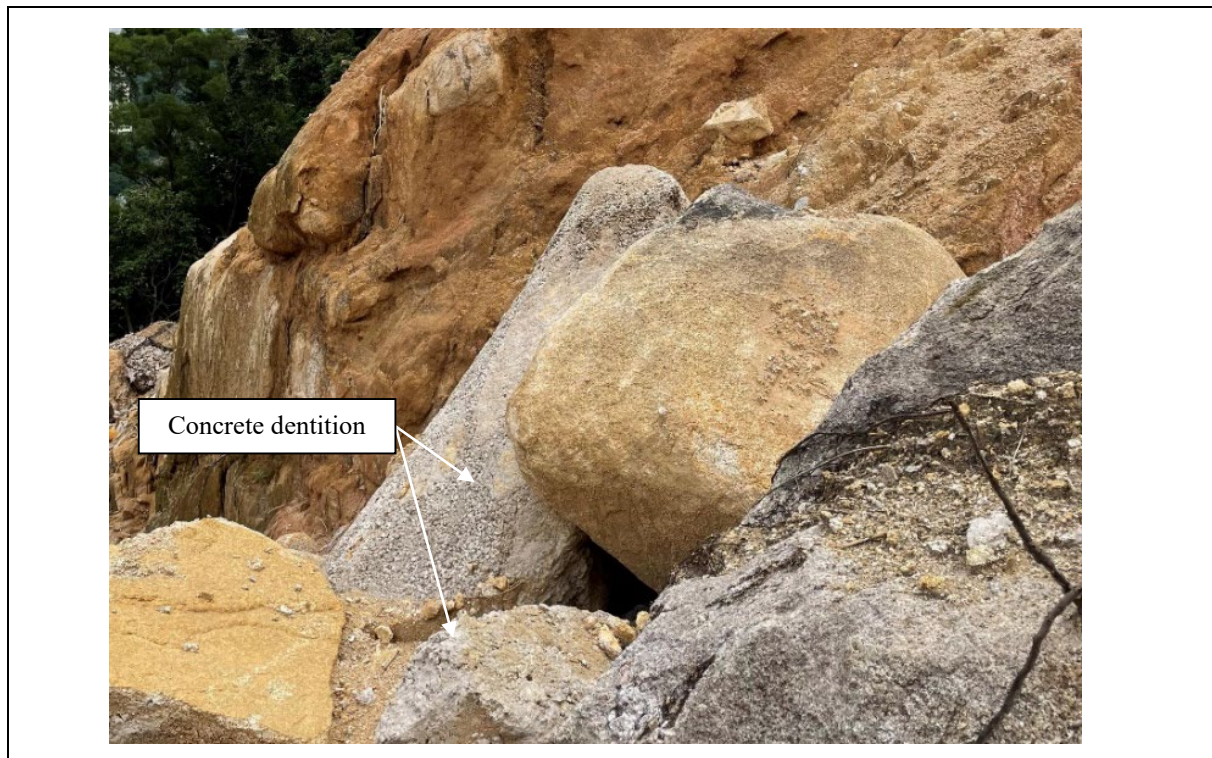
Figure 6.27 Remnants of Concrete Dentition at the Lower Landslide Scar (Photograph taken on 26 September 2023)

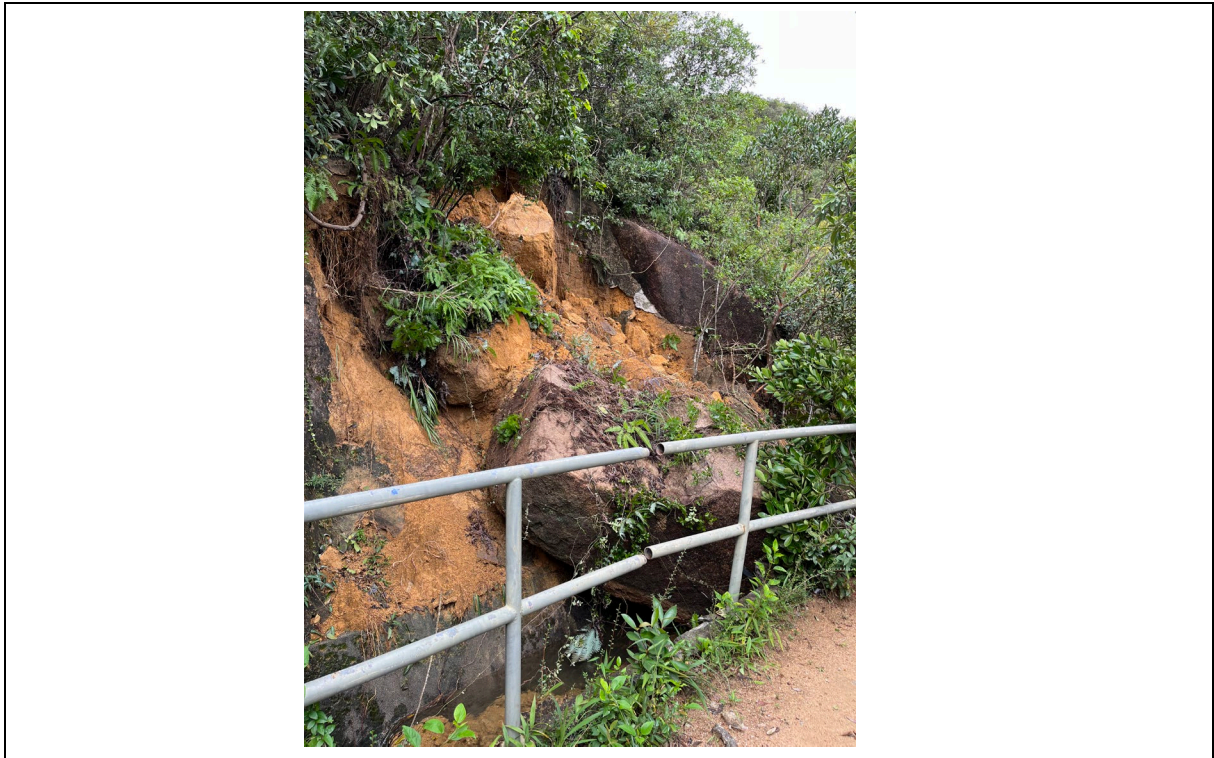
Figure 6.30 Boulder Deposited on Top of the Catchwater Channel near Intake Dam
(Photograph taken on 13 September 2023)

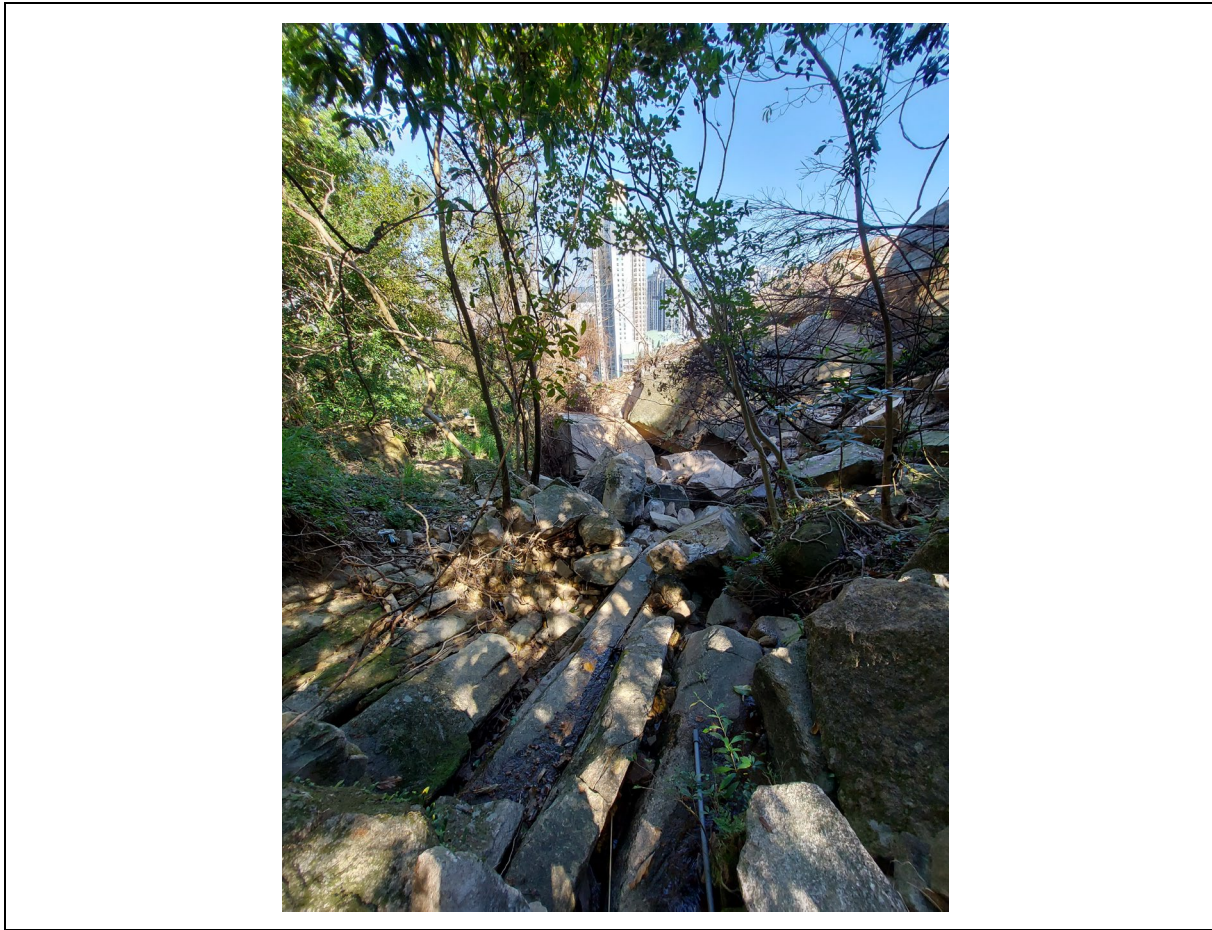
The hydrogeological conditions at the site were assessed by mapping the rocky stream course along the western flank. Exposed bedrock features in this area were inspected and their prominent joint sets were measured with typical orientations of $65^{\circ}/005^{\circ}$, $80^{\circ}/262^{\circ}$, $75^{\circ}/354^{\circ}$ and $35^{\circ}/032^{\circ}$ (Figure 6.31). In addition, steeply inclined open sub-vertical east-west striking rock joints at the rocky stream course were observed adjacent to the lower landslide scar (Figure 6.32).

Figure 6.32 Persistent Open Rock Joints along the Rocky Stream Course Adjacent to the Lower Landslide Scar (Photograph taken on 1 November 2023)
