**Detailed Study of the
8 September 2023 Landslides
on the Natural Hillside
above Yiu Hing Road,
Yiu Tung Estate,
Shau Kei Wan**

GEO Report No. 377

Fugro (Hong Kong) Limited

**Geotechnical Engineering Office
Civil Engineering and Development Department
The Government of the Hong Kong
Special Administrative Region**

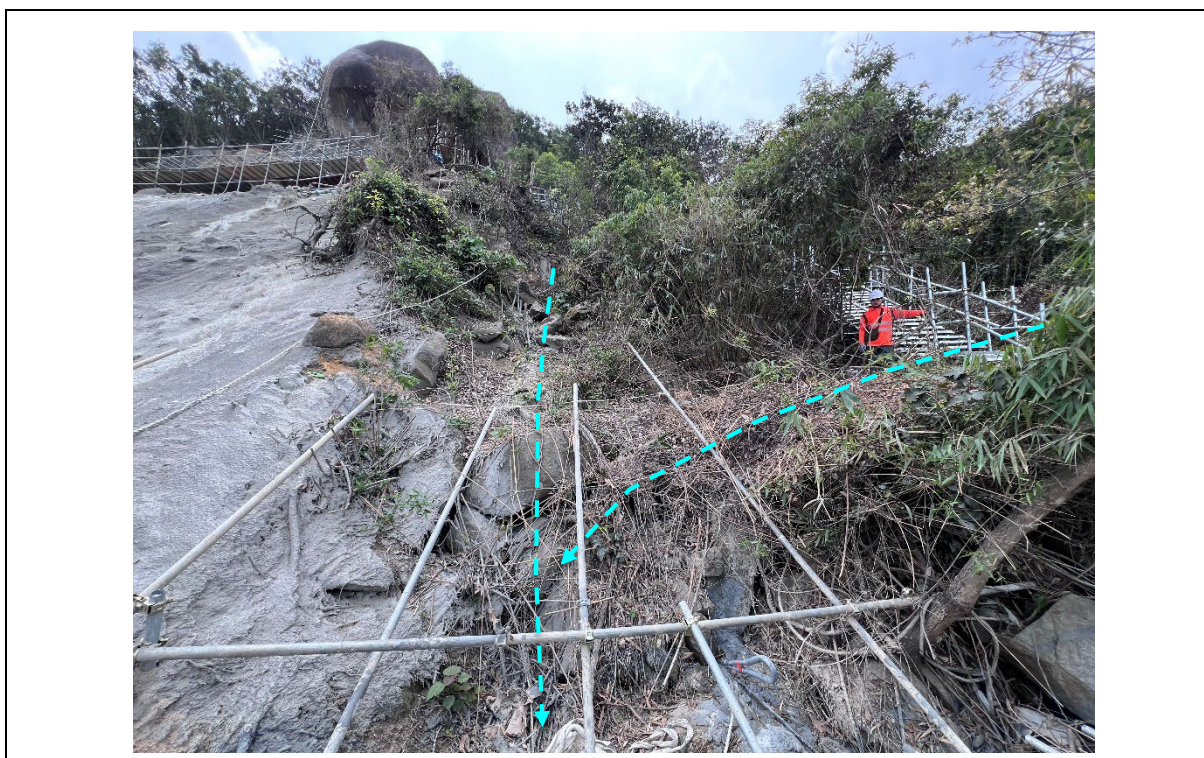
Channel runoff in the non-confined rocky stream course spreads laterally and is significantly influenced by undulating rock outcrops. These joints appear as a cascade of vertical steps and drops, which is consistent with previous observations noted in the Geotechnical Area Study (Section 3.3.3). The persistent, open sub-vertical east-west striking joints, which have been exacerbated and widened by prolonged weathering and erosion, provide a preferential pathway for runoff flowing eastward from the rocky stream course and seeping into the lower landslide scar during heavy rainstorms.

Figure 6.33 Minor Ephemeral Rocky Stream Course at the Western Flank of the Lower Landslide Scar (Photograph taken on 15 April 2024)
