# **RAINFALL AND LANDSLIDES IN 1984**

**GEO REPORT No. 1**

**J. Premchitt**

**GEOTECHNICAL ENGINEERING OFFICE  
CIVIL ENGINEERING DEPARTMENT  
HONG KONG**

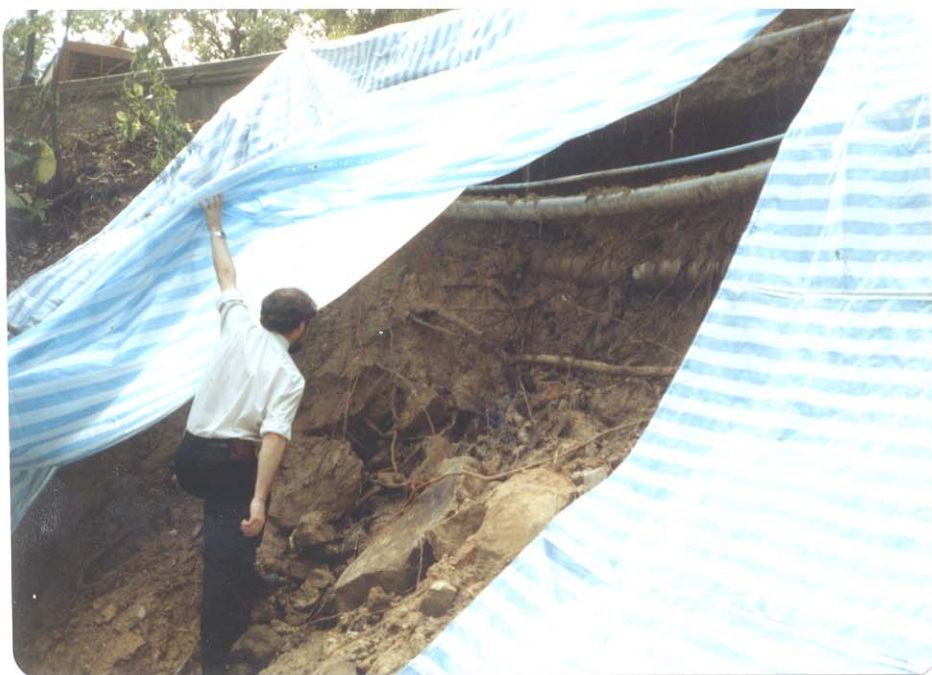
Plate 1 : Negative No.IW 9/84/OA Date: 30.4.84

(Date : 28th April, minor fill slope failure affecting road, Plate 1)

This landslide occurred on 28th April, after one-day rainfall of 44.4 mm on 27th April. The failure occurred on the down slope side of Coombe Road, on an old fill slope (catalogued as 11SW-D/F107), and resulted in a loss of most of the fill material (about 40 m<sup>3</sup>). The road was undermined and settled, and the services were interrupted. As a result, half of the road was closed, pending the repair work. The probable causes were slow movement of the fill over a period of several months, leakage of services and infiltration of rainfall. In addition it was noted that for many months prior to the failure, the road had been subjected to unusually heavy traffic as it was used for traffic diversion during the repair of the Peak Road failure which occurred in June 1983.

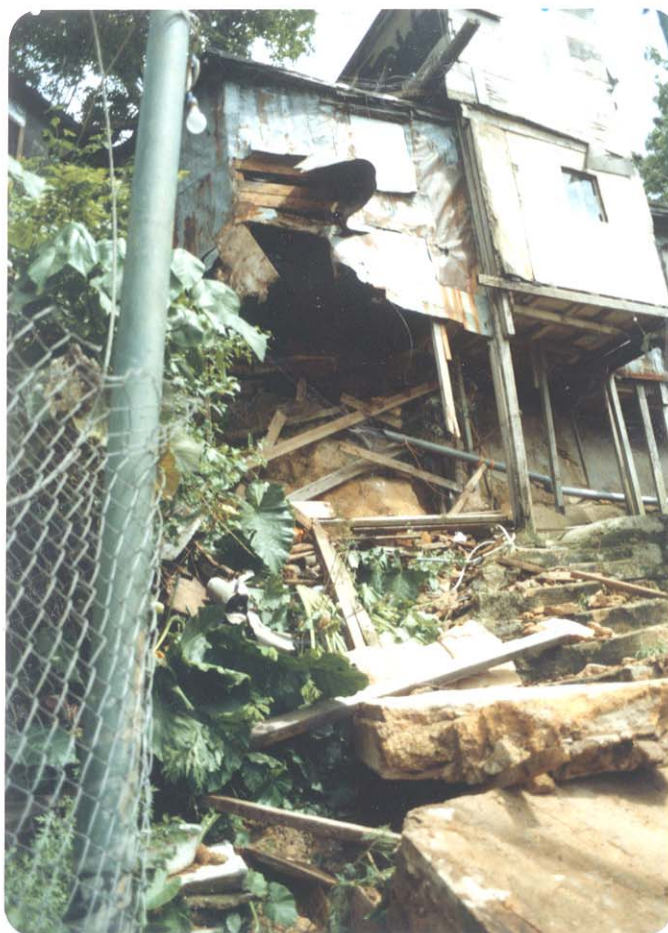
Plate 2 : Negative No. IE 2/84/5 Date : 3.5.84

The incident occurred at about 3 pm on 3rd May, resulting in a loss of foundation support and concrete floor of a collapsed hut. One man was injured in the incident. Five other huts in the area were also affected and were temporarily evacuated. Repair works were carried out on the slope and subsequently the damaged hut was reinstated.

Plate 2 - Tsin Shui Ma Tau Village, Shau Kei Wan  
(Incident No. HK 5/1) : 1 Person Injured

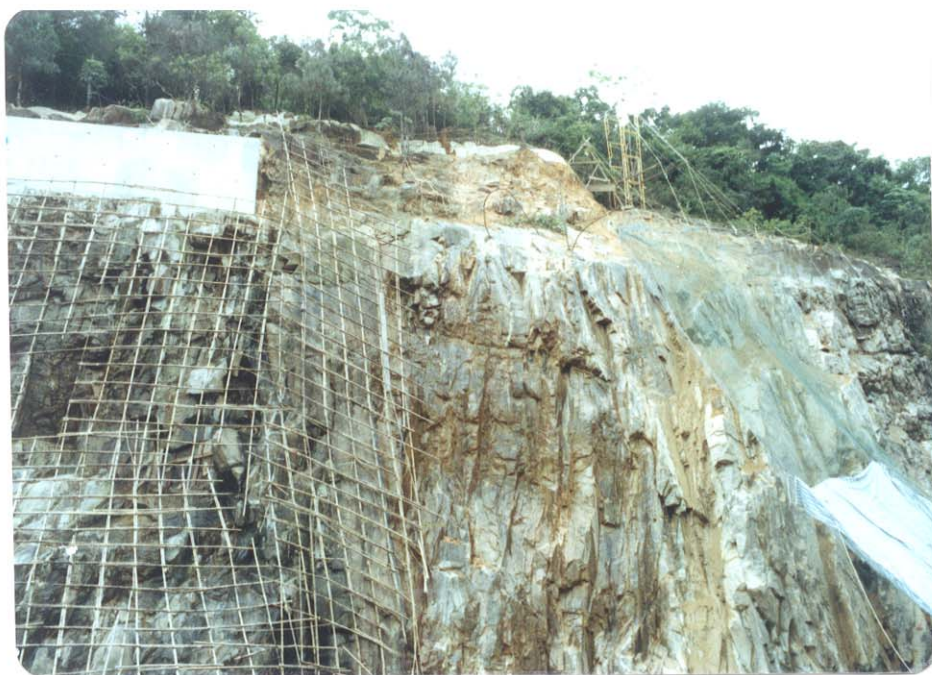
Plate 3 : Negative No.IE 21/84/17 Date: 21.5.84

There were only two rock cut slope failures, both of which were minor. They are incidents MW5/1 and HK5/3 (Plate 3).

Plate 3 - A Kung Ngam Road, Shau Kei Wan  
(Incident No. HK 5/3)

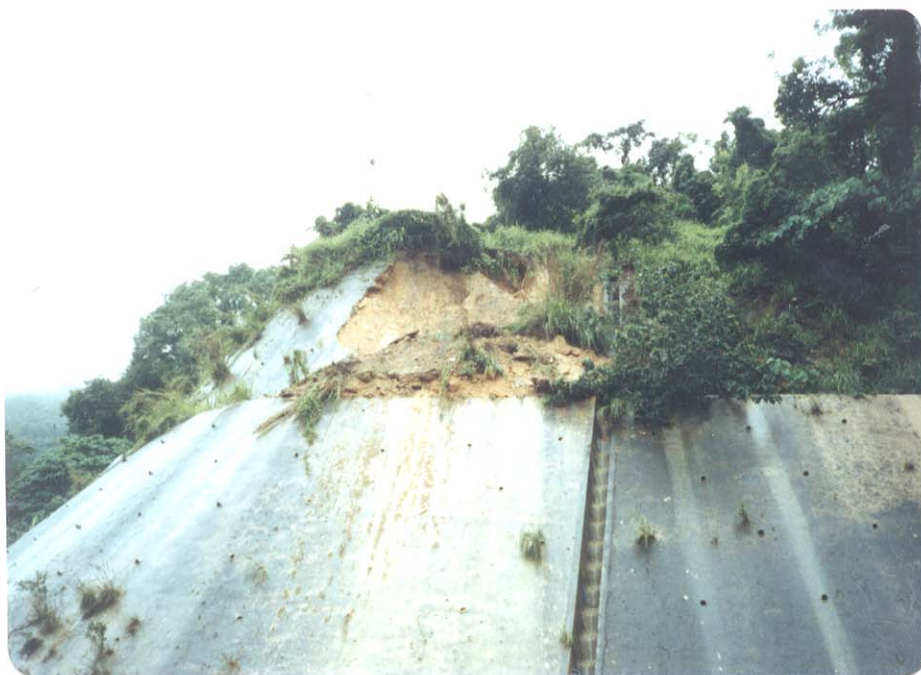
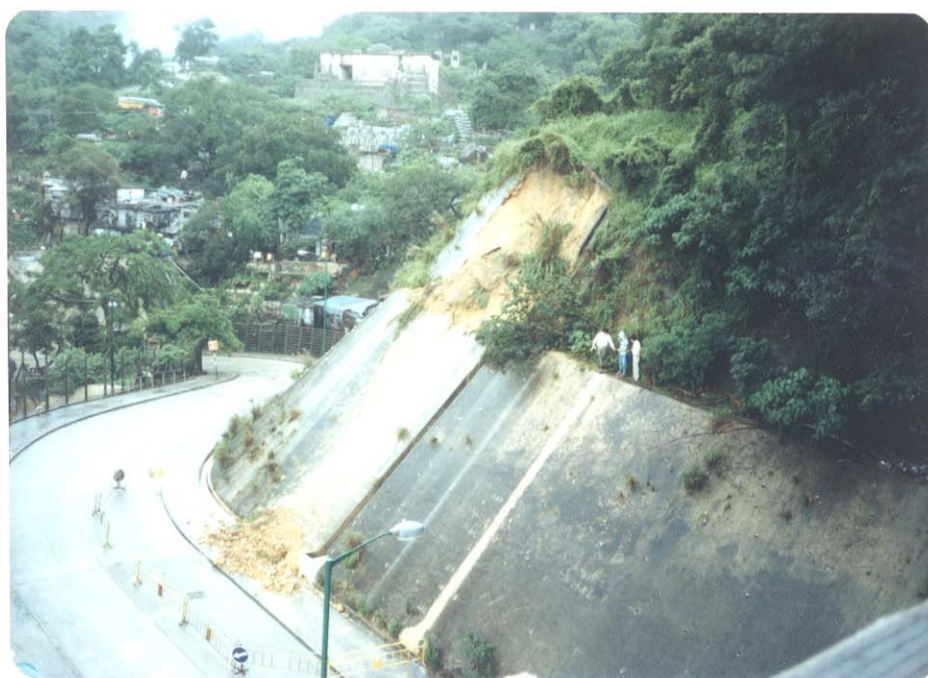
Plates 4 & 5 - Lung Wah Street, Western (Incident No. HK 5/6)

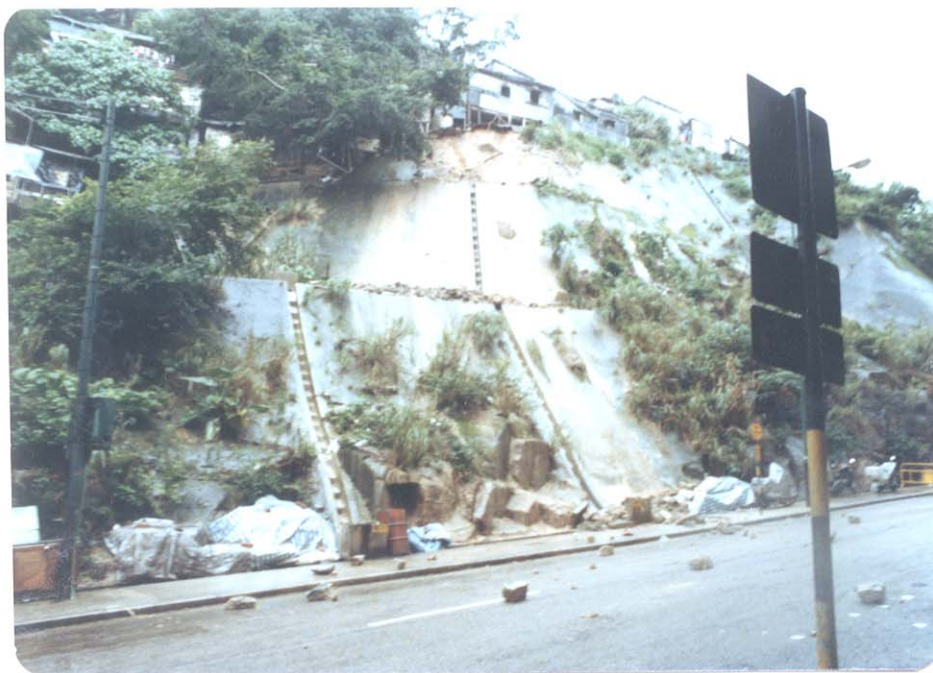
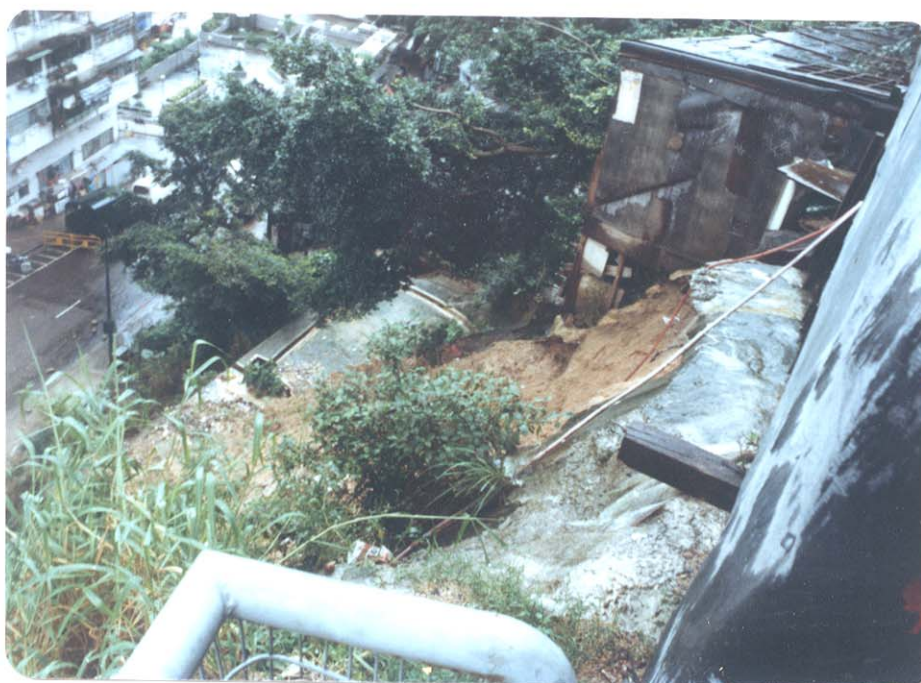
(Date : 30th May, minor soil/rock cut slope failure affecting road and squatter huts, Plates 6 & 7)

The failure occurred at about noon on 30th May during heavy rainfall (see Figure 5 and Table 1). This is the catalogued slope 11SE-B/C80, and the failure occurred at a height of about 30 m above the slope toe, involving 20 m<sup>3</sup> of completely decomposed granite soil (CDG) and rock materials. The slip debris fell down and spread over Ngoi Man Street. As a result the road was closed, four huts were permanently evacuated and ten huts were temporarily evacuated. The probable cause of the failure was the scouring action of storm water discharged by make-shift channels which had been constructed by the squatters following blockage of the original slope channels.

Plates 6 & 7 - Aldrich Terrace, Ngoi Man Street, Shau Kei Wan  
(Incident No. HK 5/7)

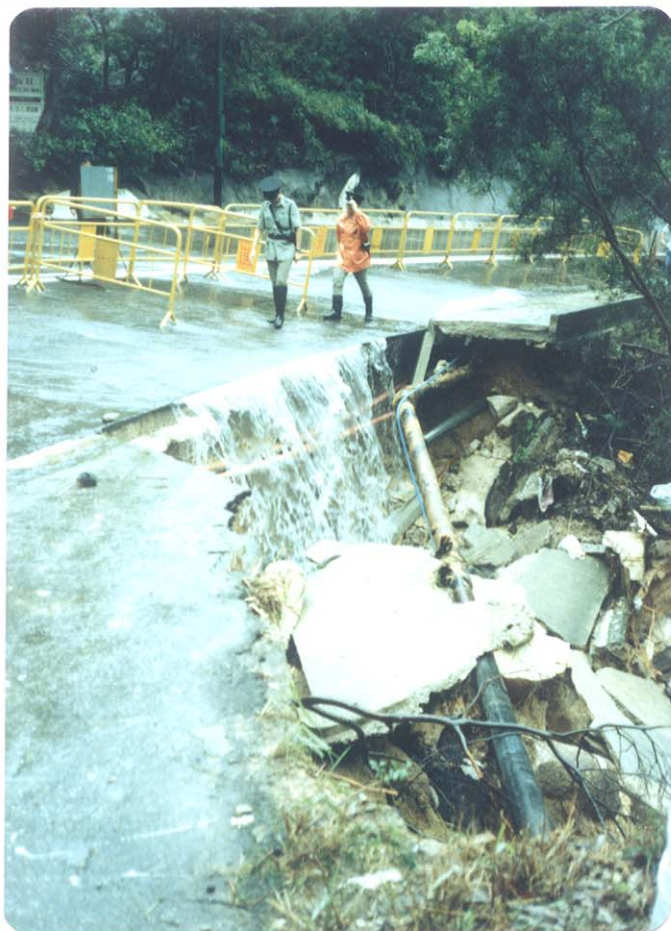
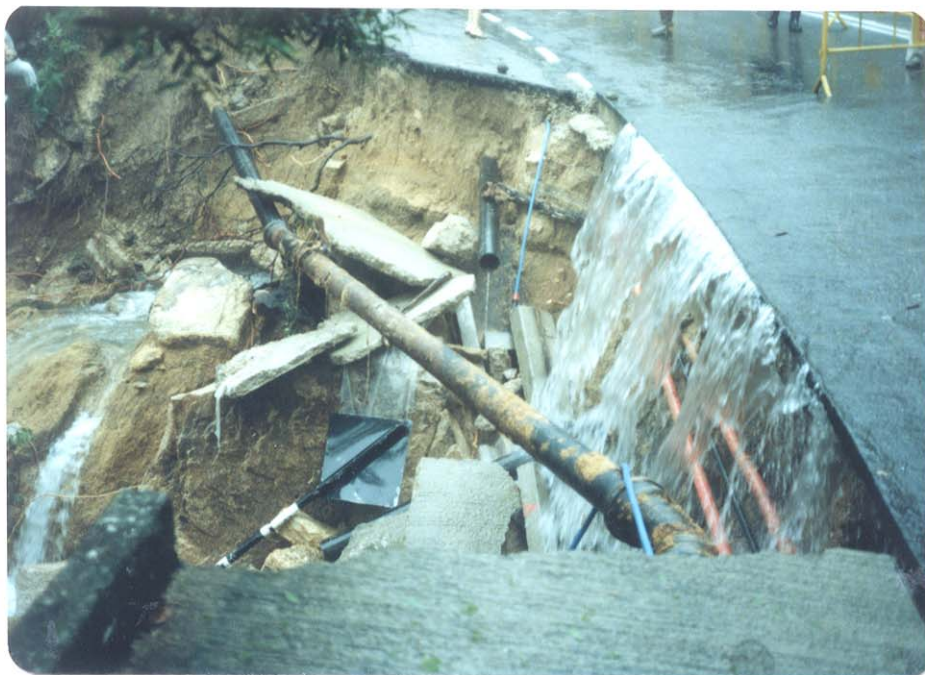
(Date : 30th May, minor failure of retaining structure affecting road, Plates 8 & 9)

This landslide occurred at about 9 am on 30th May during heavy rain (Figure 5 and Table 1). The failure involved the collapse of a 3 m high random rubble wall, with slip debris of about 30 m<sup>3</sup>. Two water pipes and a drain pipe were broken and utility cables were exposed. Due to the failure the road was entirely closed for twelve hours, after which one lane

was opened to traffic while the other lane was closed pending the repair work. The probable cause of failure was the persistent and large volume of overflowing water crossing the road due to blockage of the Wong Nai Chung catchwater above the road on the opposite side.

Plates 8 & 9 - Repulse Bay Road near No. 11, Southern District  
(Incident No. HK 5/9)

The repair work involved reinstatement by compacted rock-fill with sprayed concrete surface protection.

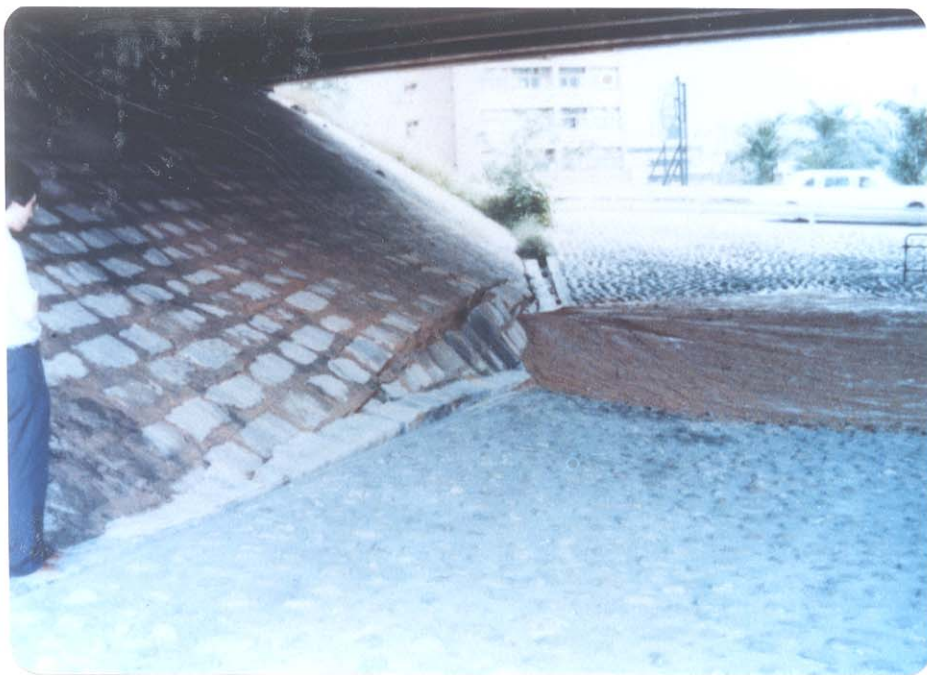
Plate 10 : Negative No. SP 202/84/12 Date : 31.5.84

(Date : 30th May, minor failure of fill embankment affecting road, Plate 10)

The incident also occurred during the notable storm on 30th May (Table 1). The existing surface protection was stone pitching without weepholes. A 10 m long horizontal crack near the toe was observed. An amount of soil washed out from the crack had accumulated at the toe. Severe bulging of the embankment was also noted. No significant damage to the road or disruption to traffic was caused by this incident. Even though the incident occurred on a day of heavy rainfall, it was also noted that a water main had burst in the vicinity at the time, and it is considered that this was probably the major cause of this failure.

The repair was carried out by excavating the failed embankment and backfilling with compacted fill, with provision of weepholes.

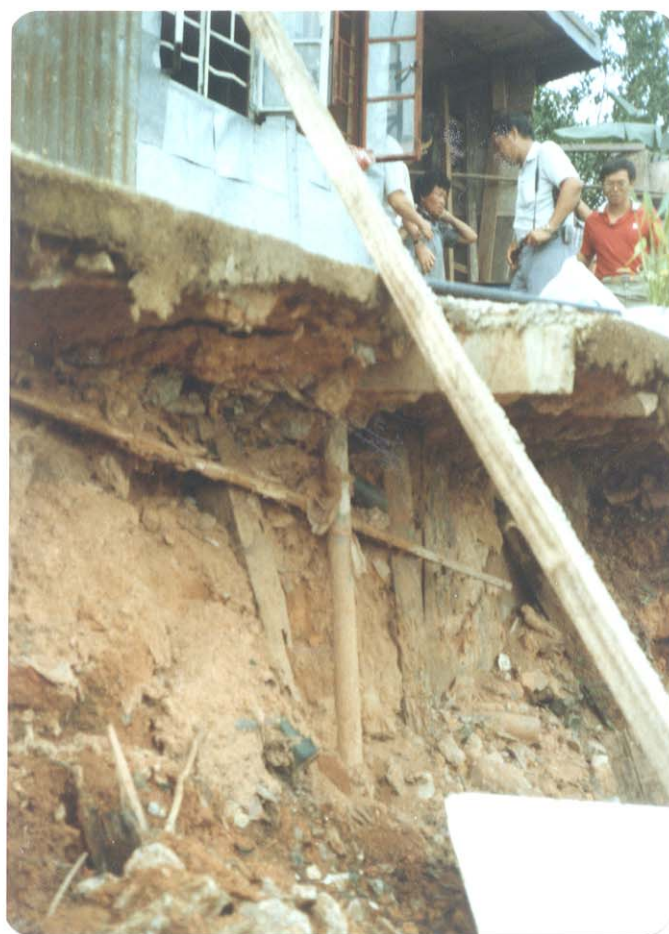
Plate 11: Negative No.MW 95/84/18 Date: 15.6.84

Plate 11 - Squatter Near Buddhist School, 9½ M.S. Castle Peak Road,  
Tsuen Wan (Incident No. MW 6/1)

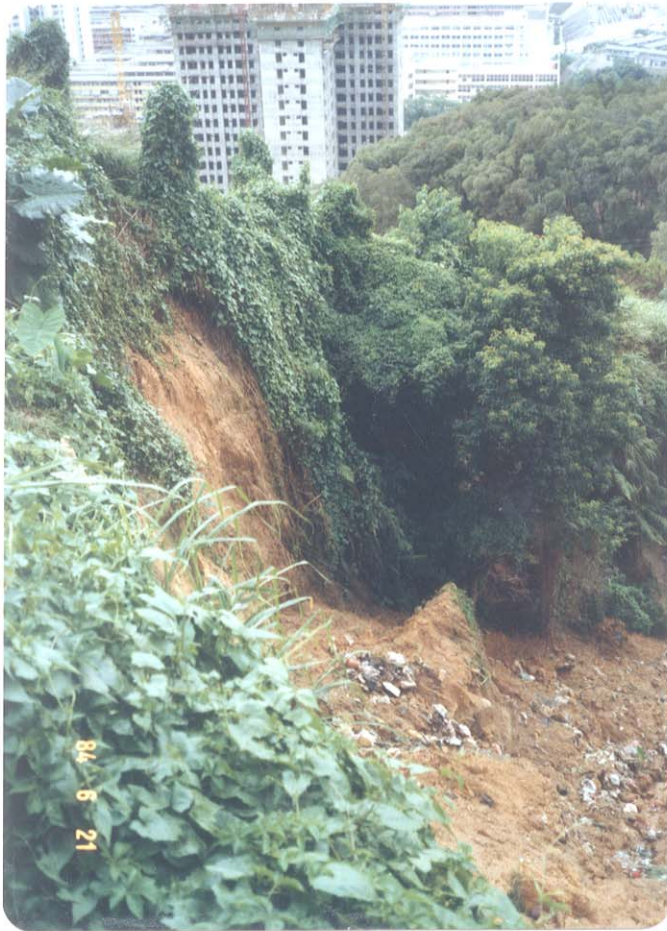
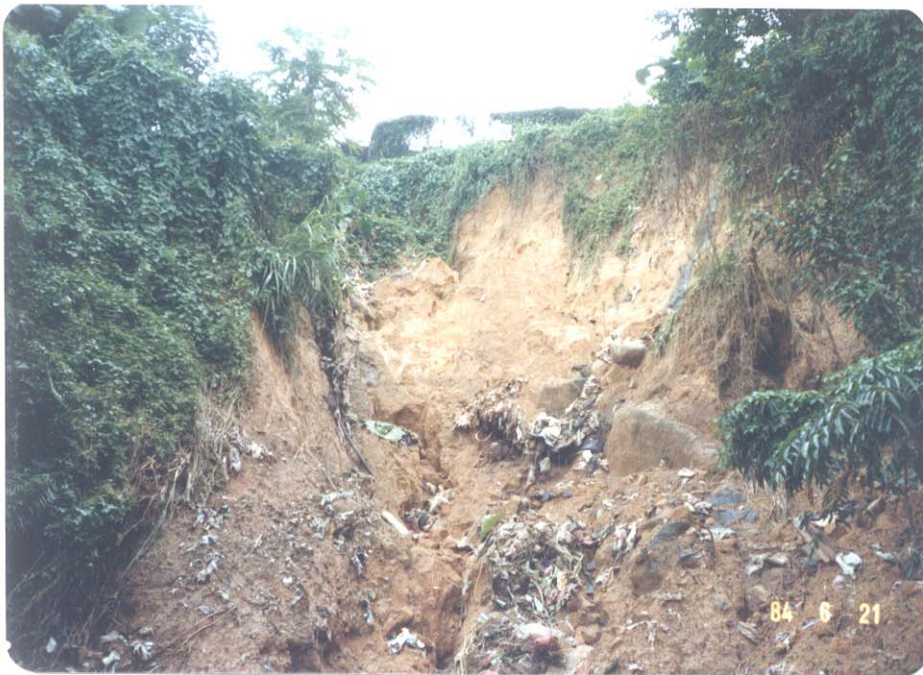
(Date : 17th June, major failure on natural slope affecting squatters, Plates 12 & 13)

This landslide occurred at about 11 am on 17th June, the day after the heavy rainfall on 16th June (Table 1). The site is a 20 m high natural slope in CDG which had experienced previous failures. The slip debris volume was about 70 m<sup>3</sup>. The failure affected a squatter footpath at the top of slope and the Lion Rock Park at the toe, and as a result part of the park area was cordoned off. The probable cause was rainfall infiltration and sewage discharge from squatter huts at the top of the slope.

Plates 12 & 13 - Lion Rock Park  
(incident No. K 6/13): Major Failure on Natural Slope

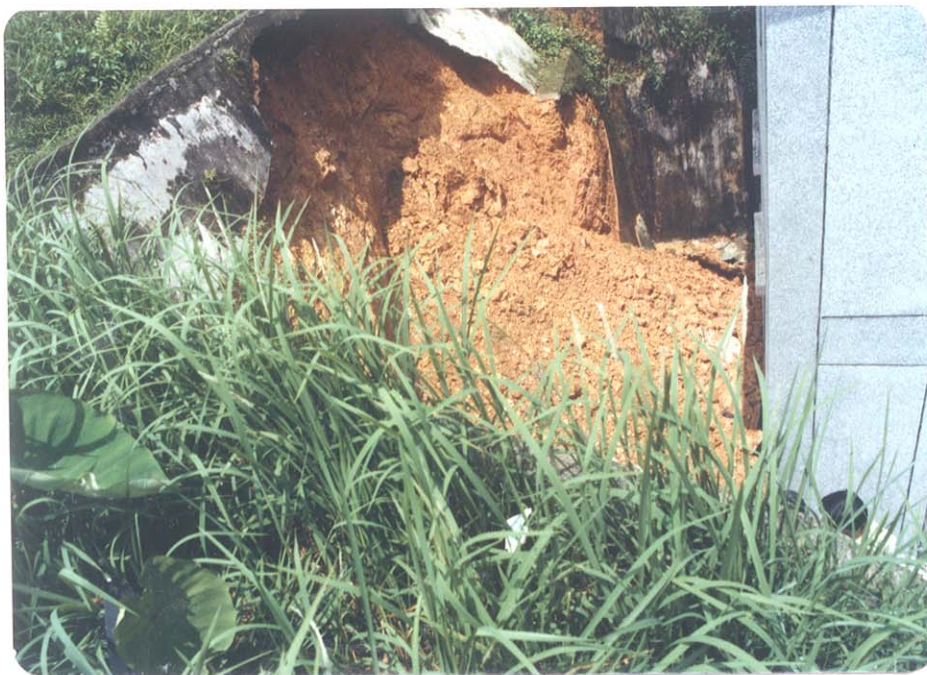
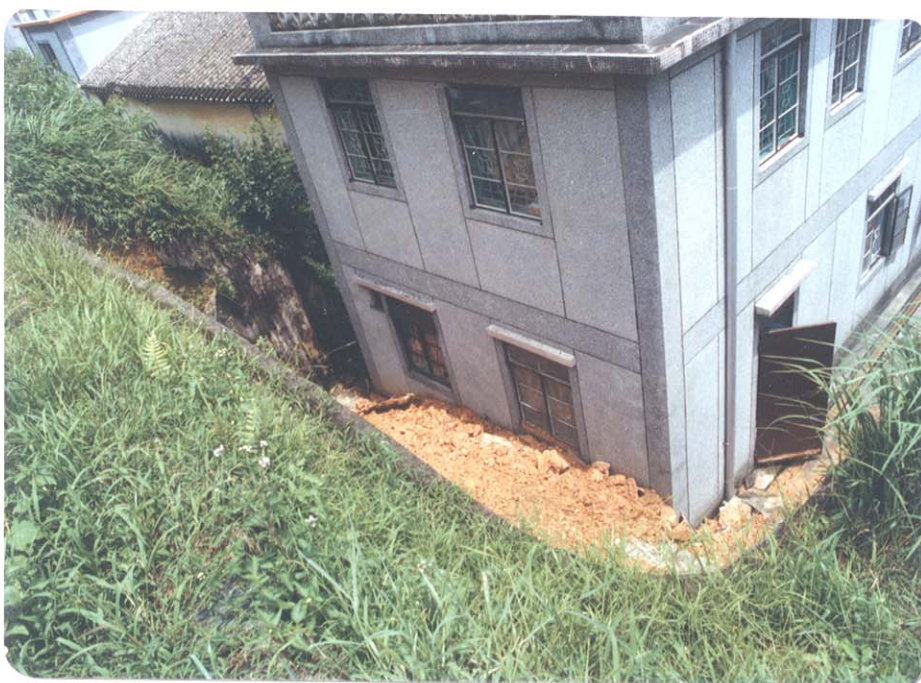
Plate 14 & 15 - 2A, Sheung Wo Hang Tsuen, Sha Tau Kok, North District  
(Incident No. ME 6/6)

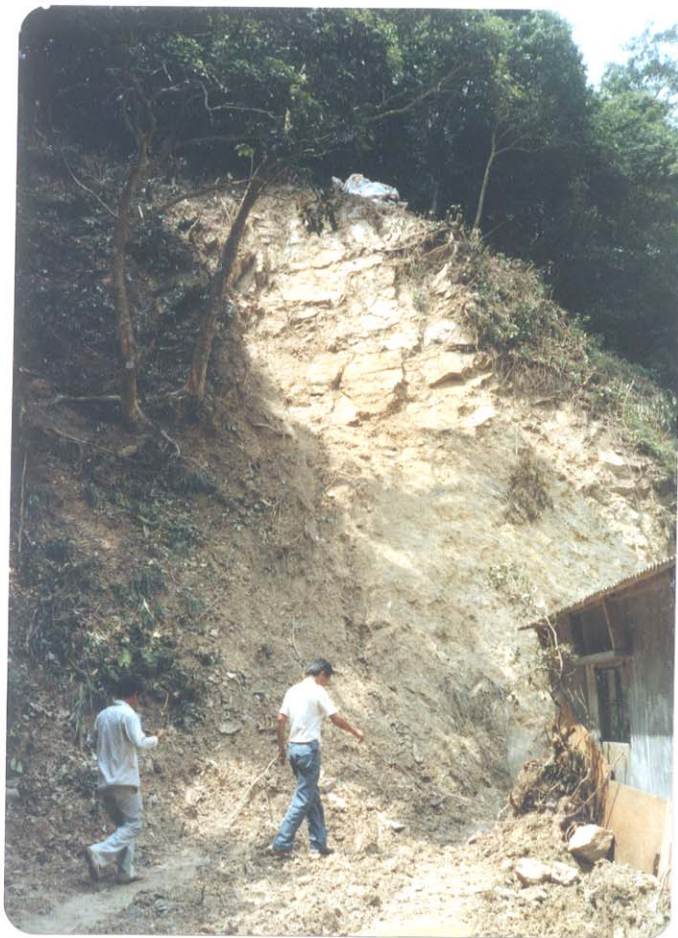
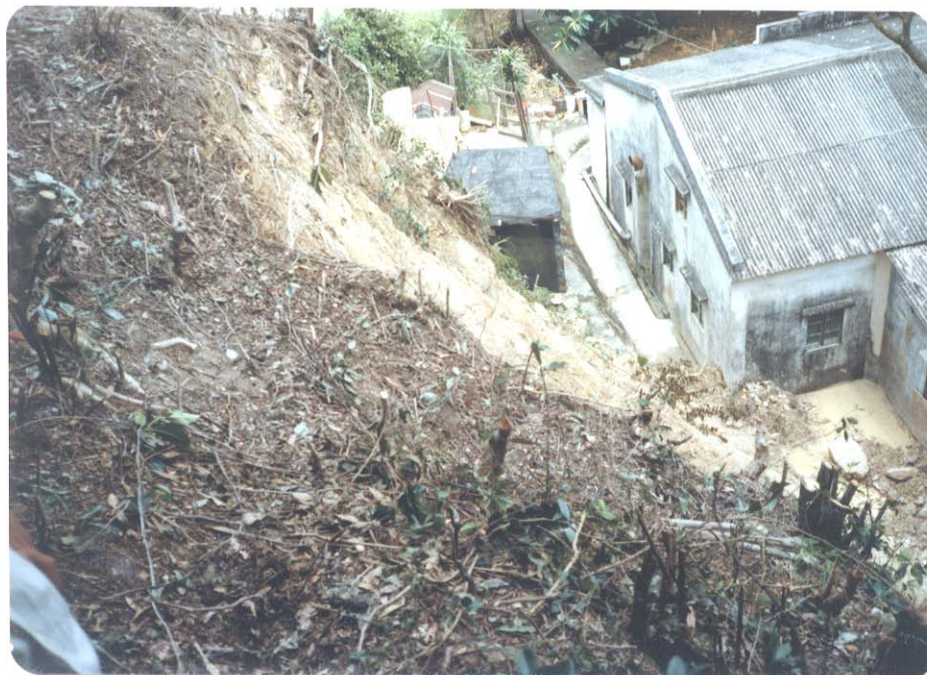
(Date : 22nd June, minor failure on soil/rock cut slope affecting building, Plates 16 & 17)

This failure occurred at about 9 pm on 22nd June, six days after heavy rain on 16th June (Table 1) and with rainfall in the intervening period of 75 mm. The site is a 12 m high soil/rock cut slope behind a village house. The superficial soil of 1-2 m thick had slipped along a 60° dipping joint plane in highly to moderately weathered volcanic rock. The slip debris consisted of soil, rock and large boulders, with a volume of about 30 m<sup>3</sup>, and piled up to 1.5 m high against the rear wall of the house. However, no structural damage to the house was observed.

Plates 16 & 17 - 25, Yim Tso Ha Tsuen, North District  
(Incident No. ME 6/7)

Repair work was carried out on the damaged area by trimming the slope and providing surface protection and drainage.

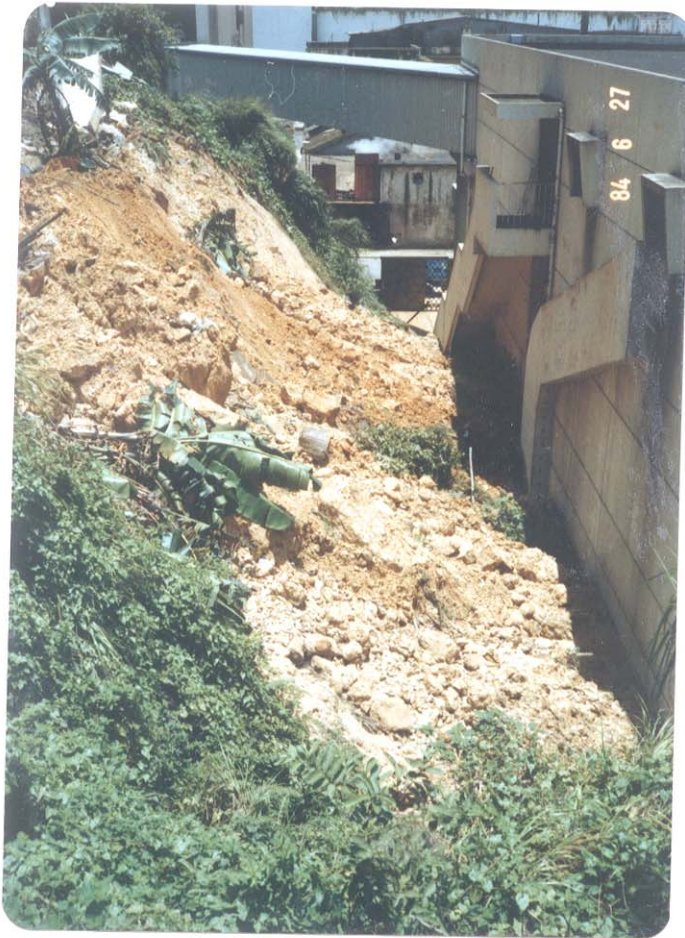
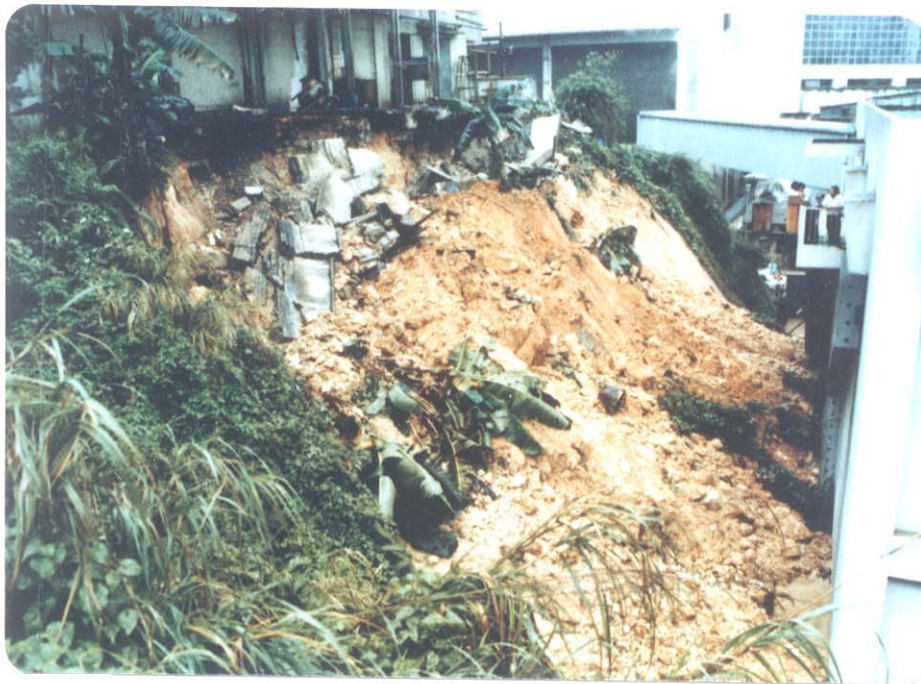
(Date : 26th June, major failure of soil cut slope affecting buildings, Plates 18 & 19)

This failure was one of the largest in 1984 and occurred at about 5 pm on 26th June, the day after the rainstorm on 25th June (Table 1). The 10 m high soil cut slope (catalogued was 7SW-C/CR103) failed for the entire length of 20 m, with a debris volume of about 300 m<sup>3</sup> piled up to 3 m high against the China Light & Power (CLP) power substation. The top of the slip surface extended into part of a platform at the crest of the slope, on which a factory has been built. Cracks were observed on the wall of the substation and temporary shoring was erected inside by CLP. There was continuous discharge from broken water pipes and sewers on to the failure area. Hoarding was erected around the 132 KV cable for protection against further failures, which could have caused power cuts throughout Kwai Chung. The probable causes of failure were infiltration of stormwater from broken sewers as well as effluents from the factory at the top of slope.

Plates 18 & 19 - CLP Substation, Wo Tong Tsui Street, Kwai Chung  
(Incident No. MW 6/3) : Major Failure on Soil Cut Slope

A Dangerous Notice was subsequently issued and permanent remedial work is being carried out on the failed slope.

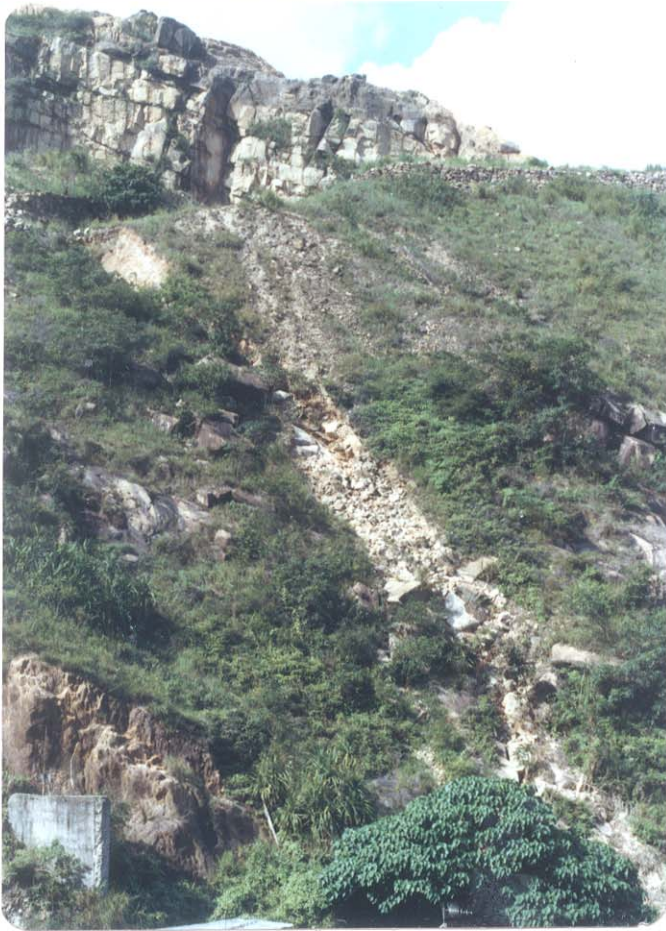
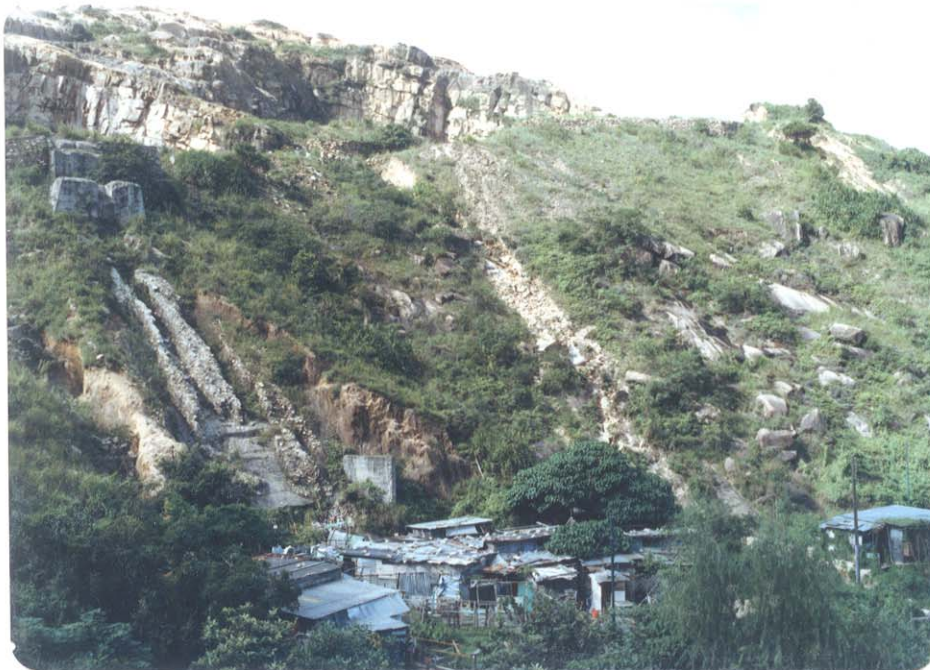
(Date : 25th June, major failure on quarry spoil fill slope affecting squatters, Plates 20 & 21)

The failure occurred on 25th June during a rainstorm (Table 1). The material involved was quarry spoil, which had been dumped on a natural slope adjacent to the quarry. This dump had failed previously and the new failure occurred just below the old slip scar. The failed mass was 0.5 m thick, 3-4 m wide and the debris volume of about 50 m<sup>3</sup> slipped down slope to a squatter village below. As a result, three huts were permanently evacuated. No repair work was undertaken.

Plates 20 & 21 - Fuk Tak New Village, KE  
(Incident No. K 6/18) : Major Failure on Quarry Spoils

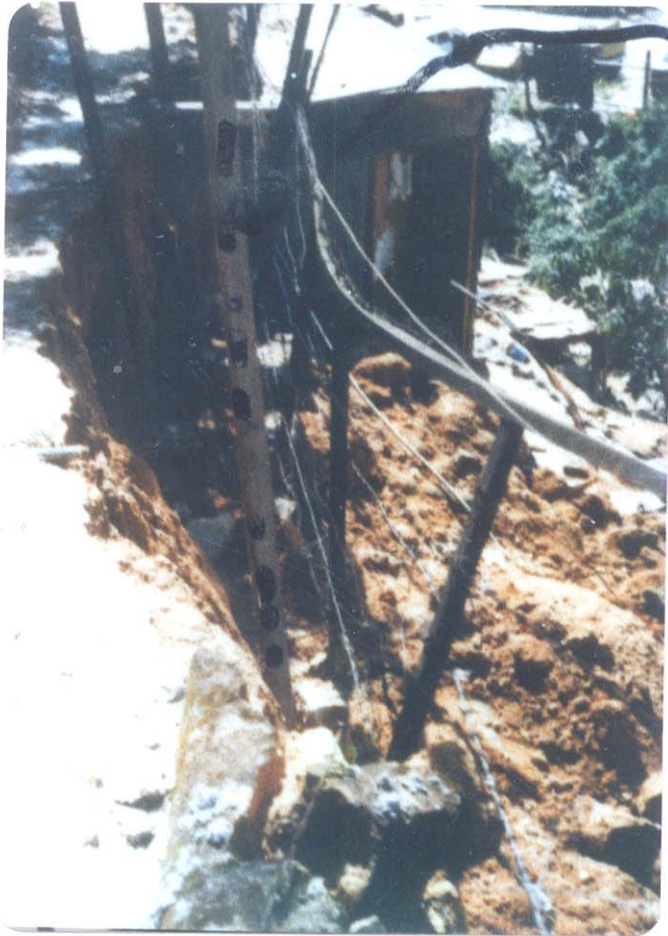
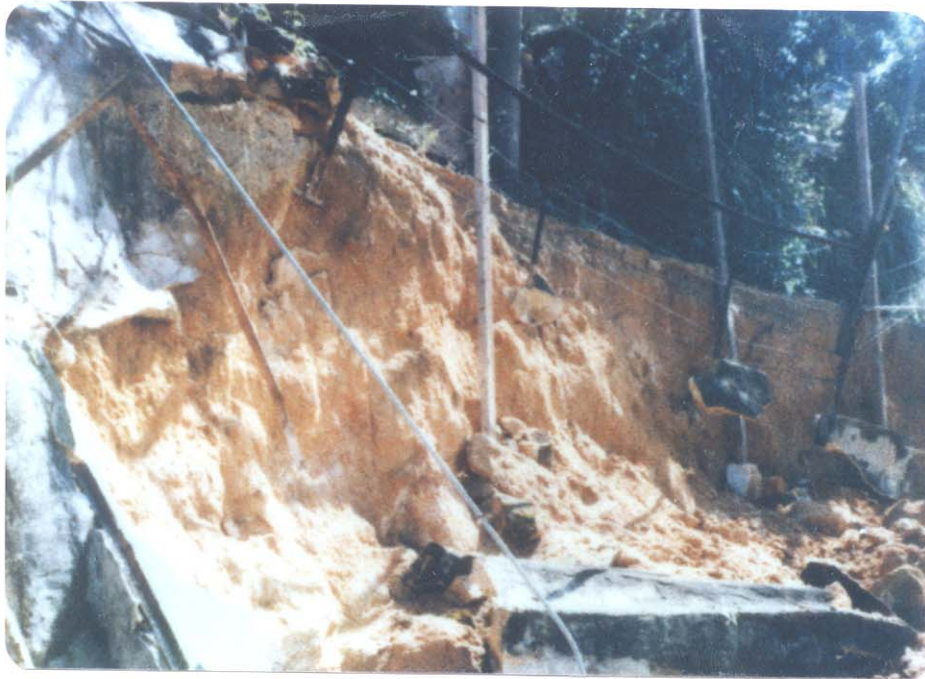
Plates 22 & 23 - Lam Tin First Village, KE (Incident No. K 7/1)

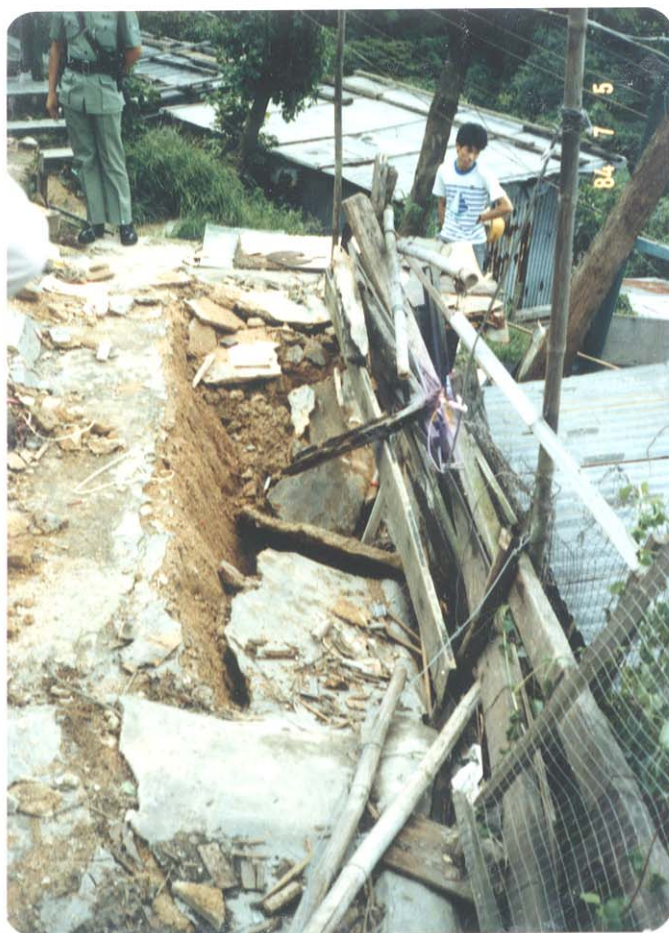
Plate 24 : Negative No. ME 131/84/9 Date : 5.7.84

Plate 24 - Chung Luen Chuen, above Tai Po Road  
(Incident No. K 7/2)

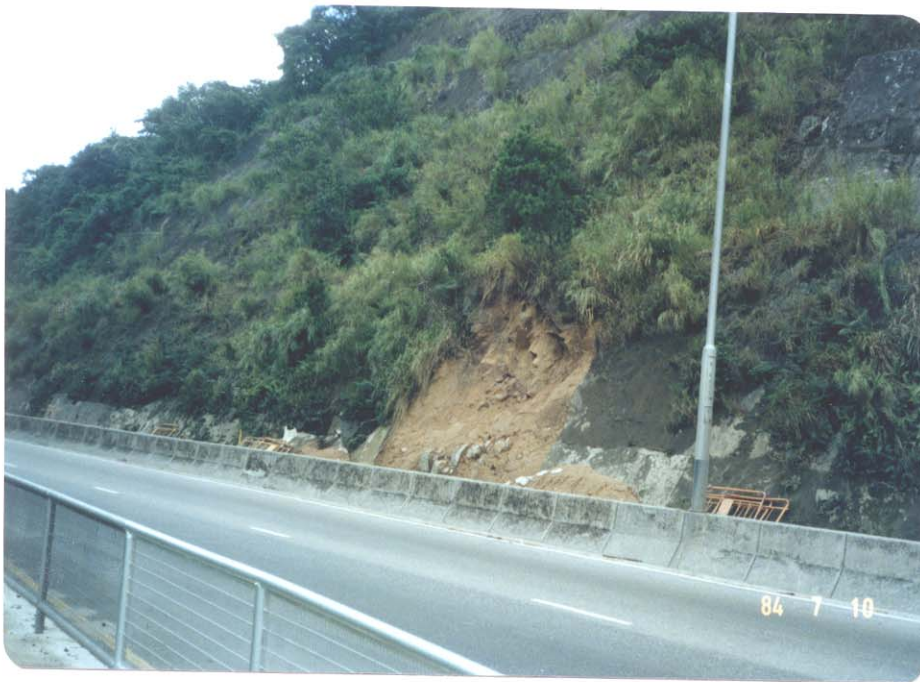
Plate 25 : Negative No. ME 129/84/18 Date : 10.7.84

There were six soil/rock cut slope failures. One of these was a major failure, i.e. incident HK9/1 (Plates 26 & 27; Section 4.12). Other minor failures are incidents HK5/7 (Plates 6 & 7; Section 4.4), ME6/7 (Plates 16 & 17; Section 4.8) and ME6/3 (Plate 25).

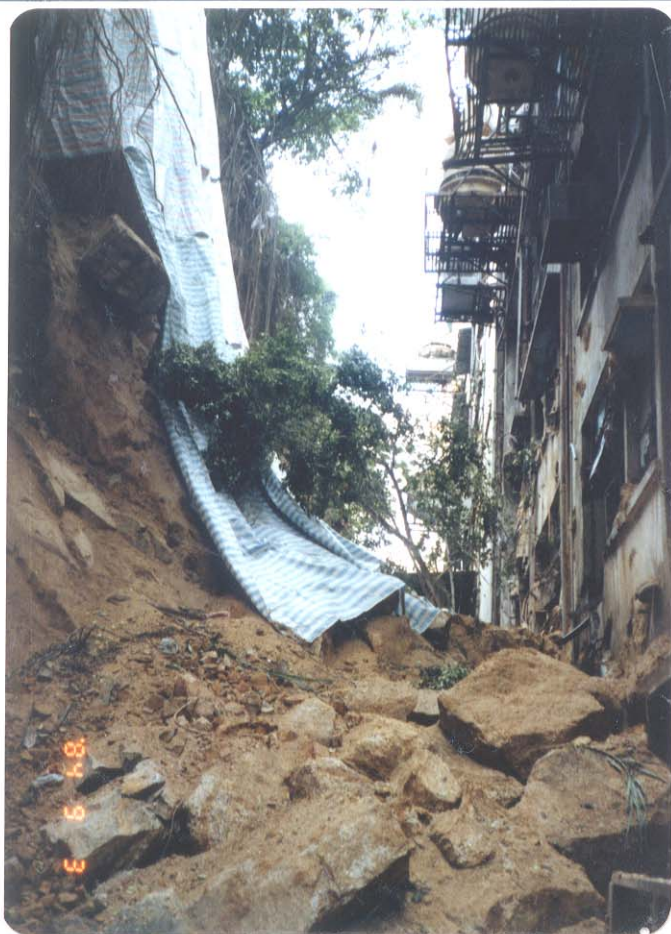
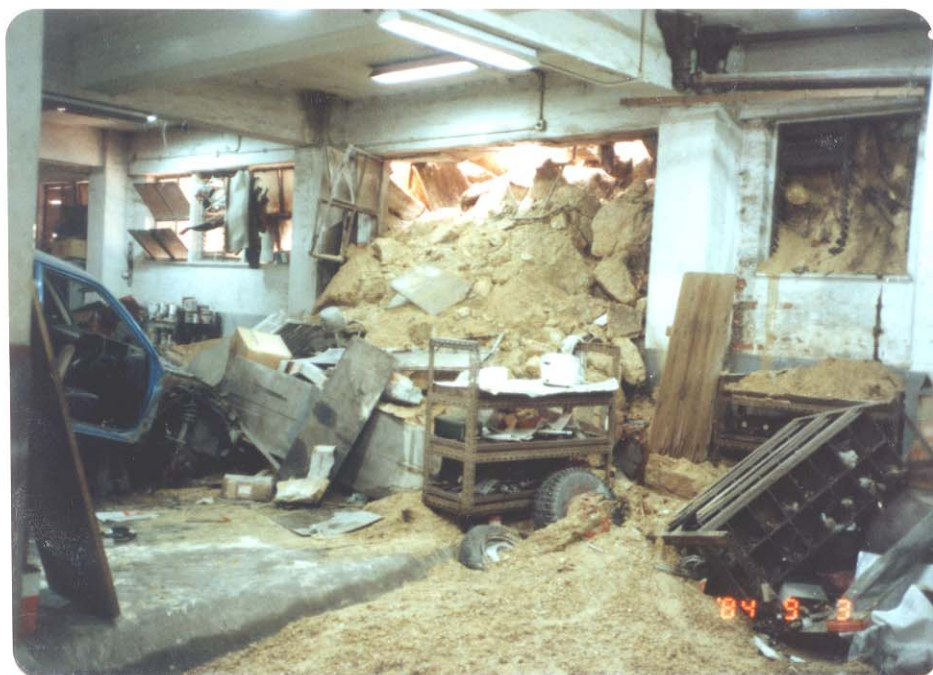
(Date : 2nd September, major failure of soil/rock cut slope affecting building, Plates 26 & 27)

This was another large failure and occurred at about 7am on 2nd September on a soil/rock cut slope (catalogued as 11SE-A/C85) of 15 m height and 85° slope angle, with a school at the top and a factory building at the toe of the slope. The slip debris volume was about 180 m<sup>3</sup> and caused complete collapse of one panel of the rear wall of the factory building, through which the debris fell and piled up inside on the ground floor. The walls on the first and second floors were also damaged. Partial closure of these floors of the factory was enforced, pending temporary remedial works. The landslide took place during heavy rainfall (Table 1). The probable causes were infiltration and the wedging effects of tree roots on the thick soil mass overlying adversely jointed rock.

Two minor failures had occurred previously at this site, in June 1982 and October 1983. A Dangerous Notice had been issued after the second of these two failures. At present the repair scheme to prevent further failures is being expedited by a private consultant.

Plates 26 & 27 - 206-208, Tsat Tsz Mui Road, North Point  
(Incident No. HK 9/1) : Major Failure on Soil/Rock Cut Slope

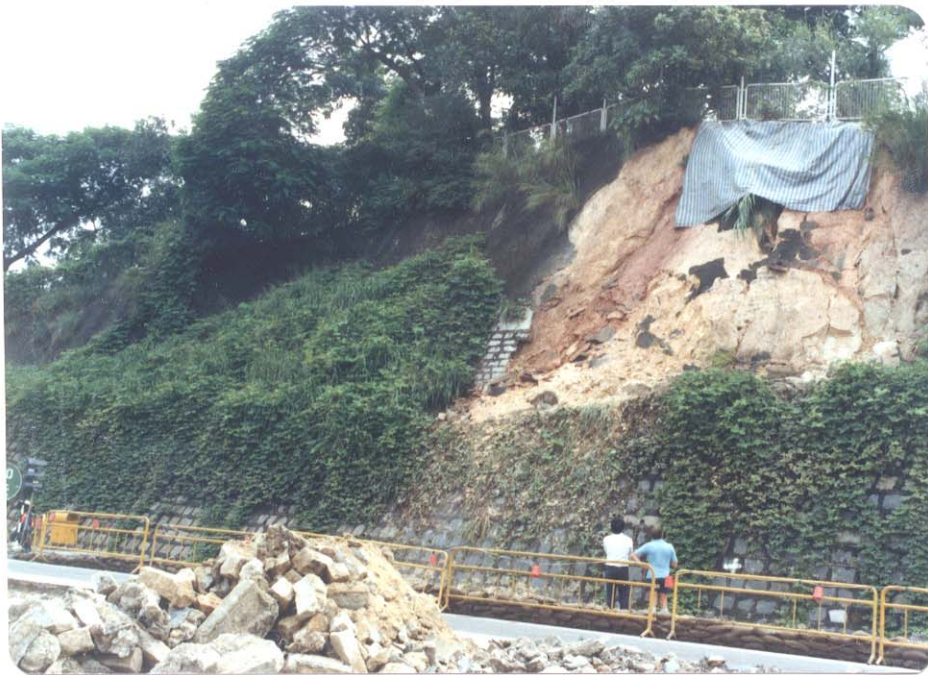
Plate 28 : Negative No. MW 144/84/5 Date : 4.9.84

(Date : 1st September, minor soil cut slope failure affecting road, Plate 28)

This landslide occurred at about 4 pm on 1st September during a rainstorm (Table 1). It was a failure on a 70°, 7 m high soil cut slope and the slide debris volume was about 30 m<sup>3</sup>. The debris blocked the footpath and one lane of the road. The fence of the private lot at the top of slope was also affected. The east-bound carriageway of Castle Peak Road was closed while repair work on the slope was being carried out, and a temporary road diversion was provided during this period. The probable cause of failure was storm water infiltration at the top of the slope.

Plate 28 - 20 MS, Castle Peak Road, Tuen Mun  
(Incident No. MW 9/1)

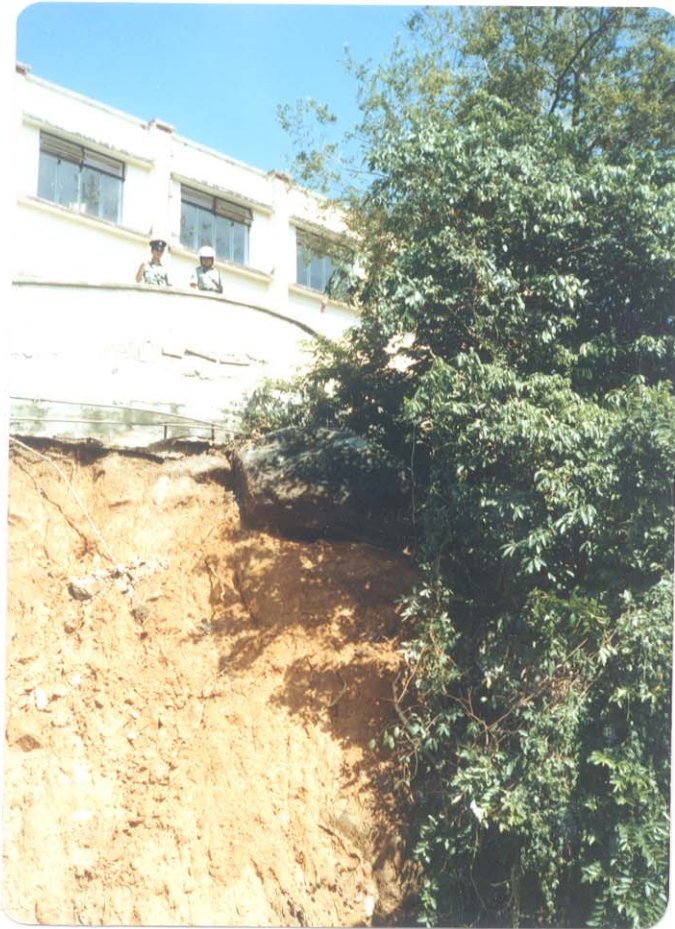
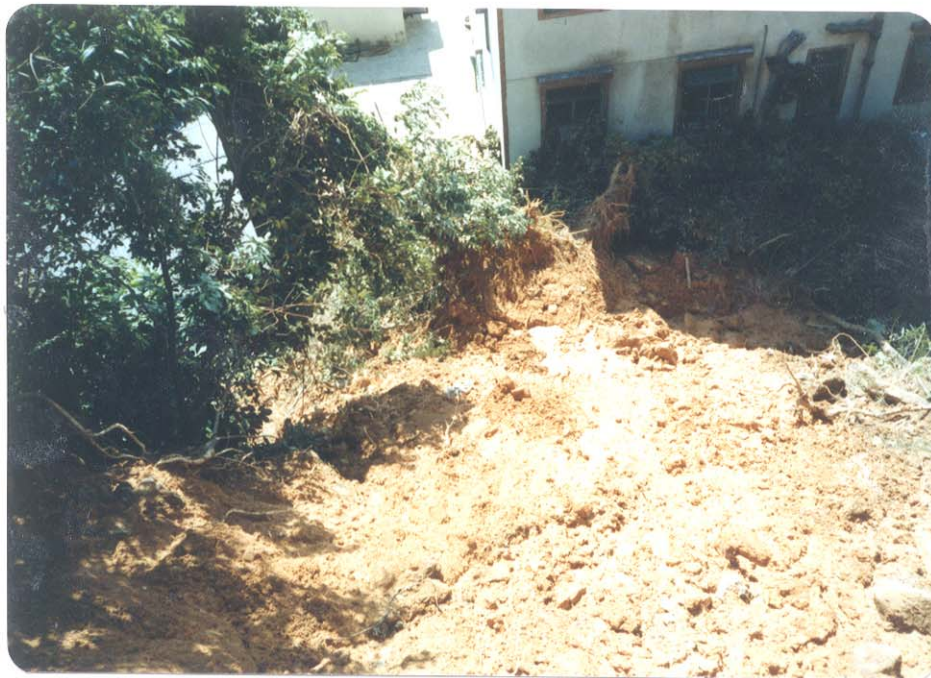
(Date : 7th September, major failure of soil cut slope affecting building, Plates 29 & 30)

Plates 29 & 30 - 56A-58, Fui Yui Ha, Sai Kung  
(Incident No. ME 9/1) : Major Failure on Soil Cut Slope

The failed slope was subsequently reinstated. The water-bearing pipe was diverted after completion of the slope remedial works.
