# **RAINFALL AND LANDSLIDES IN 1984**

**GEO REPORT No. 1**

**J. Premchitt**

**GEOTECHNICAL ENGINEERING OFFICE  
CIVIL ENGINEERING DEPARTMENT  
HONG KONG**

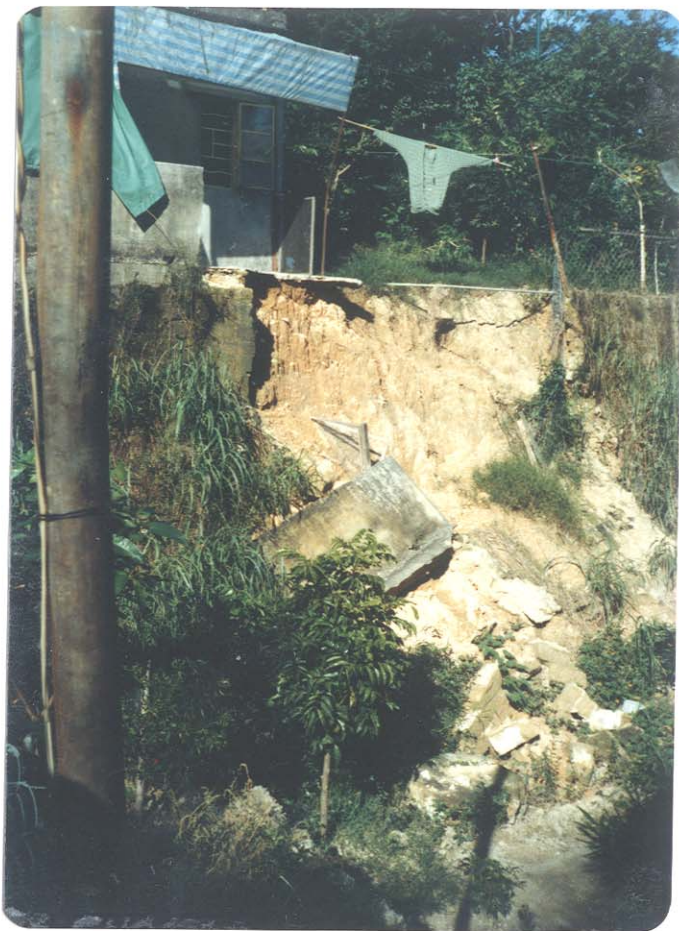
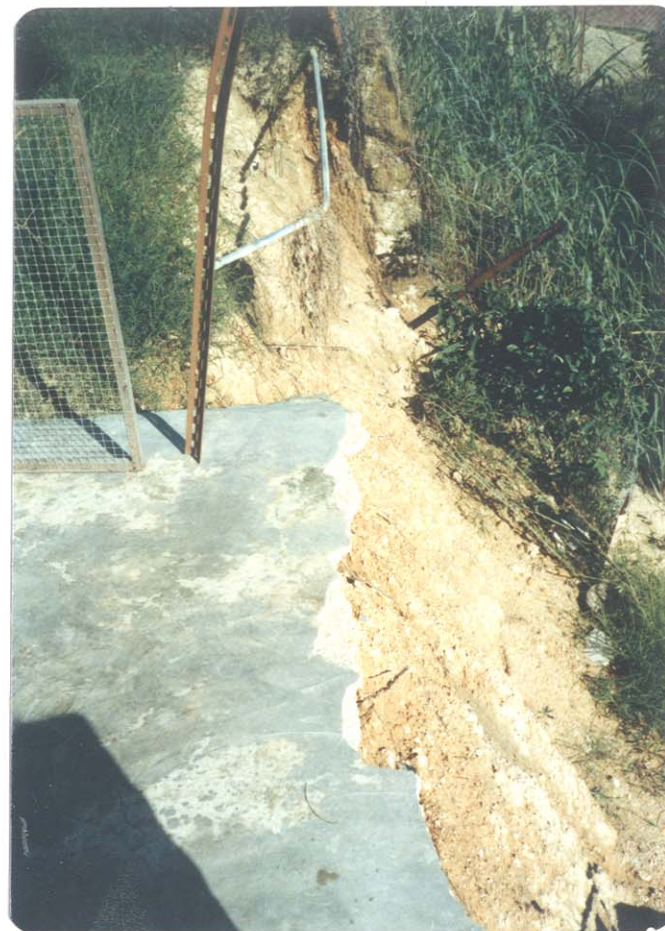
Examples of these failures are incident HK5/9 (Plates 8 & 9; Section 4.5) and MW 9/3 (Plates 31 & 32).

Plates 31 & 32 - Siu So Tsuen, Tuen Mun (Incident No. MW 9/3)

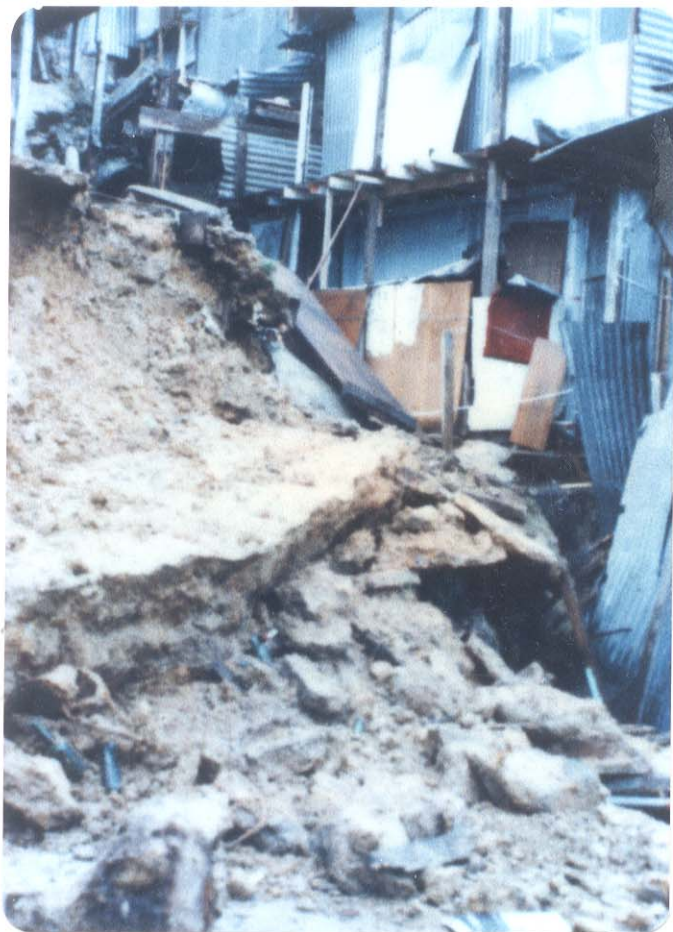
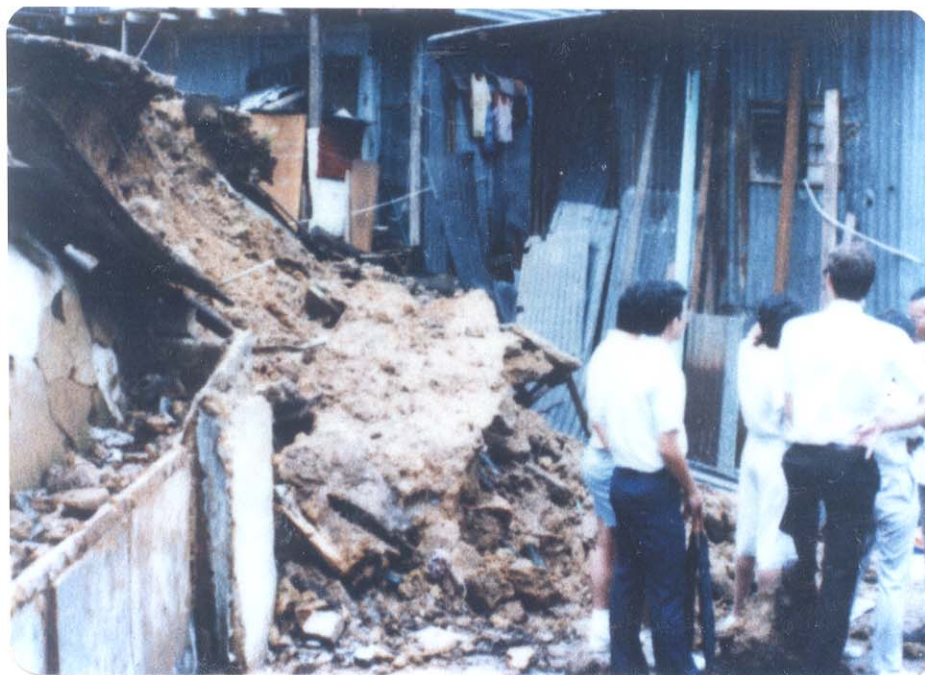
Plates 33 & 34 - Sha Tin Pass Village, Tsz Wan Shan Road, K.C.  
(Incident No. K 9/2)
