HONG KONG RAINFALL AND LANDSLIDES IN 1988

GEO REPORT No. 5

J. Premchitt

**GEOTECHNICAL ENGINEERING OFFICE
CIVIL ENGINEERING DEPARTMENT
HONG KONG**

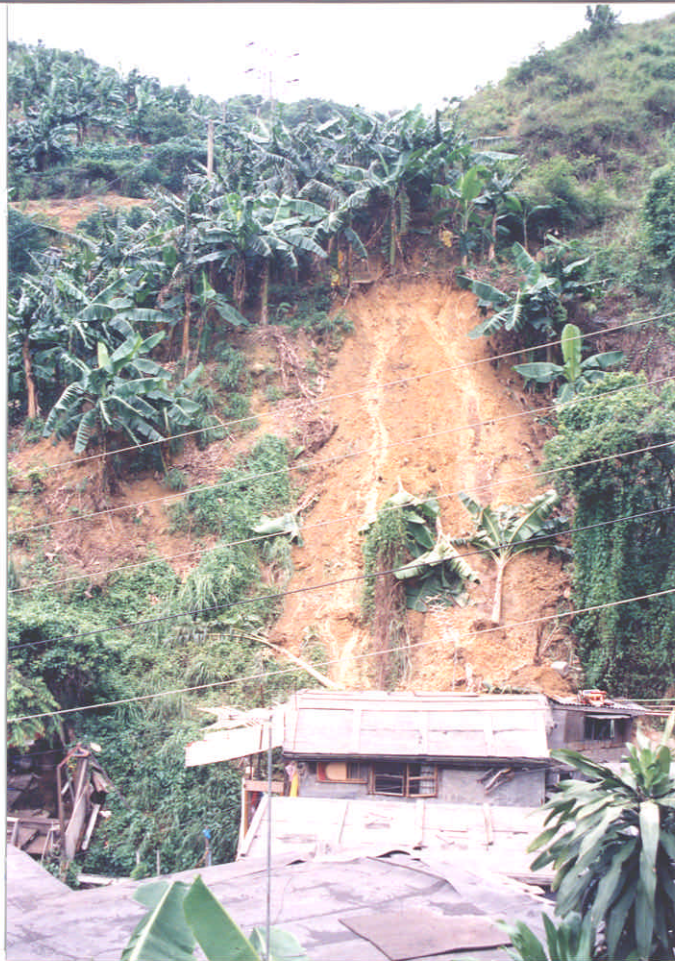
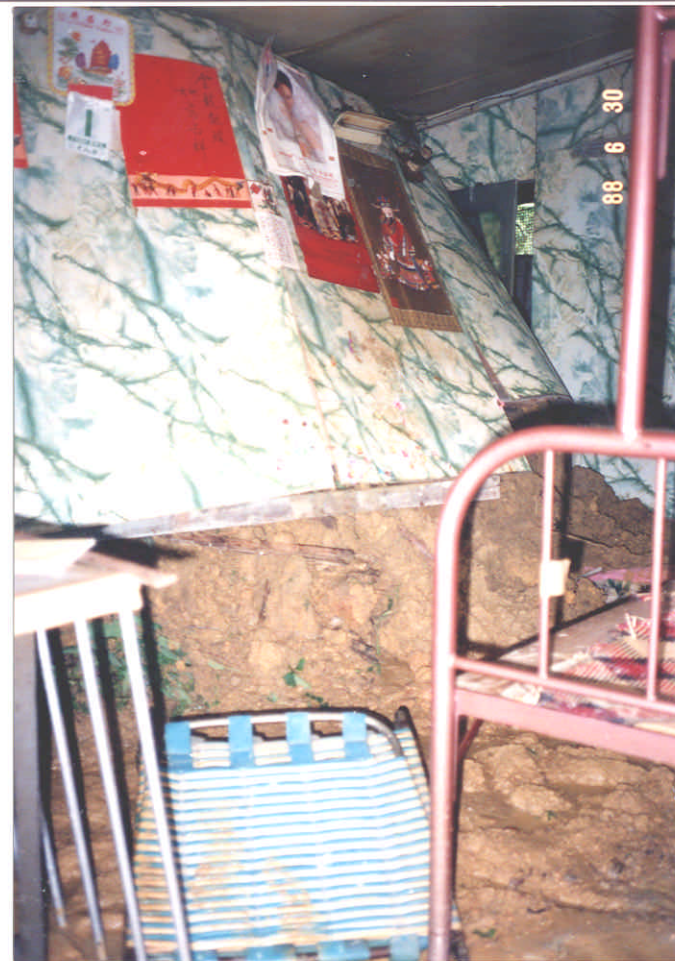
Plate 1 & 2 - Hang Hau Village, Shek Lei, Tseun Wan (Incident No. MW 6/2)

This major landslide occurred at about 0700 hours on 30th June, during a period of rainfall. It occurred in a natural slope which was a part of Smugglers Ridge in Tsuen Wan area. The failure was about 10 m wide and 15 m long. The debris volume was estimated to be about 100 cu m. The failure also involved a number of trees on the slope. The debris struck a hut at the toe of the slope and the rear portion of the hut collapsed. The huts in the vicinity were endangered by this landslide incident. As a result, three huts were permanently evacuated. The slide debris and the evacuated huts were subsequently cleared from the area.

Description : Major failure of a natural slope affecting squatters, three huts permanently evacuated.

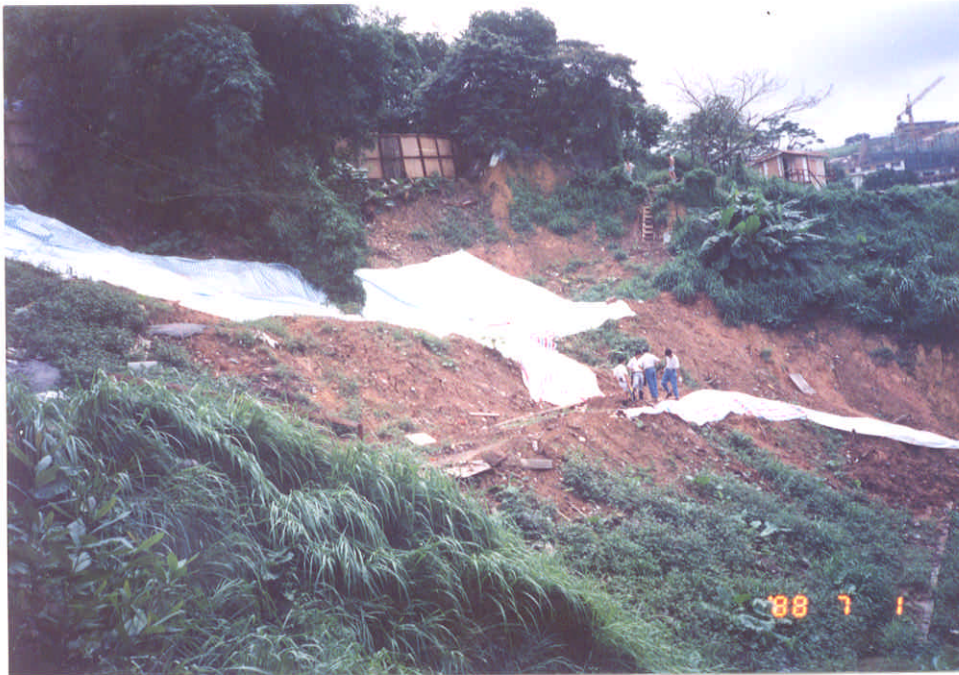
Plate 3 - Island Road Government School, Aberdeen
(Incident No. HK 6/4)

The first major failure occurred after a prolonged rainy period from 23rd to 27th June (285 mm in 5 days at GCO gauge H05, Aberdeen). A large soil mass movement occurred with a 17 m long tension crack appeared on the slope face near the top of the slope and had a vertical displacement of about 1 m. The estimated displaced volume was about 100 cu m. As a result of this failure, ten huts at the top of the slope near the tension crack were permanently evacuated. Remedial work was then carried out.

Description : Major failure of a soil cut slope affecting squatters and construction site, ten huts permanently evacuated.

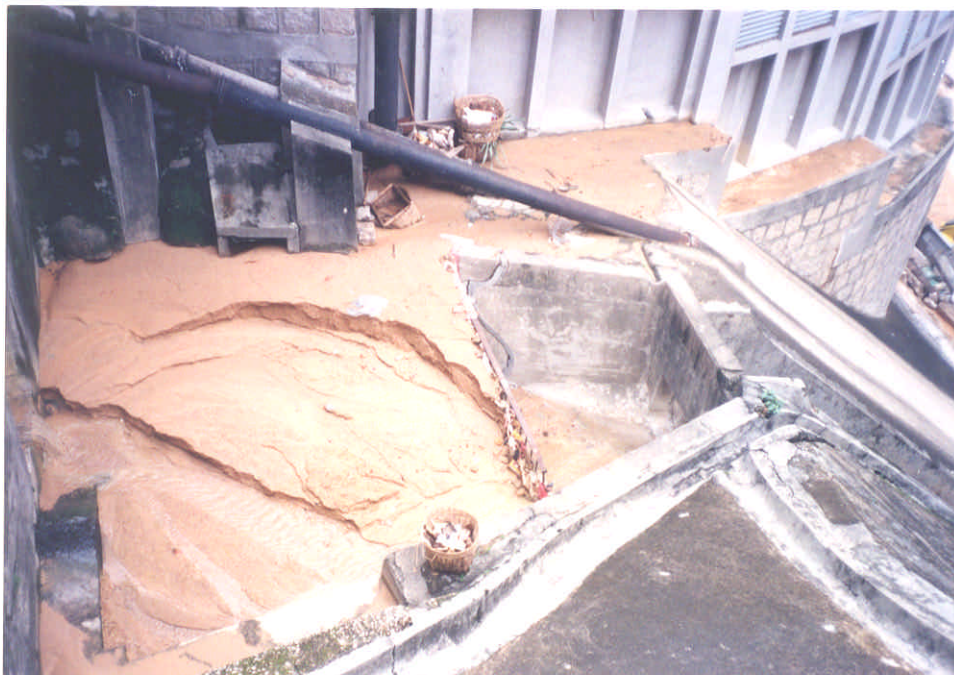
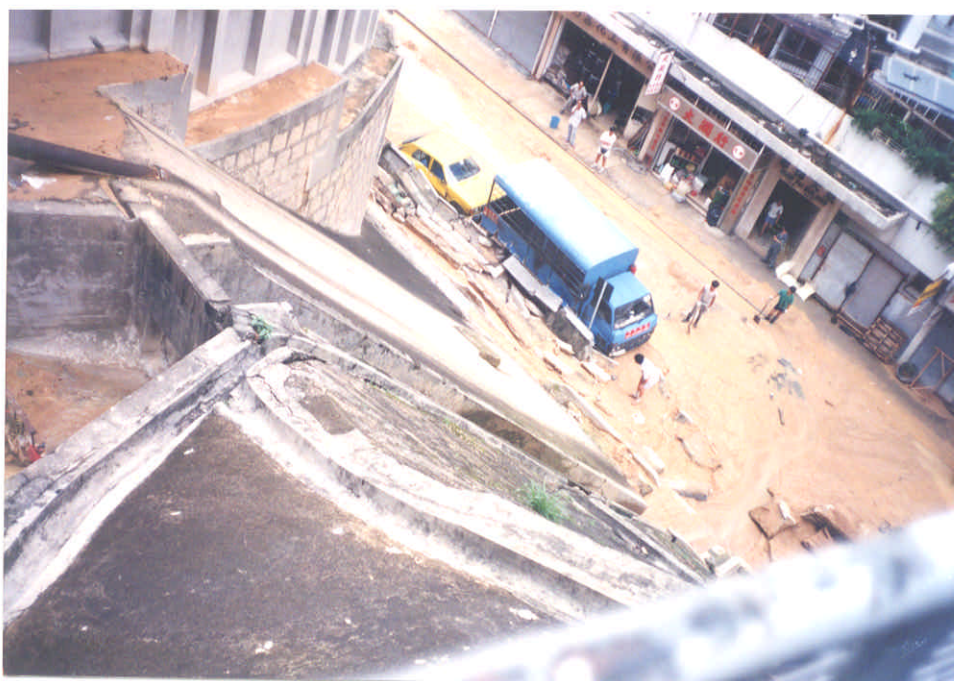
Plates 4 & 5 - Caritas Medical Centre, Sham Shui Po
(Incident No. K 7/12)

This incident was reported to have occurred at about 1725 hours on 27th July during a period of light rain (32 mm for the day). It occurred in a 20 m long section of a 1 m high concrete parapet which had been erected above a 1 m high toe wall with a catch-pit behind. This catch-pit received surface drainage water from a 10 m high, 1 m wide cascade. The catch-pit appears to have been silted up completely before the failure. This build-up of silt and water caused the wall to collapse. The total debris volume was estimated to be about 10 cu m. The debris fell on to Wing Hong Street and hit two cars parked in the vicinity. As a result of this failure, the two cars were damaged, the ground floor of two shops on the opposite side of the street were temporarily evacuated and the street was closed. The shops were reoccupied the following morning and a repair was subsequently carried out on the failure.

Description : Failure of a concrete wall due to silting up of a catch-pit, two cars damaged, two shops temporarily closed and a road closed.

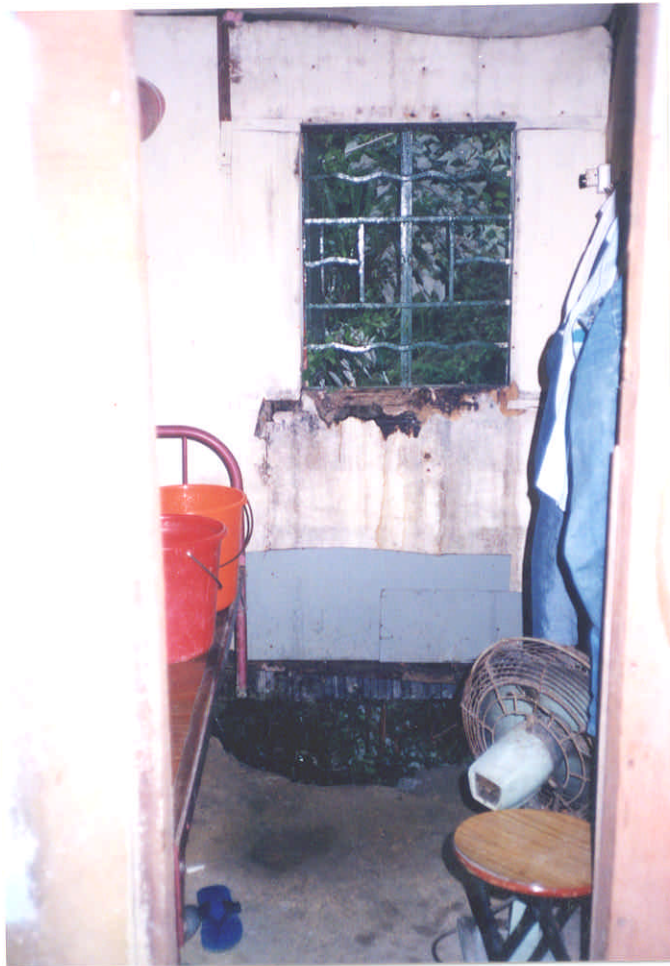
Plate 6 - Ma Wan Village, Lei Yue Mun
(Incident No. K 8/2)

This incident occurred at about 1700 hours on 14th August after a period of rainfall (more than 30 mm since midnight). It occurred in the top part of a steep, 15 m high cut slope, possibly a part of an old quarry. The total slide debris was only 2 cu m. However, a small part of the floor of a hut at the crest of the slope gave way and a person fell through the resulting hole, down the 15 m high slope and was injured. Subsequently, three huts in the area were permanently evacuated and the failure was repaired.

Description : Soil cut slope failure affecting squatters, one person fell down the slope and injured, three huts permanently evacuated.

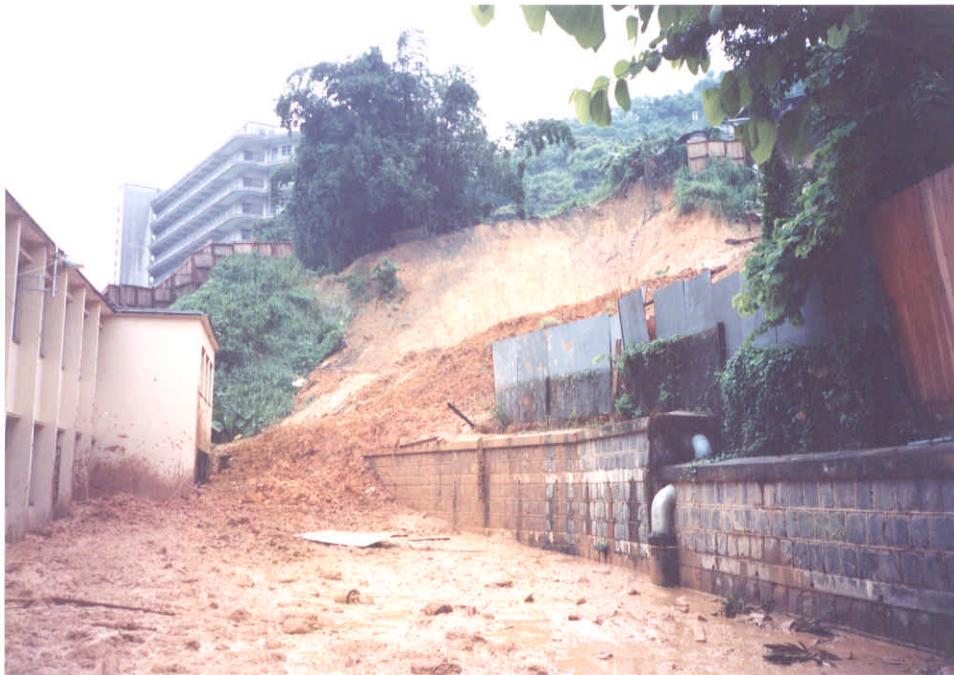
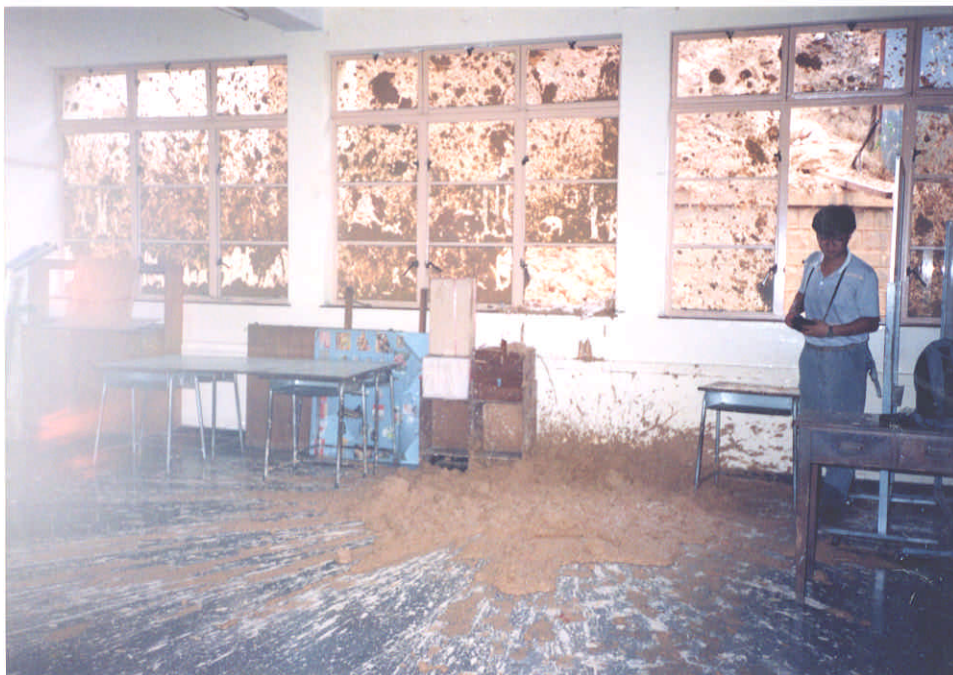
Plates 7 & 8 - Island Road Government School, Aberdeen
(Incident No. HK 8/4)

The second major failure, the largest one in 1988, occurred at about 1145 hours on 31st August and involved about 800 cu m of slide debris. This was preceded by a much smaller failure in the same area at 0930 hours, and involved about 50 cu m of the debris. There had been a period of almost continuous rainfall from the 10th to 20th August (5 to 50 mm per day for a total of 283 mm). On the 31st August, there was more than 80 mm of rain prior to the failure at 1145 hours. The failure debris was observed to be very wet. A part of this debris fell into the flooded school yard and struck the rear wall of the school building. The mud-like debris flowed into some rooms on the ground floor, which were vacant at the time. As a result of this second failure, a total of eight rooms in the school were temporarily closed, and the remedial work started immediately after the failure.

Description : Major failure of a soil cut slope affecting building,
eight rooms of a school temporarily evacuated.

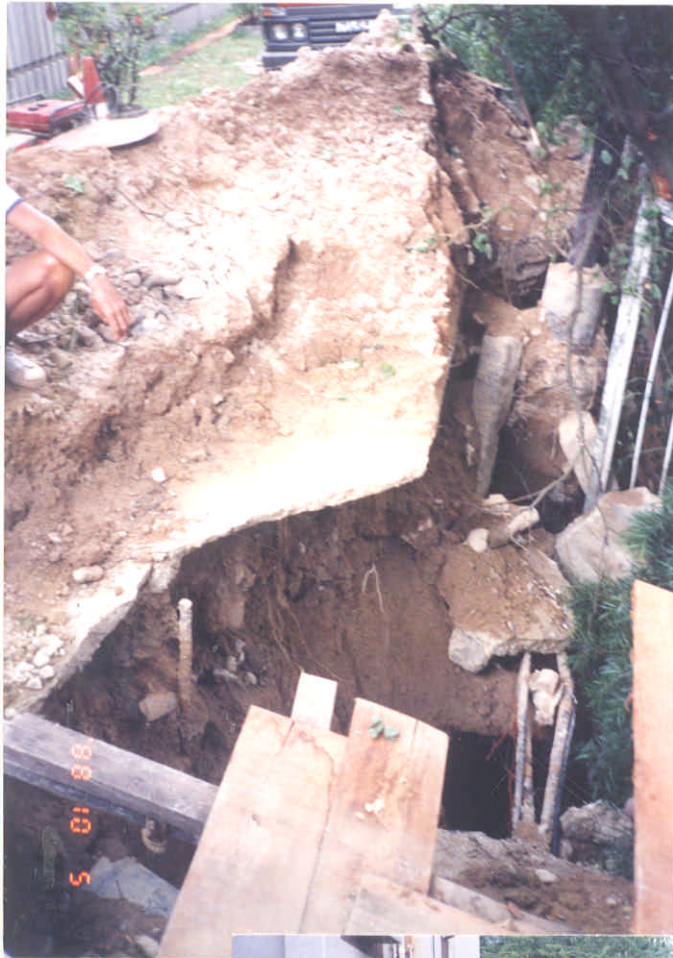
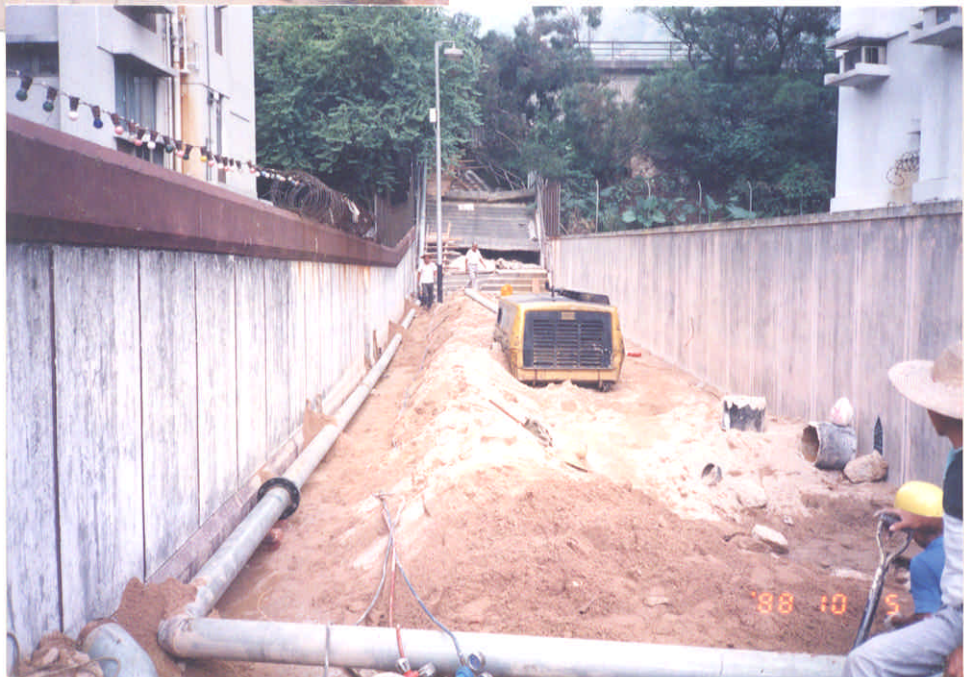
Plates 9 & 10 - 45 - 47 Broadcast Drive
(Incident No. K 10/1)

This failure occurred in the evening of 4th October due to the rupture of two 300 mm diameter water mains at the site near a staircase which led to a walkway connecting Waterloo Road and Broadcast Drive, between houses no. 45 and 47 Broadcast Drive. The ruptured mains discharged a large amount of water which caused extensive erosion-type failure of the 5 m high fill slope below the staircase. The volume of the debris was about 120 cu m and it blocked the walkway completely. The debris also flowed into nearby building lots and on to Broadcast Drive. The staircase was damaged extensively by this failure. Immediately after the failure, the existing mains were shut off and a new main was laid, the debris was removed and the staircase was reinstated.

Description : Major failure of a fill slope due to rupture of water mains, footpath blocked.

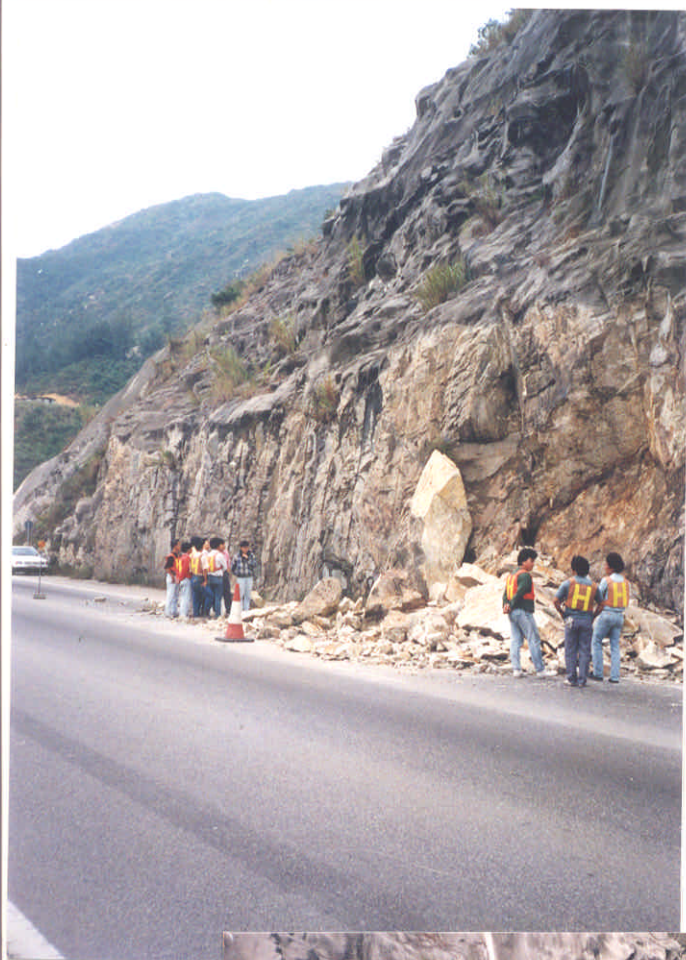
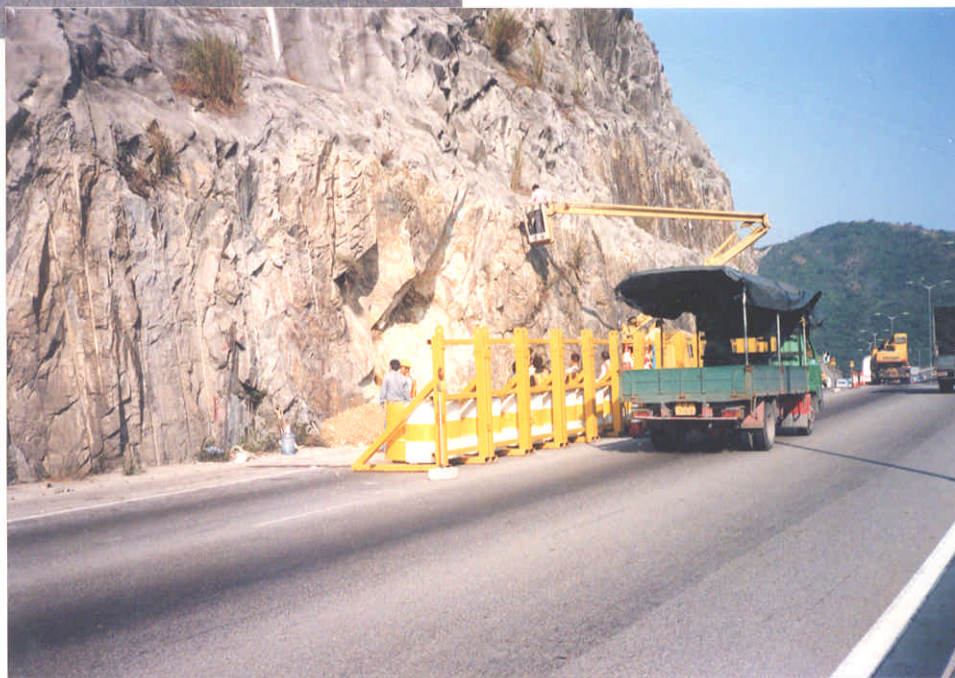
Plates 11 & 12 - Tuen Mun Highway Ch. 7550, Tsing Lung Tau
(Incident No. MW 11/1)

There were five rock cut slope failures. None of these was major. An example of minor rock cut slope failure is incident MW 11/1 (Plates 11 & 12).

Description : Rock cut slope failure affecting road,
one lane of road blocked.

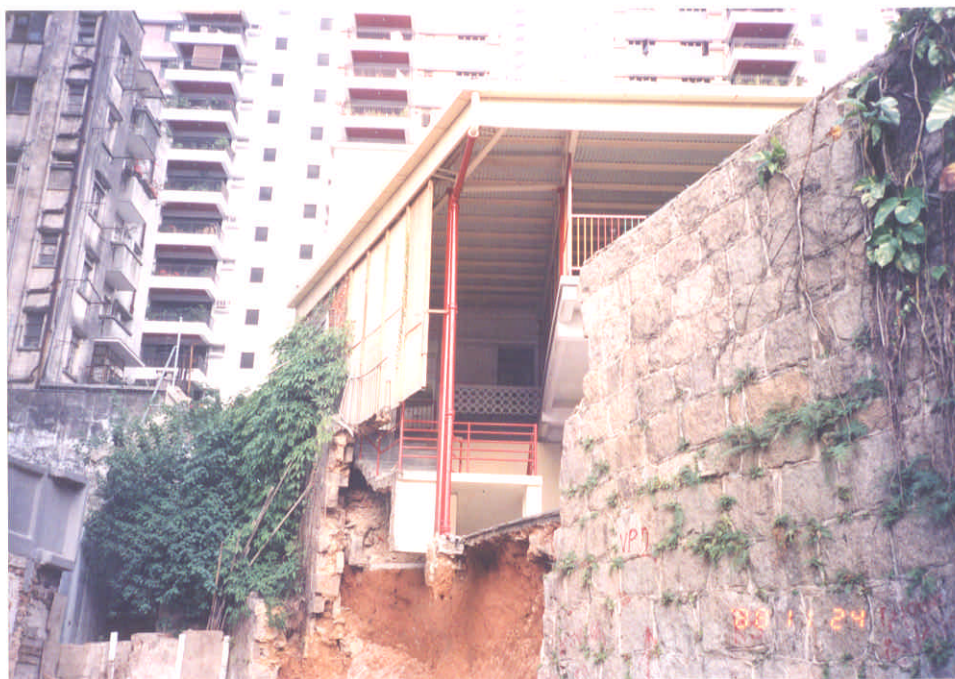
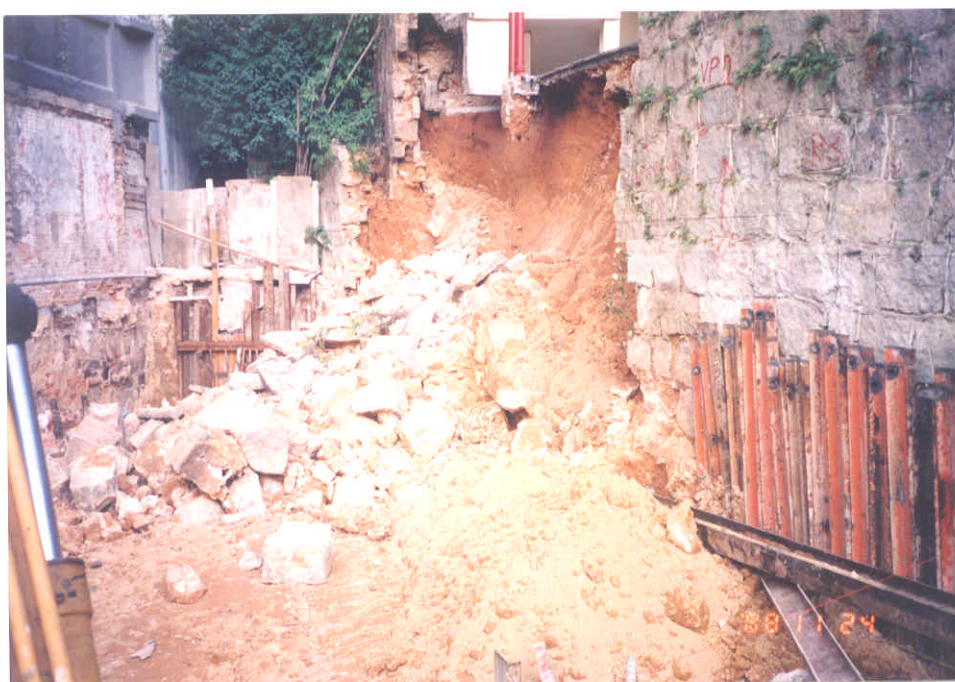
This incident occurred at about 1130 hours on 24th November, during driving of sheet piles in a construction site. It occurred in a 10 m long section of a 5.5 m high masonry retaining wall. The debris volume was approximately 20 cu m. The repeated vibration effects from driving of the sheet piles (U-shape channels), to act as a shoring to the pile cap excavation, may have contributed to the initiation of this failure. As a result, a part of the playground of St. Paul Primary School at the top of

the failure was fenced off. The construction schedule for the site at the toe of the wall was also affected. The failure was subsequently reinstated by the developer of the site.

Description : Retaining wall failure affecting building lots,
part of play ground above fenced off.
