# **HONG KONG RAINFALL AND LANDSLIDES IN 1990**

**GEO REPORT No. 14**

**K.Y. Tang**

**GEOTECHNICAL ENGINEERING OFFICE  
CIVIL ENGINEERING DEPARTMENT  
HONG KONG**

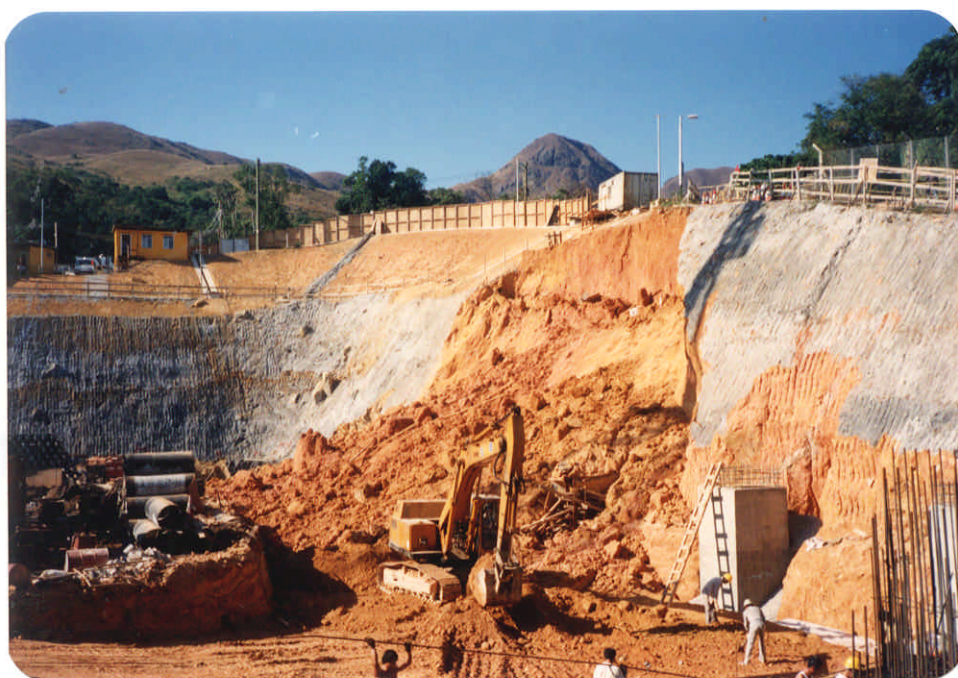
Plate 1 : Negative No. ME 9001106

(Date : 10 January, 1990. Failure of a temporary cut slope affecting a village access road, Plate 1.)

The contractor for the site formation and construction of the service reservoir formed a temporary cut slope up to 15 m high at 60° in completely weathered volcanic and then undercut the slope toe to 75° for construction of the reservoir walls and manholes. Work continued despite GEO's concern over the safety of the temporary steep slope cutting. Although the work was carried out in the dry season, about 400 m<sup>3</sup> of this temporary cut slope failed. There was no rainfall during the 24 hours before the failure (Plate 1). Part of a village access road at the crest of the slope was undermined and half of the road was closed.

**Description:** Failure of a temporary cut slope on 10 January, 1990 (about 400 m<sup>3</sup>), closing half of a village road

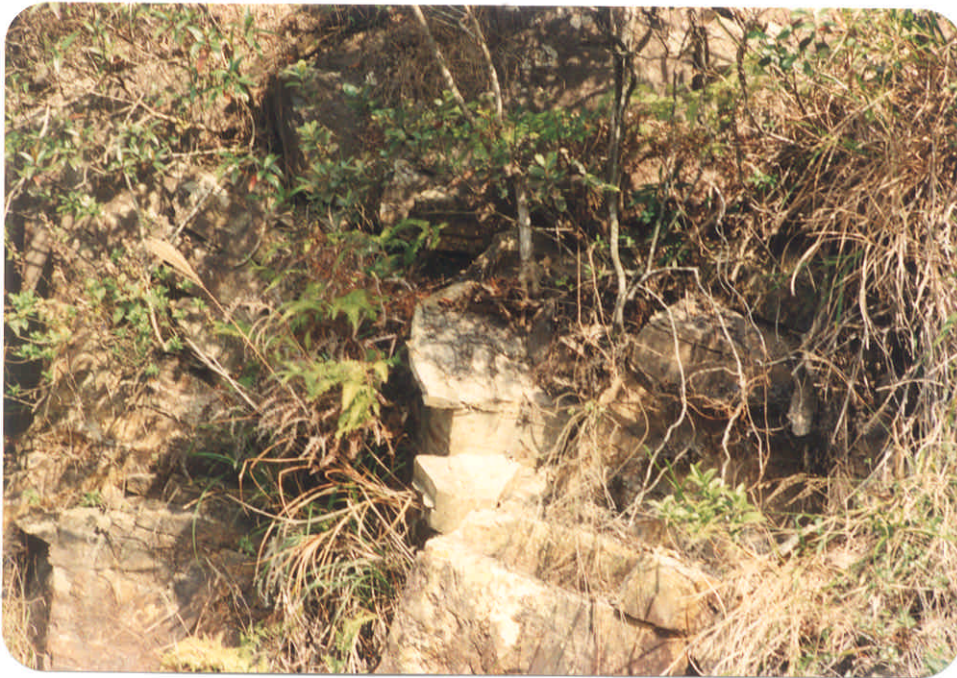
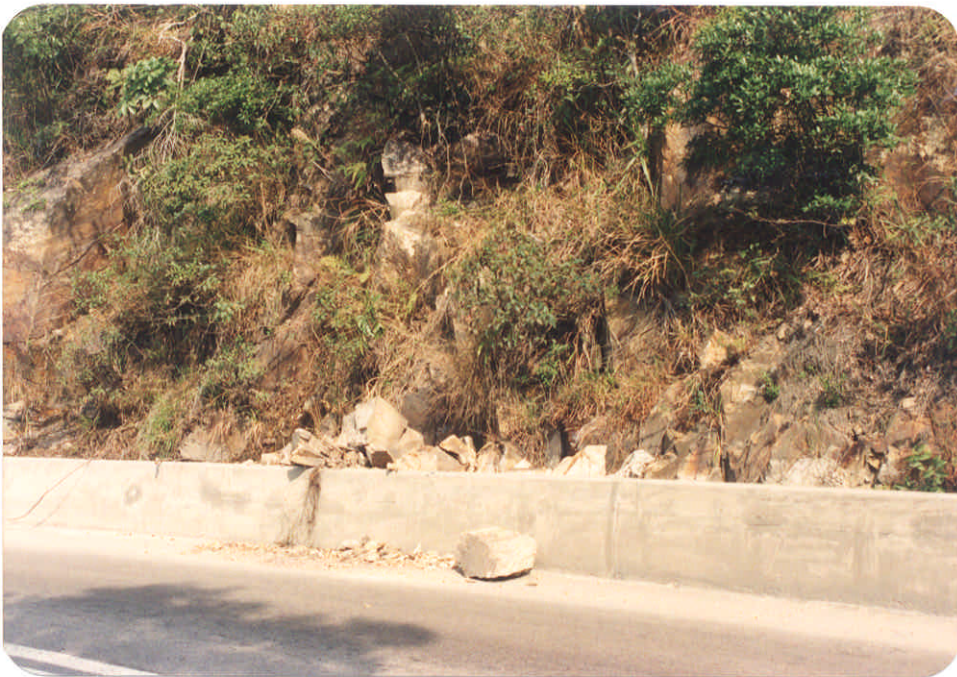
Plate 2 & 3 - Skek O Road near Sand Trap No. 41 (Incident HK 90/2/1)

**Description:** Typical example of a rock fall

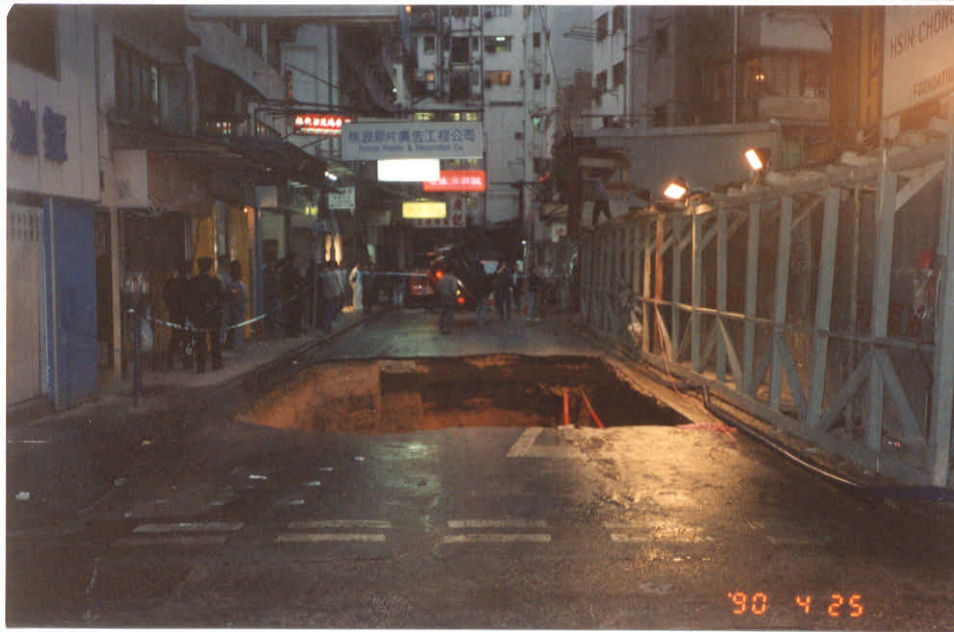
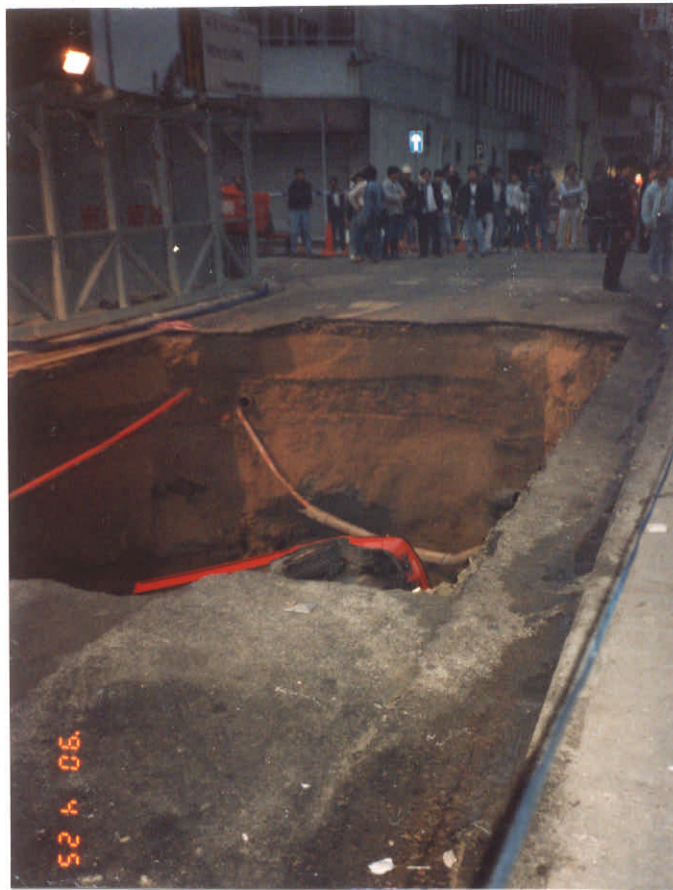
Plate 4 & 5 - Bowrington Road (Incident HK 90/4/3)

Sheet piling was used to support a basement excavation. Some sheet piles terminated at a level above the approved level, allegedly due to obstruction by boulders. Steel plates were welded to the sheet piles to support the excavated face below the sheet piles. At failure, the height of this excavated face was about 3 m. Marine sand behind the sheet wall moved into the excavation site and a water main ruptured. A hole, 6 m by 10 m in plan and 6 m deep was subsequently found on the adjacent Bowrington Road, completely sealing it off from traffic (Plates 4 and 5).

Description : Failure of a basement excavation on 6 April, 1990 resulting in subsidence of part of Bowrington Road.

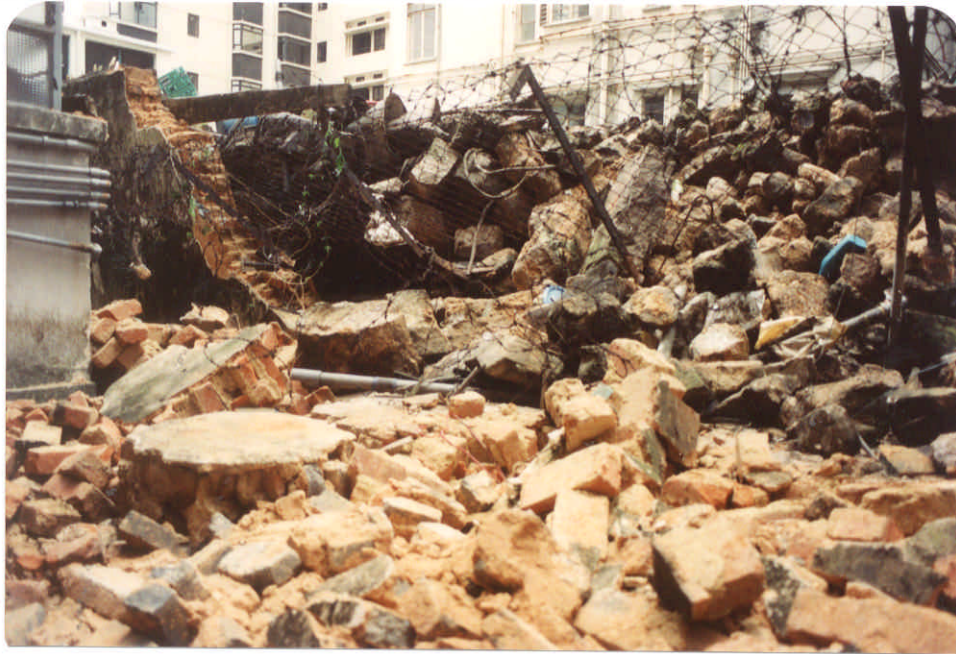
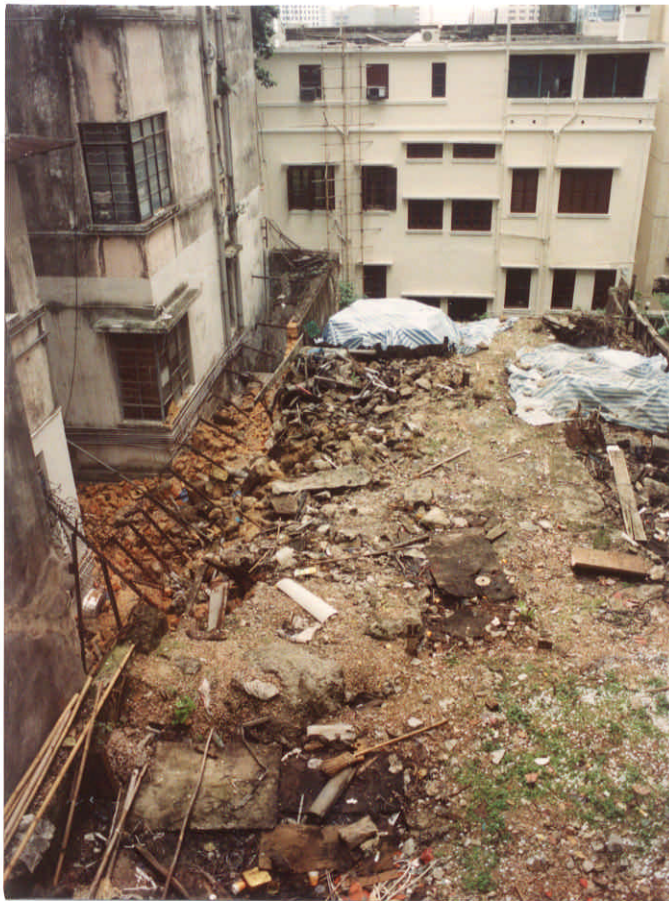
Plate 6 & 7 - No. 17 MacDonnell Road (Incident HK 90/4/1)

(Date : 10 April, 1990. Structural failure of a boundary wall affecting a private backyard, Plates 6 and 7.)

No 17 MacDonnell Road was an abandoned building site (Plate 6). Building debris had built up behind a 2 m high brick boundary wall. After a heavy rainfall in the evening of 9 April, the wall failed structurally

Description : Structural failure of a back wall on 10 April, 1990 affecting a private backyard

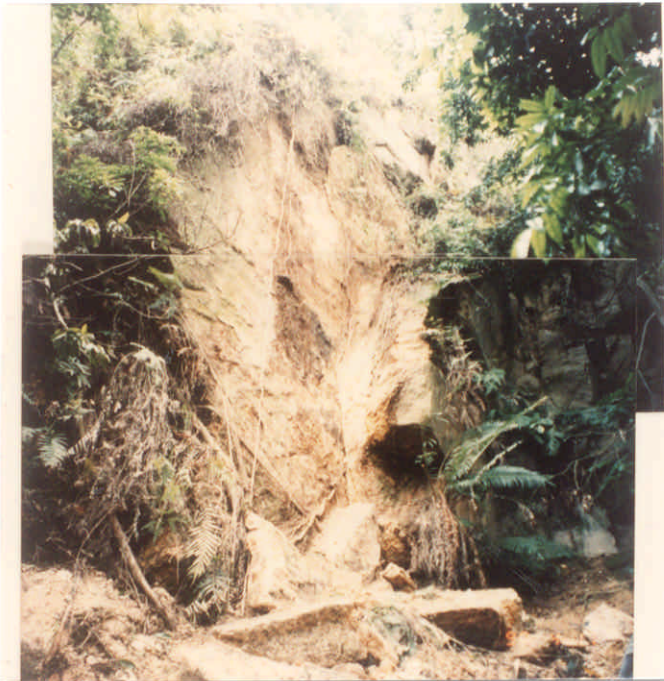
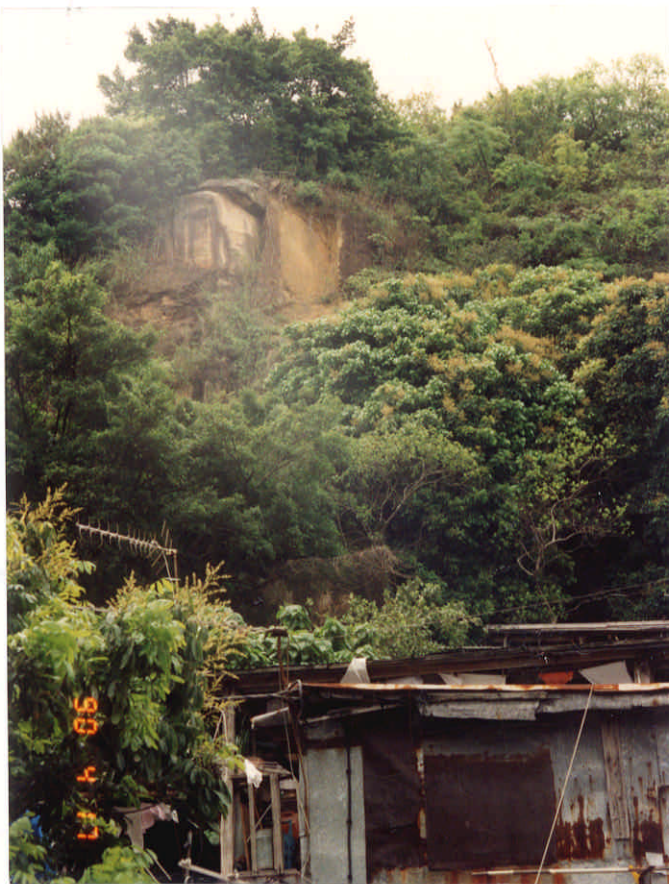
Plate 8 & 9-Cha Kwo Ling Village behind Fan Wah Street (Incident K 90/4/2)

(Date : 12 April, 1990. Failure of a rock cut slope affecting squatters, Plates 8 and 9.)

About 10 m<sup>3</sup> of rock mass was dislodged from the rock face. The causes of the failure were infiltration and weakening of a rock joint by root growth (Plate 8). There were squatter huts below the rock slope (Plate 9) but no evacuation was required as a rock fence separating the huts from the rock slope was constructed under the 1984/85 Landslip Preventive Measures Programme.

Description: Failure of a rock cut slope on 12 April, 1990 (Plate 8)  
above squatter area (Plate 9).

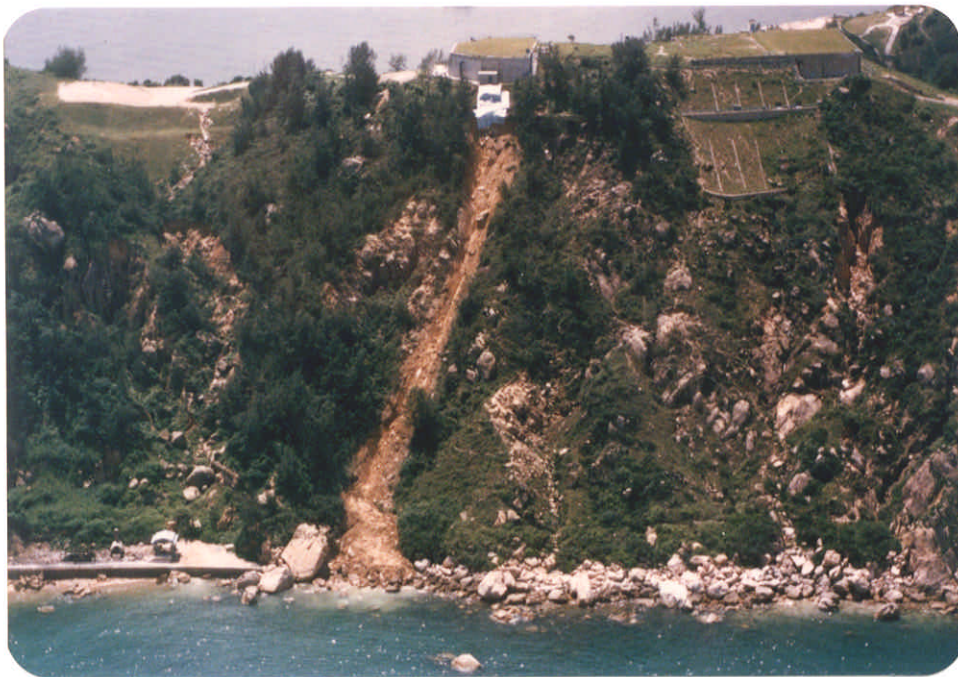
Plate 10: Negative No. SP 91085 (B) Date: 8-6-90

(Date : 8 June, 1990. Failure of a natural slope damaging part of the drainage channel system at the edge of the platform for the service reservoir, Plates 10 and 11.)

The average gradient of the natural slope below the service reservoir is about 33°. The gradient of the failed section is about 40°. About 700 m<sup>3</sup> of soil and rock slid, leaving a long scar on the natural slope immediately below the service reservoir (Plate 10). Most of the slip located within an area of rhyolite, with only part of the head scarp located in coarse-grained granite. A few days before the failure, the service reservoir was rinsed and the rinsing water was discharged onto the hillside through a discharge channel that was damaged in the failure (Plate 11). The rainfall preceding the failure was modest. After the failure, CGE/A carried out a study on the slope for WSD. Results of the study and his recommended remedial works are given in Advisory Report ADR 13/91 (Yip, 1991).

**Description:** Failure of a natural slope (About 700 m<sup>3</sup>) on 8 June, 1990 (Plate 10) damaging part of the discharge channel system at the edge of the platform of the service reservoir (Plate 11)

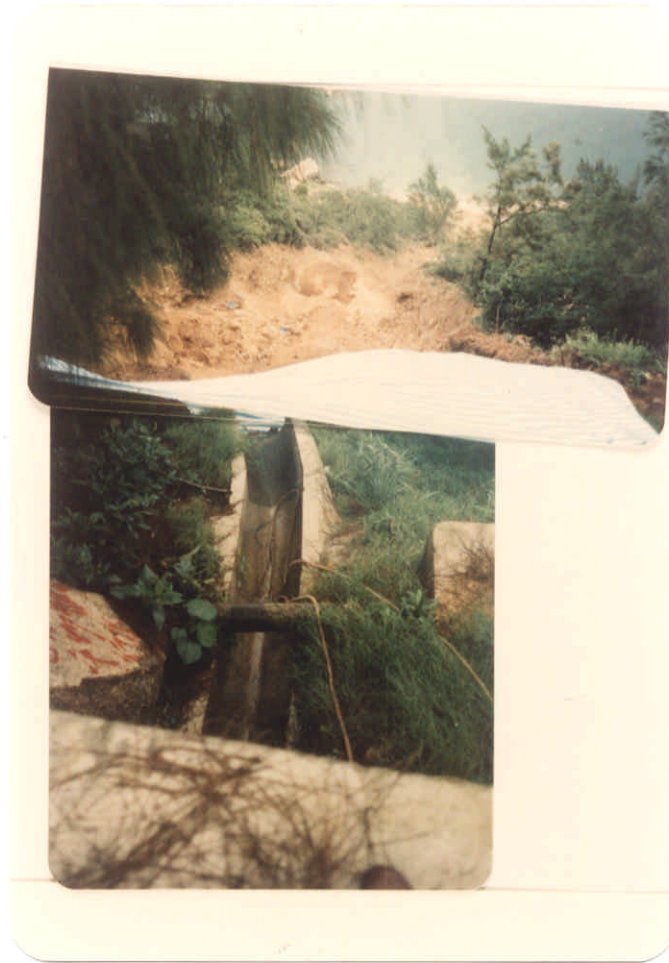
Plate 11 : Negative No. SP 9110624

**Description :** Failure of a natural slope (About 700 m<sup>3</sup>) on 8 June, 1990 (Plate 10) damaging part of the discharge channel system at the edge of the platform of the service reservoir (Plate 11)

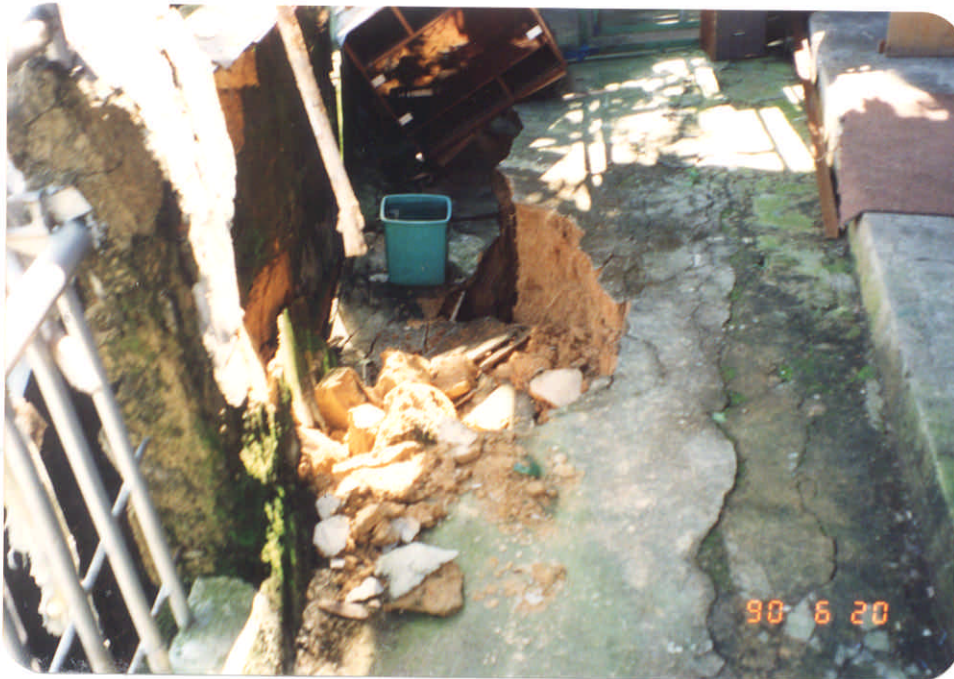
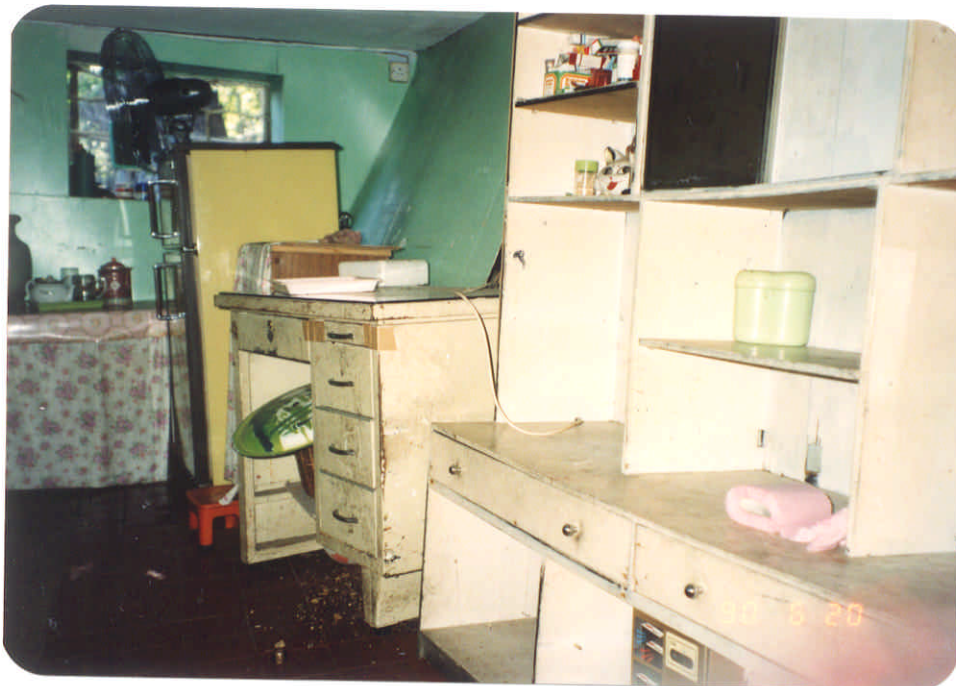
Plate 12 & 13 - Nam Shan Mei Village, Hut Nos. USD/NSM/46,47,55,56,57.  
(Incident K 90/6/9)

(Date : 20 June, 1990. Failure of a soil cut slope affecting squatters, Plates 12 and 13.)

Infiltration of rainfall caused failure of a 3 m high soil slope which was abutted by a squatter hut. The platform at the crest of the slope subsided (Plate 12) and soil slumped into the abutting hut (Plate 13). Five squatter huts were permanently evacuated.

**Description:** Failure of a soil cut slope on 20 June, 1990 resulting in permanent evacuation of five squatter huts

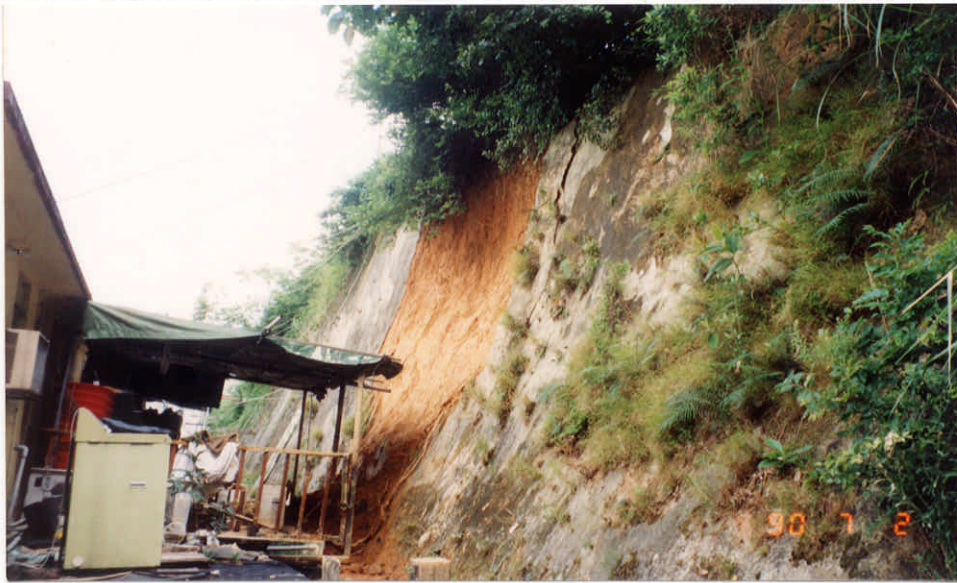
**Plate 14 : Negative No. ME 9019401**

There were 33 reported failures in soil cut slopes. The only major incident reported was ME 90/1/1 (Section 4.2) which was caused by oversteeping of a slope during construction. A typical example of cut slope failure is shown in Plate 14 (ME 90/6/8).

**Description:** Failure of a soil cut slope on 30 June, 1990 affecting an extension of a village house

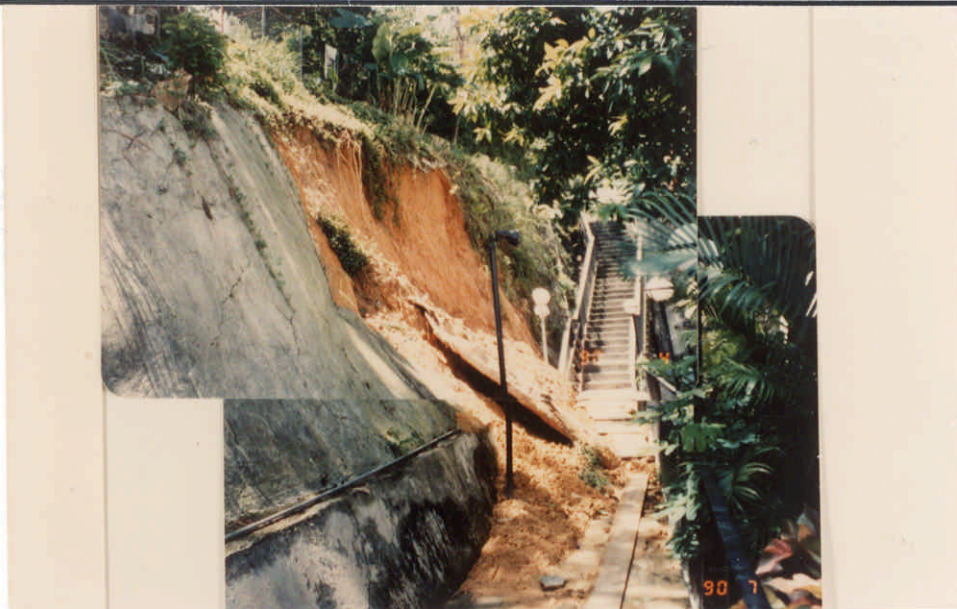
**Plate 15 : Negative No. SP 9110626**

**Description:** Failure of a soil cut slope on 30 June, 1990 blocking a footpath.

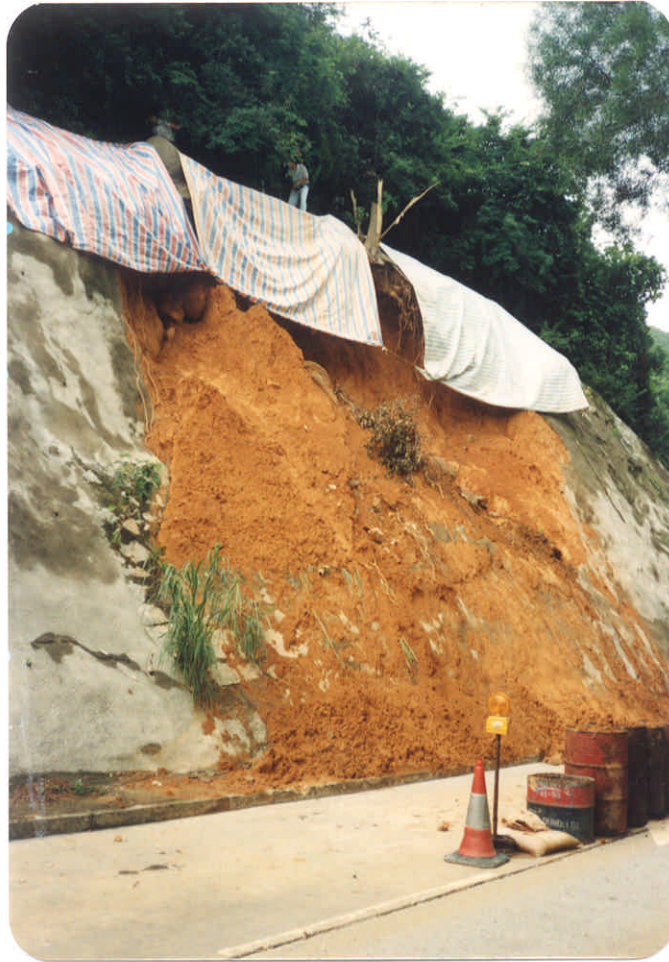
Plate 16 : Negative No. MW 9017616

(Date : 11 September, 1990. Failure a soil slope blocking part of South Lantau Road, Plate 16.)

The slope before the failure was about 9 m high and the averaged slope angle was about 55°. The slope material was bouldery colluvium. The bottom half of the slope was covered by stone pitching while the top part was probably covered by a thin layer of sprayed concrete. Failure was in the top half of the slope (Plate 16). The failure was probably caused by a

**Description :** Failure a soil slope on 11 September, 1990 blocking part of South Lantau Road.

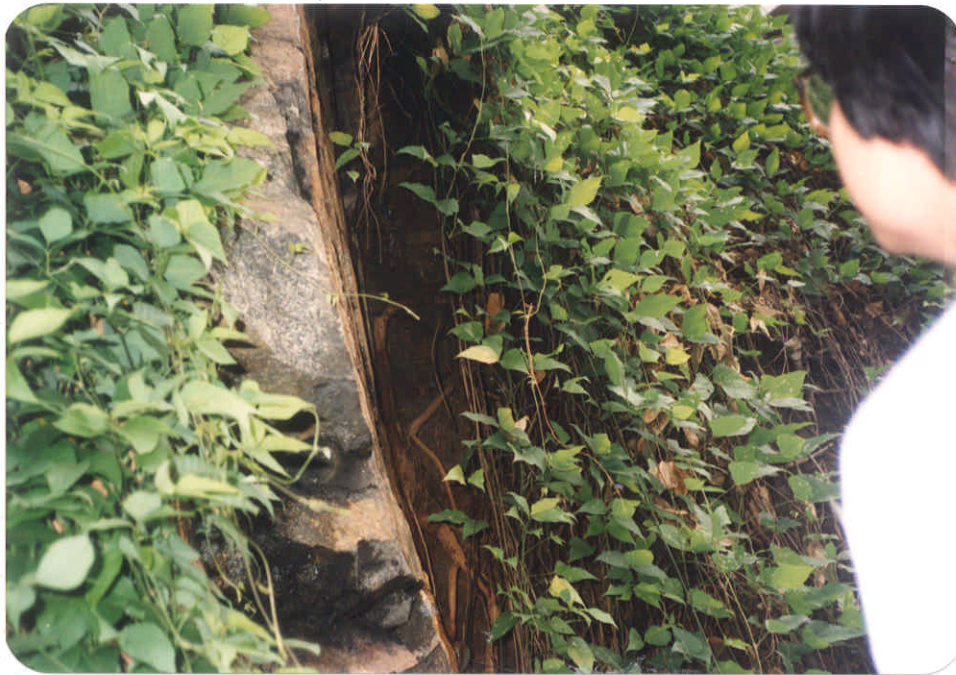
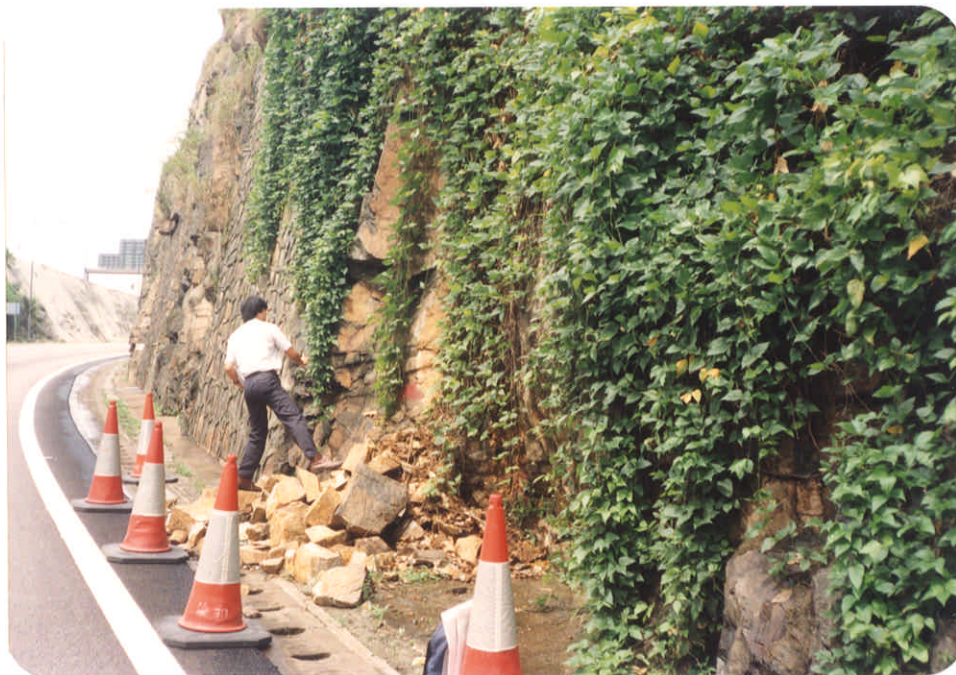
Plate 17 & 18 - Tuen Mun Road/Tsuen Wan Road (Incident MW 90/9/4)

Three failures in rock slopes were reported. An example is shown in Plates 17 and 18 (MW 90/9/4). The main causes of the failures were reported to be infiltration and disturbance of rock joints by tree roots.

**Description :** Dislodging of a rock pieces from a rock face on 11 September, 1990.

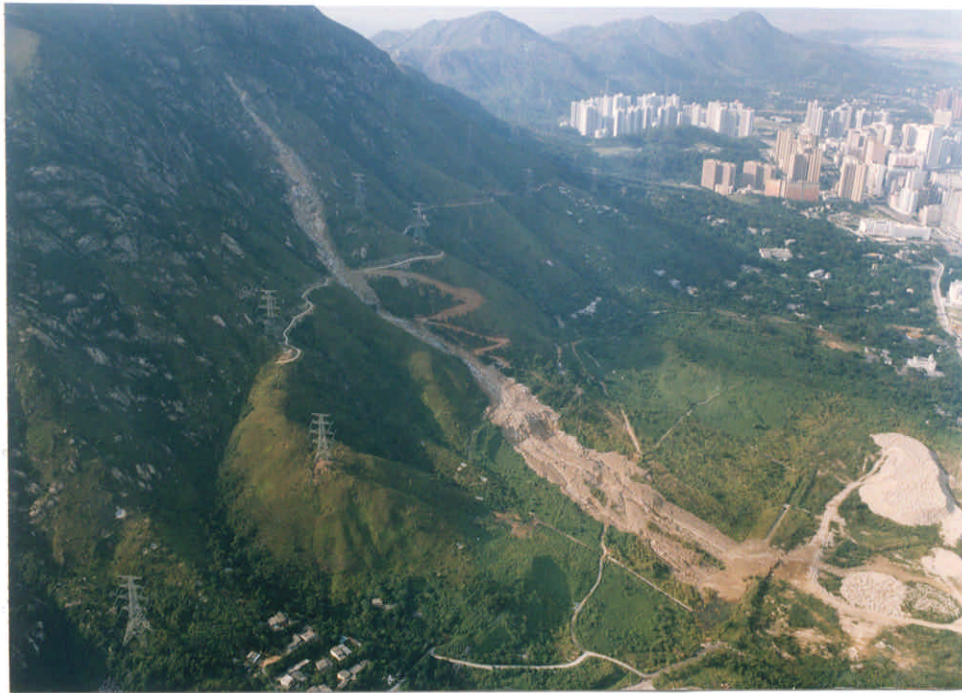
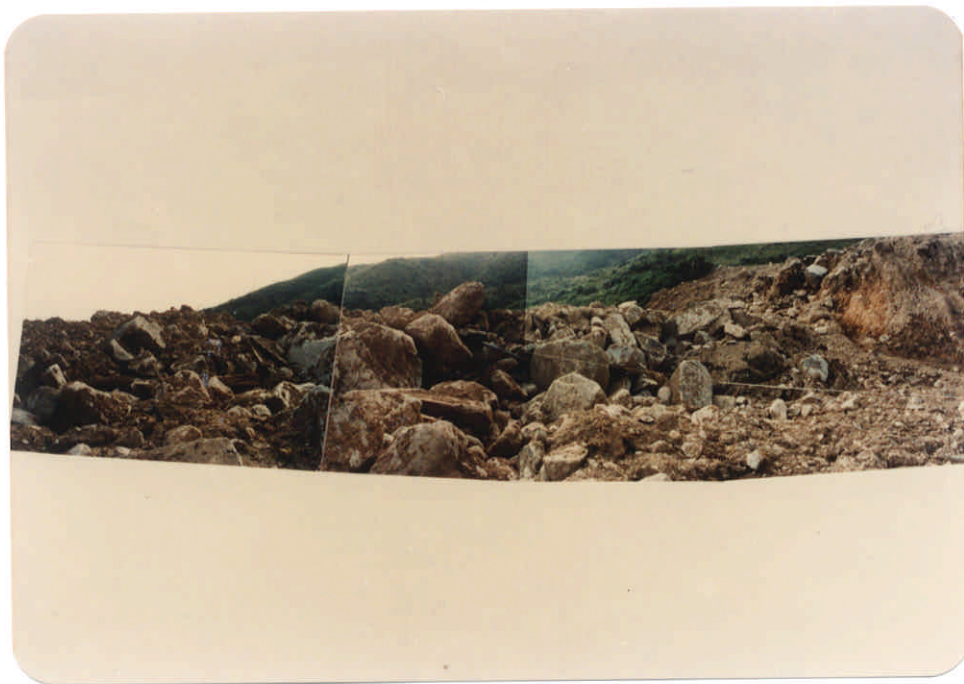
Plate 19 & 20 - Above Area 19, off Lung Mun Road, Tuen Mun  
(Incident MW 90/9/5)

(Date : 11 September, 1990. Failure of a natural slope affecting a stocking piling area below, Plates 19 and 20.)

This is among the biggest landslides in natural slopes in the history of Hong Kong (Plate 19). The length of the landslide was 1,025 m in plan. The main scarp was up to 10 m wide and the debris fan was 120 m at its widest. The depth of the landslide varied and the maximum was about 5 m. The quantity of materials involved was of the order of 22,000 m<sup>3</sup>. Gradient of the natural slope before the failure varied from about 40° at the crown of the landslide to a gentle 10° at the toe. The depleted material was mostly bouldery colluvium (Plate 20). Some insitu weathered granite and mata-andesite was also involved. The landslide developed into a debris flow spreading a large debris fan into a stockpiling area below. Chan et al (1991) had compiled a factual report on the landslide.

**Description :** Failure of a natural slope on 11 September, 1990 (about 22,000 m<sup>3</sup>) affecting a stock piling area below. A bouldery colluvium debris is shown in Plate 20

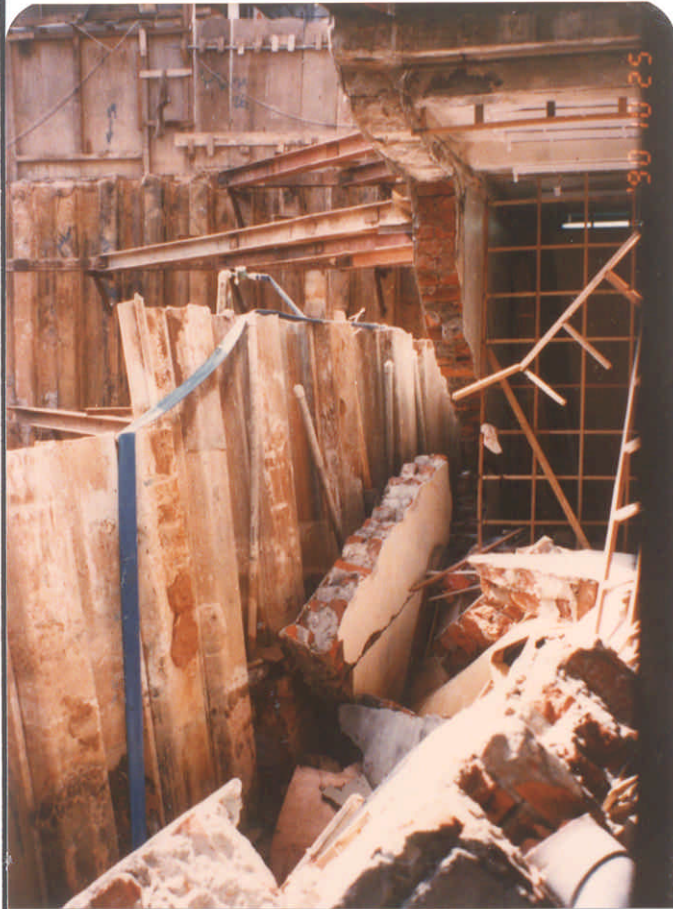
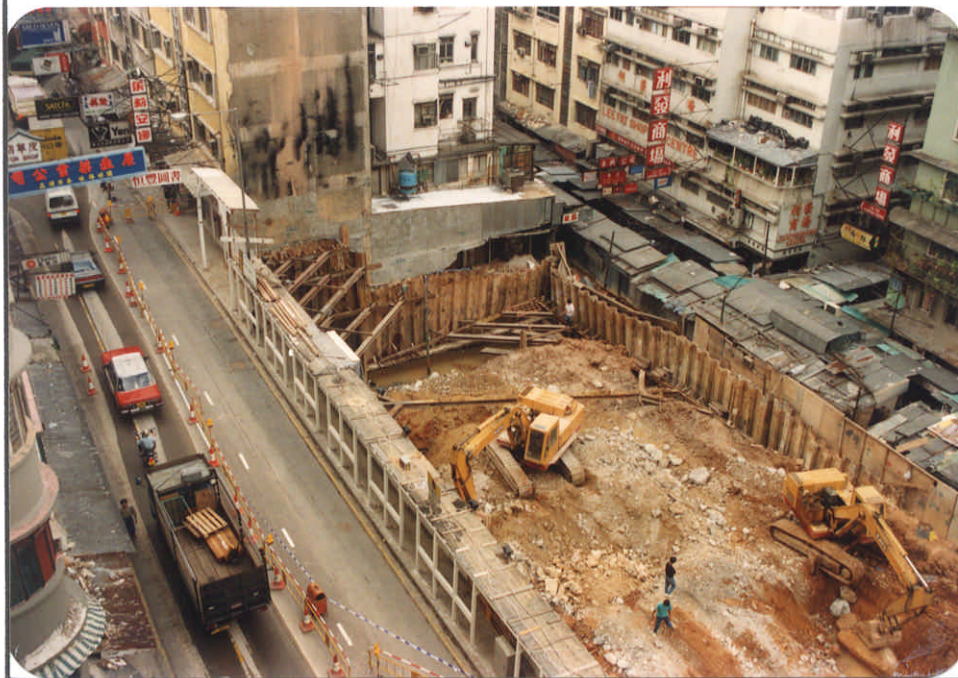
Plate 21 & 22 - Nos. 40-42 Yun Ping Road & Nos. 17-19 Jardine's Crescent  
(Incident HK 90/10/1)

(Date : 24 October, 1990. Failure of a basement excavation affecting building and road, Plates 21 and 22.)

Basement excavation in Nos. 2 - 38 Yun Ping Road was down to 4 m below ground level when failure occurred. The sheet pile wall supporting the excavation deformed excessively (Plate 21). A 100 mm diameter water main along Jardine's Crescent ruptured. The party wall of an adjacent building fell down (Plate 22). A cavity was formed on Jardine's Crescent. Two adjacent buildings were temporarily evacuated.

**Description :** Failure of a basement excavation on 24 October affecting building and road.

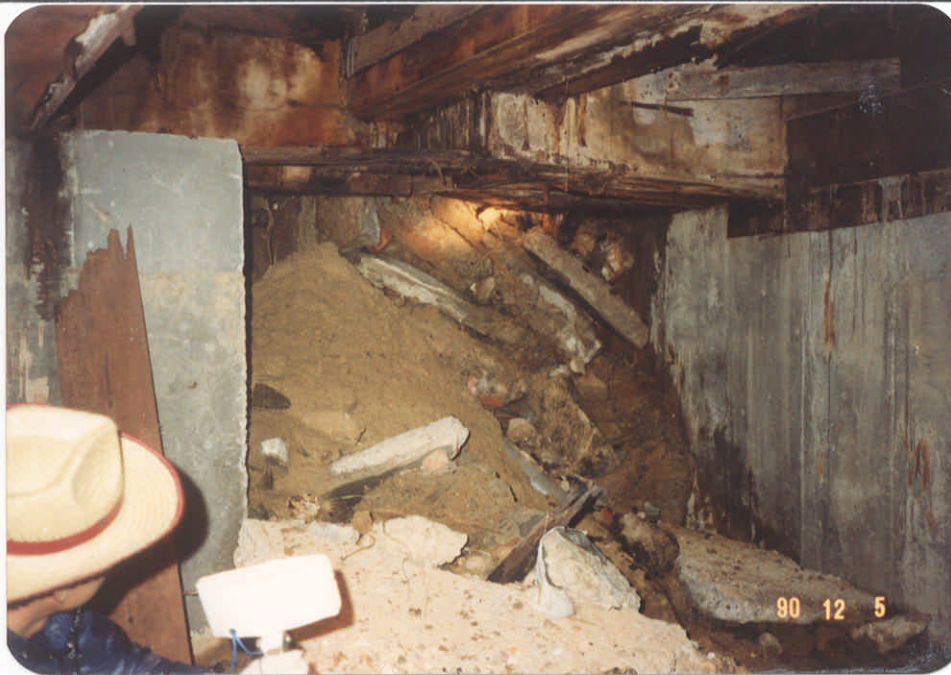
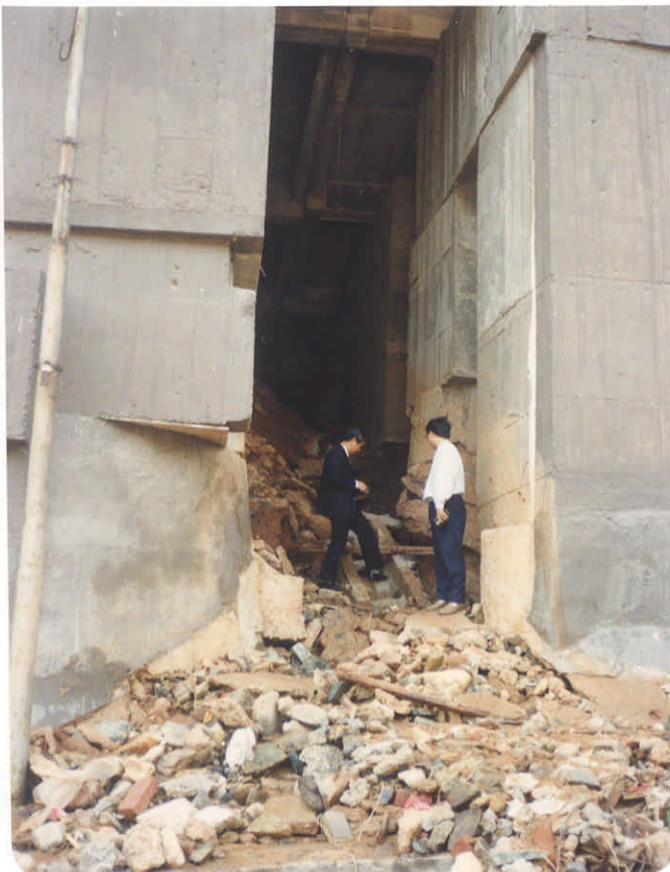
23 & 24	Kwe Yang House, Tsuen Wan Centre, No. 9, Tsuen King Circuit, Tsuen Wan (Incident MW 90/12/1)	50

(Date : 30 November, 1990. Failure of a fill slope beneath a building affecting pedestrian pavements at Tsuen King Circuit and beneath, Plates 23 and 24)

The fill slope is located beneath Tsuen Wan Centre which is a multistorey building. Some of the building caissons passed through the fill slope. Rupture of three water mains (one 200 mm and two 100 mm in diameter) at the crest of the fill slope caused failure of the slope between two groups of caissons. The failure was about 3.5 m in width and 2.5 m in depth. The side faces of the caps of the caisson groups were exposed at some locations. The failure debris moved onto a pavement below (Plate 23) and then spilled over to a nullah. Steep soil faces were formed at isolated locations in the fill (Plate 24). An advisory letter was issued to the owners of the building advising them to reinstate the failed portion of the fill slope.

**Description:** Failure of a fill slope beneath a building block on 20 November, 1990 blocking a pedestrian pavement and a nullah below the building block.
