# **HONG KONG RAINFALL AND LANDSLIDES IN 1991**

**GEO REPORT No. 20**

**N. C. Evans**

**GEOTECHNICAL ENGINEERING OFFICE  
CIVIL ENGINEERING DEPARTMENT  
HONG KONG**

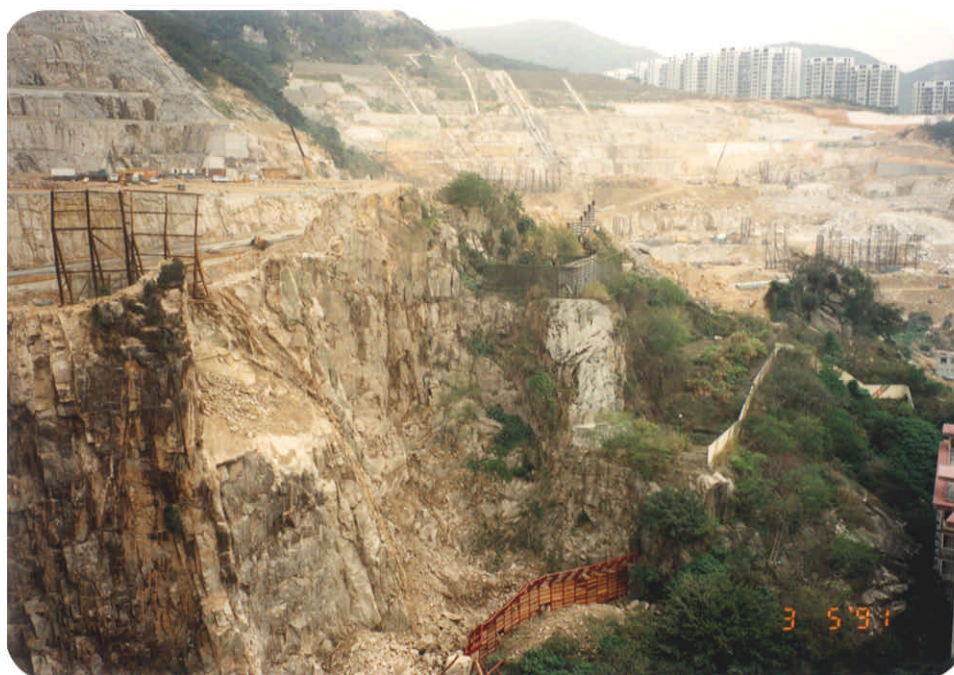
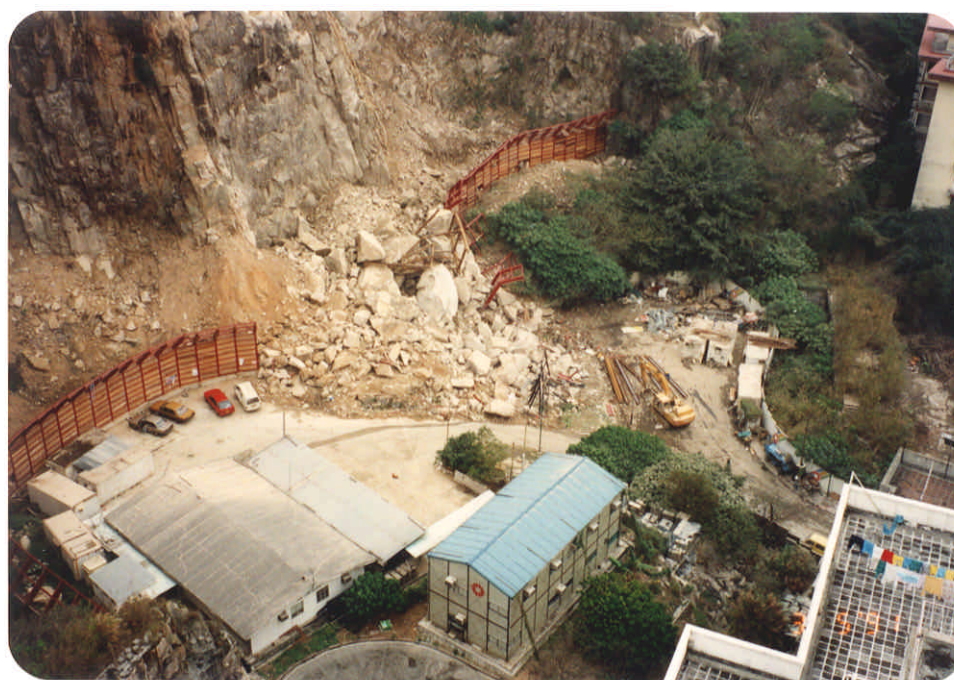
Plates 1 & 2 - Shau Kei Wan East Housing Development Site (Incident HK 2/2)

(Date: 28 February 1991. Major failure of a disused rock quarry face overlooking Hoi Ching Street, Plates 1 and 2.)

The landslide occurred at the crest of a 50 m high disused quarry face. Approximately 2,000 cu m of rock was dislodged and fell onto Housing Department Works Area 3CY situated in the base of the quarry. Six container offices and four vehicles were damaged and one man was slightly injured by a rebounding rock fragment. At the time of the failure blasting was taking place at the crest of the quarry as part of the site preparation works for the Shau Kei Wan East Housing Development Site, and the landslide is reported to have occurred within one minute of a blast that was situated within 3 m of the failure plane. GEO Report SPR 5/91 (Evans and Irfan, 1991) describes this landslide in detail and concludes that the failure was a planar slide on an unfavourably oriented discontinuity and was triggered by the blasting at the quarry crest. Rainfall was not a factor in this landslide.

Description : Major failure of a disused rock quarry face overlooking Hoi Ching Street on 28 February 1991 (about 2,000 cu m).

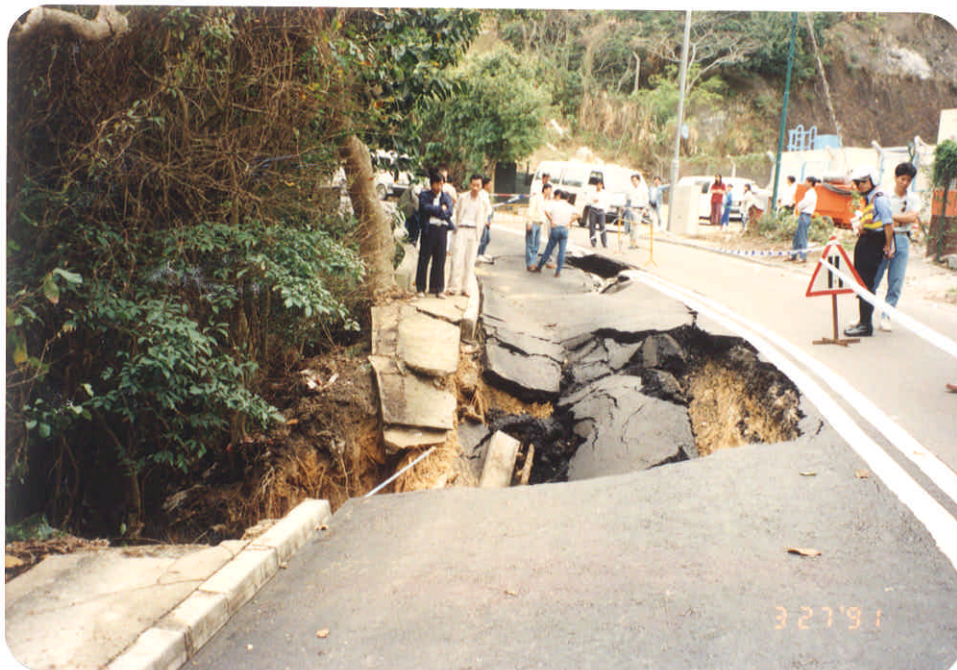
Plate 3 - Stanley Gap Road (Incident HK 3/2)

(Date: 27 March 1991. Major failure of a fill slope resulting in road blockage, Plate 3.)

The rupture of a water main in a fill slope caused a major failure involving approximately 150 cu m of silt and rock fill. An 8 m by 3 m section of Stanley Gap Road at the crest of the slope collapsed, while a further section of road about 6 m by 3 m subsided. At the toe of the failure, the playground of a residential building was affected. Rainfall was not

Description : Major failure of a fill slope on 27 March 1991 blocking both road lanes (about 150 cu m).

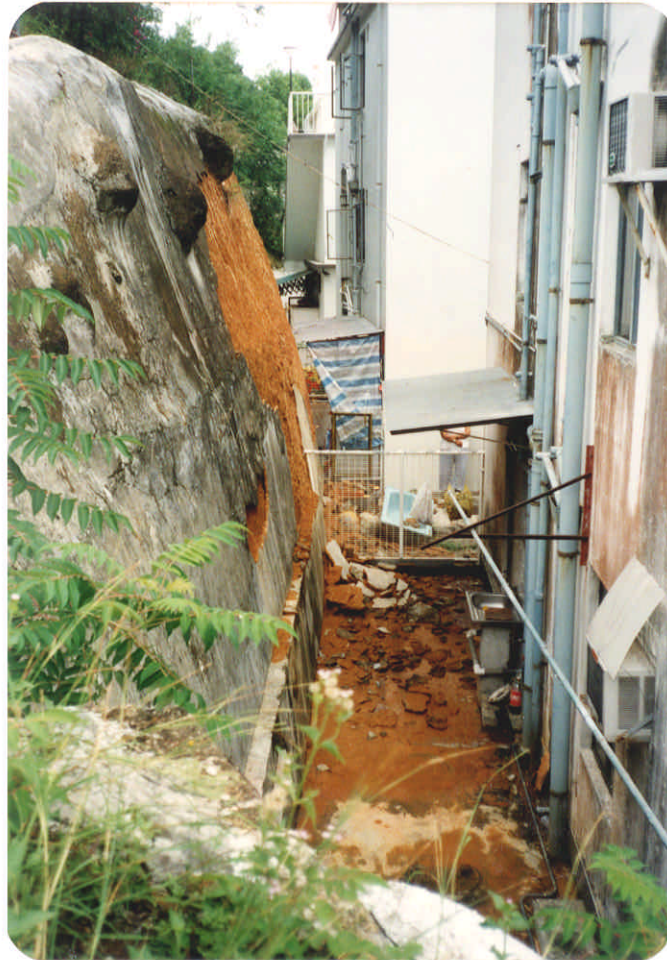
Plate 4 - No. 14 Yung Shue Long New Village, Lamma Island (Incident MW 6/6)

Description : Failure of chunam on a soil cut slope on 8 June 1991.

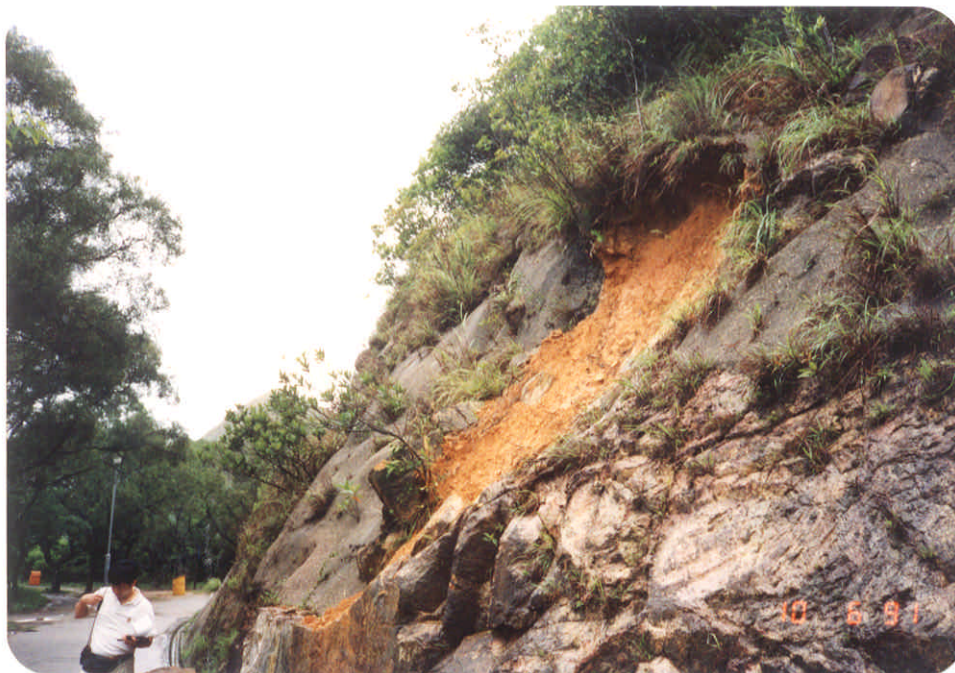
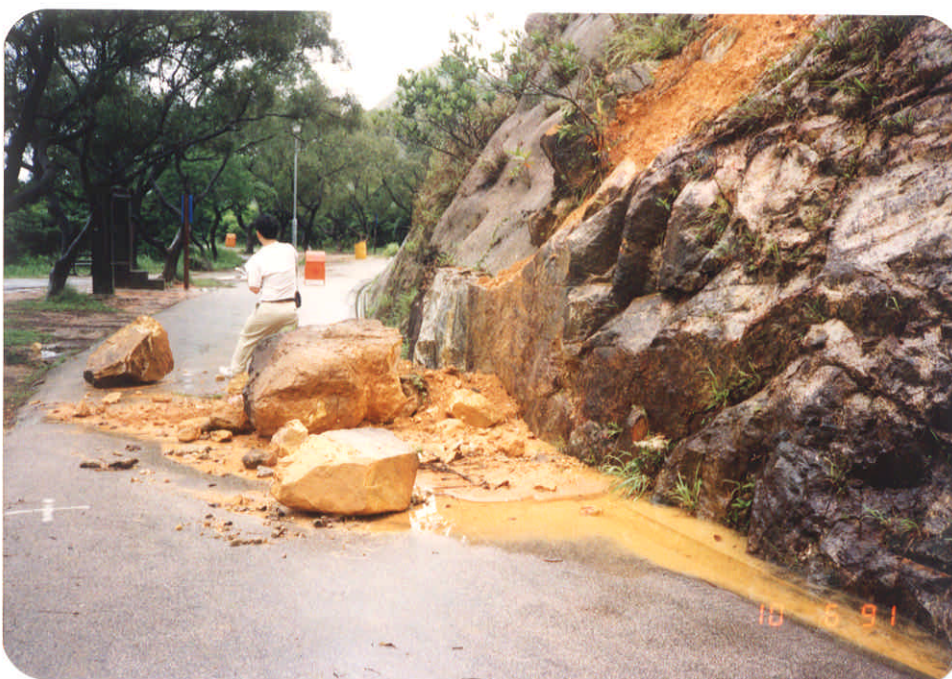
Plates 5 & 6 - Harlech Road, Victoria Gap (Incident HK 6/3)

(Date: 9 June 1991. Failure of a rock cut slope resulting in the blockage of one lane of the road, Plates 5 and 6.)

Failure of a rock cut slope during rain led to approximately 1.5 cu m of weathered rock collapsing onto Harlech Road, blocking one lane. The failure was probably caused by the erosion of weathered unfavourably oriented rock joints.

Description : Failure of a rock cut slope on 9 June 1991, blocking one road lane.

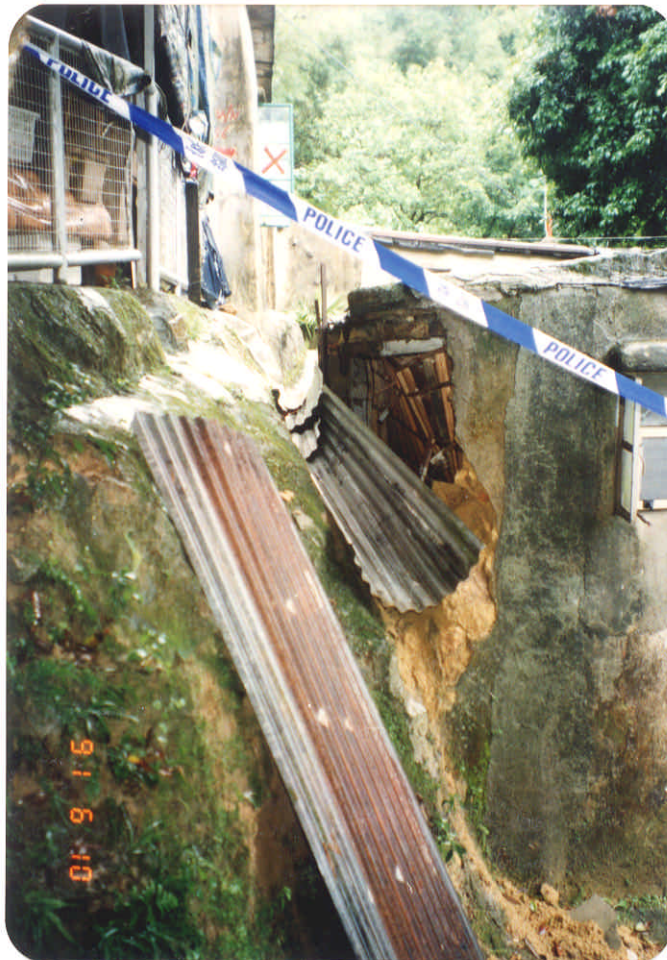
Plate 7 - Ling Nam San Tsuen, Kwun Tong, hut RKT/12A/W/243 (Incident K 6/1)

Description : Failure of a soil cut slope on 9 June 1991 leading to the permanent evacuation of two squatter huts.

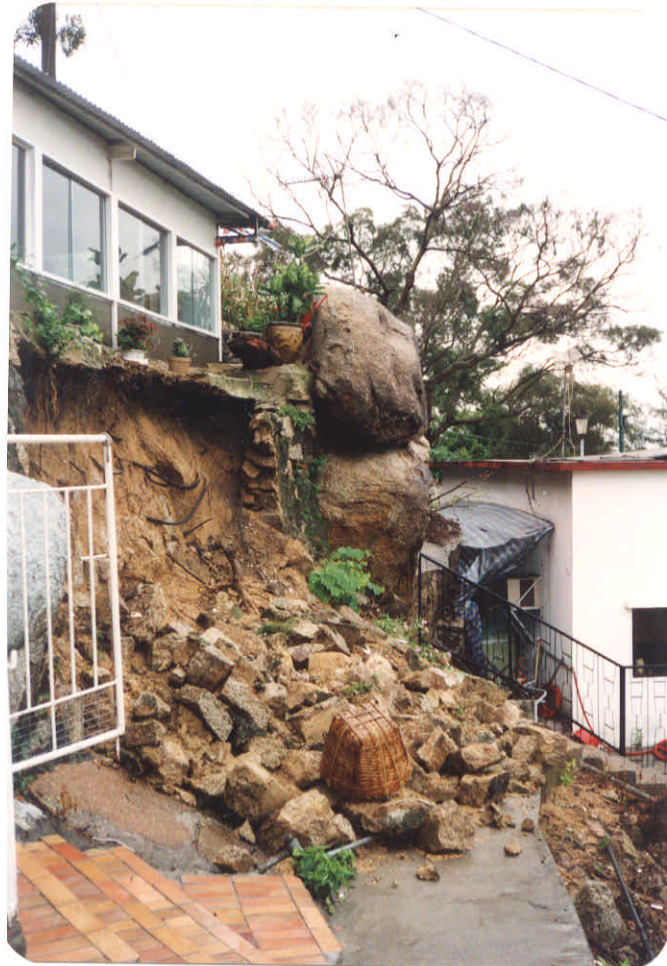
Plate 8 - No. 16, Ka Loon Tsuen, MS 14½ Castle Peak Road (Incident MW 6/3)

Description : Failure of a masonry retaining wall on 10 June 1991, affecting squatter huts and a public footpath.

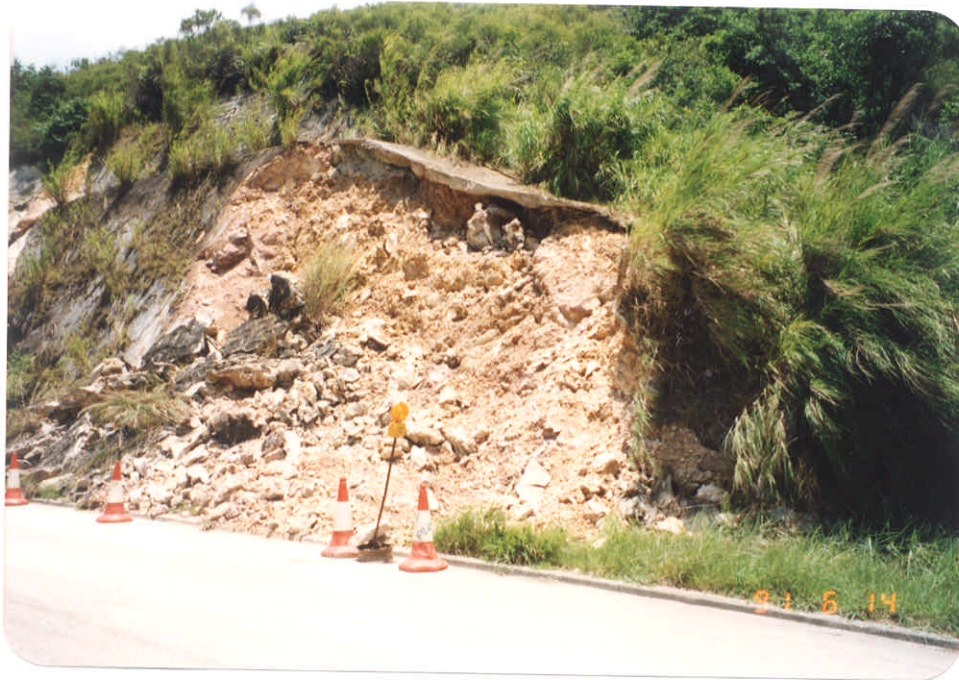
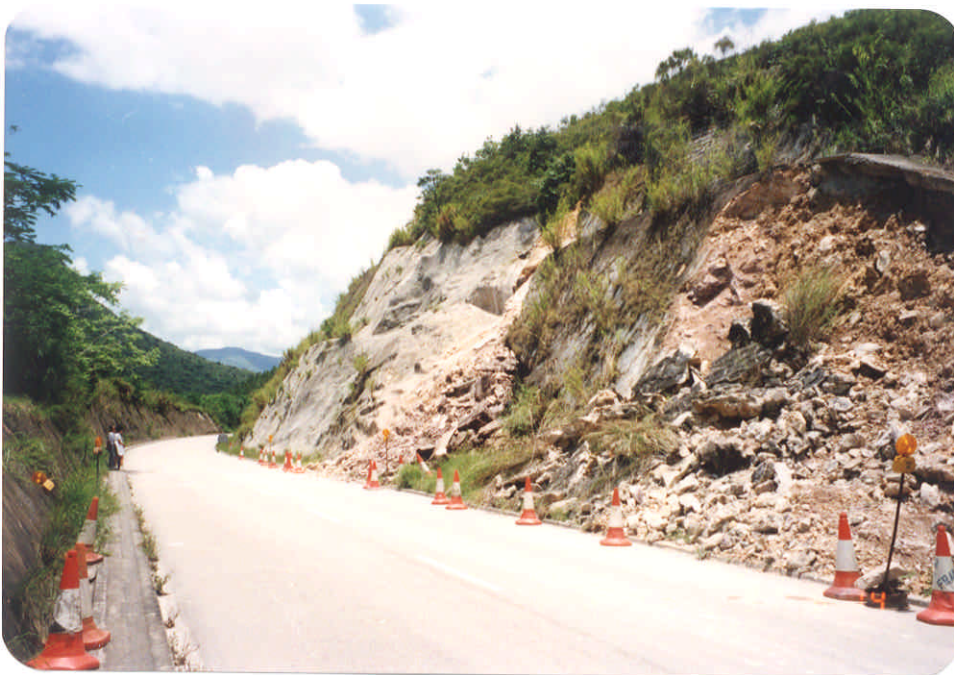
Plates 9 & 10 - Bride's Pool Road, North District, the New Territories  
(Incident ME 6/1)

(Date: 12 June 1991. Major failure of a soil and rock cut slope, Plates 9 and 10.)

Erosion and infiltration caused a major failure (approximately 70 cu m) in a soil and rock cut slope. A pedestrian pavement and a rural road were affected.

Description : Major failure of a soil and rock cut slope on 12 June 1991 affecting a rural road.

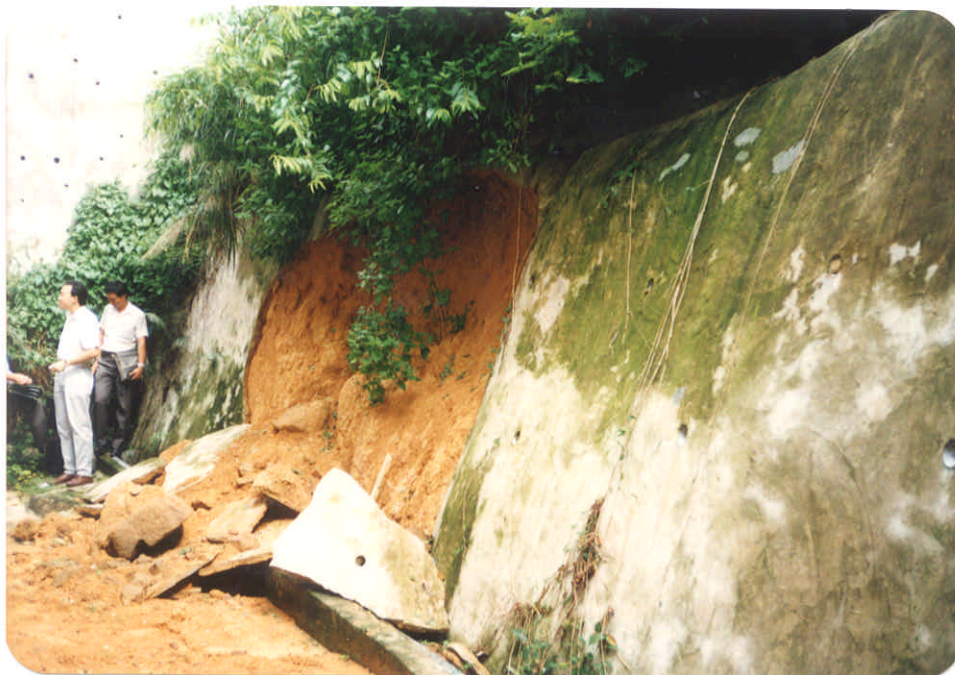
Plate 11 - 72 Po Wah Yuen, Lamma Island (Incident MW 6/10)

Description : Failure of a soil cut slope on 20 June 1991 resulting in the partial blockage of a back lane.

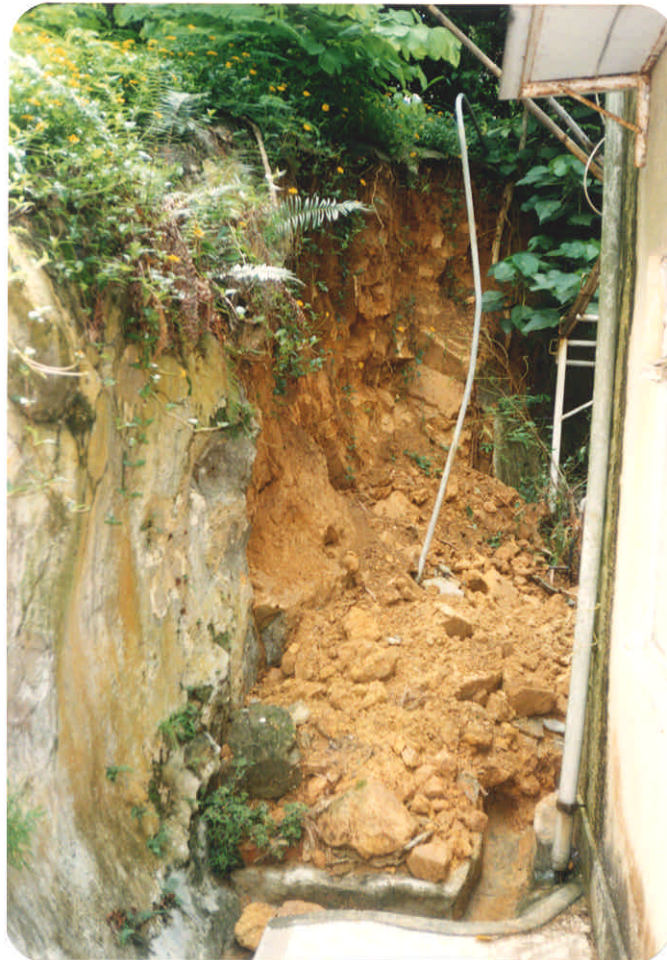
Plate 12 - 84A Tai Peng New Village, Lamma Island (Incident MW 6/11)

Description : Failure of a soil and rock cut slope on 20 June 1991 resulting in the blockage of a back lane.

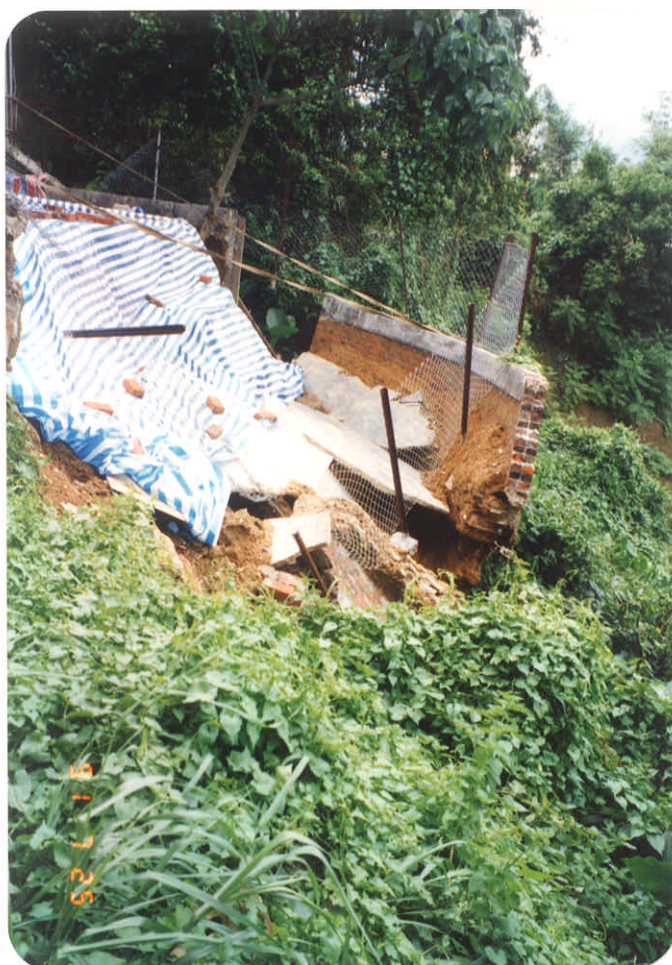
Plate 13 - No. 143, Ha Wo Che Village, Shatin (Incident ME 7/1)

(Date: 23 July 1991. Failure of a retaining wall and loose fill, Plate 13.)

Infiltration during heavy rain associated with Typhoon Brendan led to the failure of a brick retaining wall, concrete paving and associated loose backfill. Typhoon Signal No 8 was hoisted at the time. Approximately 20 cu m of material was involved and the retaining wall was displaced about 1 m downslope and was left overhanging a steep slope. A closure order was subsequently placed on parts of two village houses at the toe of the slope while emergency works were carried out under BO Section 27 A(4).

Description : Failure of a retaining wall on 23 July 1991 resulting in the temporary evacuation of two village houses.

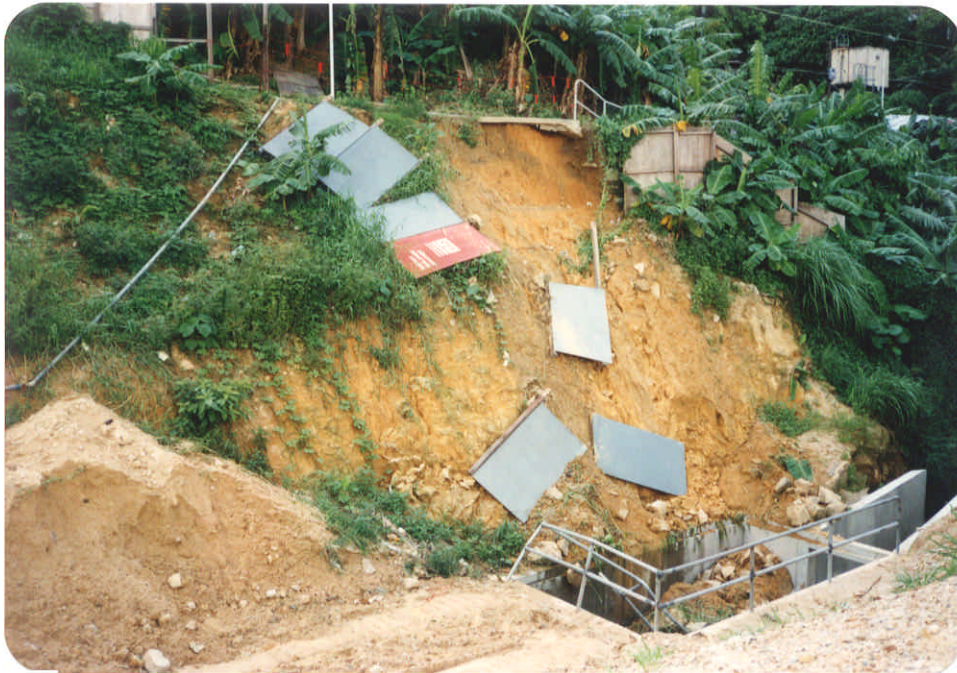
Plate 14 - Shek Li Street, Kwai Chung (Incident MW 7/4)

Description : Failure of a soil cut slope (date unknown) resulting in the closure of a pedestrian pavement.

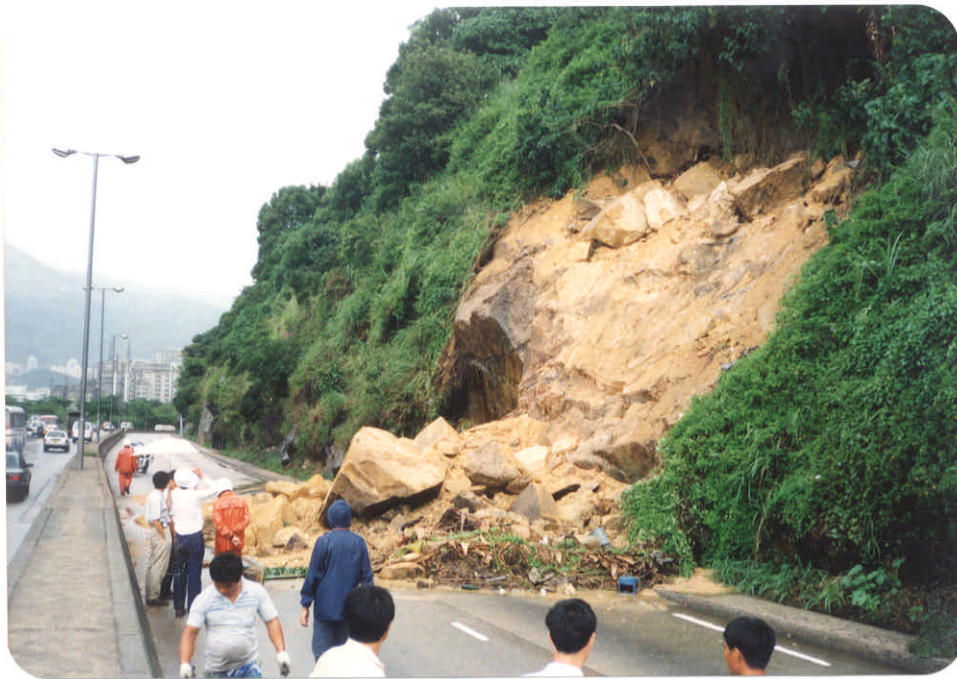
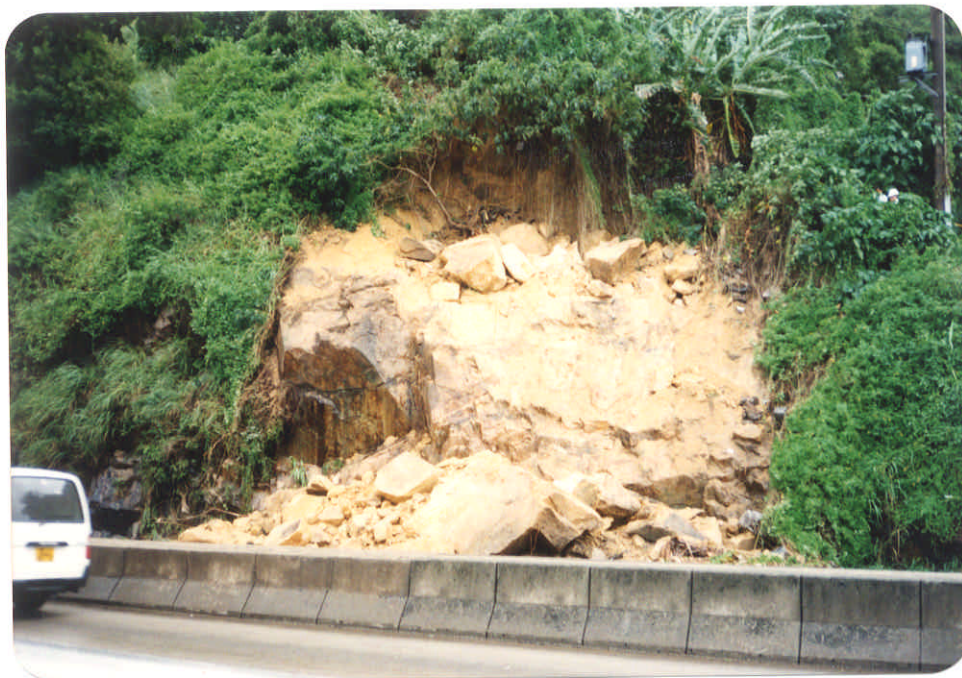
Plates 15 & 16 - MS 6, Castle Peak Road (Incident MW 8/3)

(Date: 15 August 1991. Failure of a soil and rock cut slope, resulting in the blockage and closure of Castle Peak Road, Plates 15 and 16.)

Infiltration during heavy rain associated with Typhoon Fred, and subsequent seepage, caused curvi-linear/planar failure of a rock cut slope comprising granite with moderately to highly decomposed joints. The cut slope adjoining Castle Peak Road here is about 15 m high with a slope greater than 70° and with a thin capping of residual soil. The failure involved approximately 30 cu m of soil and rock which collapsed onto Castle Peak Road,

blocking two lanes and the adjoining footpath. In addition, the failure crest came within one metre of an electricity power pole. A boulder estimated to weigh over 5 tonnes was left overhanging the upper part of the slip.

Description : Failure of a soil and rock cut slope on 15 August 1991 resulting in the blockage of two road lanes.

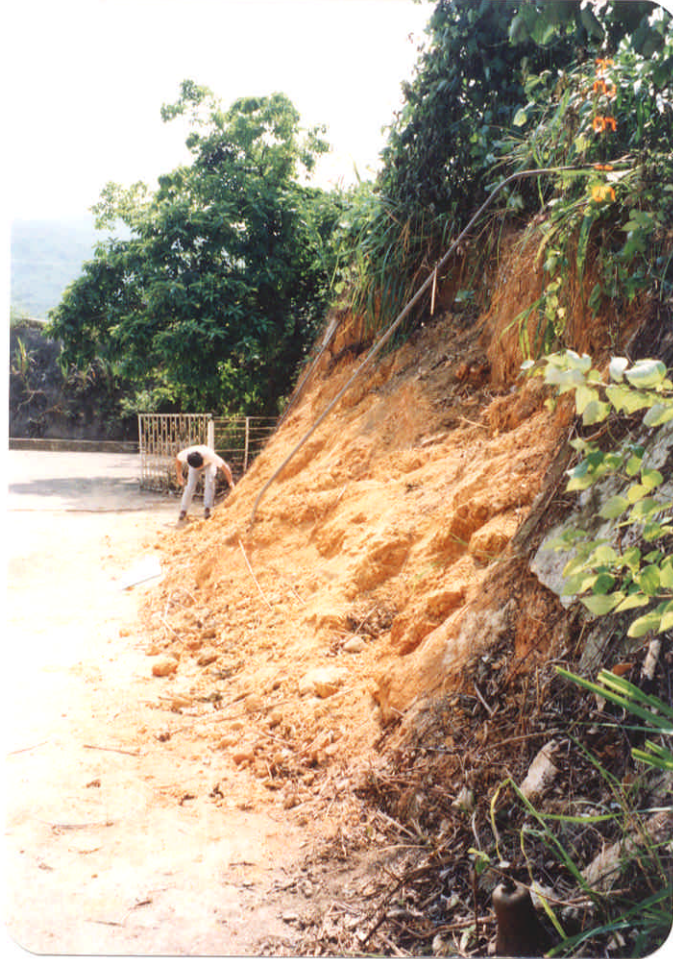
Plate 17 - Slope in front of Lot 161, Sheung Sze Wan (Incident ME 9/1)

Description : Failure of a soil cut slope on 15 September 1991 affecting an access road.

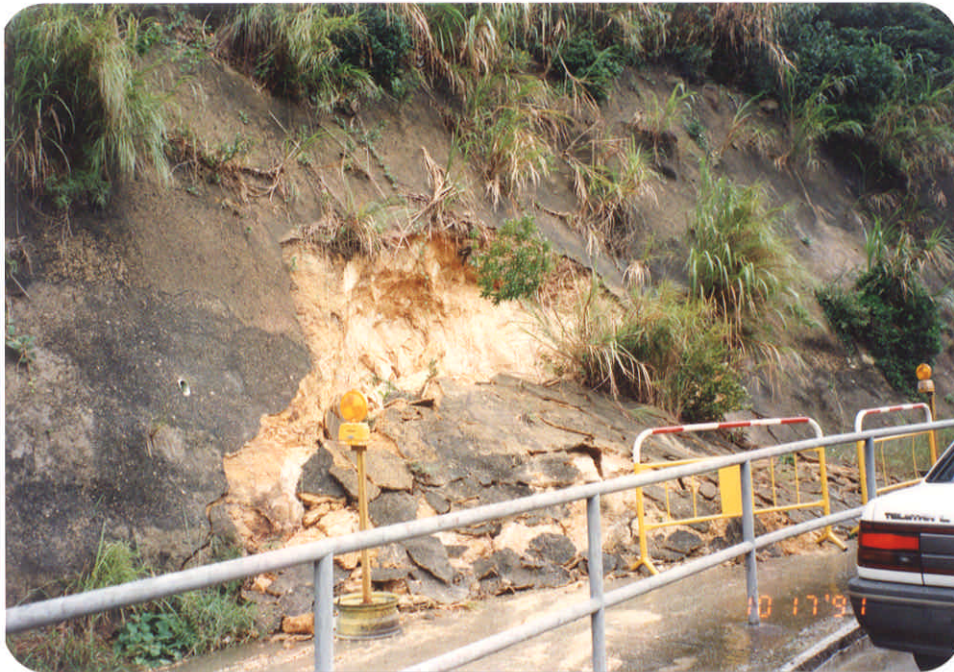
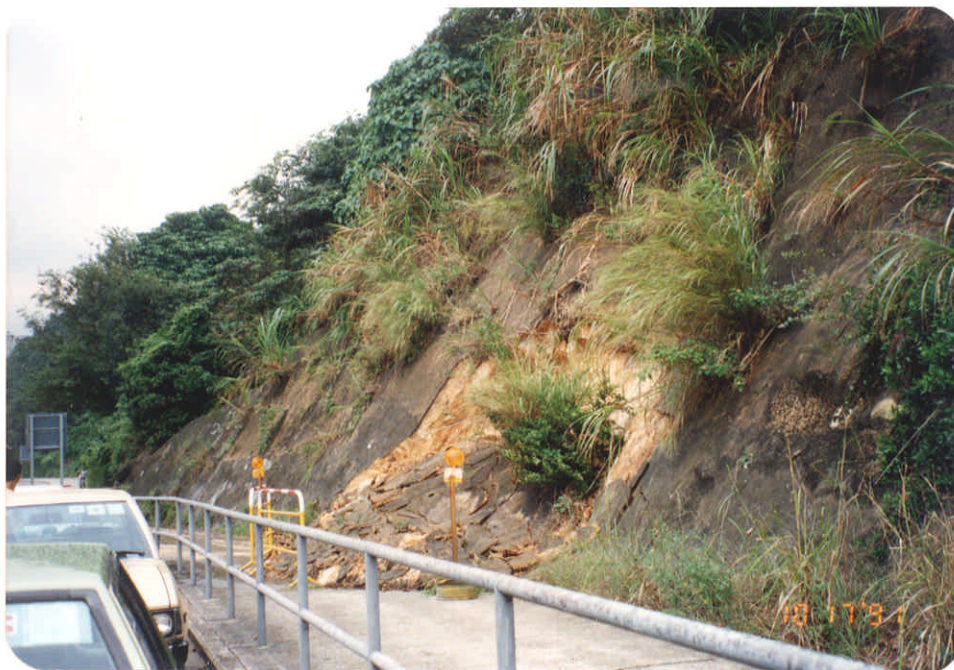
Plates 18 & 19 - Chai Wan Road, Shau Kei Wan (Incident HK 10/5)

(Date: unknown. Failure of a soil cut slope, blocking a pedestrian pavement, Plates 18 and 19.)

Approximately 10 cu m of highly to completely weathered granite failed and blocked the pedestrian pavement. Seepage of water was observed from a natural pipehole in the upper part of the slip scar. It is probable that the failure was induced by groundwater movement.

Description : Failure of a soil cut slope (date unknown) blocking a pedestrian pavement.

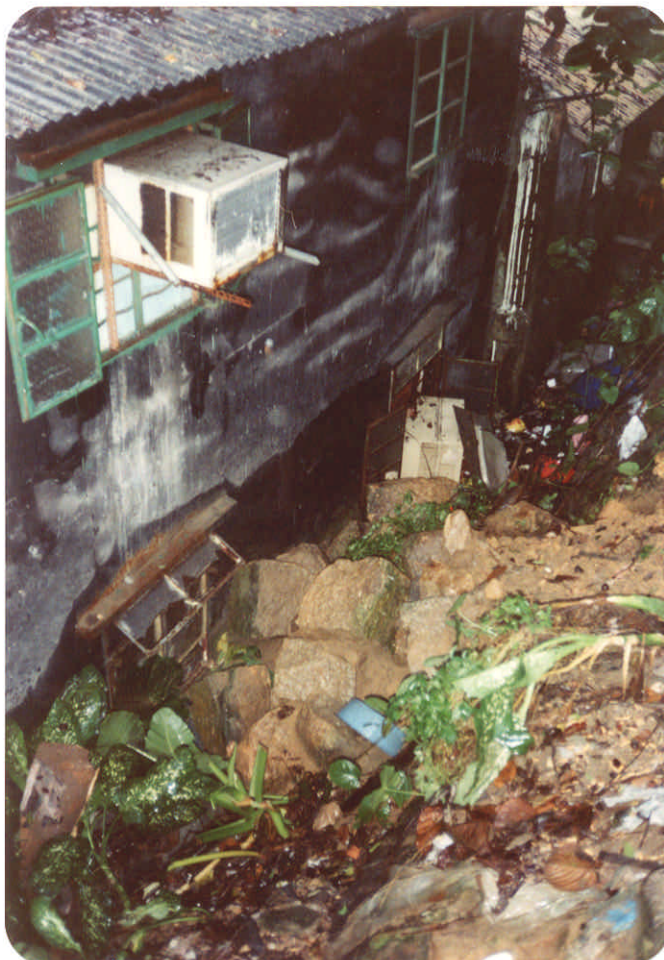
Plate 20 - House 1A, Lei Uk Tsuen, Shatin (Incident MW 10/3)

(Date: 15 October 1991. Failure of a masonry rubble retaining wall, affecting squatters, Plate 20.)

Infiltration of rainwater caused the failure of a 1.5 m length of a 3.5 m high by 7.5 m long masonry rubble retaining wall and associated loose soil backfill. The failure involved about 3 cu m of material which collapsed into the back lane of two huts, which were temporarily evacuated as inspection showed that the remaining parts of the wall were also showing signs of distress.

Description : Failure of a masonry retaining wall on 15 October 1991 resulting in the temporary evacuation of two huts.

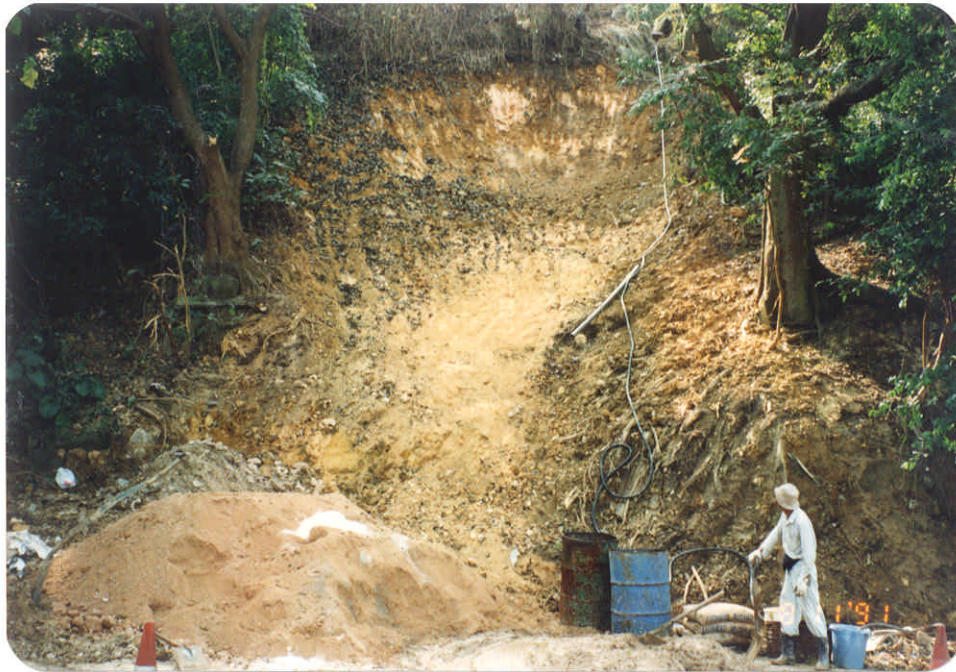
Nine natural slope failures were reported, forming 10% of all incidents. None of these failures were major. Plate 21 (Incident HK 10/12) shows a failure of this type.

Description : Failure of a natural slope on 28 October 1991, affecting a pedestrian pavement.
