REPORT ON THE RAINSTORM OF AUGUST 1982

GEO REPORT No. 26

**GEOTECHNICAL ENGINEERING OFFICE
CIVIL ENGINEERING DEPARTMENT
HONG KONG**

This report was produced in 1982 as a permanent record of the effects of the rainstorms that occurred in the period of 15th to 19th of August 1982 with particular emphasis on the location, type and size of the more serious landslide incidents. It is a factual report and, apart from acknowledging that the landslides were caused by intense rainfall, does not attempt to explain the mechanisms and causes of failure.

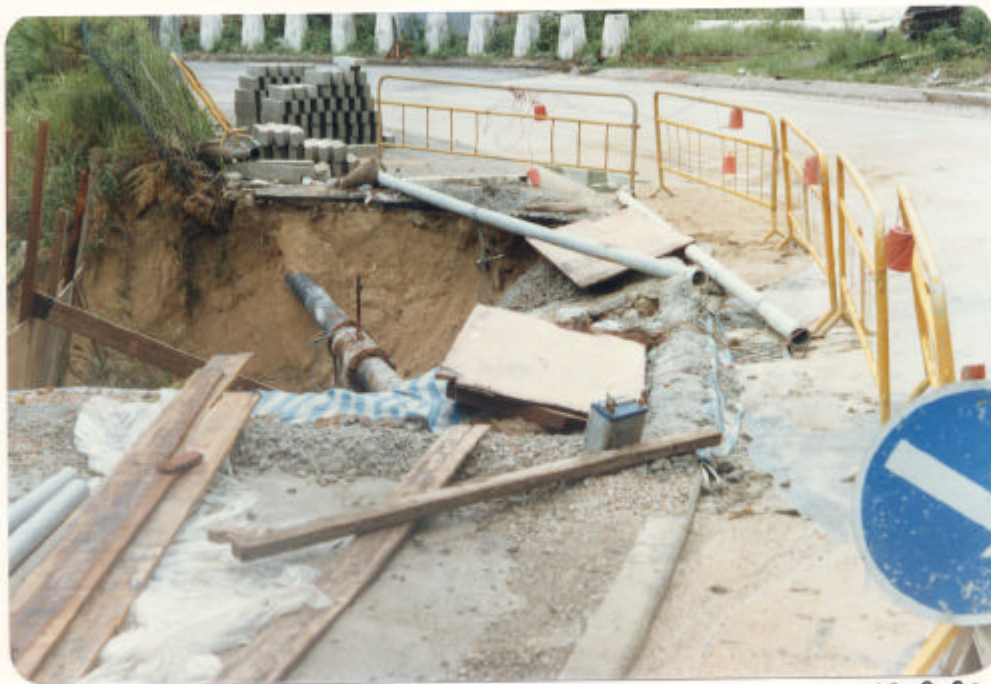
Plate 1 illustrates this type of erosion or washout feature. In this case, surface water collected on the road overtopped the kerb and initiated the 'failure' of the slope below.

Plate 1 : Deep Water Bay Road : Minor failure of a
(Incident No. HK/8/28) fill slope

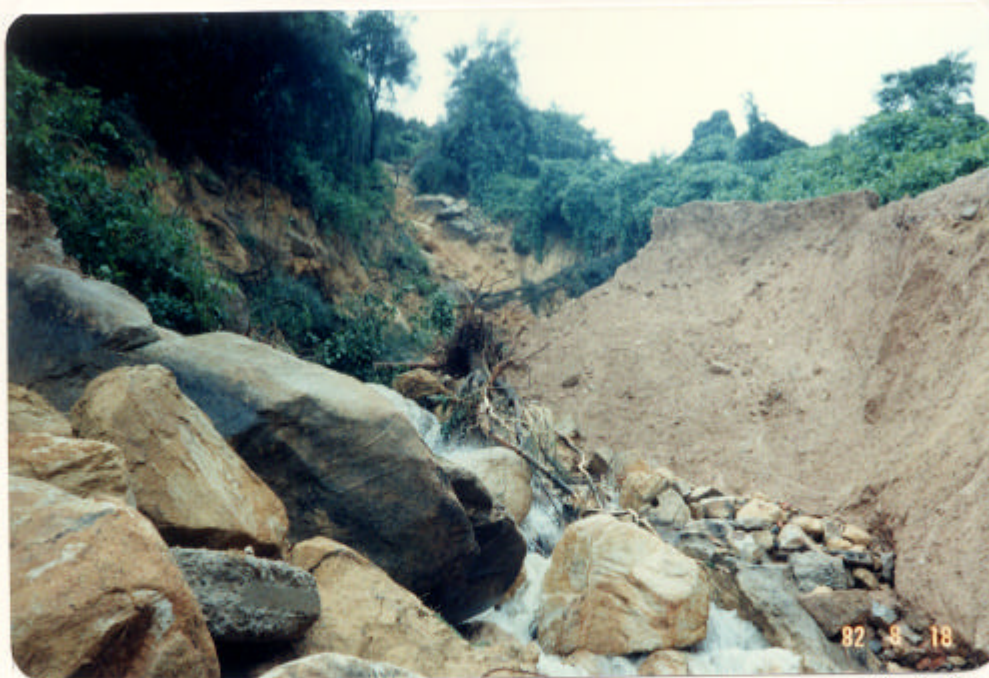
Plate 2 : Mount Butler Quarry : Major failure of a
(Incident No. HK/8/23) fill slope

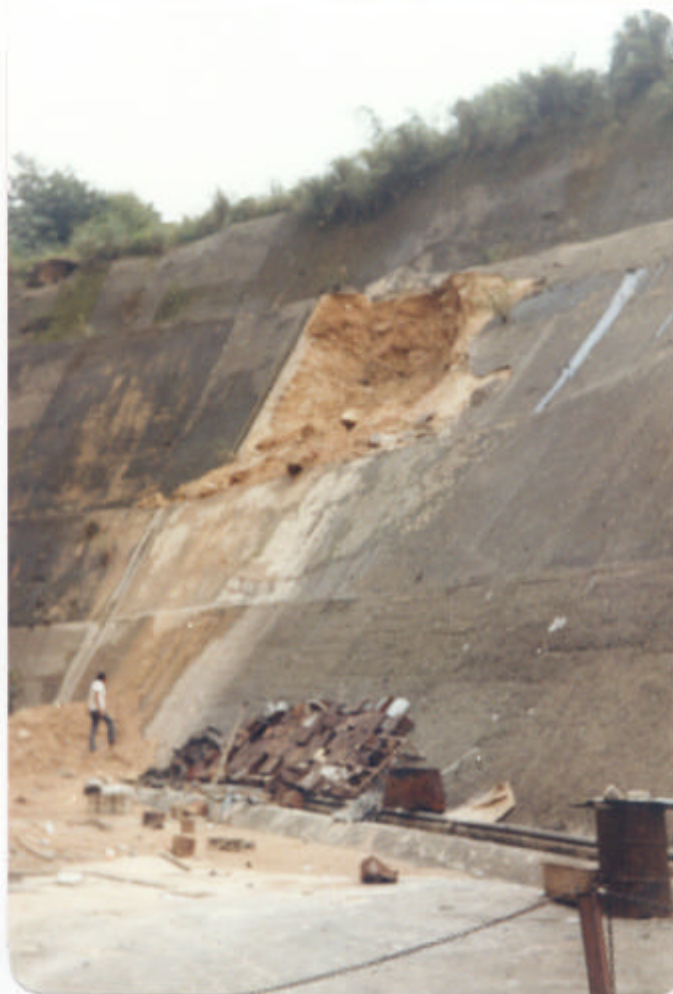
Plate 3 : Kung Yip Street, Kwai Chung
(Incident No. NT/8/47)

The upper to middle section of a 22 m high chunammed cut slope in decomposed granite failed on 16th August. Failure occurred over a height of approximately 7 m of grade IV/V decomposed granite, standing at 45° to 50°. The cause of the failure was a rise in the groundwater table as a result of the heavy rain. Many of the weepholes through the chunam cover were blocked by

vegetation. There was a patch of no fines concrete beneath the zone where the failure took place, suggesting that minor minor movement had occurred before. The debris from the failure fell into an open space behind a factory building. There was no damage to the building.

: Minor failure of a soil
cut slope (7SW-C/C208)

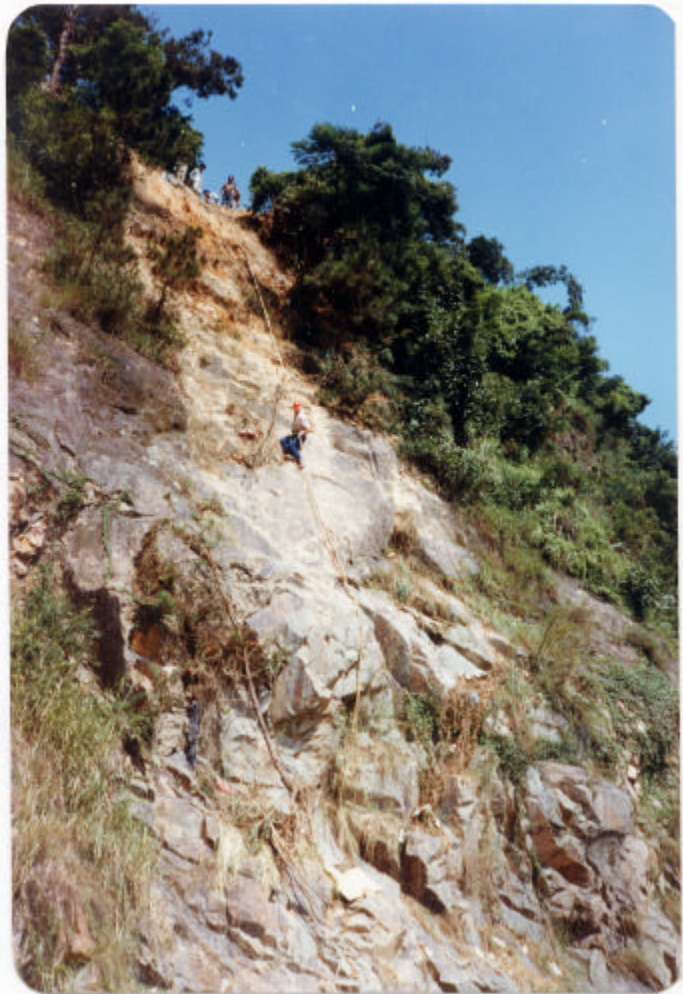
Plate 5 : 5 $\frac{3}{4}$ MS Castle Peak Road
(Incident No. NT/8/24)

Plate 5 shows a typical soil/rock cut slope. In this case, the soil part of the slope failed and the debris blocked one lane of Castle Peak Road.

: Major failure of a soil/
rock cut slope
(11NW-A/C62)

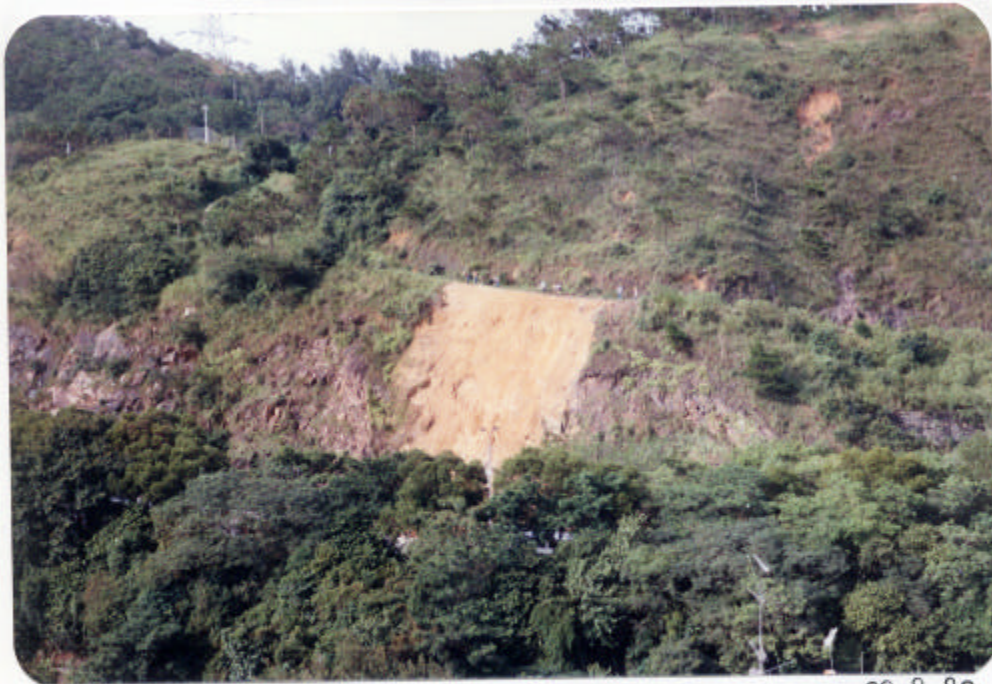
Plate 6 is a distant view of the top part of the failed slope, with Castle Peak Road hidden by the trees below. The original cut slope was approximately 25 m high, with the bottom 8 m at 85° and the upper part at 60°. The near-vertical base of the slope is formed in slightly to moderately decomposed granite, with the upper part in grade IV material. There is about 2 m of grade V material at the slope crest. Failure occurred on a distinct joint plane dipping out of the face at approximately 55°. Because the rock face at the toe was so steep, the failure debris slid completely off the slope and covered both Kowloon bound lanes of Castle Peak Road. Infiltration of water through the footpath above the

slope is thought to have been the main cause of failure. The inside lane of the Kowloon bound carriageway was closed for nine weeks while remedial works were carried out.

Plate 6 : 5 $\frac{1}{2}$ MS Castle Peak Road : Major failure of a soil/rock
(Incident No. NT/8/23) cut slope (11NW-A/C63)

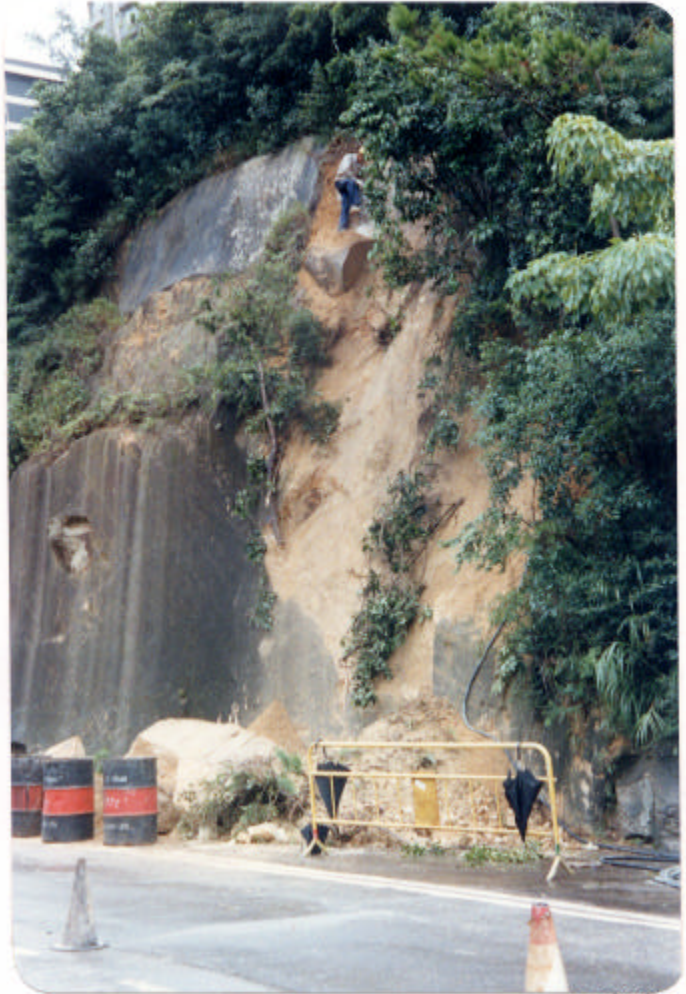
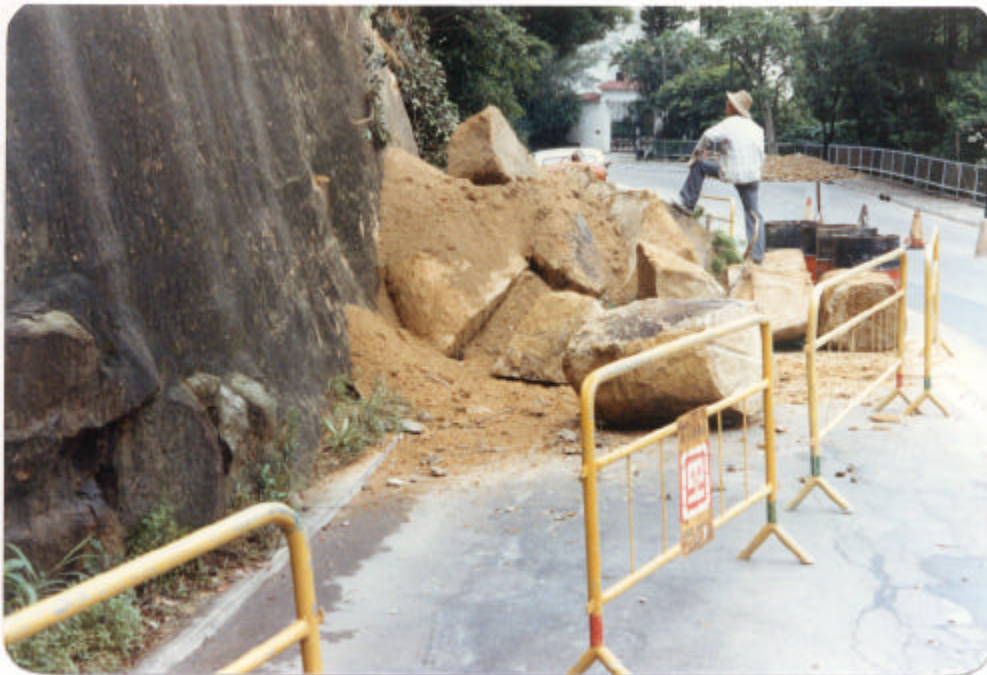
Plates : Repulse Bay Road
7 and 8 (Incident No. HK/8/27)

An irregular failure occurred in the upper 7 m of a 60°, 10 m high slope, cut into Hong Kong granite of variable weathering profile. Several large corestones of rock embedded in the soil matrix at the slope crest were broken out by the failure and fell onto the road below. No seepage was observed during the various site inspections, and it appears that failure was initiated by water infiltrating into the slope crest. One lane of Repulse Bay Road was closed for three days to allow the clearance of debris and the removal of a number of other corestones that had been undermined by the failure.

: Minor failure of a
soil/rock cut slope

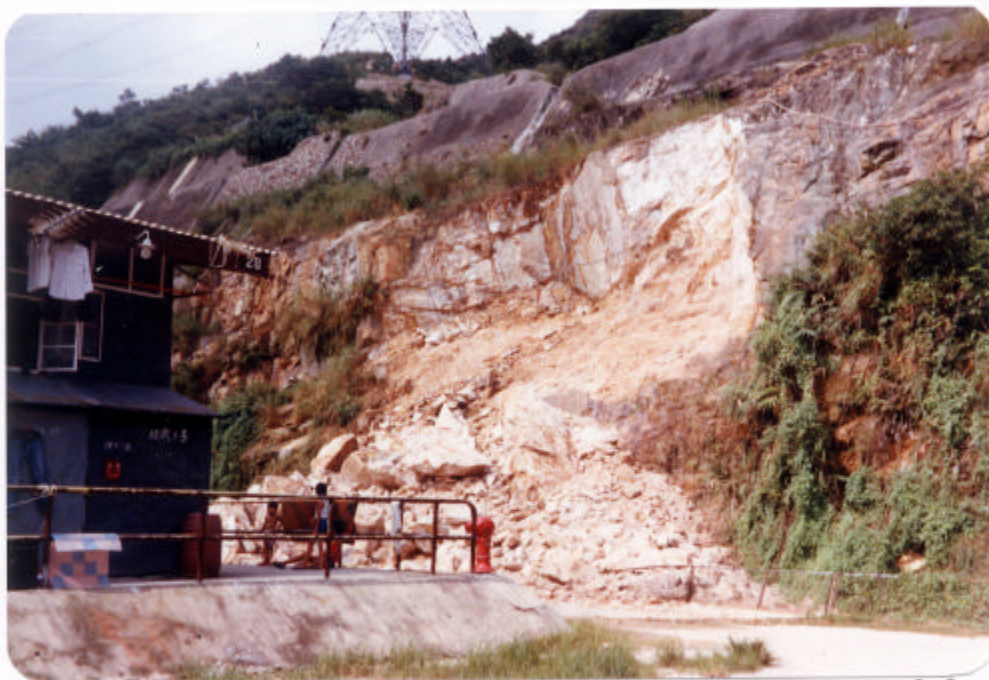
Plate 9 shows a typical rock cut slope. In this case, failure occurred on one dominant plane and the debris partially blocked the access road to the Shek Yam Temporary Housing Area.

Plate 9 : Shek Yam Temporary Housing Area : Major failure of a
(Incident No. NT/8/69) rock cut slope
(7SW-C/C153)

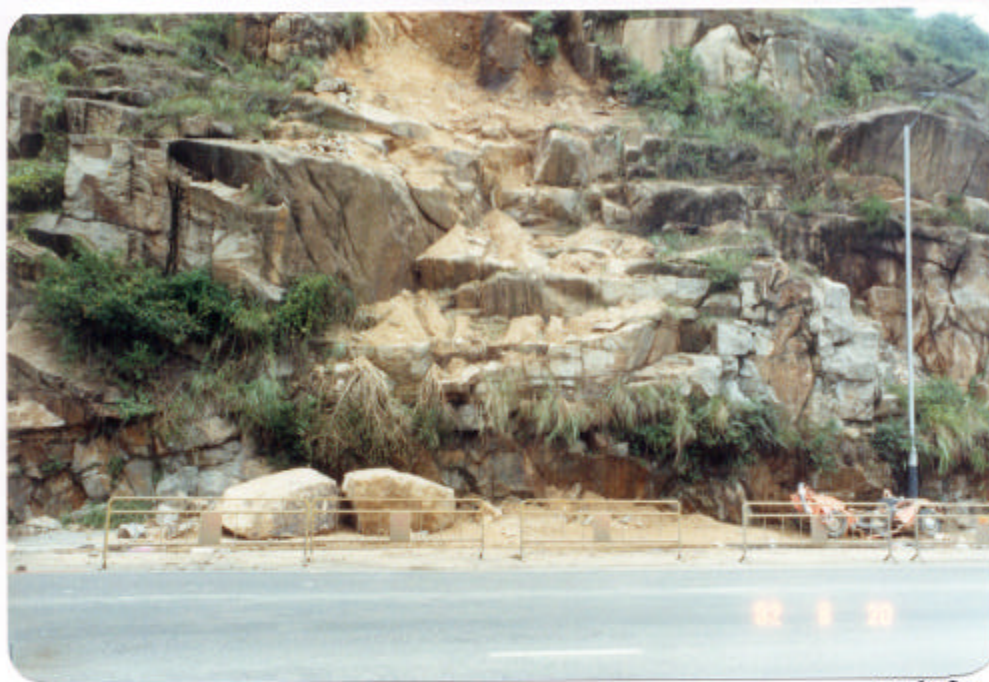
The failure involved the sliding of large blocks of granite rock on relatively shallow, 30° to 40°, joint planes with sub-vertical backing joints providing the release surface. The debris, which was substantially large blocks up to 4 m³, blocked one and a half lanes of the Kowloon bound carriageway of Kwai Chung Road.

Plate 10 : Kwai Chung Road : Major failure of a rock
(Incident No. NT/8/26) cut slope (11NW-A/C79)

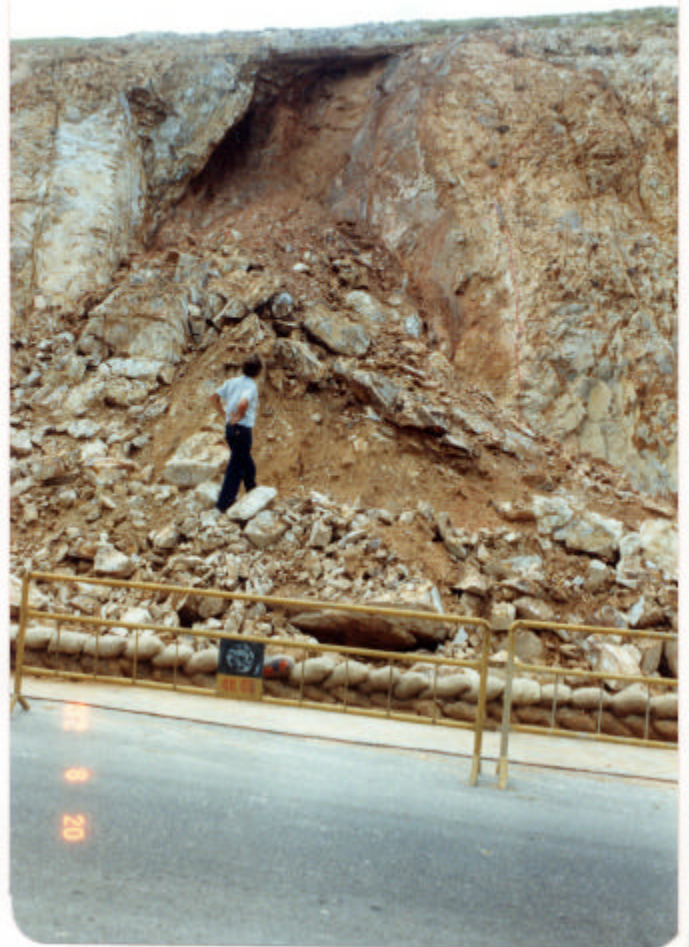
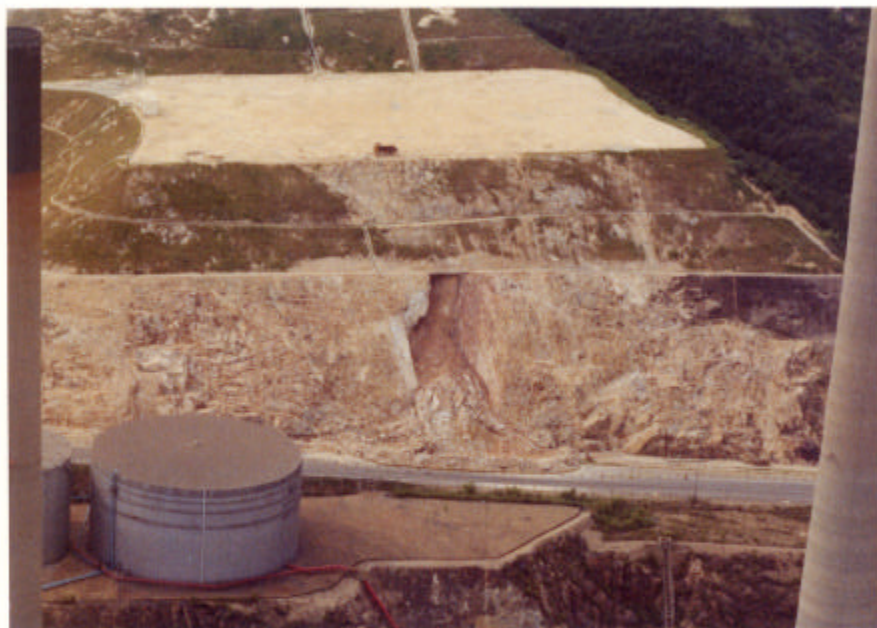
Plates 11 and 12

This slope was under construction at the time of the August rainstorm. The failed area comprises hydrothermally altered, moderately decomposed, granite. Either side of the failure, there were more competent, major intrusions of granite porphyry. The failure surfaces were coated with kaolin and manganese

dioxide. The main failure plane dipped steeply at an oblique angle to the slope surface. A number of other joints acted as release surfaces, and, combined with the main plane, provided a daylighting wedge. The debris, which was substantially small blocks of fractured rock, slid to the slope toe and blocked one lane of road TY1.

Plates : Above Road TY1, Tsing Yi
11 and 12 South Service Reservoir
(Incident No. NT/8/81)

: Major failure of a rock
cut slope

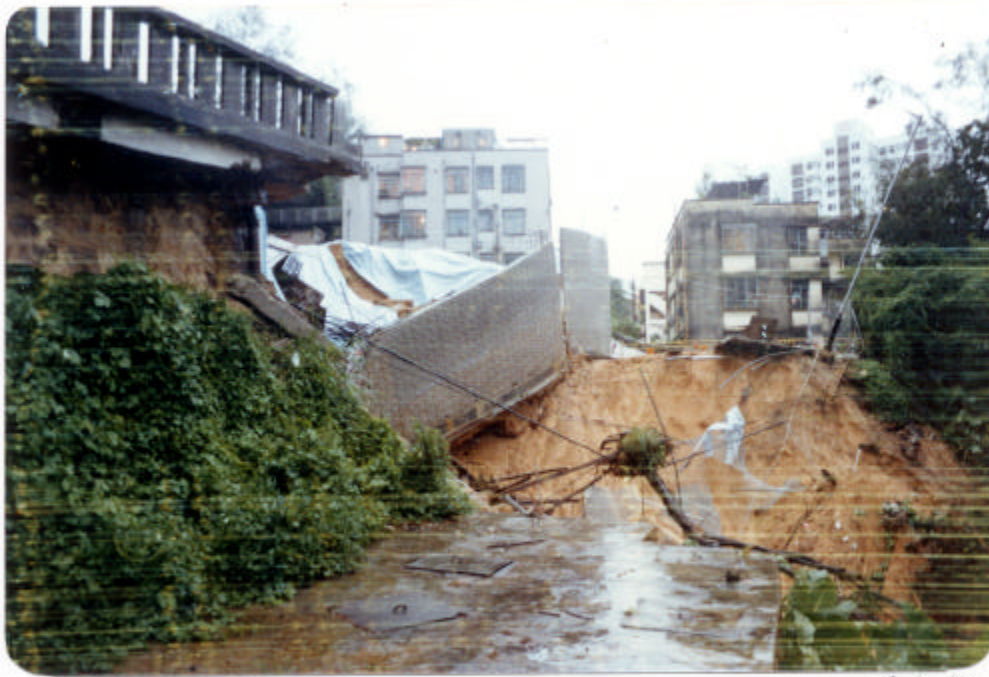
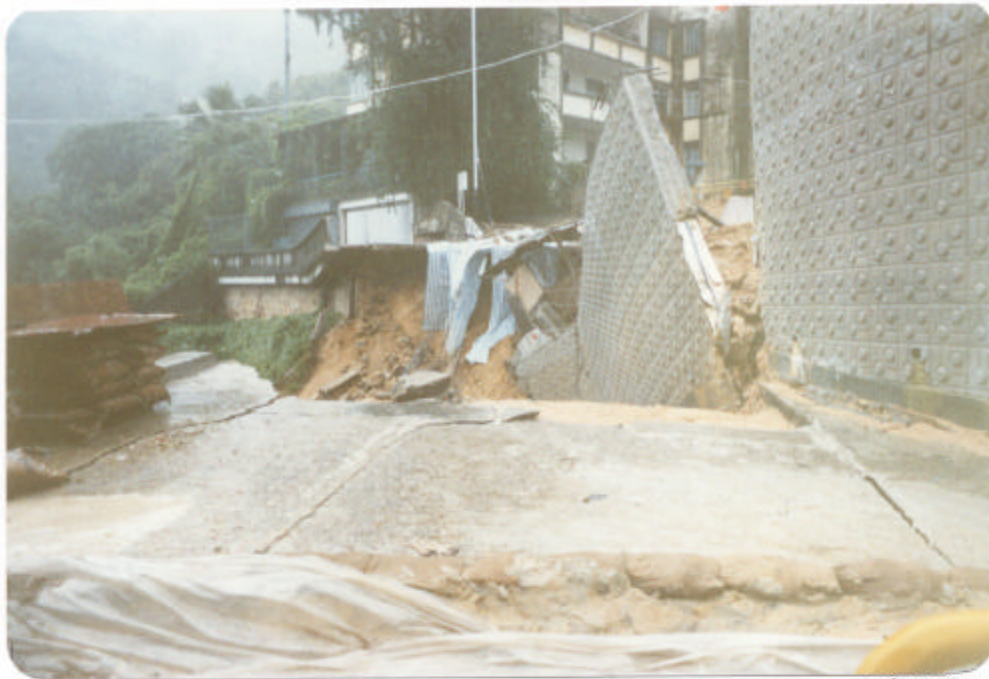
This failure occurred in two stages. The first, at 9.00 a.m. on the 31st July 1982, involved the failure of a 3 m high masonry retaining wall with a height to width ratio of 3 to 1. This wall was supporting the road leading to Chung Shan Terrace. The second stage was during the August rainstorm, when the situation worsened and, at 4.00 p.m. on the 16th August, a recently constructed, 6 m high reinforced concrete, cantilever wall collapsed. The cause of this collapse is thought to be the undermining of the wall footing by the previous slip.

Plate 13 and 14 : 7, Chung Shan Terrace, NT : Major failure of
(Incident No. GCB 6/8) a retaining wall

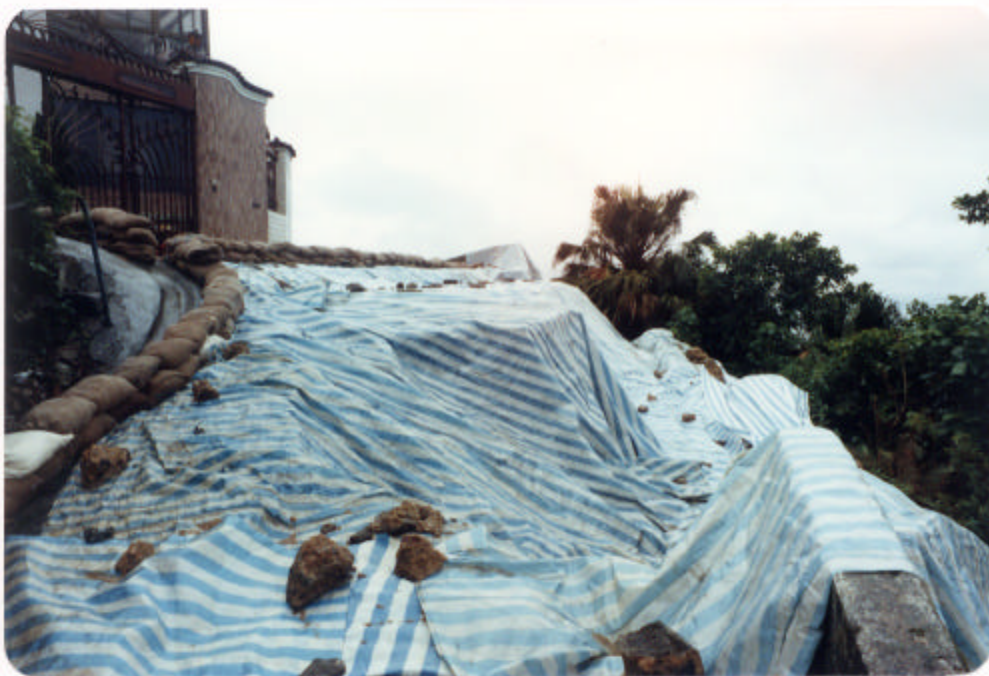
A 4.5 m high masonry wall, which supported the access road to Nos. 25 and 26 Lugard Road, collapsed at 10.00 a.m. on the 17th August. The volume of the failure has been estimated at 70 m³ and the debris consisted of wall blocks and decomposed volcanic soil. The access road was cut and No. 25 Lugard Road was threatened by undermining.

Plate 15 : 25, Lugard Road, HK : Major failure of
(Incident No. GCB 1/8) a retaining wall

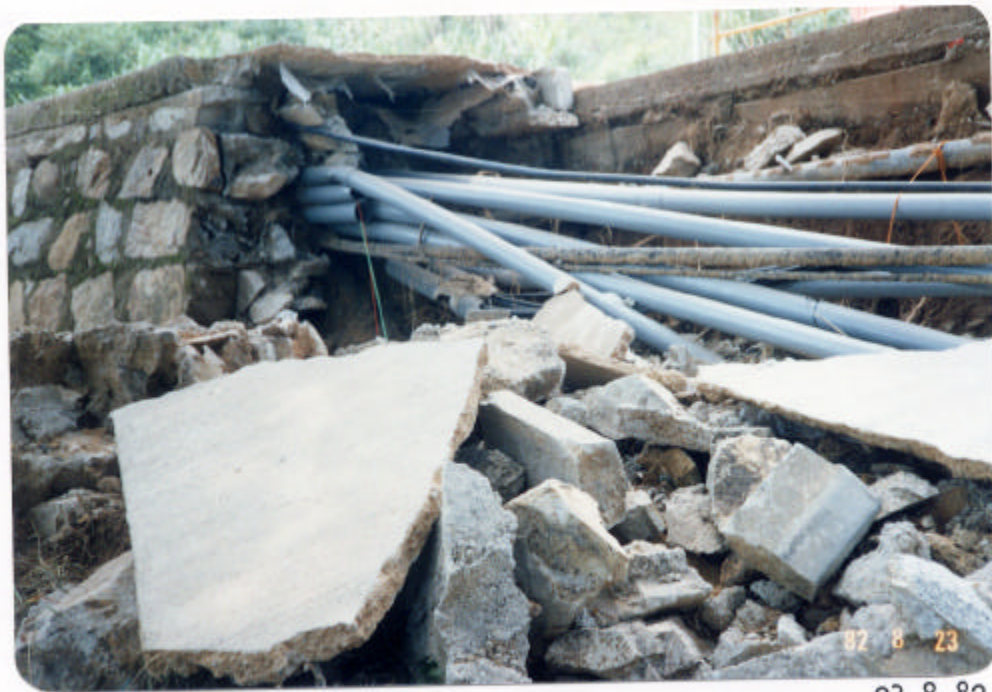
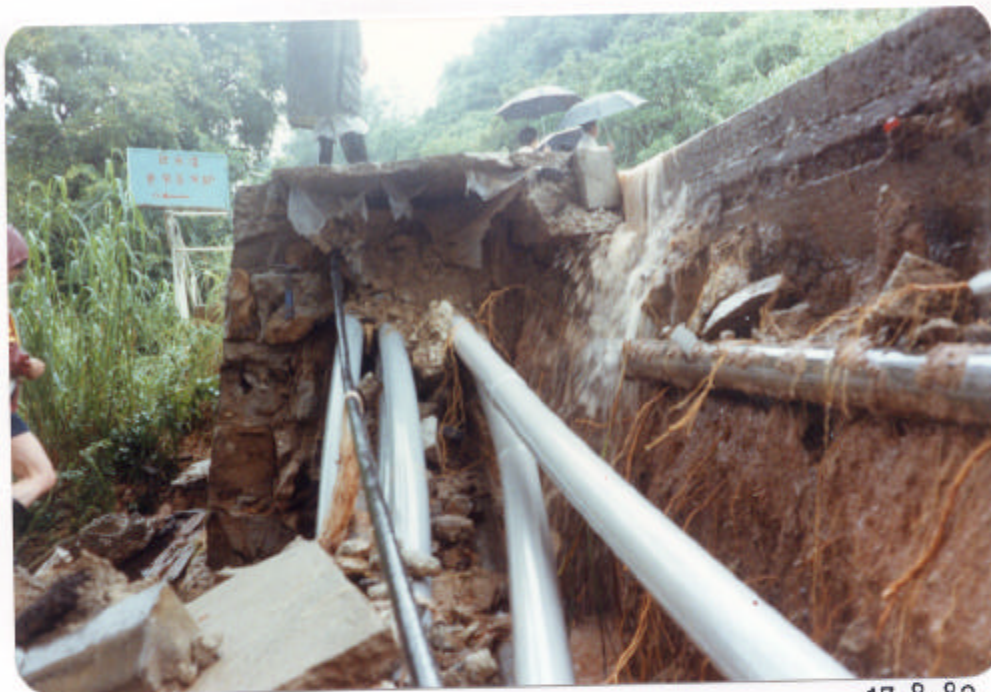
Saturation of soil in front of a 2 m high masonry retaining wall caused a bearing failure, which in turn caused a compound slope failure. A 16 m length of Castle Peak Road was undermined and a reinforced concrete beach house was threatened at the slope toe. The saturation that initiated failure was due to water from a road gully discharging directly onto the slope supporting the wall.

Plates 16 and 17 : 9½ MS Castle Peak Road : Major failure of a
(Incident No. NT/8/16) retaining wall

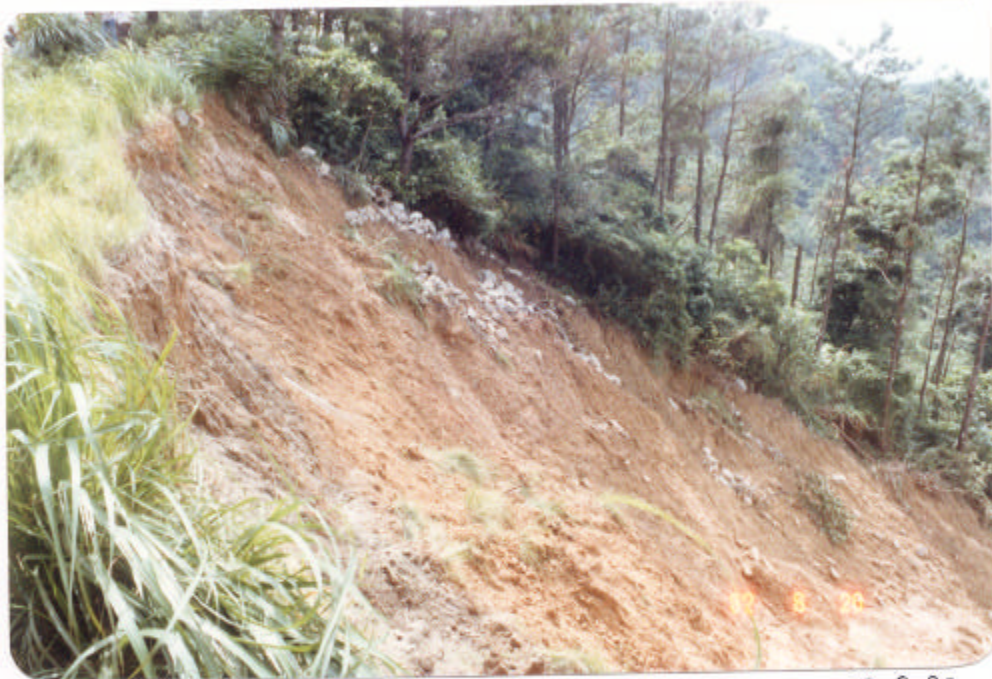
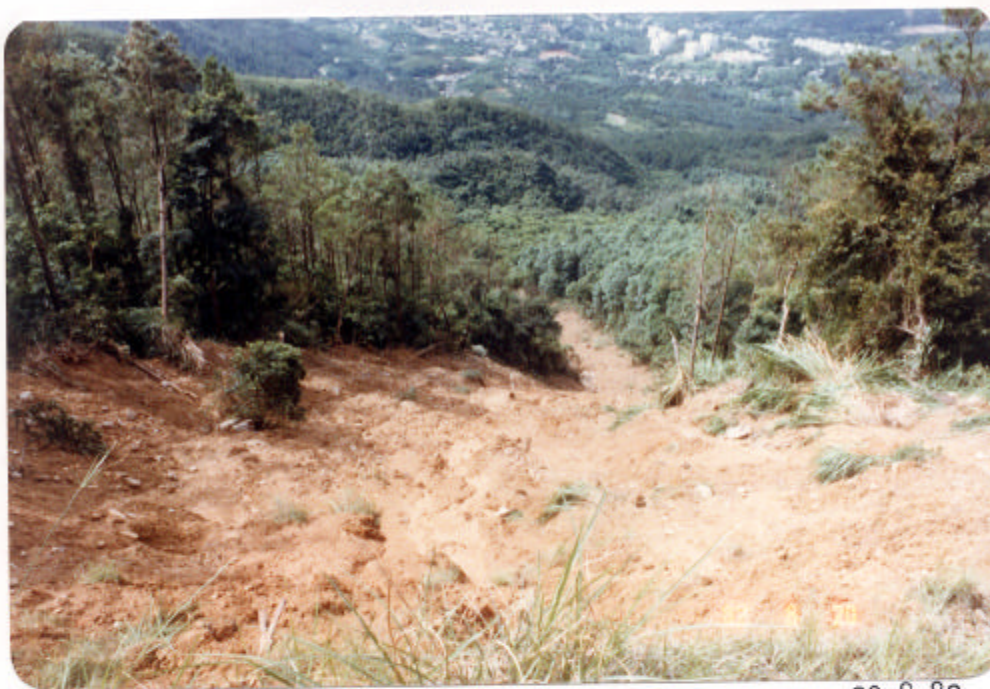
Plates 18 and 19 : 13 MS Route Twisk : Major failure of a natural/
(Incident No. NT/8/39) fill slope

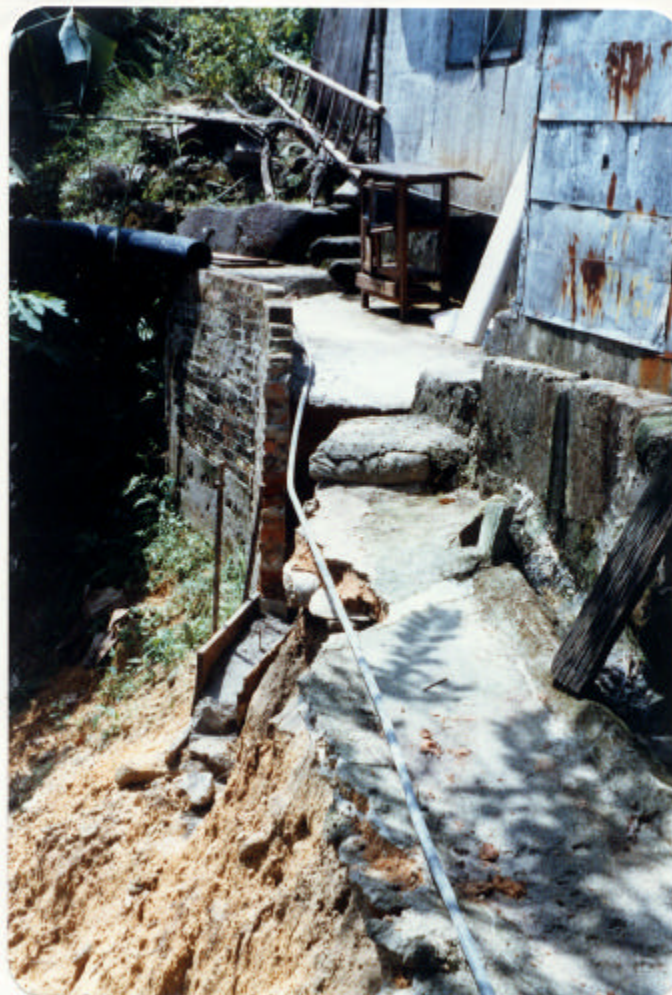
Plate 20 : Nam She Hang, Shatin
(Incident No. NT/8/45)

: 1 hut permanently
evacuated

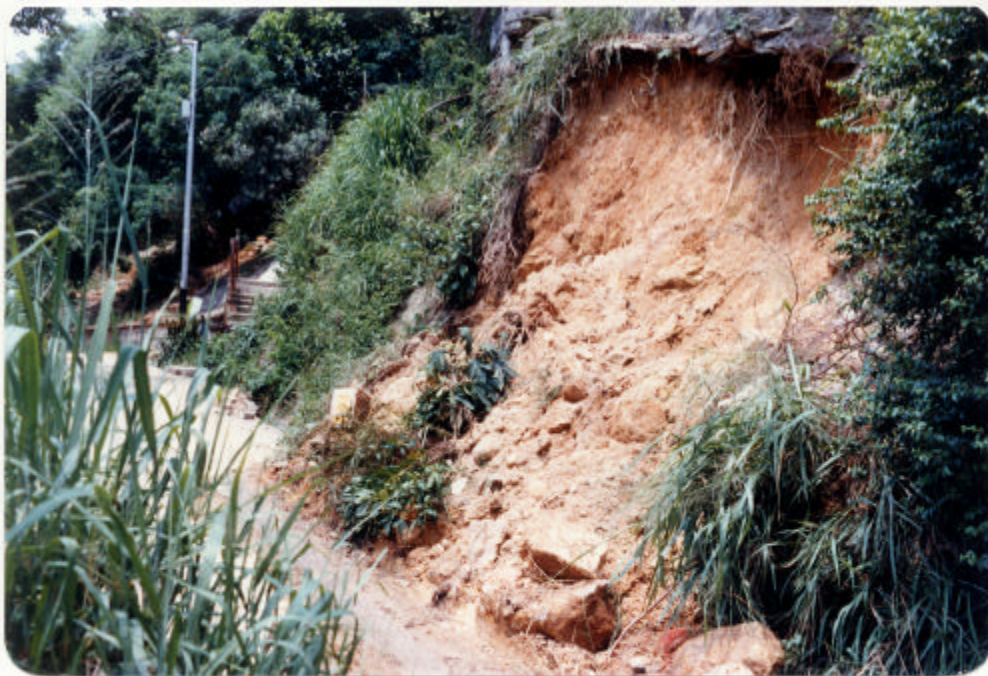
Plate 21 : 481 to 482, Sham Tseng, Tsuen Wan : 2 huts permanently
(Incident No. NT/8/53) evacuated

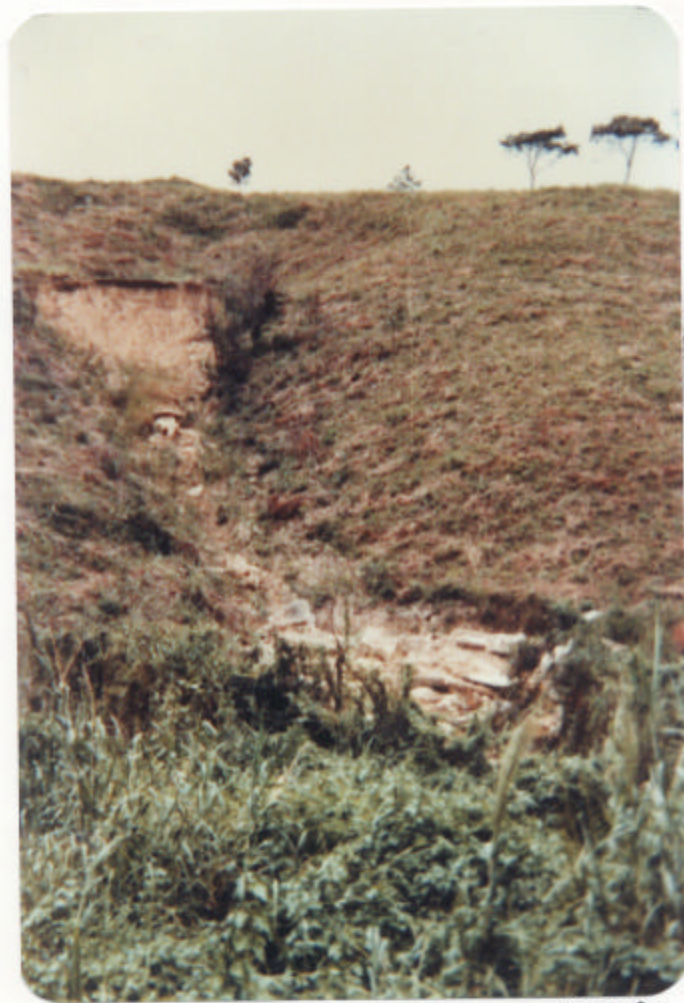
Plate 22 : Yau Kam Tau, Tsing Yi : 1 killed and
(Incident No. NT/8/27) 1 injured

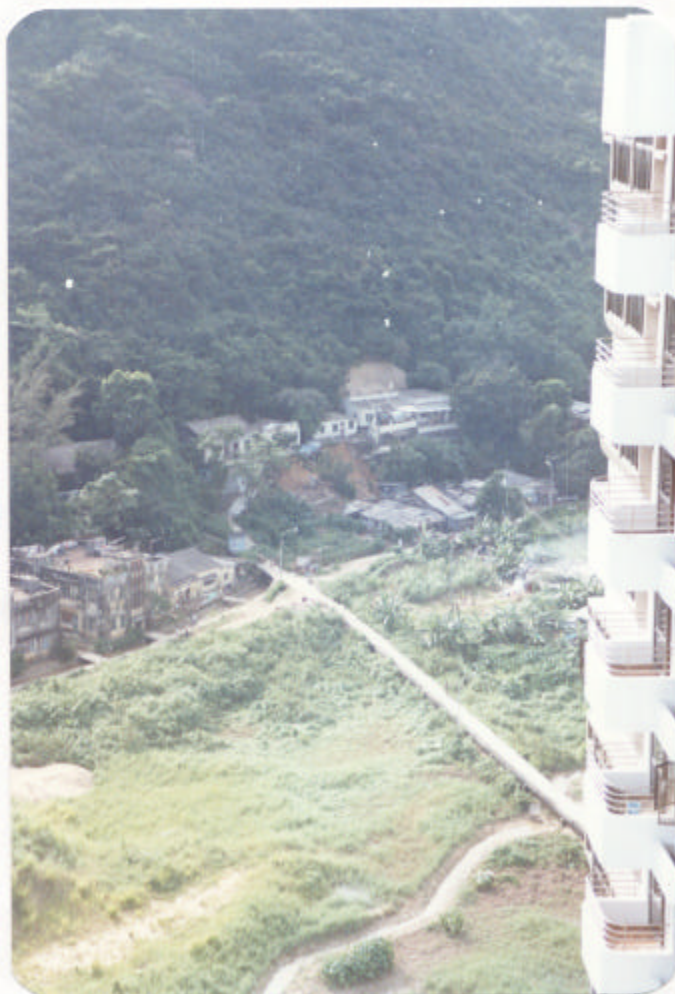
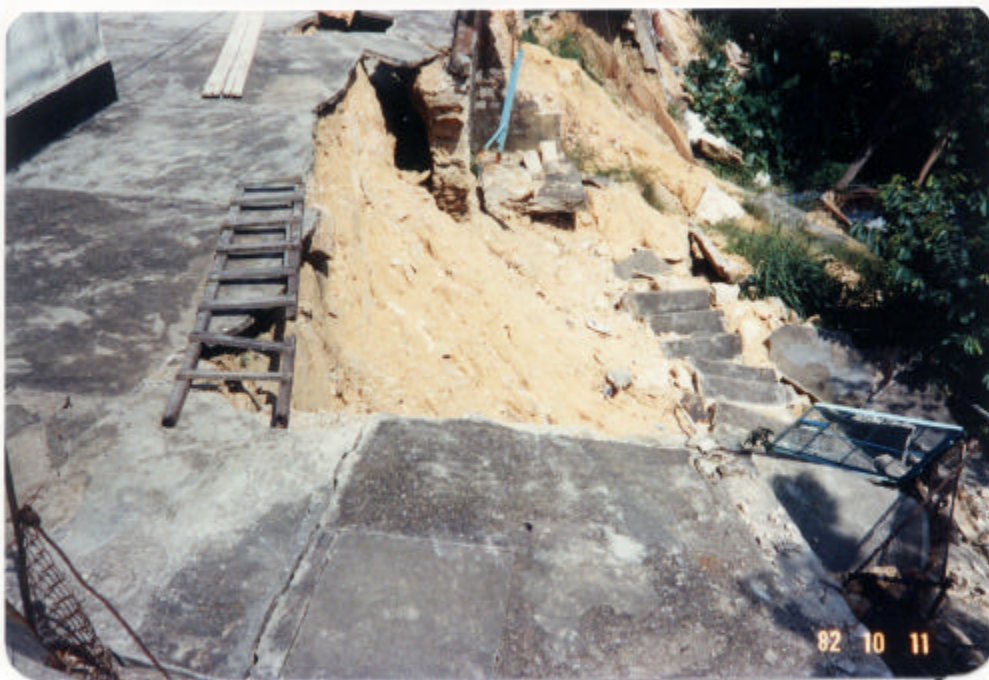
Plates : Kau Wah Keng San Tsuen
23 and 24 (Incident No. NT/8/8)

: 2 killed, 3 village type
houses closed and 5 groups
of huts permanently
evacuated.

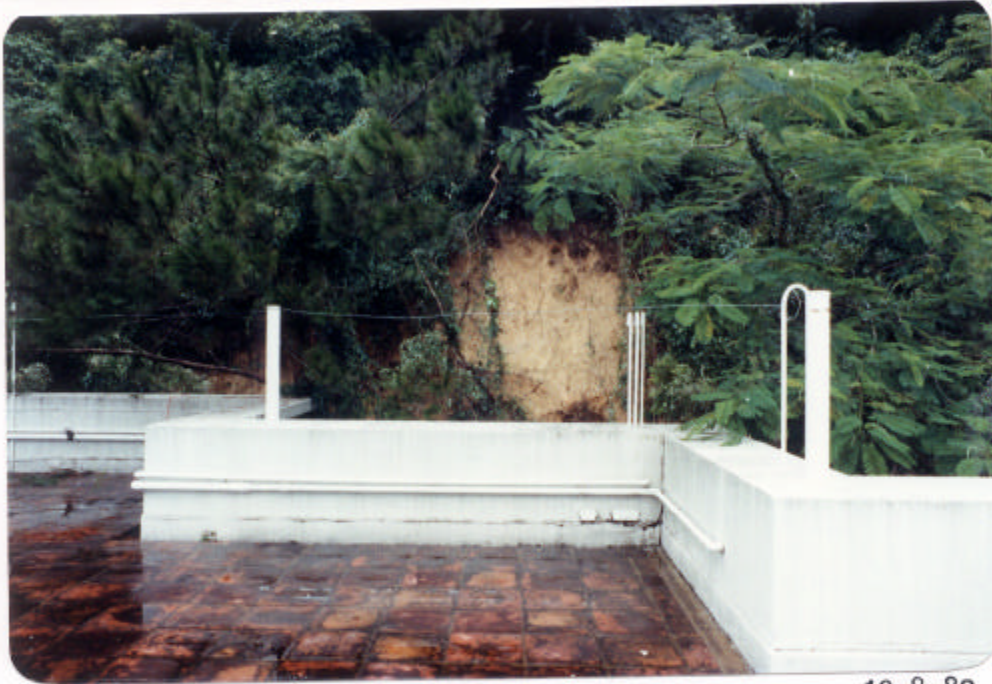
Plate 25 : 45, Island Road, HK : 'D' slope notice recommended
(Incident No. GCB 4/8)

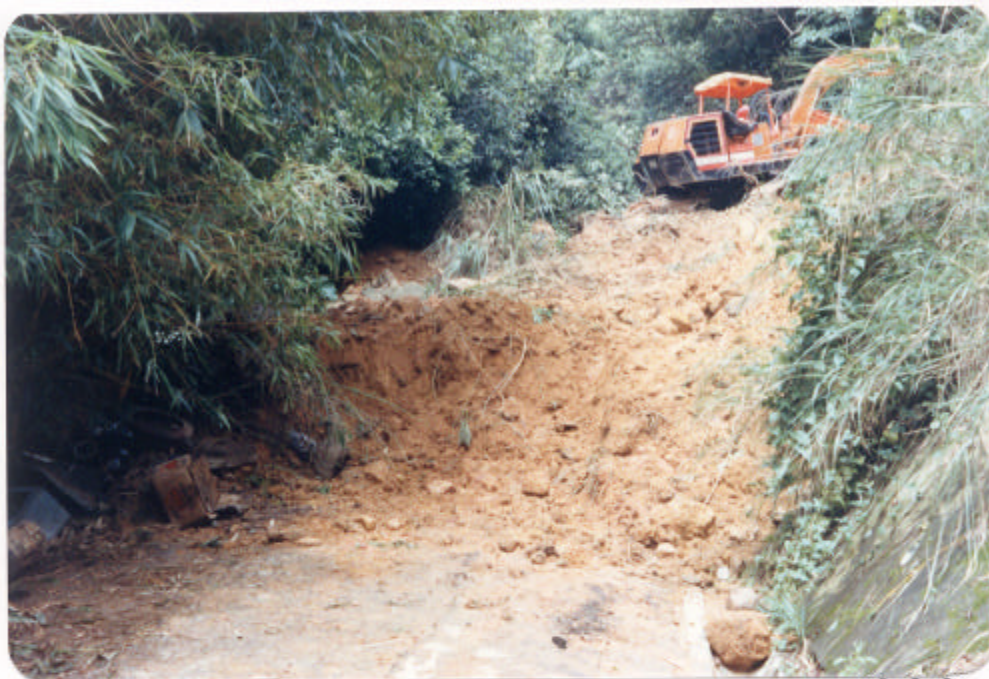
Plate 26 : Peel Rise Squatter Area, Aberdeen : Road blocked for
(Incident No. HK/8/16) 13 days, 3 huts
permanently evacuated
and 1 hut temporarily
evacuated

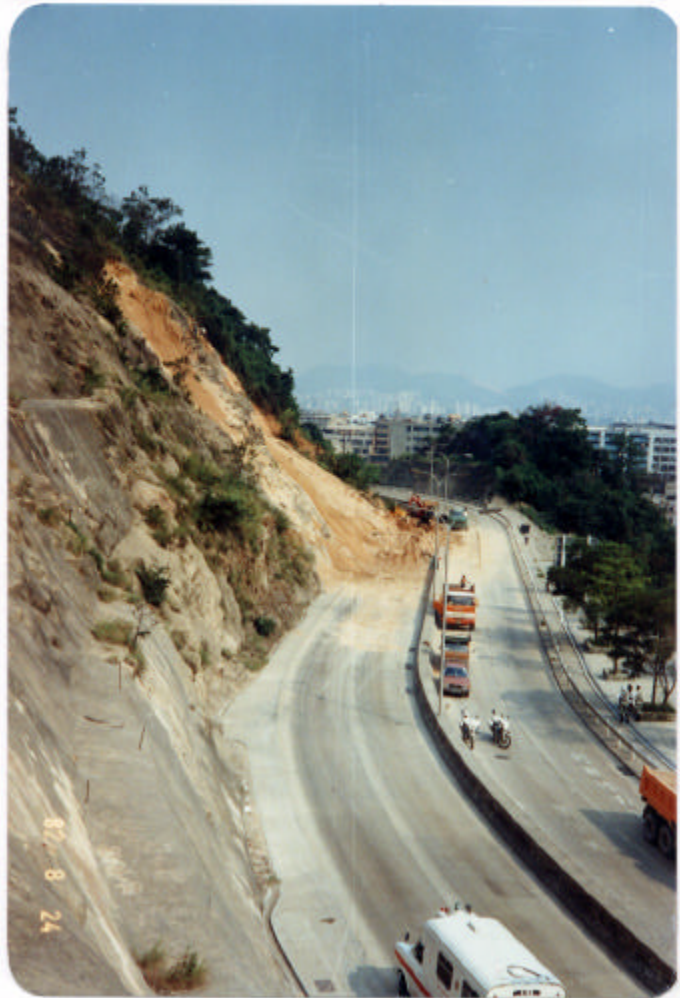
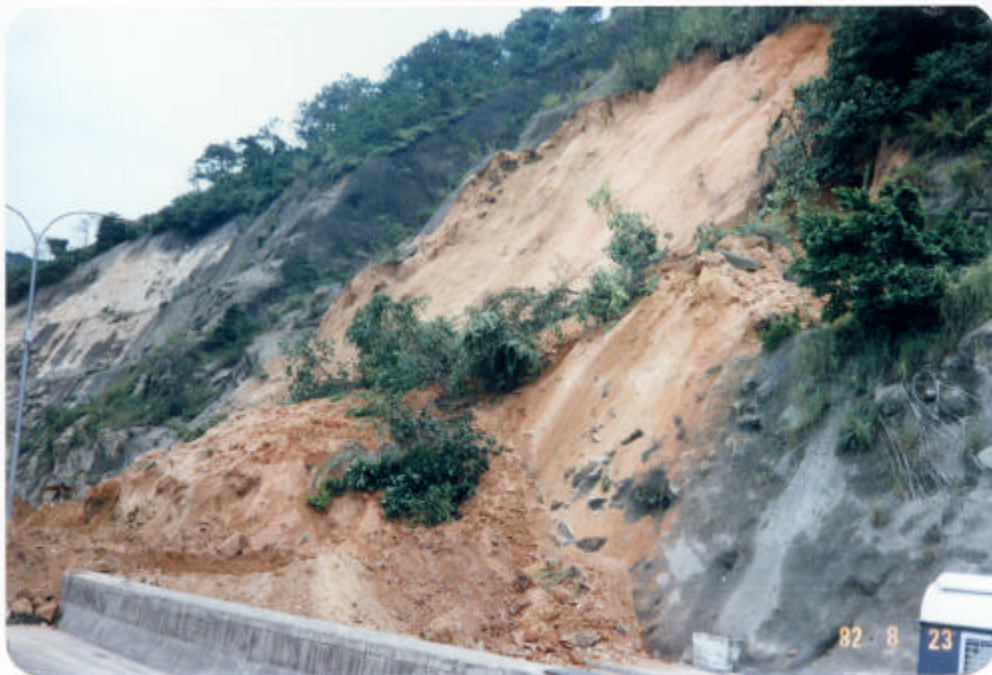
Plates 27 and 28

Plates : Ching Cheung Road
27 and 28 (Incident No. K/8/29)

: Eastward bound lanes
closed for two months

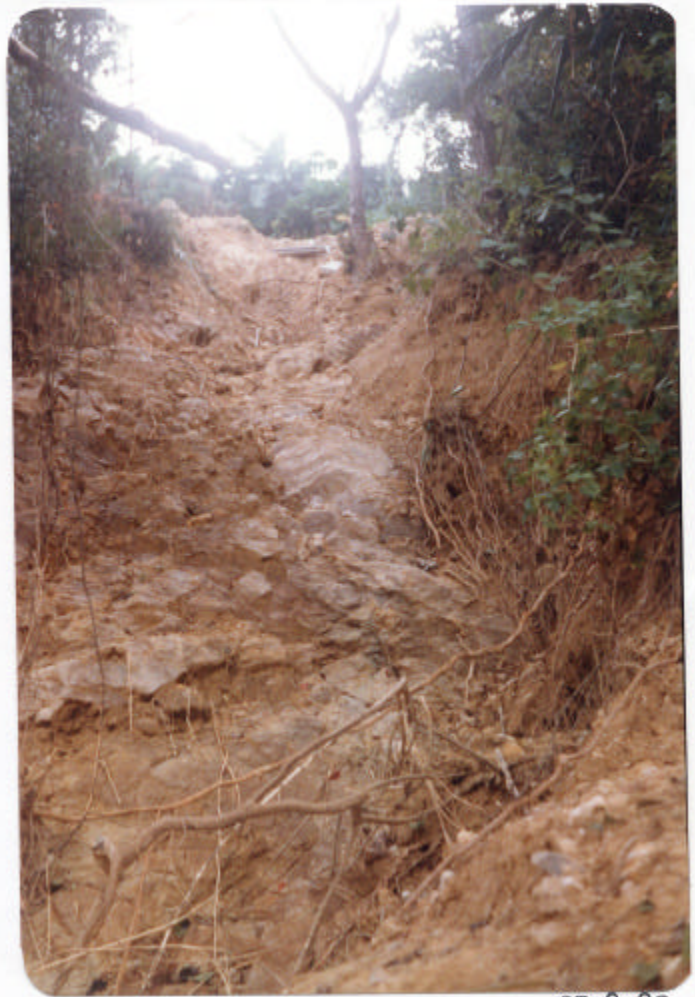
Plate 30 : Cheung Hang Road (E)
(Incident No. NT/8/72)

: Road closed

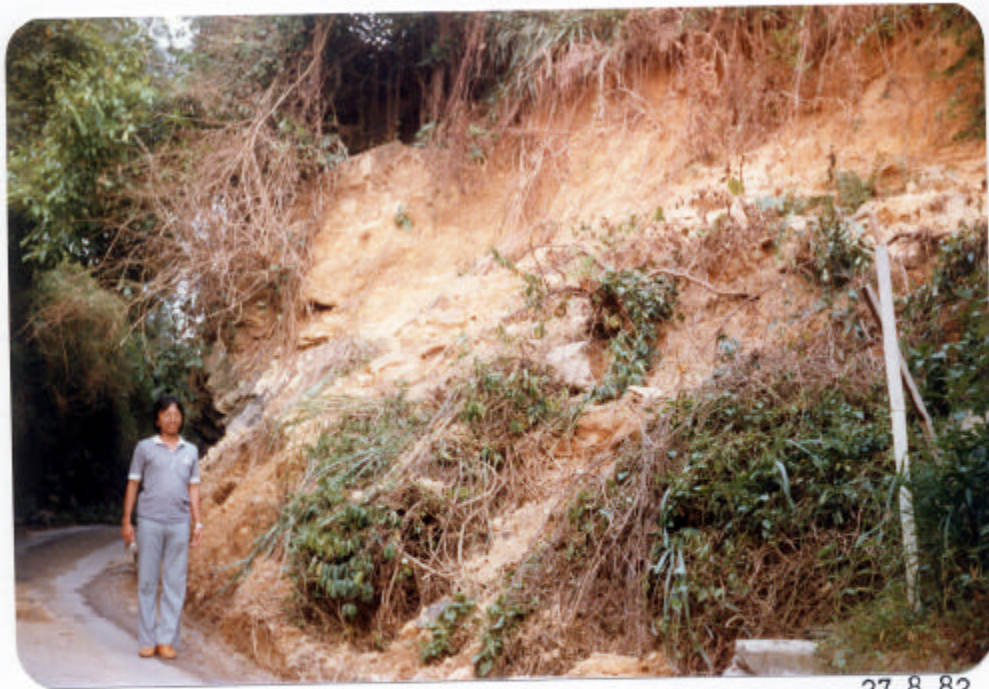
Plate 31 : Cheung Hang Road (A) : Road totally blocked
(Incident No. NT/8/11) by debris

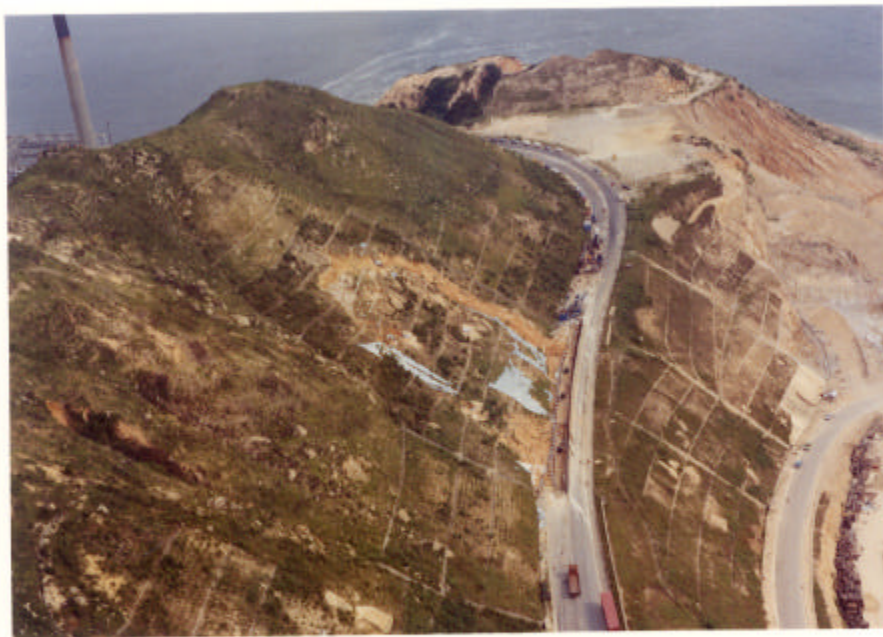
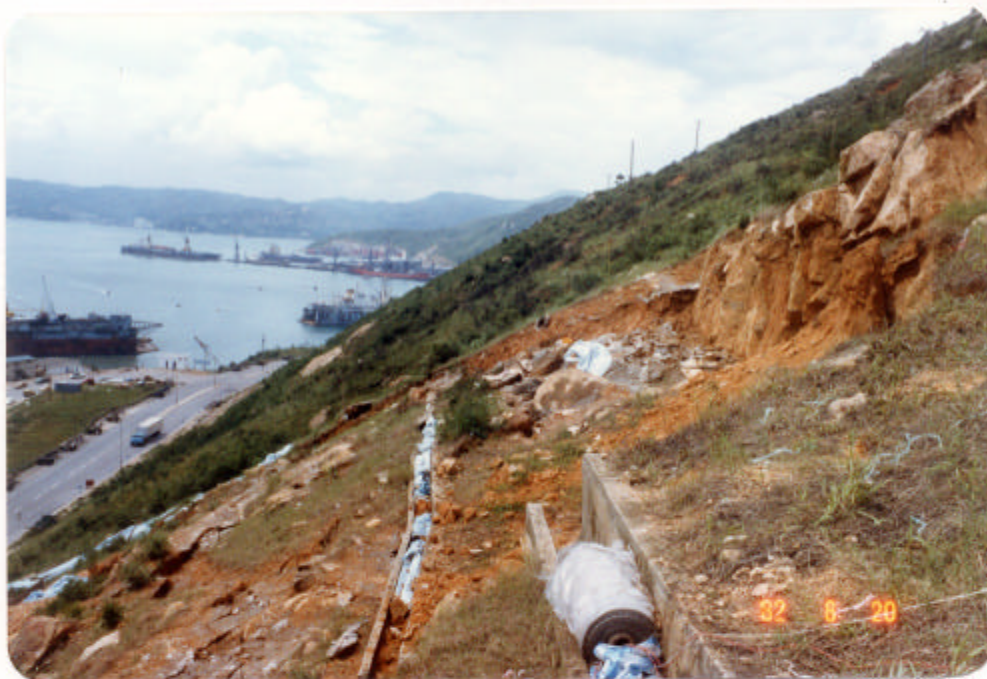
Plates 32 and 33 : Road TY1, Ch. 2400, Tsing Yi Island
(Incident No. NT/8/15)

: One lane of road closed
