REPORT ON THE RAINSTORM OF AUGUST 1982

GEO REPORT No. 26

**GEOTECHNICAL ENGINEERING OFFICE
CIVIL ENGINEERING DEPARTMENT
HONG KONG**

This report was produced in 1982 as a permanent record of the effects of the rainstorms that occurred in the period of 15th to 19th of August 1982 with particular emphasis on the location, type and size of the more serious landslide incidents. It is a factual report and, apart from acknowledging that the landslides were caused by intense rainfall, does not attempt to explain the mechanisms and causes of failure.

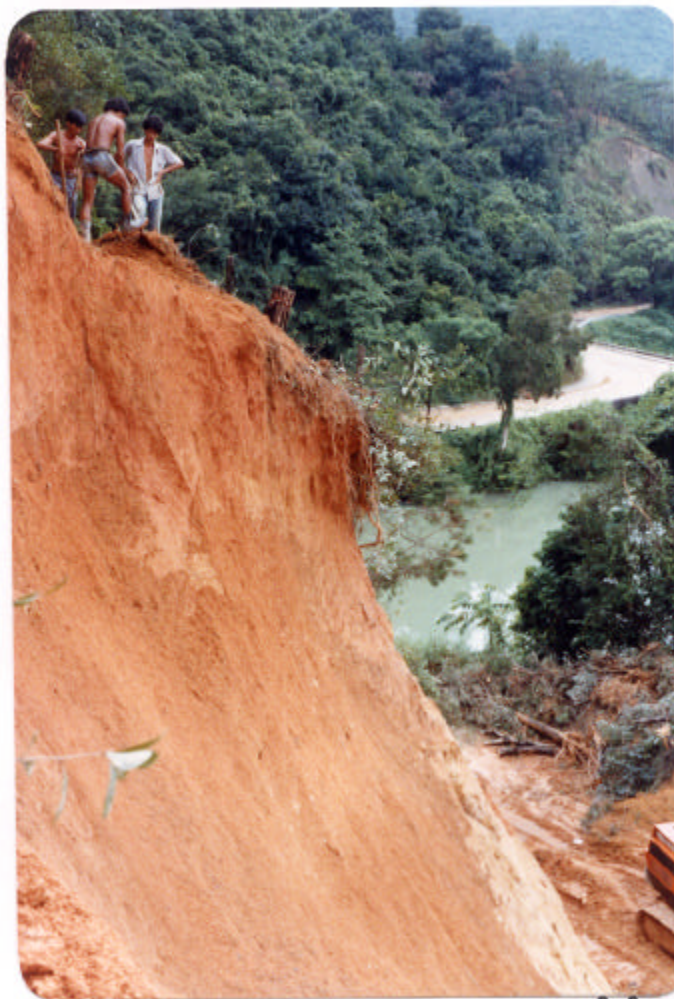
Plate 36 : 5½ MS Tai Po Road
(Incident No. NT/8/18)

: Both lanes blocked
for four days

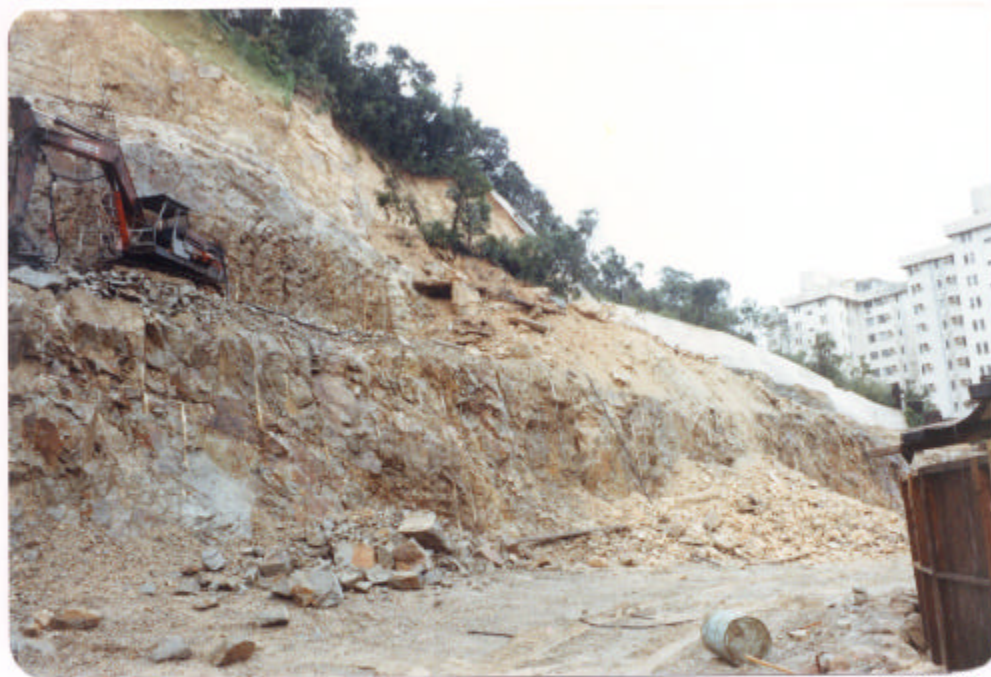
Plate 37 : RBL 1044, South Bay Close, HK : Construction site -
(Incident No. GCB 3/8) no casualties
