LANDSLIPS CAUSED BY THE JUNE 1983 RAINSTORM

GEO REPORT No. 27

**GEOTECHNICAL ENGINEERING OFFICE
CIVIL ENGINEERING DEPARTMENT
HONG KONG**

**This report was originally produced in August 1984
as GCO Special Project Report No. SPR 1/84**

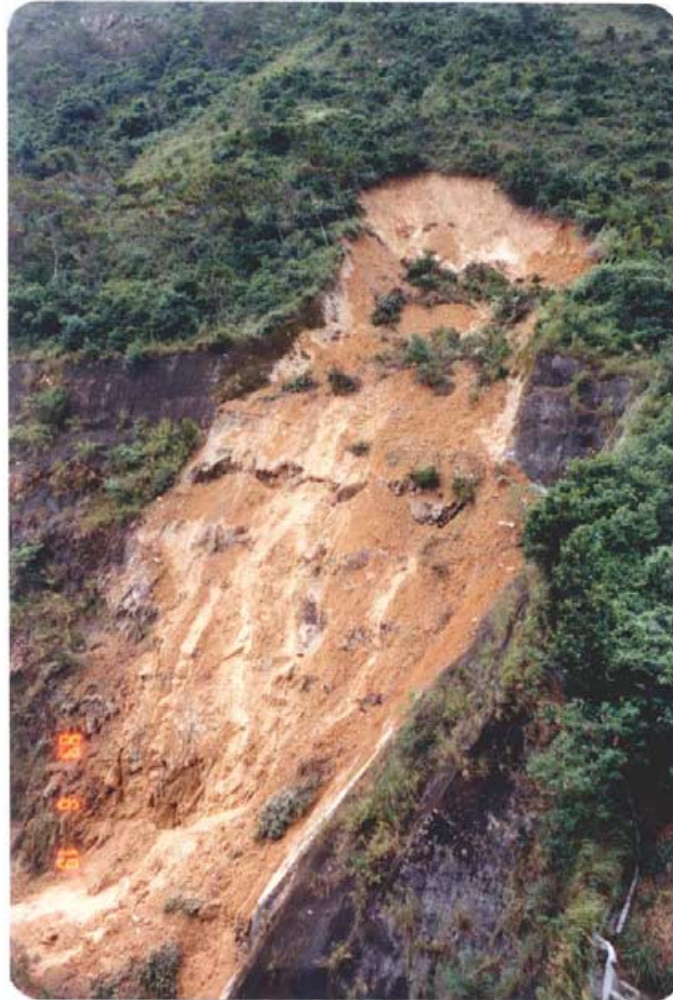
1. Major soil/rock cut slope failure.
2. Upper portion of the slope failed previously and was chunamed.
3. Present failure probably due to pore pressure build-up along sheeting joint sliding plane.
4. See Section 5.1 for further details.

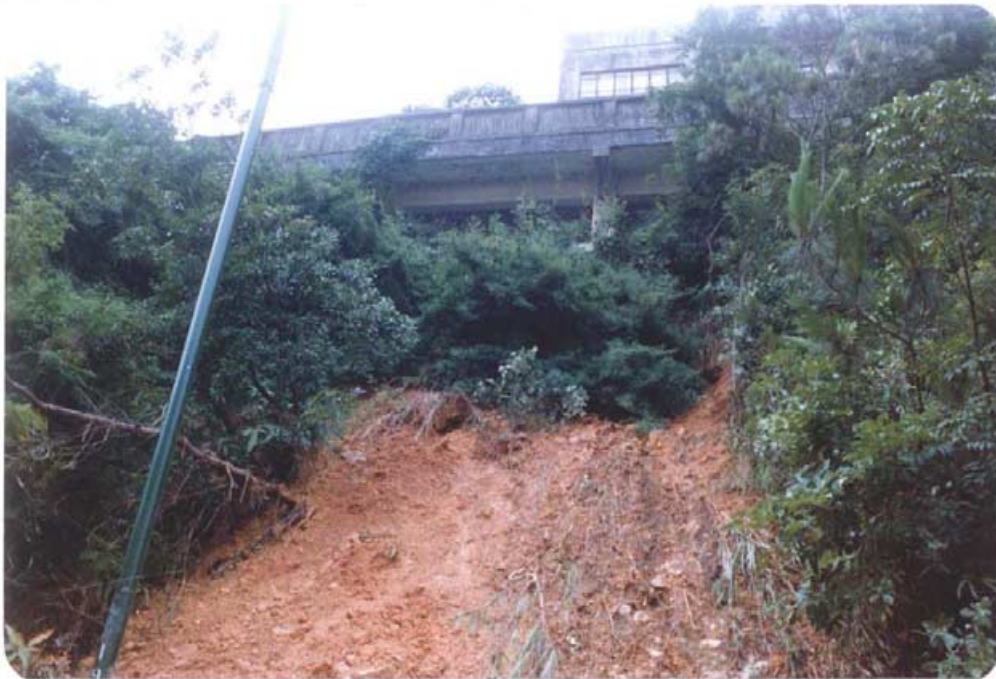
1. Major soil cut slope failure.
2. Heavy runoff from the car park podium infiltrated the slope from above and caused the failure.
3. Foundation of car park podium was slightly undermined and the road below was partially blocked.

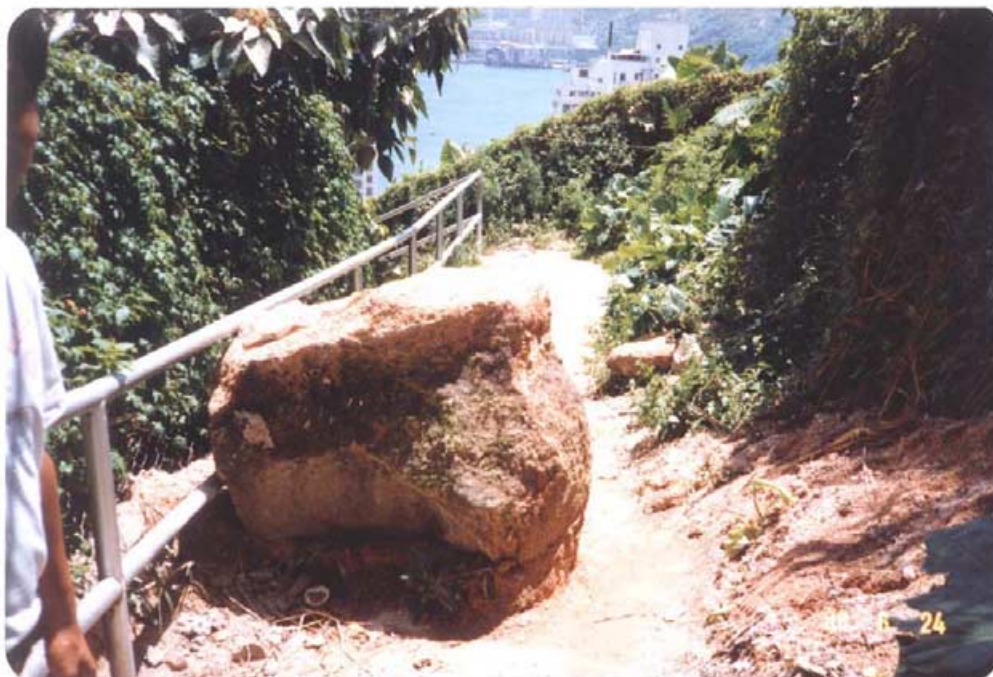
1. Minor soil cut slope failure.
2. Slope comprised predominantly of Grade II materials with one large boulder.
3. Soil debris which blocked the access footpath was removed by the villager immediately after failure, leaving the heavy boulder behind.

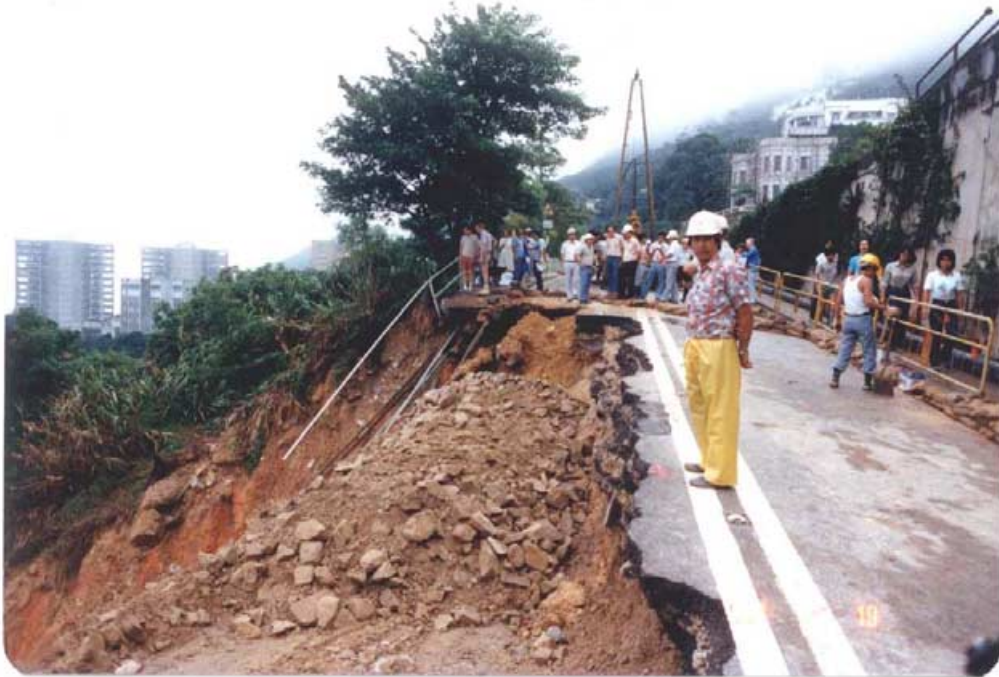
The major fill slope failure at the Peak Road, Incident No. HK 6/12, caused major disruptions in the Peak area (Plates 15 and 16). Peak Road was closed for a week following the collapse of the section near Magazine and Guilford Roads until a temporary steel bridge was constructed. Section 5.2 will discuss some details of the failure.

1. Major fill slope failure.
2. Caused by infiltration from the road.
3. See Section 5.2 for details.
4. Road collapsed and closed for 1 week until the erection of a temporary steel bridge.

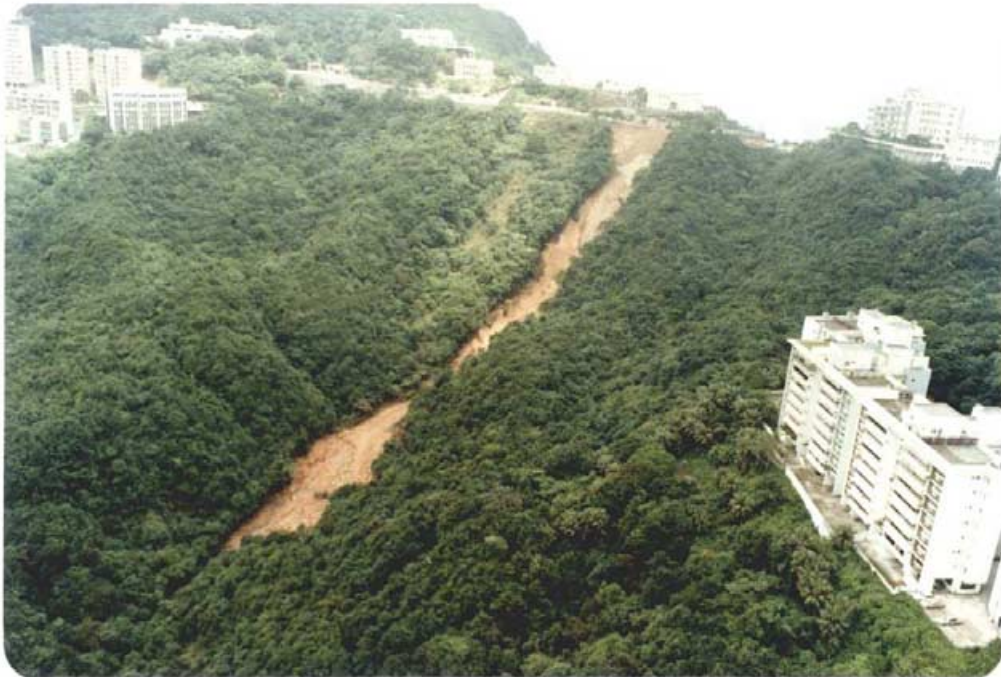
1. API photo of elongated slip scar.

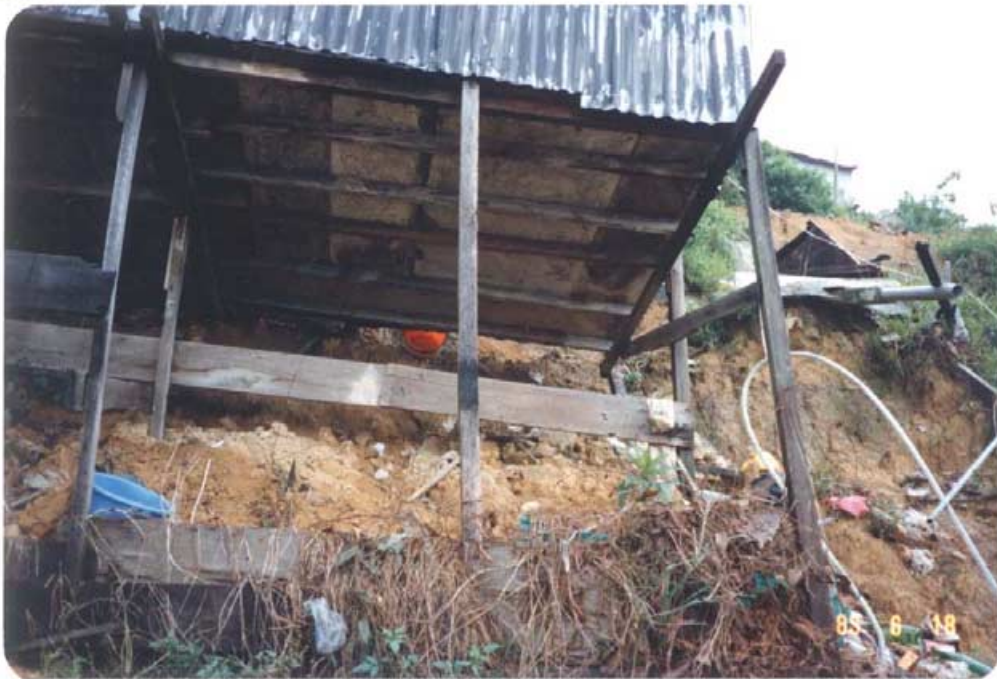
1. Minor erosion of fill slope/platform underneath squatter huts.
2. 1 hut permanently evacuated and 2 huts temporarily evacuated.

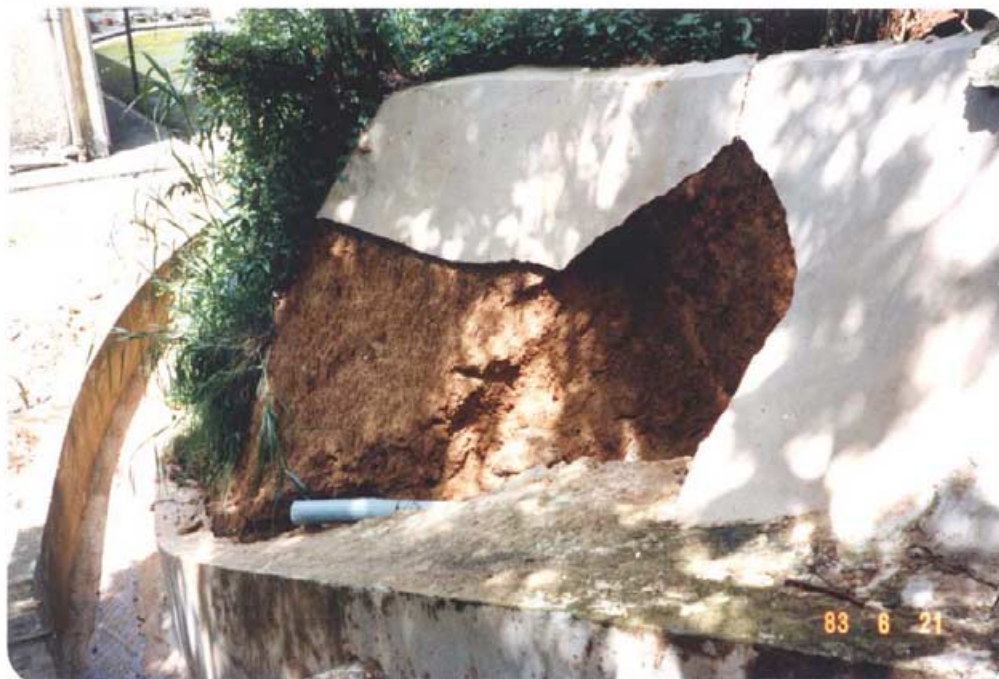
1. Erosion of backfill around pipe.
2. Caused by preferential seepage around the pipe in poorly compacted backfill.
3. Affected both squatter huts above the slope and the backyard of the home for the aged.

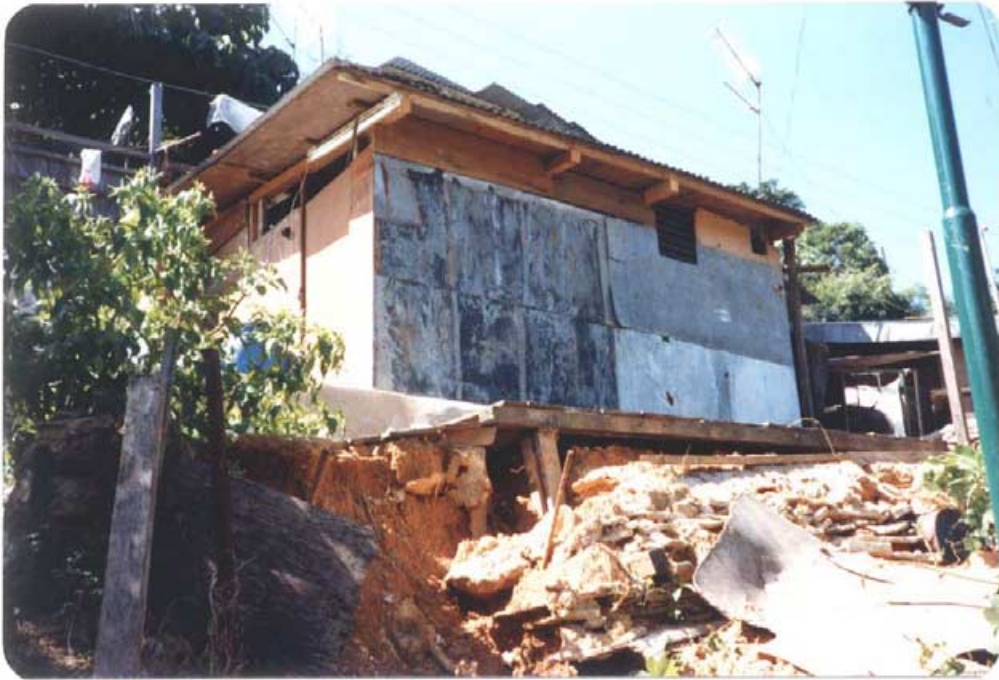
1. Minor fill slope failure in squatter area.
2. Probably due to discharge from the squatter hut above.
3. No evacuation necessary as the hut was not in immediate danger.

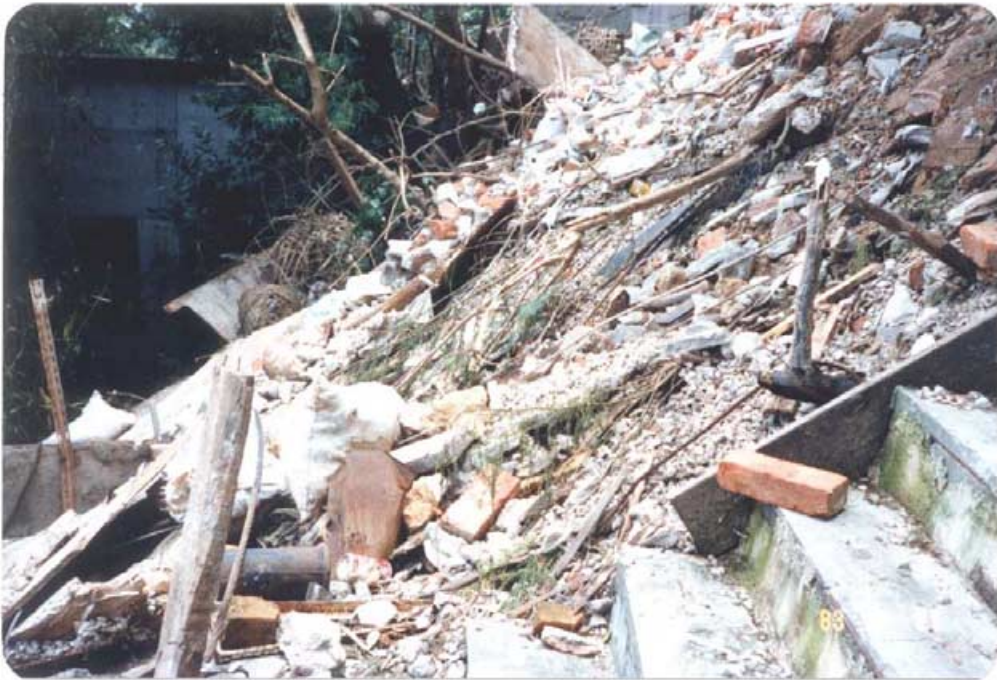
1. Failure of a fill slope consisting of loose randomly placed building debris in squatter area.
2. No major consequence.

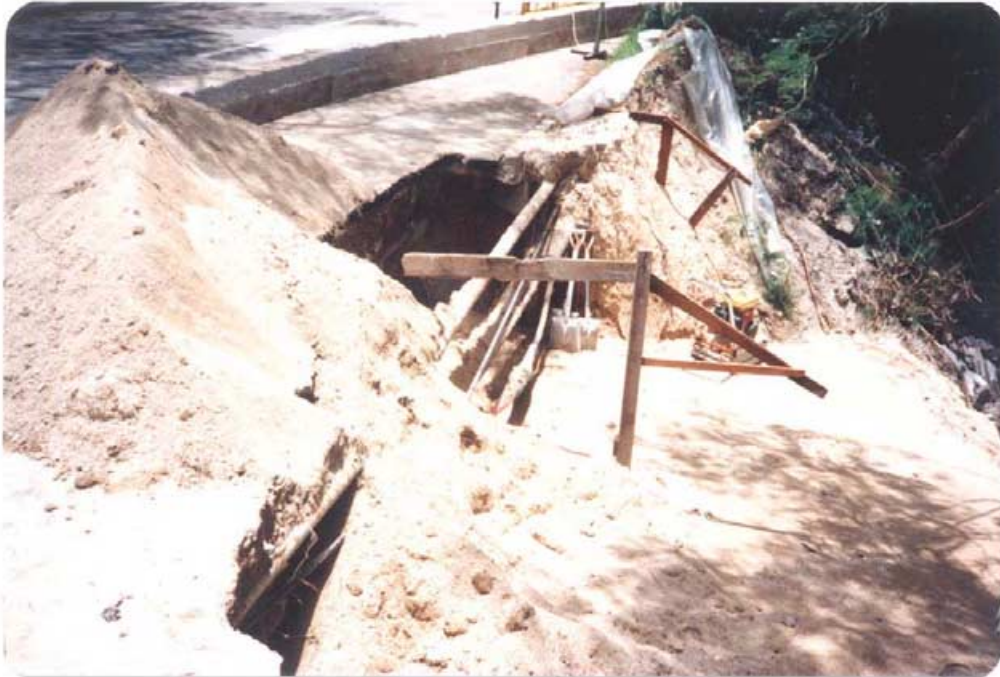
1. Minor erosion of fill embankment due to runoff from the road.
2. Picture shows remedial works underway.
3. The remedial work consisted of backfilling, recompaction and a small retaining wall at the toe to contain the backfill.

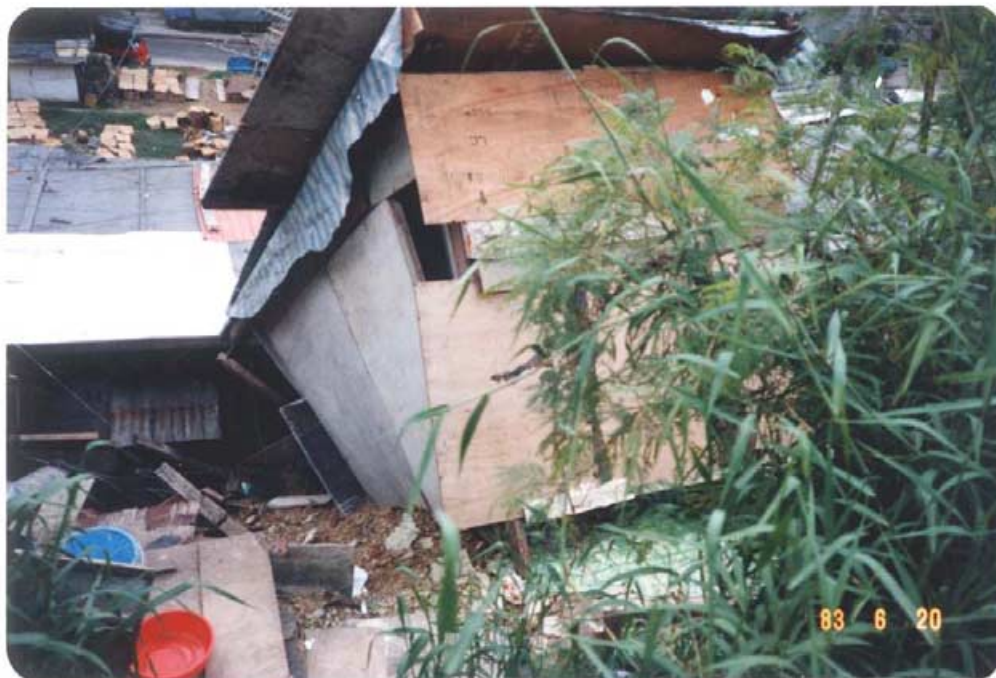
1. Erosion of fill platform underneath squatter huts.
2. Resulted in the tilting forward of squatter huts.
3. 1 hut was permanently evacuated and 4 temporarily evacuated.

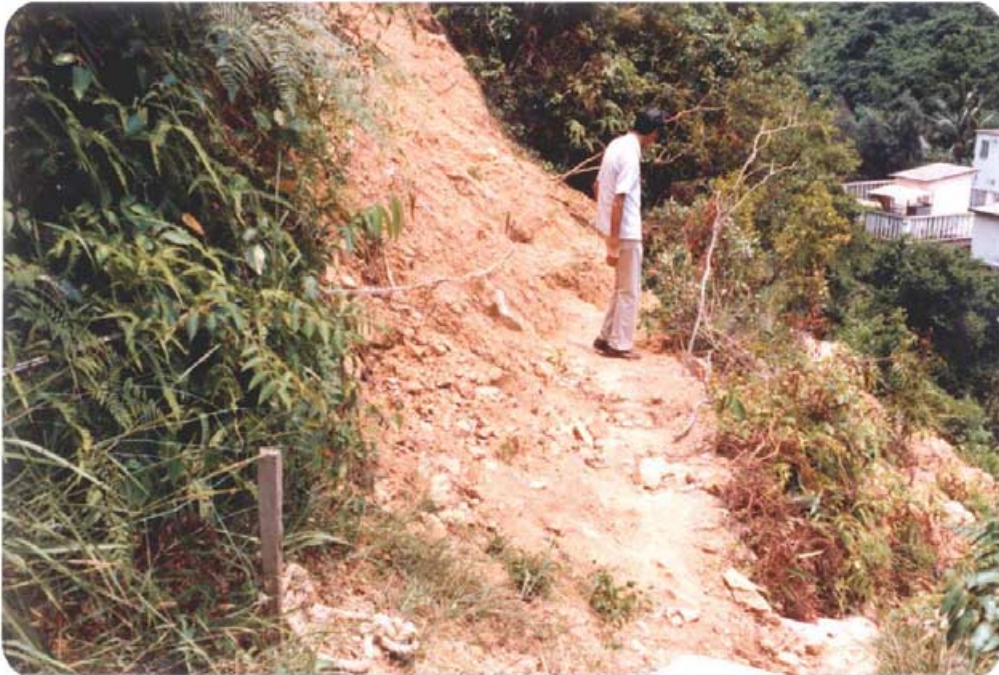
1. Major natural slope failure above a footpath.
2. Slide debris travelled downslope a considerable distance and affected the houses below.
3. 1 house permanently evacuated.

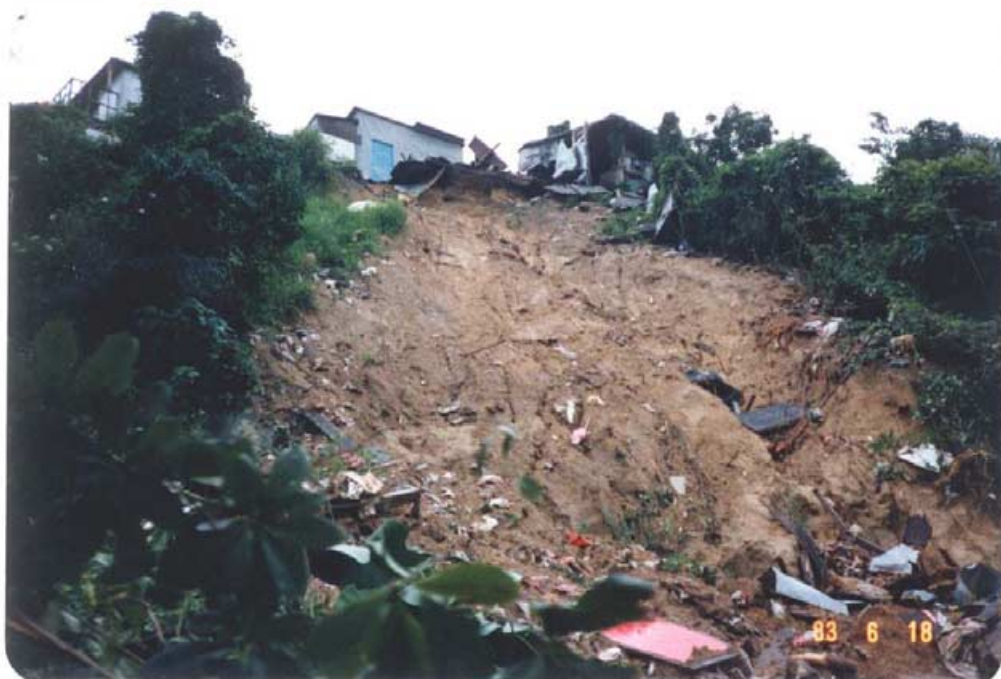
1. Major failure of a natural slope in squatter area.
2. Slope had failed previously.
3. Caused by discharge from the squatter huts above the slope.
4. 4 huts evacuated.

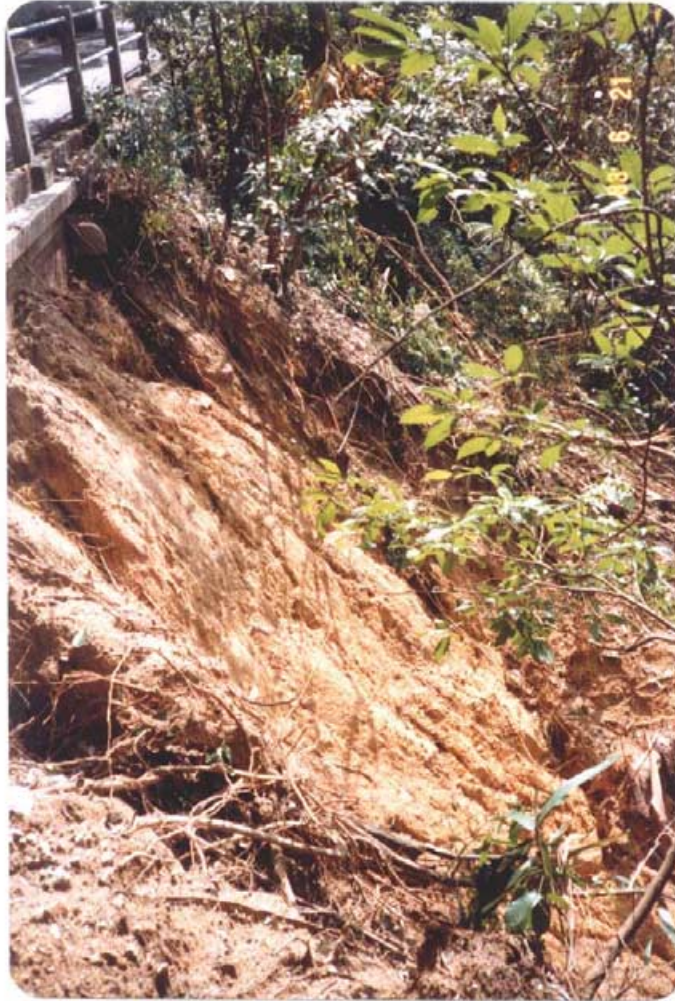
1. Minor erosion of a natural slope below Bowen Road.
2. Caused by overflow from the road above.

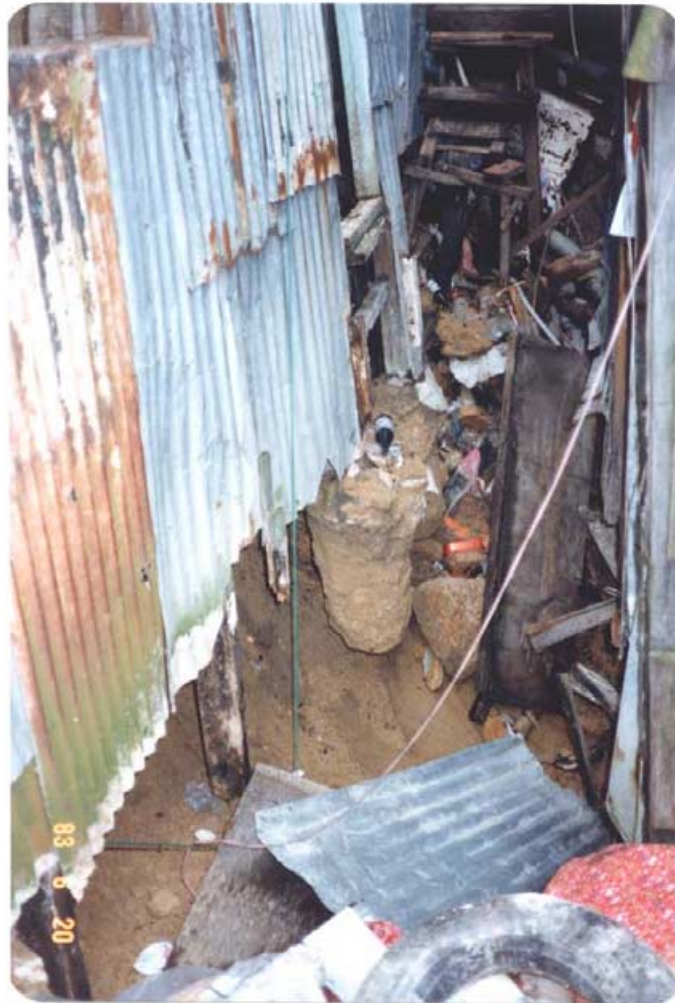
1. Minor erosion of natural slope below squatter huts.
2. Foundations of huts undermined.
3. 2 squatter huts evacuated.

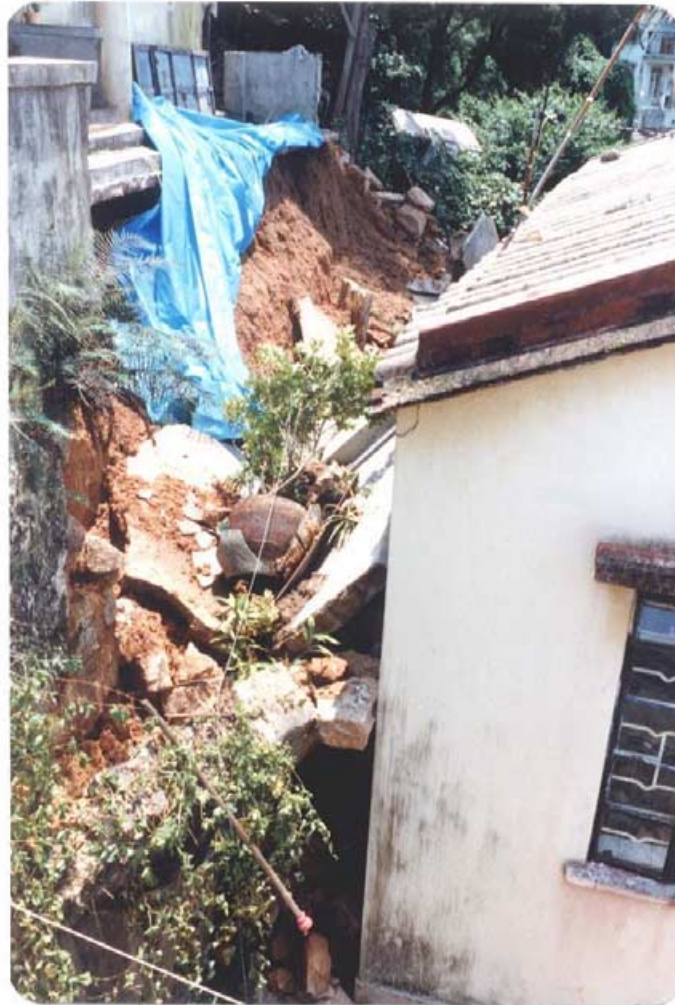
1. Major retaining wall failure which affected houses.
2. Water pressure built-up behind the wall which has no drainage failures.
3. Signs of distress were observed in the wall a year previously.
4. 3 houses were evacuated.

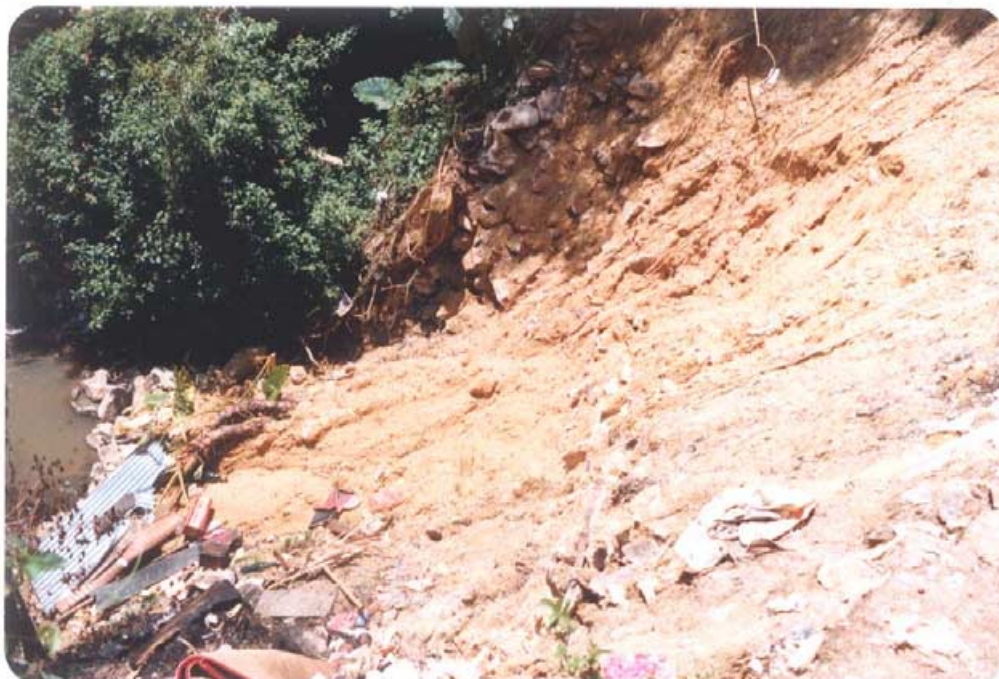
1. Major rubble retaining wall failure.
2. Debris blocked a stream below.
3. Foundation for a public toilet above the wall undermined.

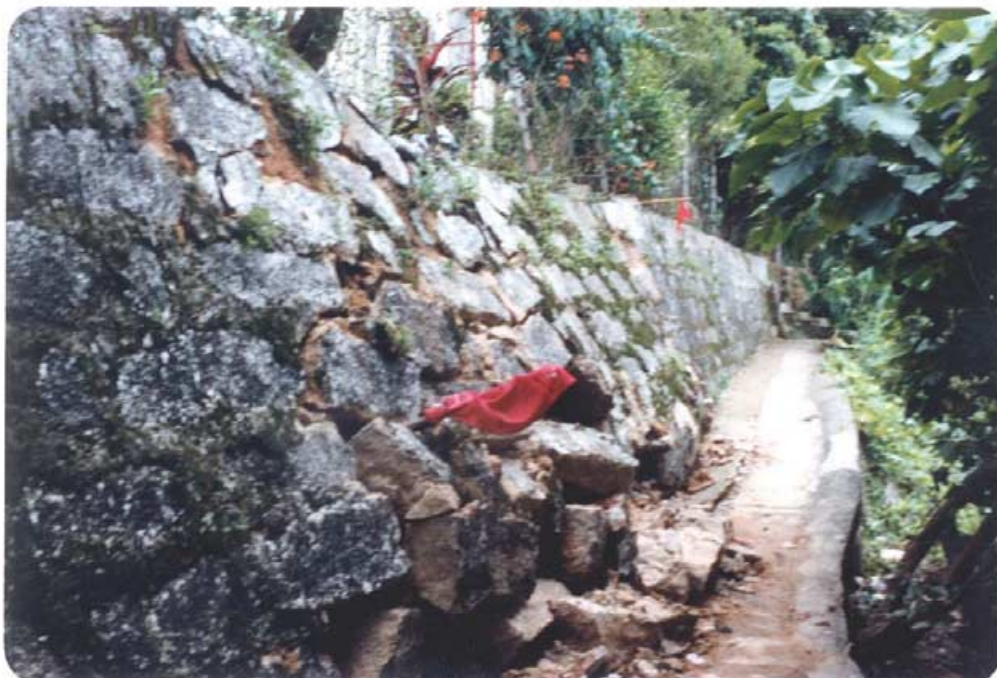
1. **Partial failure of small rubble retaining wall.**
2. **Retaining wall bulged and platform of the house above cracked as a result.**

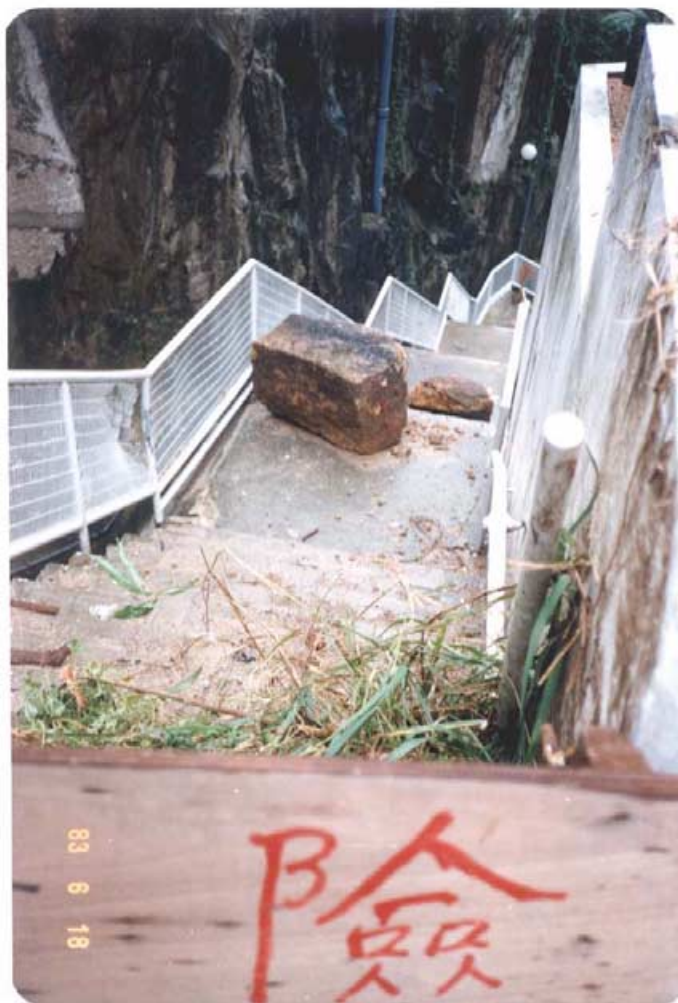
1. Minor rock fall from natural slope which damaged part of the staircase to private apartments.

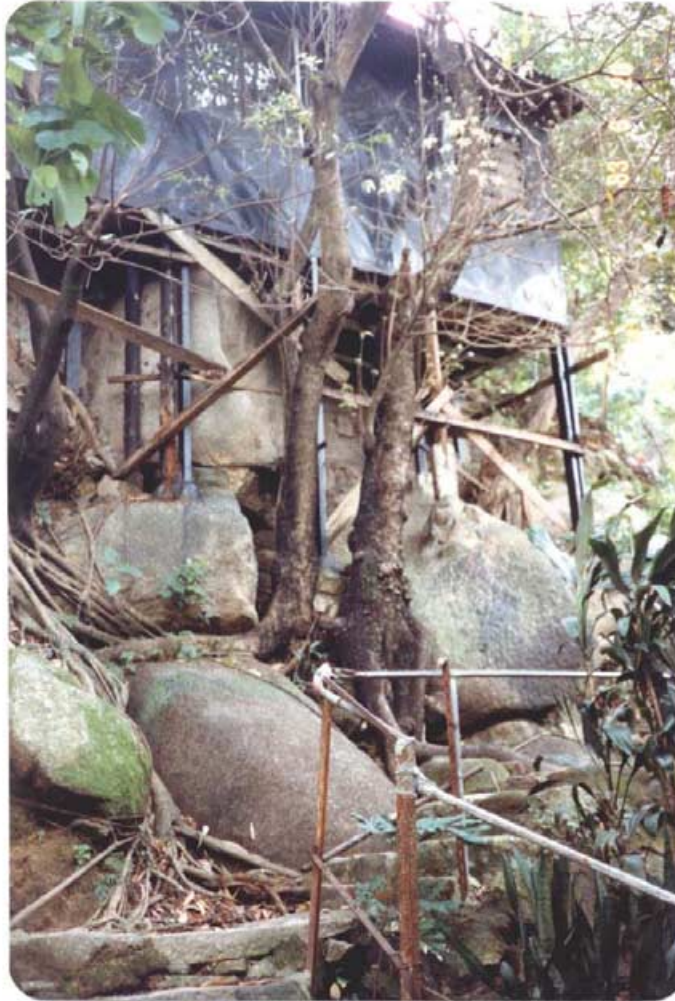
1. Squatter huts founded on unstable boulders.
2. Extensive evacuation of over 50 huts in the area.
3. See Section 5.5 for further details.

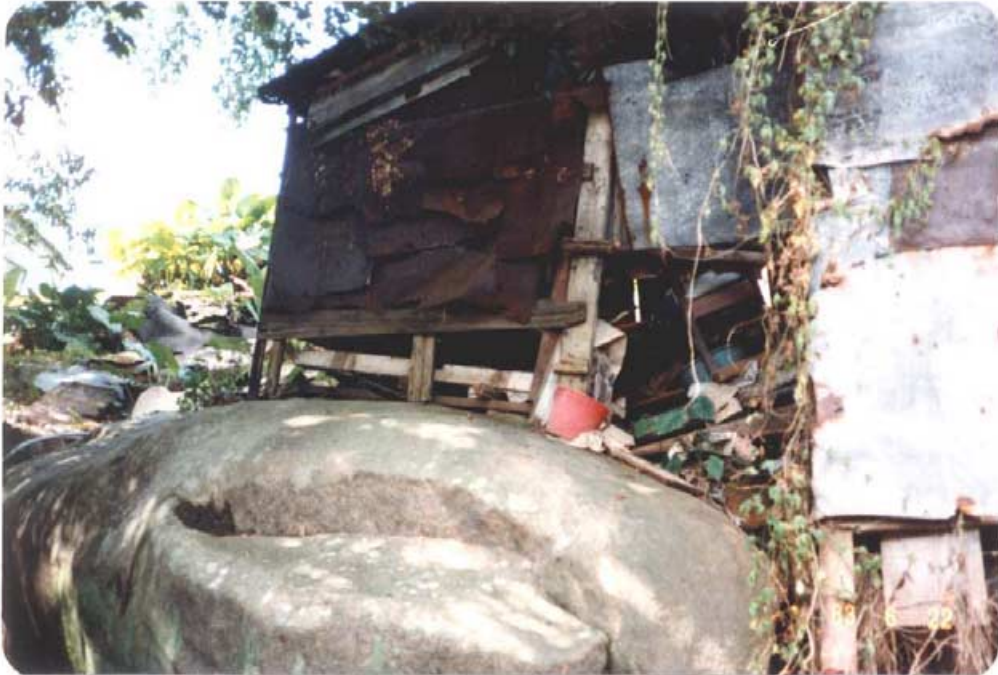
1. Huts founded on unstable boulders.
2. 3 huts evacuated.

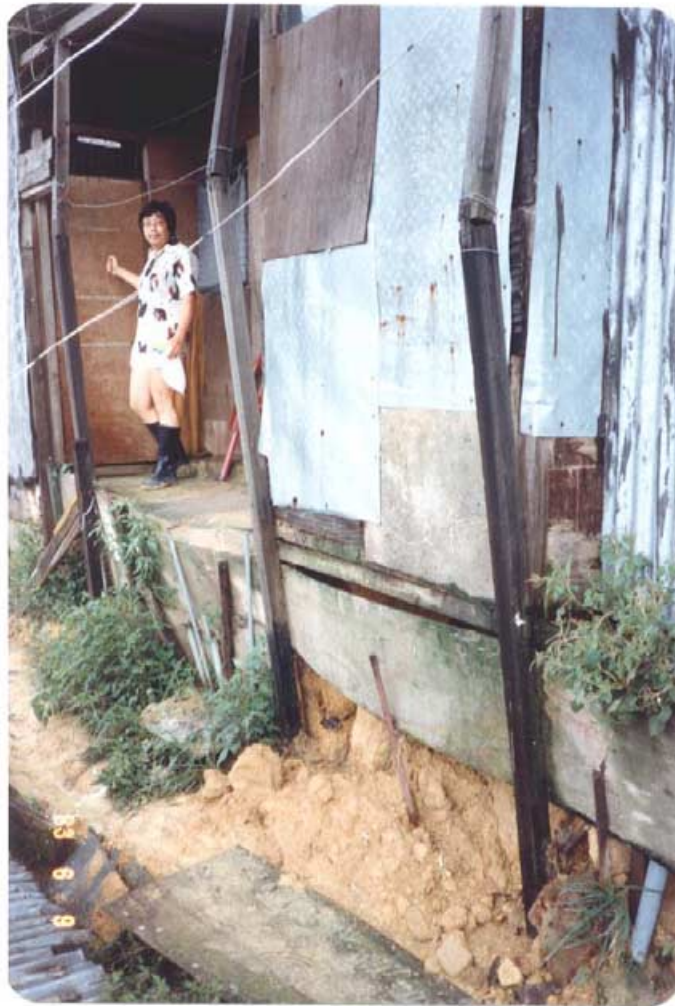
1. Erosion of fill platform underneath a squatter hut.
2. Foundation partly exposed and huts tilted.
3. 2 huts evacuated.

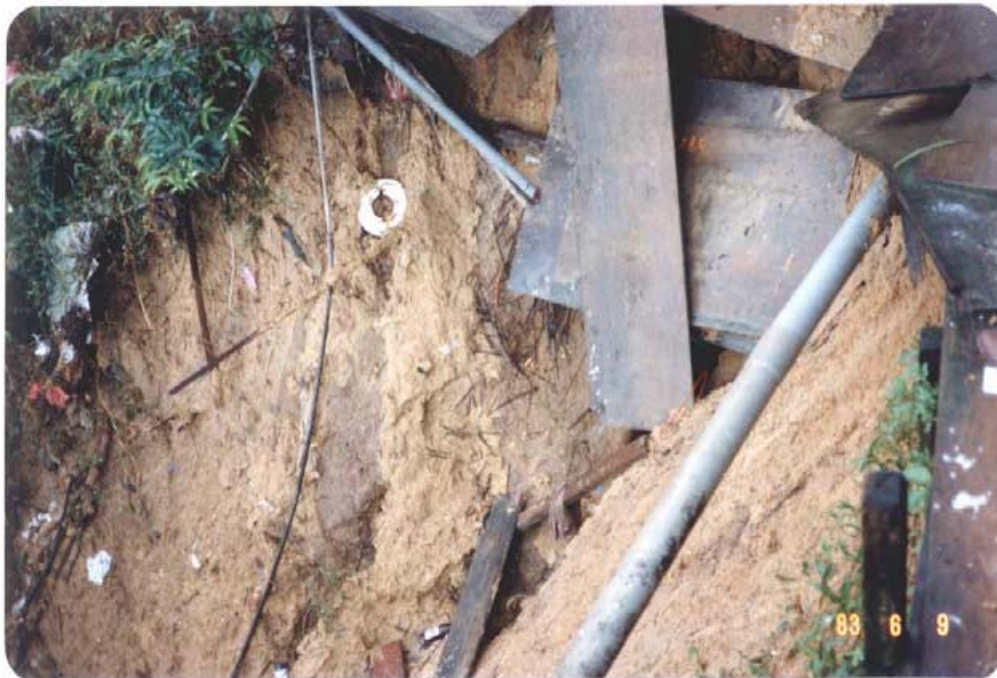
1. Erosion of a fill platform over a natural gully underneath a squatter hut.
2. The small diameter by-pass pipe buried in the fill was under capacity for the storm discharge and the fill platform was therefore eroded.
3. Foundation of the hut was undermined and the hut evacuated.
