APPENDIX A

REPORT ON THE STUDY OF OLD MASONRY RETAINING WALLS  
BY GCO (1980)

APPENDIX D

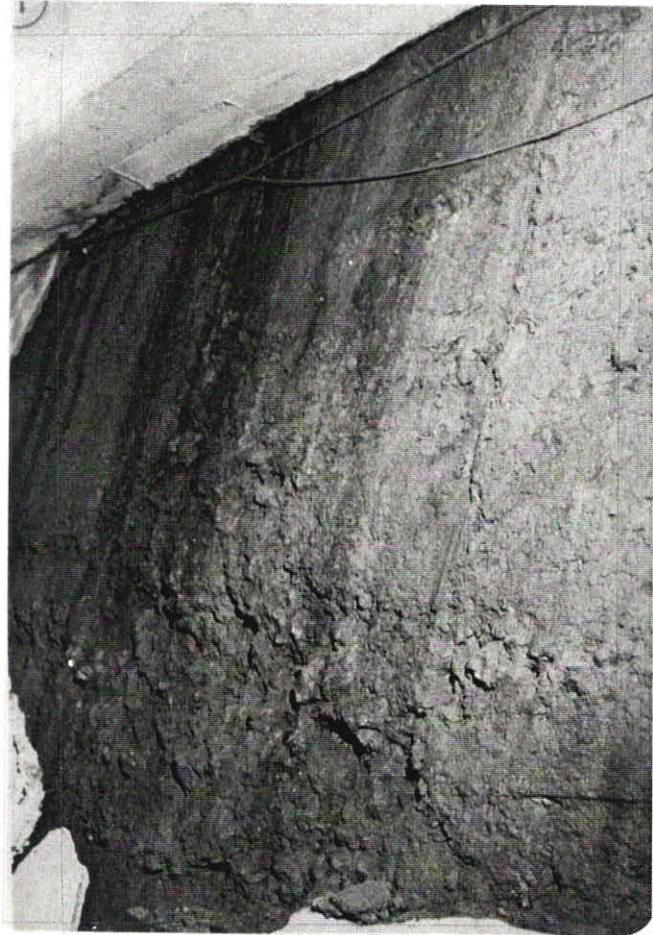
Negative No. R/W 81.12.18

5. The unfailed sections of the wall was again brought to attention in the September 1973. The wall was found to be composed of poor quality lime stabilised soil. It crept under pressure and high groundwater regime. Consequently, it pressed against the beams and columns of the building and induced shear cracks on them. Where the wall is not supported by the structural members of the building, it bulged out (Plates D3.1 to D3.4).

Plate D3.1 -  
Retaining Wall at Castle Road -  
Poor Quality Material of the Wall

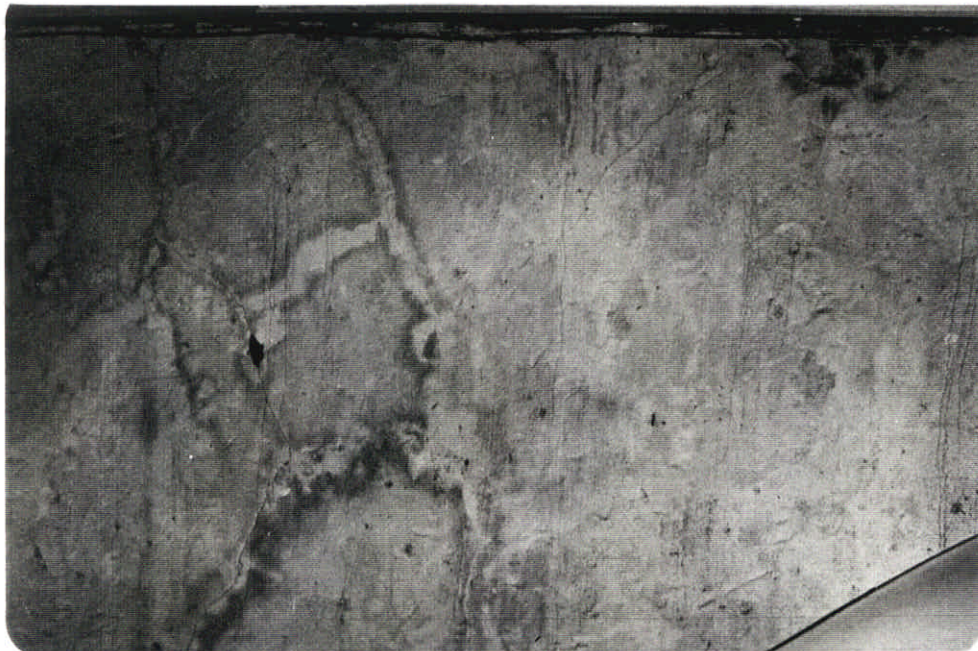
Negative No. R/W 81.12.15

Plate D3.2 - Retaining Wall at Castle Road - Cracks Induced on the Surface Finish  
by the Bulging of the Wall

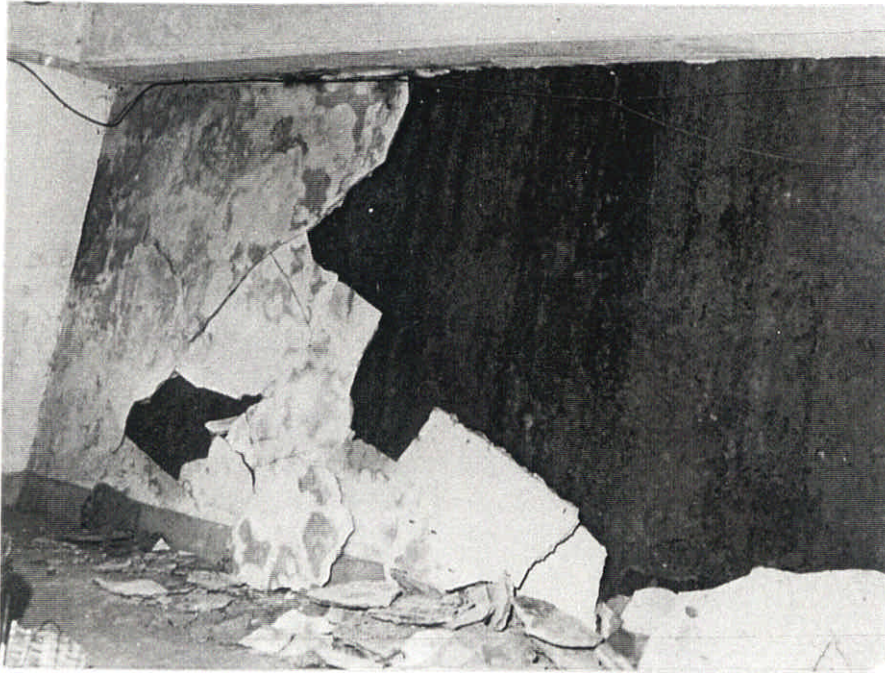
Negative No. R/W 81.12.16

Plate D3.3 - Retaining Wall at Castle Road - Bulging of the Wall Caused Failure of the Plaster Layer

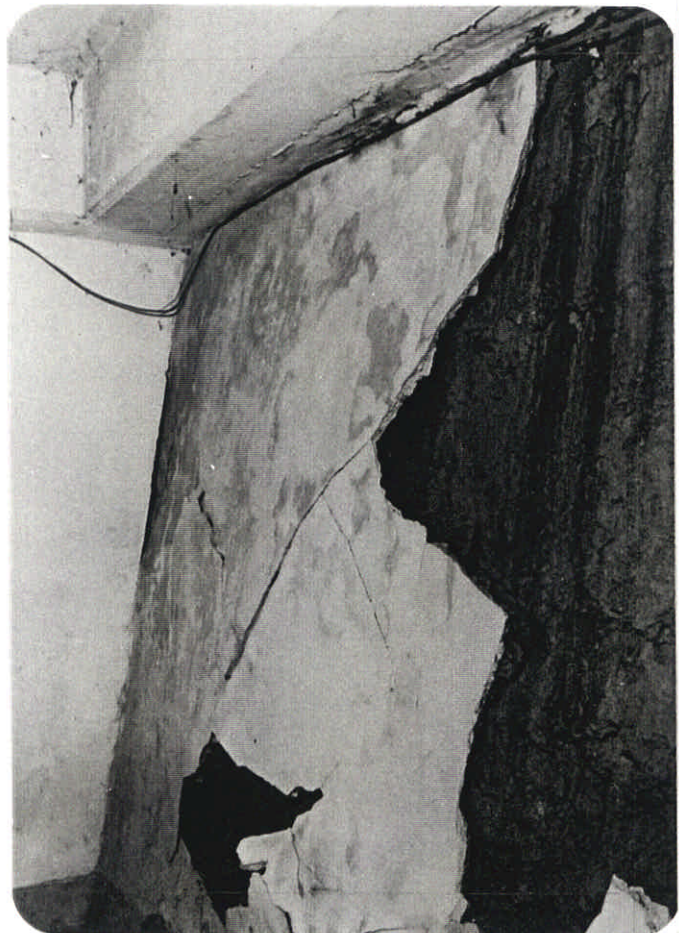
Negative No. R/W 81.12.17

Plate D3.4 -  
Retaining Wall at Castle Road -  
Shear Cracks Caused by the  
Pressure from the Yielding Retaining  
Wall

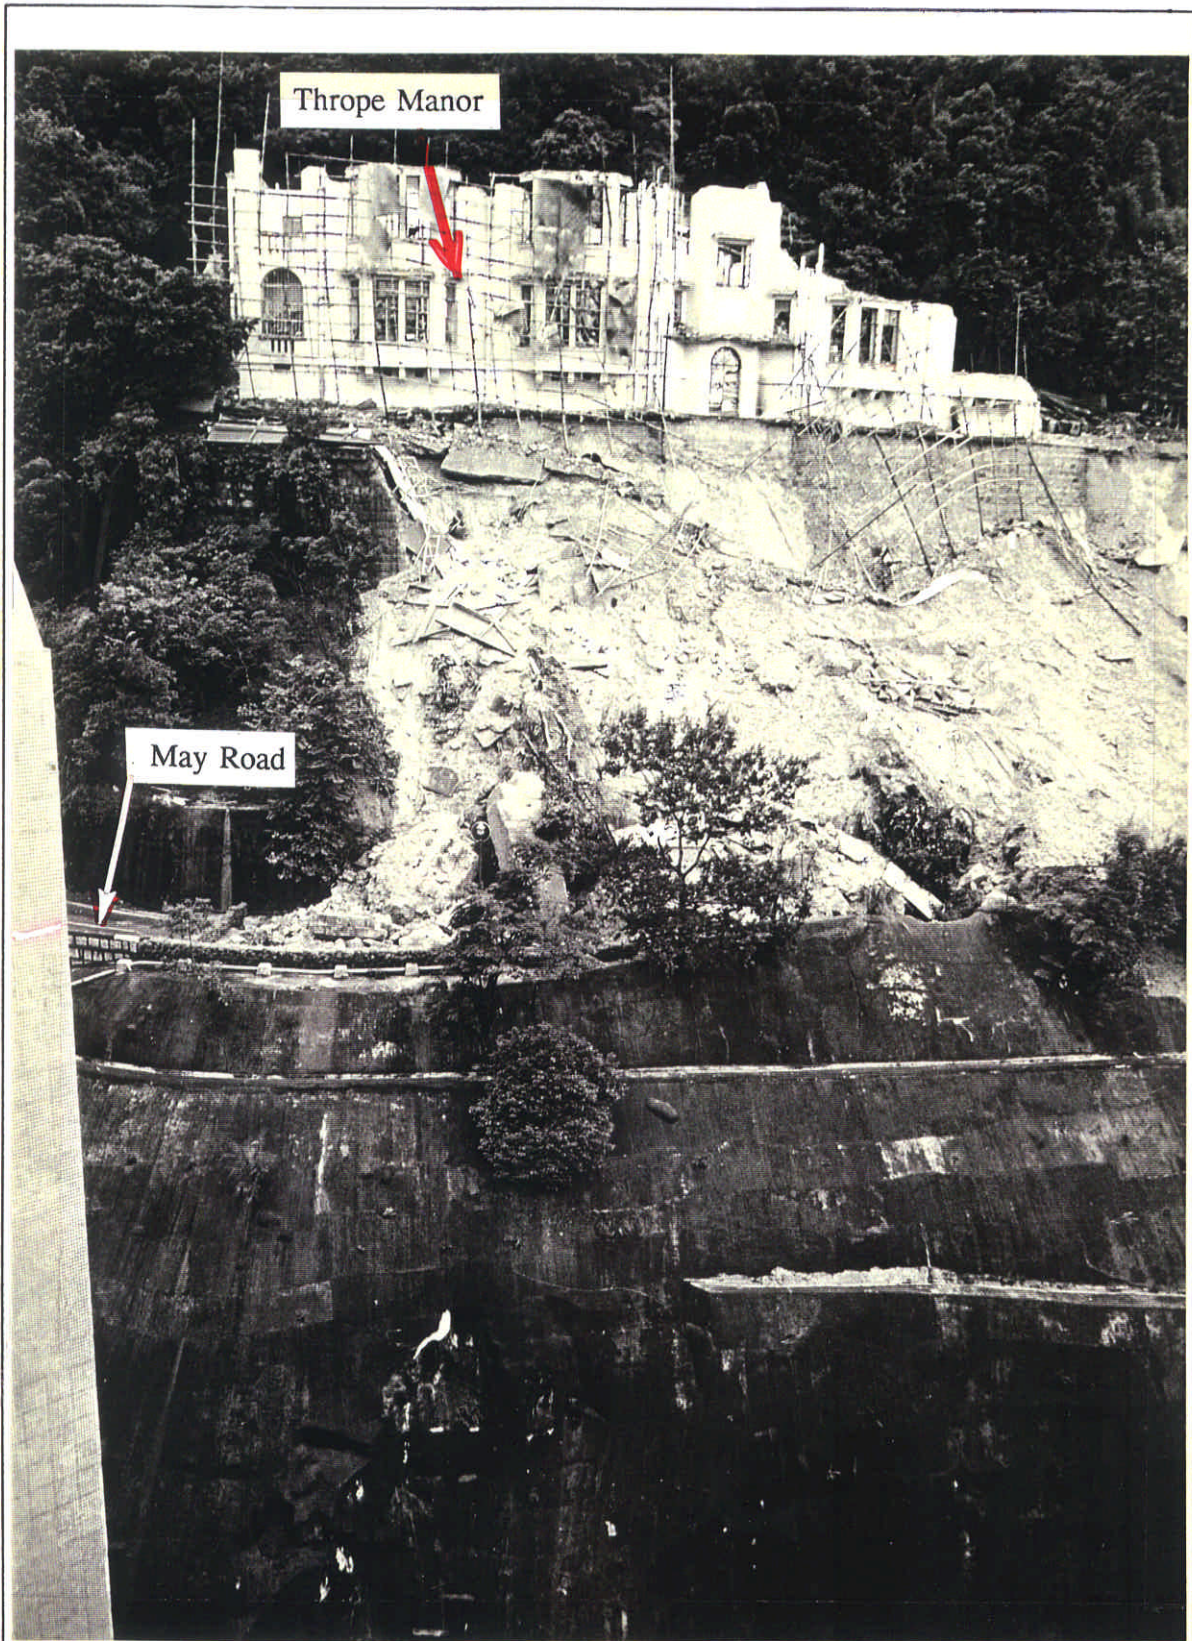
Negative No. 7/98/73

6. As the party of engineers approached the site, the second slip occurred. This was the major slip. It was described by the inspection engineers as "the sliding and overturning of a major portion of a retaining wall". The failed wall was the subject wall.

7. Plates D4.1 to D4.3 shows the failure at the day of the incident.
8. The fallen wall was described as "to have remained intact with sections weighing approximately 200 tons". These large sections nearly fell over the edge of the cut slope at the rear of Grenville House but was stopped in time by a low bund at the crest of the slope.

Plate D4.1 - Retaining Wall at May Road - Photo of the Failure Taken from Grenville House (I)

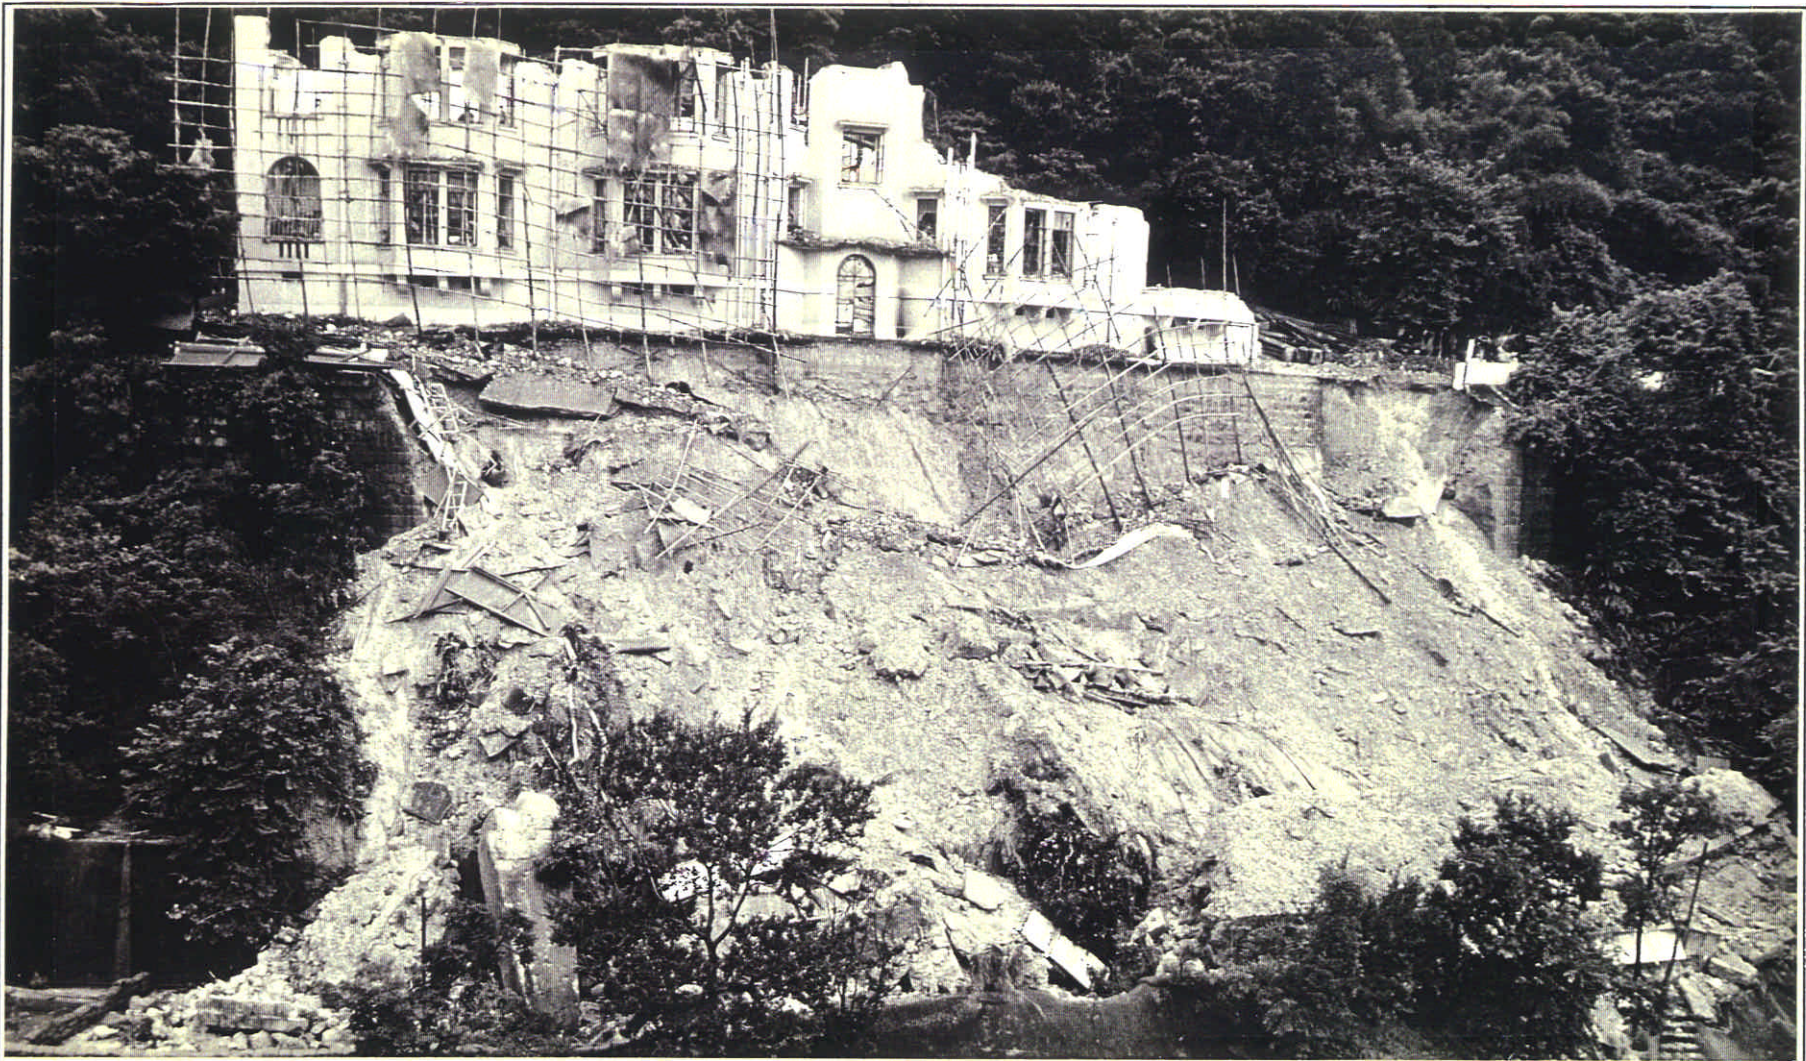
Negative No. 8/98/73

Plate D4.2 - Retaining Wall at May Road - the Failure (II)

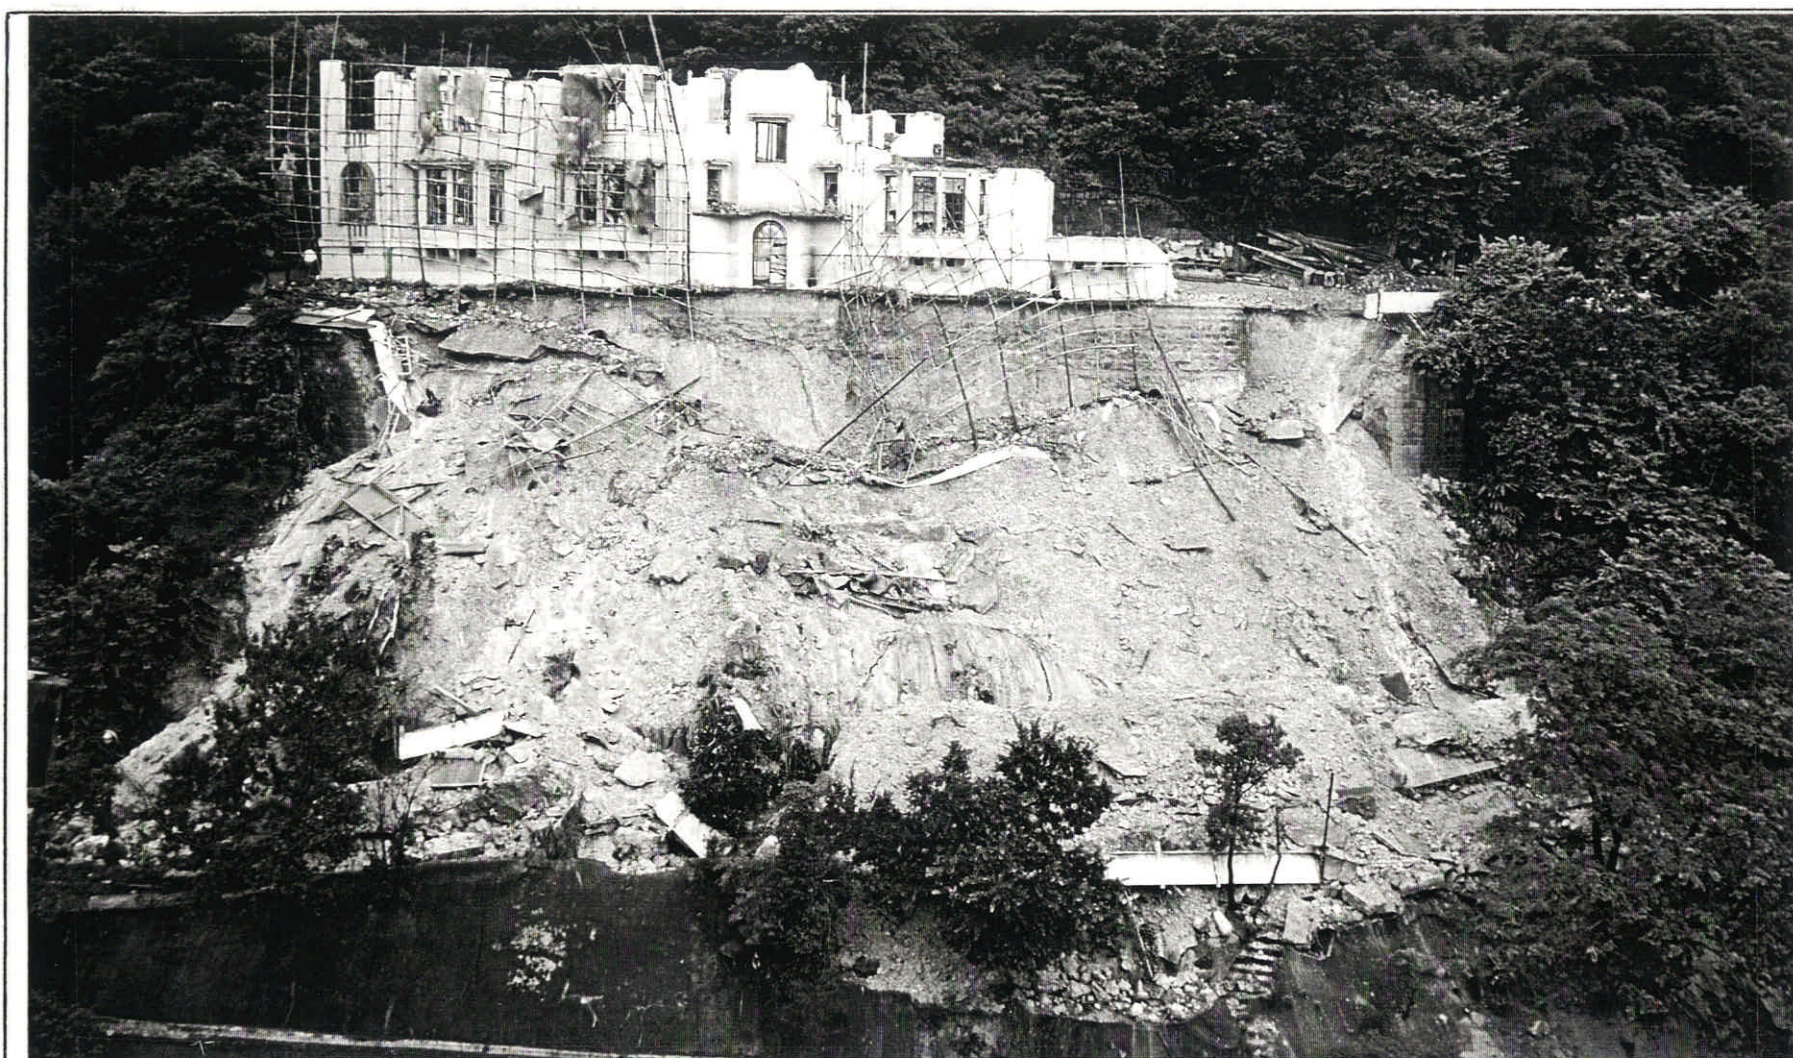
Negative No. 3/98/73

Plate D4.3 - Retaining Wall at May Road - the Failure (III)

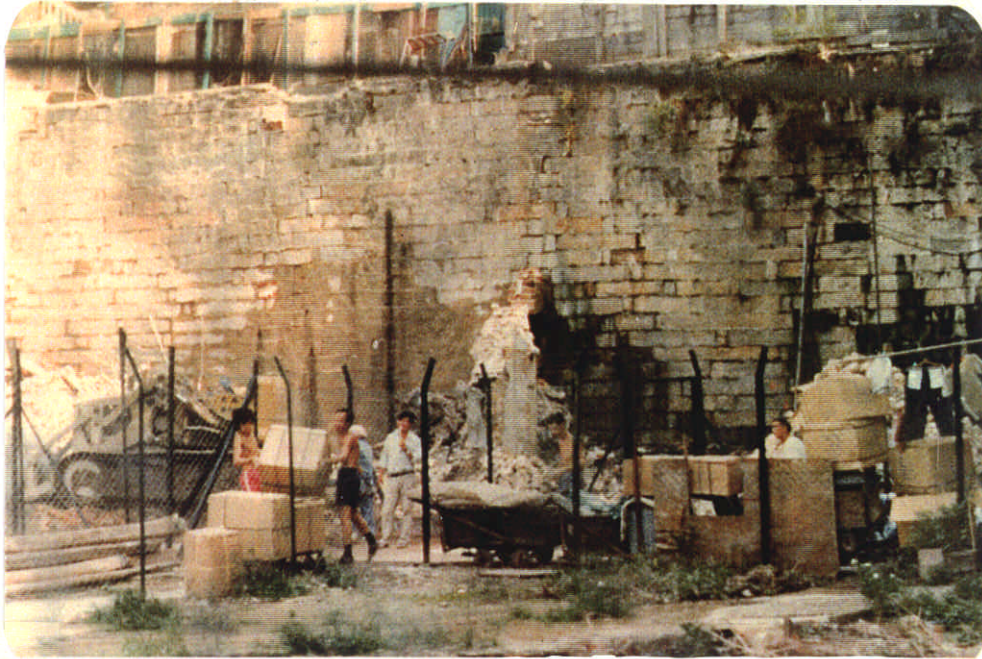
Negative No. R/W 81.09.01

7. Plate D6.1 shows the wall near 10, 11 Circular Pathway towards the end of the demolition work.
8. On 8.8.77, when the demolition works were substantially completed, a post-demolition inspection was made (by the same engineer of the pre-demolition inspection) on the area. A continuous crack was found on Circular Pathway adjacent to the granite blocks of the retaining wall.

Plate D6.1 - Retaining Wall at Circular Pathway - the Wall at the End of the Demolition of the Houses on the Toe Platform

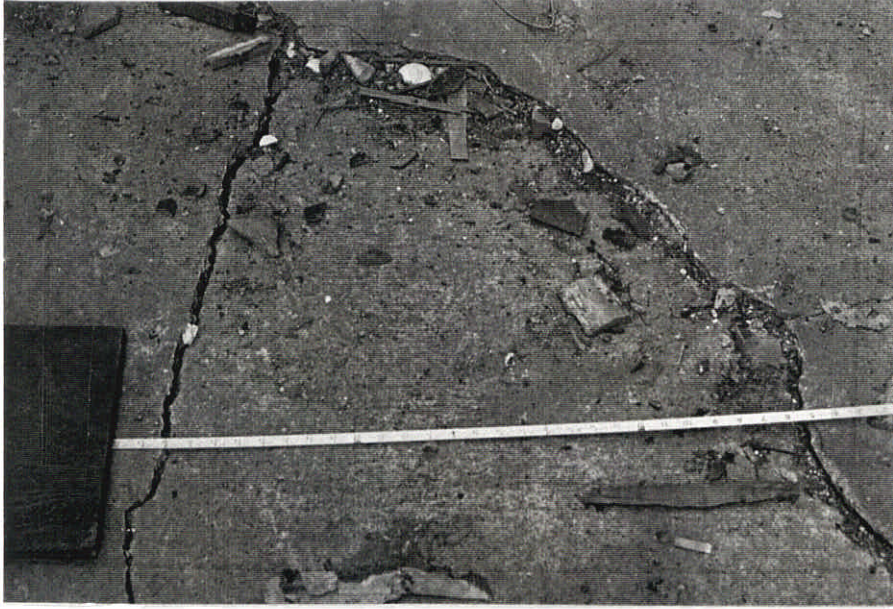
Negative No. 8/59/77

Plate D6.11 - Retaining Wall at Circular Pathway - Detail of the Cracks on the Pathway (I)

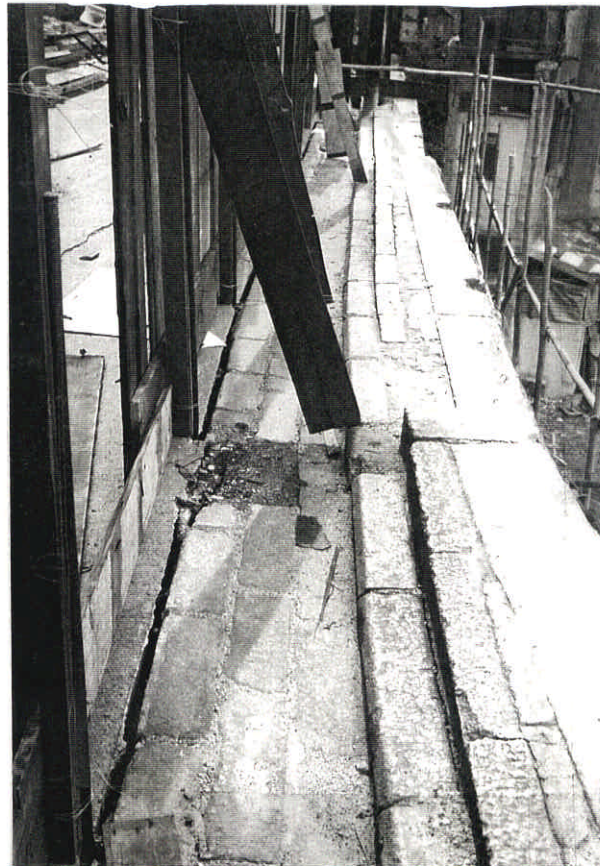
Negative No. 7/59/77

9. The wall was inspected again on 9.8.77, the crack was found to have "noticeably" widened (to 6 mm wide).
10. On 10.8.77, the wall was classified as "showing signs of movement and instability in condition of prolonged rainfall".

Plate D6.12 -  
Retaining Wall at Circular Pathway -  
the Crack between the Wall and the  
Pathway

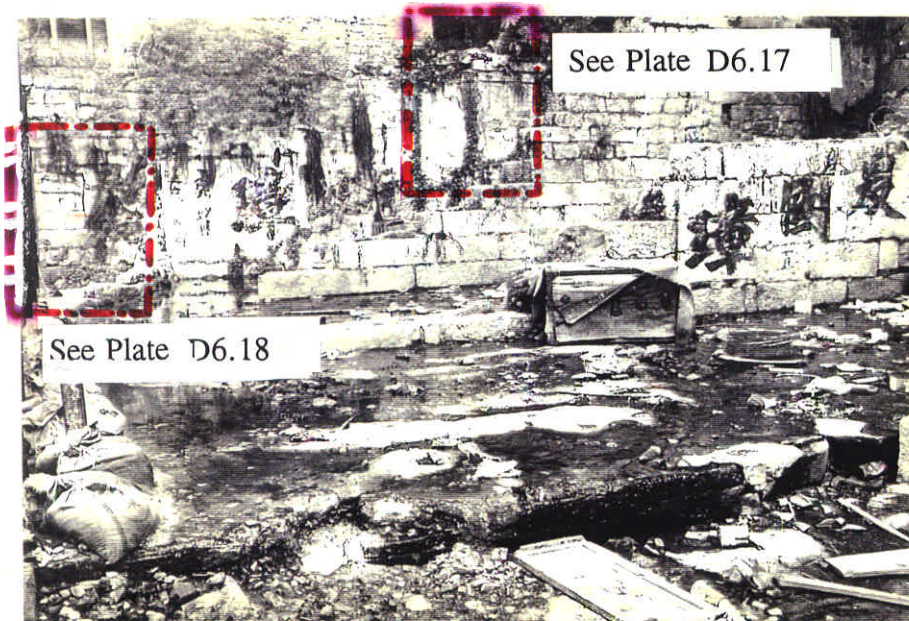
Negative No. 15/59/77

Plate D6.16 - Retaining Wall at Circular Pathway - Movements Observed on the Vacant Sites at the Crest Platform (below 127-133 Hollywood Road)

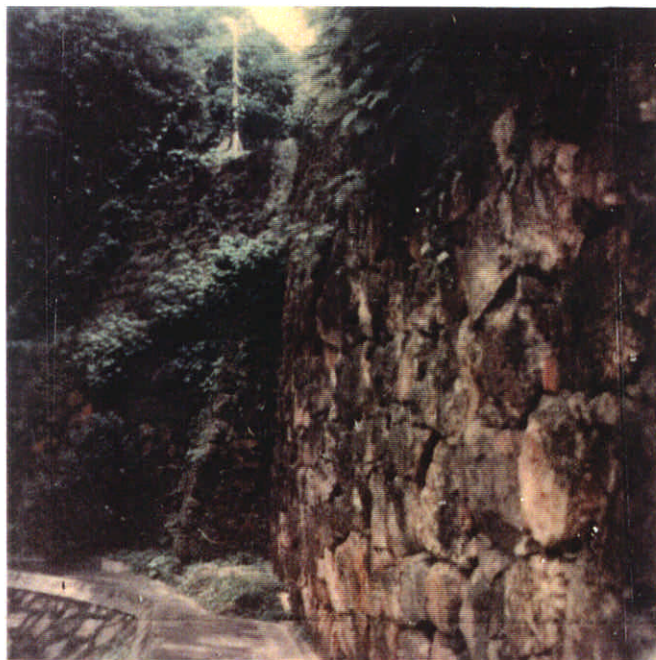
Negative No. R/W 81.12.13

3. The wall was inspected by a geotechnical engineer on 11.5.78. He discovered signs of instability, i.e. "bulging, voids between blocks, and compression cracking at the face" (Plate D7.1).

Plate D7.1 - Retaining Wall at 22, Old Peak Road - Bulging of the Retaining Wall

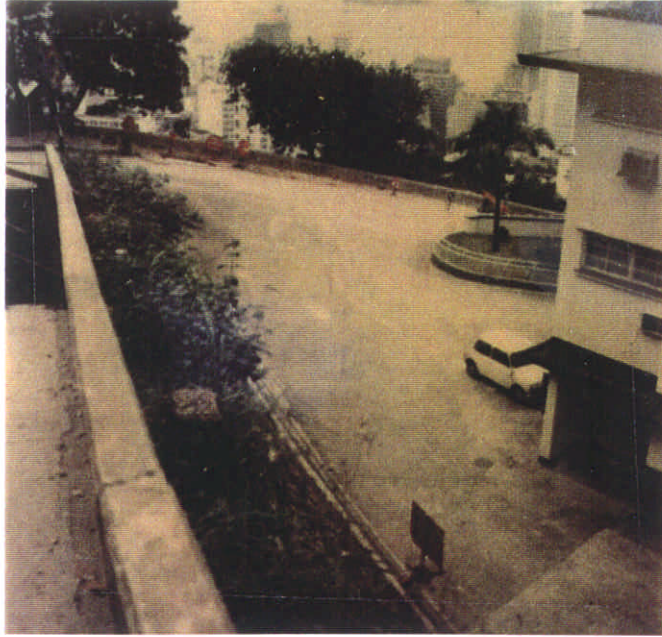
Negative No. R/W 81.12.11

Plate D7.2 - Retaining Wall at 22, Old Peak Road - Bulged Parapet at the Crest of the Wall

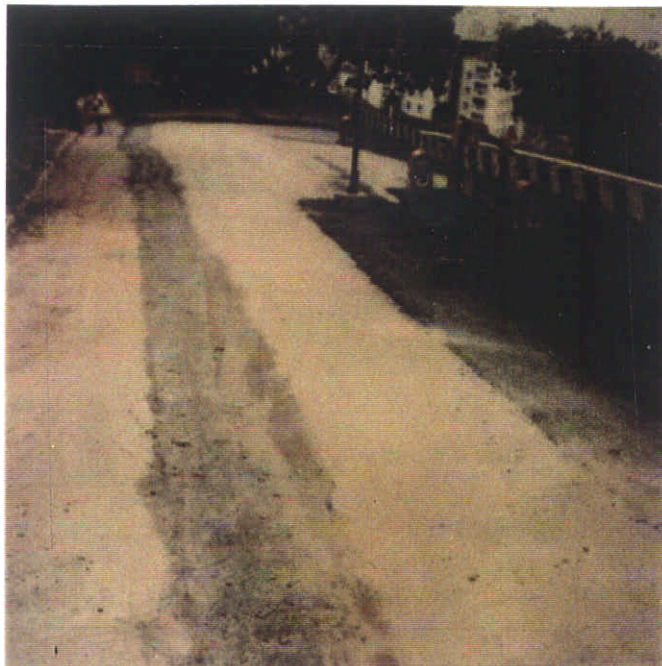
Negative No. R/W 81.12.12

4. It was not known whether these signs were new or had been there for a period of time.
5. There were signs of subsidence and cracking on the road at the crest. From the photographs (Plate D7.3 to D7.4) it can be seen that there was a newly reinstated trench on the uphill side of the road. At approximately midway between the trench and the parapet was a long continuous crack parallel to the alignment of the road. There has been some subsidence on the area between the crack and the parapet. The darker colour of newly repatched road surface could be seen.

Plate D7.3 - Retaining Wall at 22, Old Peak Road - Recent Road Works on Old Peak Road

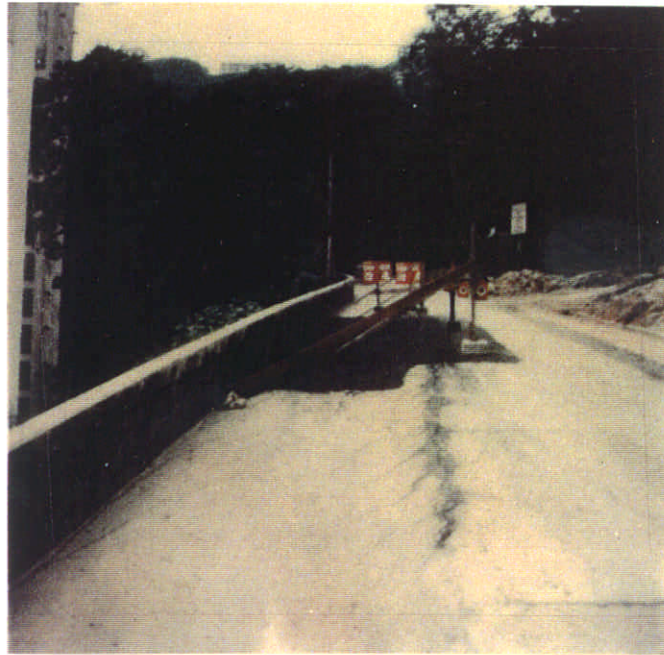
Negative No. R/W 81.12.09

Plate D7.4 - Retaining Wall at 22, Old Peak Road - Longitudinal Crack on Old Peak Road

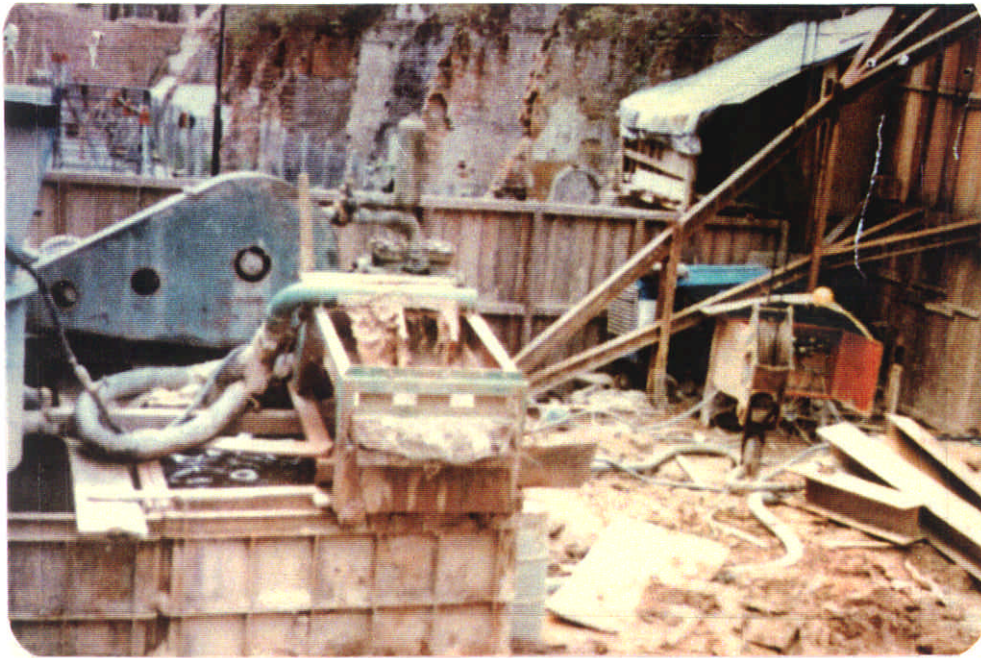
Negative No. R/W 81.17.14

Plate D8.4 - Retaining Wall at Fat Hing Street - View of the Shoring Adjacent to the Portion of the Wall Which Later Failed

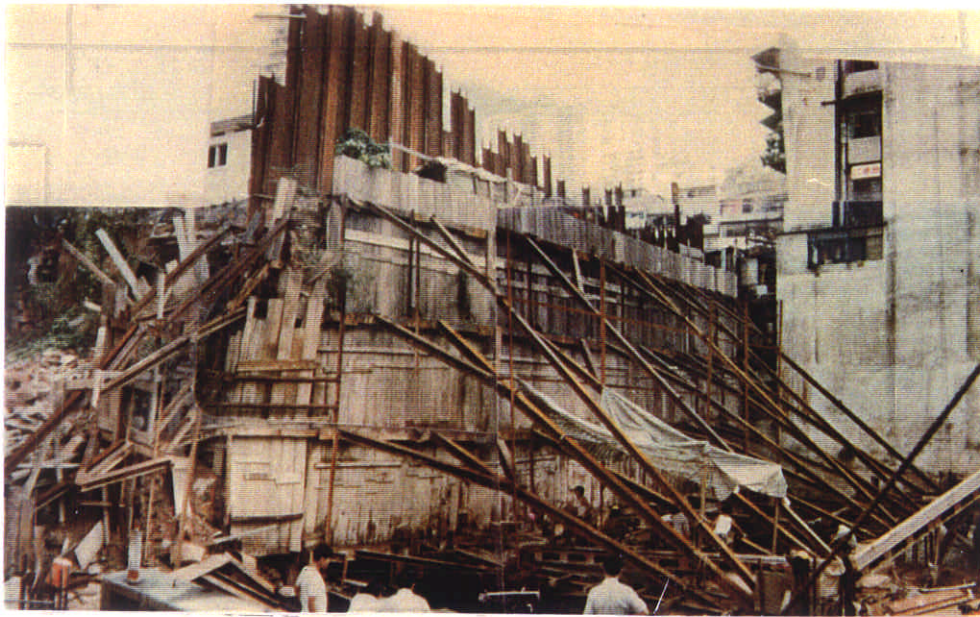
Negative No. R/W 81.17.18

Plate D8.6 - Retaining Wall at Fat Hing Street - Panoramic View of the Shoring to the Tied Face Wall at the Adjacent Site, after the Incident

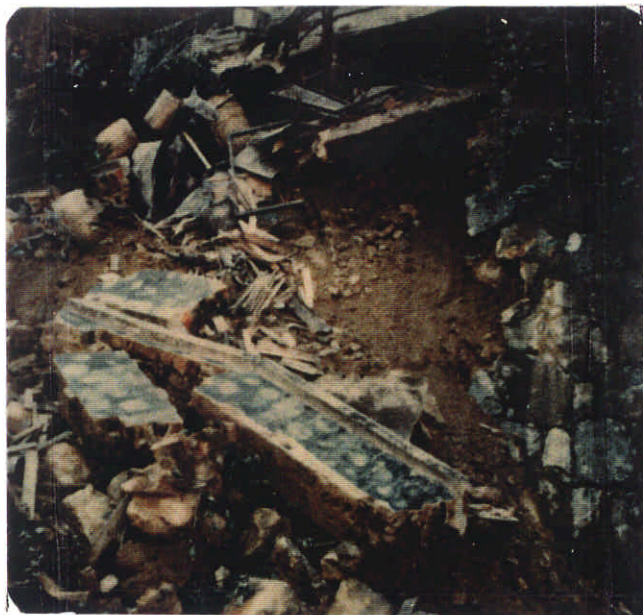
Negative No. R/W 81.09.16

Plate D9.2 - Retaining Wall at Wing Wa Terrace - the Failure, Looking South-East

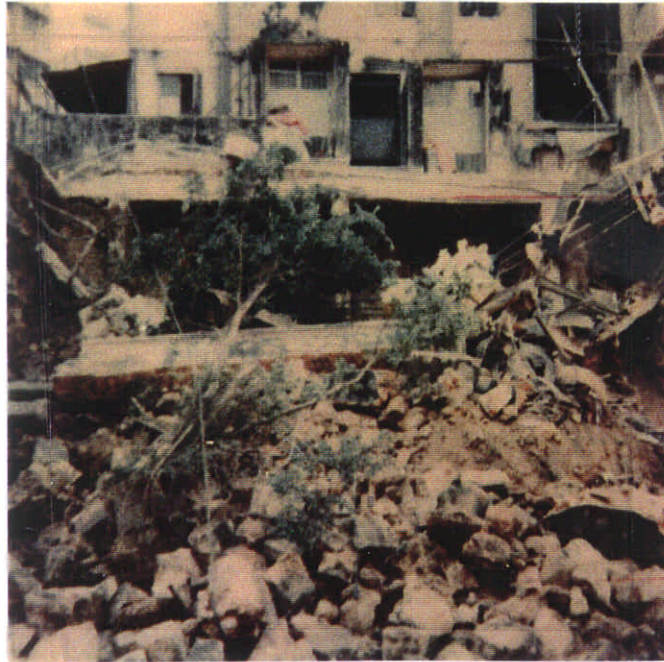
Negative No. R/W 81.12.08

Plate D9.3 - Retaining Wall at Wing Wa Terrace - the Failure, Looking South

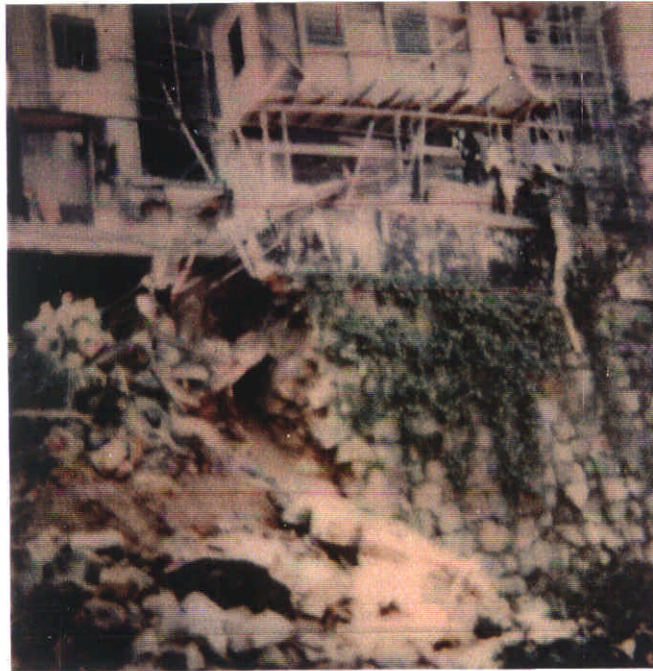
Negative No. R/W 81.12.00

Plate D9.4 - Retaining Wall at Wing Wa Terrace - the Failure, Looking South-West

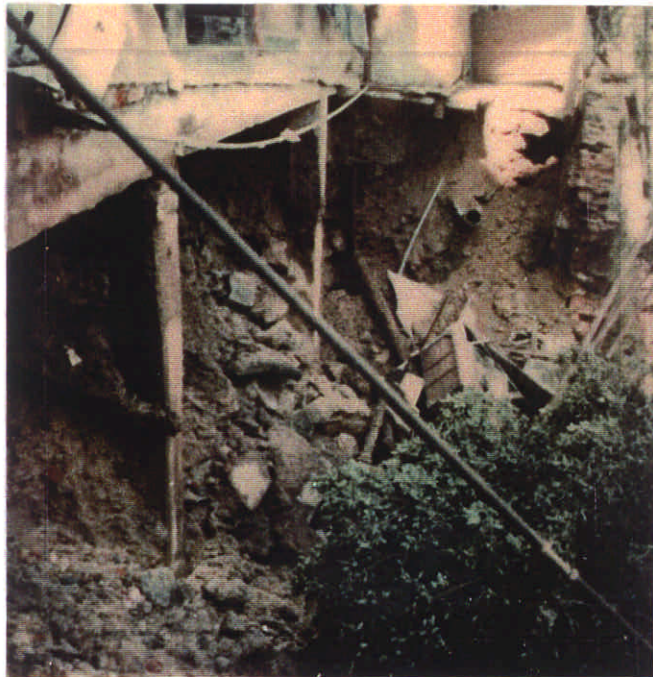
Negative No. R/W 81.12.05

Plate D9.5 - Retaining Wall at Wing Wa Terrace - the Failure, Looking West
