# **PERFORMANCE OF HORIZONTAL DRAINS IN HONG KONG**

**GEO REPORT No. 42**

**R.P. Martin, K.L. Siu & J. Premchitt**

**This report was originally produced in December 1994  
as GEO Special Project Report No. SPR 11/94**

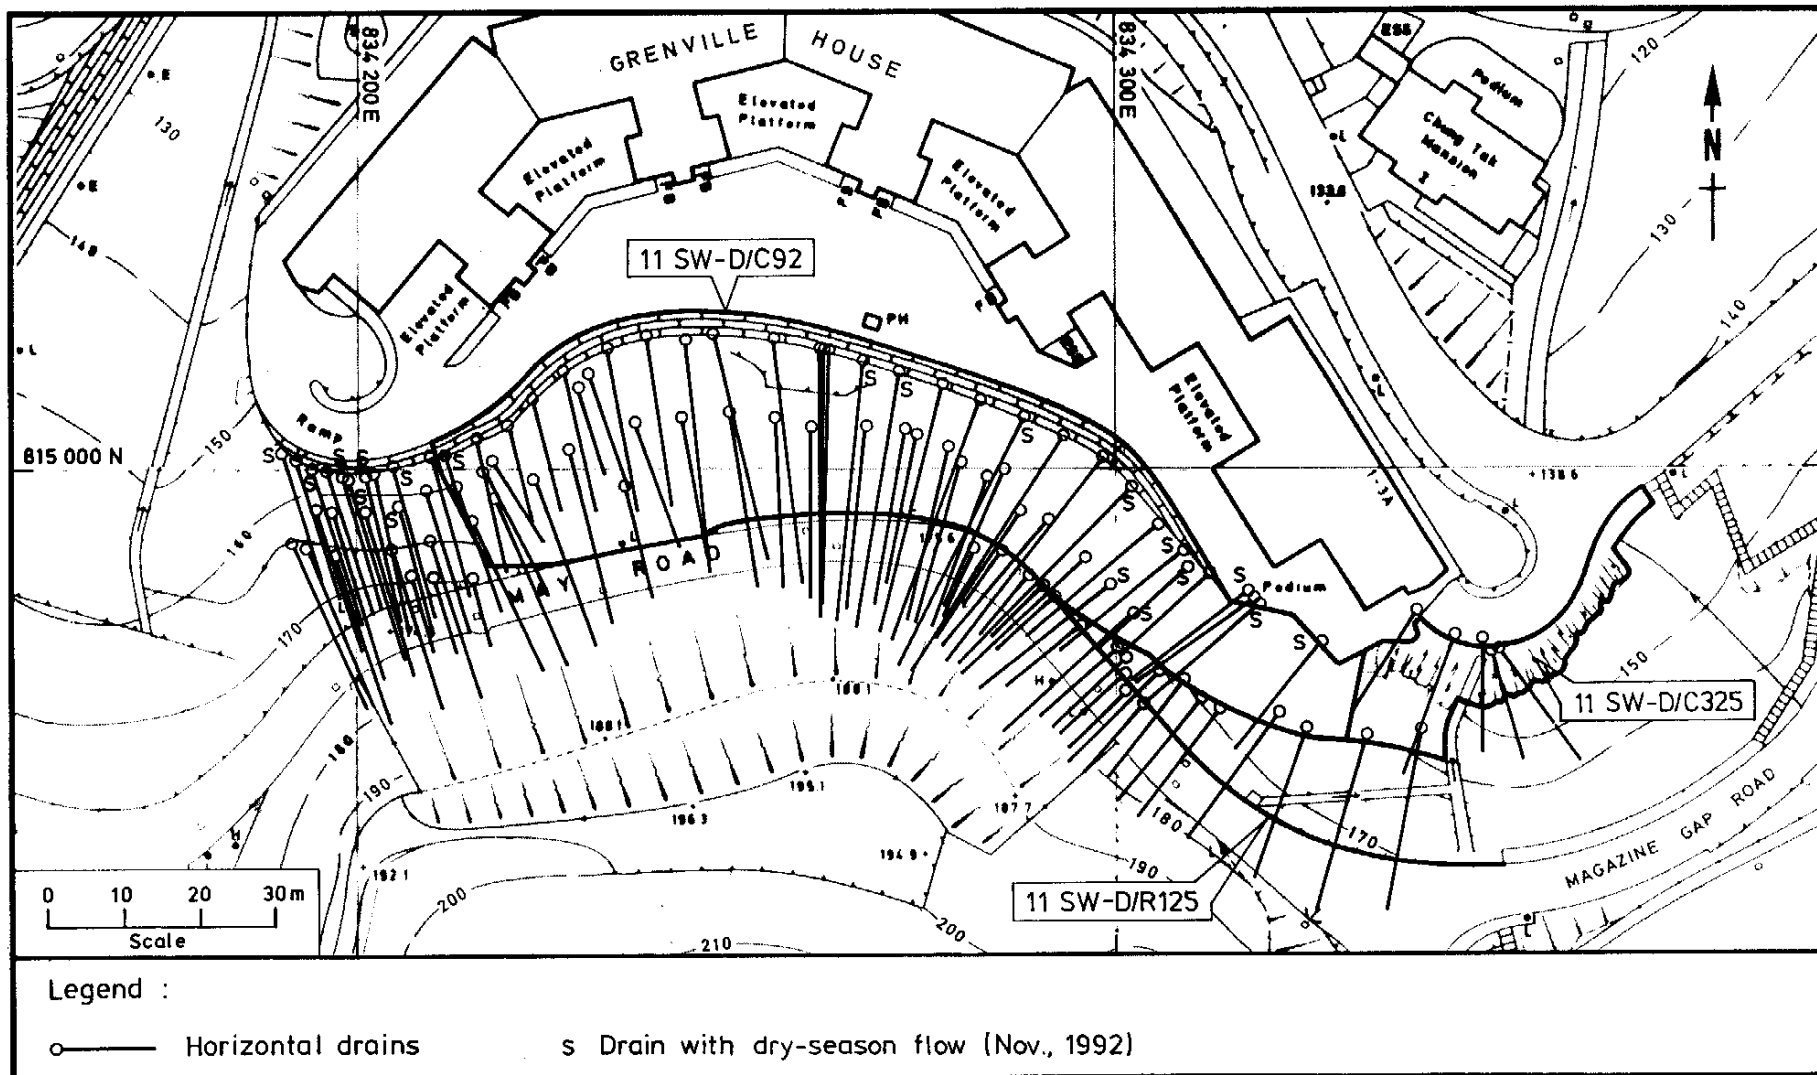
Figure 12 - Layout of Horizontal Drains Behind Grenville House (after Tong & Maher, 1975)

Inspection of the slope in November 1992 revealed no signs of distress or deterioration around the drain outlets. It is clear that at least 15 of the drains produce perennial flows (Figure 12). Although the performance of the drains has not been comprehensively assessed from piezometric monitoring, the conclusion from the available evidence is that the drain system appears to be functioning satisfactorily and effectively after more than 18 years.

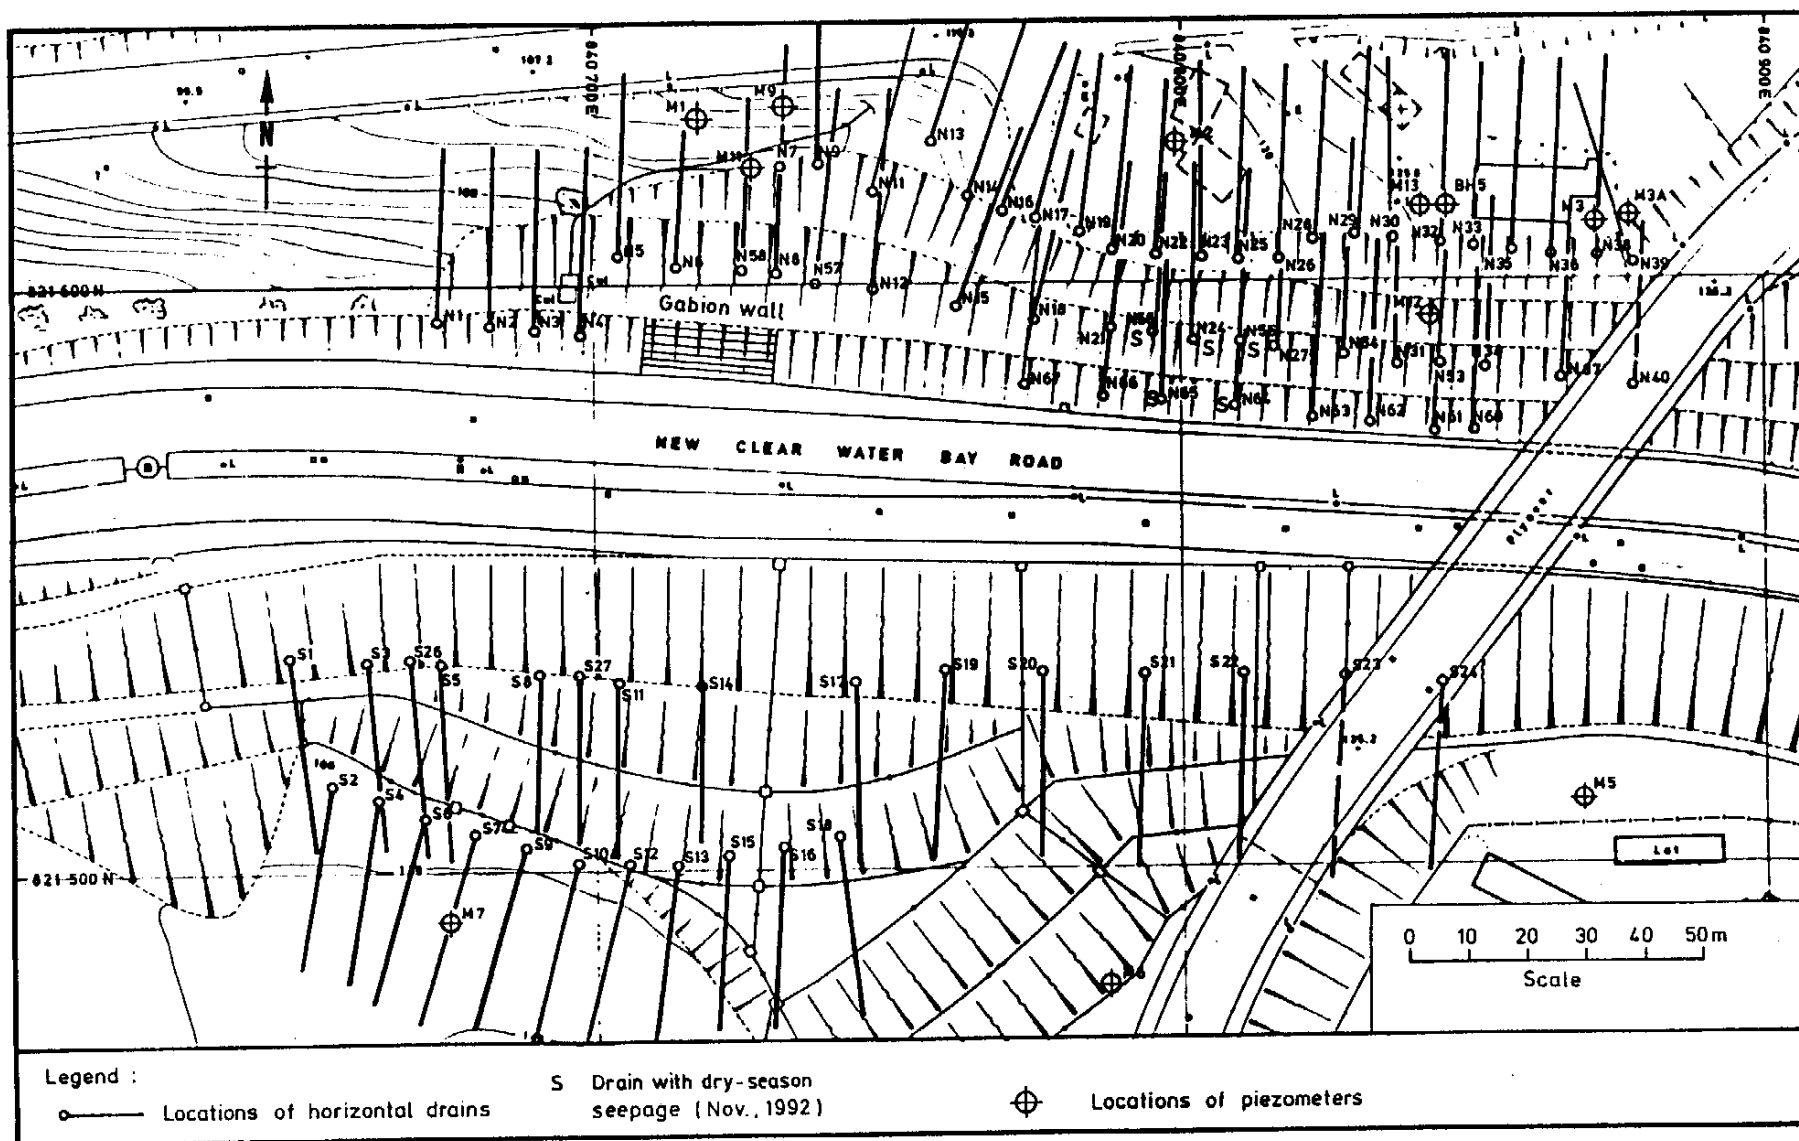
Figure 16 - Layout of Horizontal Drains at New Clear Water Bay Road (after MAA,1983)

The fact that piezometric levels continued to be drawn down over a period of six years indicates that the drains have significantly improved the stability of these slopes. Inspection in November 1992 revealed no signs of slope distress or deterioration. Dry-season seepage was noted in a group of five drains in the central part of the northern slope (Figure 16).

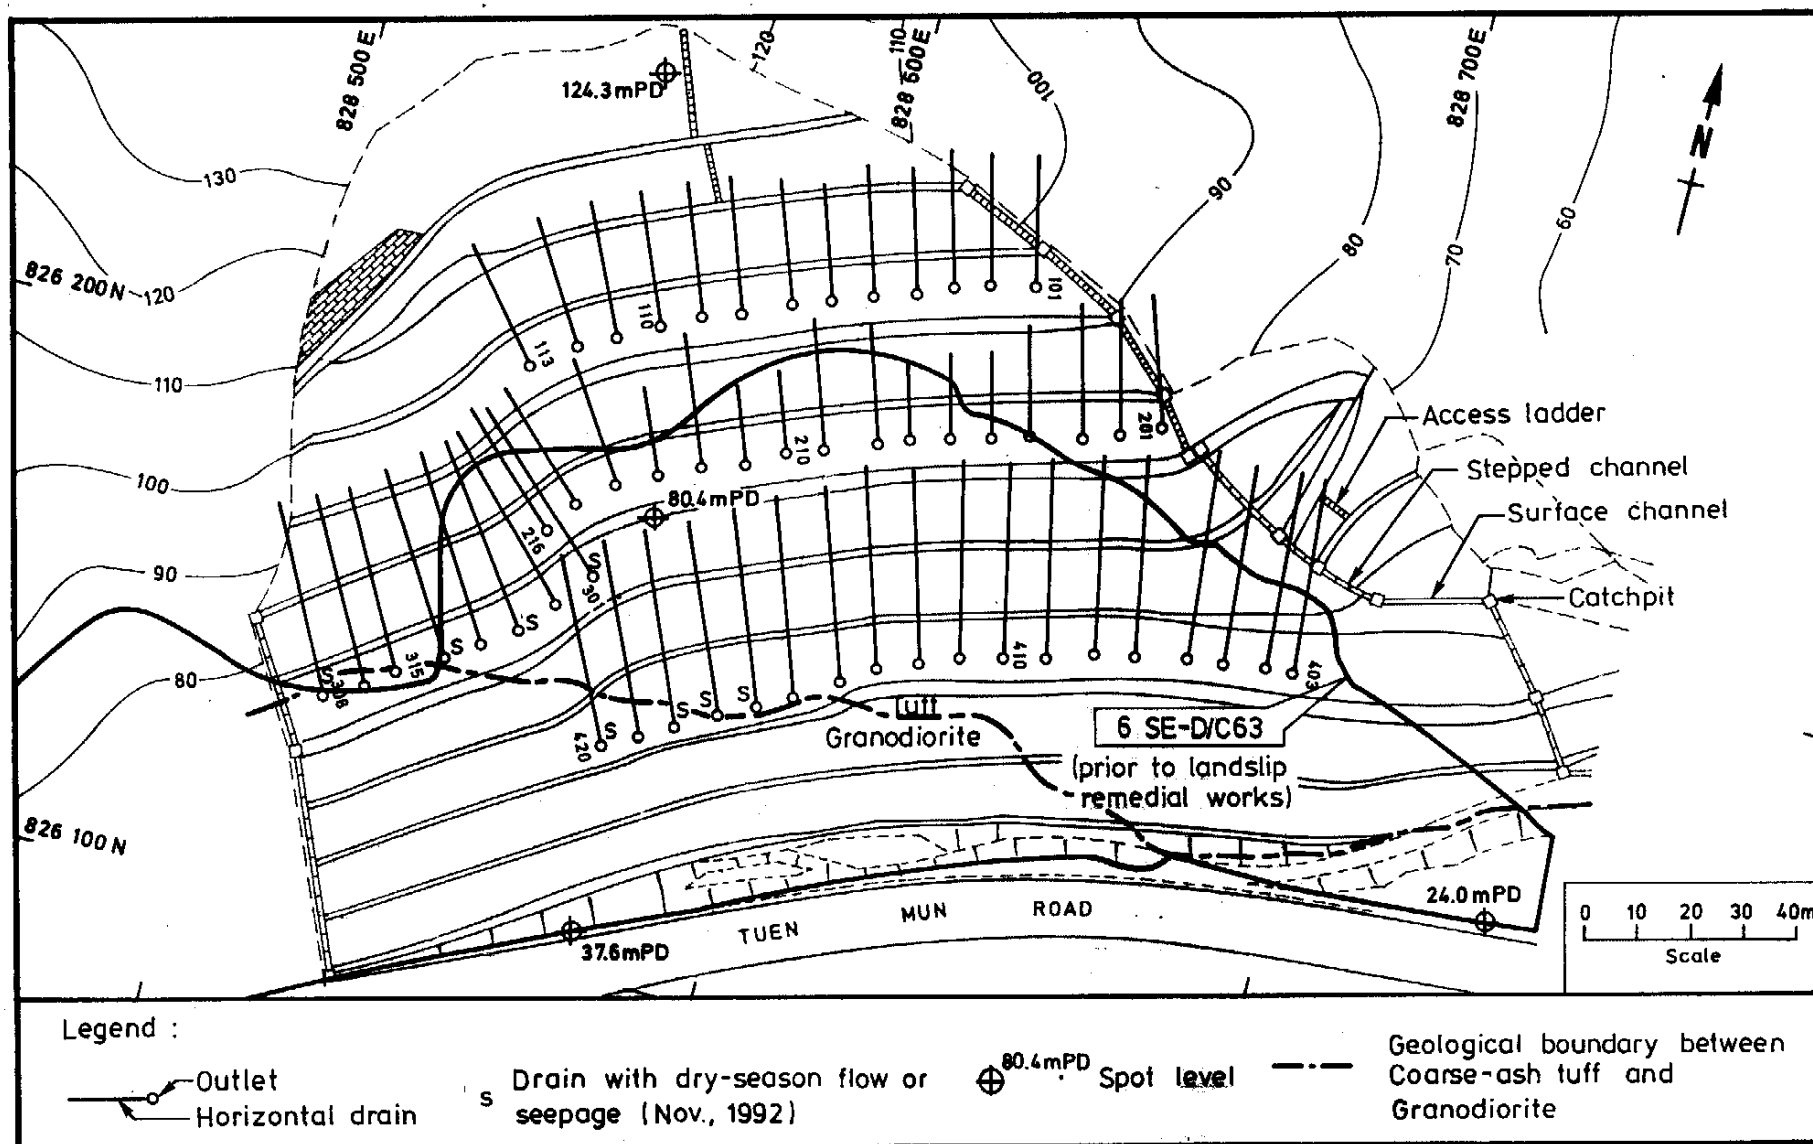
Figure 19 - Layout of Horizontal Drains at Pun Shan Tsuen

Annual inspections and monitoring in the first nine years since installation suggest that there has been no significant deterioration in drain performance. Several drains in the lowest two rows have permanent flows, as shown in Figure 19. Clearly the drains at this site have been effective in achieving the design objective and are making a significant contribution to the long-term stability of the slope.

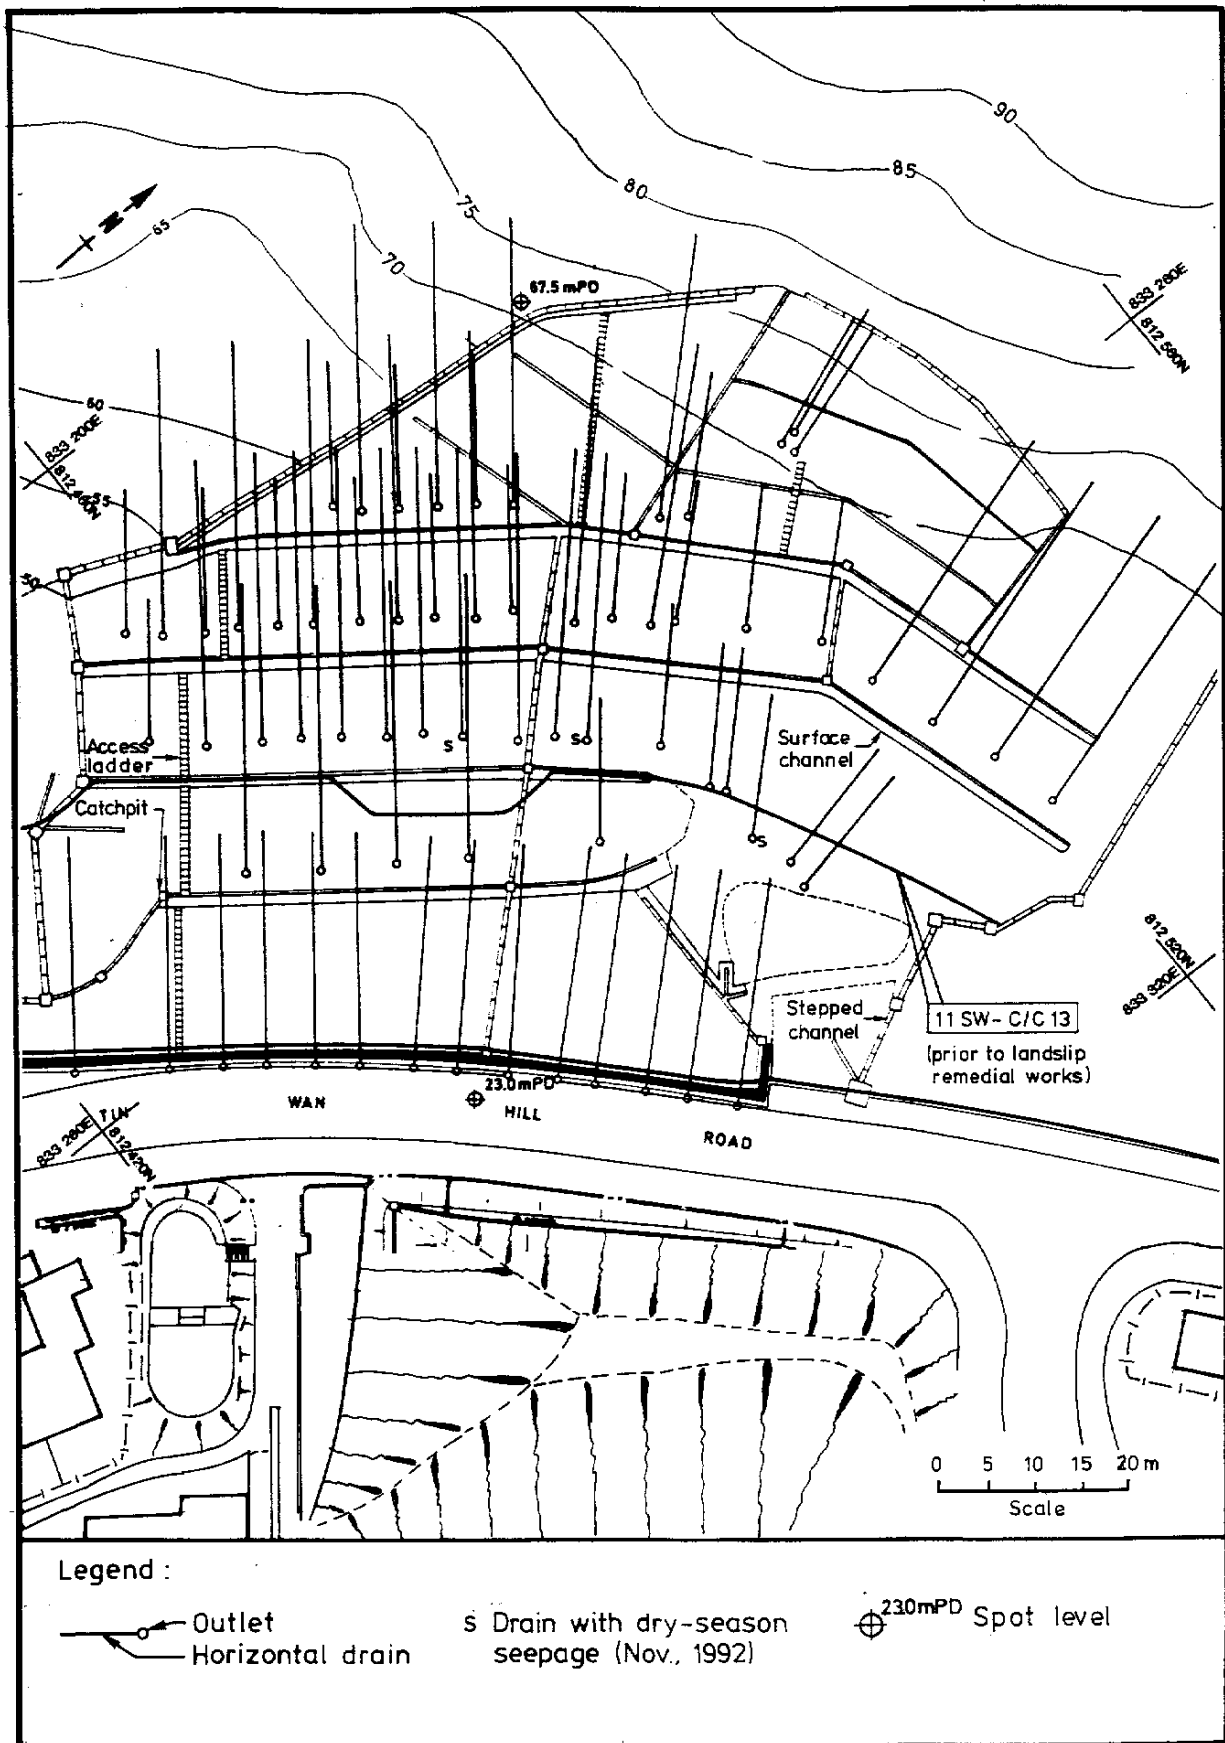
Figure 28 - Layout of Horizontal Drains at Tin Wan Hill Road

A site visit in November 1992 revealed that three drains showed evidence of perennial flows (Figure 28). Up to mid-1993 the slope had remained in a stable condition and no significant piezometric rises had been detected. This suggests the drains are continuing to perform satisfactorily.

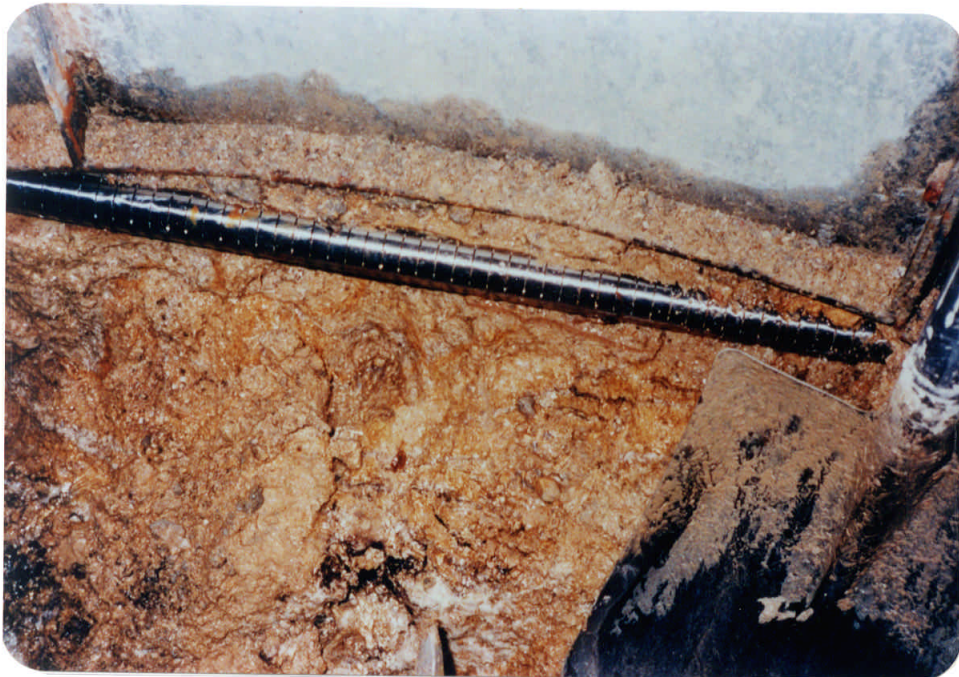
Figure 1F shows a drain including a stainless steel pipe which requires special techniques to install. This type has been used at one site in the Mid-levels area where drains of up to 90 m were required (see Section 3.1). The holes were drilled using an Odex down-the-hole hammer with full casing, telescoped to permit the required hole depth to be achieved. A 36 mm-diameter stainless steel pipe was then installed in the hole, after which the casing was withdrawn. The inner end of the pipe is provided with slots on one side to act as a well screen. Various grout pipes were then installed before the last section of casing was removed. The outer portion of the drain, which was expected to be above the water table, is not fitted with a screen and grout was placed between the pipe and the hole to prevent water flow in the annulus. Plate 4 shows an exhumed drain of this type.

Plate 4 - Exhumed Steel Liner in UngROUTED Drain  
D208B at Po Shan

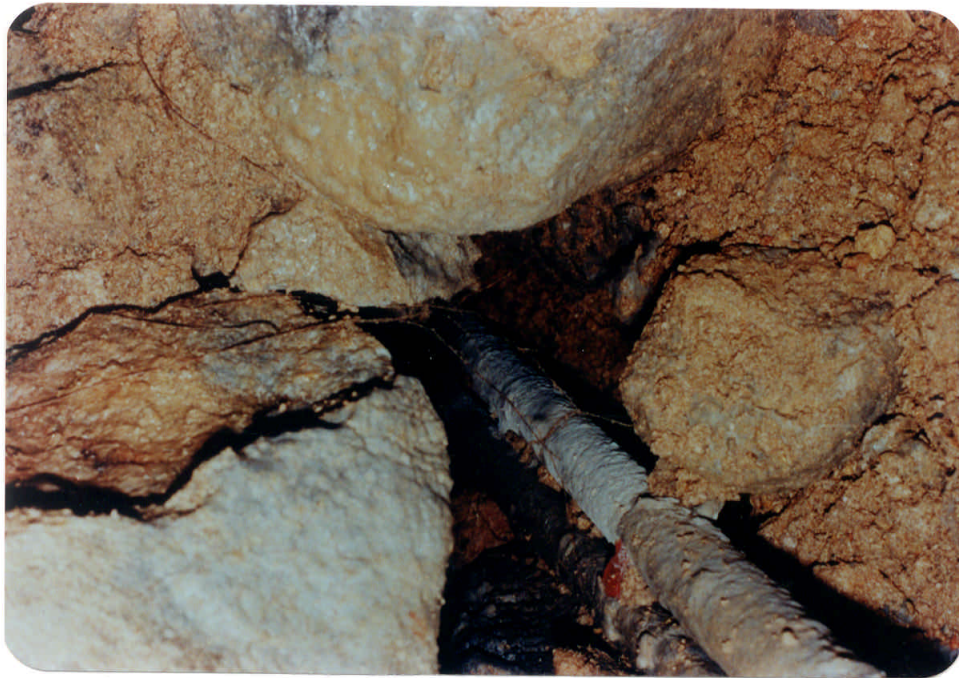
Several drains were uncovered and examined during excavation of the drainage caissons. The first was drain D208, which is about 60 m long. This had been drilled through bouldery fill behind the retaining wall and grouted using double-stage grout pipes. The exhumed drain is shown in Plate 8. The first-stage grout had not completely filled up all the voids and therefore did not provide a proper seal for the second-stage grouting. Water was found to be seeping slowly through the void below the pipe. The amount of seepage was found to increase after the drain was temporarily turned off. The second drain uncovered was D208B. This is a 20 m long, ungrouted drain screened over almost its full length. The supporting soil around the drain was found to have collapsed as shown in Plate 4. Water was found discharging into the excavation through the slots. This ceased when a root blockage lower down the drain was removed. The third drain examined was D203B, which was fully grouted using a tube-a-manchette, followed by two other grouts in each of their respective pipes as indicated in Figure 7. The drain was found to be fully sealed as shown in Plate 9 and no leakage of water was observed.

Plate 8 - Exhumed Grouted Drain D208 at Po Shan,  
with Surrounding Voids

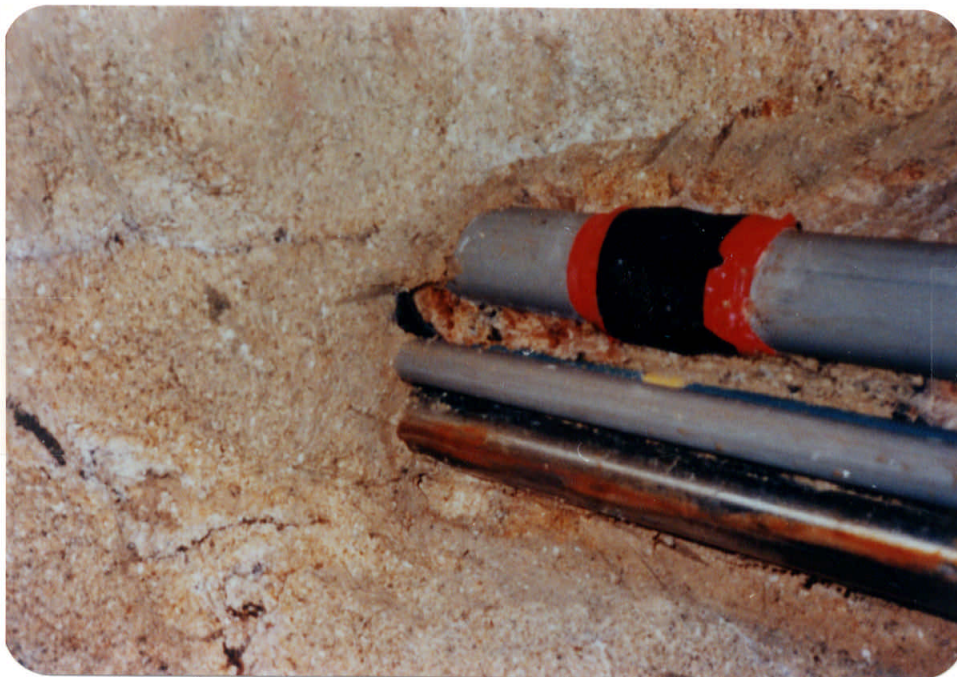
Plate 9 - Exhumed Grouted Drain D203B at Po Shan,  
Fully Sealed

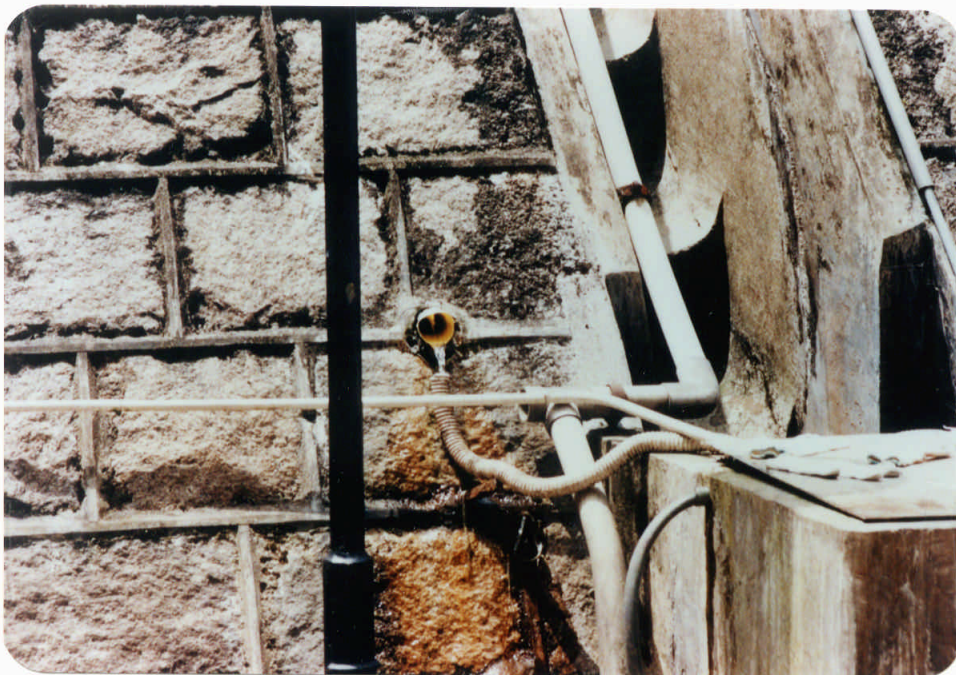
Plate 11 - Flowing Drain at Base of Slope Behind  
Grenville House

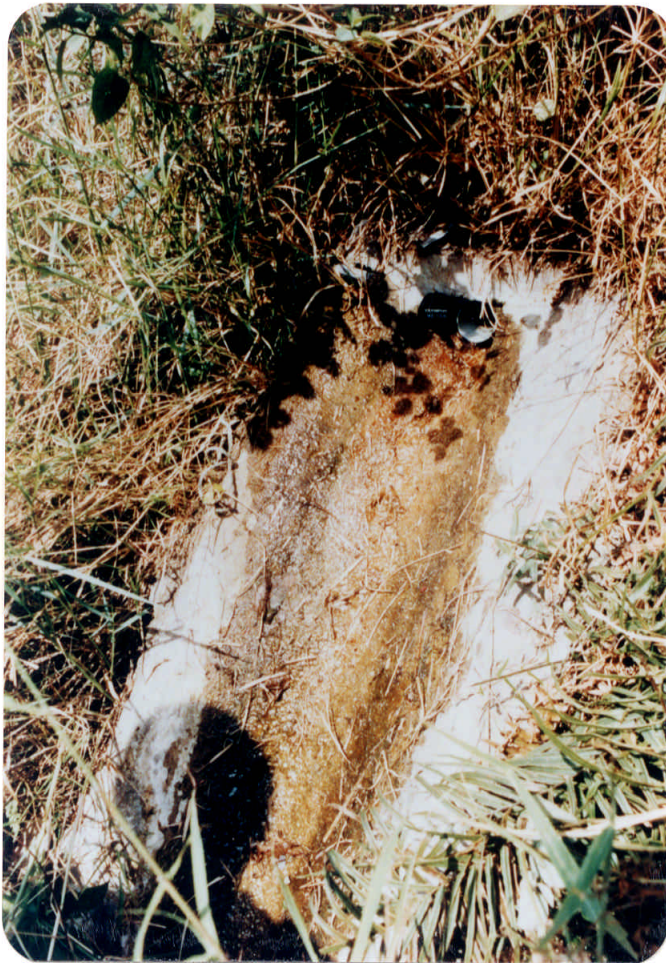
Plate 14 - Drain Outlet Showing Seepage Stains,  
New Clear Water Bay Road

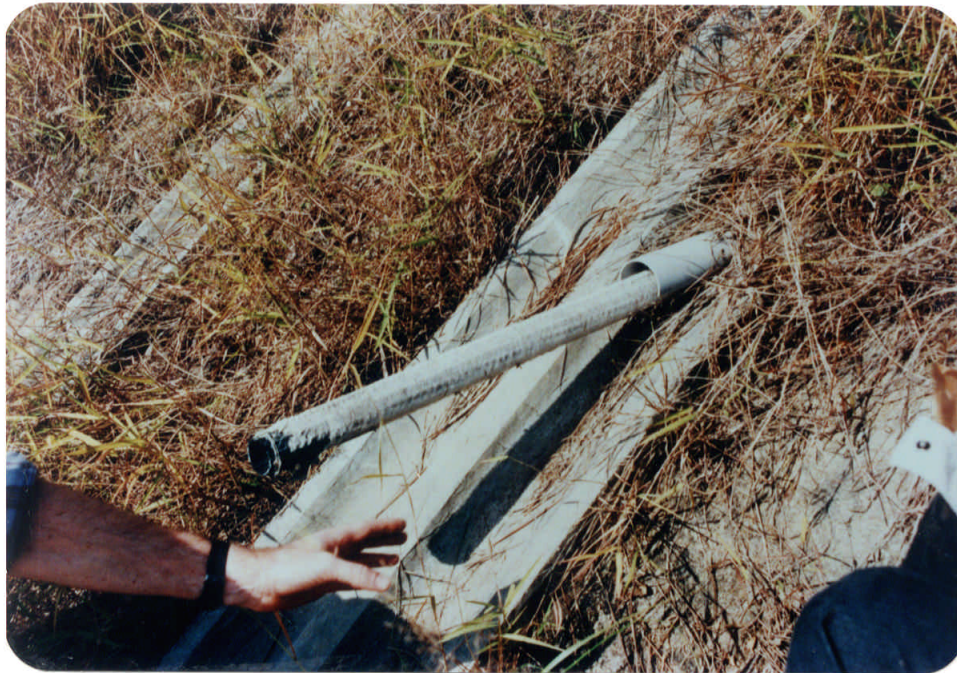
Whiteside (1987) also examined the conditions of the drains insitu one year after installation. The inner liners were extracted from five drains to investigate whether they had become clogged. Silt was present to varying degrees, in some places up to 10 mm thick over the geotextile filter. However, based on the flow data this did not seem to have affected the drain performance. Several inner liners were partly exhumed during a site visit in November 1992. An example is shown in Plate 22. In all cases both the liner and the geotextile filter were in good condition.

Plate 22 - Partly-exhumed Inner Liner from Drain at  
Tin Wan Hill Road

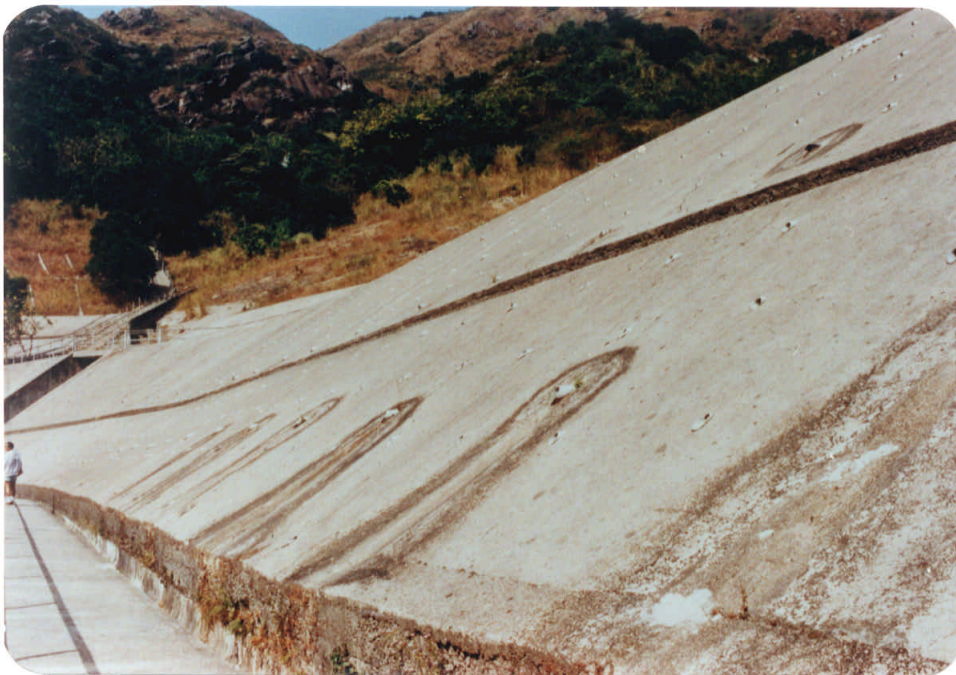
Plate 28 - Flow Scour on Chunam Surface Below  
Drain Outlets at Tsz Wan Shan Estate
