**GENERAL REPORT
ON LANDSLIPS
ON 5 NOVEMBER 1993
AT MAN-MADE FEATURES
IN LANTAU**

GEO REPORT No. 44

H.N. Wong & K.K.S. Ho

**GEOTECHNICAL ENGINEERING OFFICE
CIVIL ENGINEERING DEPARTMENT
HONG KONG**

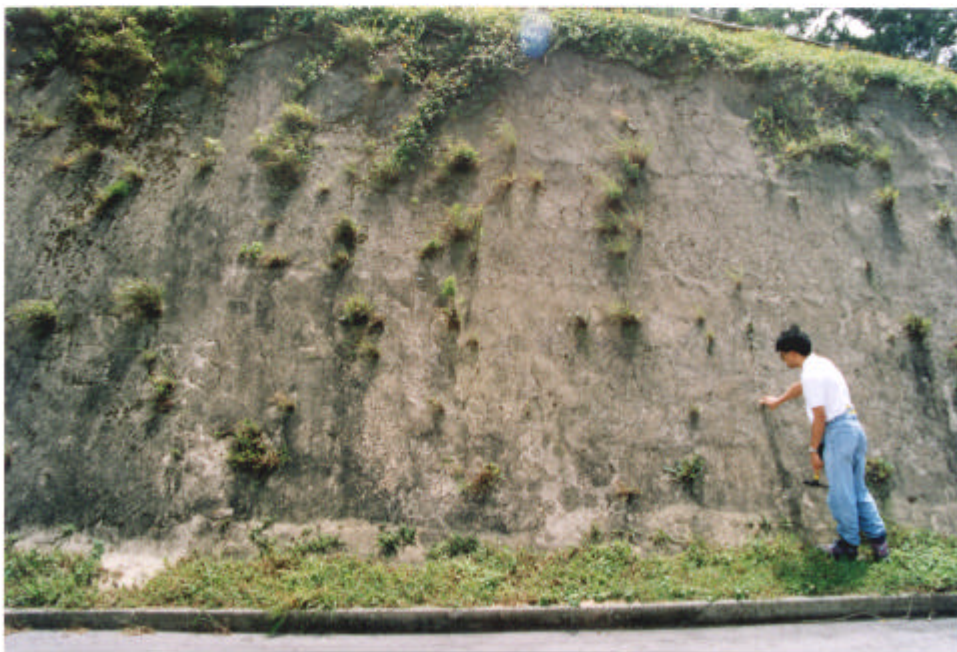
Negative No. SP9408514

Plate 2 - Example of Rigid Cover in Fair Condition

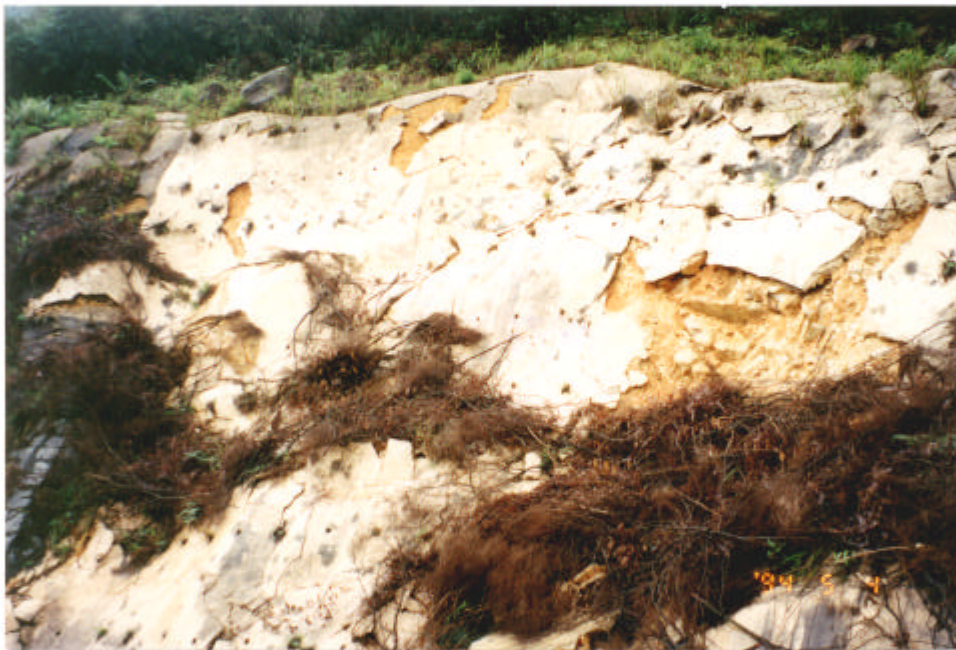
Negative No. SP9404820

Plate 3 - Example of Rigid Cover in Poor Condition

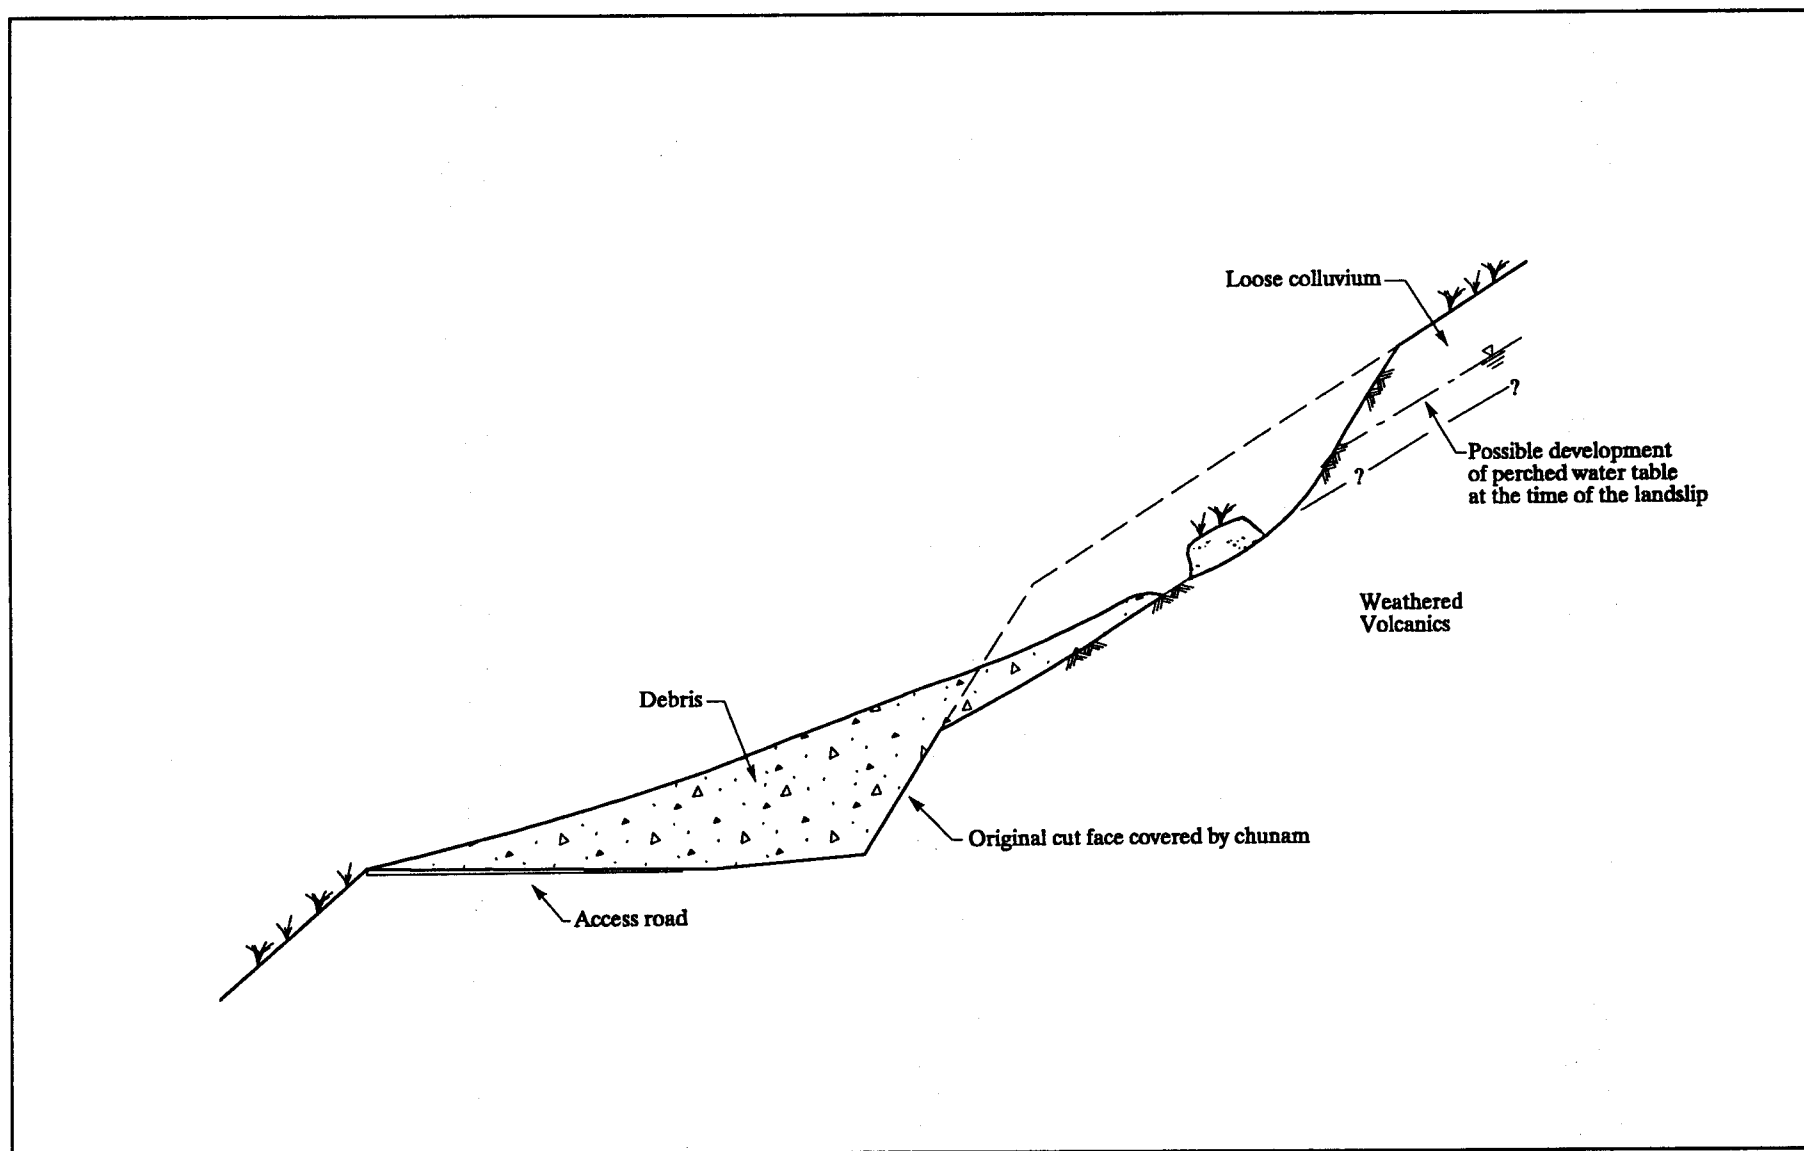
Figure B1 - Cross-section of Landslip No.L223

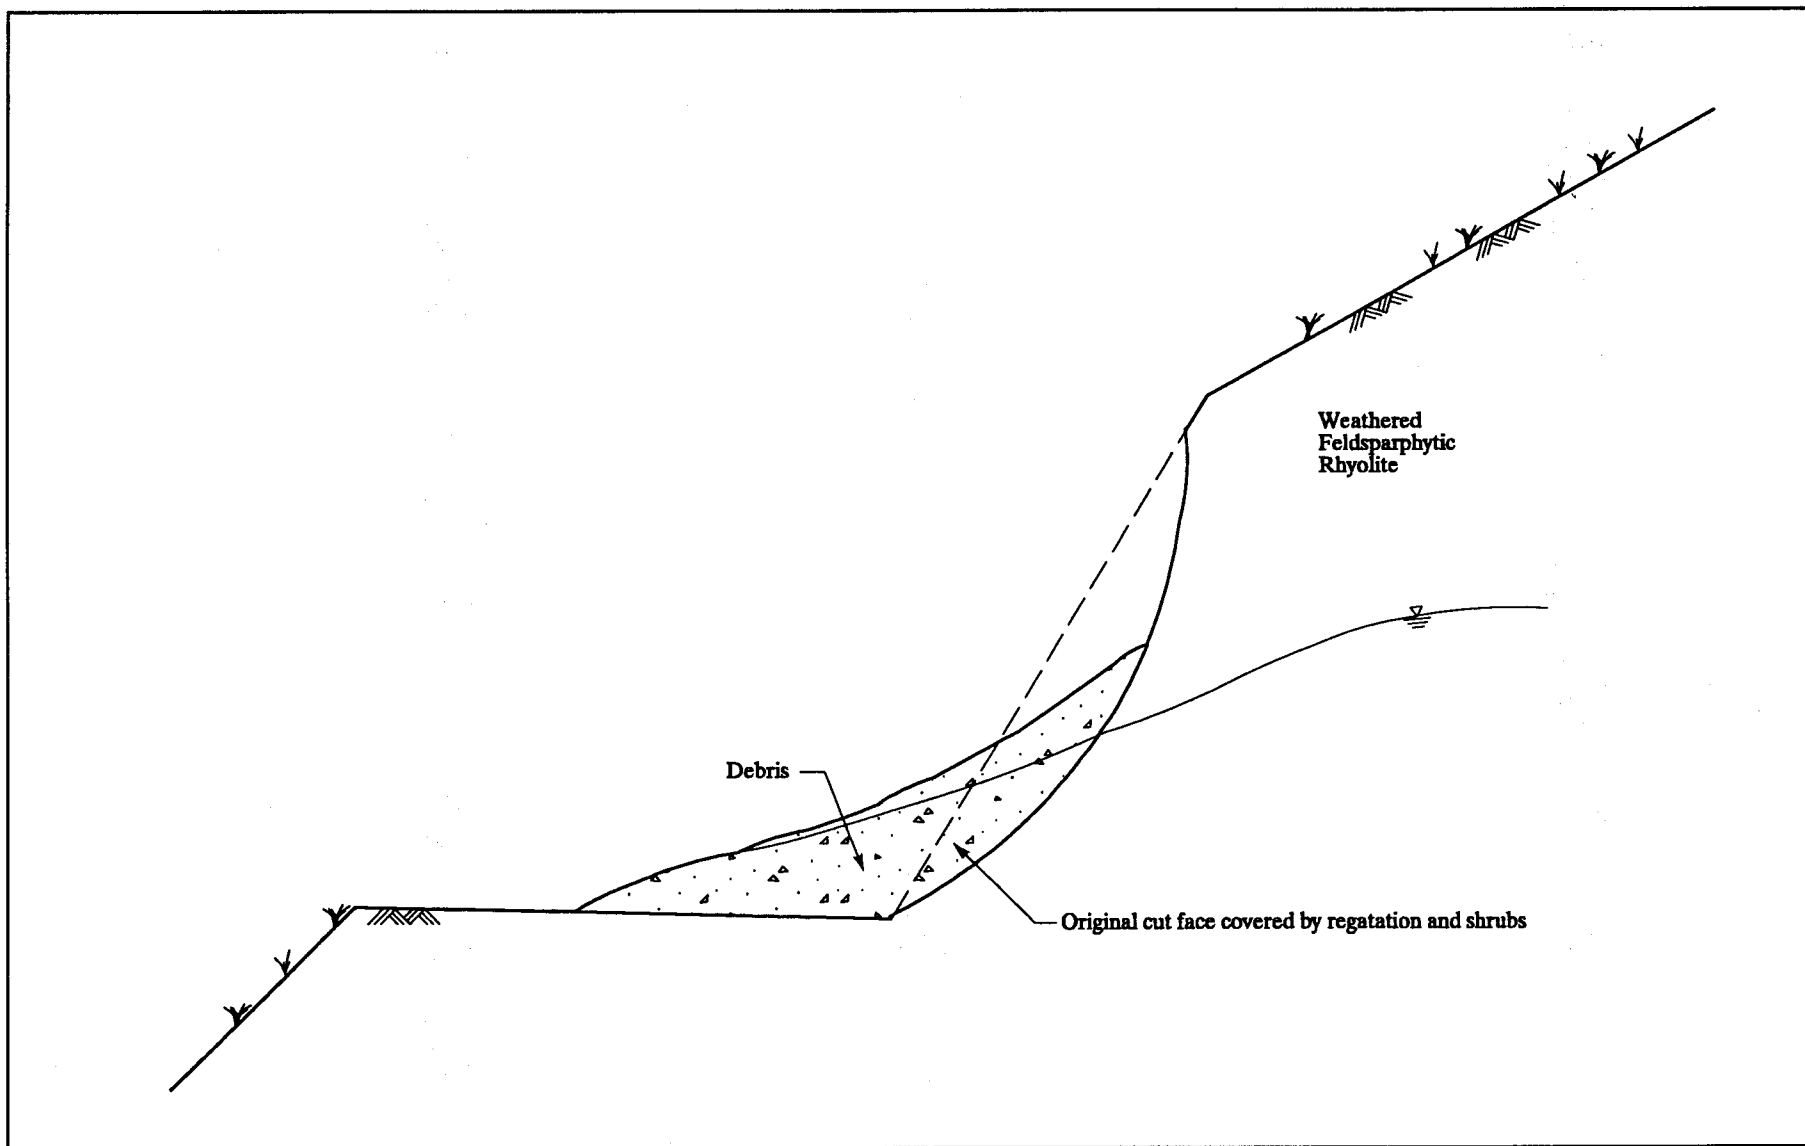
Figure B2 - Cross-section of Landslip No.L92

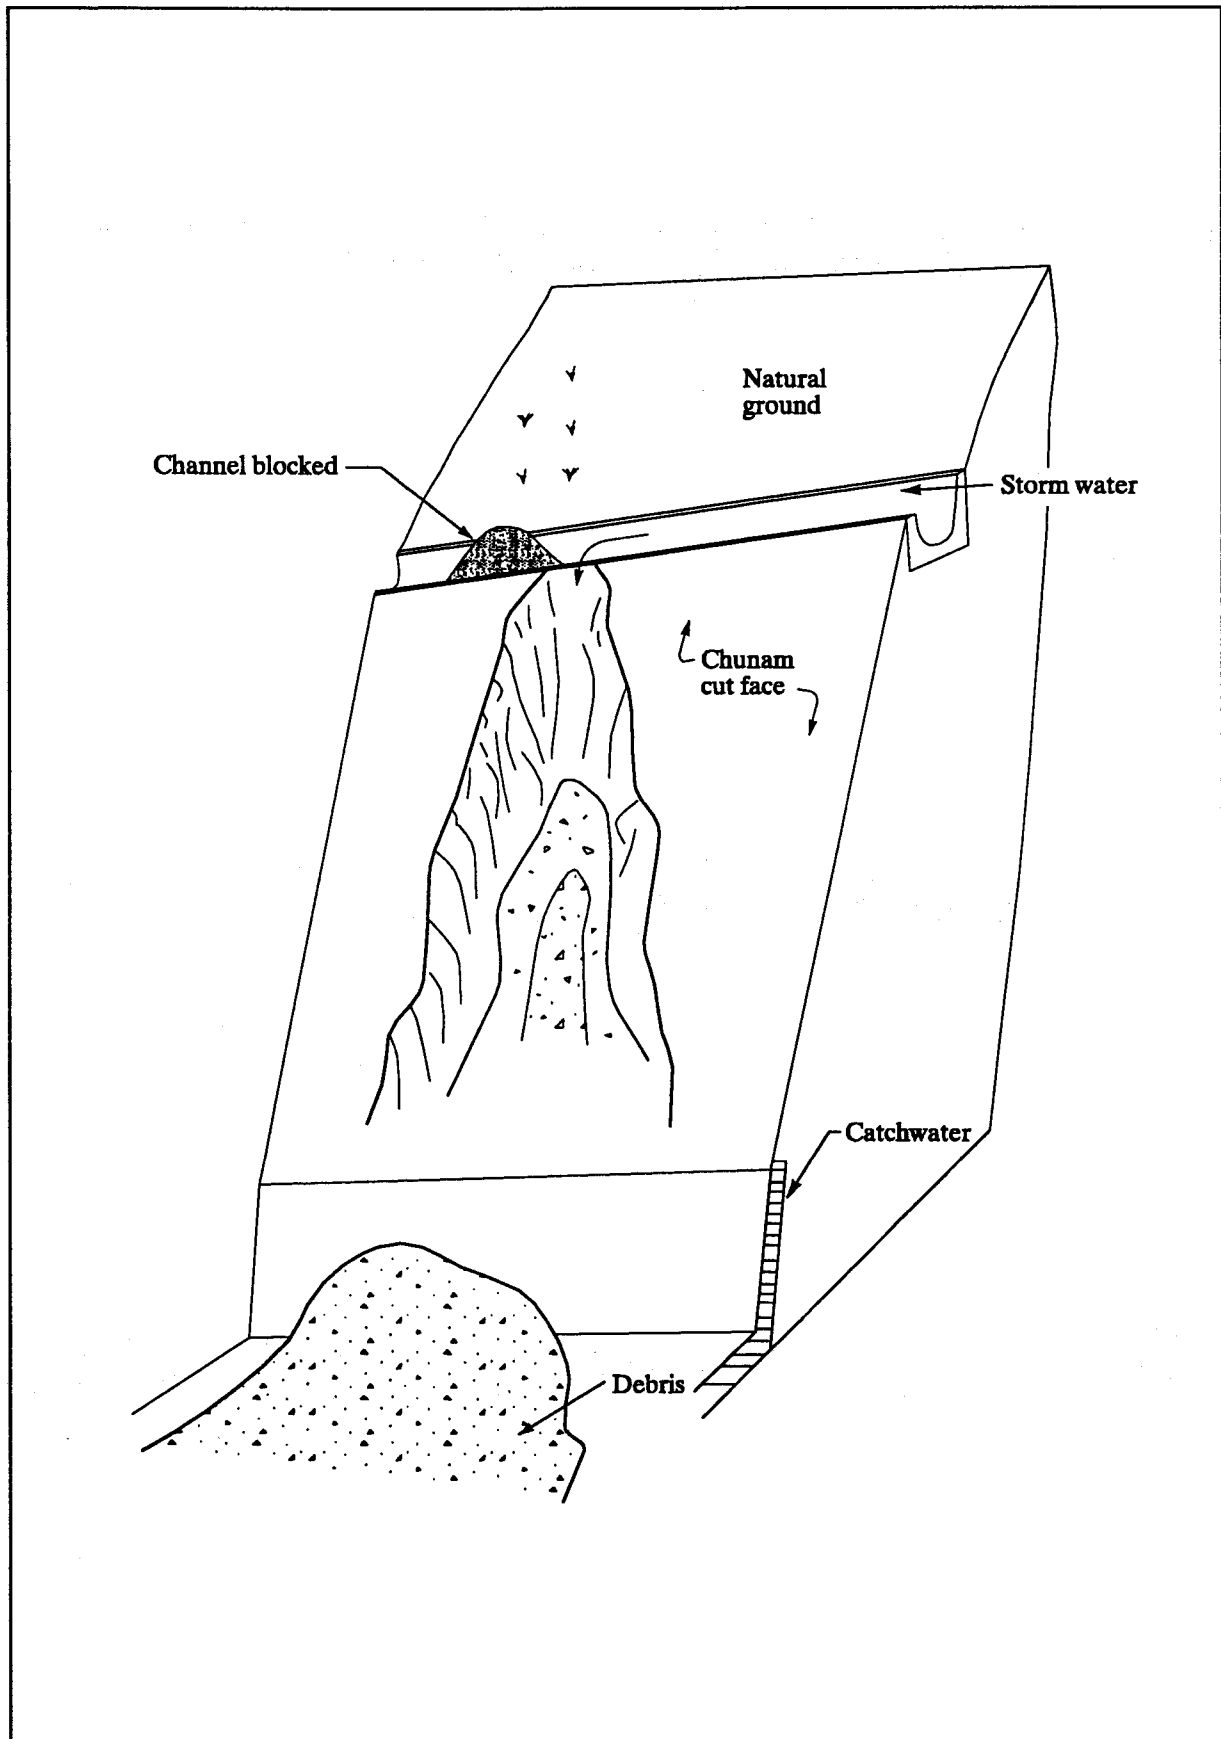
Figure B3 - Schematic View of Landslip No.L162

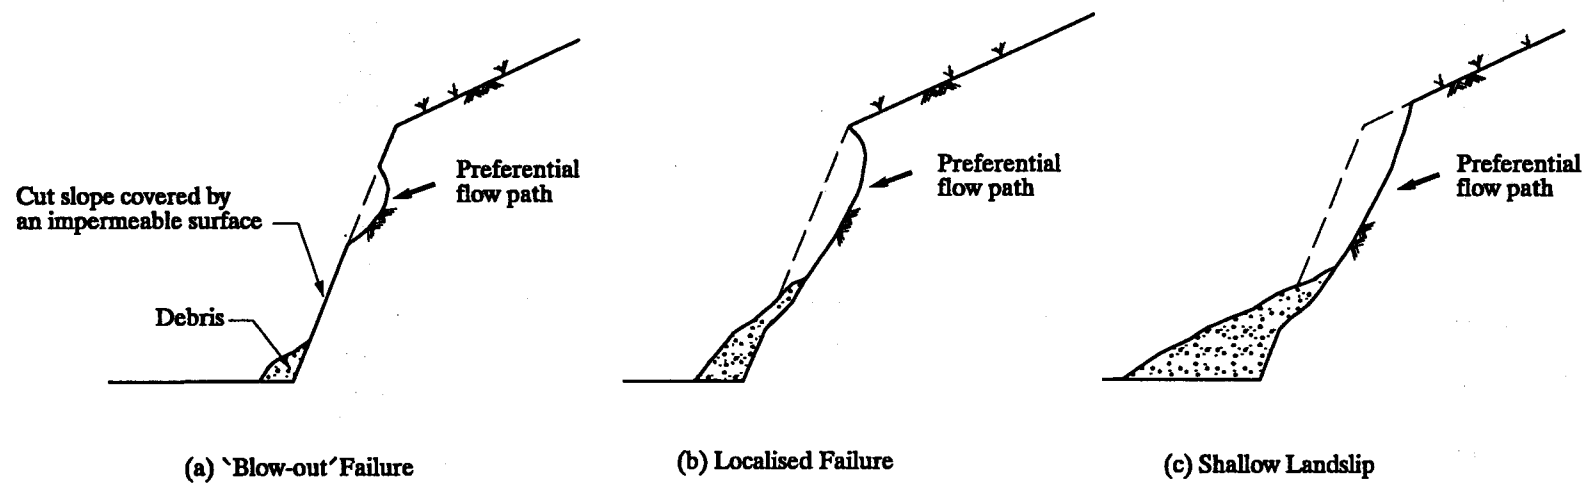
Figure B4 - Landslip of Different Extent Caused by Seepage Behind the Rigid Slope Cover

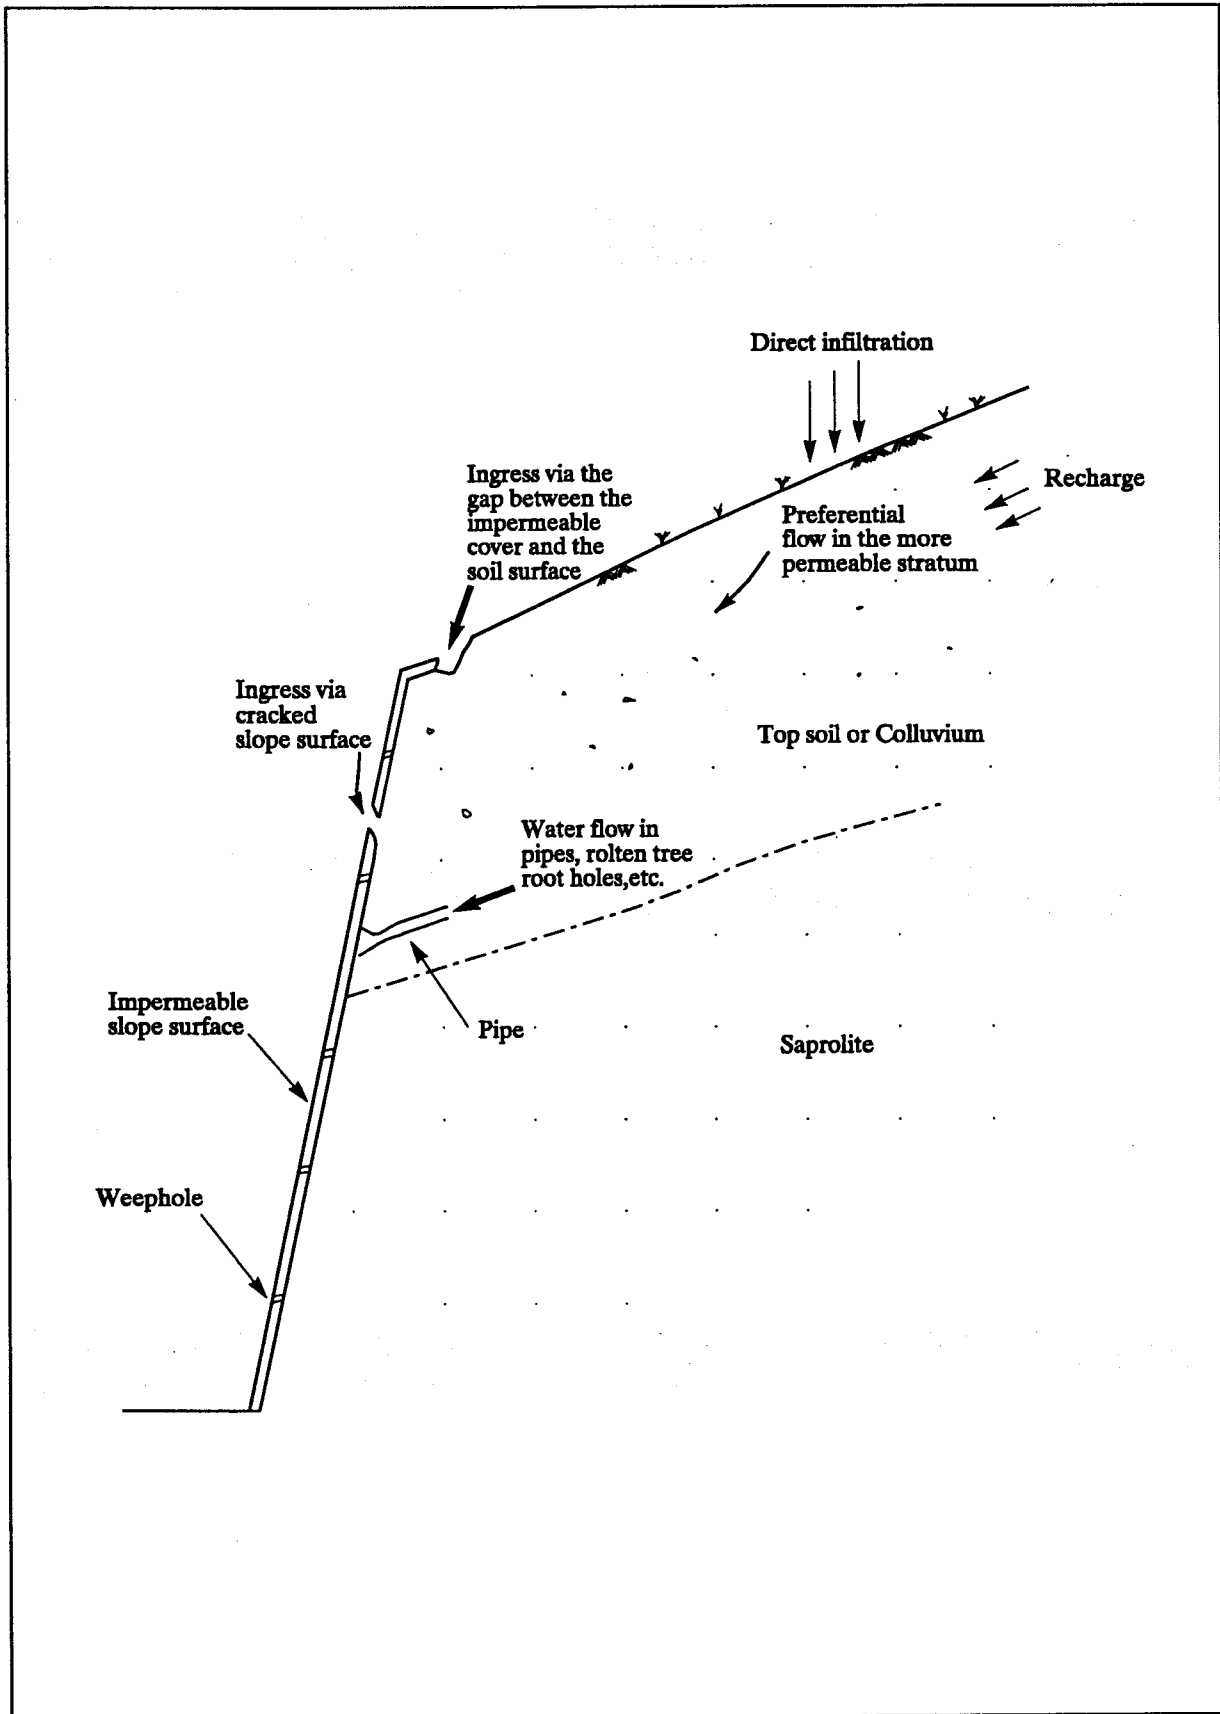
Figure B5 - Typical Preferential Flow Path Leading to Seepage Behind a Rigid Slope Cover

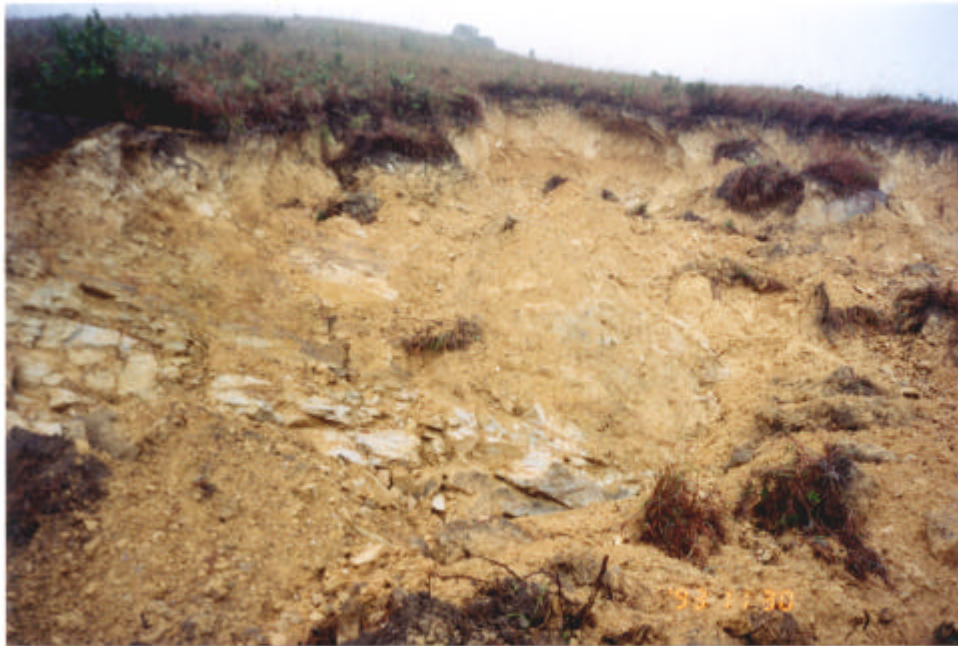
Negative No. SP93206C33

Plate B1 - Landslip No. L223 Caused by Development of Perched Water Pressure

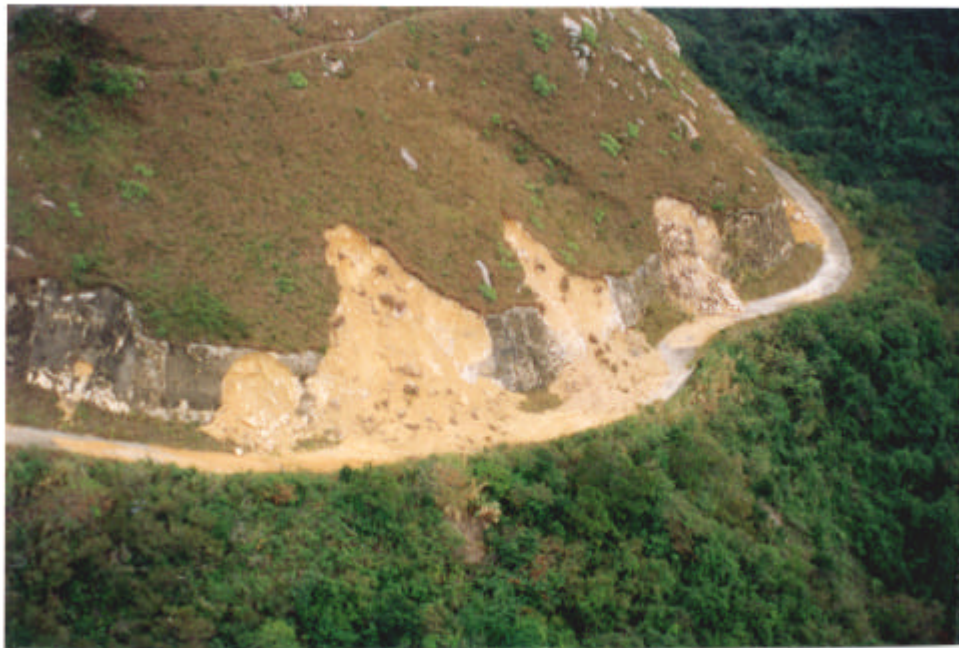
Negative No. SP9319826

Plate B2 - Scarp of Landslip No. L223 Exposing the Thin Colluvium Layer Overlying Weathered Volcanics

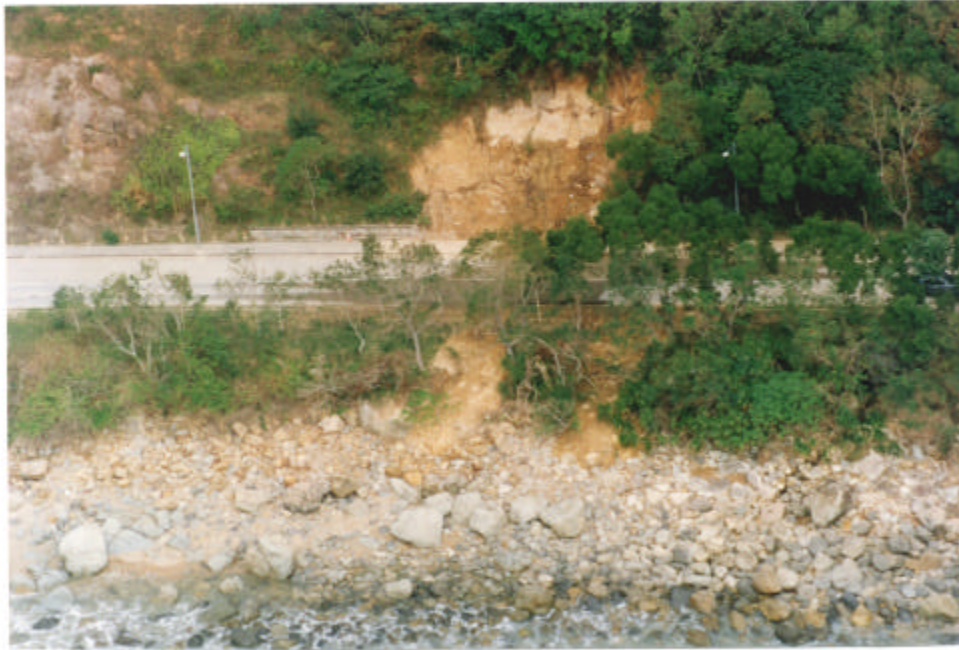
Negative No. SP9320530

Plate B3 - Landslip No. L92 Caused by Rise in Main Groundwater Table

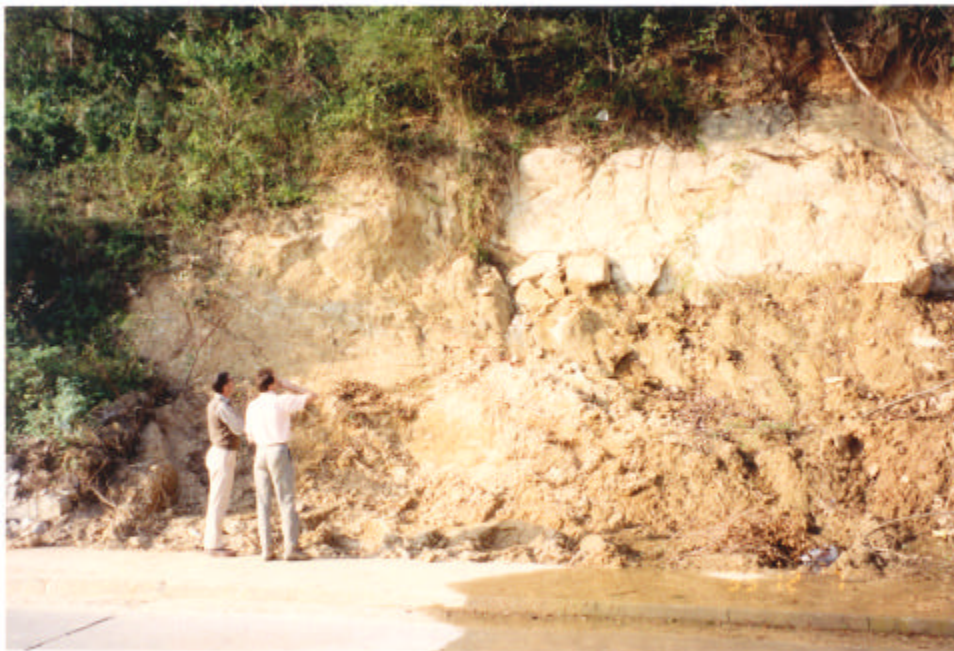
Negative No.SP93209C06

Plate B4 - Debris of Landslip No. L92

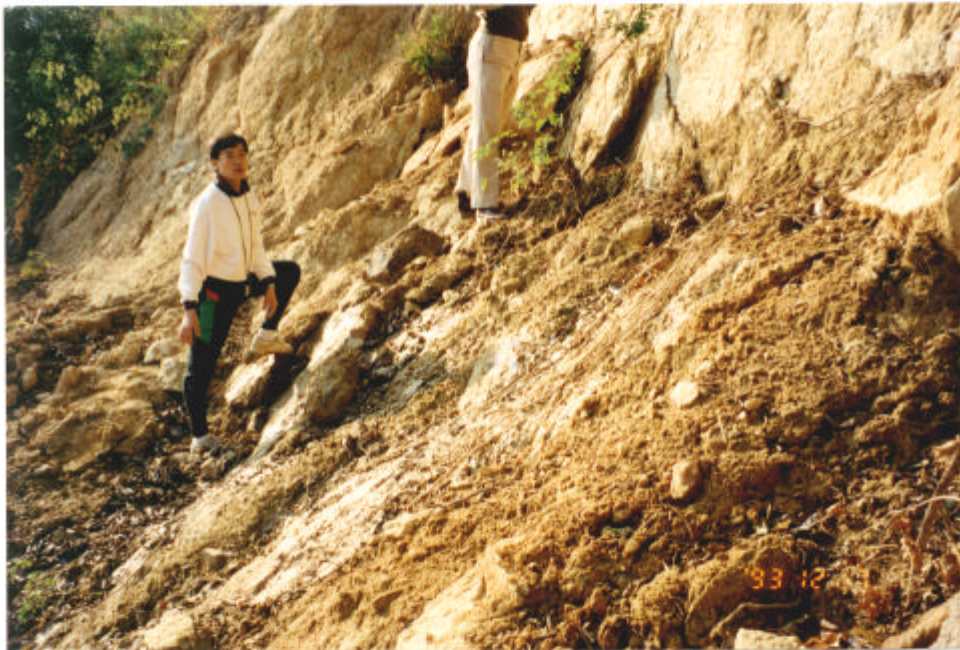
Negative No.SP93209C04

Plate B5 - Scar of Landslip No. L92 where Water Seepage was Observed

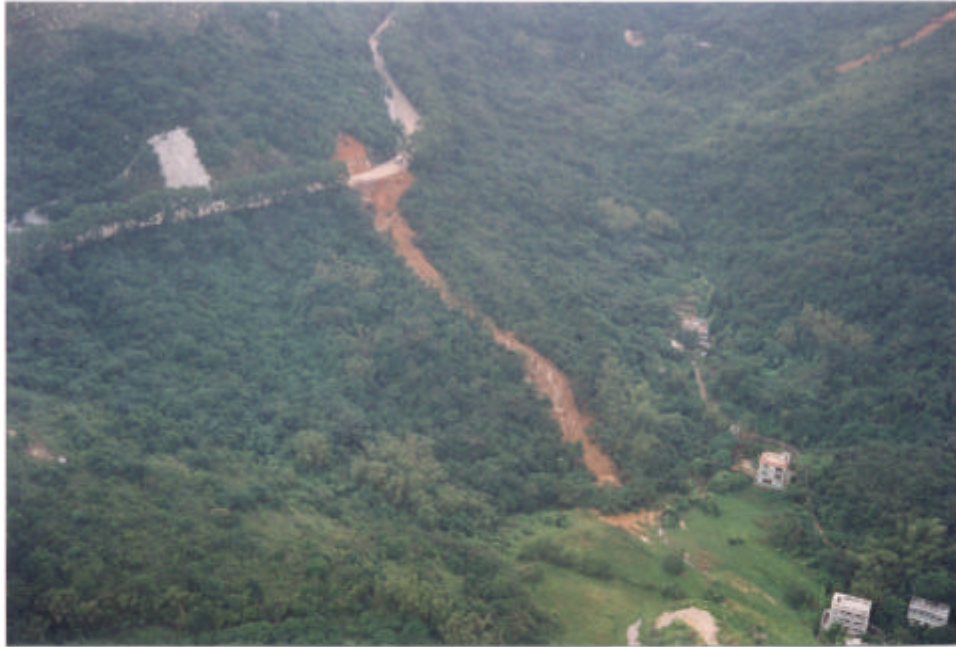
Negative No. TP243/4

Plate B6 - Aerial View of Landslip No. L32 Caused by Wash-out

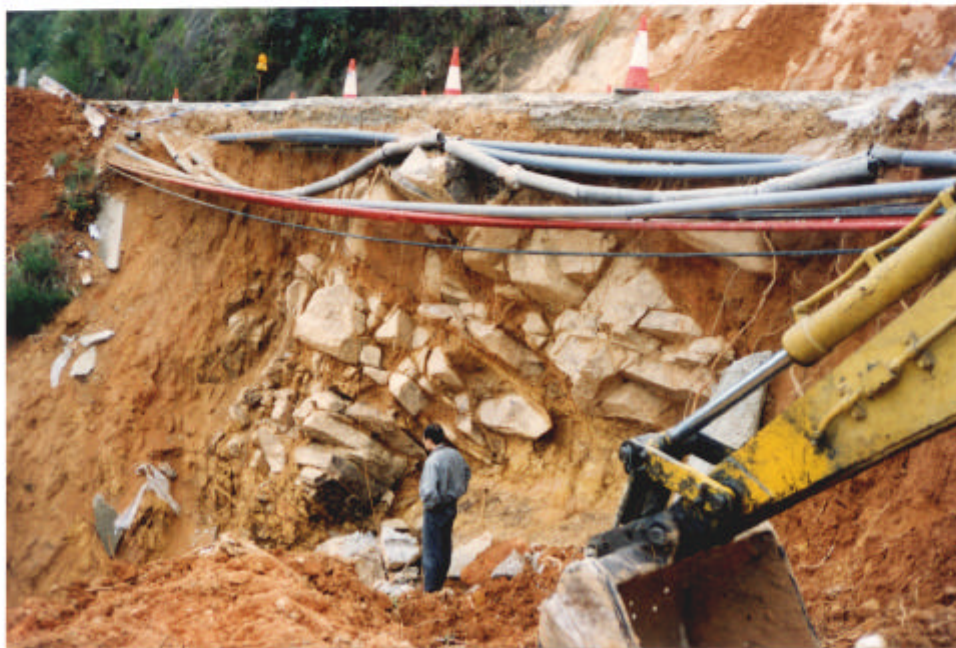
Negative No. MW93337-23

Plate B7 - Salient Features of Landslip No. L32

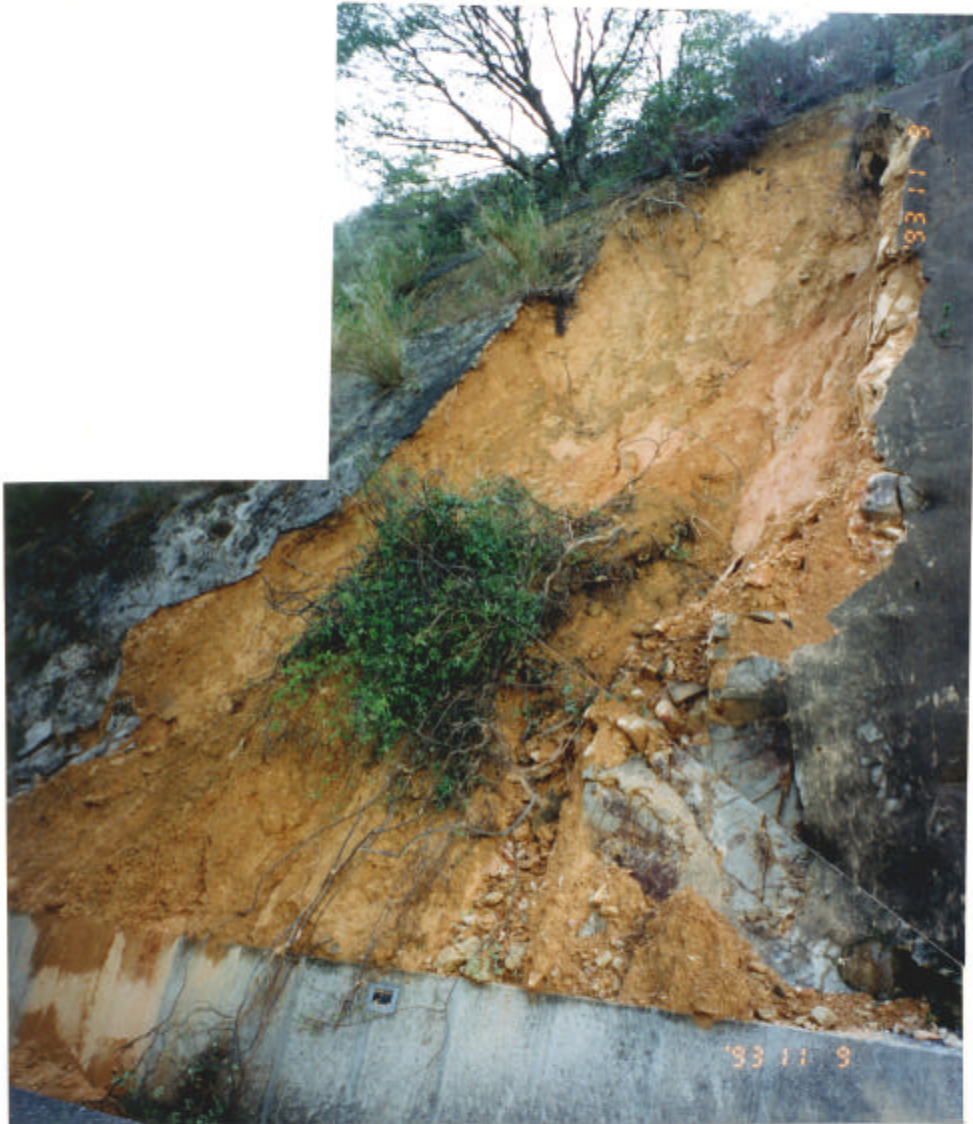
Negative No. SP93156C10 & SP93156C11

Plate B8 - Landslip No. L162 Caused by Wash-out

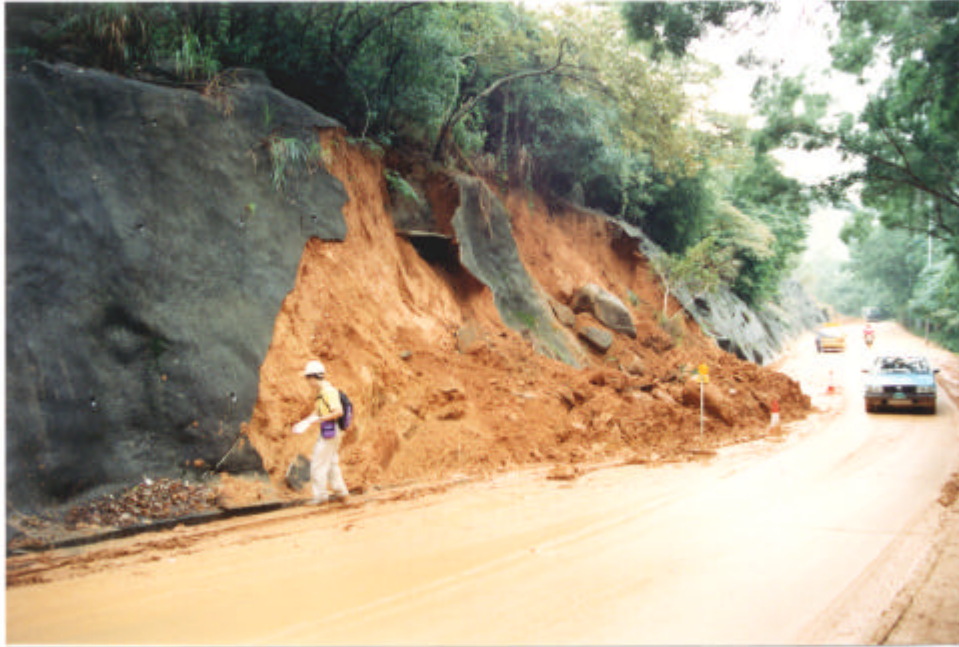
Negative No. SP93142C16

Plate B9 - Landslip No. L30 Caused by Infiltration Through Crest Slope

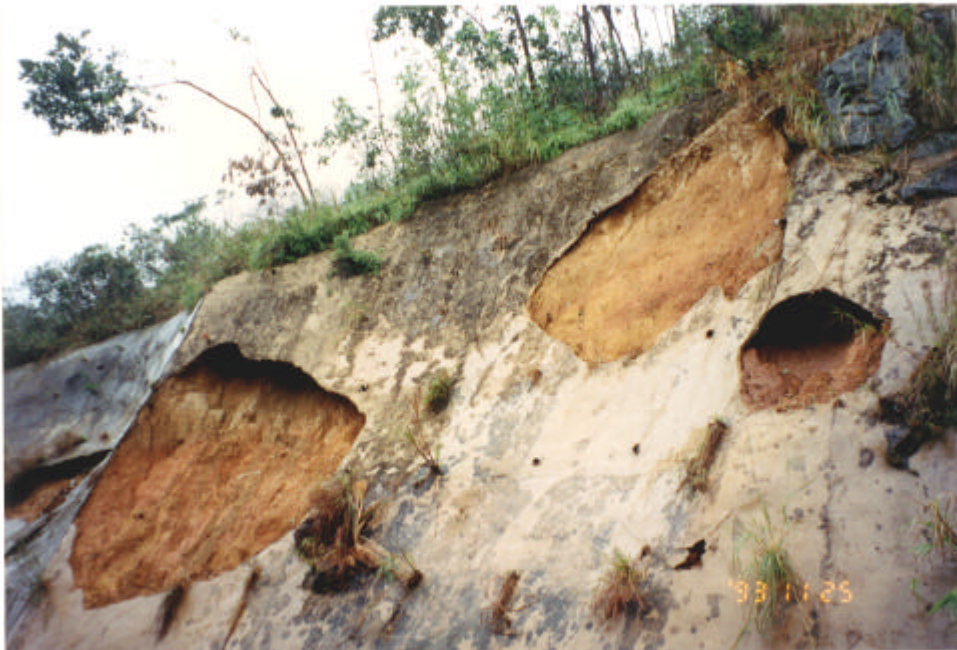
Negative No. SP9318812

Plate B10 - Landslip No.L264 Caused by Seepage Behind the Rigid Surface

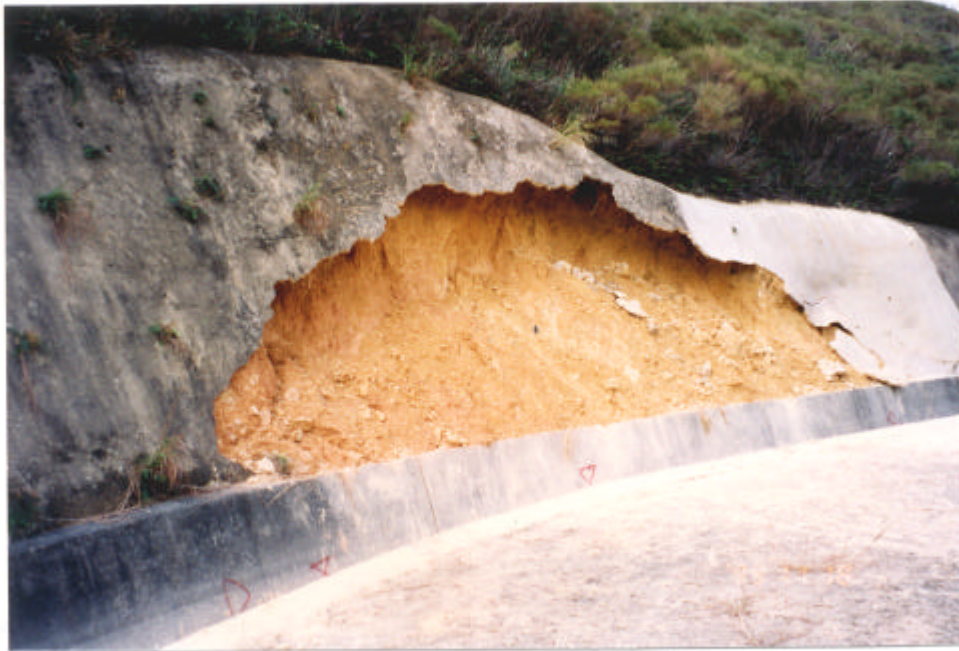
Negative No. SP9317220

Plate B11 - Landslip No. L200 Caused by Seepage Behind the Rigid Surface

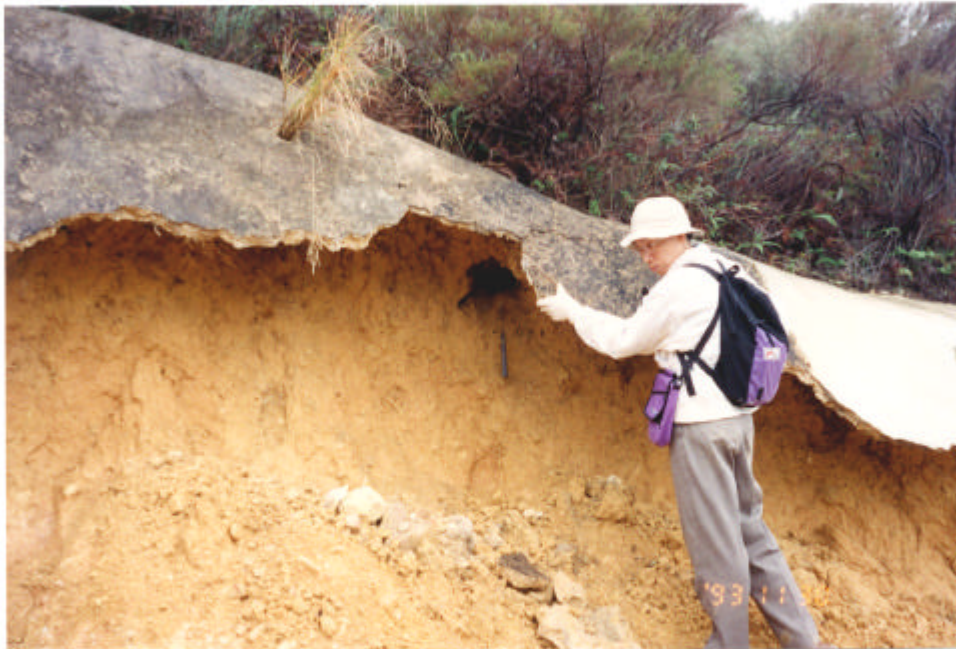
Negative No. SP9319725

Plate B12 - The Upper Part of Landslip No. L200 Showing the Presence of a Pipe (Possibly a Snake Barrel)

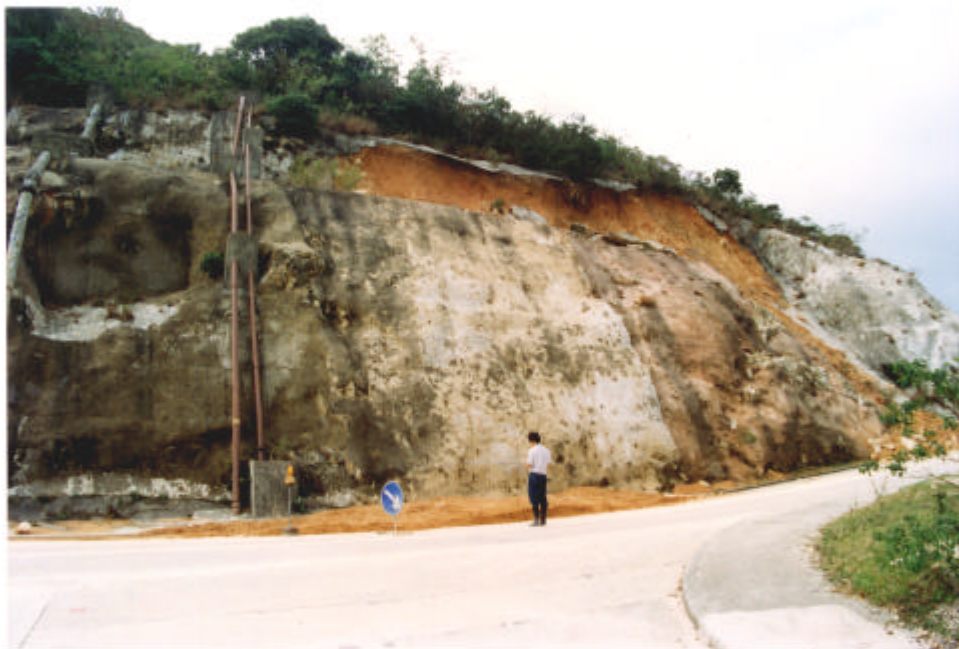
Negative No. SP9319024

Plate B13 - Landslip No. L108 Caused by Seepage Behind the Rigid Surface
