# **INVESTIGATION OF SOME MAJOR SLOPE FAILURES BETWEEN 1992 AND 1995**

**GEO REPORT No. 52**

**GEOTECHNICAL ENGINEERING OFFICE  
CIVIL ENGINEERING DEPARTMENT  
HONG KONG**

# **SECTION 1 : REPORT ON THE INVESTIGATION OF THE 8 MAY 1992 BAGUIO LANDSLIDE**

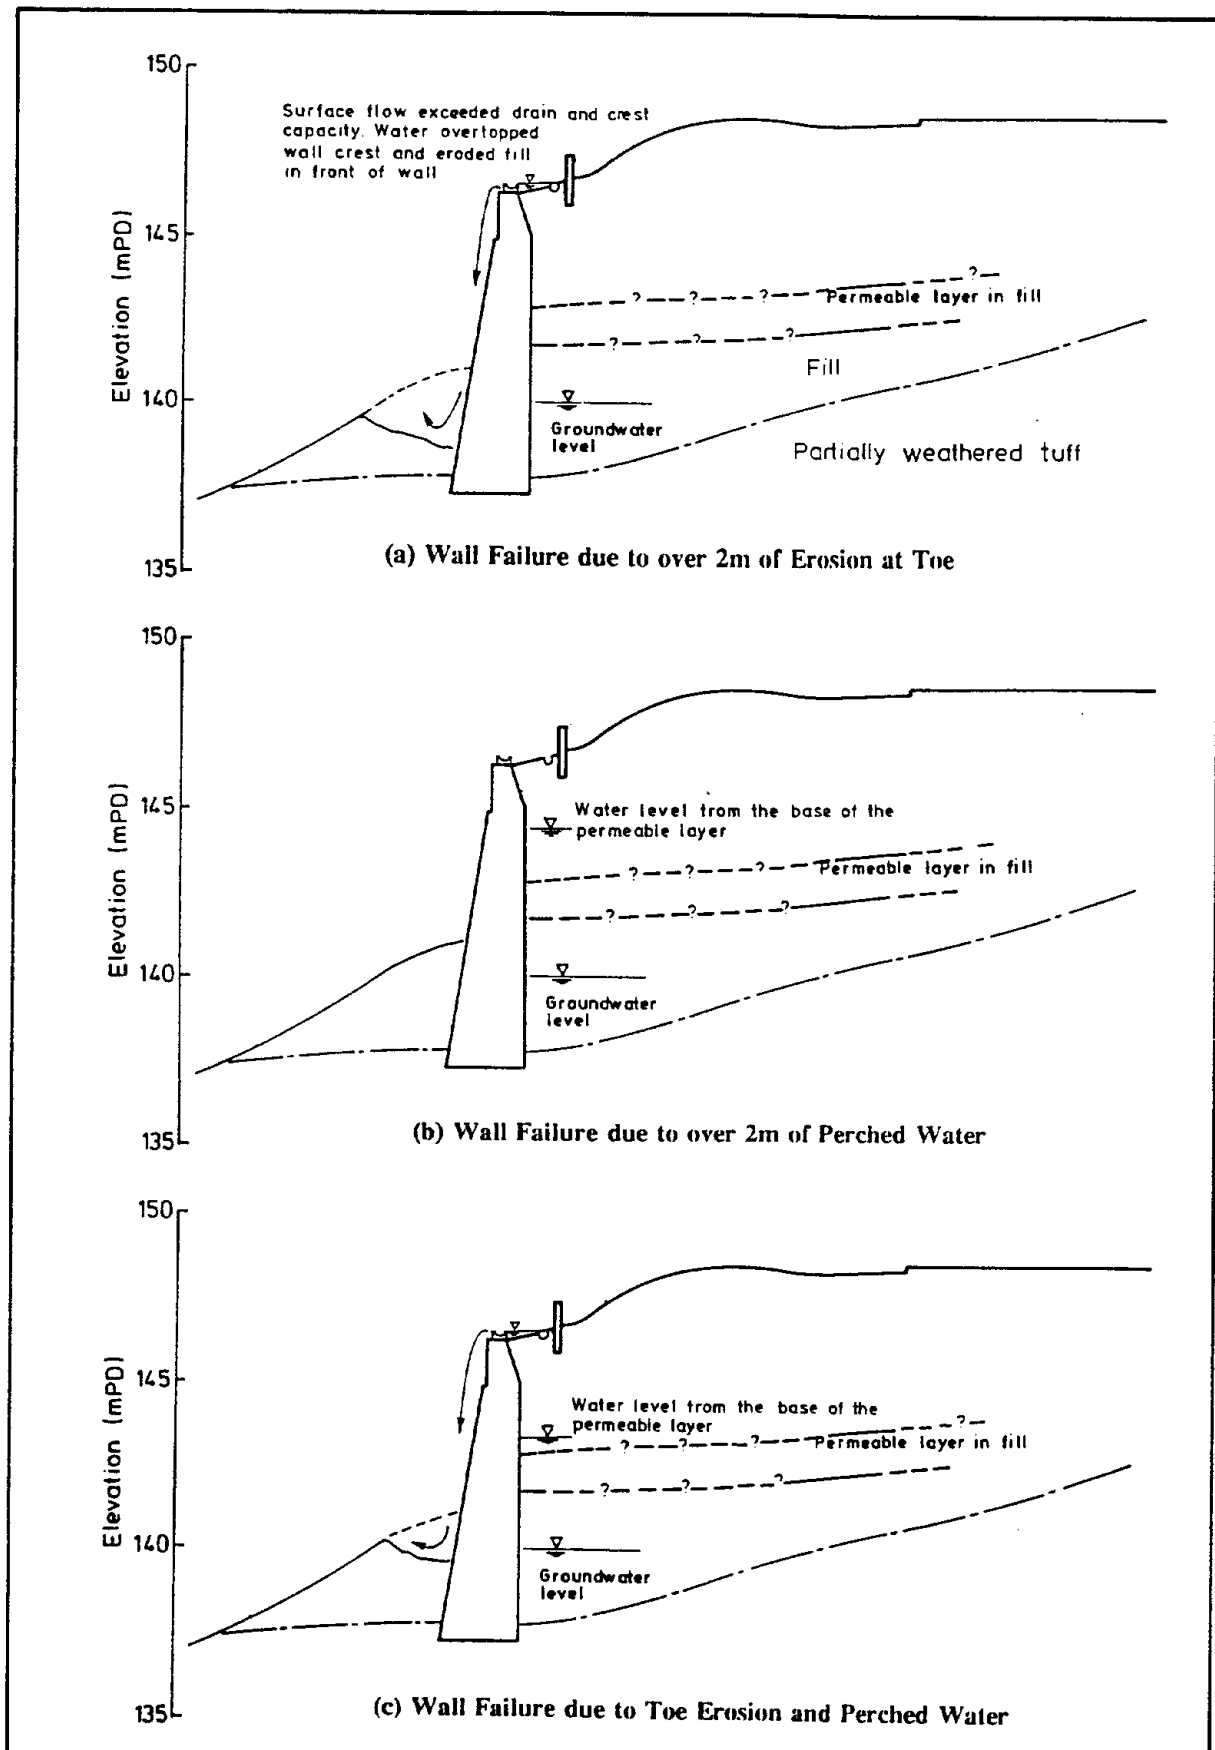
Figure 15 - Possible Conditions for the Failure of the Masonry Retaining Wall

The landslide started with the collapse of the masonry retaining wall supporting the fill platform. No drawings of this retaining wall have been found and its nature and dimensions have had to be estimated from such evidence as is now available from site surveys, aerial photographs and interviews with former farm employees. As part of this investigation the stability of this structure has been analysed by conventional theoretical methods, assuming it was in good structural condition prior to failure. The results of the analyses are summarised in Table 1 and illustrated in Figure 15.

The calculations indicate that the masonry retaining wall could in theory have failed through loss of support if a layer of soil greater than 2 m in thickness was lost from the ground in front of the wall. This could be a result of toe erosion (Figure 15a) or slope failure due to transient high internal water pressures. Erosion is considered more likely to be the cause than slope failure and this is corroborated by the evidence of eye-witnesses who reported that at the time of the wall failure, trees and other vegetation in front of the fill platform remained intact.

Water that enters the ground will tend to seep downward. When the water meets a less permeable layer, it will tend to accumulate there to form 'perched water'. From the analyses, the masonry retaining wall could in theory have failed, without loss of ground in front of the wall, if perched water developed on a surface at 143 mPD elevation to a depth greater than 2 m (Figure 15b).

There are also combinations of lesser degrees of toe erosion and perched water that might in theory have caused the masonry retaining wall to fail (Figure 15c). Surcharge pressures from the limited filling carried out for the THA were included in the calculations, but the effect of these was found to be negligible.

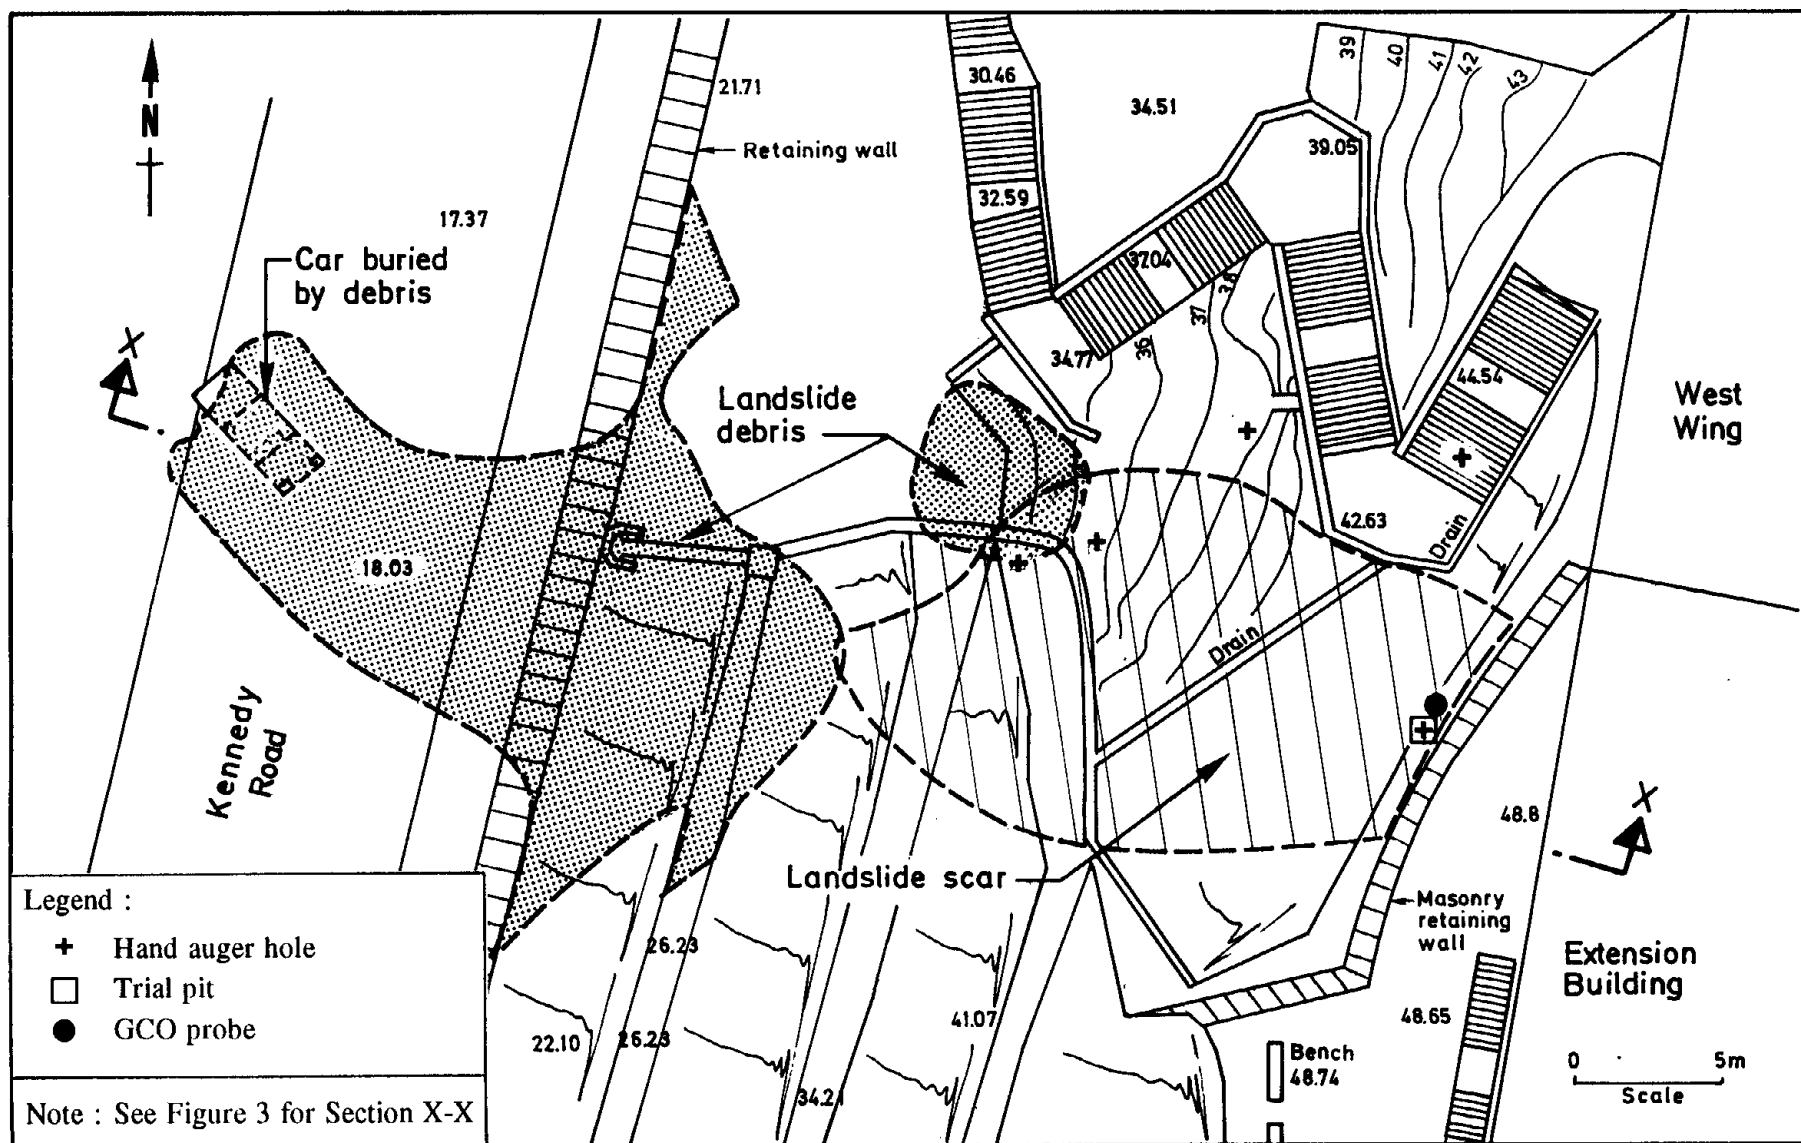
Figure 2 - Plan of the 8 May 1992 Landslide

A plan showing the failed area and the location of the debris is given in Figure 2. A cross-section of the site after the landslide is shown in Figure 3. About 500 cubic metres of debris slipped down from the failed area and buried the section of Kennedy Road below.

Field mapping was conducted by the GEO within the week following the landslide, before the scar was covered by shotcrete to prevent further failure. Within the constraints of limited time and the threat of further failure, a simple ground investigation including one trial pit, one 'GCO probe' and five hand auger holes was carried out at the locations shown in Figure 2.

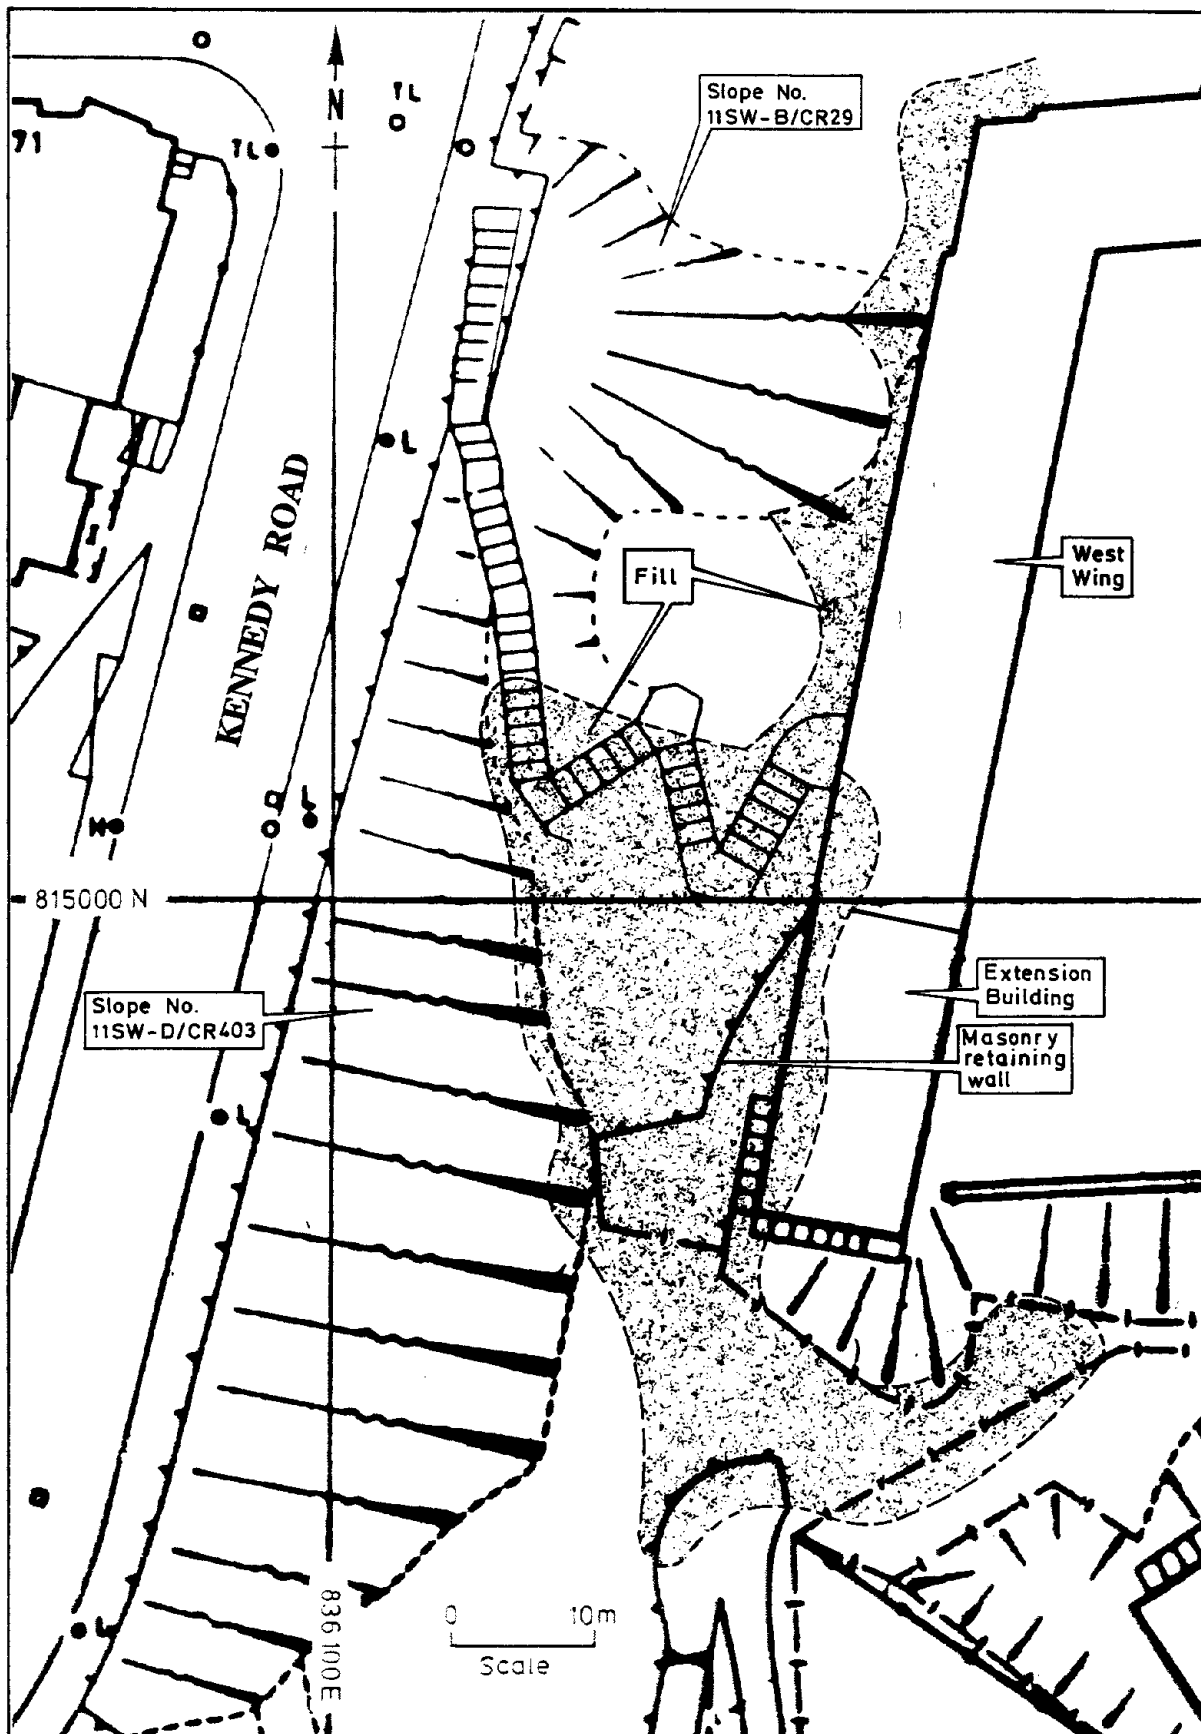
Figure 4 - Probable Extent of Fill

The ground that failed on 8 May 1992 was located above the crest of cut slope No. 11SW-D/CR403 (Figure 1). It consisted principally of fill comprising silty-sand-sized material with pieces of brick and stone, and was covered by trees and undergrowth before the landslide. A study of old maps and aerial photographs shows that the fill was placed between 1930 and 1949. The probable extent of fill, as interpreted after the event from aerial photographs taken in 1949, is shown in Figure 4.

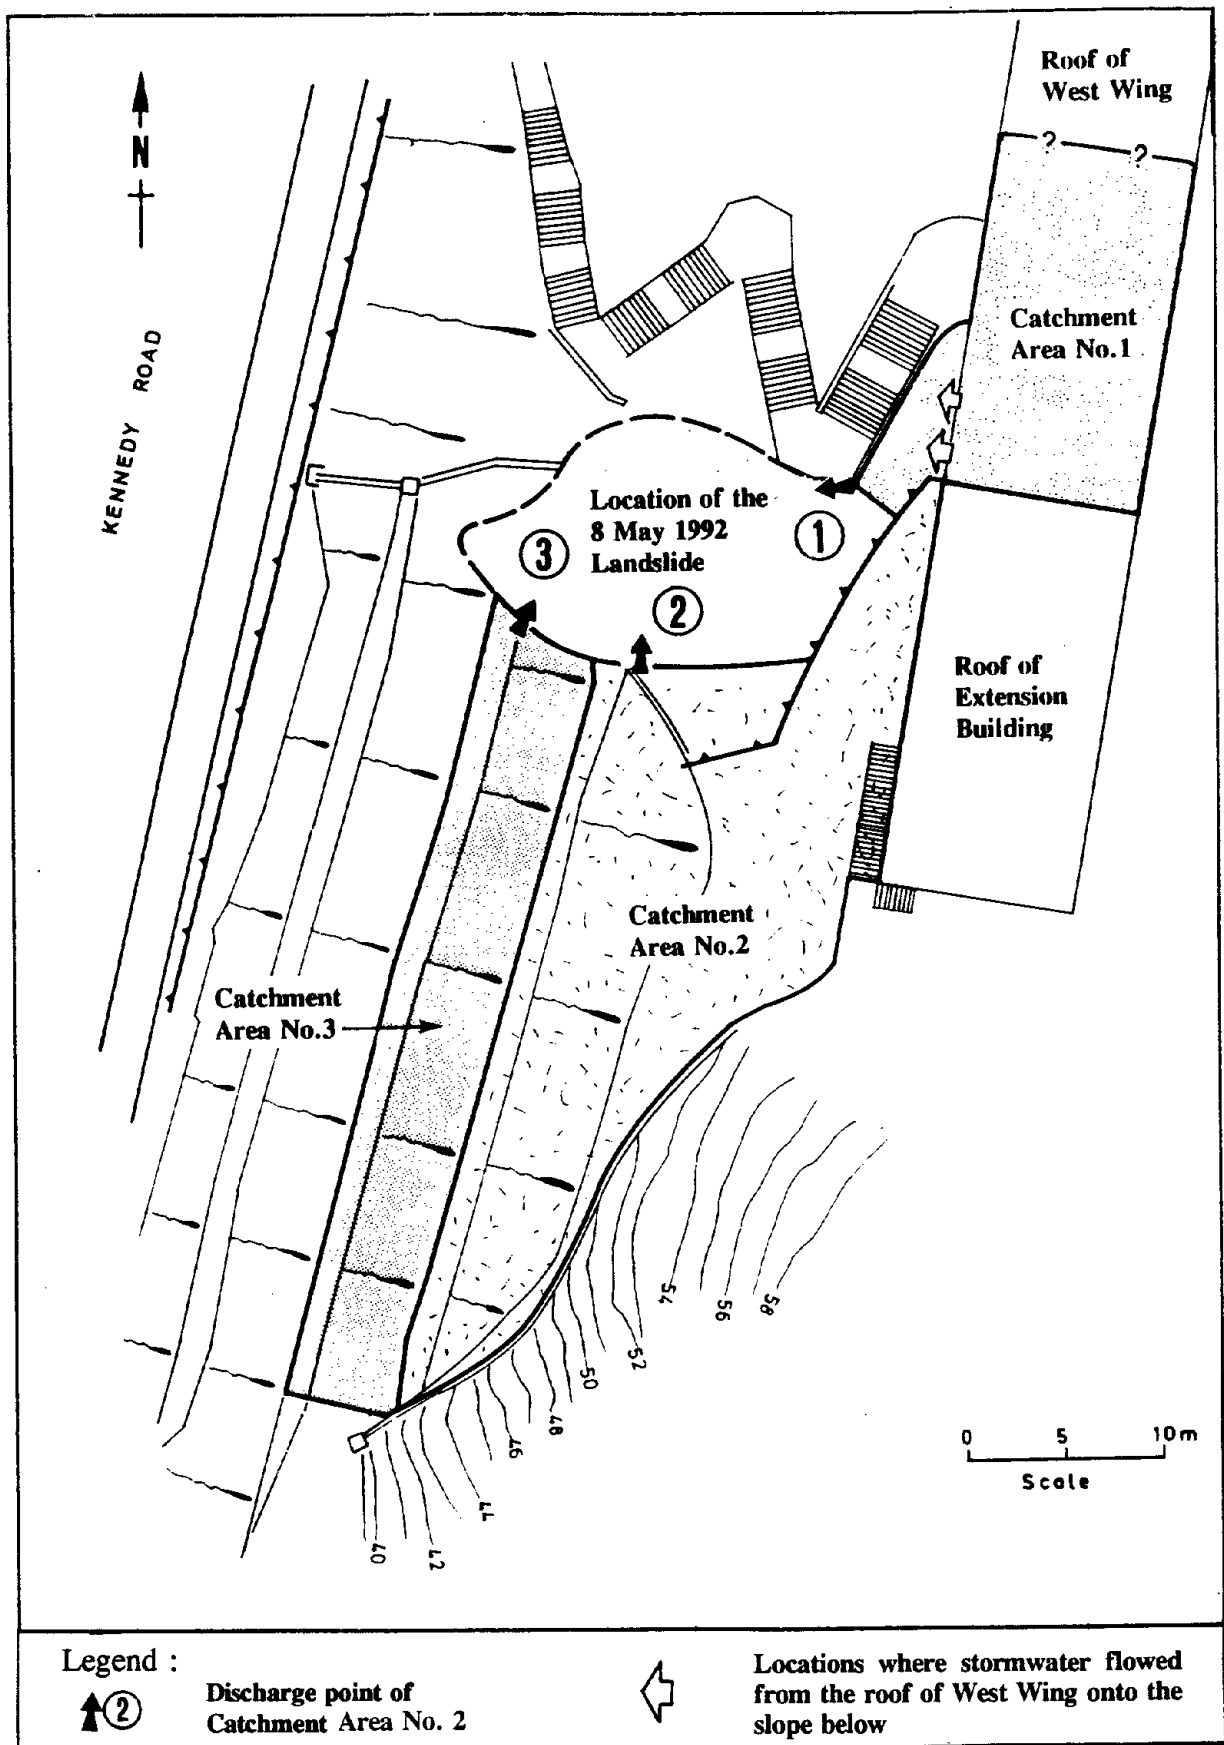
Figure 6 - Catchment Areas Adjoining the Location of the 8 May 1992 Landslide

Three catchment areas in which runoff would have been collected and discharged via surface drainage channels onto the site of the 8 May landslide are shown in Figure 6. From calculations, during the period from about 6:10 a.m. to 8:10 a.m. on 8 May 1992, a maximum of 2000 litres per minute of stormwater would have been discharging from these catchment areas to the surface channels on the slope. In theory, from survey records made before the failure, the design capacity of the surface drainage channels on the slope was sufficient to accommodate stormwater flows during the rainstorm in the morning of 8 May 1992. As such, direct rainfall on the slope would be the primary source of water infiltration. However, if the drainage channels were blocked or broken before the failure, a large amount of stormwater might have overflowed onto the slope.

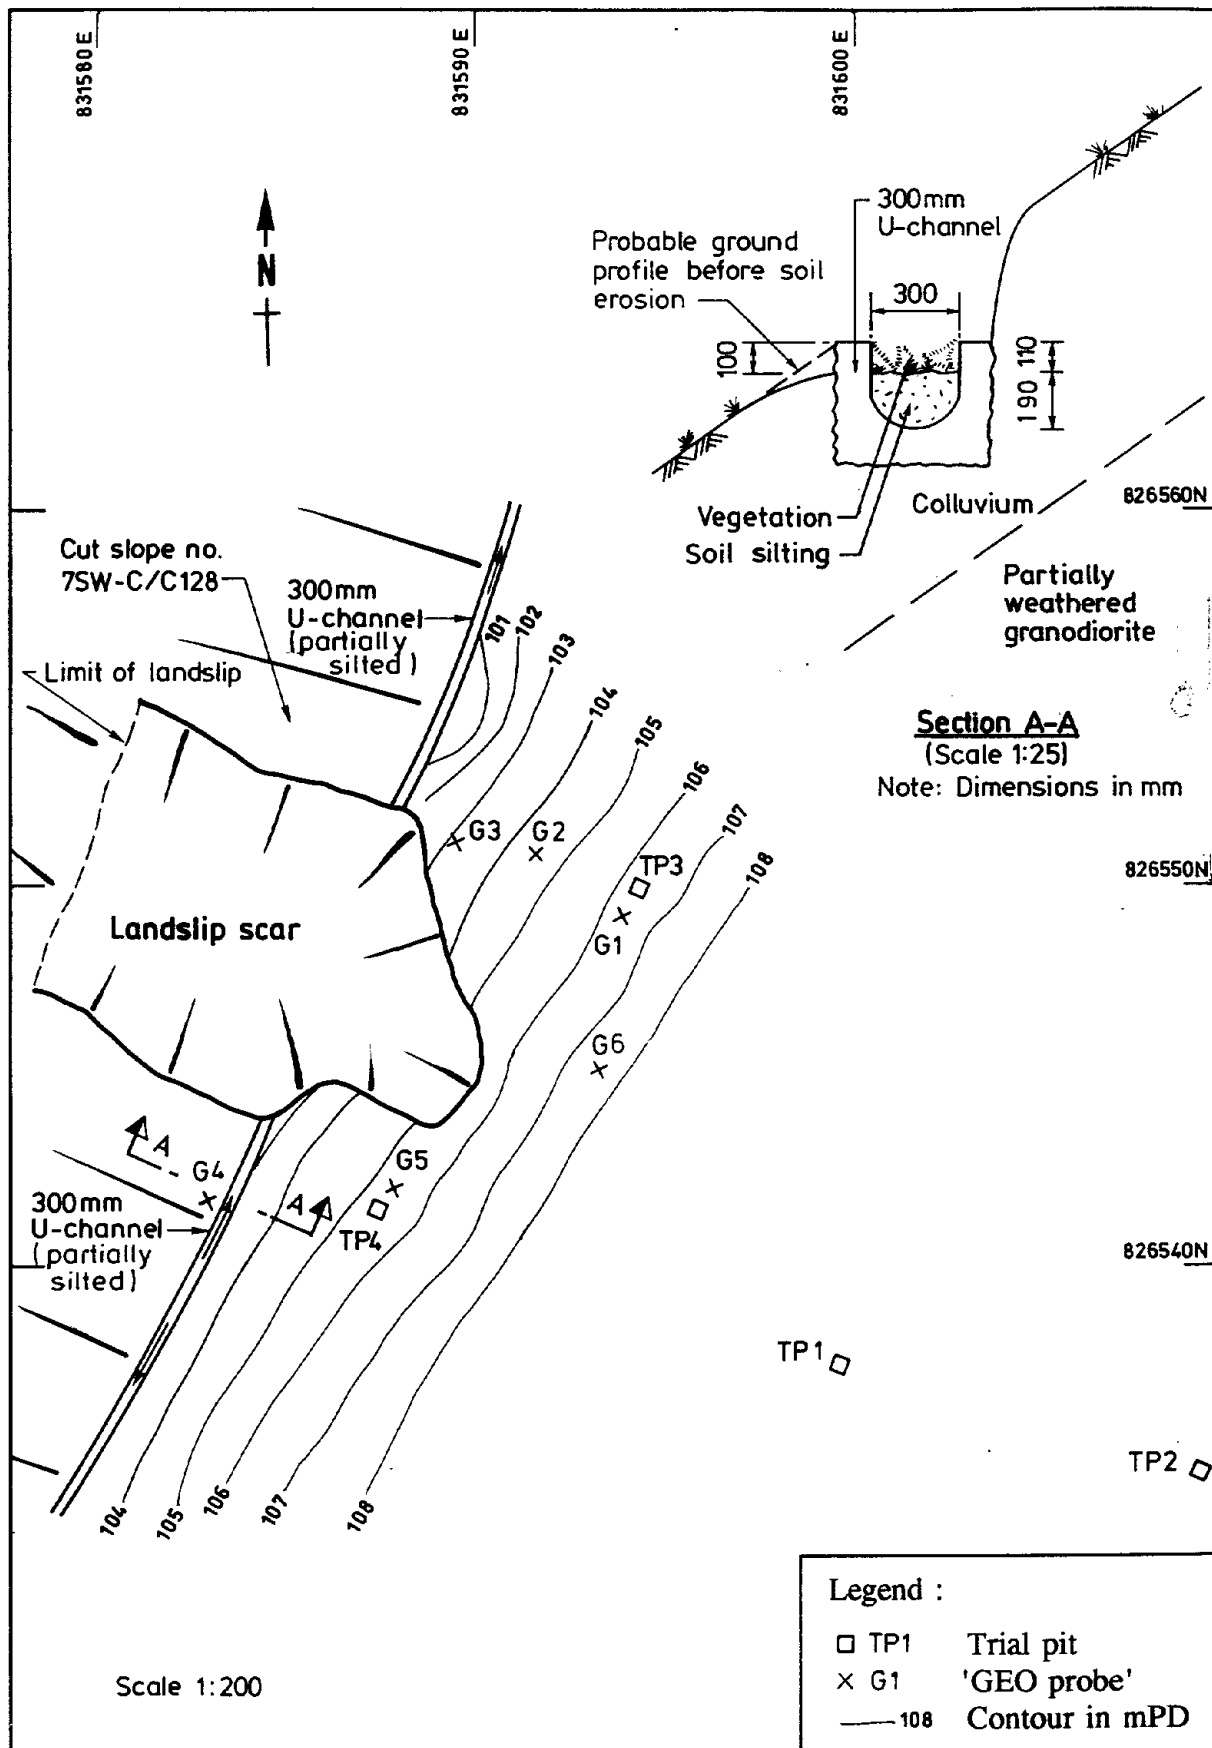
Figure 5 - Plan of the Landslip Scar

Field mapping and ground investigation were conducted by the GEO shortly after the landslide. Field work including four trial pits and six 'GEO probes' was carried out at the locations shown in Figure 5. Based on the information obtained from the field mapping and the ground investigation, a cross-section of the failed cut slope was constructed as shown in Figure 6. The ground at the location of the landslide comprised colluvium about 1 m thick over partially weathered granodiorite. Colluvium consists of deposits formed by the downslope movement of soil and rock over a long period of time (several thousands to hundreds of thousands of years) under the action of gravity, commonly found on the lower reaches of natural slopes in Hong Kong. The slope failure appears to have taken place entirely within the colluvium, exposing the underlying partially weathered granodiorite. Field tests showed that the colluvium adjacent to the landslide scar was very loose, having a 'GEO probe' resistance of less than 5, and was more permeable than the partially weathered granodiorite underneath. Laboratory tests on samples collected from the site confirmed that the colluvium was very loose.

Site inspections after the landslide revealed that the cut slope did not have a surface protection except for a chunamed portion of the slope at a distance about 10 m to the southwest. The cut slope was overgrown with vegetation and there was a 300 mm U-channel along the crest of the slope at the location shown in Figure 5. The remaining portions of the U-channel on both sides of the landslide scar were found to be partially silted. Evidence of soil erosion was also observed in the vicinity of the remaining portions of the U-channel (for example, see section A - A in Figure 5).

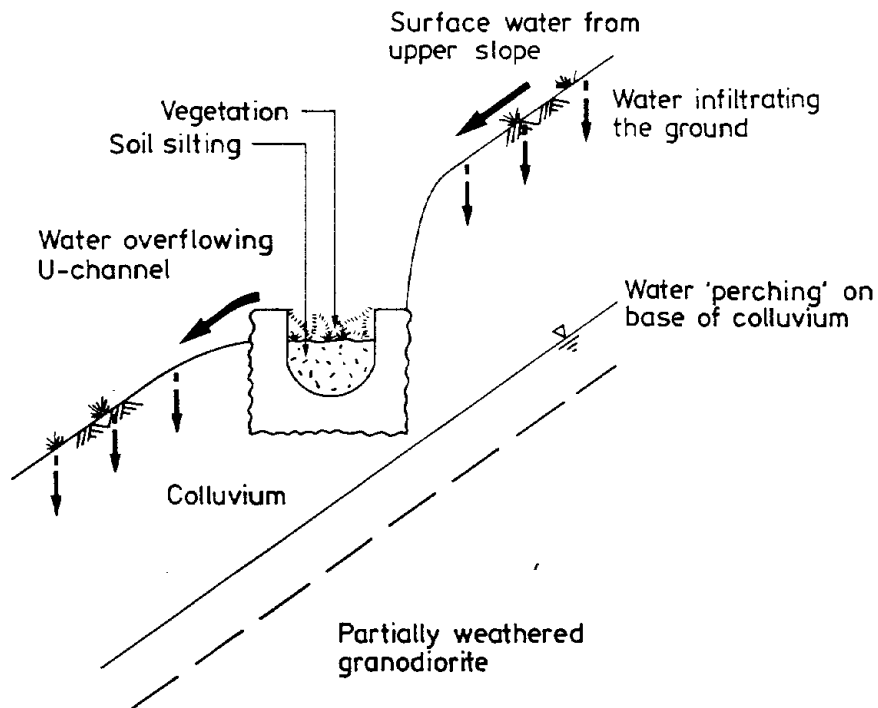
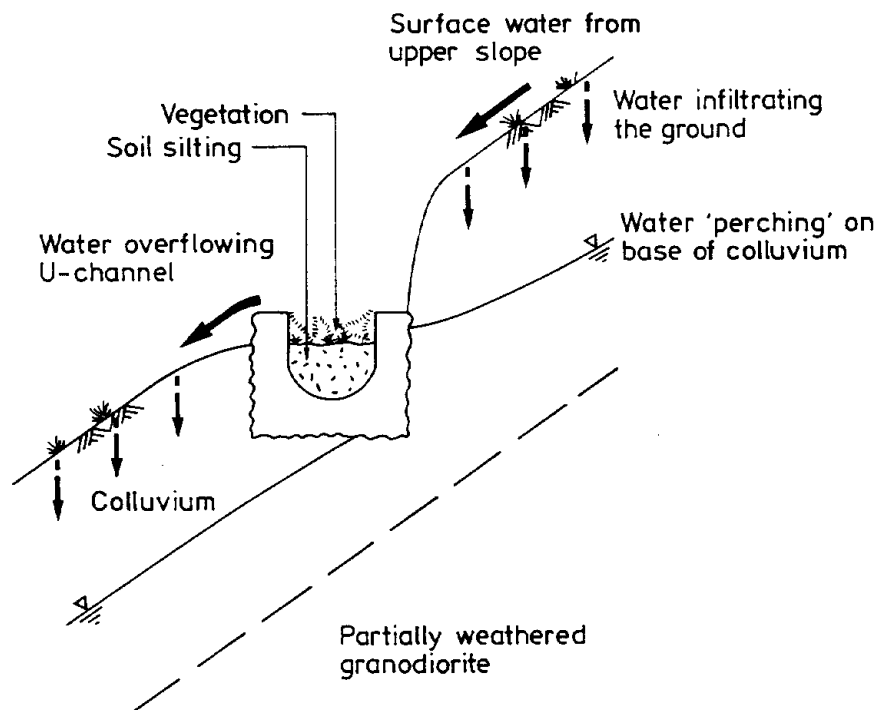
Figure 7 - Possible Conditions for the Failure of the Slope

During the heavy rainfall on 16 June, rain water could infiltrate the ground which was covered by natural vegetation. Water that entered the ground would tend to seep vertically downward under the action of gravity. When the water met the less permeable partially weathered granodiorite, its direction of movement would become parallel to the surface of the partially weathered granodiorite and a 'perched water' table would develop. Pressure generated by 'perched water' would adversely affect the stability of the slope. As infiltration continued, the 'perched water' level would gradually rise (Figure 7(a)). The stability of the thin layer (1 m) of very loose colluvium would have been sensitive to rise in 'perched water' level.

Analyses by conventional theoretical methods showed that the cut slope could in theory have failed if the 'perched water' on the downslope side of the U-channel developed to a depth greater than about 0.5 m from the base of the colluvium. Analyses also showed that higher water level behind the U-channel due to damming had little effect on the stability of the slope but could have enlarged the failure zone up the slope.
