APPRAISAL OF PERFORMANCE OF RECOMPACTED LOOSE FILL SLOPES

GEO REPORT No. 58

**This report was originally produced in July 1998
under Consultancy Agreement No. GEO 14/97**

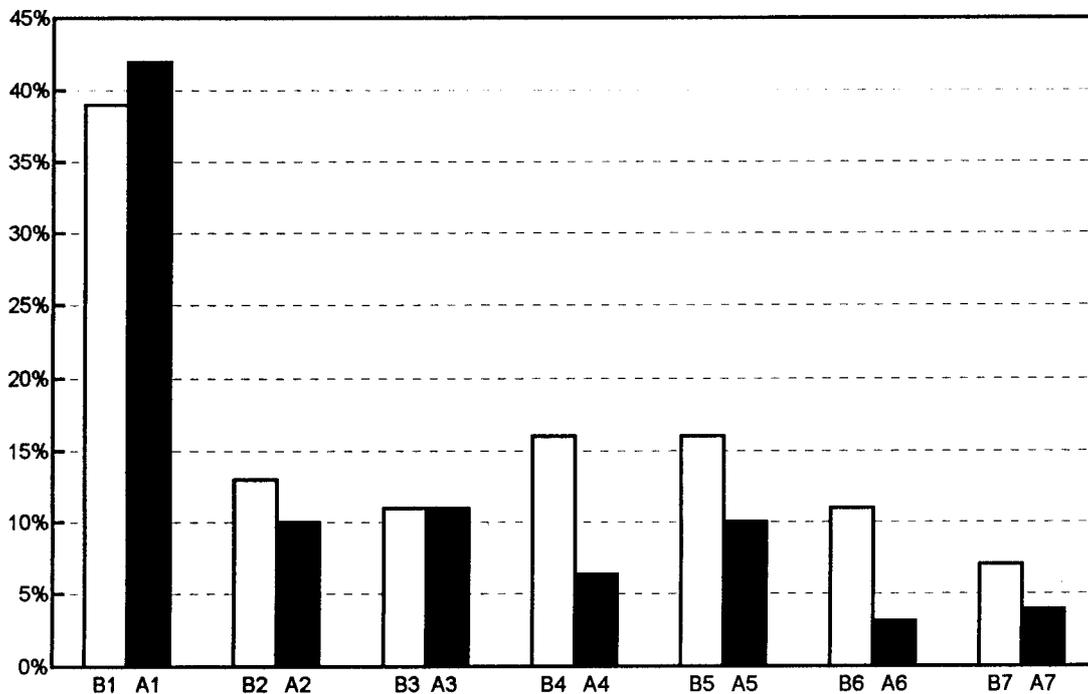
Figure 4.1b - Histogram showing the Occurrence Frequency of Observed Problems from Inspections of Slopes before and after LPM Programme

Figure 4.1a and Figure 4.1b show a comparison of the long term problems before and after the LPM works. The comparison is expressed in terms of percentage of the number of slopes having a certain problem to the total number of recompacted slopes. It should be noted that the number of slopes having a certain problem is based on the available records. A comparison of the percentage of the problem occurring before and after the LPM works gives some idea on the effects of the LPM works. The comparison shows that, after the LPM works, there is a marked improvement in terms of displacement and cracked surface cover. The problem of seepage and leakage is about the same before and after the LPM works. Both before

The improvement on displacement problem is substantial. Reductions of 73% and 43% are noted in the reported settlement and horizontal movement problems, respectively. This improvement seems reasonable as recompaction has reduced the compressibility of at least the top 3 m of fill.

There is about a 23% reduction in broken surface drainage systems after the LPM works. Two possible causes are responsible for the drainage system to break: poor quality work and movement of the soil supporting the drainage system. The records show that, 18% and 15%, respectively before and after the LPM works, of the broken drain cases are observed in association with reported settlement and/or movement problem. These numbers are probably on the low side as there have been no precise monitoring programme for the cases. Only fairly obvious settlements and/or movements are entered into the records. Nevertheless, these relatively low numbers suggest that a significant portion of the broken drains are caused by poor quality work. Thus, it will be cost effective to improve construction quality for reducing drain damage. Flexible joints may be useful for fills that are still settling.

The slope surface cover also performs much better after the LPM works. There are reductions of 63% and 38% in eroded and cracked covers, respectively. This improvement is consistent with the better treatment of the cover involved in the LPM works.

The lack of improvement on the seepage and leakage problem may indicate poor performance of the drainage layer placed behind the recompacted fill. In view of the importance of this drainage layer, as discussed in Section 9, for reducing the likelihood of a deep-seated failure and liquefaction potential of the underlying loose fill, effort must be directed in checking the effectiveness of this drainage layer.

The blockage of surface drainage and weepholes is usually caused by soil washed down from the upper part of the slope and by vegetation. Recompaction does not affect these causes and hence it will not reduce the blockage problem. In fact, there is a tendency to use hydroseeding for a vegetated cover during the LPM works. This may cause a higher possibility and hence a more severe problem of blockage as the vegetation takes root and becomes mature.

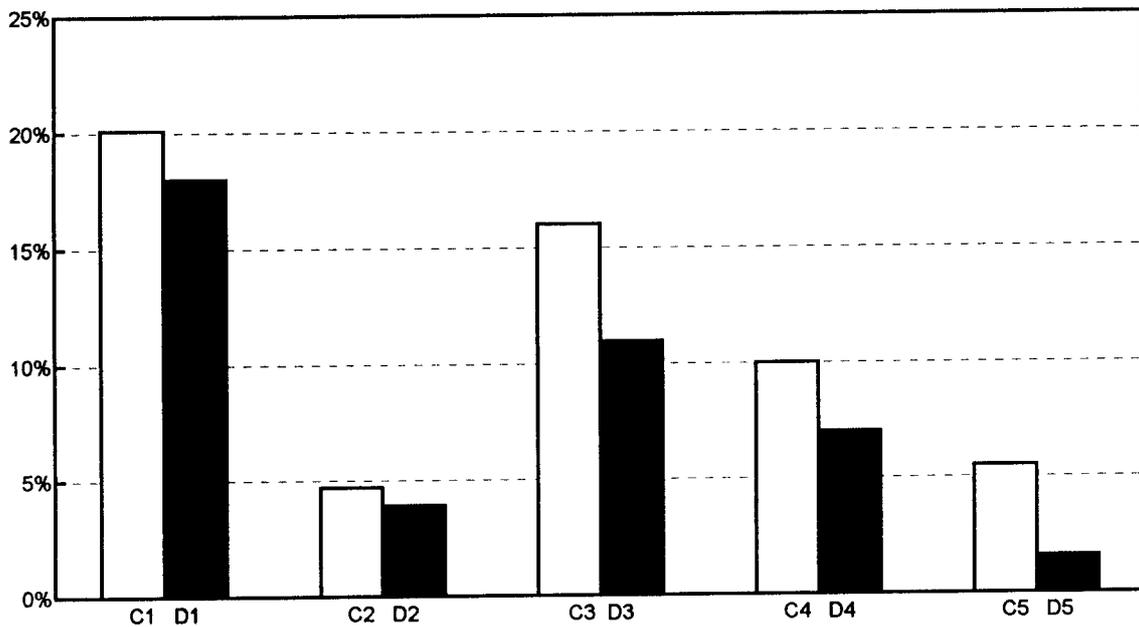
Figure 4.2b - Histogram showing the Occurrence Frequency of Observed Problems from Inspections of Retaining Walls before and after LPM Programme

Table 4.3 records the problems observed for the retaining walls before the LPM. The drainage condition refers to the drainage channels on top and bottom of the retaining wall and weepholes on the face of the wall. Cracking in the wall may be in the vertical direction or inclined from the vertical.

Table 4.4 is similar to Table 4.3 except it applies to the condition after the LPM programme.

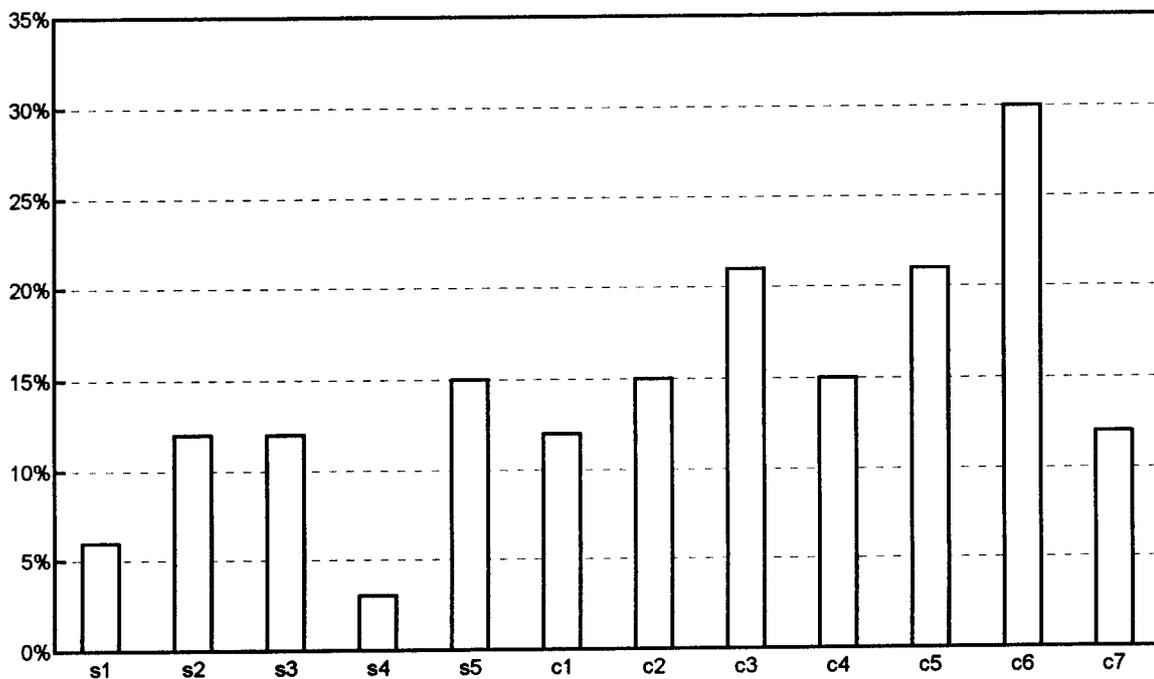
Figure 4.4b - Histogram showing the Occurrence Frequency of Site Constraints and Construction Problems from Inspections of Recompacted Fill Slopes before and after LPM Programme

Note: The above information is based on the 33 features with construction problems.
