HONG KONG RAINFALL AND LANDSLIDES IN 1995

GEO REPORT No. 59

C.K.L. Wong

**GEOTECHNICAL ENGINEERING OFFICE
CIVIL ENGINEERING DEPARTMENT
THE GOVERNMENT OF THE HONG KONG
SPECIAL ADMINISTRATIVE REGION**

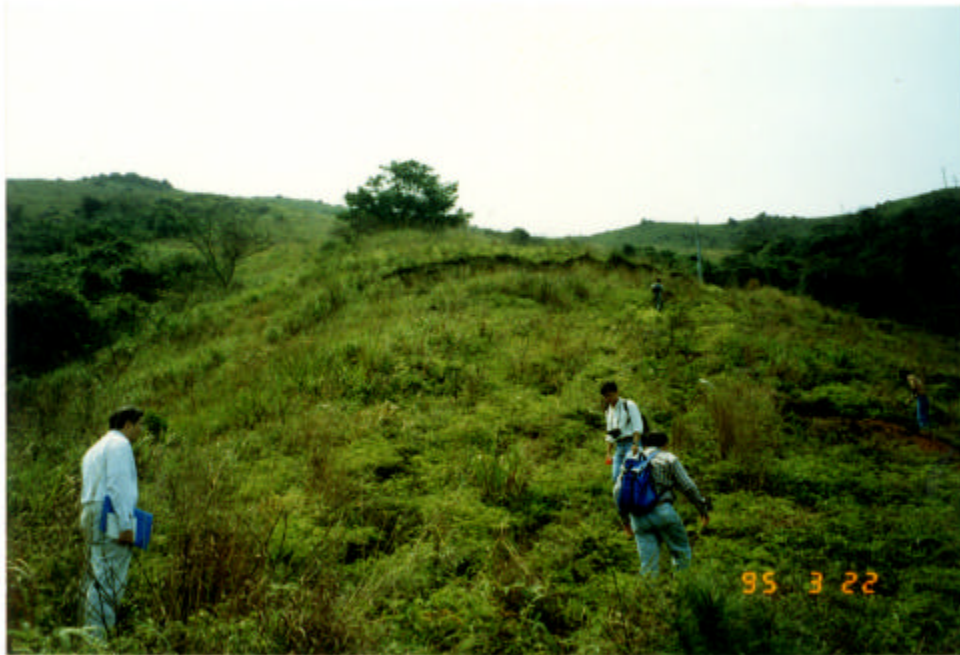
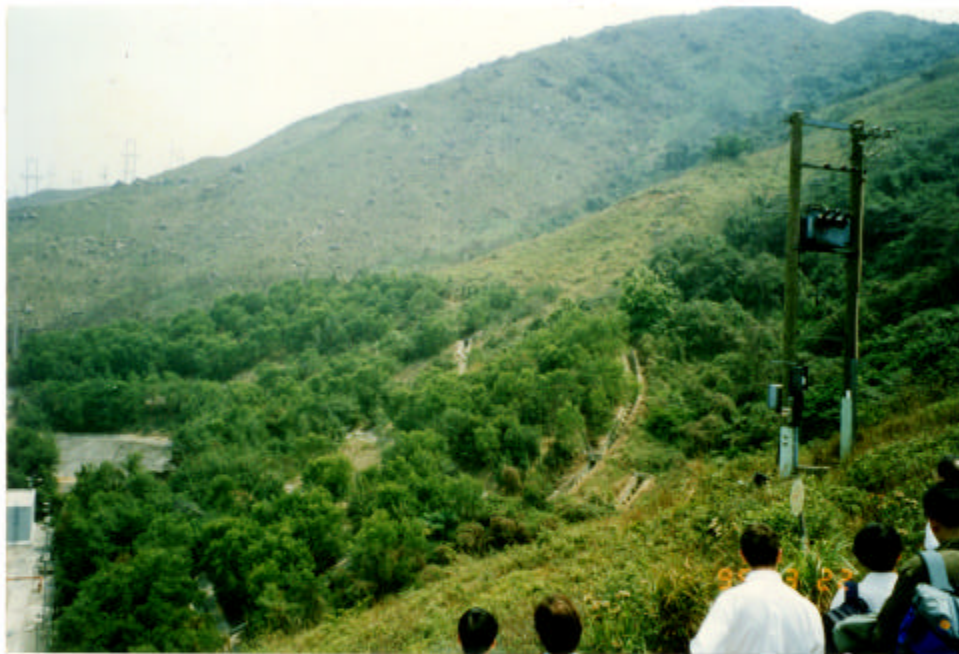
Plates 1 & 2 - Sham Shui Kok Sub-station, Lantau (Incident MW 95/3/1)

(Date : Not certain. Major failure of a soil cut slope affecting a building lot construction site, Plates 1, 2 & 3)

An extensive slow moving failure of a soil cut slope at the site of Sham Shui Kok Sub-station, North Lantau was reported to the GEO in 1995. It was observed from aerial photographs and site photographs that slope movement probably commenced in 1992. The failure involved part of a 42 m high cut slope with an average slope angle of 29° and a 24° steep natural slope above the cut slope. Both the natural and cut slopes were covered by vegetation. The failure mass has been moving slowly. The landslide volume was estimated to be about 20 000 m³ to 30 000 m³ over an area of about 60 m in height and 80 m in width. Although the failed portion of the cut slope had not exhibited significant displacement, tension cracks were found to be opening up on the natural slope above and the surface channels on the cut slope had been damaged. The failure was probably associated with the cutting of the natural slope.

Description : Major failure of a soil cut slope. Plate 1 shows the scarp and part of the natural slope involved in the landslide. Plate 2 shows the 42 m high cut slope and the natural slope above it.

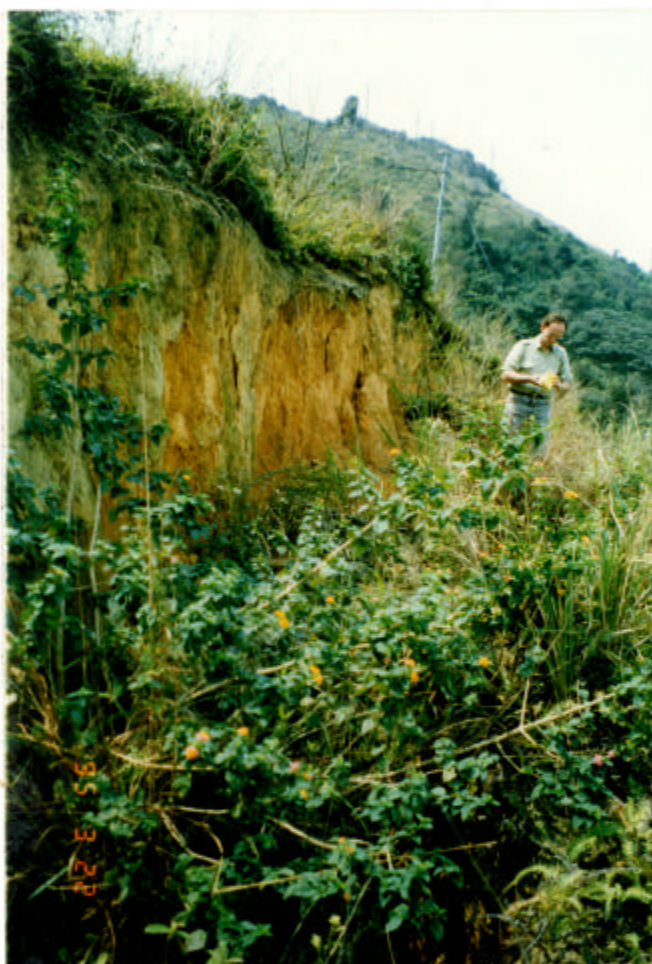
Plate 3 - Sham Shui Kok Sub-station, Lantau (Incident MW 95/3/1)

Description : Scarp of the landslide.

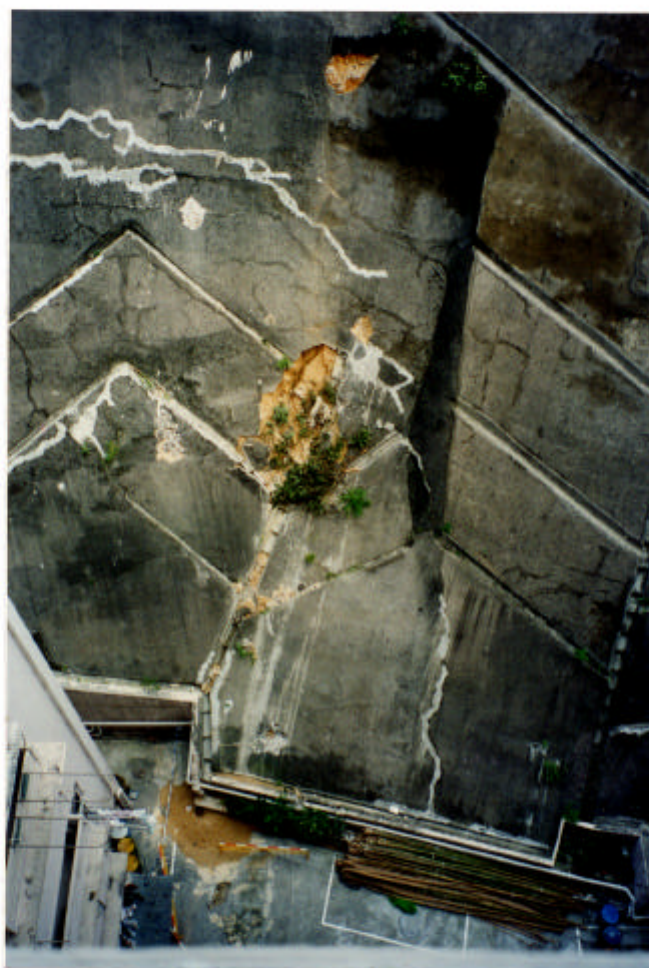
Plate 4 - Behind Kingsford Garden, 202-216 Tin Hau Temple Road, Braemar Hill
(Incident HK 95/7/1)

(Date : 4 July 1995. Boulder fall from a natural slope into a building lot resulting in the damage of four cars, Plate 4)

At about 8:15 a.m. on 4 July, three boulders fell down from a natural slope behind Kingsford Garden, 202-216 Tin Hau Temple Road, Braemar Hill. The natural slope was above a 25 m high soil cut slope. It is possible that the three boulders originated from one big boulder that broke into three pieces when rolling down the slope. The average dimension of the boulders was about 1 m. The boulders damaged four cars. The failure was probably caused by loosening of the ground supporting the boulders, as a result of the rain that preceded the failure.

Description : Boulder fall from a natural slope resulting in the damage of four cars.

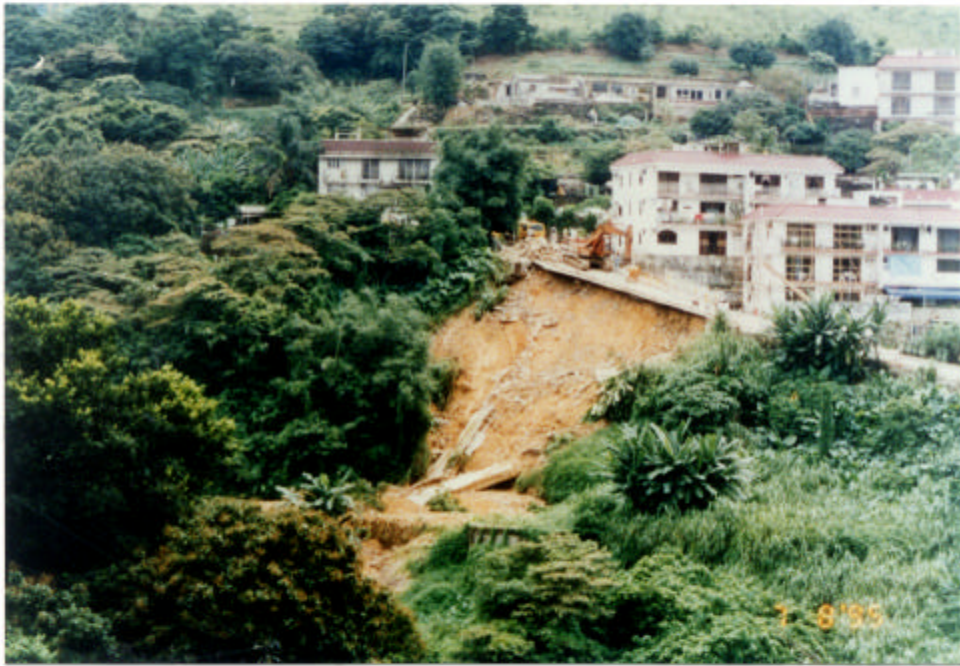
Plate 5 - Pak Shek Toi Road, Sai Kung (Incident ME 95/8/7)

(Date : 5 August 1995. Major failure of a fill slope resulting in the closure of an access road and a pedestrian pavement, Plate 5)

At about 8:30 a.m. on 5 August, about 600 m³ of fill slipped as a result of failure of a fill slope together with a 2 m high retaining wall at its crest which was supporting Pak Shek Toi Road. The fill slope was about 20 m high and was covered by vegetation before the landslide. The portion that failed was about 13 m high and 30 m wide. The maximum depth of failure was about 4 m. This resulted in the closure of Pak Shek Toi Road and the pedestrian pavement alongside the road. The failure was probably due to stormwater overflow from Pak Shek Toi Road onto the fill slope.

Description : Major failure of a fill slope resulting in the closure of an access road and a pedestrian pavement.

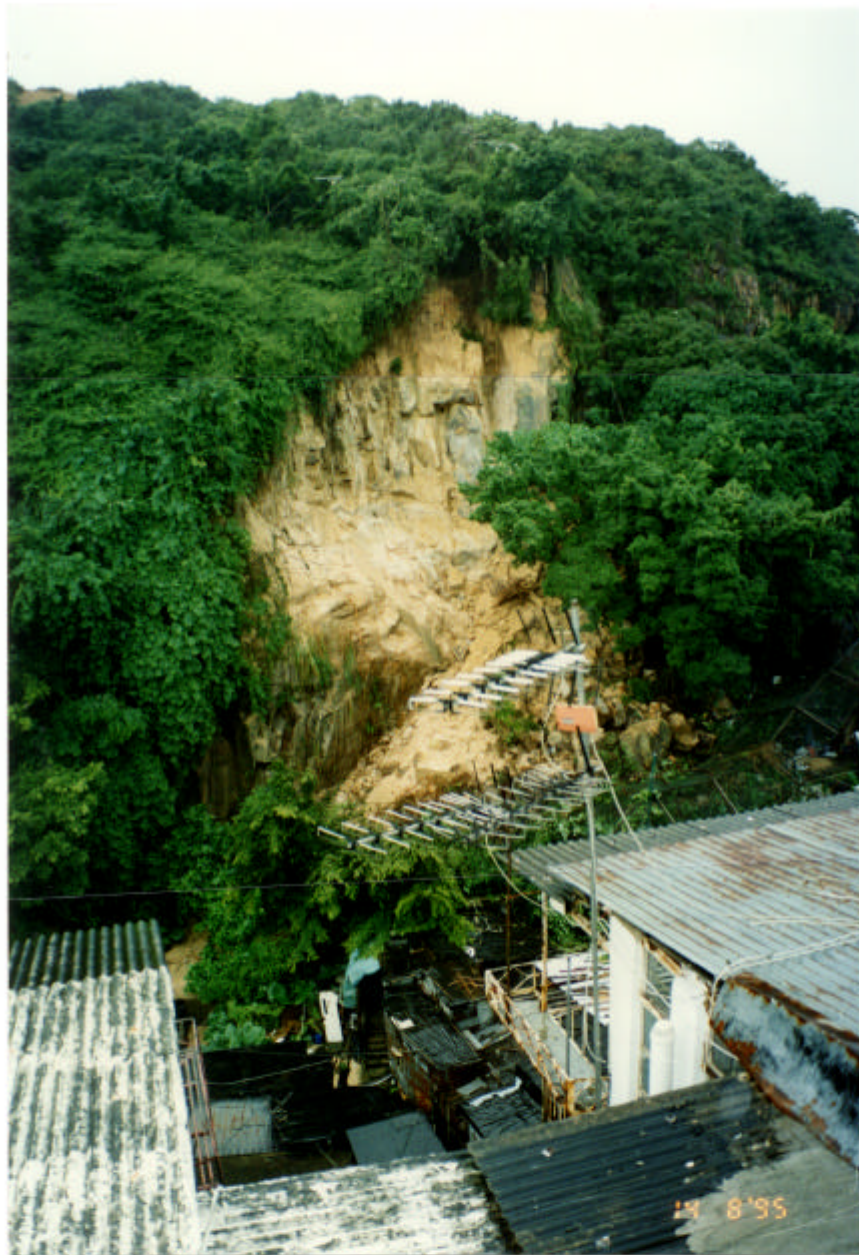
Plate 6 - 33 Fan Wa Street, Cha Kwo Ling (Incident K 95/8/7)

(Date : 12 August 1995. Failure of a soil/rock cut slope resulting in the permanent evacuation of 40 huts with 152 residents, Plate 6)

At about 5:00 p.m. on 12 August, a failure took place at 33 Fan Wa Street, Cha Kwo Ling, resulting in the permanent evacuation of 40 squatter huts with 152 residents. The portion that failed was an old quarry face and about 30 m high and 20 m wide. The landslide was probably triggered by heavy rain.

Description : Failure of a soil/rock cut slope resulting in the permanent evacuation of 40 huts with 152 residents.

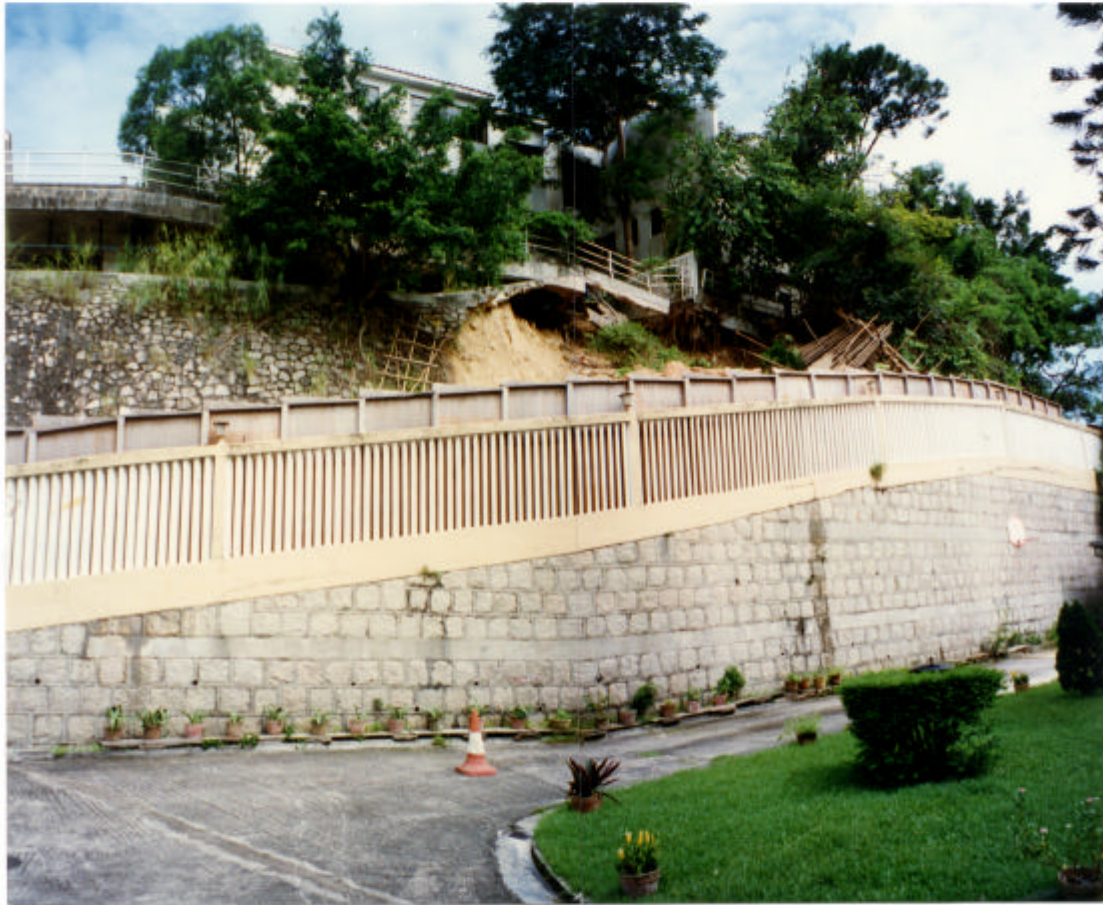
Plate 7 - Slope No. 11SW-D/CR160, 18 Shouson Hill Road, Shouson Hill
(Incident HK 95/8/73)

(Date : 12 August 1995. Major failure of a soil cut slope resulting in the temporary evacuation of four flats and blockage of a building access, Plate 7)

On 12 August 1995, about 400 m³ of weathered rock slipped from a soil cut slope (No. 11SW-D/CR160) below No. 18, Shouson Hill Road. The slope was about 10 m high and covered by stone-pitching before the landslide. The portion that failed was about 10 m high and 15 m wide. This resulted in the temporary evacuation of four flats and the blockage of an access road to No. 12 Shouson Hill Road. The landslide was probably triggered by the intense rain preceding the failure.

Description : Major failure of a soil cut slope resulting in the temporary evacuation of four flats and blockage of a building access.

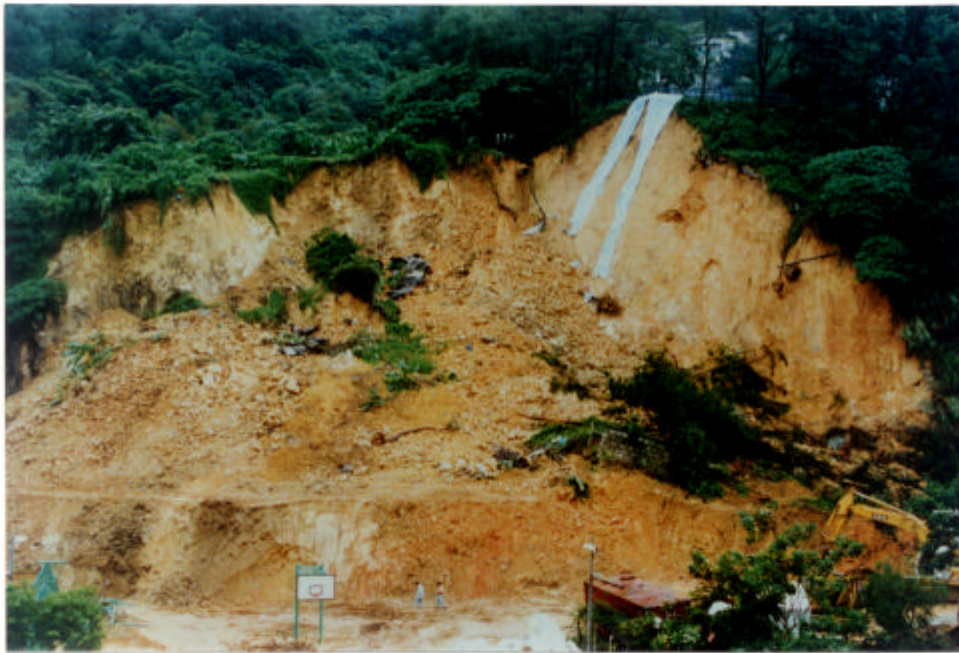
Plate 8 - Slope No. 11SE-D/C42, Chai Wan Baptist Church, 30 Fei Tsui Road, Chai Wan (Incident HK 95/8/43)

(Date : 13 August 1995. Major failure of a soil/rock cut slope resulting in one fatality, one injury and closure of Fei Tsui Road and part of a building, Plate 8)

The portion of the slope that failed was about 23 m high and 70 m wide. The average depth of the landslide was about 15 m. The landslide released about 14 000 m³ of debris and was the largest reported fast-moving failure of a permanent cut slope in weathered tuff in Hong Kong. The landslide debris covered the lower part of the cut slope, the open space in

Description : Major failure of a soil/rock cut slope resulting in one fatality, one injury and closure of a road and part of a building.

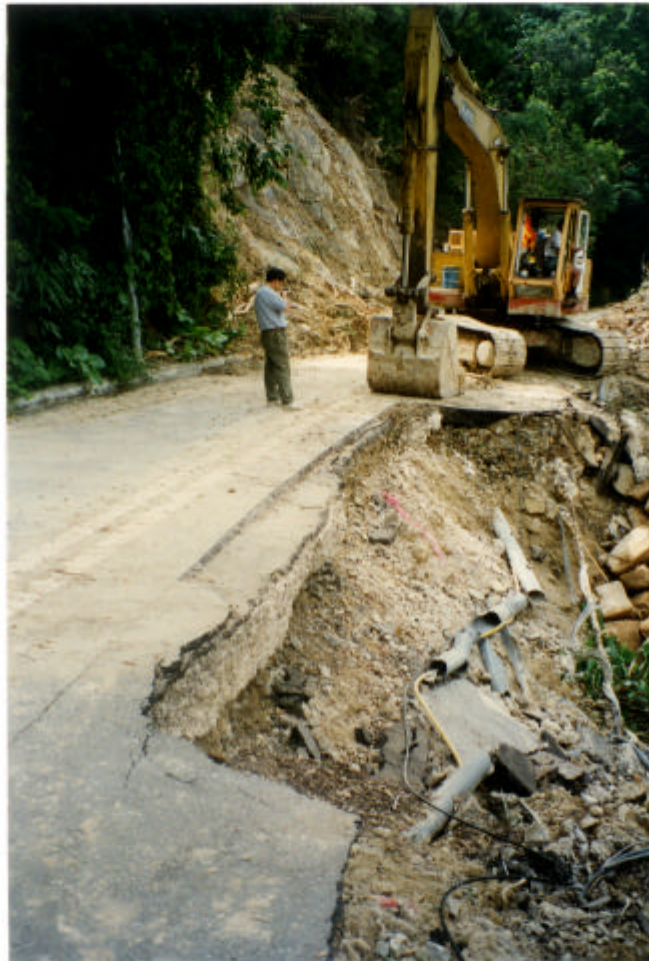
Plate 9 - Slope No. 11SW-D/C147, 24 Shouson Hill Road, Shouson Hill
(Incident HK 95/8/19)

(Date : 13 August 1995. Major failures of a soil cut slope and a natural slope resulting in the blockage of a road and fencing off of a carpark area, Plate 9)

Two slope failures took place at about 2:00 a.m. near 24 Shouson Hill Road, Shouson Hill. One of the failure involved 230 m³ of colluvium slipping down from a soil cut slope (No. 11SW-D/C147) onto Shouson Hill Road. The slope was about 10 m high and was covered by vegetation. This resulted in the blockage of two lanes of Shouson Hill Road. Another failure involved 80 m³ of colluvium slipping down from a natural slope below Shouson Hill Road and resting against the back wall of a carpark below the road. The slope was about 12 m high and was covered by vegetation. This resulted in the partial collapse of Shouson Hill Road and the fencing off of a carpark area. Both failures were probably triggered by infiltration and wash out during heavy rain.

Description : Major failures of a soil cut slope and a natural slope resulting in the blockage of a road and fencing off of a carpark area.

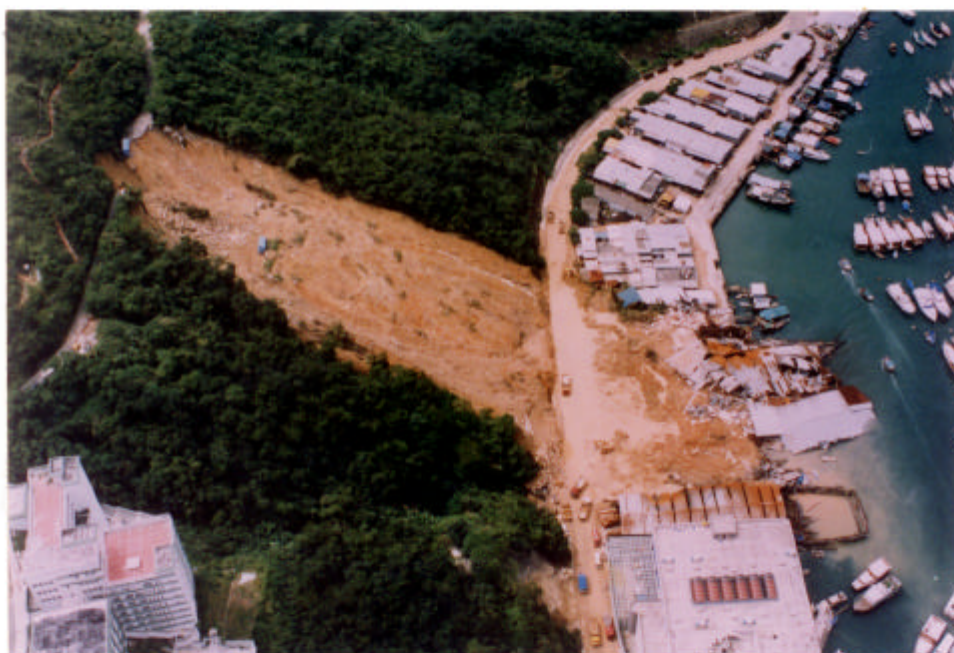
Plate 10 - Shum Wan Road, Aberdeen (Incident HK 95/8/49)

(Date : 13 August 1995. Major failure of the hillside above Shum Wan Road, resulting in two fatalities, five injuries, damage to three shipyards and a factory and closure of two roads, Plate 10)

On 13 August 1995, a landslide took place at the hillside above Shum Wan Road, Aberdeen. It caused the collapse of a 30 m long section of Nam Long Shan Road. Nam Long Shan Road was about 5 m wide at the location of the landslide, and there was a passing bay on the downhill side of the road. The passing bay was about 5 m wide and was supported by a fill embankment about 10 m high from toe to crest. The hillside was about 70 m high. Prior to the landslide, the hillside was densely vegetated and had an overall gradient of about 27°.

The failure was preceded by a minor failure of the fill embankment which occurred at a time between 11 p.m., 12 August, and 3 a.m., 13 August, followed by the collapse of Nam Long Shan Road at about 4:30 a.m. The landslide resulted in a 70 m high scar, with a width varying from 50 m to 90 m. The landslide released about 26 000 m³ of soil and rock. The landslide debris crossed Shum Wan Road and damaged three shipyards and a factory near the seafront. The landslide resulted in two fatalities, five injuries, and the closure of Nam Long Shan Road and Shum Wan Road.

Description : Major failure of a hillside, resulting in two fatalities, five injuries, damage to three shipyards and a factory and closure of two roads.

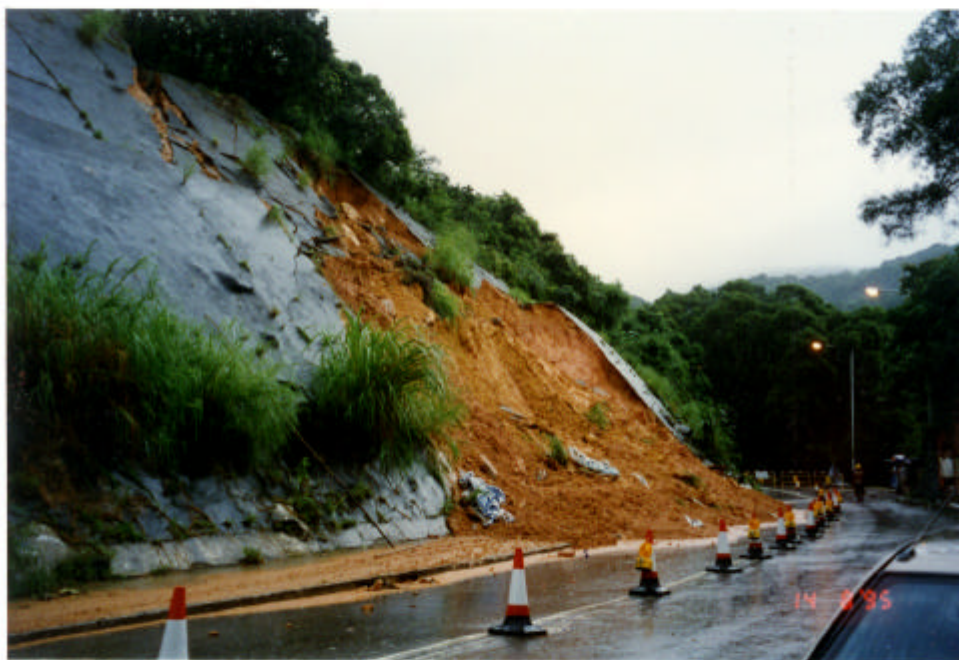
Plate 11 - Slope No. 8SW-A/C8, Junction of Sai Sha Road and Tai Mong Tsai Road, Sai Kung (Incident ME 95/8/11)

(Date : 13-14 August 1995. Major failure of a soil cut slope resulting in the closure of a road, Plate 11)

Between 13 and 14 August, about 2 000 m³ of weathered rock slipped progressively from a soil cut slope (No. 8SW-A/C8) at the junction of Sai Sha Road and Tai Mong Tsai Road, Sai Kung. The slope was about 20 m high, with an average slope gradient of 40°, and was covered by chunam. The portion that failed was about 14 m high and 60 m wide. The failure was probably due to infiltration resulting from prolonged and intense rainfall.

Description : Major failure of a soil cut slope resulting in the closure of a road.

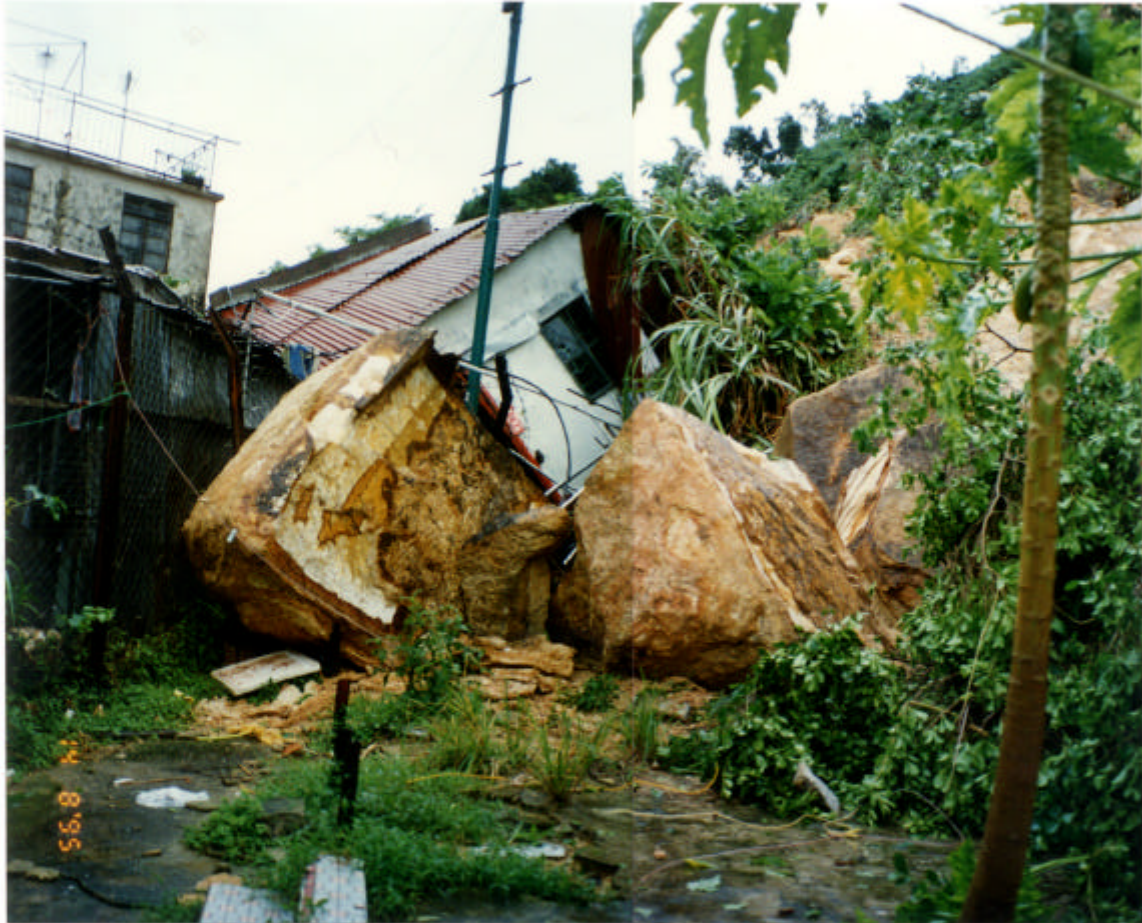
Plate 12 - Slope No. 11SE-B/C113, 503 Ma Wan Village, Lei Yue Mun
(Incident K 95/8/16)

(Date : 14 August 1995. Major failure of a soil/rock cut slope resulting in the permanent evacuation of 24 huts, Plate 12)

At about 8:00 a.m. on 14 August, about 400 m³ of weathered rock slipped from a soil rock cut slope (No. 11SE-B/C113) above No. 503 Ma Wan Village, Lei Yue Mun. The slope was an old quarry face about 30 m high and was covered by chunam and vegetation before failure. This resulted in the permanent evacuation of 24 squatter huts. The failure was probably due to infiltration resulting from prolonged and intense rainfall.

Description : Major failure of a soil/rock cut slope resulting in the permanent evacuation of 24 huts.

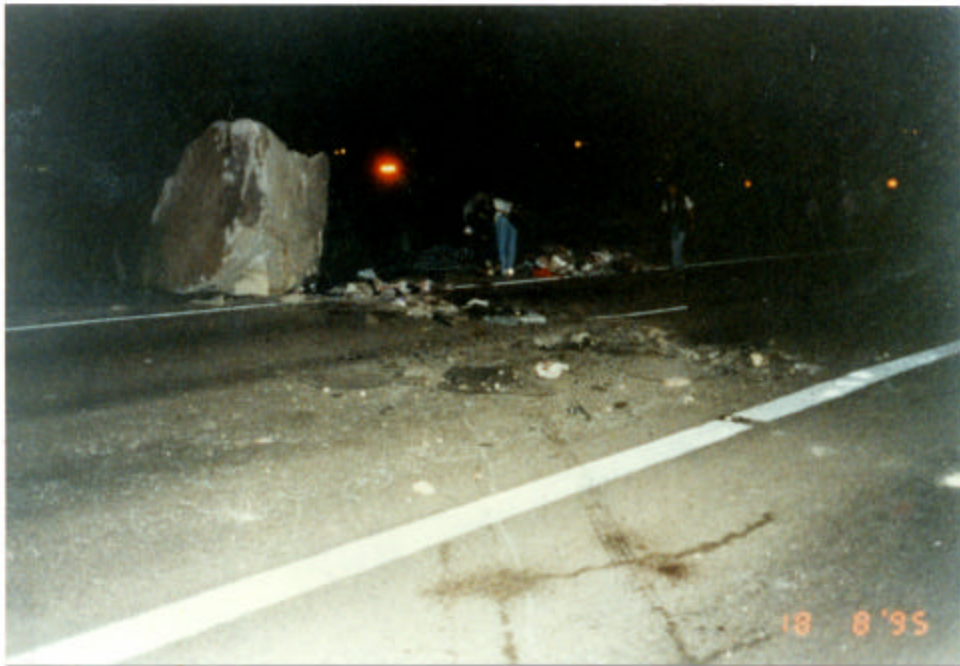
Plate 13 - Slope No. 6SW-D/C18, Road Widening Project Site near Siu Lam, Tuen Mun Highway (Incident MW 95/8/21)

At about 6:50 p.m. on 18 August, a boulder about 2 m x 2 m x 2.5 m in size fell down from a soil/rock cut slope (No. 6SW-D/C18) alongside Tuen Mun Highway near Siu Lam. Before the failure, slope works were being carried out at the location as part of the Tuen Mun Highway road widening project. The boulder hit a car and resulted in one fatality and one injury. The three Kowloon-bound lanes of Tuen Mun Highway were closed after the failure.

Description : Boulder fall from a construction site resulting in one fatality, one injury and closure of three lanes of Tuen Mun Highway.

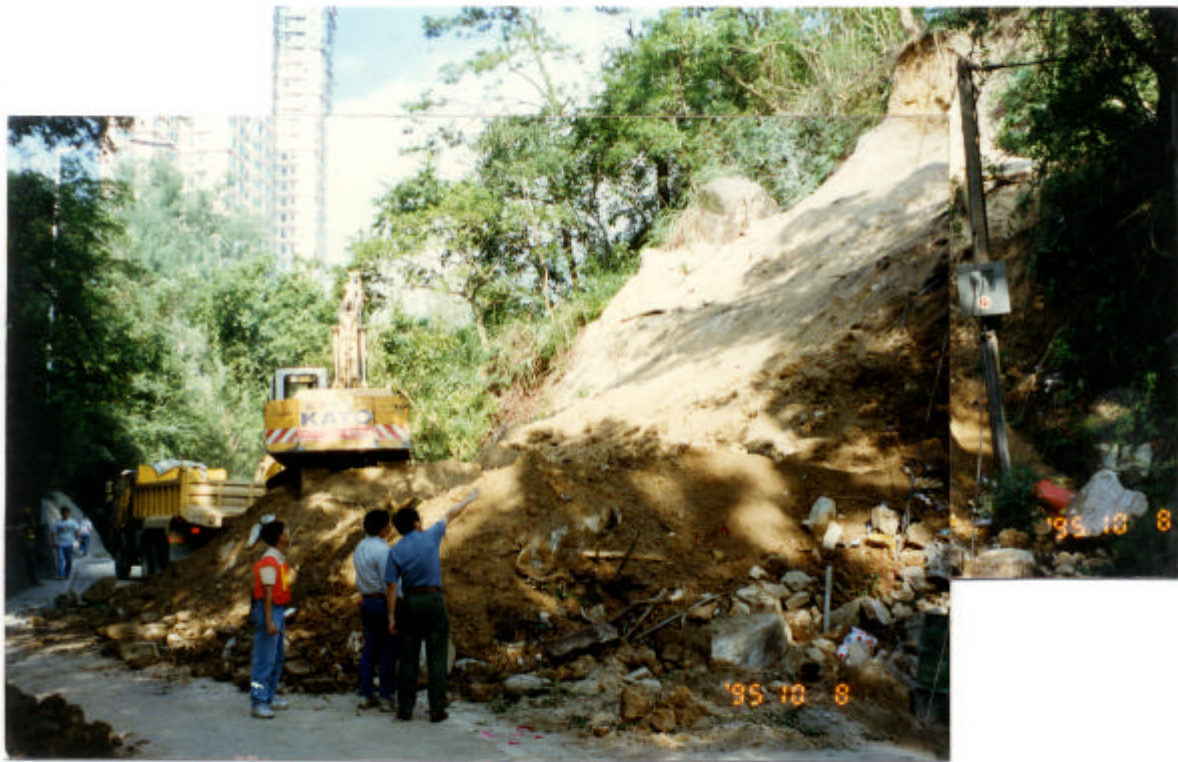
(Date : 6 October 1995. Failure of a soil/rock cut slope resulting in two injuries and blockage of a road, Plate 14)

of two bus passengers. The slope was about 9 m high and was covered by vegetation before the landslide. The failure was probably due to infiltration from preceding rainfall. Insufficient maintenance resulting in the loosening of soil due to tree root action might also have contributed to the failure.

Description : Failure of a soil/rock cut slope resulting in two injuries and blockage of a road. The debris at the toe of the slope was trimmed from the slope after the landslide, as part of the remedial works.
