**ASSESSMENT OF
GEOLOGICAL FEATURES
RELATED TO RECENT
LANDSLIDES IN VOLCANIC
ROCKS OF HONG KONG
PHASE 2A -
CHAI WAN STUDY AREA**

GEO REPORT No. 60

S.D.G. Campbell & N.P. Koor

**GEOTECHNICAL ENGINEERING OFFICE
CIVIL ENGINEERING DEPARTMENT
THE GOVERNMENT OF THE HONG KONG
SPECIAL ADMINISTRATIVE REGION**

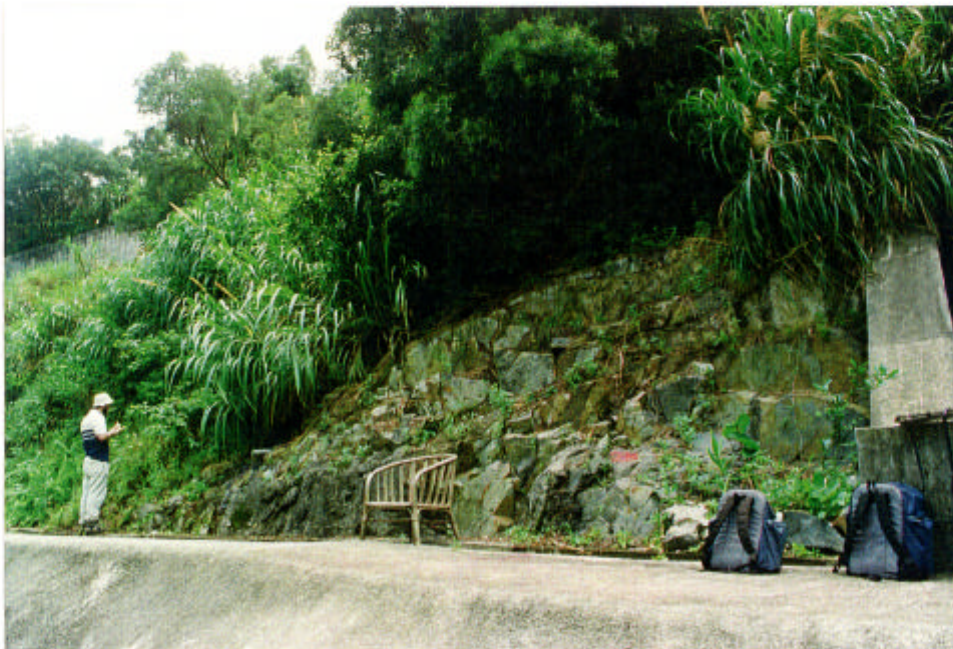
Kaolin concentrations at Siu Sai Wan appear near a relatively planar rock mass weathering zone interface between the PW0/30 zone and the PW90/100 zone (Plates 3-5). Such concentrations are often preferentially at or immediately above the interface (Plates 6-9). Kaolinitic clay is common along joints in the PW0/30 zone above the interface, and particularly those subparallel to the interface (Plates 10 & 11). However, kaolin concentrations were not observed more than two metres below the interface in any of the extensive cut slopes in rock (PW90/100) alongside the estate. Although the transition from PW0/30 to PW90/100 zone is abrupt (with the PW50/90 zone very thin or absent) and planar on a local scale, across the estate as a whole marked variations are seen in the depth at which the transition occurs. The most pronounced example of this variation (Plate 12) coincides with a northeast-southwest-trending fault that can be traced as a photolineament towards the southwest: the weathering transition steps upwards to the southeast across the steeply northwest-dipping fault. This fault-related feature is seen even more clearly in photographs taken during development of the slope (Plate 13). Other examples of fault-related control of the depth of weathering were identified during the development of slope 11SE-D/C181 (f. 69 in GCI 3/2/105) on the southeast side of the estate. Where the weathering transition is locally upwardly convex, significant seepage occurs, but seepage is more generally associated with the transition. Vegetation in general is concentrated at, and above the transition.

Plate 3 - General View of Planar, Obliquely Outward-dipping PW0/30 and PW90/100 Rock Mass Weathering Zone Interface (84356 81362), Associated with Kaolinitic Clay Development, in Slope 11SE-D/C188, West of Siu Sai Wan Estate (Taken 17/7/96)

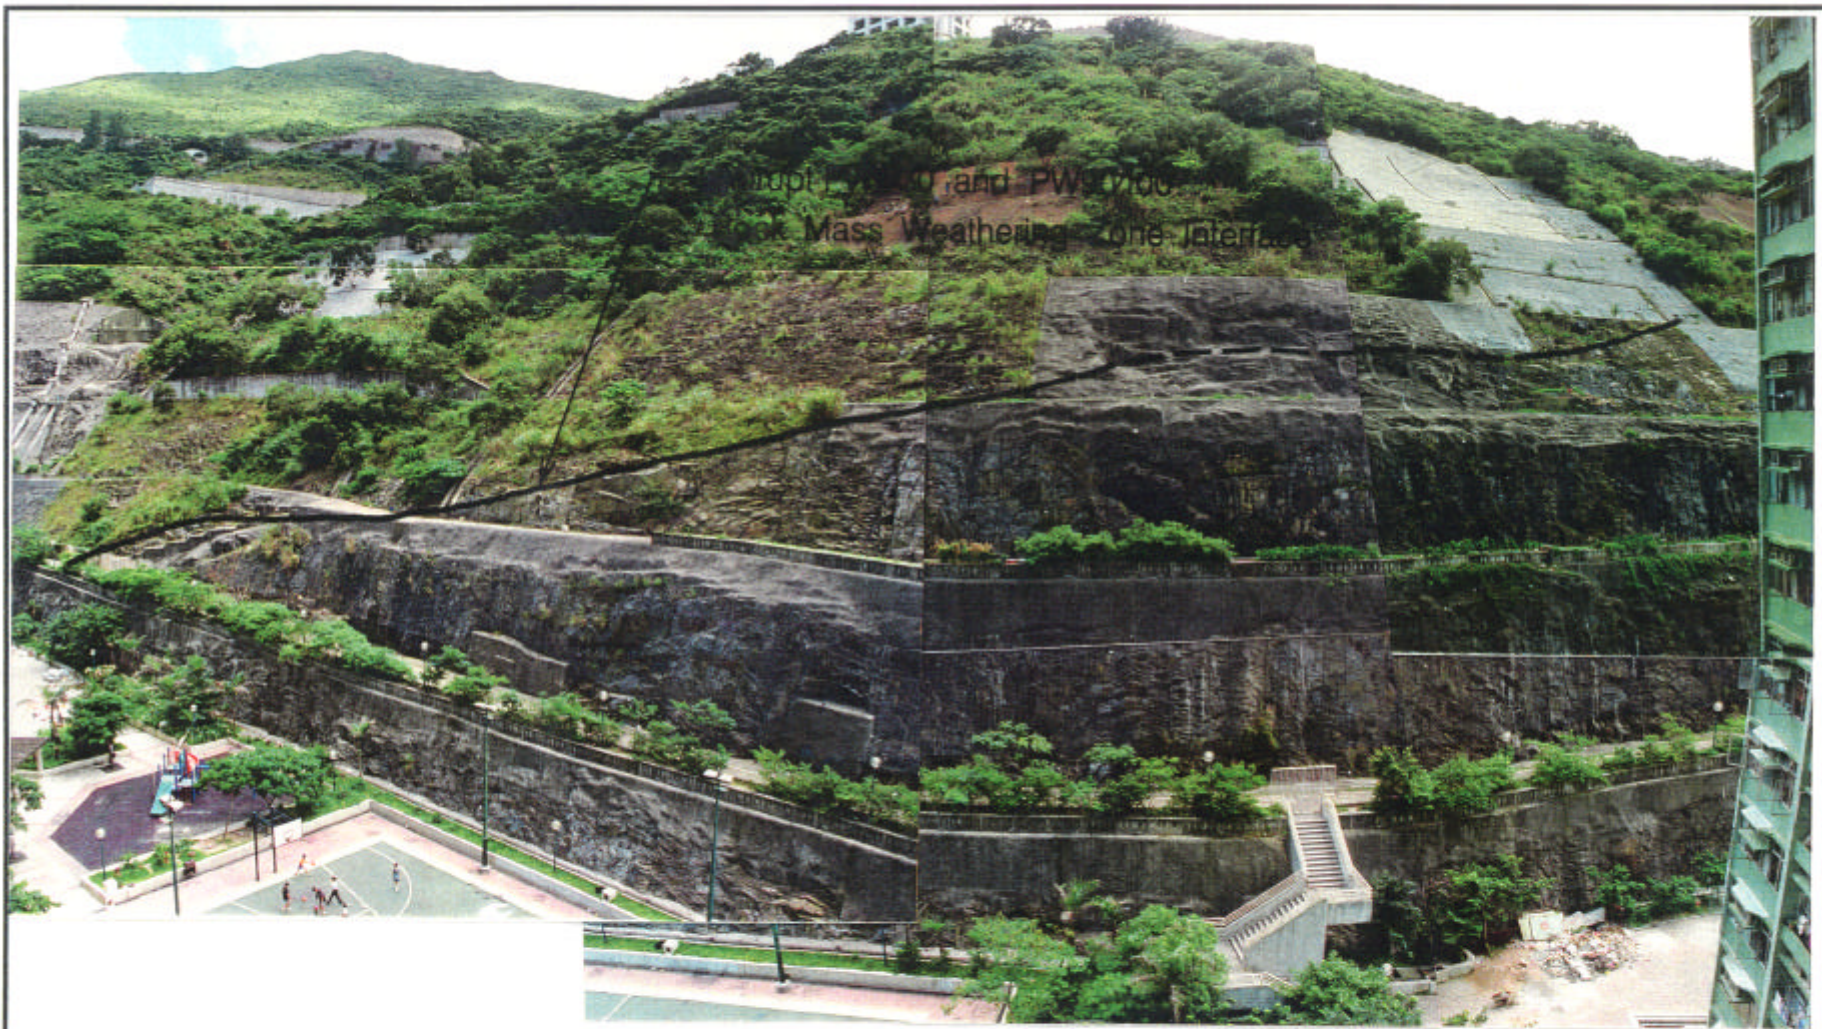
Plate 4 - Low-level Oblique View to the West, of Slope 11SE-D/C188, on the West Side of Siu Sai Wan Estate, Showing the PW0/30 and PW90/100 Rock Mass Weathering Zone Interface, and Associated with Seepage and Kaolinitic Clay Development (Taken 2/7/96)

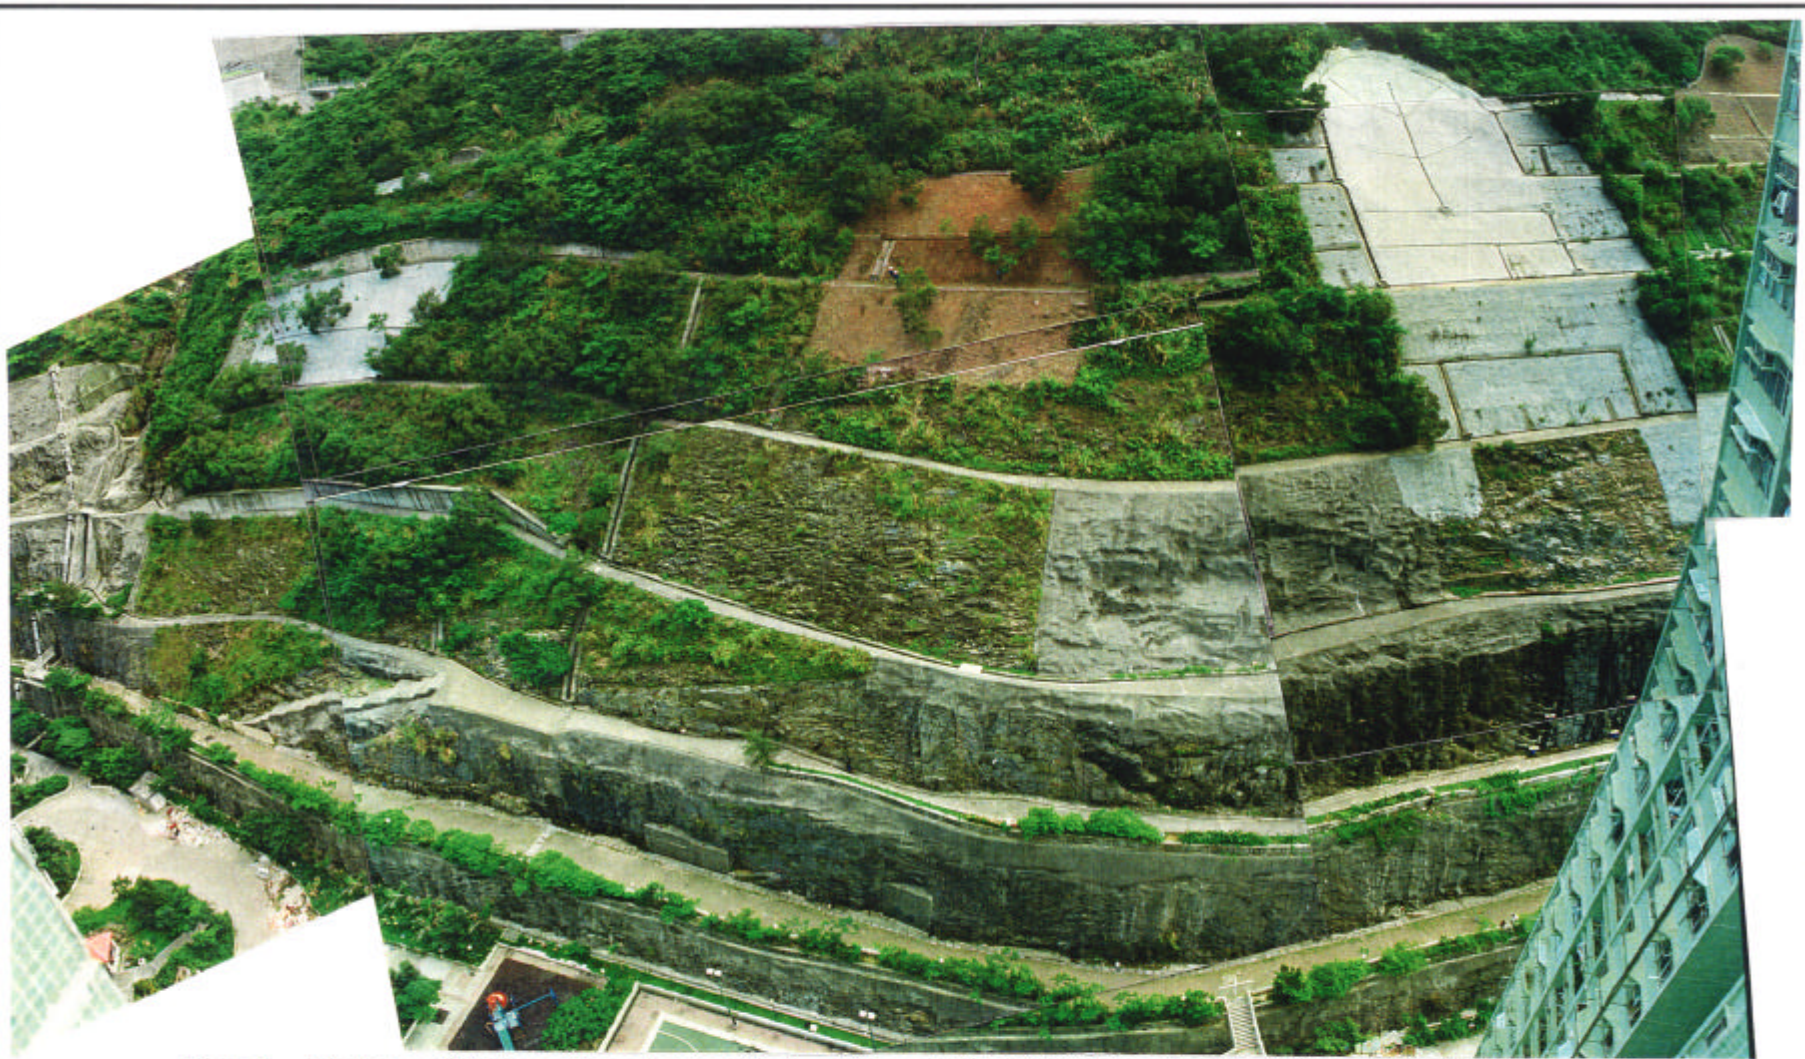
Plate 5 - High-level Oblique View to the West, of Slope 11SE-D/C188 on the West Side of Siu Sai Wan Estate, Showing the PW0/30 and PW90/100 Rock Mass Weathering Zone Interface, and Associated with Seepage and Kaolinitic Clay Development (Taken 2/7/96)

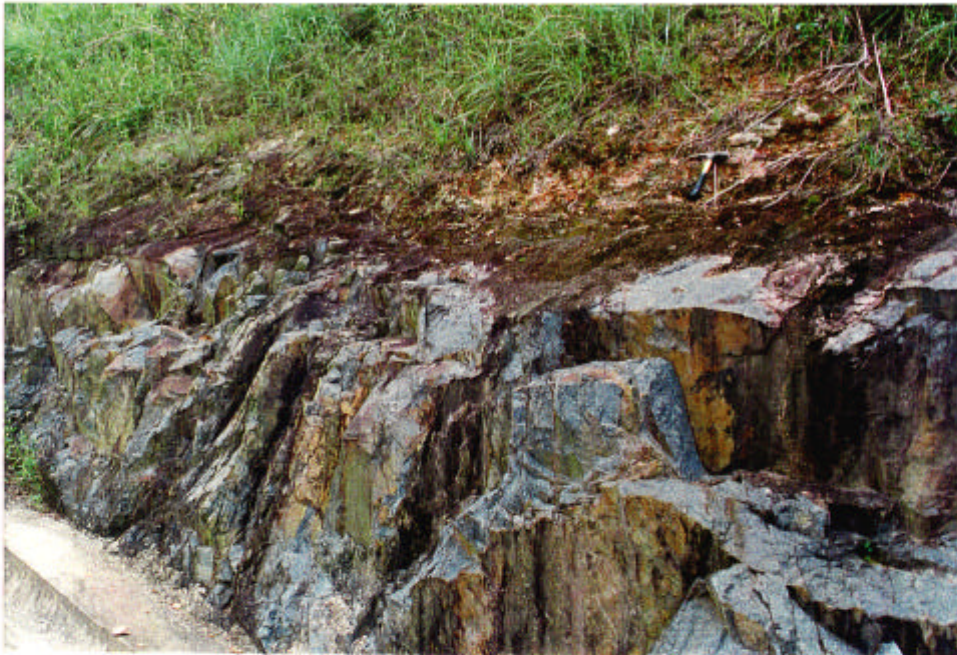
Plate 6 - General View of Outward-dipping, Planar PW0/30 and PW90/100 Rock Mass Weathering Zone Interface (843478 813884), Associated with Kaolinitic Clay Development, in Slope 11SE-D/C187, Northwest of Siu Sai Wan Estate (Taken 24/7/96)

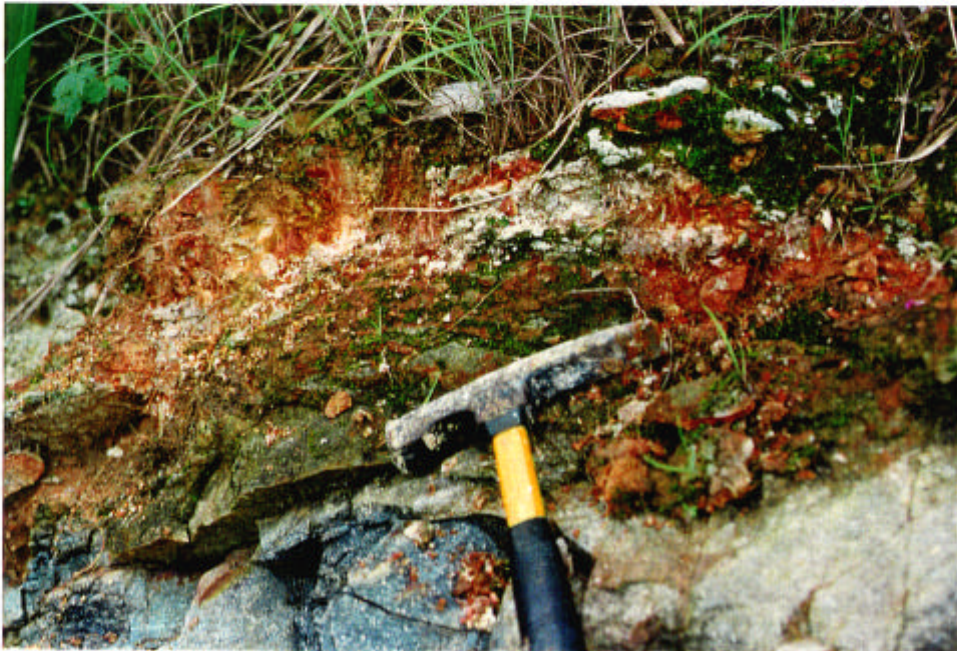
Plate 7 - Close-up of Exposure Shown in Plate 6, Showing Kaolinitic Clay Development along the Outward-dipping, Planar PW0/30 and PW90/100 Rock Mass Weathering Zone Interface (843478 813884), Slope 11SE-D/C187, Northwest of Siu Sai Wan Estate (Taken 24/7/96)

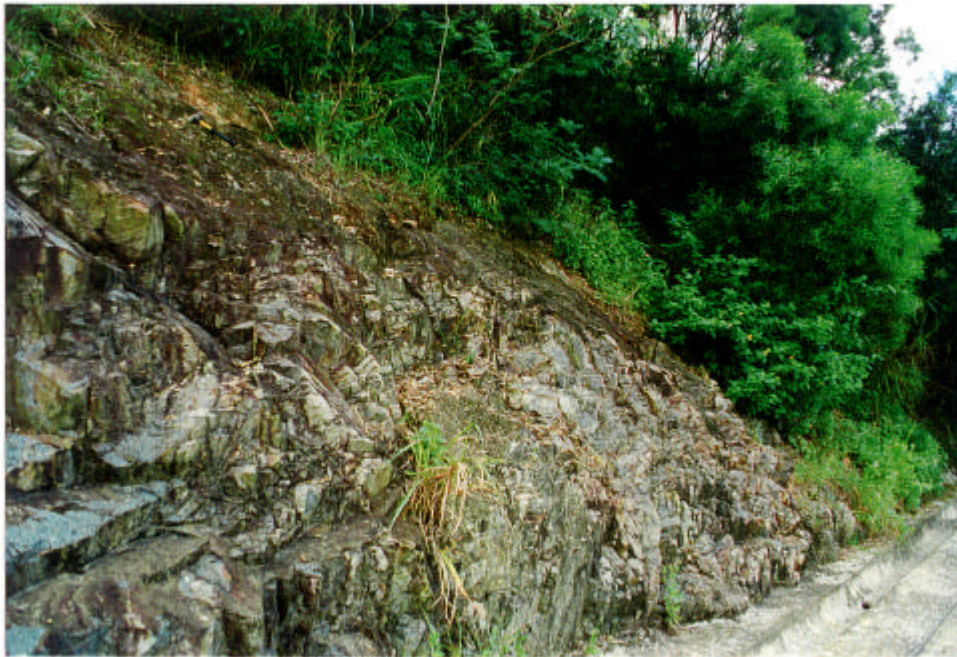
Plate 8 - General View of Outward-dipping, Planar PW0/30 and PW90/100 Rock Mass Weathering Zone Interface (843510 813932), Associated with Kaolinitic Clay Development, Slope 11SE-D/C187, Northwest of Siu Sai Wan Estate (Taken 24/7/96)

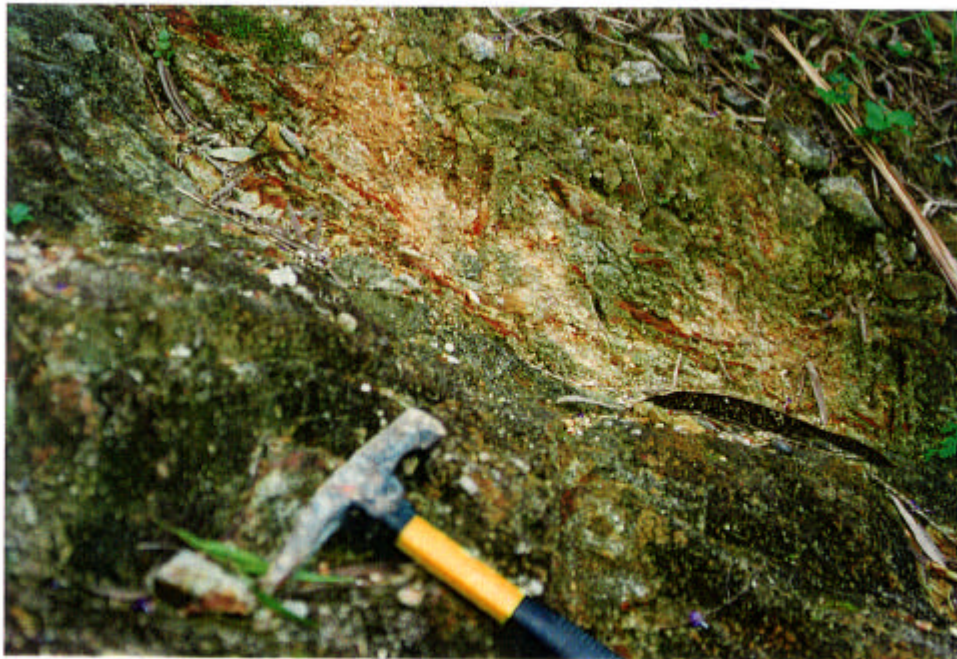
Plate 9 - Close-up of Exposure Shown in Plate 8, Showing Kaolinitic Clay Developed along Outward-dipping, Planar, PW0/30 and PW90/100 Rock Mass Weathering Zone Interface (843510 813932), Slope 11SE-D/C187, Northwest of Siu Sai Wan Estate (Taken 24/7/96)

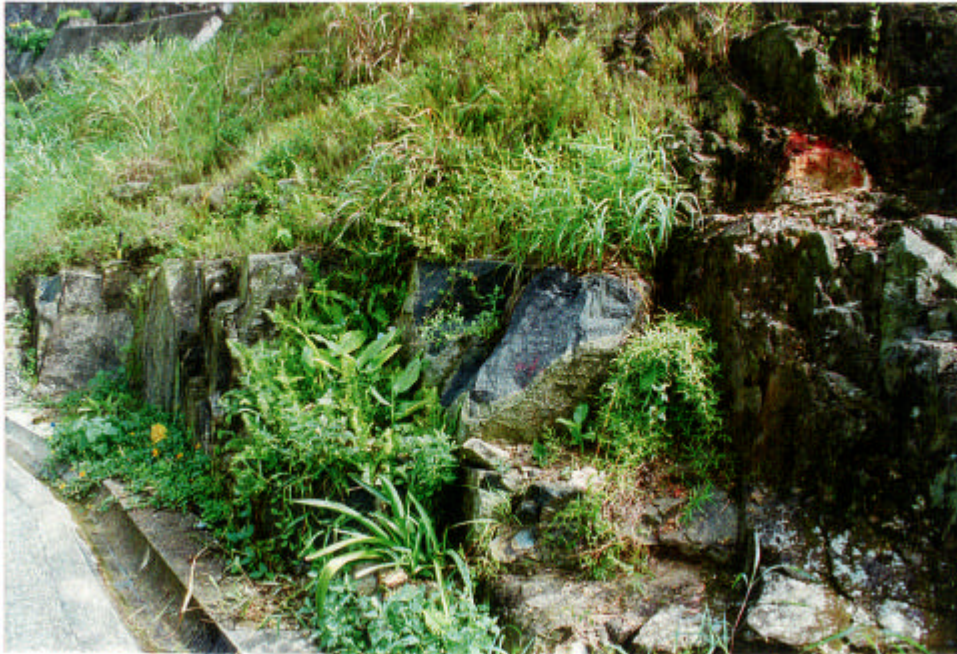
Plate 10 - General View To South, of the PW0/30 Zone Containing the Kaolinitic Clay-infilled Joint Shown in Plate 11, with Occasional, Large, Joint-bounded Cores Comprising Tuff, Predominantly of Weathering Grade II (Taken 24/7/96)

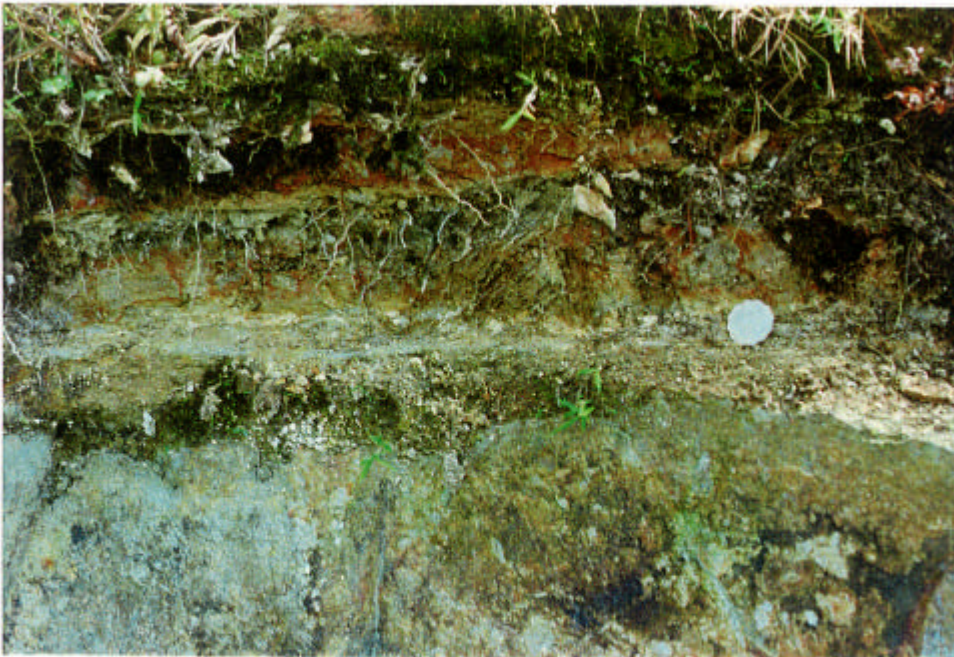
Plate 11 - White Kaolinitic Clay Vein (c.10 mm) Infilling a Shallowly-inclined Joint (843582 813586), Dipping Directly Outward within the PW0/30 Zone in Slope 11SE-D/C188, West of Siu Sai Wan Estate (Taken 24/7/96)

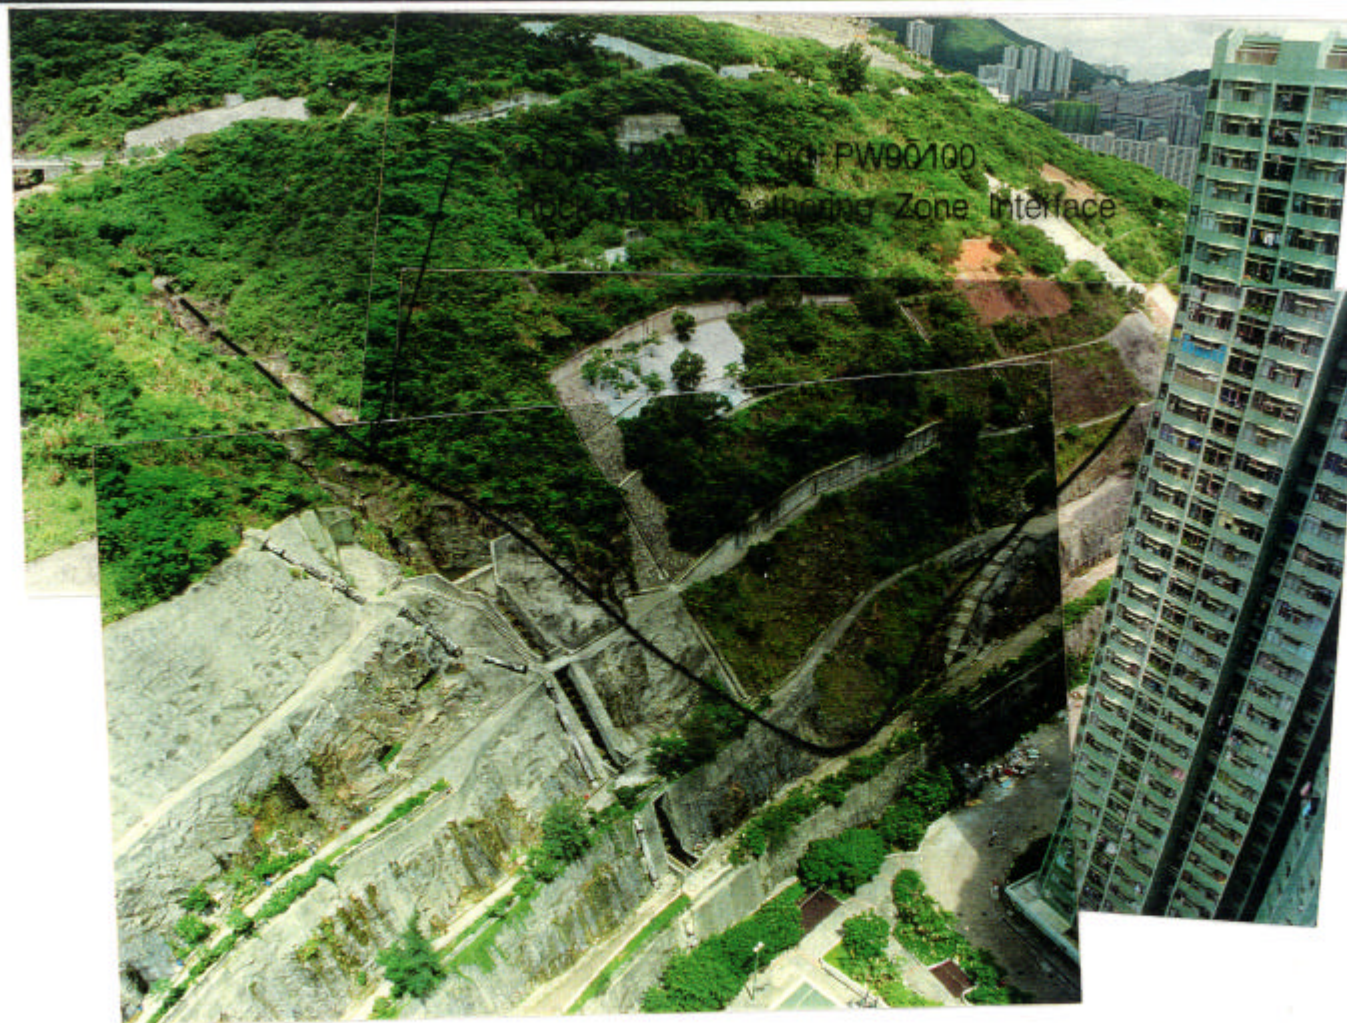
Plate 12 - High-level Oblique View to Northwest, of Slope 11SE-D/C188 on the West Side of Siu Sai Wan Estate, Showing Pronounced Local Variation in the Depth of Weathering (Taken 2/7/96)

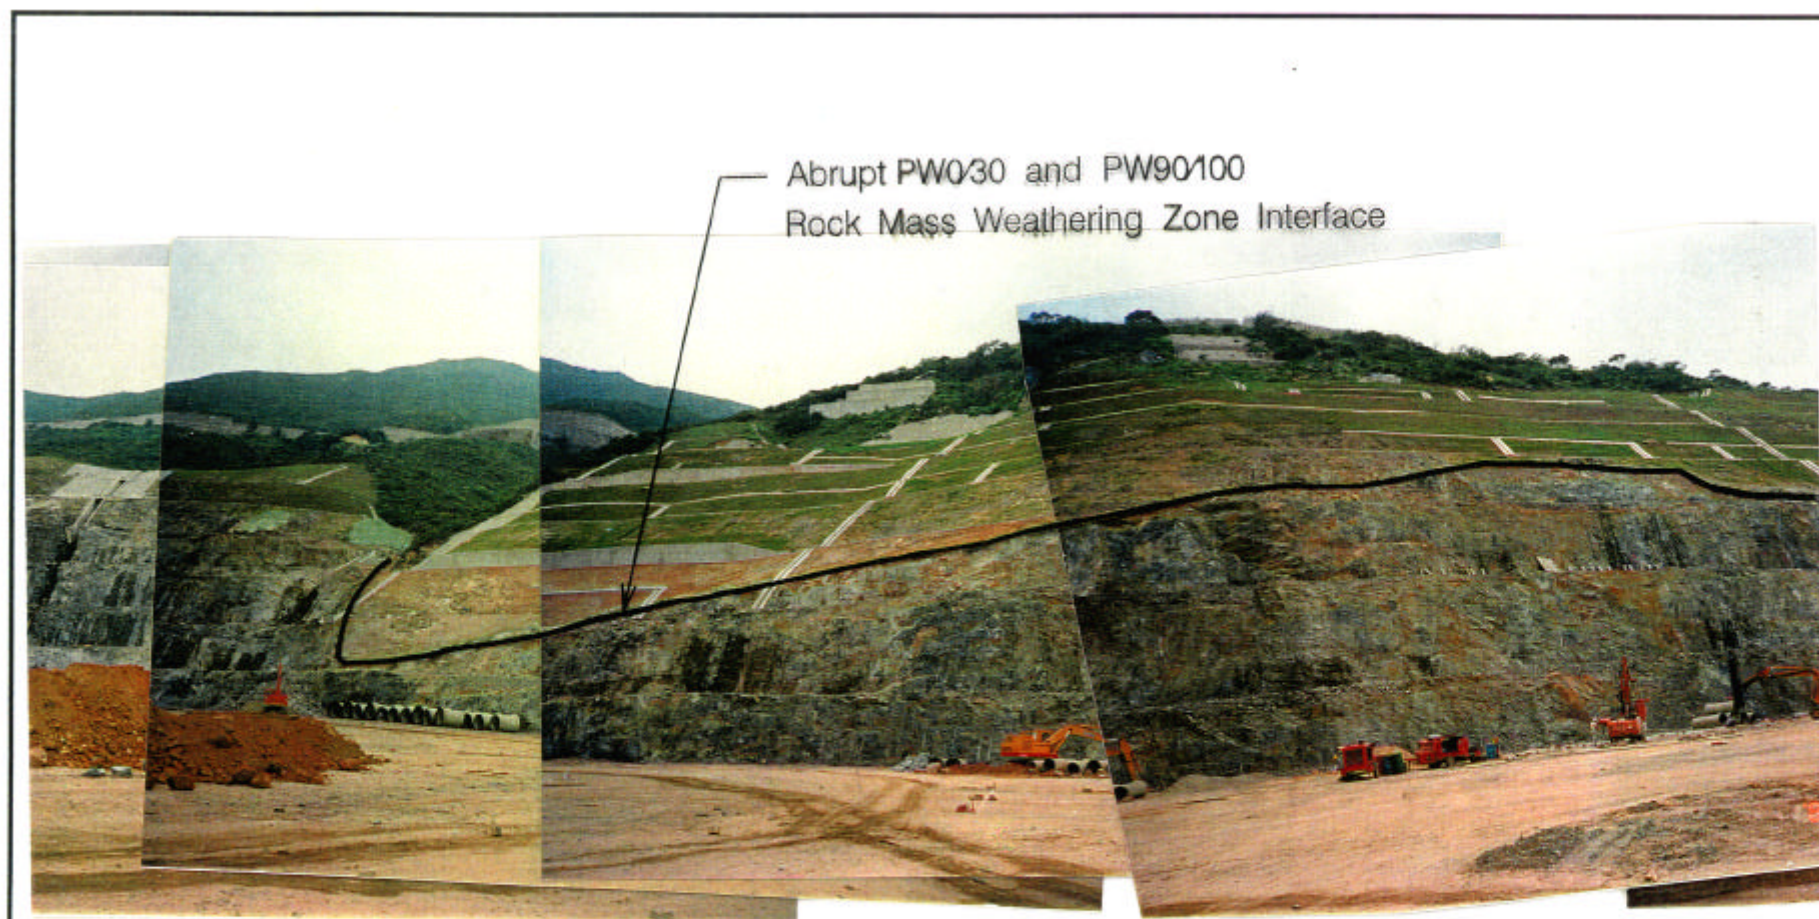
Plate 13 - View to the West, of Slope 11SE-D/C188 During Development, Showing Variable Weathering Depth, Related to Faulting, and the Generally Planar PW0/30 and PW90/100 Rock Mass Weathering Zone Interface (from f.69 in GCI 3/2/105; Taken 28/4/87)

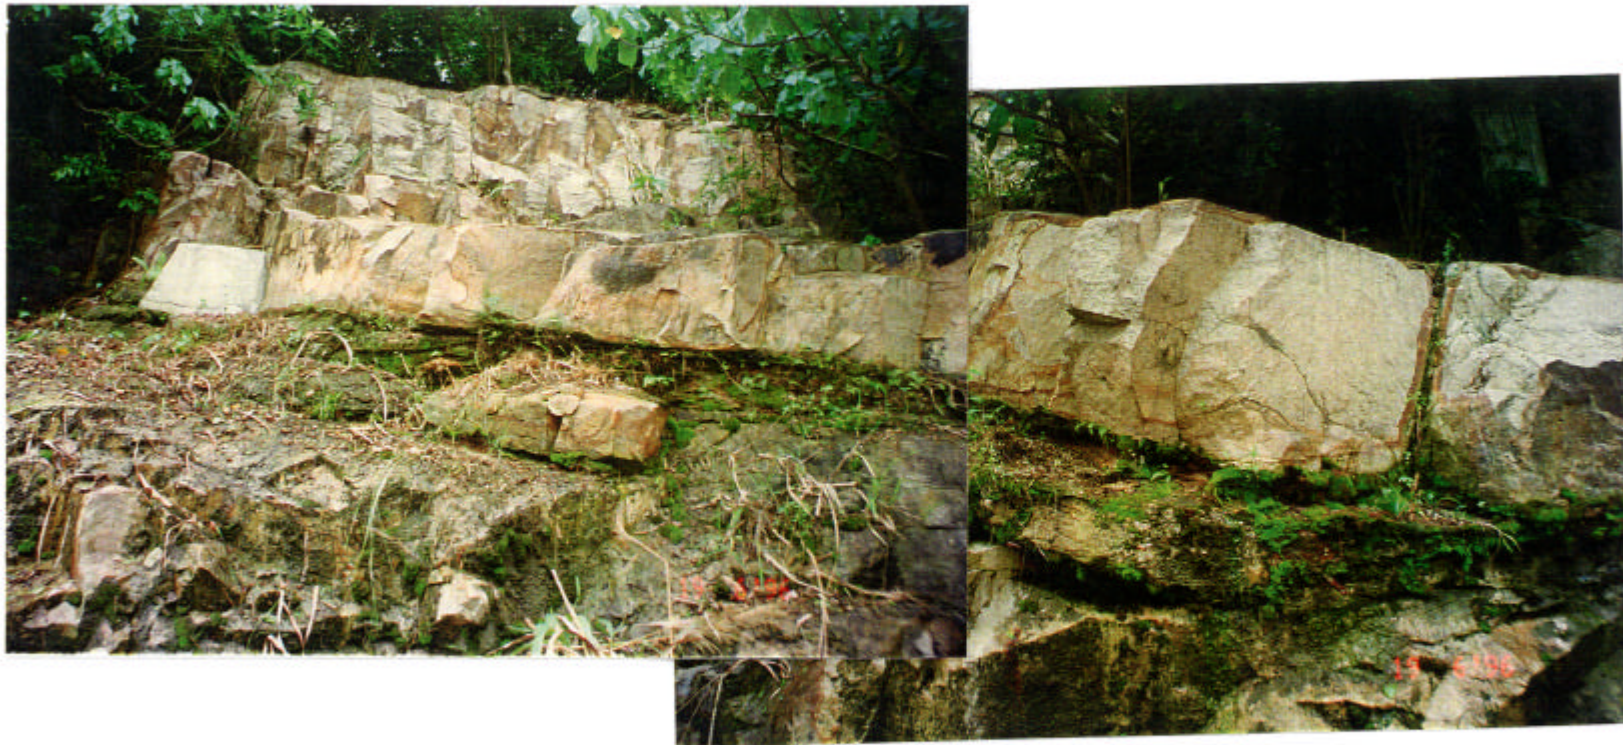
Plate 15 - Close-up of Slope 11SE-D/C49, as in Plate 14, Showing Foliation in the Seams, in Contrast to the Predominantly Grade II to III Rock Bounding the Seams. Incipient Movement along the Margins of the Seam is Shown by Detachment on Steeply-inclined Joints in Rock above the Seam in the Upper Part of the Plate (Taken 19/6/96)

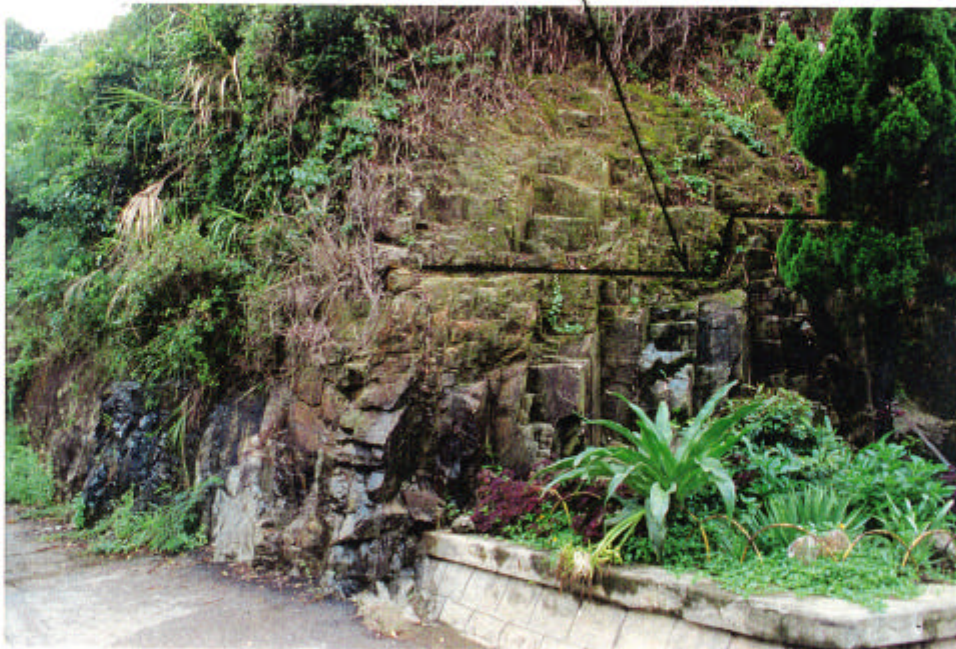
Weathered Joint

Plate 16 - A Wide, Weathered, Shallowly-inclined Joint in Slope 11SE-D/C98, West Side of Cape Collinson Road. The Joint Infill is of Completely Decomposed Tuff and Kaolinitic Clay. The Joint Locally Steps and Bifurcates across Subvertical Joints (Taken 15/7/96)

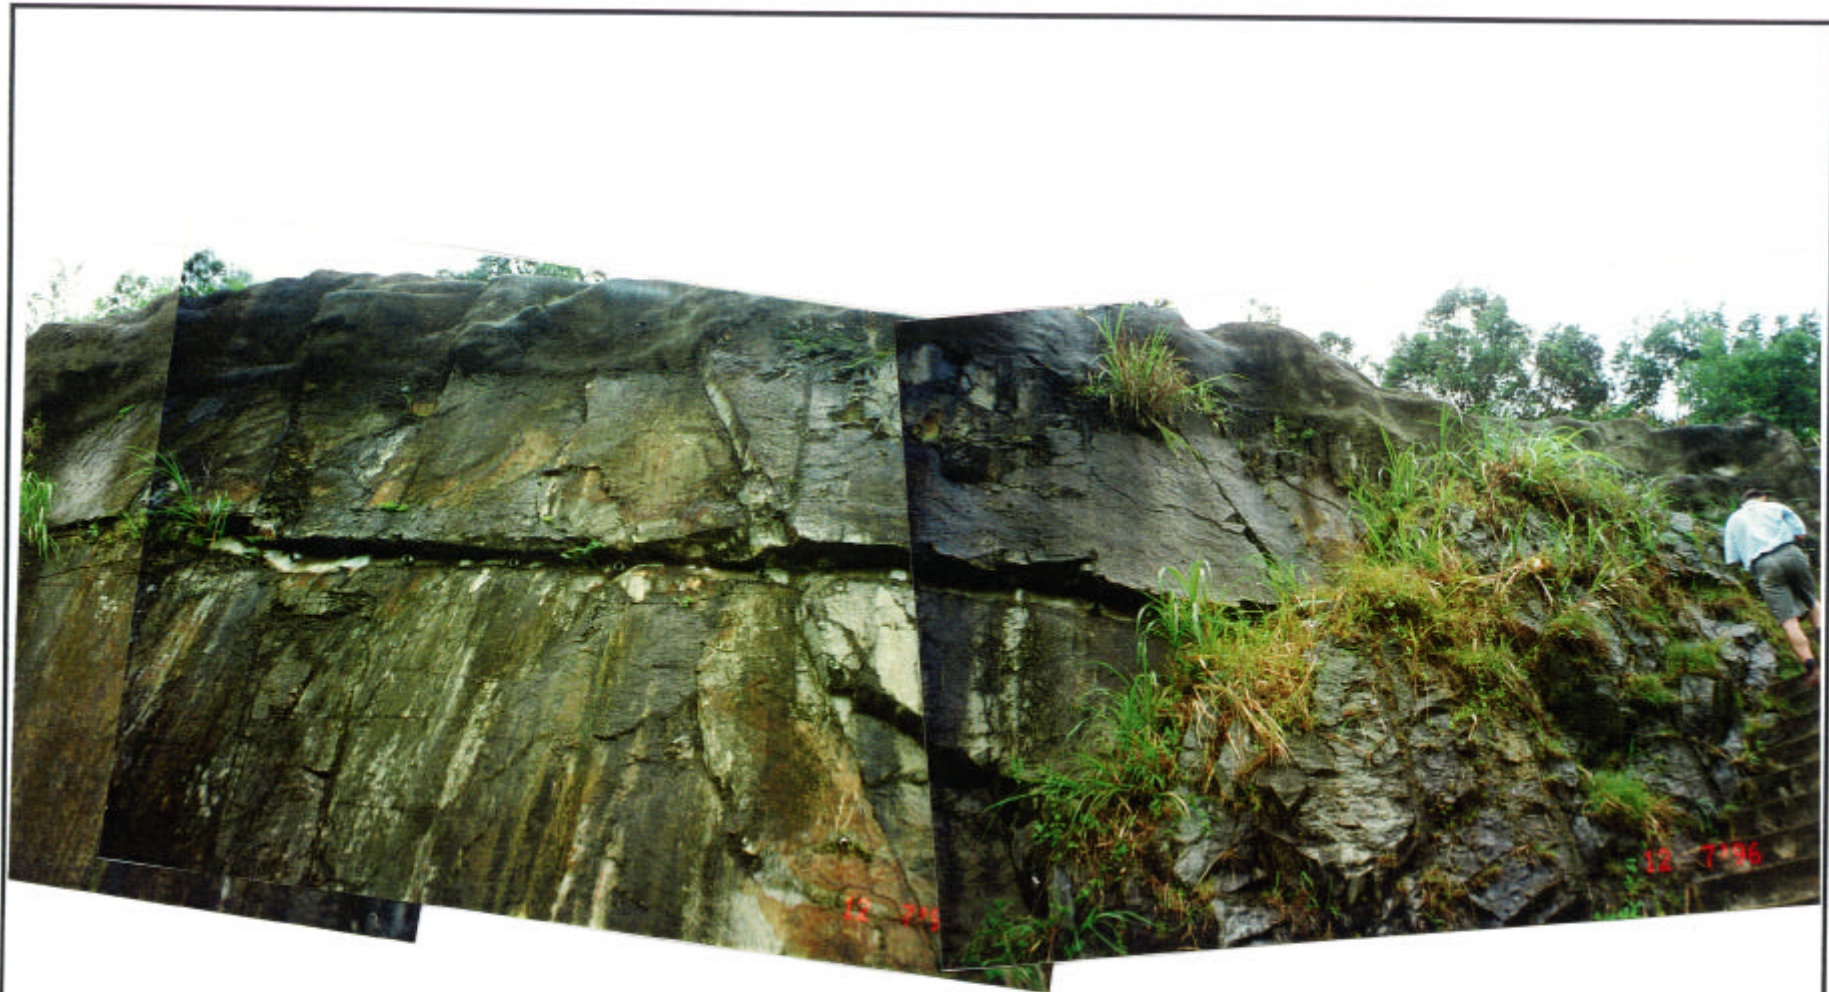
Plate 17 - Prominent Weathering of Tuff (843435 813785) along a Moderately Wide, Shallowly-inclined Joint, Dipping into the Slope, at the North End of Slope 11SE-D/C188, West of Siu Sai Wan (Taken 12/7/96)

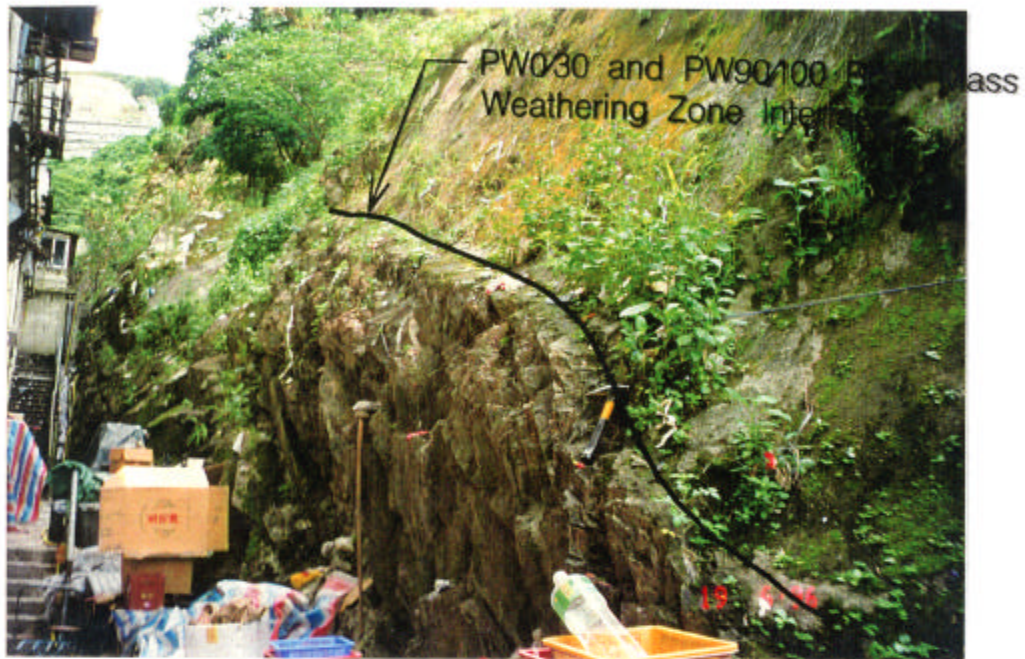
- (b) Slope 11SE-D/C14. (Plates 17 & 18) Reports note that the interface between the PW0/30 and PW90/100 zone dips in a northerly direction.
- (c) Slope 11SE-D/C17 adjacent to San Ha Street. Low-angle joints dipping out of the rock cut slope are evident in photographs, together with what appears to be some low-angle zones of partially weathered rock. Extensive seepage is noted in the slopes behind Chai Wan Estate (Map No. 6).

Plate 18 - Planar Interface in Tuff, Separating the PW90/100 and PW0/30 Zones, Looking South at Slope 11SE-D/C14, South of Fei Tsui Road (Taken 5/7/96)

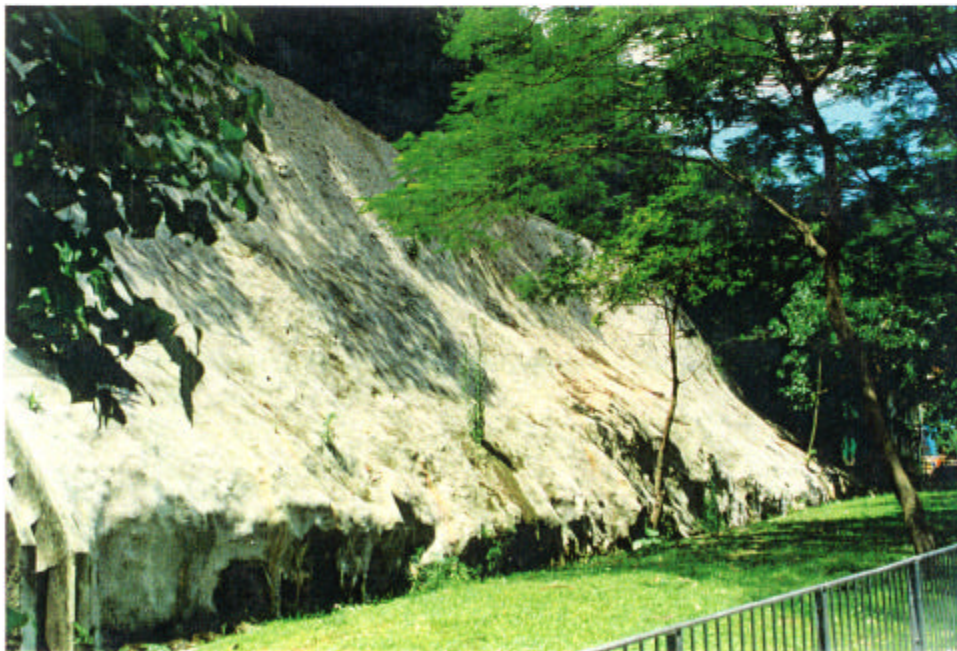
Plate 19 - Oblique View of Slope 11SE-D/C41, Looking Southwest, on the South Side of Fei Tsui Road, Showing Concavity in the Shotcreted Slope Approximately Coinciding with the Outward-dipping PW0/30 and PW90/100 Rock Mass Weathering Zone Interface. Eutaxitic Fabric also Dips Outward in Exposed Rock near the Slope Base (Taken 5/7/96)

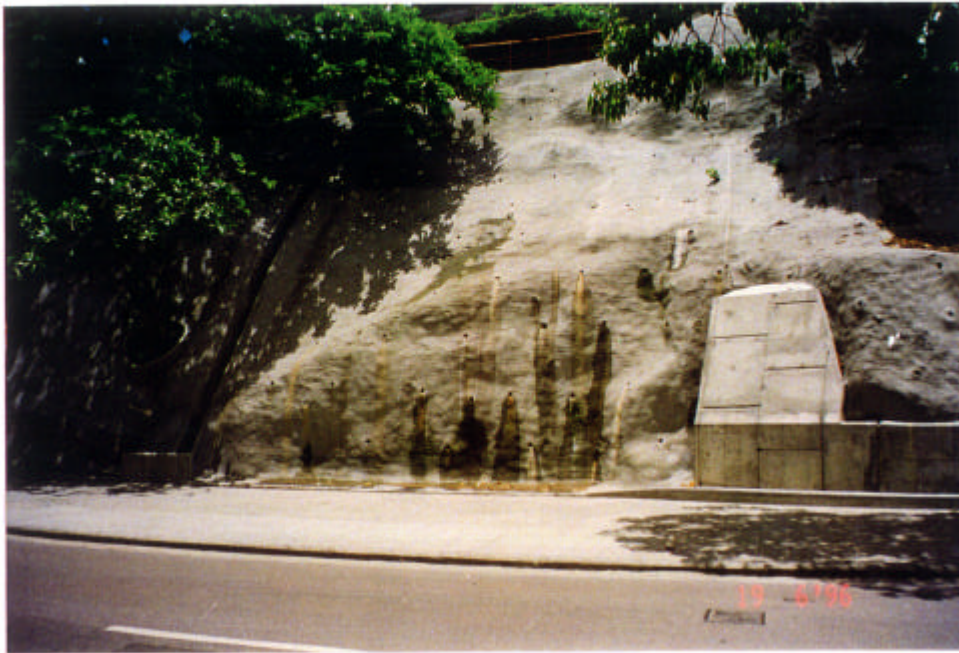
Plate 20 - Seepage from Weepholes in Shotcreted Slope 11SE-D/C17 on the Southeast Side of San Ha Street. Several Small Landslides (Map No.3) have Occurred along this Slope which is a Modification of the Pre-reclamation Cliff Line (Taken 19/6/96)

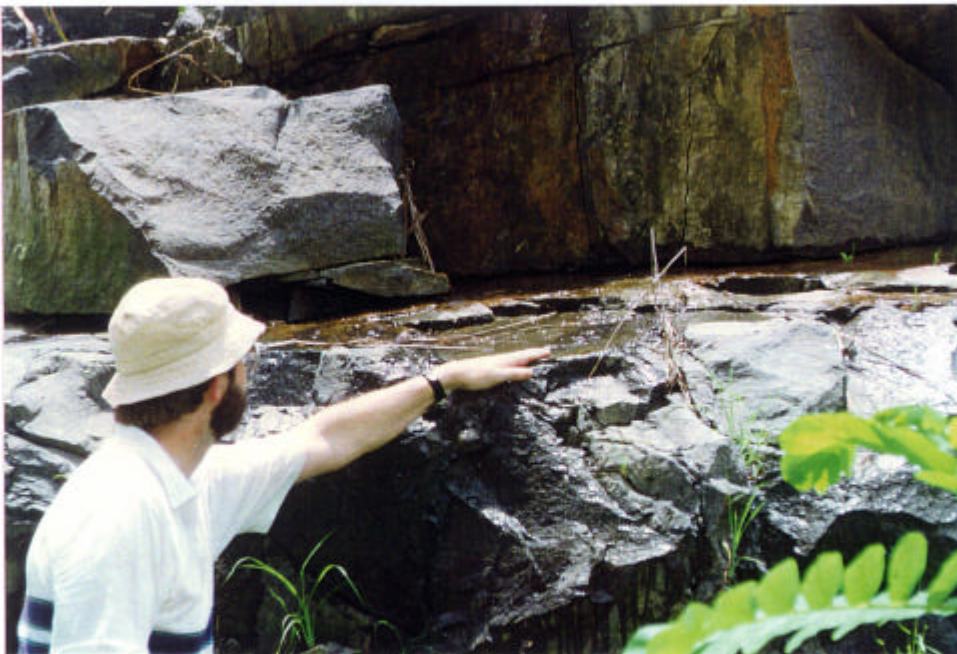
Plate 21 - Extensive Seepage from Shallowly-inclined Joint (84430 813690) Dipping Outward from Slope 11SE-D/C181, Southeast of Siu Sai Wan Estate (Taken 26/6/96)

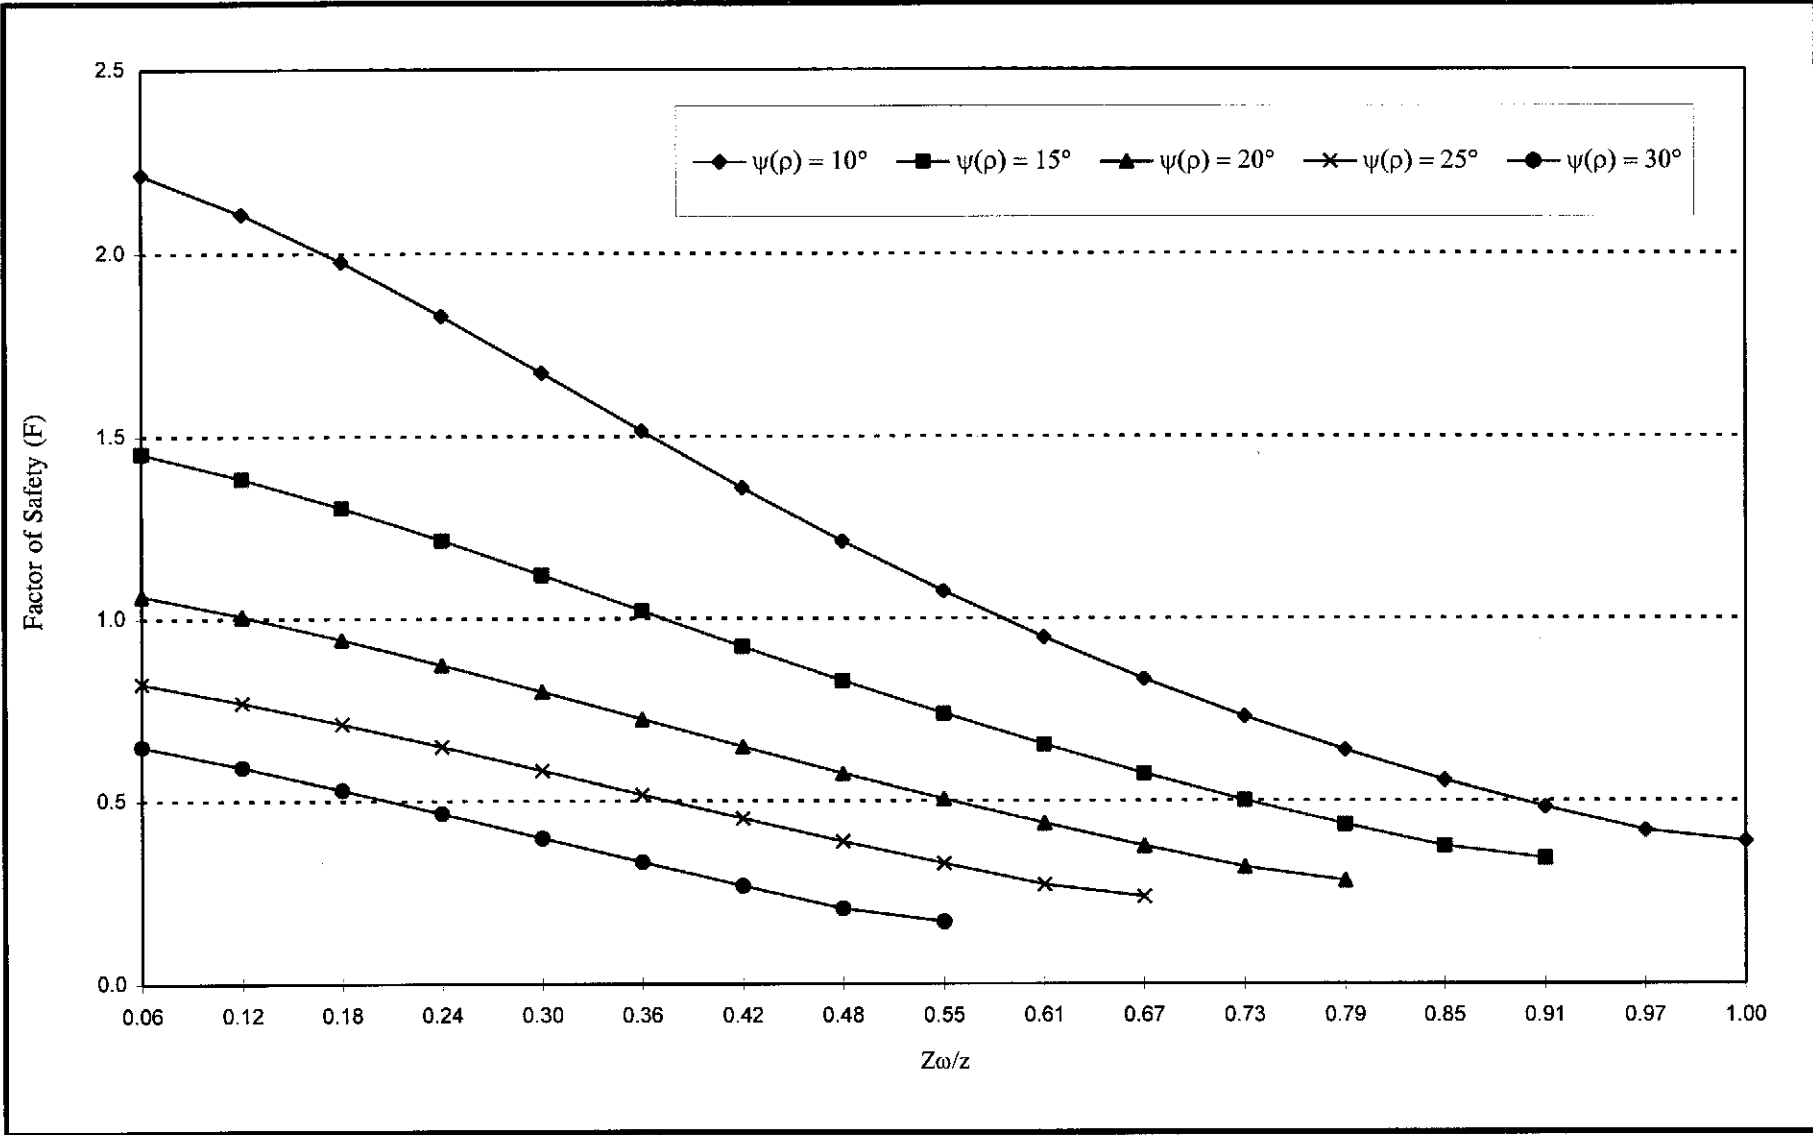
Figure 5.2 - Factor of Safety (F) vs Depth of Water in Tension Crack (Z_w)/Depth of Tension Crack (z)

Figure 5.2 demonstrates that the factor of safety drops below unity when the ratio between the depth of water in the joint and the depth of joint is about 0.4 for a sliding surface inclination of 15°. Any sliding surface at a higher inclination is less stable. Figure 5.3. demonstrates that the inclination of the slope surface has very little influence on the stability of the slope.
