FACTUAL REPORT ON THE NOVEMBER 1993 NATURAL TERRAIN LANDSLIDES IN THREE STUDY AREAS ON LANTAU ISLAND

GEO REPORT No. 61

H.N. Wong, Y.M. Chen & K.C. Lam

**GEOTECHNICAL ENGINEERING OFFICE
CIVIL ENGINEERING DEPARTMENT
THE GOVERNMENT OF THE HONG KONG
SPECIAL ADMINISTRATIVE REGION**

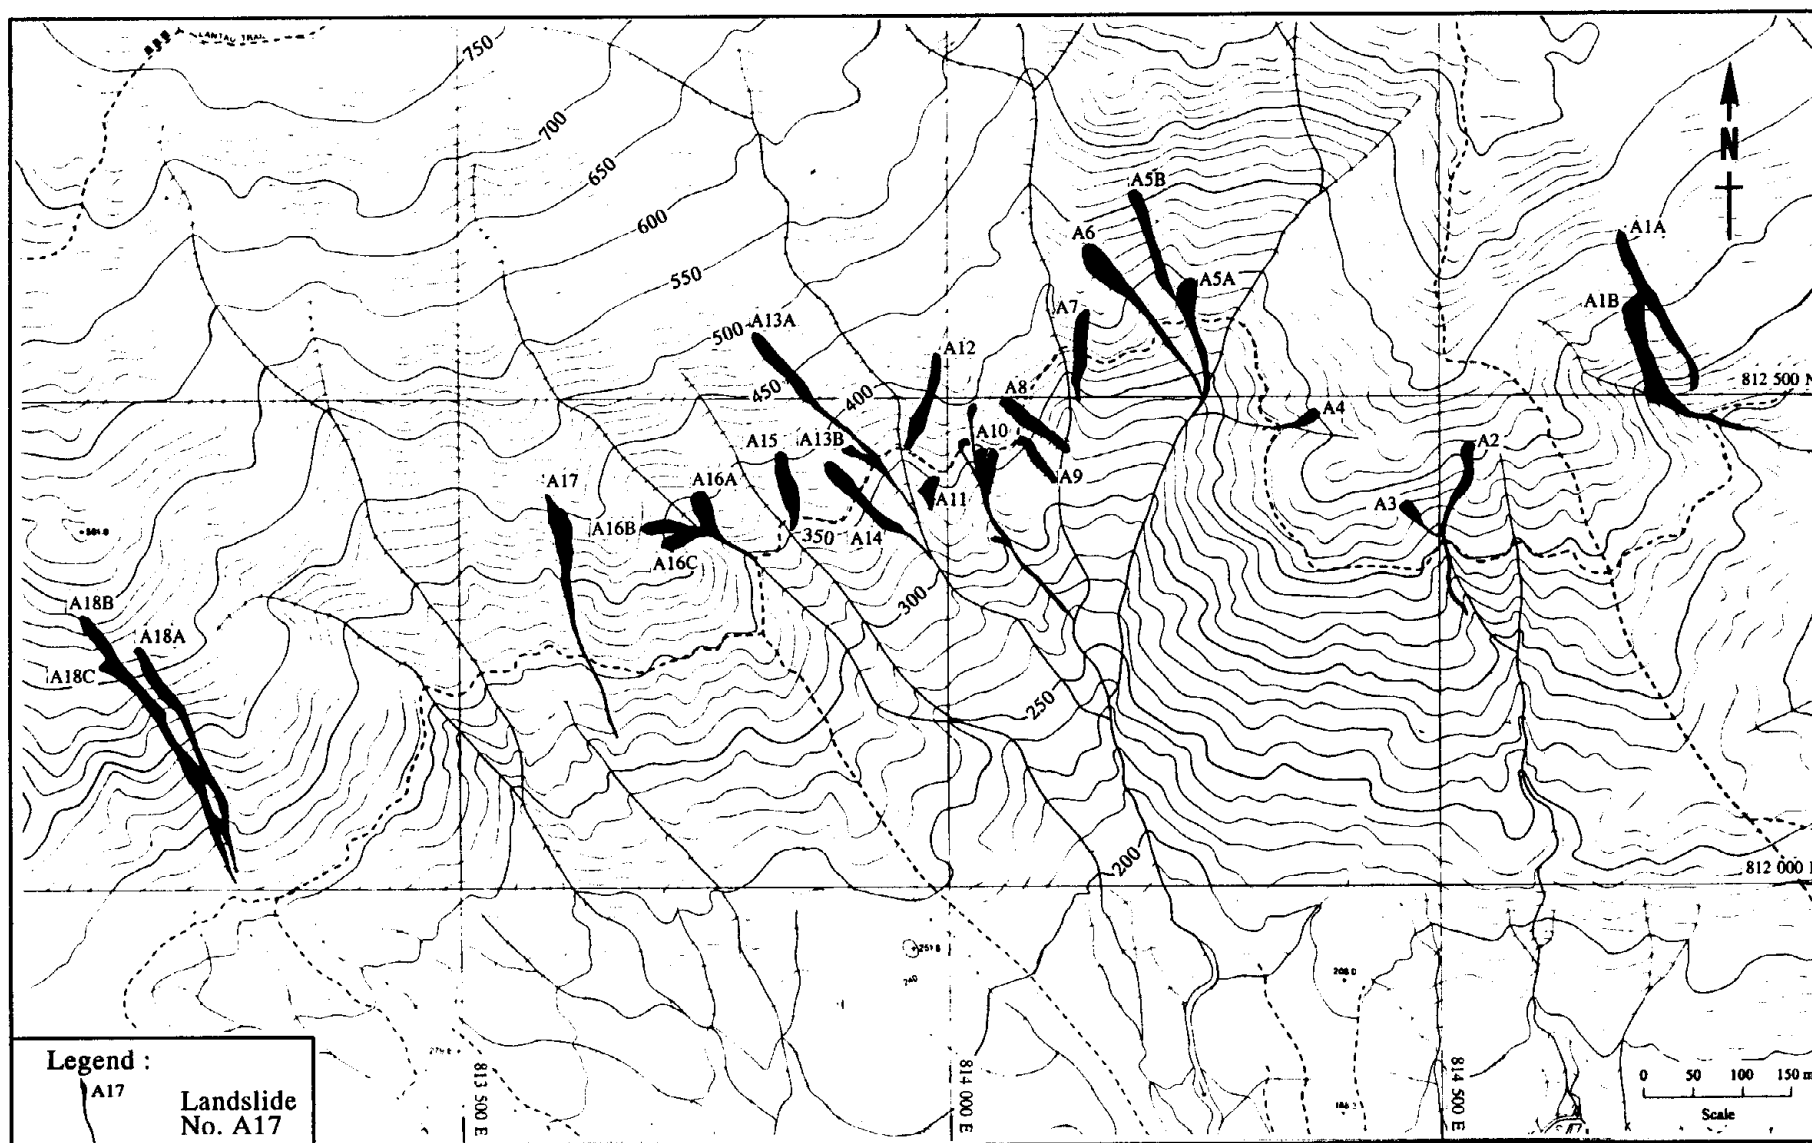
Figure 3 - Landslides in Study Area A

Area A comprises eighteen groups of 28 landslides along a two-kilometre stretch of hiking trail between Tung Chung Au and Nam Shan. An aerial photograph of the area is given in Plate 1. The locations of the landslides are shown in Figure 3.

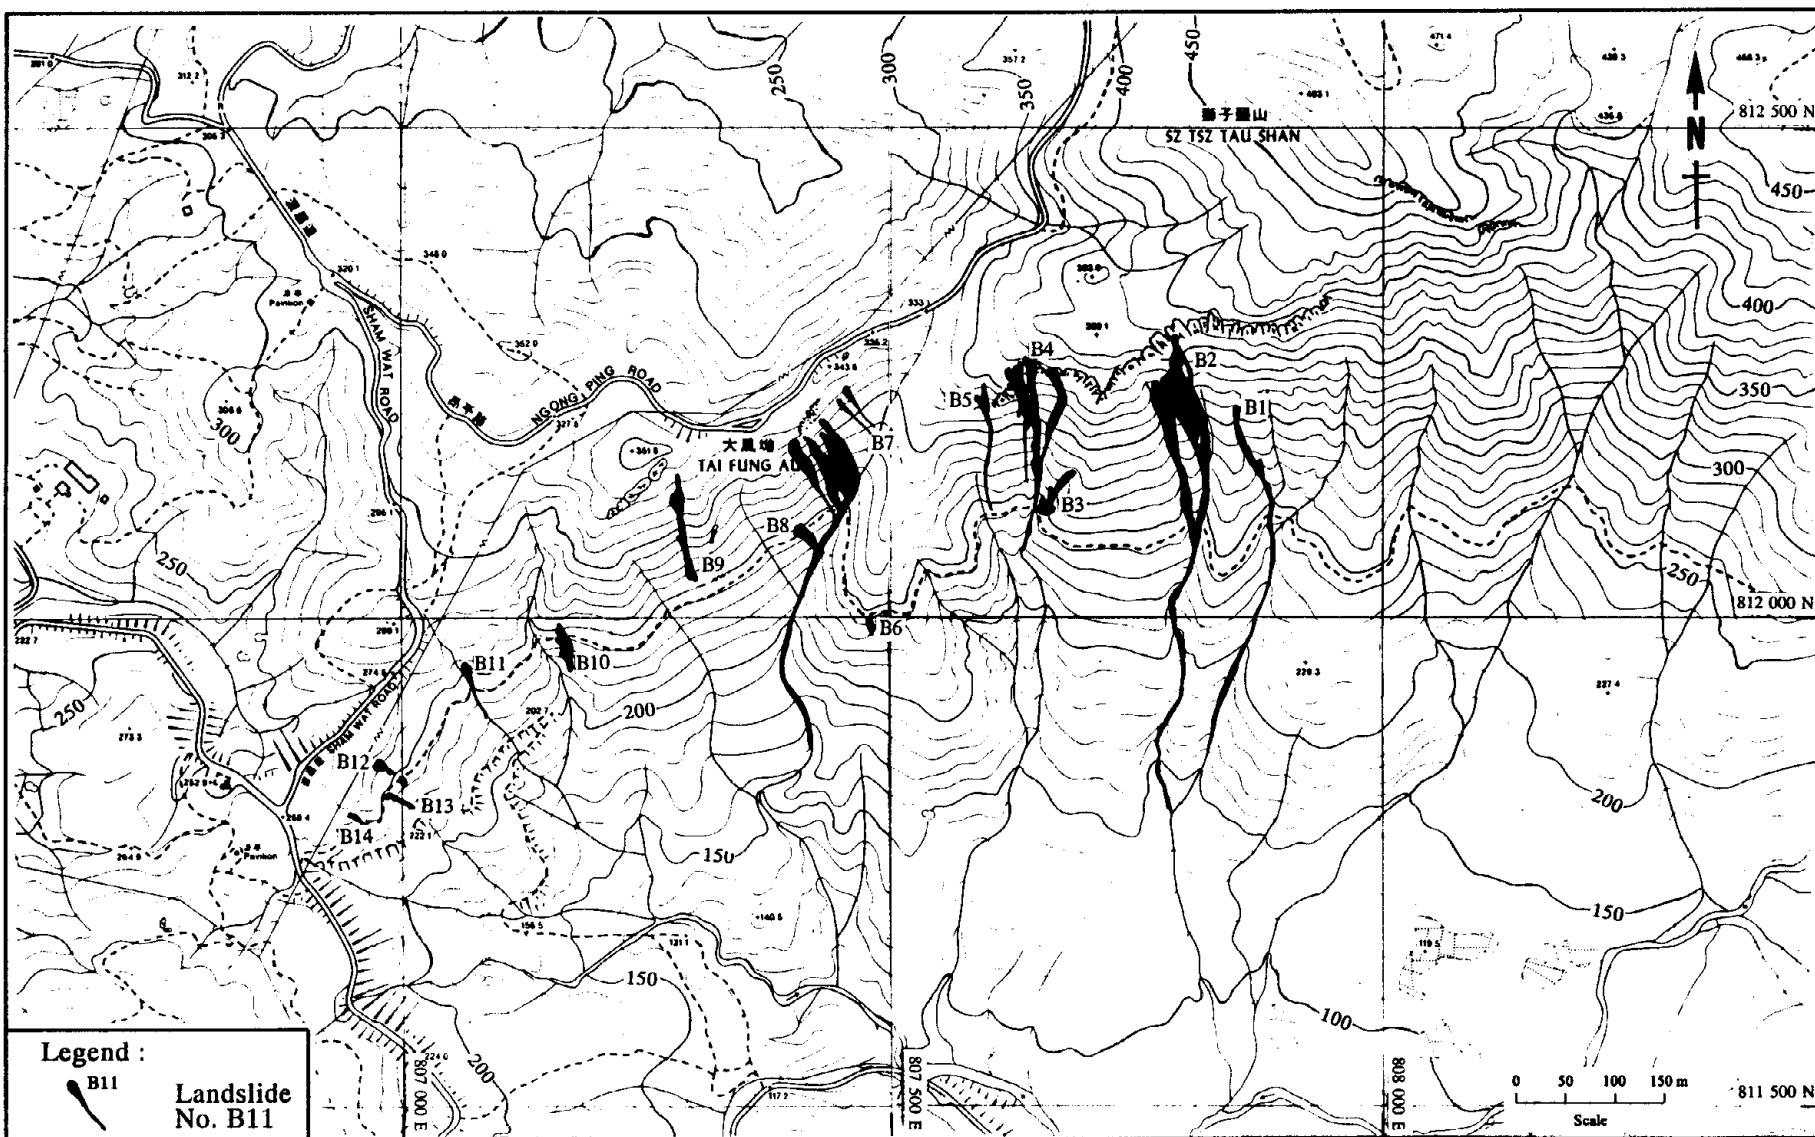
Figure 4 - Landslides in Study Area B

Fourteen groups of 27 landslides in Area B were studied. They are located along a one-kilometre stretch of hiking trail to the east of Keung Shan Road along the northern side of Shek Pik Reservoir (Figure 4). An aerial photograph of the sites is given in Plate 2.

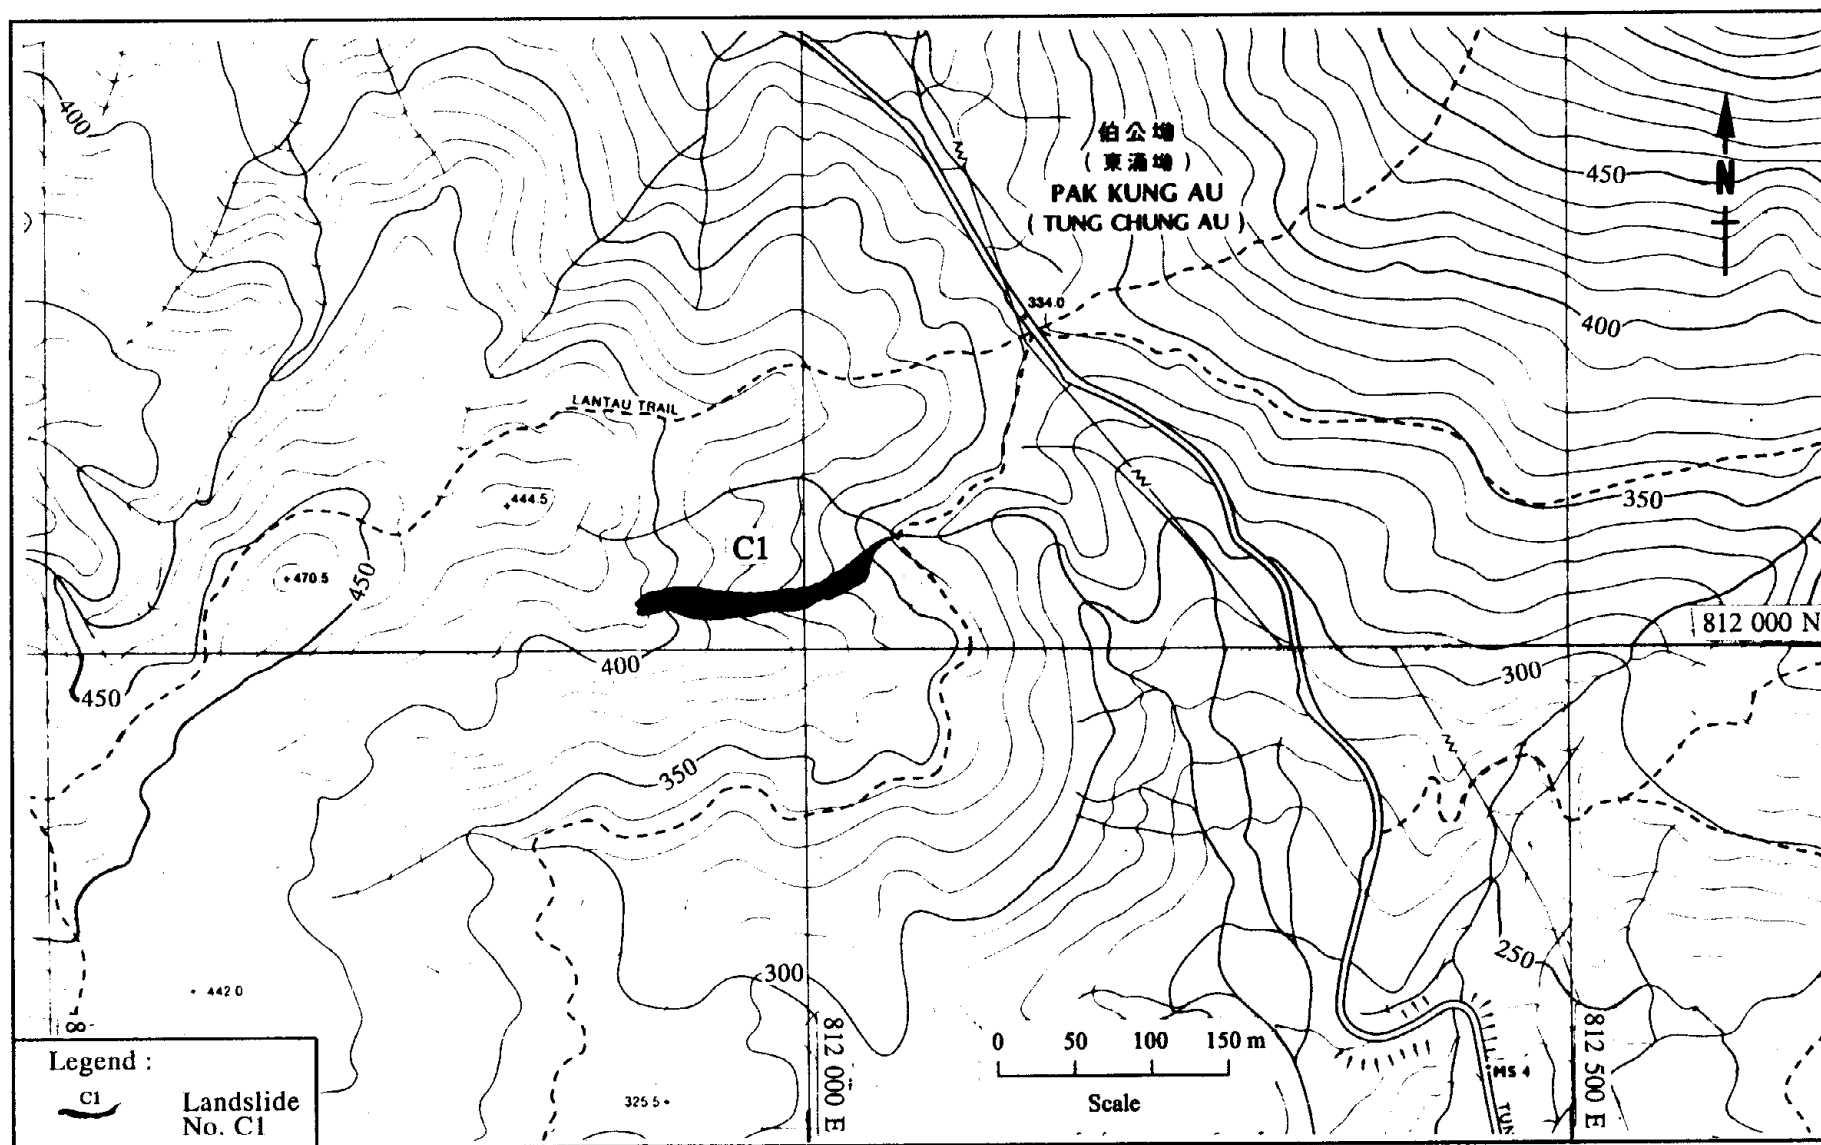
Figure 5 - Landslide in Study Area C

A landslide in Area C, located about 400 m southwest of Tung Chung Au, was studied (Plate 3 and Figure 5). This landslide was selected because of its unusual debris mobility.

Landslide C1 appears to be an exception to the observations of landslides involving

'gravitational' movement, in that the debris of the landslide travelled a long distance of about 120 m along a comparatively gentle sloping surface (about 20° to the horizontal). In this landslide, the debris slid along the ground surface downslope of the source of the failure, stripping only the vegetation and leaving the top soil more or less intact. There were no signs of any significant hydraulic action from surface running water affecting the pre-deposition debris movement.
