**ASSESSMENT OF
GEOLOGICAL FEATURES
RELATED TO RECENT
LANDSLIDES IN VOLCANIC
ROCKS OF HONG KONG
PHASE 2B -
ABERDEEN STUDY AREA**

GEO REPORT No. 67

C.A.M. Franks, S.D.G. Campbell & W.W.L. Shum

**GEOTECHNICAL ENGINEERING OFFICE
CIVIL ENGINEERING DEPARTMENT
THE GOVERNMENT OF THE HONG KONG
SPECIAL ADMINISTRATIVE REGION**

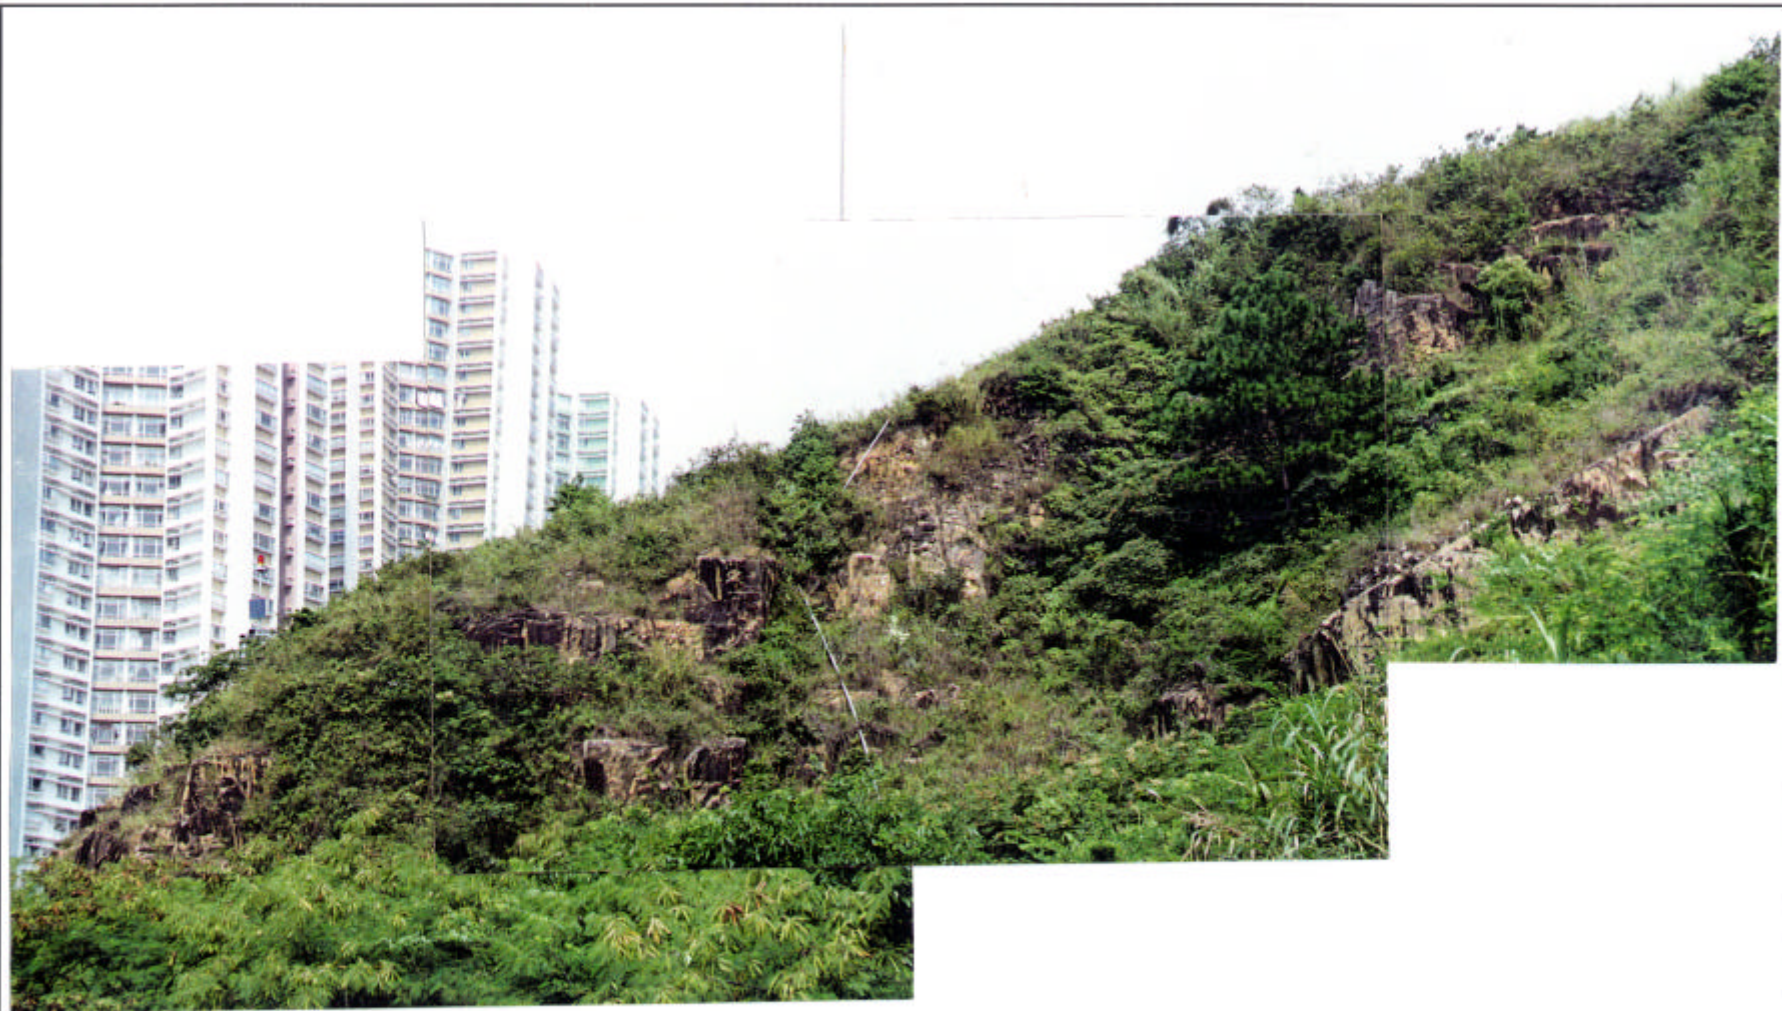
Plate 2 - North Flank of Large Ancient Landslide Scar (833335E 811350N) Along the Former Coastline, North of Slope 15NW-A/C3, Showing the Relationship of the Soil Profile to Joints (Subvertical, Subhorizontal and Inclined Parallel to the Natural Slope); the Inclined Planar Discontinuity (Lower Right) is at or near to the Basal Surface of Rupture of the Landslide. (Taken 3/10/96)

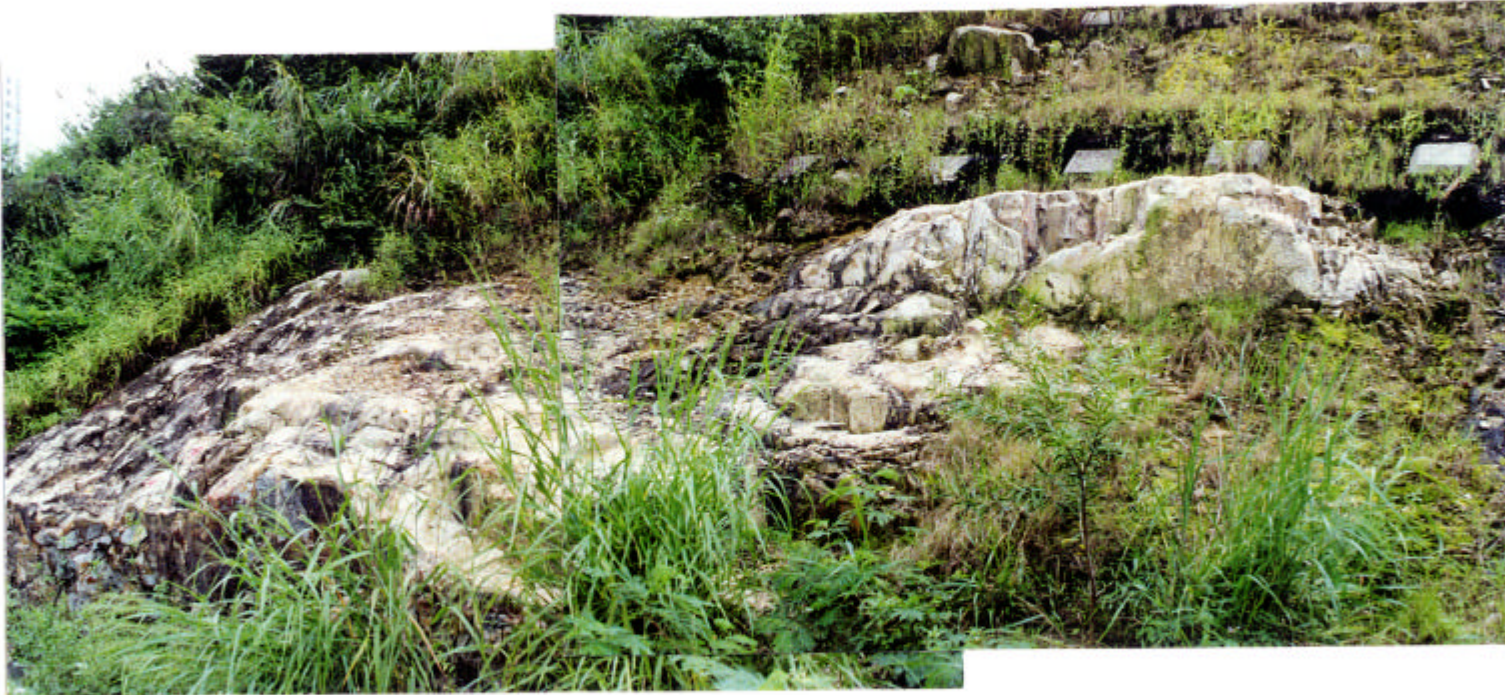
Plate 3 - Unregistered Slope (833550E 811500N) on Road Leading to Water Service Reservoir within Eutaxitic Fine Ash Vitric Tuff, Showing the Development of Subhorizontal and Inclined (Parallel to the Natural Slope) Stress Release Joints and Their Relationship to the Interface Between the PW90/100 and PW0/30 Rock Mass Weathering Zones. (Taken 1/10/96)

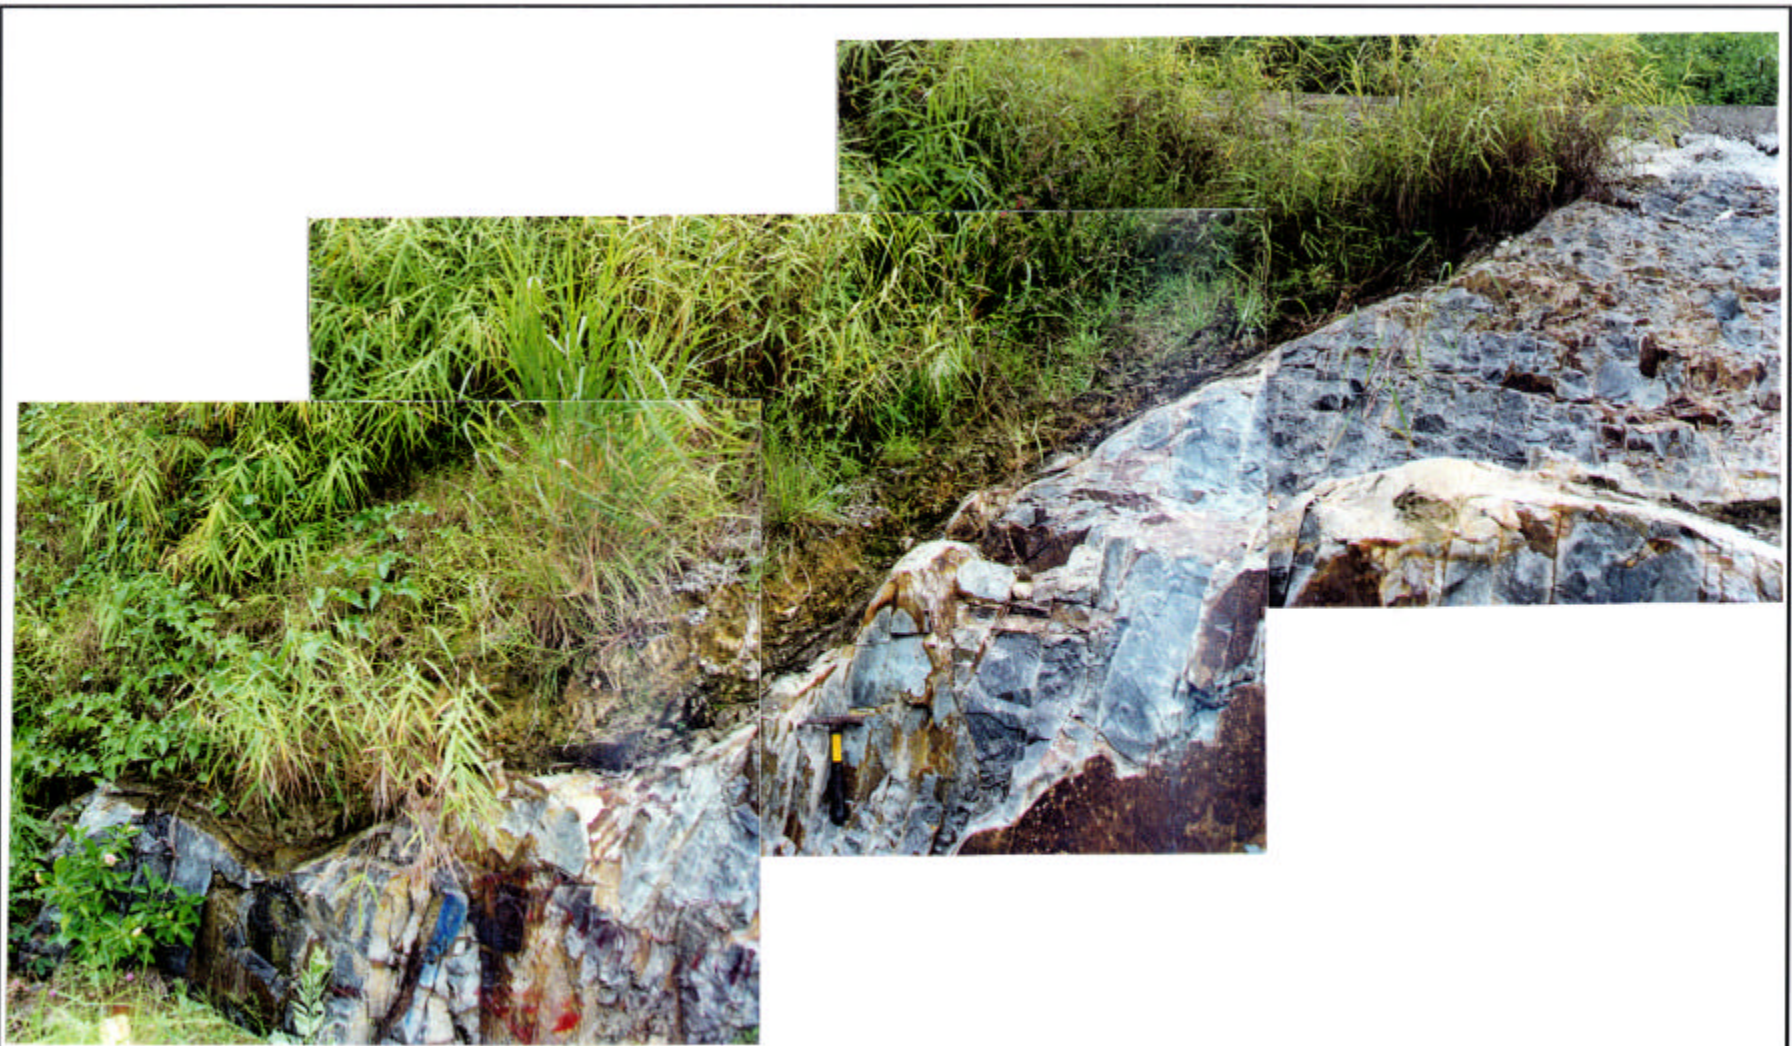
Plate 4 - Unregistered Slope (833470E 811360N) as in Plate 3, Showing An Abrupt Discontinuity between the PW90/100 Rock Mass Weathering Zone and Colluvium; the Concave-Upward Discontinuity Comprises Two Shallowly-inclined Stress-release Joint Sets, Whose Intersection Plunges Approximately Down-slope. (Taken 1/10/96)

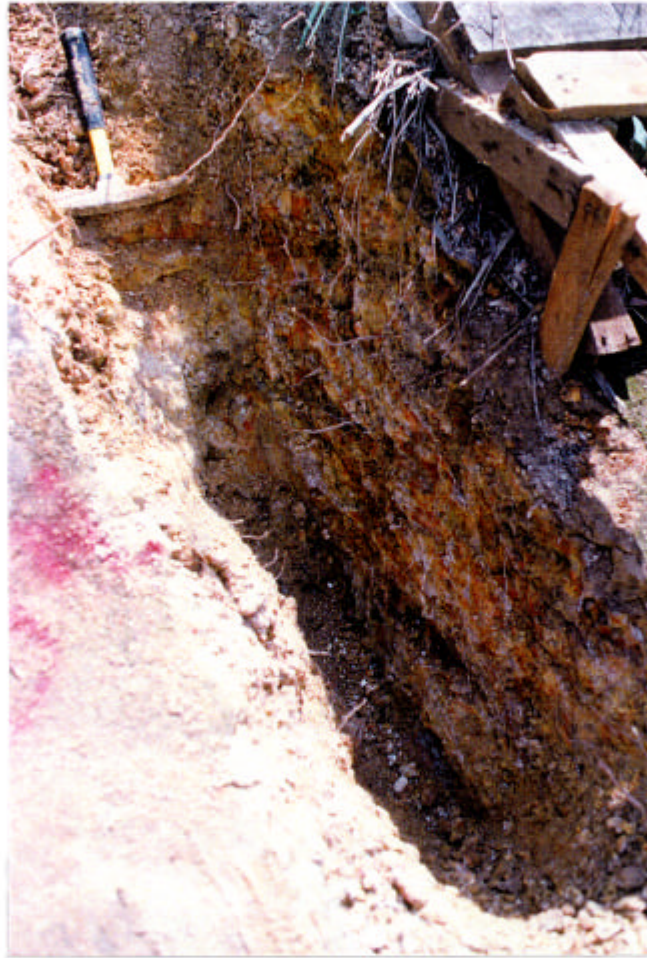
Plate 5 - Highly to Completely Weathered Fine Ash Vitric Tuff Containing Abundant, Laterally-continuous Kaolin Veins, Occurring Immediately below the Plane That Formed the Basal Surface of a Failure That Occurred in Slope 15NW-B/C6 (835265E 811620N) on Nam Long Shan Road in 1965. (Taken 8/5/96)

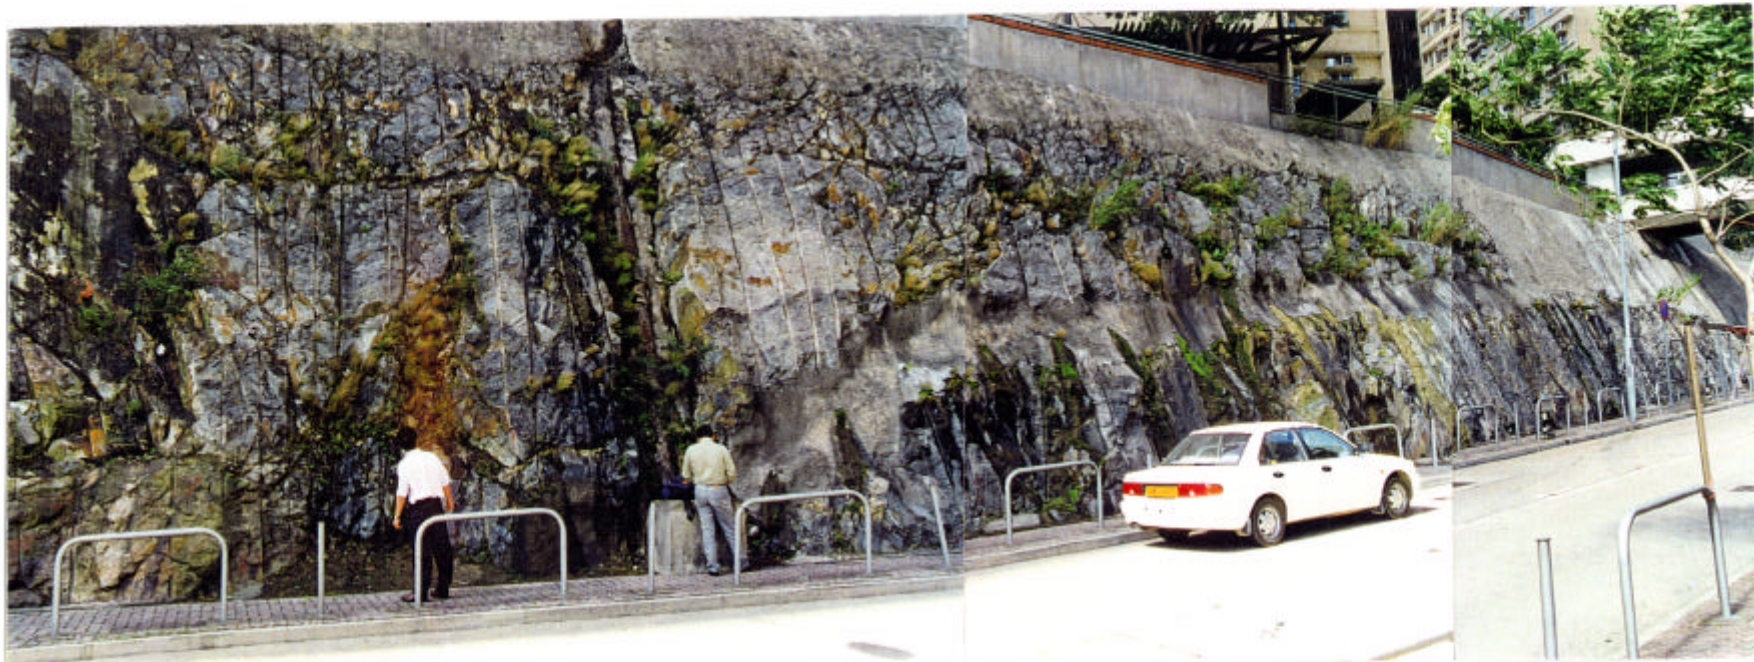
Plate 6 - Unregistered Slope 15NW-3B/S10 (834250E 811530N), in Lei Tung Estate Showing a Relatively Planar Weathered Seam (Largely Covered by Chunam) of Kaolinitic Clay, c.150 mm Thick, Dipping c.30-35° out of the Slope at about Mid-height within Grade II Tuff. Extensive Groundwater Seepage was Noted from the Seam during Site Inspection. (Taken 12/11/96)

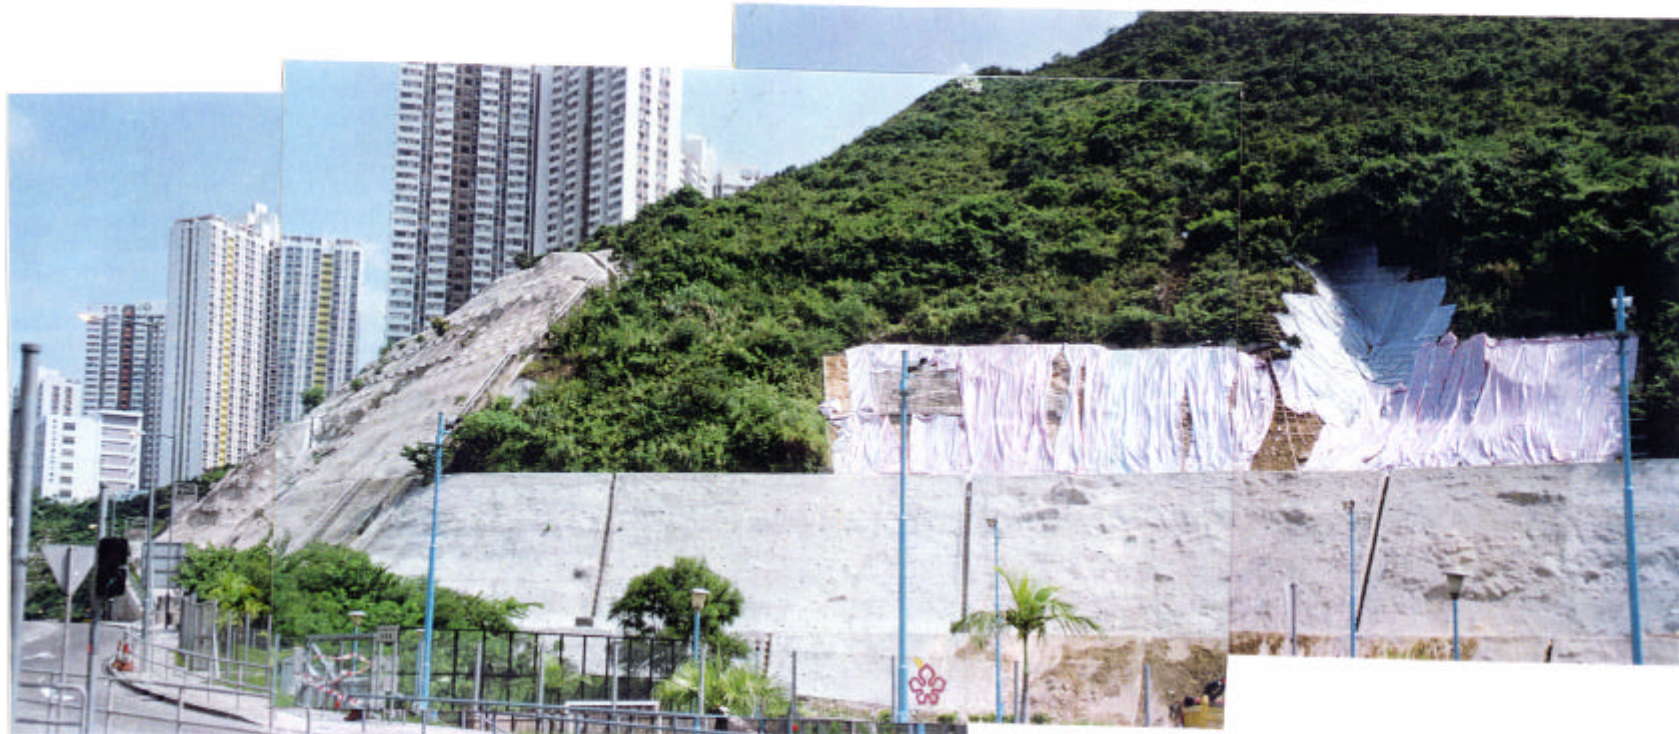
- (f) Kaolinitic clay veins and infills up to 15 mm thick on relict joints were noted in grade IV tuff exposed in the top of slope 15NW-A/C1 on Lee Nam Road, Ap Lei Chau.

Plate 7 - Slope 15NW-A/C1, Corner of Ap Lei Chau Bridge Road and Lee Nam Road (833650E 811620N). Completely to Highly Decomposed Tuff with Many Relict Joints Infilled with Kaolinitic Clay. Six Landslide Incidents Have Occurred in This Slope Between 1993 and 1996, the Most Recent (Right-Hand Side Covered by Sheeting) Occurred on 5/9/96. (Taken 1/10/96)

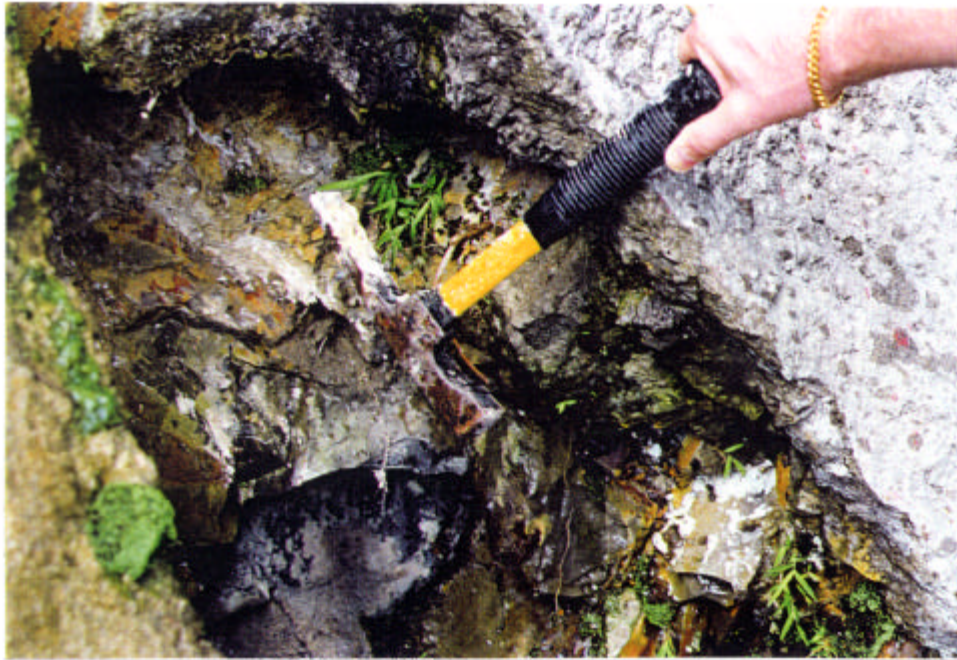
Plate 8 - Close-up (834255E 811530N) of Weathered Kaolinitic Clay Seam in Unregistered Slope 15NW-3B/S10, Lei Tung Estate as Shown in plate 3. (Taken 12/11/96)

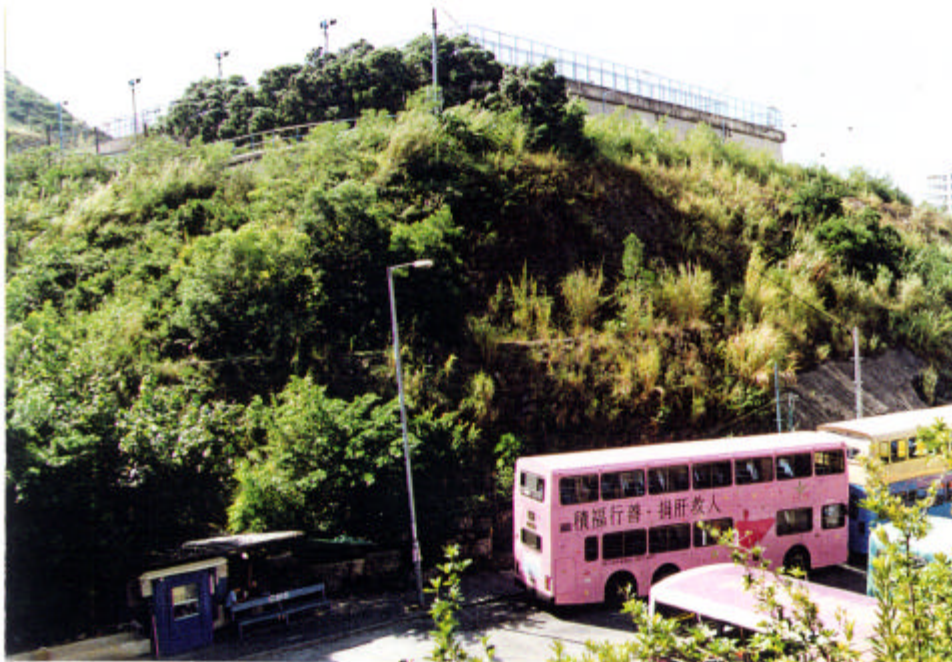
- (g) Thin seams of kaolinitic clay, up to 10 mm thick, on joints within grade IV/III fine ash tuff were noted in the slope 15NW-B/C92 above the bus station within the Lei Tung Estate, Ap Lei Chau.

Plate 9 - Slope 15NW-B/C92 (834100E 811300N), by the Bus Terminus at Lei Tung Estate, in Decomposed Siliceous Fine Ash Tuff with Extensive Kaolinitic Clay Infills in Relict Joints within Grade IV/V Decomposed Bedrock. (Taken 12/11/96)

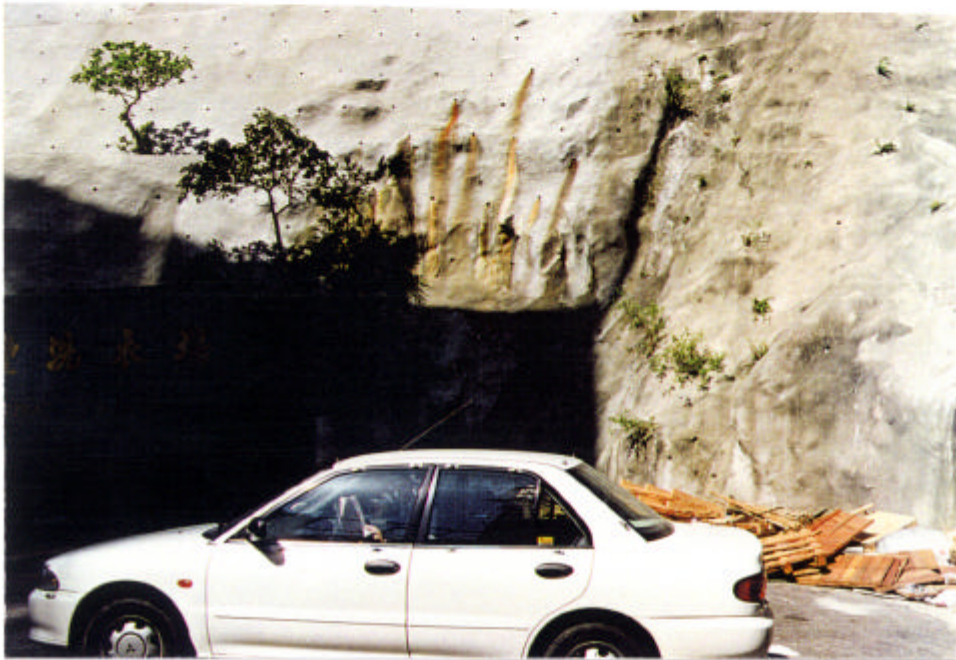
Plate 10 - Slope 11SW-D/C91 (835440E 812420N) adjacent to Tong Bin Lane, Has Had Previous Small to Moderate Size Landslides. Heavy Groundwater Seepage was Noted from Slope Mid-height during Site Inspection. (Taken 12/11/96)

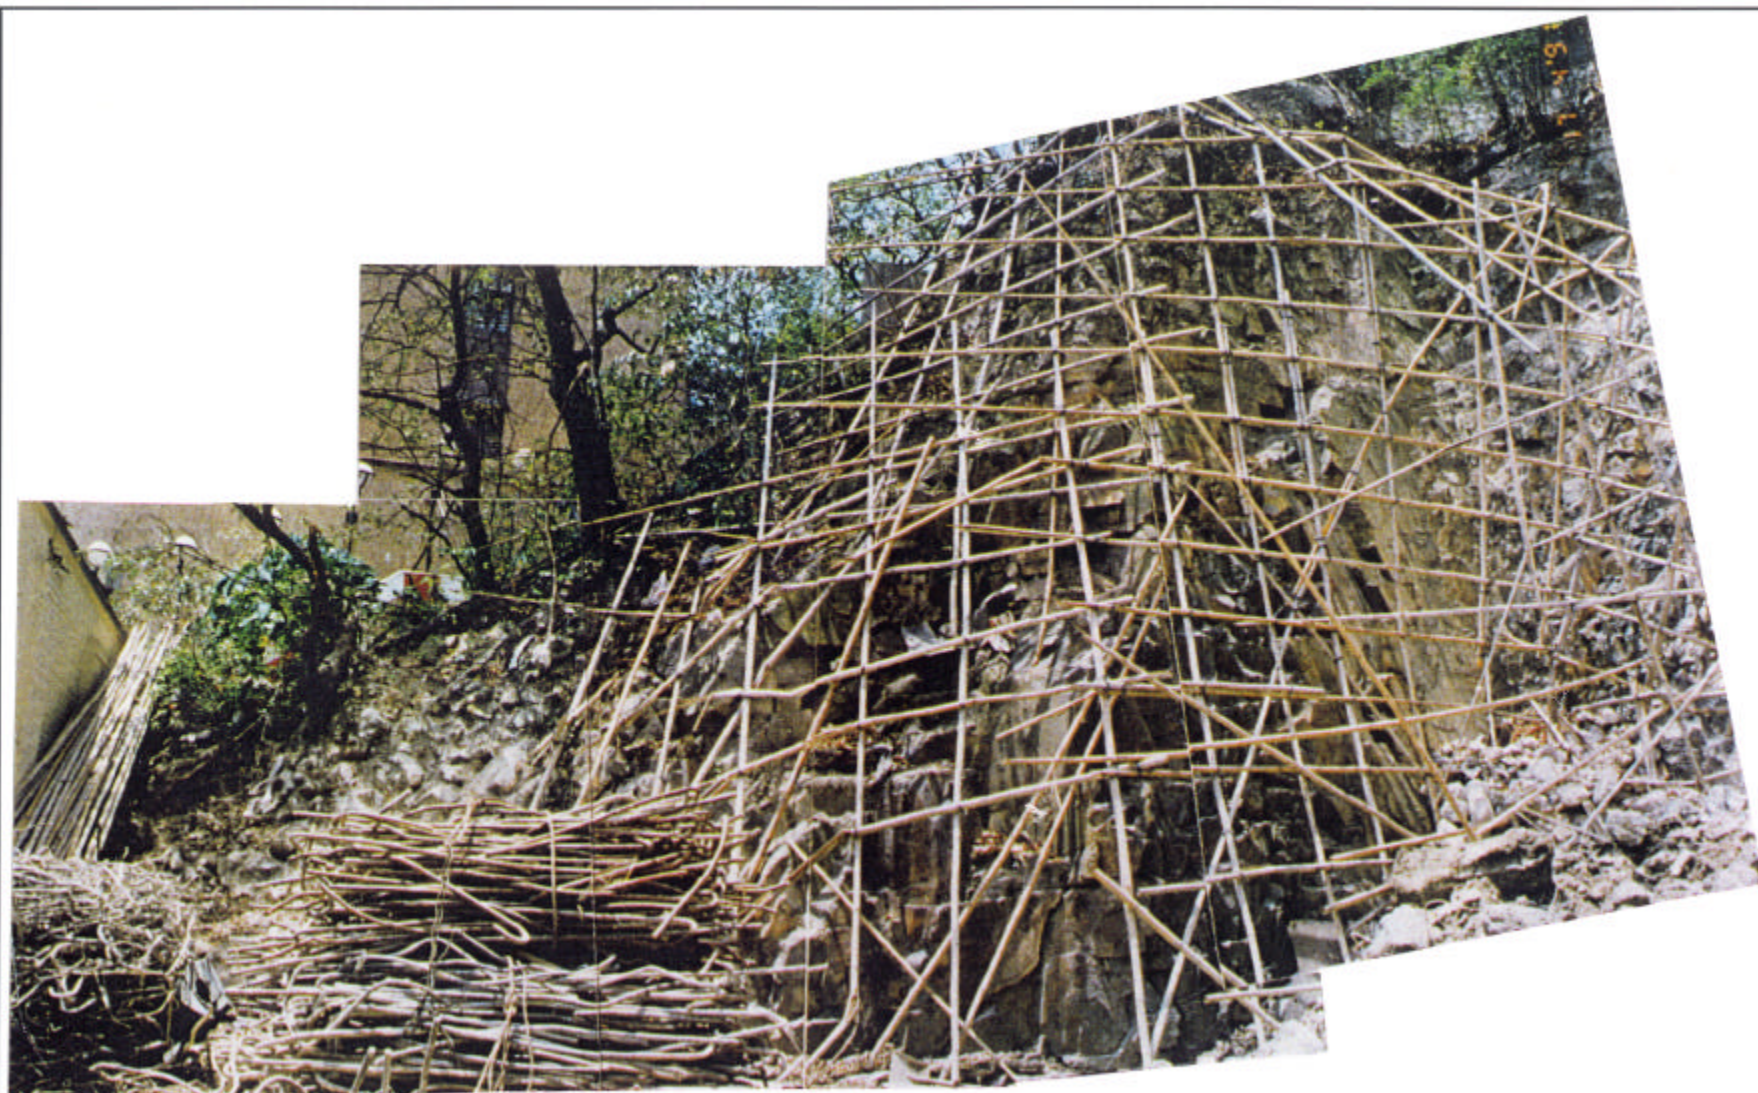
Plate 11 - Unregistered Slope 11SW-23D/S15 (834260E 812070N) behind 66-72 Aberdeen Main Road, Photographed during Site Formation (District file 21/07/90) Showing a Planar Feature Dipping 20° out of the Rock Slope. (Taken 21/7/90)
