HONG KONG RAINFALL AND LANDSLIDES IN 1996

GEO REPORT No. 70

GEOTECHNICAL ENGINEERING OFFICE
CIVIL ENGINEERING DEPARTMENT
THE GOVERNMENT OF THE HONG KONG
SPECIAL ADMINISTRATIVE REGION

This report was originally produced in October 1997 as GEO Special Project Report No. SPR 7/97

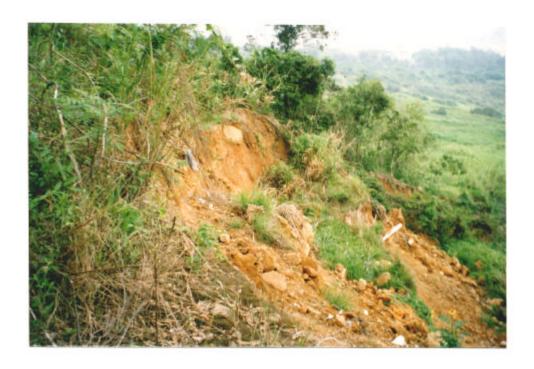
Plate 1 - Above Golf Driving Range, Area 19, Tuen Mun (Incident MW 96/5/3)

(Date: January 1996. Major failure of a soil cut slope affecting a track, Plate 1)

A major failure of a soil cut slope above a golf driving range Area 19, Tuen Mun was identified by the GEO in May 1996. According to a villager, the slope had probably failed in January. The failure involved the upper part of a 45 m high cut slope with an average slope angle of 30°. The failed portion was 6 m high and 115 m in breath, resulting in a failure volume of about 750 m³ of decomposed volcanics and colluvium. An old failure scar was noted below the failed portion. There was a track above the slope and part of it fell away with the landslide. This failure was possibly associated with run off from uphill blocked channels.

Description: Major failure of a soil cut slope affecting a track.

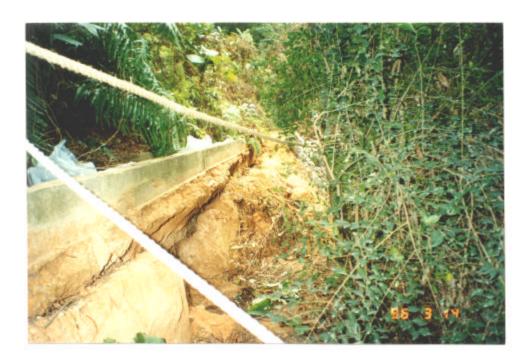
Plate 2 - STTL 410, Pik Tin Street, Shatin (Incident MW 96/3/3)

An incident involving major signs of distress in the form of tension cracks on a soil

The slope was about 23 m high with an average slope angle of 40° with berms at every 8 m. There was a natural hillside above the cut slope. It had a vegetation cover (trees and bushes). Tension cracks were found above the first and second berms. The drains were found to be blocked or broken. This incident was probably associated with insufficient maintenance.

Description: Major signs of distress of a soil cut slope resulting in a construction site being affected.

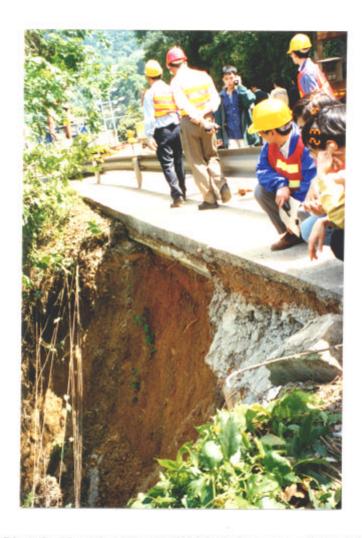
Plate 3 - Near Savanna Garden, Tai Po Road, Tai Po Kau (Incident ME 96/4/3)

(Date: 23 April 1996. Fill slope failure resulting in closure of a road, Plate 3)

On 23 April, a landslide took place at the fill slope on the downhill side of Tai Po Road, Tai Po Kau. The fill slope was about 20 m high with a slope angle of about 30°. It was covered with grass before failure. At the time of landslide, trench excavation was being carried out across the road on the uphill side. The failure was probably caused by rupture of a watermain in the trench during excavation, which could have led to considerable subsurface seepage to the downhill side of the road. Subsidence of part of the road surface and washing out of the fill slope occurred as a result. Tai Po Road was closed due to this failure.

Description: Fill slope failure resulting in closure of a road.

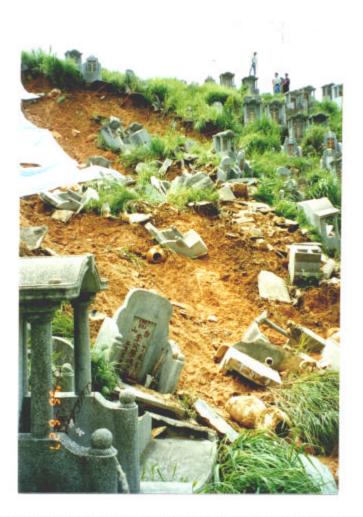
Plate 4 - Wo Hop Shek Cemetery, Fanling (Incident MW 96/6/5)

(Date: 25 June 1996. Major failure of a soil cut slope affecting a cemetery, Plate 4)

On 25 June, about 80 m³ of weathered rock fell from a grassed soil cut slope at Wo Hop Shek Cemetery, Fanling, causing damage to a large number of buried urns on the slope. The cut slope was about 18 m high with an average slope angle of 45°. The failure involved the full height of the slope and was about 20 m wide. It affected the cemetery and was probably caused by surface water infiltration into the slope after heavy rainfall.

Description: Major failure of a soil cut slope affecting a cemetery.

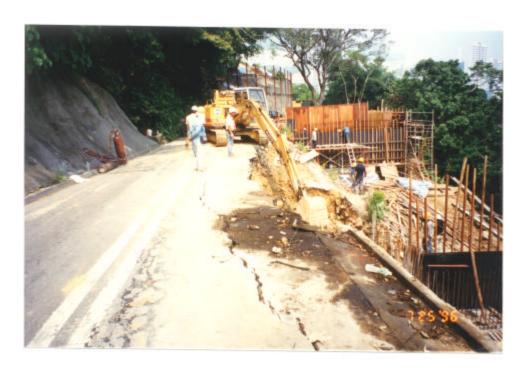
Plate 5 - Near 212 Victoria Road, Pok Fu Lam (Incident HK 96/7/4)

(Date: 25 July 1996. Major failure of a temporary cut slope affecting a construction site and resulting in closure of a road, Plate 5)

At about 8:00 a.m. on 25 July 1996, a sub-vertical temporary cut for the construction of a retaining wall on the downhill side of Victoria Road (part of the Highways Department Victoria Road Improvement Project), failed and resulted in a failure volume of 75 m³. The temporary cutting was about 10 m in height with an average angle of 80°. The failure debris, estimated to be about 10.5 m in breadth, 4 m in length with a maximum depth of 1.8 m, was trapped behind the partially completed retaining wall.

Based on site inspection on 25 July 1996, the failure was probably caused by the lack of temporary support to the sub-vertical cut.

Description: Major failure of a temporary cut slope affecting a construction site and resulting in closure of a road.

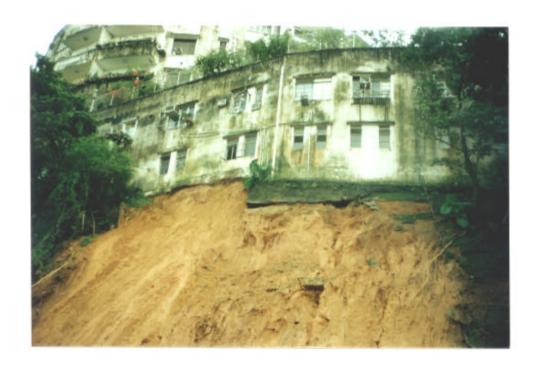
Plate 6 - Below 1 Wang Fung Terrace, Tai Hang (Incident HK 96/9/4)

(Date: 14 September 1996. Failure of a soil cut slope resulting in the temporary evacuation of 45 flats, blockage of a road and closure of a carpark, Plate 6)

At about 5:00 p.m. on 14 September, about 30 m³ of weathered rock and a tree slipped from a soil cut slope below No. 1 Wang Fung Terrace. The slope was about 15 m high with an inclination of 70-75°. It was covered by broken chunam before the landslide. This failure resulted in temporary evacuation of 45 flats and a carpark above the slope, and closure of two lanes of Tai Hang Road below the slope.

According to the field observation on the following day, the channel at the slope crest was blocked with debris. A downpipe was discharging water onto this channel. Deep gullies were found at the slip scar immediately below the discharge point of the broken channel. Lack of maintenance and tree root action were considered to be the major factors contributing to the failure.

Description: Failure of a soil cut slope resulting in the temporary evacuation of 45 flats, blockage of a road and closure of a carpark.

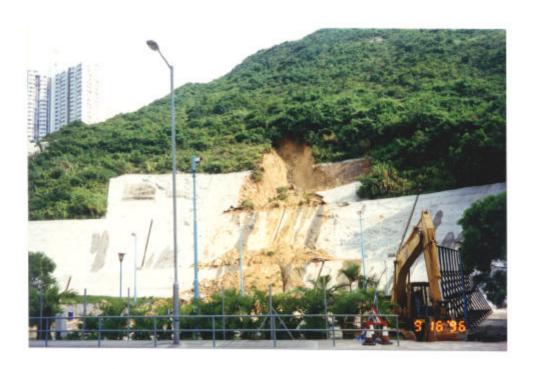
Plate 7: Negative No. I9648218 Taken on: 16-9-96

(Date: 14 September 1996. Major failure of a soil cut slope resulting in a sports playground being affected, Plate 7)

The slope was about 30 m high, with an average inclination of 45°. The natural terrain above it was sloping at 35° and was covered with shrubs and grass. Before the failure the slope was covered by shotcrete. The portion of the slope that failed was about 12 m high and 9 m wide, with a maximum depth of failure of about 3 m. The debris was found to be soft and wet with a debris length of 14 m, affecting the open space and sports playground below.

The failure was probably caused by infiltration from the intense rainfall into the natural hillside above.

Description: Major failure of a soil cut slope resulting in a sports playground being affected.
