一九九七年六月四日
九華徑上村 26 號
山泥傾瀉事件報告
**REPORT ON THE LANDSLIDES
AT HUT NO. 26 KAU WA KENG
UPPER VILLAGE OF
4 JUNE 1997**

土力工程處報告系列第 76 號
GEO REPORT No. 76

合樂亞洲顧問公司
Halcrow Asia Partnership Ltd.

香港特別行政區政府
土木工程署
土力工程處
**GEOTECHNICAL ENGINEERING OFFICE
CIVIL ENGINEERING DEPARTMENT
THE GOVERNMENT OF THE HONG KONG
SPECIAL ADMINISTRATIVE REGION**

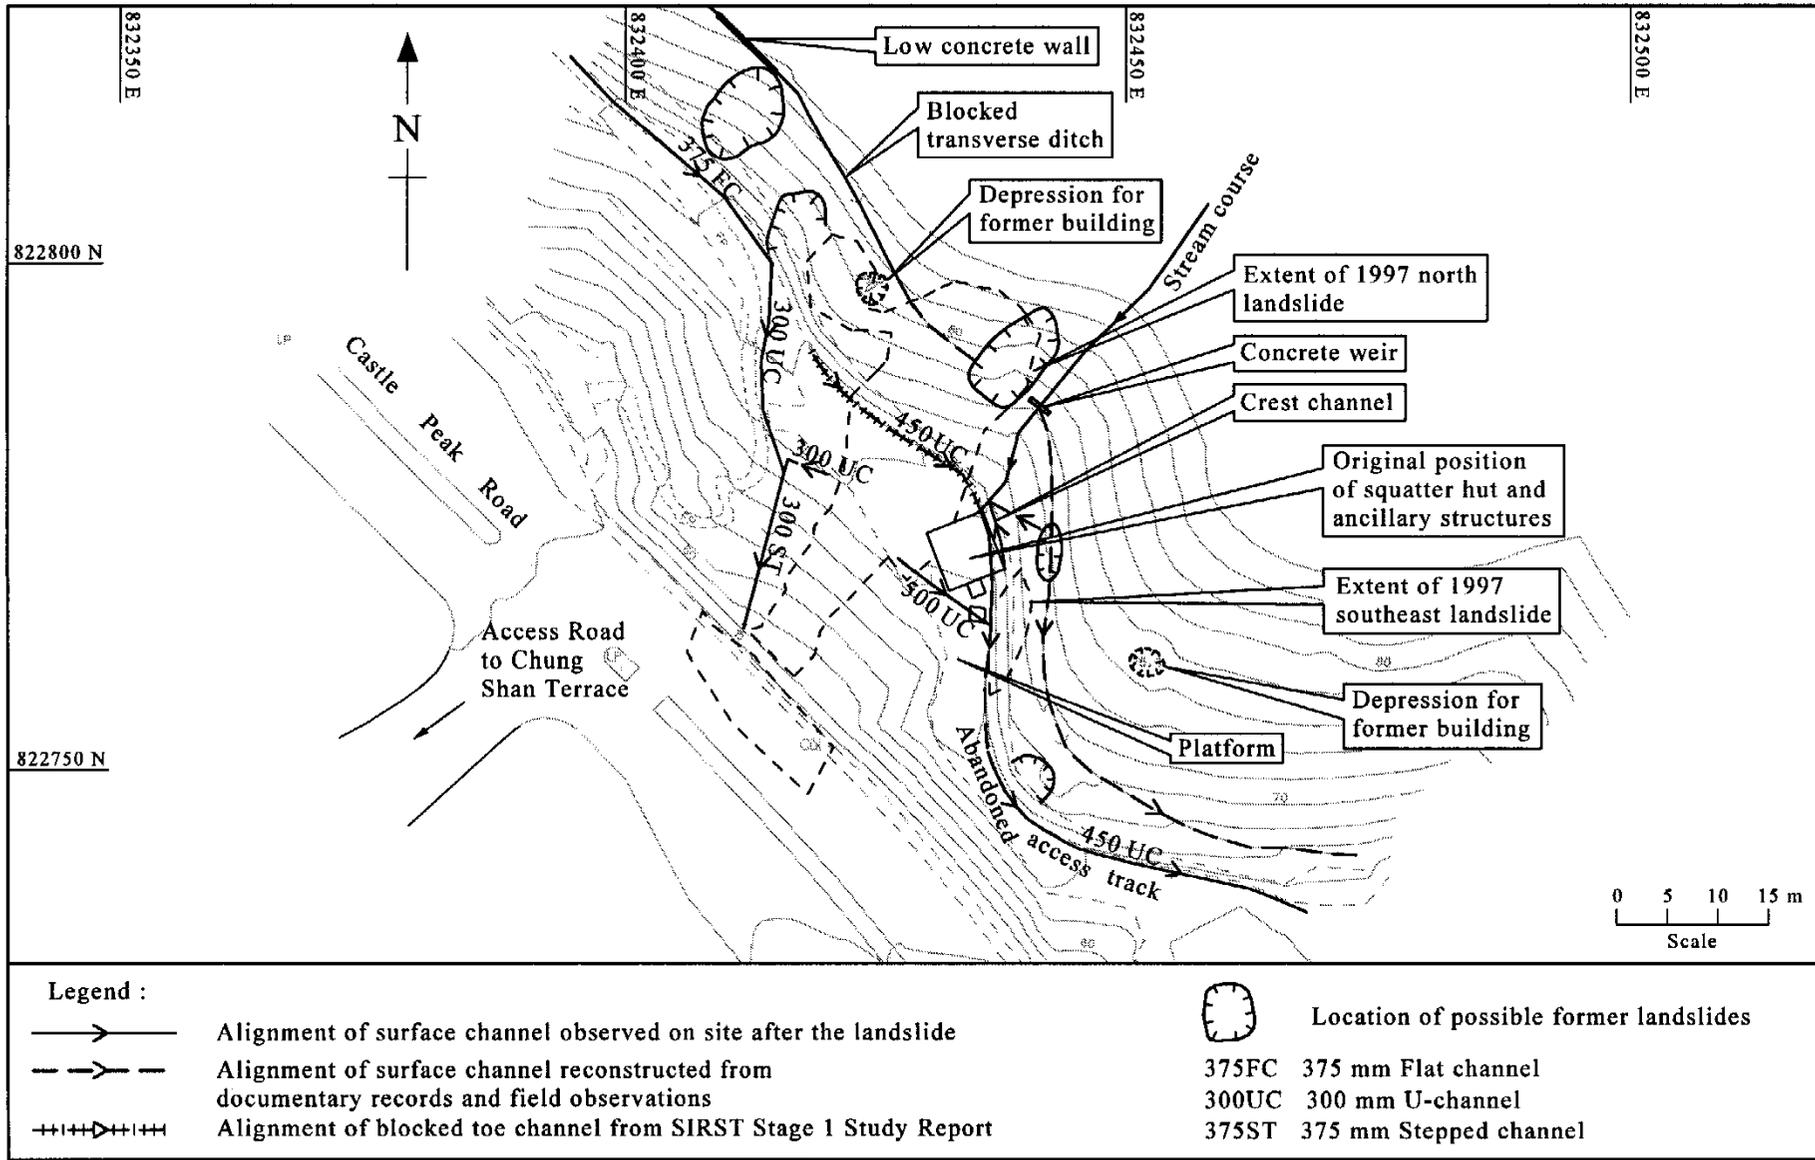
Figure 3 - Pre-landslide Drainage and Other Features

The probable layout of surface drainage prior to the landslide, as interpreted from site observations after the landslide and available documentary records, is shown in Figure 3. A transverse ditch locally supported by concrete walls, crossed the hillside northeast of the hut. The ditch was observed, at the point shown on Plate 4, to be completely filled with soil that had been there before the 1997 landslides.

The GEO has no records of any previous reported landslides in the vicinity of the site of the 1997 landslides. There are also no past natural terrain failures in the area recorded in GEO's Natural Terrain Landslide Inventory (Evans et al, 1997). From a review of the aerial photographs, it was found that four small-scale landslides might have occurred previously at and above the cut slopes between 1954 and 1963 (Figure 3).

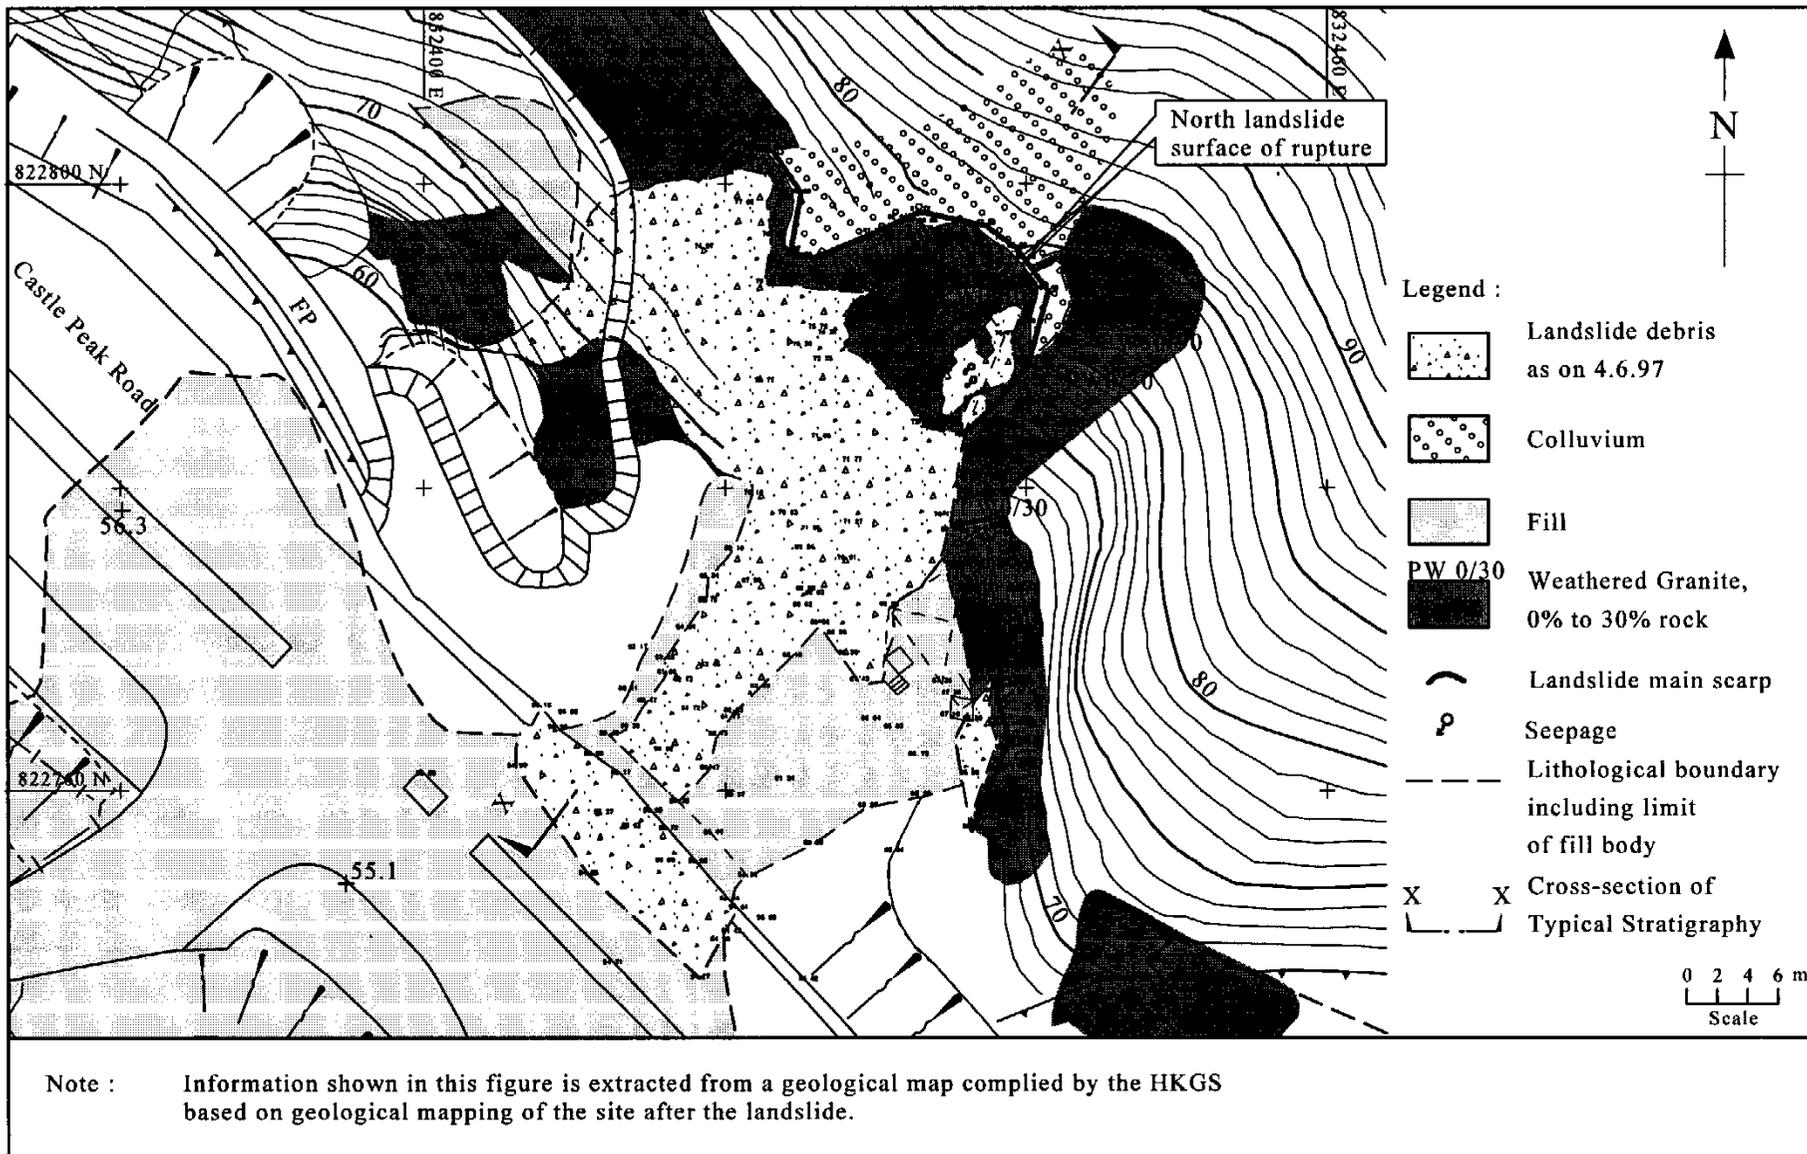
Figure 8 - Simplified Geological Map of the Landslides

Geological and other related features observed by the HKGS at and near the landslide site are shown in Figure 8. A geological section through the site is shown in Figure. 9. The predominant lithology consists of medium-grained, varying locally to coarse-grained, granite. Immediately upslope of the north landslide, weathered granitic rock is overlain by a layer of colluvium, up to about 2 m thick. Colluvium up to 1 m thick was also observed in the main scarp of the landslide.

- (a) a large amount of seepage was observed emanating from the discontinuities in the weathered granite exposed at the main scarp in the early afternoon of 4 June 1997 (Figure 8),

- (c) after the landslide scar had been trimmed back and covered by shotcrete through which weepholes and raking drains were installed, as part of urgent repair works to the failure, seepage was noted from the raking drains and the weepholes during and after heavy rain from June to October 1997 (Figure 8), and

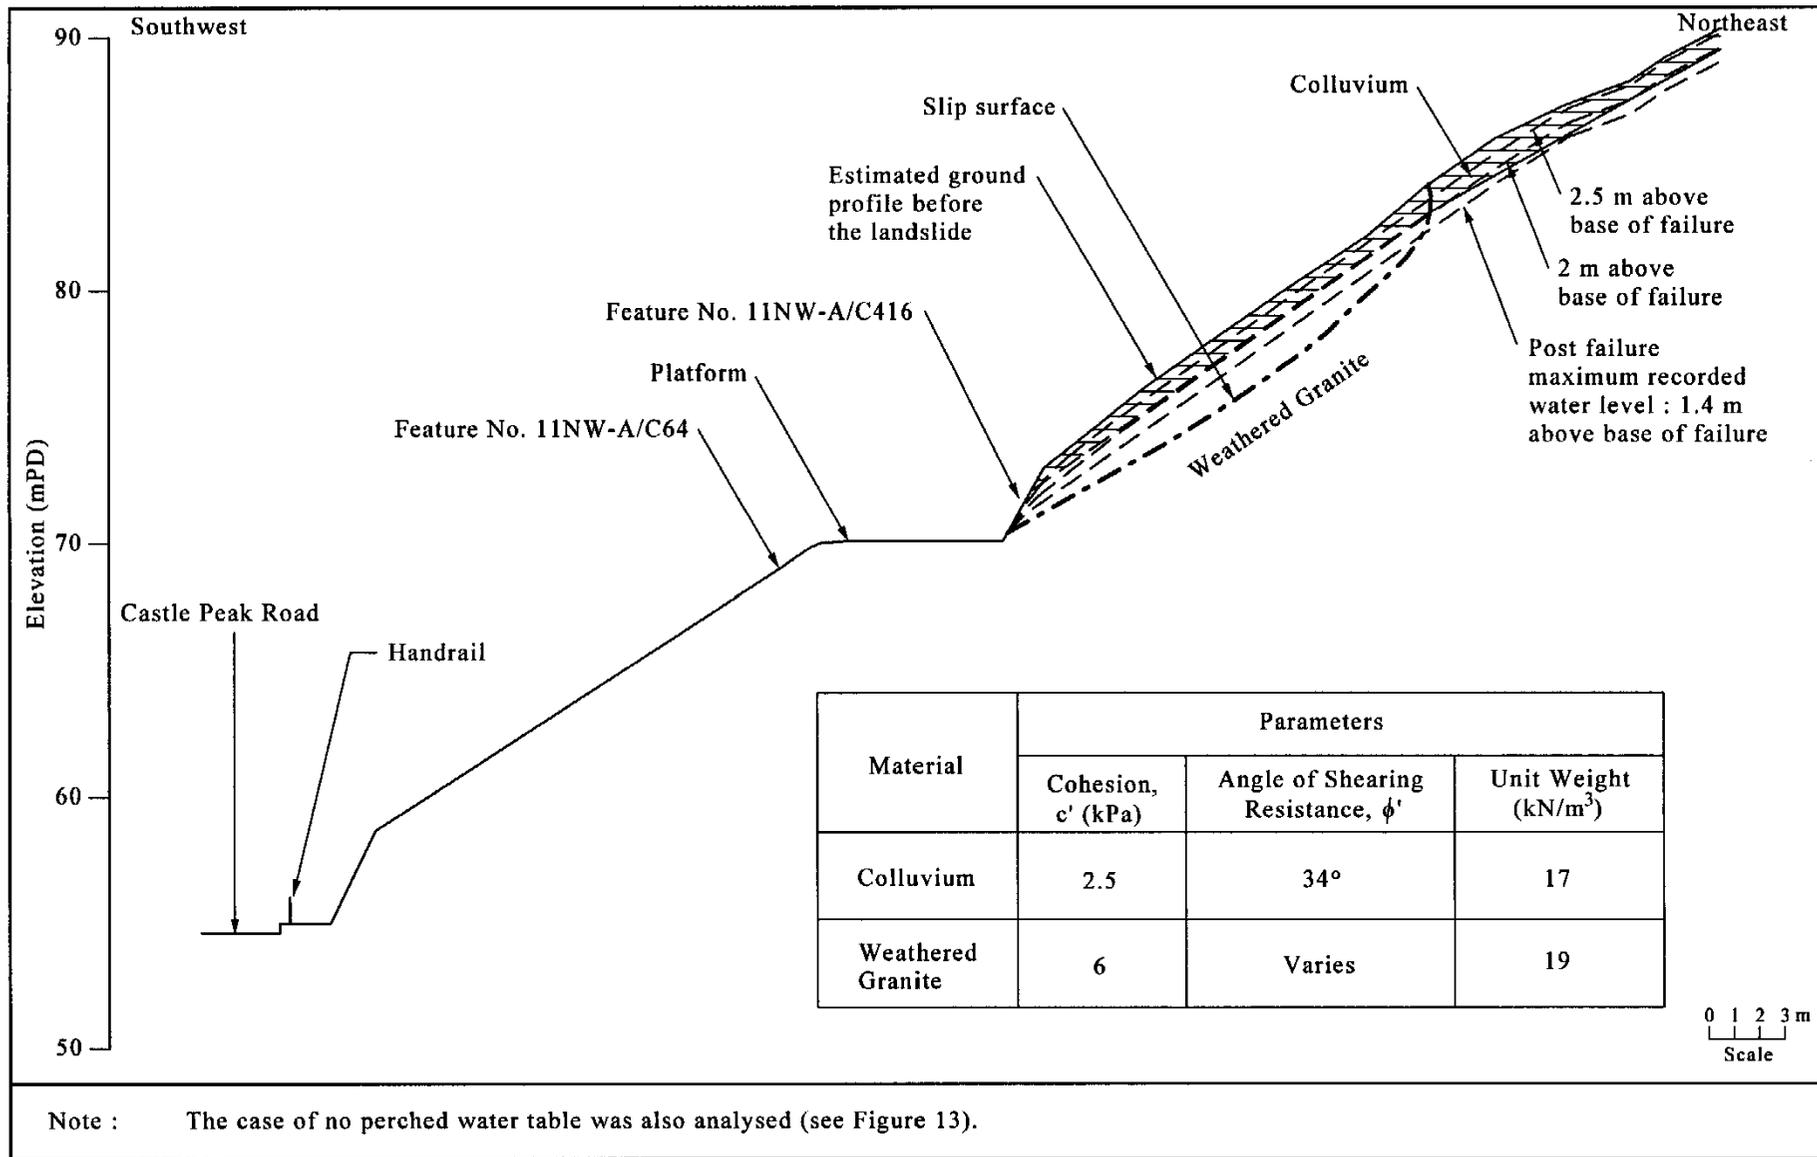
Figure 12 - Representative Cross-section of the Landslide for Theoretical Stability Analyses

base of the landslide. The groundwater regime will have been altered by the landslide itself, so that the measurements made after the failure may not be entirely representative of groundwater pressures before the landslide. As a best estimate, the groundwater pressure acting on the failed portion of the slope at the time of the landslide might correspond to that of a perched water table at about 1 m to 2 m above the basal surface of the landslide (see Figure 12).

Information obtained from the post-failure ground investigations, laboratory testing, and site observations and measurements was used in the analyses. A representative cross-section of the landslide site and the input parameters adopted in the analyses are shown in Figure 12. Stability analyses were undertaken for the failed section for different groundwater conditions, ranging from zero groundwater pressure to that corresponding to a perched water

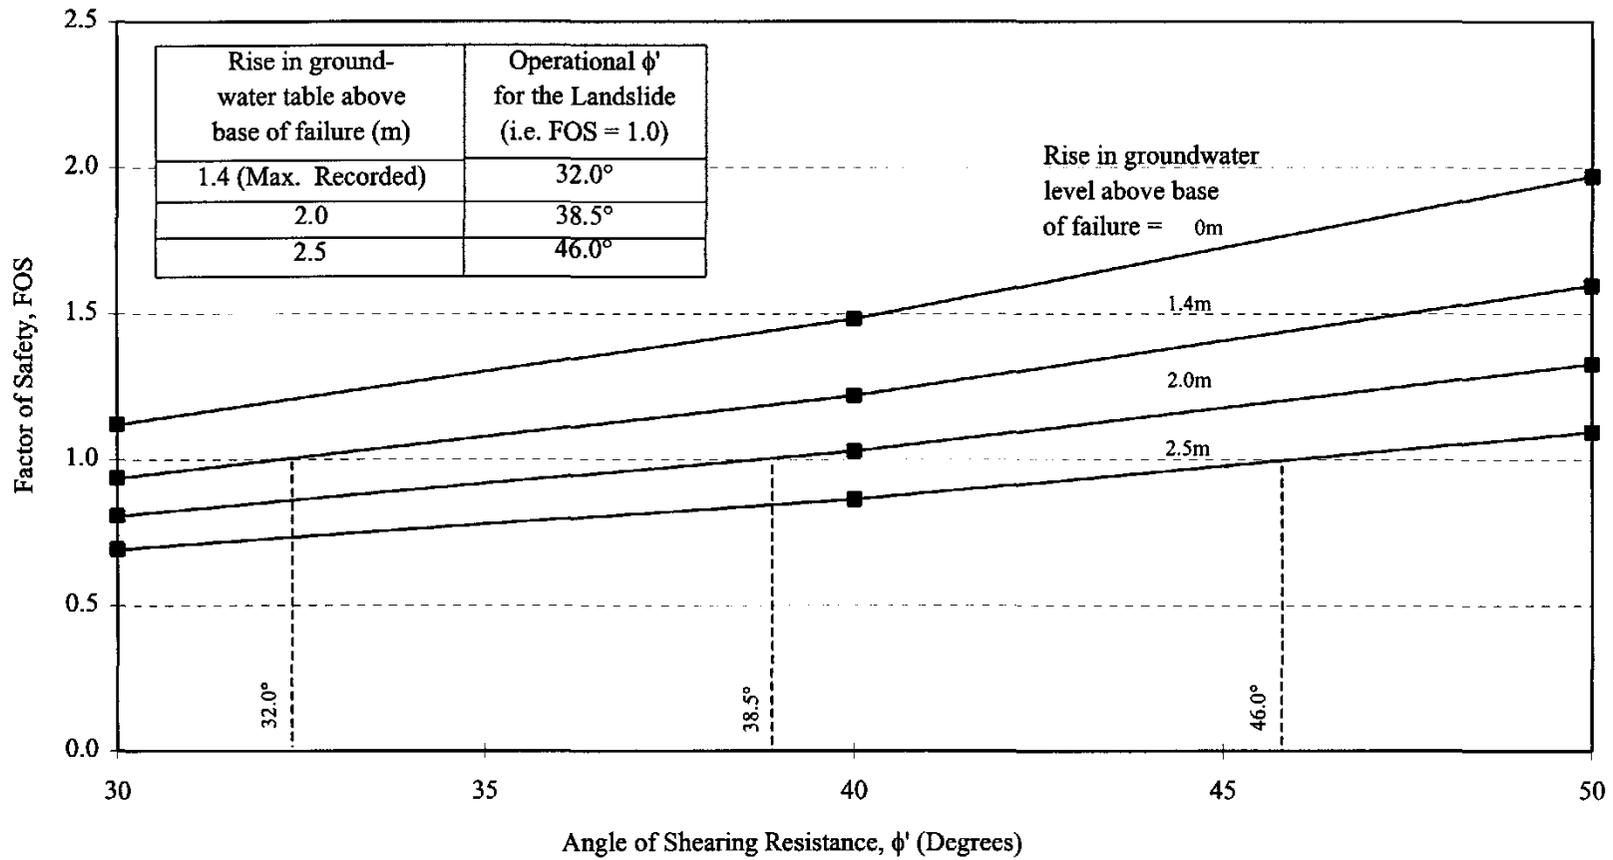
Figure 13 - Results of Theoretical Stability Analyses

The results of the analyses are summarised in Figure 13. For a factor of safety of 1.0 at failure, the angle of shearing resistance, ϕ' , of the weathered granite was found to be between 32° and 46°, for rises in a perched water table above the basal surface of the landslide of between 1.4 m and 2.5 m. The strength of the decomposed granite measured by laboratory tests lies within this range, and for this strength the analyses show that a rise in water table of about 1.8 m above the basal surface would have been sufficient for failure to have occurred.

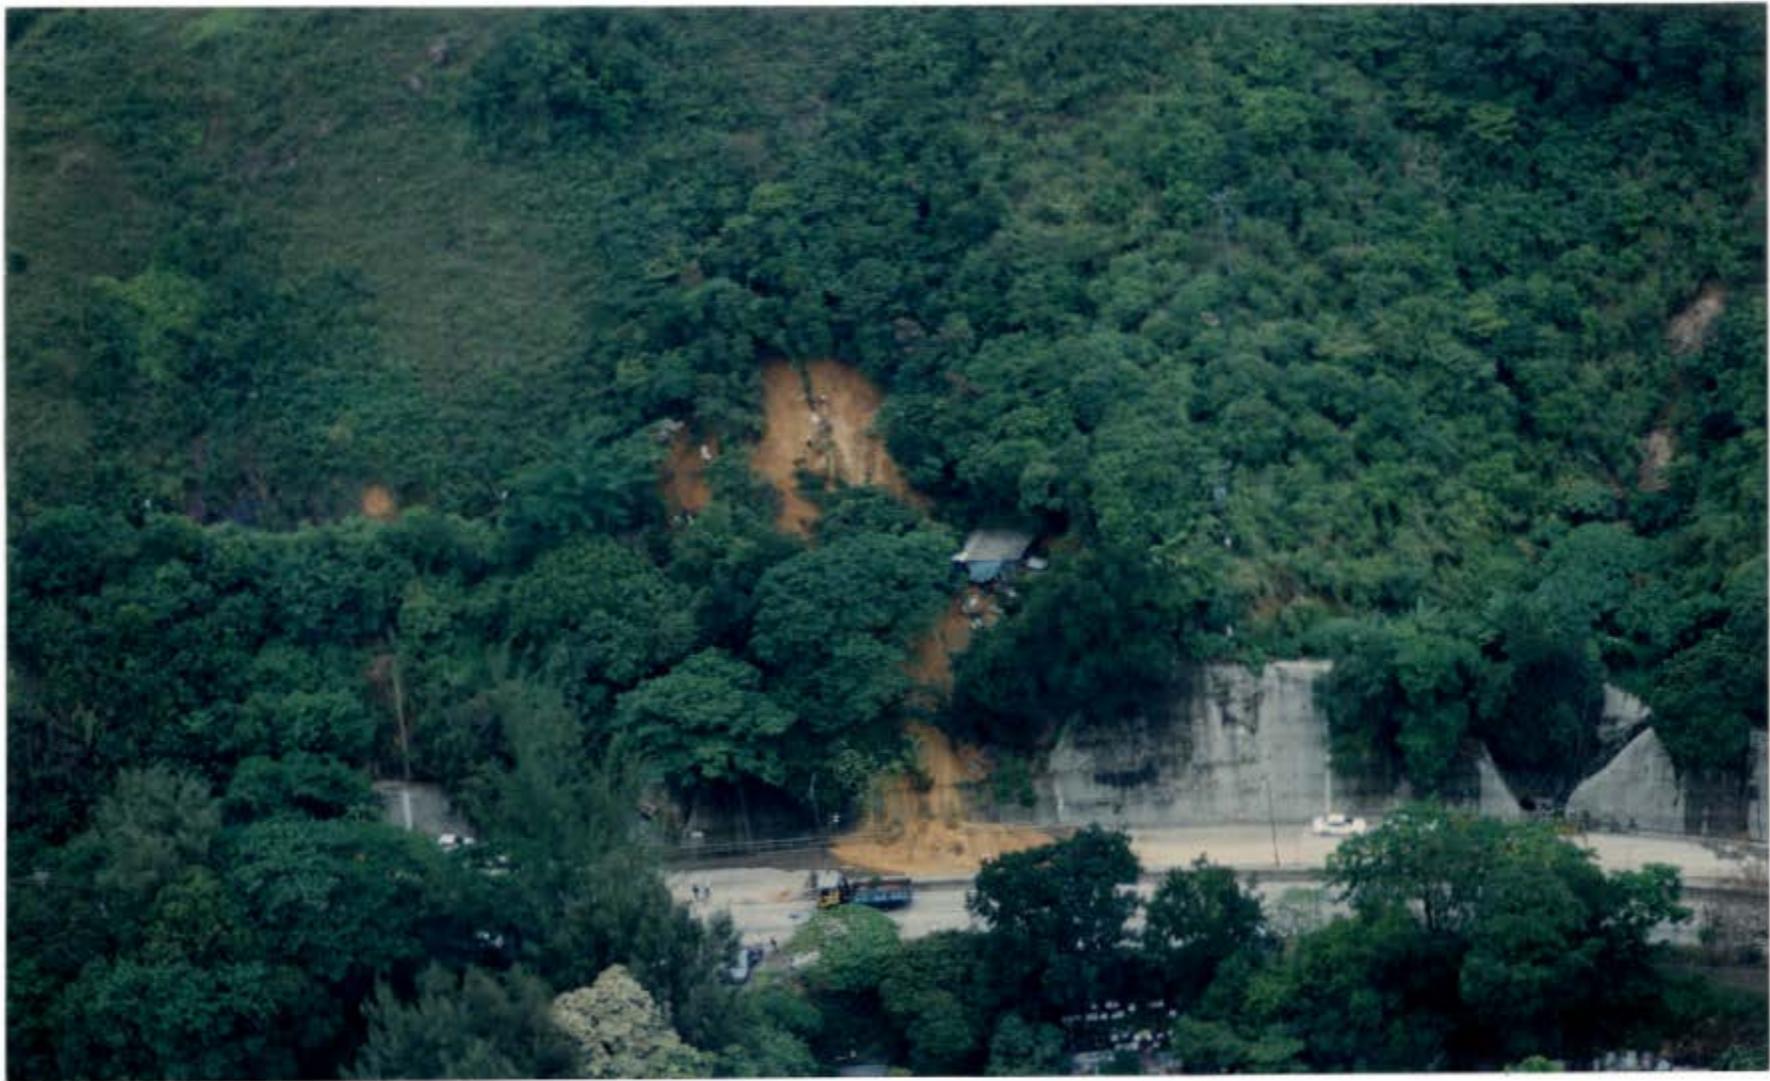
Plate 1 - Photograph of the Site of the Landslides Taken in the Afternoon of 4 June 1997 (See Figure 14 for Location)

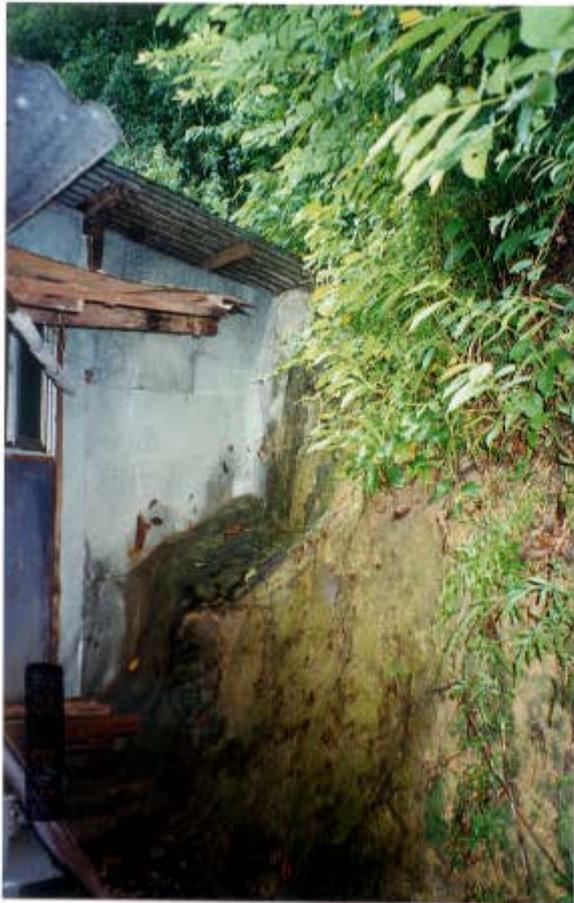
Plate 2 - Eastern Corner of No. 26
Kau Wa Keng Upper
Village Built into Slope
No. 11NW-A/C416
(Photograph Taken on
22 August 1996.
Reproduced from SIRST
Inspection by Binnie
Consultants Ltd. See
Figure 14 for Location)

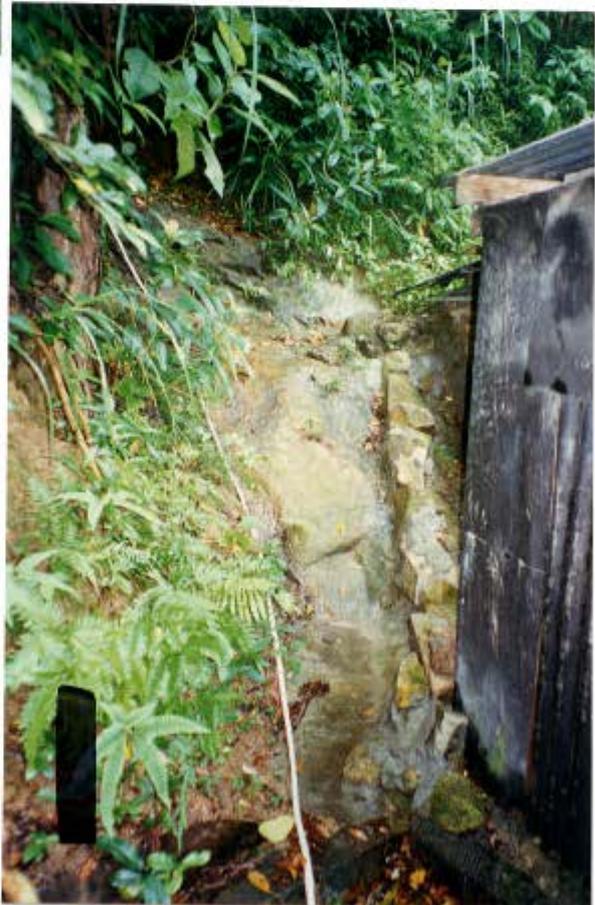
Plate 3 - Northern Corner of No. 26
Kau Wa Keng Upper Village
Showing the Stream Course
(Photograph Taken on
22 August 1996.
Reproduced from SIRST
Inspection by Binnie
Consultants Ltd. See Figure
14 for Location)

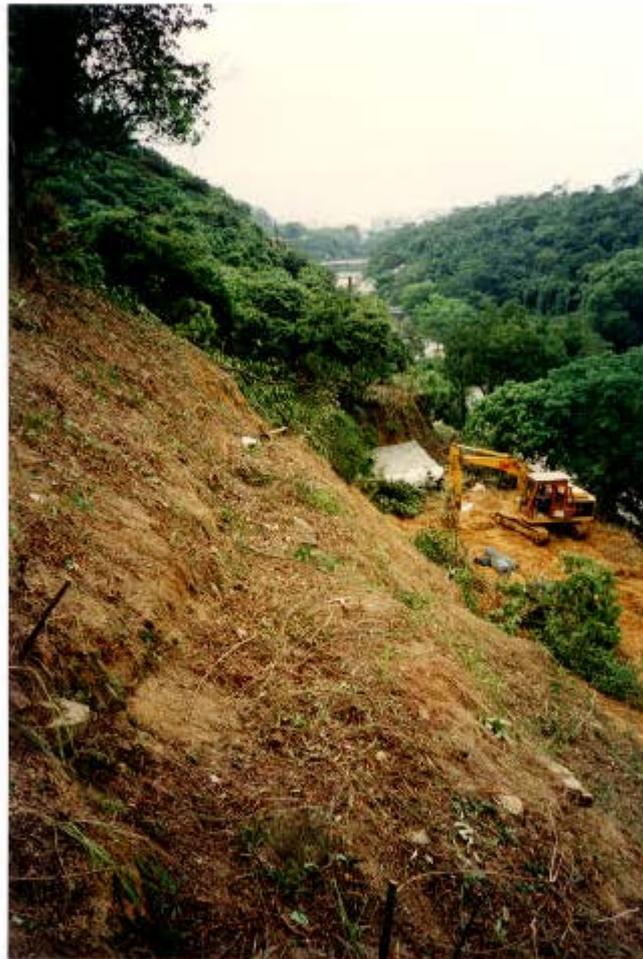
Plate 4 - Line of Transverse Ditch Filled with Soil (Photograph
Taken on 6 June 1997. See Figure 14 for Location)

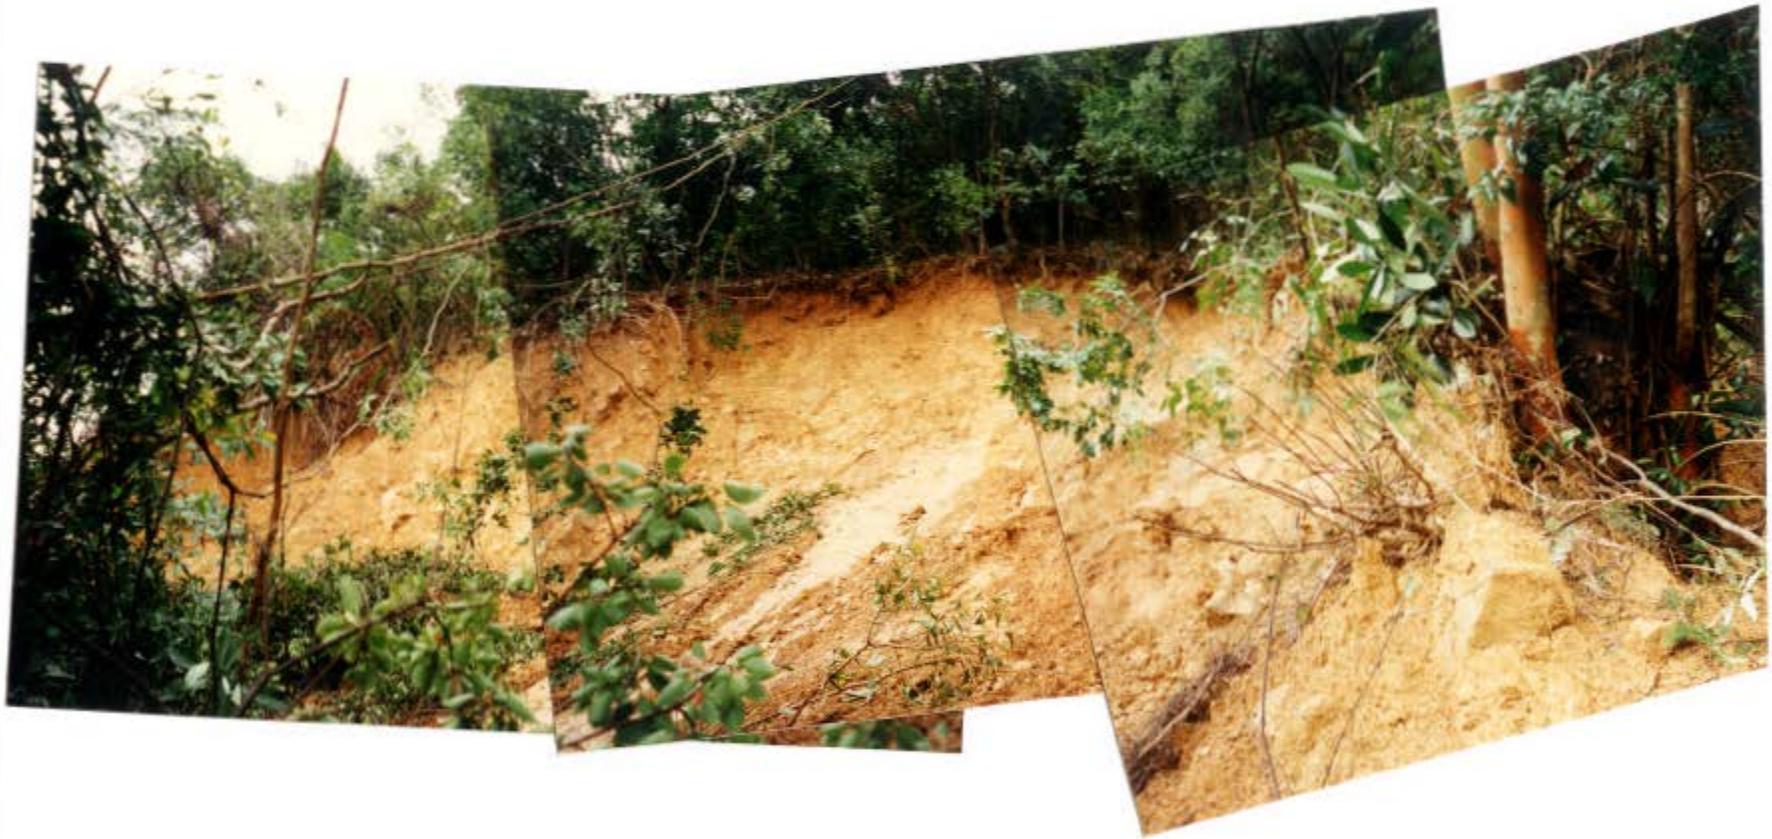
The surface of rupture of the north landslide occurred largely on a slightly undulating discontinuity, typically inclined at about 30° to the southwest. The main scarp in the northeast of the failure was inclined at about 42° to the southwest. This surface was partly exposed on 4 June 1997, when it was recorded as about 9 m in width and 8 m long in the direction of landsliding (Plates 5 and 7). It was later exposed for about a further 2 m downslope in a trial trench. The landslide scarp was markedly asymmetric in transverse section and the depth of rupture was observed to be up to 5 m on the northwest side. There, subvertical southeast dipping joints with extremely narrow apertures also acted as release surfaces, in combination with discontinuous joints subparallel to and above the surface of rupture. No tension cracks were observed on 4 June 1997 behind the main scarp. The depth of rupture tapered to about 1 m on the southeast side of the landslide. A narrow discontinuity, locally up to 20 mm wide, was observed extending upslope from the surface of rupture (Plate 7). This discontinuity is interpreted as the unfailed portion of the same discontinuity that largely controlled the surface of rupture. Occasional rootlets were seen growing along this discontinuity and onto the surface of rupture itself, indicating that the discontinuity had possibly been a partly open structure for some time prior to the failure. Significant seepage was flowing out of the discontinuity in the early afternoon of 4 June 1997 and became minimal at about 4 p.m.

Plate 5 - View of North Landslide Showing Slip Surface (Photograph Taken on 4 June 1997. See Figure 14 for Location)

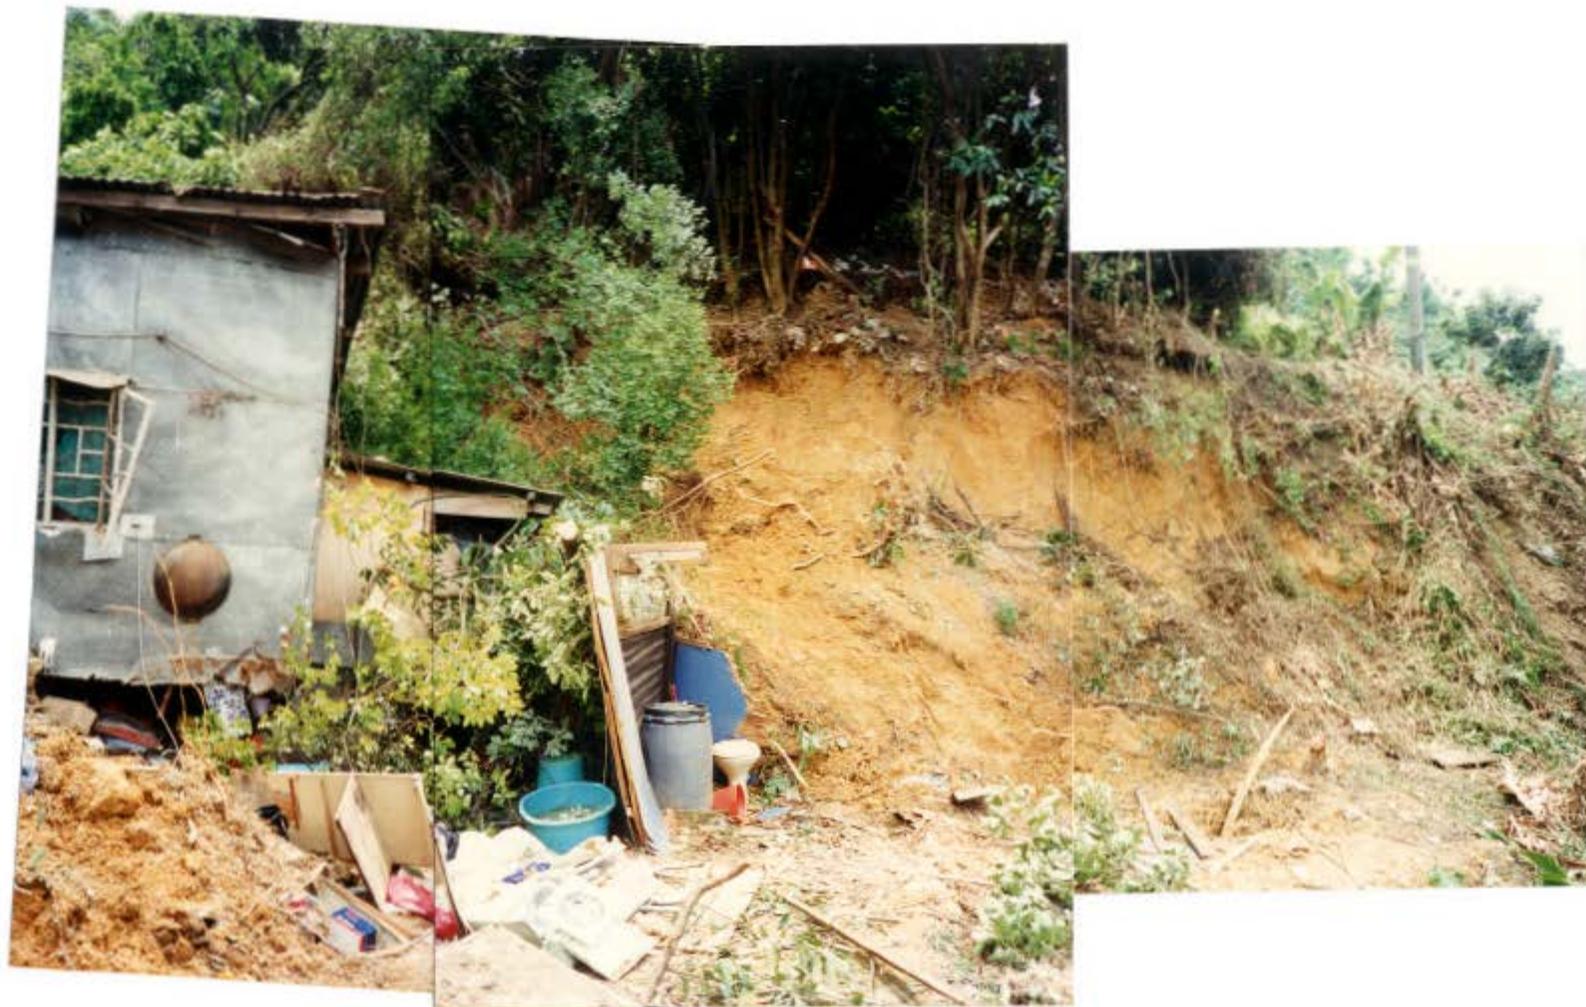
The main body of the southeast landslide occurred some time after the north landslide. The southeast landslide had no influence on the damage sustained by the squatter hut and the fatality.

Plate 6 - View of Southeast Landslide in the Afternoon of 6 June 1997 (See Figure 14 for Location)

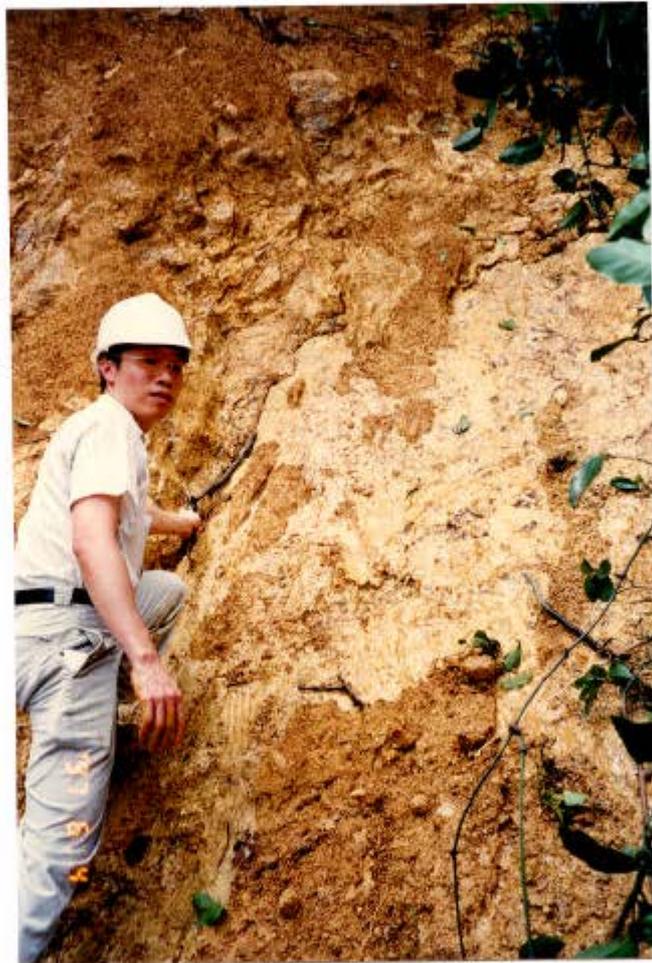
Plate 7 - Details of Landslide Surface with Seepage (Photograph Taken on 4 June 1997. See Figure 14 for Location)

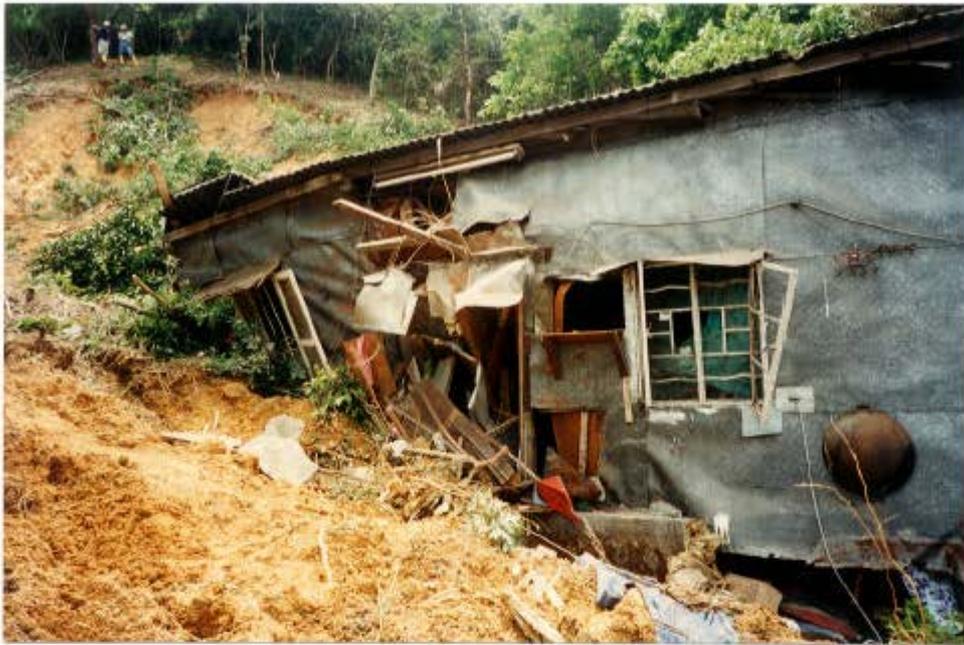
Plate 8 - Damage to Southwest Side of No. 26 Kau Wa Keng Upper Village
(Photograph Taken on 6 June 1997. See Figure for Location)

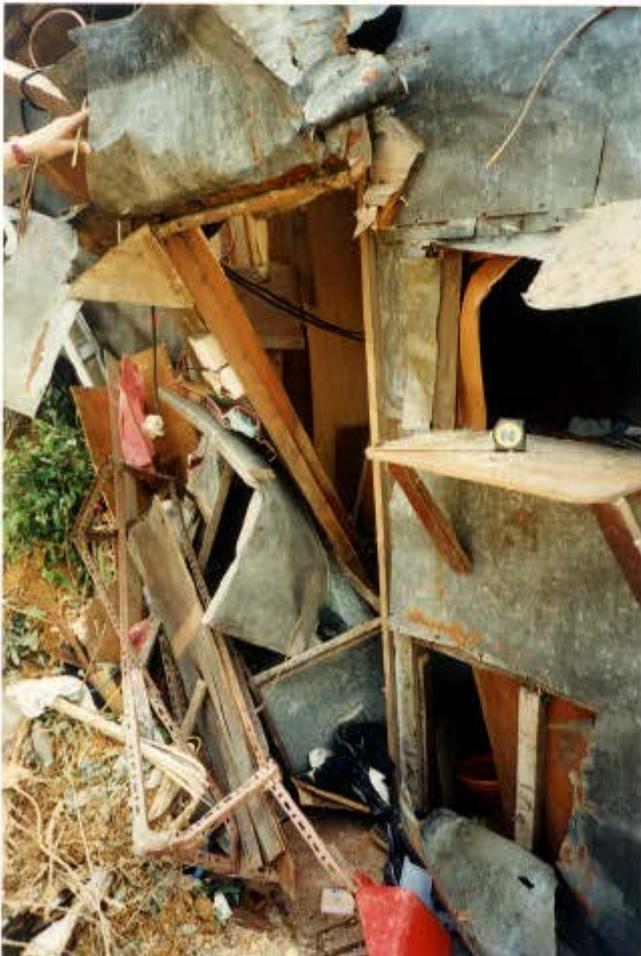
Plate 9 - Damage to Front Door
Frame of No. 26 Kau Wa
Keng Upper Village
(Photograph Taken on
6 June 1997. See Figure
14 for Location)

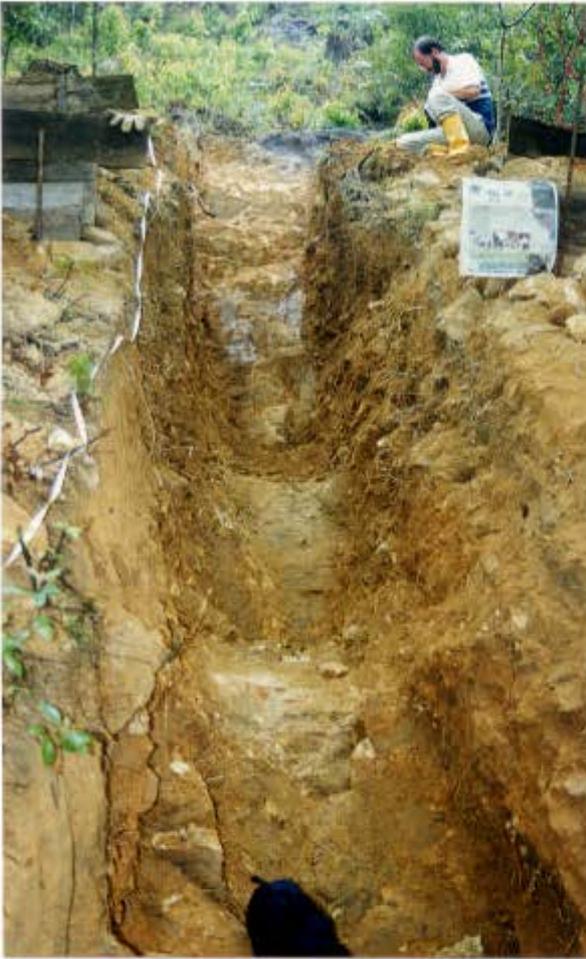
The colluvium observed in the main scarp was a firm to stiff, brown, sandy very clayey silt with occasional gravel, cobbles and boulders of highly to moderately decomposed fine to medium-grained granite, medium-grained granite and aplite. Colluvium was exposed in the trial trench and trial pits behind the main scarp and was proved to extend for about 25 m upslope, terminating against exposed granite (Plate 10). The colluvium in this area comprises firm, dark brown, slightly sandy clayey silt with some gravel and cobbles of granite. Evidence of bioturbation through insect activity was found, resulting in the formation of nest cavities up to about 50 mm to 100 mm across.

Plate 10 - Colluvium Overlying Granite in Trial Trench TT2 (Photograph Taken on 25 August 1997. See Figure 14 for Location)

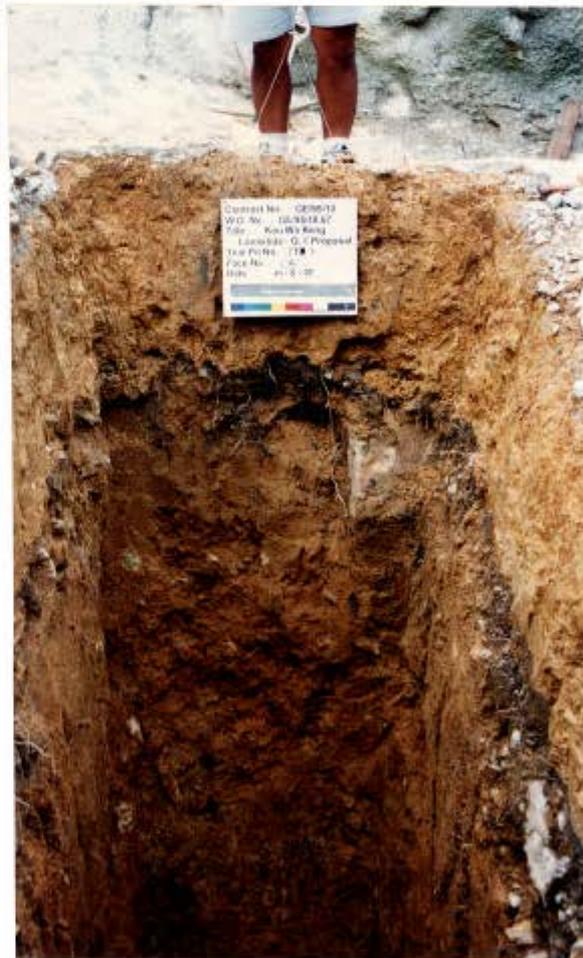
Plate 11 - Landslide Debris Overlying Thin Soil and Fill on the Platform (See Figure 14 for Location)
