一九九七年七月二日  
萬佛寺山泥傾瀉事件報告  
**REPORT ON THE LANDSLIDE  
AT TEN THOUSAND  
BUDDHAS' MONASTERY  
OF 2 JULY 1997**

土力工程處報告系列第 77 號  
GEO REPORT No. 77

合樂亞洲顧問公司  
Halcrow Asia Partnership Ltd.

香港特別行政區政府  
土木工程署  
土力工程處  
**GEOTECHNICAL ENGINEERING OFFICE  
CIVIL ENGINEERING DEPARTMENT  
THE GOVERNMENT OF THE HONG KONG  
SPECIAL ADMINISTRATIVE REGION**

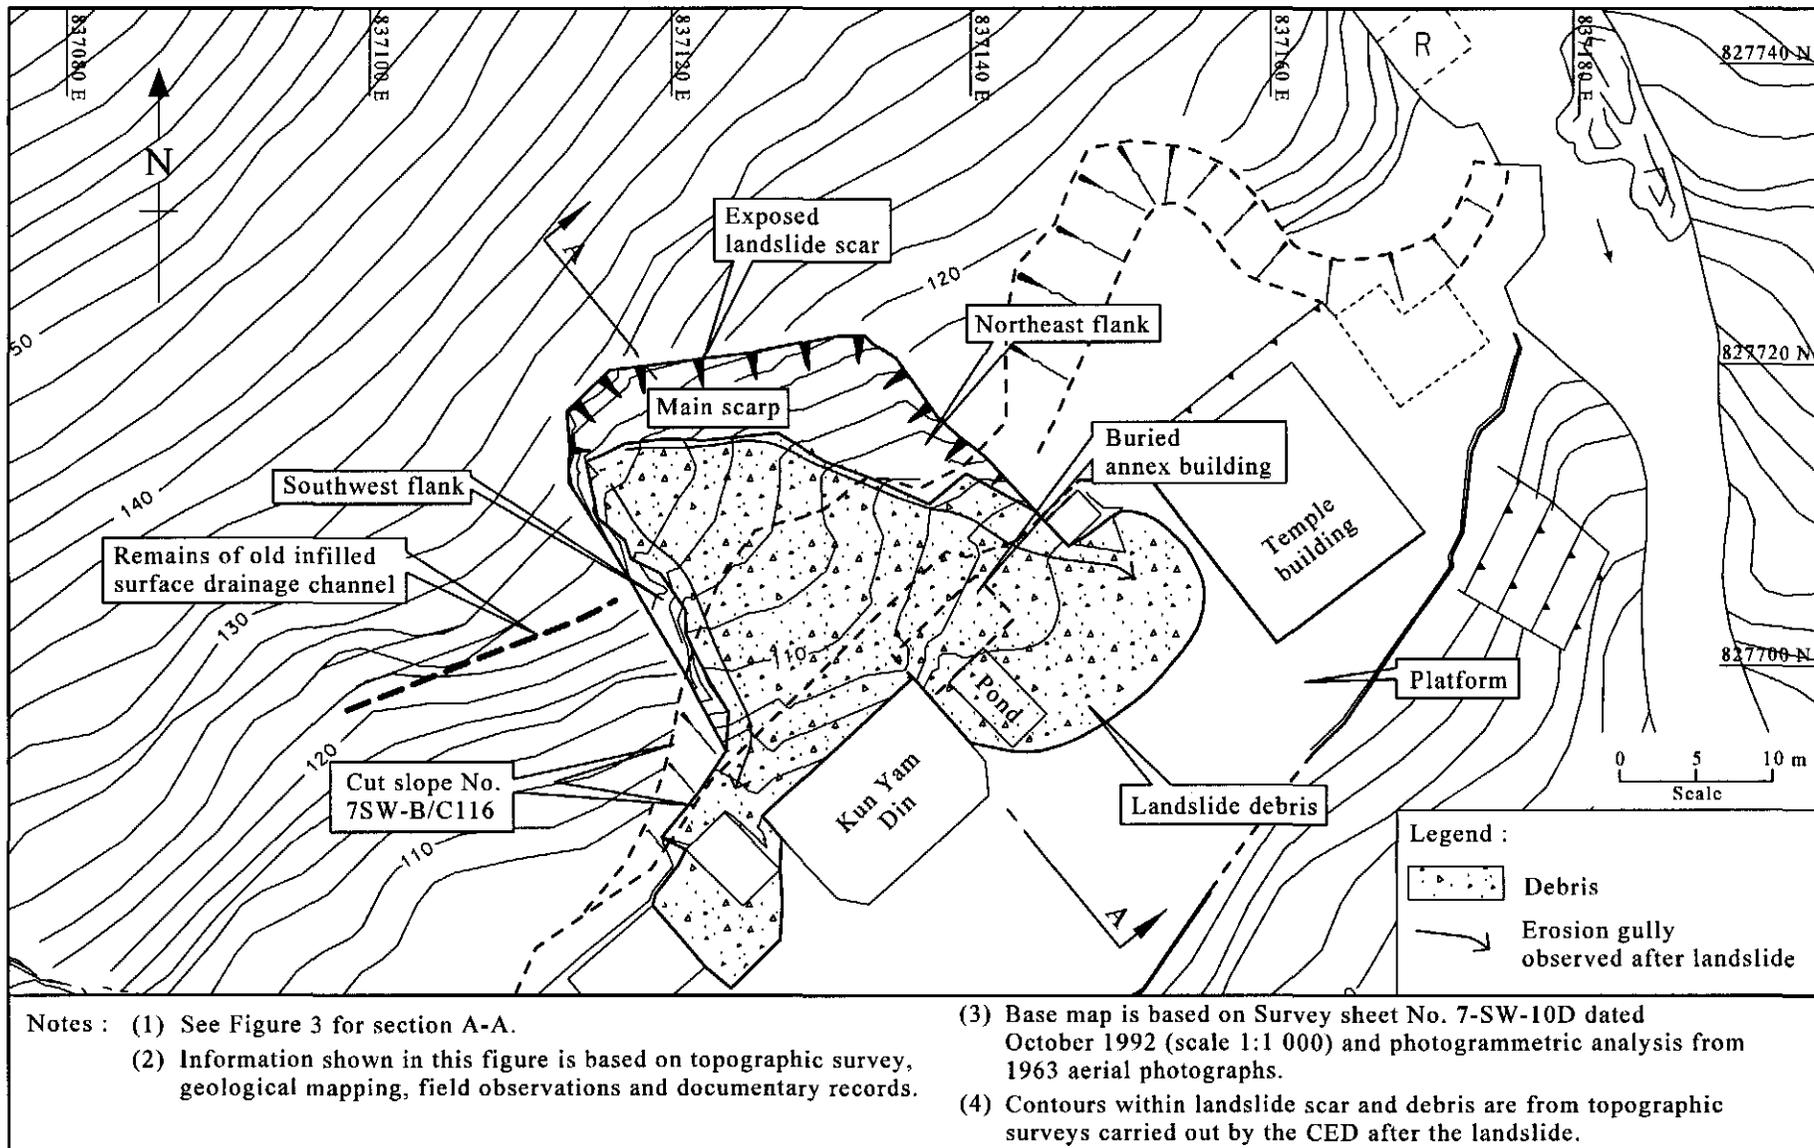
Figure 2 - Plan of the Landslide

The remains of an old, infilled, man-made concrete drainage channel was found adjacent to and truncated by the southwest flank of the landslide (Figure 2). The channel was located along a 2 m wide track that had originally been formed as a shallow cutting, but which had subsequently become almost completely obscured over a period of years by soil and vegetation debris. The track and channel were not found on the northeast side of the landslide. No other man-made surface drainage channels were present in the cut slope or hillside behind the platform.

During an inspection after the landslide on 2 July 1997, copious seepage was observed issuing from about 2 m below ground level in the main scarp of the landslide (Section 7.4). Seepage flow and surface runoff water resulted in the formation of erosion gullies along both sides of the debris (Figure 2).

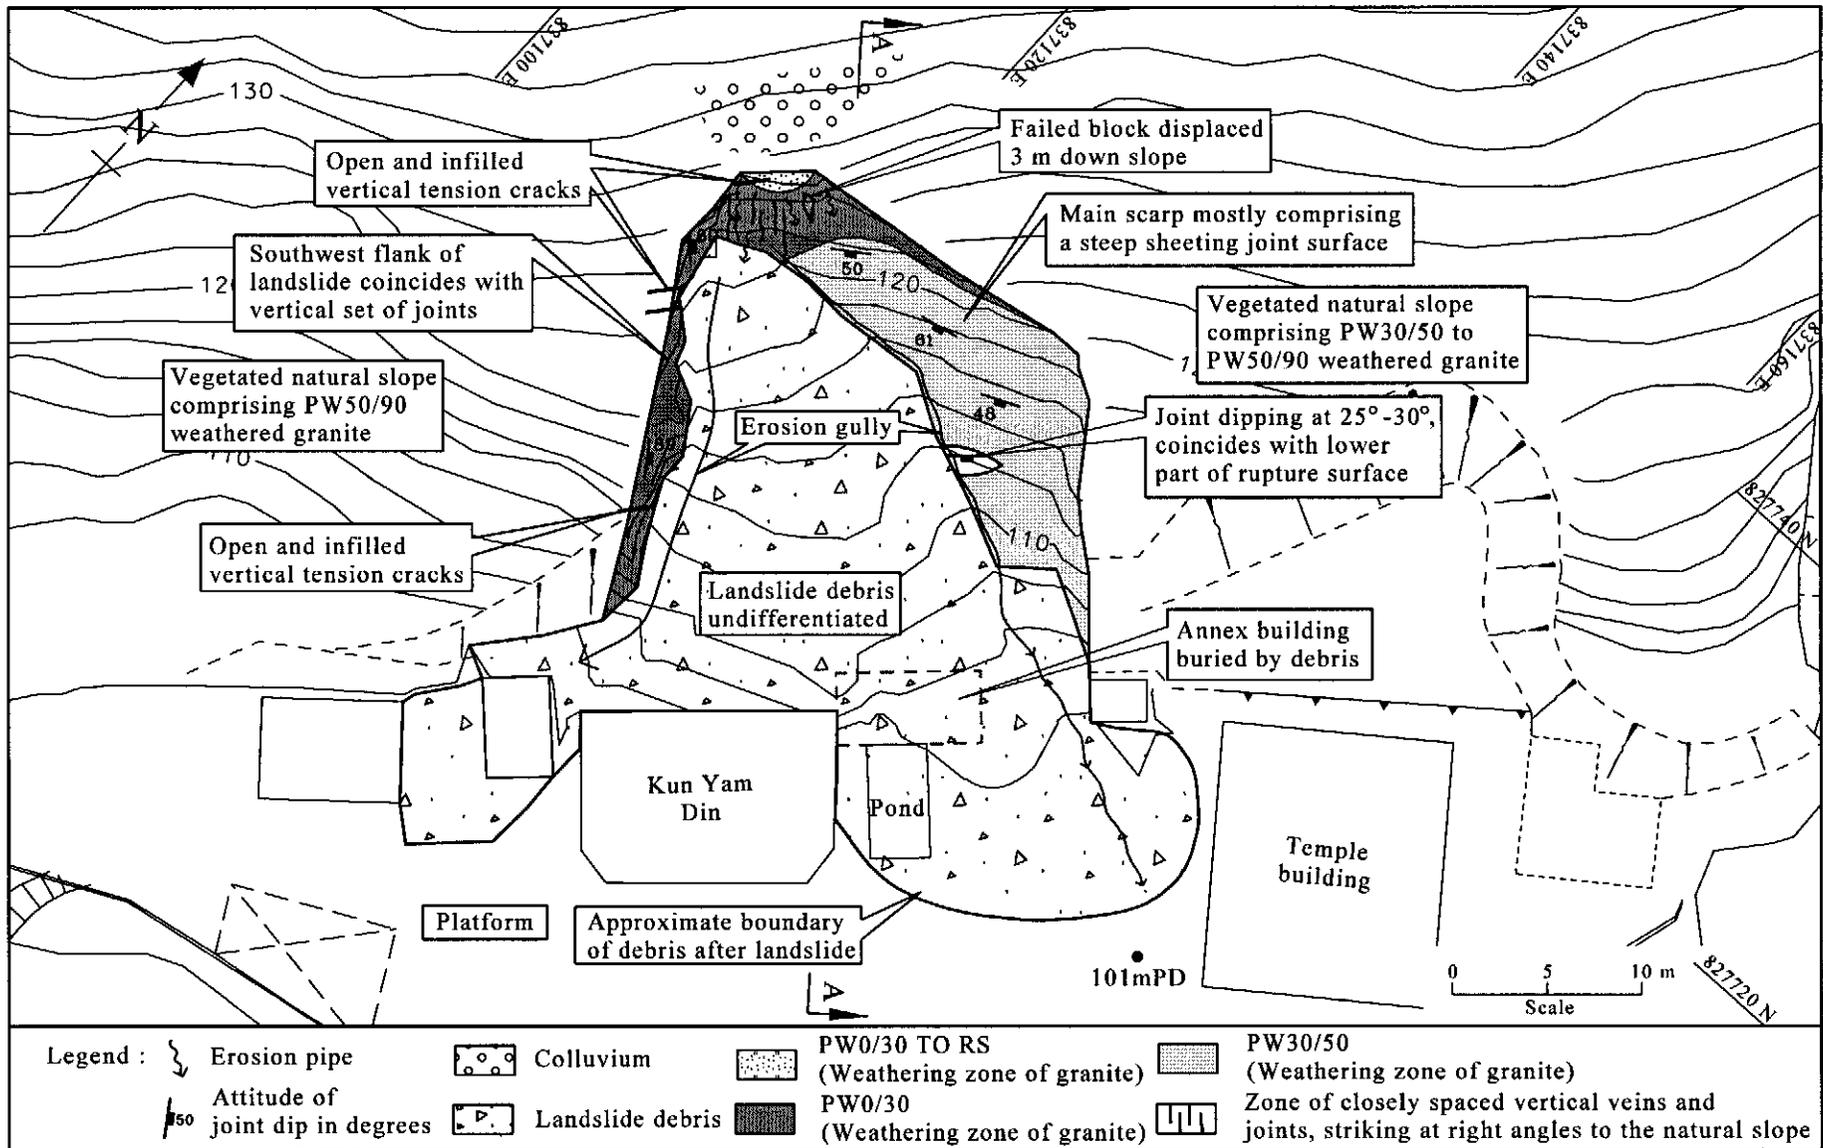
Figure 8 - Geological Plan of the Landslide Area

A major set of sub-vertical veins and relict joints was observed to strike at right angles to the slope throughout the landslide scar and in adjacent rock outcrops (Figure 8). These discontinuities were closely spaced (60 mm to 200 mm apart) on the southwest side of the failure scar, becoming very widely spaced (up to 4 m apart) towards the northeast flank. The veins were infilled with vertical layers of quartz that were slightly open, which would have allowed the flow of seepage water. The apertures of the majority of the joints were also slightly open in the upper part of the main scarp and became closed with increasing depth. Several of these veins and joints formed the sub-vertical face of the exposed southwest flank of the landslide. Close examination of the highly decomposed granite revealed localised zones of extremely closely spaced micro-fracturing, which were of the same orientation as the major set of veins and joints.

Partly infilled sub-vertical cracks, with the same dip direction as the hillside, were observed in the zone of heterogeneous weathered granite exposed in the southwest flank of the landslide (Figure 8 and Plate 7). Typically, the apertures of the cracks were moderately narrow (20 mm to 60 mm) and partly infilled with dry to moist, slightly clayey, sandy silt debris, which was probably derived from material washed-in from the ground surface of the hillside. Occasional relict joints, with similar orientations to the cracks and persistences generally less than about 1 m, were observed in the main scarp. It is thought that these joints may have opened in the past to form the cracks, although in some cases, the cracks have clearly formed along the vertical boundaries between corestones and the weaker highly decomposed granite.

In the center of the main scarp, a block of relatively intact material of about  $5 \text{ m}^3$  volume was found to have been displaced by about 3 m down the sheeting joint from its original position at the crest of the landslide (Figure 8). The release surfaces around the back of the block coincided with two relict joints coated with the same debris material that was

Shortly after the landslide on 2 July 1997, copious water seepage was observed issuing from the main scarp at about 2 m below ground surface (Figure 8). The seepage emanated from erosion pipes formed through the soil (Plate 9), and from the slightly open relict joints and quartz veins. The amount of seepage reduced substantially about one week after the heavy rain stopped on 3 July 1997.

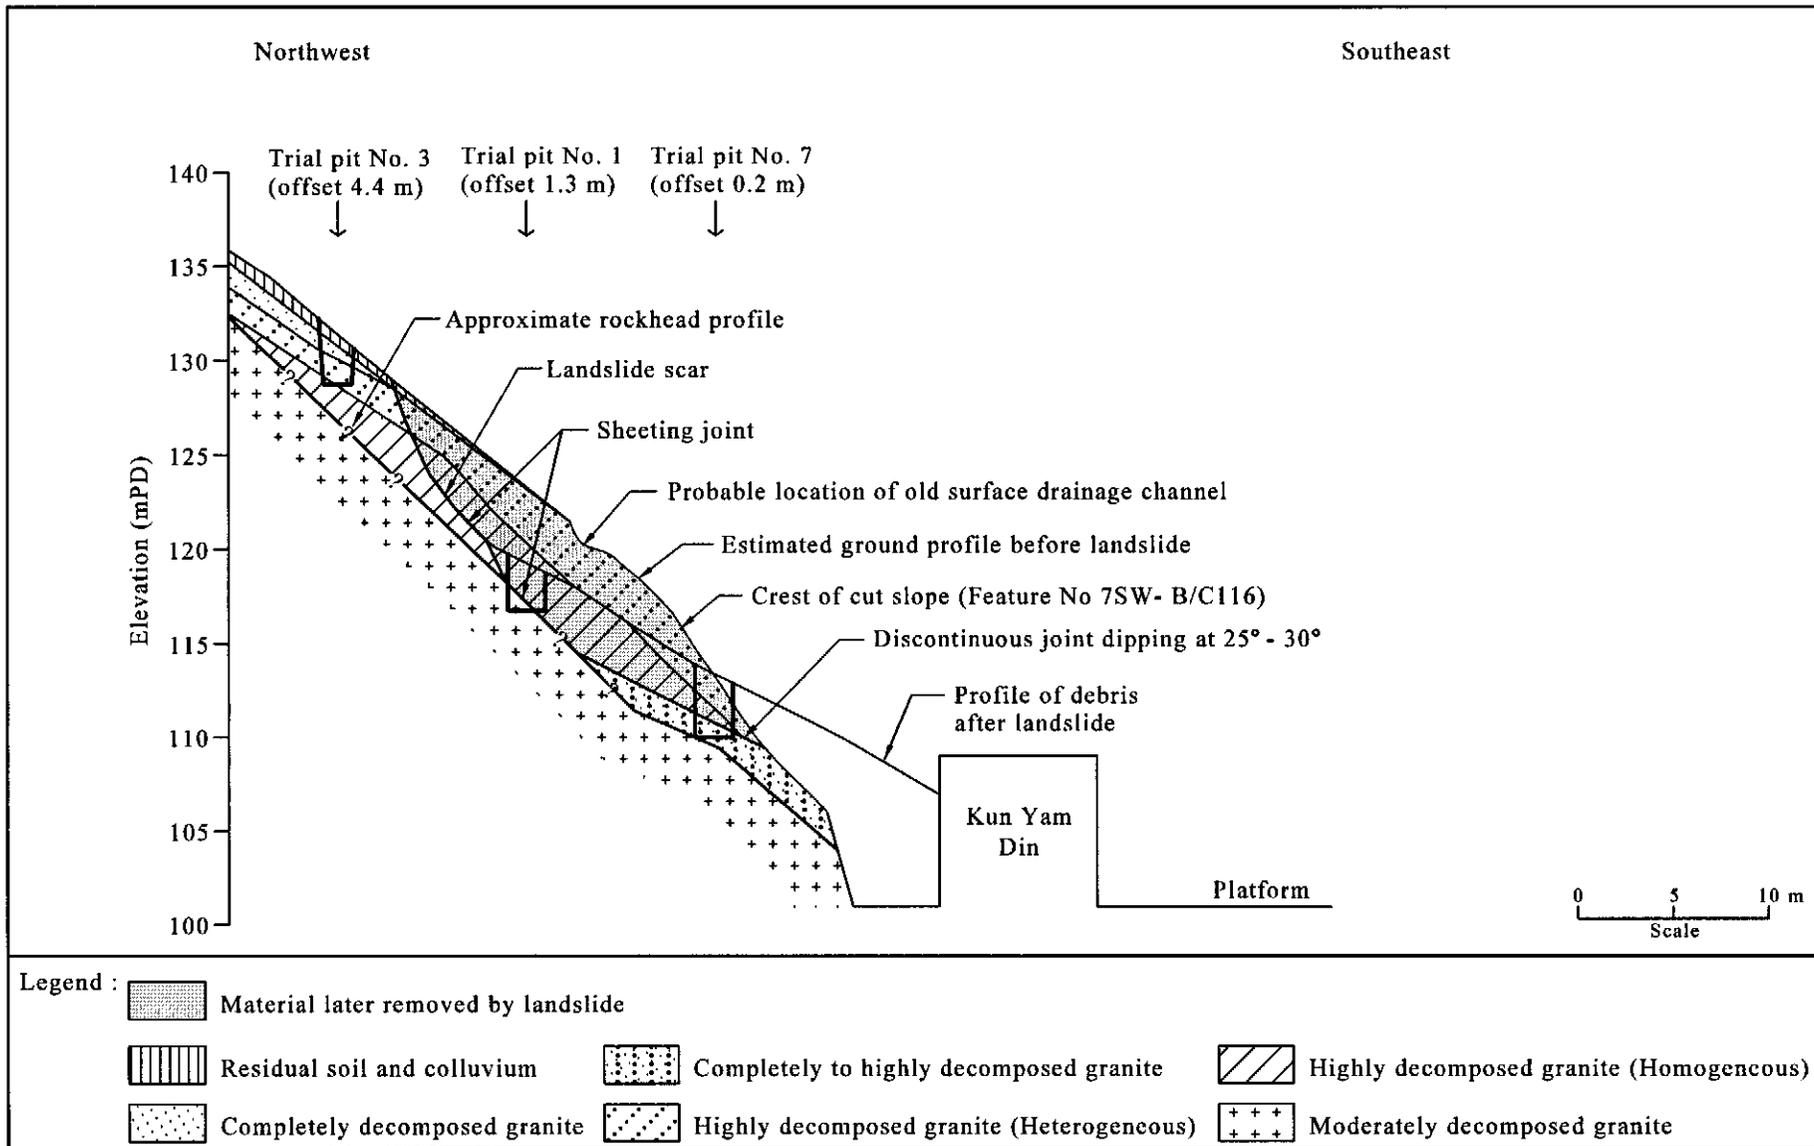
Figure 9 - Section A-A Showing the Typical Stratigraphy Through the Landslide Site

The landslide occurred within 4 hours of the heavy rainfall that commenced in the early morning of 2 July 1997. Surface runoff of the rainfall would have been slightly impeded by vegetation and the undulating bouldery slope. It is inferred that surface water had infiltrated rapidly through the discontinuous thin layers of residual soil and colluvium into the partly open cracks, joints and soil erosion pipes present in the 1 m to 6 m of weathered granite above rockhead. The hydrological conditions were therefore favourable to the development of transient groundwater pressure in the weathered granite at times of heavy rain. A best estimate of the likely pressure acting on the failed portion of slope would be a water table about 1 m to 4 m above inferred rockhead, with rockhead being the interface between moderately decomposed granite and highly decomposed granite (Figure 9).

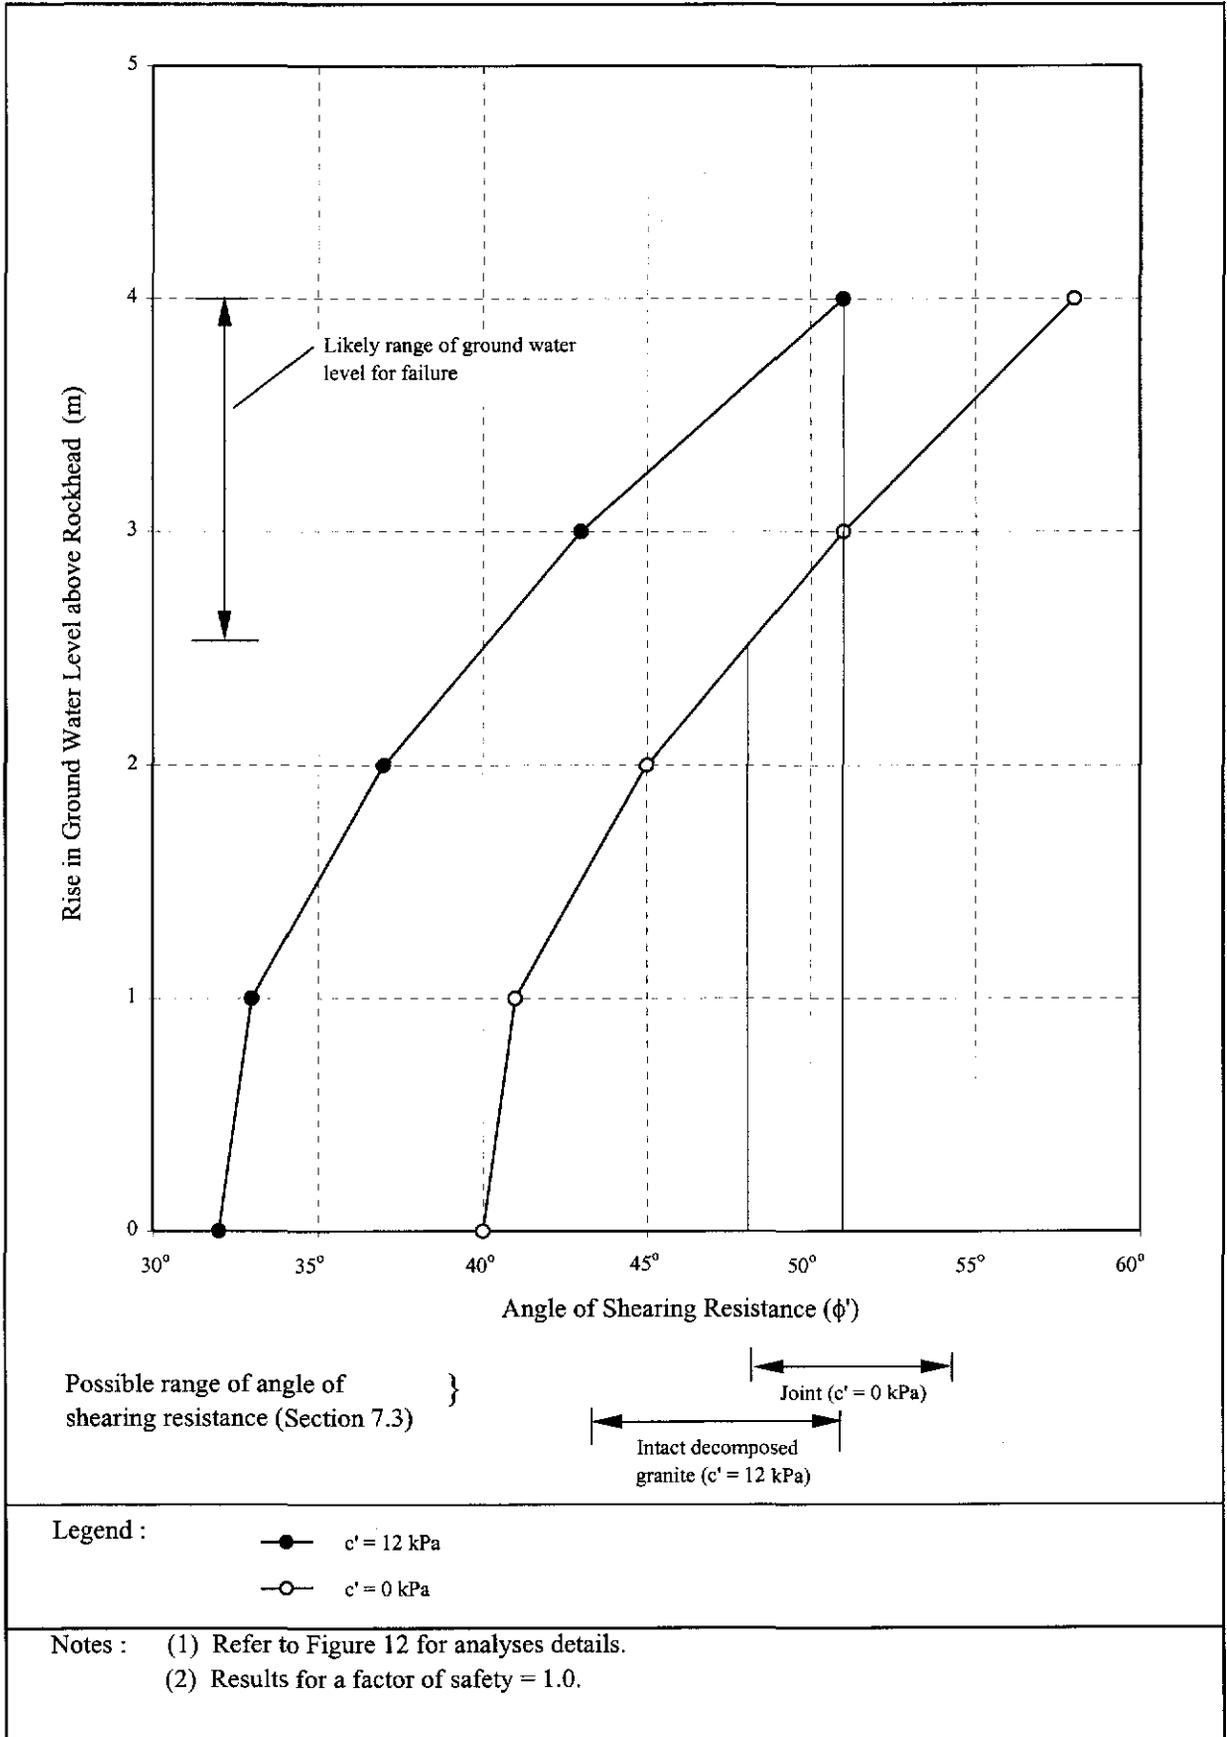
Figure 13 - Results of Theoretical Stability Analyses

The results of the analyses are summarised in Figure 13, for cases of 0 kPa and 12 kPa cohesion ( $c'$ ) with variable angle of shearing resistance ( $\phi'$ ) operating along the surface of rupture. Zero cohesion is taken as representative of the sheeting joint, which coincides with most of the surface of rupture. A cohesion value of 12 kPa is used to examine the theoretical stability of the slope in the case of failure through intact decomposed granite, without the influence of a pre-existing discontinuity. The results show that for the likely ranges of shear strength parameters for the slope-forming material (Section 7.3), a rise in the groundwater table above rockhead of about 2.5 m to 4.0 m would have been sufficient for failure to have occurred. This suggests that the theoretical stability analyses, for these assumptions, are credible.

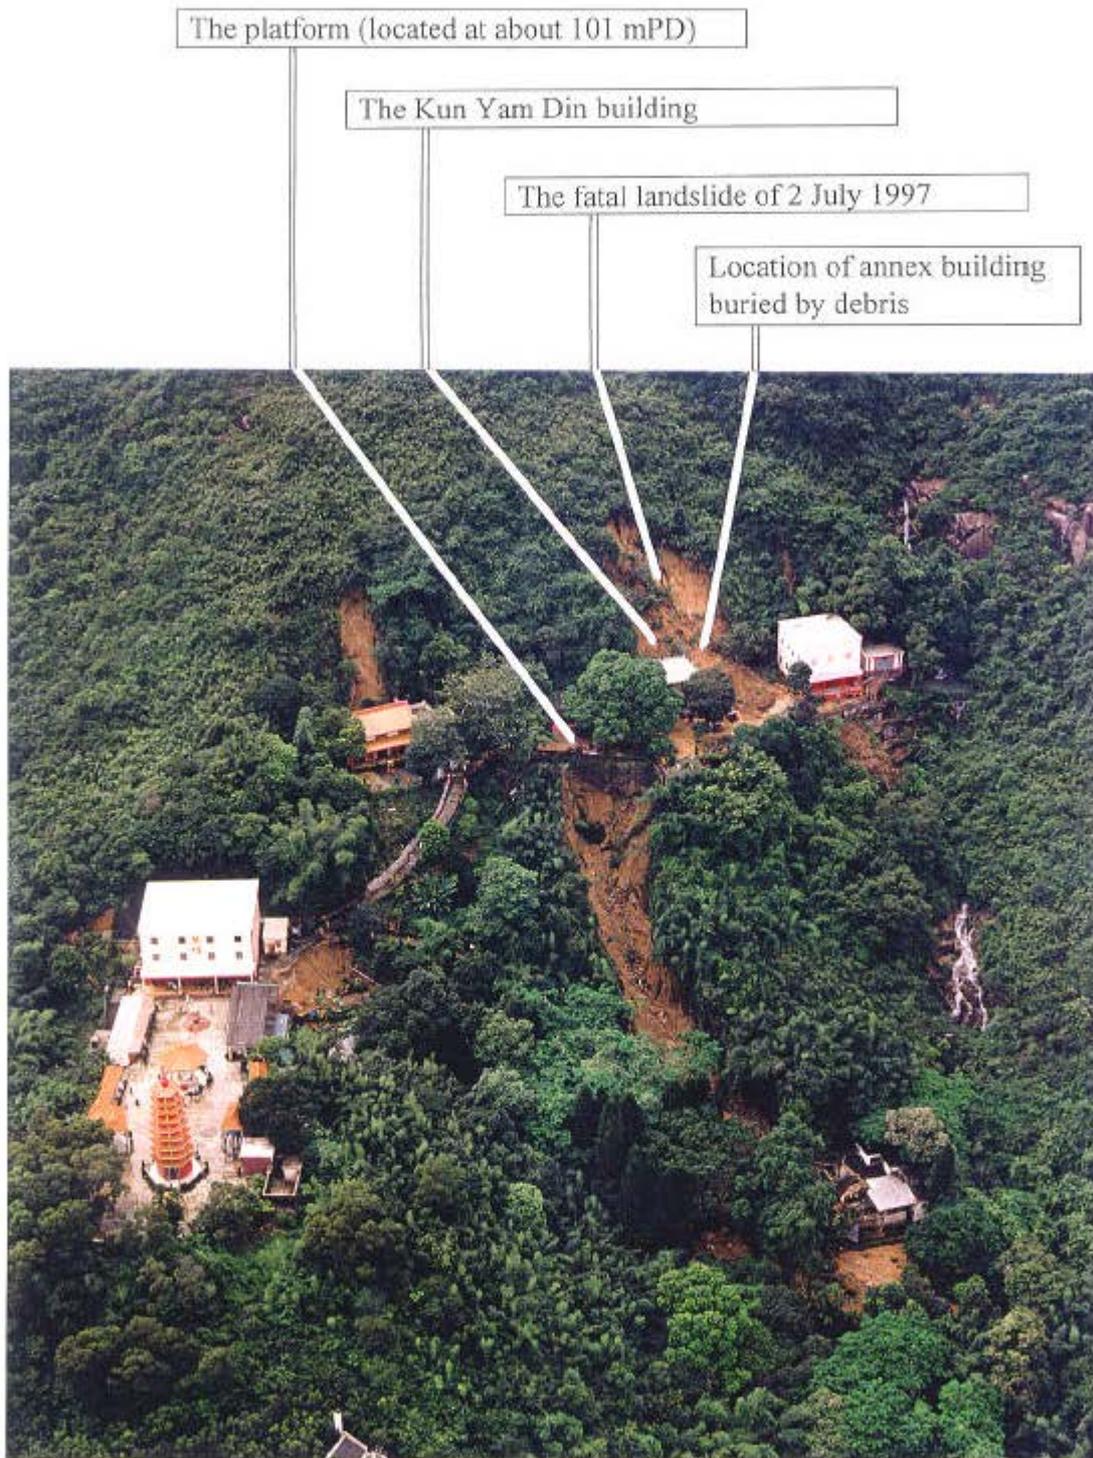
Plate 1 - Oblique Aerial View of the Site of the Landslide (Photograph Taken in the Afternoon of 3 July 1997. See Figure 14 for Location)

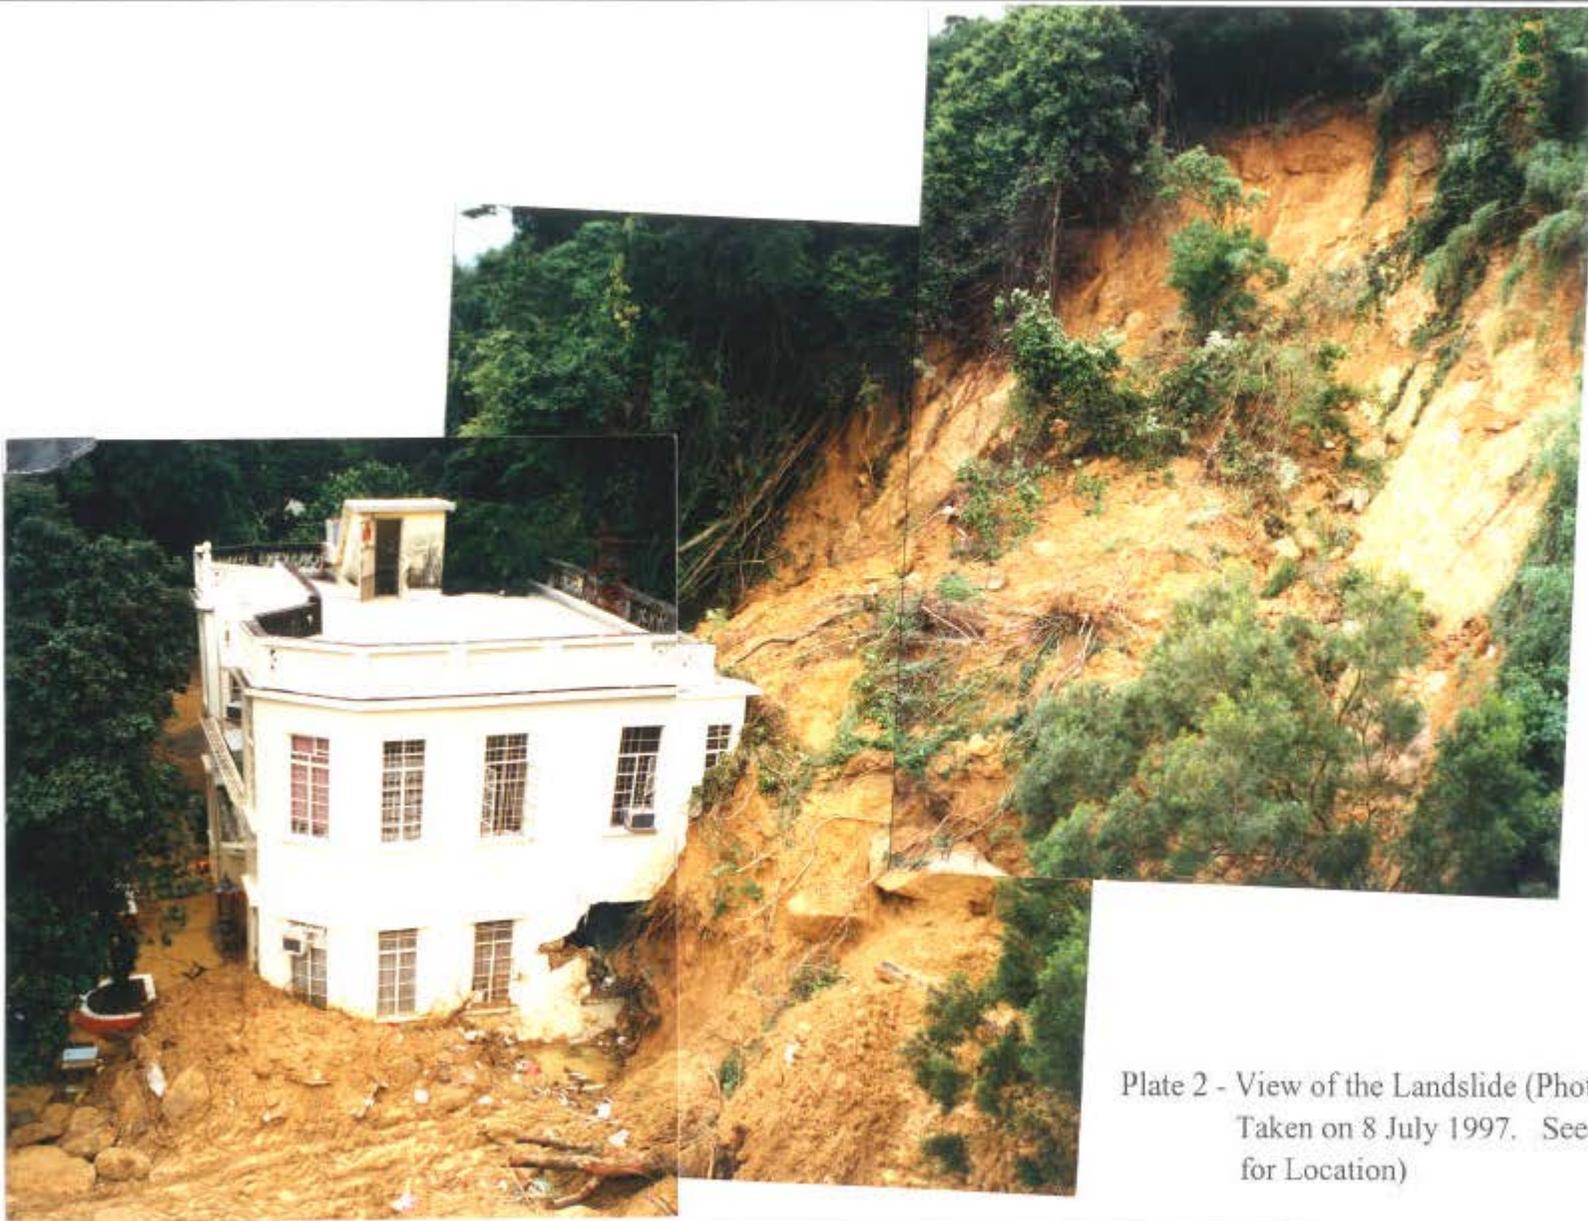
Plate 2 - View of the Landslide (Photograph  
Taken on 8 July 1997. See Figure 14  
for Location)

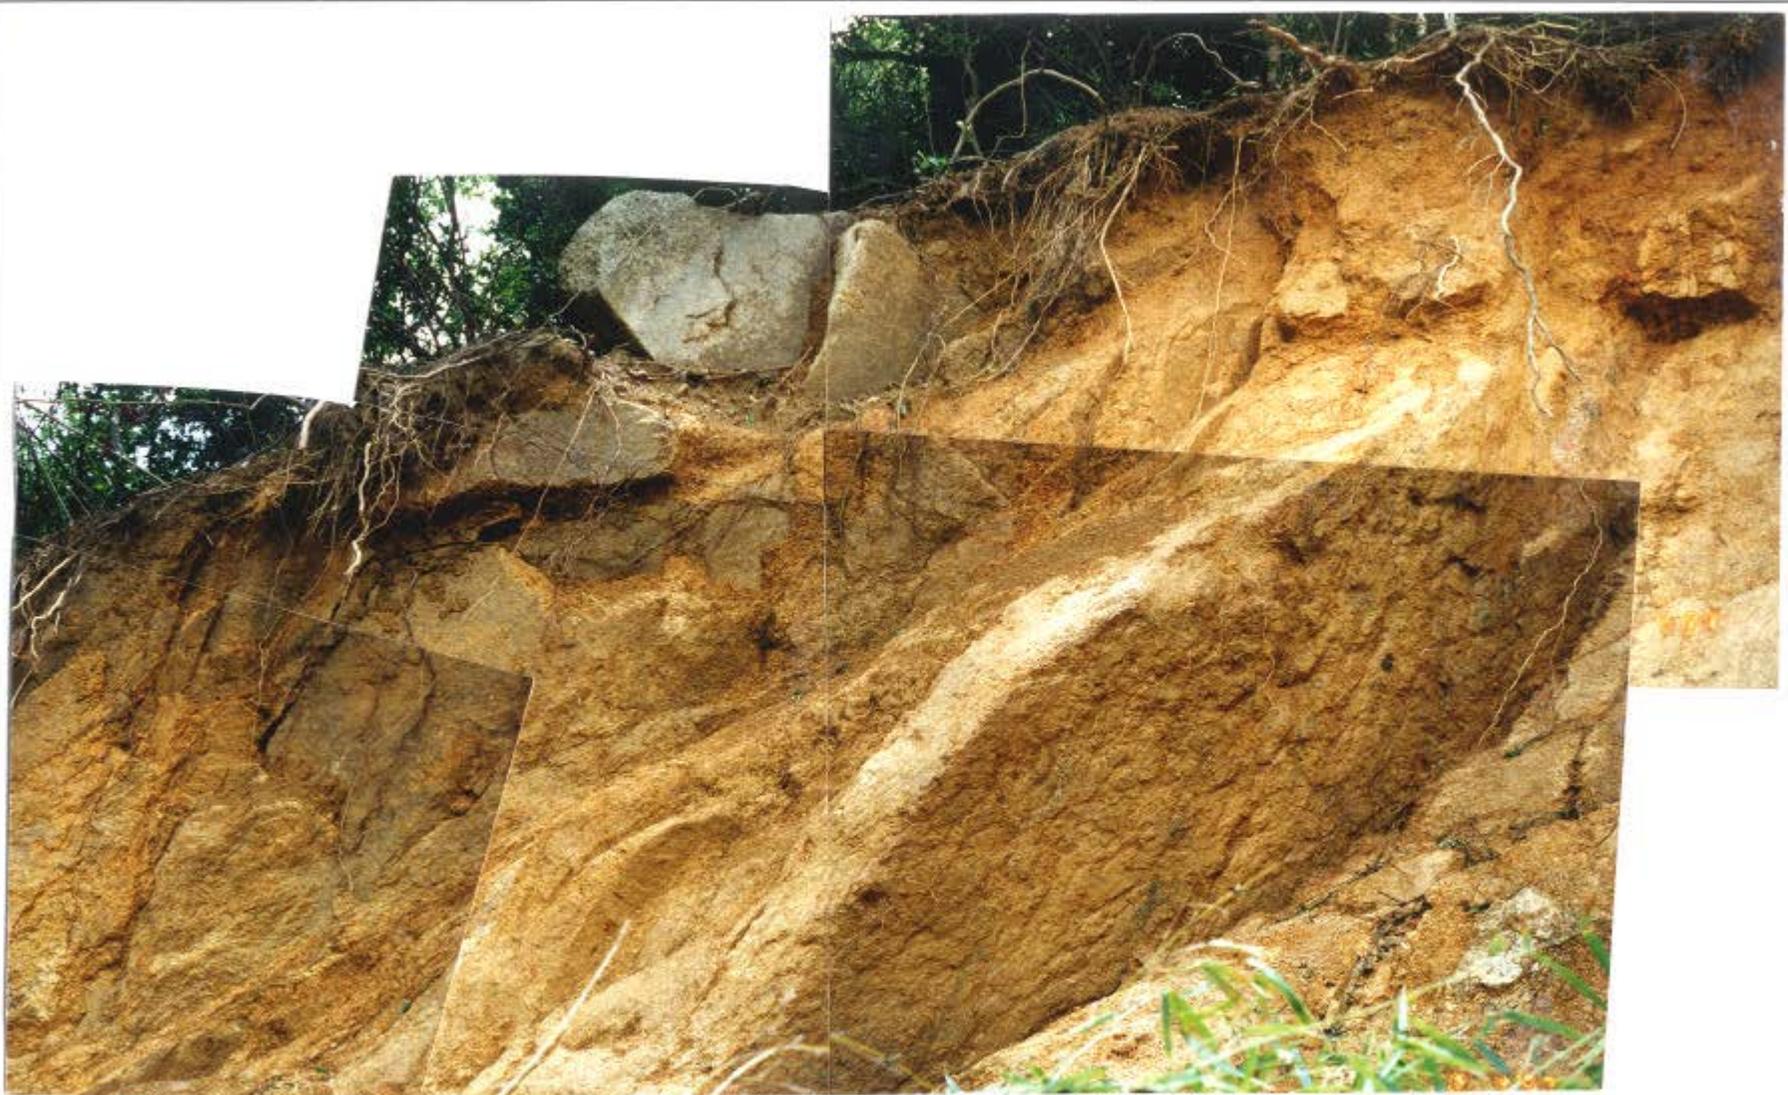
Plate 3 - View of Southwest Flank of the Landslide (Photograph Taken on 7 July 1997. See Figure 14 for Location. Note the Grey Decomposed Granite Boulder on the Ground Surface and the Vertical Planar Discontinuity in the Lower Right Corner of the Photograph Associated with a Dominant Set of Sub-Vertical Veins and Joints)

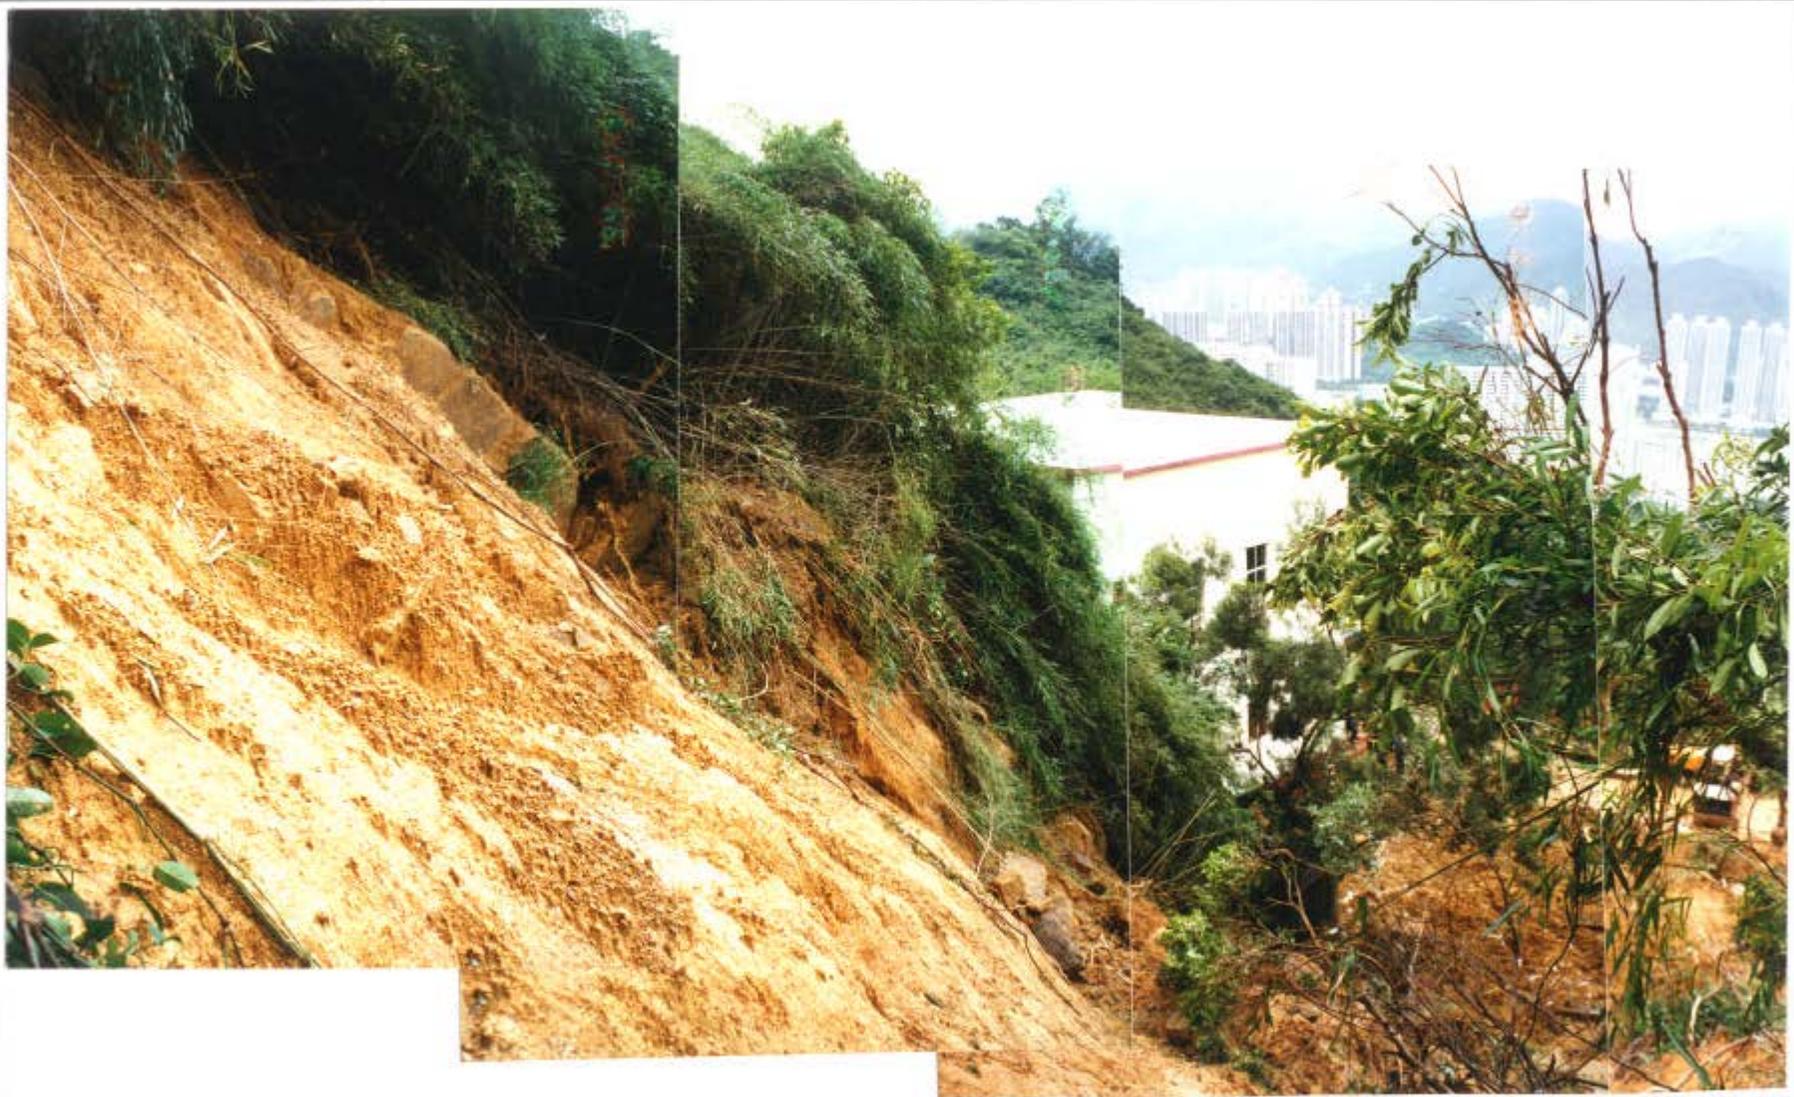
Plate 4 - View of the Sheeting Joint Surface (Photograph Taken on 7 July 1997. See Figure 14 for Location.  
Note that the Northeast Flank of the Landslide Merges with the Natural Hillside)

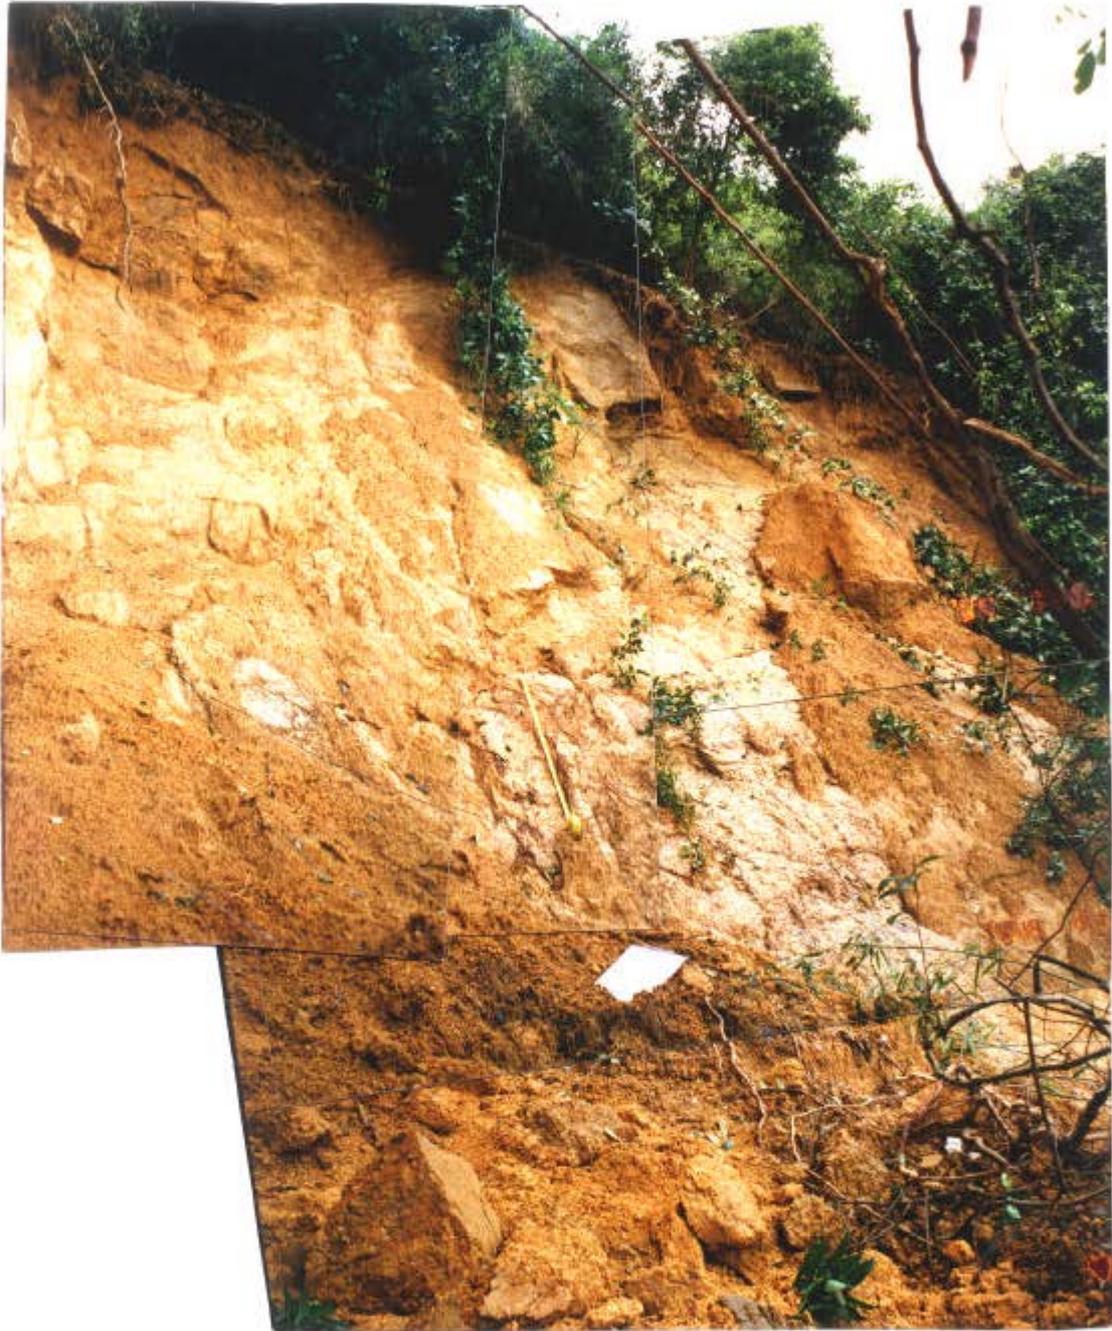
The upper part of the landslide rupture surface was formed both along the sheeting joint and through the intact weathered granite, giving rise to a steep curved surface (Plate 5), whereas the largest central section of the rupture surface was formed entirely along the sheeting joint. The lower part, which was exposed in the erosion gully on the northeast side of the landslide and in four of the trial pits, coincided with a set of infrequent, discontinuous, undulating joints which dipped southeast, directly out of the slope, at about  $30^\circ$  (Plate 6). A thin layer of pale grey, slightly sandy clayey silt, up to 20 mm in thickness, was found to partly coat and infill some of these joints.

Plate 5 - View of the Upper Part of the Main Scarp Showing the Zone of PW0/30 to RS Weathered Granite and the Sheeting Joint Surface (Photograph Taken on 7 July 1997. Scale is a 1 m Tape. See Figure 14 for Location)

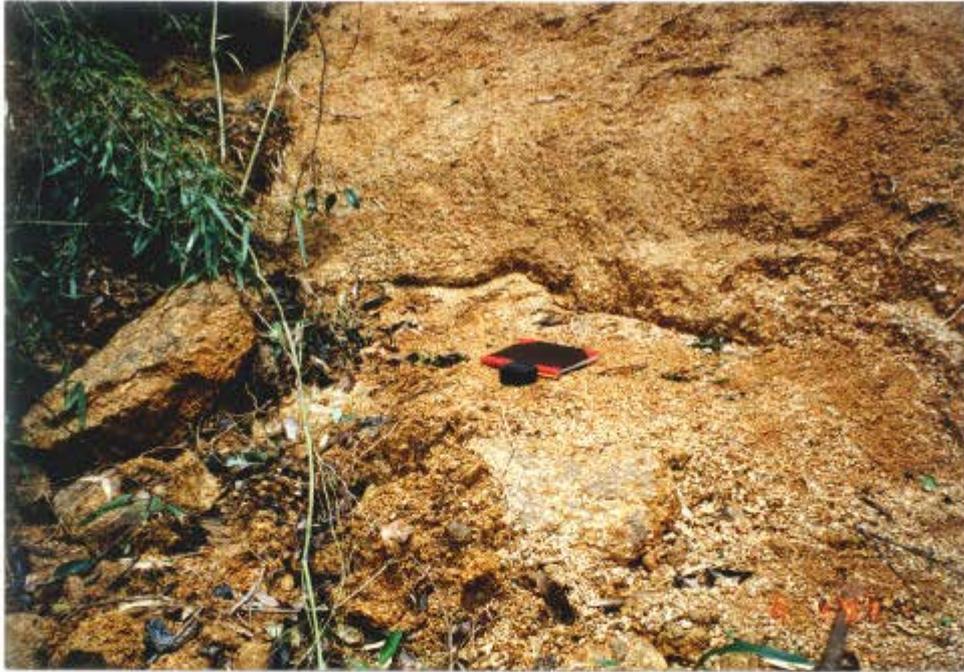
Plate 6 - A Joint Exposed in an Erosion Gully, Dipping at  $30^{\circ}$ , Forming the Lower Part of the Rupture Surface (Photograph Taken on 4 August 1997. See Figure 14 for the Location)

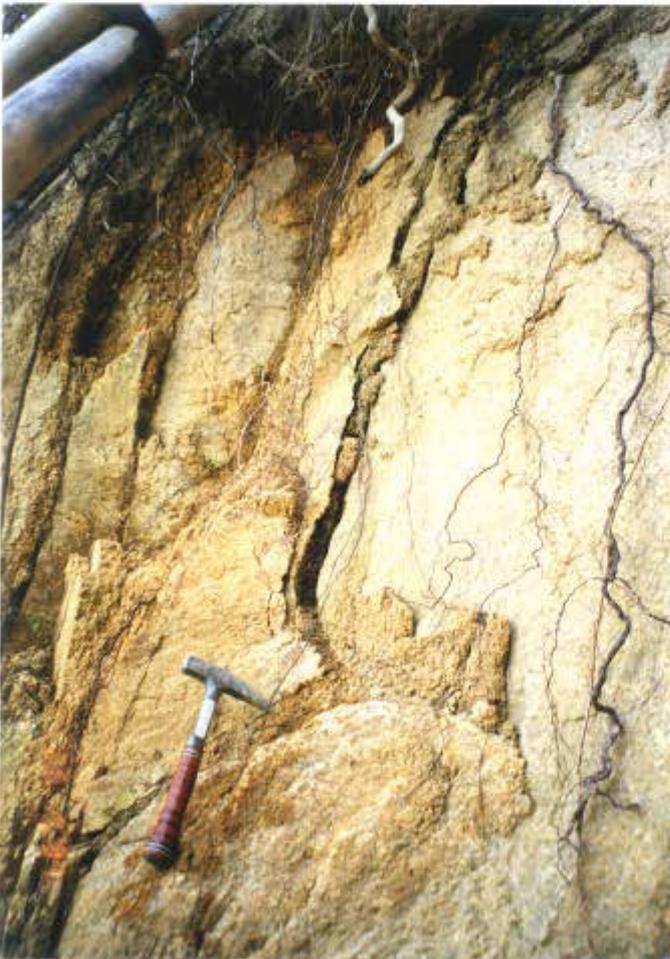
Plate 7 - View of Sub-Vertical Infilled Crack in the Southwest Flank of the Landslide (Photograph Taken on 26 September 1997. See Figure 14 for Location)

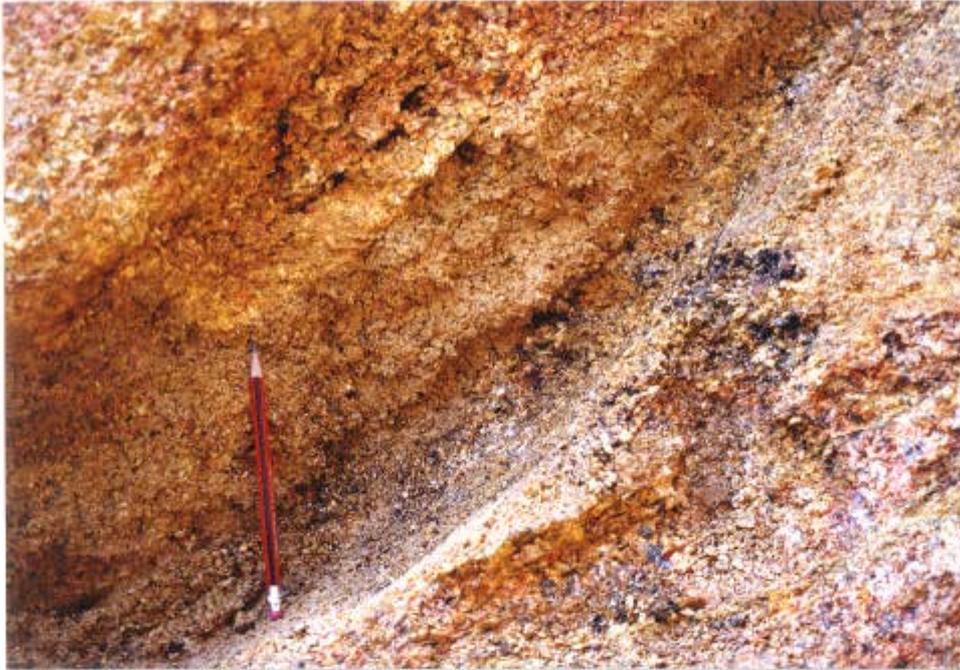
Immediately above the lower part of the landslide rupture surface, a 0.2 m thick layer of soft, wet, medium-brown, slightly clayey, gravelly, silty sand was observed in trial pit excavations (Plate 8). This layer showed obvious signs of disturbance and represented the end product of intensive shearing at the base of the landslide. It appears that a significant proportion of the debris above this layer moved *en masse* as a 'raft' of material in the landslide.

Plate 8 - Layer of Sheared Material at the Base of the Landslide (Photograph Taken on 12 November 1997. Note the Layer is about as Thick as the Length of Pencil. See Figure 14 for Location)

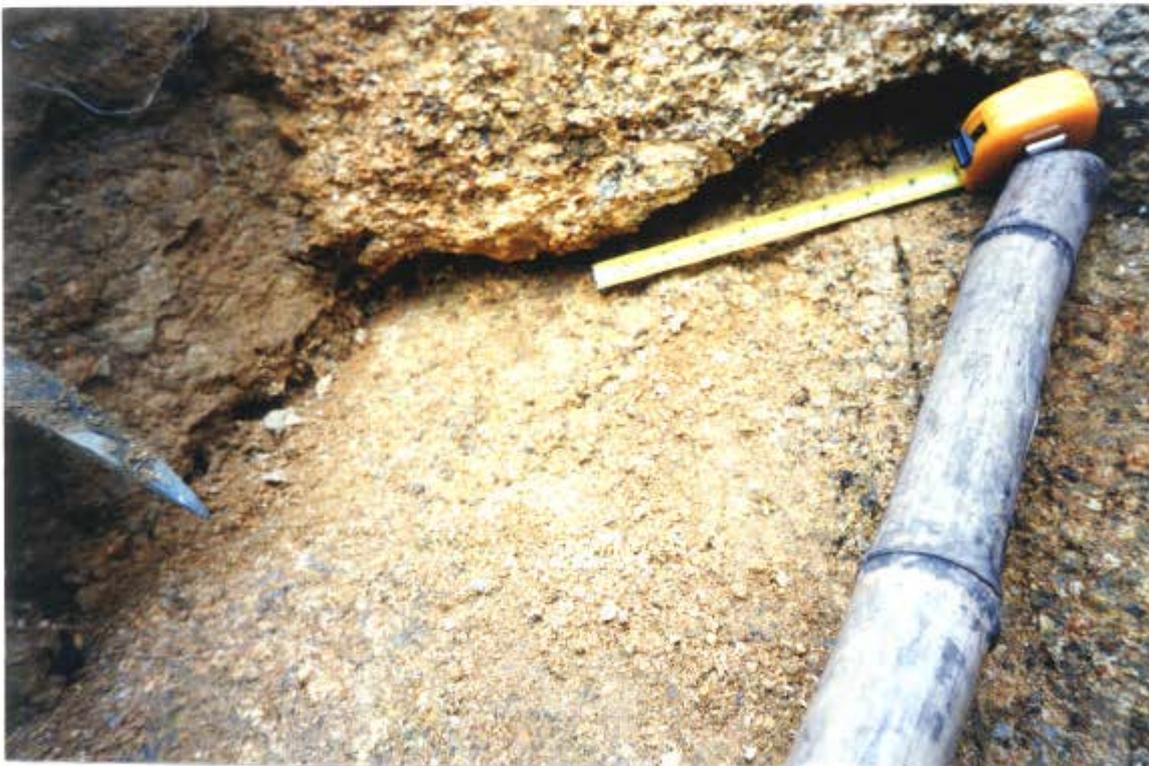
Plate 9 - View of an Erosion Pipe in the Northeast Corner of the Main Scarp (Photograph Taken on 23 September 1997. See Figure 14 for Location)
