INVESTIGATION OF SOME SELECTED LANDSLIDE INCIDENTS IN 1997 (VOLUME 1)

GEO REPORT No. 79

**SECTION 1 :
DETAILED STUDY OF THE
LANDSLIDE AT UNIVERSITY
KOWLOON-CANTON
RAILWAY CORPORATION
STATION ON 2 JULY 1997**

**This report was originally produced in March 1998
as GEO Landslide Study Report No. LSR 1/98**

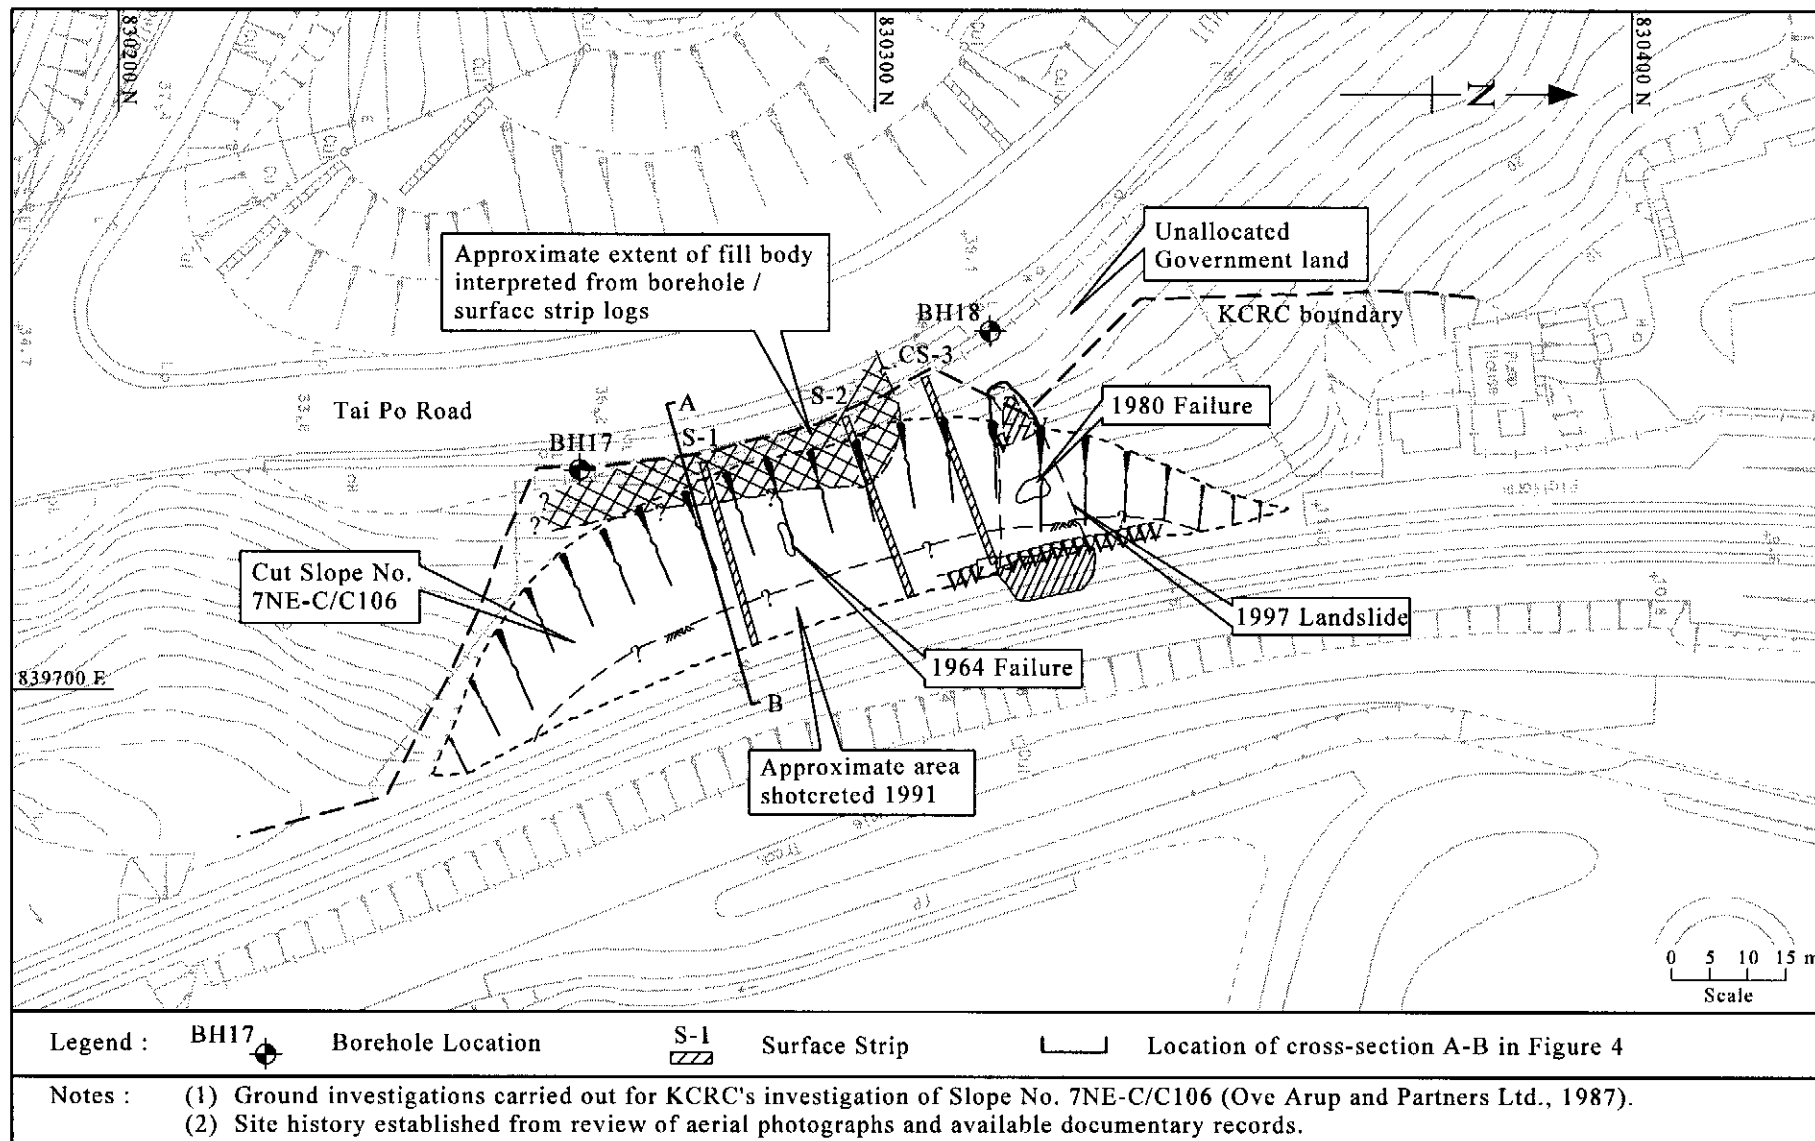
Figure 3 - Land Status and Site History

The cut slope can be seen on the earliest available aerial photographs of the area, taken in 1963. Features which appear to be shallow failures were evident in the central and northern parts of the cut slope in photographs taken in 1964 and 1980 respectively (Figure 3). No records relating to these incidents have been located.

Borehole BH18, sited upslope of the landslide (Figure 3), encountered slightly decomposed medium- to coarse-grained granite at a depth 9.3 m, overlain essentially by completely decomposed granite (CDG). Surface strip CS3, located nearest to the landslide site, exposed completely decomposed granite over most of its length, though the lower 7.3 m were recorded as highly to moderately decomposed granite.

Borehole BH17, located about 50 m south of the landslide (Figure 3) proved slightly decomposed, coarse-grained granite at a depth of 10.8 m overlain by a variable sequence (6.8 m thick) of moderately to completely decomposed granite. The borehole also recorded a 4 m thickness of "loose greyish and yellowish brown silty fine to coarse sand" which was

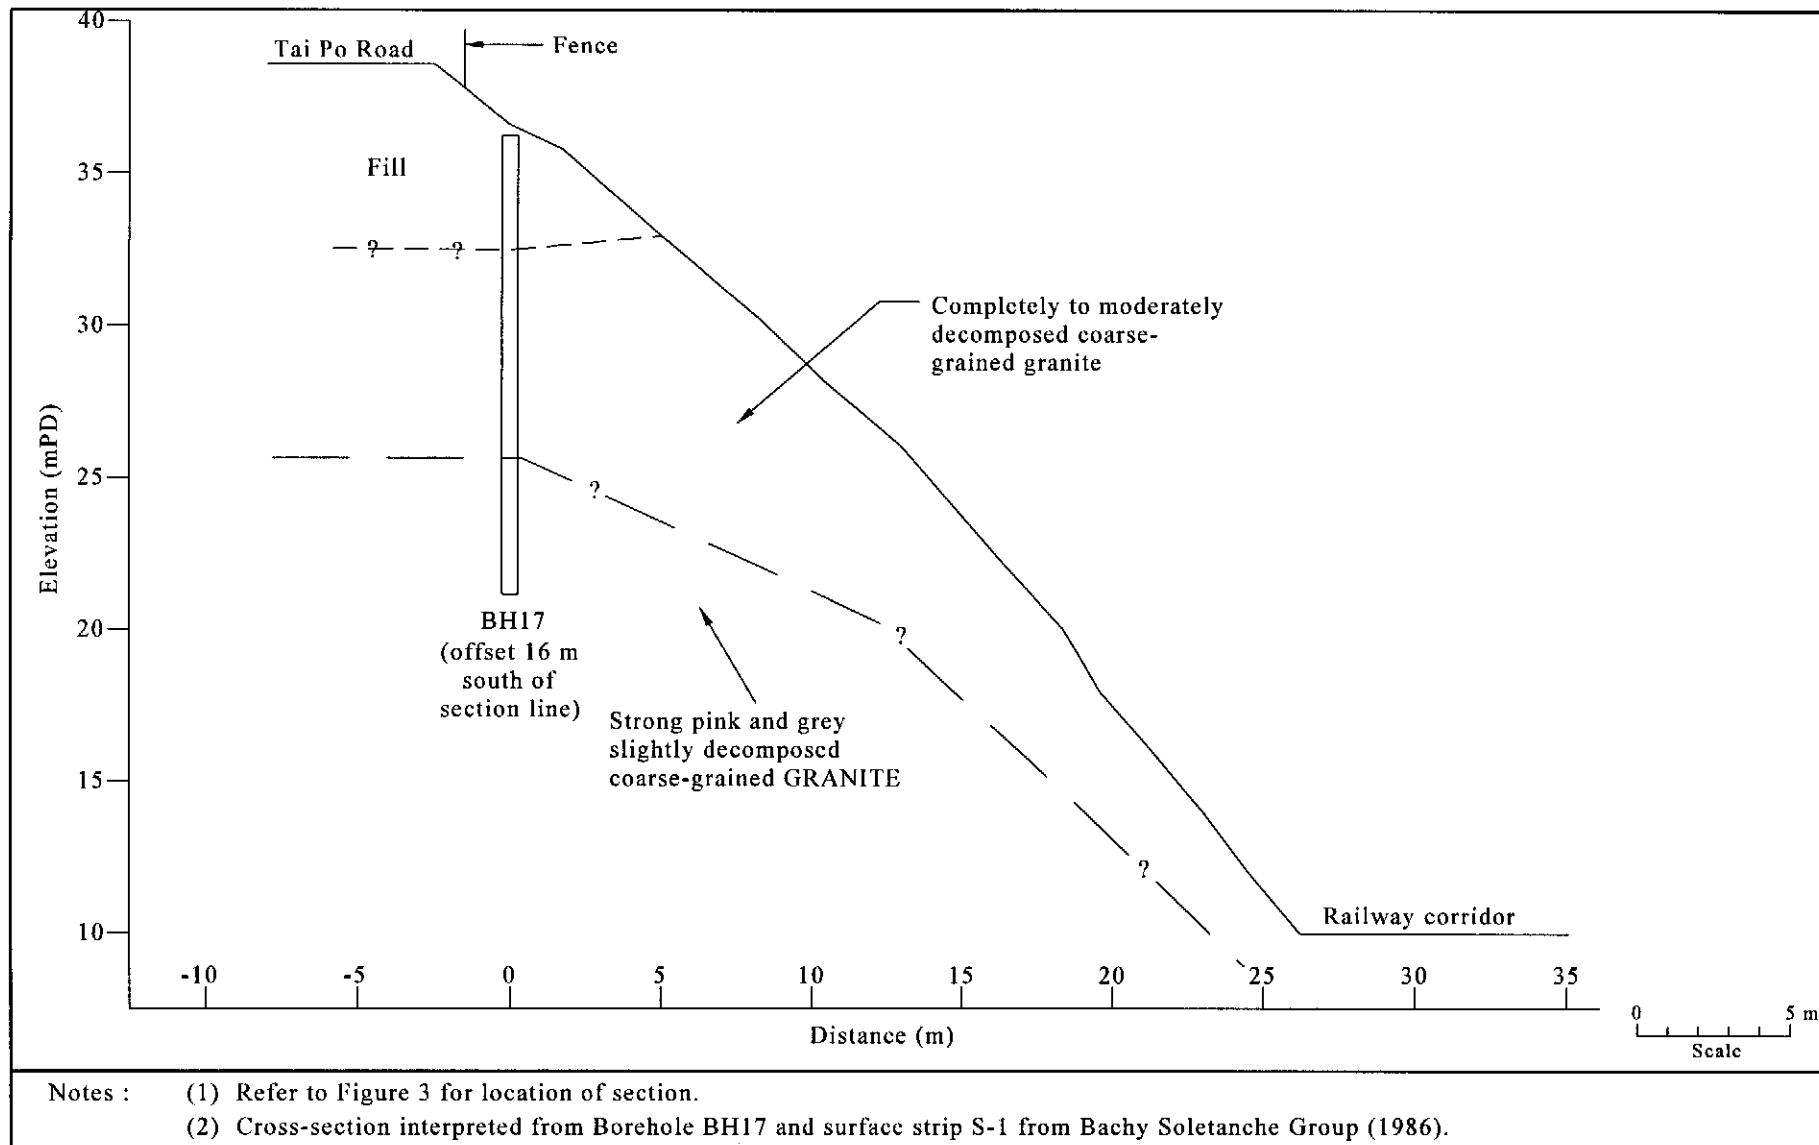
Figure 4 - Cross-section A-B through the Southern Part of Cut Slope No. 7NE-C/C106
Showing the Presence of the Fill Body

The borehole and surface strip logs show the presence of a loose fill body at the crest of the southern part of the slope away from the location of the recent landslide site. The possible extent of the fill body, based on interpretation of KCRC's ground investigation data is shown in plan in Figure 3 and in section on Figure 4.

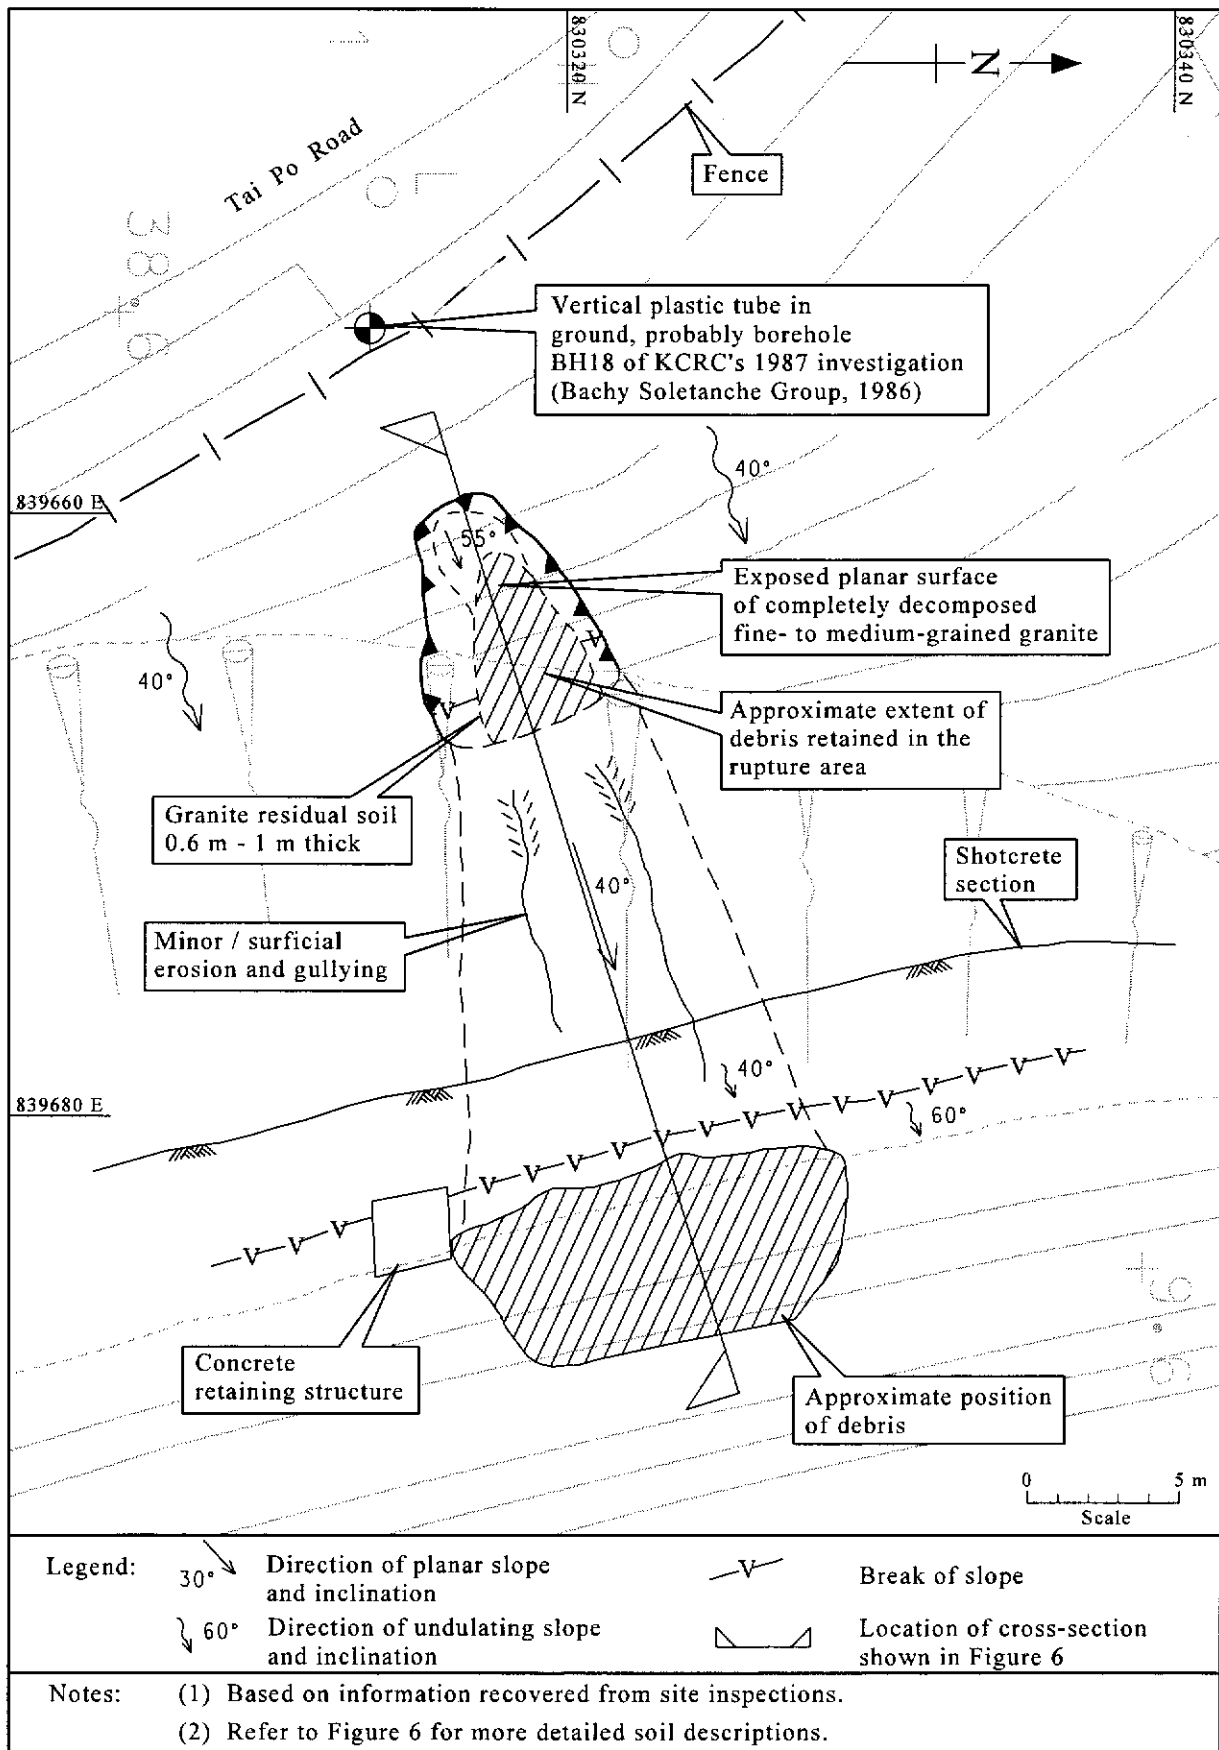
Figure 5 - Site Plan and Landslide Details

Observations made during inspections of the landslide are annotated in Figure 5 and a cross-section through the failed section is given in Figure 6. Photographs of the landslide are shown in Plates 1 to 4.

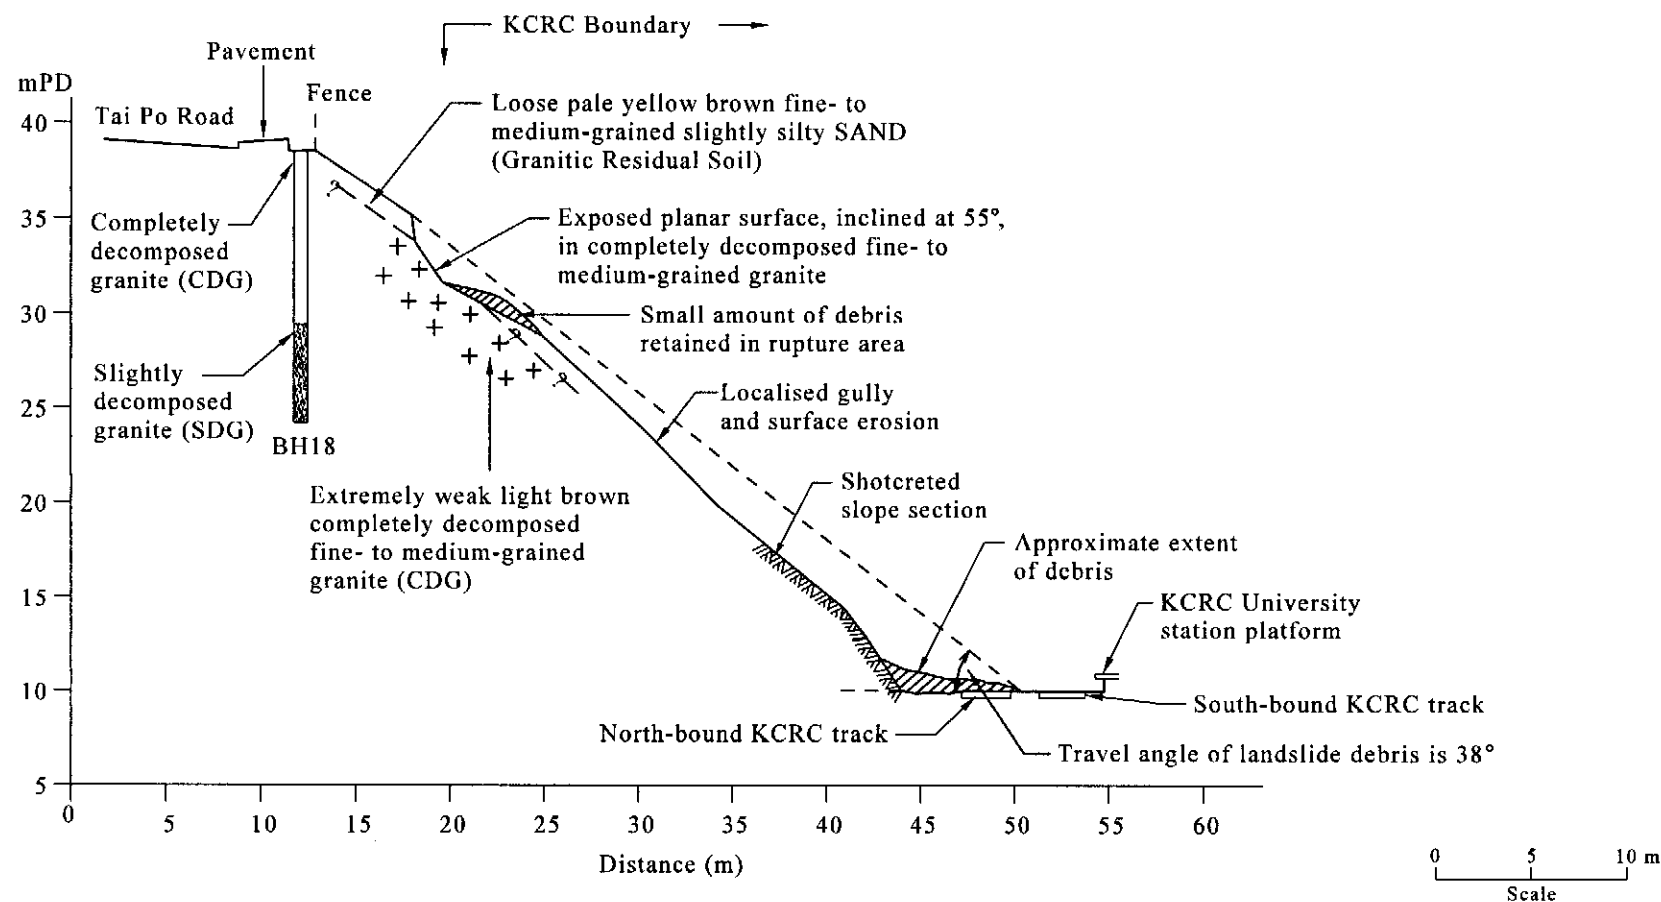
Figure 6 - Cross-section through the Landslide

The landslide occurred 8 m below Tai Po Road, producing a rupture surface about 9.2 m long and up to 7 m wide. The volume of failure was estimated at about 30 m³. The landslide involved both the cut slope and the ground over its crest. The failure was shallow, reaching a maximum depth of about 1 m.

The failure scar exposed between 0.6 m and 1 m of granitic residual soil overlying completely decomposed fine- to medium-grained granite (Figure 6). A planar surface inclined at 55°, possibly a relict discontinuity, was exposed in the completely decomposed granite at the upper part of the failure scar.

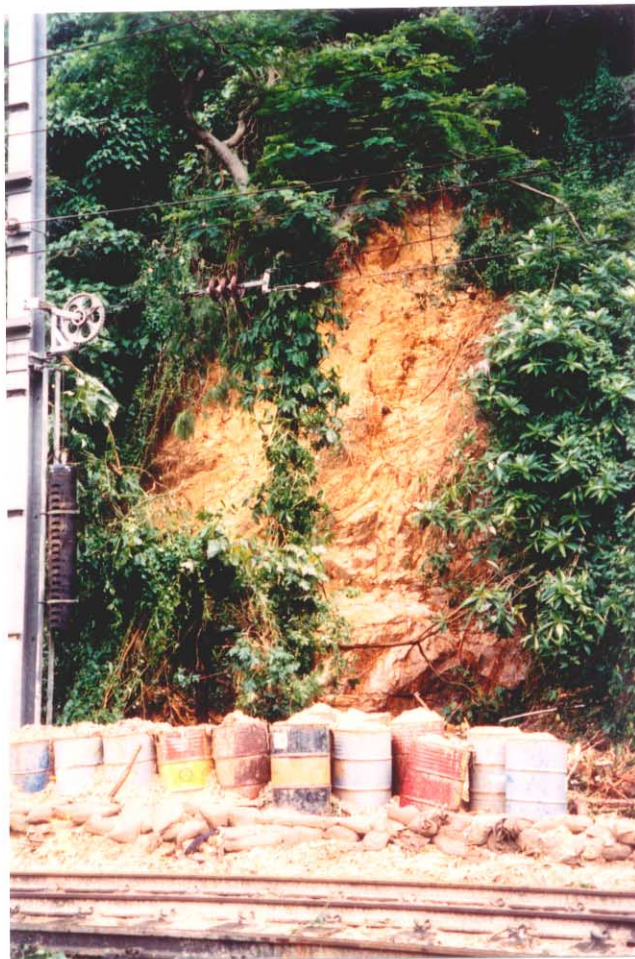
Prior to failure the lower 6 m section of the cut slope had been shotcreted, but elsewhere the slope was densely vegetated (Figure 2 and Plate 1).

Plate 1 - General View of the Landslide Site
(Photograph Taken on 4 July 1997)

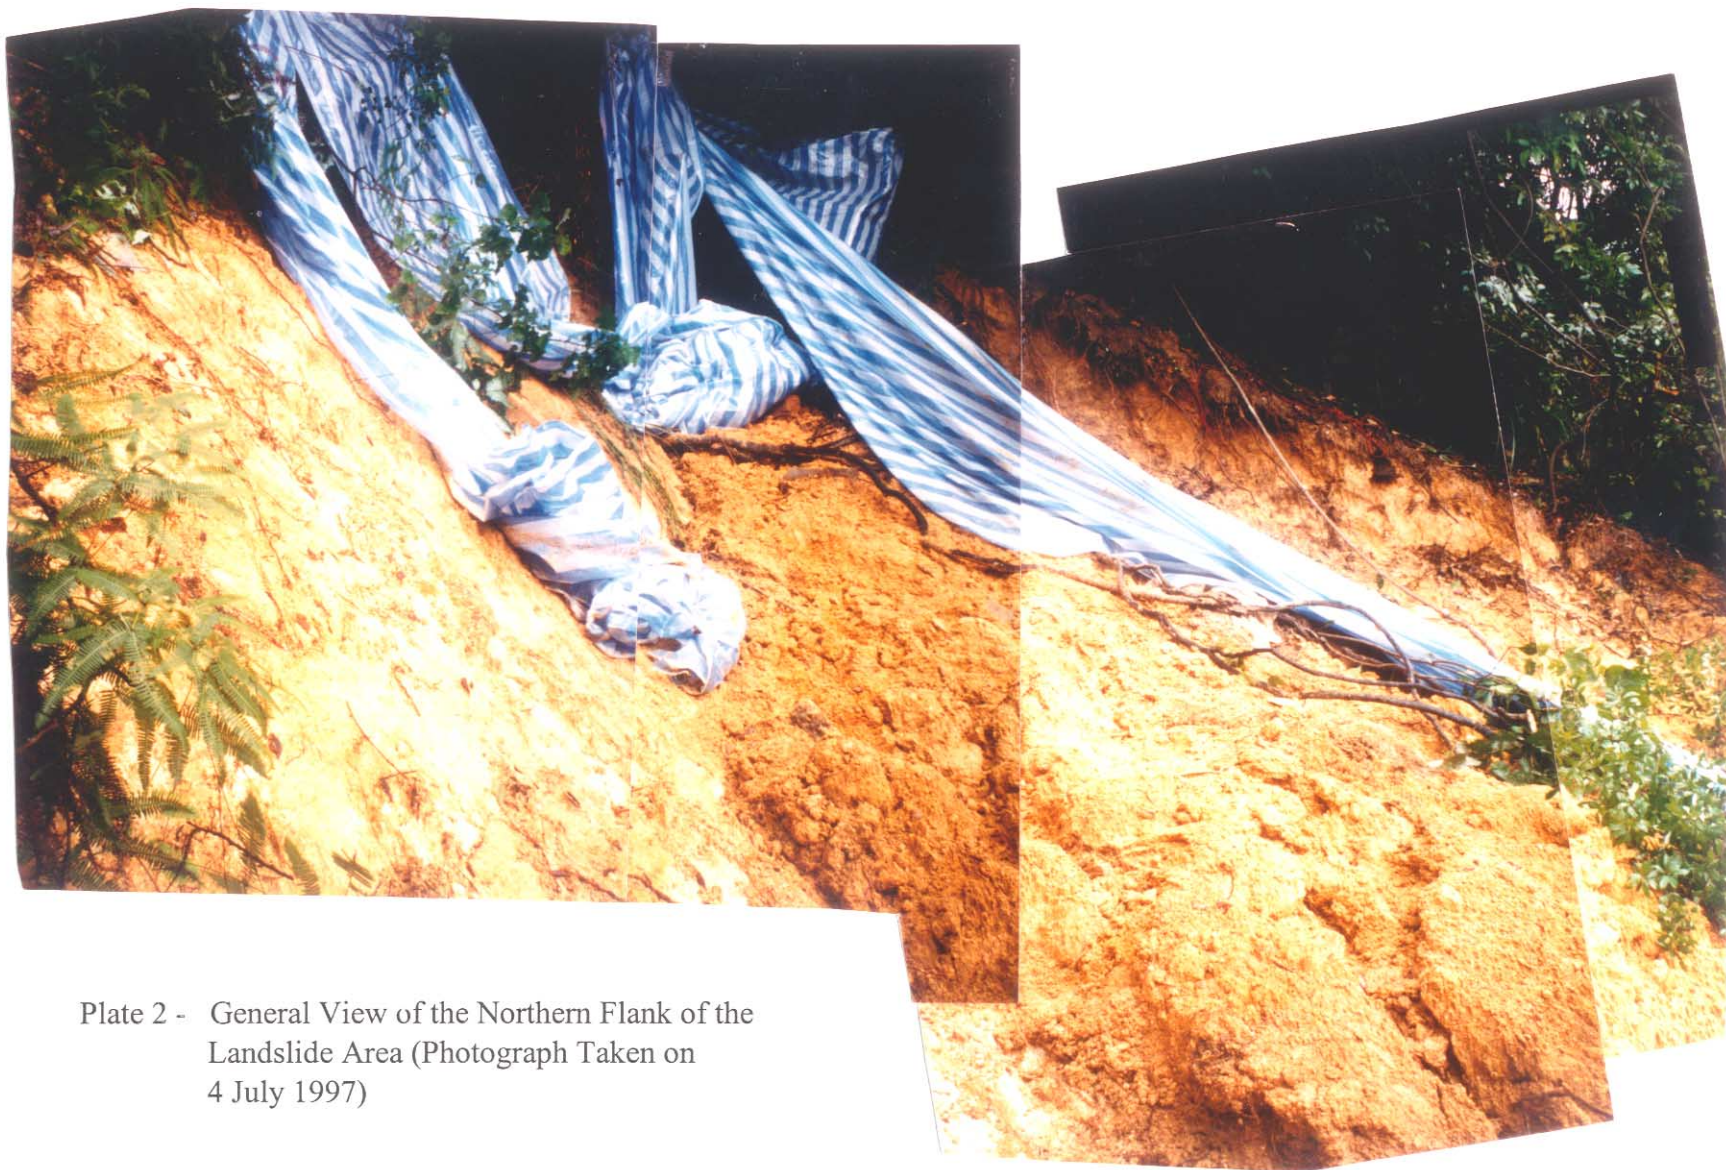
Plate 2 - General View of the Northern Flank of the
Landslide Area (Photograph Taken on
4 July 1997)

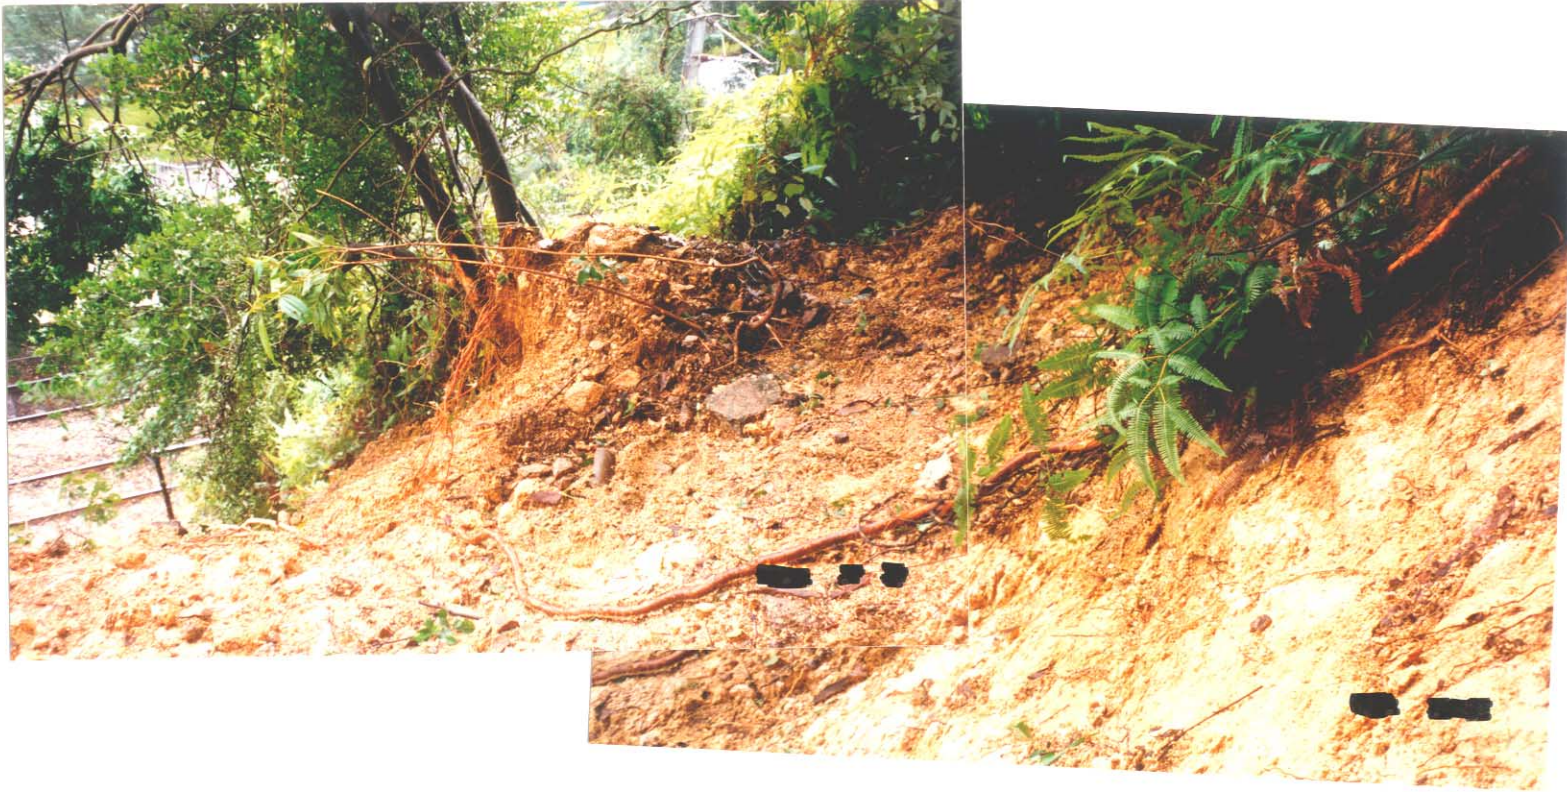
Plate 3 - General View of the Southern Flank of the Landslide Area (Photograph Taken on 4 July 1997)

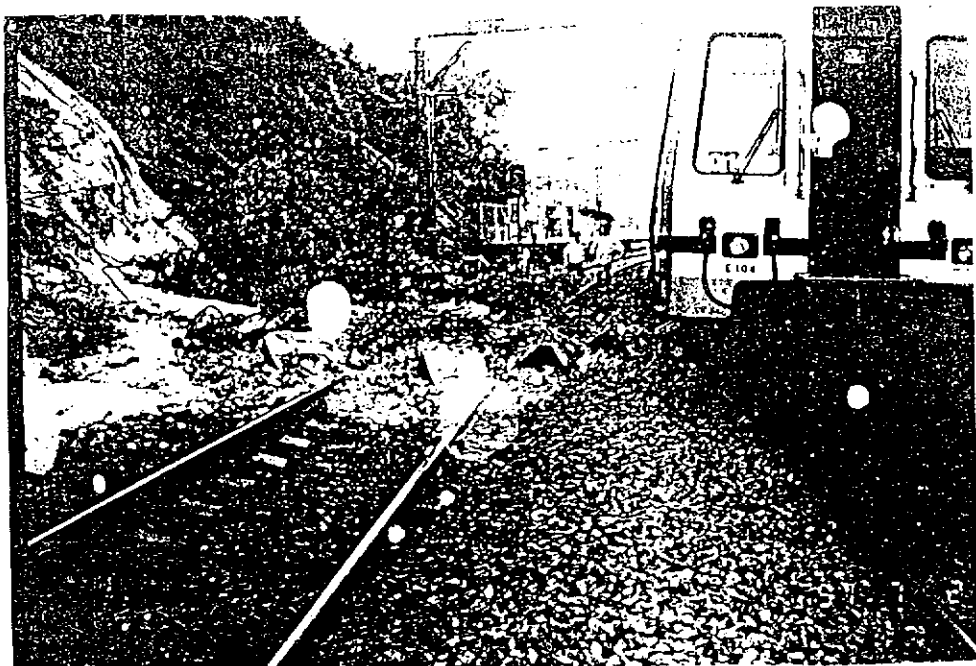
Plate 4 - Copy of Photograph Taken by KCRC Staff Soon After Failure
on 2 July 1997 (Photograph Taken on 2 July 1997)
