**SECTION 2 :
DETAILED STUDY OF THE
LANDSLIDE NEAR
KOWLOON-CANTON RAILWAY
CORPORATION FO TAN
STATION ON 2 JULY 1997**

Halcrow Asia Partnership Ltd

**This report was originally produced in March 1998
as GEO Landslide Study Report No. LSR 4/98**

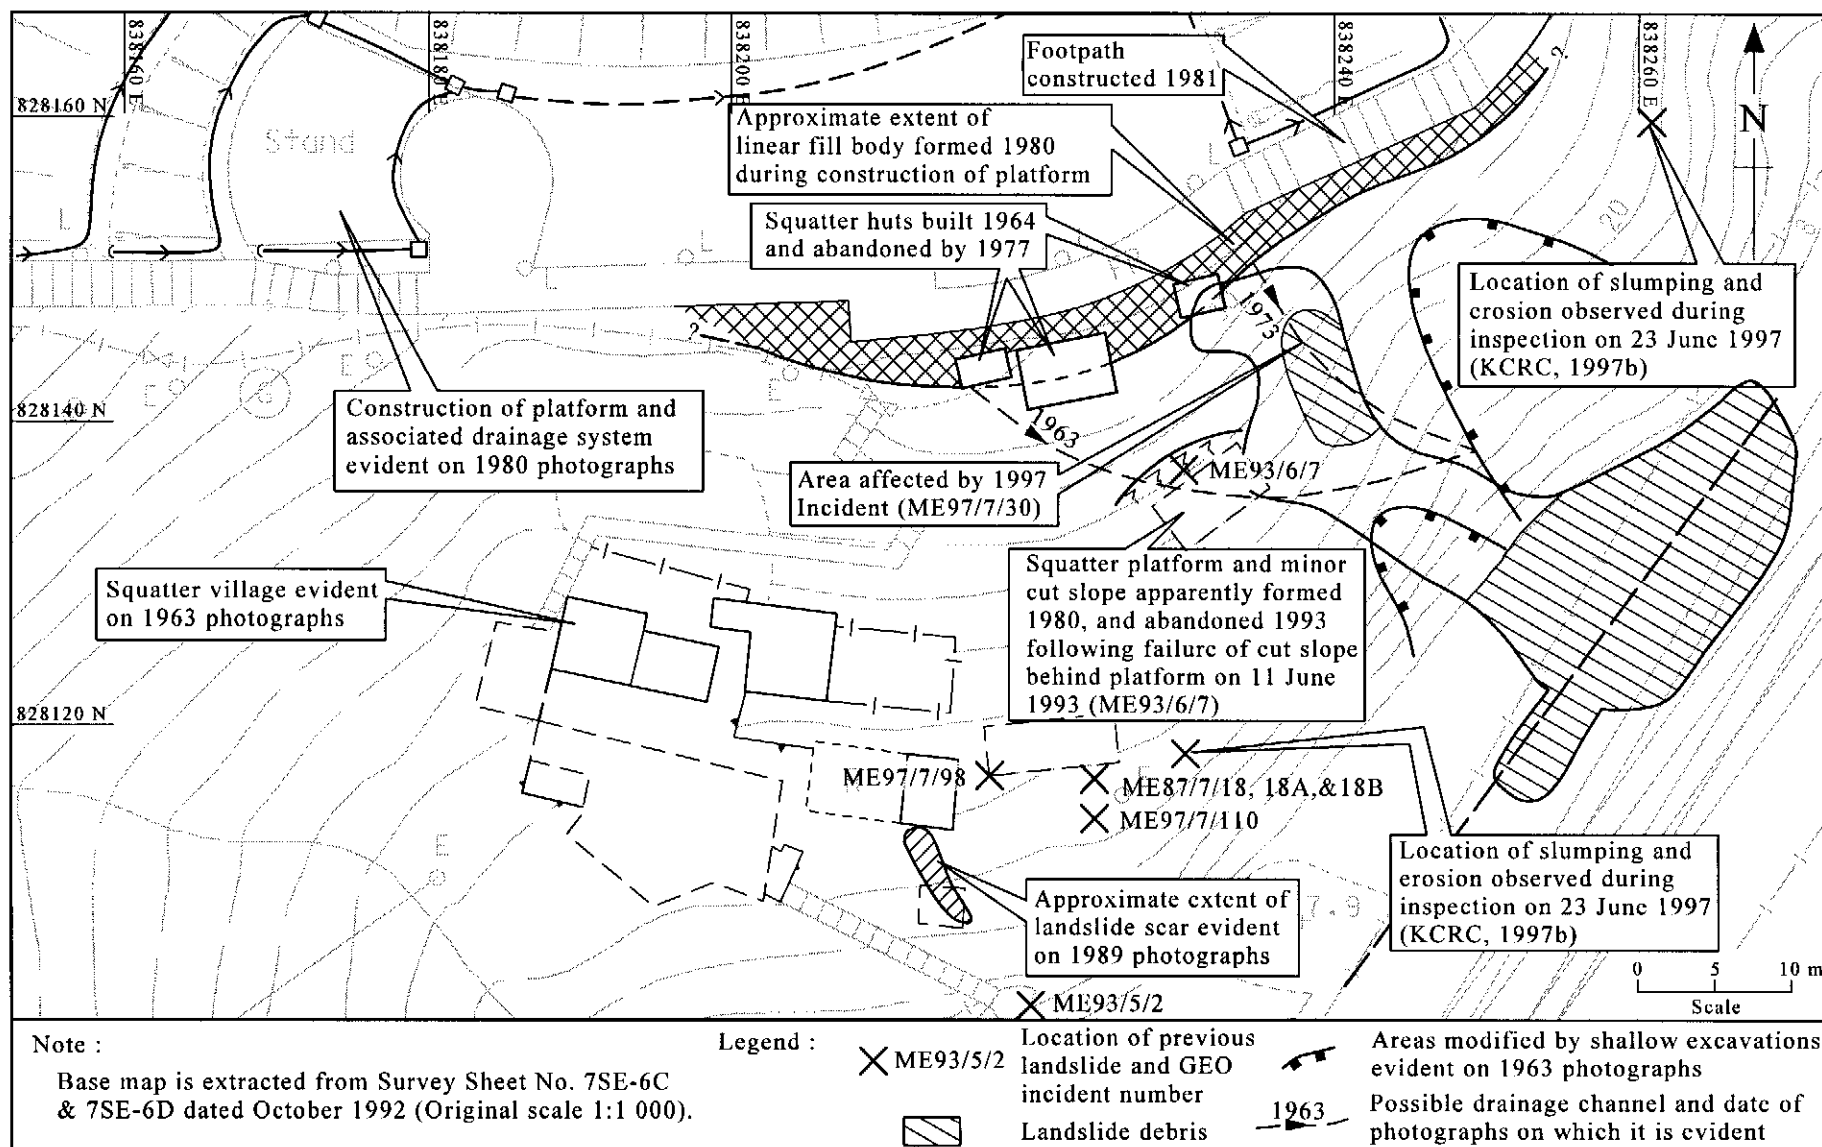
Figure 3 - Site History

The GEO's Landslide Incident Report database indicates that three minor failures occurred nearby in July 1987 (Incident Nos. ME87/7/18, 18A and 18B, Figure 3). Information available in the database indicates that the volume of each of the failures was about 3 m³ and that a nearby squatter hut was affected. The incidents were reportedly caused by infiltration. A failure (Incident No. ME93/5/2) also occurred near a footpath in the same village in May 1993 (Figure 3). The volume of failure was reported as 6 m³ and the failure was attributed to infiltration and an oversteep slope profile.

A squatter hut (No. XRCSW/13), previously located on the platform affected by the landslide on 2 July 1997, was permanently evacuated following a failure on 11 June 1993 (Incident No. ME93/6/7, Figure 3). According to the GEO Incident Report, the failure was about 2 m³ in volume and occurred on a minor cut slope formed behind the squatter hut. The failure involved weathered rock and was attributed to infiltration.

Two small landslides (GEO Incident Nos. ME97/7/98 and ME97/7/110), located immediately southwest of the July 1987 failures (Figure 3), were reported to the GEO on 16 July 1997 and 24 July 1997 respectively. Shotcrete was applied to the slopes soon after the failures and this prevented detailed inspection by HAP. According to the GEO Incident Reports, the failures each involved about 2 m³ of residual soil and were caused by infiltration. The KCRC rail tracks were not affected.

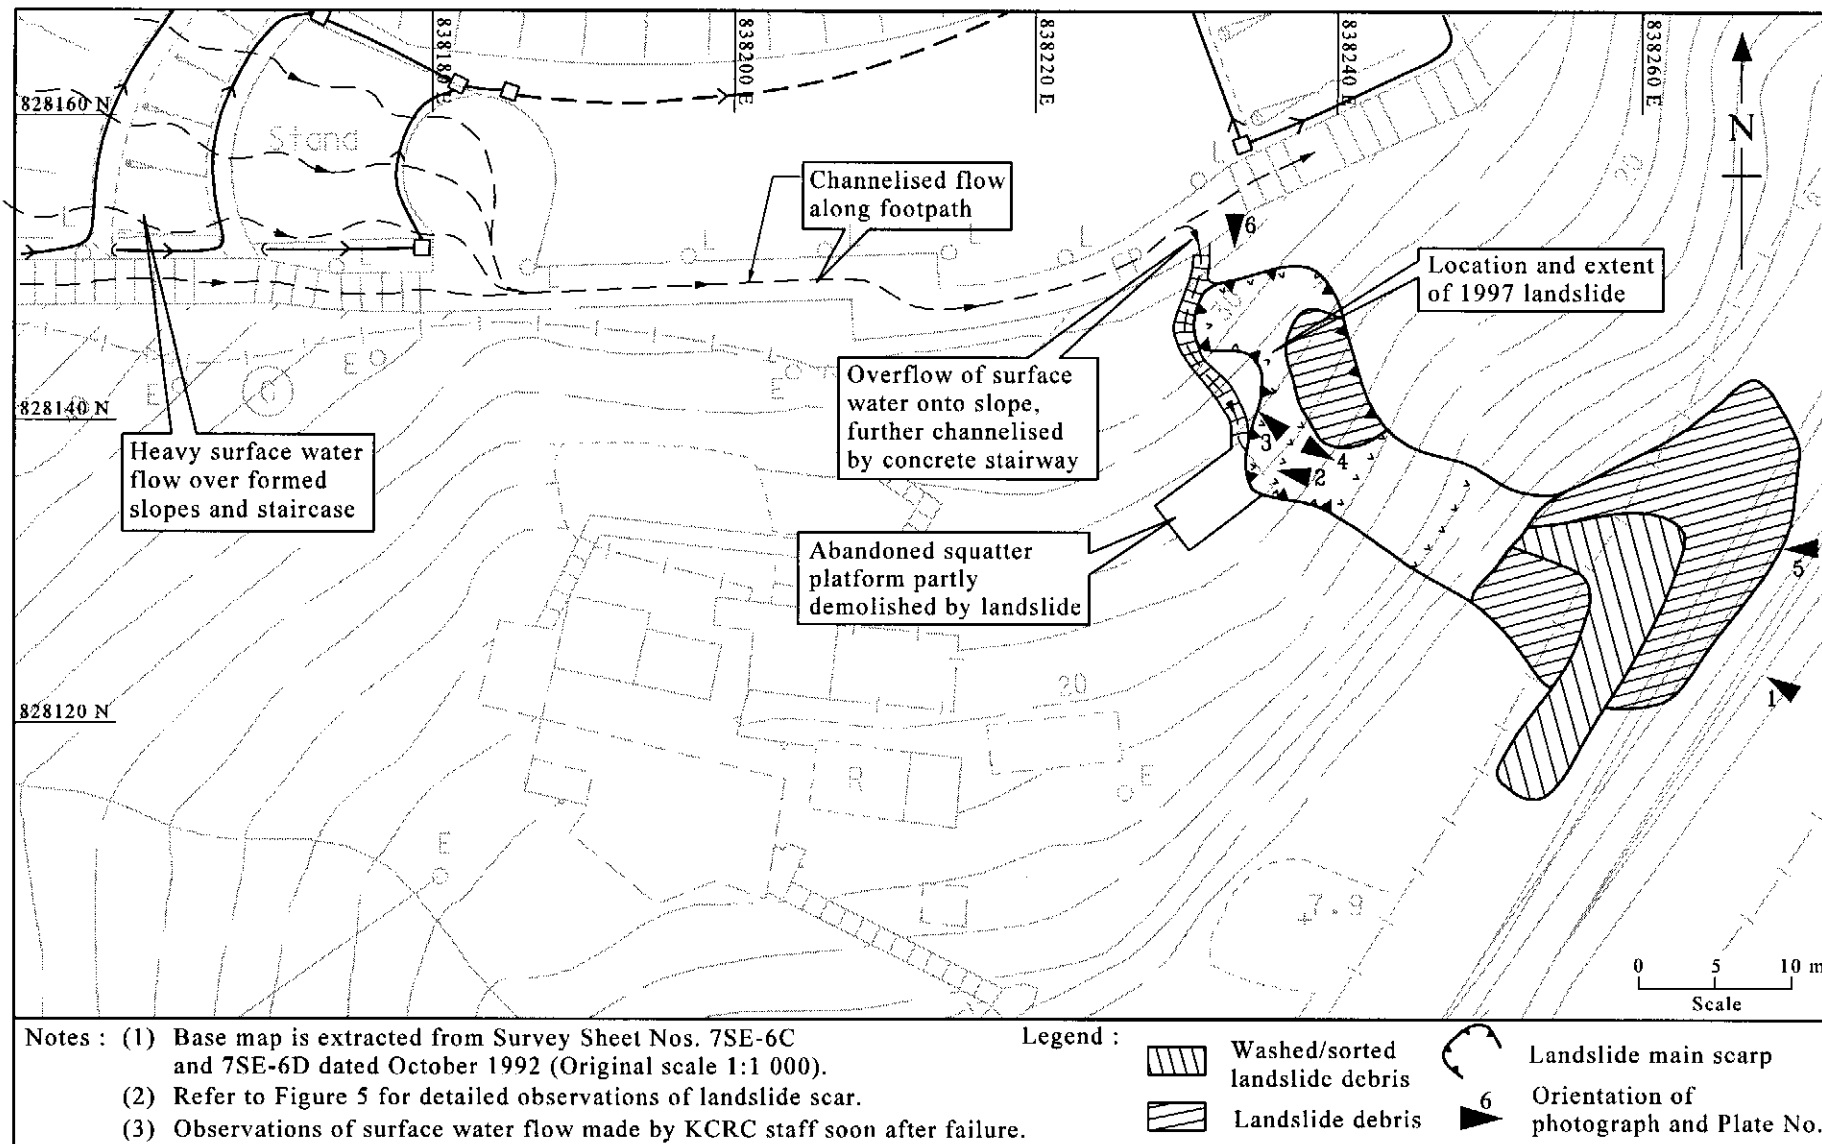
Figure 4 - General Site Details and Landslide Observations

KCRC staff, when inspecting the landslide on the day of the failure, observed surface water flowing along the platform at the crest of the slope (Figure 4). Part of the surface flow was channelled into the landslide by the footpath and staircase leading to the squatter platform. The washout action of the surface flow eroded a gully below the rupture zone of the initial failure (Plate 4) and significantly reworked debris at the toe of the slope.

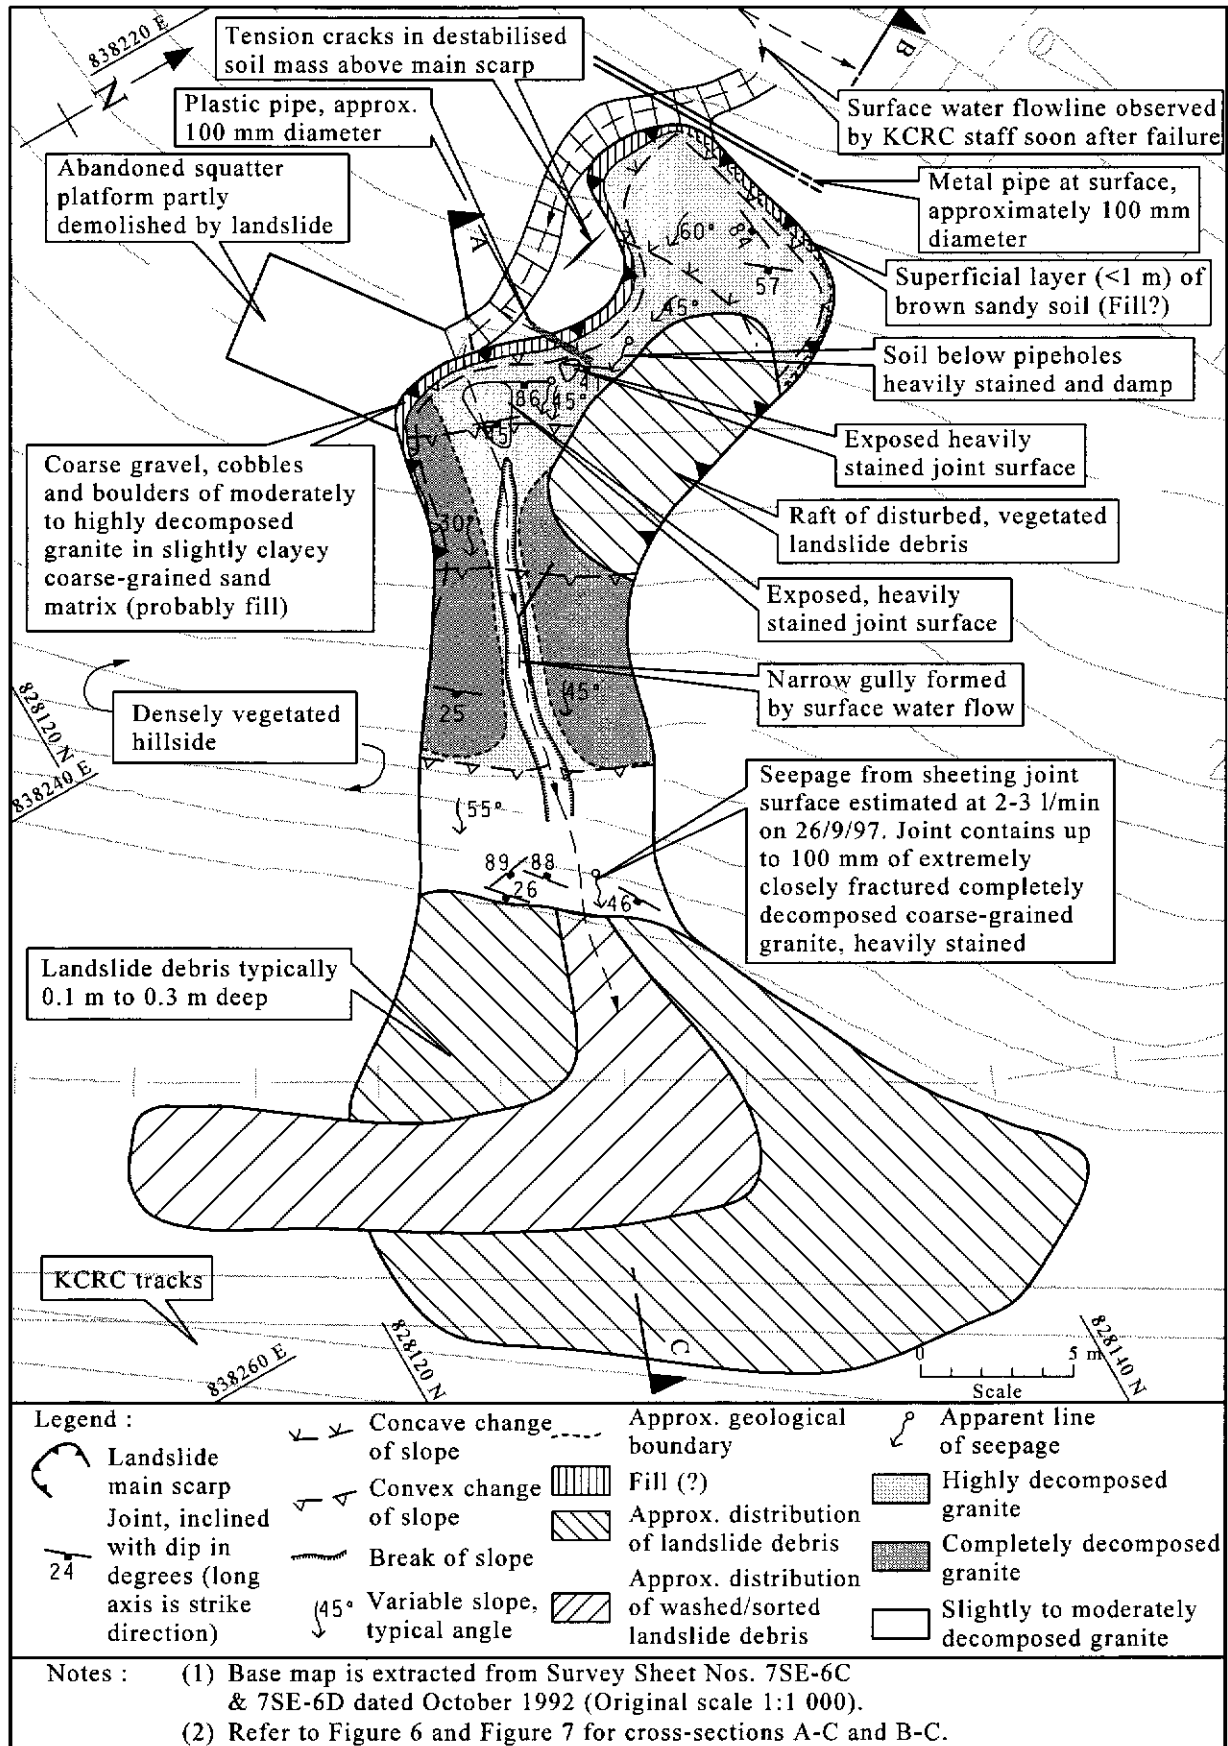
Figure 5 - Detailed Landslide Observations

The landslide exposed slightly to moderately decomposed granite in the lower part of the slope, and highly and completely decomposed materials higher up. Heavily stained surfaces dipping at between 45° and 55° were exposed locally in the base of the landslide scar, which were interpreted as sheeting joint surfaces (Figure 5).

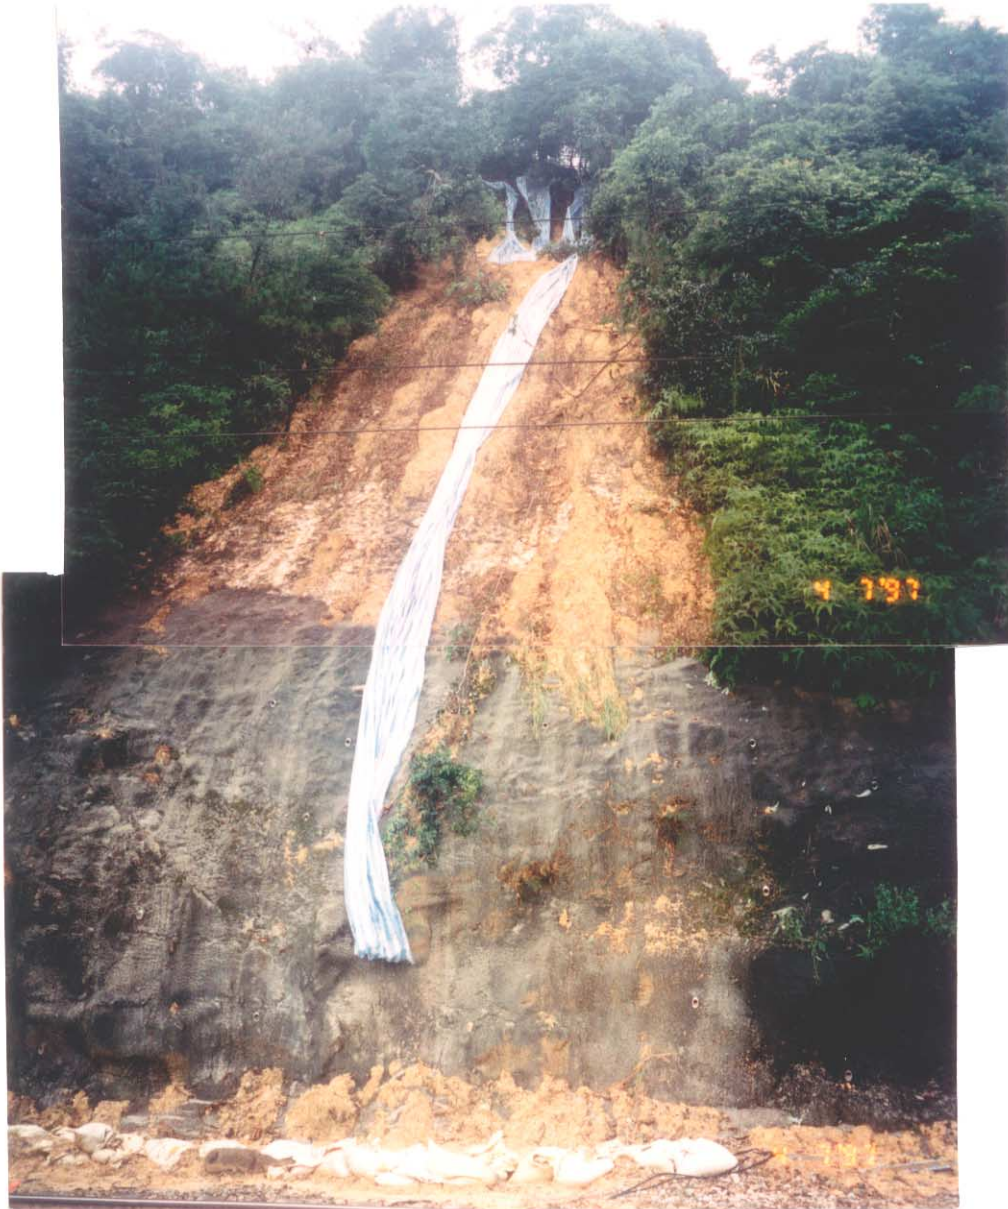
The landslide originated from the upper part of the slope. It produced a failure scar typically about 15 m long and 8 m wide, with an average depth of about 1.5 m. The volume of failure was estimated to be about 100 m³ (Plate 1).

Plate 1 - General View of the Lower Part of the Landslide
(Photograph Taken on 4 July 1997)

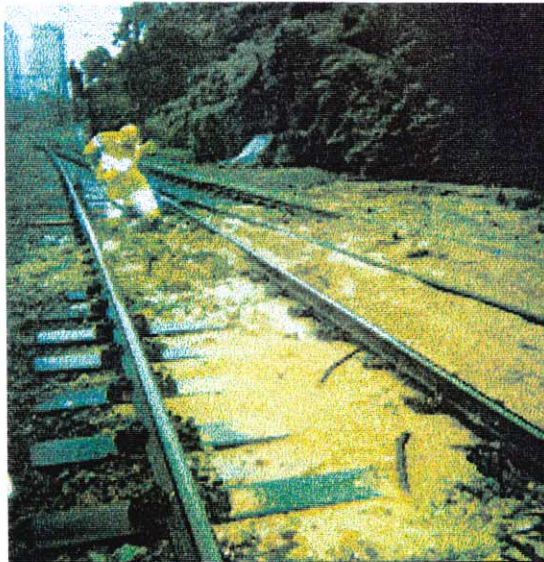
Plate 2 - General View of the Landslide Debris
(Photograph Taken on 2 July 1997)

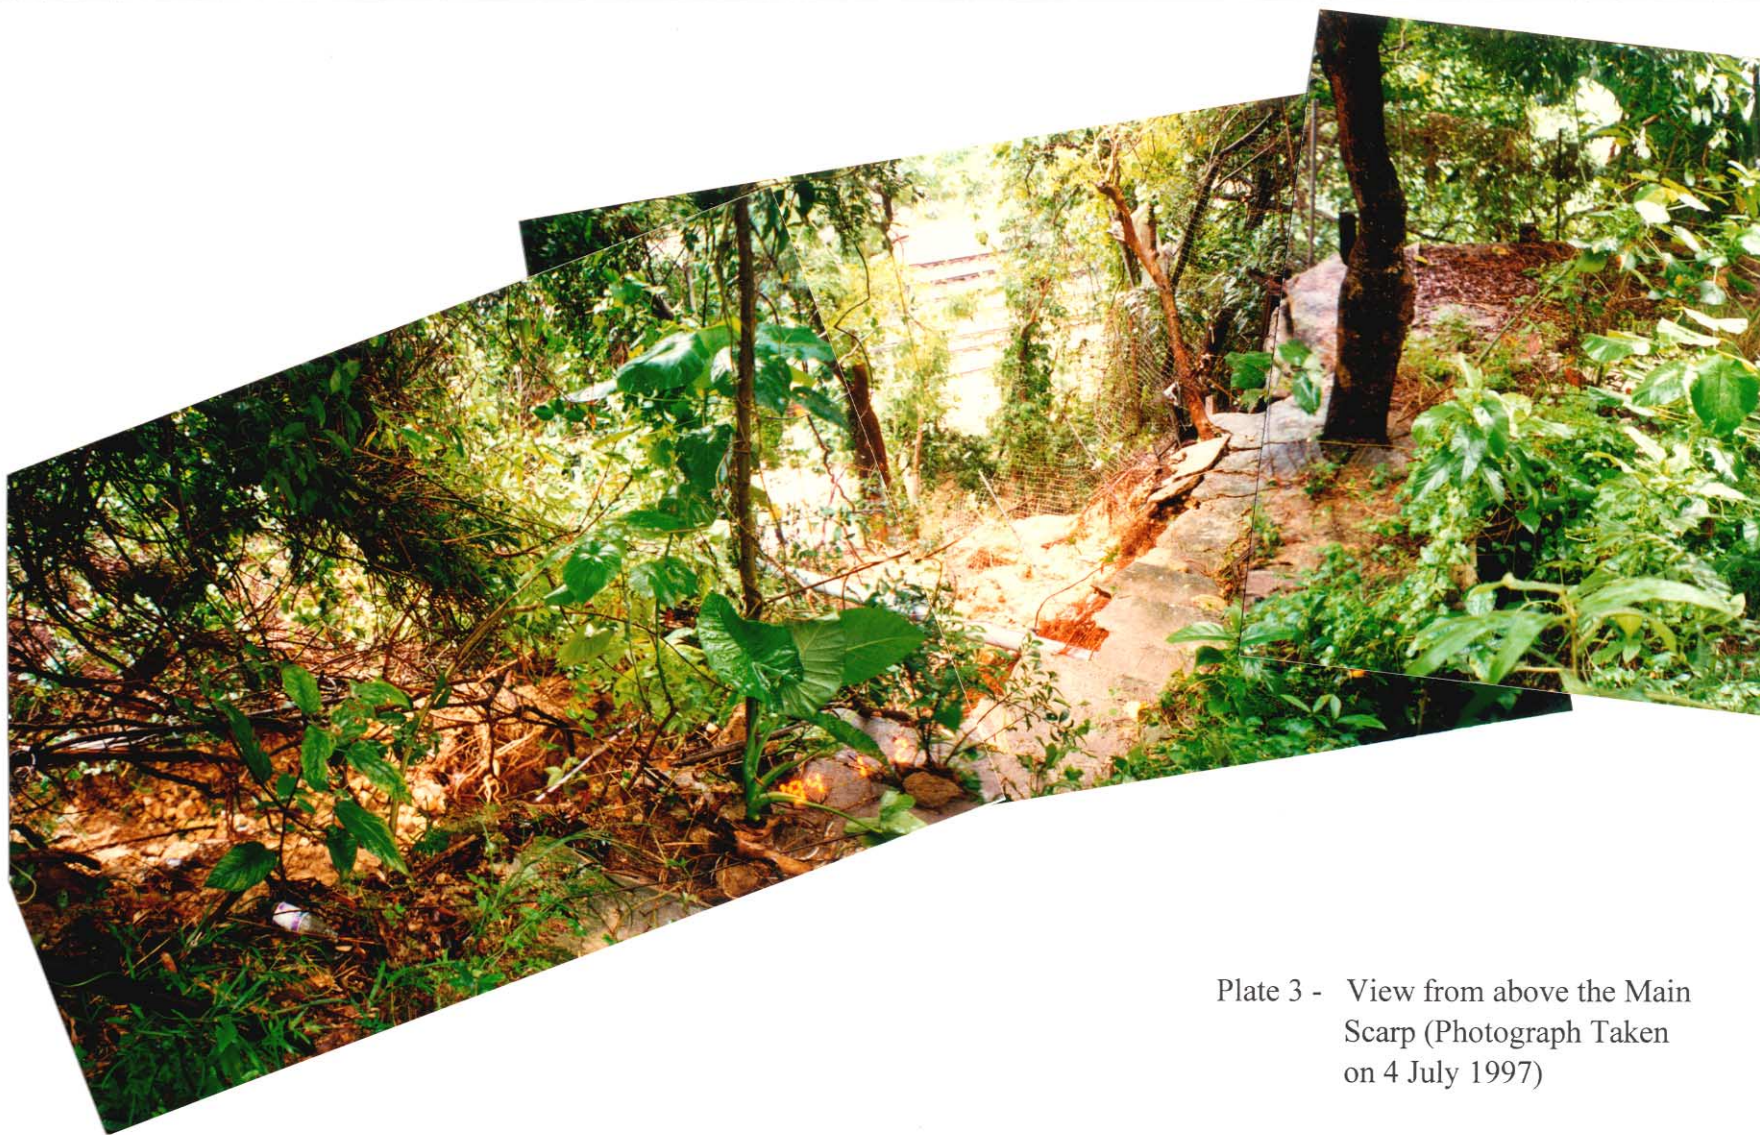
An abandoned squatter platform exists mid-way up the slope which was accessed down a concrete stairway from the main footpath at the crest of the slope (Plate 3). A squatter village is located southwest of the landslide.

Plate 3 - View from above the Main
Scarp (Photograph Taken
on 4 July 1997)

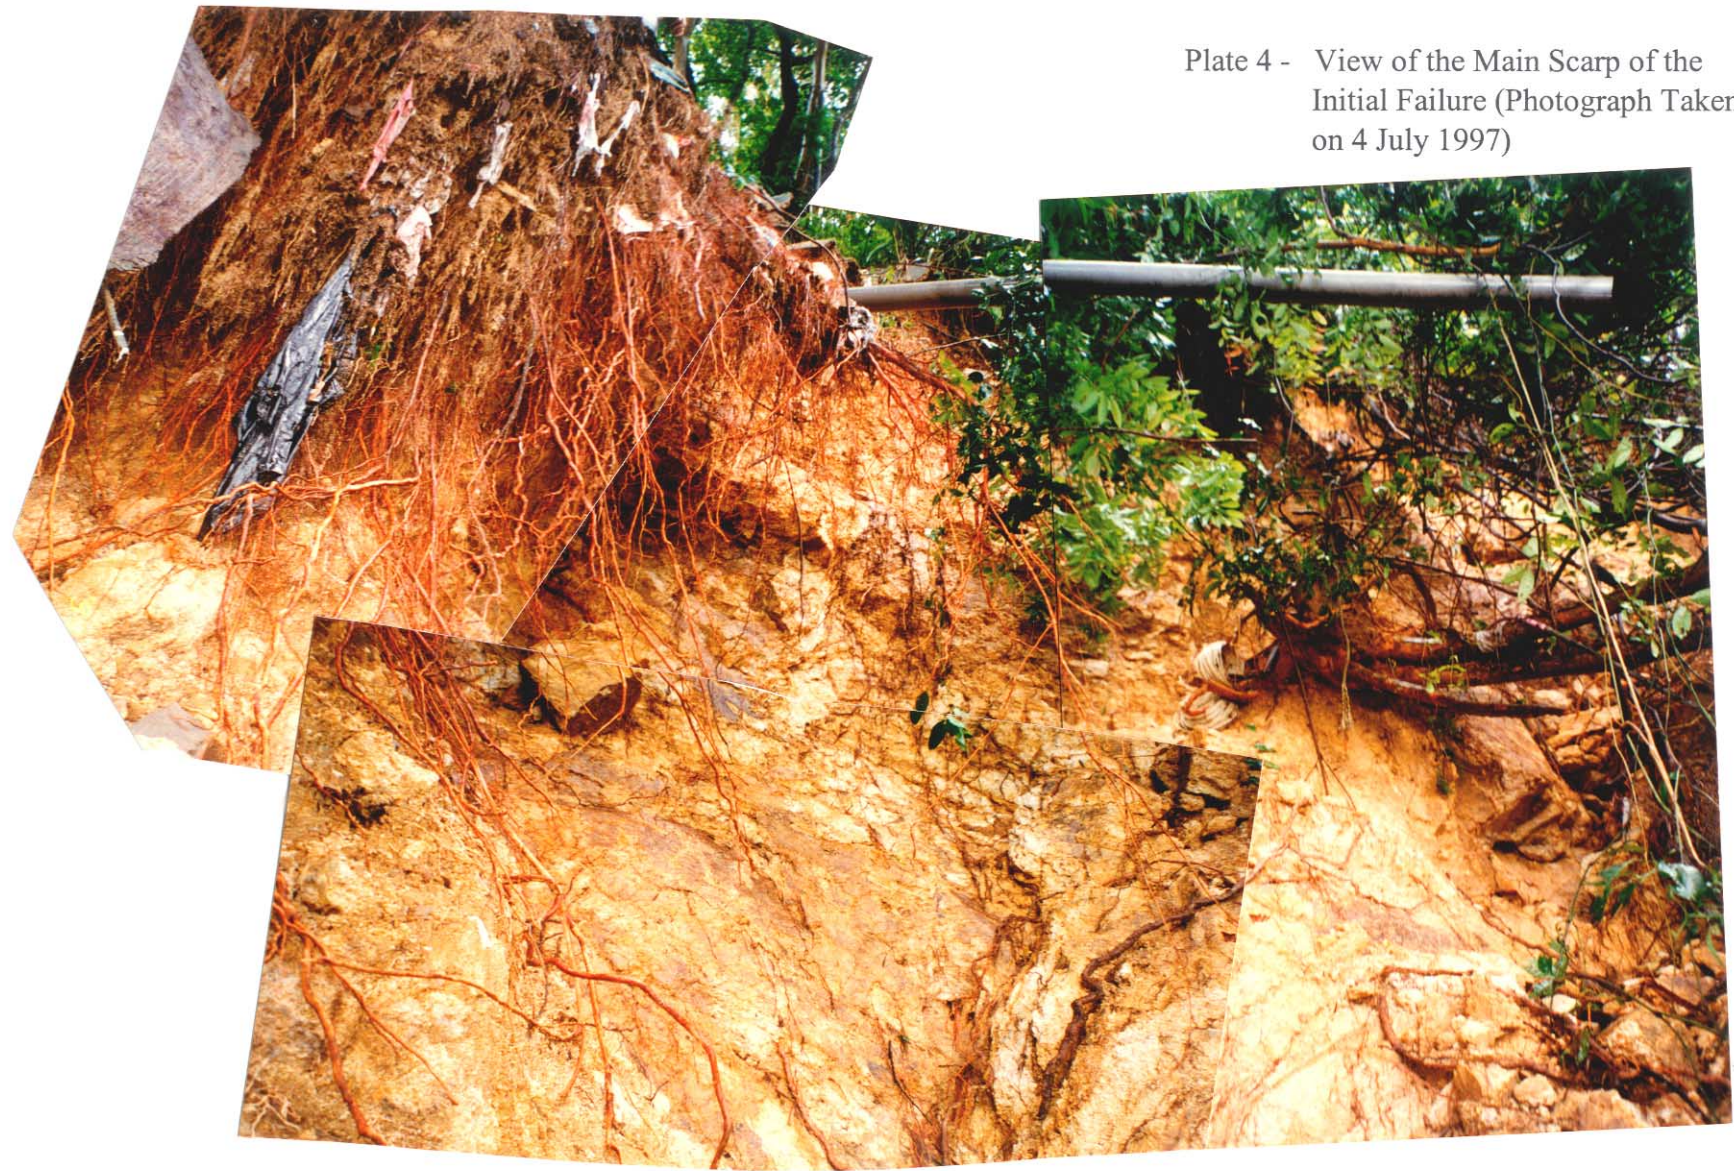
Plate 4 - View of the Main Scarp of the Initial Failure (Photograph Taken on 4 July 1997)

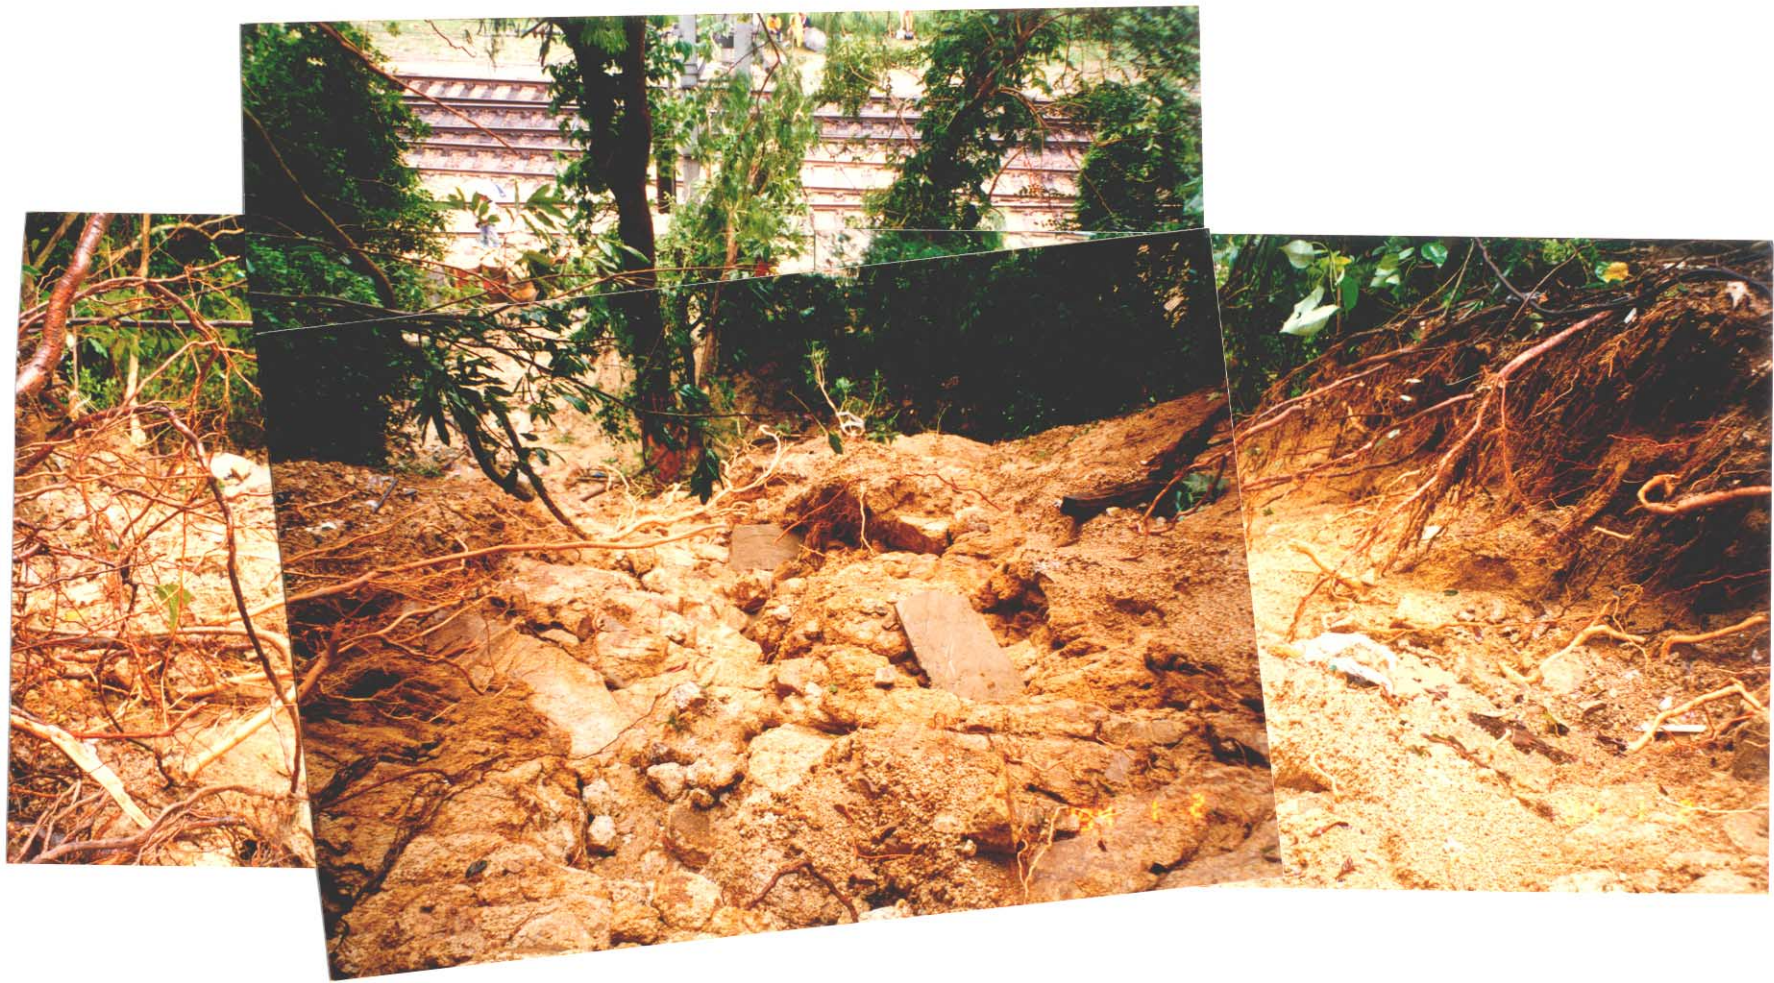
Plate 5 - Downslope View (Photograph Taken on 4 July 1997)

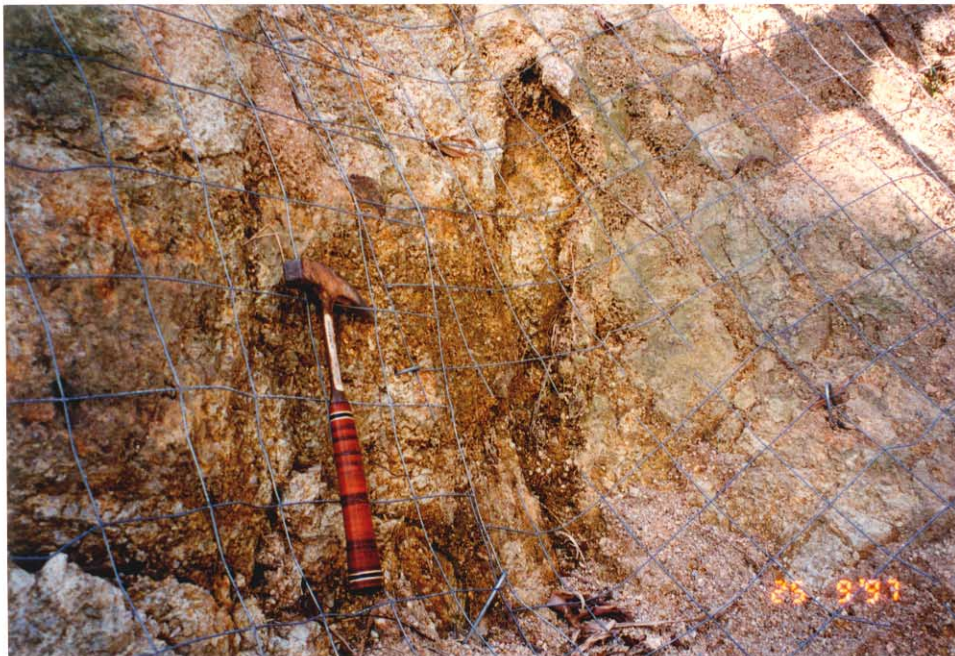
A particularly pronounced surface, inclined at 45°, was exposed in the area associated with the initial failure. Two voids or erosion pipes, typically between 50 mm and 70 mm in diameter, extended into the slope at the interface between a similar exposed surface and overlying material near the central part of the rupture zone (Plate 6). Soil around the pipes and on the surface was heavily stained.

Plate 6 - Erosion Pipe Exposed in the Central Part of the Main Scarp
(Photograph Taken on 25 September 1997)
