**SECTION 3 :
DETAILED STUDY OF THE
FLOODING INCIDENT
AT MEI CHUNG COURT,
SHATIN ON 2 JULY 1997**

Halcrow Asia Partnership Ltd

**This report was originally produced in May 1998
as GEO Landslide Study Report No. LSR 6/98**

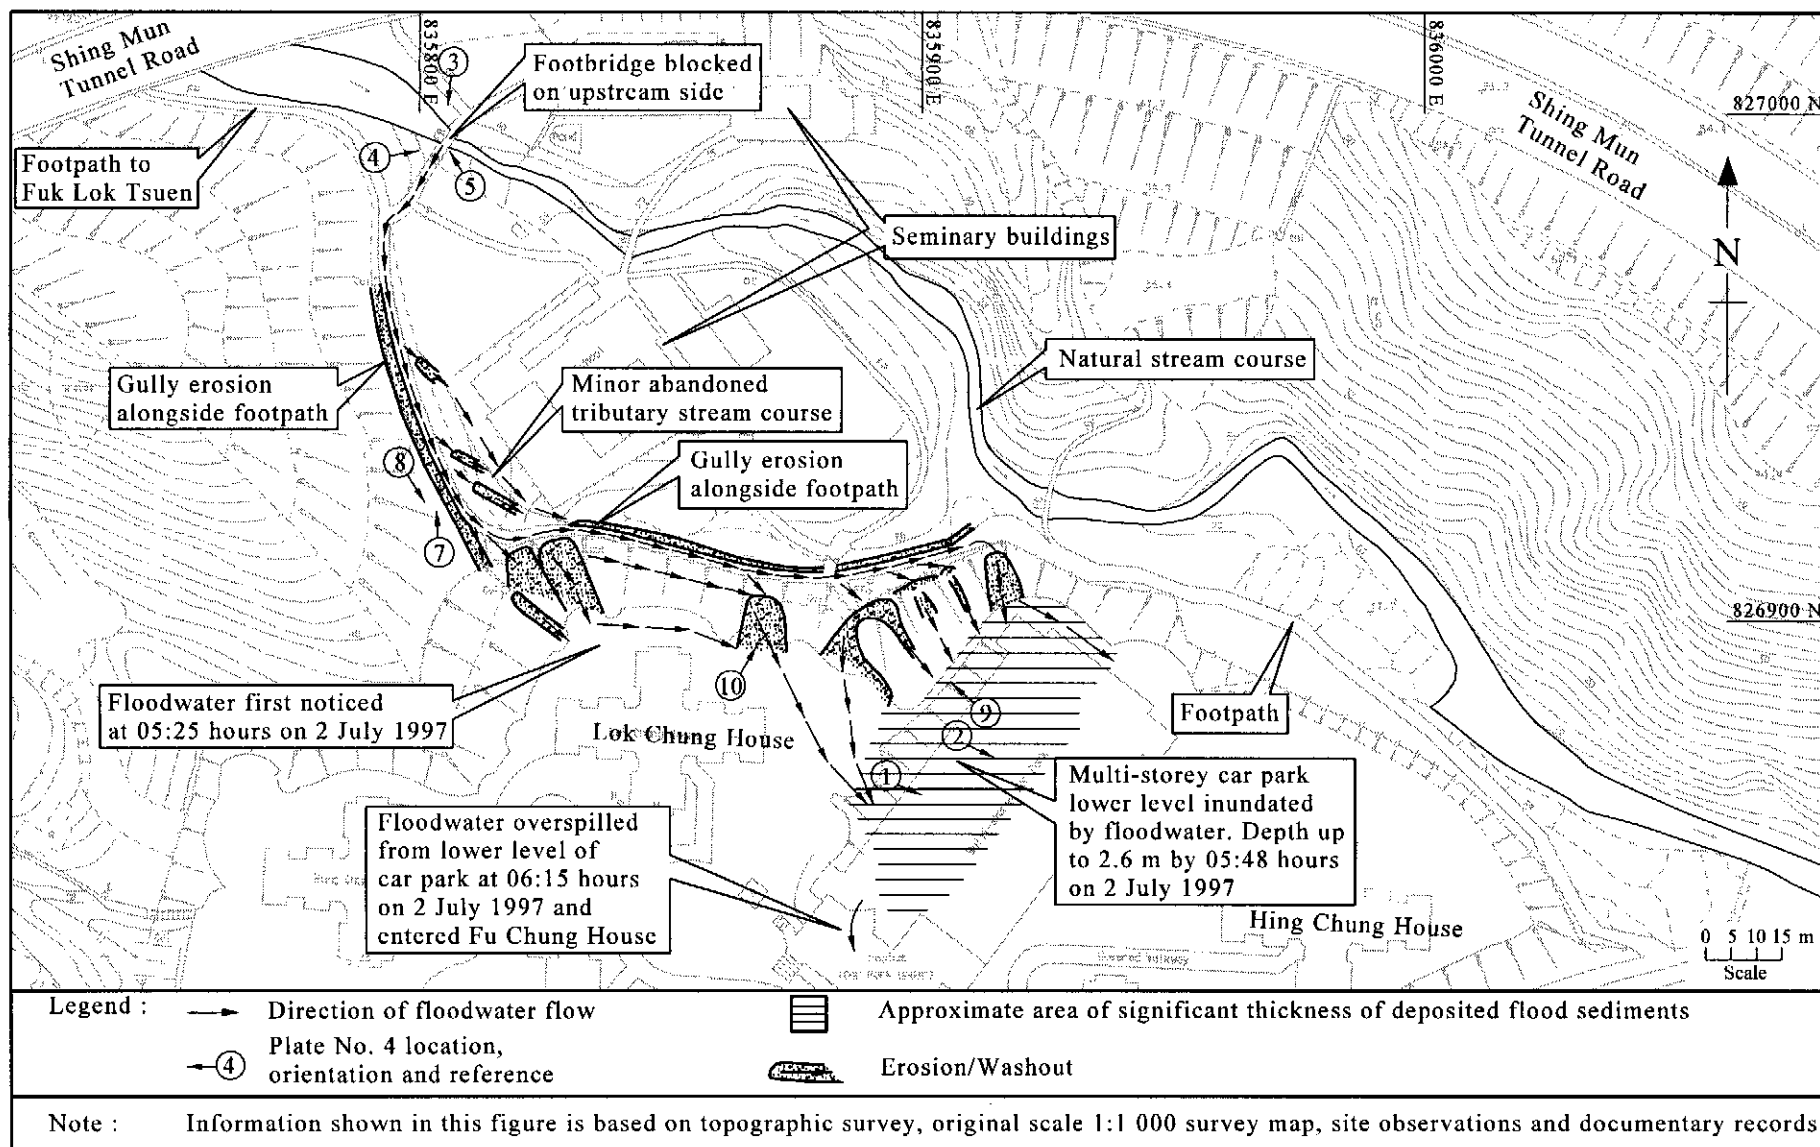
Figure 3 - Plan of Area Showing Details of Flooding Incident

During the rainstorm on 2 July 1997, stormwater flow within the natural stream course over-spilled the stream banks at the location of a blockage at a footbridge (Figure 3). Stormwater flooded onto a nearby footpath and, in part, was diverted downhill towards Mei Chung Court, sited on a cut platform below the level of the footpath.

Flood damage within the estate included severe erosion of slopes concentrated at six locations (Figure 3), undermining and erosion of paved areas mainly concentrated in the play area to the east of Lok Chung House, damage to fixtures in Lok Chung and Fu Chung House and damage to around seventy vehicles within the car park. The Fuk Luk Tsuen footpath above the estate suffered gully erosion and undermining.

The floodwaters which reached the estate caused serious erosion to two cut slopes (Nos. 7SW-D/C791 and 7SW-D/CR801), to the north of the multi-storey car park and Slope No. 7SW-D/C790 to the north of Lok Chung House (Figures 2 and 3).

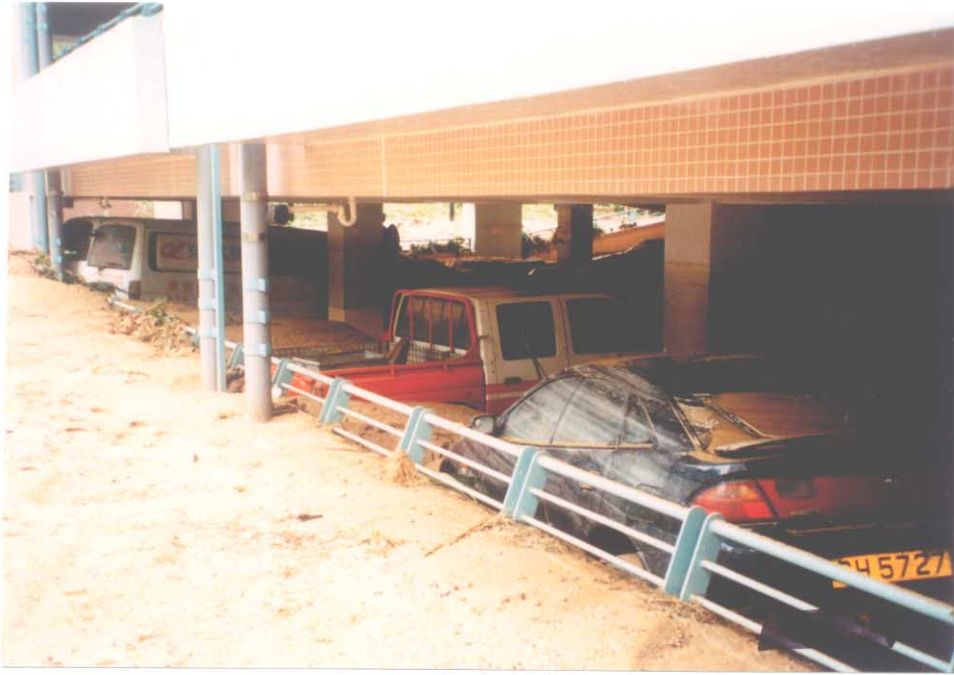
A photograph taken on 3 July 1997 is shown in Plate 1. This shows the accumulated sediment in the lower level of the multi-storey car park after floodwater had subsided.

Plate 1 - View of Basement Level (L1) of Multi-storey Car Park
(Photograph Taken on 3 July 1997)

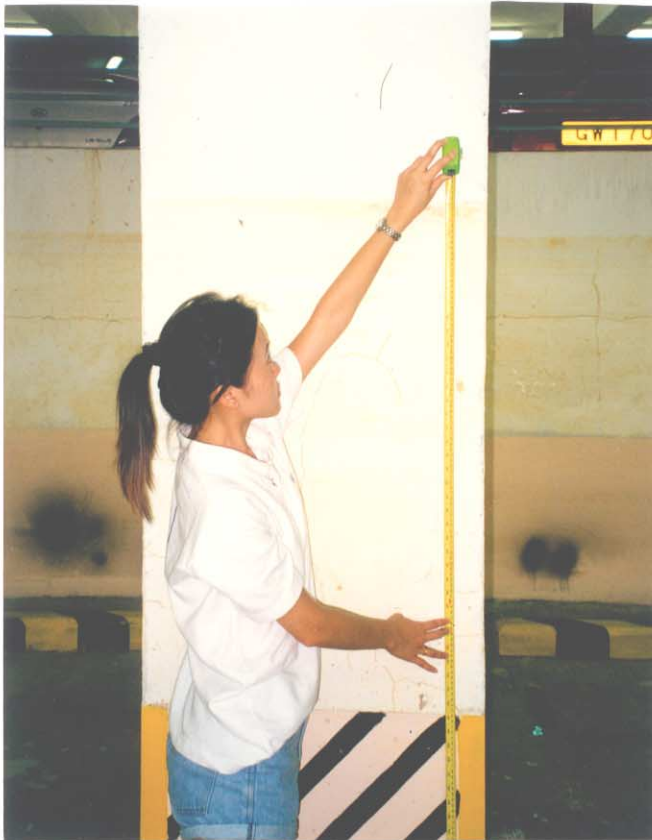
Staining on the walls and columns inside the basement level of the car park indicated a floodwater level of about 1.7 m (Plate 2), though some eye-witnesses stated that the flooding was up to 2.5 m deep. The floodwater deposited soft sandy silt debris in the basement, with an estimated volume of about 100 m³.

Plate 2 - View of Floodwater
Staining, up to 1.7 m,
in Car Park
(Photograph Taken in
August 1997)

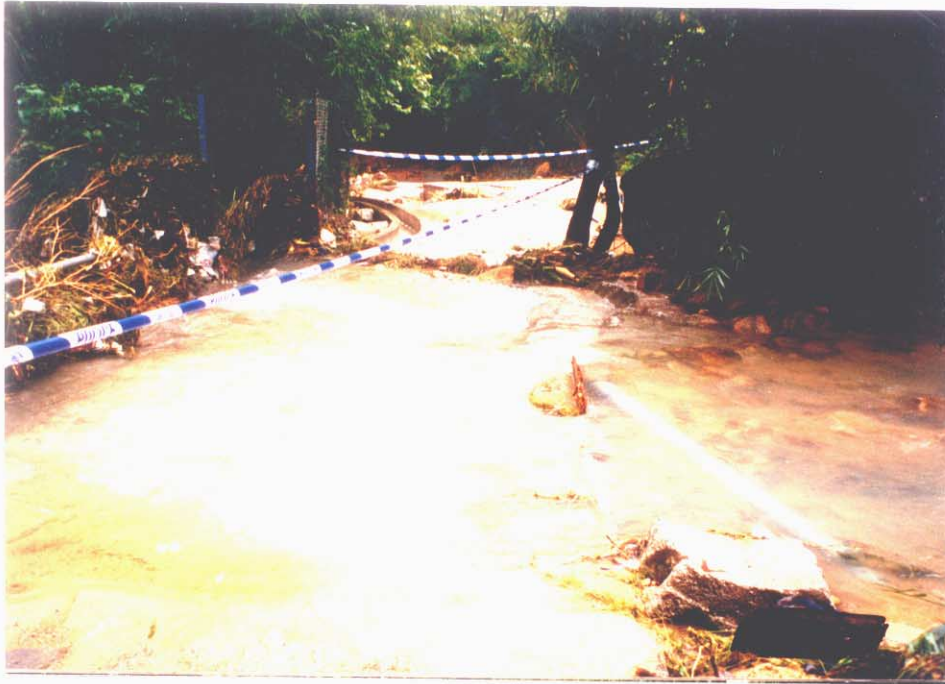
On the upstream side of the footbridge an accumulation of debris (comprising silty sandy gravel with many sub-rounded cobbles and some sub-rounded boulders) was found to

have completely blocked the upstream side of the bridge. This can be seen in a photograph taken during the morning of 3 July 1997 (Plate 3).

Plate 3 - View of Footbridge where Stream Over-spilled its Channel
(Photograph Taken on 3 July 1997)

Following the incident, to prevent recurrence of flooding, the existing footbridge was demolished, obstructions within the natural stream course removed, and a new bridge constructed. The eroded section of Fuk Lok Tsuen footpath was also repaired.

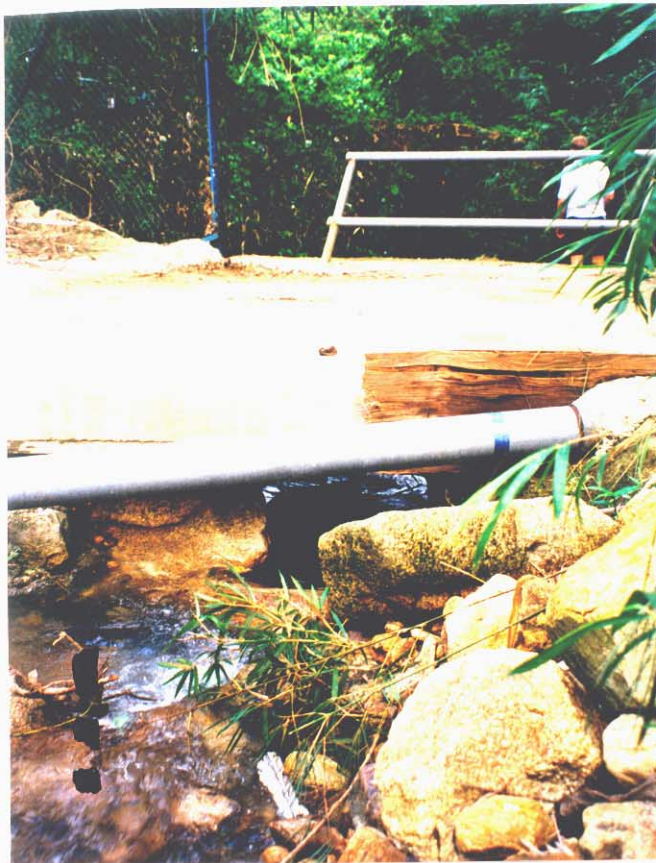
Clearance of debris from the channel upstream of the bridge by the DSD revealed up to about 0.8 m depth of generally loose debris underlain by more bouldery debris (Plate 4). The space beneath the bridge, on the unblocked downstream side, was about 1.7 m wide by 1 m high (Plate 5). The width of the stream course either side of the bridge varied, but typically ranged from 3 m to 4 m.

Plate 4 - General View of
Upstream Edge of
Footbridge Following
Clearance Works
(Photograph Taken in
August 1997)

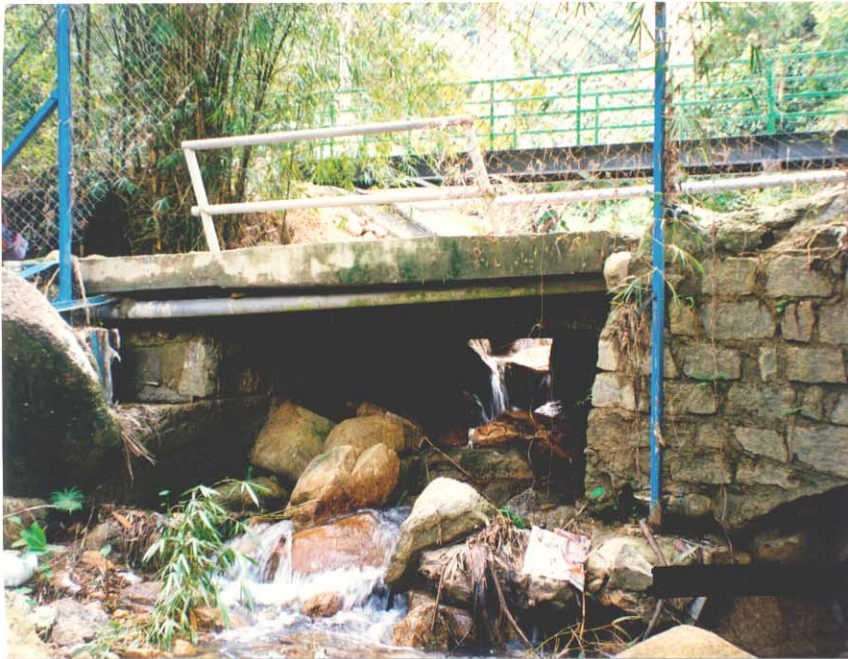
The deck of the footbridge was constructed in concrete (Plate 5), the appearance of which suggested the possibility of a later date of construction than 1949 (the earliest available aerial photographs, see Section 2.2). The construction of the deck may coincide with the resurfacing of the footpath, as identified in the 1992 aerial photographs (Table 1).

Plate 5 - General View of Unblocked Downstream Edge of Footbridge
(Photograph in August 1997)

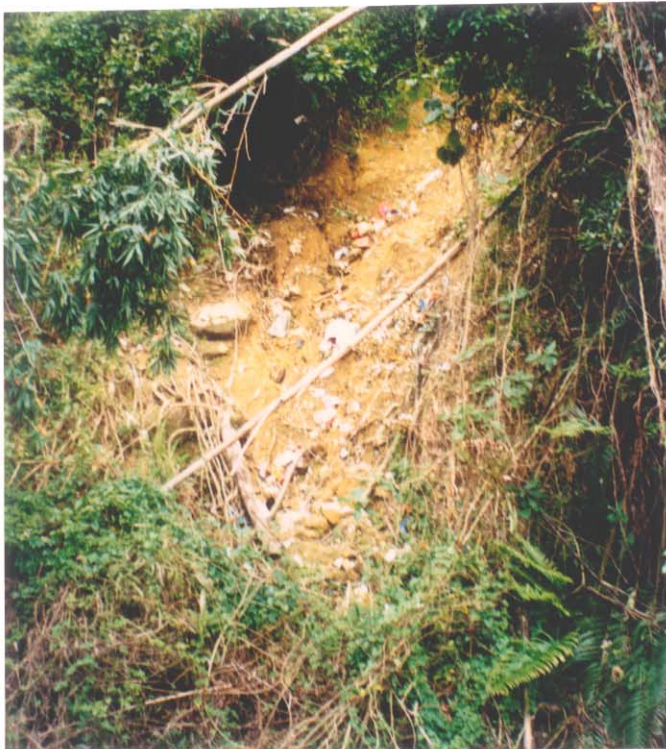
Plate 6 - View of Possible
Recent Landslide on
Stream Bank
(Photograph in August
1997)

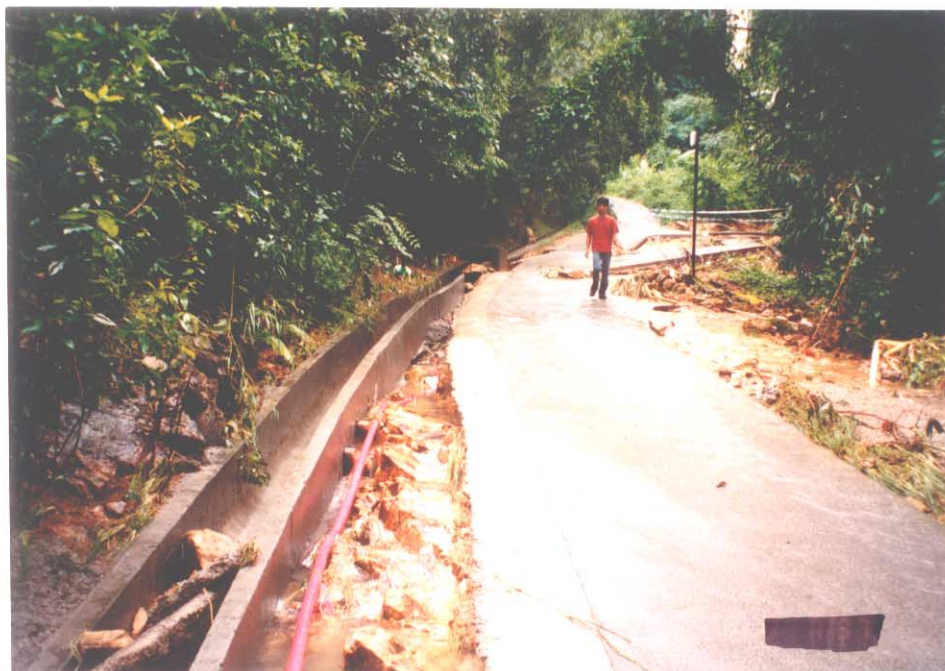
Plate 7 - Gully Erosion alongside Fuk Lok Tsuen Footpath
(Photograph Taken on 3 July 1997)

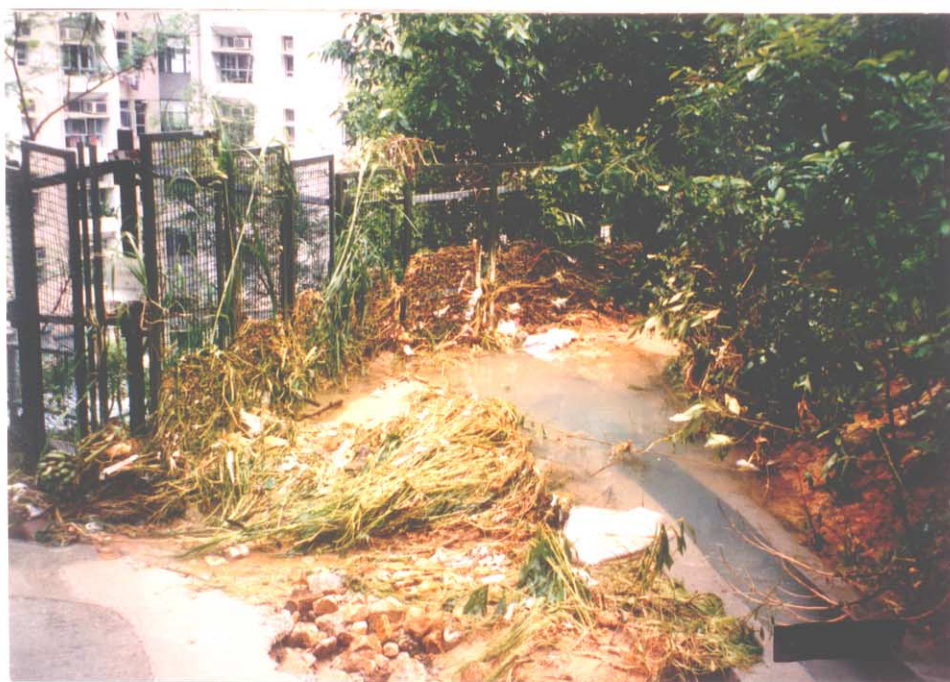
Uphill of the estate, erosion gullies formed parallel to the footpath from the footbridge to the estate, exploiting the existing surface drainage channel and an abandoned stream course (Figure 3). A photograph taken on 3 July 1997 shows the extent of the erosion (Plate 7). Where floodwater entered the estate, flood debris accumulated against the estate boundary fence (Plate 8).

Plate 8 - Accumulation of Flood Debris against Estate Boundary Fence
(Photograph Taken on 3 July 1997)

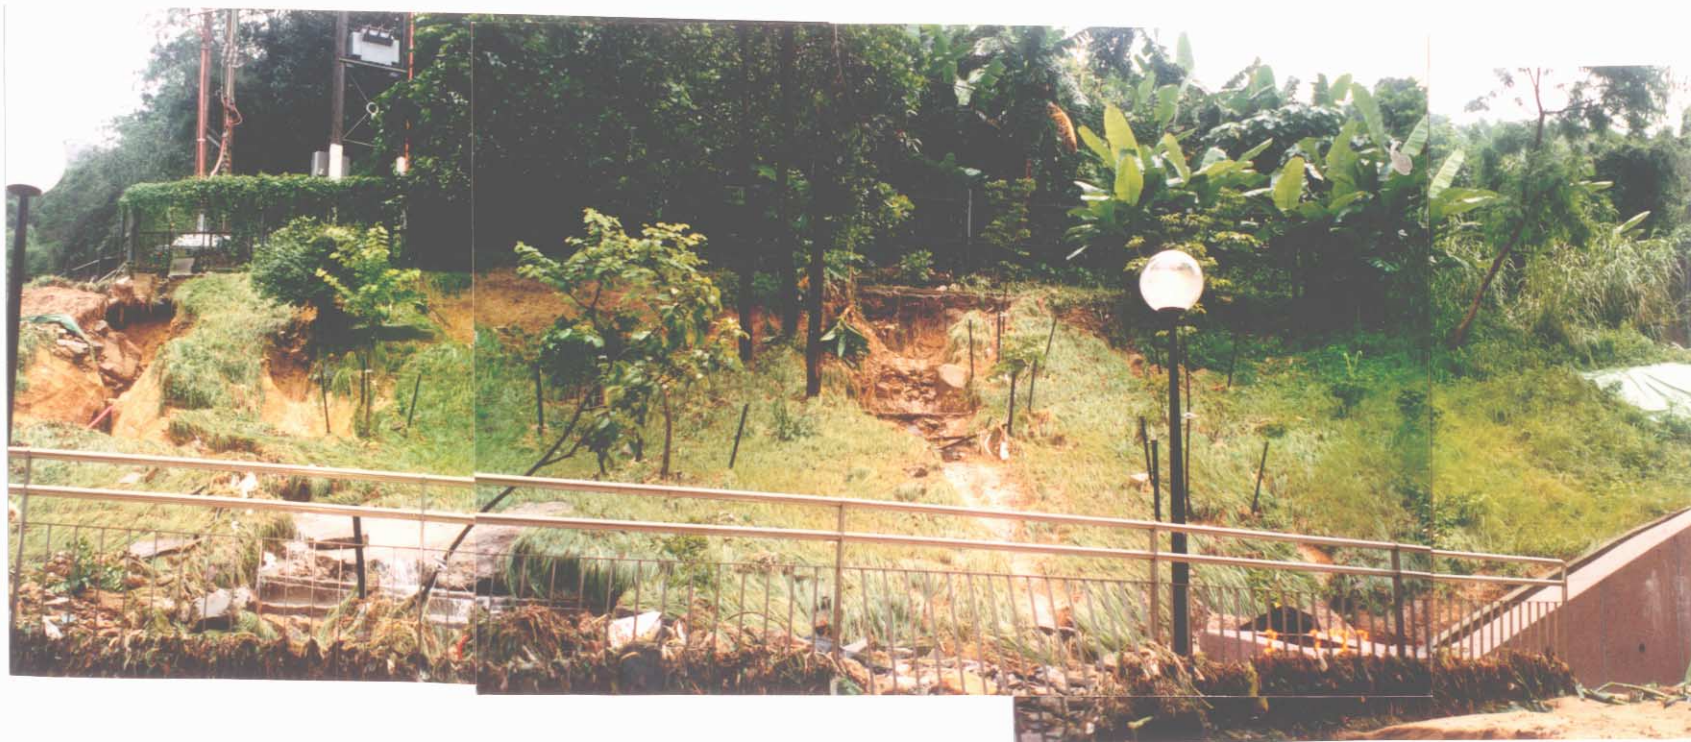
Erosion scars were observed on the cut slope (No. 7SW-D/C791) at four locations beneath the section where floodwater entered the estate or over-topped the slope drainage (Plate 9). The scars were generally less than 1 m deep but locally up to 2 m deep. Exposures

in the erosion scars showed localised fill up to 1 m deep overlying completely decomposed granite. It is estimated that a total volume of about 45 m³ of soil was washed from the slope.

Plate 9 - Photograph Showing Flood Damage to Cut Slope No. 7SW-D/C791 at Mei Chung Court
(Photograph Taken on 3 July 1997)

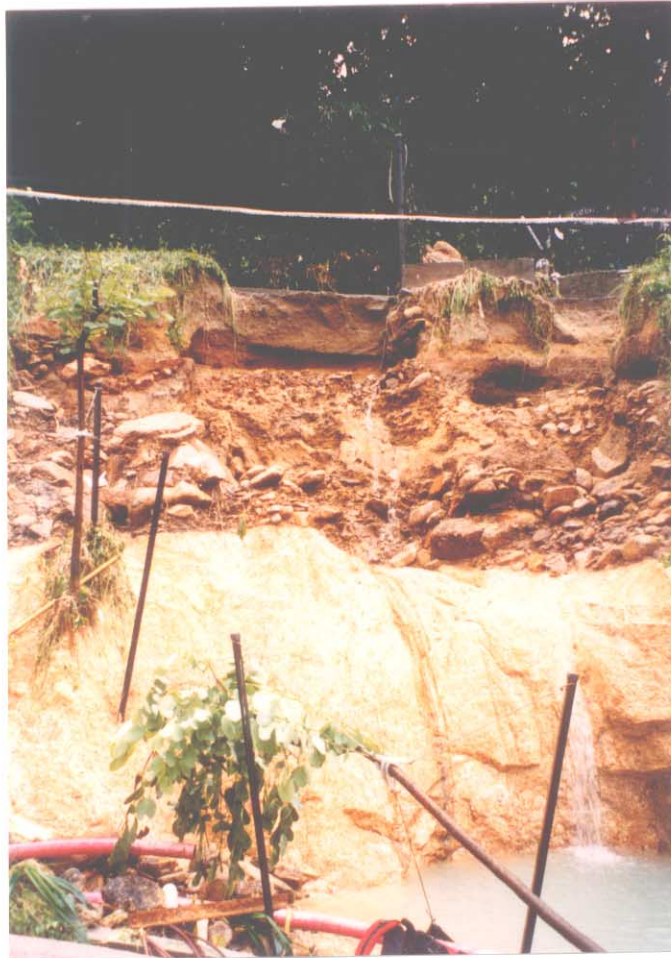
Erosion scars were concentrated at two locations on Slope No. 7SW-D/C790. The scars to the northwest of Lok Chung House were shallow, typically 0.5 m deep within completely decomposed granite. To the northeast of Lok Chung House a further scar, over 2 m deep exposed alluvial deposits (of dense sandy gravel with many sub-rounded cobbles and occasional sub-rounded boulders) overlying completely decomposed granite (Plate 10). The estimated volume of the soil removed from the slope was 55 m³.

Plate 10 - View of Erosion Scar and Undermined U-Channel on Slope
No. 7SW-D/C790 (Photograph Taken on 3 July 1997)
