**SECTION 4 :
DETAILED STUDY OF THE
FLOODING INCIDENT
AT TUEN MUN ROAD
YAU KOM TAU
ON 2 AND 3 JULY 1997**

Halcrow Asia Partnership Ltd

**This report was originally produced in May 1998
as GEO Landslide Study Report No. LSR 7/98**

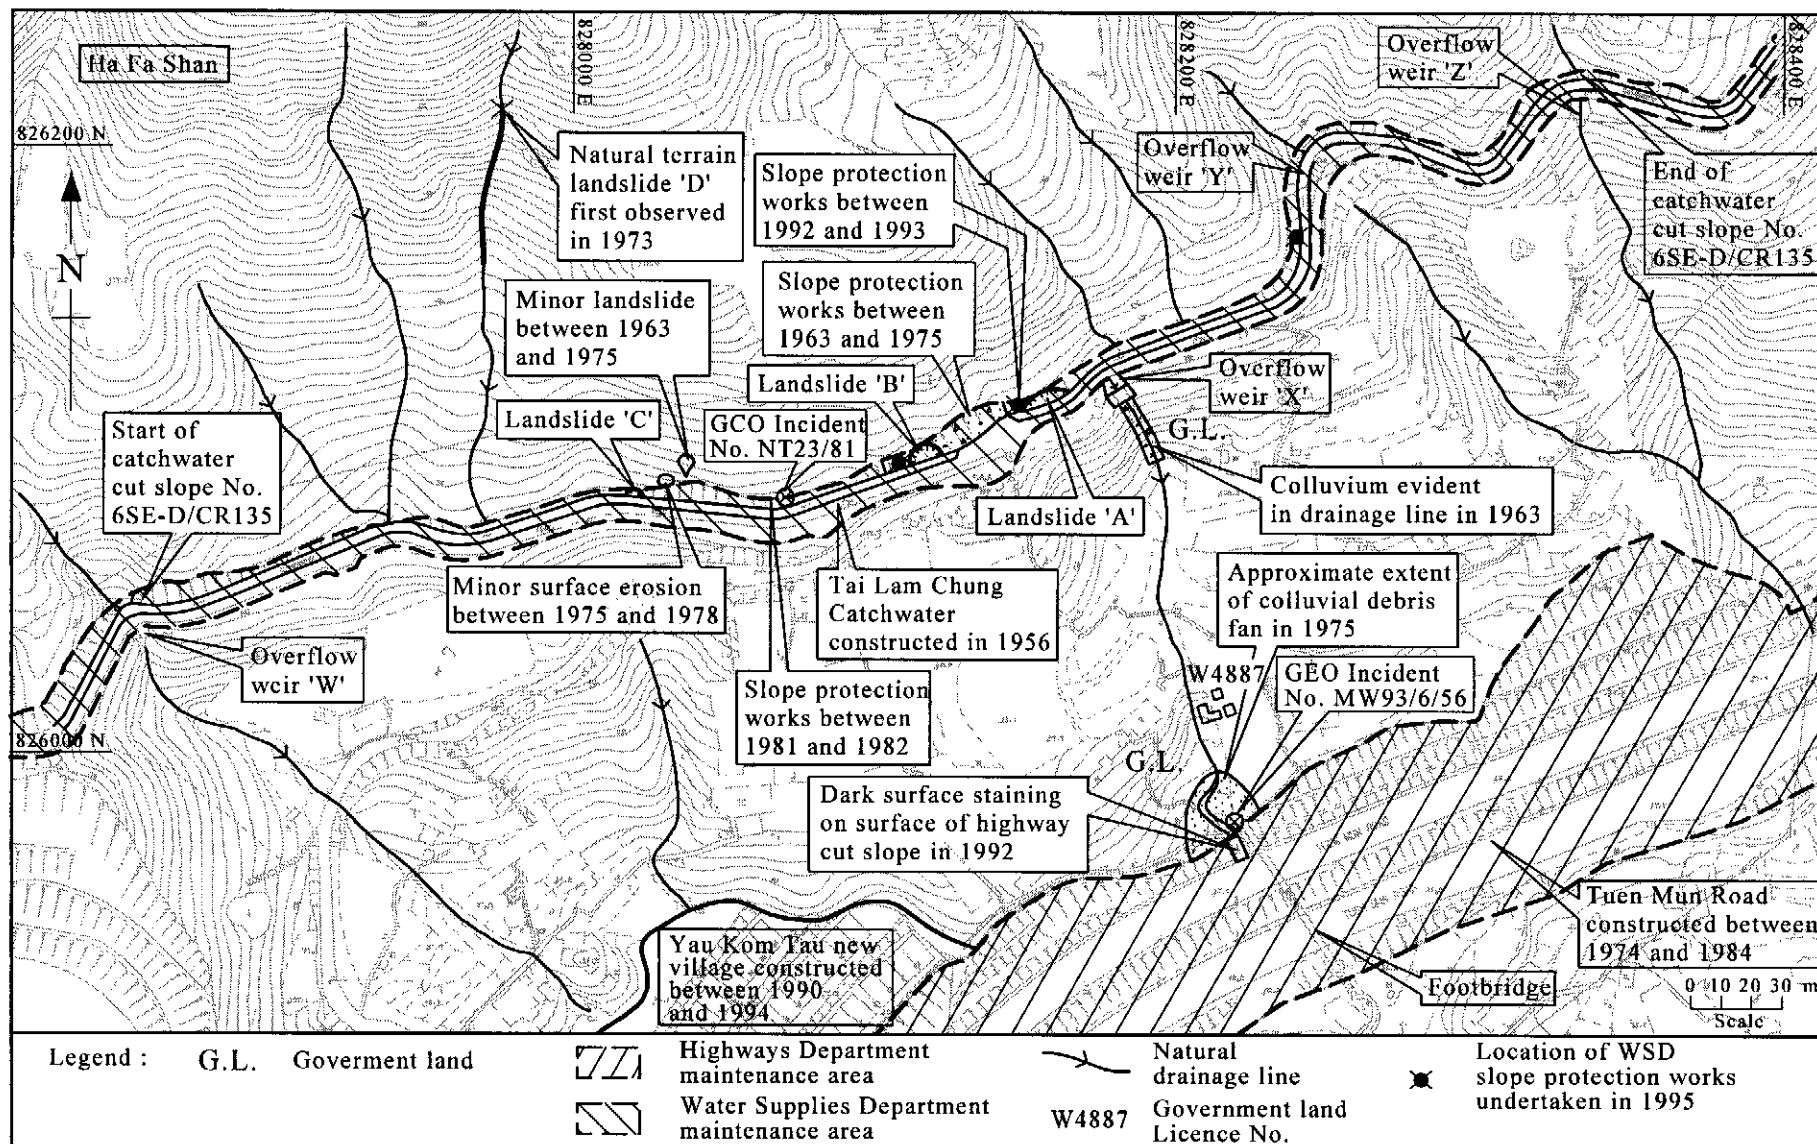
Figure 3 - Site History and Land Status

Inspection of aerial photographs dated 1975 shows a minor landslide above the catchwater cut slope about midway between overflow weirs 'W' and 'X' (Figure 3). However, the failed material did not reach the catchwater. Minor erosion just below this area is apparent on aerial photographs taken in 1978.

GEO's Landslide Incident Report database also contains a record of an incident (GEO Incident No. MW93/6/56) which occurred on 16 June 1993 and involved blockage of the trapezoidal drainage channel 'D' (Figure 3). The incident was reportedly caused by "run off washing down boulders in natural stream course". Unblocking of the channel and reinstatement of the ground was recommended by GEO in the incident report.

The previous reported incidents, together with the 1997 landslides, form a notable cluster (Figure 3).

There is a notable cluster of past incidents near the location of the three landslides which occurred on the catchwater cut slope in July 1997. Up to seven natural terrain landslides have been identified on the hillside above the catchwater. Protective surfacing has been applied to sections of the catchwater cut slope (No. 6SE-D/CR135) on at least four occasions, one of which was at the location of GCO Incident No. NT23/81. There was also a previous blockage of the trapezoidal drainage channel 'D' above highway cut slope No. 6SE-D/C64 in June 1993 (GEO Incident No. MW93/6/56).

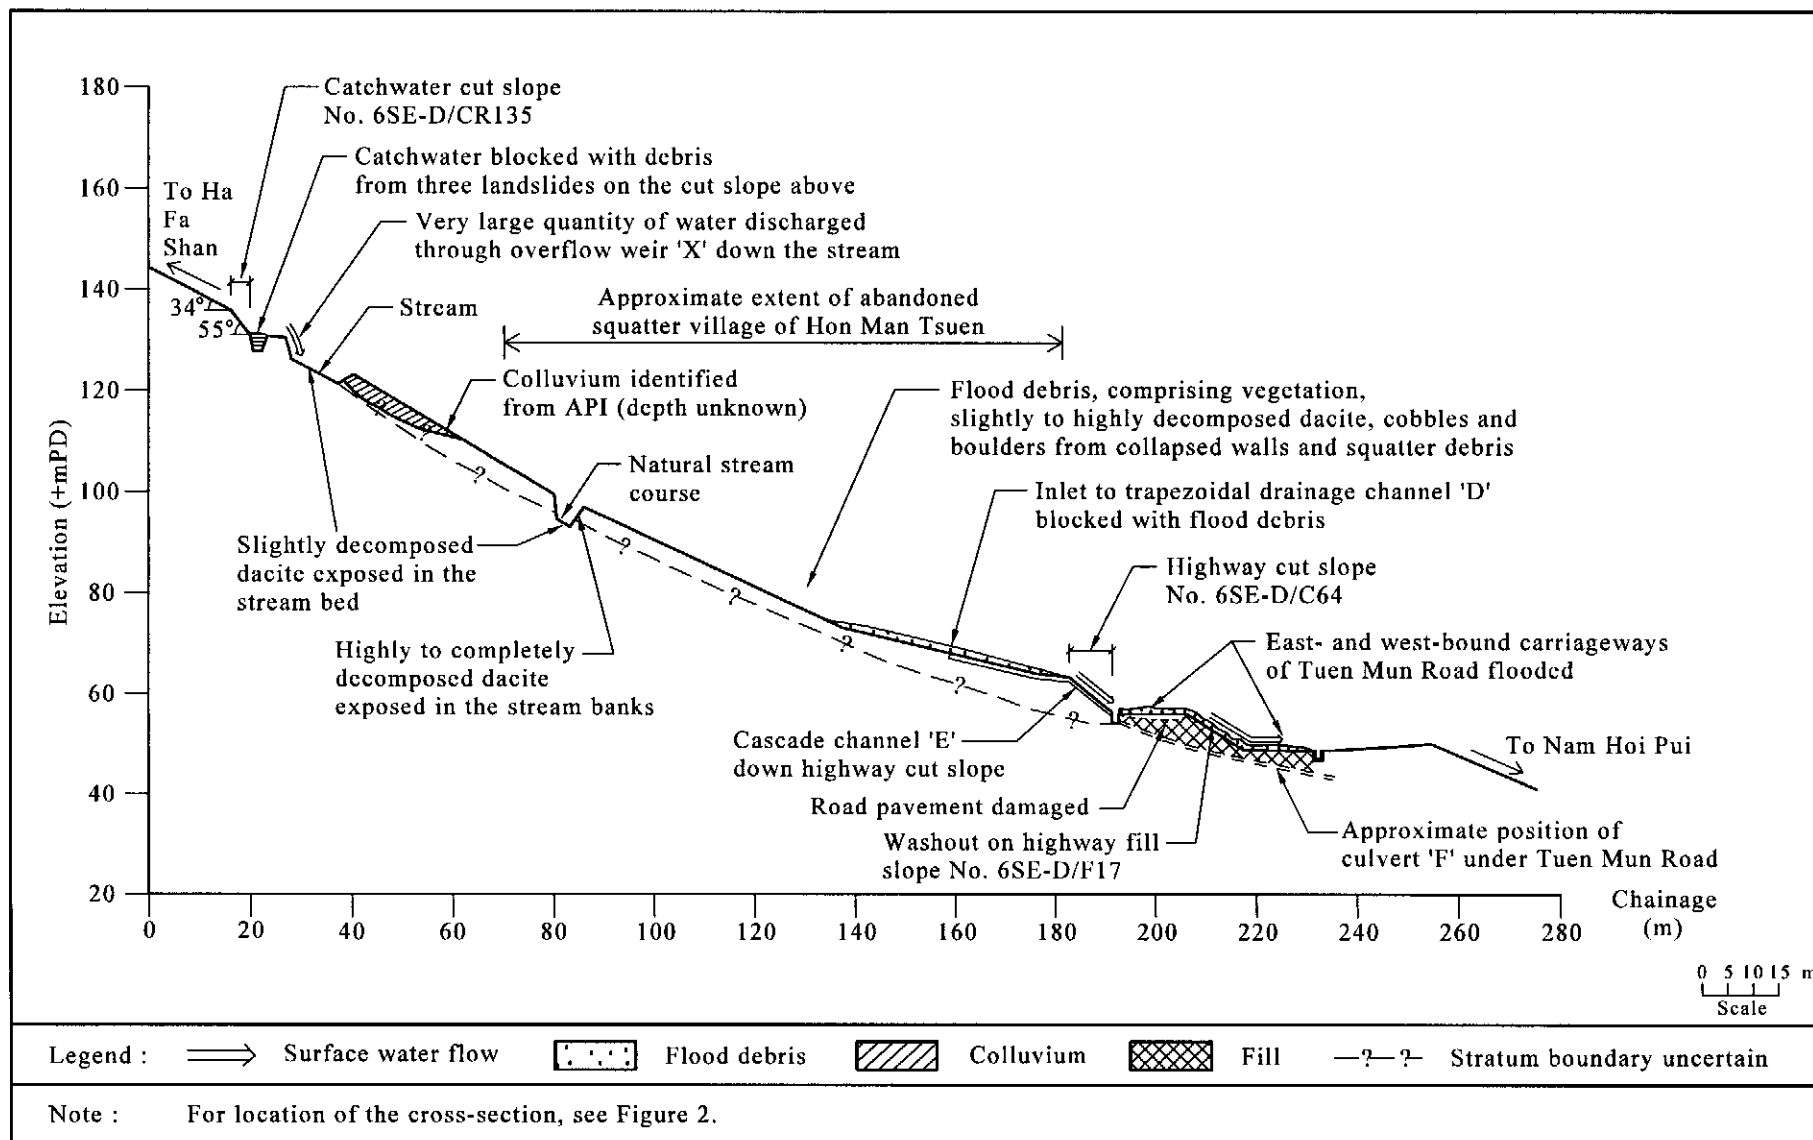
Figure 4 - Geological Cross-section

There has been no previous ground investigation along the catchwater cut slope No. 6SE-D/CR135. The subsurface conditions of the cut slope have been assessed from field observations by HAP of the main scarps of the three landslides. All three main scarps exposed weak to very weak, highly to completely decomposed dacite, and material of a similar nature was also observed in the banks of the stream. In the bed of the stream, moderately strong to strong, slightly decomposed dacite was exposed.

At the time of inspection by HAP on 3 July 1997, Slope Nos. 6SE-D/C64 and 6SE-D/F17 had been shotcreted as part of the urgent repair works. The closest borehole to the site was drilled at the crest of Slope No. 6SE-D/C64 during the ground investigation for Tuen Mun Road Stage II works supervised by HyD consultants Scott Wilson Kirkpartick & Partners (SWKP). The borehole encountered 3 m of colluvium described as a dense light brown slightly gravelly sand with some cobbles overlying dense light brown and white clayey gravelly sand (completely decomposed volcanics).

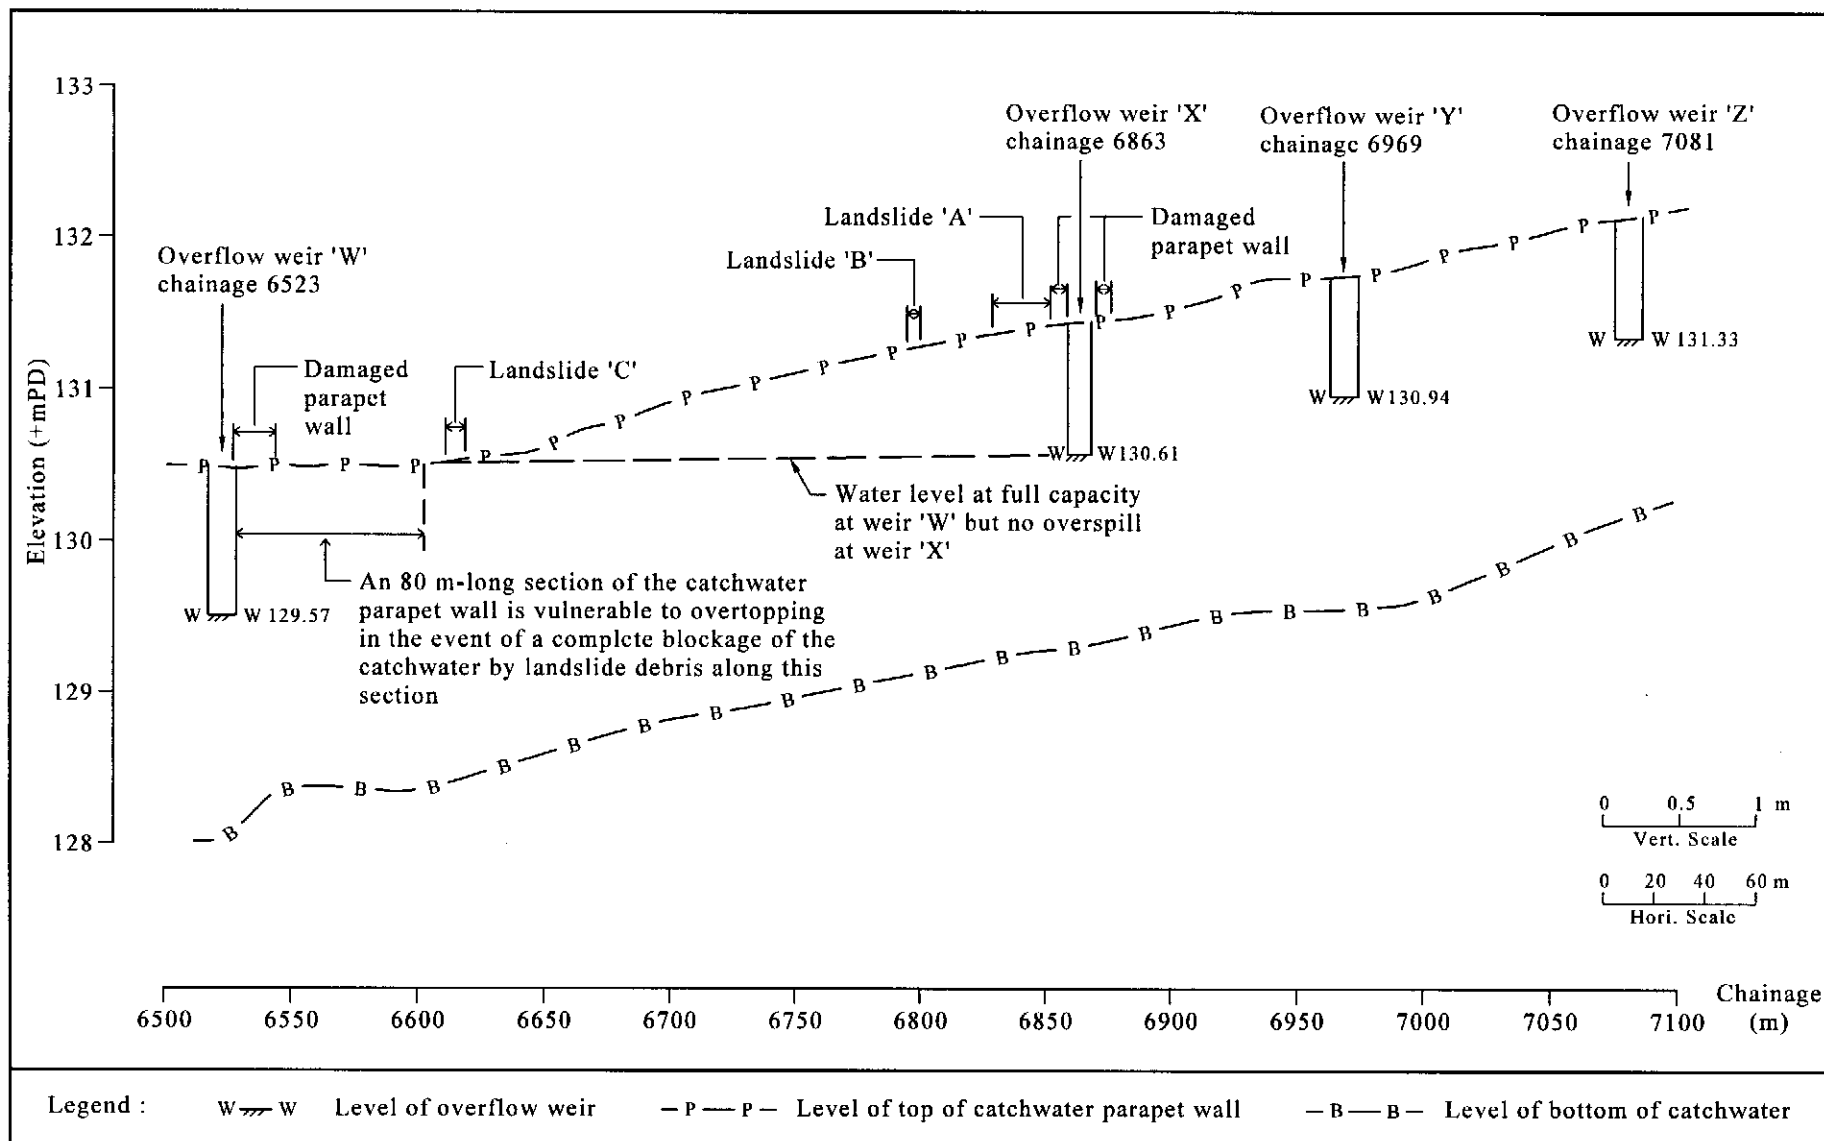
Figure 9 - Interpretation of Level Survey Results along the Tai Lam Chung Catchwater

The results of a level survey of the catchwater carried out by HAP after the incident, indicated that the height of the catchwater parapet wall above overflow weir 'X' was probably sufficient to prevent overtopping of the catchwater in the event of blockage at the locations of the three landslides (Figure 9). It is considered likely that overflow weirs 'Y' and 'Z' would also have discharged stormwater as a result of the blockage of the catchwater. There was no evidence of overtopping of the parapet wall of the catchwater upstream of overflow weir 'X'.

In addition, the level survey determined that an 80 m long section of the catchwater parapet wall immediately upstream from overflow weir 'W' is vulnerable to overtopping in the event of a complete blockage of the catchwater along this section with landslide debris (Figures 1 and 9).

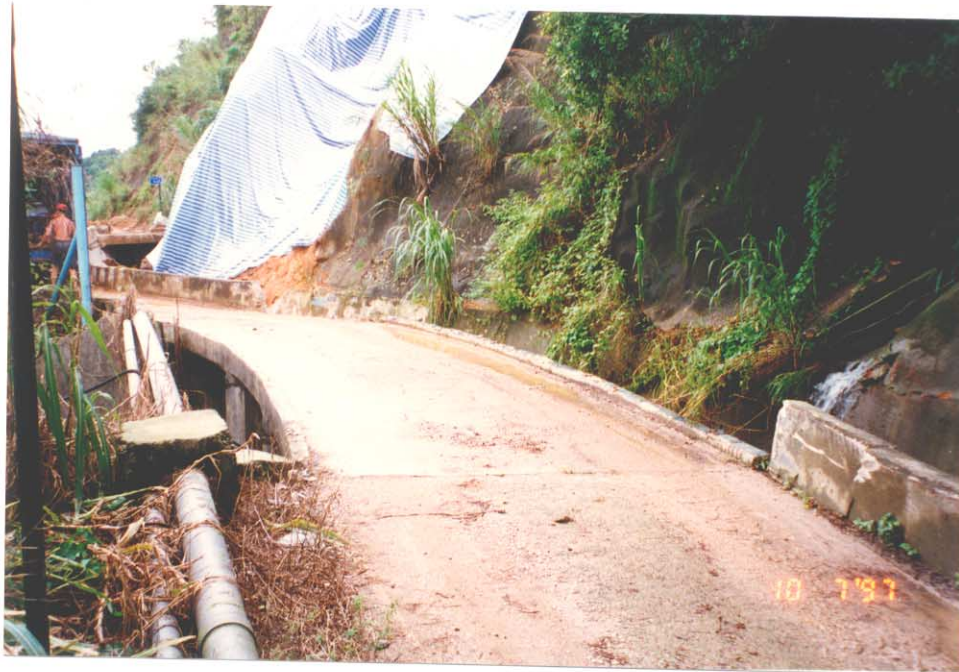
The catchwater cut slope (No. 6SE-D/CR135) was affected by three landslides on 2 July 1997 (Plates 1 to 3). The locations of the landslides 'A', 'B' and 'C' are shown in Figure 1. Landslide 'A' was about 1.5 m deep with an estimated volume of 280 m³ and occurred on a part-vegetated, part-surfaced, 55°, 18 m high soil cut slope. Landslides 'B' and 'C' were about 1 m deep with estimated volumes of about 100 m³ and 35 m³. They occurred on vegetated, 60°, soil cut slopes of around 10 m high and 5 m high respectively. The material involved in each of the landslides was completely decomposed dacite. The travel angle for all three landslides was in excess of 30° and the debris mobility is therefore not unusual for rain-induced landslides in Hong Kong (Wong & Ho, 1996).

Plate 1 - View Showing Overflow Weir 'X' and Landslide 'A' on the Tai Lam Chung Catchwater Cut Slope No. 6SE-D/CR135 (Photograph Taken on 10 July 1997)

Following the incident, WSD contractors trimmed the main scarps of landslides 'A', 'B' and 'C', applied shotcrete protection and carried out repairs to drainage channels and the concrete catchwater channel. HyD propose to undertake "survey, design and modification to the inlet channel system" (HyD, 1997b). HyD also arranged for the stream to be cleared out and the banks of the stream above the trapezoidal drainage channel to be protected with shotcrete.

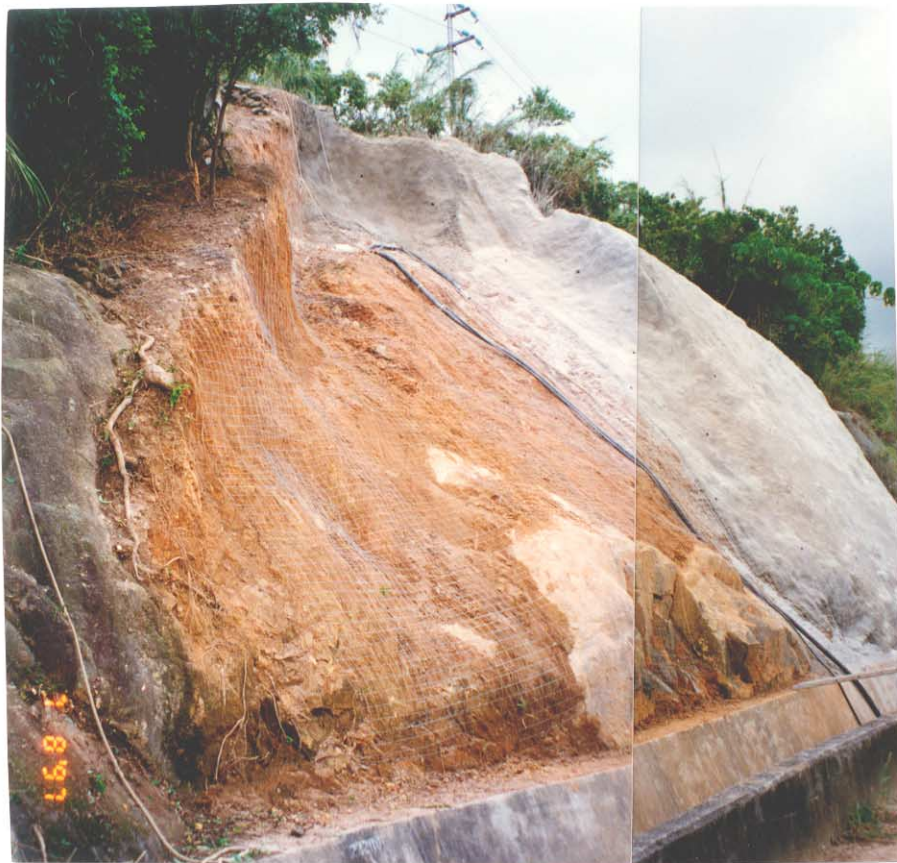
Plate 2 - Landslide 'B' on the Tai Lam Chung Catchwater Cut Slope No. 6SE-D/CR135 (Photograph Taken on 7 August 1997)

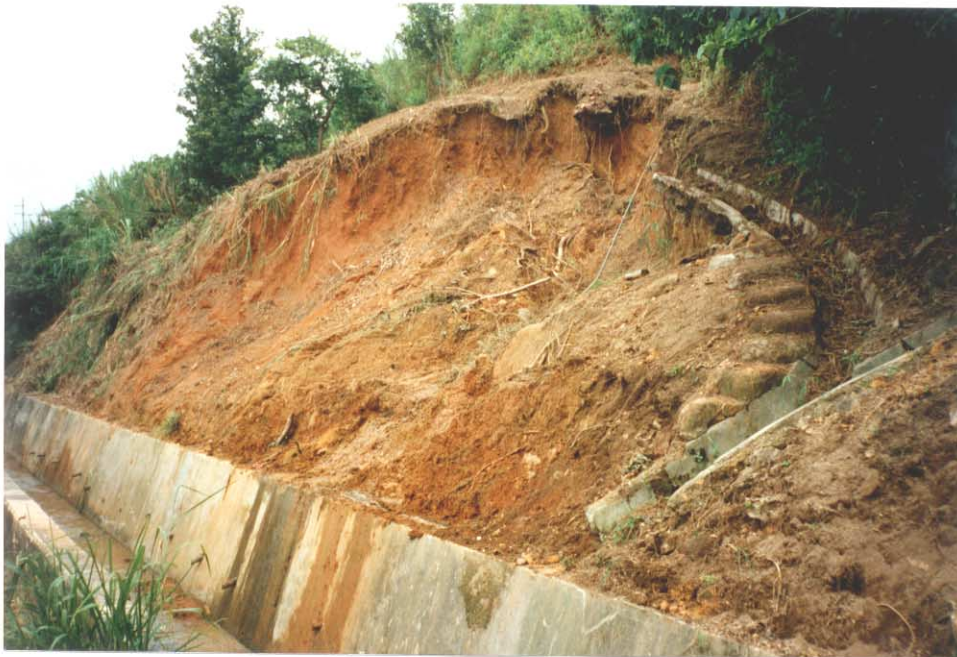
Plate 3 - Landslide 'C' on the Tai Lam Chung Catchwater Cut Slope No. 6SE-D/CR135 (Photograph Taken on 7 August 1997)

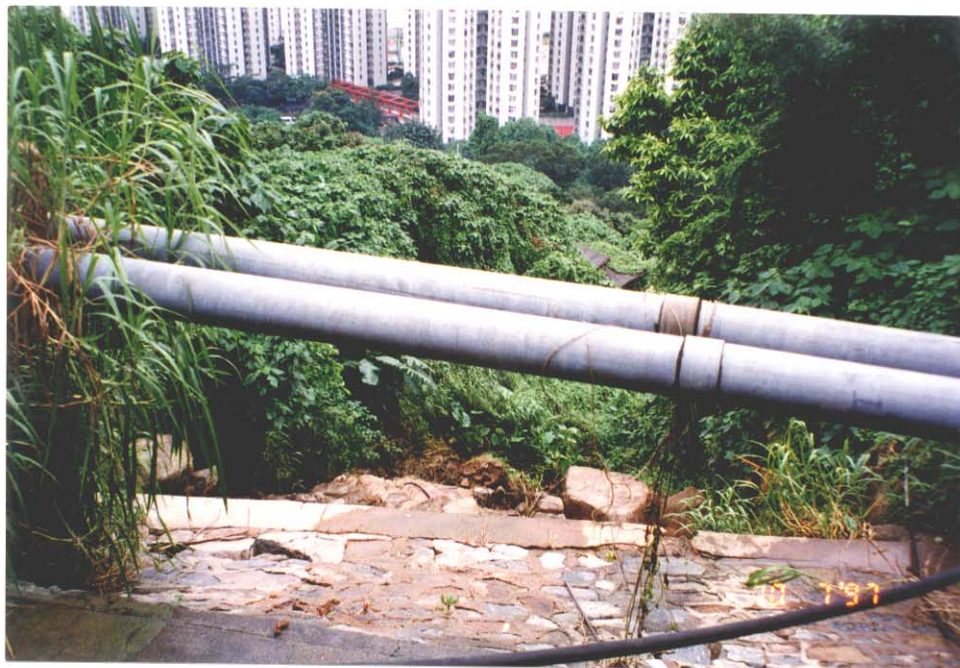
- (c) Complete blockage of the catchwater by the landslide debris resulted in the discharge of stormwater through the overflow weir 'X', causing the erosion of a large quantity of debris from the bed and banks of the stream.

Plate 4 - View Down the Stream from Overflow Weir 'X' on the Tai Lam Chung Catchwater (Photograph Taken on 10 July 1997)

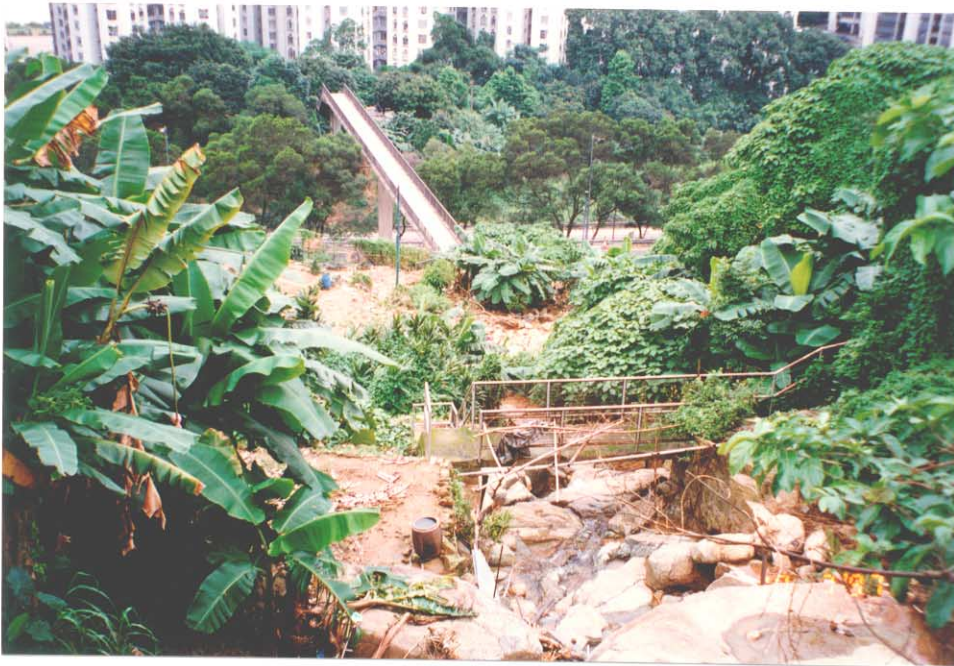
The stormwater eroded the banks of the stream. Existing boulders in the bed of the stream together with eroded soil, vegetation, loose masonry and rubbish from the adjacent abandoned squatter platforms were all transported downstream (Plates 5, 6 & 7). As a result, the whole length of the trapezoidal drainage channel 'D' above the highway cut slope (No. 6SE-D/C64) became completely blocked with debris (Plates 8 & 9). As a consequence, there was an uncontrolled discharge of stormwater and debris down the highway cut slope on either side of the cascade channel 'E' (Plate 10), onto both carriageways of Tuen Mun Road.

Plate 5 - View Down the Stream Showing the Flood Debris
(Photograph Taken on 10 July 1997)

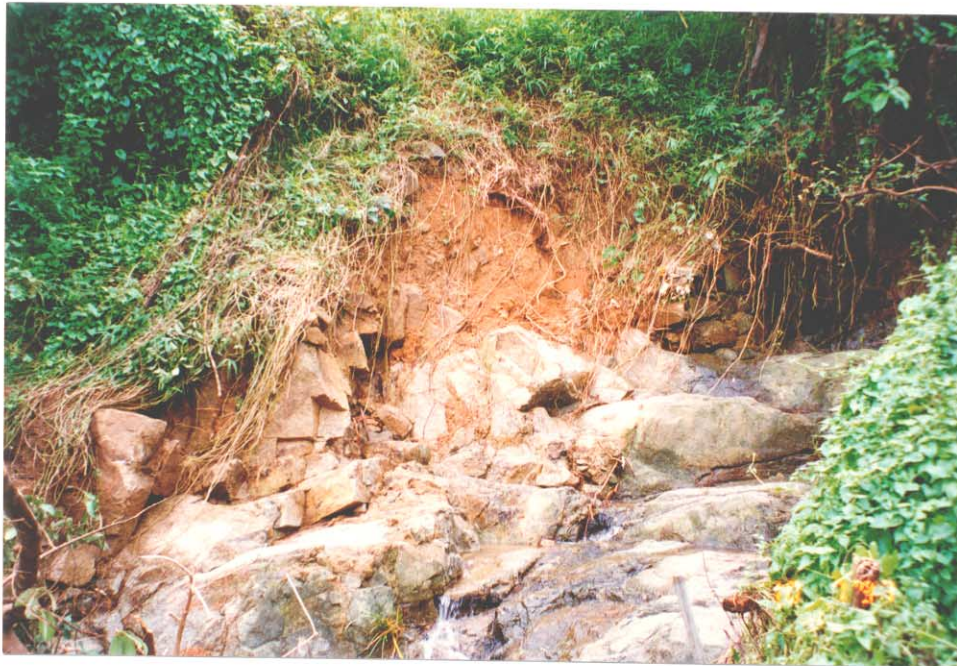
Plate 6 - Erosion of Banks of the Stream (Photograph Taken on 10 July 1997)

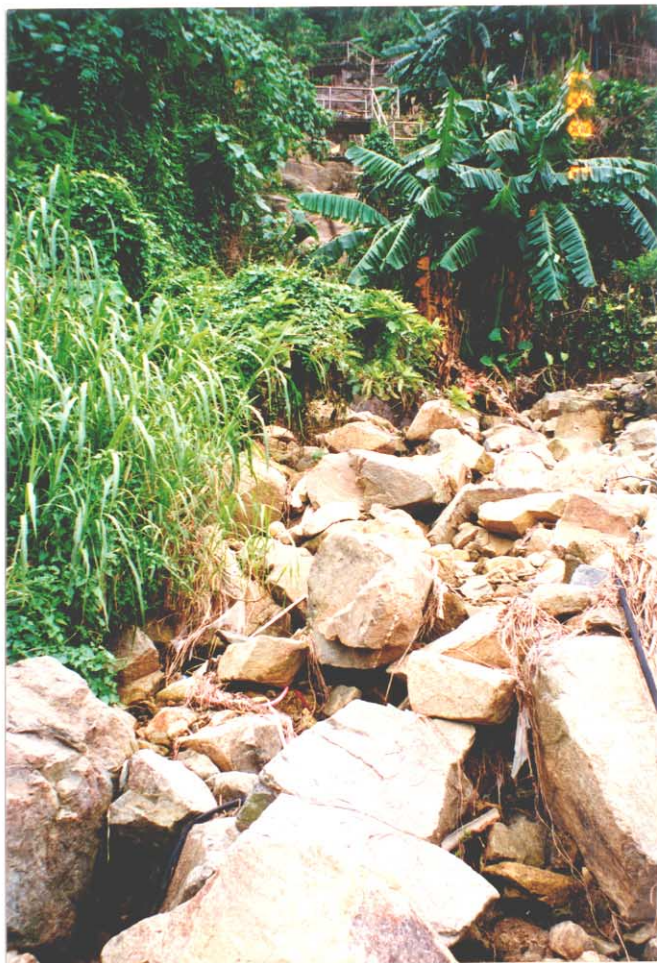
Plate 7 - Flood Debris Accumulated at a Break in Slope of the Stream (Photograph Taken on 7 August 1997)

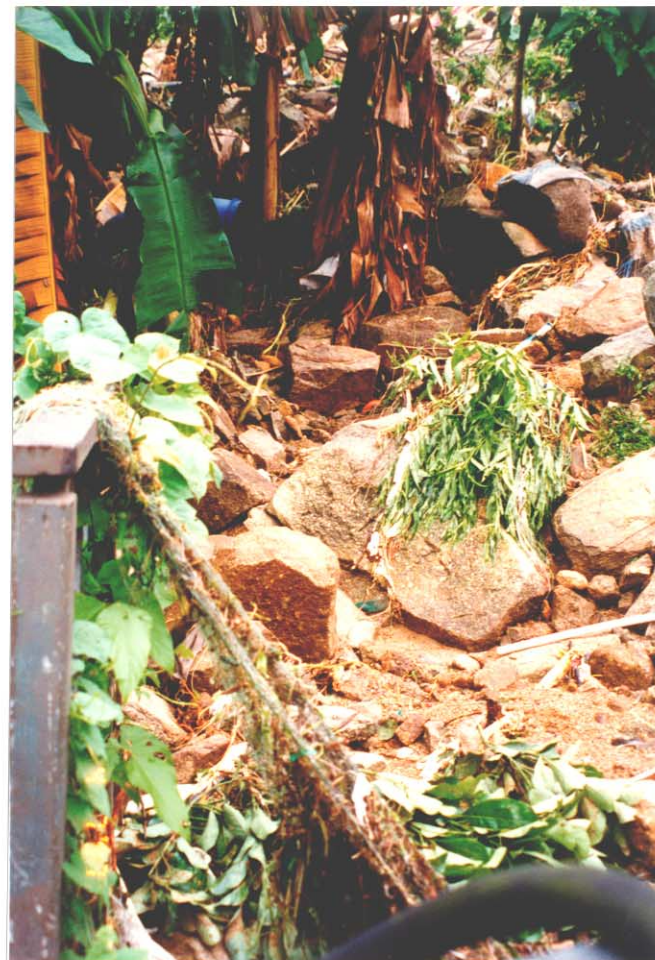
- (d) The constriction made by the footbridge at the outfall of the trapezoidal drainage channel 'D', which discharges to cascade channel 'E' on the highway cut slope, was liable to have contributed to the blockage of the trapezoidal channel by flood debris.

- (e) Blockage of the trapezoidal channel with debris prevented drainage of stormwater and resulted in uncontrolled

Plate 8 - Trapezoidal Drainage Channel 'D' Completely Blocked with Flood Debris (Photograph Taken on 4 July 1997)

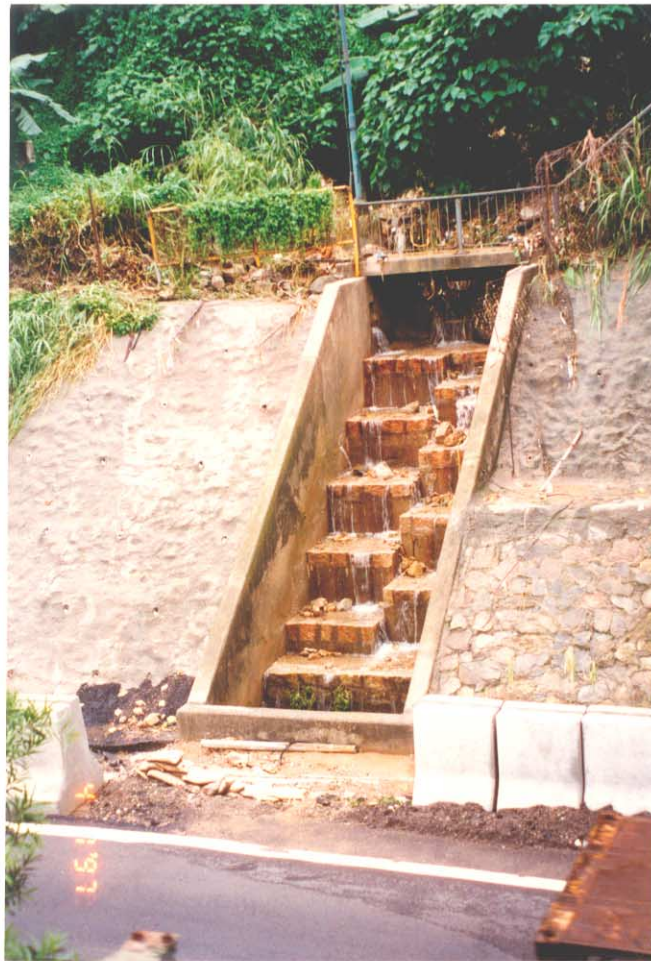
Plate 9 - Cascade Channel 'E' down Cut Slope No. 6SE-D/C64
Prior to Debris Clearance (Photograph Taken on 4 July 1997)

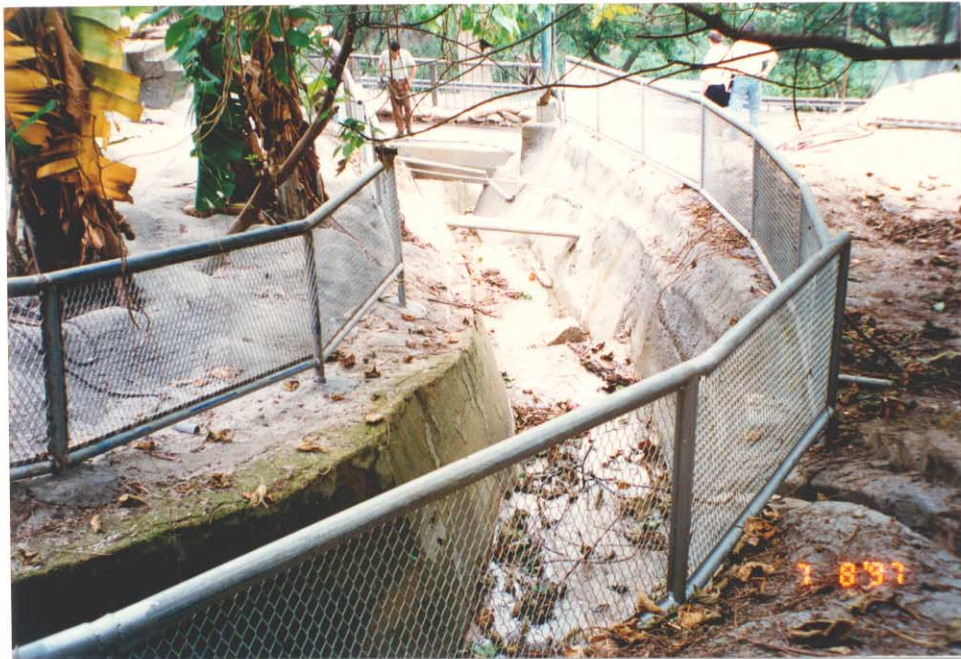
Plate 10 - Trapezoidal Drainage Channel 'D' above Cut Slope
No. 6SE-D/C64 after Urgent Repair Works (Photograph
Taken on 7 August 1997)

HyD contractors undertook urgent repair works to Tuen Mun Road between 02:15 hours and 15:15 hours on 3 July 1997. Apart from clearing the flood and washout debris, they applied shotcrete to the damaged slope Nos. 6SE-D/C64 and 6SE-D/F17. The west-bound carriageway was re-opened at 05:30 hours on 3 July 1997 and the east-bound carriageway was re-opened at 15:30 hours on 3 July 1997. There was significant disruption to traffic during the flooding incident and subsequent urgent repair works.

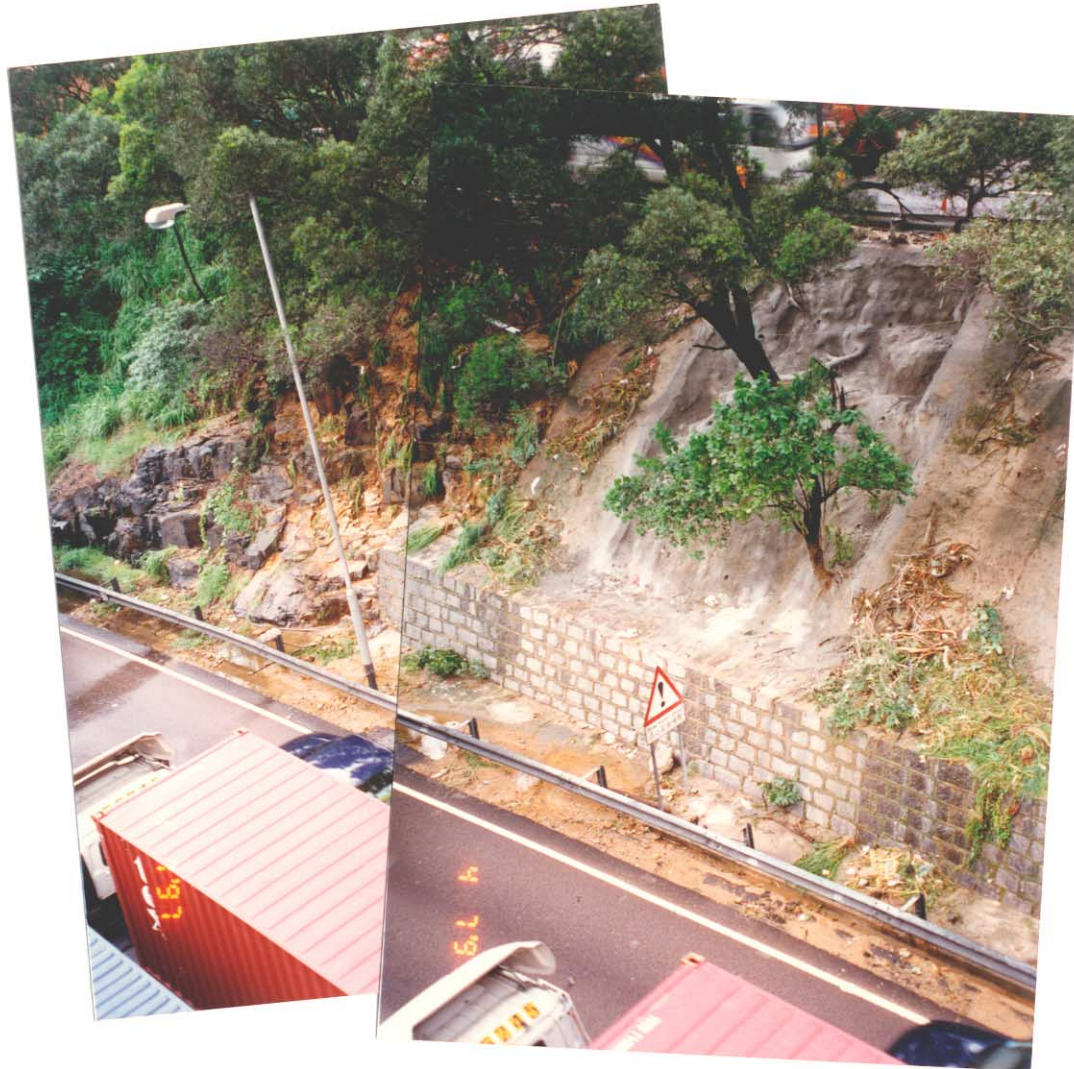
The impact of debris striking the road and the scouring action of the water caused damage to the surface of the east-bound carriageway of Tuen Mun Road for a length of approximately 50 m (HyD, 1997a).

Plate 11 - View of Fill Slope
No. 6SE-D/F17
between the East-
and West-Bound
Carriageways of
Tuen Mun Road
(Photograph Taken
on 4 July 1997)
