REPORT OF THE INDEPENDENT REVIEW PANEL ON FILL SLOPES

GEO REPORT No. 86

**GEOTECHNICAL ENGINEERING OFFICE
CIVIL ENGINEERING DEPARTMENT
THE GOVERNMENT OF THE HONG KONG
SPECIAL ADMINISTRATIVE REGION**

**This report was originally produced in December 1976 by
the Independent Review Panel on Fill Slopes appointed by
the Government of Hong Kong**

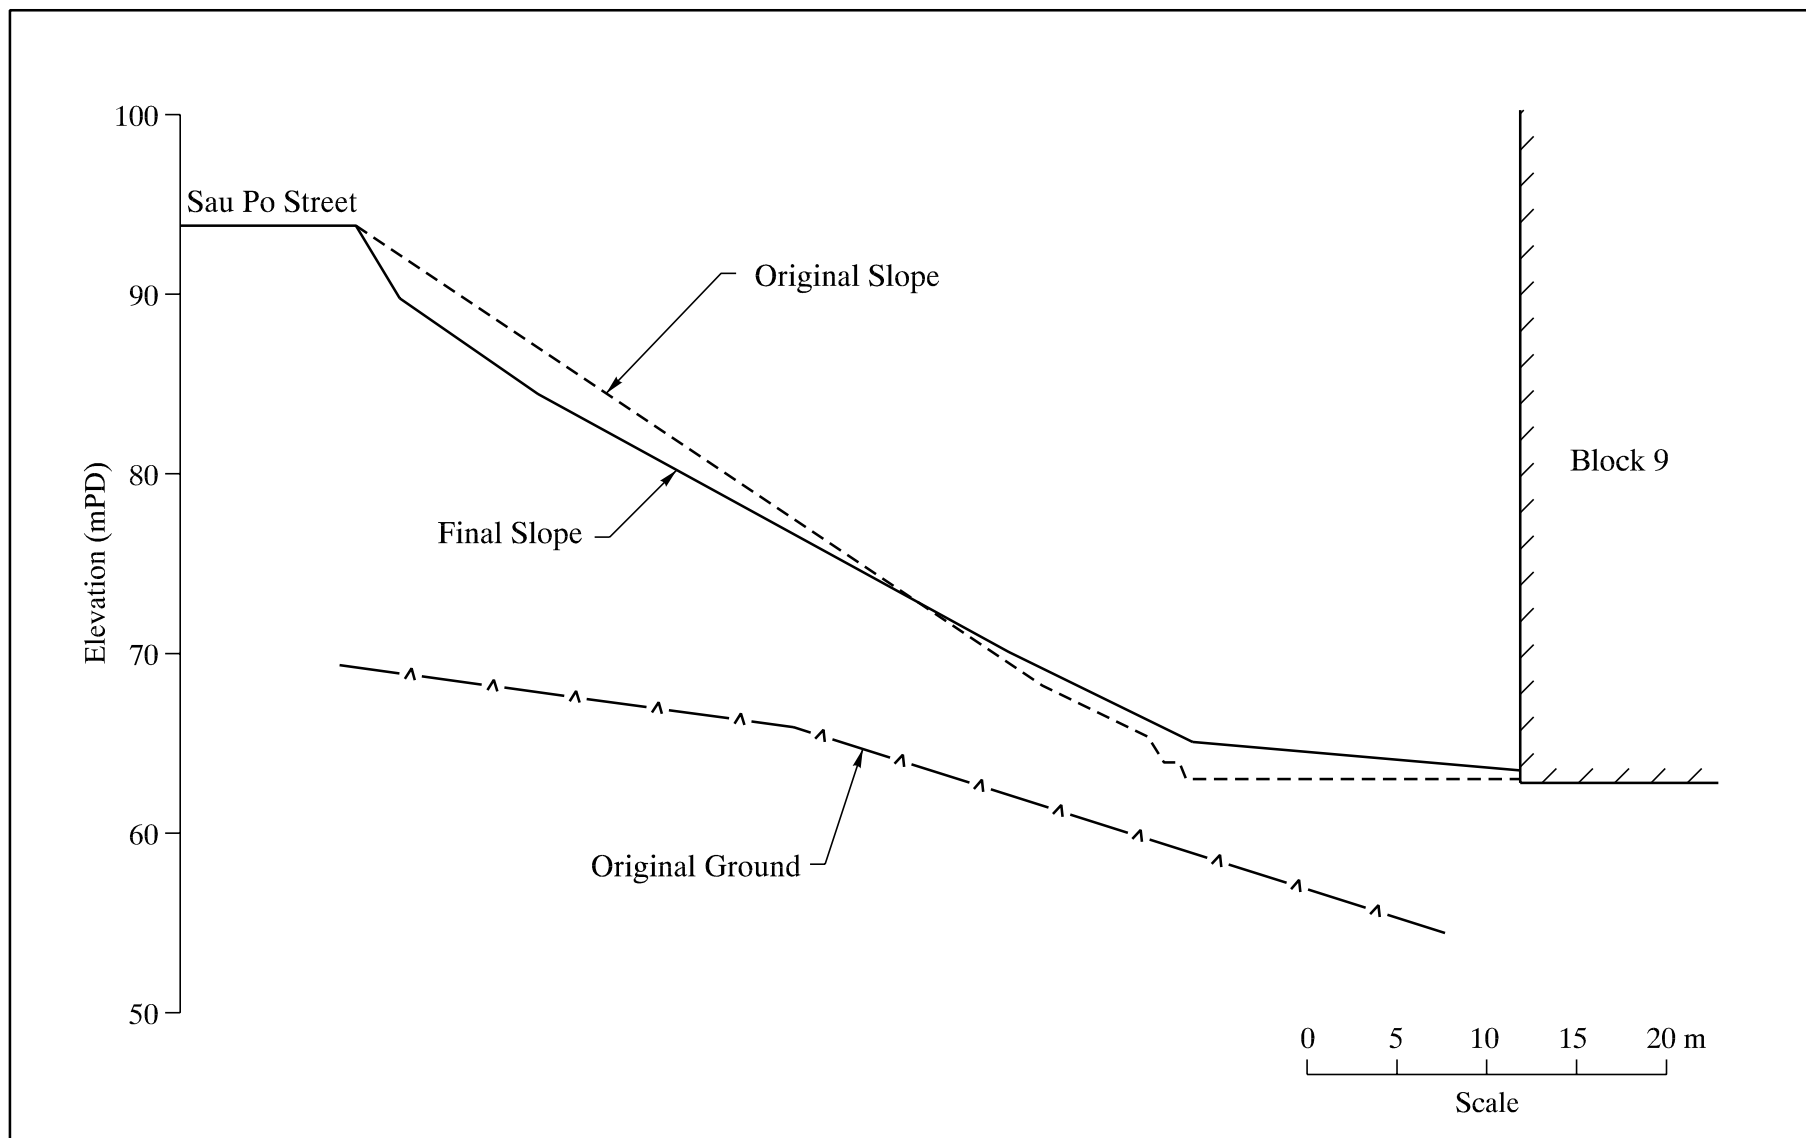
Figure 2 - Typical Section

- (ii) The soil on the slope was in an extremely loose state to a depth of at least 2 m below the slope surface, the dry densities being in the range of 1.25 to 1.55 t/m^3 (average 1.35 t/m^3), corresponding to about 75% of standard compaction.

3.9 For direct infiltration of rainwater, the depth of potential collapse is controlled by the rate at which water can percolate through the soil, by the rate and duration of the rains, and by the initial water content of the soil. As described in Appendix C it is estimated that the depth of wetted potentially collapsible soil, that could have developed at Sau Mau Ping during the August 1976 rainstorm, is of the order of 2 to 6 m. The actual thickness of failed material producing the mud avalanche was about 4 m (Ref. 2). Consequently, rainwater

infiltration into loose fill is the prime suspect for the disaster.
