# **INVESTIGATION OF SOME SELECTED LANDSLIDE INCIDENTS IN 1997 (VOLUME 2)**

**GEO REPORT No. 88**

**Halcrow Asia Partnership Ltd.**

**GEOTECHNICAL ENGINEERING OFFICE  
CIVIL ENGINEERING DEPARTMENT  
THE GOVERNMENT OF THE HONG KONG  
SPECIAL ADMINISTRATIVE REGION**

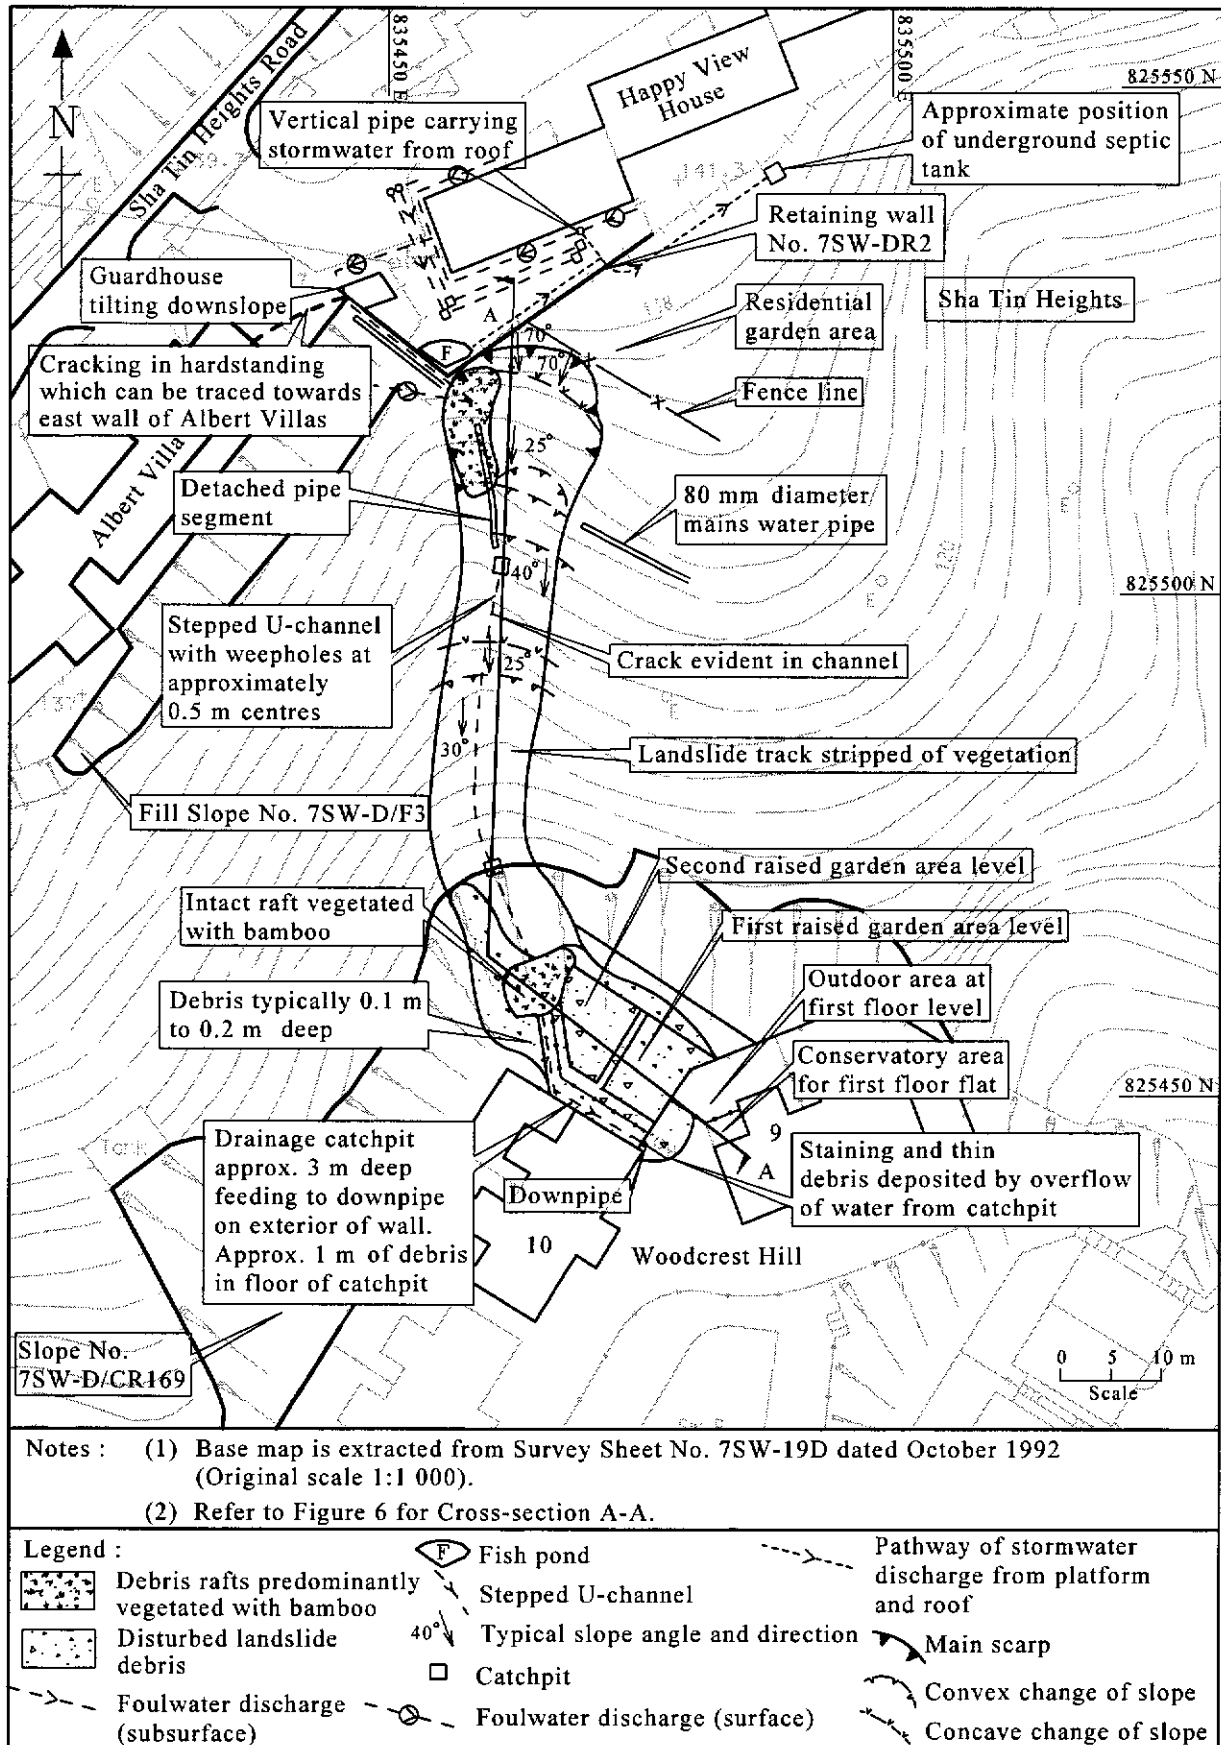
Figure 5 - Site Plan and Details of Landslide Incident No. MW97/6/12

The landslide originated near the crest of the slope at the toe of the cracked section of Retaining Wall No. 7SW-D/R2 (Plate 1). The main scarp was about 20 m long and 15 m wide, with an average depth of about 1.5 m (Plate 2, Figures 5 and 6). The volume of failed material was estimated to be about 150 m<sup>3</sup>.

An 80 mm diameter metal pipe, which previously crossed the area, was ruptured by the landslide, and a 10 m long segment was evident on the displaced raft (Figure 5). Records obtained from the Water Supplies Department (WSD) indicate that this pipe was a private mains supply installation. Reports from the Management Office of Woodcrest Hill indicate that the supply to the pipe was turned off after the failure in order to restrict discharge of water on to the slope.

The drainage system of the platform area is designed to collect and transmit stormwater to a septic tank away from the landslide location (Figure 5). Interviews with residents of Happy View House indicated that the system generally functions properly and that accumulation and flow of water from the platform area was not observed prior to the failure and has not been seen during previous heavy rainfall events. Run-off or stormwater discharge from the platform, therefore, appears to be an unlikely source of water. Similarly, there was no evidence, according to the residents, to indicate that leakage of water from the pipe occurred before the landslide.

Following the landslide, HyD cleared the landslide debris and applied a surface protection of shotcrete, in accordance with the GEO's recommendations. Further movements of the retaining wall were noted by FHL ten days after the landslide, prompting the urgent works as described in Section 2.3.2. During HAP's inspections, it was noted that there were considerable signs of distress immediately upslope of the wall. In addition to the tilted guardhouse noted by OAP (1995), there are cracks in the adjacent hardstanding area and within the northeast wall around Albert Villa (Figure 5).

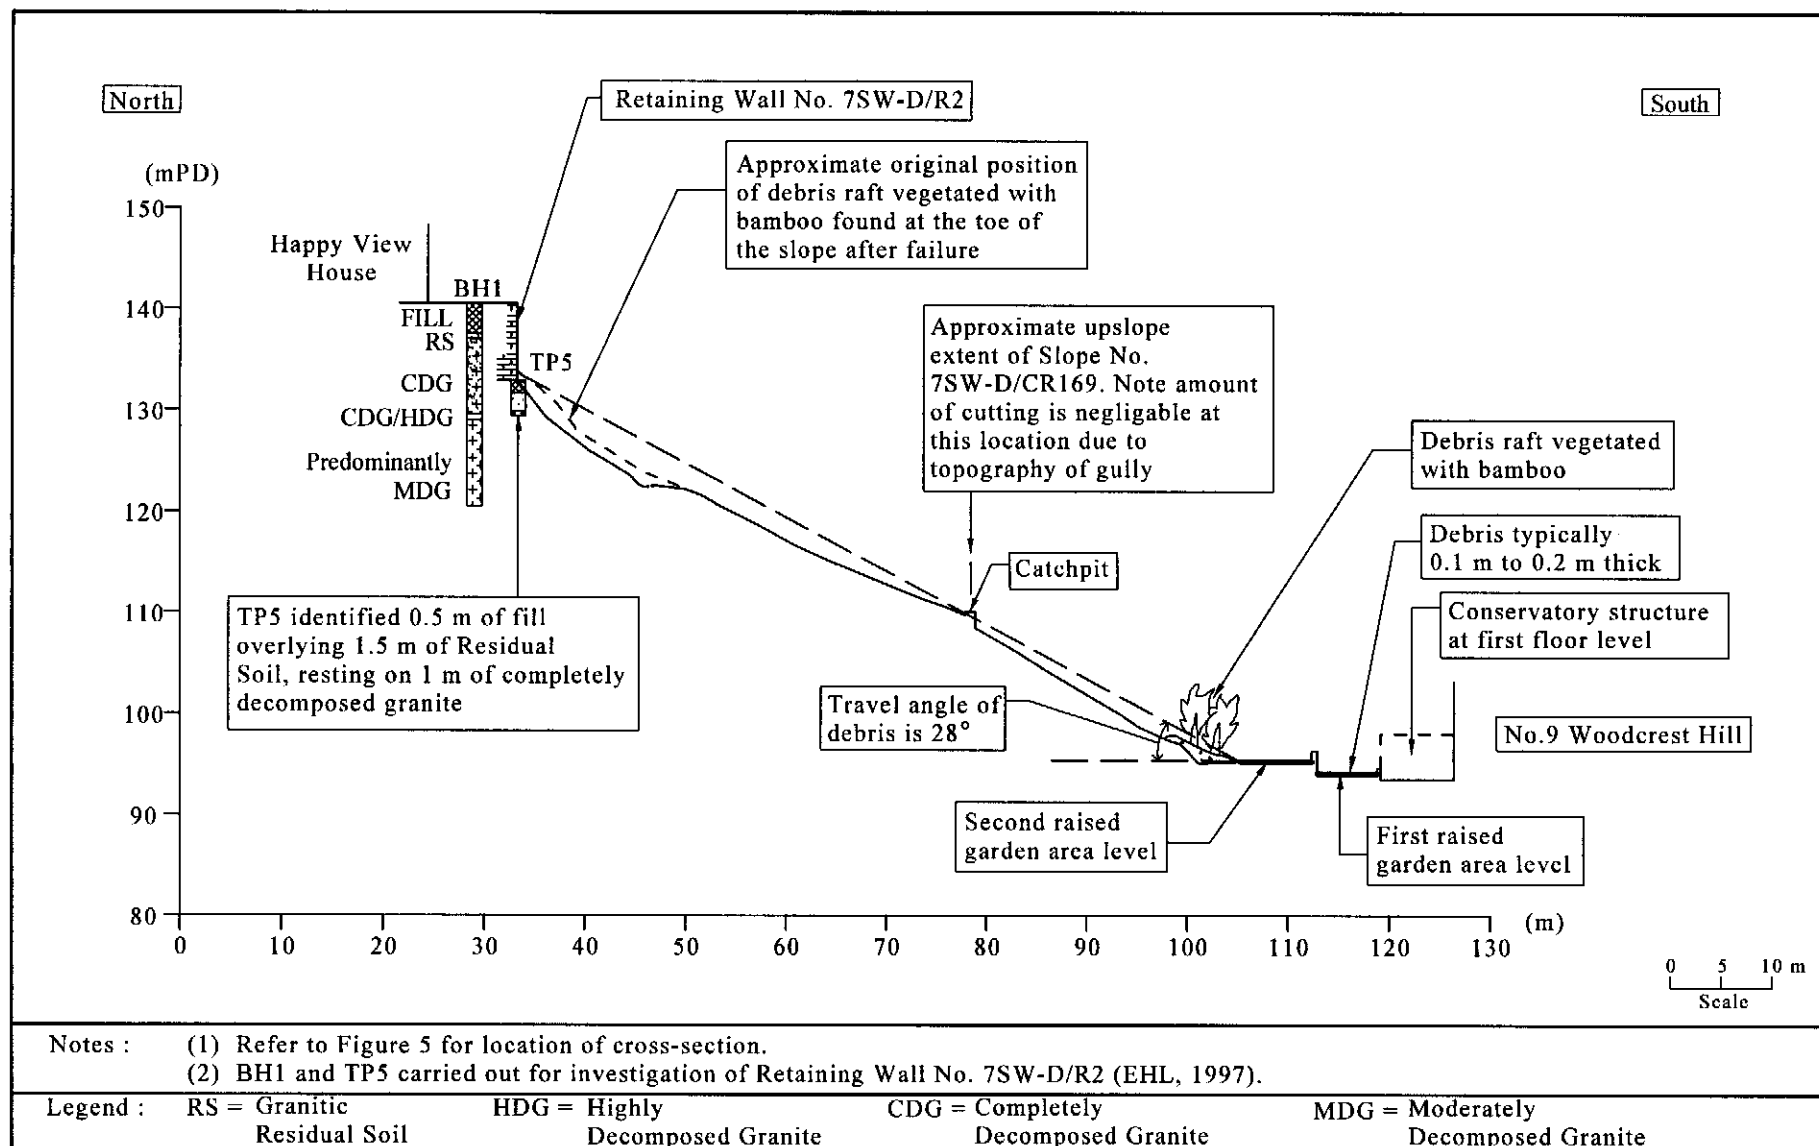
Figure 6 - Cross-section A-A Through Landslide Incident No. MW97/6/12

The maximum horizontal travel distance of the failed mass was about 90 m. The travel angle of the landslide debris, measured from the crest of the failure to the distal end of the debris raft in the second raised garden area (Figure 6), was 28°. According to Wong & Lam (1996), the debris mobility is comparable to that of other natural terrain landslides which could have been subjected to some influence of surface water.

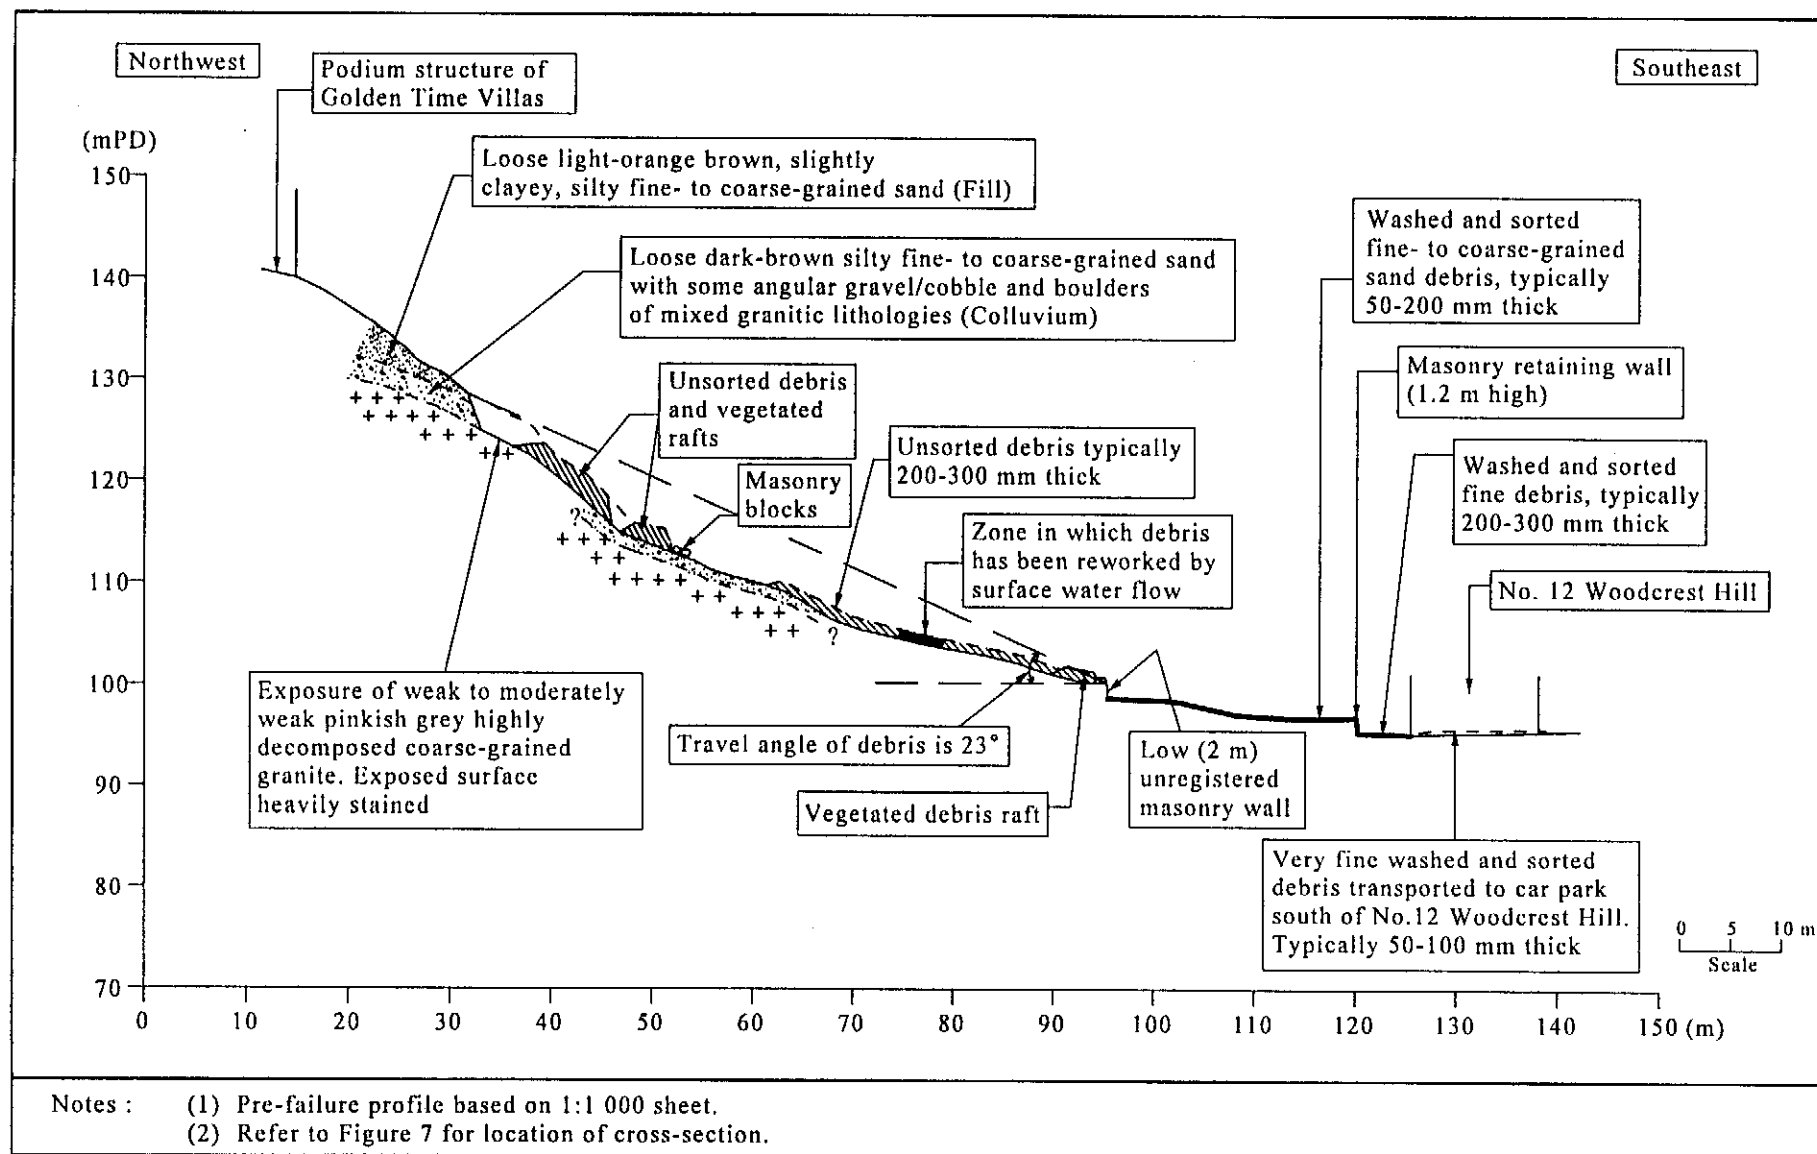
Figure 8 - Cross-section B-B Through Landslide Incident No. MW97/6/23

The landslide originated in apparent natural terrain, from an area of the slope about 15 m southeast of Golden Time Villas. The failure produced a main scarp about 25 m long, up to 11.5 m wide and with an average depth of 1.5 m (Plate 7, Figures 8 and 9). The volume of the failed mass was estimated to be about 170 m<sup>3</sup>.

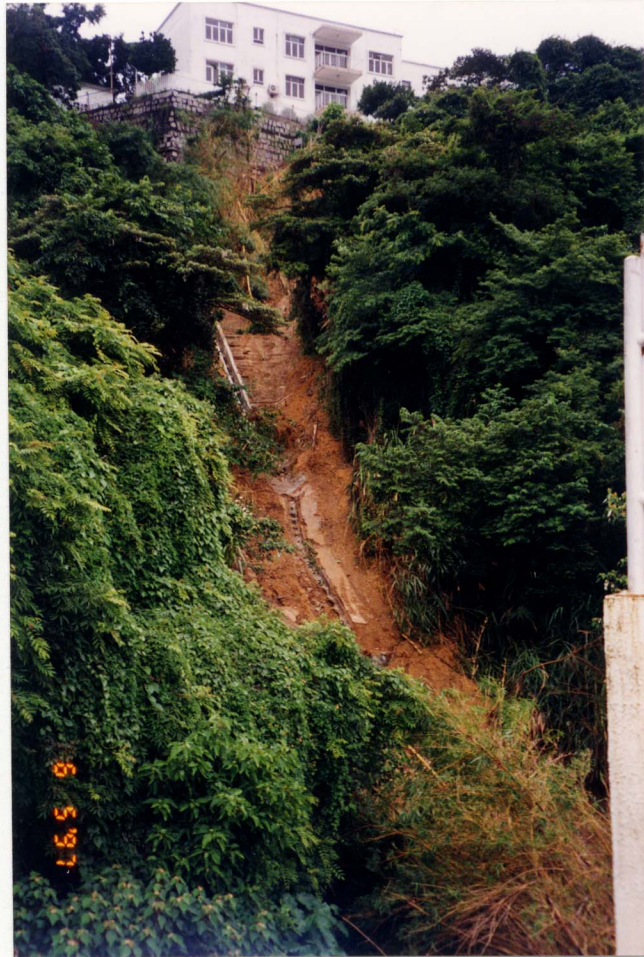
Plate 1 - General View of the Setting of Incident No. MW97/6/12  
(Photograph Taken on 5 June 1997. Note Retaining  
Wall No. 7SW-D/R2 and the Buildings of Happy View  
House at the Crest, and the Pre-existing Stepped Drainage  
Channel along the Centre of the Debris Track)

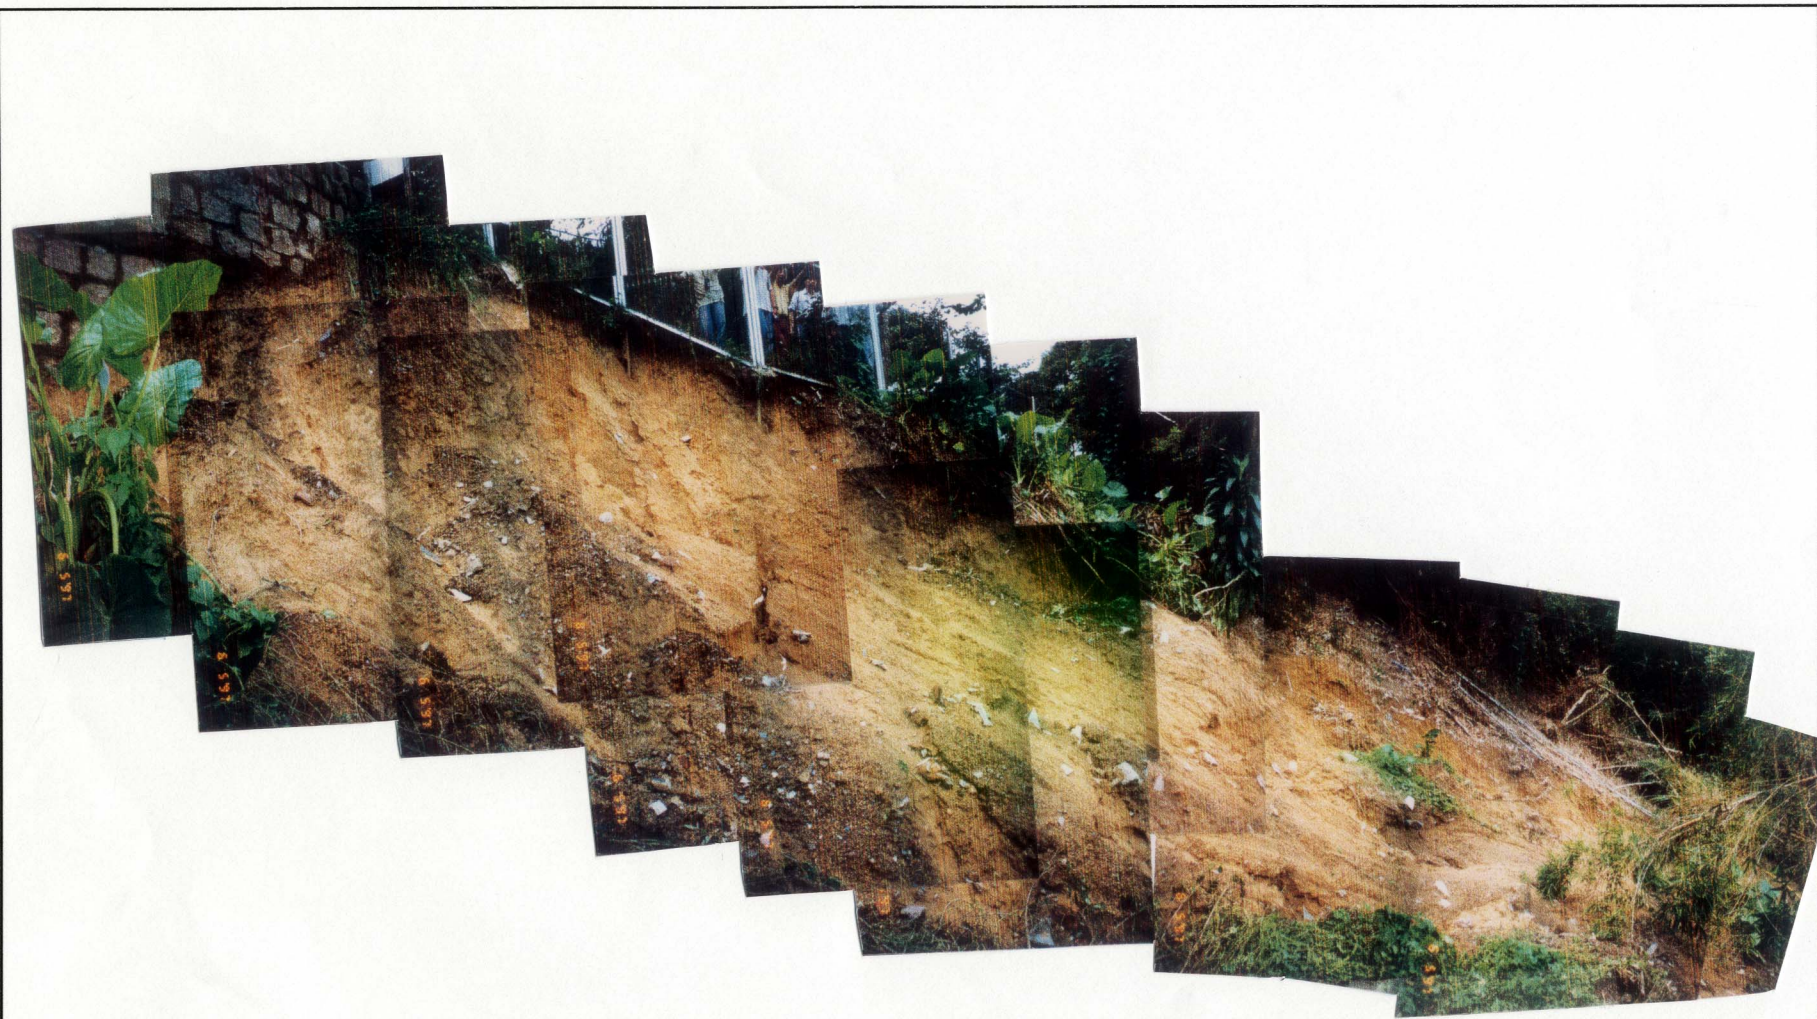
It was not possible to safely access the main scarp of the failure, but the exposed material appeared to be significantly more granular than the underlying residual soil encountered in trial pit TP5, formed subsequently at the central part of the main scarp (Figures 4 and 6). This observation, together with the known deposition of fill in the head of the gully during the development of Happy View House, suggest that the material involved in the failure was predominantly fill. The failure appeared to have originated as a sliding failure within this material.

Plate 2 - View Looking Northeast Across the Main Scarp of Incident No. MW97/6/12 (Photograph Taken on 5 June 1997)

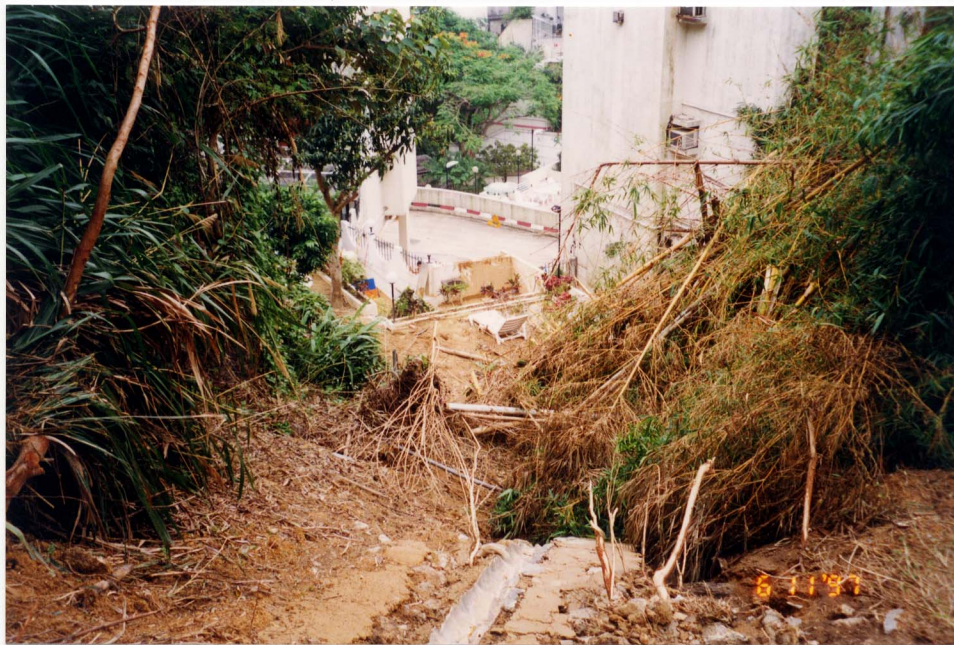
Plate 3 - Southwestern View of the Lower Part of the Gully Showing the Distribution of Landslide Debris from Incident No. MW97/6/12 (Photograph Taken on 11 June 1997. Note the Vegetation Pile on the Right of the Frame and the Debris on the Patio Areas of Woodcrest Hill)

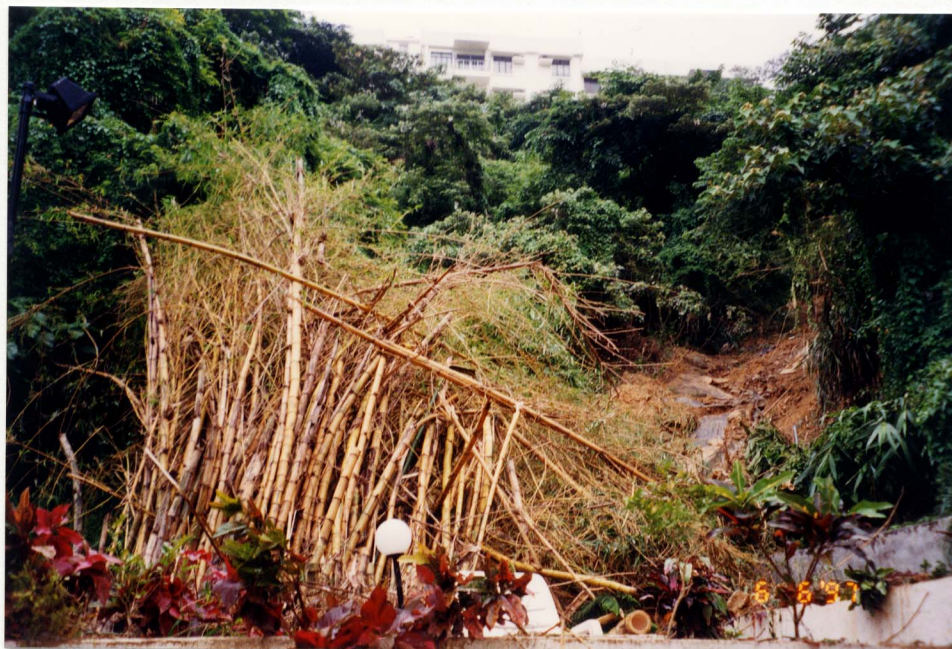
Plate 4 - Upslope View of the Gully at Incident No. MW97/6/12 (Photograph Taken on 6 June 1997. Note the Intact Raft of Landslide Debris Covered by Bamboo)

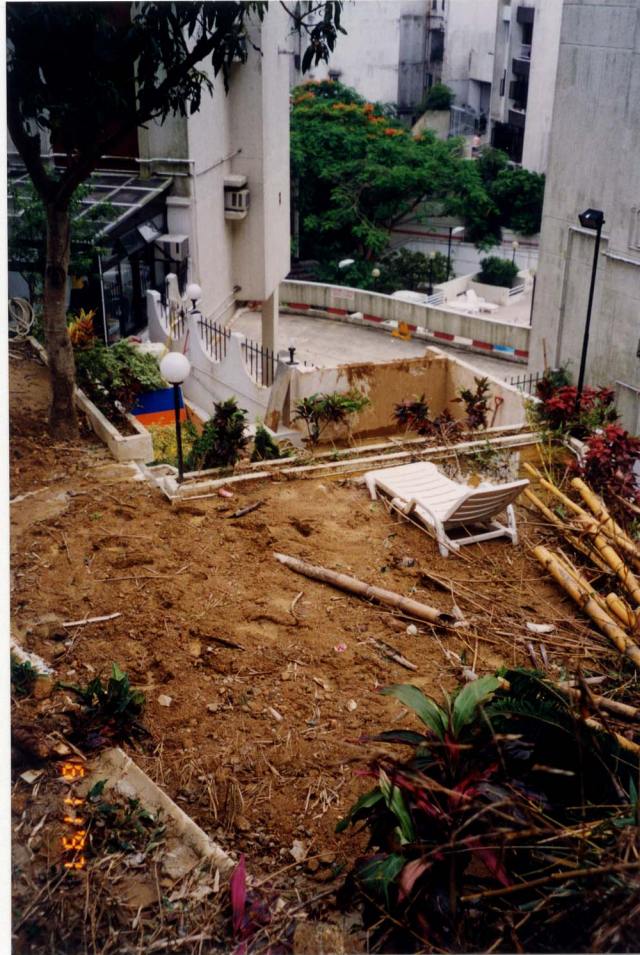
Plate 5 - View of Debris from Incident No. MW97/6/12 which Inundated the Patio of a First Floor Flat at No. 9, Woodcrest Hill (on left of frame) (Photograph Taken on 11 June 1997)

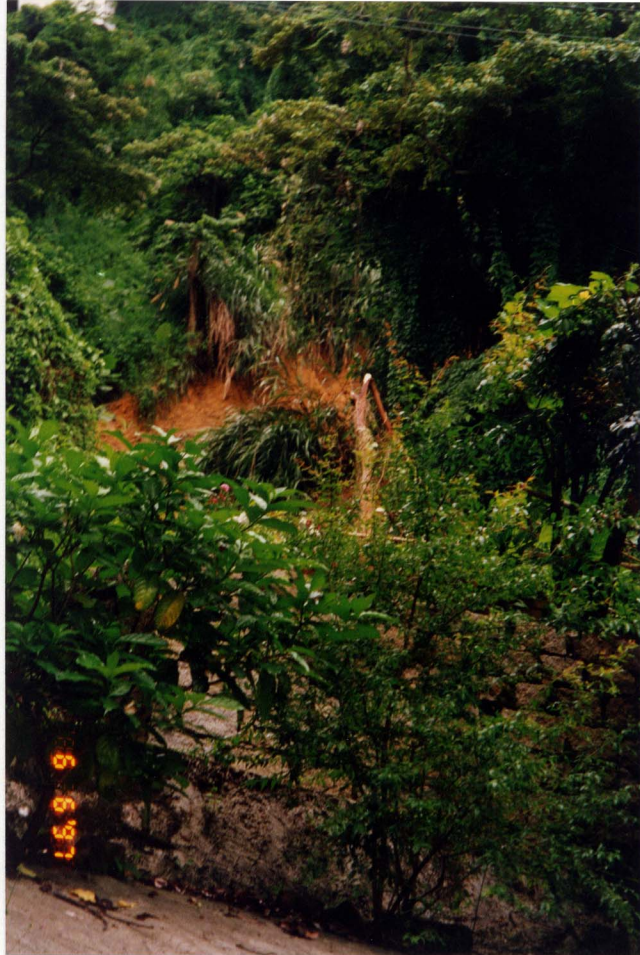
Plate 6 - Upslope View of Incident No. MW97/6/23  
(Photograph Taken on 6 June 1997)

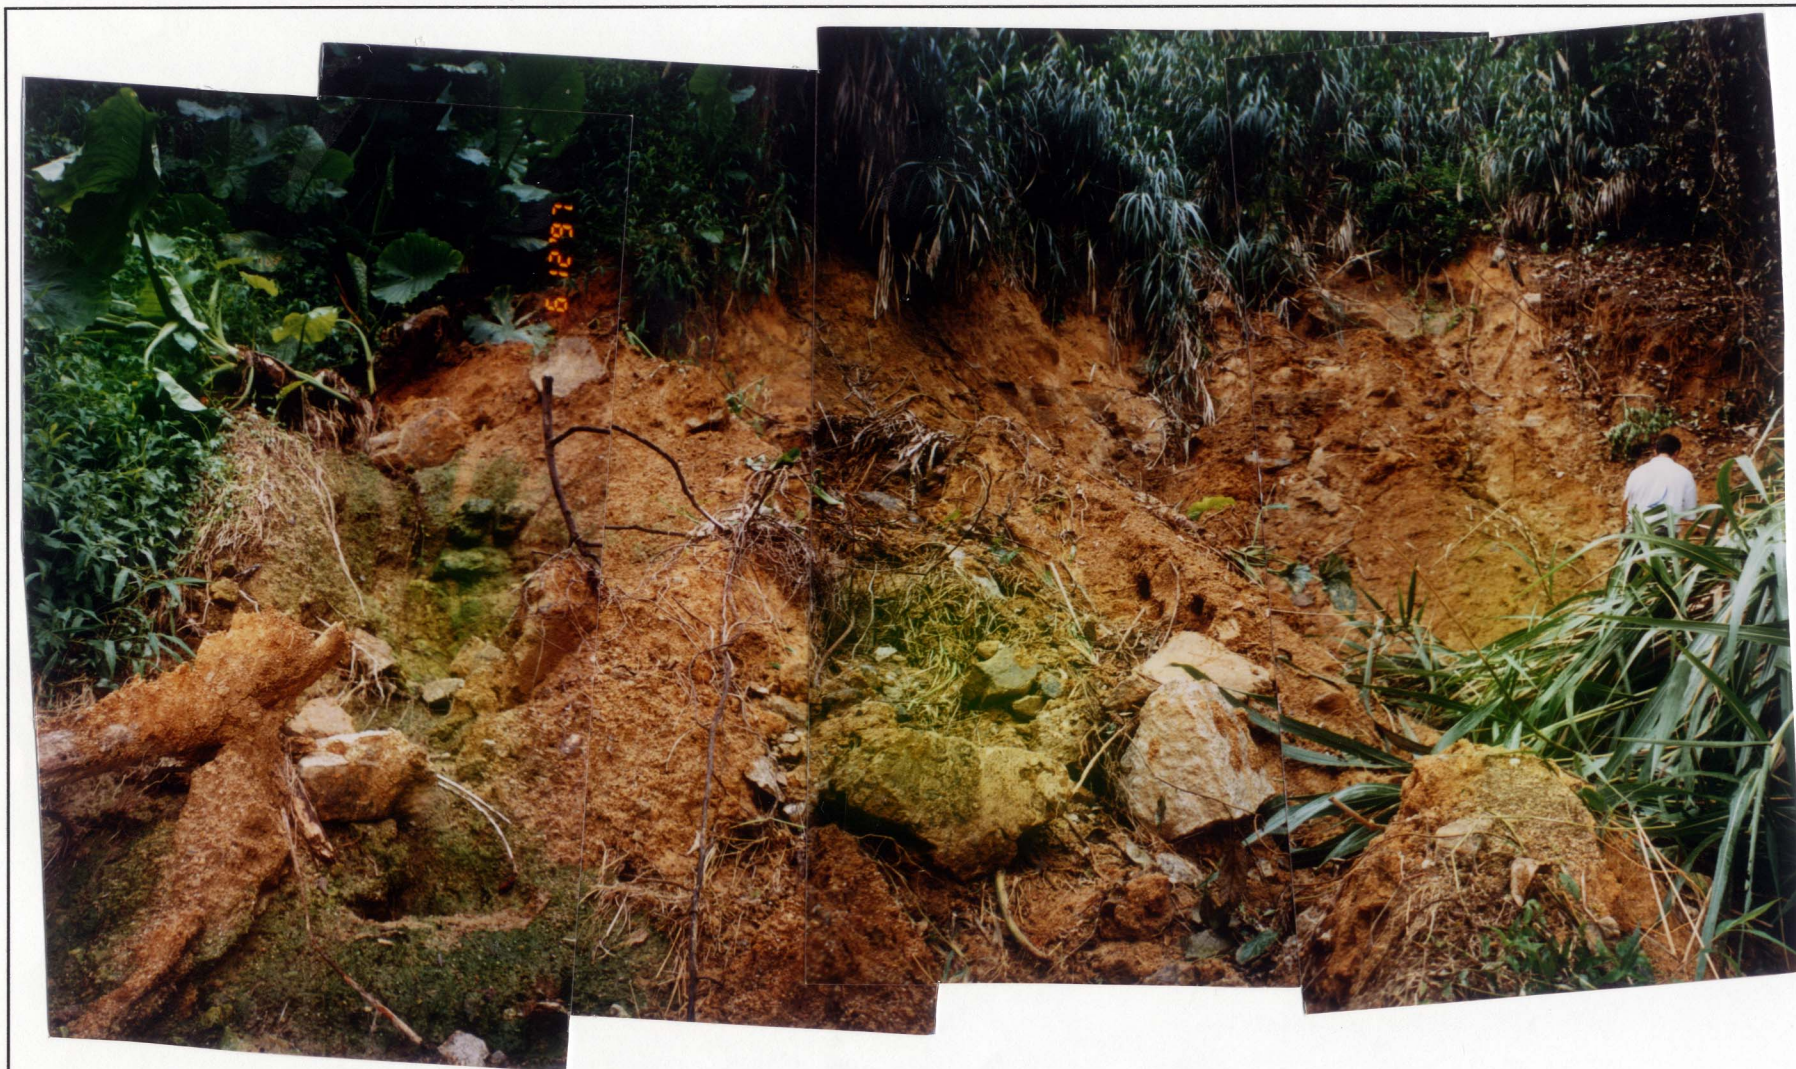
The failure occurred predominantly in colluvium and the overlying fill. A heavily stained surface of highly decomposed granite was exposed beneath these superficial materials in the upper part of the main scarp. The morphology of the main scarp suggests that the landslide may have occurred in three phases (Figure 7). The initial failure was probably the largest, with an estimated volume of 130 m<sup>3</sup>. Debris from this failure, including a vegetated raft, which travelled about 65 m down the gully and was deposited in a relatively flat area above a retaining wall behind No. 12 Woodcrest Hill (Plate 11 and Figure 7). Some of the debris from this phase of the failure was deposited within the stream bed near the toe of the main scarp. Debris from two subsequent, retrogressive failures totalling about 40 m<sup>3</sup> in volume, appeared to have been retained largely within the main scarp. Material retained in the main scarp had been subjected to significant erosion by post-failure surface water flow.

Plate 7 - Upslope View of the Main Scarp of Incident No. MW97/6/23 (Photograph Taken on 12 June 1997.  
Note the Algae Stained Streamcourse on Left of Frame)

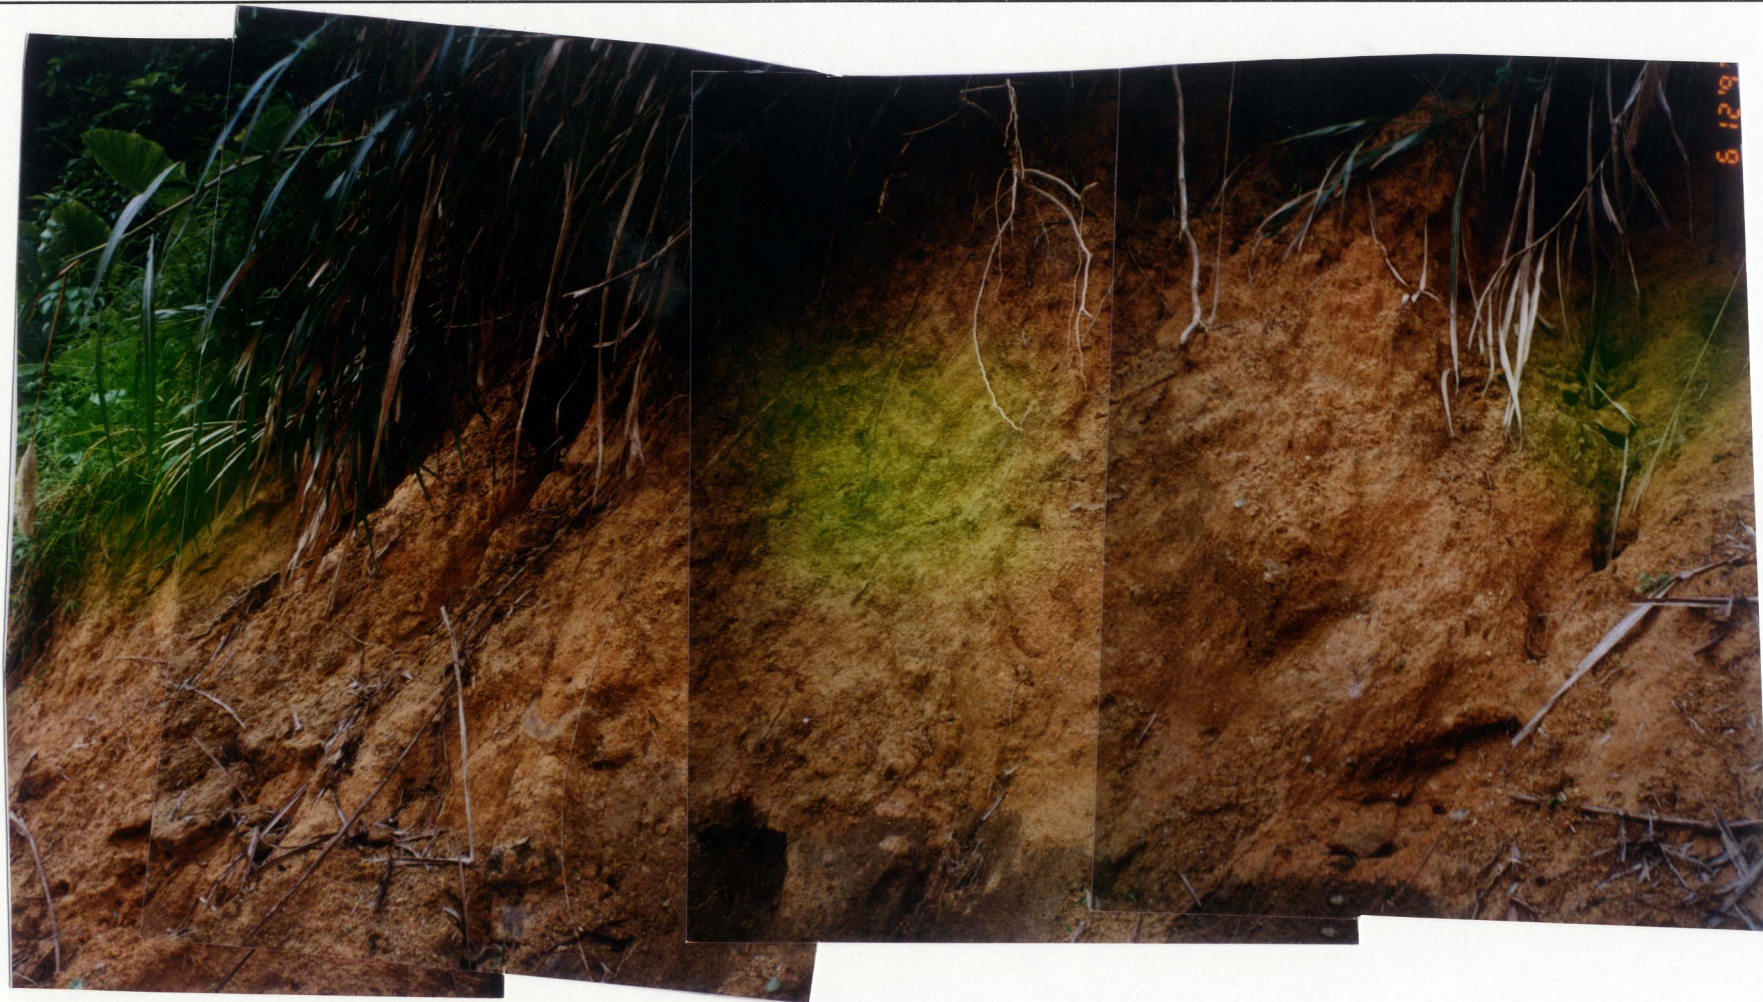
Plate 8 - Close-up of Western Flank of the Main Scarp of Incident No. MW97/6/23 (Photograph Taken on 12 June 1997. Note the Sub-horizontal Contact between the Pale Granular Fill and Underlying Material Interpreted as Colluvium, and Possible Pipes in Centre and Right of Frame)

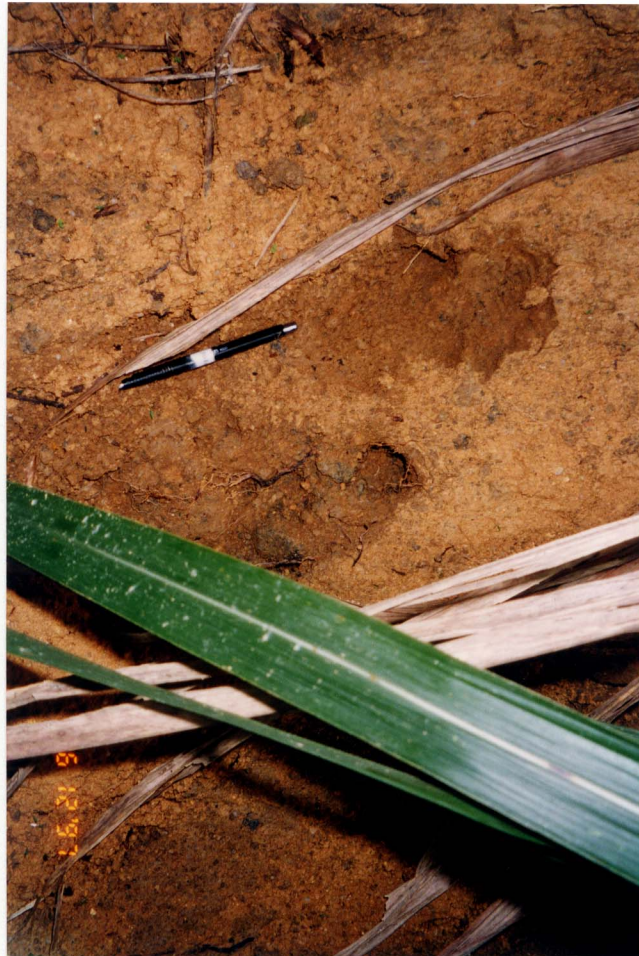
Retrogression of the landslide, and the narrowing of the main scarp in an upslope direction, suggest that a concentrated source of water may have initiated the development of the failure. Three erosion pipes were also observed within the colluvium and fill which indicate that groundwater flows had occurred in the near-surface materials at the landslide site. It is possible that the groundwater flow that formed the erosion pipes is related to the ongoing discharge of water on to the slope from Golden Time Villas. No seepages were observed from the erosion pipes during an inspection of the landslide site on the day following the failure.

Plate 9 - Close-up of Pipes in Colluvium in the Main Scarp of Incident  
No. MW97/6/23 (Photograph Taken on 12 June 1997)

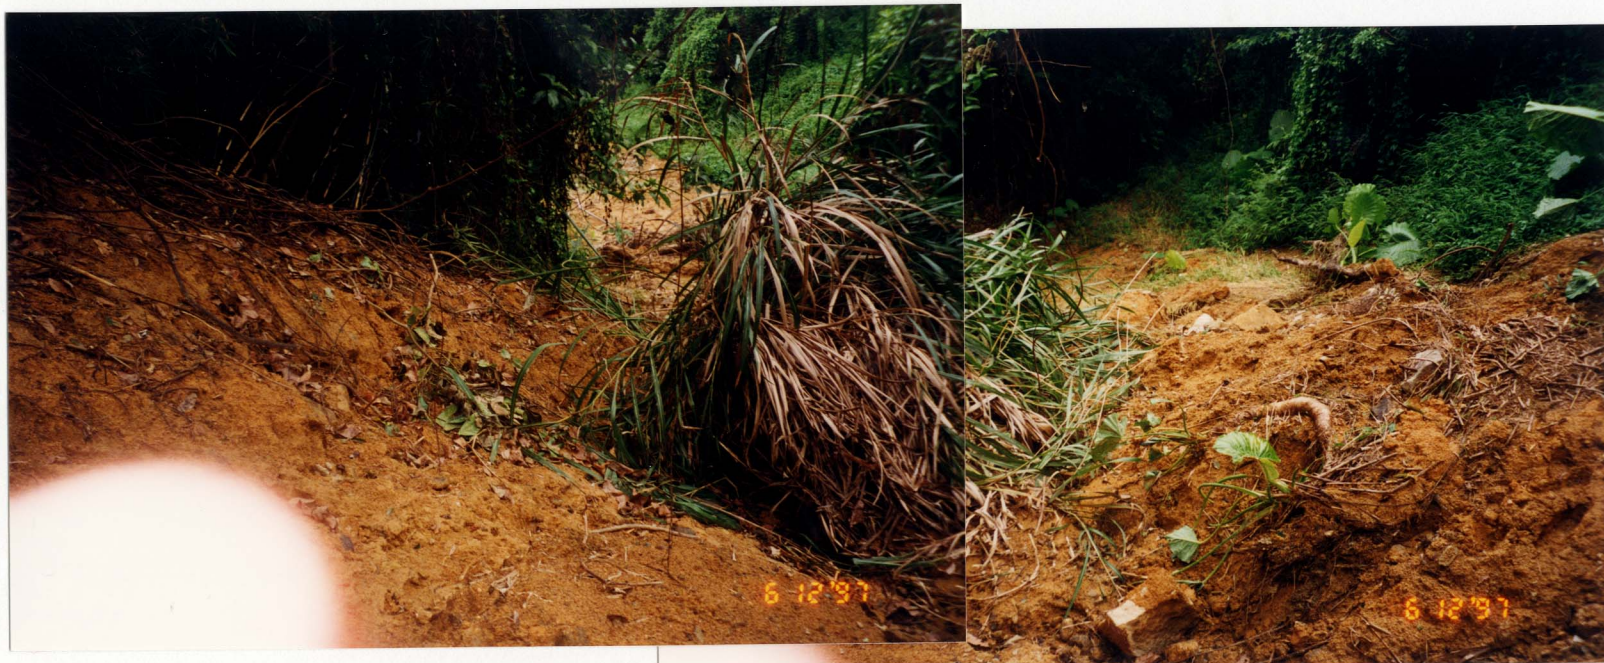
Plate 10 - Downslope View of Incident No. MW97/6/23 (Photograph Taken on 12 June 1997.  
Note the Vegetated Raft of Debris Centre Frame)

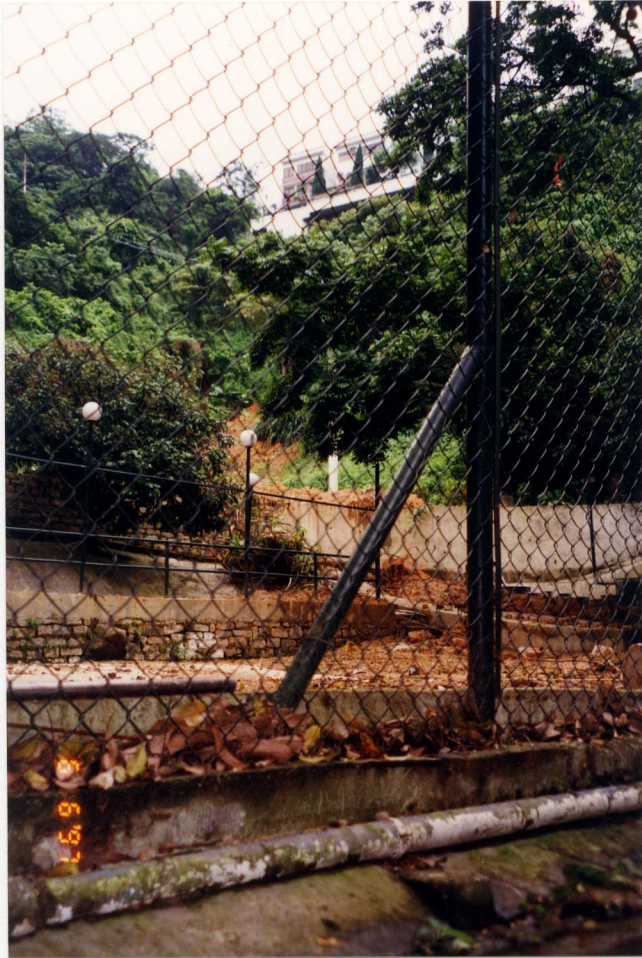
Plate 11 - Upslope View of  
Lower Part of  
Debris Trail From  
Incident No.  
MW97/6/23  
(Photograph Taken  
on 6 June 1997)

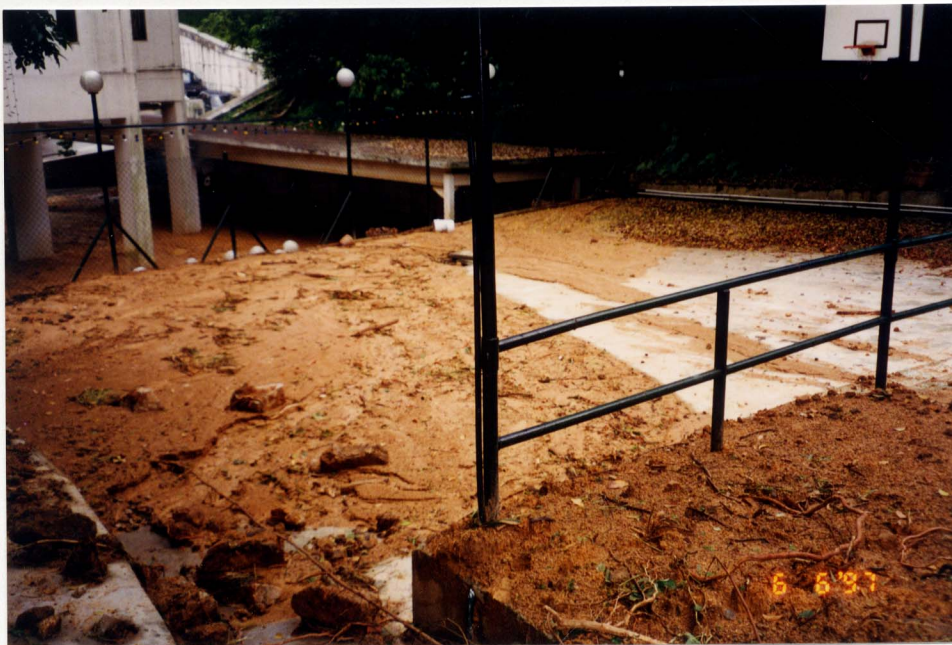
Substantial re-working of the debris occurred after the failure and resulted in progressive inundation of the playground and carpark area near No. 12 Woodcrest Hill. It appears likely that

Plate 12 - View of Debris Run-out at Toe of Slope Following Incident  
No. MW97/6/23 (Photograph Taken on 6 June 1997)
