**SECTION 2:
DETAILED STUDY OF THE
LANDSLIDE BEHIND
BLOCKS 3 AND 4
WONDERLAND VILLAS,
KWAI CHUNG
ON 8 MAY 1997**

Halcrow Asia Partnership Ltd

**This report was originally produced in May 1998
as GEO Landslide Study Report No. LSR 11/98**

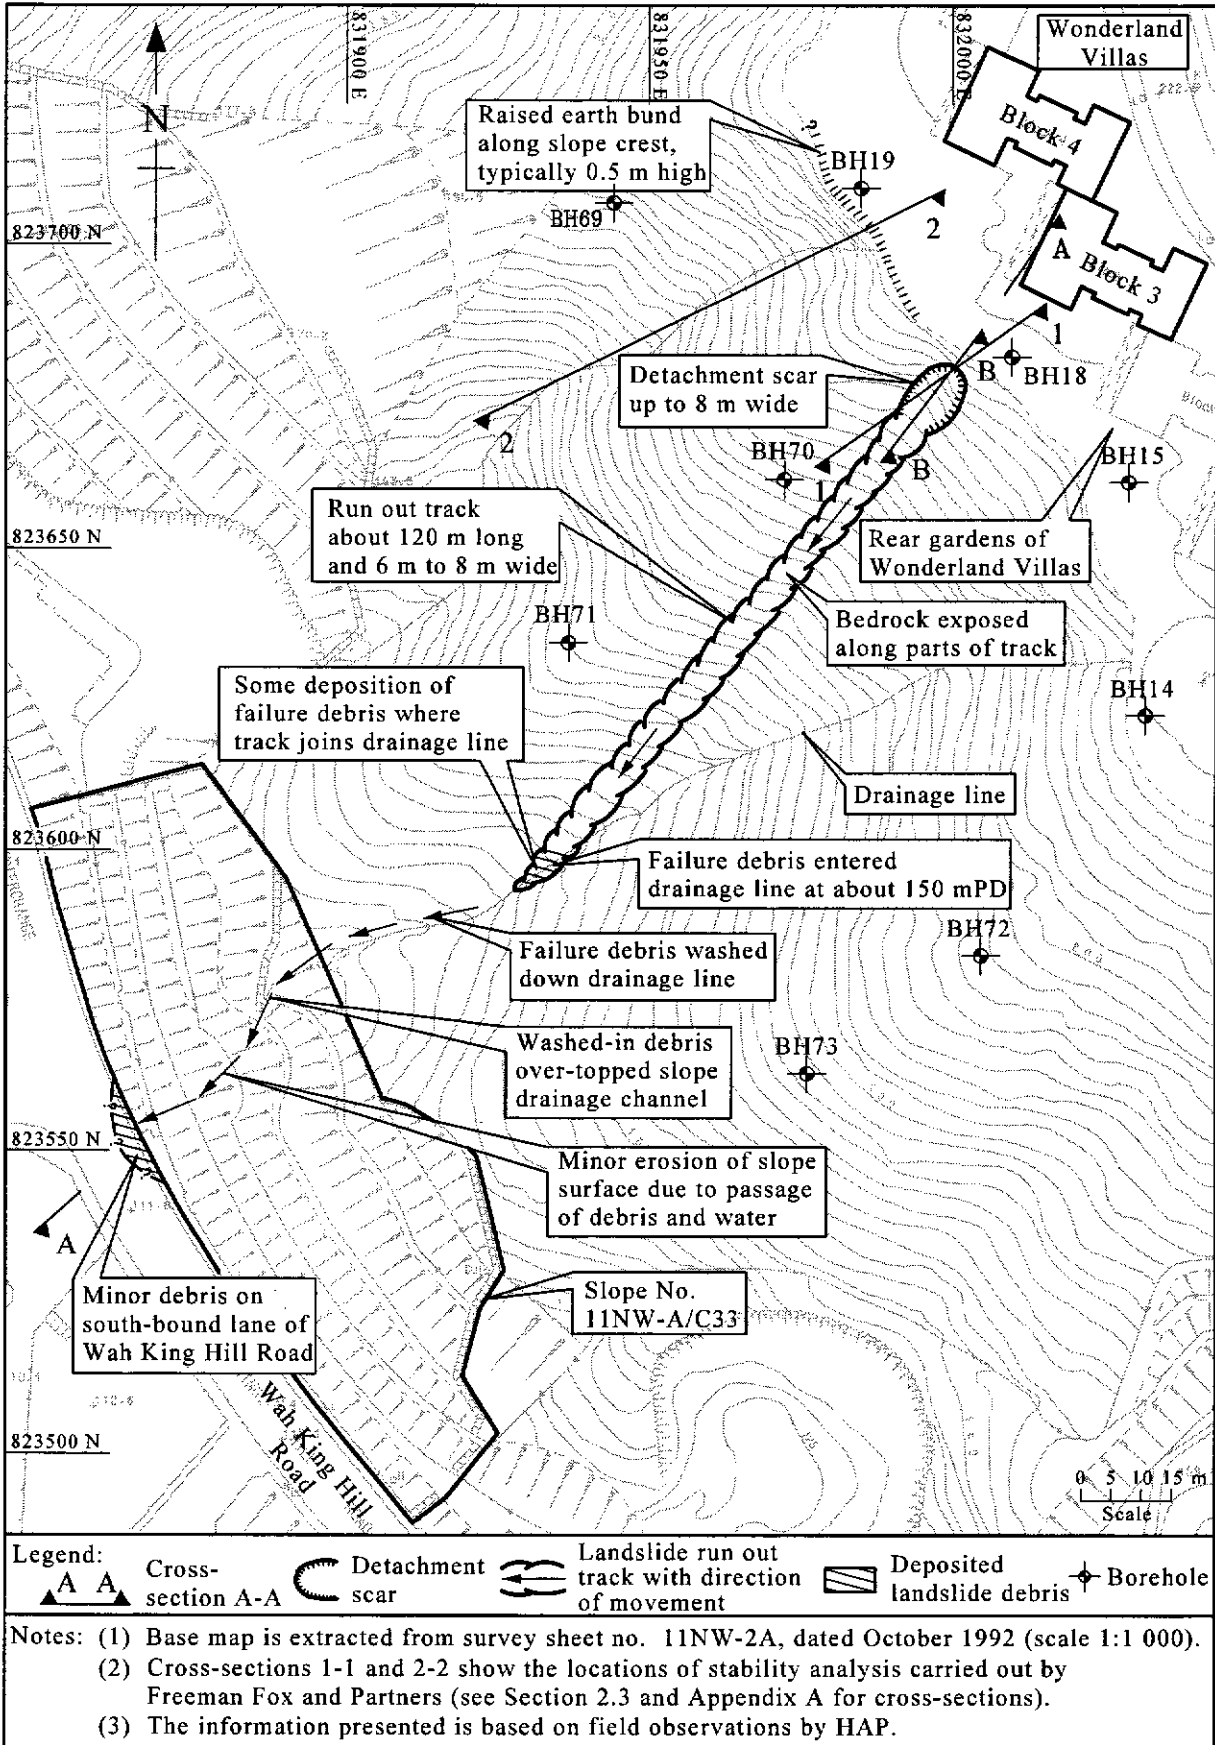
Figure 2 - Plan of Landslide

The location of the landslide is shown in Figure 2. The failure occurred at the crest of a natural hillside at approximately 220 mPD, behind Blocks 3 and 4 Wonderland Villas, Kwai Chung and above Wah King Hill Road. The failure comprised a detachment scar at the slope crest with a run out track (Plate 1). A drainage line intercepted the run out track at about 150 mPD and diverted the landslide debris onto cut slope No. 11NW-A/C33 and then onto Wah King Hill Road.

A walk-over survey was undertaken at the site on 8 May 1997 to establish details of the incident. The observations are presented in Figure 2 and a cross-section through the landslide detachment scar is shown in Figure 4. The landslide involved two phases of movement: initial sliding of in situ material from beneath the slope crest followed by the detached material over-riding the existing ground surface along the run out track. The failed material entered a drainage line, in which it was washed downstream over slope No. 11NW-A/C33 and onto Wah King Hill Road.

The landslide run out track from the detachment scar to its intersection with a drainage line was approximately 120 m long and 6 m to 8 m wide (Figure 2 and Plate 4). The inclination of the track was typically between 33° and 35°. Inspection of the track showed that the landslide debris over-rode the existing ground surface, flattening and stripping vegetation along its path. Along the center-line of the track were areas of exposed bedrock (Plate 4), possibly the result of removal of the overlying thin soil deposits by the passage of landslide debris. On the outer margins of the track, low deposition levées were present. The net volume of the failed material appeared to have remained almost constant throughout its travel.

At about 150 mPD the landslide debris was intercepted by a natural drainage line that obliquely intersected the run out track (Figure 2). Deposition of landslide debris upslope of the drainage line suggests that the momentum of the debris was decreasing as it entered the drainage line, where it was contained (Plate 5). Debris was subsequently washed downstream, some 40 m, to where the drainage line meets a man-made drainage channel at the crest of slope No. 11NW-A/C33. Inundation of the channel by the debris caused overtopping of the channel resulting in minor erosion of the slope surface and deposition of debris onto the footpath and Wah King Hill Road below.

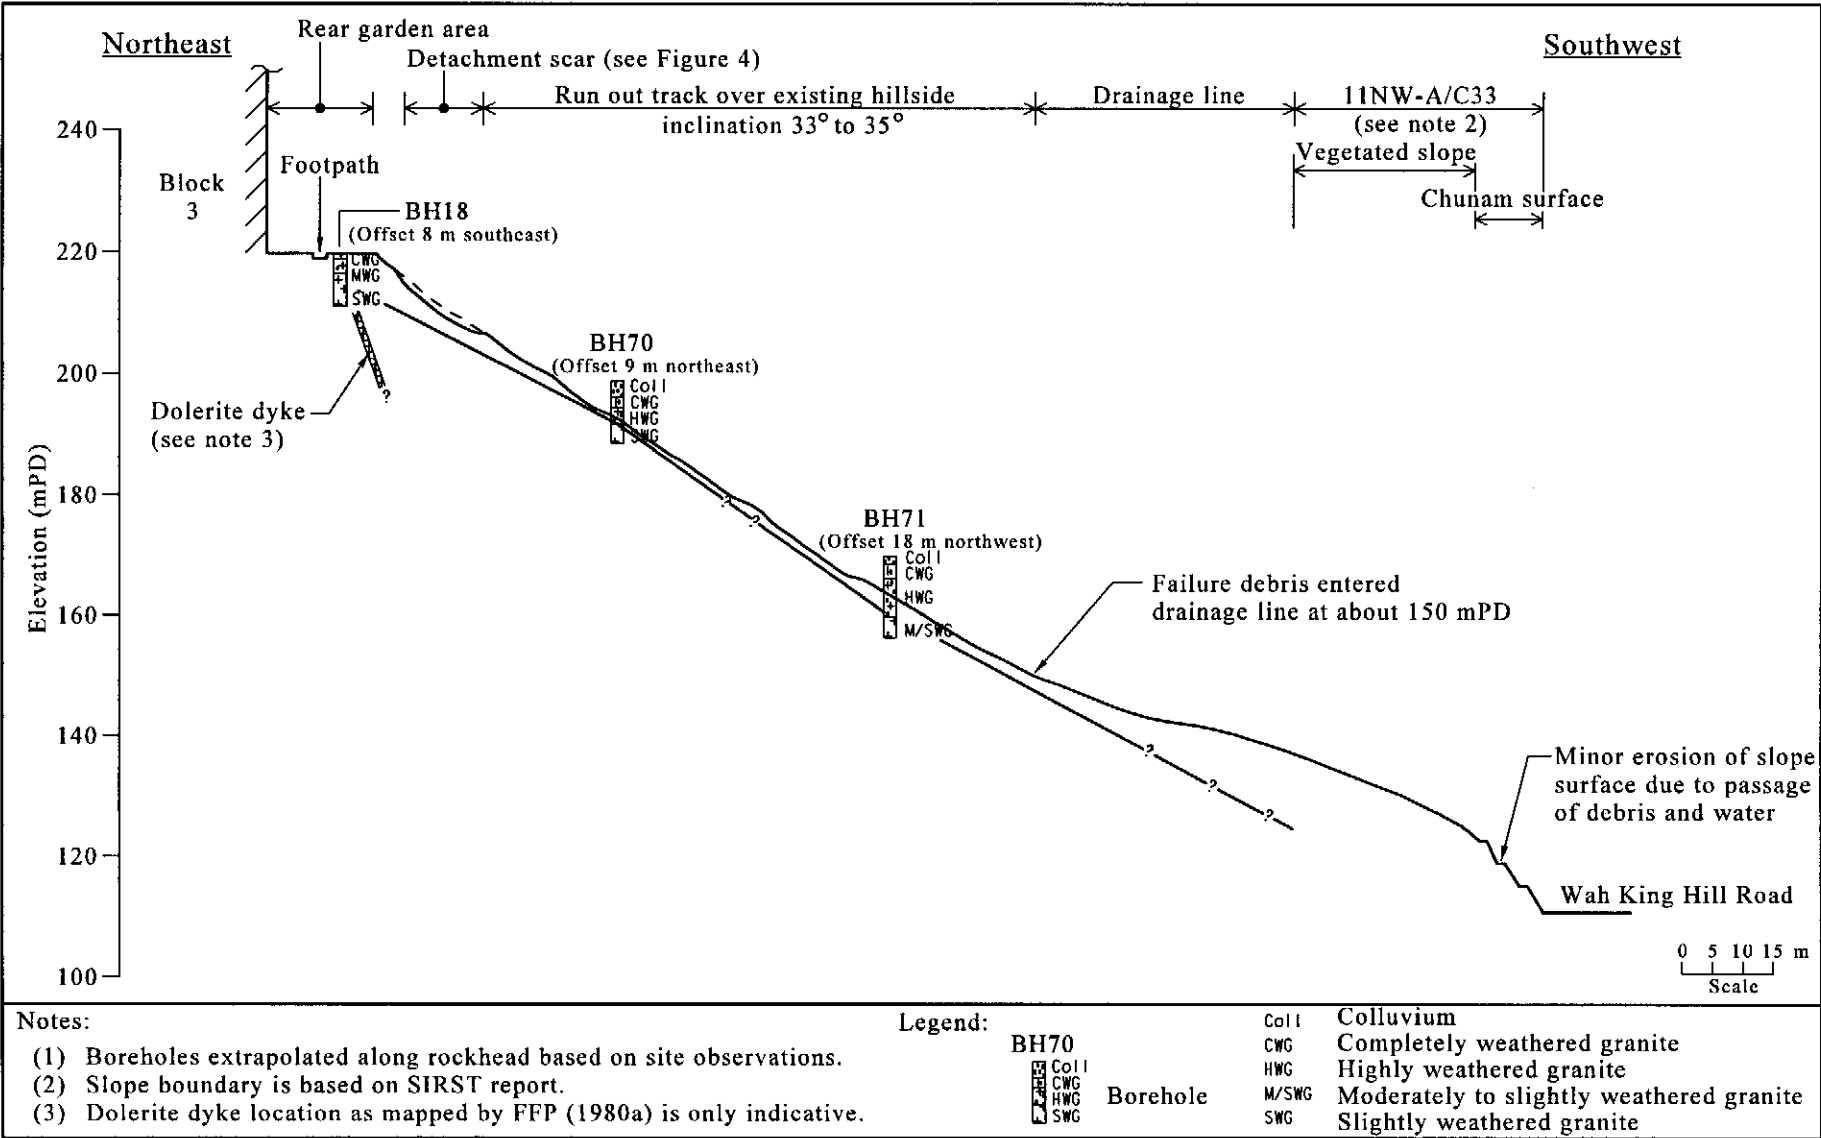
Figure 3 - Cross-section A-A through Landslide Run Out Track

The Hong Kong Geological Survey 1:20 000 scale Sheet 11 (GCO, 1986) shows the site to be underlain by major intrusive granite. Previous ground investigation information indicated that the general lithological sequence of the natural hillside below Blocks 3 and 4 comprised a covering of colluvial deposits which thin upslope, overlying weathered granite with bedrock rising towards the surface upslope. A section along the landslide track is shown in Figure 3.

A dolerite dyke, aligned parallel to and outcropping within the crest area of the natural hillside, was identified by FFP (1980a), see Figure 3. The dyke, 0.3 m to 4 m wide, was located about 5 m behind the head of the detachment scar. The dyke had a dip of 65° to 85° towards 240° to 260° and several minor faults, 0.05 m to 0.22 m wide, were parallel to it.

Groundwater monitoring from piezometers in boreholes sunk in the natural hillside during the investigation for the Wonderland Villas development was undertaken in the early 1980's. Monitoring records indicated that the base groundwater level at the location of the 1997 failure was below rockhead (Figure 3).

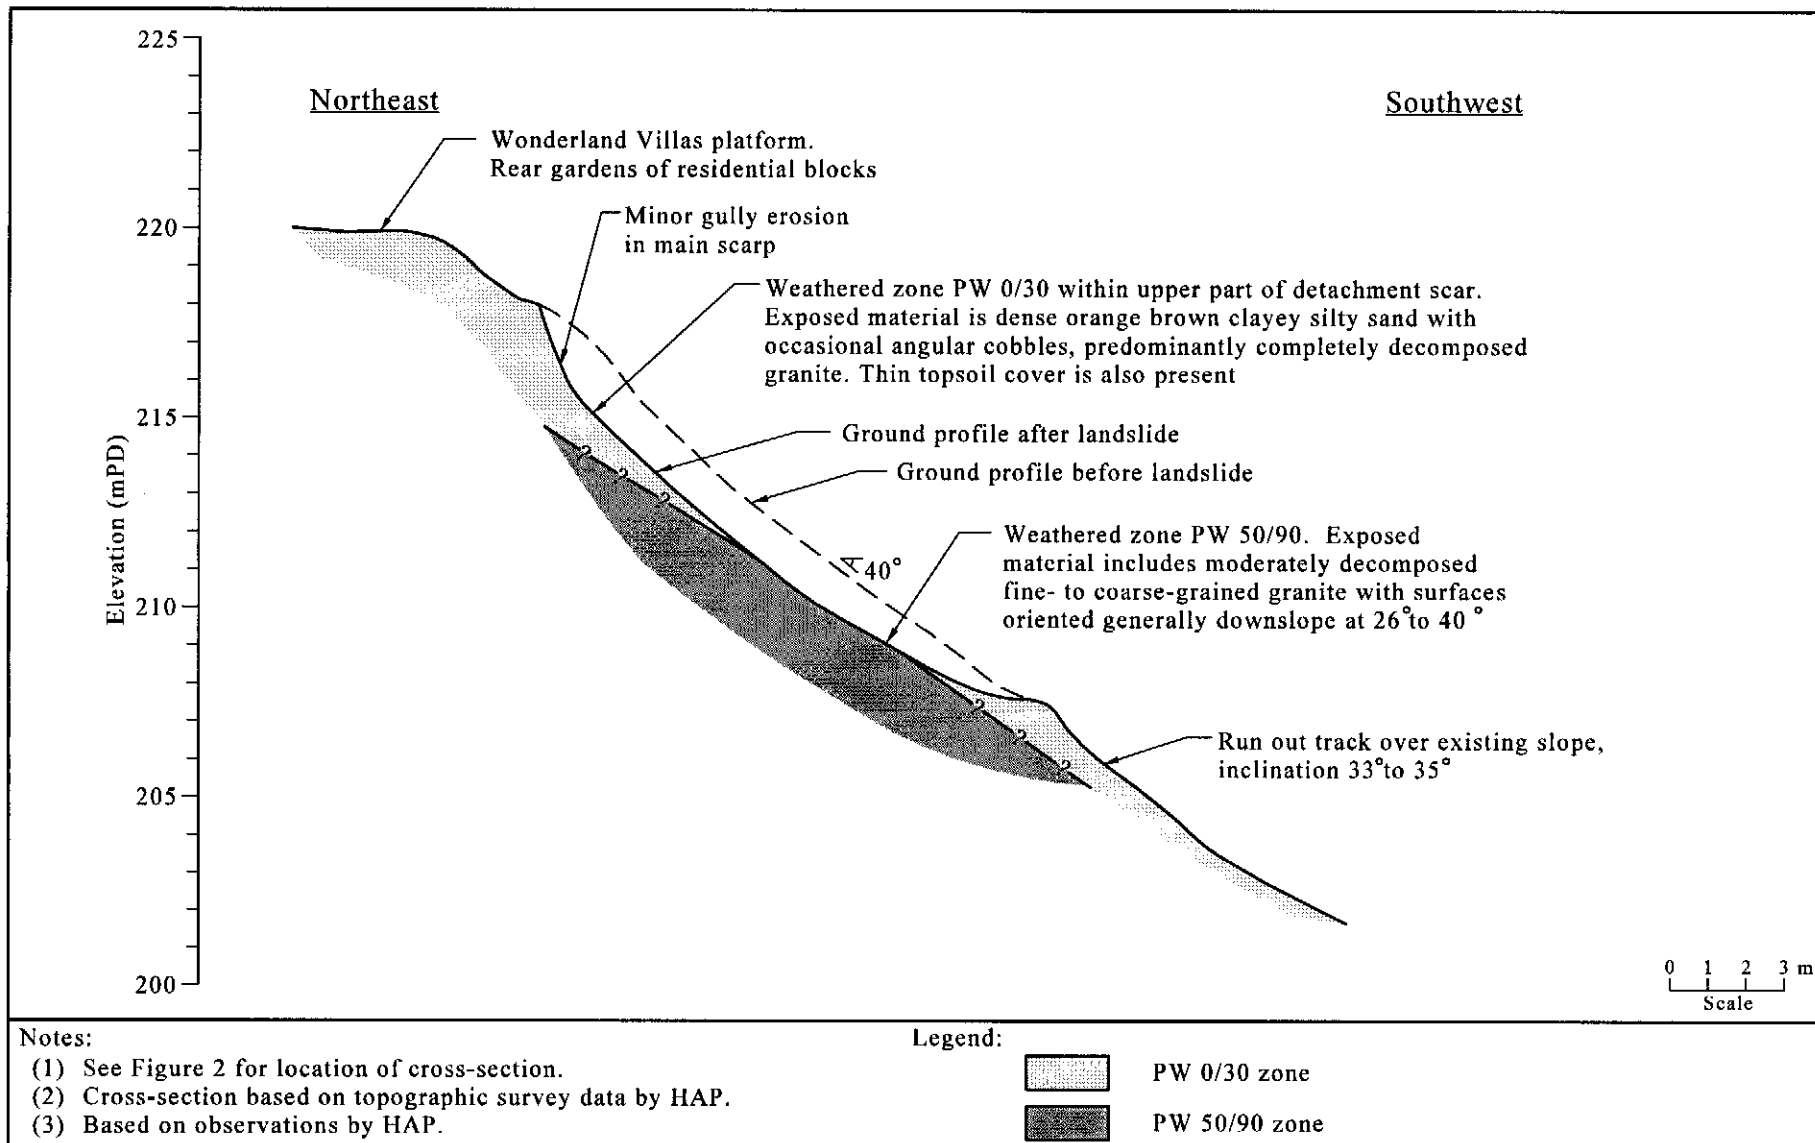
Figure 4 - Cross-section B-B through Landslide Detachment Scar

The material identified in the detachment scar was orange brown clayey silty sand with occasional angular cobbles within a mass weathering zone of PW 0/30, comprising principally completely decomposed granite, over a weathering zone of PW 50/90 that contained moderately decomposed fine- to coarse-grained granite (Figure 4).

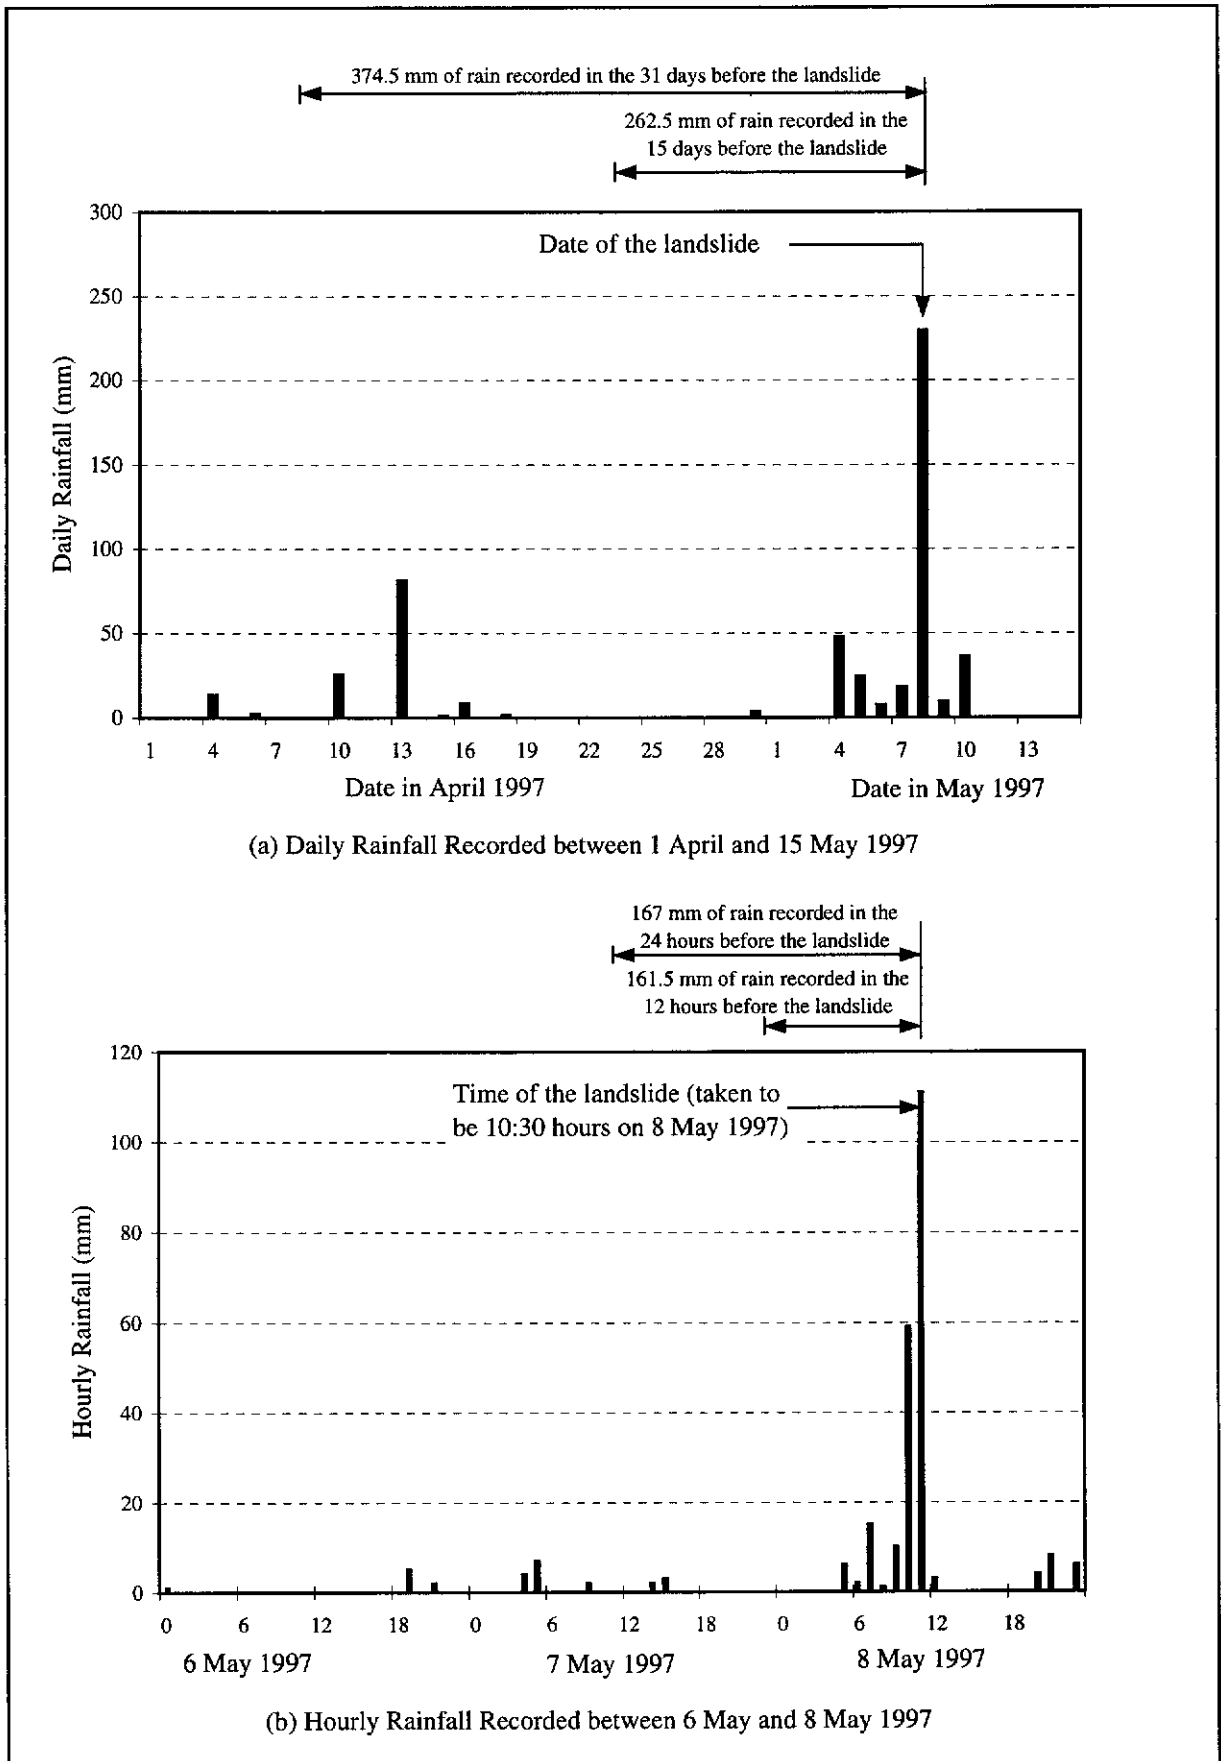
Figure 5 - Rainfall Recorded at GEO Raingauge No. N04

The nearest GEO automatic raingauge No. N04 is located at Kai Kwong Lau, Cho Yiu Estate, Lai King, about 0.9 km southwest of the landslide. The daily rainfall recorded between 1 April and 13 May 1997, and hourly rainfall between 6 and 8 May are shown in Figure 5. The 12-hour and 24-hour rainfall recorded prior to 10:30 hours on 8 May 1997, by which time the failure had occurred, were 162 mm and 167 mm respectively. Rainfall on 8 May 1997 started at about 04:00 hours and intensified significantly from 08:45 hours peaking at about 10:30 hours.

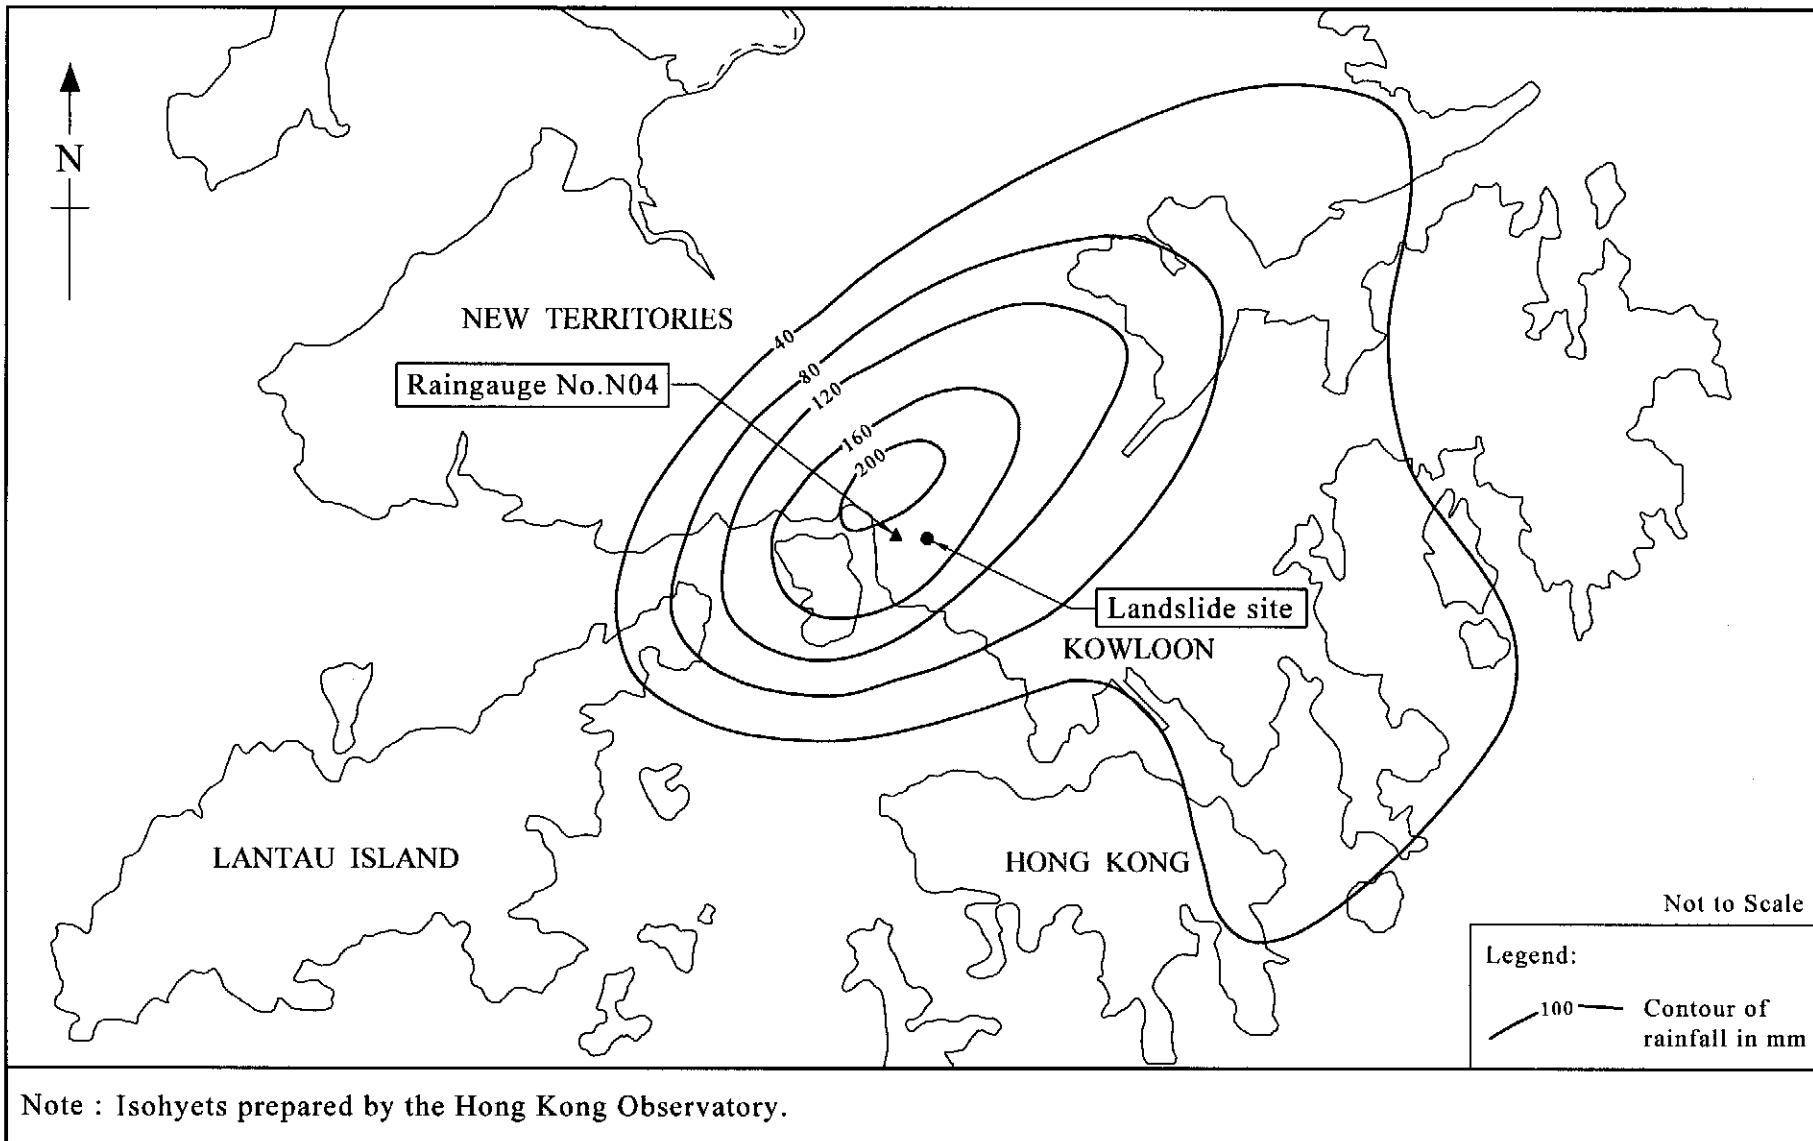
Figure 6 - Isohyets of Rainfall from 04:00 hours to 10:30 hours on 8 May 1997

An isohyet plot of the rainstorm prior to failure is shown in Figure 6. This shows that the peak rainfall intensity prior to the failure was centred northwest of the site, with a cumulative rainfall at the landslide site of between 160 mm and 200 mm.

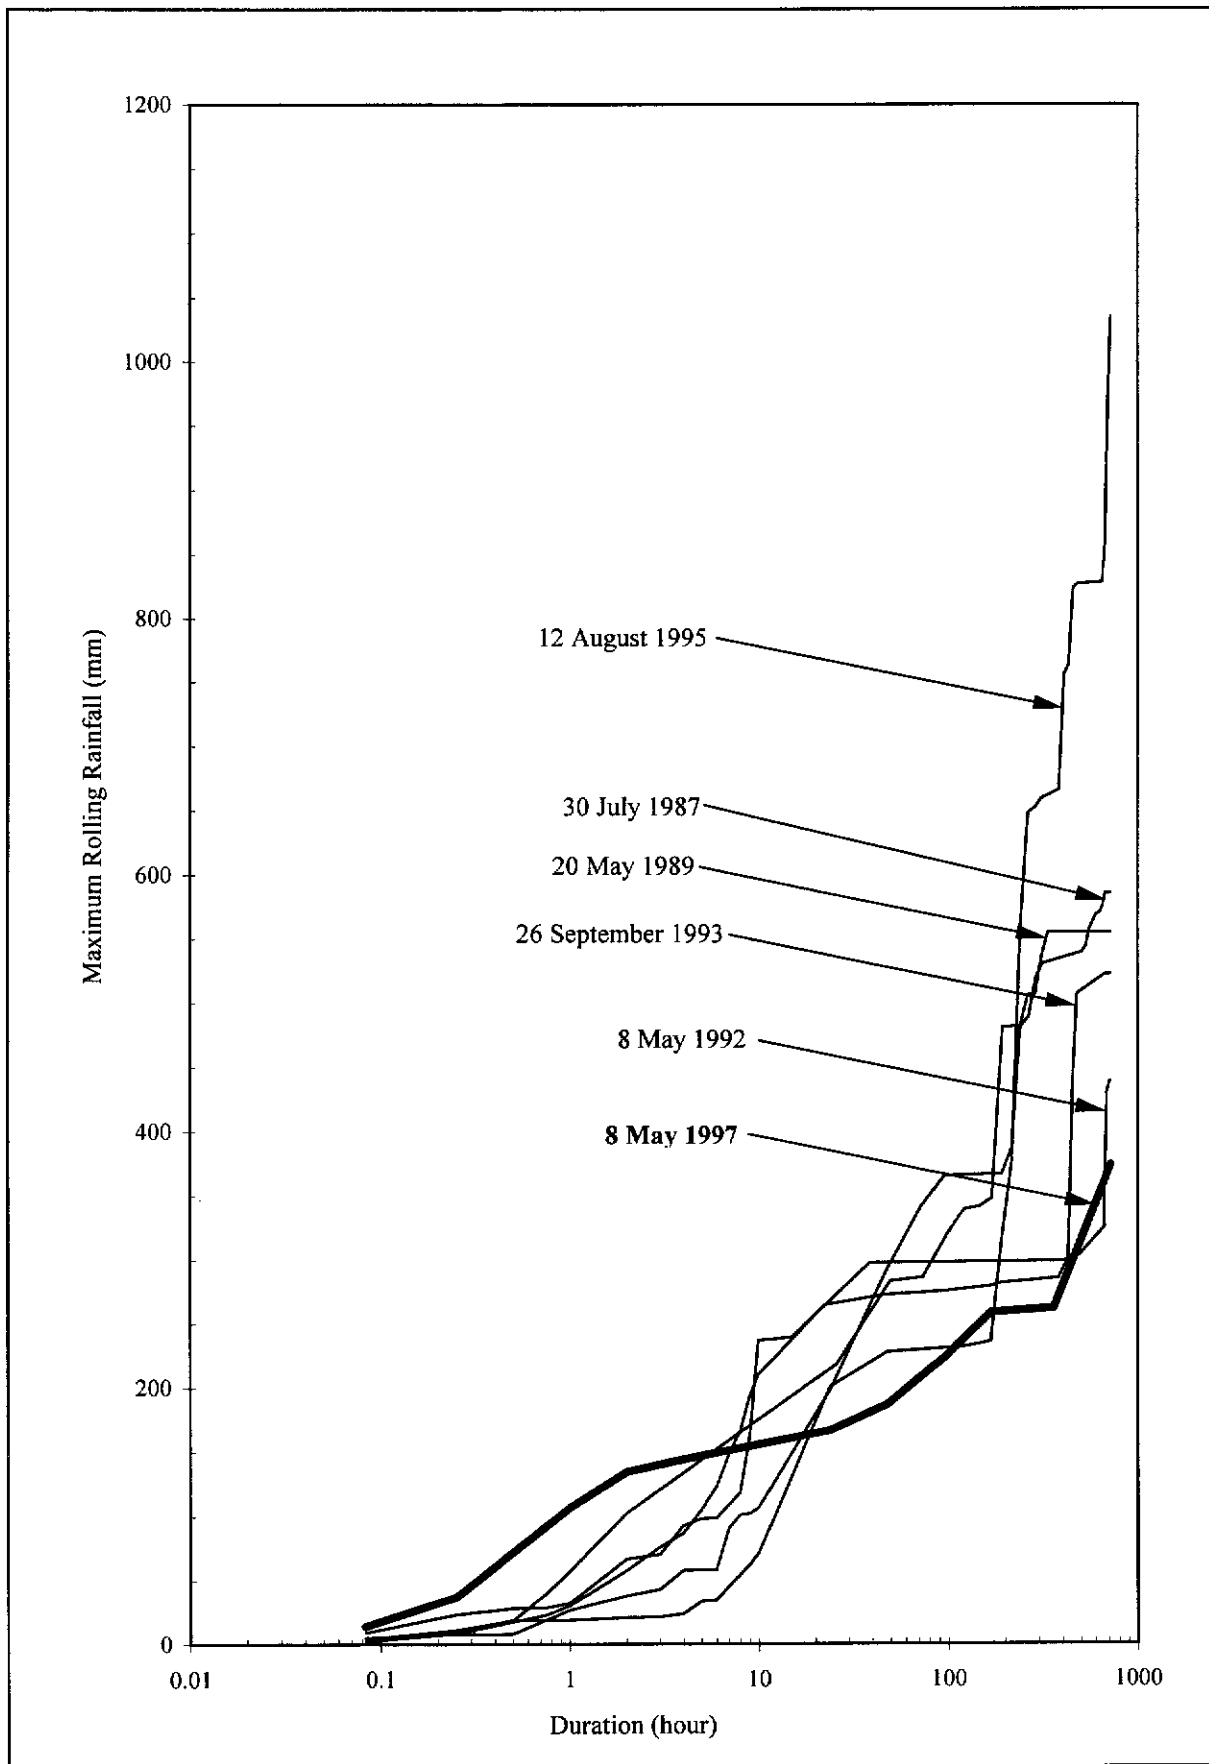
Figure 7 - Maximum Rolling Rainfall at GEO Raingauge No. N04 for Major Rainstorms

major rainstorms recorded at raingauge No. N04 since its installation in 1978 is shown in Figure 7. The rainfall preceding the 1997 landslide was the highest recorded at the raingauge for durations of less than 4 hours but was comparatively less intense than some of the previous rainstorms for rainfall durations of 1 day or more.

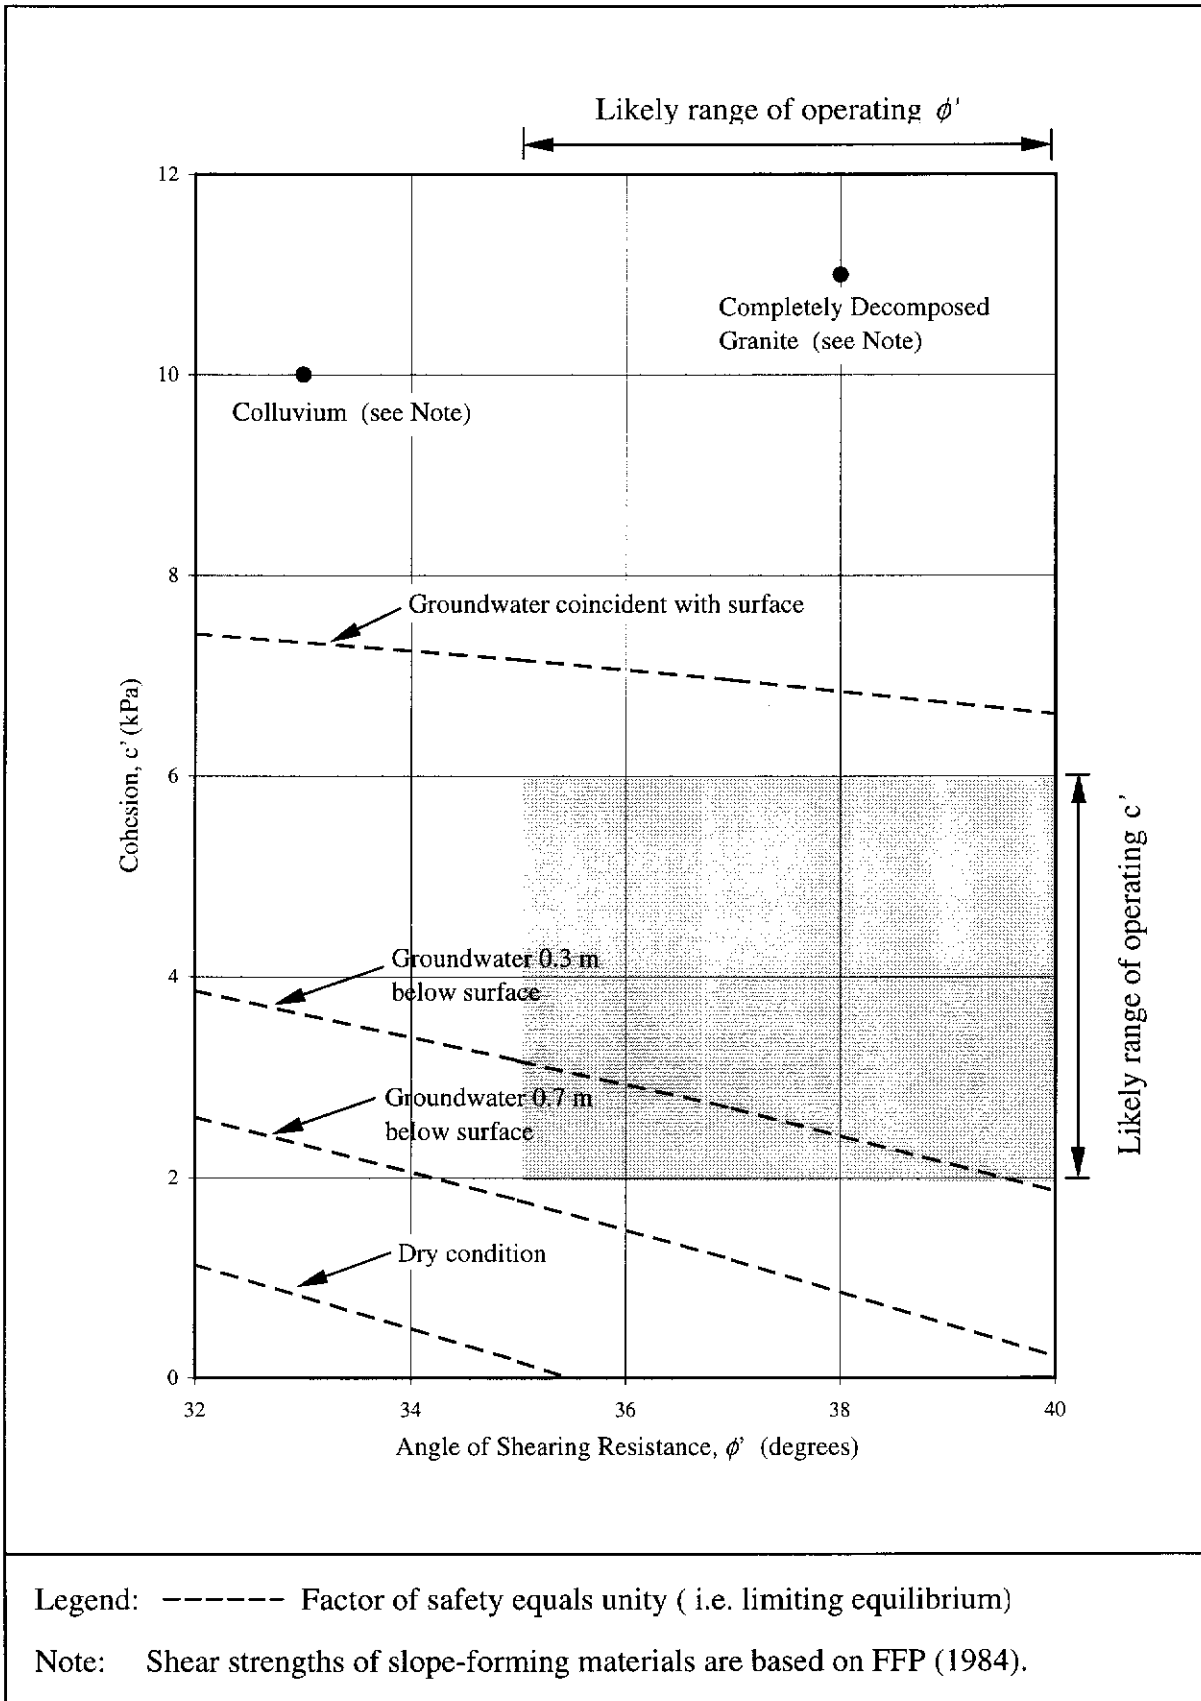
Figure 8 - Limiting Equilibrium Condition in Terms of Different Shear Strengths and Groundwater Regime

The results of the analysis (Figure 8) indicate that for the lower bound shear strengths, the factor of safety approaches unity when the water approaches to within about 0.6 m of the ground surface. For the upper bound shear strength parameters, failure is predicted when the groundwater approaches close to the surface.

The shear strength parameters used by FFP (1984) to analyse the hillside as part of the design of Wonderland Villas were higher than those used in the present analysis (see Figure 8). The higher factors of safety calculated by FFP (1984) were obtained by stability analyses of a different part of the slope, where the rockhead and the corresponding groundwater level were at greater depth.

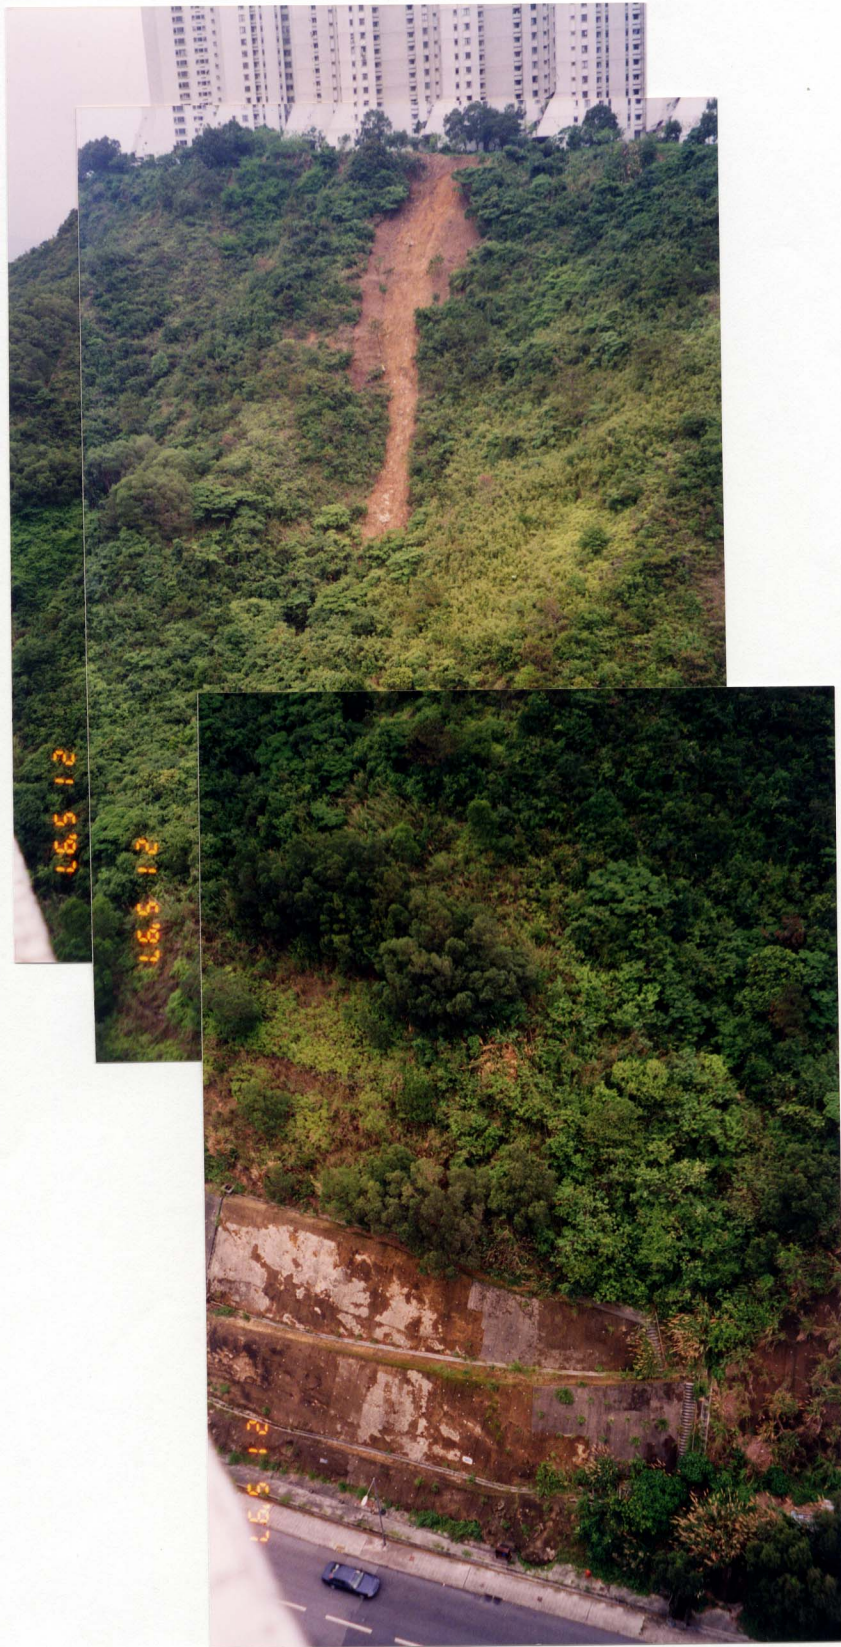
The general slope profile along the failure track was planar with an inclination of between 33° and 35°. At the location of the detachment scar the slope profile was slightly concave with an inclination of up to 40°. In plan, the detachment scar was located within a topographical depression, which appears to be the head of a poorly developed drainage line (Figure 2). The natural hillside has a dense vegetation cover of low shrubs and trees (Plate 1).

Plate 1 - General View of Landslide (Photograph Taken on 21 May 1997)

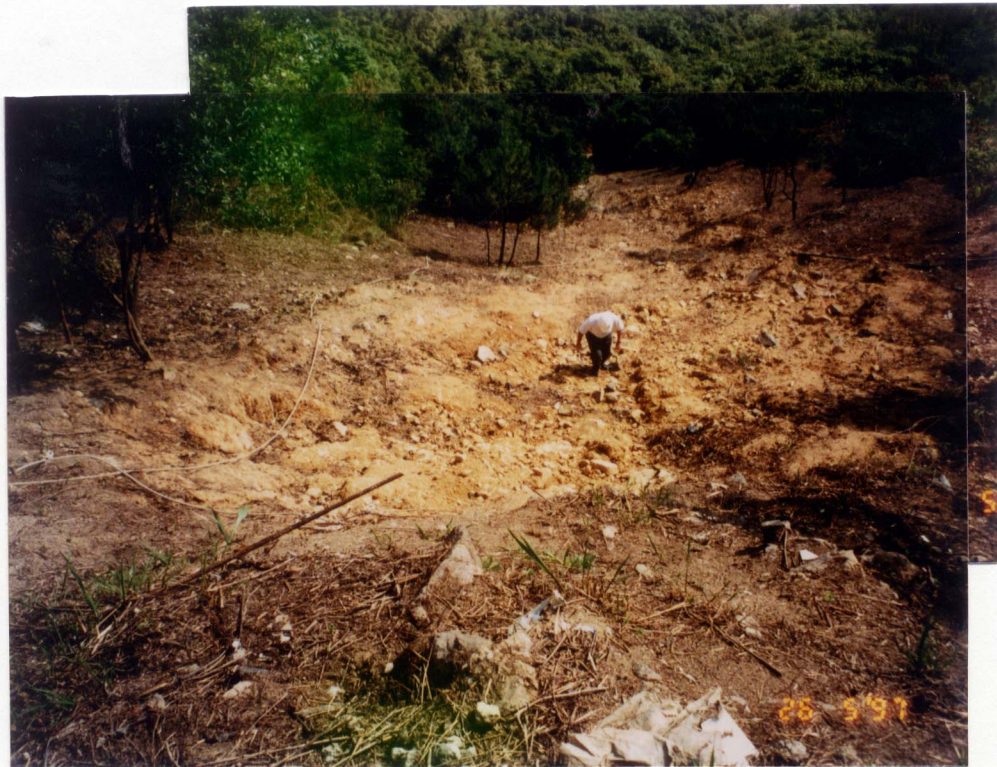
The detachment scar is located about 2 m below the crest of the natural hillside between 208 mPD and 218 mPD. The scar is spoon-shaped, about 8 m wide, 16.5 m in length, with an average depth of less than 1 m and a maximum depth of 1.5 m (Plate 2). The volume of the scar is estimated to be about 80 m³.

Plate 2 - View of Detachment Scar (Photograph Taken on 26 May 1997)

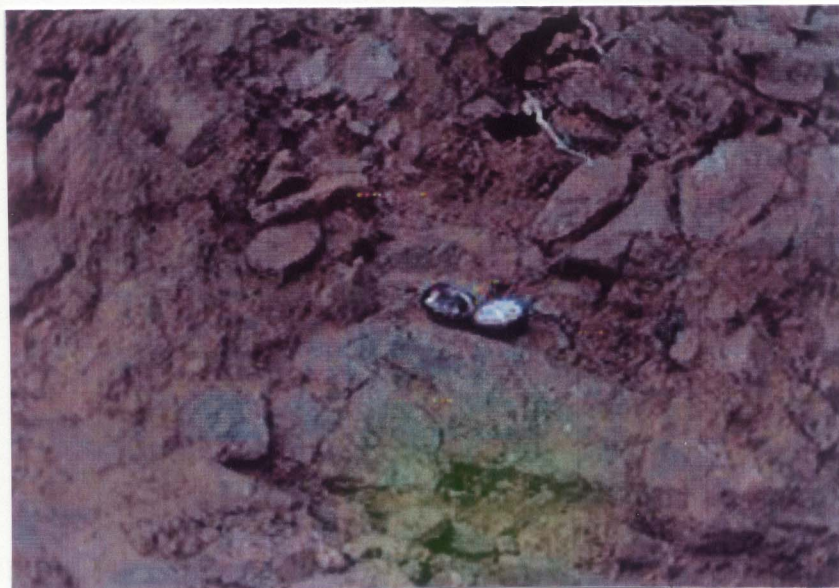
Exposed within the lower section of the scar was a mass weathering zone of PW 50/90 that comprised intact moderately decomposed fine- to coarse-grained granite with some rough planar surfaces orientated downslope at 26° to 40° (Plate 3). The upper section of the scar comprised principally completely decomposed granite of mass weathering grade PW 0/30 with a thin covering of topsoil (Figure 3). Inspection of the adjacent slope area revealed some construction and domestic waste materials, apparently tipped onto the slope surface.

Plate 3 - Close-up View of Zone PW 50/90 Exposed in Scar (Photograph Taken on 8 May 1997)

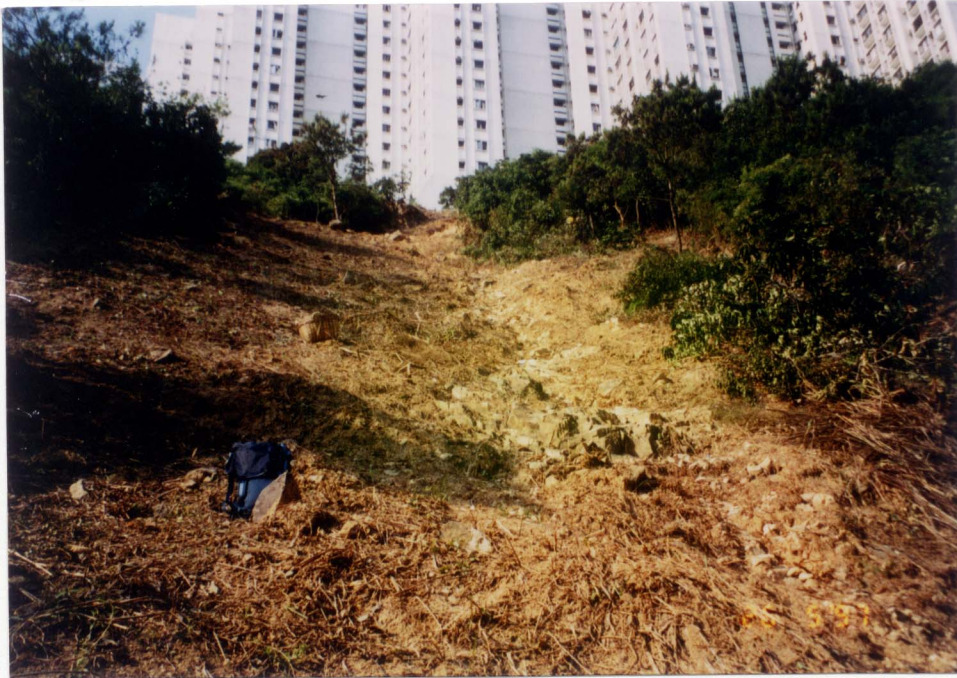
Plate 4 - View Looking Up Run Out Track (Photograph Taken on 26 May 1997)

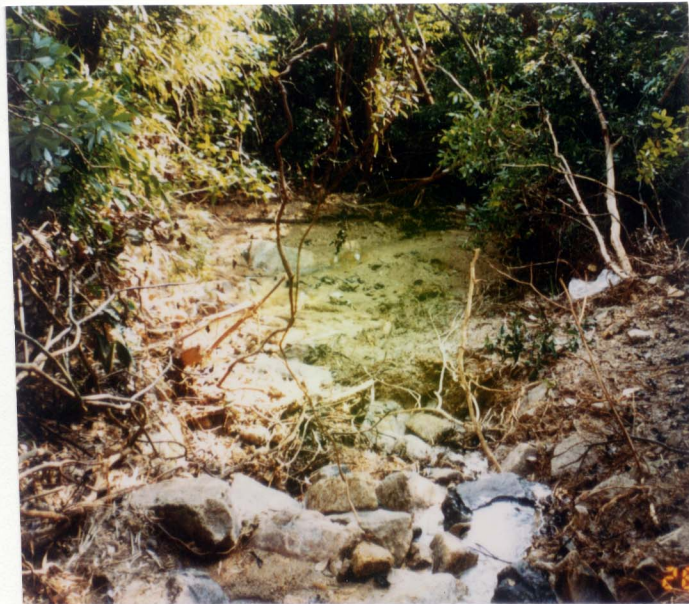
Plate 5 - View from within Drainage Line Showing Landslide Debris. Landslide Entered Stream from Right (Photograph Taken on 26 May 1997)
