**SECTION 3:
DETAILED STUDY OF THE
LANDSLIDES AT
KAU WA KENG SAN TSUEN
ON 4 JUNE 1997**

Halcrow Asia Partnership Ltd

**This report was originally produced in July 1998
as GEO Landslide Study Report No. LSR 13/98**

This report presents the findings of a detailed study of four landslides (GEO Incident Nos. MW97/5/14, MW97/6/49, MW97/6/50 and MW97/6/56) which occurred on slopes adjacent to Kau Wa Keng San Tsuen on 4 June 1997. Debris from the landslides affected the squatter village, but no fatalities or injuries were reported.

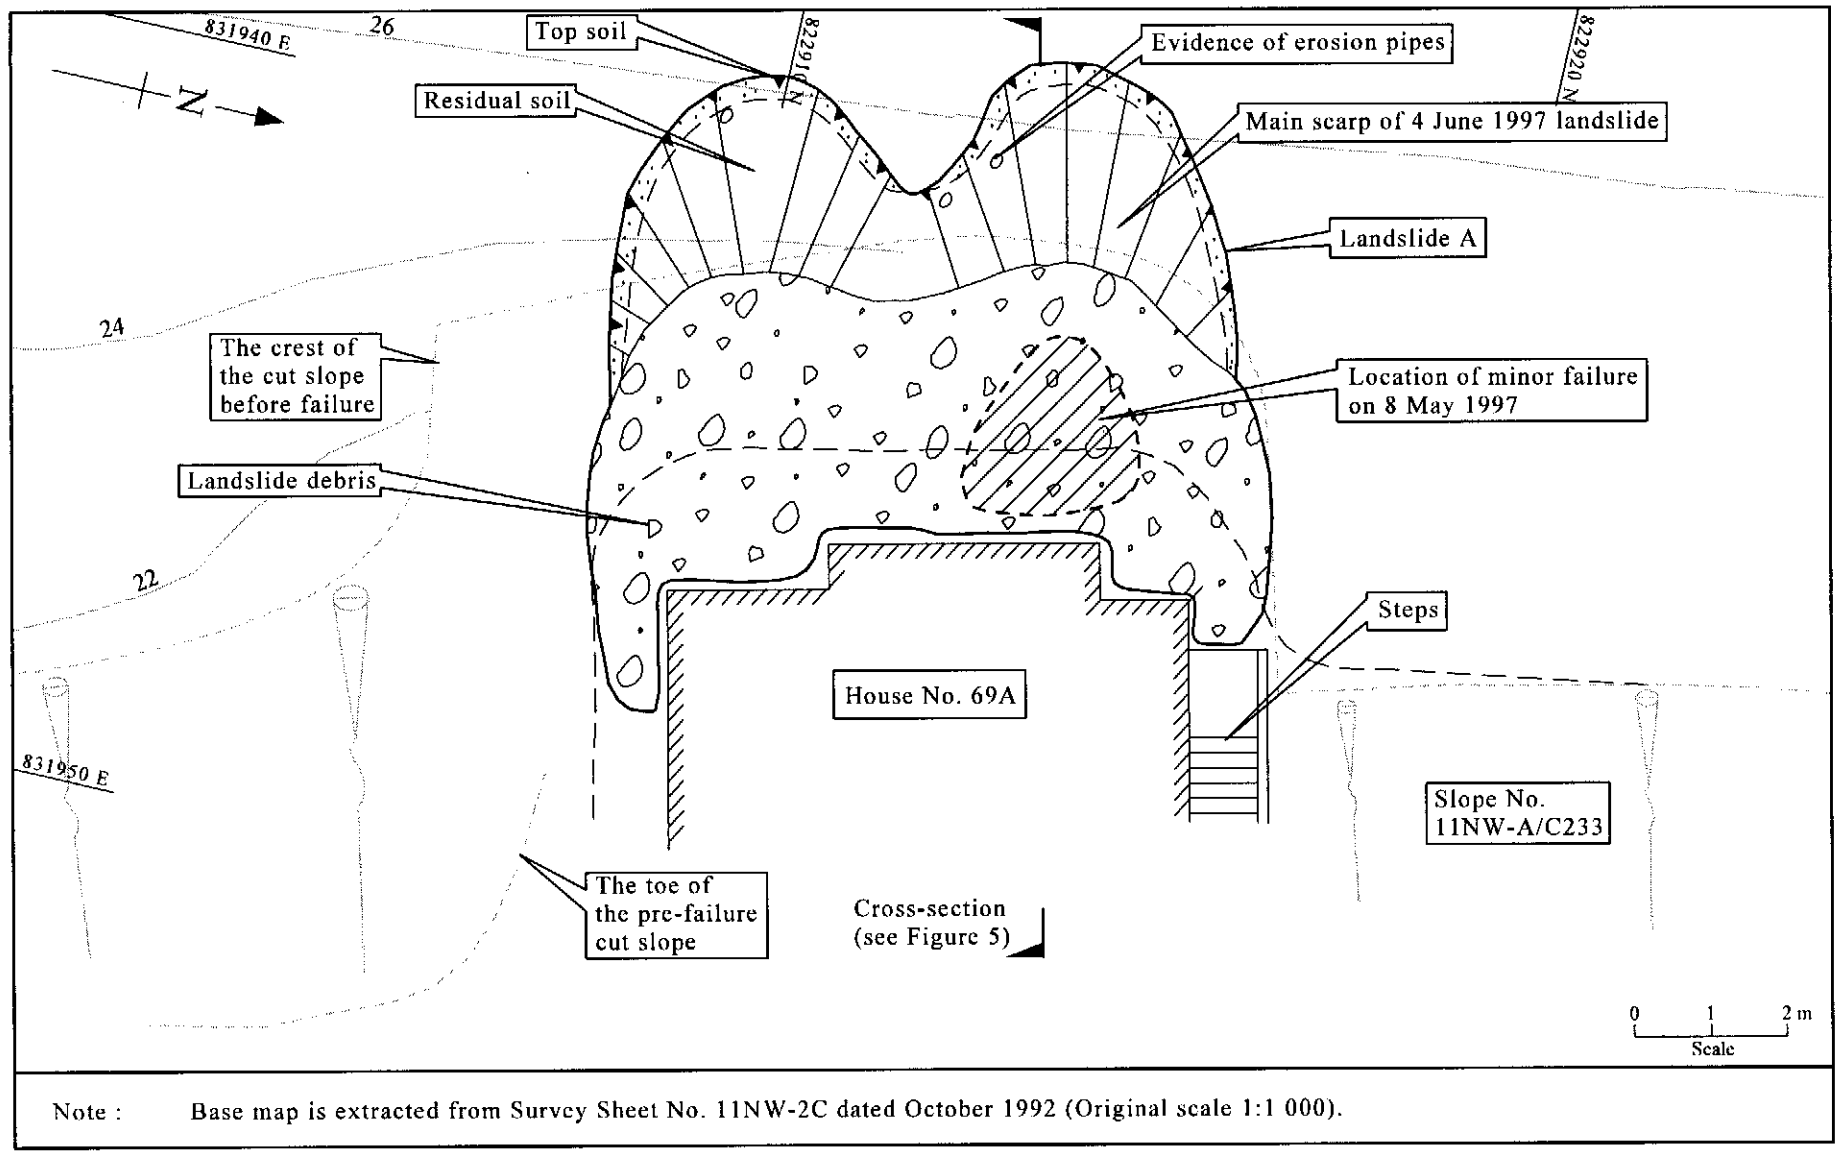
Figure 4 - Plan and Details of Landslide A

A plan and cross-section of the landslide are shown in Figures 4 and 5 respectively.

A minor landslide (GEO Incident MW97/5/14) with an estimated volume of 5 m³ occurred on the lower half of the northern part of the cut slope behind house No. 69A during heavy rainfall on 8 May 1997 (Plate 5). Inspections by HAP after the incident revealed cracking of the chunam cover extending laterally across the unfailed, upper part of the cut slope. A larger landslide subsequently affected the entire cut slope on 4 June 1997 (Plate 6).

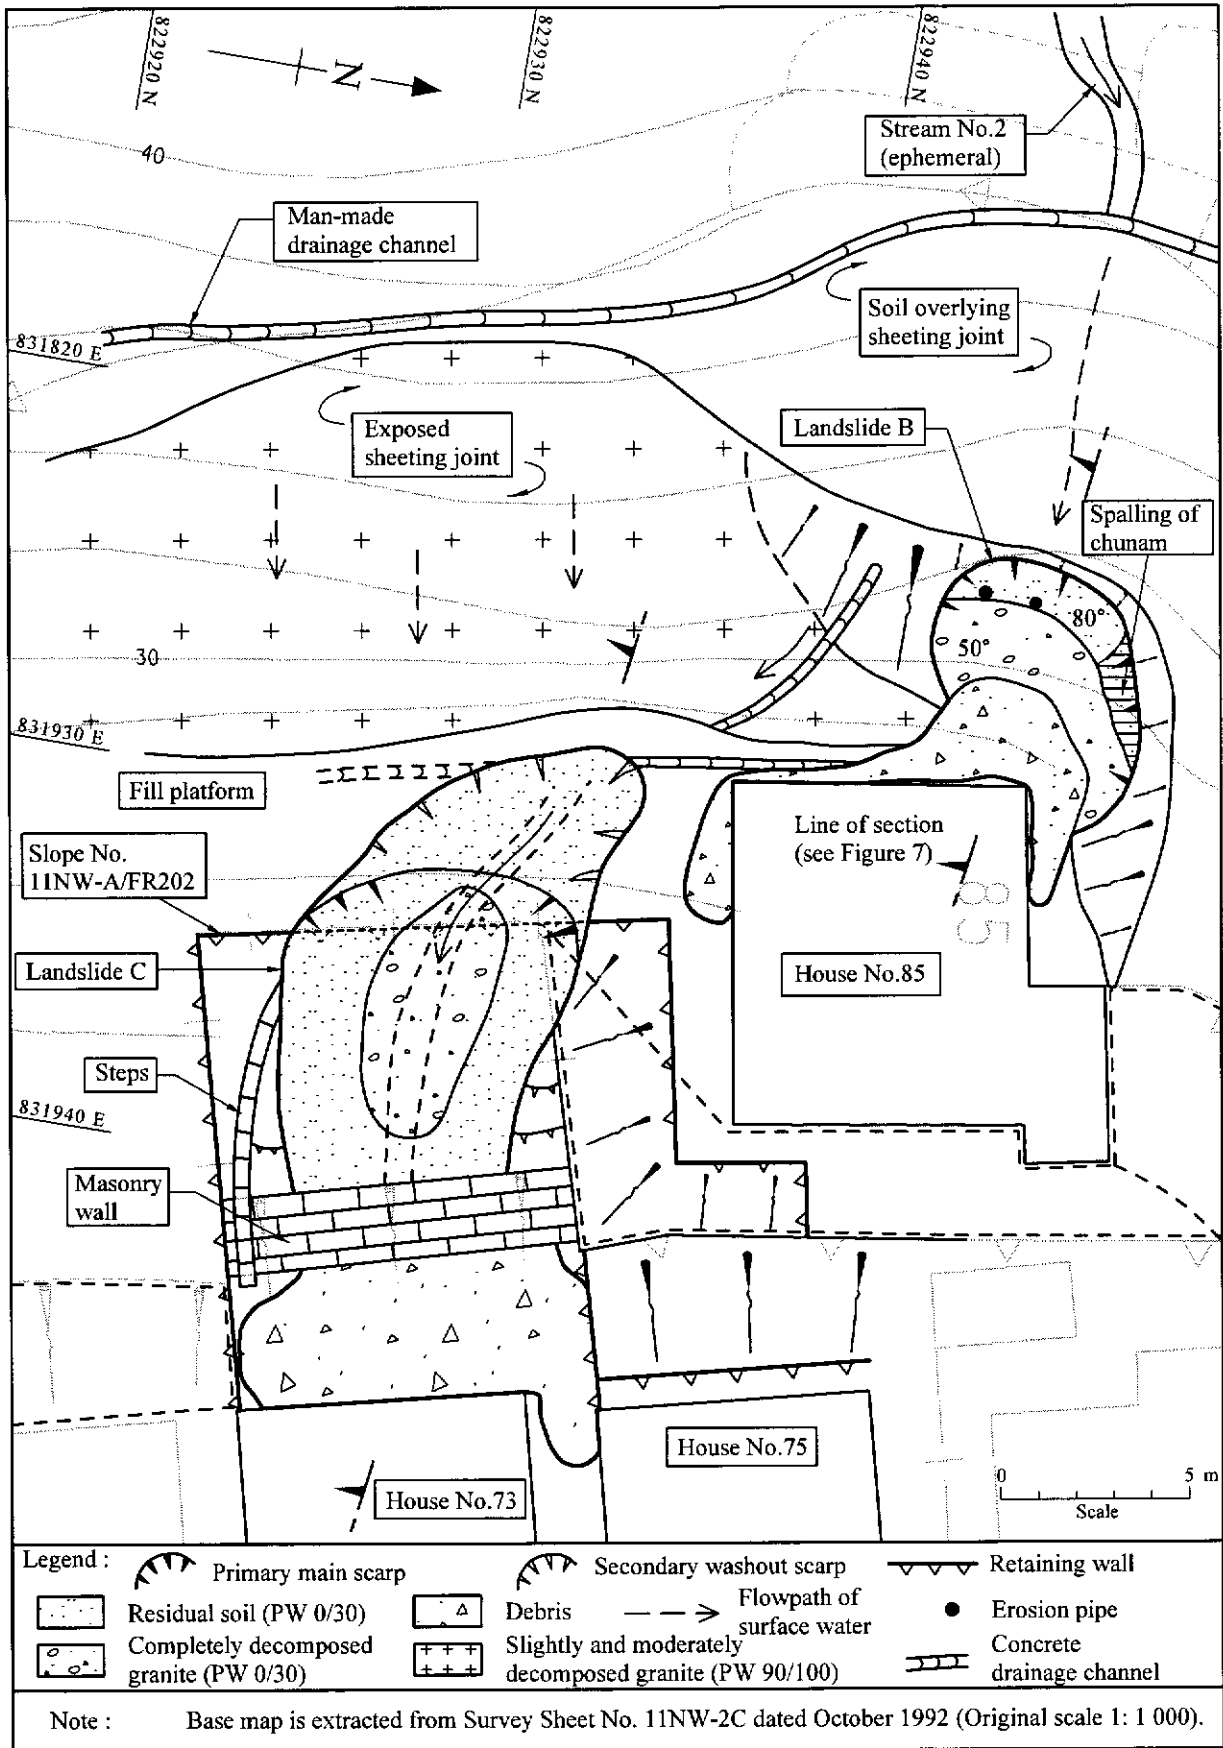
Figure 6 - Plan and Details of Landslides B and C

A plan and cross-section of the landslide (GEO Incident MW97/6/49) are shown in Figures 6 and 7 respectively.

also occurred adjacent to the north flank of the landslide but without further failure of the soil in the slope (Figure 6).

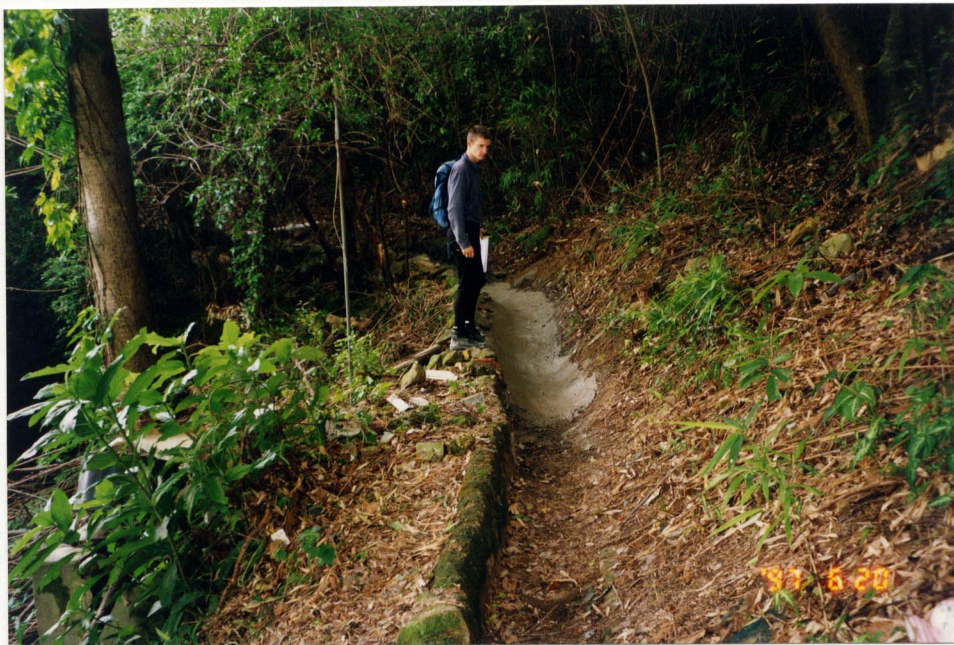
A man-made drainage channel, constructed to intercept surface water stream flows and run-off, traverses the natural hillside upslope of the village for about 280 m (Figure 2). On inspection by HAP in June 1997, the standard of construction and maintenance was found to vary along the length of the channel. Where it was founded on rock, the channel tended to be properly formed (Plate 3) whereas in soil terrain, it was typically shallow and infilled with foreign material (Plate 4).

Plate 4 - View of the Surface Water Run-off Channel Above the Village
(Photograph Taken on 20 June 1997)

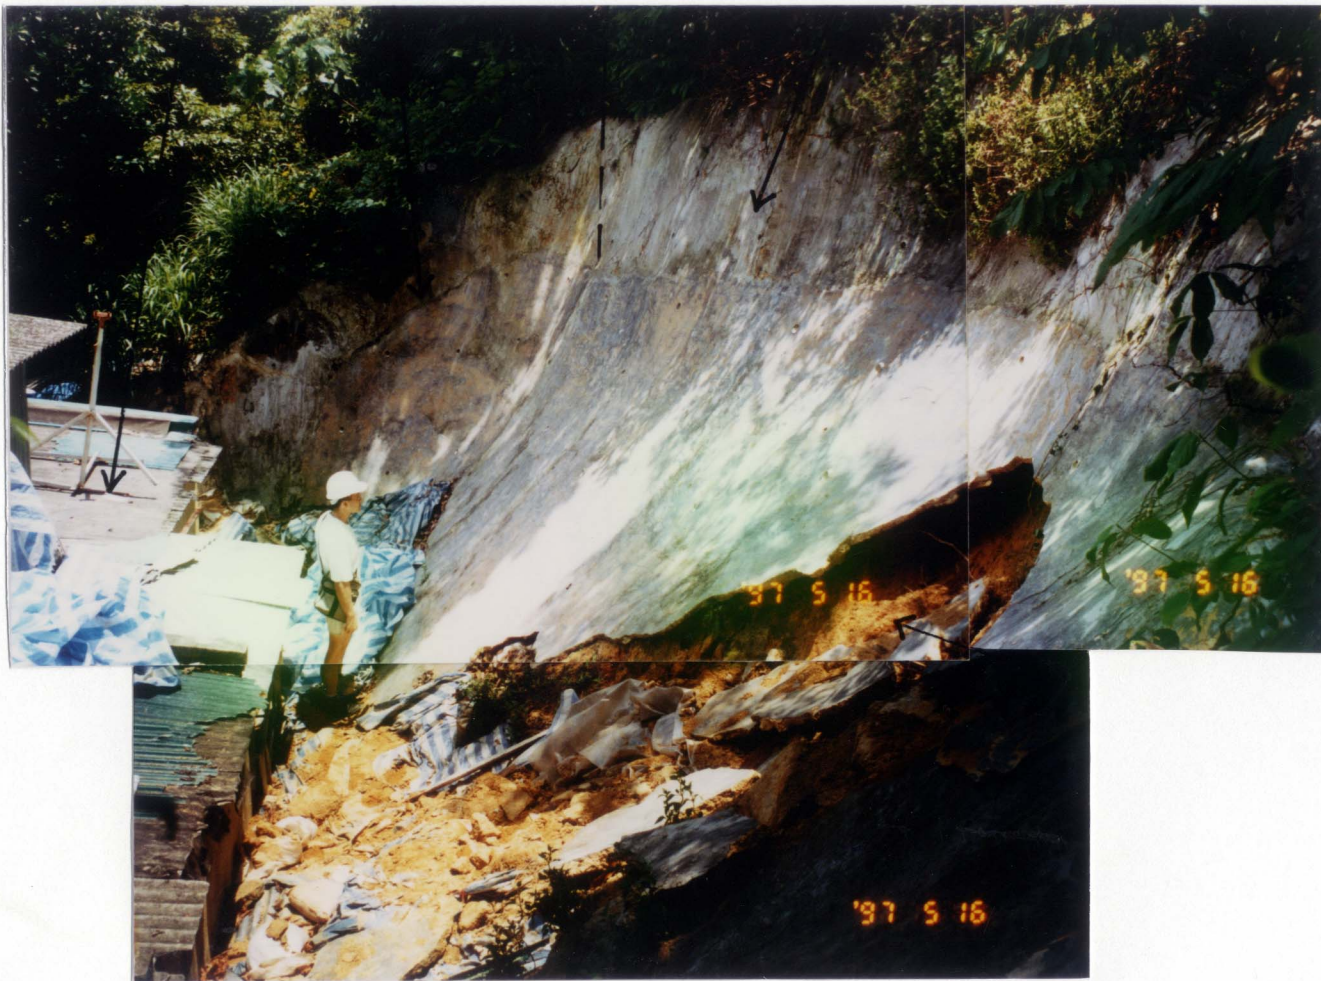
Plate 5 - View of the Small Failure Before Landslide A (Photograph Taken on 5 May 1997)

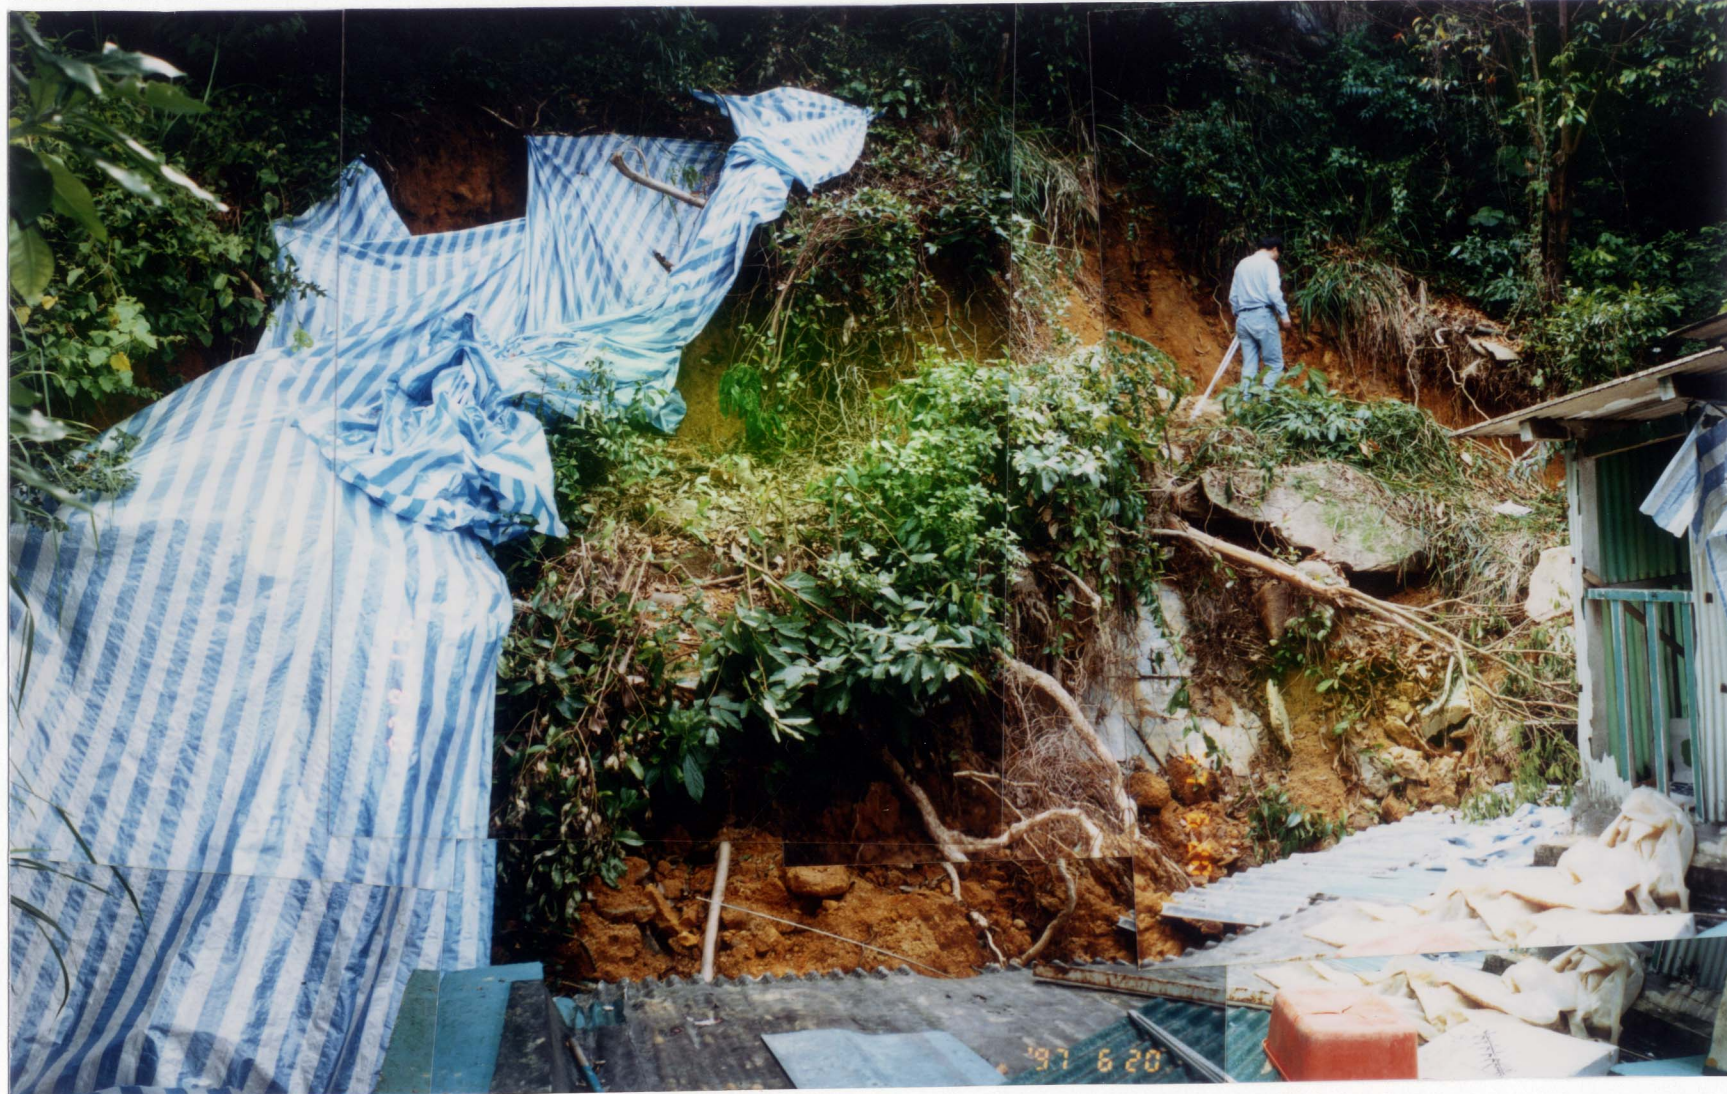
The landslide of 4 June 1997 was about 8 m wide and 5 m long, with an estimated

volume of 80 m³, the debris of which came to rest against the rear wall of house No. 69A. The landslide was about 2.5 m deep and exposed granitic residual soil overlying highly to completely decomposed, medium- to coarse-grained granite. In places, a fabric of closely spaced discontinuities aligned parallel to the slope was present in the soil. The failure took place along the discontinuities and the debris slipped downslope in a single translational sliding movement. Several erosion pipe holes were observed in the main scarp, about 1 m below ground level. The debris comprised loose to firm, moist to wet, slightly clayey gravelly sand with occasional angular shaped cobbles. The travel angle of the landslide debris was estimated to be in excess of 30°, despite the debris having come to rest against the rear wall of house No. 69A. This angle is within the typical range for rain-induced failures in Hong Kong (Wong & Ho, 1996).

Plate 6 - View of Landslide A (Photograph Taken on 20 June 1997. Note the Entire Slope Shown in Plate 2 has Failed)

House No. 69A was unoccupied at the time of the landslide, following permanent evacuation of the property on 30 April 1990. After the landslide, arrangements were made for the Highways Department to carry out urgent repair works (GEO, 1997a).

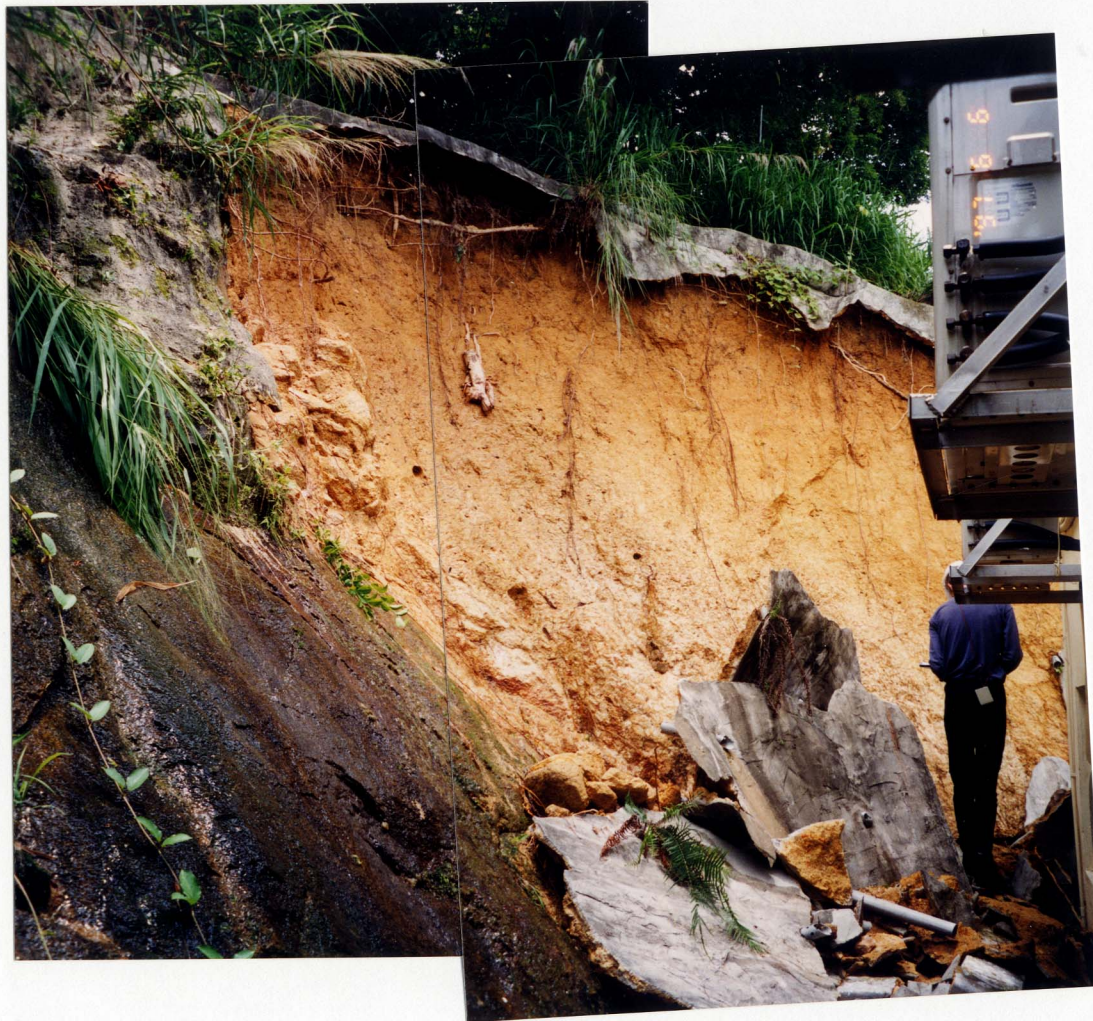
The landslide involved the full height of the cut slope (Plate 7) and exposed a 2 m thick layer of residual soil overlying completely decomposed medium-grained granite. The failure was about 9 m wide, 5m long and 1 m deep. The main scarp of the landslide was inclined at 50° to 70° to the horizontal. The estimated volume of the landslide was 15 m³, the debris from which accumulated against the rear wall of house No. 85. The travel angle of the landslide debris was estimated to be in excess of 30° which is within the typical range for rain-induced failures in Hong Kong (Wong & Ho, 1996).

Plate 7 - View of Landslide B (Photograph Taken on 6 June 1997. Note the Water Flowing on the Steep Sheeting Joint Surface Below the Failed Soil Cut Slope)

Following the landslide, the GEO recommended permanent evacuation of house No. 85 (GEO 1997b).

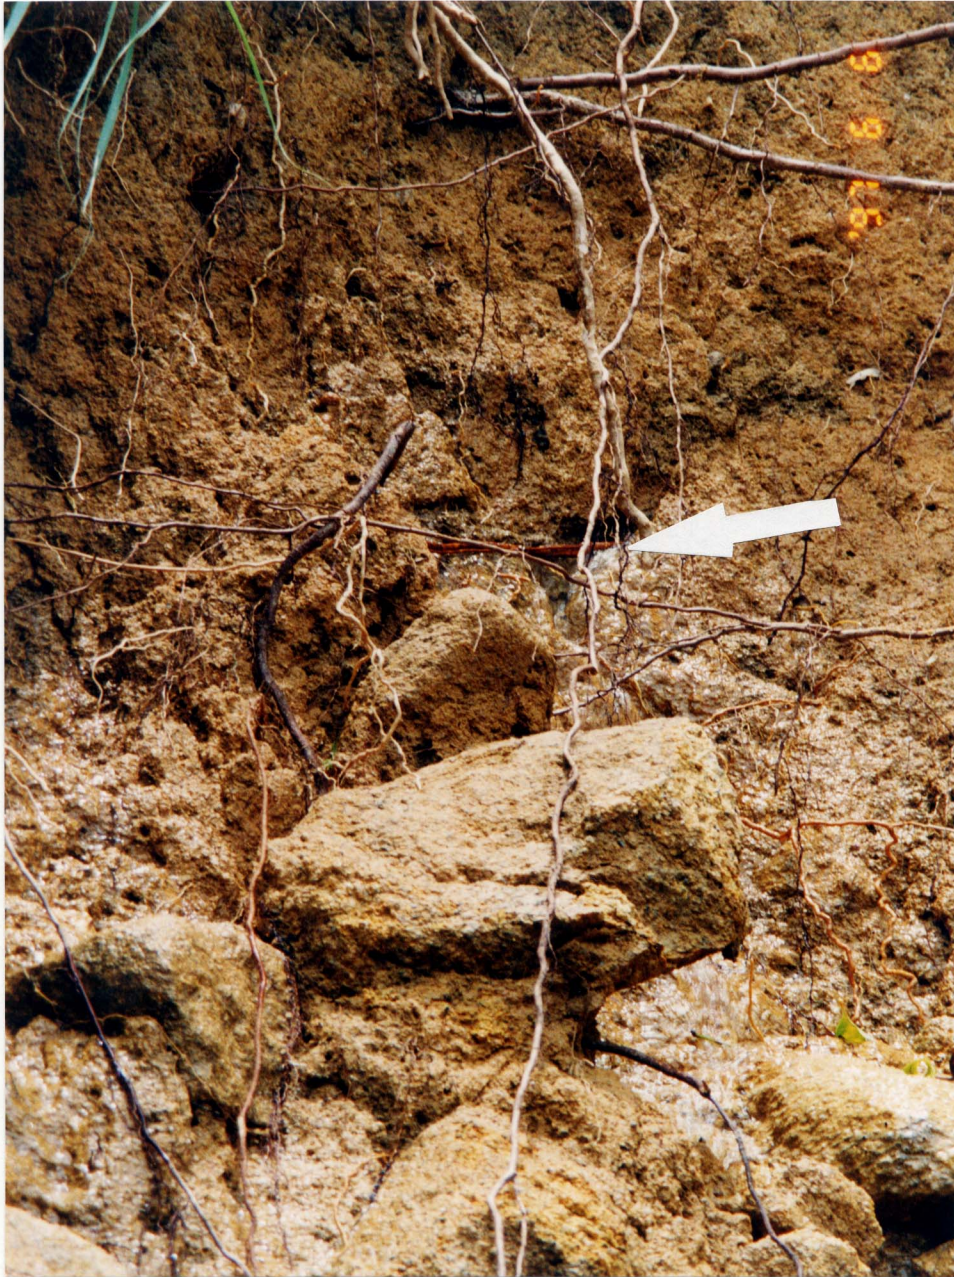
Two days after the failure, water was observed flowing over the entire exposure of the sheeting joint. This remained the case on repeated site visits over the following two weeks, even during dry weather. Over this period, water was also issued from an erosion pipe hole located in the main scarp, about 2 m below ground level (Plate 8).

Plate 8 - An Erosion Pipe in the Main Scarp of Landslide B (Photograph Taken on 6 June 1997. Note the Arrow Points to Flowing Water Issuing from the Pipe in the Centre of the Photograph)

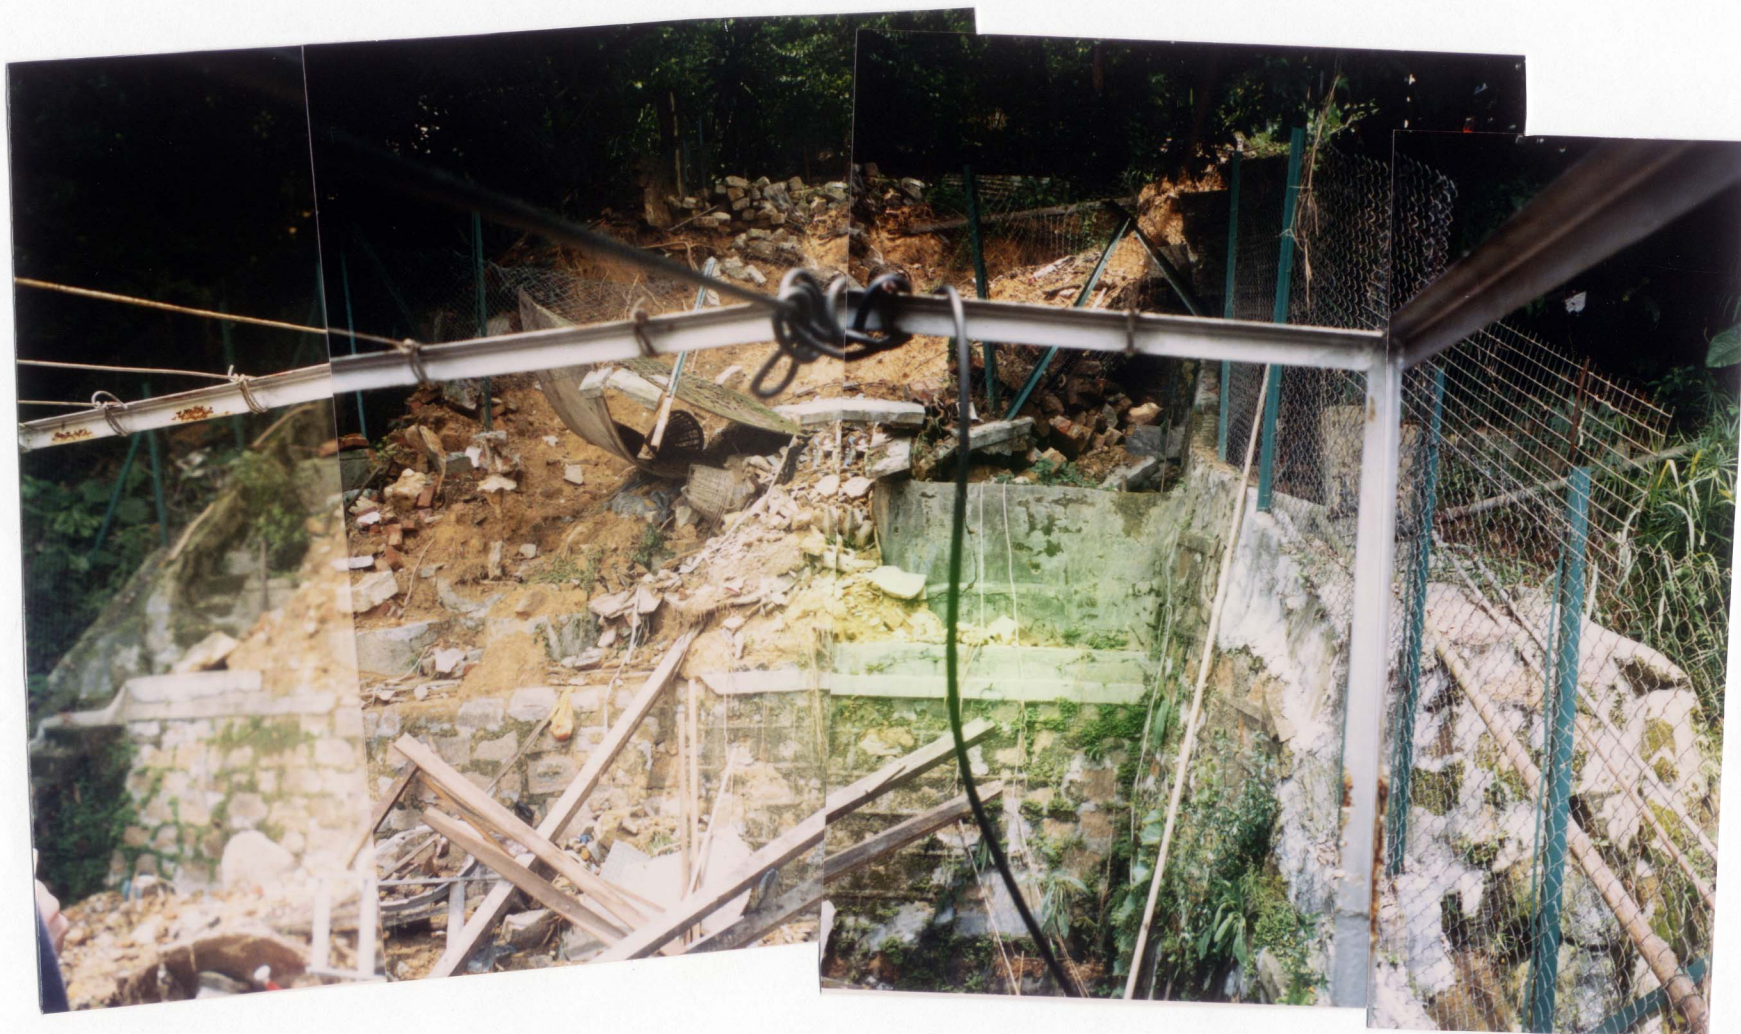
The landslide involved part of a terraced fill slope comprising three brick retaining walls (Plates 9 and 10) and produced an estimated 60 m³ volume of debris. The failure was about 9 m wide, 6 m long and had a maximum depth of 2 m. The bulk of the landslide debris was derived from the uppermost terrace platform, which was retained by a 2 m high cemented brick wall. The landslide exposed highly and completely decomposed medium-grained granite.

Plate 9 - View of Landslide C (Photograph Taken on 6 June 1997. Note that the Fill Platform was Located Near the Top of the Landslide Scar)

Following the landslide, the GEO recommended permanent evacuation of house No. 73 (GEO, 1997c).

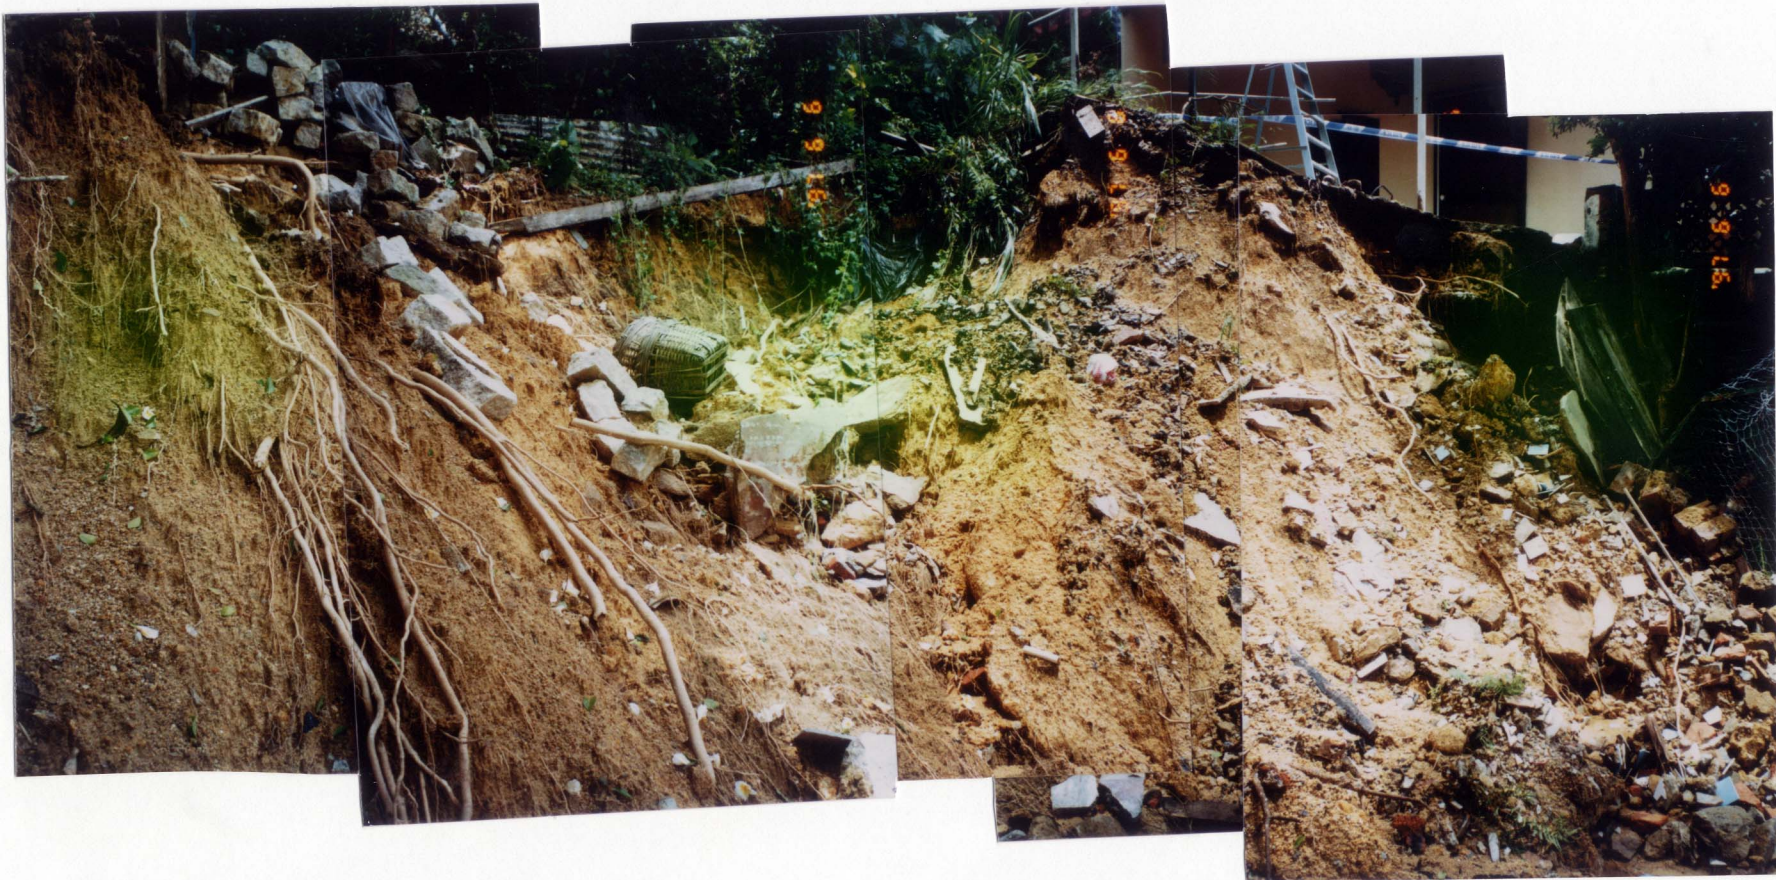
Plate 10 - View of the Upper Part of Landslide C (Photograph Taken on 6 June 1997. Note the Secondary Washout Channel Extending to the Back of the Full Platform)

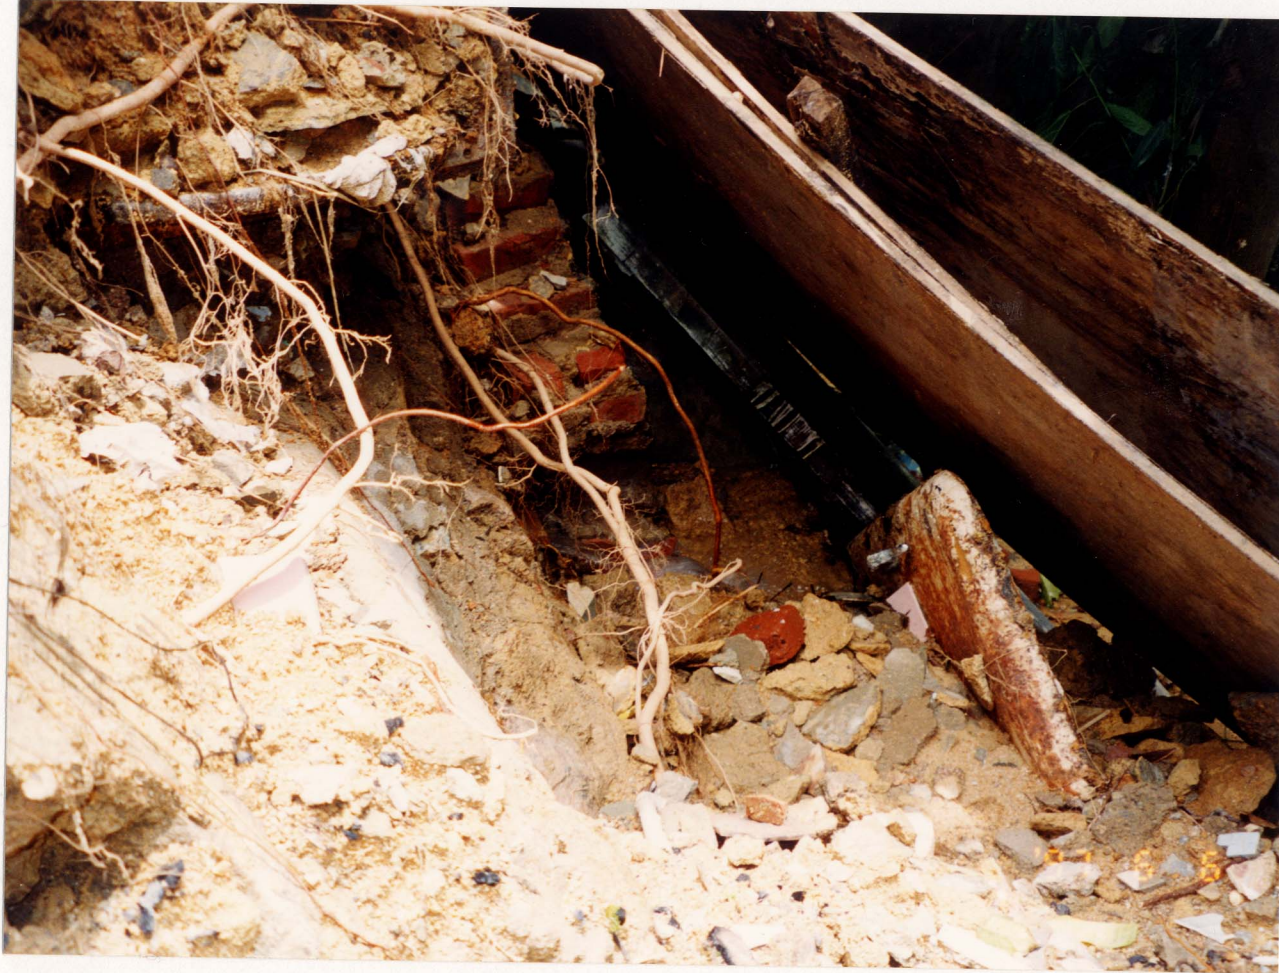
The brick wall at the crest of the fill body was 300 mm thick (Plate 11). The fill exposed in the main scarp comprised loose to very loose, wet, pale orangish and greyish brown, silty gravelly sand with angular cobbles and small boulders of highly decomposed granite, pieces of brick and concrete, and numerous voids.

Plate 11 - View of the Thin Brick Retaining Wall Involved in Landslide C (Photograph Taken on 6 June 1997)

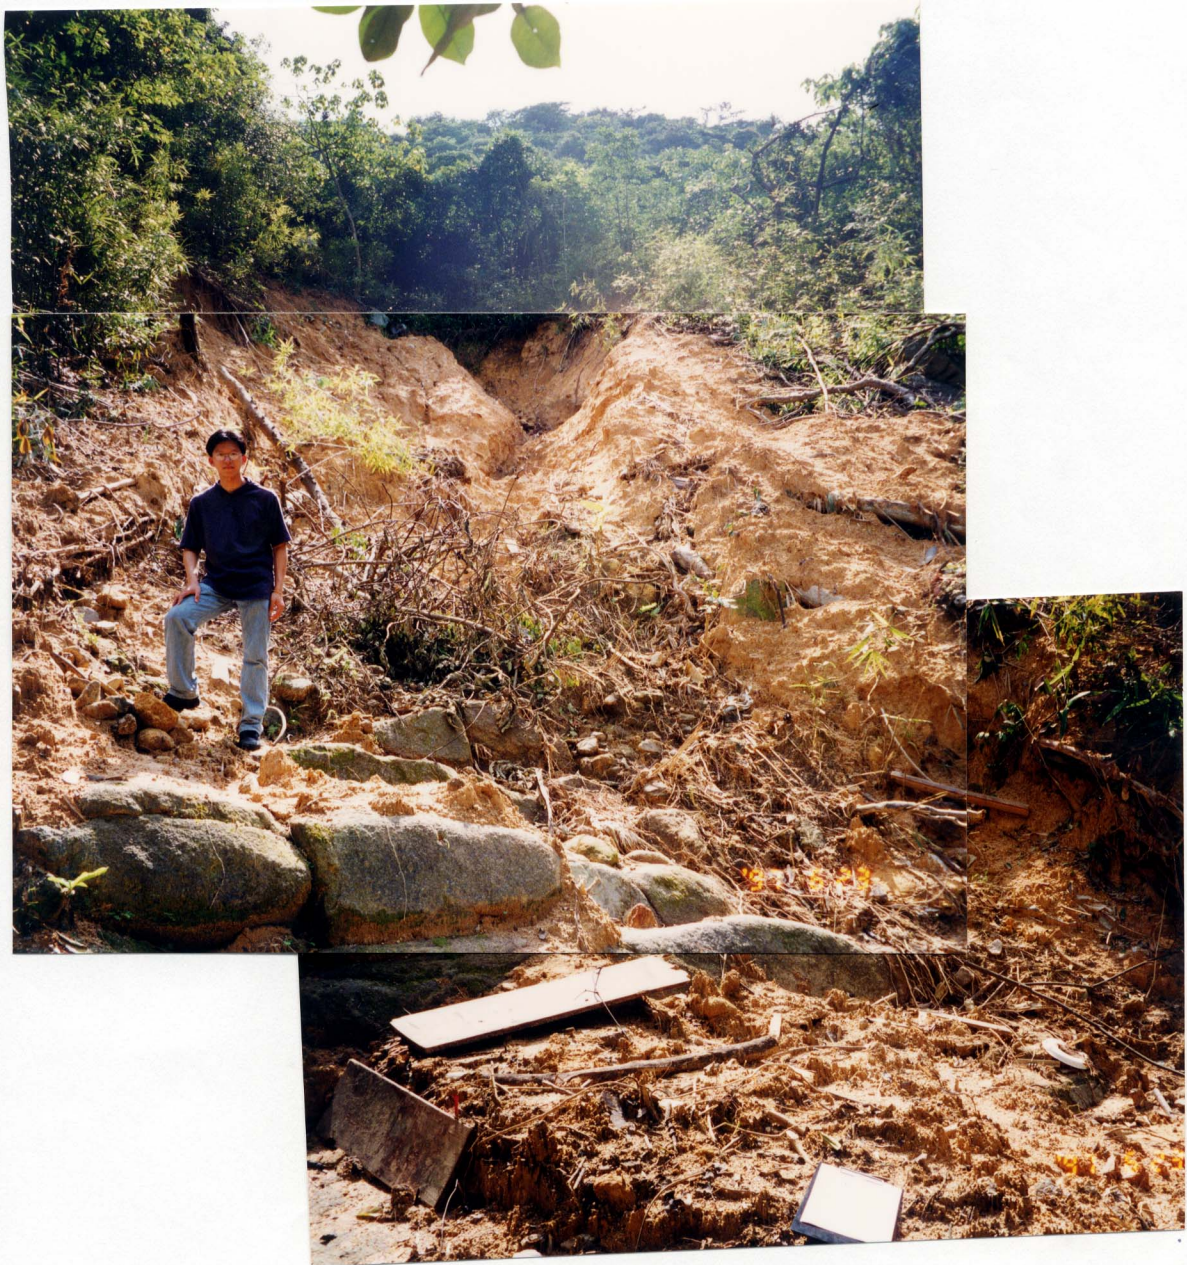
The landslide mostly involved the failure of a fill slope and was 35 m long, 11 m wide and 4 m deep, with an estimated volume of about 500 m³. The geometry of the main scarp suggests there were two phases of failure. An initial failure most likely occurred at the front of the fill slope where the gradient was steep, which was later followed by a washout caused by surface water flow from an ephemeral stream (Figures 10 and 11). The travel angle of the initial landslide debris was slightly in excess of 30° and within the typical range for rain-induced failures in Hong Kong (Wong & Ho, 1996).

Plate 12 - View of Landslide D (Photograph Taken on 23 June 1997.
Note the Deep Channel in the Upper Part of the Landslide)

Following the landslide, the GEO recommended permanent evacuation of house No. 139C and urgent repair works to the slope (GEO, 1997d). The resident was re-housed and the Highways Department were requested by the Housing Department to "liaise with DLO/Kwai Tsing for commencement of the urgent slope repair works as recommended by CGE/MW, GEO" (Housing Department, 1997b).

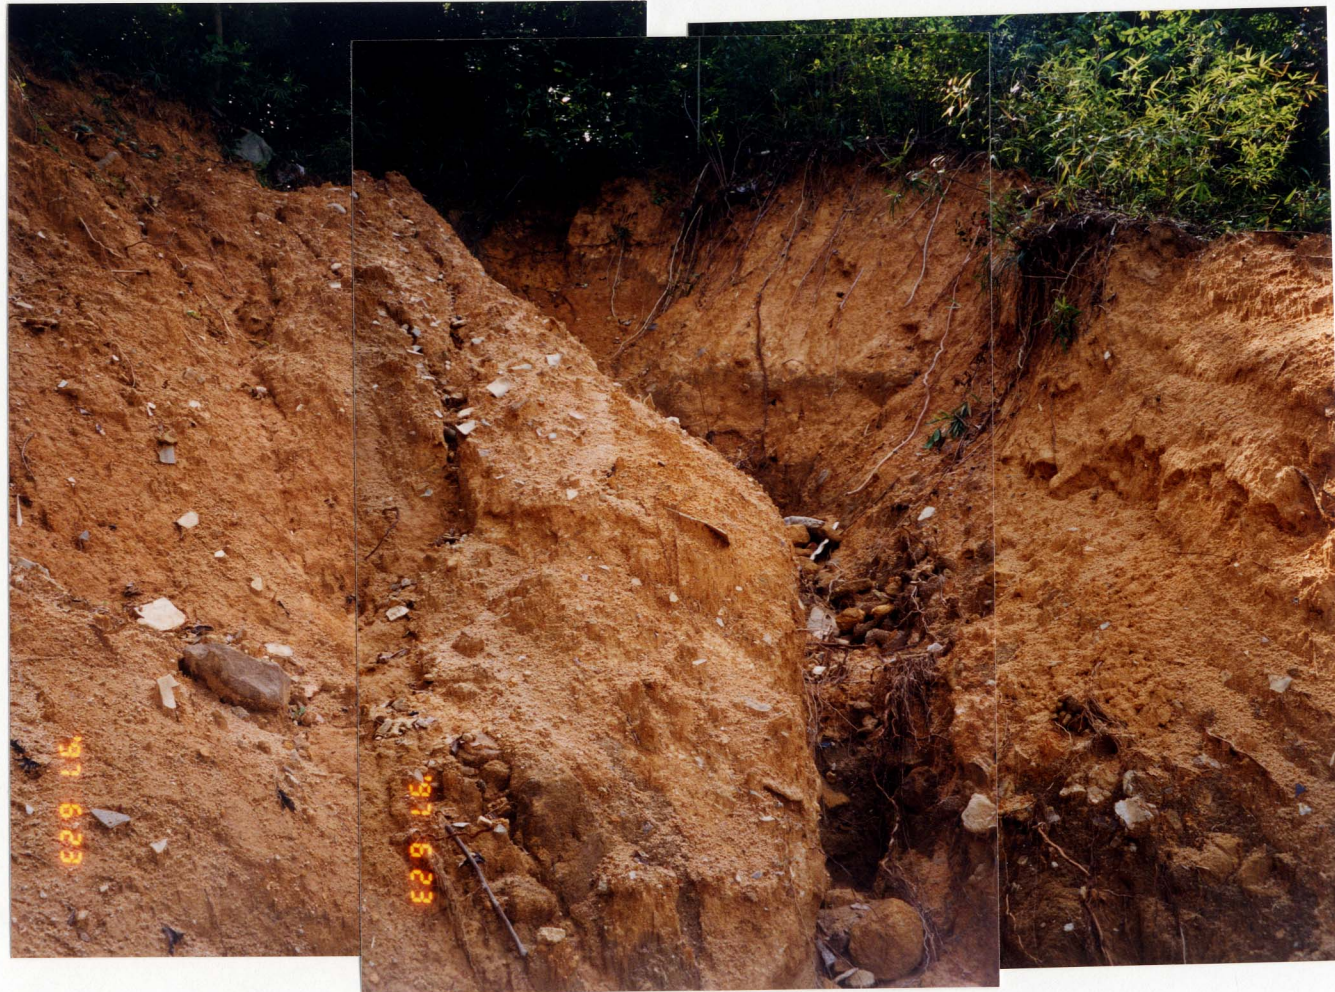
During inspections by HAP several weeks after the landslide, a dry streamcourse containing cobbles, small boulders and flattened vegetation was identified above the crest of the landslide. The fill adjacent to the main scarp was also found to be in a saturated condition. Interviews with residents in the vicinity of the landslide have confirmed that on the day of the failure, water was seen flowing over the crest of the main scarp. The washout phase of the landslide cut a deep, stepped erosion channel (Plate 13) and extended the main scarp further up the hillside.

Plate 13 - View of the Erosion Channel in the Upper Part of Landslide D (Photograph Taken on 23 June 1997)

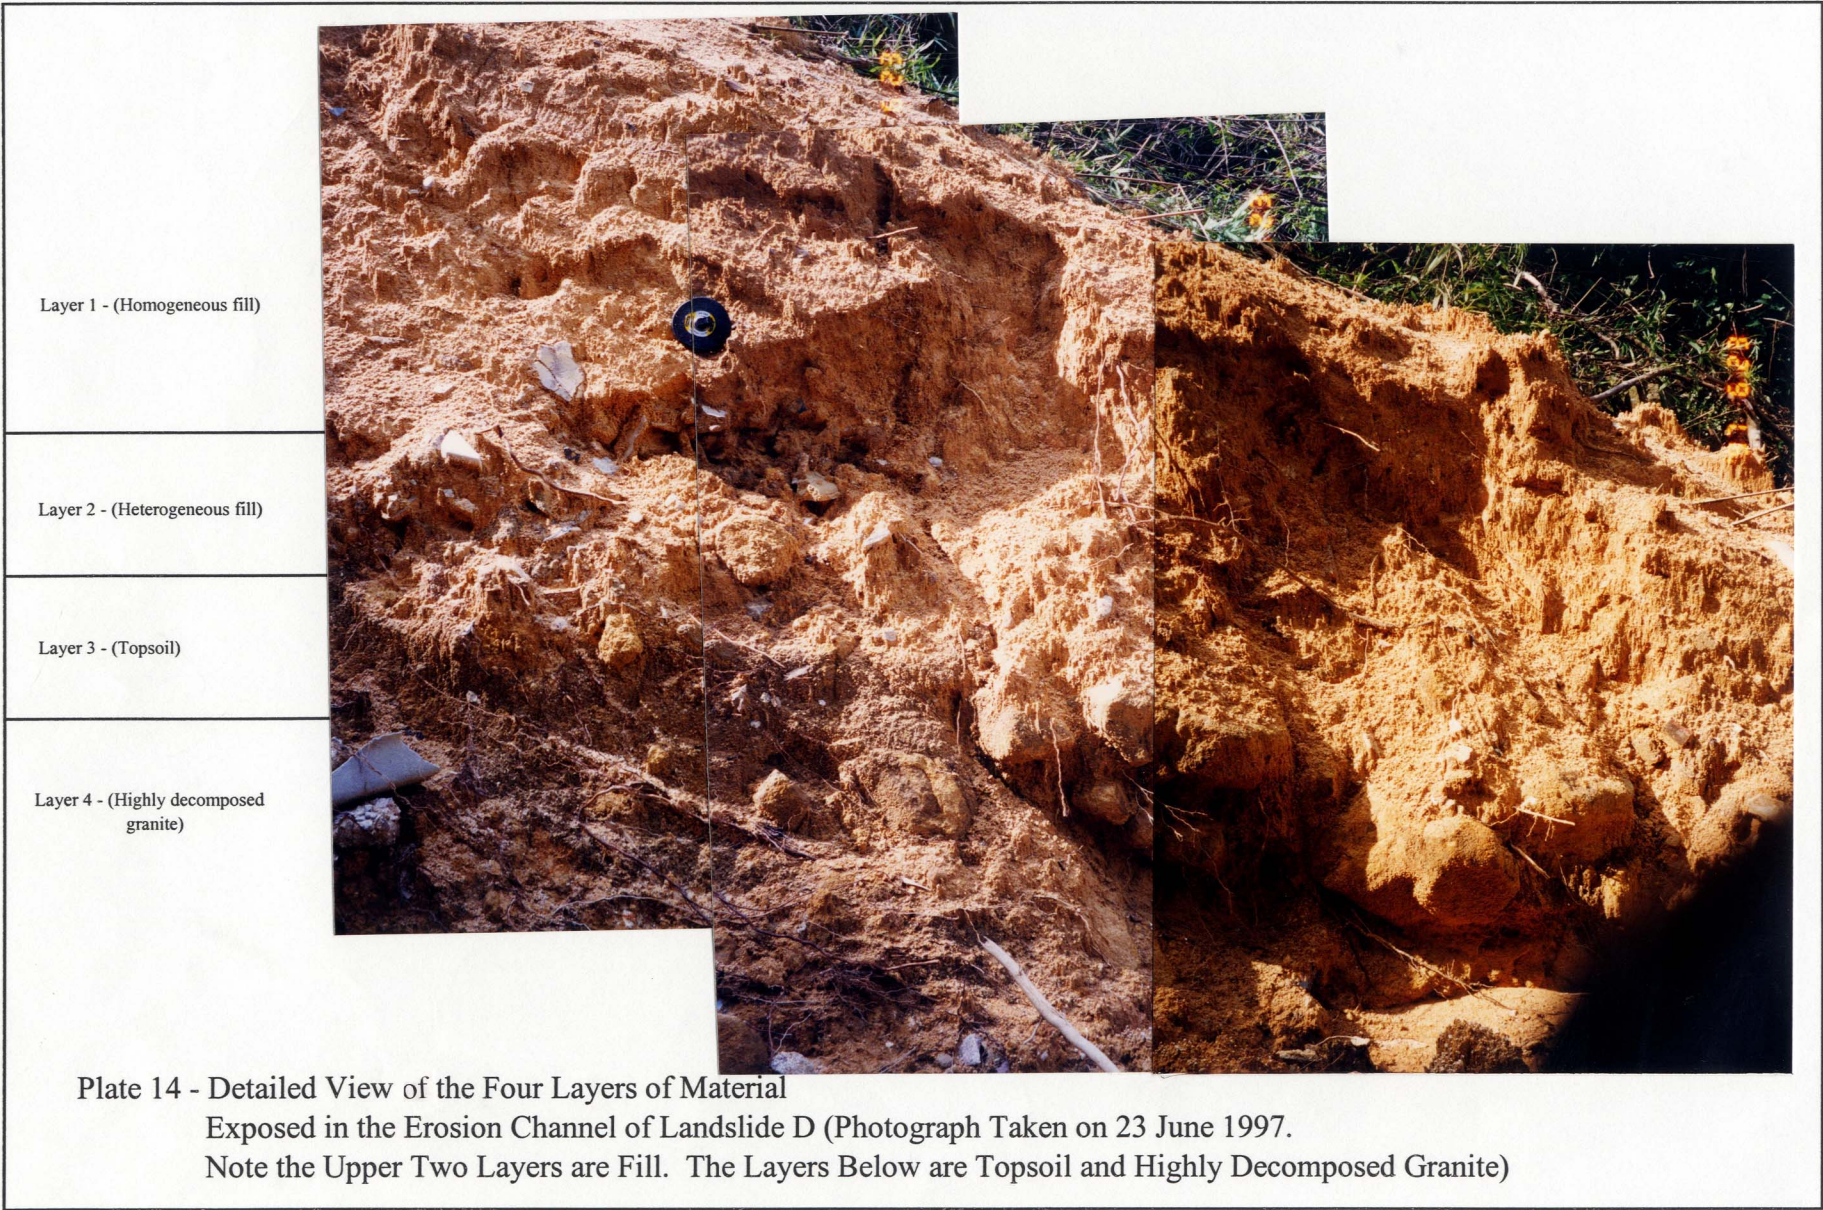
The washout channel exposed four layers of material (Plate 14). The upper layer comprised 1 m to 2 m of relatively homogeneous, loose, sandy gravel fill with small pieces of old chunam. The second layer was up to 1 m thick and composed of heterogeneous loose, granitic fill with small boulders. The fill was underlain by a thin layer of topsoil comprising firm, moist, dark greyish brown, slightly gravelly, slightly clayey, sandy silt which in turn was underlain by decomposed granite. The landslide debris was mainly composed of fill material.
