**SECTION 4:  
DETAILED STUDY OF THE  
LANDSLIDE AT  
TUEN MUN ROAD  
NEAR TING KAU  
ON 2 JULY 1997**

**Halcrow Asia Partnership Ltd**

**This report was originally produced in June 1998  
as GEO Landslide Study Report No. LSR 14/98**

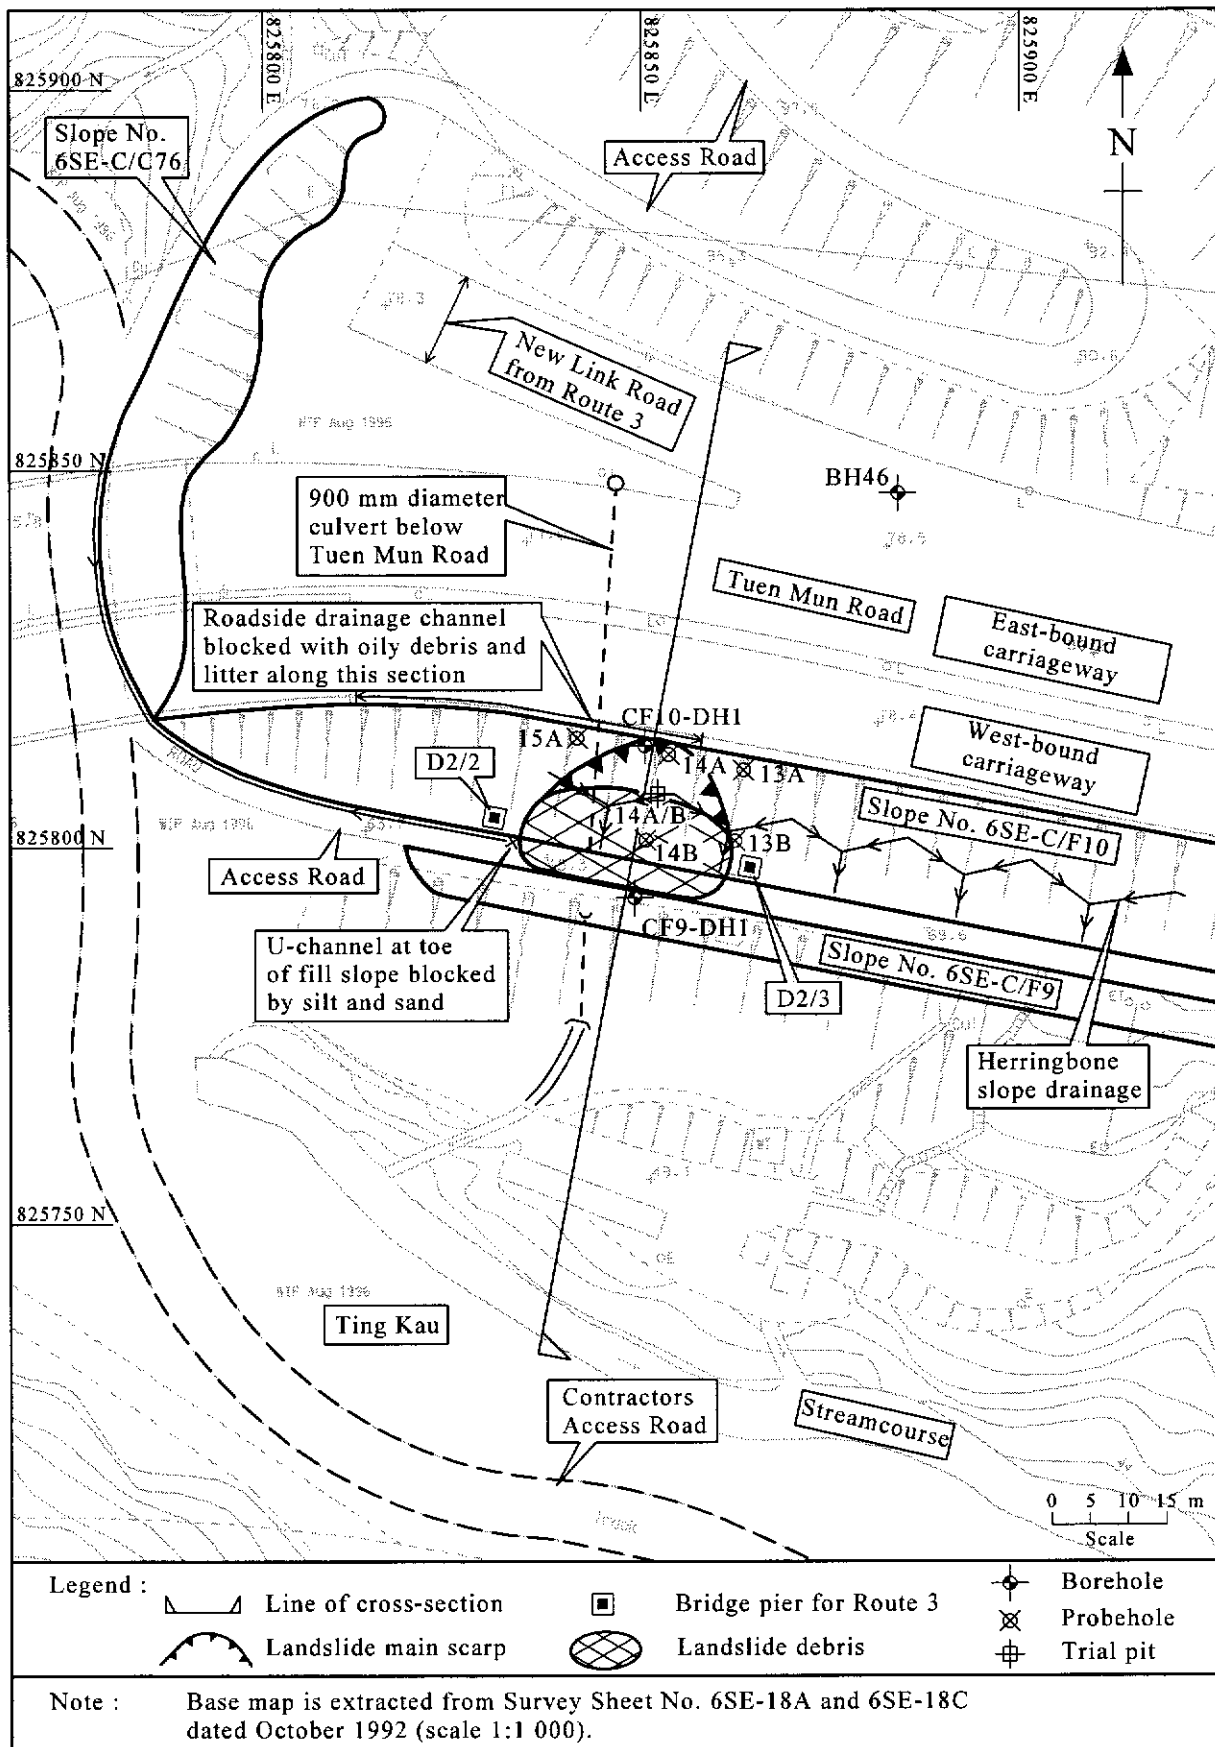
Figure 2 - Plan of the Landslide Site

The location of the landslide is shown in Figures 1 and 2. The landslide occurred on fill Slope No. 6SE-C/F10 below Tuen Mun Road. The debris from the landslide blocked the access road at the toe of the fill slope. Below the access road, there was another fill slope (No. 6SE-C/F9) which was unaffected by the landslide. The landslide was located between two bridge piers (D2/2 and D2/3) which had been constructed for a viaduct for the Country Park Section of the Route 3 Project (Figure 2 and Plate 1).

Two boreholes (CF9-DH1 and CF10-DH1) were drilled near the site of the landslide (Figure 2) during the 1995 ground investigation by Lam Geotechnics Limited (LG, 1995). A third borehole (BH46) was drilled near the site during a ground investigation between July

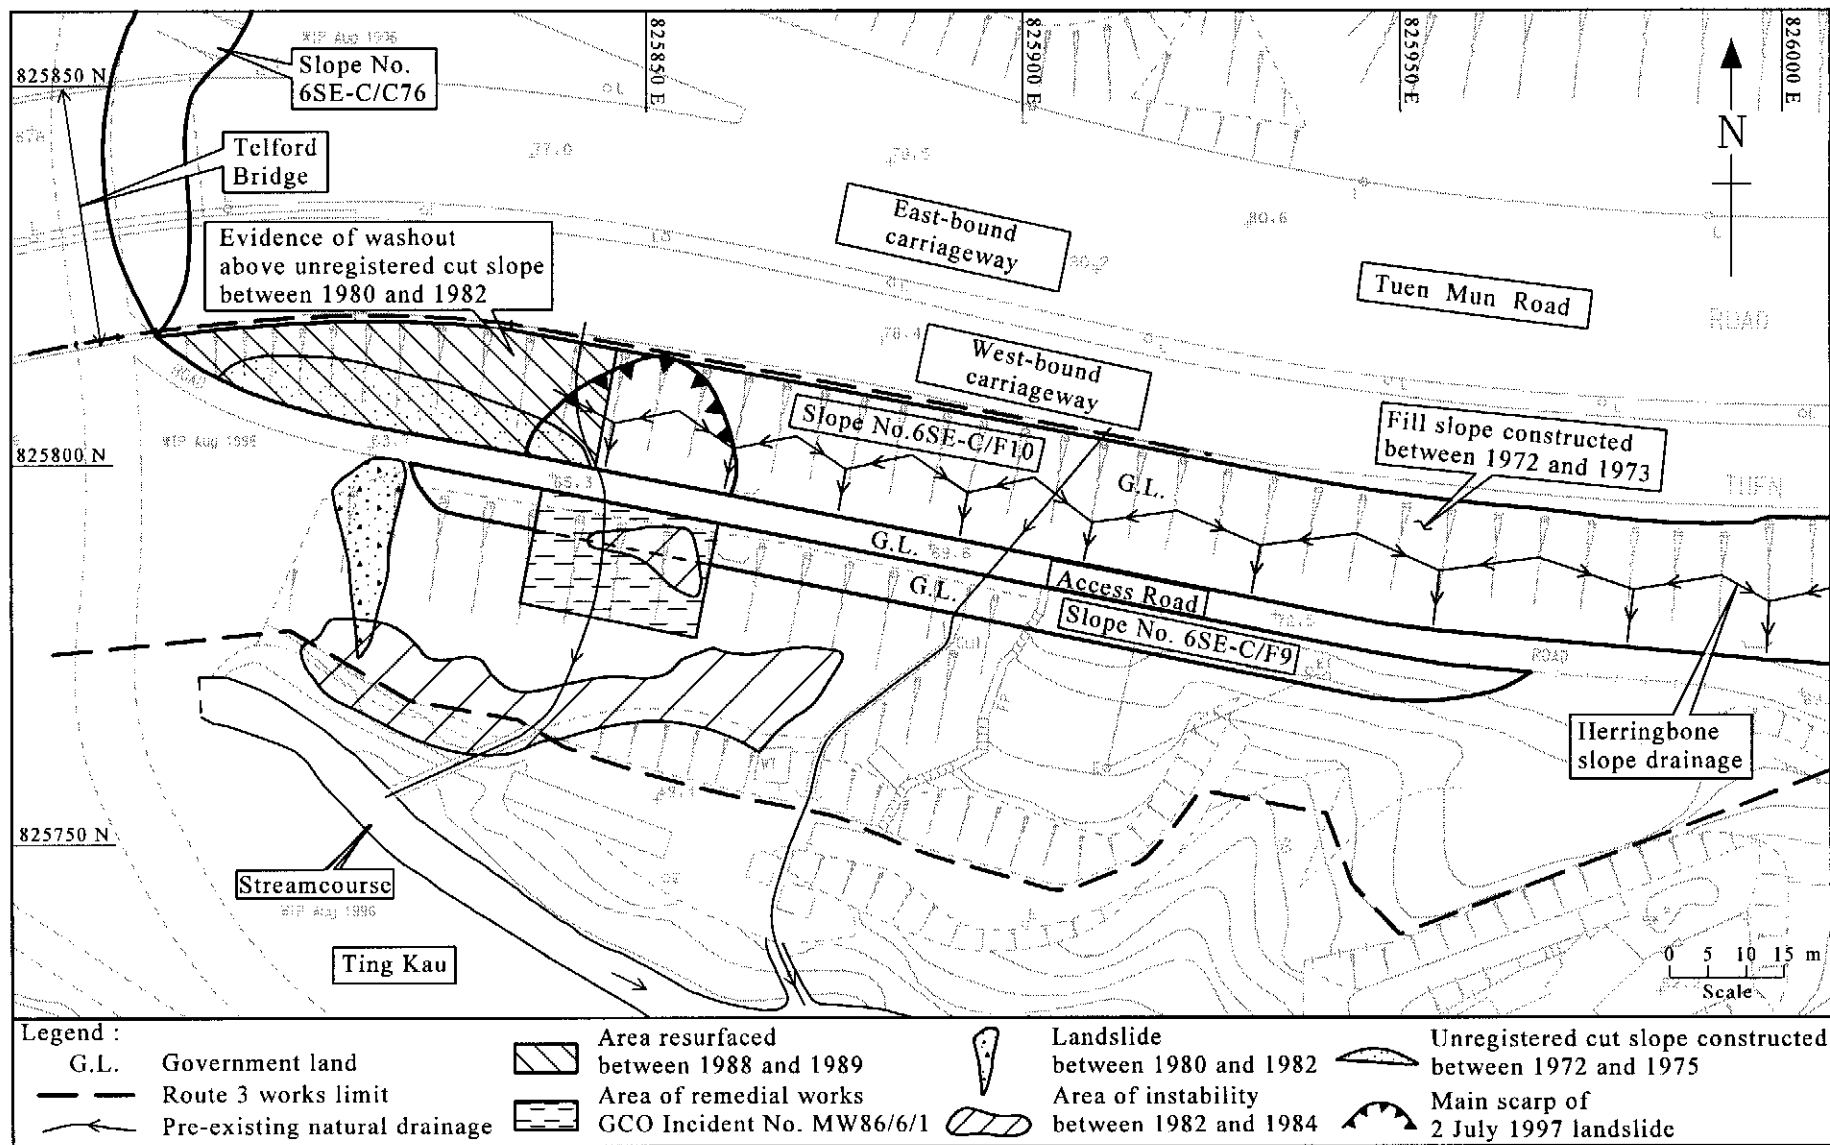
Figure 3 - Site History and Land Status

The aerial photographs taken in 1982 indicate that there had been a minor landslide on the natural terrain above the unregistered cut slope (Figure 3). By 1984, this area had been subject to repair works. Between 1988 and 1989, further surface protection measures had been applied to the previously affected area and to the unregistered cut slope below. At this time repair works were also undertaken on an area of instability (GEO Incident No. MW86/6/1) on Slope No. 6SE-C/F9 (see Section 2.3).

In July 1986, an aerial photograph interpretation (API) report was prepared by the GCO following Incident No. MW86/6/1 (GCO, 1986). The incident was inspected by the GCO in May 1986 who reported a minor failure and collapse of part of the herringbone drainage on Slope No. 6SE-C/F9 (Figure 3). The API report indicated that Slope No. 6SE-C/F9 and the partly modified slopes below had a history of instability from 1980 to 1986, the extent of which is shown in Figure 3.

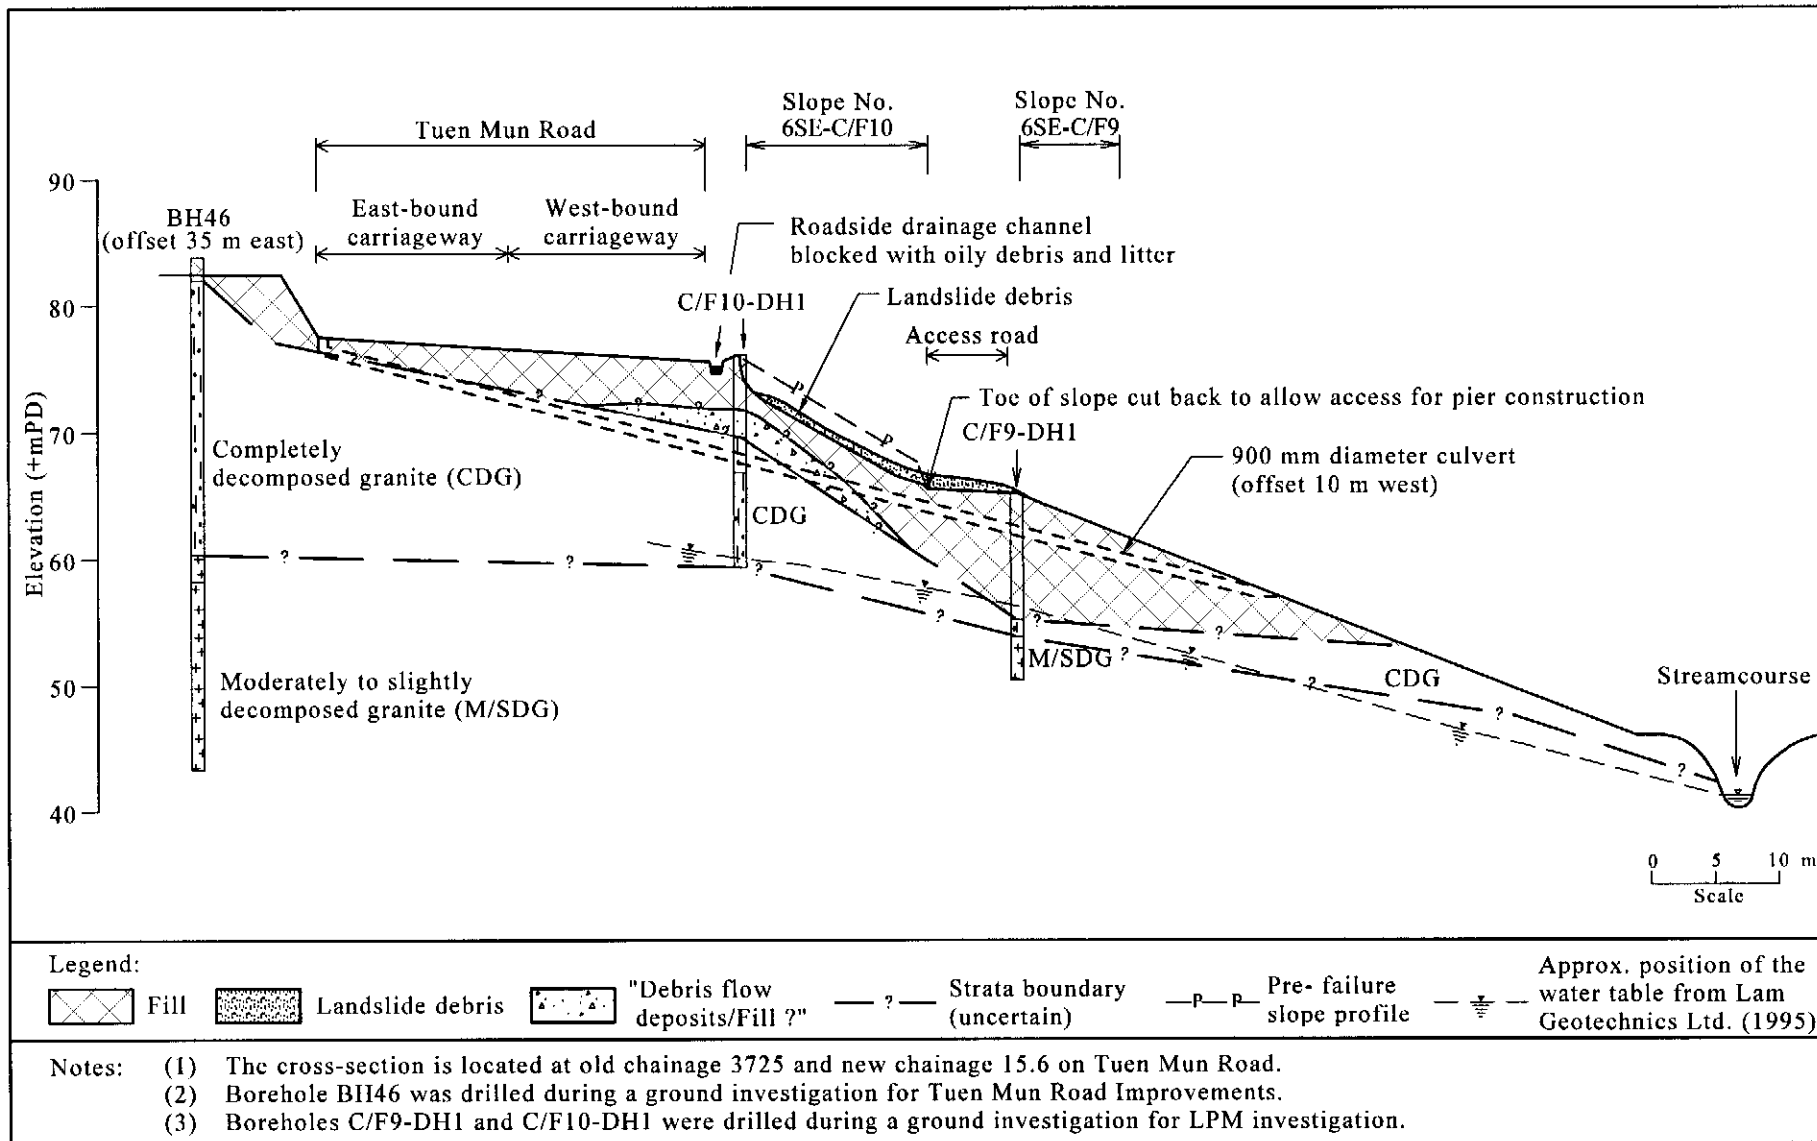
Figure 4 - Cross-section Through the Landslide

and October 1993 by Intrusion Prepakt (Far East) Limited (IP, 1993) for the proposed improvements to Tuen Mun Road. The boreholes have been used to prepare the geological cross-section (Figure 4).

Borehole CF9-DH1 was located on the access road between Slope No. 6SE-C/F10 and Slope No. 6SE-C/F9. The borehole encountered 11 m of fill, consisting of a loose to medium dense brownish yellow clayey silty fine to coarse sand. The fill materials were underlain by 1.3 m of completely to highly decomposed granite, below which moderately to slightly decomposed granite was encountered to the base of the borehole at 50.7 mPD. Groundwater was recorded in a piezometer at a depth of 8.6 m below ground level at about 57 mPD.

Borehole CF10-DH1 was located on the verge of Tuen Mun Road at the crest of Slope No. 6SE-C/F10. The borehole encountered 4.5 m of fill consisting of soft to firm brownish yellow clayey sandy silt and medium dense pinkish grey spotted grey slightly clayey silty sand. Underlying the fill the borehole encountered 4.25 m of material described as "fill/debris flow deposit" comprising firm to stiff, brownish yellow clayey sandy silt with occasional subangular fine quartz gravel and occasional cobble-size moderately weak to moderately strong rock fragments. These deposits materials were overlying 9.2 m of completely to highly decomposed granite to the base of the borehole at 59.24 mPD. Groundwater was recorded in a piezometer at a depth of 15.6 m below ground level at about 61 mPD.

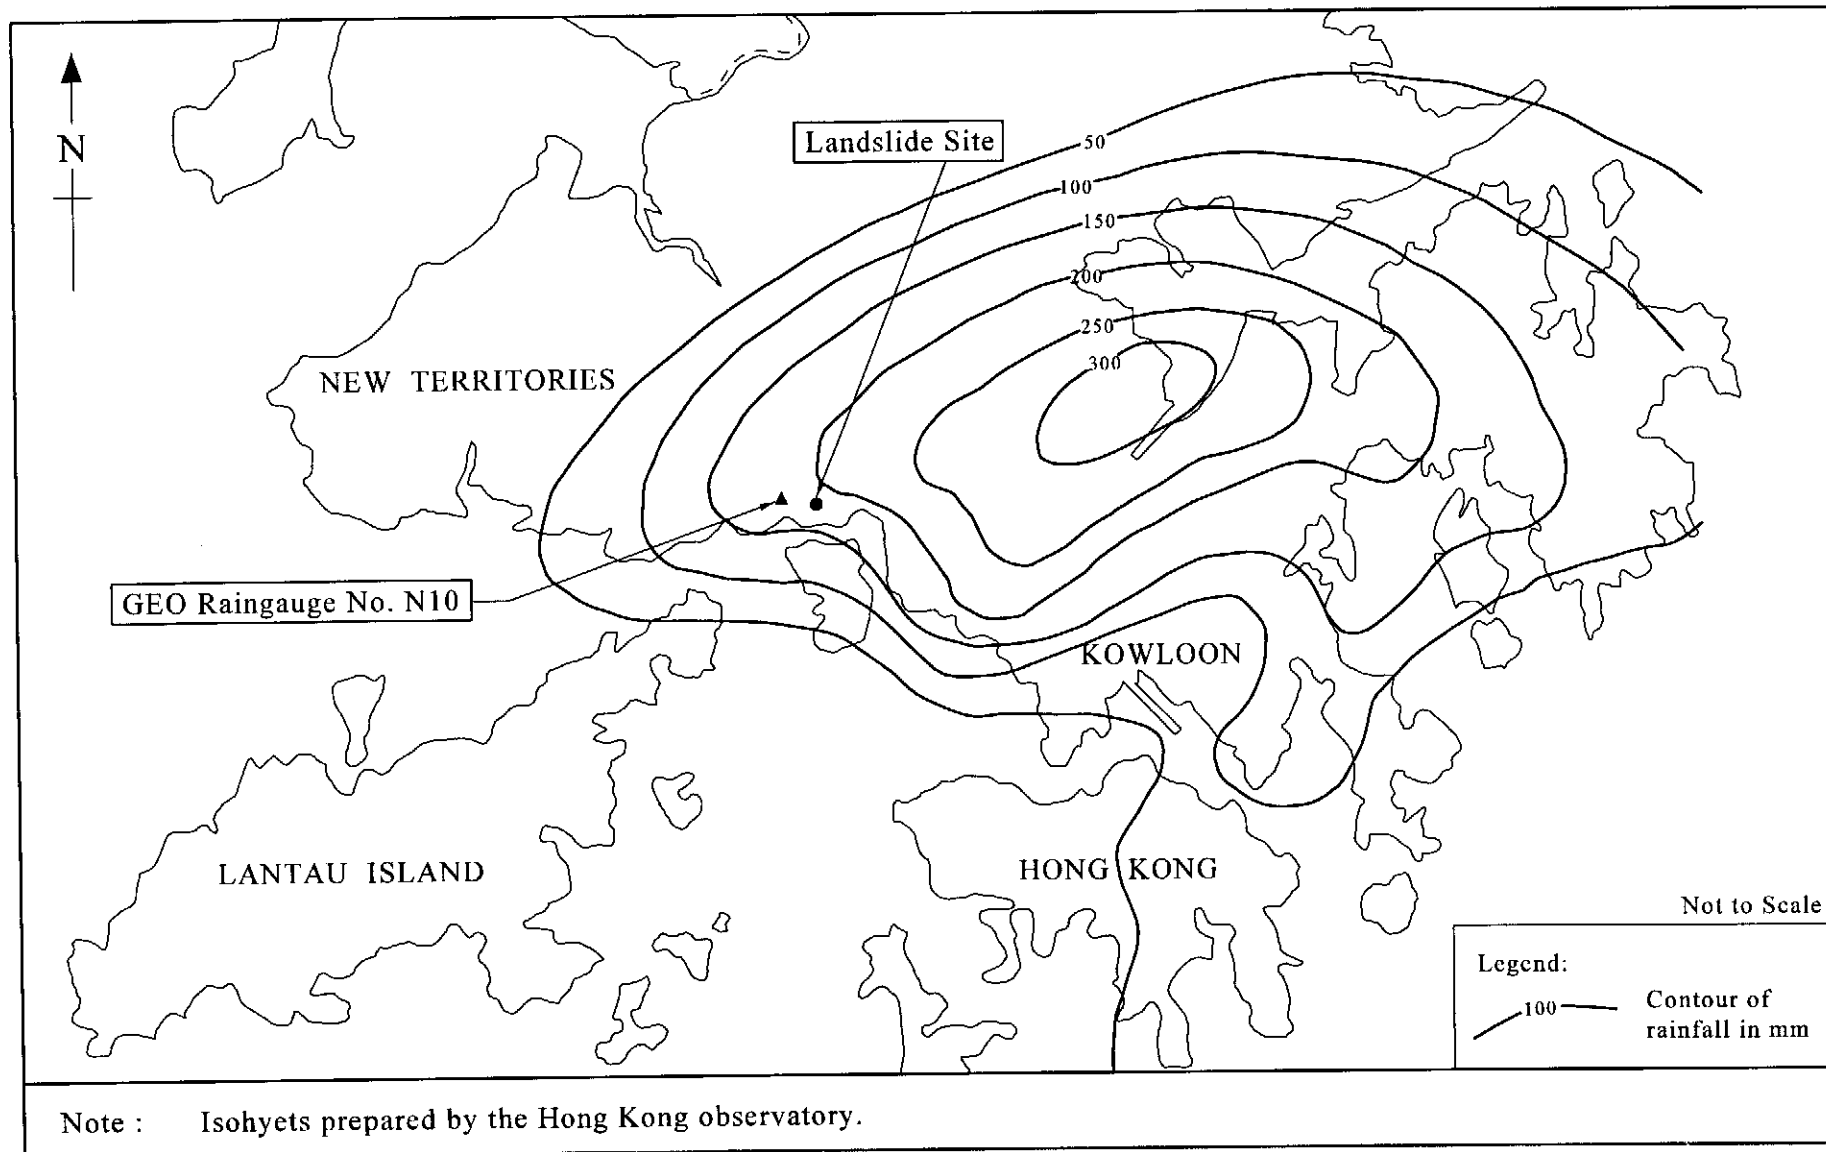
Figure 6 - Isohyets of Rainfall Between 02:00 Hours and 09:30 Hours on 2 July 1997

The nearest GEO automatic raingauge No. N10 is located at Sham Tseng Emmanuel Primary School, about 2.5 km west of the landslide site (Figure 1). The daily rainfall recorded in June and July 1997 is shown in Figure 5a. There was 664.5 mm and 364 mm of rainfall in the 31 days and 15 days before the landslide respectively. The hourly rainfall from 29 June 1997 to 2 July 1997 is shown in Figure 5b. There was 186 mm and 178 mm of rainfall in the 24 hours and 12 hours before the landslide respectively. Isohyets of rainfall prior to the landslide on 2 July 1997 are shown in Figure 6.

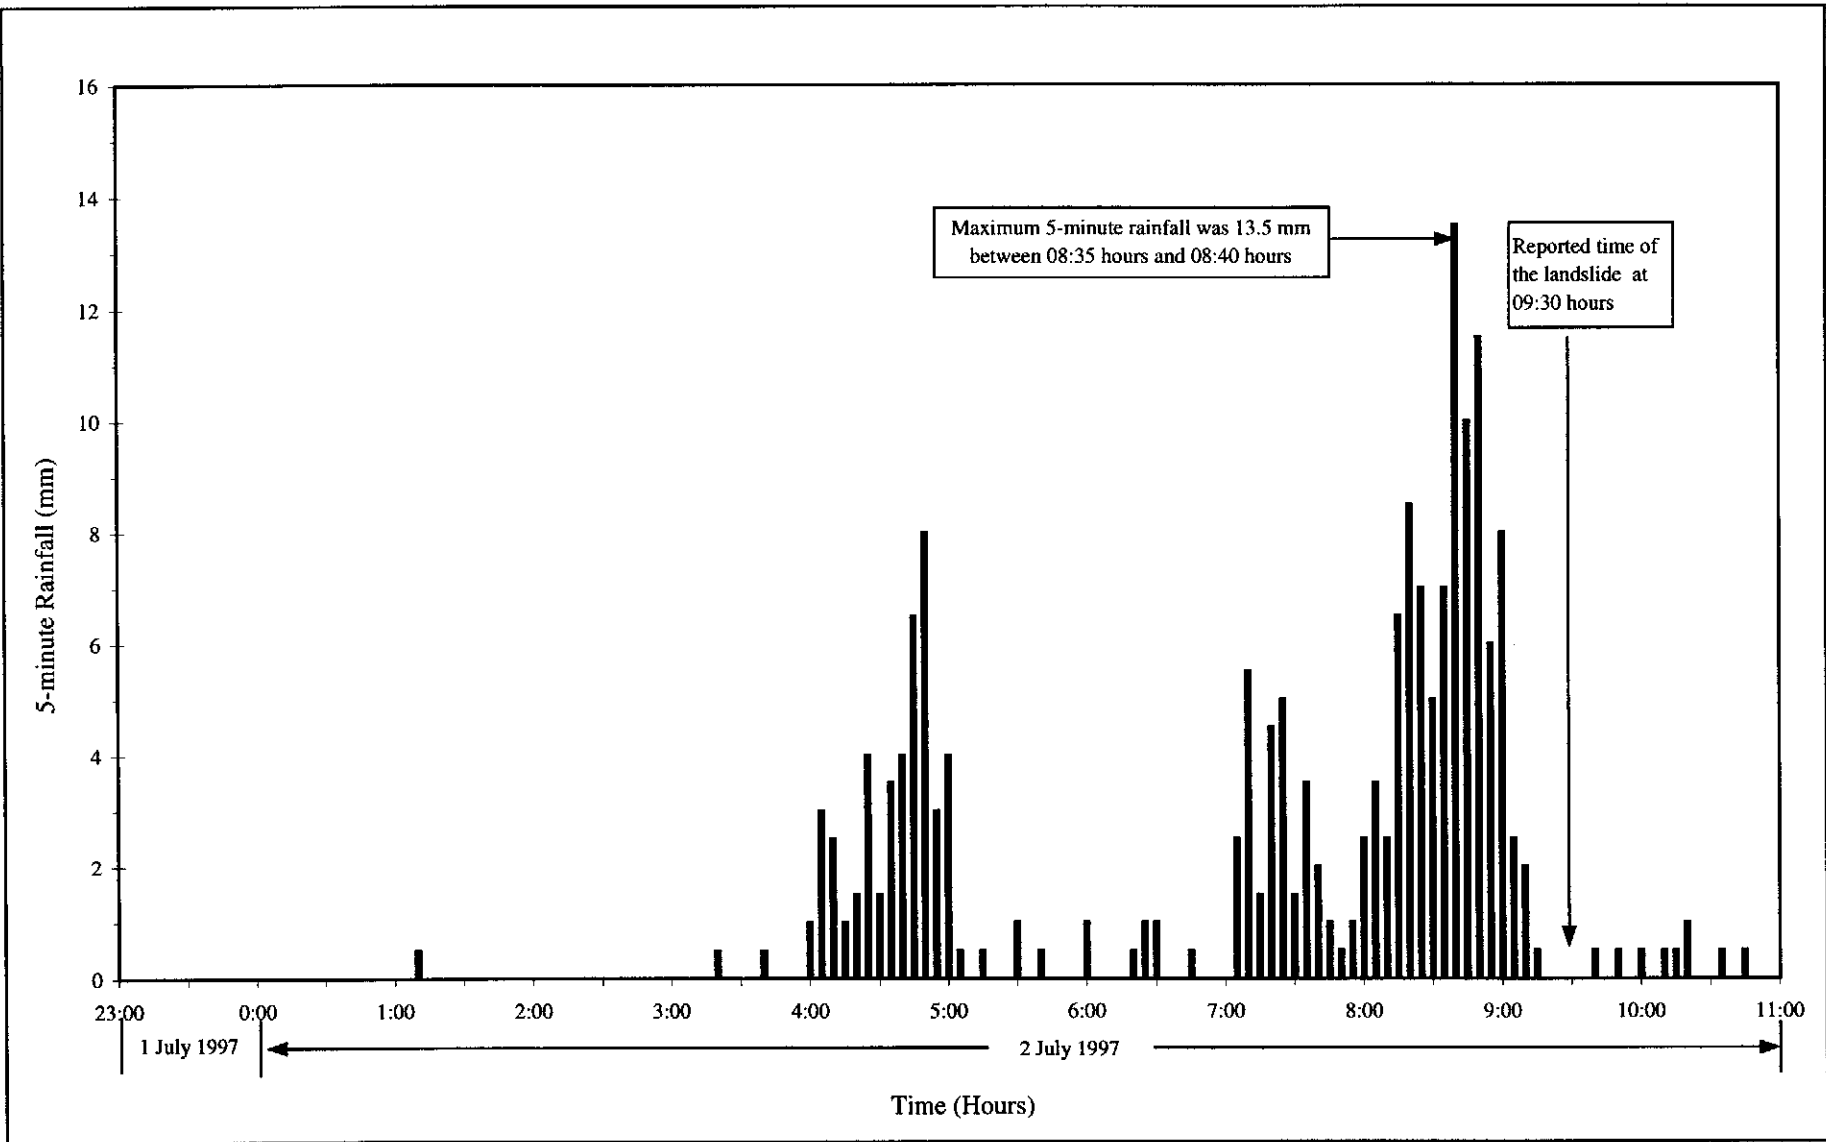
Figure 7 - Rainfall Recorded at GEO Raingauge No. N10 at 5-minute Intervals on 1 and 2 July 1997

The rainfall recorded at GEO raingauge No. N10 at 5-minute intervals is shown in Figure 7. The figure shows that the maximum intensity of the rainstorm (as indicated by the 5-minute rainfall) occurred between 08:35 hours and 08:40 hours on 2 July 1997.

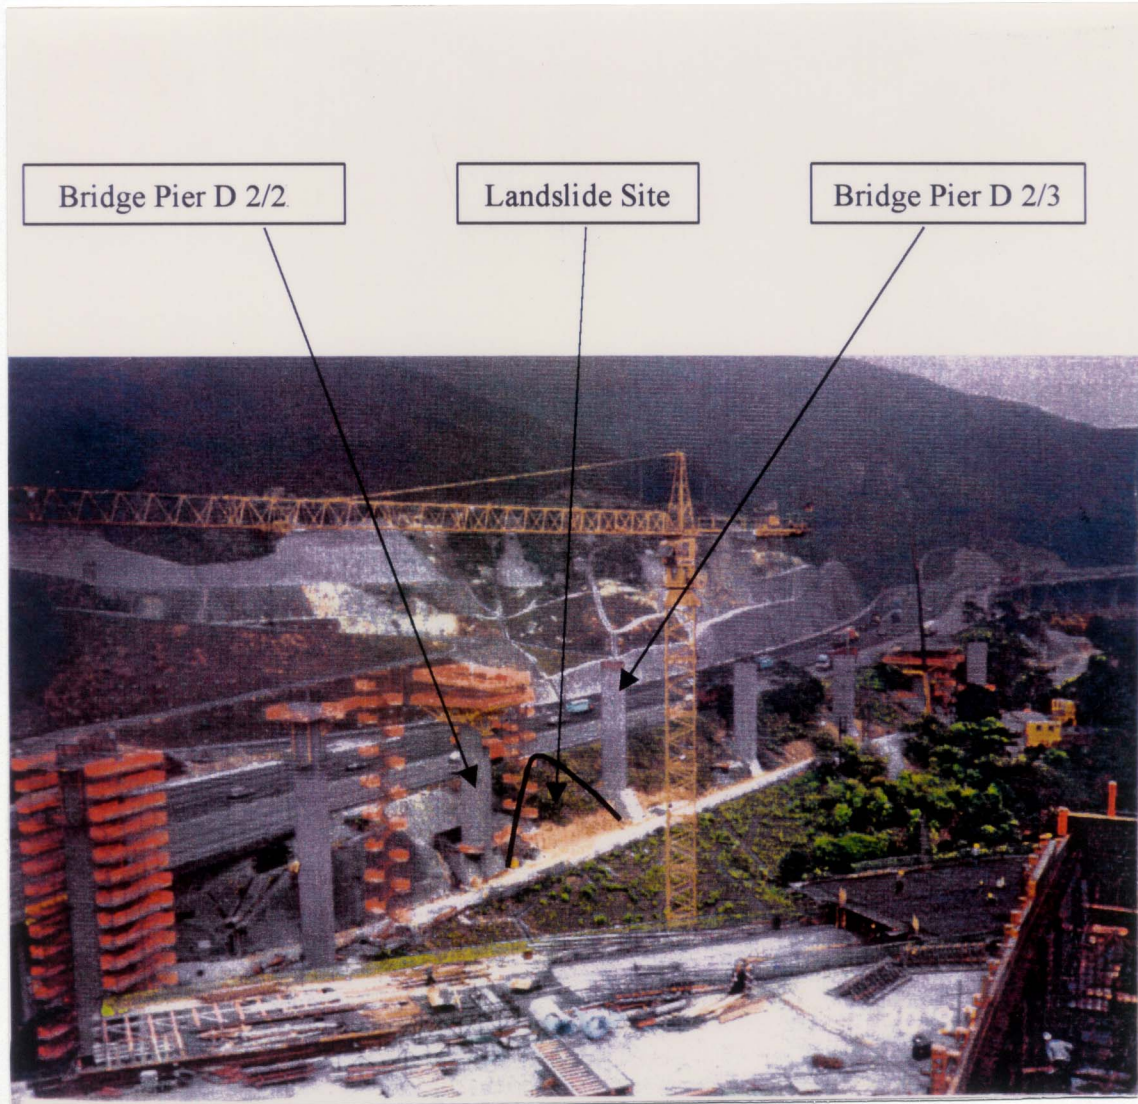
An aerial photograph taken in January 1997 (Plate 1) shows that the toe area of Slope No. 6SE-C/F10 had been cut back to allow access for the construction of bridge piers for Route 3. The construction of Route 3 was undertaken by the Route 3 Contractors Consortium (R3CC). At this time, bridge pier D2/2 was under construction and the foundation excavation for bridge pier D2/3 was underway.

Plate 1 - View showing the Construction of Bridge Piers D2/3 and D2/2 for Route 3 Adjacent to Tuen Mun Road (Photograph Taken in January 1997)

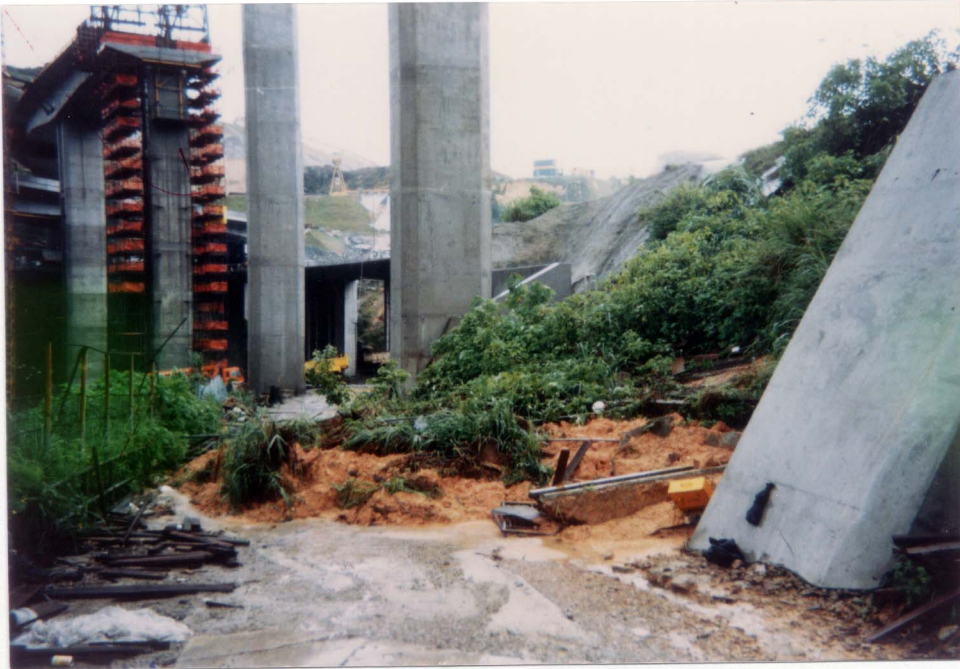
The landslide affected the full height of Slope No. 6SE-C/F10 between Tuen Mun Road and the access road. The failure was up to 25 m wide, 13 m long and 1.2 m deep and had an estimated volume of about 200 m<sup>3</sup>. The debris blocked the access road at the toe of the fill slope. The travel angle of the landslide debris was 28°. The travel angle was 28°, which is at the upper end of the range commonly observed for sliding failures of fill slopes in Hong Kong (Wong & Ho, 1996). The majority of the landslide debris was deposited within the main scarp without travelling further downslope (Plates 1 and 2).

Plate 2 - View to the West Along the Access Road Which was Blocked with Landslide Debris (Photograph Taken on 2 July 1997. Note Bridge Pier D2/3 in the Foreground and Bridge Pier D2/2 in the Centre of the Photograph)

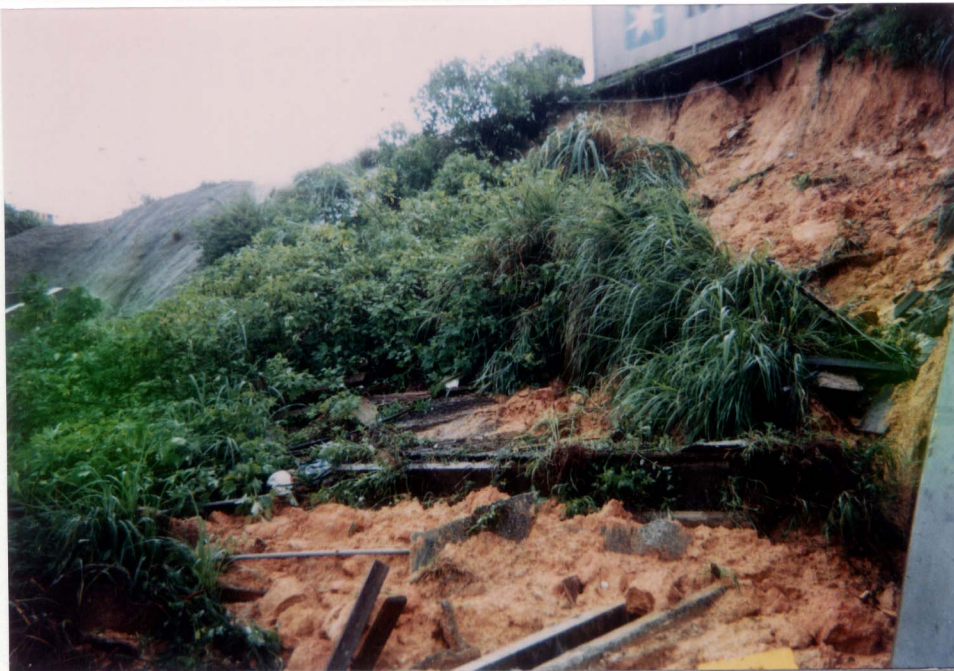
The fill exposed in the main scarp was loose orangish brown very silty fine to medium sand. During an inspection by HAP on 3 July 1997, no seepages were observed from the main scarp and the landslide debris was in a moist to wet condition. The debris comprised fill with artefacts of broken U-channel and chunam (Plates 3 and 4).

The main scarp undermined part of the verge of Tuen Mun Road, and a void was formed about 5 m wide, 1.2 m high and 1.5 m deep (Plate 3). A small water pipe and two steel cable conduits running in the verge were exposed by the landslide (Plate 5). There was no apparent leakage of water from the water pipe.

Plate 3 - View of the Eastern Flank of the Landslide (Photograph Taken on 2 July 1997. Note the Sections of Broken U-channel in the Debris)

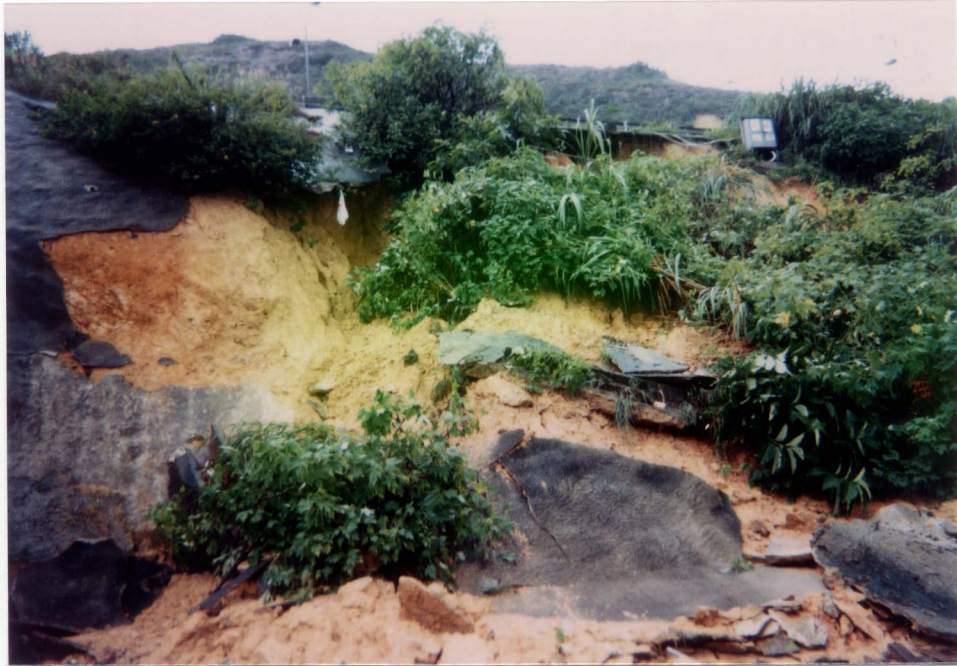
Plate 4 - View to the Western Flank of the Landslide (Photograph Taken on 2 July 1997. Note the Broken Chunam Surfacing in the Debris)

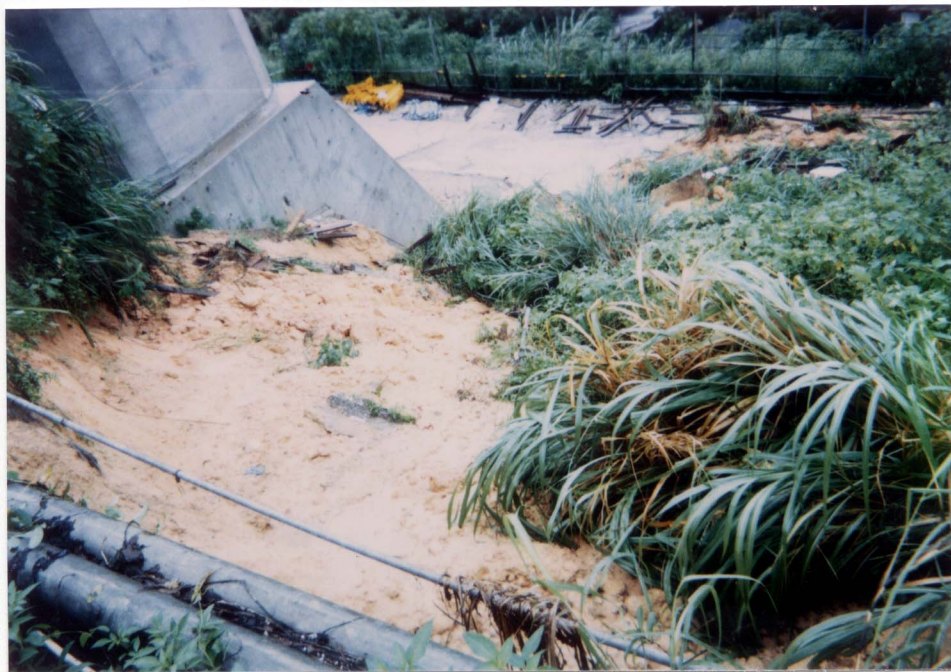
Plate 5 - View from the Crest of the Landslide (Photograph Taken on 2 July 1997. Note the Small Water Pipe and the Two Cable Conduits Exposed by the Landslide)

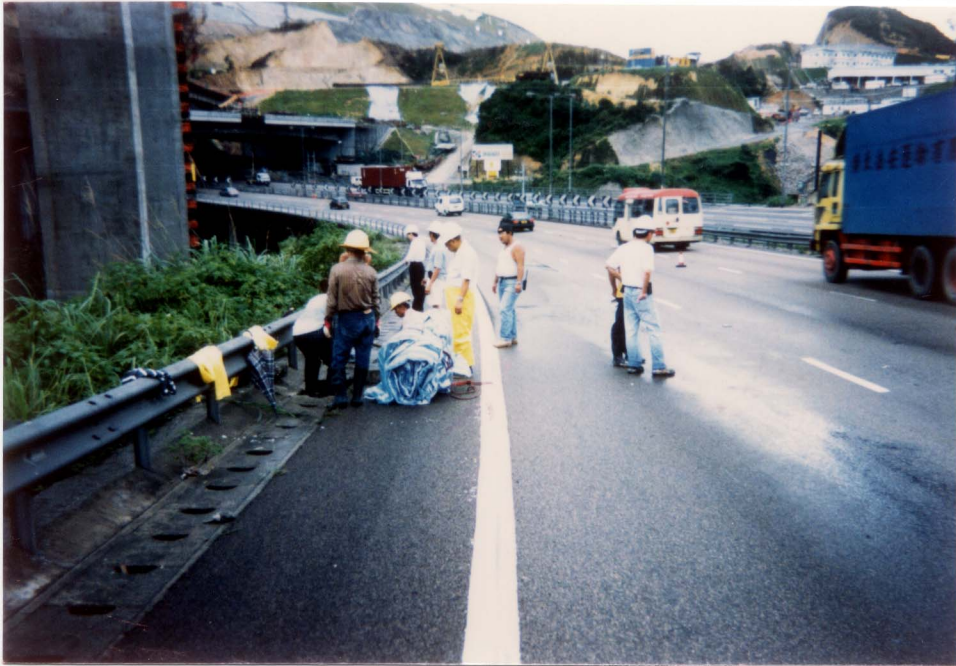
About five hours after the landslide the inner and middle lanes of the west-bound carriageway of Tuen Mun Road were closed by the police to allow engineers to inspect a crack in the road pavement. The crack was about 20 m-long and 5 mm wide, and was located upslope of the landslide on the inside lane of the west-bound carriageway, about 4 m from the crest of the slope on which the failure occurred (Plate 6). During the lane closure, HyD contractors and contractors working for R3CC inspected the roadside drainage channel and found that it "was totally blocked by silt and refuse" (Gammon Construction Limited (GCL, 1997). The landslide was located on Slope No. 6SE-C/F10 immediately below the blocked roadside drainage channel. HyD contractors and workmen from GCL undertook urgent repair works to the slope, in accordance with the recommendations of GEO. The west-bound carriageway was re-opened about 6 hours later, after completion of the urgent repair works (Plates 8 and 9).

Plate 6 - View to the West Along Tuen Mun Road During the Inspection of the Roadside Drainage System and the Road Pavement (Photograph Taken on 2 July 1997)

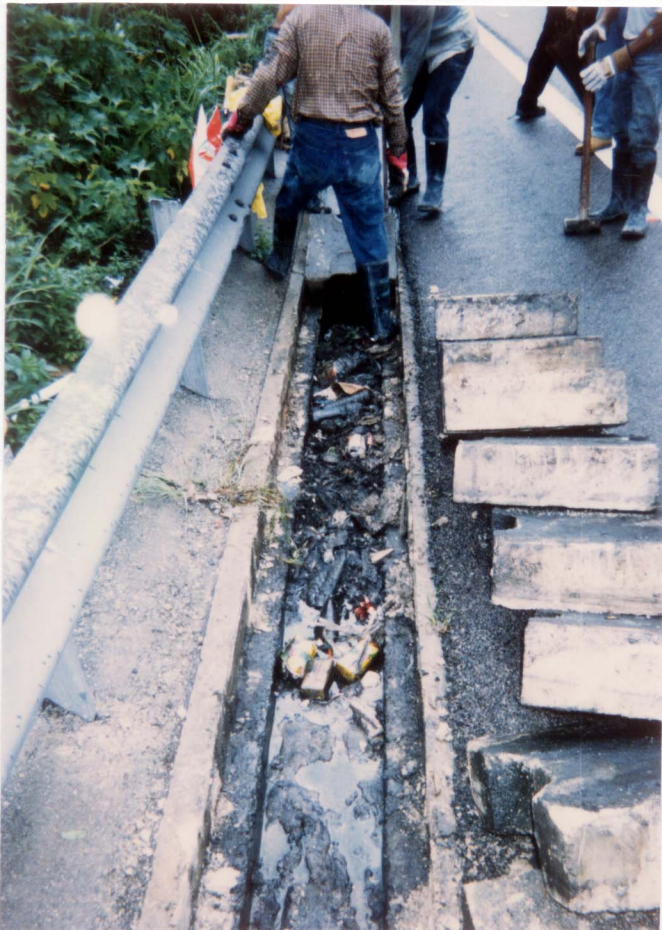
The landslide was located immediately below a blockage of the surface water drainage channel alongside Tuen Mun Road. In addition, the ground topography in the vicinity was such that stormwater run-off from the west-bound carriageway of the road collected by the channel would have been diverted onto the fill slope below, as a result of the blockage. It is considered probable that the concentrated discharge of surface water onto the slope from the blocked drainage channel, during the period of heavy rainfall, which commenced from about 07:00 hours on 2 July 1997, was the principal source of water contributing to the failure. The water would have wetted the fill, and possibly also led to local erosion and hence increased infiltration. Infiltration would have resulted in the development of local seepage pressures, and a reduction in the effective stress and shear strength of the fill due to elevated porewater pressure which triggered the sliding failure. A further contributory factor was the removal of support from the toe of the fill slope, due to cutting into the slope by construction activities.

An assessment was undertaken on the adequacy of the capacity of roadside drainage channel using published design formulae (GCO, 1984). The check determined that, in a clean state, the roadside drainage channel would have been of a sufficient capacity to accommodate stormwater run-off from the west-bound carriageway of Tuen Mun Road. A blockage however, would have significantly reduced the capacity of the channel and led to overflowing of the channel.

- (a) the roadside drainage channel, which is at a low point in the road verge, became completely blocked with oily debris and litter at sometime prior to 2 July 1997,

Plate 7 - Roadside Drainage Channel to the West of the Landslide Site (Photograph Taken on 2 July 1997. Note the Blockage of the Channel with Oily Debris and Litter)

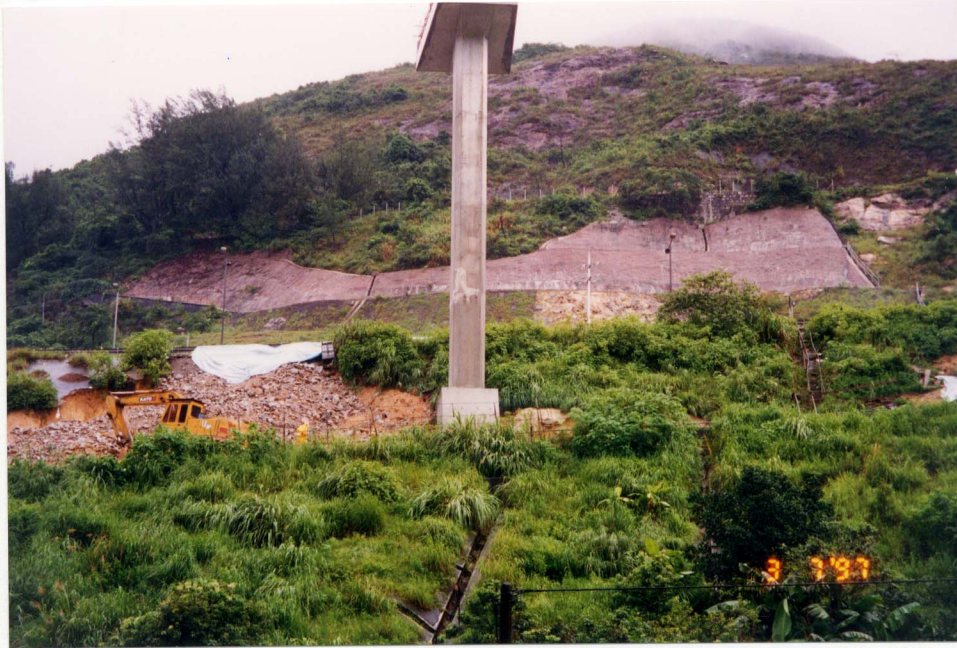
Plate 8 - View Showing the Urgent Repair Works (Photograph Taken on 3 July 1997. Note the Vegetation Covering the Slope to the East of the Landslide and Chunam Covering the Slope to the West of the Landslide)

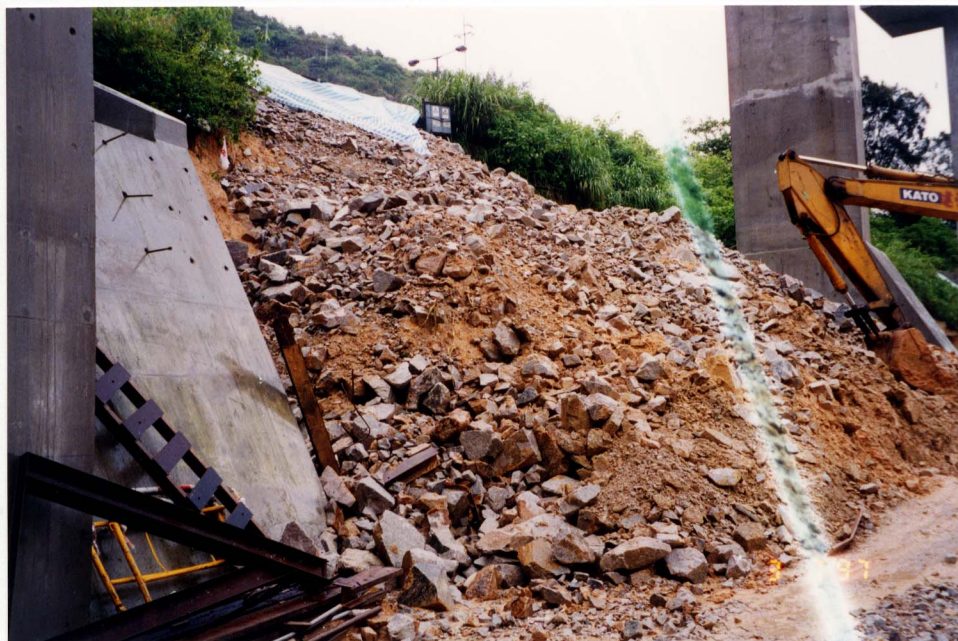
Plate 9 - Close-up of the Urgent Repair Works Showing the Main Scarp Infilled with Rockfill (Photograph Taken on 3 July 1997)
