**SECTION 5:  
DETAILED STUDY OF THE  
LANDSLIDE  
AT LAI CHO ROAD  
KWAI CHUNG  
ON 4 JUNE 1997**

**Halcrow Asia Partnership Ltd**

**This report was originally produced in October 1998  
as GEO Landslide Study Report No. LSR 16/98**

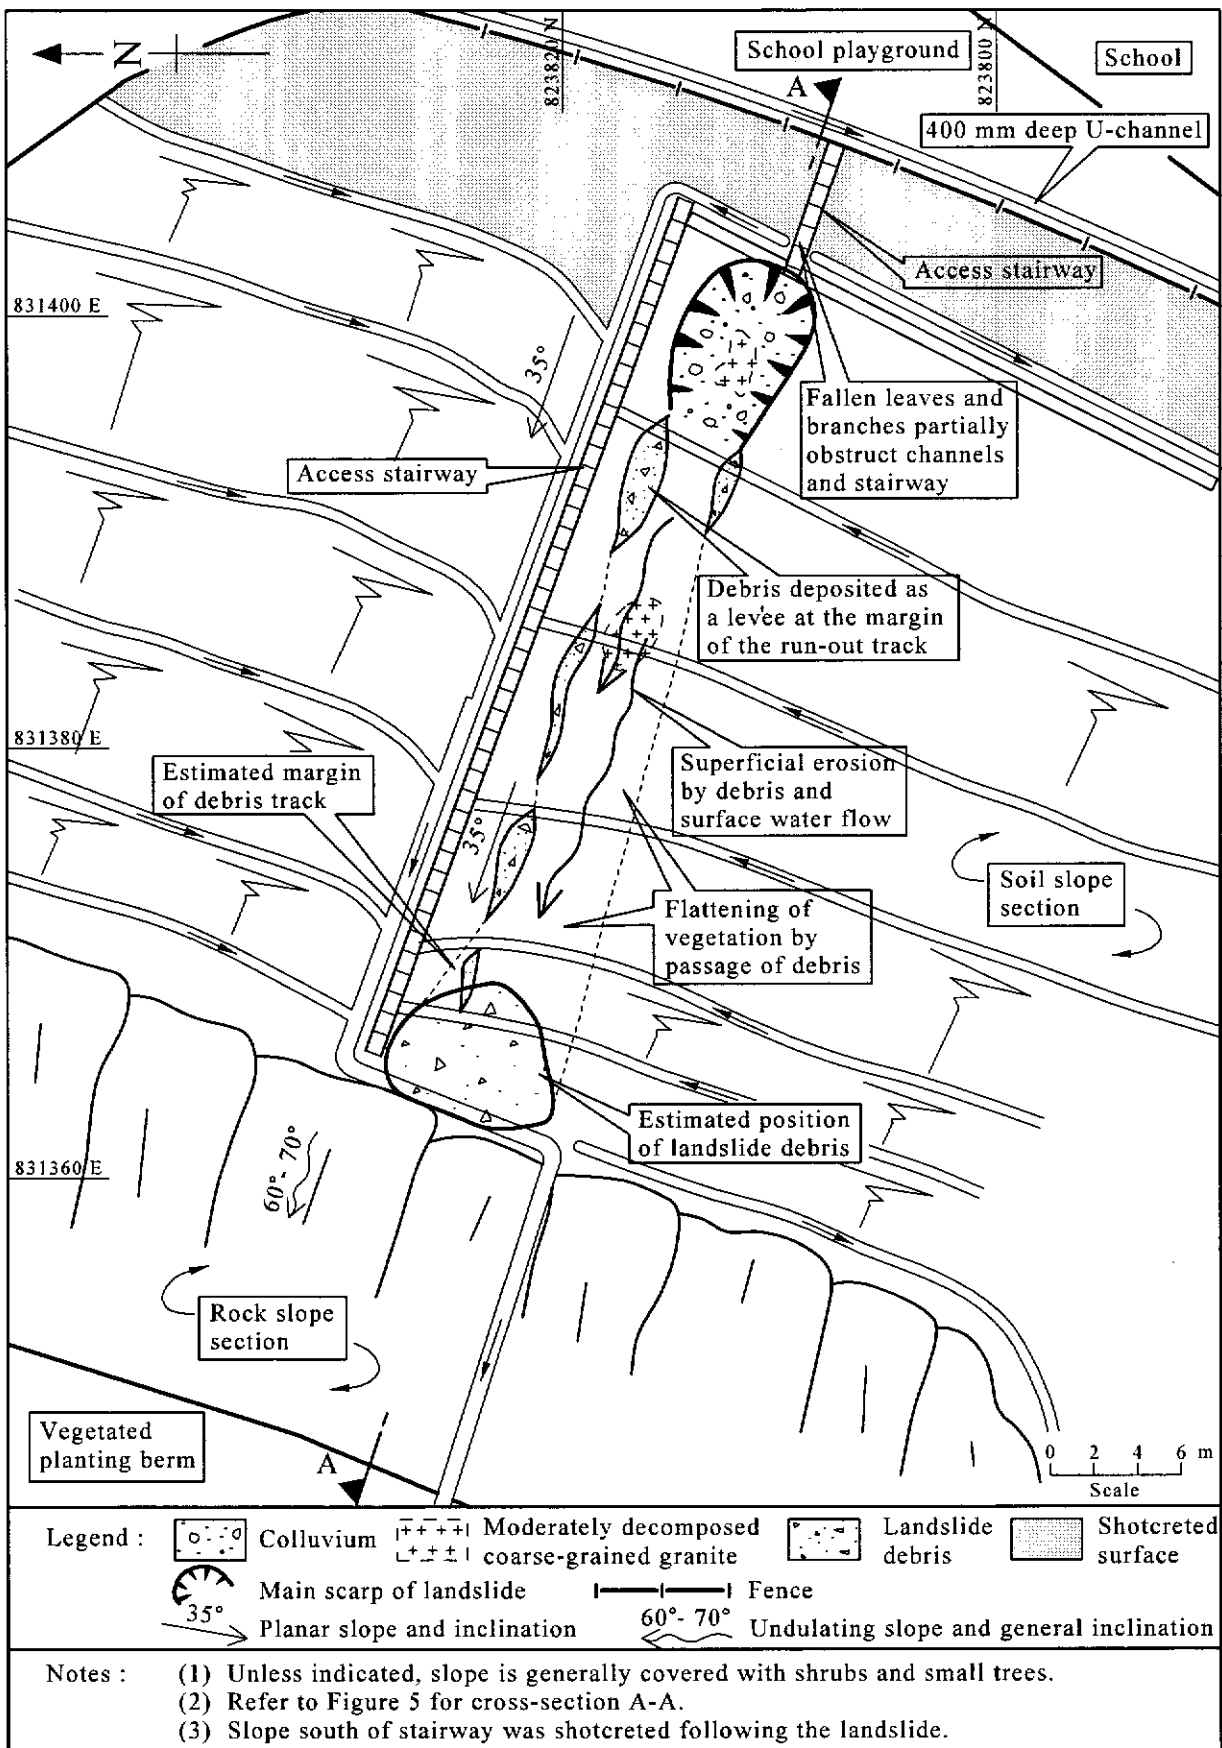
Figure 4 - Observations of the Landslide

Observations made by HAP in a walkover survey at the site on 18 June 1997 are presented in Figure 4 and a representative cross-section through the landslide is given in Figure 5. Photographs of the landslide are shown in Plates 1 to 8.

The landslide occurred about 5 m below the crest of the slope and formed a main scarp 11 m long, 6 m wide and about 1 m deep. The volume of the main scarp was estimated at 33 m<sup>3</sup>. A drainage channel and the access stairway located immediately behind the main scarp were partially covered with fallen leaves and branches and showed no evidence of surface water flow.

Debris from the landslide travelled down the slope and accumulated at the toe of the soil portion of the slope (Figures 4 and 5, Plate 5). The run-out track was about 40 m long and 6 m to 7 m wide. Inspection of the landslide track showed that the debris travelled over the prevailing ground surface, flattening vegetation along its path and locally eroding the slope surface. Low levées were present predominantly on the northern side of the run-out track (Figure 4 and Plate 6). The levées were generally between 0.1 m and 0.5 m deep and a maximum of about 2 m wide. The size of the levées generally decreased towards the toe of the slope.

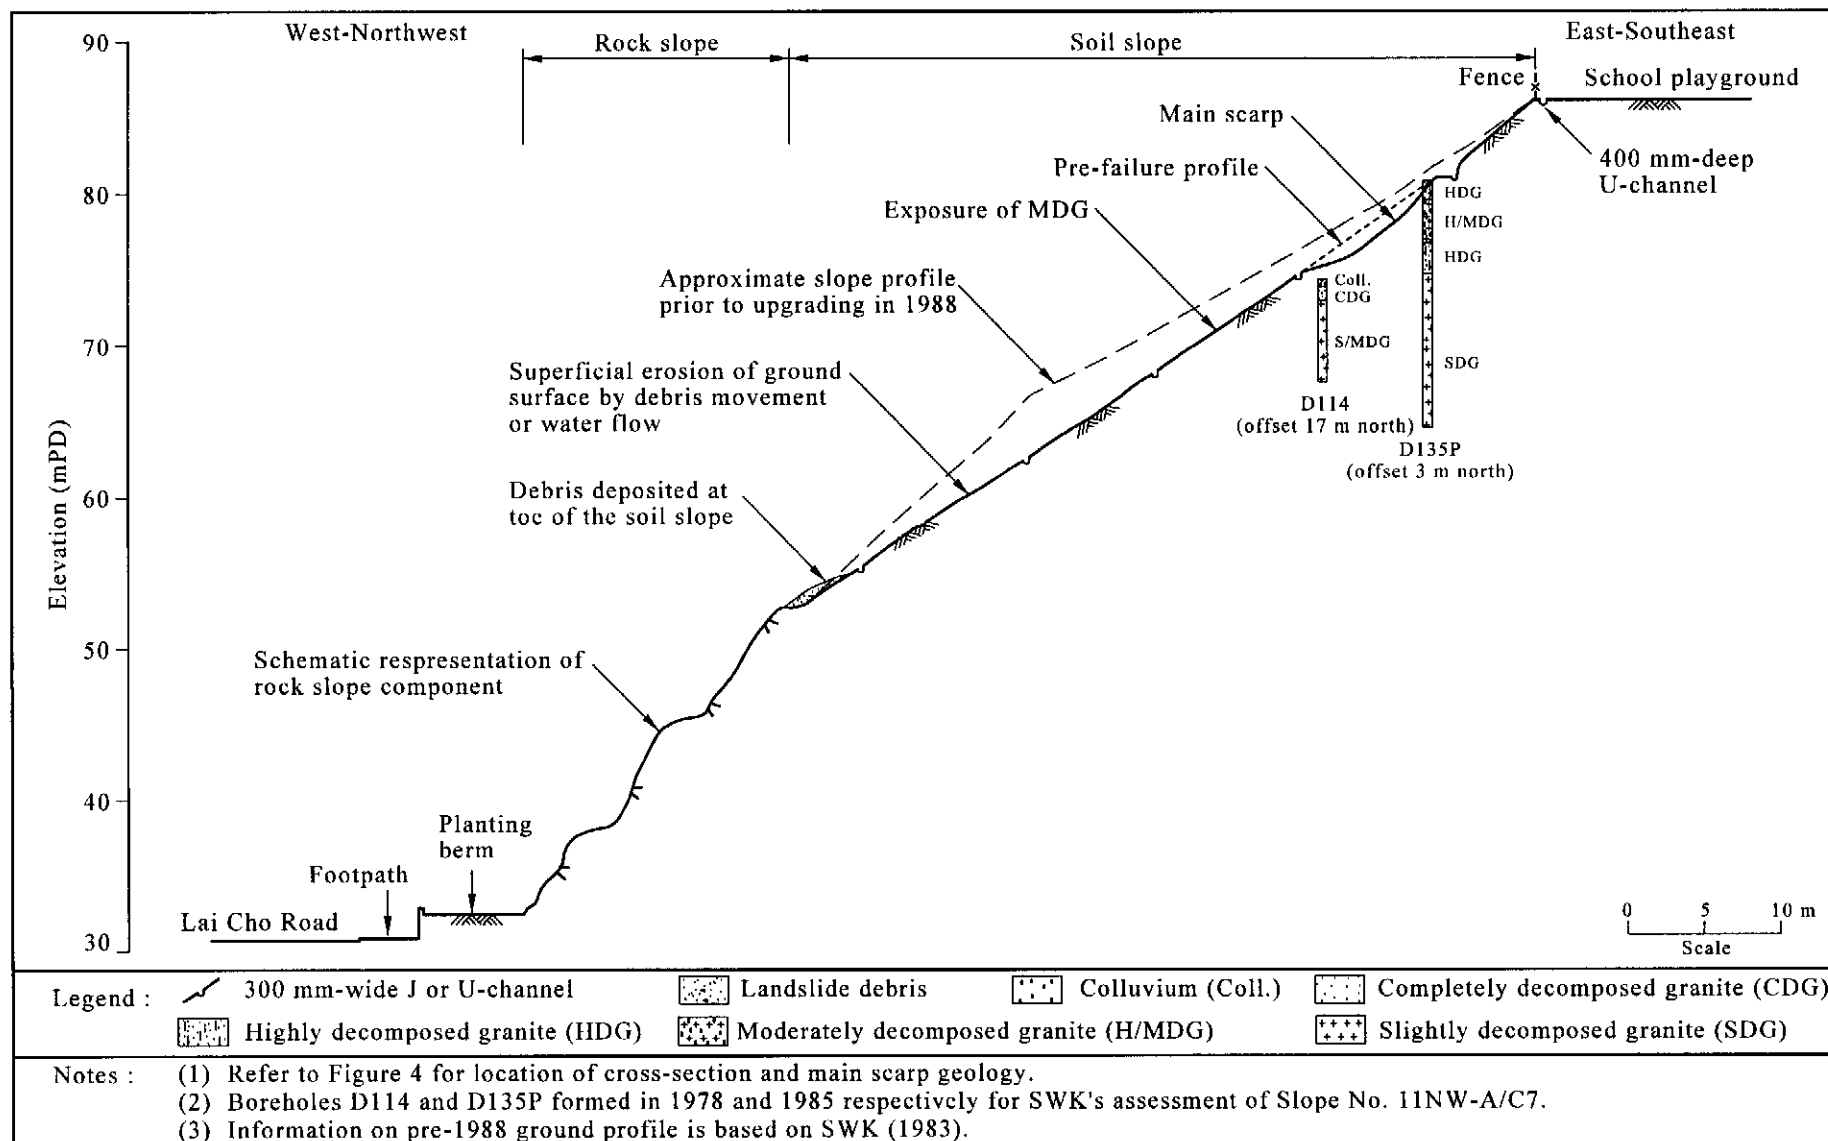
Figure 5 - Cross-section A-A through the Landslide

The mode of detachment appeared to be a shallow sliding failure of the superficial colluvium, controlled in part by the interface with the underlying moderately decomposed granite.

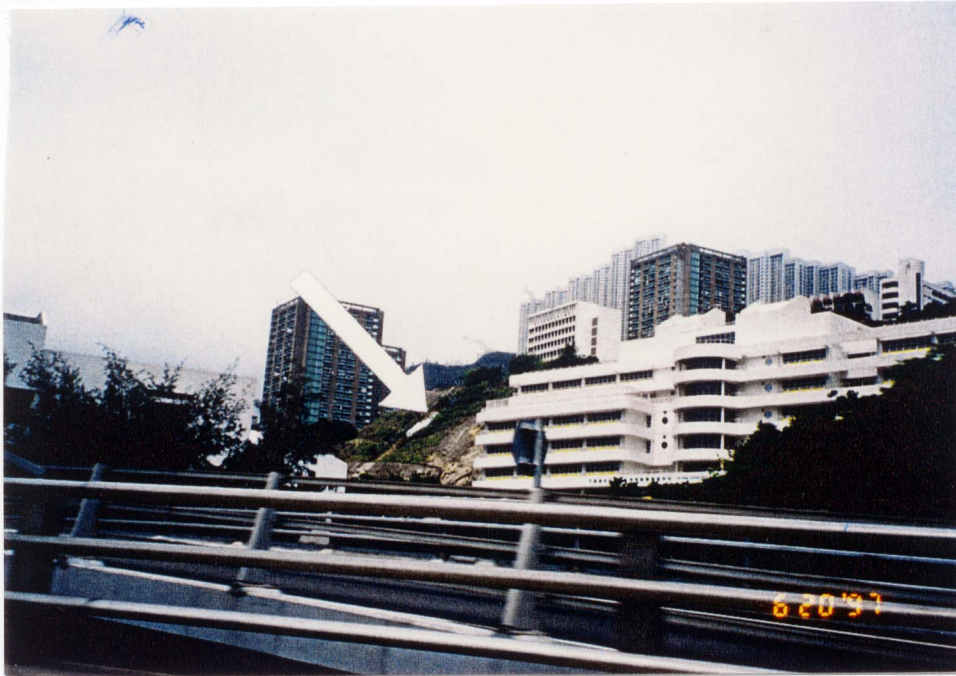
Plate 1 - General View of Slope No. 11NW-A/C7. The Arrow Indicates the Position of the Main Scarp (Photograph Taken on 20 June 1997)

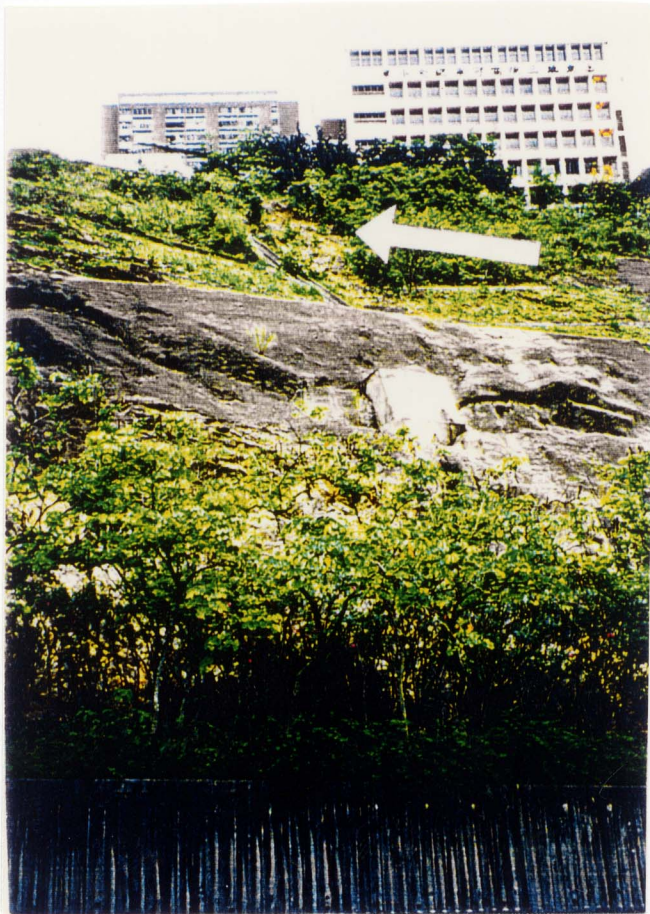
Plate 2 - Close View of Slope No. 11NW-A/C7. The Arrow Shows the Landslide Run-out Track (Photograph Taken on 6 June 1997)

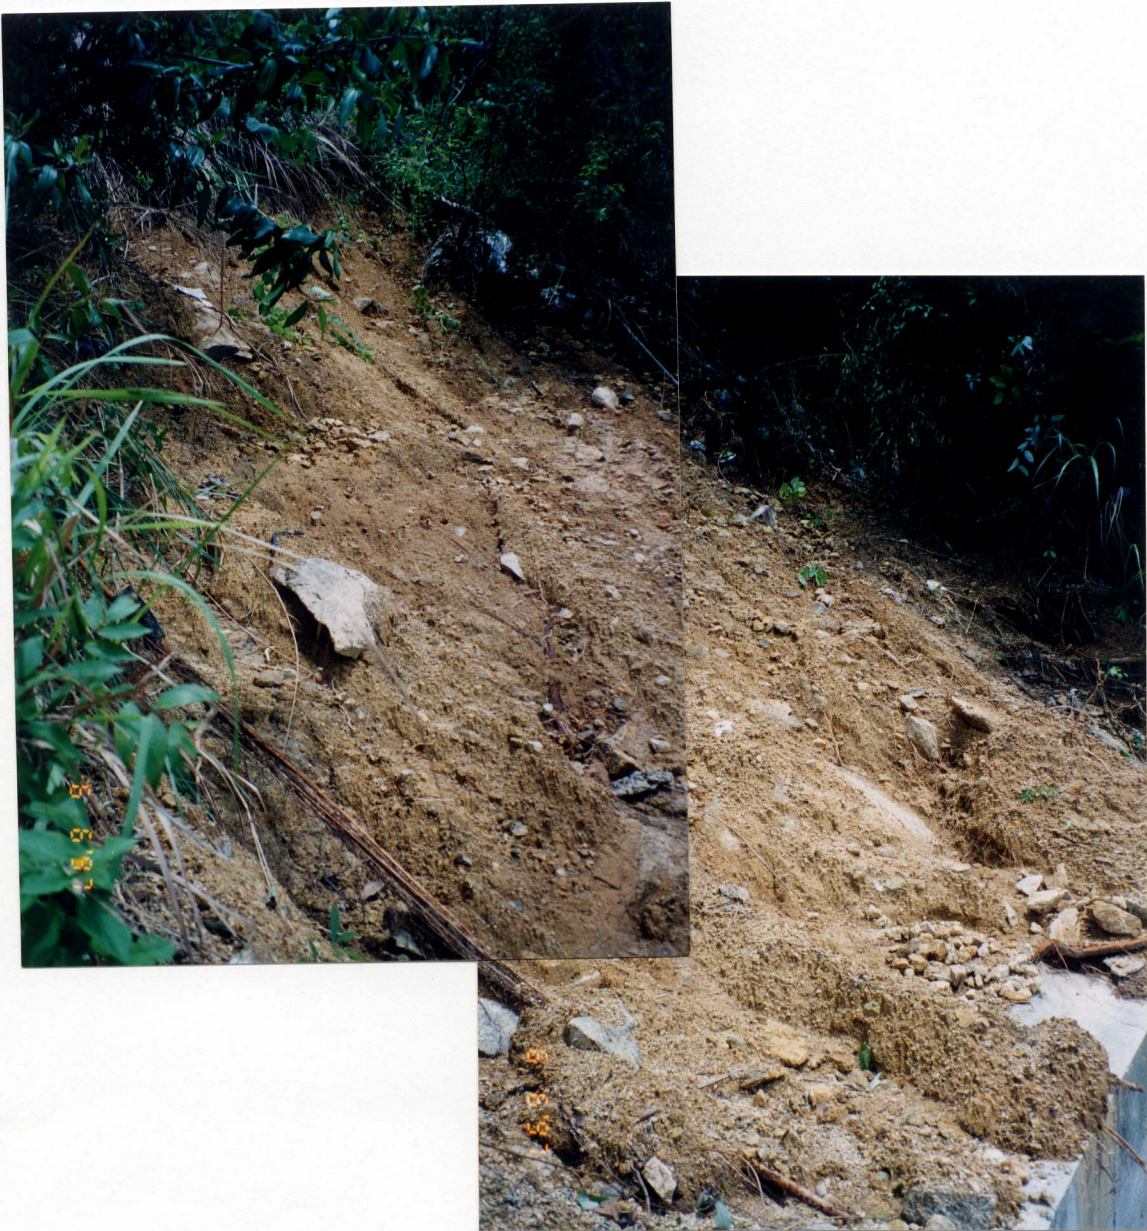
Moderately decomposed coarse-grained granite was exposed in the base of the main scarp. The weathered granite was overlain by about 1 m of loose fine- to coarse-grained sand with some angular cobble- and boulder-sized fragments of highly and moderately decomposed granite, which was interpreted by HAP as colluvium (Plates 3 and 4).

Plate 3 - Close View of the Lower Part of Main Scarp and Debris of  
the Landslide (Photograph Taken on 6 June 1997)

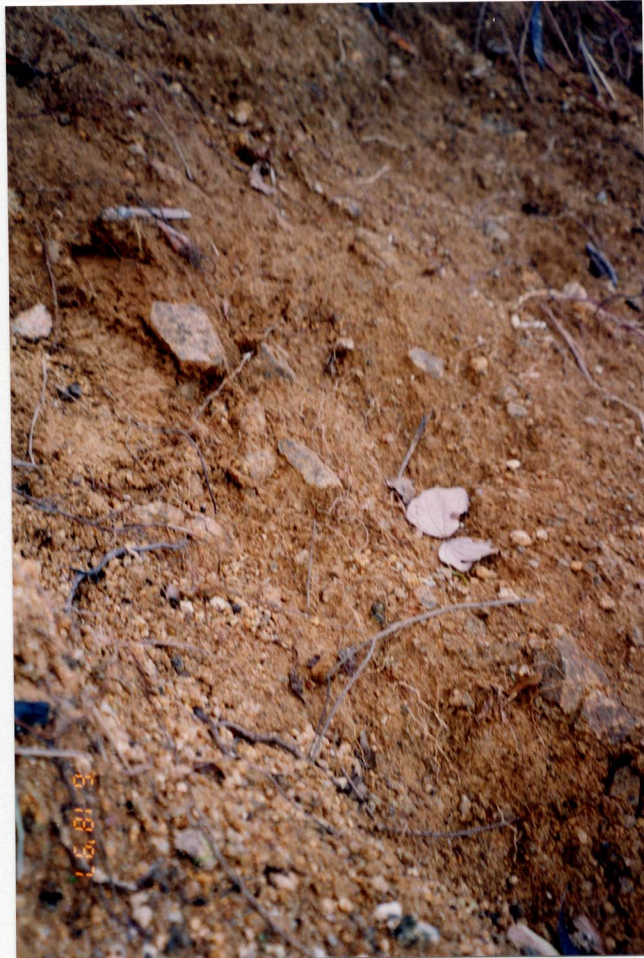
Plate 4 - Close-Up View of Loose Granular Material Interpreted by  
HAP as Colluvium (Photograph Taken on 18 June 1997)

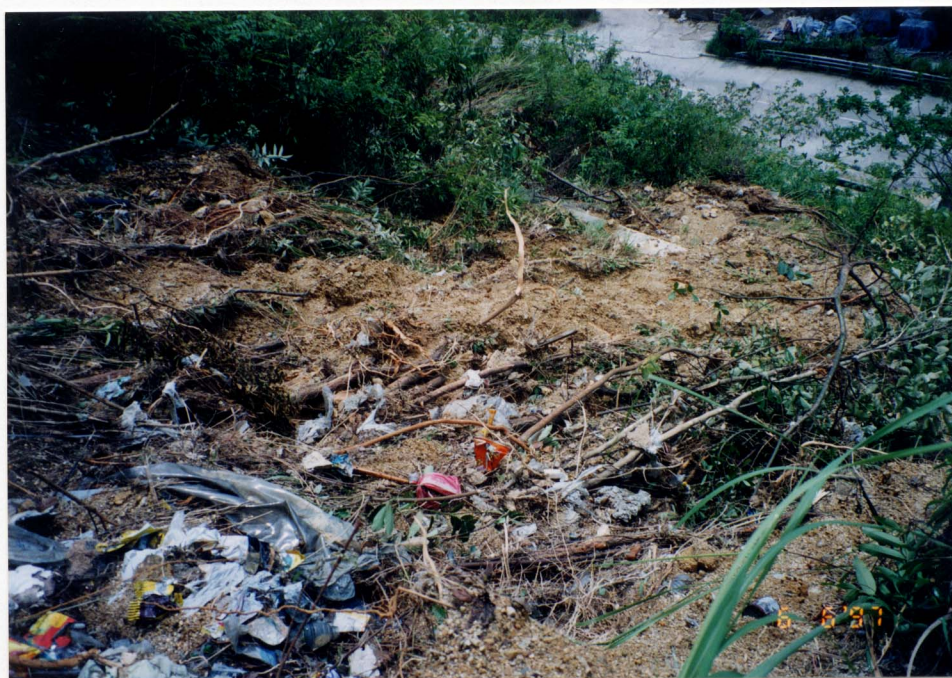
Plate 5 - Landslide Debris at the Toe of the Soil Portion of Slope No. 11NW-A/C7 (Photograph Taken on 6 June 1997)

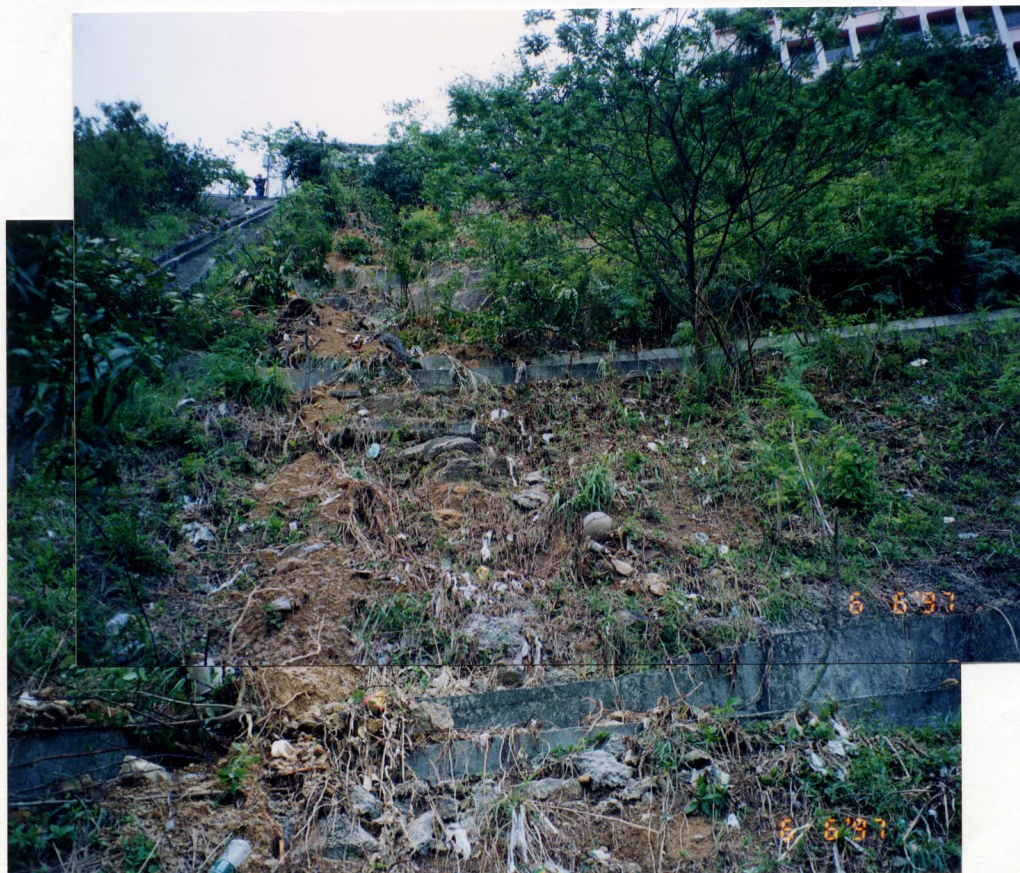
Plate 6 - Upslope View of the Landslide Run-out Track (Photograph Taken on 6 June 1997)

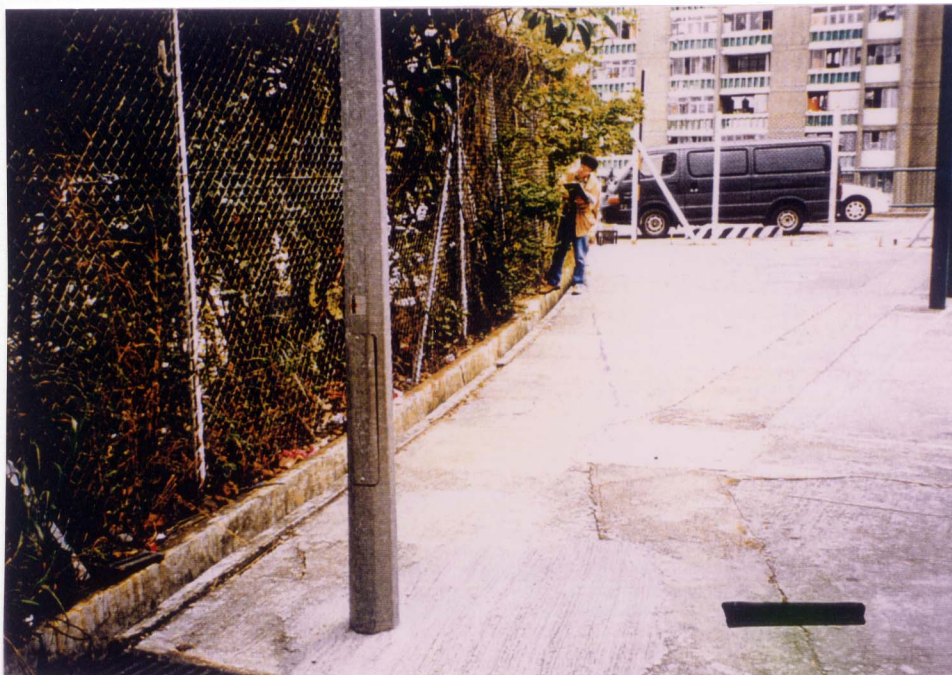
Inspection of the area upslope of the landslide scar indicates that rainfall accumulating on the playground would flow into a 400 mm deep U-channel and be diverted away from the landslide site. Interviews with staff members of the Ko Ho Ning Memorial Primary School indicated that water up to about 40 mm deep was observed on the playground during the rainstorm on the day of the failure but that run-off did not overtop the channel and flow onto the slope. There was no evidence of surface water flow between the playground and the landslide site. Stormwater run-off from the playground seems, therefore, an unlikely source of water at the landslide site.

Plate 7 - Playground of Ko Ho Ning Memorial Primary School Upslope of the Landslide Site (Photograph Taken on 25 May 1998)

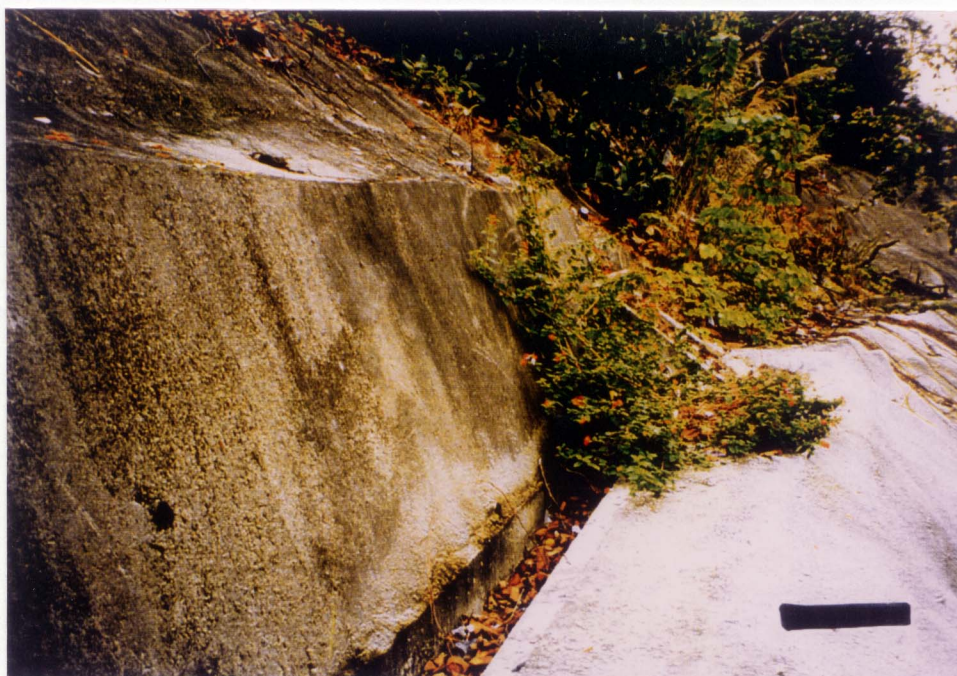
The landslide was inspected by the GEO on 6 June 1997. According to the Incident Report prepared by the GEO, there was no evidence that blockage of the U-channel above the landslide scar obstructed passage of stormwater along the channel and caused overtopping onto the crest of the slope. In addition, the channel falls away from the landslide and the shotcreted catchment between the playground area and the landslide scar is small and unlikely to generate a significant amount of stormwater run-off.

Plate 8 - Partial Obstruction of U-Channel above the Landslide Scar (Photograph Taken on 6 June 1997)
