INVESTIGATION OF SOME SELECTED LANDSLIDE INCIDENTS IN 1997 (VOLUME 3)

GEO REPORT No. 89

SECTION 1: DETAILED STUDY OF THE LANDSLIDES AT TAO FUNG SHAN CHRISTIAN CEMETERY ON 2 JULY 1997

**This report was originally produced in March 1998
as GEO Landslide Study Report No. LSR 2/98**

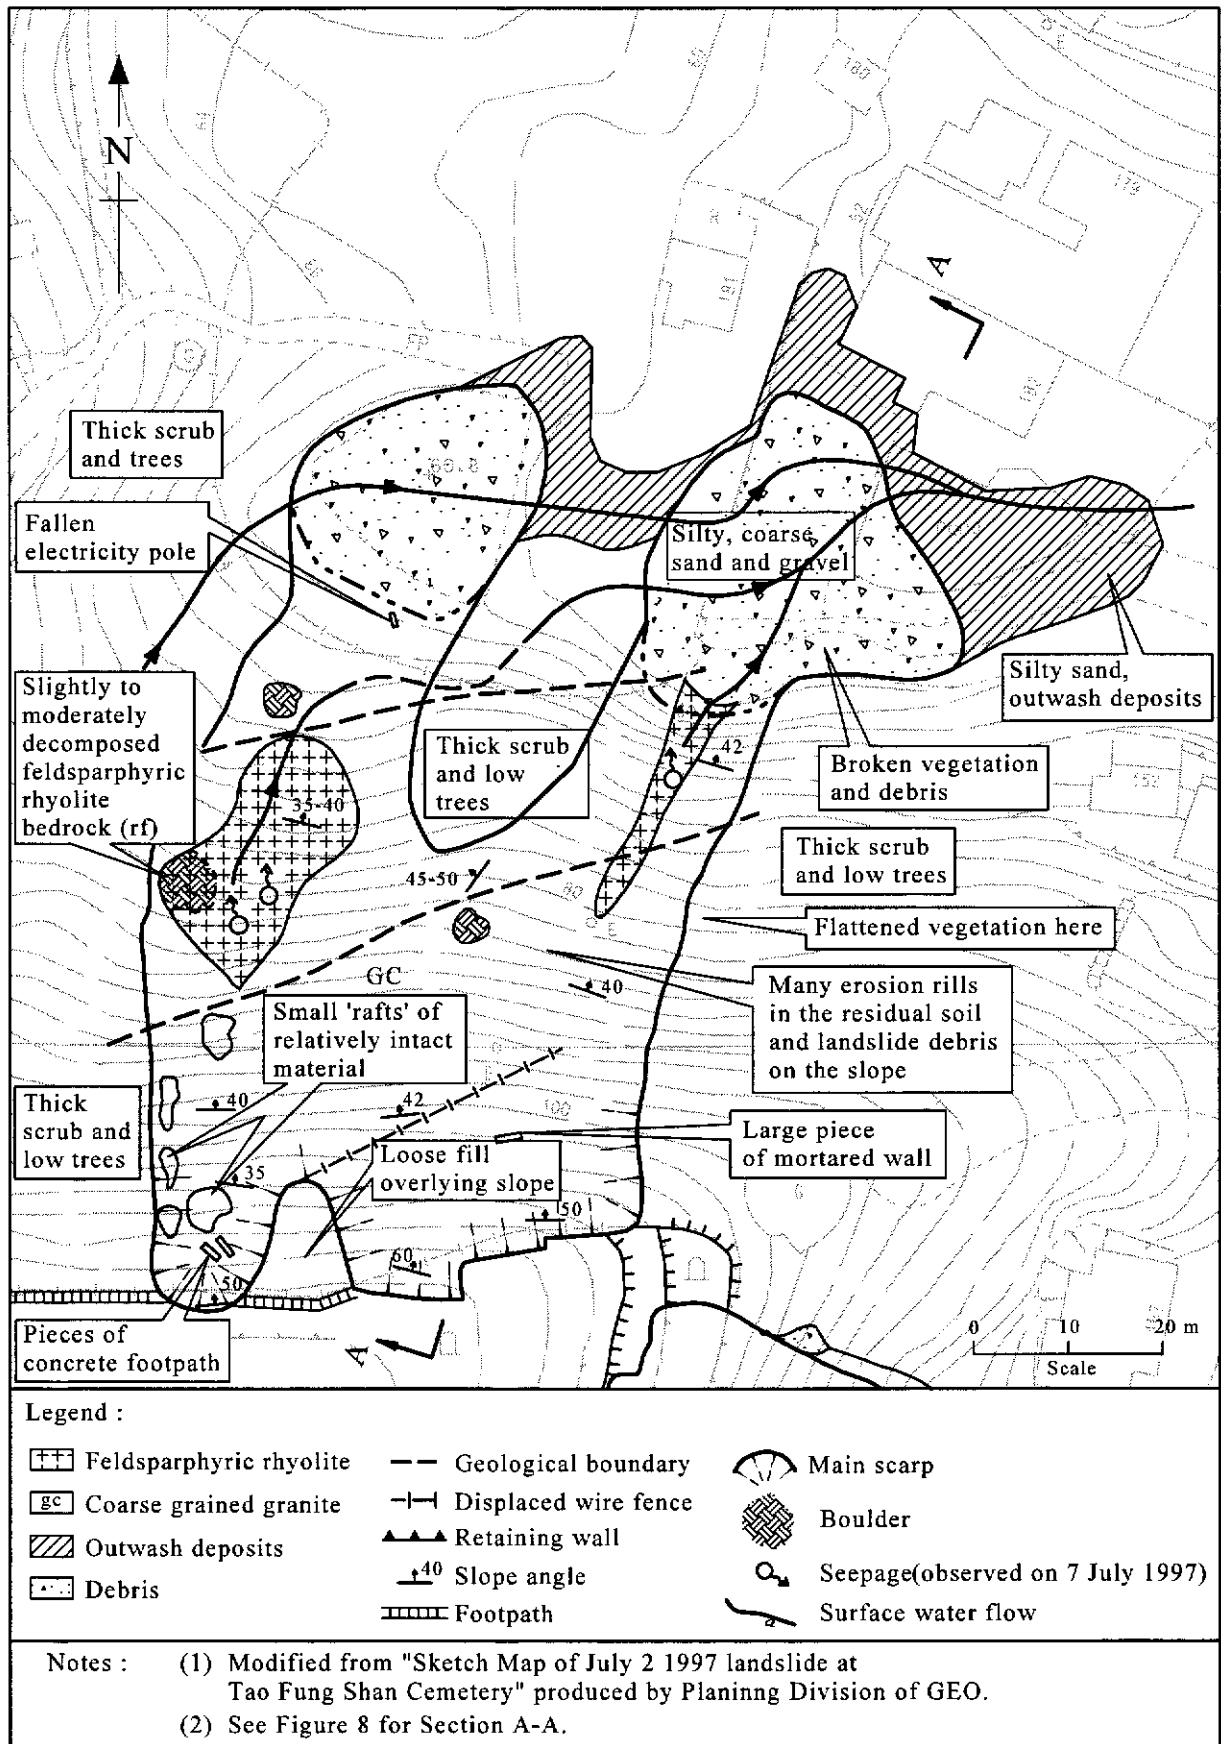
Figure 7 - Site Plan and Details of Landslide A

A plan of the failure is given in Figure 7 and a representative cross-section through the landslide is given in Figure 8. Photographs of the landslide are shown in Plates 4 and 5.

The landslide involved failure of an unregistered fill slope on the northern perimeter of the cemetery, the debris from which travelled down the natural terrain and over a low retaining wall at the toe of the slope. The landslide caused damage to several abandoned and derelict buildings at the toe of the slope. The masonry wall that had previously failed in 1993, adjacent to abandoned house No. 183, collapsed in the central portion and a surface electricity line was cut.

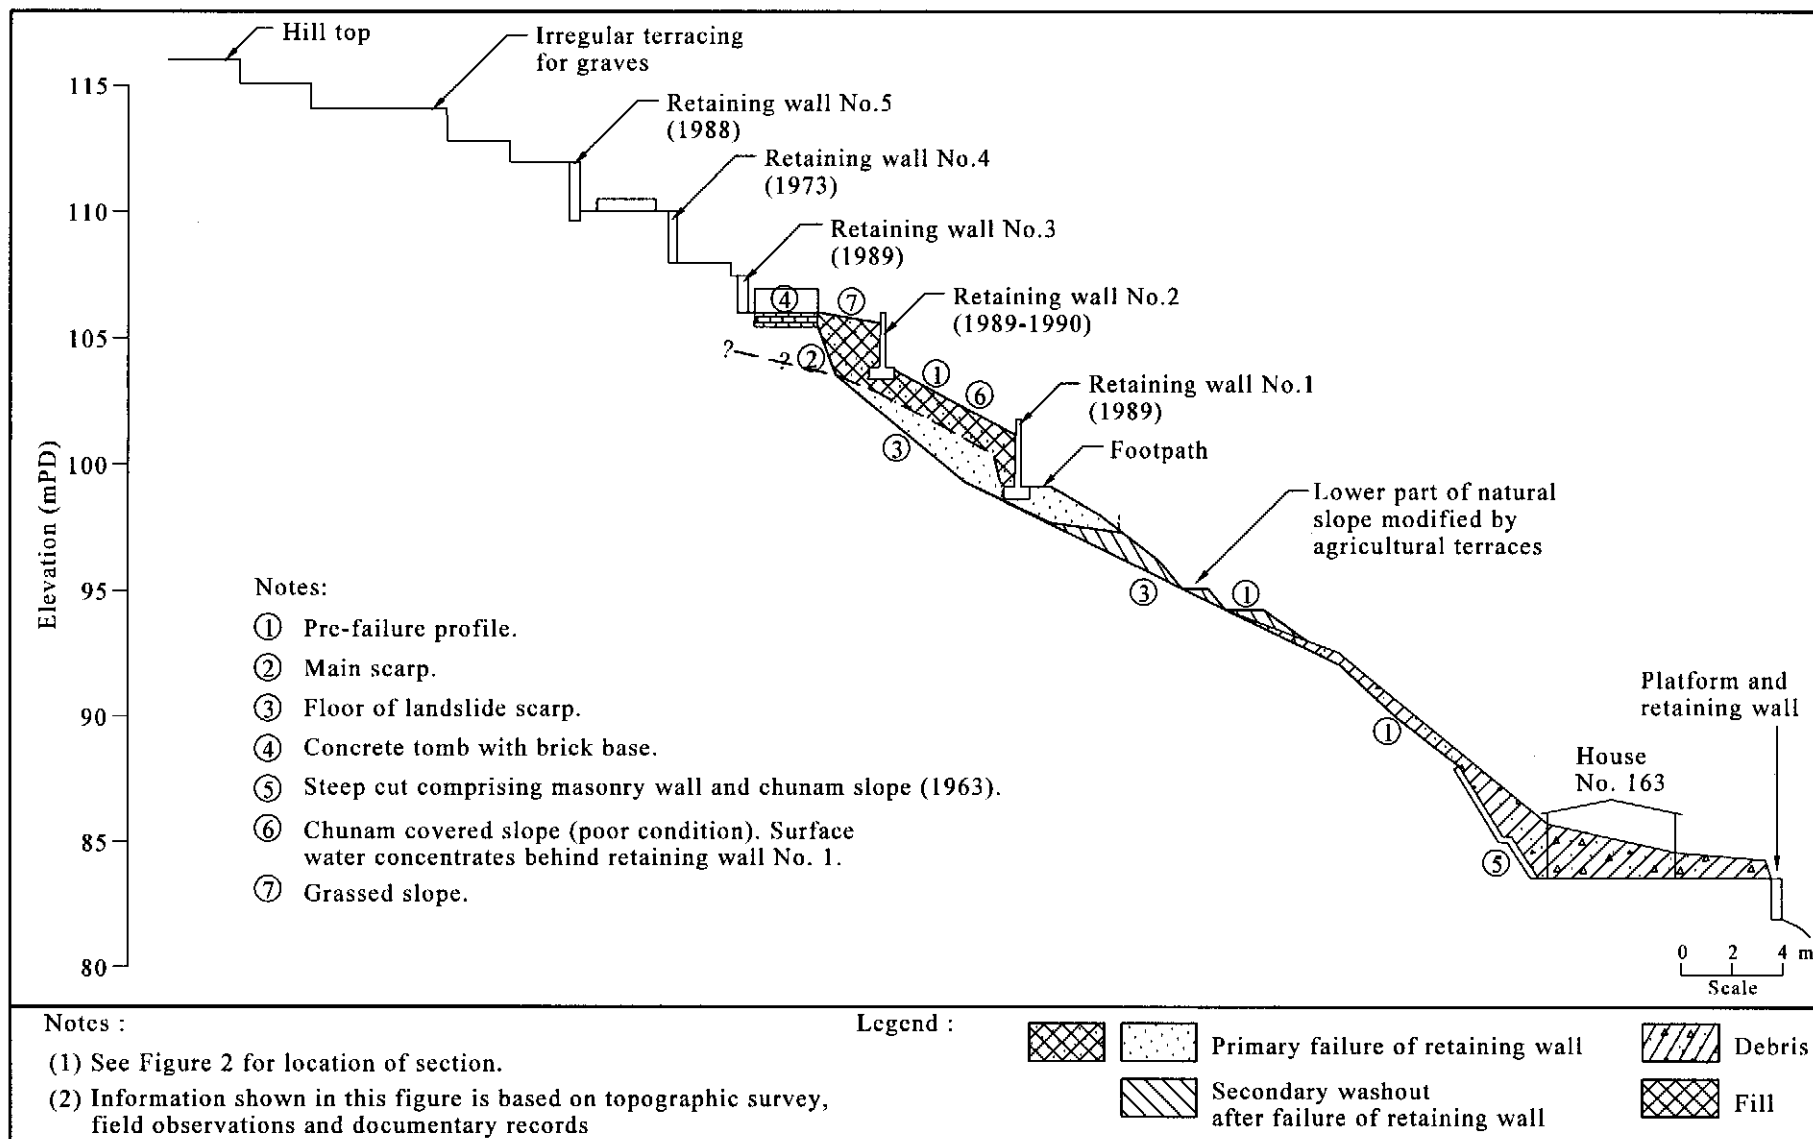
Figure 10 - Cross-section B-B of Landslide B

Details of the failure are presented in Figure 9 and a representative cross-section through the landslide is given in Figure 10.

The landslide primarily involved the failure of two retaining walls at the eastern end of the cemetery. The central sections of the walls failed, both measuring about 25 m in length. Cracking and limited amounts of rotation of adjacent unfailed sections of the walls also occurred. Most of the landslide debris originated from behind the retaining walls and travelled downslope, stripping about 150 m^3 of additional material from the natural hillside and coming to rest on the cut and fill platform below the cemetery. The total volume of the debris was estimated to be about 400 m^3 . The landslide demolished part of house No. 163.

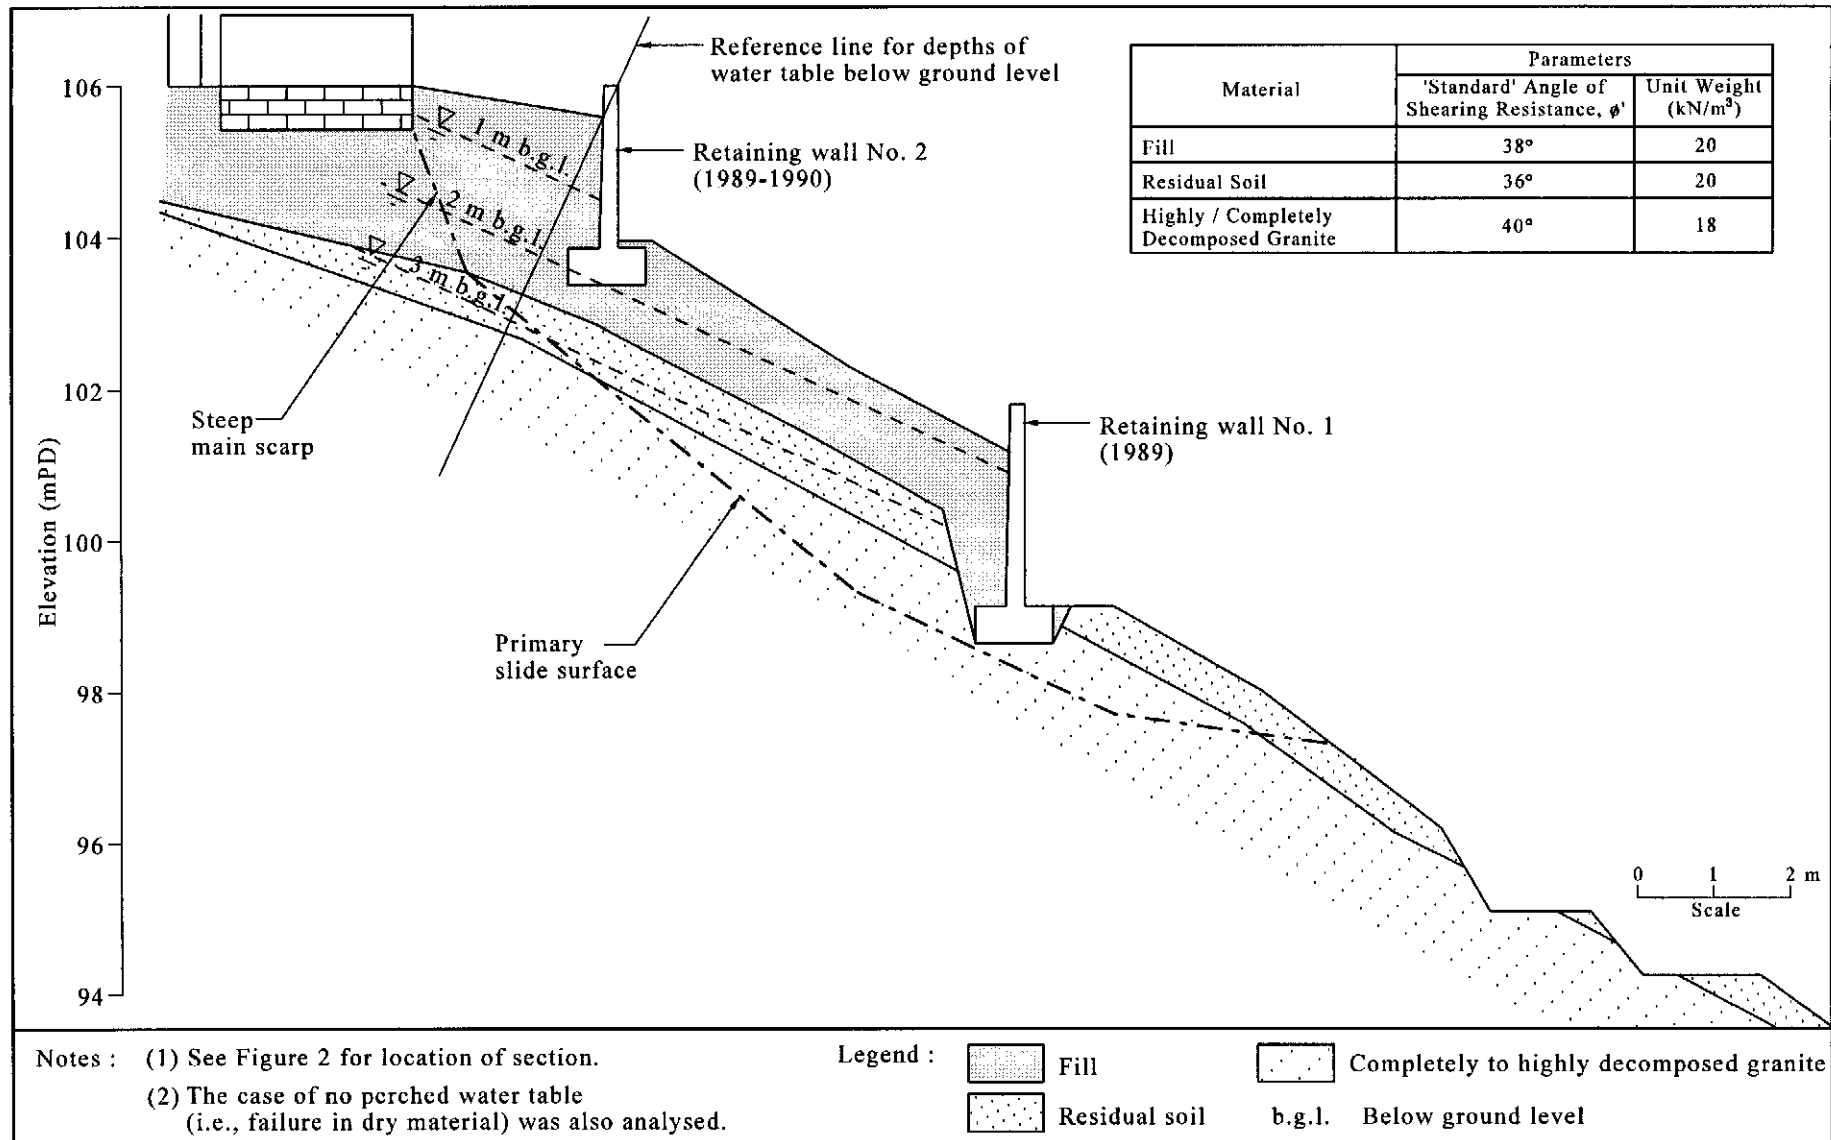
Figure 14 - Representative Cross-section of Landslide B used for Theoretical Stability Analyses

Theoretical stability analyses were carried out for the slope using the cross-section profile and assumed shear strength parameters shown in Figure 14 to replicate the interpreted failure mechanism. The results are presented in Figure 15. The analyses indicate that water pressure would have been critical for triggering the landslide given a typical range of soil strength parameters. The absence of effective drainage within the walls would have permitted a water table to develop within the fill, leading to a reduction in stability and ultimately to failure.

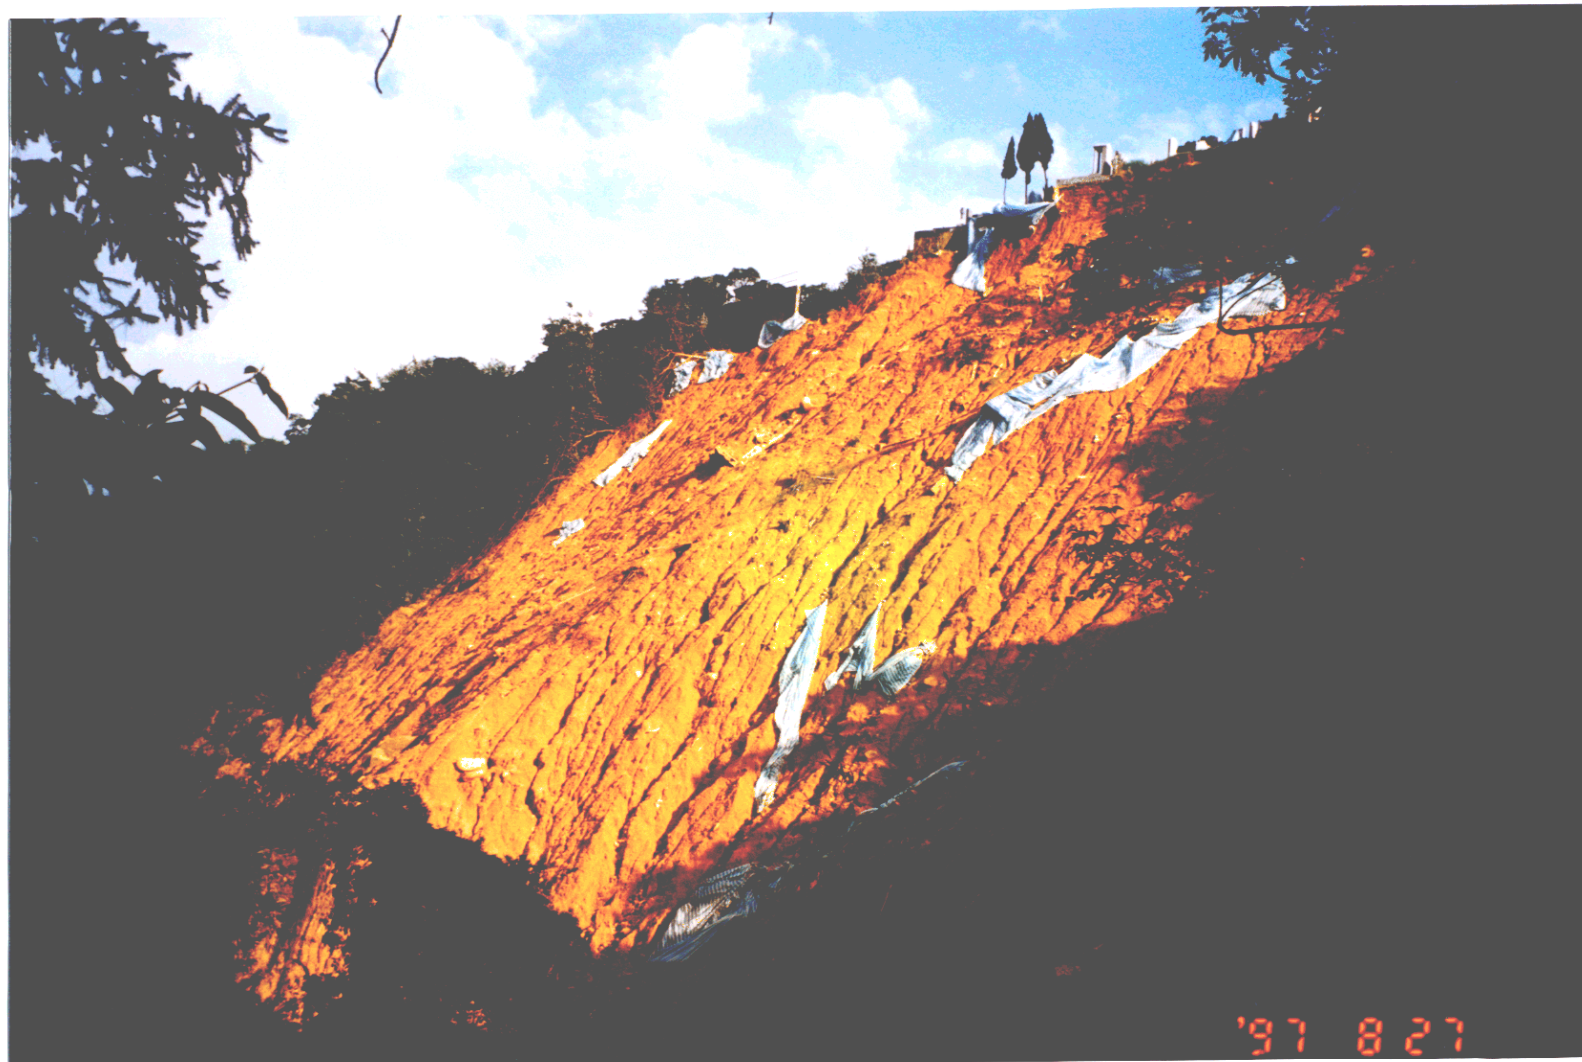
Plate 4 - View of Landslide A (Photograph Taken on 27 August 1997)

The main scarp of the landslide measured 52 m wide and comprised two back scarps separated by an area of densely vegetated loose fill, which had not collapsed during the landslide. The larger back scarp to the east was about 32 m wide, 15 m long, 3 m high and inclined at about 50° to 60° (Plate 4). The smaller back scarp to the west was about 10 m wide, 10 m long, 2 m high and inclined at about 50°.

The volume of debris derived from the main scarp was estimated to be about 600 m³ and an estimated volume of about 300 m³ of soil and debris was entrained as the landslide travelled down the natural hillside. Although an area of 3 500 m² was affected by the landslide, only a thin layer of material was removed from the natural slope. Extensive rills formed by subsequent surface water erosion were observed, cutting through the residual soil to expose the underlying granitic rock.

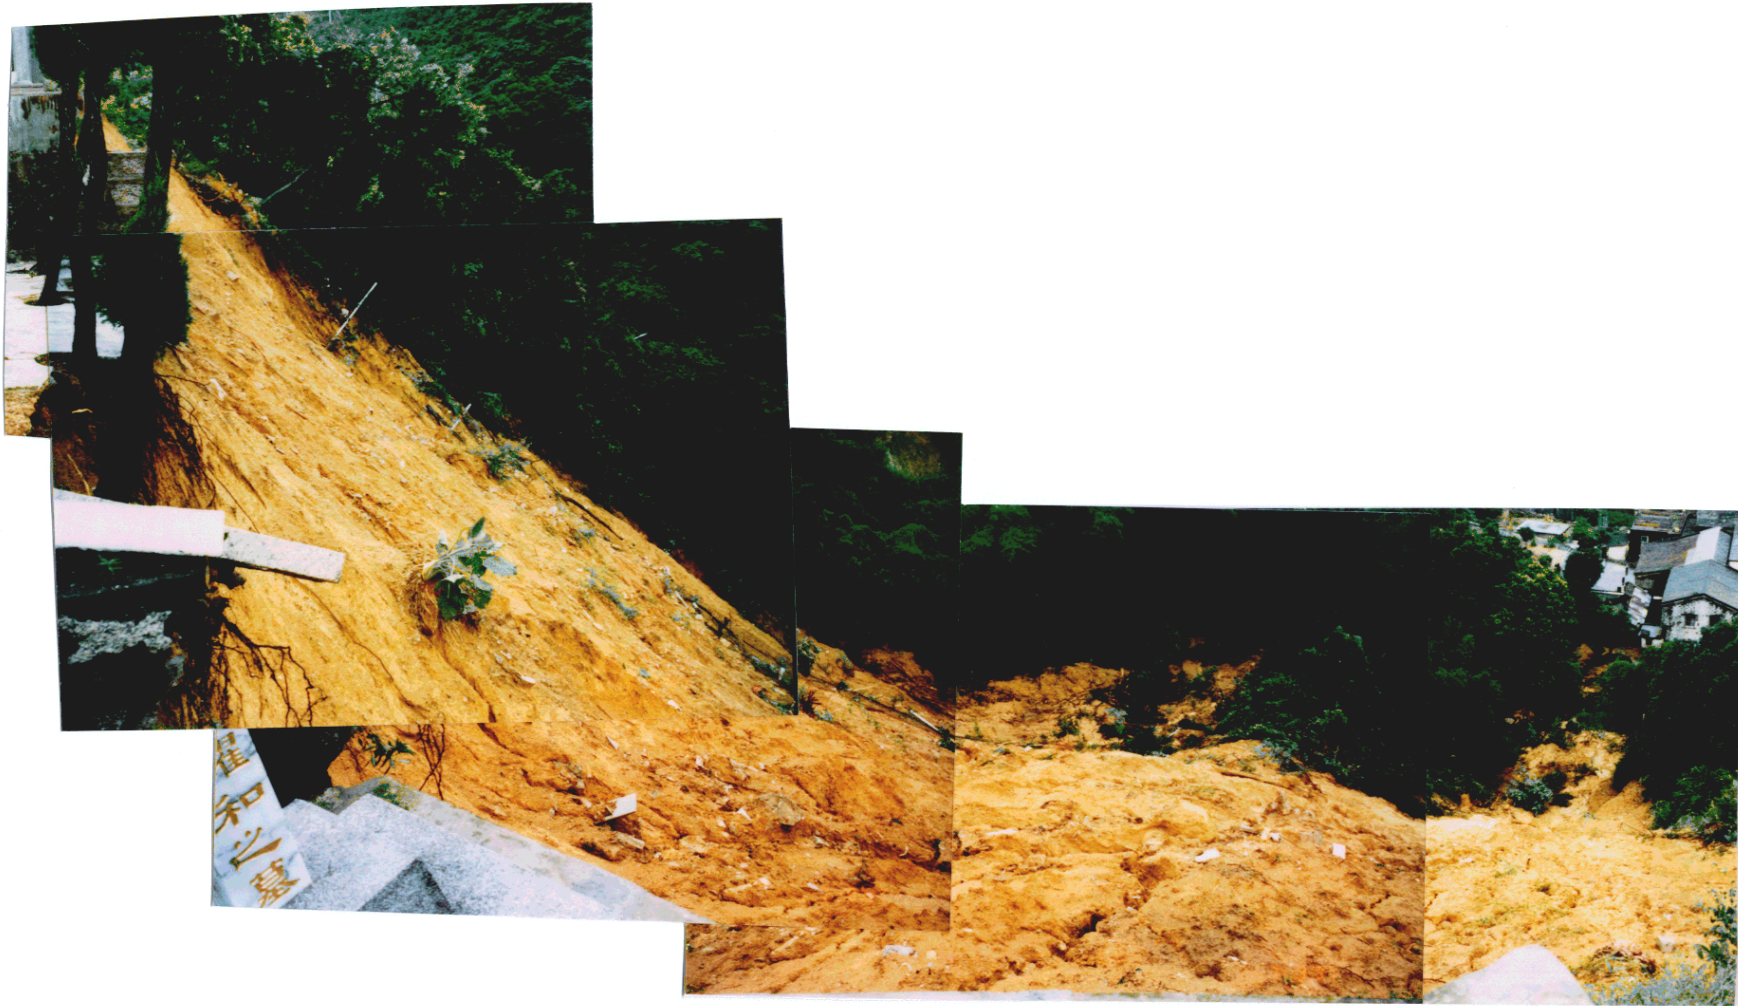
Natural erosion pipe holes up to 100 mm in width were observed at depths of 2 m below ground level in the fill, and in the main scarp, appeared to be most numerous where the fill was adjacent to the brickwork of the graves. Further down the natural slope, seepage was observed issuing from the base of the landslide scar at about 65 mPD to 80 mPD. During an inspection on 27 August 1997, stream water was flowing from a natural springline at an elevation of 65 mPD in the centre of the debris trail below the larger back scarp.

Plate 5 -The Main Scarp of Landslide A (Photograph Taken on 3 July 1997)
(Note Photograph Taken from the Crest of the Northern Slope, Showing
the Debris Trails and Steep Upper Part of the Main Scarp)

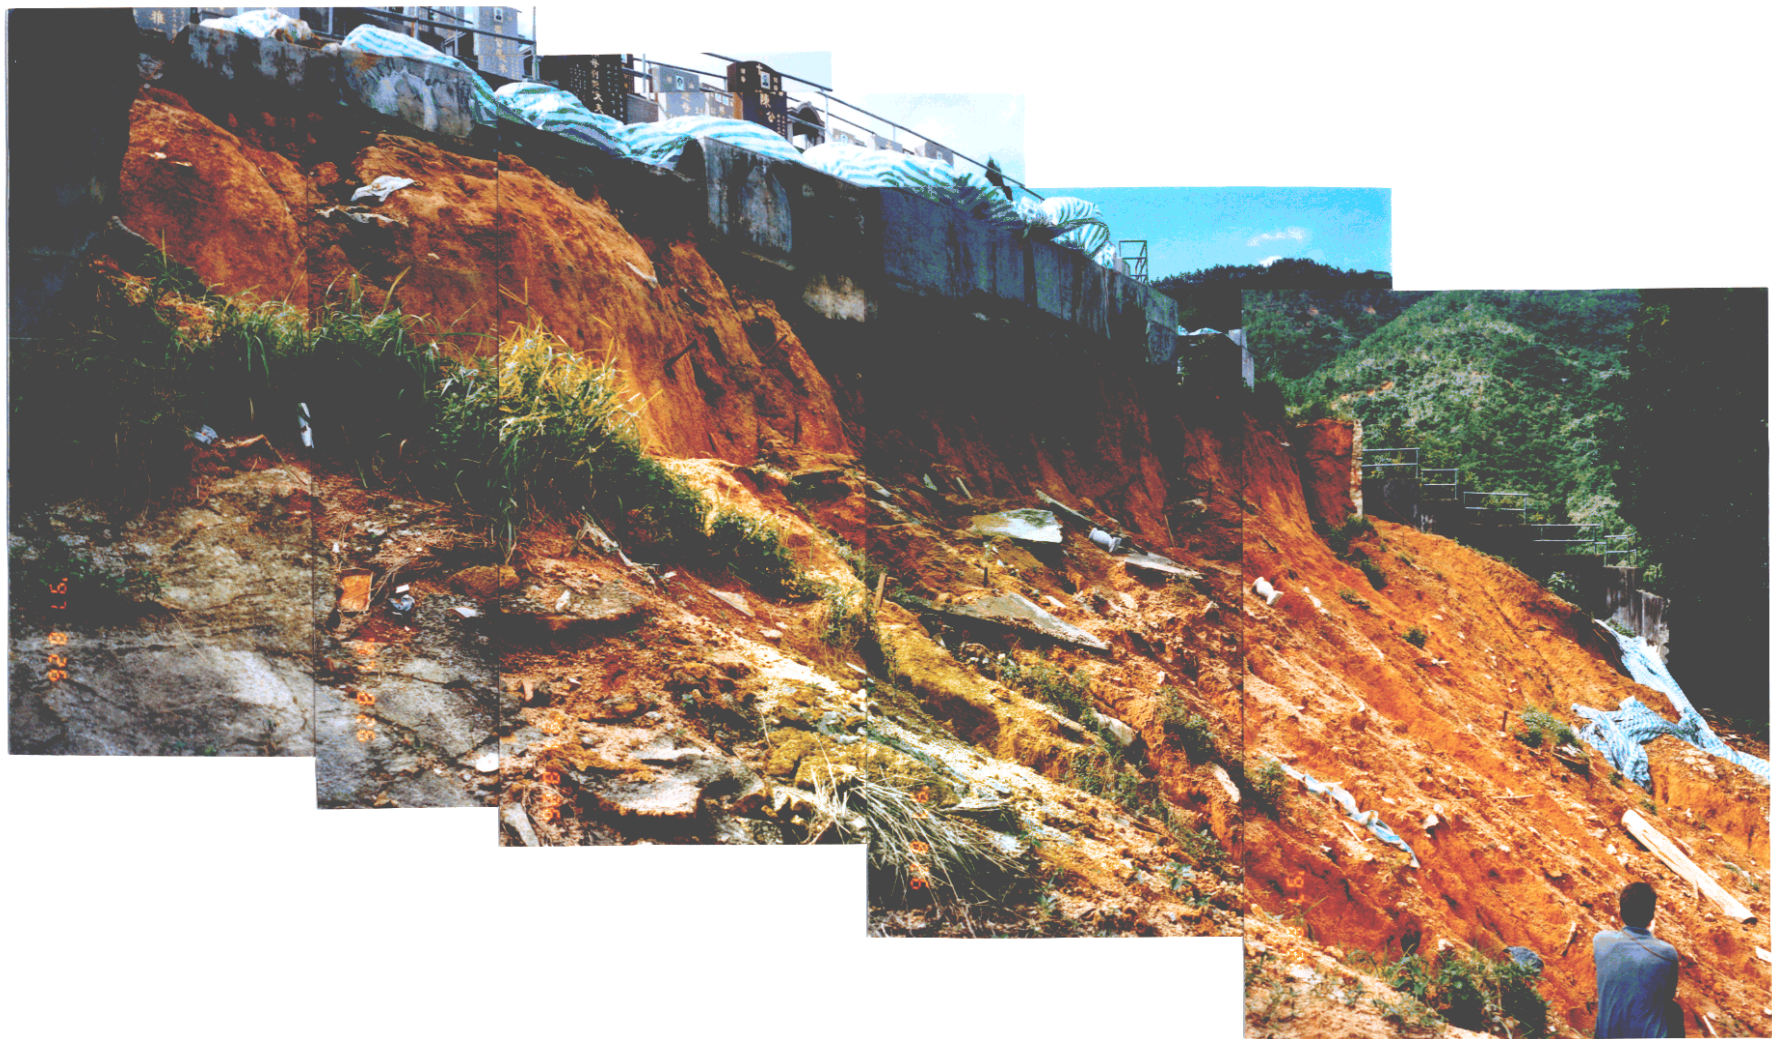
The main scarp extended about 2 m upslope from the original position of retaining wall No. 2 and was about 28 m wide, 2 m high and inclined at about 80° . The exposed material comprised wet, firm to soft, slightly gravelly, slightly clayey sandy silt (fill) up to 2 m thick overlying moist to firm, slightly gravelly, slightly clayey sandy silt (residual soil). Part of the main scarp coincided with smooth sub-vertical surfaces in the fill and residual soil, that clearly existed before the landslide (Plates 6). It is likely that these surfaces represent old chunam covered faces of the fill slope prior to the construction of retaining wall Nos. 1 and 2. Extensive gully erosion of the landslide scarp, up to 1 m deep, cut through the residual soil to expose completely to highly decomposed granite.

Plate 6 - The Main Scarp of Landslide B (Photograph Taken on 26 August 1997)
(Note the Smooth Surface of the Pre-existing Slope)

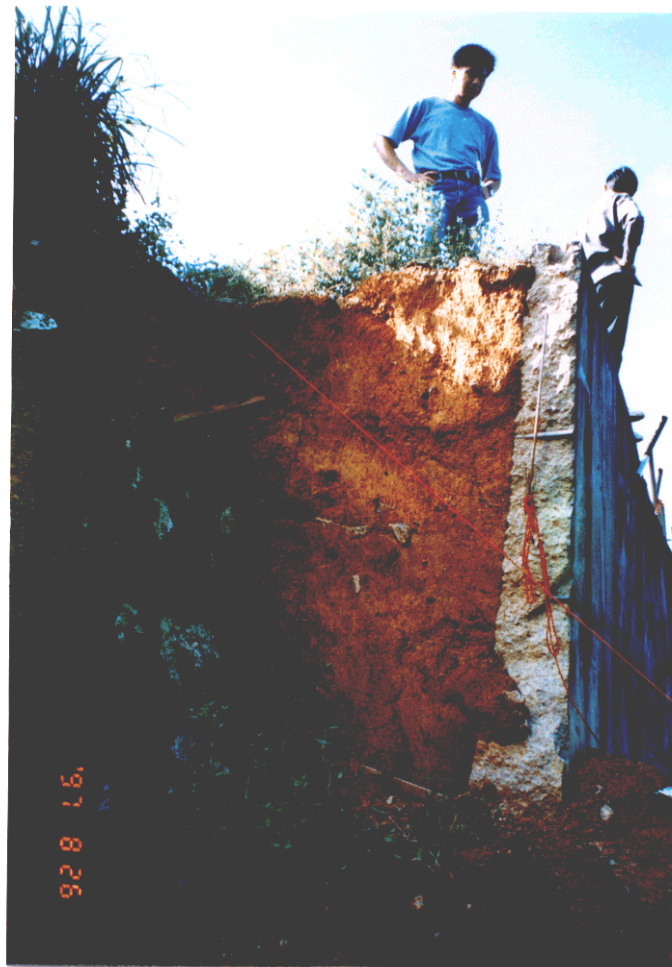
The two retaining walls at the eastern end of the cemetery were not designed and constructed to current standards. Empirical design methods were used which resulted in structures that were inadequately founded and drained.

Landslide B was almost certainly initiated by failure of retaining wall Nos. 1 and 2. Excessive surface water run-off, which has also been observed by the CMB in the past, would have led to concentration of surface water behind the retaining walls and, owing to the lack of maintenance of chunam coverings, a high rate of infiltration is likely to have occurred. Surcharge loading due to the retaining walls and the saturated fill behind them, along with the inevitable reduction in shear strength, most likely led to a rapid, fast-moving failure involving both walls.

Plate 7 - Retaining Wall No. 2 of Landslide B (Photograph Taken on 8 August 1997)

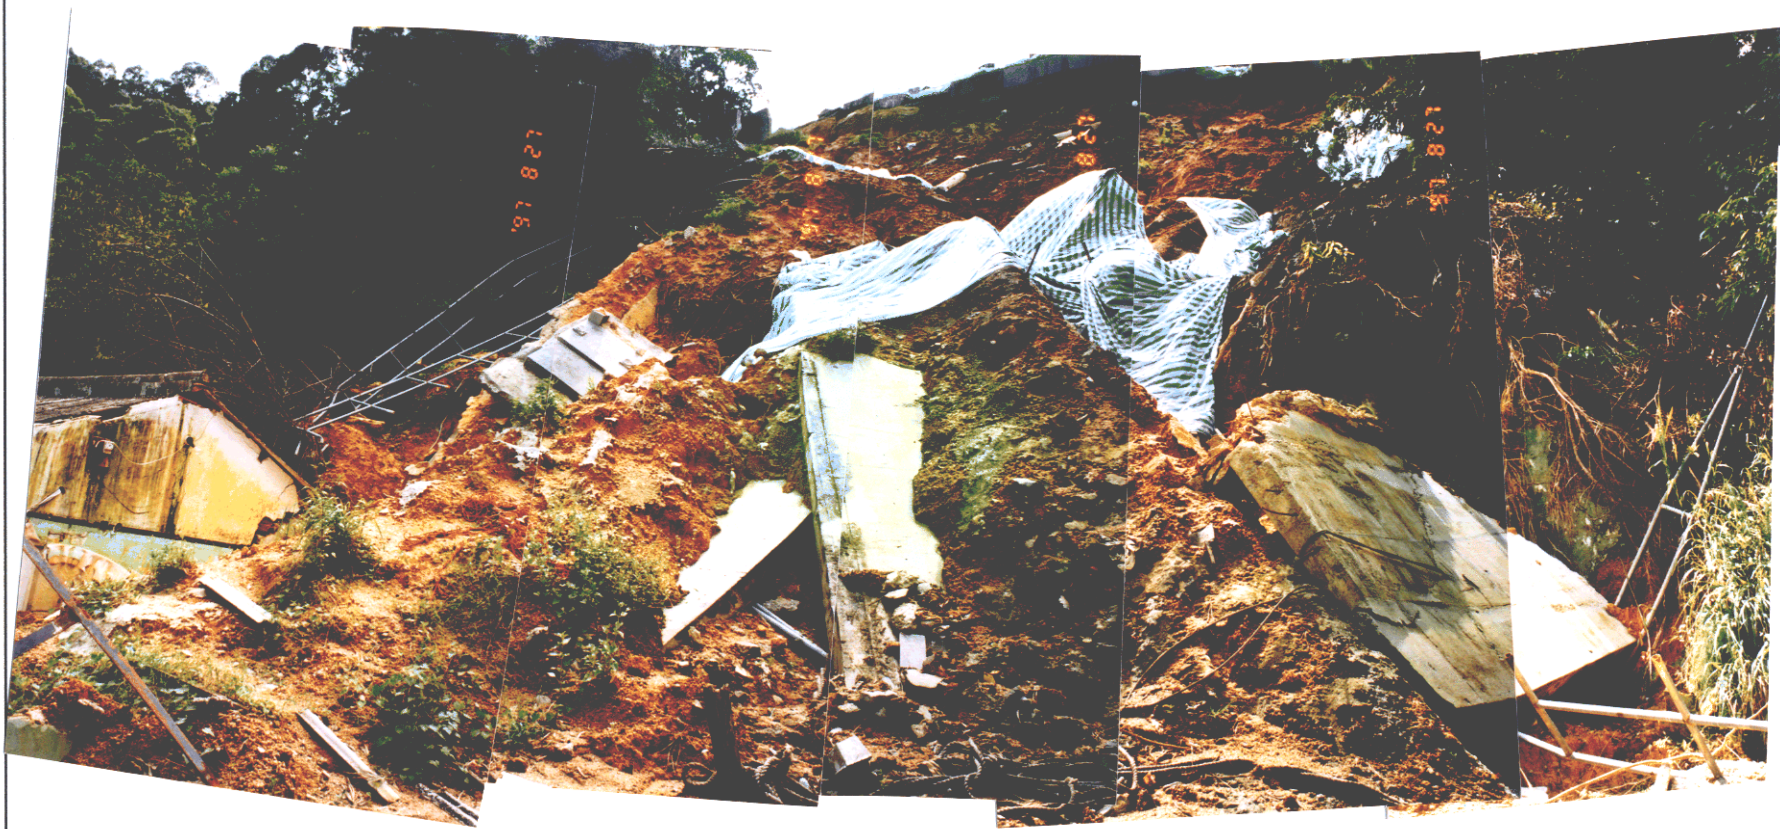
Although some debris, up to 1 m thick, was evident at the southern side of the landslide scarp, the bulk of the debris came to rest on the platform where house No. 163 was located. It comprised wet, soft to very soft, remoulded fill and residual soil, and included steel railings, the remains of two graves and several intact lengths of the retaining walls, one of which was about 16 m long (Plate 8). The travel angle of the landslide was about 35° which, according to Wong & Ho (1996), is typical for rain-induced landslides. The GEO observed further debris,

Plate 8 - The Debris from Landslide B and the Partly Demolished House No. 163 (Photograph Taken on 8 August 1997)
