SECTION 2: DETAILED STUDY OF THE LANDSLIDE AT CHUNG SHAN TERRACE, LAI KING HILL ROAD ON 4 JUNE 1997

Halcrow Asia Partnership Ltd

**This report was originally produced in May 1998
as GEO Landslide Study Report No. LSR 3/98**

FOREWORD

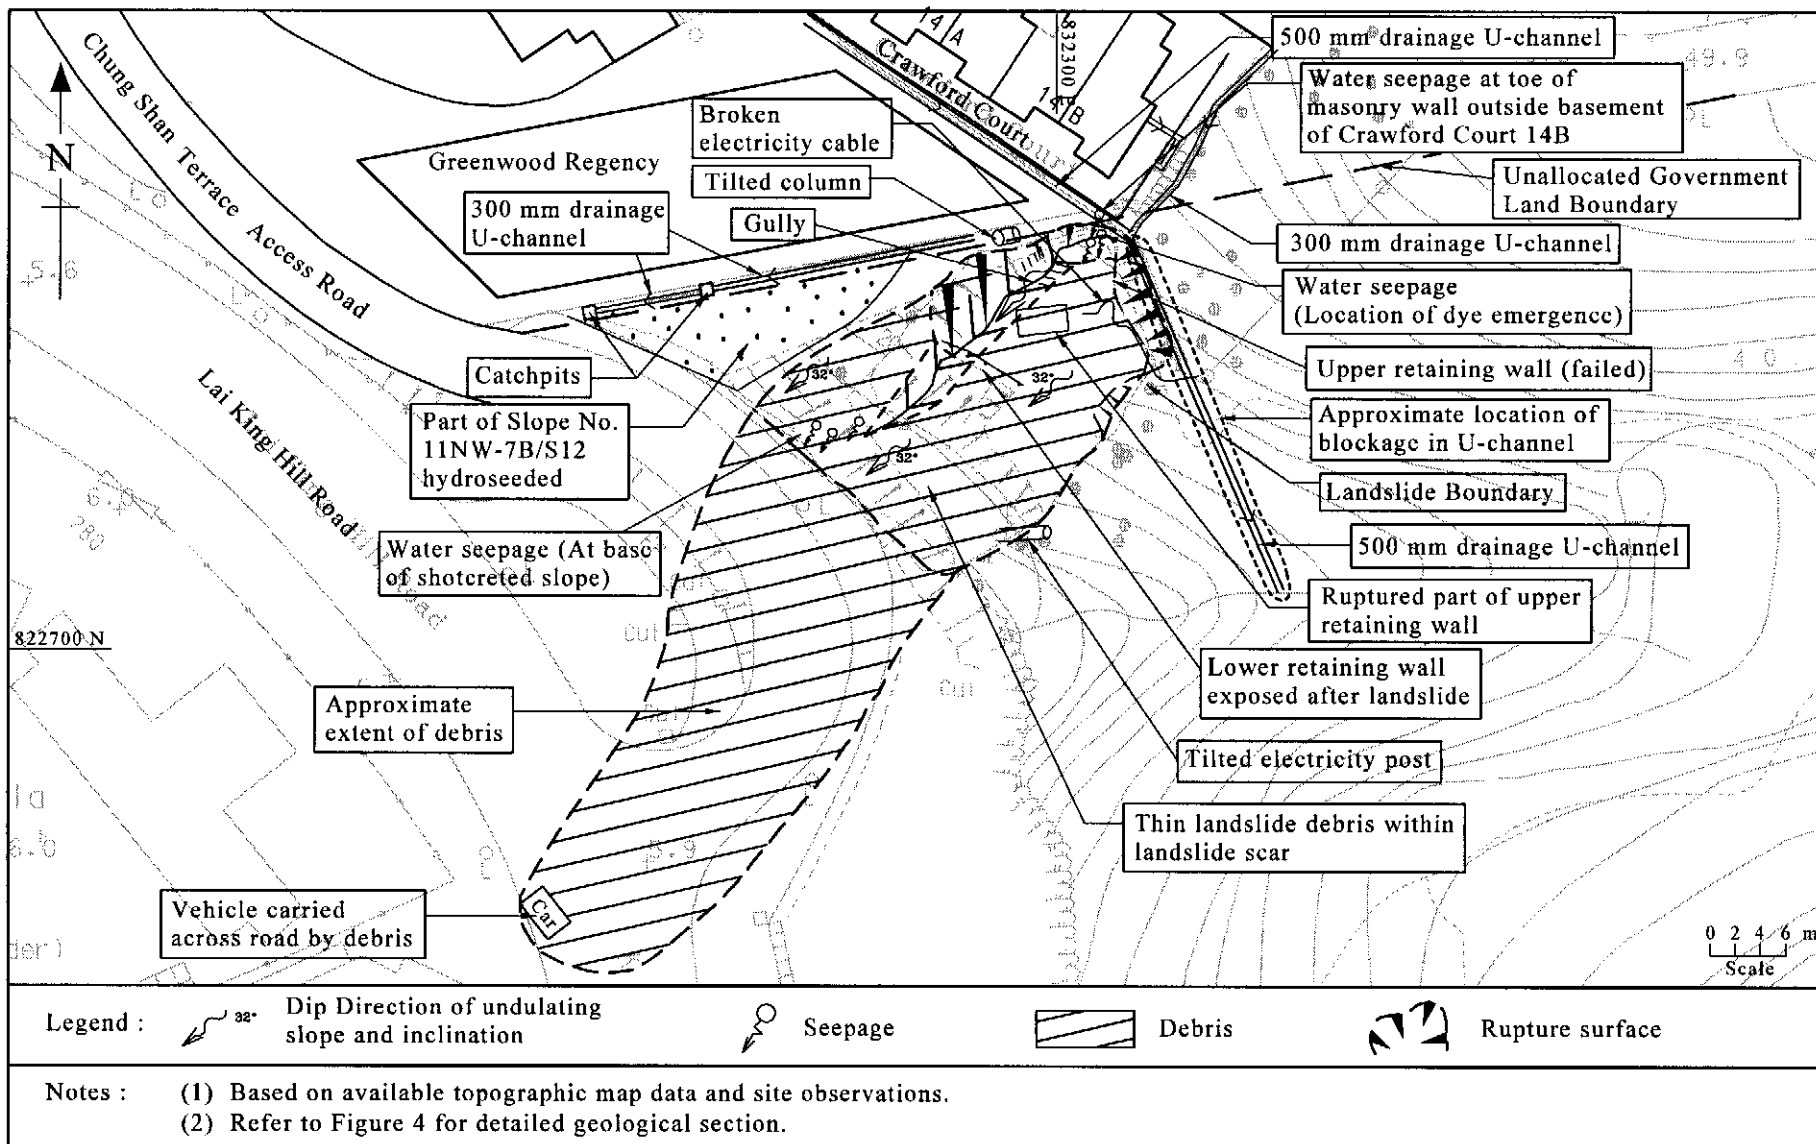
Figure 2 - Plan of Landslide Site

Nos. 14A and 14B Crawford Court are located at the crest of the landslide and the recently built Greenwood Regency is situated to the west (Figure 2). Between Crawford Court and Greenwood Regency, there is a 500 mm U-channel which drains southeast, past the crest of the landslide (Plate 2) to a natural stream course. The stream conveys water to a culvert at the toe of the slope, south of the landslide. After the landslide, it was noted that the U-channel was blocked with vegetation about 6 m southeast of the landslide.

The WIP site identified by the SIFT consultants referred to the construction of Greenwood Regency. This development was constructed between 1995 and 1997. A temporary emergency vehicular access road was constructed across SIFT Feature No. 11NW-7B/S12 directly to the west of the landslide area. This development removed the previously observed potentially unstable slope and on demobilisation from the site, the temporary access road was removed and part of the SIFT feature reinstated and hydroseeded (Figure 2).

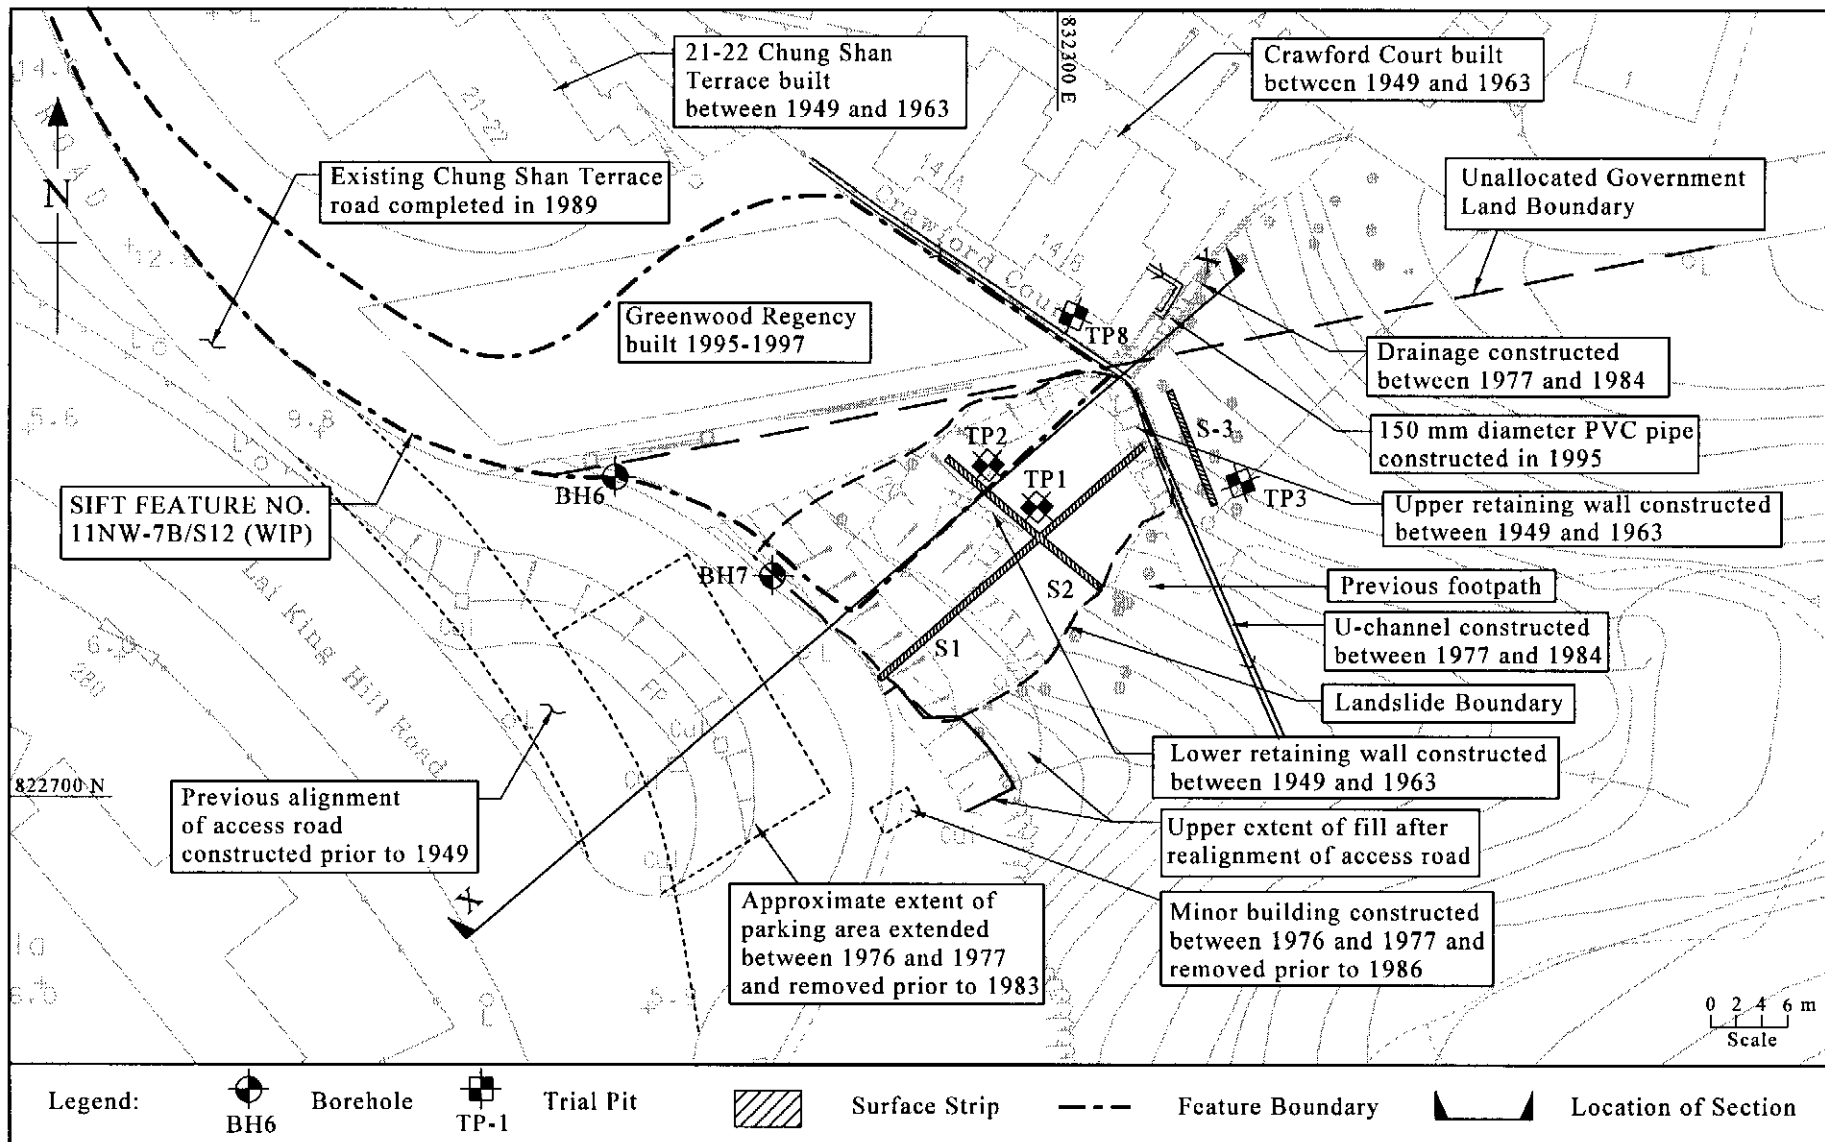
Figure 3 - Land Status and Site History

The landslide mostly affected unallocated Government land, but the adjacent SIFT Feature No. 11NW-7B/S12 was also involved (Figure 3).

The history of the site has been established from a sequential series of aerial photographs and documentary records. Locations relevant to the site history are shown in Figure 3.

The area was evaluated by the GEO's SIFT (Systematic Inspection of Features in the Territory) programme in March 1995 and it was found that a 'Works in Progress' (WIP) feature was located within the area of interest. It is noted in the SIFT records that "works in progress, registerable features may be present". The boundary of the area is shown in Figure 3.

Information on subsurface conditions has been obtained from two boreholes (BH6 and BH7) and one trial pit (TP8) sunk during the investigations for the development of Greenwood Regency (Enpack Geotechnical Engineering, 1993), and from the ground investigation carried out for the present study. The latter comprised three trial pits (TP1, TP2 and TP3), two chunam strips (S1 and S2) and one trial trench (S3). The trial pits were excavated and logged by the GEO's term contractor (GEO, 1997) whilst the chunam strips and trial trench were excavated by HyD. The locations of all the exploratory holes are shown on Figure 3.

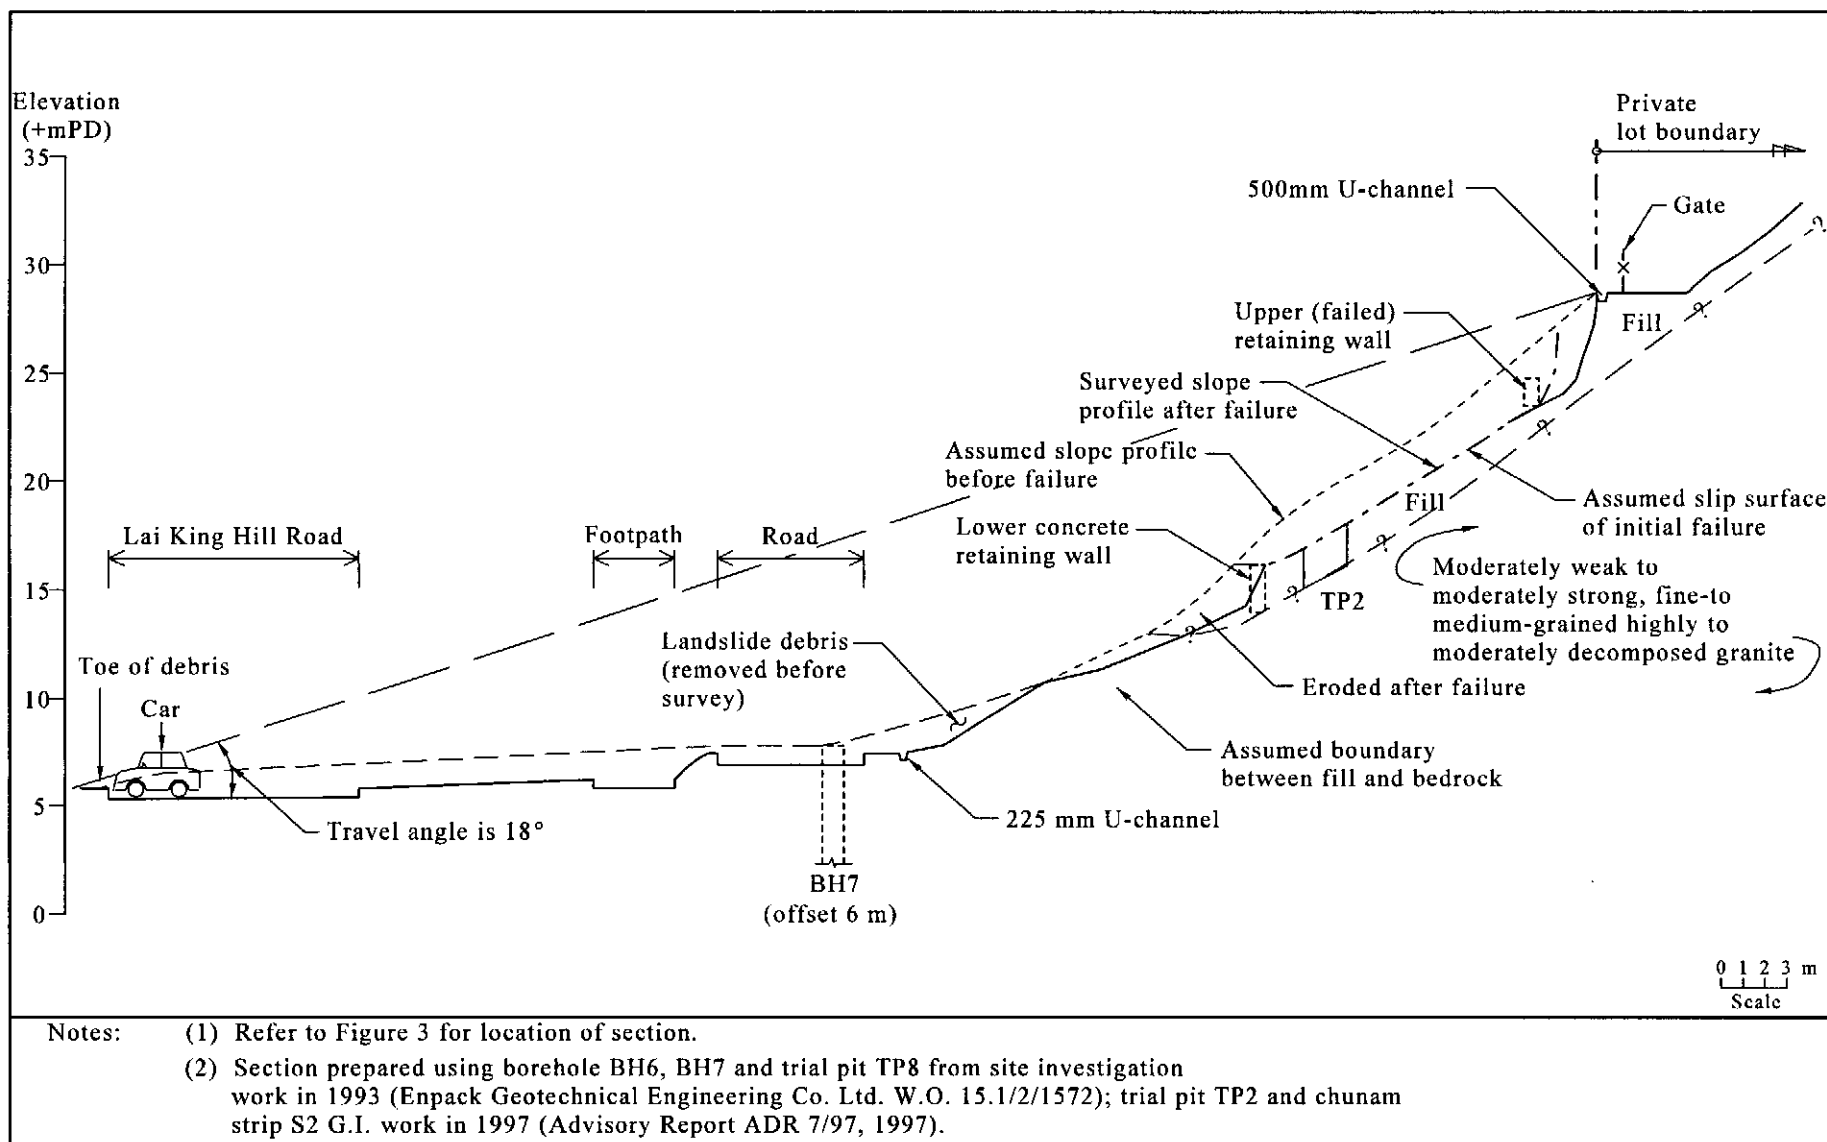
Figure 4 - Geological Section Through the Landslide

A geological section through the landslide is presented in Figure 4, which is based on the results of the recent investigation and site observations. The site is mantled by fill whose thickness varies across the site from about 2 m in the southeast to about 4 m in the northwest flank of the landslide. The fill consists mainly of sandy silt to sandy clayey silt with gravel and brick fragments. Three in situ density tests carried out in the fill within the failed slope gave an average degree of compaction of 75% (GEO, 1997) indicating that the fill was in a loose state. The fill beneath the upper concrete wall comprised cobbles and gravel of granite.

A cross-section through the slope, based on the observations described above is shown in Figure 4. It is concluded that a sliding failure occurred within the fill along a failure surface which extended from the upper concrete retaining wall to a 'strong point' in the slope formed by the lower concrete retaining wall. The displaced material passed over the lower concrete retaining wall and crossed Chung Shan Terrace Access Road where it hit the car, which was pushed about 30 m over gently-sloping ground to the north-bound lane of Lai King Hill Road. The occupants of the car escaped without injury. The water which subsequently flowed down the landslide eroded an estimated 50 m^3 of material and resulted in wash out of fine material for a considerable distance beyond the toe of the landslide, southwards down Lai King Hill Road.

The travel angle of the landslide, measured from its crest to the distal end of the debris, was 18° (Figure 4). The landslide ran out about 45 m from the toe of the slope, mostly over the gently inclined, lower part of Chung Shan Terrace access road.

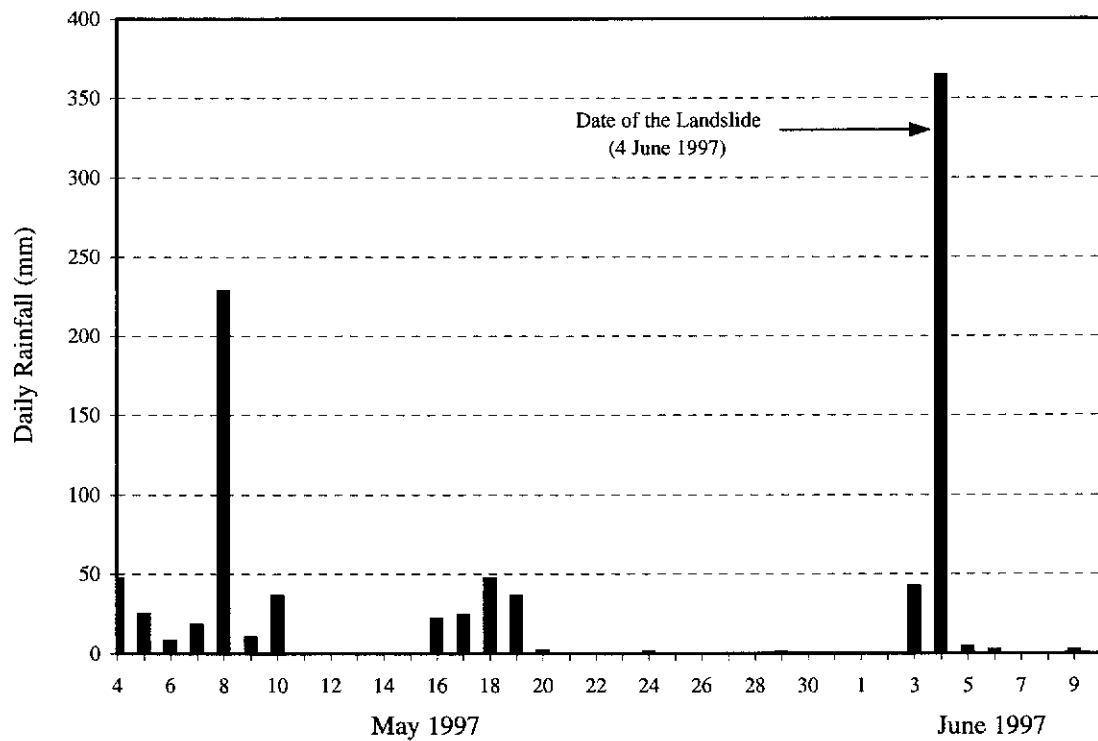
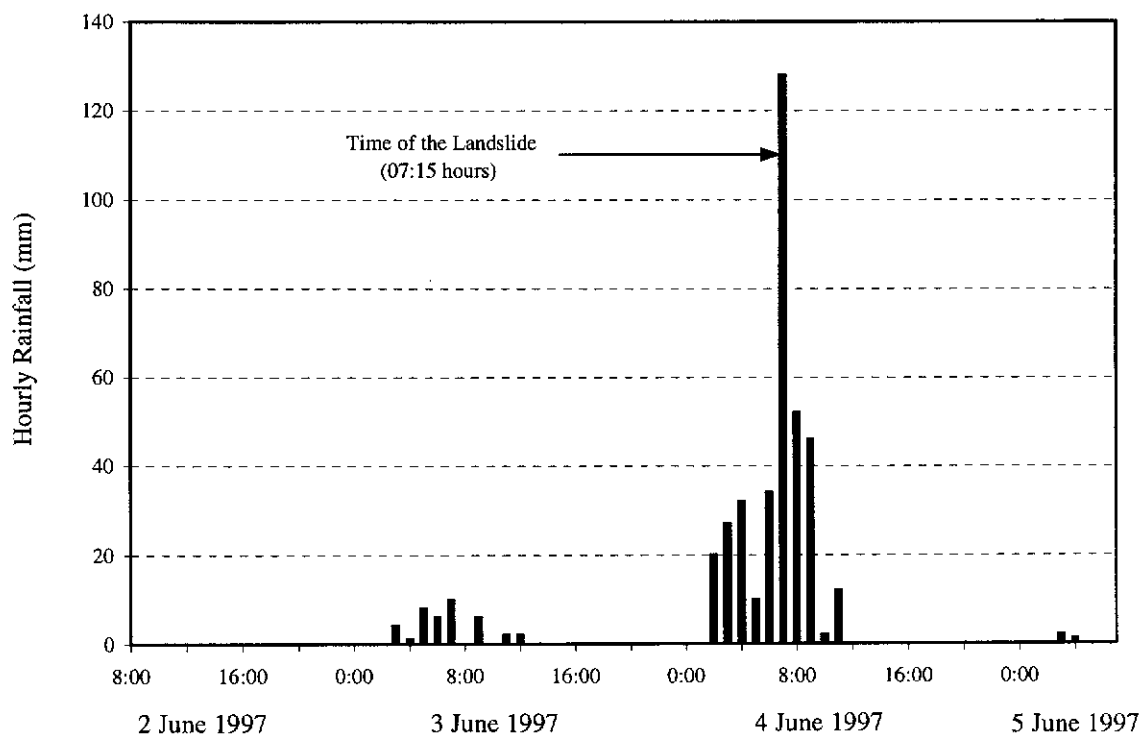
Figure 5 - Rainfall Records of GEO Raingauge No. N04

The nearest GEO automatic raingauge, No. N04, is located about 880 m northwest of the landslide on the roof of Kai Kwong Lau, Cho Yiu Estate, Lai King (Figure 1). The daily

rainfall between 4 May and 4 June 1997 and hourly rainfall between 2 June and 4 June 1997 are presented in Figure 5.

On 4 June 1997, intermittent rainfall occurred between 01:30 hours and 05:10 hours before intensifying up to the time of the landslide at 07:15 hours. Isohyets of rainfall for the period prior to the landslide are shown in Figure 6. The 12-hour and 24-hour maximum rolling rainfalls before the landslide were 252.5 mm and 263 mm respectively (Table 1). The maximum rolling hourly rainfall of 128.5 mm occurred between 06:15 hours and 07:15 hours on 4 June, i.e. immediately before the landslide.

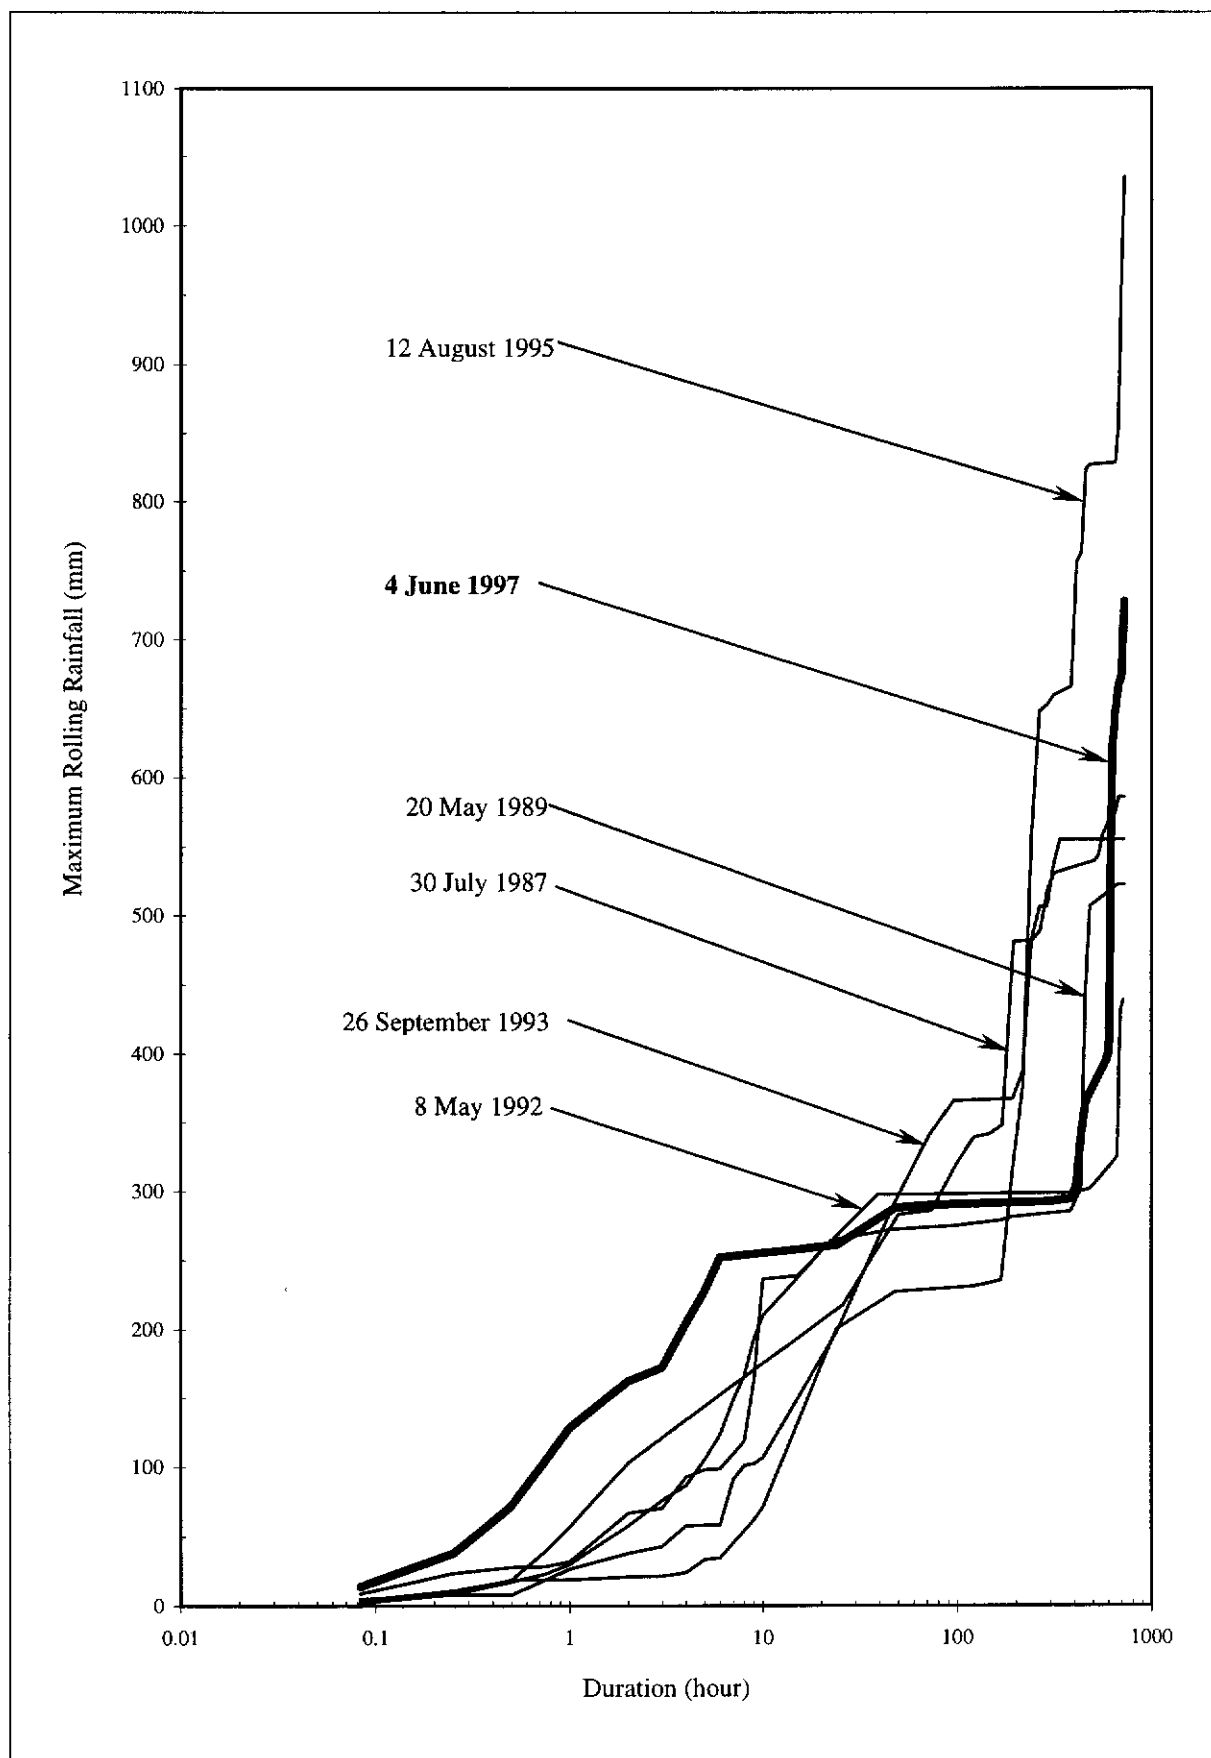
Figure 7 - Maximum Rolling Rainfall at GEO Raingauge No. N04 for Major Rainstorms

Figure 7 presents a comparison of the pattern of the rainfall prior to the landslide with those of previous major rainstorms recorded at GEO raingauge No. N04 since its installation in 1978. It can be seen that the rainfall preceding the landslide was the highest recorded at the raingauge for durations of less than 12 hours but was comparatively less intense than some of the previous rainstorms for rainfall durations of 12 hours or more.

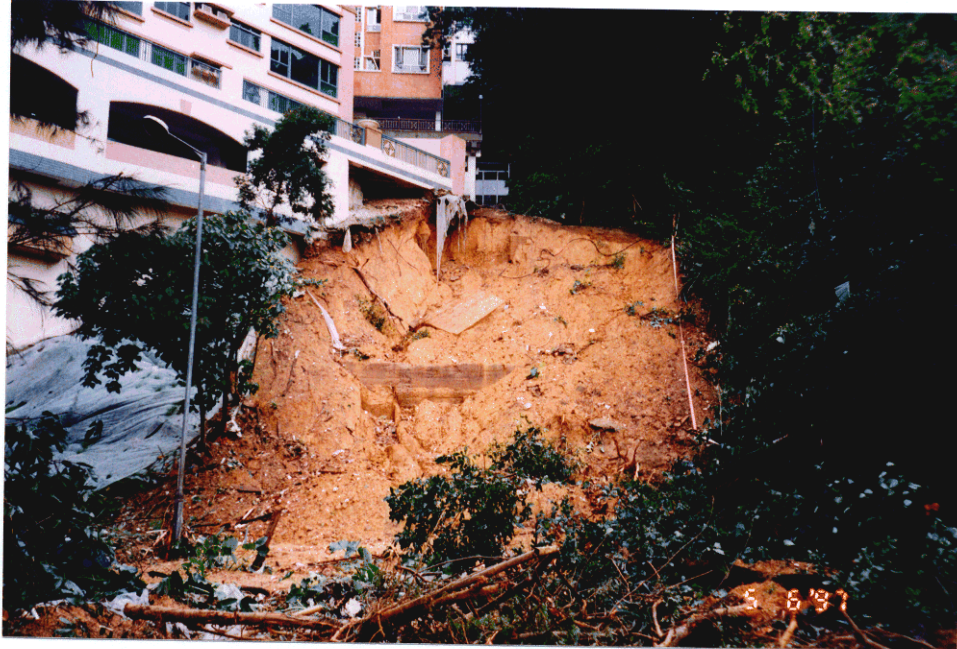
Plate 1 - General View of the Landslide (Photograph Taken on 5 June 1997)

The landslide is located above Chung Shan Terrace Access Road which connects Lai King Hill Road with Castle Peak Road (Figure 1). The fill slope on which the failure occurred is about 22 m high and has a horizontal extent of about 35 m (Plate 1). Average slope angles adjacent to the area of the failure ranged from about 32° to 34° to the horizontal. Prior to the failure, much of the slope was densely vegetated.

The landslide was 18 m wide, 15 m long and had an average depth of about 3 m, with an estimated volume of about 450 m³. The height of the main scarp varied from about 2 m in its eastern part adjacent to the U-channel (Plate 2), to about 4 m in the northern corner where a podium of Greenwood Regency was slightly undermined (Plate 1).

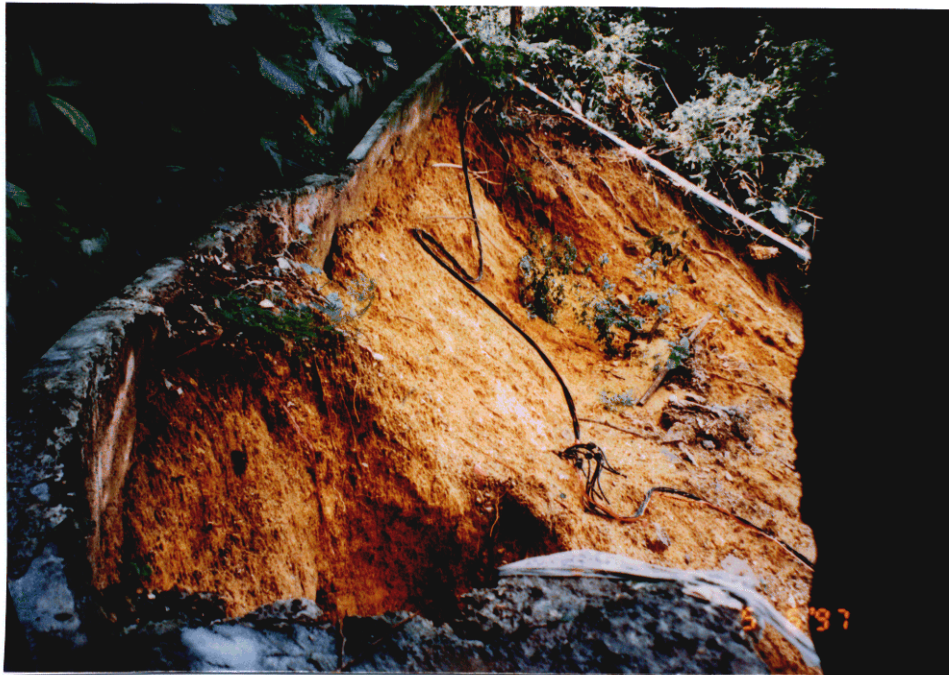
Plate 2 - View of 500 mm U-Channel at the Crest of the Landslide
(Photograph Taken on 5 June 1997)

During the severe rainstorm, overflow from the U-channel that passes along the crest of the landslide would probably have occurred where the channel was blocked. However, the blockage does not correspond with the landslide location and any water overtopping the channel would probably have flowed towards the stream and not the landslide area. Elsewhere, the U-channel was found to be in a good maintenance condition. Overflow or leakage from the U-channel is therefore not considered to be a likely source of water entering the failed slope.

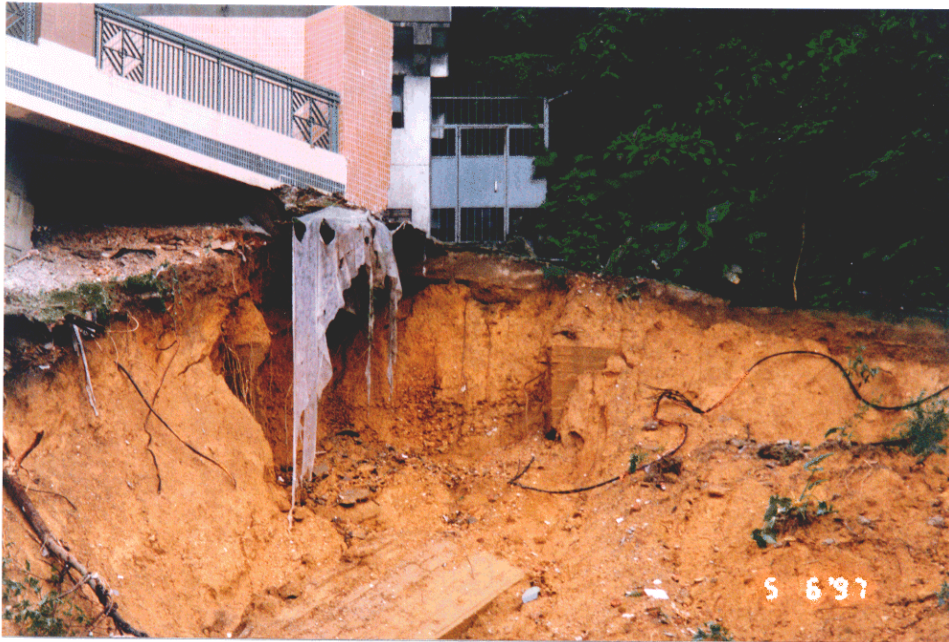
Plate 3 - View of the Northern Corner of the Main Scarp
(Photograph Taken on 5 June 1997)

The landslide occurred within an unregistered fill slope, exposing two concrete retaining walls that were previously buried in the fill (Plate 3). The upper concrete retaining wall, about 1 m high, was located just downslope of the crest of the landslide and failed during the incident. The lower wall, about 1.7 m high, was at about mid-slope and remained intact. Both walls were about 0.5 m thick.

A relatively smooth surface, slightly eroded along its northwestern side and dipping at 32° downslope, was observed after the failure between the main scarp and the lower concrete retaining wall. A 6 m-long section of the failed upper concrete wall came to rest on this

surface (Plate 3). The ends of the upper concrete retaining wall left within the slope protruded from the fill on either side of the main scarp (Plate 4). The eastern end was relatively straight indicative of a construction joint whilst the western end was uneven and had been fractured. There were no weepholes within the wall. It was noted that the wall was founded on coarse fill. The lower concrete retaining wall was founded on moderately decomposed granite. It, too, had no weepholes. About 8 m of the wall became exposed and, the full height of the wall was made visible by erosion of fill on its downslope side. An erosion gully originating in the northern corner of the main scarp extended through the upper part of the landslide. Downhill of the lower concrete retaining wall and beyond the limits of the gully, slope angles of 32° to the horizontal were measured. Comparison with the pre-landslide topography suggests that these slopes formed part of the original ground, over which the landslide debris travelled.

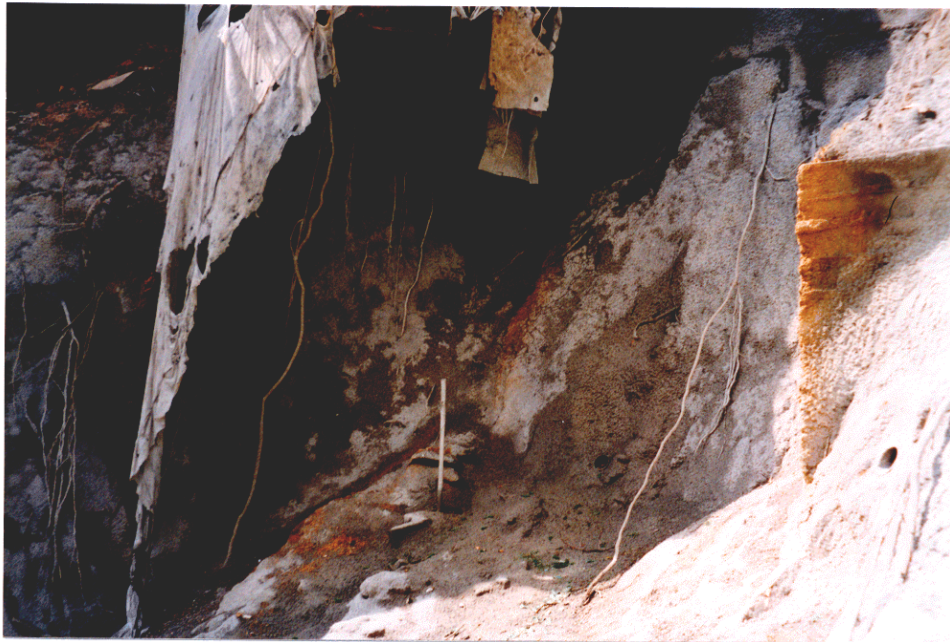
Plate 4 - Northern Corner of Main Scarp Showing Ends of the
Upper Concrete Retaining Wall (Photograph Taken on
17 June 1997)

The initial failure probably occurred as a result of the collapse of the fill upslope of the lower concrete retaining wall. Collapse of the fill was most likely to have been promoted by infiltration and consequent saturation and possible elevation of porewater pressure within it and, probably, by water pressures acting on the upper concrete retaining wall which would have impounded water behind it in the absence of weep holes. The foundation of the wall may have also been undermined by water passing beneath it. Failure occurred along a surface which extended from behind the upper concrete retaining wall and daylighted above the lower wall. An alternative, but less likely, scenario could be that the initial failure took place between the two retaining walls, thereby allowing the upper wall to topple forward.

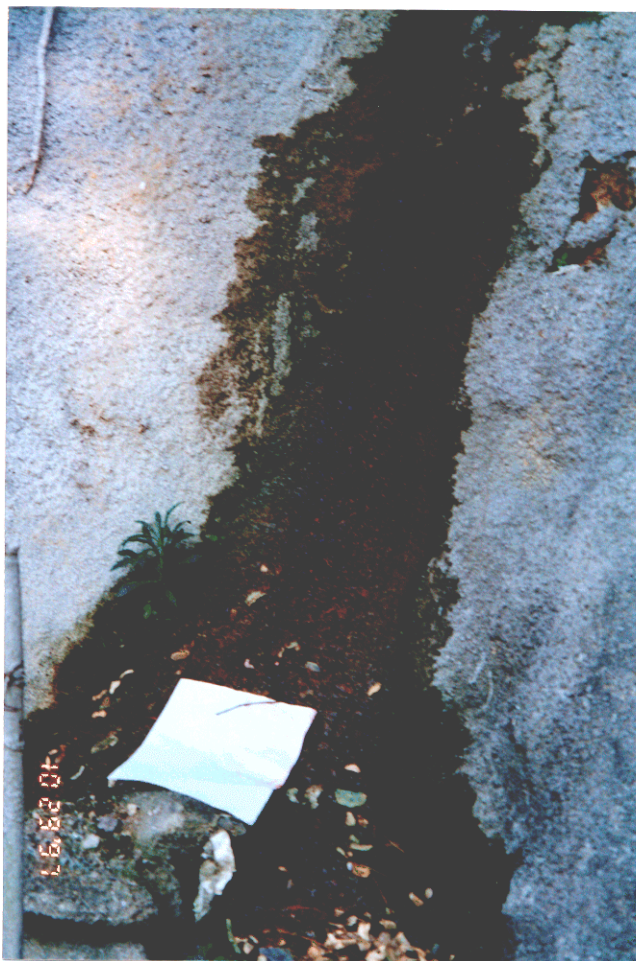
Plate 6 - Close-up of Seepage of Dye from Main Scarp (Photograph Taken on 29 October 1997)

After the landslide, leakage from the recently installed disposal pipe at Crawford Court (see Section 2.2 above) was established by a tracer test. On 29 October 1997, red dye was poured into the 150 mm PVC pipe in the basement at Crawford Court. The dye reappeared 10 minutes later within seepages from the main scarp of the landslide (Figure 2 and Plate 6). The average velocity of the tracer was about 1 m/min. No dye appeared from the other seepages in the main scarp of the landslide.

Leakage from the combined storm and foulwater drainage system from Crawford Court was confirmed by the tracer test after the incident (Section 3.2). If the leakage were present on 4 June 1997, the combined foul and (mainly) stormwater discharges from Crawford Court would soon have entered the upper part of the slope where its downslope flow would have been impeded by the upper concrete retaining wall. Alternatively, the drainage system may have fractured suddenly, for some unidentified reason, before the landslide.
