**SECTION 3:  
DETAILED STUDY OF THE  
LANDSLIDE AT  
GLORIOUS PRAISE CHRISTIAN  
CENTRE, KWAI CHUNG  
ON 8 MAY 1997**

**Halcrow Asia Partnership Ltd**

**This report was originally produced in July 1998  
as GEO Landslide Study Report No. LSR 5/98**

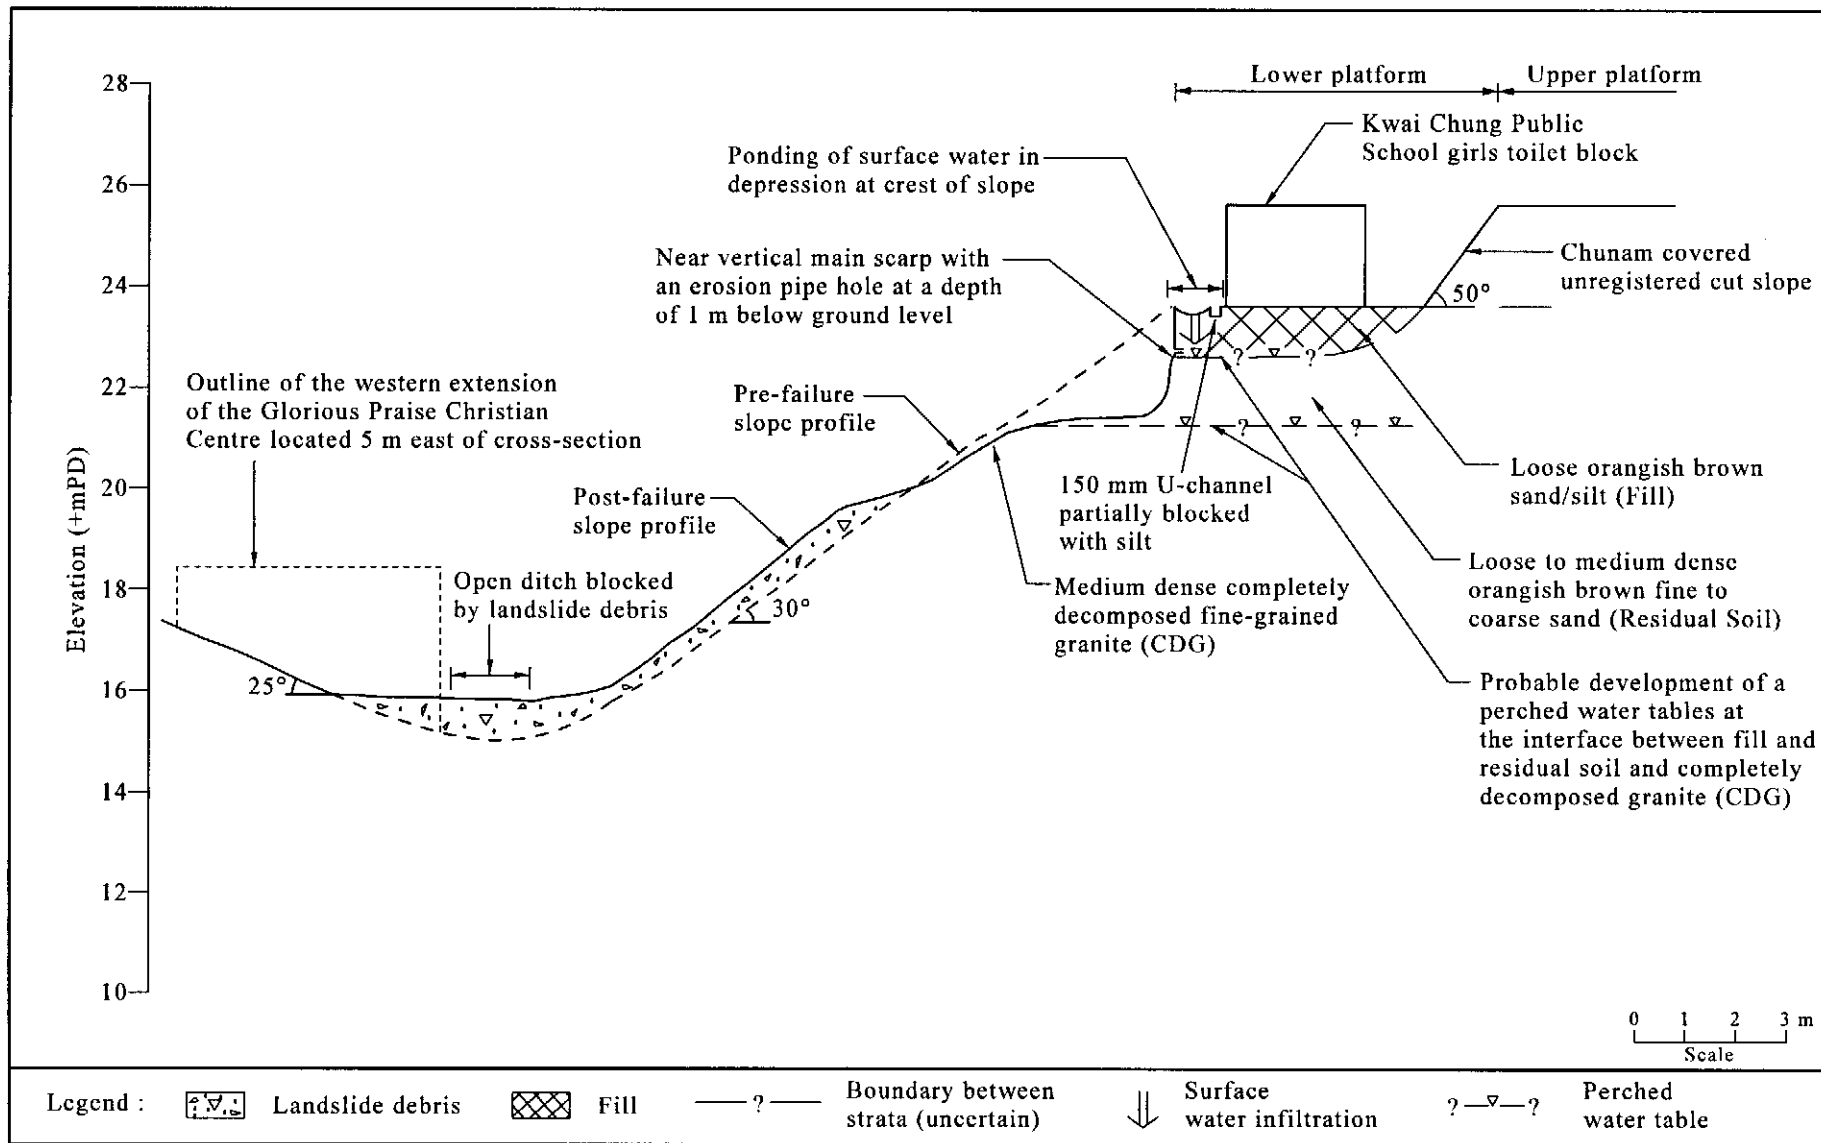
Figure 4 - Geological Cross-section

The geological memoir (Addison, 1986) and Sheet 7 of the Hong Kong Geological Survey 1:20 000 Map Series (GCO, 1986), indicate that the site is underlain by fine-grained granite. There were no records of boreholes drilled within close proximity to the landslide at the Geotechnical Information Unit (GIU) of GEO. A geological cross-section through the landslide is shown in Figure 4.

The above factors contributed to the wetting of the ground, the development of perched water tables and elevated porewater pressures at the interfaces between fill and residual soil and residual soil and completely decomposed granite. It is noted that the lower part of the rupture surface was located along the interface between residual soil and completely decomposed granite.

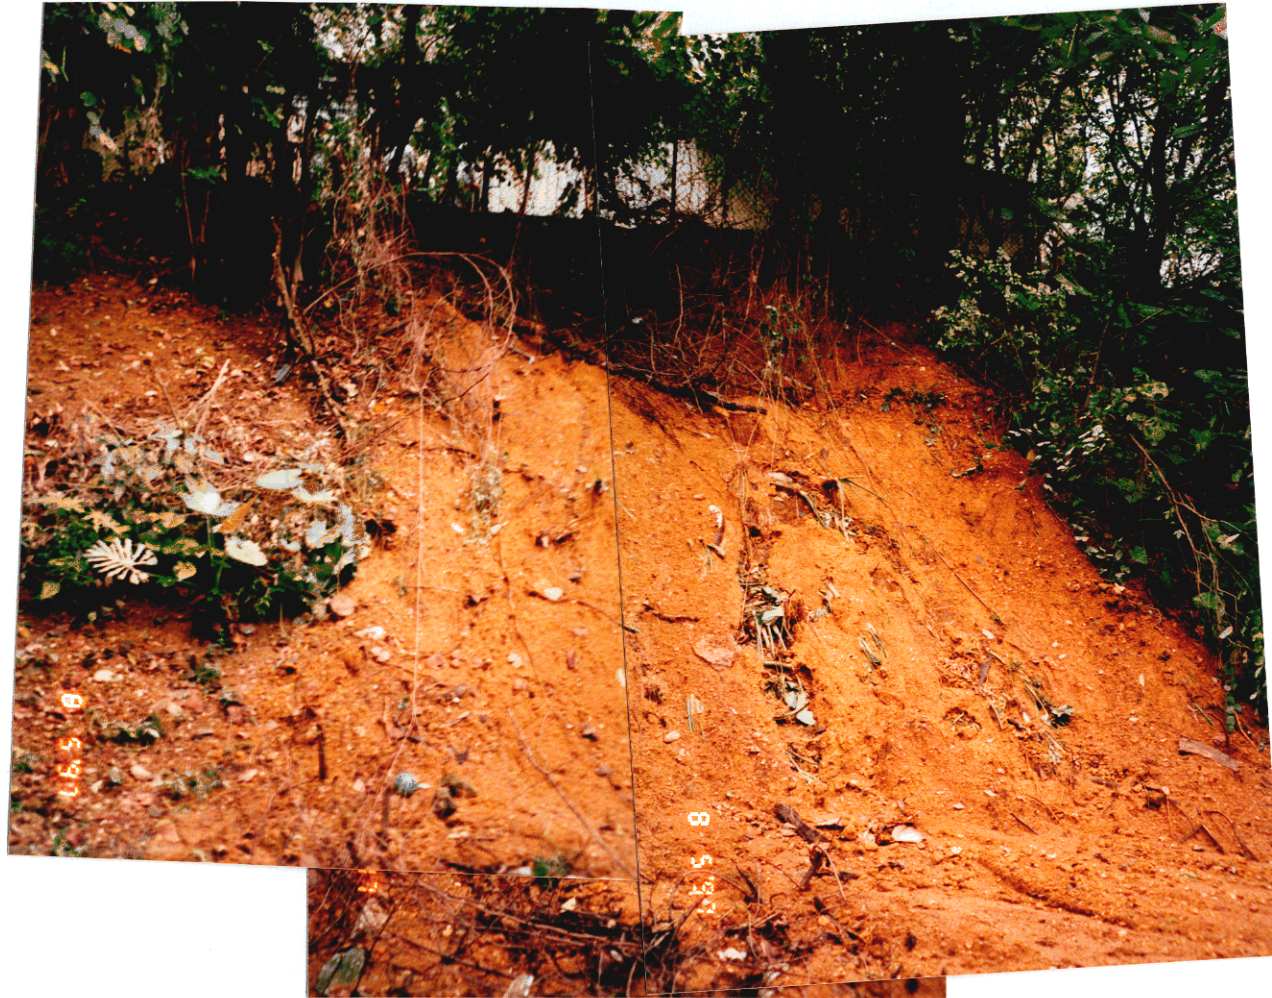
On the morning of 8 May 1997, a landslide (GEO Incident No. MW97/5/18) occurred on a 9 m high partly modified natural hillside between Kwai Chung Public School (KCPS) and Glorious Praise Christian Centre (GPCC), Kwok Shui Road, Kwai Chung (Figure 1, Plate 1). Debris from the landslide accumulated at the toe of the slope adjacent to GPCC. The landslide also undermined part of a platform of the KCPS at the crest of the slope. No fatalities or injuries were reported.

Plate 1 - View of the Landslide Showing the Debris on the Slope (Photograph Taken on 9 May 1997)  
(Note the Main Scarp is Obscured at the Crest of the Slope)

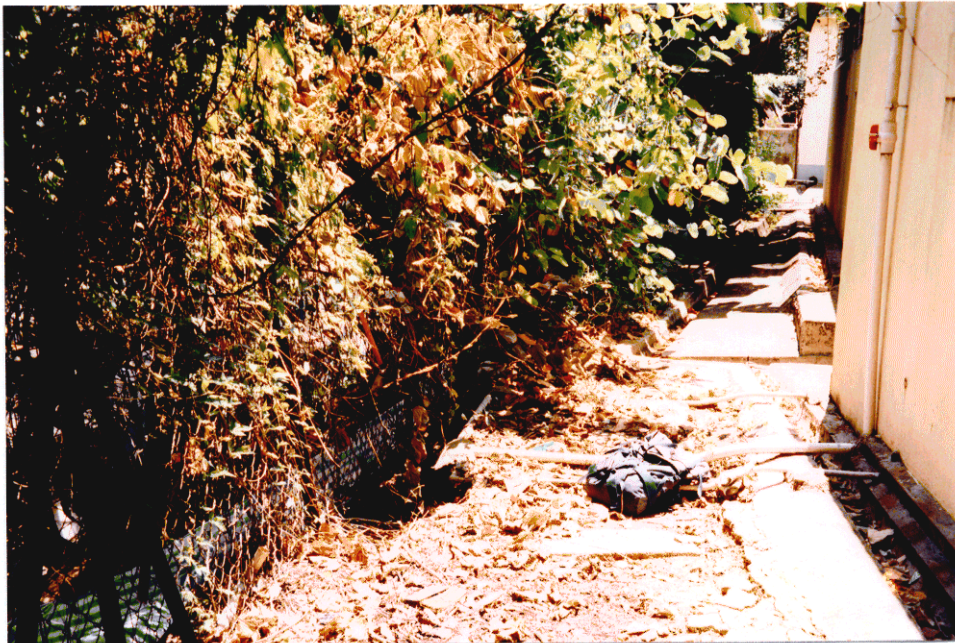
It is concluded that the landslide on 8 May 1997 was triggered by intense short duration rainfall. The landslide was probably caused by stormwater infiltration in the area of a shallow surface depression at the rear of the girls toilet block near the crest of the slope. Stormwater would also have run-off from the edge of the platform onto the unsurfaced slope below, due to the partial blockage of the U-channel drainage system and discharge point 'Z'. The concentrated discharge of a large volume of surface water onto the slope, which had no surface water drainage provision, would have resulted in rapid infiltration, the saturation of the fill and residual soil and a reduction in soil suction leading to slope failure.

Plate 2 - View Along the Lower Platform Behind the Toilet Blocks of Kwai Chung Public School (Photograph Taken on 15 May 1997)  
(Note the Slight Depression of the Ground Surface in the Area behind the Girls Toilet Block Above the Main Scarp of the Landslide)

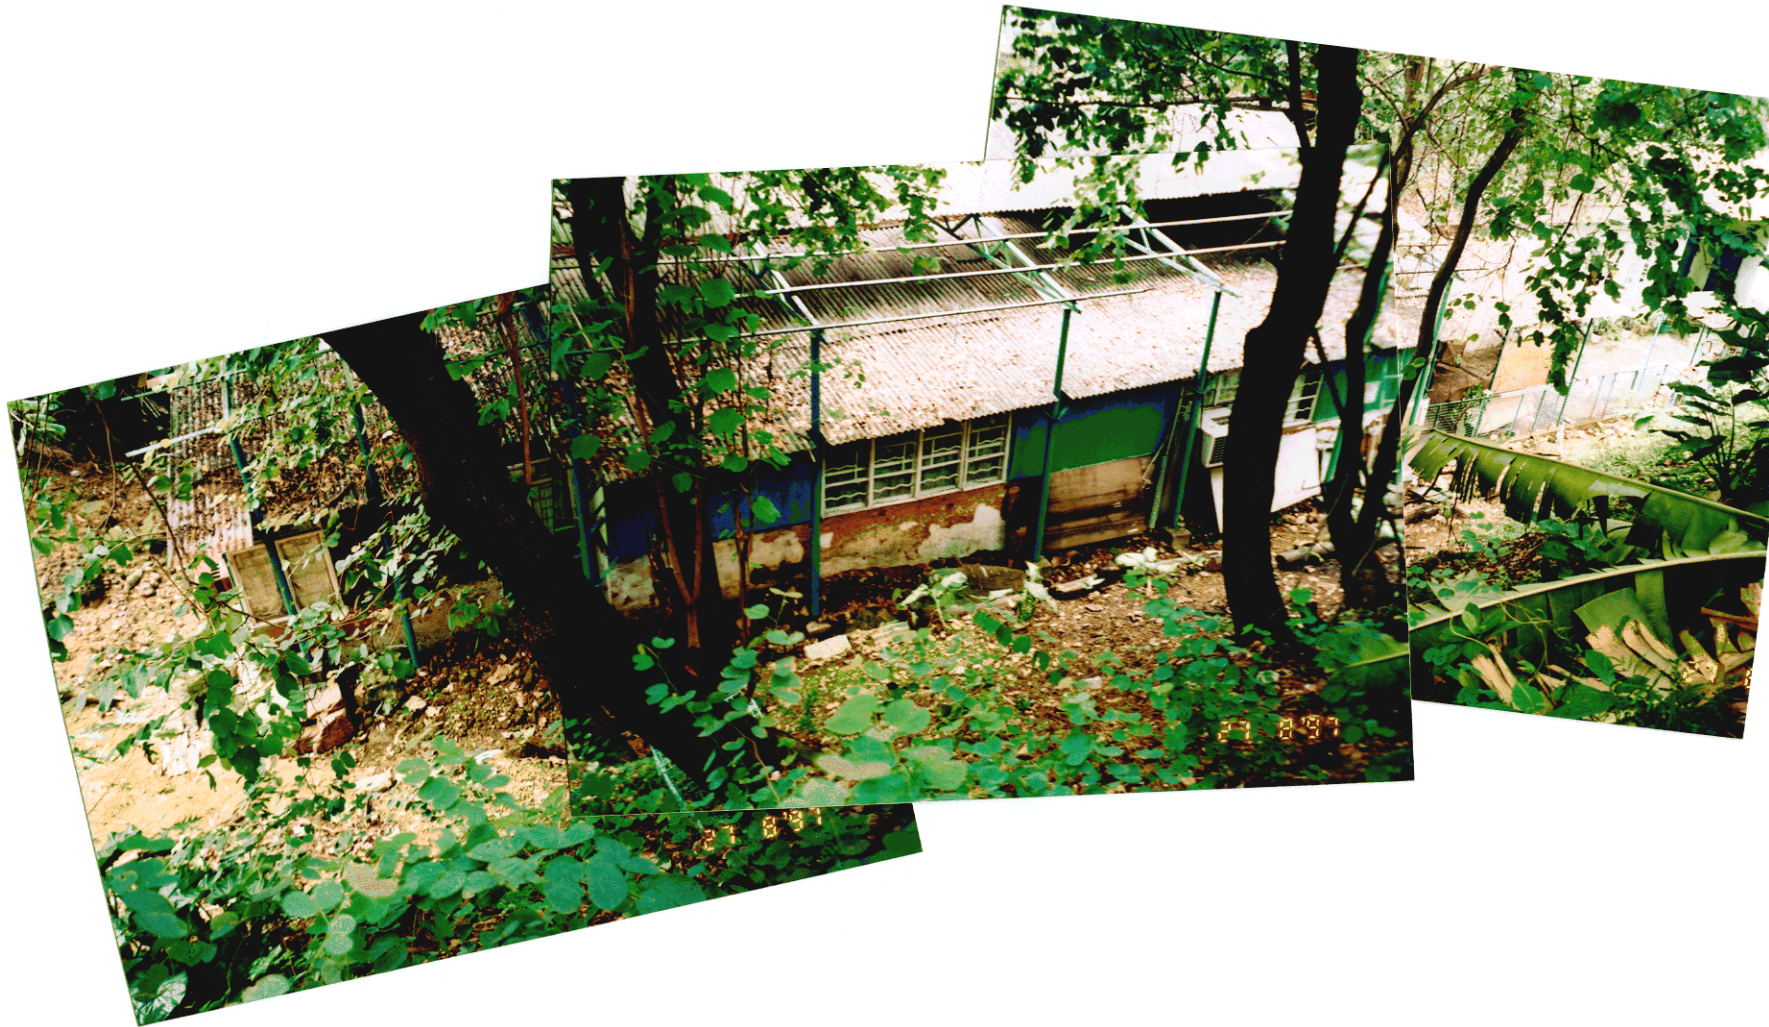
The main part of the slope between KCPS and GPCC has not been previously modified by any noticeable man-made cutting or filling. The slope angle varies between 30° to 35° to the horizontal. The slope had a dense cover of vegetation and trees prior to the landslide and there are no surface water drainage channels on the slope. At the toe of the slope, adjacent to GPCC, there is an open ditch 1 m to 2 m wide and about 1 m in depth.

The pasteur of GPCC reported (pers com) that “during the summer wet months the platform area on which the centre was built periodically flooded.” It was observed that there was a plastic pipe laid in the open channel at the toe of the slope, the pasteur indicated (pers com) that “this pipe was ineffective and regularly became blocked.”

Plate 3 - View Downslope to Glorious Praise Christian Centre Showing the Open Ditch at the Toe of the Slope  
(Photograph Taken on 27 August 1997)

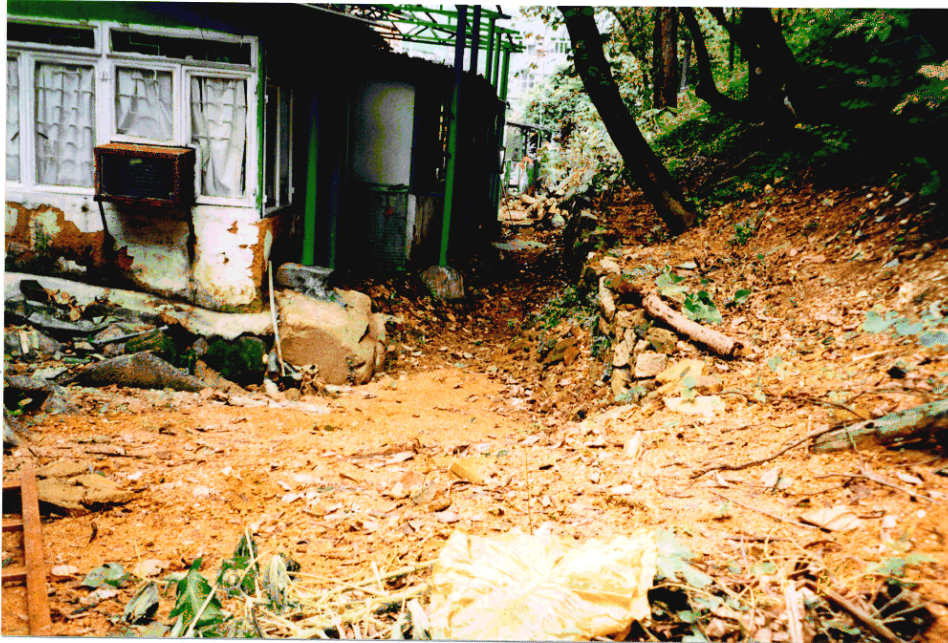
Plate 4 - View to the East Showing the Rear of Glorious Praise Christian Centre and the Open Ditch at the Toe of the Slope (Photograph Taken on 27 August 1997)

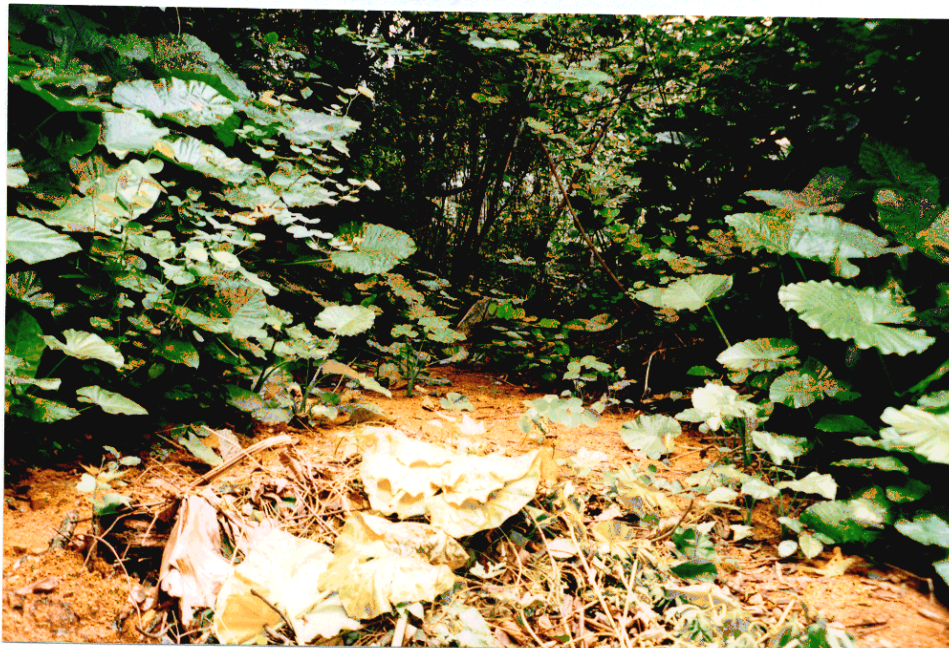
The failure was a rapid translational slide within fill and residual soil forming the upper part of the slope, located beneath the lower platform of KCPS. The failure was up to 4.9 m wide, 5.8 m long and 0.8 m deep and the estimated volume of the landslide was 20 m<sup>3</sup>. The base of the rupture surface was at the interface between residual soil and completely decomposed granite. The landslide debris accumulated in an open ditch at the toe of the slope and the lobe of debris extended to within 5 m of GPCC (Plates 3 & 4). There was secondary washout of the debris by heavy rainfall after the landslide, which resulted in the erosion and deposition of fine silt and sand to a small ephemeral pond, about 30 m to the west of the landslide (Plate 5).

Plate 5 - View to the West Showing the Secondary Washout of Debris (Photograph Taken on 27 August 1997)

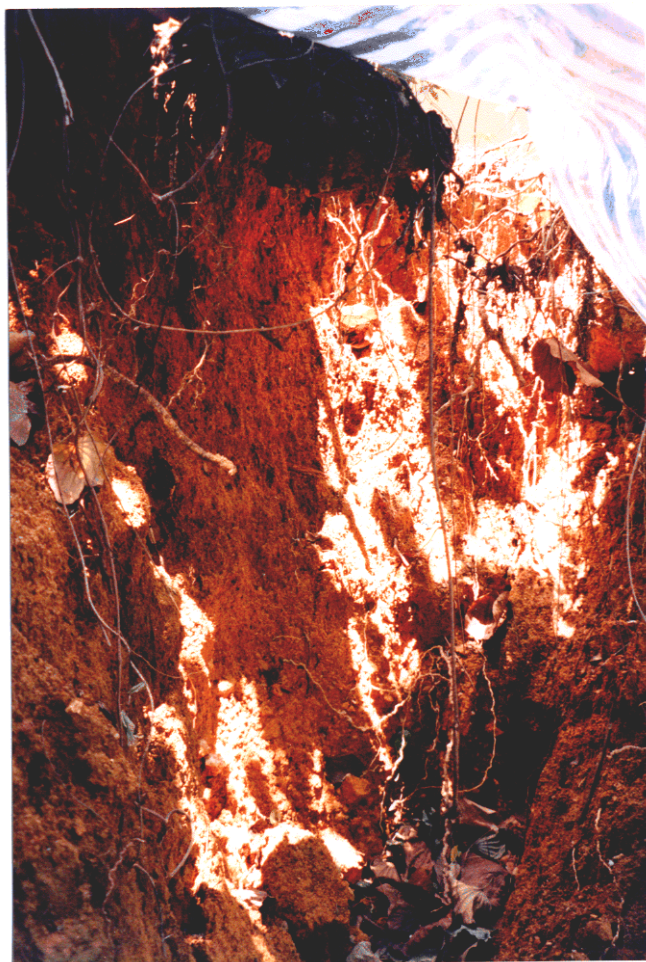
The landslide debris comprised fill and residual soil which was very wet at the time of inspection by HAP on 9 May 1997. The crest of the lower platform below the toilet blocks was slightly undermined by the near-vertical main scarp of the landslide (Plates 6 & 7). There was evidence of piping in the main scarp at a depth of 1 m below the level of the lower platform, however, no seepages were observed from pipelides in the main scarp at the time of inspection.

- (a) From the crest of the landslide to a depth of 1 m, loose, light orangish brown fine silty sand (Fill).
- (b) 1 m to 2.5 m below the crest of the landslide, loose, light to medium dense light orangish brown fine- to coarse- grained sand (Residual Soil).
- (c) 2.5 m to 3.5 m below the crest of the landslide, medium dense completely decomposed fine-grained granite (CDG).

Plate 6 - Close-Up View Showing the Near-Vertical Main Scarp (Photograph Taken on 15 May 1997)

Following the landslide the Architectural Services Department (Arch SD) carried out urgent slope repair works. The works consisted of the clearance of vegetation from the slope, placement of no fines concrete in the landslide scarp, the provision of shotcrete surface protection and the replacement of surface water drainage channels.

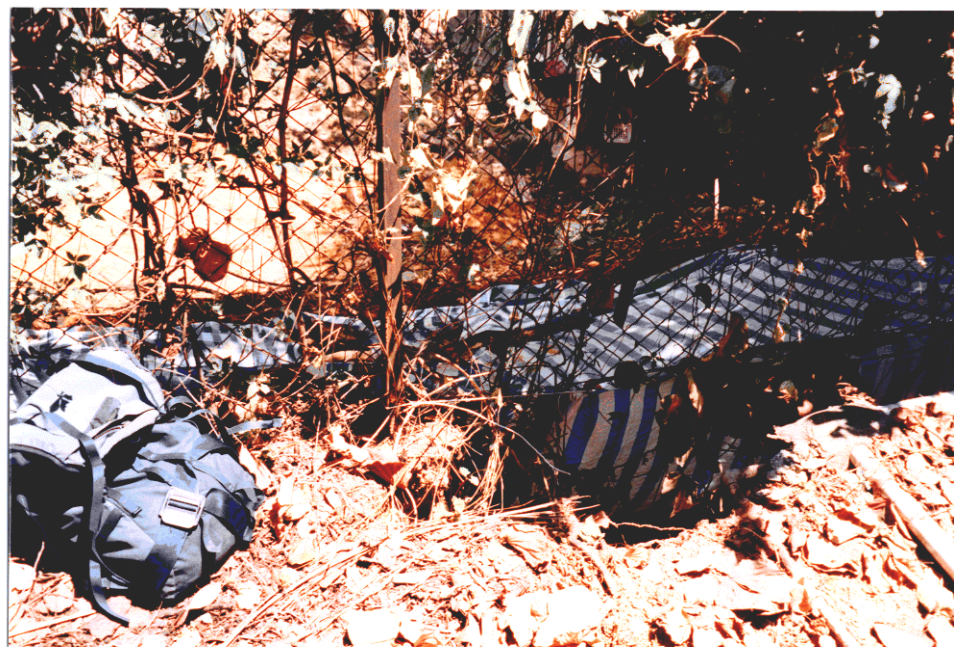
- (g) Two water supply pipes (installed above ground) were located along the crest of the slope connecting to the girls toilet block. No leakage was apparent from the two pipes.

Plate 7 - View Showing the Undermining of the Lower Platform at the Crest of the Slope behind the Girls Toilet Block of Kwai Chung Public School (Photograph Taken on 15 May 1997)  
(Note the Two Water Supply Pipes in the Right-Hand Corner of the Photograph)
