**SECTION 4:
DETAILED STUDY OF THE
LANDSLIDE NEAR
LIDO BEACH,
CASTLE PEAK ROAD
ON 2 JULY 1997**

Halcrow Asia Partnership Ltd

**This report was originally produced in June 1998
as GEO Landslide Study Report No. LSR 8/98**

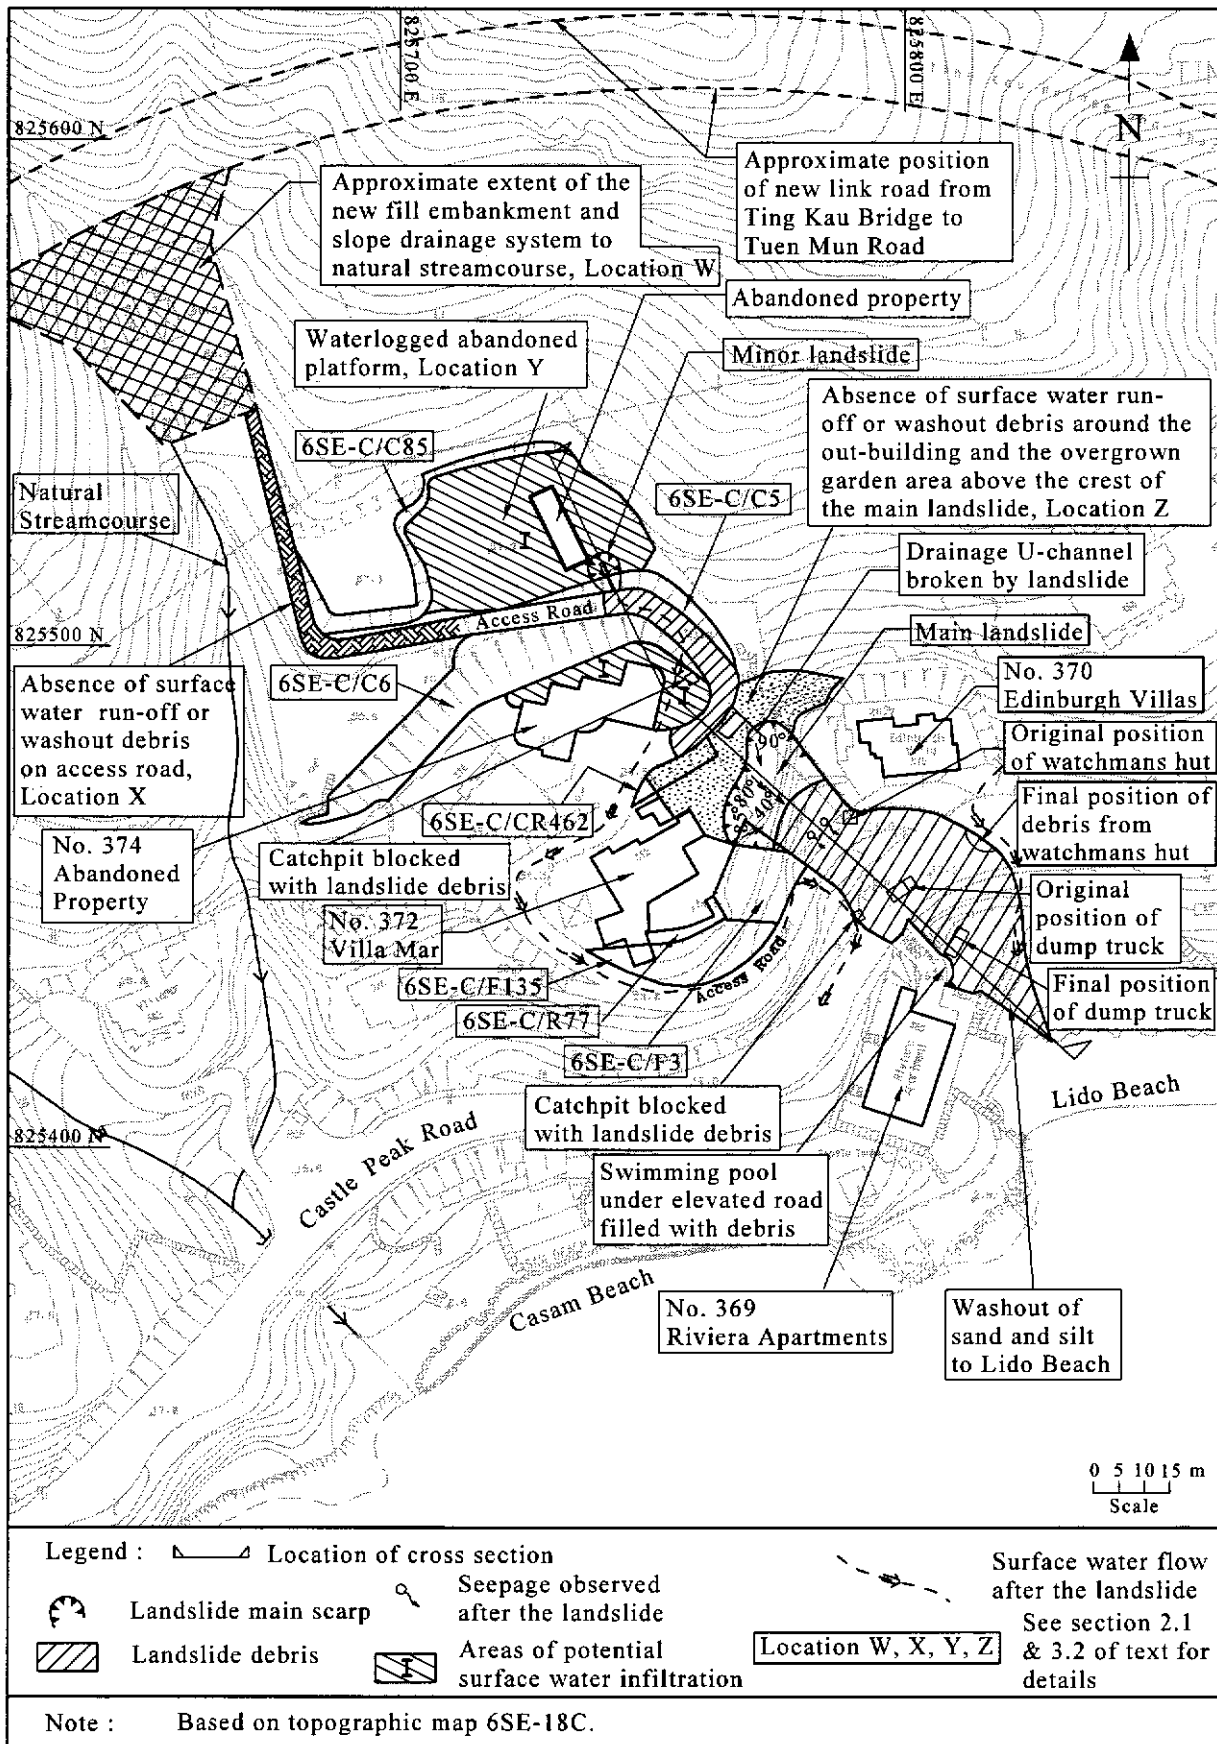
Figure 2 - Plan of the Landslide Site

The landslide debris was observed to be very wet when inspected after the landslide on 2 July 1997 (Plate 8). The debris comprised silty fine to coarse sand, tree roots, vegetation, blocks of masonry retaining wall, sections of stepped channel, and debris from the destroyed watchman's hut. No obvious seepages were noted in the main scarp during inspections made on 2 and 3 July 1997. However, on 7 July 1997 when the debris had been removed from the lower part of the rupture surface and rockfill had been placed, moderately strong seepage was observed at two locations, approximately 5 m upslope from the access road (Figure 2).

Inspections of the surrounding area by HAP about 2 hours after the main landslide on 2 July 1997, found that the upper platform Y (Figure 2) was waterlogged and provided the source of the surface water, which was observed flowing down the rupture surface of the minor landslide on cut Slope No. 6SE-C/C5 and onto the access road below. The surface water was diverted over the edge of cut Slope No. 6SE-C/C6 by landslide debris deposited on the access road, into an area of hardstanding around the abandoned property No. 374. There was an accumulation of silt and water on the hardstanding, which suggests that the drainage system around No. 374 and its connection to the 300 mm stepped channel might not have been functioning or had become blocked as a result of siltation. Surface water drained from the hardstanding onto the access road and flowed down the road. After the landslide it was diverted by the debris on the access road down the cut slope onto Castle Peak Road (Figure 2).

At the time of the inspection there was no evidence of surface run-off onto the main landslide from the access road above (location Z, Figure 2) or from the area between the access road and Edinburgh Villas. The U-channels on the fill slope below Villa Mar were found to be blocked with silt and leaf litter and would not have been capable of transmitting any significant water flow towards the landslide area.

The drainage system around the rock fill embankment associated with the link-road construction works north of the landslide was also inspected by HAP. At the time of inspection, about 2 hours after the landslide, the surface water drainage system on the rock fill embankment was found to be working satisfactorily. There was no evidence that overflow of surface water down the access road had occurred from the drainage system (location X, Figure 2).

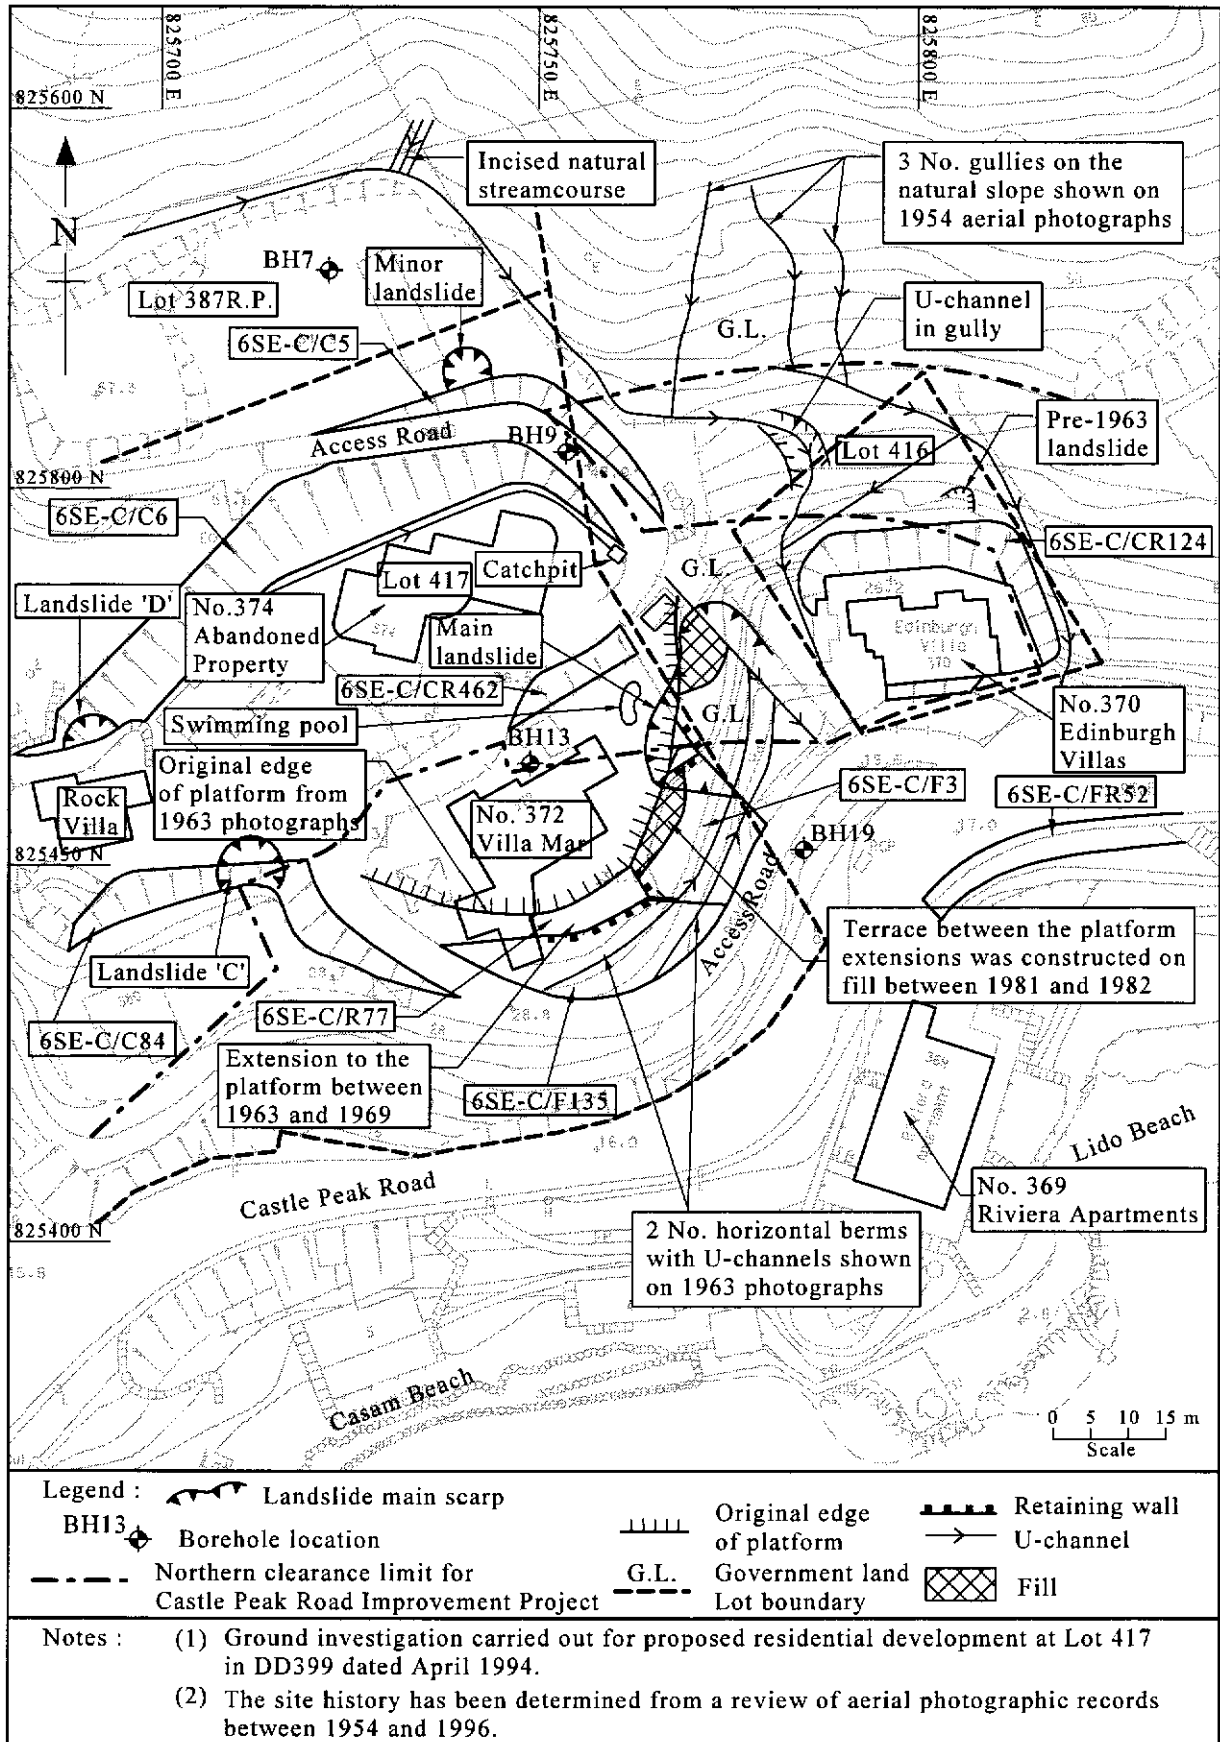
Figure 3 - Land Status and Site History

The landslide occurred mostly within unallocated Government land although the western flank of the landslide affected a fill slope (No. 6SE-C/F3) within private Lot No. 417 (Figure 3). The minor landslide also occurred within private Lot 417, although the cut slope (No. 6SE-C/C5) on which the failure occurred extends into unallocated Government land.

The original extent of the platform around Villa Mar, as indicated by aerial photographs, is shown on Figure 3. An out-building below the bend in the access road appears to be on an extension of the main fill platform. Aerial photographs show that the platform around Villa Mar was modified by two extensions between 1963 and 1969. The southern end of the platform was extended to form a rectangular garden supported by a low retaining wall. Near the eastern end of the platform, another low retaining wall was added to extend the platform to the south of the swimming pool. The fill slopes downslope of the two extensions do not appear to have been modified.

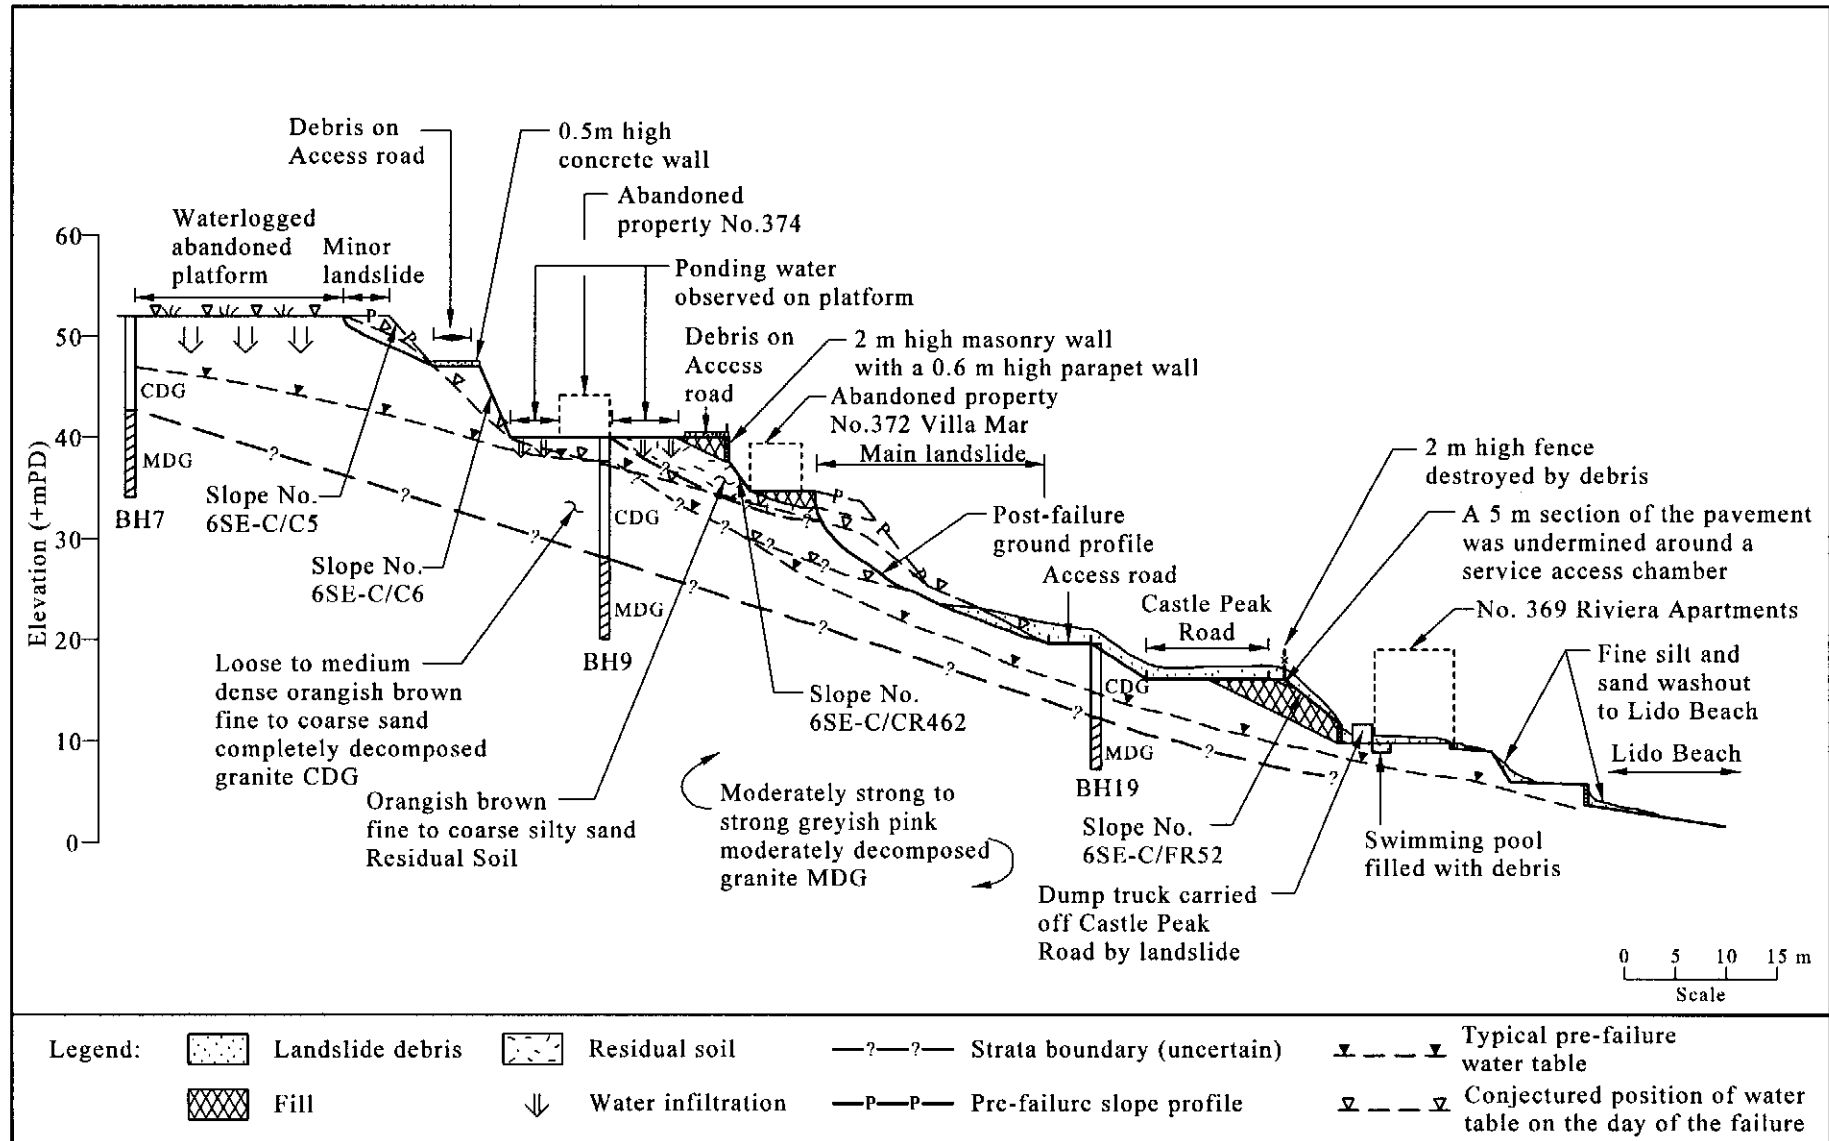
Figure 4 - Geological Cross-section

A report prepared by Greg Wong & Associates (GW&A, in 1995) includes records of three boreholes (BH7, BH9 and BH19) in the vicinity of the landslide (Figure 3). The borehole records and groundwater level data were used to prepare the geological cross-section shown in Figure 4.

The boreholes (BH7 and BH9), upslope of the landslide, encountered 12.7 m and 15.9 m, respectively, of completely decomposed granite which was recovered as a silty fine sand, overlying moderately to slightly decomposed granite. Groundwater was encountered at a depth of 5 m in both boreholes. Borehole BH19, sunk in the access road below the landslide

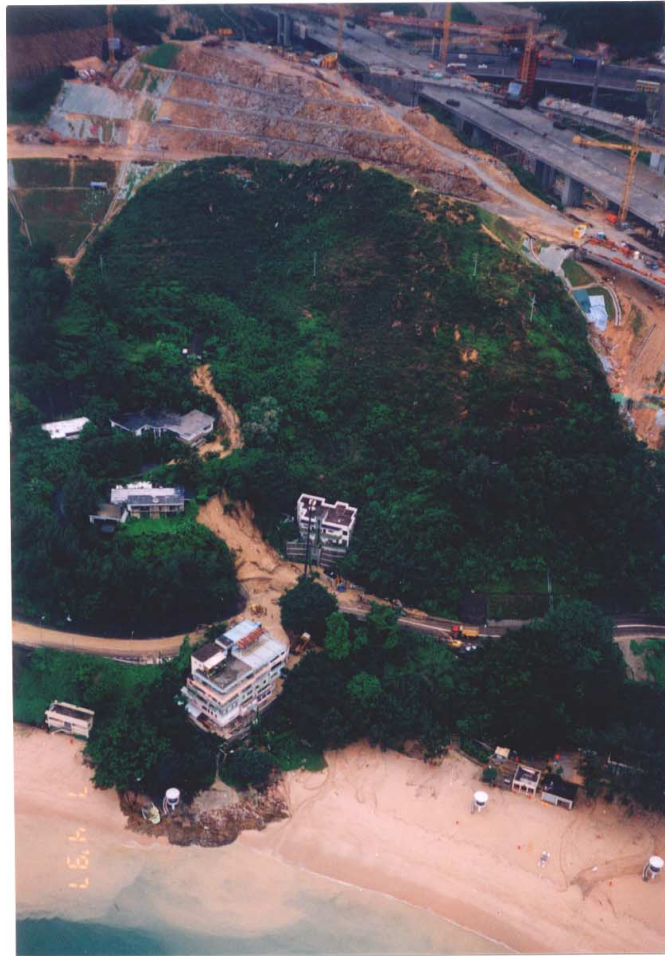
Plate 1 - An Aerial Photograph Showing the Main Landslide on the Slope between No. 372 Villa Mar and No. 370 Edinburgh Villas above Castle Peak Road near Lido Beach (Photograph Taken on 4 July 1997)
(Note the Minor Landslide on the Slope above the Access Road)

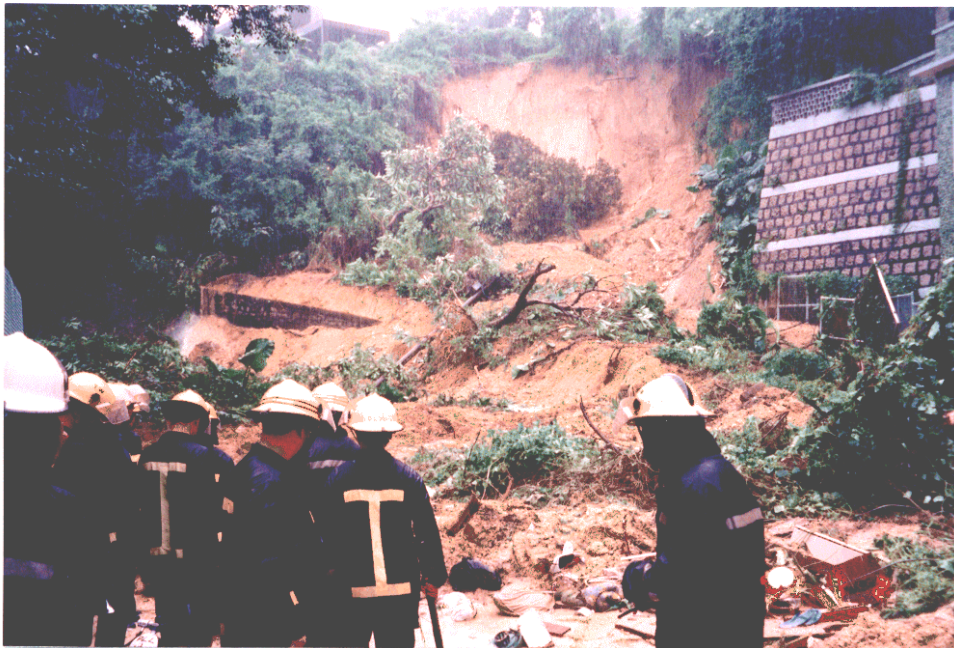
Plate 3 - General View of the Main Landslide between No. 370 Edinburgh Villas and No. 372 Villa Mar at the Crest of the Slope (Photograph Taken on 2 July 1997)

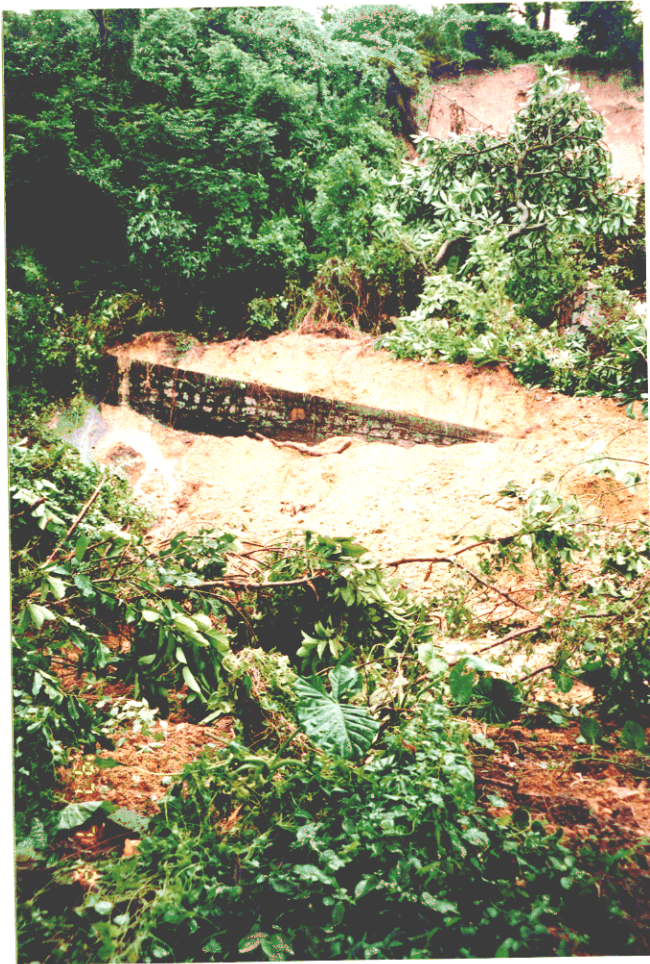
The rupture surface of the landslide was 25 m wide, 20 m long and up to 3 m deep. The estimated volume of displaced material was 750 m³, of which approximately two-thirds was completely decomposed granite and the remaining third was a mixture of residual soil and fill (Plate 3). The landslide debris was affected by minor slumping and secondary washout as a result of subsequent rainfall and surface water run-off (Plates 4 and 5).

Plate 4 - View of the Eastern Flank of the Main Landslide
Showing a Fallen Electricity Pole within the Landslide
Debris (Photograph Taken on 2 July 1997)

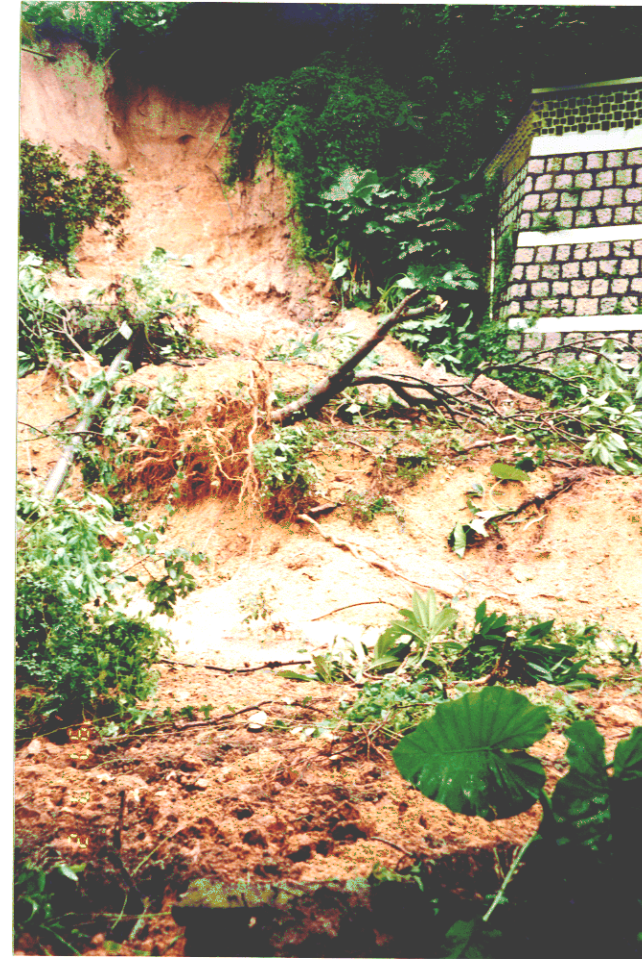
Plate 5 - View of the Western Flank of the Main Landslide
Showing a Section of Masonry Retaining Wall
within the Landslide Debris (Photograph Taken on
2 July 1997)

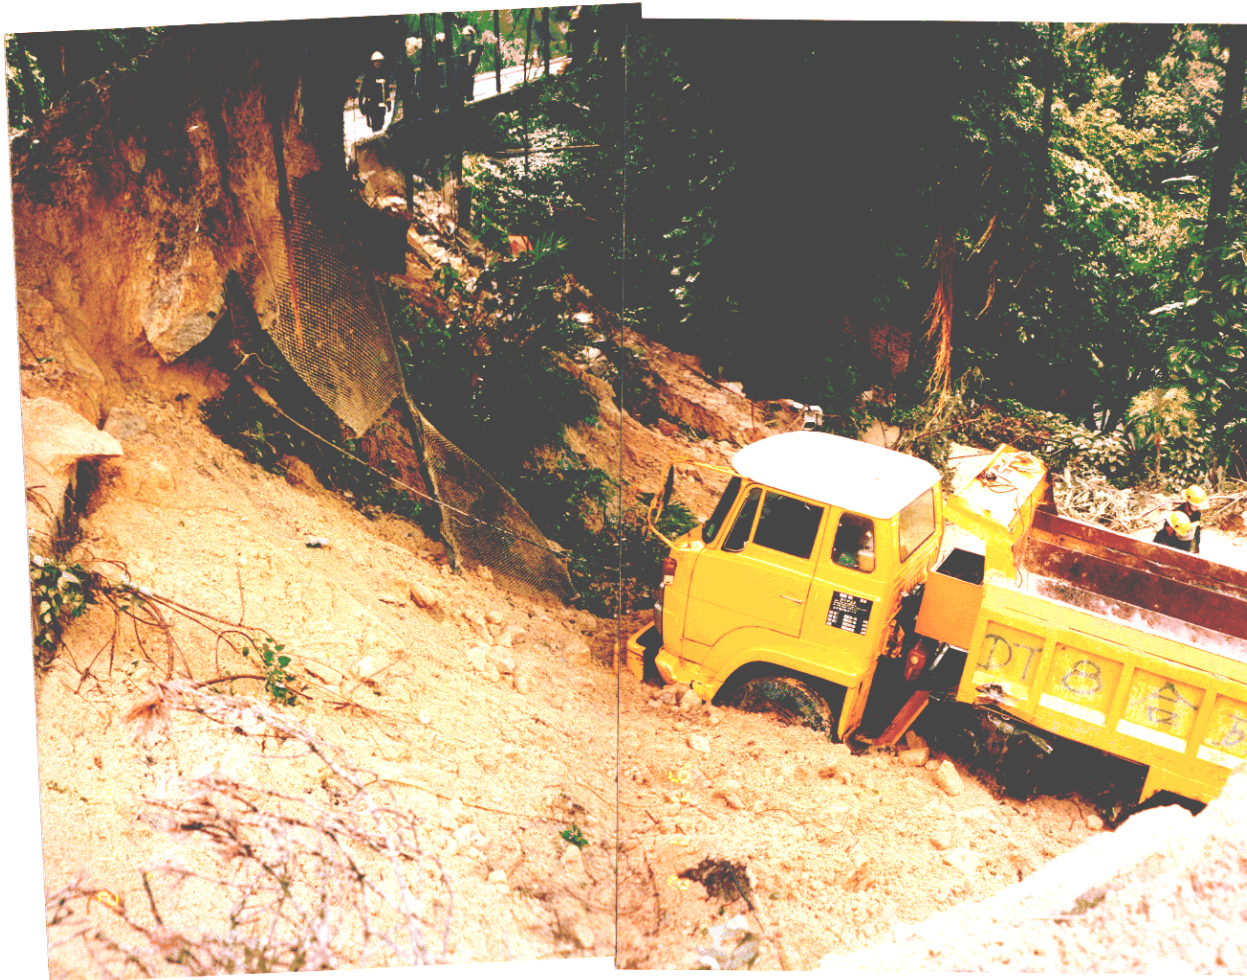
Plate 6 - View from the Elevated Road to No. 369 Riviera Apartments Showing the Dump Truck which was Carried by the Landslide down the Slope below Castle Peak Road (Photograph Taken on 2 July 1997)

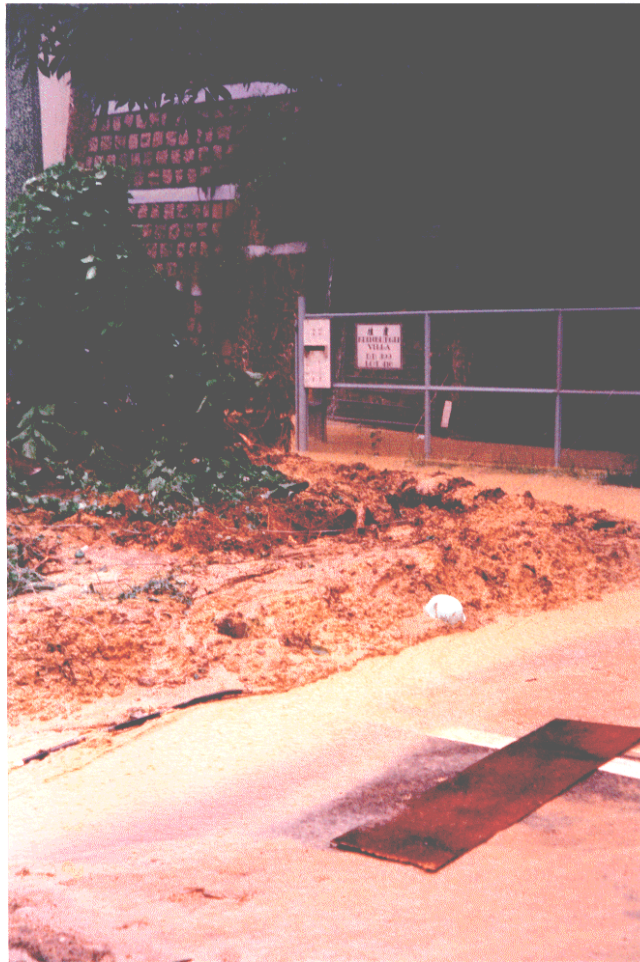
Plate 8 - View of the Landslide Debris on Castle Peak Road adjacent to No. 370 Edinburgh Villas (Photograph Taken on 2 July 1997)
(Note the Wet Condition and the Silt and Sand on the Surface of Castle Peak Road and Surface Water flowing around the Debris)

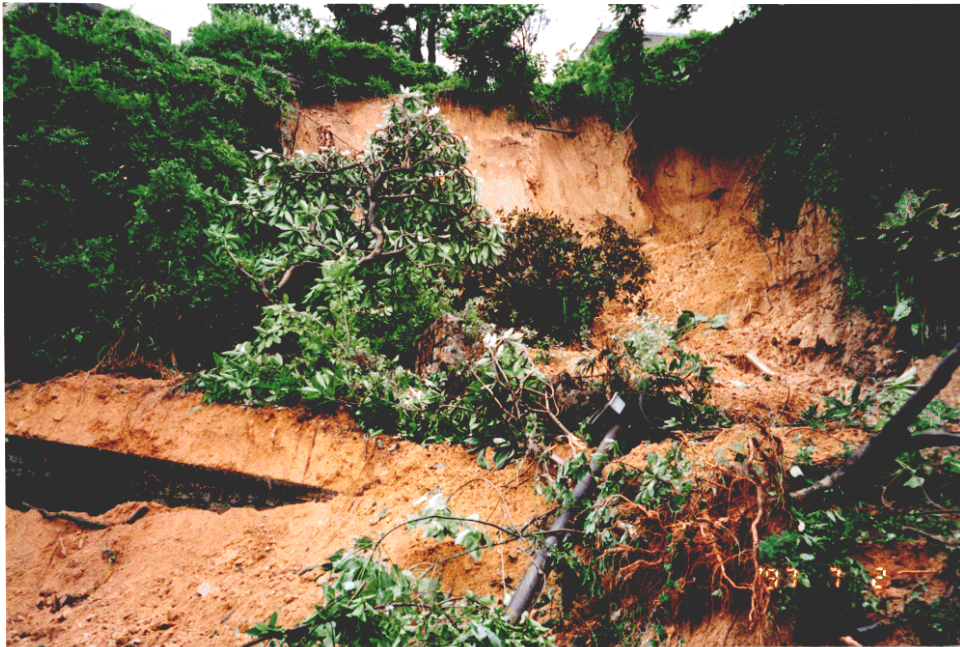
A severed 75 mm diameter steel pipe was observed at a depth of about 1.2 m below ground level, protruding from the fill near the centre of the main scarp (Plate 9). Immediately after the landslide this pipe was observed to be discharging water onto the debris below the main scarp. Observations made on 3 July 1997 (the day after the landslide) indicated that water discharge from the pipe had ceased. Contractors working for HyD reported that when they trimmed back the main scarp the pipe was found to be connected to the base of the swimming pool in the garden of Villa Mar. The swimming pool was subsequently removed during the trimming back of the main scarp.

Plate 9 - General View of the Main Landslide (Photograph Taken on
2 July 1997)
(Note the Drain Pipe from the Swimming Pool at the Crest of the
Slope discharging Water onto the Debris)
