**INVESTIGATION OF SOME
SELECTED LANDSLIDE
INCIDENTS IN 1997
(VOLUME 4)**

GEO REPORT No. 90

**SECTION 1:
DETAILED STUDY OF THE
LANDSLIDE AT
ST. JOSEPH'S ANGLO
CHINESE SCHOOL
NGAU TAU KOK
ON 3 AUGUST 1997**

**This report was originally produced in November 1998
as GEO Landslide Study Report No. LSR 17/98**

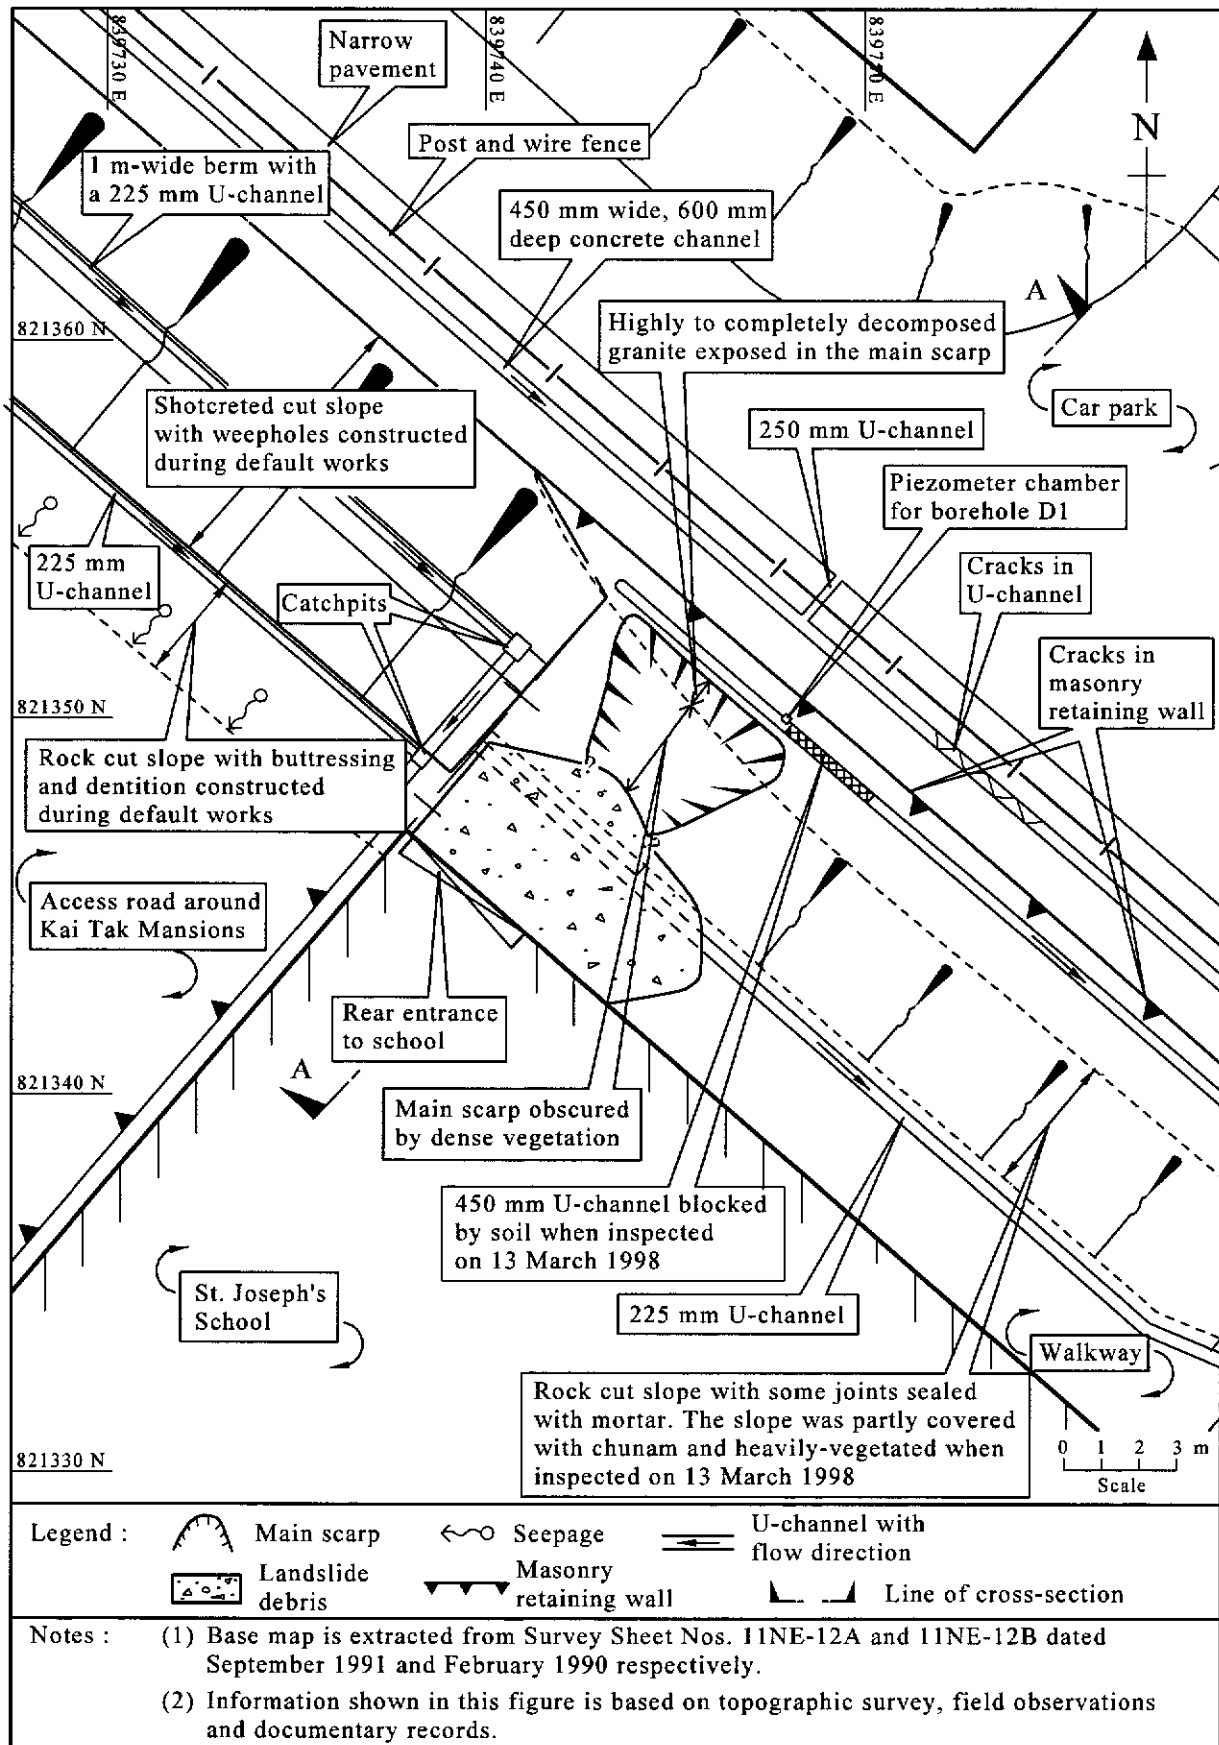
Figure 2 - Plan of the Landslide Site

Surface water run-off from the car park and grassed area at the southern corner of the upper platform drains southwest to a 450 mm concrete channel behind the masonry retaining wall. The channel was cracked in a number of places (Figure 2). The site inspection by HAP in March 1998 noted that the channel was partly blocked by vegetation causing localised ponding of water.

The masonry retaining wall was cracked at two locations (Figure 2). Immediately above the 1997 landslide site, there is a 1 mm- to 2 mm-wide open crack, the lower part of which had been partly covered over with shotcrete after the landslide (Plate 6). The second crack is located about 15 m along the wall from the failure (Plate 7). This crack is about 10 mm wide and the southeastern part of the wall had moved forward by about 10 mm. There is evidence of previous repairs to this crack.

A detailed plan of the landslide is shown in Figure 2 and a representative section through the landslide is presented in Figure 4. Photographs of the failure are shown in Plates 1 and 10.

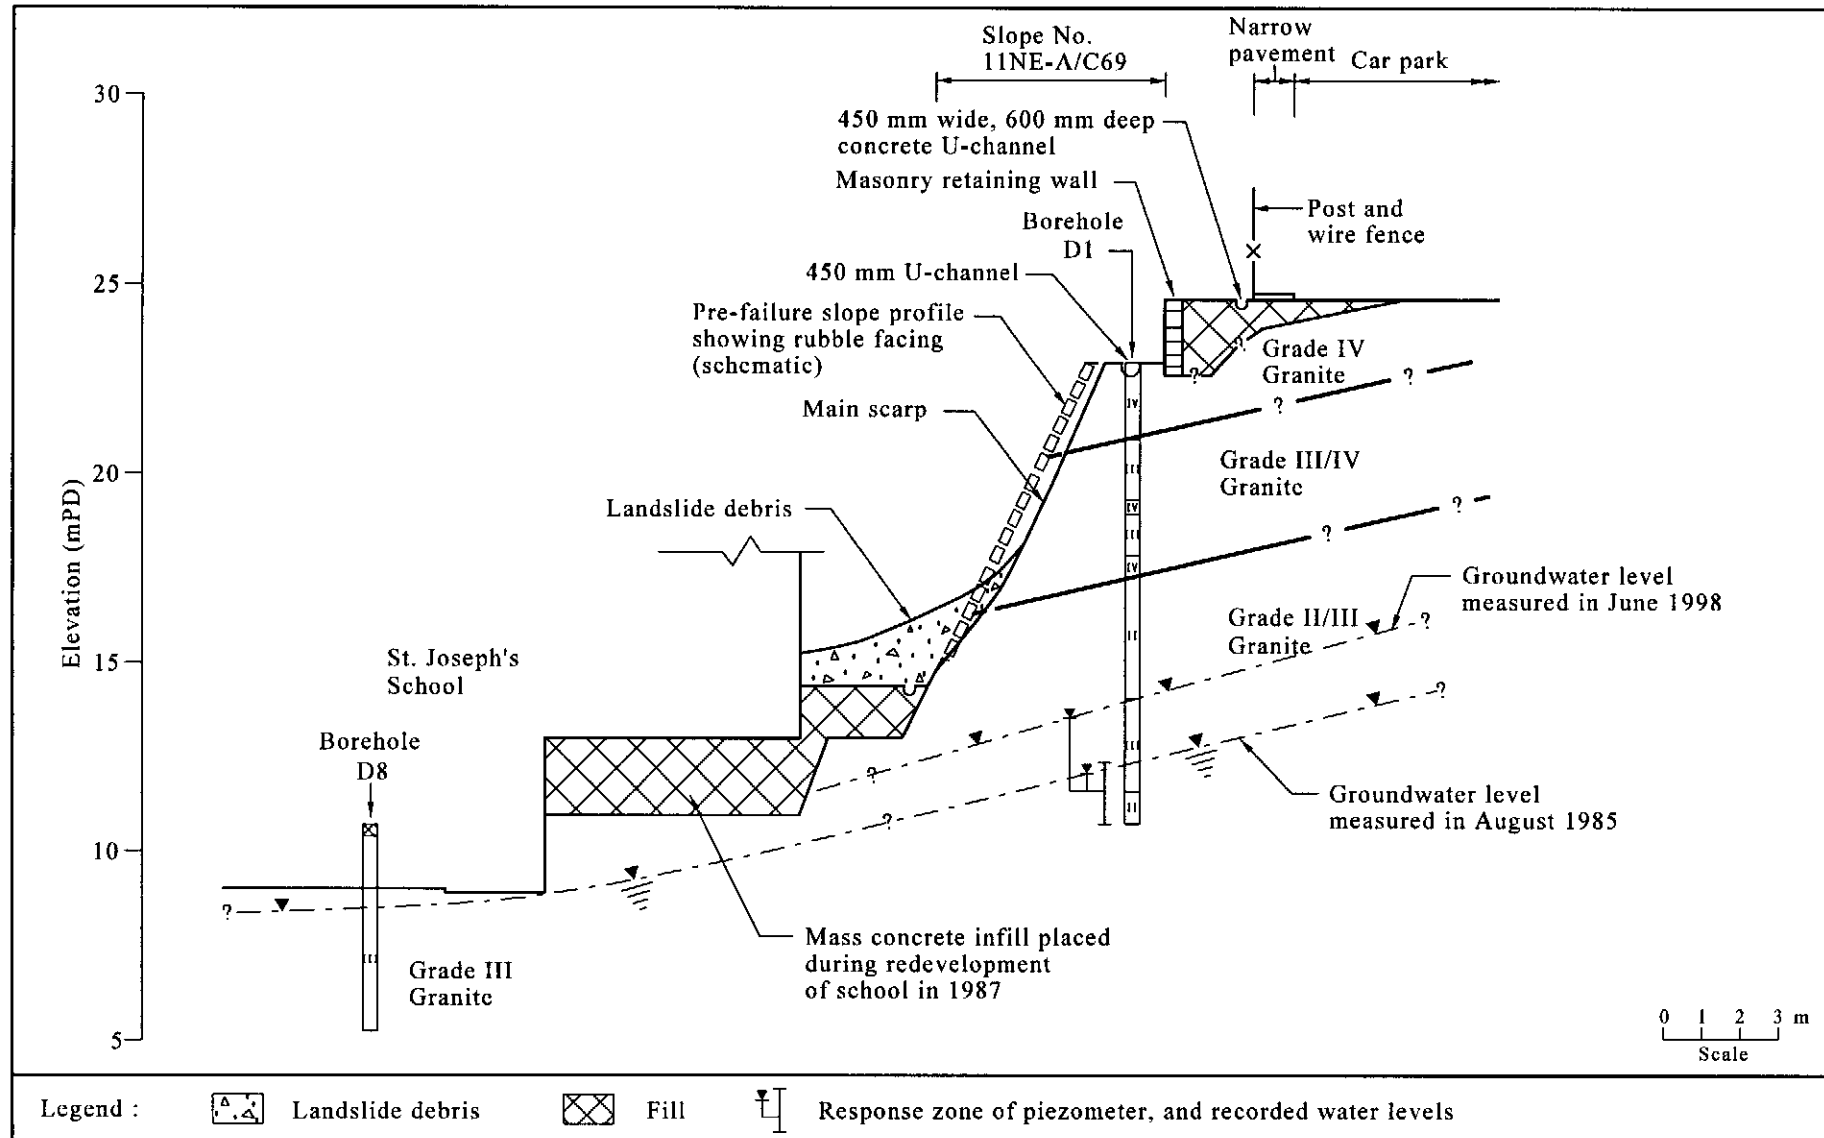
Figure 4 - Geological Cross-section A-A through the Landslide

A geological section specific to the location of the landslide (Figure 4) was prepared using information from borehole D1 and the report by MGS (1985). Borehole D1, located on the berm immediately upslope of the landslide, encountered about 2 m of highly decomposed granite, described as very dense pinkish yellowish brown silty sand with relict structure. Below this about 4 m of moderately decomposed granite with bands of highly decomposed rock was proved. The former, possibly corestones, was described as weak to moderately strong yellowish brown coarse-grained moderately decomposed granite. Between 5.7 m and 12 m below the berm, moderately to slightly decomposed granite was encountered. This material was described as strong mottled light grey and pink medium-grained closely to widely jointed slightly to moderately decomposed granite. The thickness of completely decomposed granite and highly decomposed granite increases to the northwest and southeast of borehole D1, possibly reflecting the differential weathering profile of the spur through which the slope was excavated.

Piezometers and standpipes were installed in both the superficial deposits and bedrock in boreholes D1 to D3, D5 and D6. The maximum water level measured between 12 and 31 August 1985 was about 13 mPD (MGS, 1985). The piezometer installed in borehole D1 was monitored on 11 June 1998, 2 days after a Black Rainstorm, and a water level of 14.1 mPD was recorded (Figure 4).

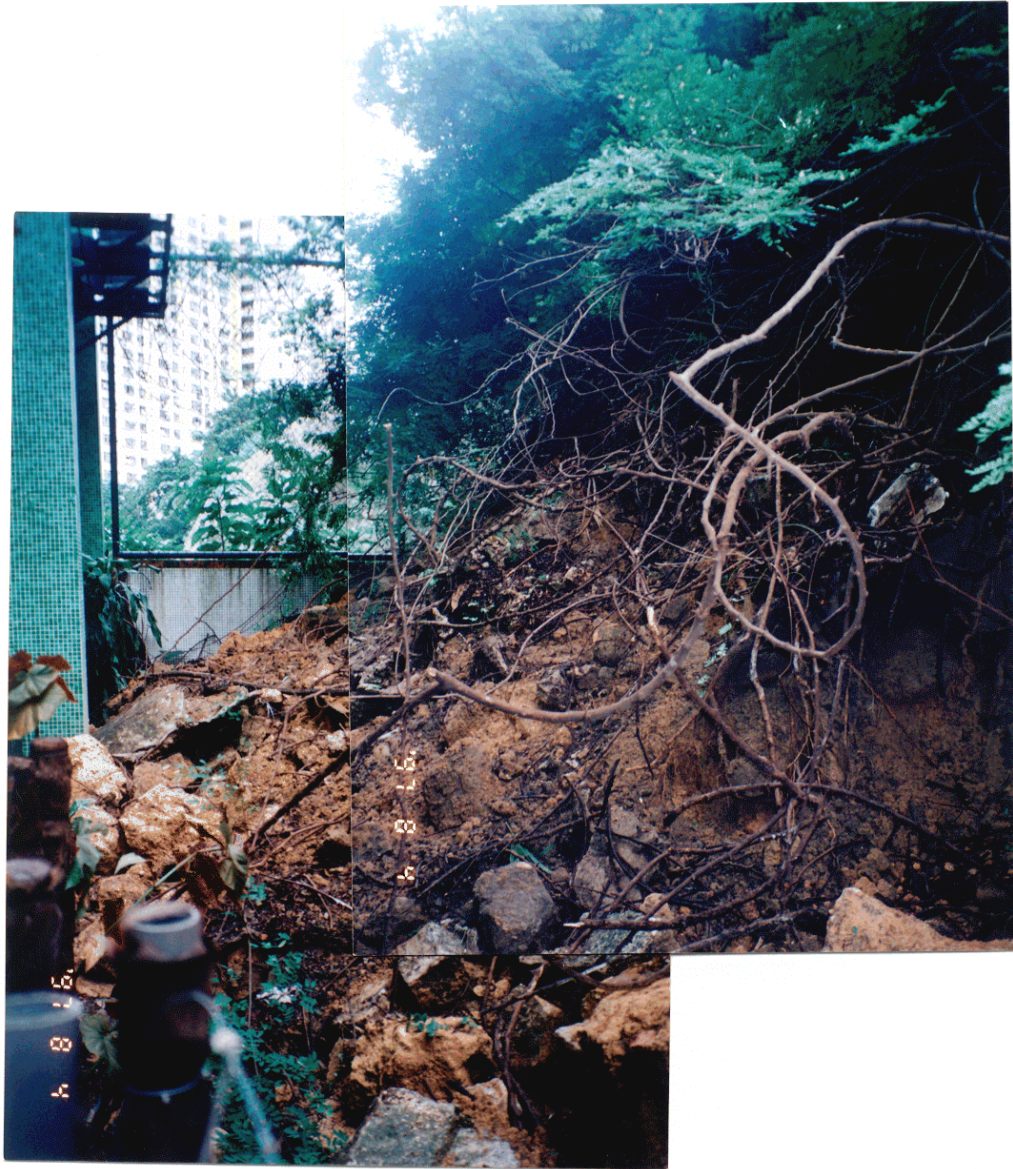
In the early morning of 3 August 1997, a landslide (GEO Incident No. K97/8/1) occurred on a soil/rock cut slope behind St. Joseph's Anglo Chinese School (hereafter referred to as St. Joseph's School), Kwun Tong Road, Ngau Tau Kok (Figure 1). The landslide involved the collapse of an old rubble face (stone pitching) and the soil behind. Debris from the landslide accumulated in a narrow walkway between the slope and the back of the school (Plate 1). No fatalities or injuries were reported.

The debris was deposited on the 4 m-wide yard at the back of the school and accumulated against the wall at the back of the school to a maximum height of about 1.5 m. It consisted of rubble blocks, weathered granite, chunam and vegetation. The travel angle of the debris could not be established because the debris was obstructed by the wall.

Plate 1 - Landslide Debris between the Slope and School Wall
(Photograph Taken on 4 August 1997)

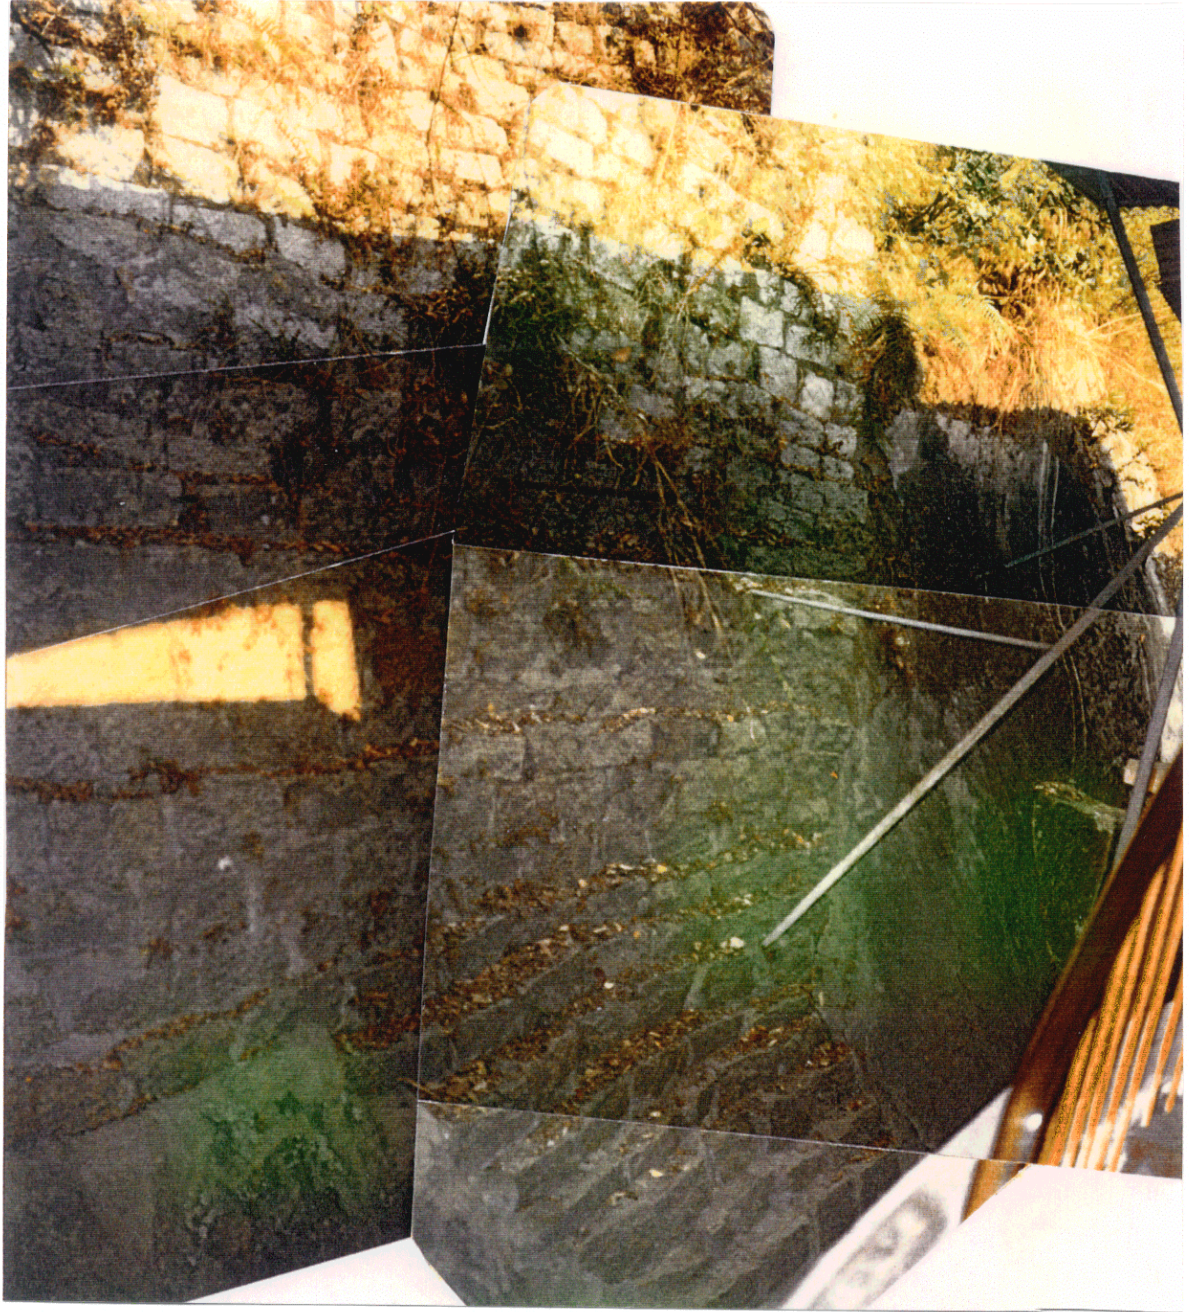
Plate 2 - View of the Rubble Facing before Redevelopment of
St. Joseph's School (Photograph Taken on 15 January 1986)

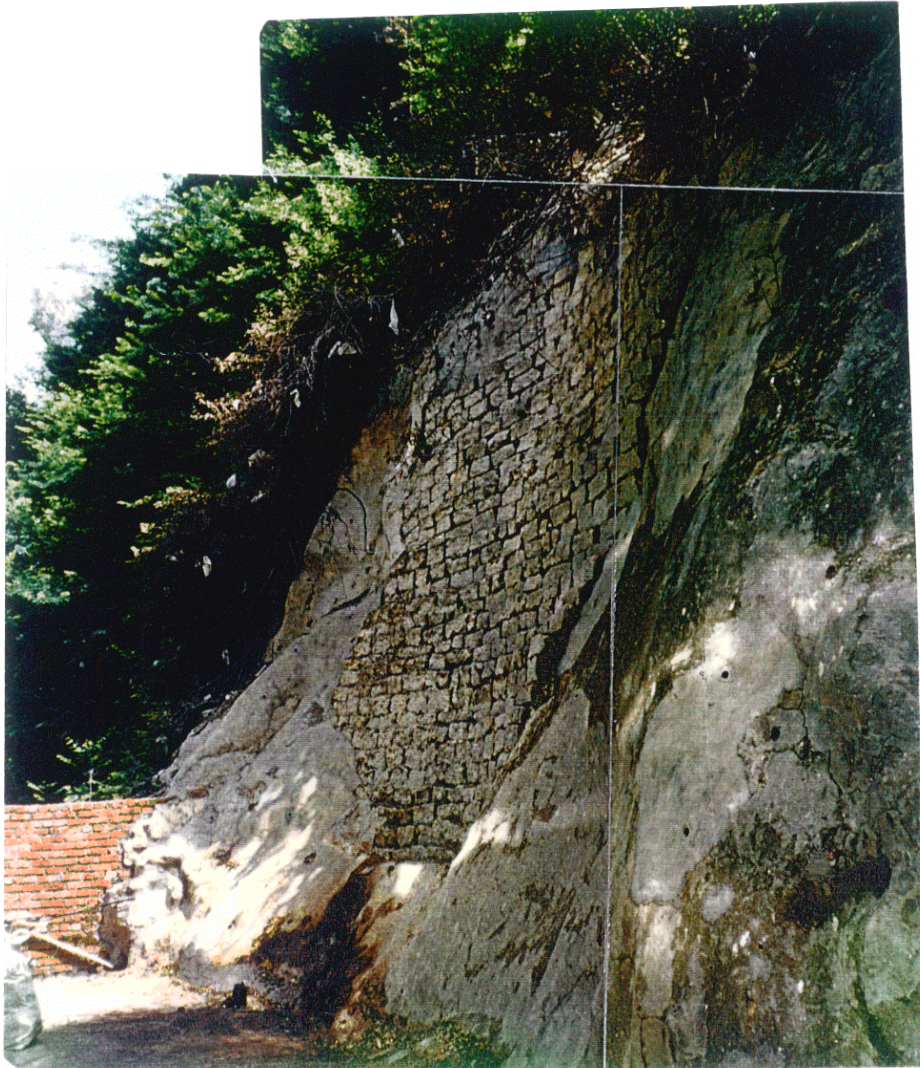
Plate 3 - View of the Rubble Facing during the Redevelopment of St. Joseph's School (Photograph Taken on 20 July 1987)

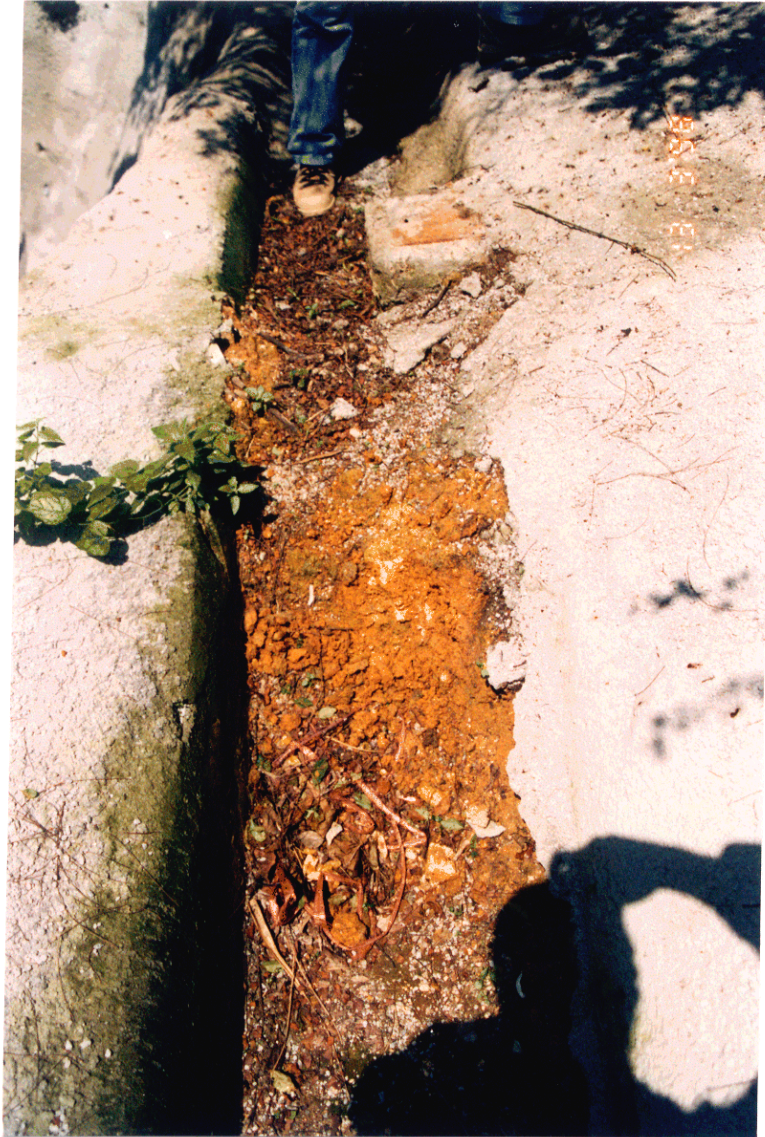
Behind St. Joseph's School, a 450 mm surface drainage U-channel directs water to the southeast along the crest of the slope in front of the masonry retaining wall. Site inspections by HAP in October 1997 and March 1998 noted that the drainage channel was partially blocked by a chamber housing a piezometer (Plate 4) and by soil and vegetation (Plate 5). Staff at the school reported that during heavy rainfall the U-channel often overflowed down the face of the slope.

The most likely source of water ingress was overflow from the blocked U-channel at the crest of the slope, due in part to the presence of a piezometer chamber and lack of maintenance. This would have led to surface infiltration through the crest area and open joints in the facing blocks. This is consistent with eye-witness reports of water flow down the face of the slope during periods of heavy rainfall (see Section 2.1). The infiltration probably resulted in saturation of the near-surface soils and the build-up of water pressure behind the facing, in turn leading to the failure.

Plate 4 - U-channel at the Crest of the Slope Blocked by a Piezometer Chamber and Soil (Photograph Taken on 13 March 1998)

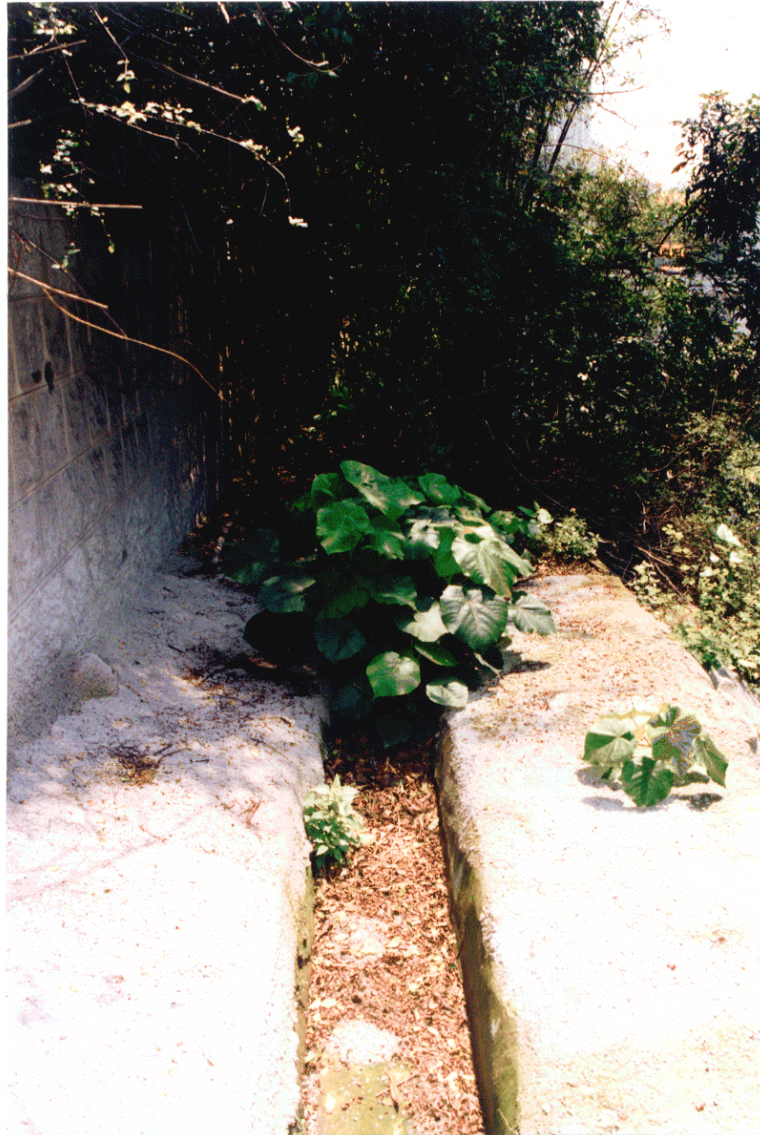
Plate 5 - U-channel at the Crest of the Slope with Infilling
of Vegetation (Photograph Taken on 13 March 1998)

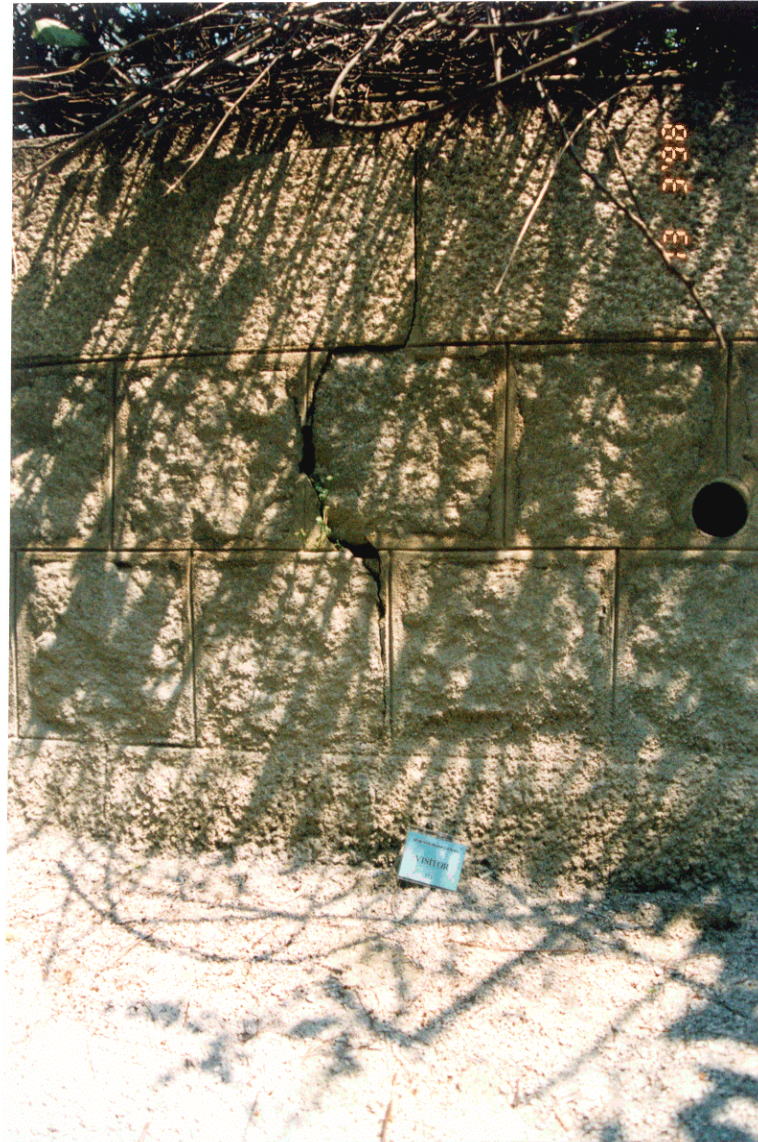
Plate 6 - Crack in the Retaining Wall above the Landslide
(Photograph Taken on 13 March 1998)

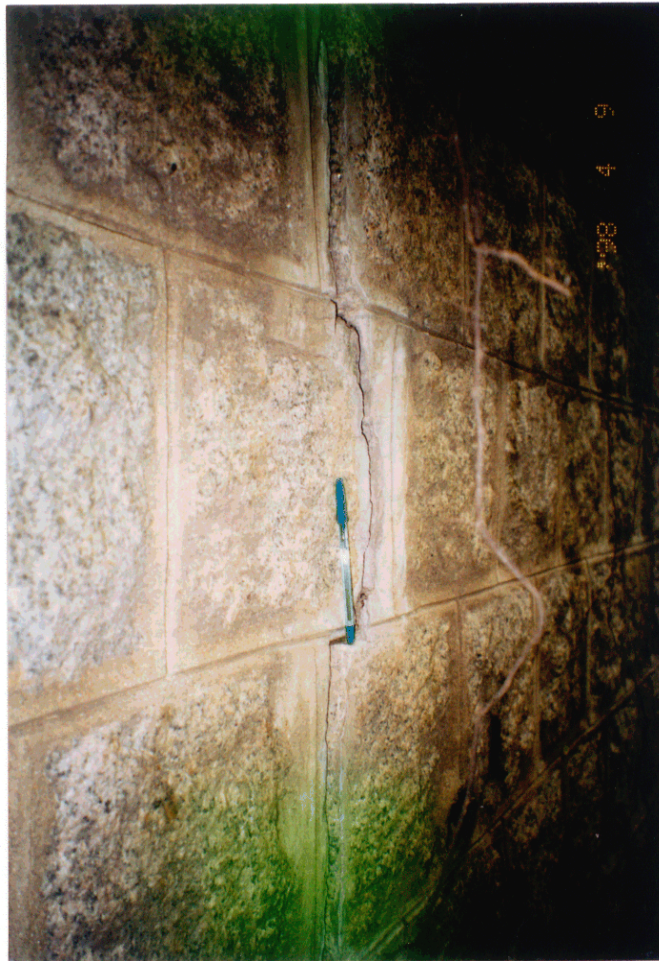
Plate 7 - Crack in the Retaining Wall about 15 m Southeast of the Landslide (Photograph Taken on 9 April 1998)

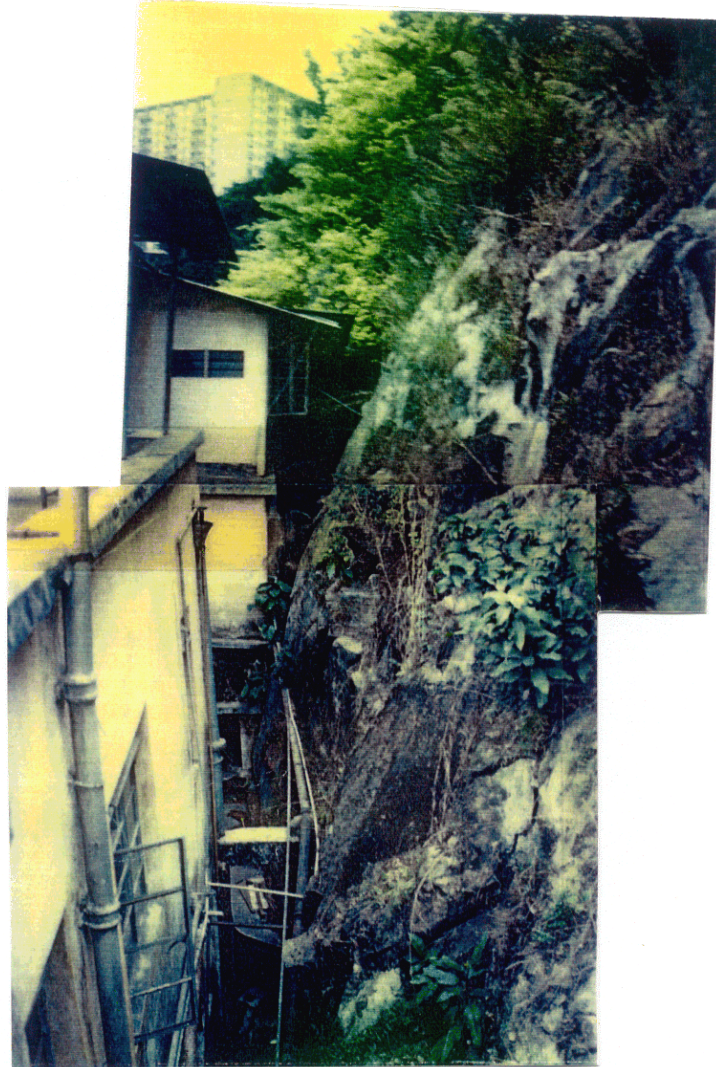
Photographs taken during 1985 show that one of the original buildings of St. Joseph's School was constructed directly against the lower 2 m to 3 m of the slope (Plate 8). The upper two thirds of the slope above the building was covered by a rubble facing. The surrounding cut slope was partly covered by chunam.

Plate 8 - View Showing Part of the Original St. Joseph's School Built Against the Base of the Slope Prior to the Redevelopment of the School (Photograph Taken on 22 August 1985)

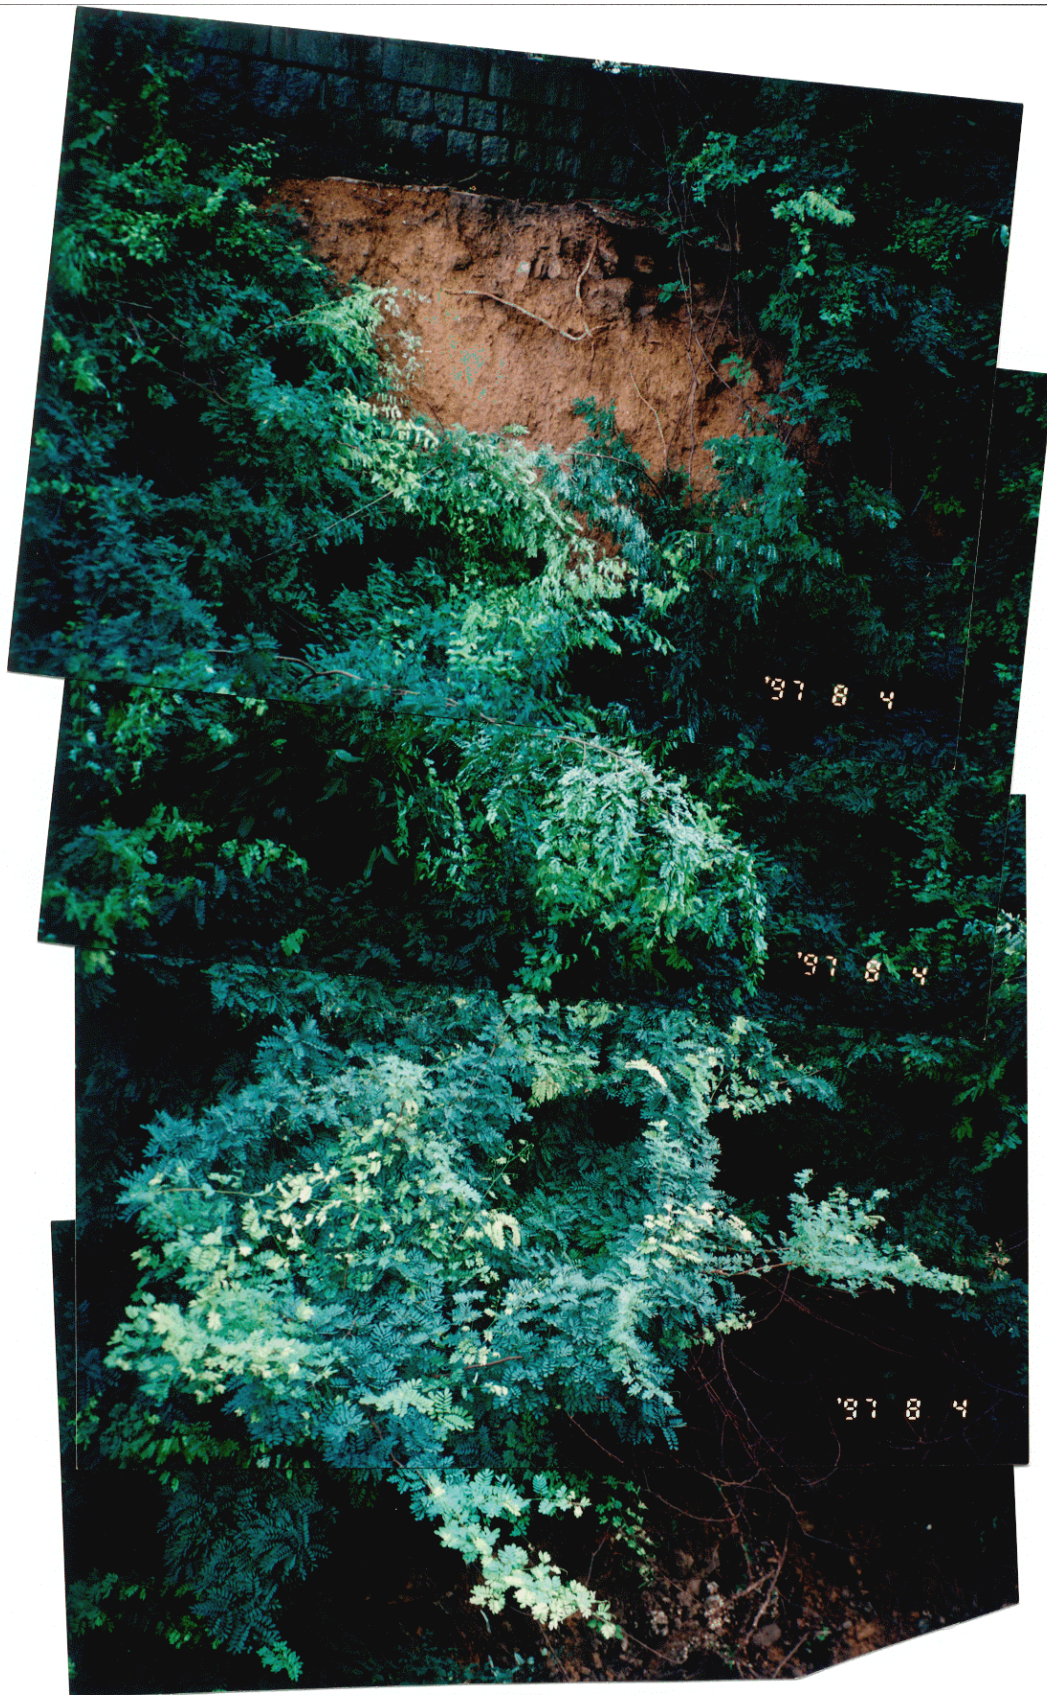
The landslide affected almost the full height of the cut slope. The main scarp was about 8 m long and 5 m wide. It was difficult to assess the depth of the landslide since the urgent repair works had already been completed by the Buildings Department before HAP inspected the site. Nevertheless the volume of the failed material was estimated to be about 25 m³.

The failure involved the collapse of the rubble facing covering a concavity within the slope. The failure surface extended from the U-channel on the crest to close to the toe of the slope. The main scarp, which was inclined at about 50° to 60° to the horizontal, exposed about 2 m of highly to completely decomposed granite at the crest whilst the remaining section of the scarp was obscured by dense vegetation (Plate 10). Although the northwest flank of the main scarp was concave, the southeast flank was generally planar, with a similar orientation to one of the major joint sets (dip/dip direction of 81°/293°). The granite blocks present within the debris were generally less than 400 mm thick. The location and shallow profile of the landslide together with the composition of the debris indicate that it was primarily the rubble facing that failed.

Plate 10 - General View of the Crest of the Landslide
(Photograph Taken on 4 August 1997)

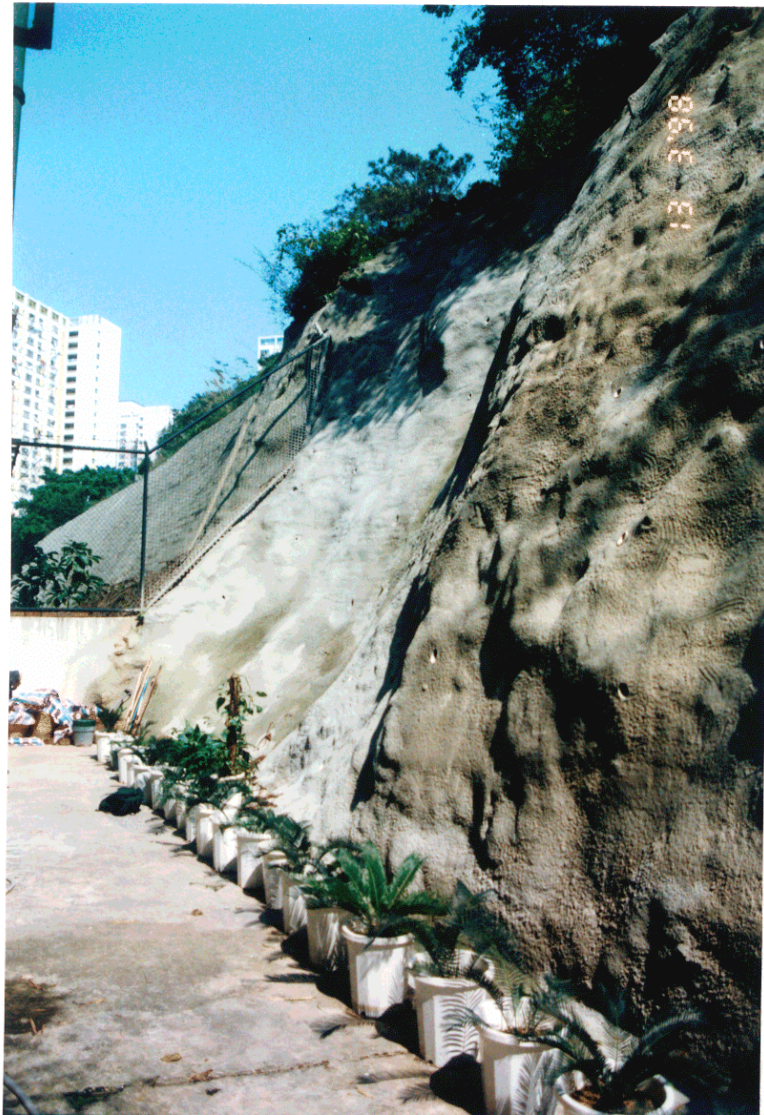
Plate 11 - View of the Slope after Completion of Urgent Repair Works
(Photograph Taken on 13 March 1998)

Following the landslide, the GEO recommended trimming the loose material from the failure scar, applying shotcrete cover and reconstructing the damaged surface U-channel at the crest of the slope. Plate 11 shows the slope after completion of the urgent repair works by the Buildings Department.
