**SECTION 4:  
DETAILED STUDY OF  
TWO LANDSLIDES  
AT KWAI CHUNG ROAD  
LAI KING  
ON 8 MAY 1997 AND  
4 JUNE 1997**

**Halcrow Asia Partnership Ltd**

**This report was originally produced in November 1998  
as GEO Landslide Study Report No. LSR 20/98**

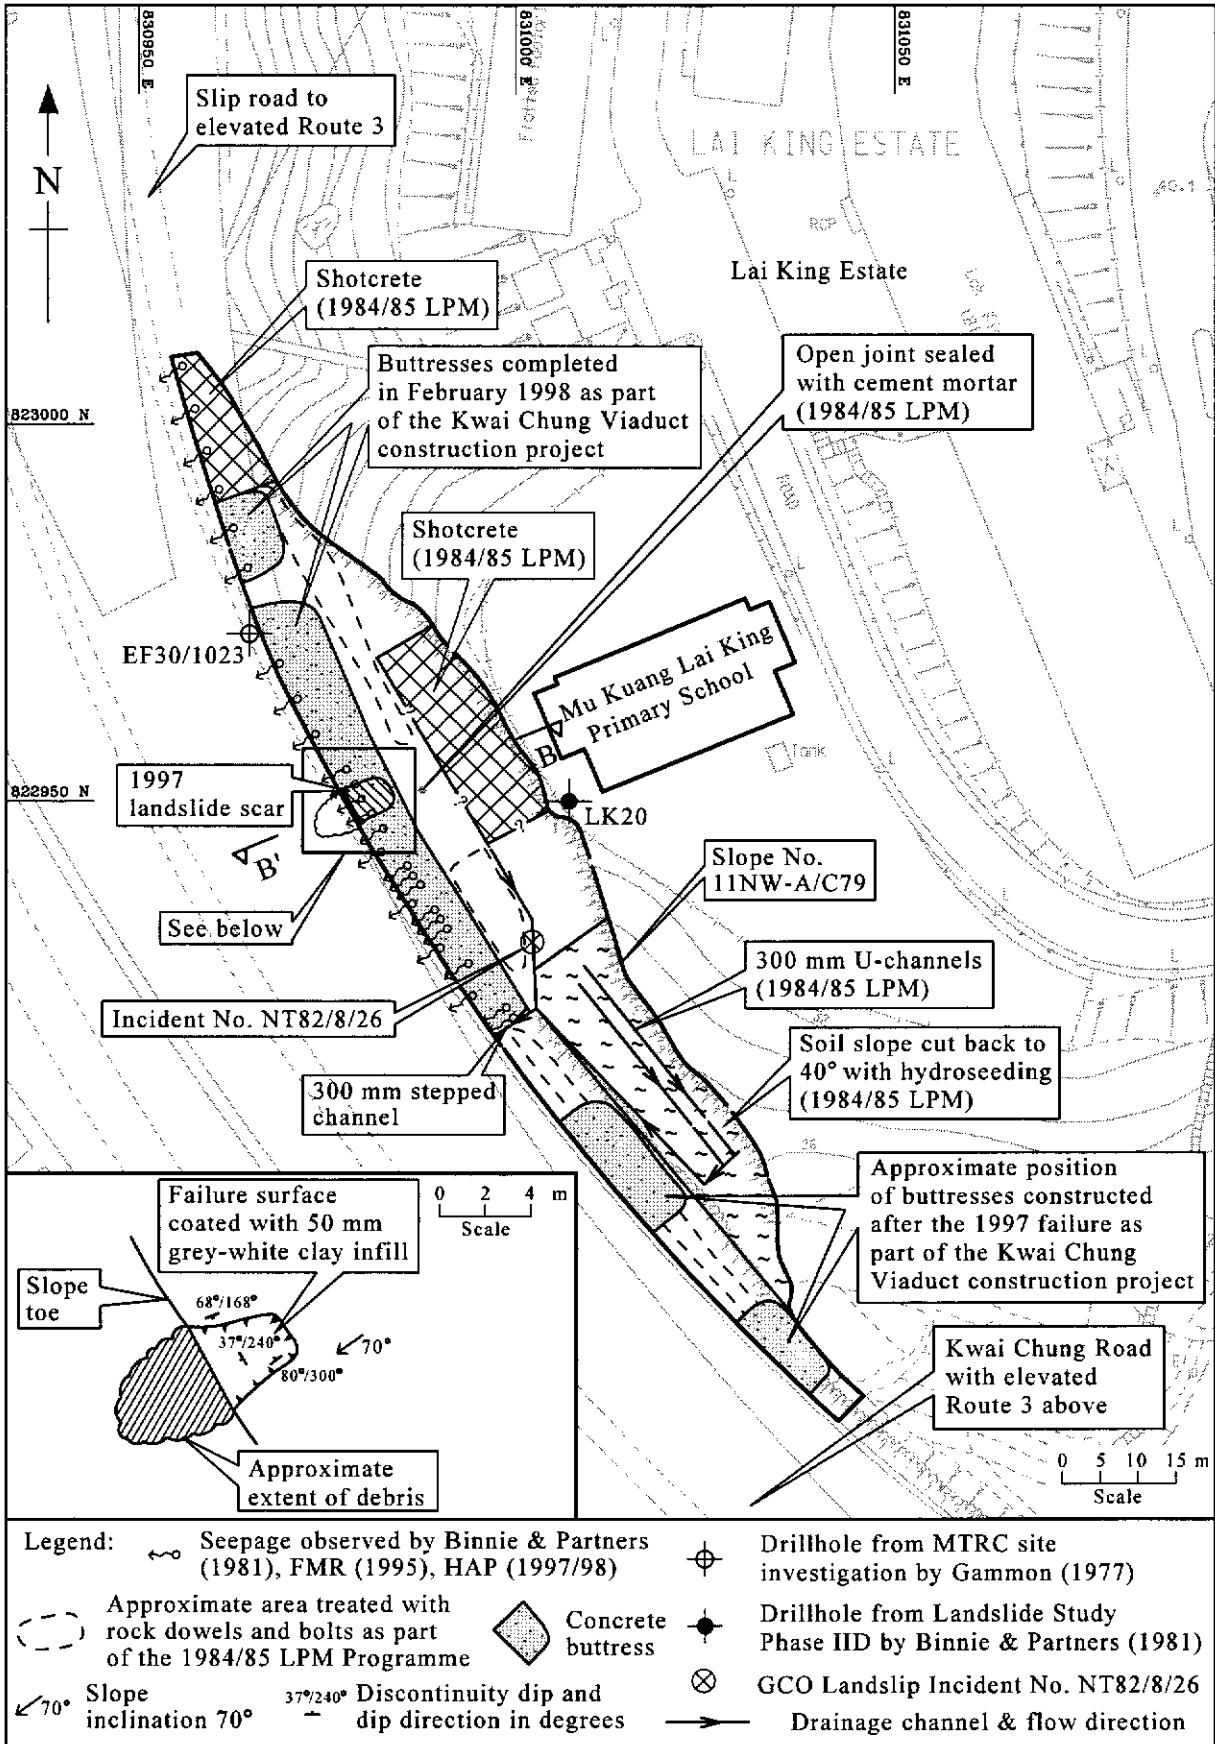
Figure 2 - Site Plan (GEO Incident No. MW97/5/6)

The locations of the landslides are shown in Figure 1. GEO Incident No. MW97/5/6 (Figure 2) occurred in the central part of a 170 m long soil/rock cut slope (No. 11NW-A/C79). The slope has a maximum height of about 28 m. The lower 16 m of the slope comprise predominantly bare rock, inclined at between 75° and 90° to the horizontal. The upper part of the slope is formed in soil and is inclined at about 40° to the horizontal. Its surface is

The cut slope was assessed in 1996 by consultants to HyD in association with construction of the Route 3 Kwai Chung Viaduct (Scott Wilson, 1996). As part of the investigation vegetation was cleared and an access scaffold erected to “more thoroughly investigate the condition of the rock slope and to carry out joint mapping”. Subsequently, “selective mapping of the rock joints was carried out” to identify “only (the) major (discontinuity) sets”. Stereographic analysis of the discontinuity data, assuming a friction angle of 39°, identified potential for “sliding and toppling failure” and concluded that remedial measures were necessary. Clay infill to discontinuities was not identified during the assessment by Scott Wilson. Proposed remedial works, which included construction of a buttress at the toe where the 1997 landslide occurred, were submitted in November 1996 and subsequently checked and approved by the GEO in February 1997. The remedial works were under construction at the time of the 1997 landslide, but the intended works had not been carried out at the actual location of the failure. Construction of the buttress, which would have supported the part of the slope that failed, was subsequently completed in February 1998 (Figure 2).

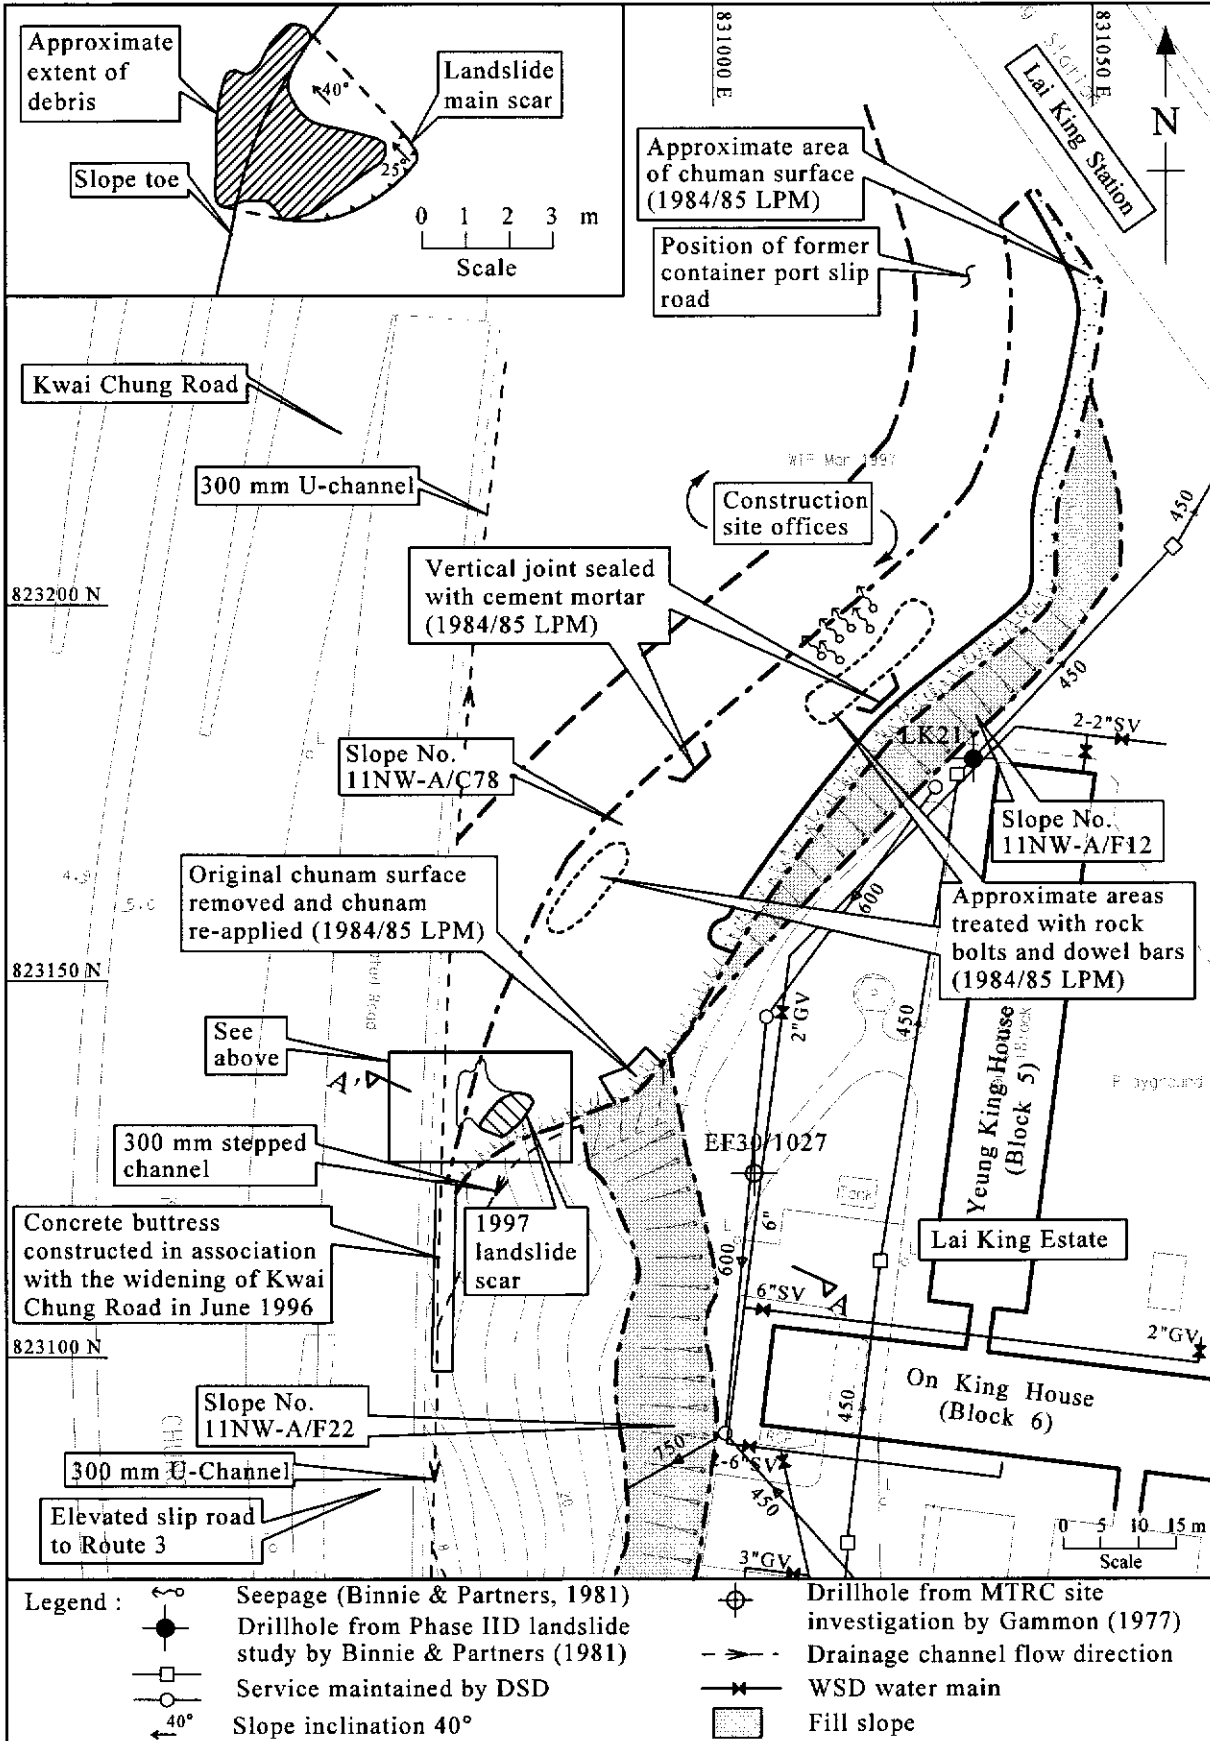
Figure 3 - Site Plan (GEO Incident No. MW97/6/21)

The landslide was located at the southern end of Slope No. 11NW-A/C78 (Figure 3). The failure occurred about 4 m above the toe of the slope and was 6 m wide, 5 m long and 1 m deep, with an estimated volume of about 15 m<sup>3</sup> (Plates 3 and 4). The debris accumulated on the open space at the toe of the slope adjacent to an access path (Plate 3).

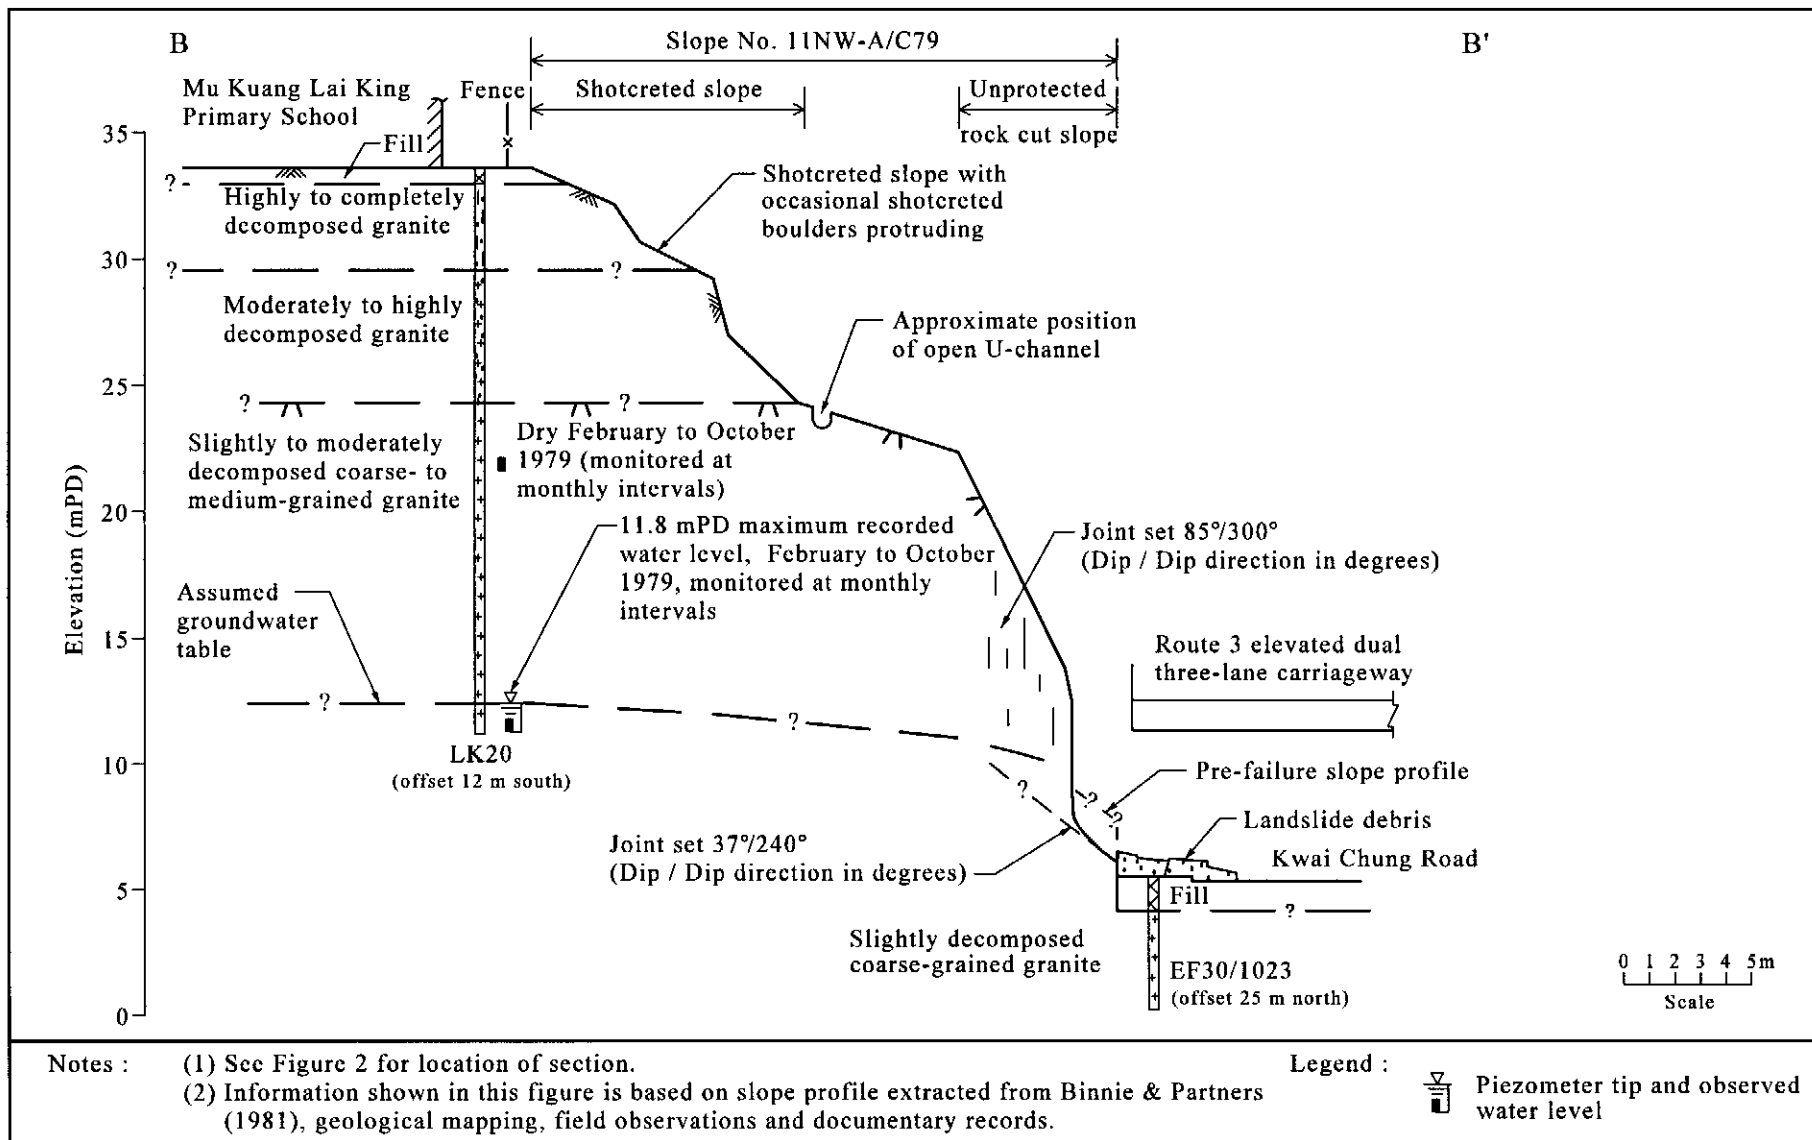
Figure 6 - Cross-section through the Landslide (GEO Incident No. MW97/5/6)

In May 1997 and February 1998, HAP inspected the slope and observed seepage from most of the weepholes in the buttress which was constructed following the landslide incident (see Section 2.3.1). Seepage stains and damp patches were noted on the buttress, up to 0.2 m above the toe of the slope. At the location of a 300 mm stepped-channel, 50 m south of the landslide scar (Figure 2), moderate seepage was also observed from the rock face, up to 3 m above the slope toe. An assumed groundwater table within the slope, based on piezometer data and recent seepage observations, is shown in Figure 6.

The landslide affected the lower rock slope portion of Slope No. 11NW-A/C79 adjacent to Kwai Chung Road. The base of the failure was about 1 m above the road level. The failure was 3 m wide, 5 m long and 1.5 m deep with an estimated volume of about 23 m<sup>3</sup>. The debris was deposited on the verge and partially blocked the inside lane of the Kowloon-bound carriageway of Kwai Chung Road (Figure 6 and Plate 1).

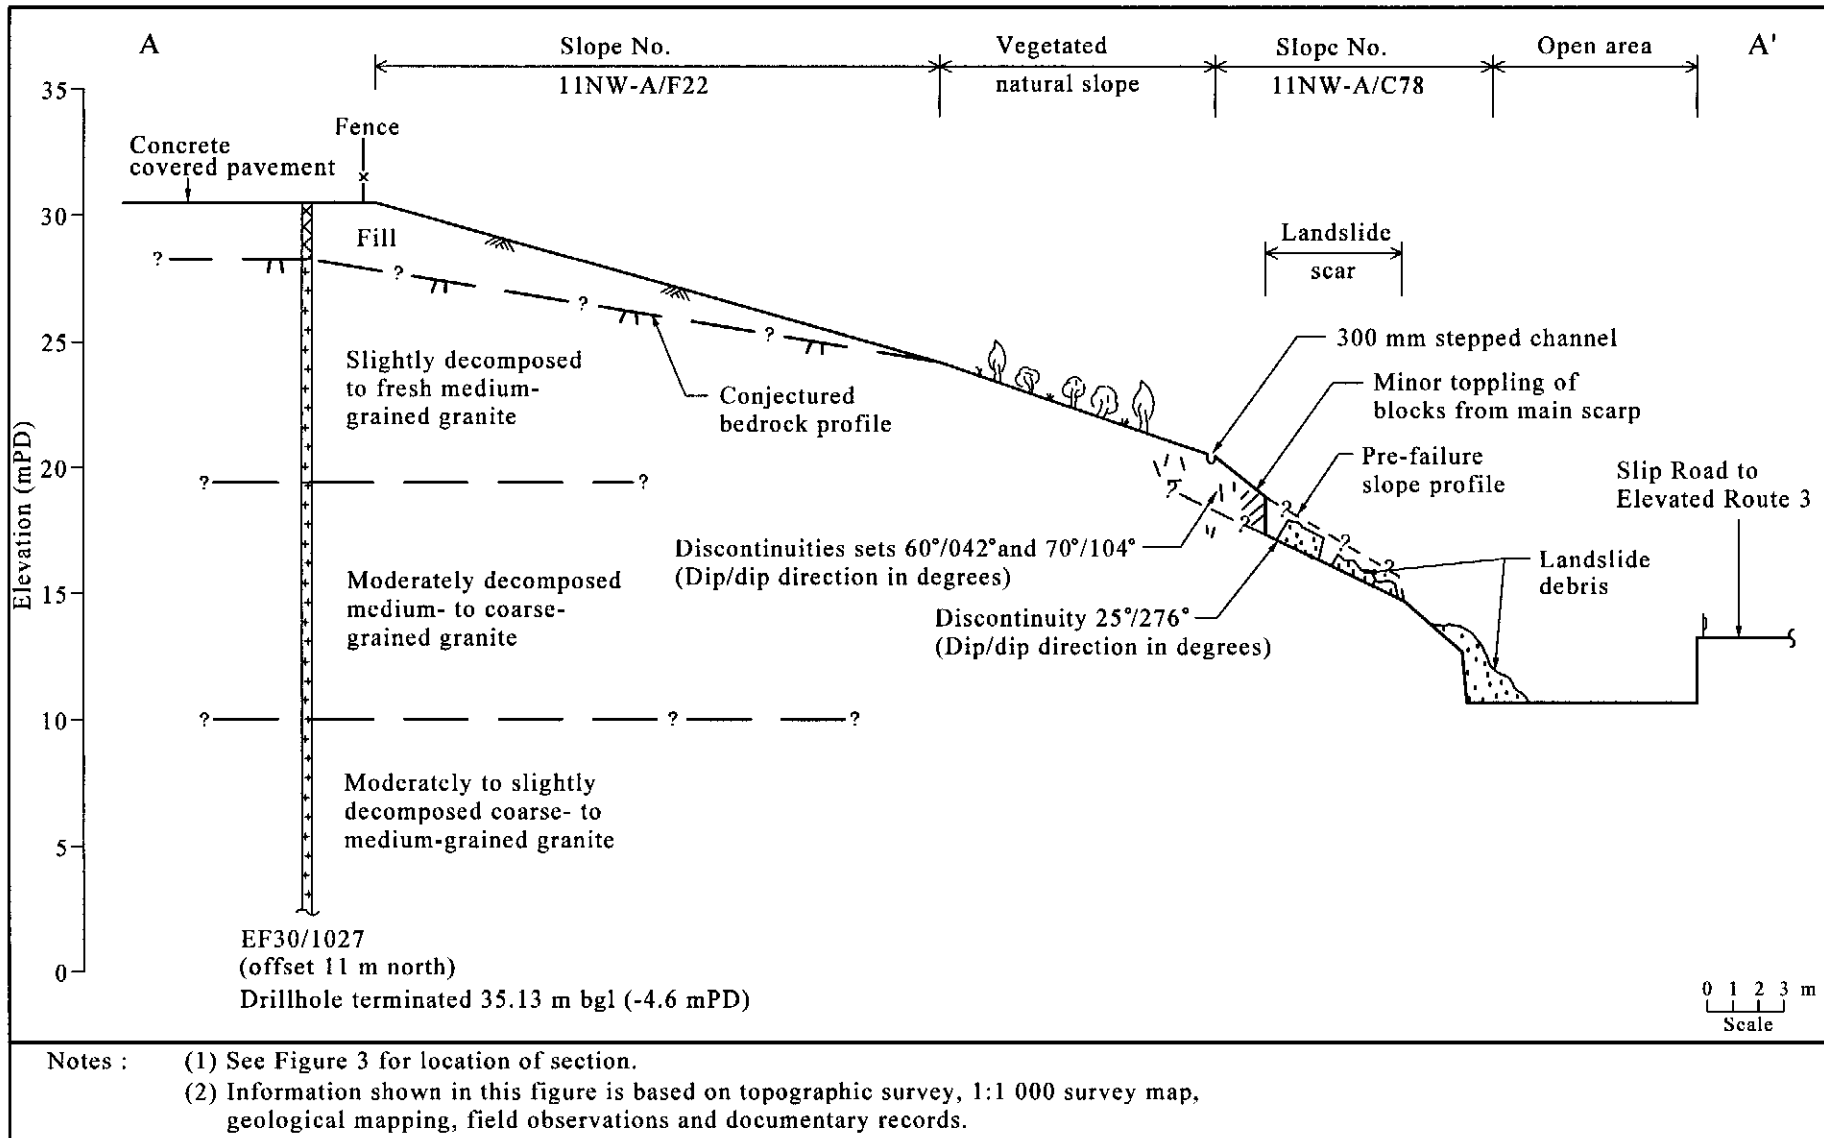
Figure 7 - Cross-section through the Landslide (GEO Incident No. MW97/6/21)

below (Figure 7 and Plate 5). Evidence of failure by minor toppling, controlled by the closely-spaced high-angled discontinuities, was apparent from the main scarp.

The landslide on Slope No. 11NW-A/C78 was located close to the crest of the rock slope (Figure 7). The absence of observed seepage on this part of the slope suggests that the base groundwater does not repeatedly rise to such elevations. It is more probable, therefore, that the landslide was caused by local development of transient water pressure on the clay-infilled basal discontinuity in response to infiltration of rainfall into the unprotected area upslope of the landslide site. The closely-spaced, high-angle discontinuities present behind the main scarp may have assisted the infiltration process. Water pressure in the discontinuities would have destabilised the rock mass, initiating detachment and sliding. Not all the blocks had sufficient momentum to reach the toe of the slope, possibly due to dissipation of water pressure during movement of the rock mass on a moderately steep ( $25^\circ$ ) sliding surface.

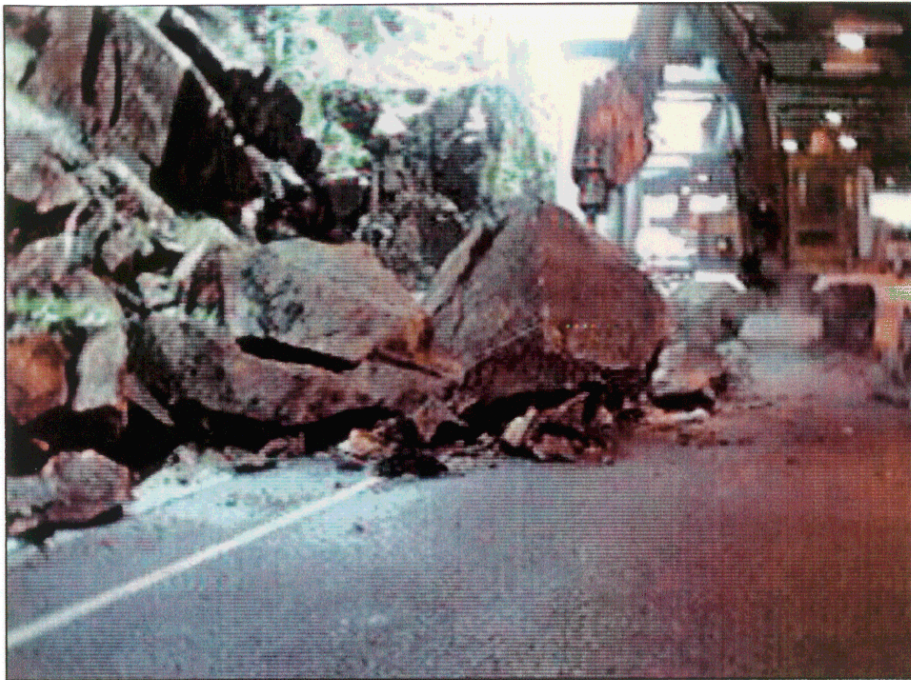
moderately to slightly decomposed granite. The debris comprised several large angular blocks in excess of 3 m<sup>3</sup> and numerous smaller-sized angular blocks (Plate 1).

Plate 1 - View to Southeast of Landslide Debris on the Kowloon-bound Carriageway of Kwai Chung Road, Incident No. MW97/5/6 (Photograph Taken on 8 May 1997)

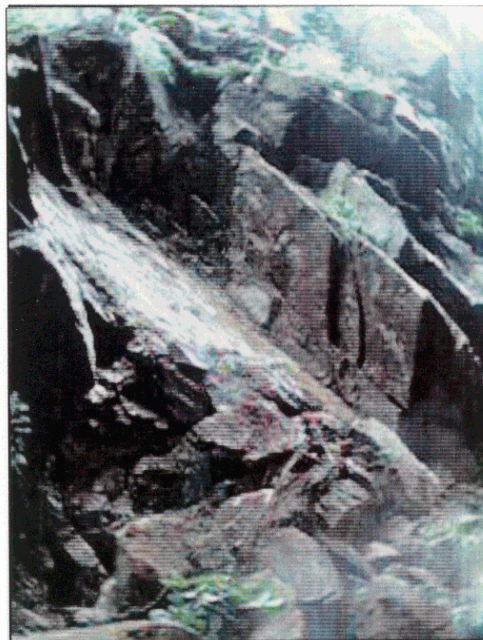
HAP observed three planar, clay-coated discontinuities at the location of the failure with dips and dip directions of  $37^{\circ}/240^{\circ}$ ,  $85^{\circ}/300^{\circ}$  and  $68^{\circ}/168^{\circ}$  (Plate 2). Loose blocks were evident on either side of the failure, with joint apertures of up to 50 mm. The lower slope face has an irregular and blocky appearance.

The location and shape of the basal failure surface was controlled by an adversely orientated discontinuity dipping at 37° with a dip direction of 240° (Plate 2). The discontinuity surface was coated with about 50 mm of soft white-grey clay. During the inspection by HAP on 8 May 1997, no seepage was observed on the failure surface, although in the vicinity of the failure there was seepage from similarly orientated discontinuities daylighting at about 0.5 m above the toe of the slope. The landslide probably occurred rapidly and involved sliding of the rock mass along the adversely orientated, clay-coated discontinuity.

Plate 2 - View to Southeast Showing the Failure Scar and Sliding Surface of Incident No. MW97/5/6 (Photograph Taken on 8 May 1997)

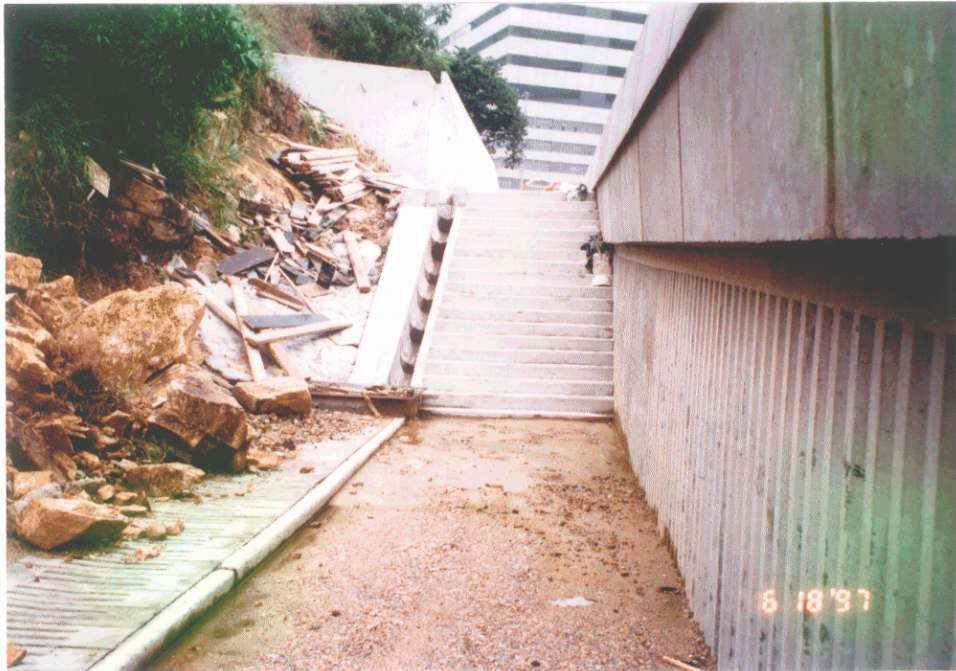
Plate 3 - View of Debris at Slope Toe from Incident No. MW97/6/21  
(Photograph Taken on 18 June 1997)

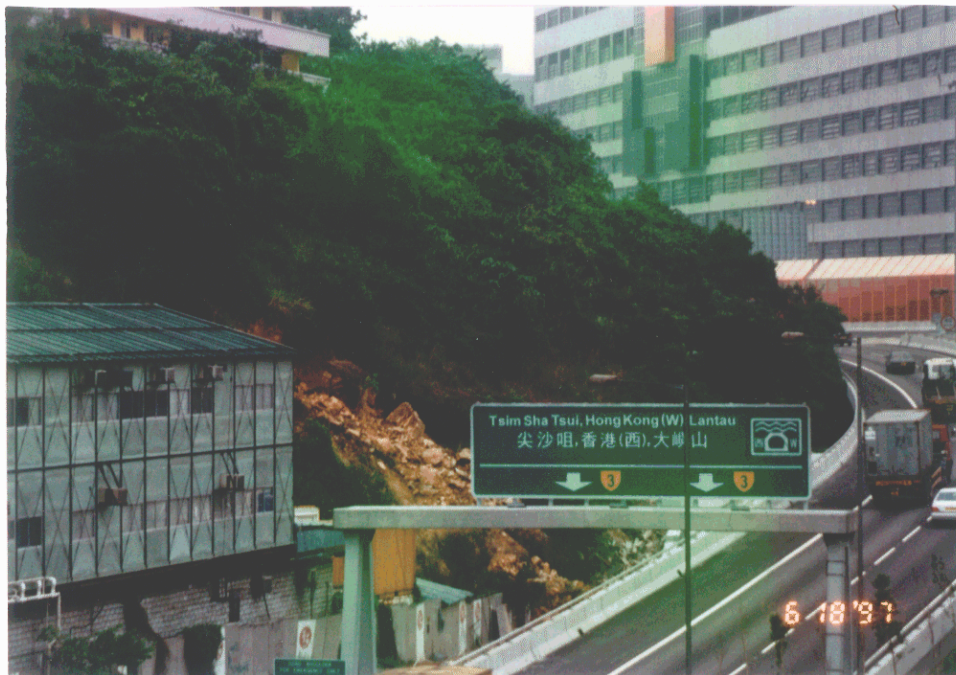
Plate 4 - General View to South Showing Incident No. MW97/6/21  
(Photograph Taken on 18 June 1997)

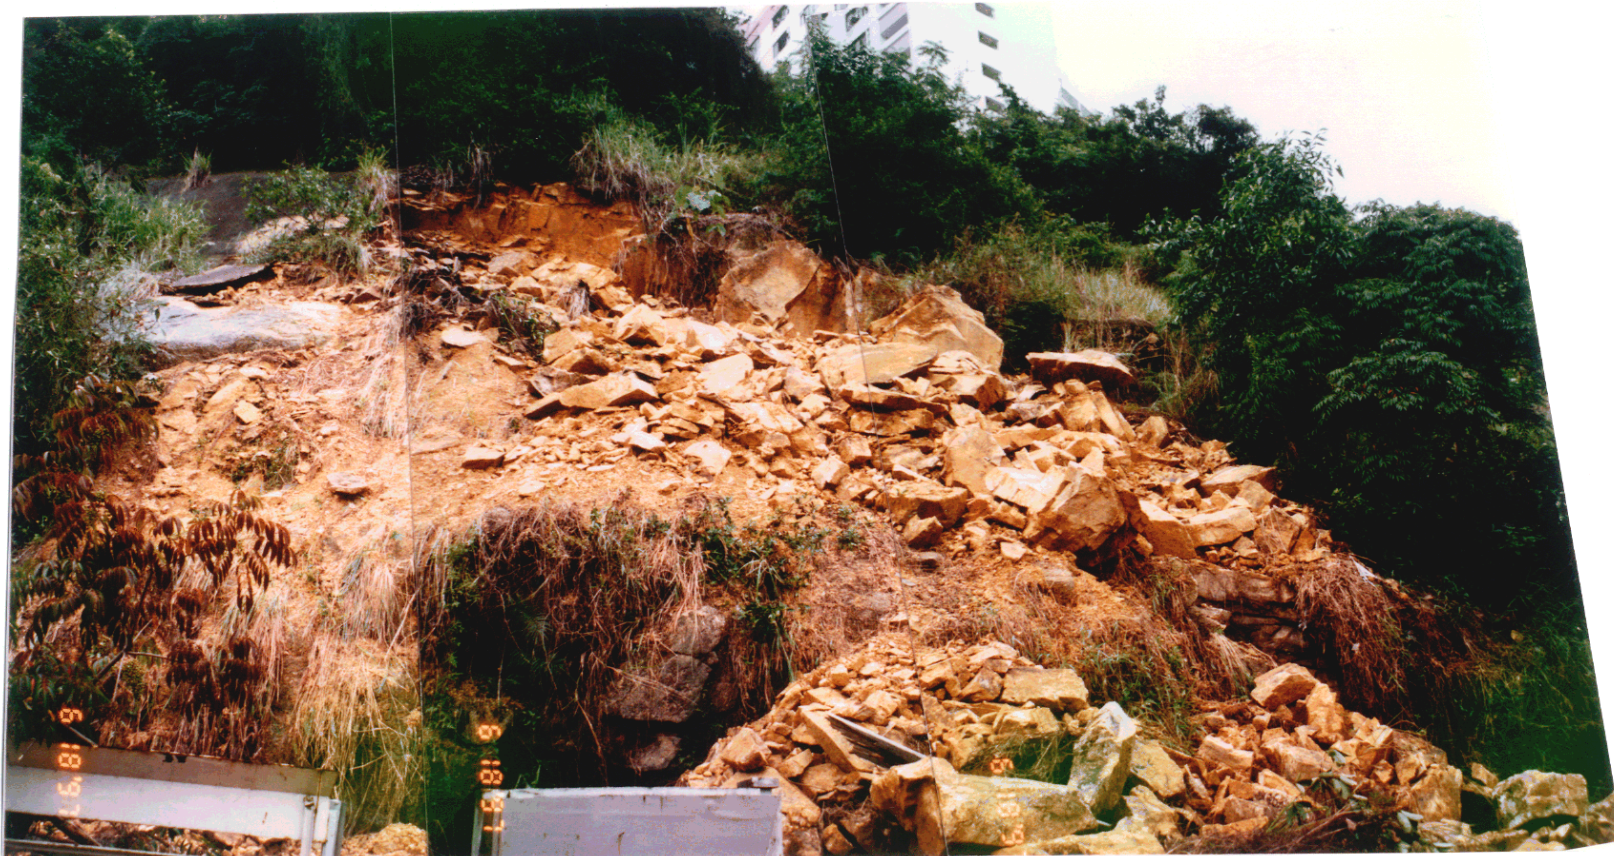
The landslide debris consisted of blocky moderately strong, medium-grained, moderately decomposed granite, with individual block sizes of less than 1 m<sup>3</sup> (Plate 5).

The landslide probably occurred rapidly and involved sliding of detached rock blocks over a basal discontinuity dipping at 25°, which had a coating of clay-rich material up to about 20 mm thick. Other discontinuities along the southern flank and main scarp of the failure facilitated the detachment of further material. Following sliding, the outermost detached blocks fell over the 2 m high near-vertical face at the toe of the slope and onto the open space

Plate 5 - Detailed View of Incident No. MW97/6/21 (Photograph Taken on 18 June 1997)
