INVESTIGATION OF SOME SELECTED LANDSLIDE INCIDENTS IN 1997 (VOLUME 5)

GEO REPORT No. 91

**SECTION 1:
DETAILED STUDY OF THE
LANDSLIDE AT
HONG TSUEN ROAD,
SAI KUNG
ON 3 JULY 1997**

**This report was originally produced in December 1998
as GEO Landslide Study Report No. LSR 21/98**

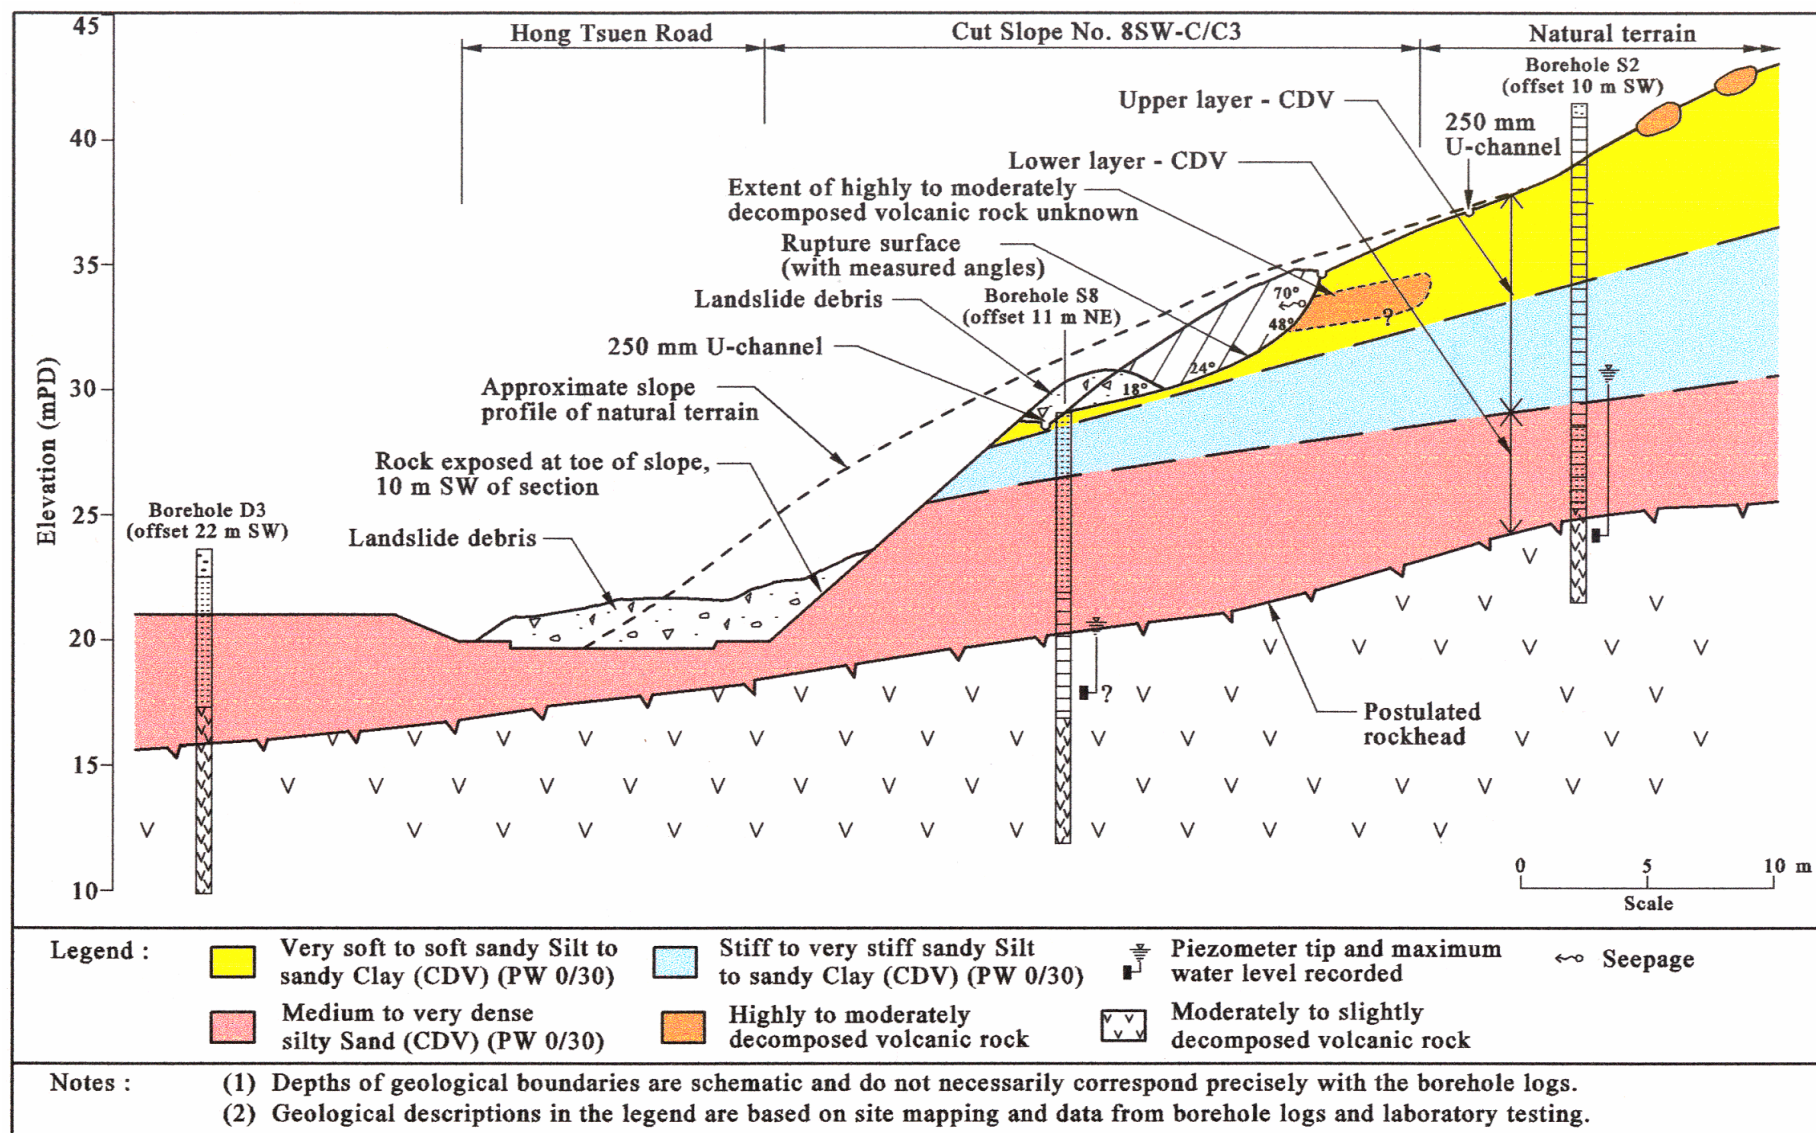
Figure 4 - Geological Cross-section through the Landslide

Monitoring of piezometers continued and in June 1982 WSA "re-examined the stability of Section Q1-Q1" through Slope No. 8SW-C/C3, following a recorded rise of about 4 m in a piezometer installed in a borehole on Slope No. 8SW-C/C86, about 250 m to the southeast of the 1997 landslide site (Figure 1). They concluded, "there is some doubt as to the stability of the slope". An existing piezometer in borehole S2 had been damaged and WSA recommended to the Junk Bay Development Office (JBDO) that "it would be advisable to install a new piezometer". In September 1982 a piezometer was installed at a depth of 11.2 m (one metre above rockhead) in borehole S8 on the first berm (Figures 3 and 4).

There have been four ground investigations in the vicinity of the slope (Gammon, 1979; WSA, 1980; Gammon, 1981 and Gammon, 1987). Four boreholes and one trial pit are of relevance (Figure 3). HAP has used information from these investigations and site observations to prepare a geological section (Figure 4).

Stability analyses were carried out to assess the possible range of shear strengths and groundwater pressures that may have been operational at the time of failure. The cross-section through the landslide, on which stability analyses were carried out using the rigorous method of Morgenstern and Price (1965), is presented in Figure 11. The pre-failure profile was established from topographical survey plans and the geometry of the failure surface was based on site measurements made by HAP (Figure 4).

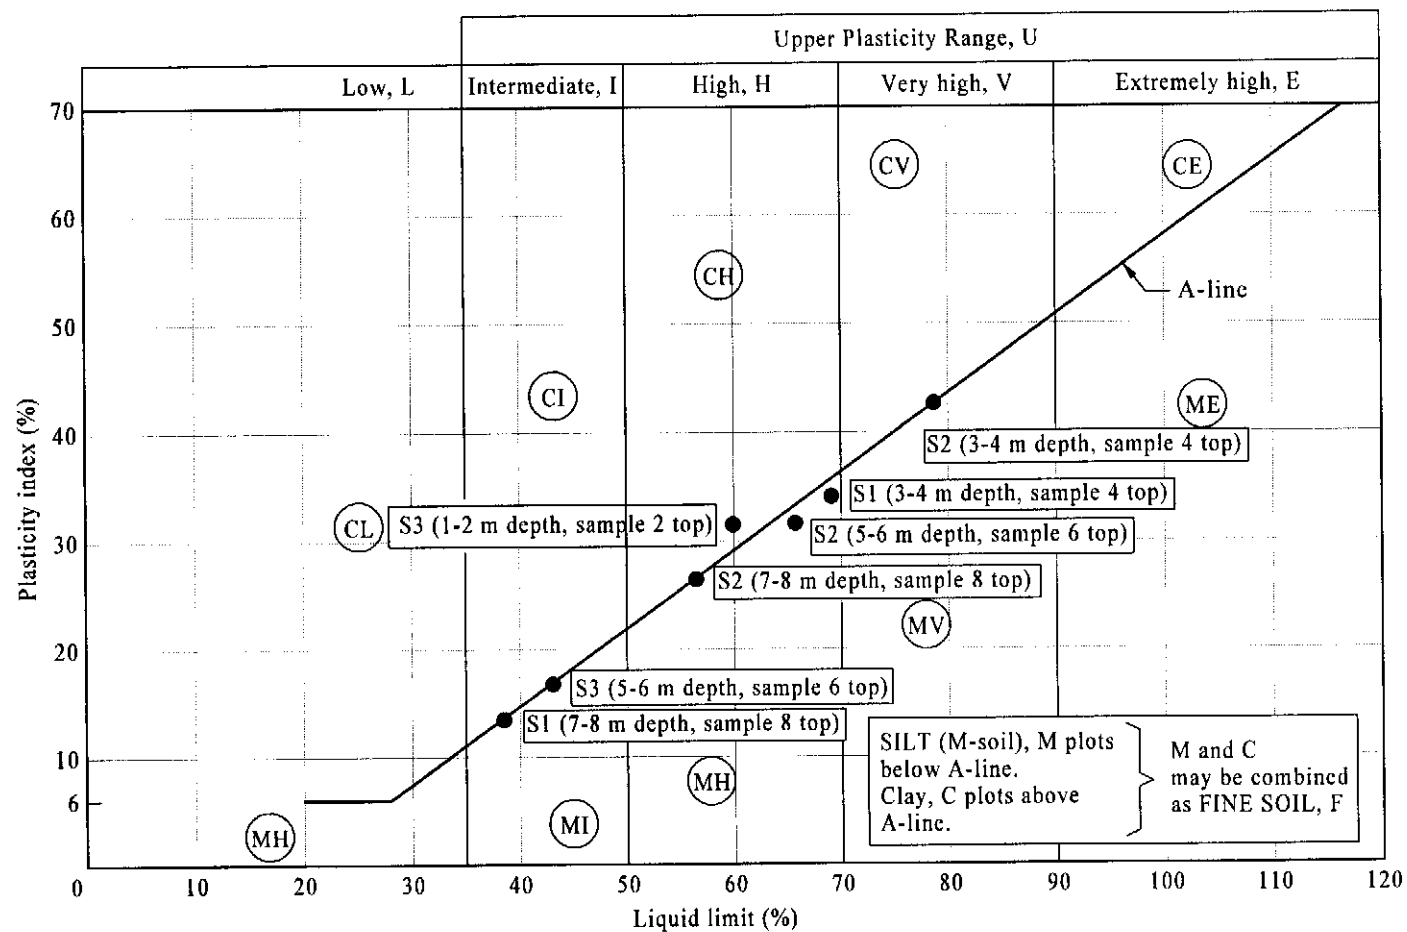
Figure 5 - Results of Soil Classification Tests in Accordance with the Standard Plasticity Chart of Geoguide 3 (GCO, 1988)

The results of Atterberg limit tests (WSA, 1980) on samples from the upper layer are plotted on the standard plasticity chart given in Geoguide 3 (GCO, 1988) in Figure 5. The failure occurred entirely within this upper layer of clay-rich CDV.

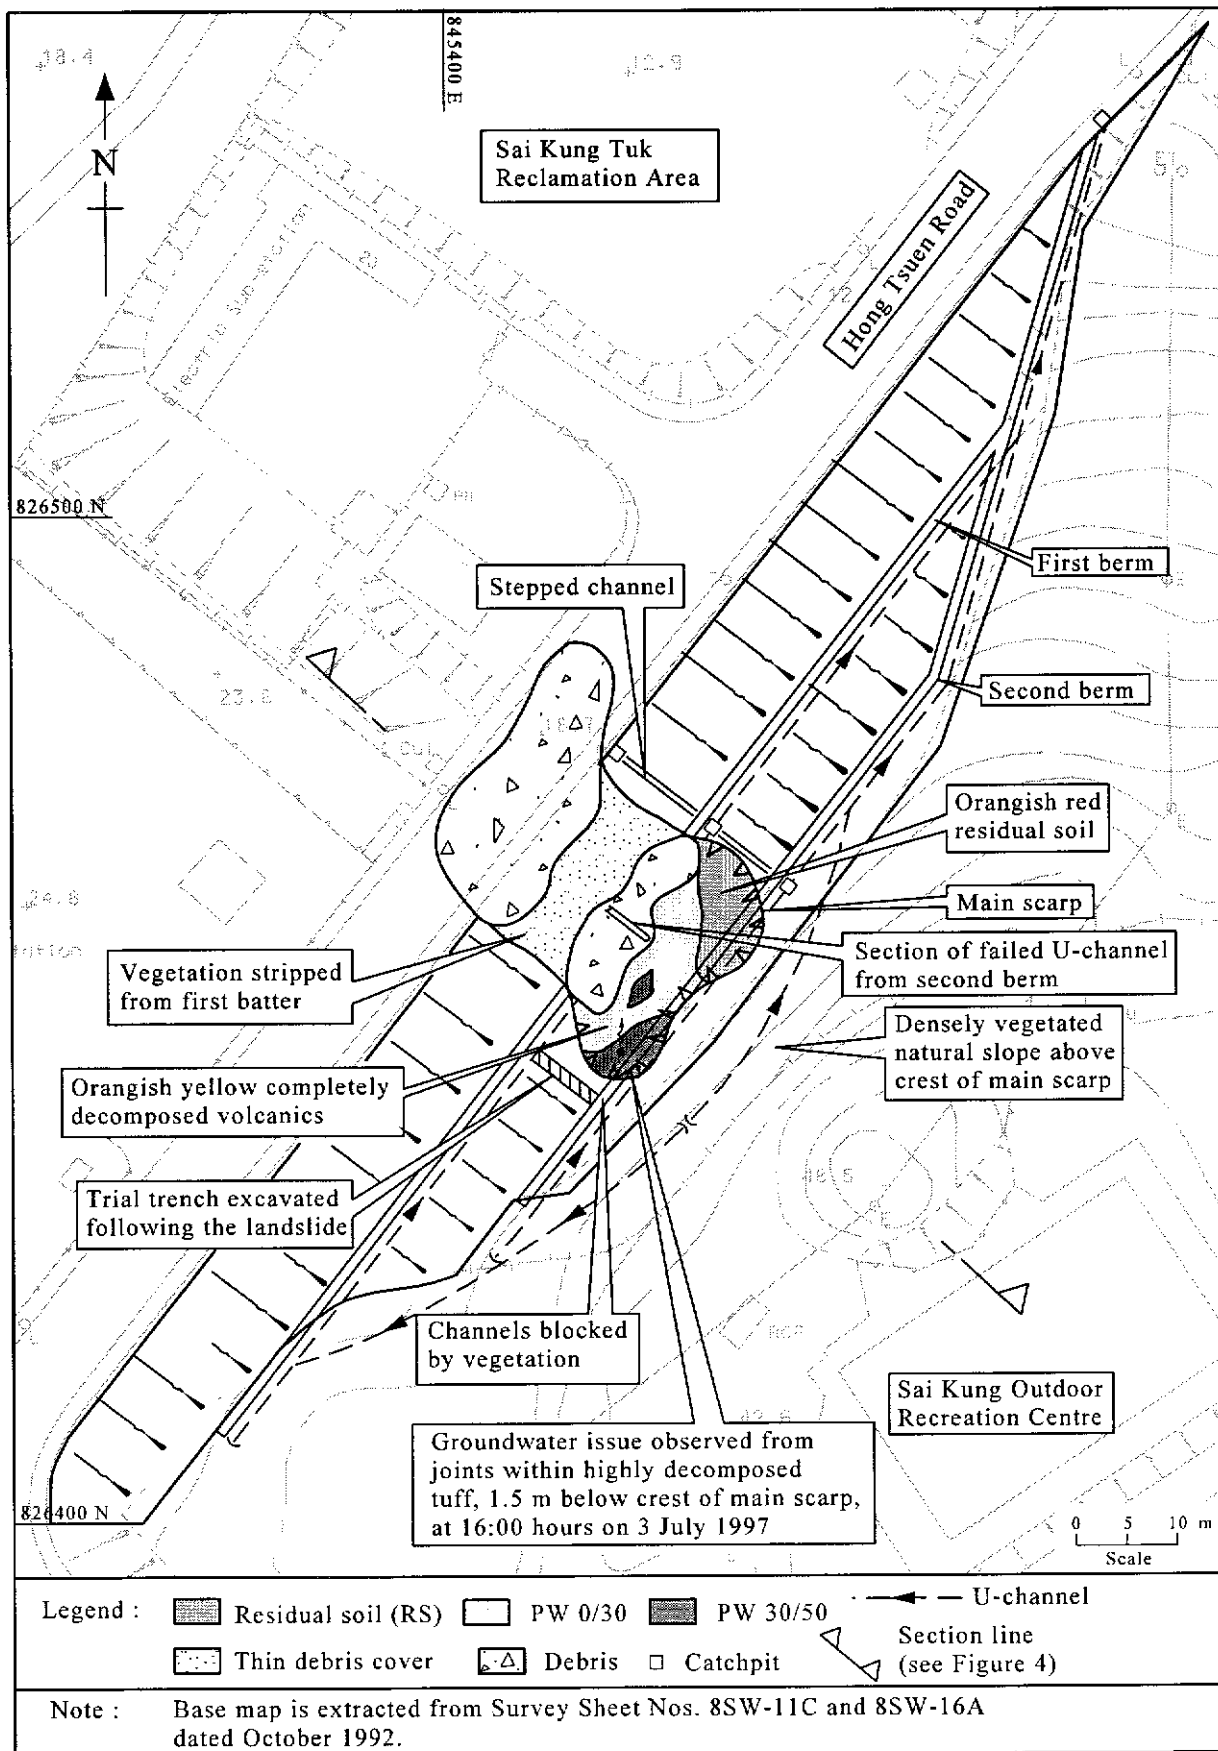
Figure 6 - Site Plan and Details of the Landslide

The weathering grade of material exposed in the main scarp decreased from northeast to southwest (Figure 6 and Plate 5). In the northeastern part of the main scarp residual soil, comprising mostly homogeneous, soft to firm, moist to wet, orange red, sandy silt to sandy clay, was exposed. This material is also locally exposed to the northeast of the landslide (Plate 6). In the centre of the main scarp, there was CDV of mass weathering grade PW 0/30, comprising completely decomposed, coarse ash crystal tuff described as fissured to intact, firm to stiff, moist to wet, orange yellow, slightly gravelly, sandy silt to sandy clay. Similar material was exposed in a shallow trial trench excavated along the second batter to the southwest of the failure (Figure 6 and Plate 7). The southwestern part of the main scarp revealed a large corestone of pale orange yellow, highly and moderately decomposed, coarse ash crystal tuff, with medium- to closely-spaced discontinuities. This tuff was intersected by

During an inspection at about 16:00 hours on 3 July 1997 HAP observed water issuing approximately 1.5 m below the ground surface from the large corestone in the southwestern side of the main scarp (Plate 9). When the site was inspected 6 days later this flow of water had ceased. HAP also observed that the U-channels in the vicinity of the main scarp were partially blocked with vegetation (Figure 6).

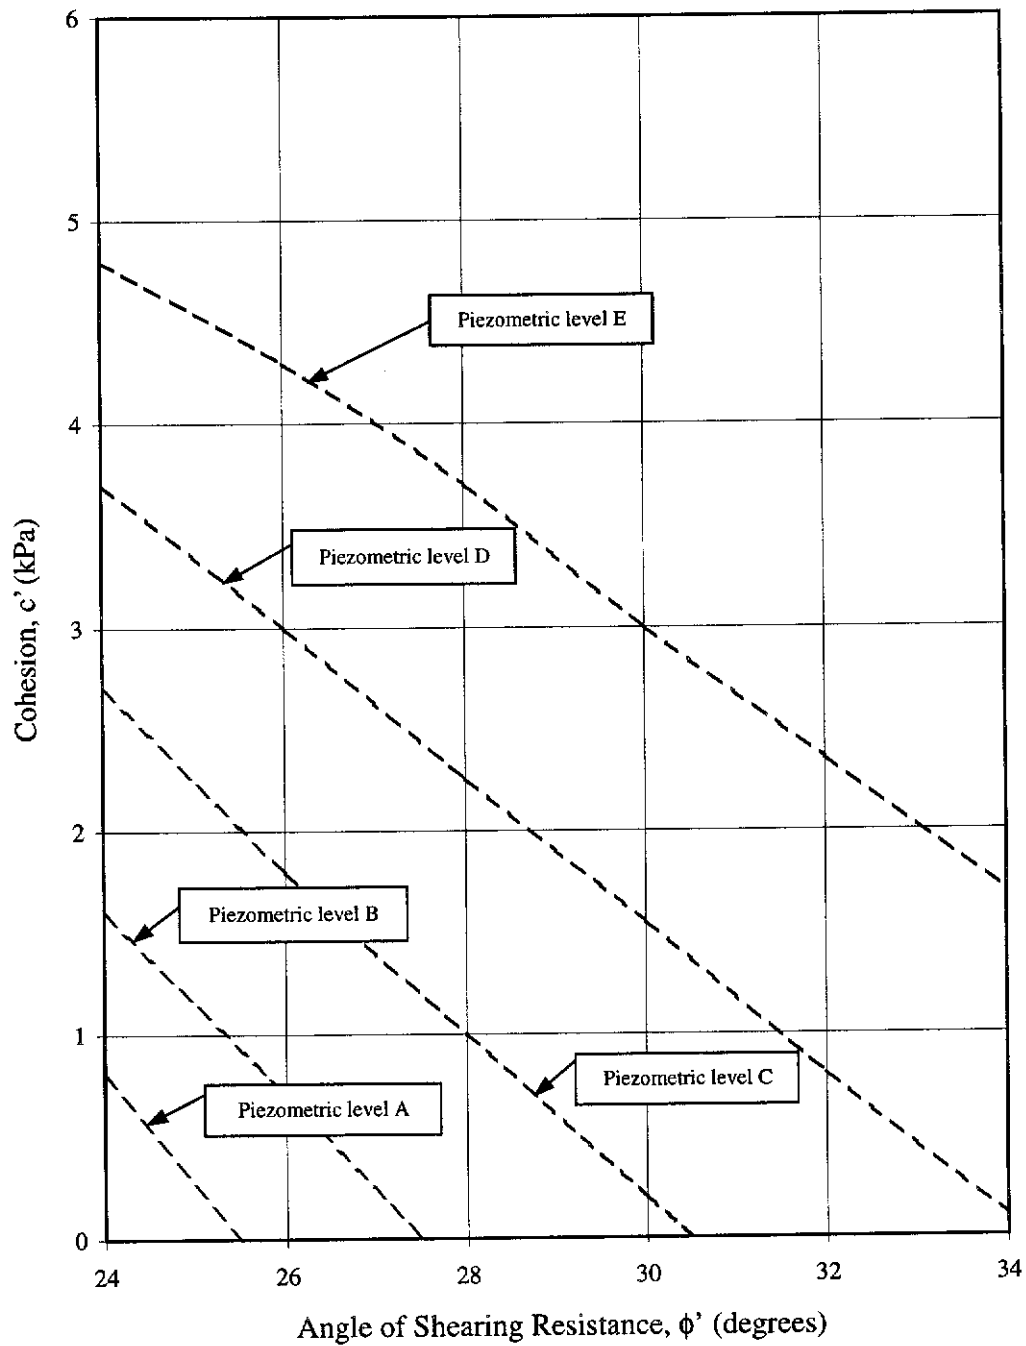
Figure 12 - Summary of Theoretical Stability Analyses

The results of the stability analyses, which support the idea that the failure was likely to have been the result of a combination of low shear strength material and high groundwater, are summarised in Figure 12.

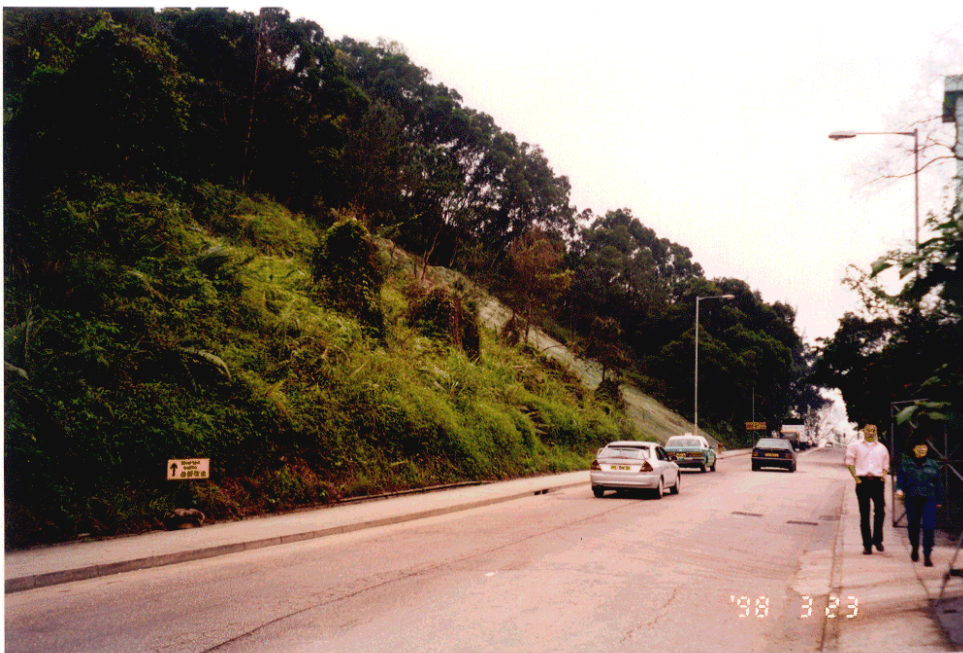
The landslide occurred on a registered soil cut slope on the southeast side of Hong Tsuen Road (Figure 1 and Plate 1). The cut slope is 185 m long, 17 m high in its central part and consists of three batters with two 1.5 m- to 2 m-wide berms. The lower, middle and upper batters are inclined at about 42°, 35° and 24°, respectively. Above its crest, a narrow strip of natural terrain separates the cut slope from a platform occupied by the Sai Kung Outdoor Recreation Centre. The cut slope and surrounding natural terrain are vegetated by shrubs, trees, bamboo, grass and ferns.

Plate 1 - View of Hong Tsuen Road and Adjacent Cut Slope No. 8SW-C/C3 After Urgent Repair Work was Completed (Photograph Taken on 23 March 1998. Note the Photograph is Looking Southwest and the Landslide Occurred Where the Slope is Shotcreted, Near the Lamp Post)

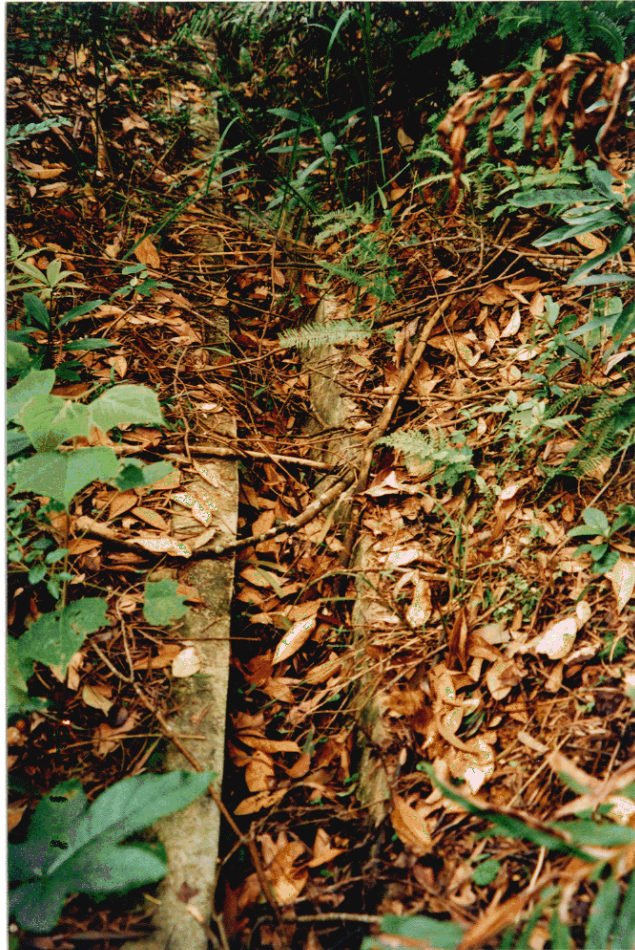
During inspections by HAP on 3 July 1997 and 23 March 1998, the U-channels in the vicinity of the 1997 landslide were partly blocked with vegetation debris (Plates 2 and 3).

There is evidence of inadequate slope maintenance in that the U-channel near the crest of the landslide was observed to be partially blocked after the failure. However, the contribution of this to the landslide was unlikely to be significant given the scale and mode of failure.

Plate 2 - Partly Blocked Drainage U-channel on the Second Bench Adjacent to the Southwest Flank of the Landslide (Photograph Taken on 23 March 1998)

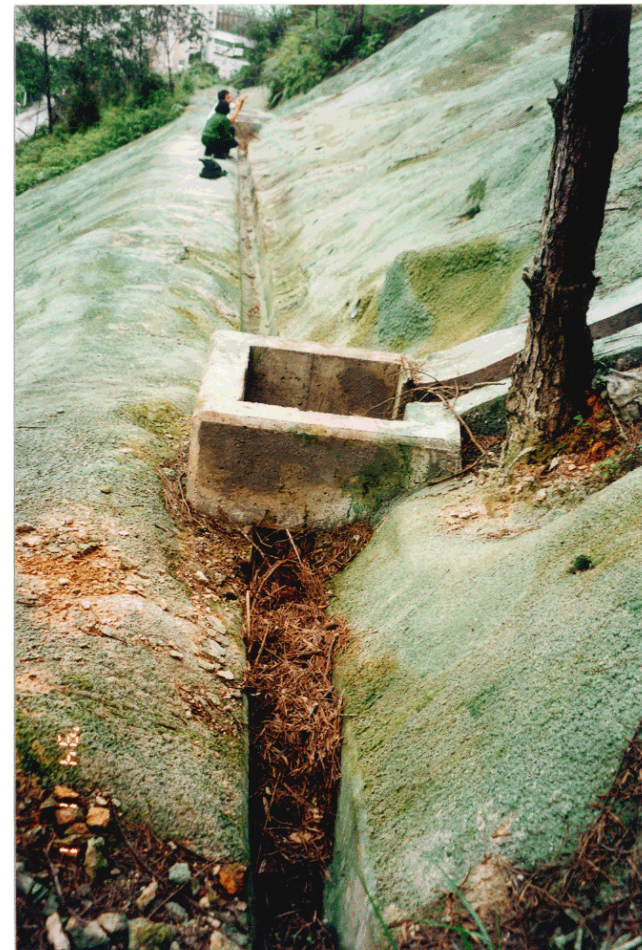
Plate 3 - Drainage U-channel Partially Blocked by Vegetation at a Catchpit (Photograph Taken on 23 March 1998. Note the Blockage Occurred after Repair Works were Completed)

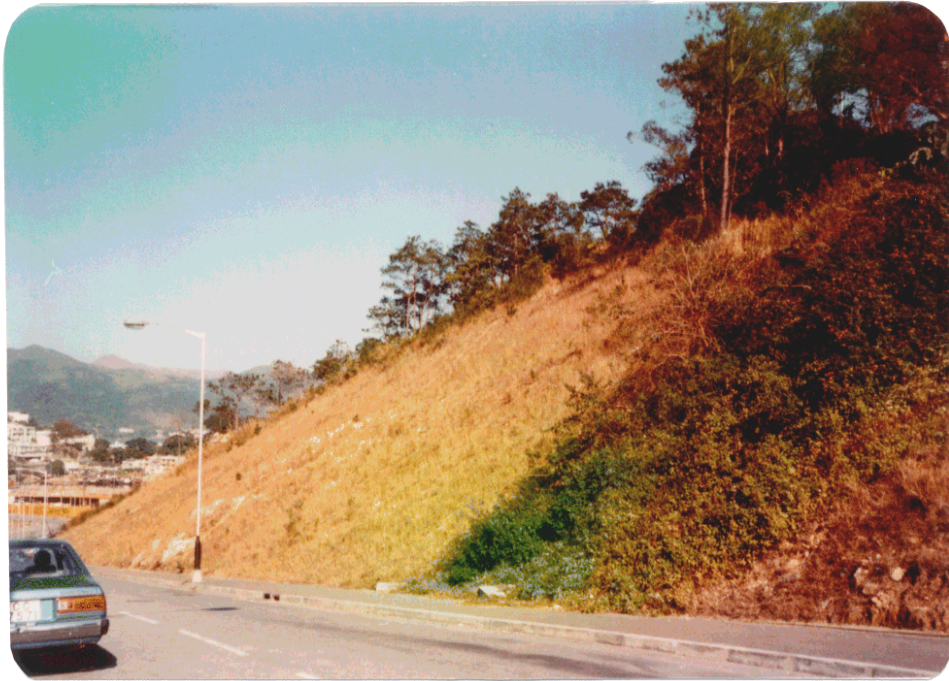
On 14 January 1981, WSA, B & P and GCO carried out a joint site inspection of the slopes and a retaining wall on the Sai Kung Development. According to the caption to one of the site record photographs, "there is a perennial discharge into cracked surface water drains" (Plate 4). The precise location of this discharge is not known but it is believed to be close to the 1997 landslide site.

Plate 4 - Site Record Photograph Showing "Lush Growth Where There is a Perennial Discharge into Cracked Surface Water Drains"
(Photograph Taken on 14 January 1981)

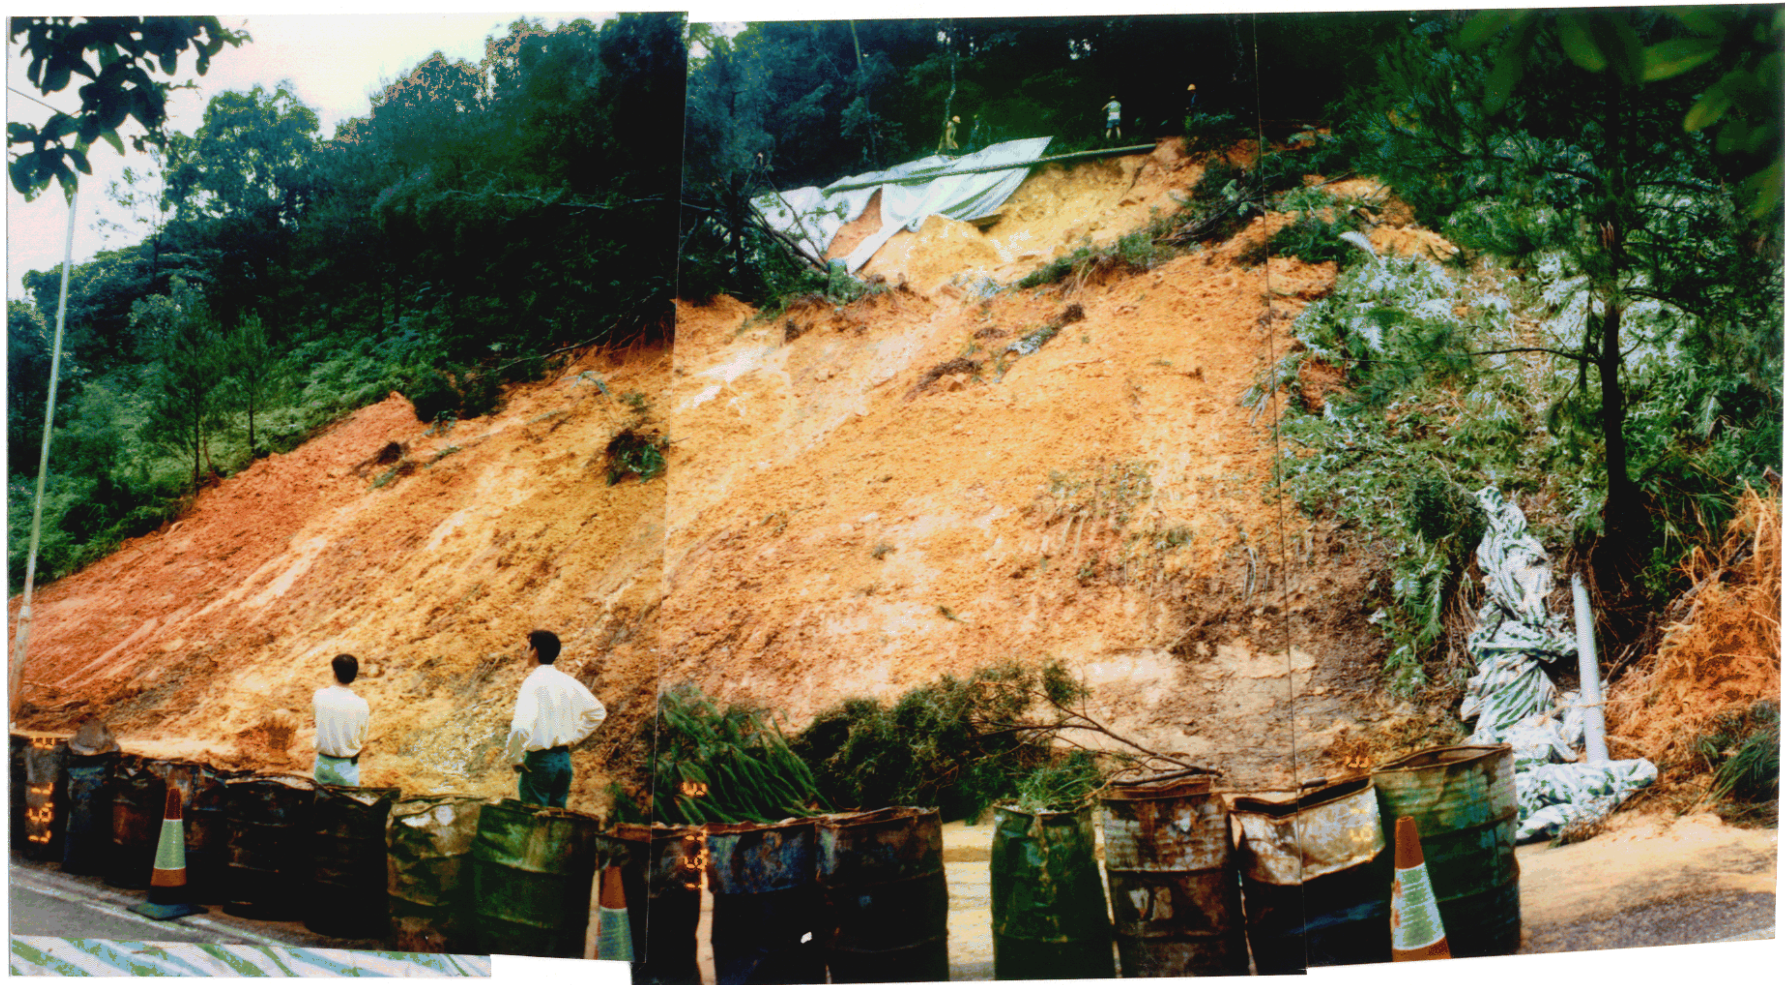
The landslide occurred in the centre of the middle batter and locally undercut the second berm and its associated U-channel. The toe of the rupture surface, which was exposed following the clearance of landslide debris (Plate 5), was observed to daylight at the first berm. The rupture surface of the landslide was about 25 m wide, 12 m long and was up to 2.4 m below the original surface of the cut slope. The angle of the rupture surface, measured relative to the horizontal, increased from 18° near the base of the landslide to near-vertical towards the crest. The angle between the toe of the landslide rupture surface and the crest, which extended to the back of the second berm, was about 28° to the horizontal.

Plate 5 - View of the Landslide (Photograph Taken on 3 July 1997. Note the Colour Change Across the Site from Orangish Red Residual Soil to Orangish Yellow Completely Decomposed Volcanics)

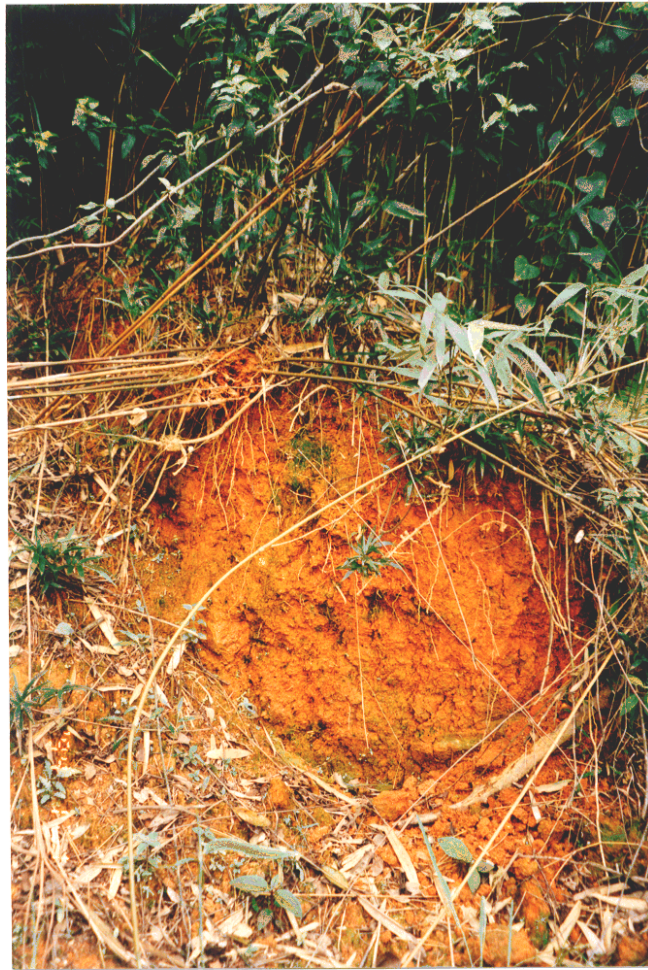
Plate 6 - Residual Soil Exposed by Erosion on the Slope Adjacent to the Landslide (Photograph Taken on 23 March 1998)

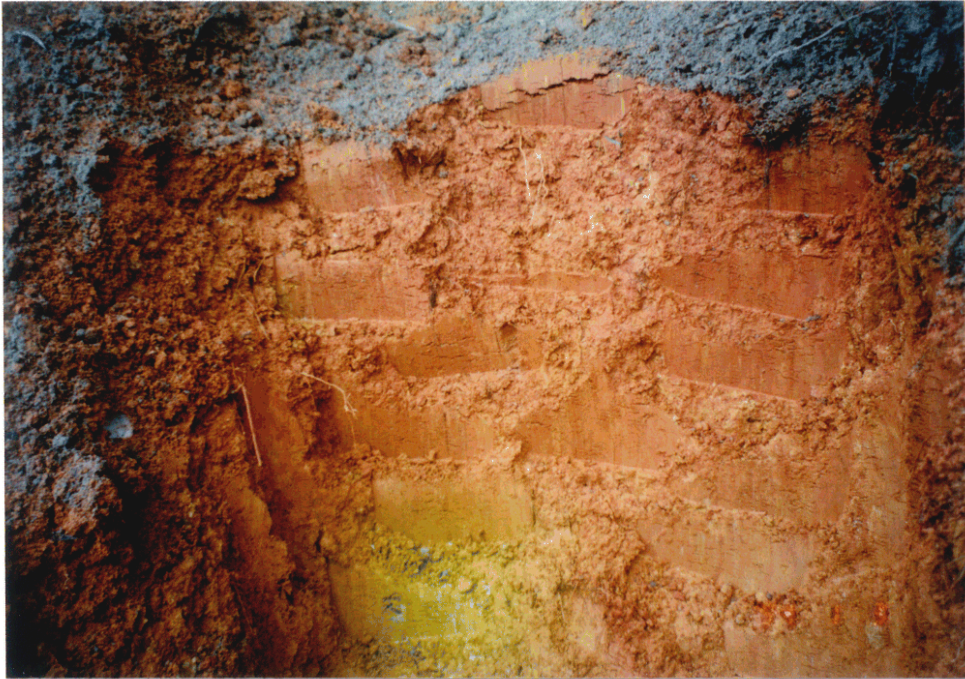
Plate 7 - Completely Decomposed Volcanics Exposed Near Ground Level
in a Trial Trench Excavated to the Southwest of the Main Scarp
of the Landslide (Photograph Taken on 9 July 1997)

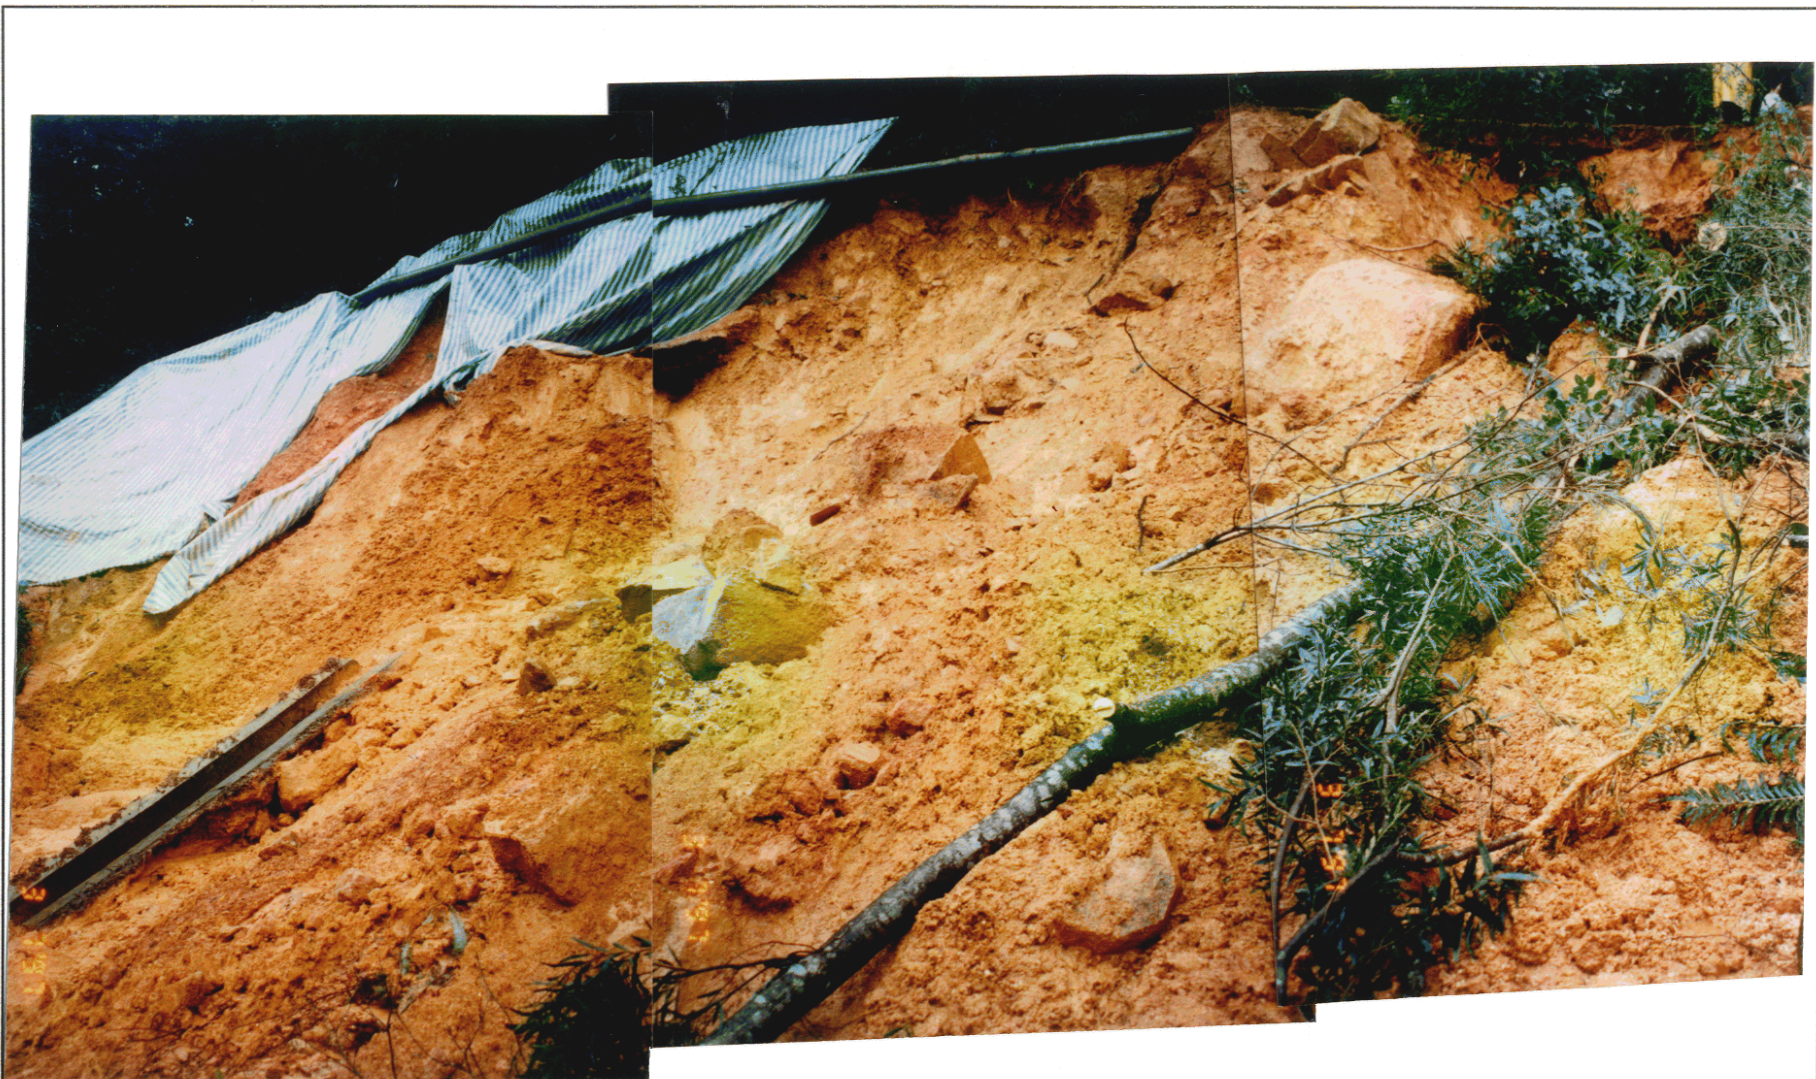
both near vertical and sub-horizontal, but not adverse, planar discontinuities. Some discontinuities had apertures up to about 30 mm wide and were stained with iron and manganese oxides (Plates 8 and 9). The width of the discontinuity may have been a result of the landslide.

Plate 8 - Close-up View of the Main Scarp (Photograph Taken on 3 July 1997. Note the Blocks of Rock in the Debris Derived from the Southwest Corner of the Main Scarp)

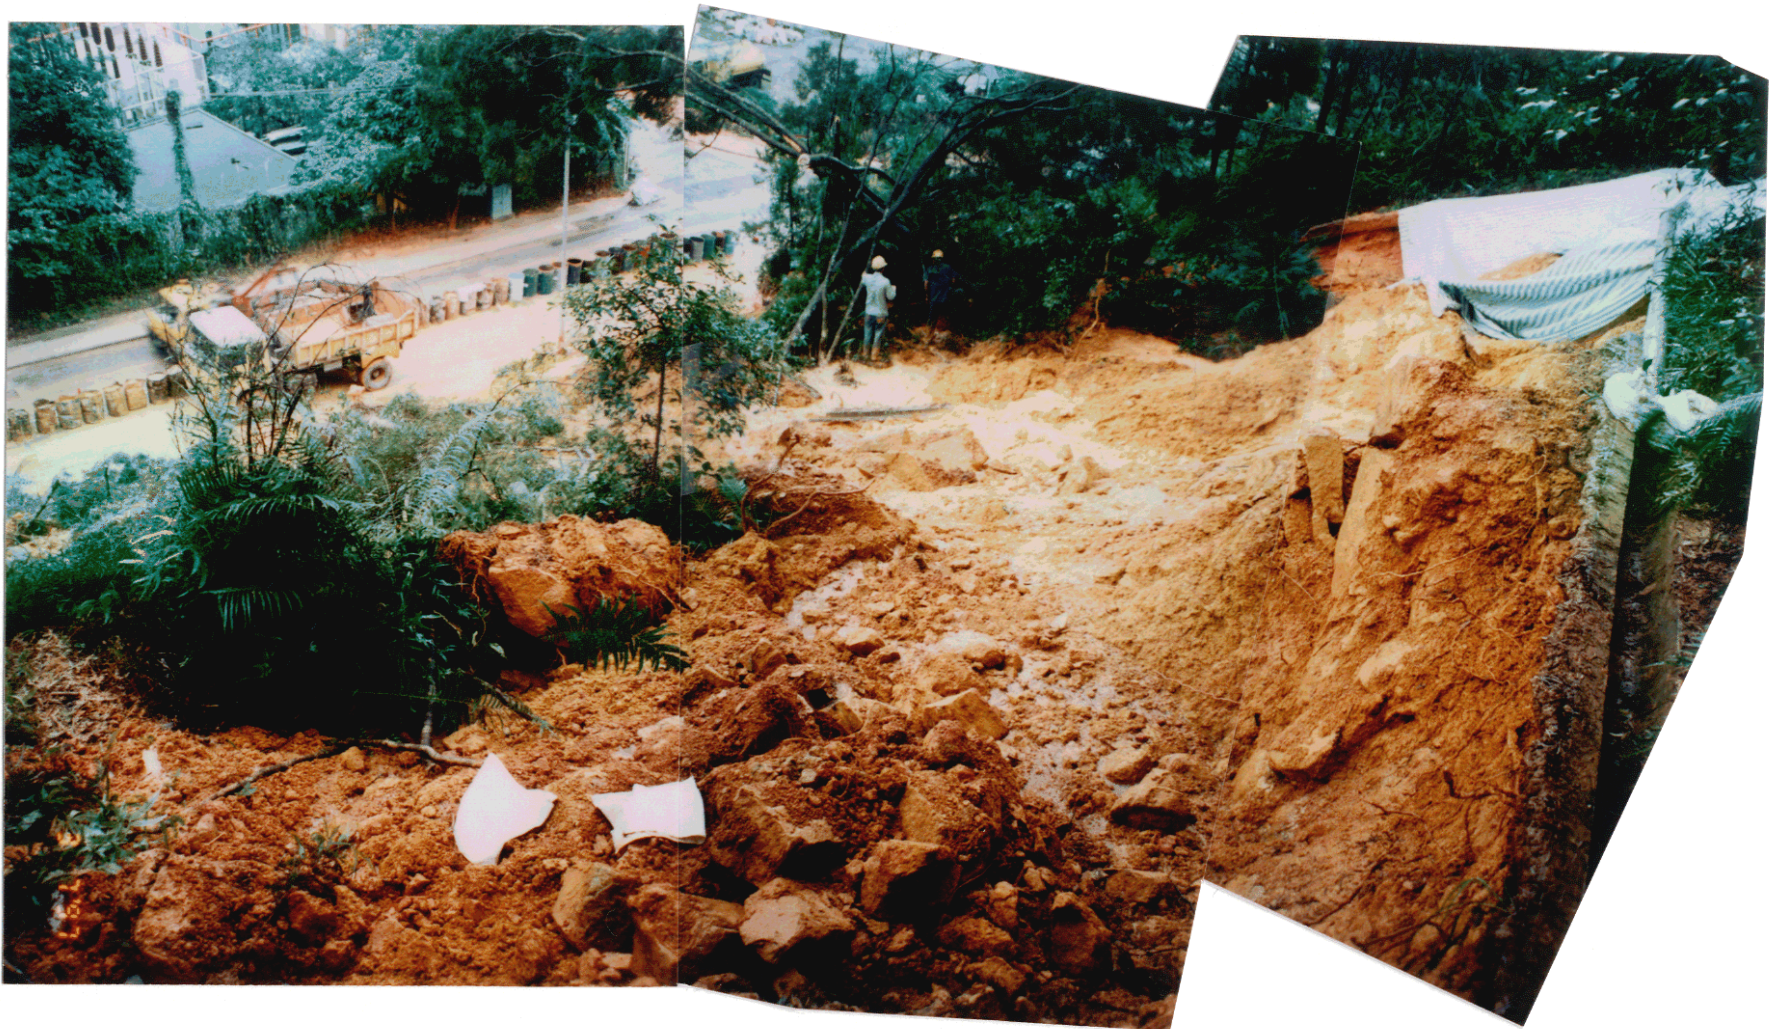
Plate 9 - View of the Main Scarp Looking North (Photograph Taken on 3 July 1997. Note the Exposed Corestone Comprising Jointed Moderately Decomposed Volcanics in the Main Scarp and the Issue of Groundwater)

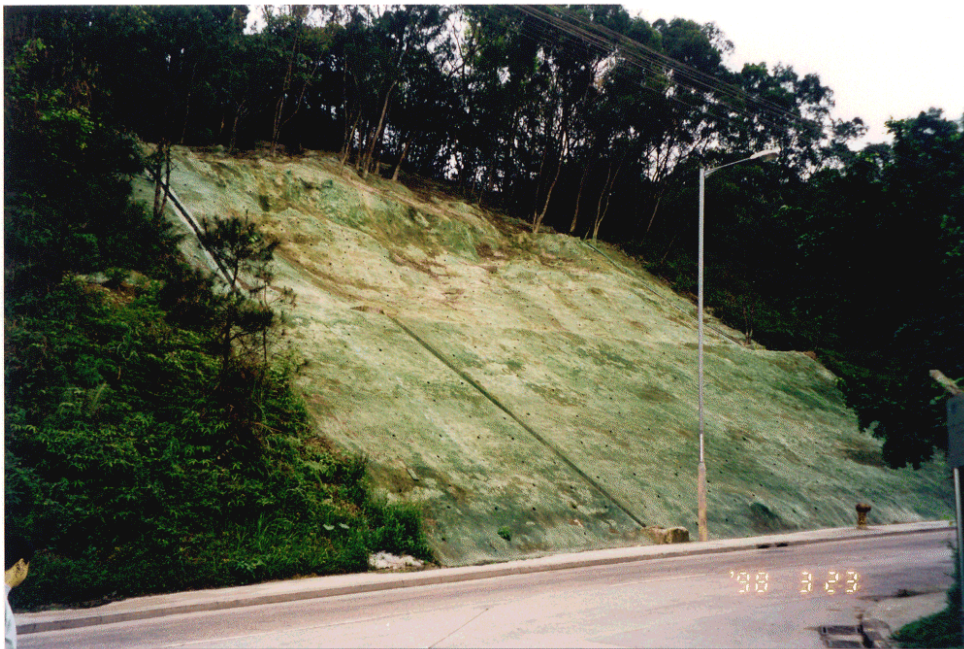
Plate 10 - View of Slope No. 8SW-C/C3 after Urgent Repair Work was Completed (Photograph Taken on 23 March 1998. Note the Landslide Scar Visible on the Upper Part of the Slope and Daylighting at the First Bench)

Following the landslide, HyD carried out urgent repair works comprising removal of debris, shotcreting of the affected area of the slope and re-instatement of the surface drainage system (Plate 10).
