**SECTION 2:
DETAILED STUDY OF
THE LANDSLIDES
AT NOS. 1 TO 5
CHUNG SHAN TERRACE
LAI CHI KOK
ON 4 JUNE 1997**

Halcrow Asia Partnership Ltd

**This report was originally produced in December 1998
as GEO Landslide Study Report No. LSR 22/98**

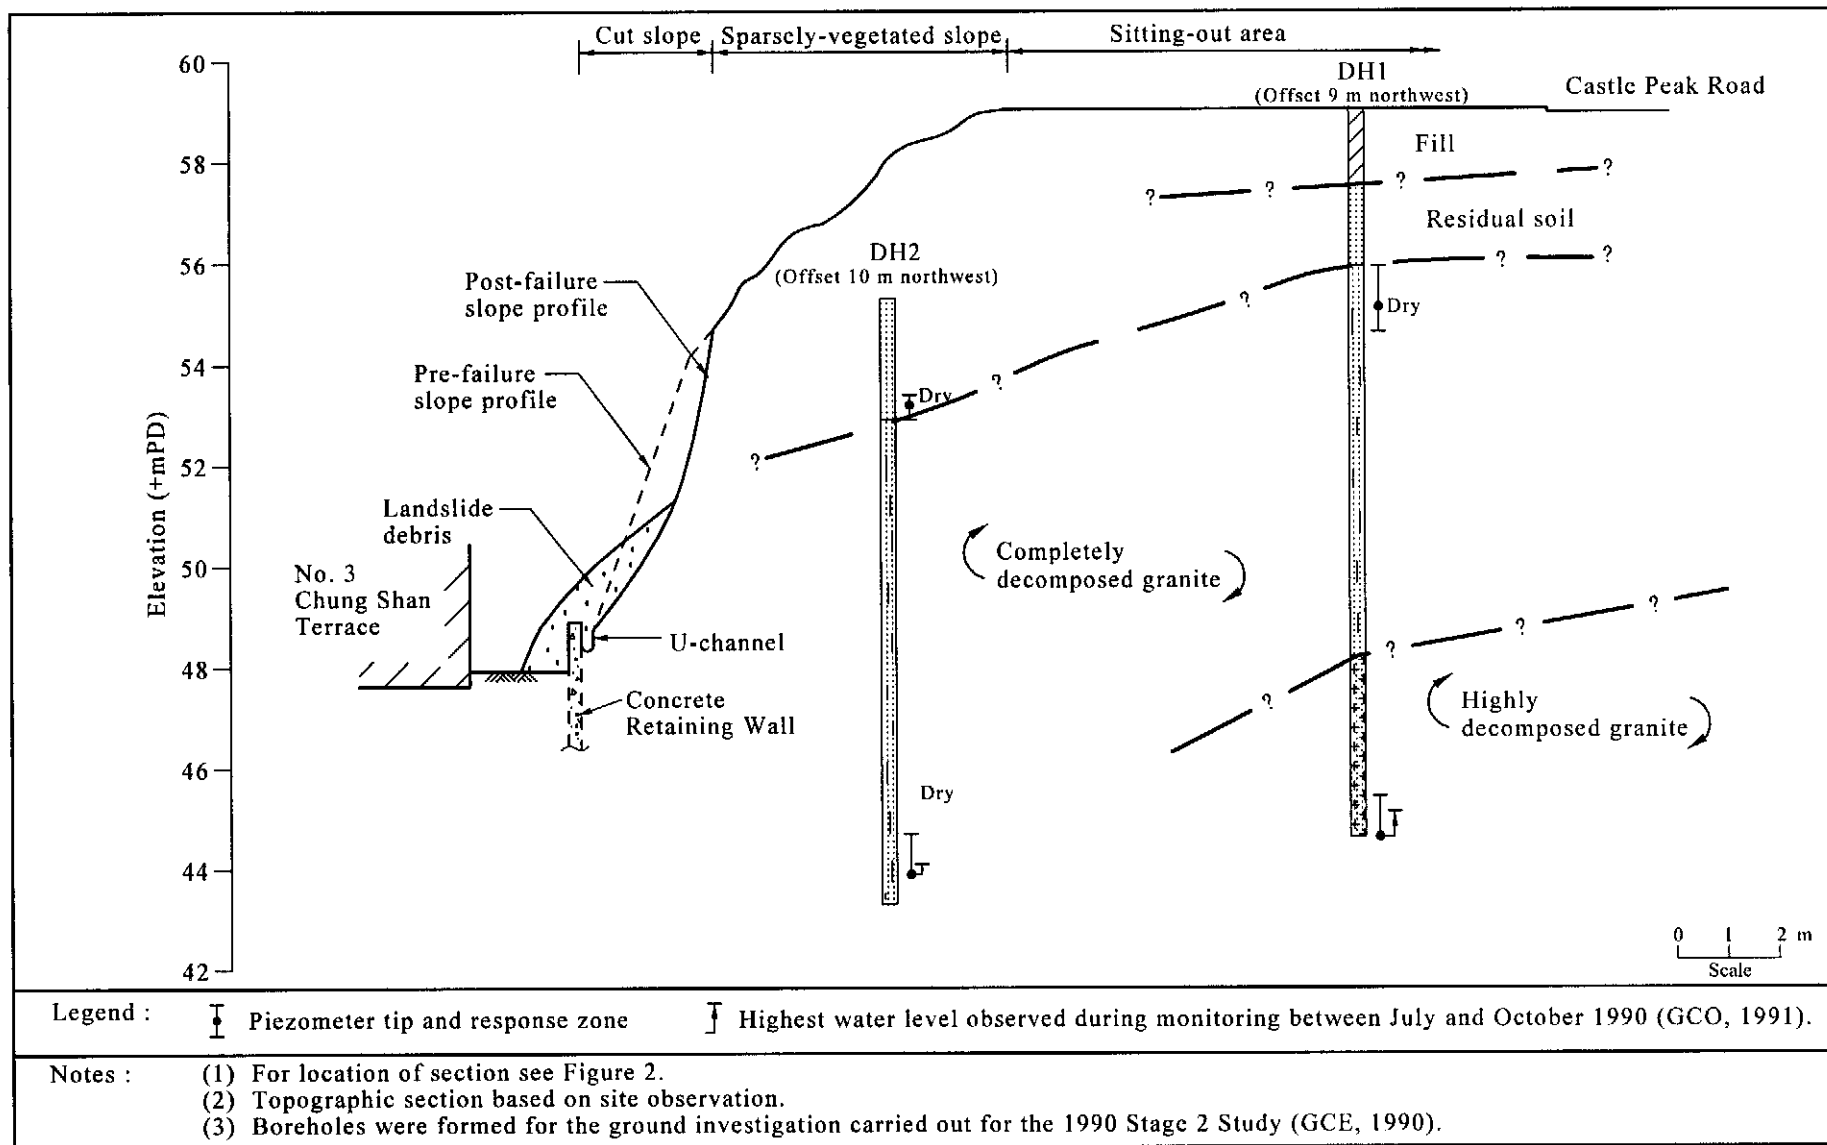
Figure 4 - Cross-section A-A through Landslide A1

A geological section showing the ground conditions near the location of landslide A1, interpreted from GCE's borehole information (GCE, 1990), is presented in Figure 4. The information suggests that the crest of the slope has a cover of about 2 m of fill, overlying about 2 m of residual soil that comprised medium-dense to dense clayey sand. The residual soil overlies about 7 m of completely decomposed granite and below that, highly decomposed granite. The highest observed water level, based on monitoring of piezometers installed in boreholes at the site between July and October 1990, was well below the base of landslide A1 (Figure 4).

A cross-section through landslide A1, the largest of the landslides affecting the cut slope behind Nos. 1 to 3 Chung Shan Terrace, is shown in Figure 4 and a photograph of the landslide taken after completion of urgent repair works is shown in Plate 2.

The rupture surface of landslide A1 was estimated to be about 8 m wide, 6 m long and 0.5 m deep. The volume of the displaced debris was estimated to be about 10 m³. Landslide debris overtopped the retaining wall at the toe of the slope and accumulated behind Nos. 2 and 3 Chung Shan Terrace.

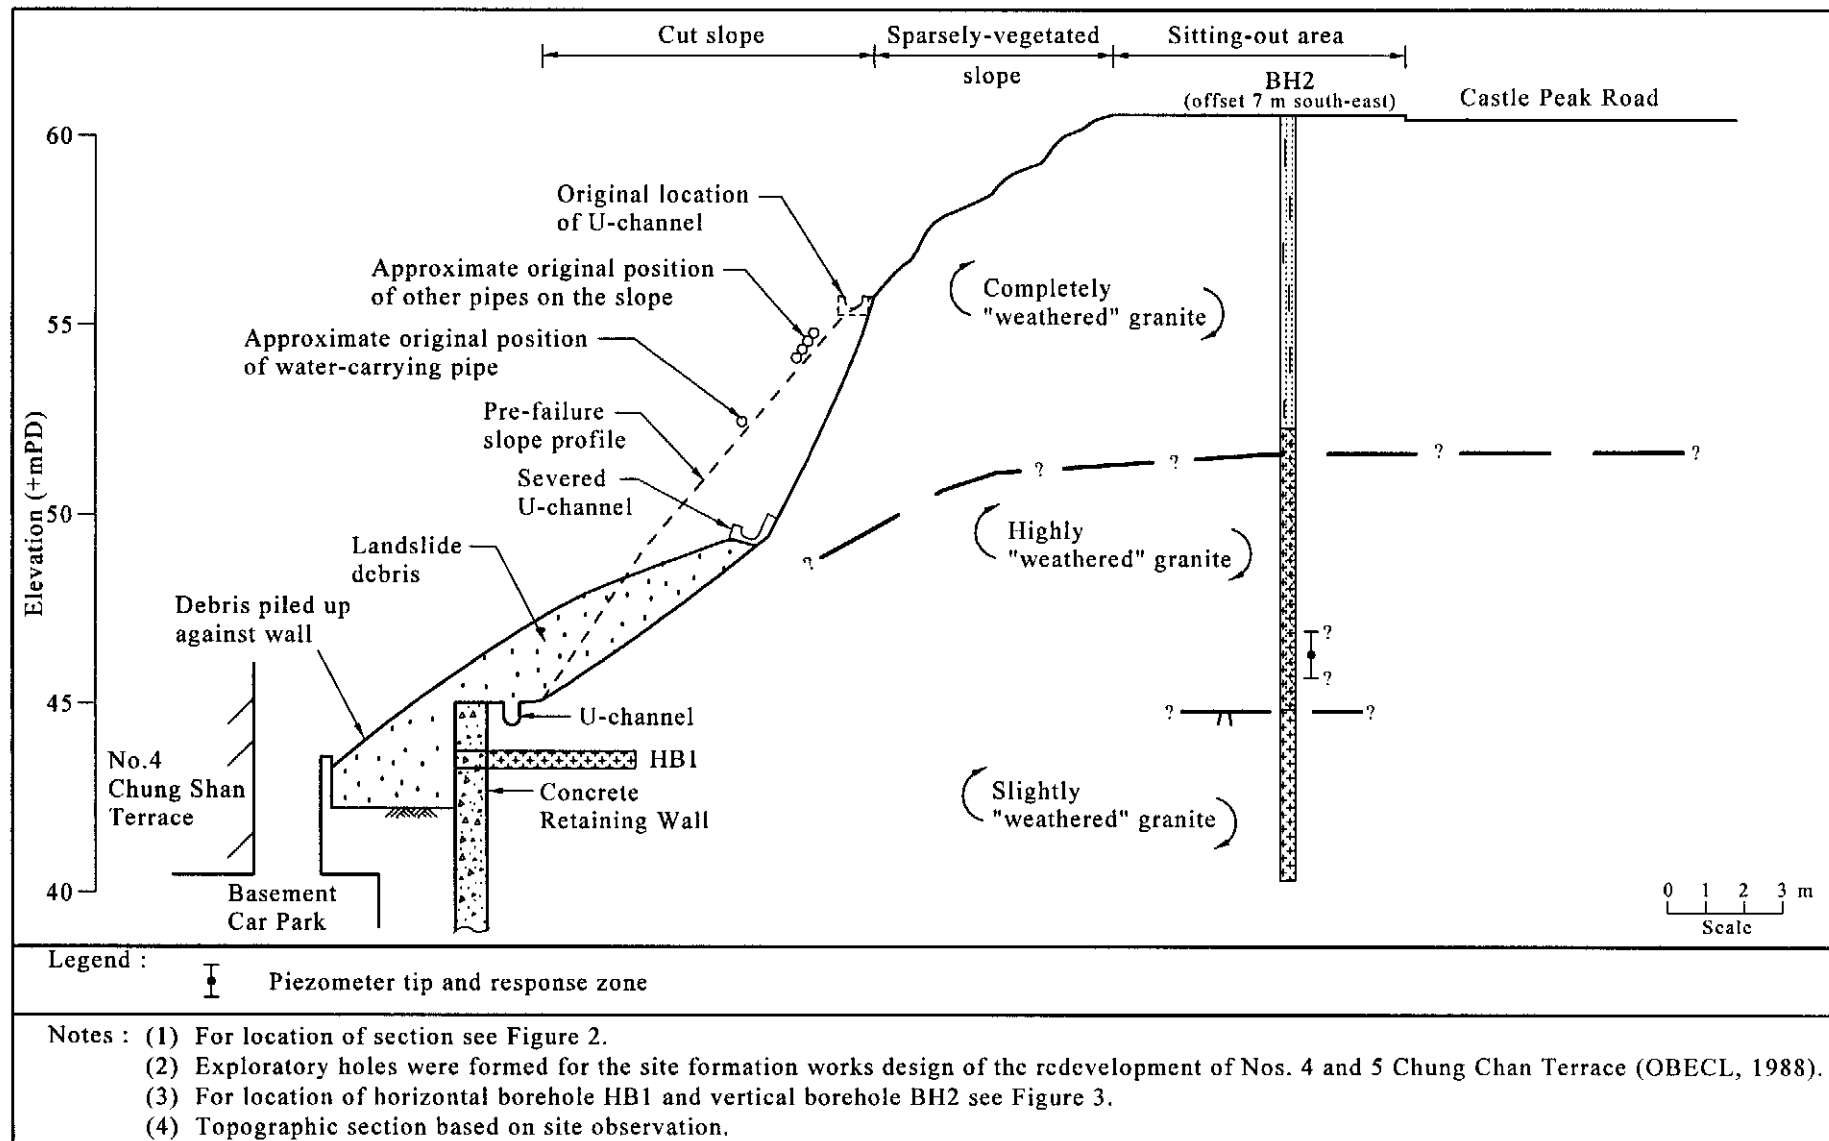
Figure 5 - Cross-section B-B through Landslide B

A geological section showing the ground conditions near the location of landslide B, interpreted from the OBECL ground investigation data (1988), is presented in Figure 5. Borehole BH2 proved "completely weathered" granite to a depth of about 8 m, overlying about 7 m of "highly weathered" granite and below that, slightly "weathered" granite. According to the geotechnical report on the site formation aspects of the redevelopment of

A cross-section through landslide B is shown in Figure 5 and photographs taken soon after the failure are presented in Plates 5 and 6.

The rupture surface of the landslide was about 16 m wide, 7 m long and up to 1.5 m deep. The estimated volume of the landslide was about 85 m³. The material exposed in the main scarp was completely decomposed granite consisting of predominantly medium-dense brown mottled light yellow silty fine- to coarse-grained sand. There was no evidence of adversely oriented discontinuities or groundwater seepage from the main scarp. Inspection of intact and broken sections of the U-channel near the crest of the main scarp found no evidence of blockage that may have caused overflow of surface water onto the slope before failure.

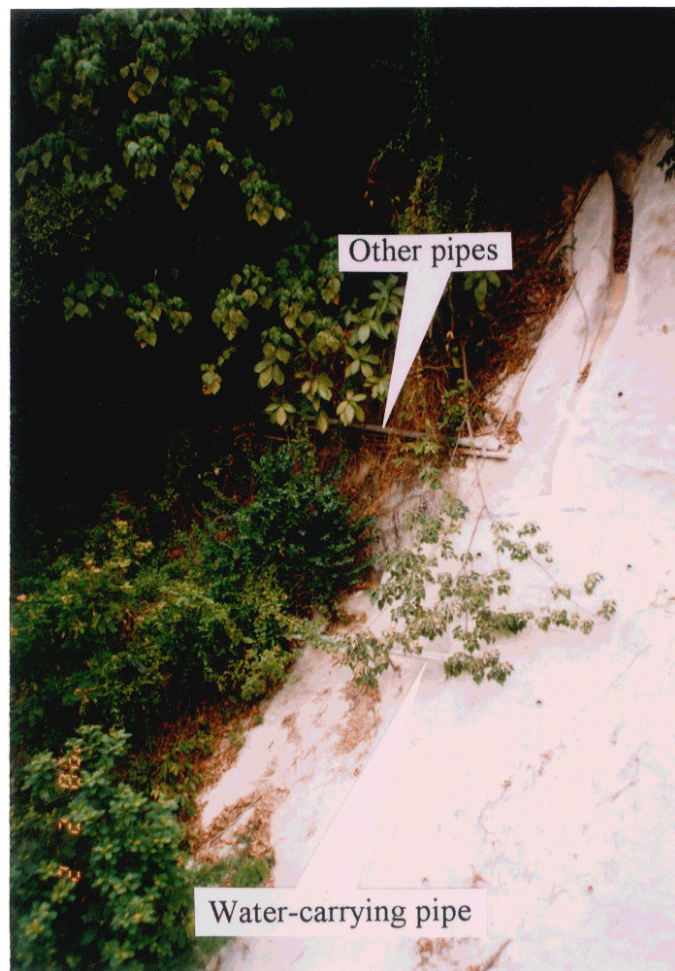
At the location of landslide B, the cut slope is about 12 m high and inclined at about 50° to the horizontal. Its surface was predominantly covered with small shrubs and grass prior to the landslides. U-channels were present at its crest and toe. Prior to the landslide, the slope was crossed at about mid-height by a water-carrying pipe and further upslope by a group of pipes. All the pipes were above the slope surface (Figure 2, Plate 1).

Landslide debris destroyed the fence on the retaining wall and piled up behind No. 4 Chung Shan Terrace. The landslide engulfed the slope protection put in place after the 1992 incident, destroyed a U-channel on the slope and displaced a catchpit associated with the U-channel (Plate 6). The landslide also severed the water pipes on the surface of the slope that caused water leakage and erosion of a channel through the landslide debris before the water flow was brought under control by installation of a stopcock on the pipe. Vegetation on debris rafts in the upper part of the landslide debris remained upright while vegetation on rafts at the toe toppled forward. The presence of the rafts suggests that this failure also occurred principally by shallow sliding. The travel angle of landslide B cannot be established because the run-out of the debris was constrained by a wall behind No. 4 Chung Shan Terrace.

Plate 1 - Water-carrying Pipe and Other Pipes Ruptured by Landslide B

Following the landslide incident in 1992, the GEO advised the Buildings Department (BD) that repair and maintenance works would be needed. On 14 September 1992, the BD issued an Advisory Letter to Sinotrade Development Ltd (SDL), who manage Nos. 4 and 5 Chung Shan Terrace, suggesting that they provide "surface protection to the slip surface" and relocate "the 50 mm water pipe away from the slope" (Figure 2). The slope protection works had been completed by November 1995. Reminders of the need to relocate the water pipe were sent to the owners by the BD on 11 December 1995 and 14 May 1996 respectively, but the relocation of the pipe had not been carried out prior to the 1997 failures.

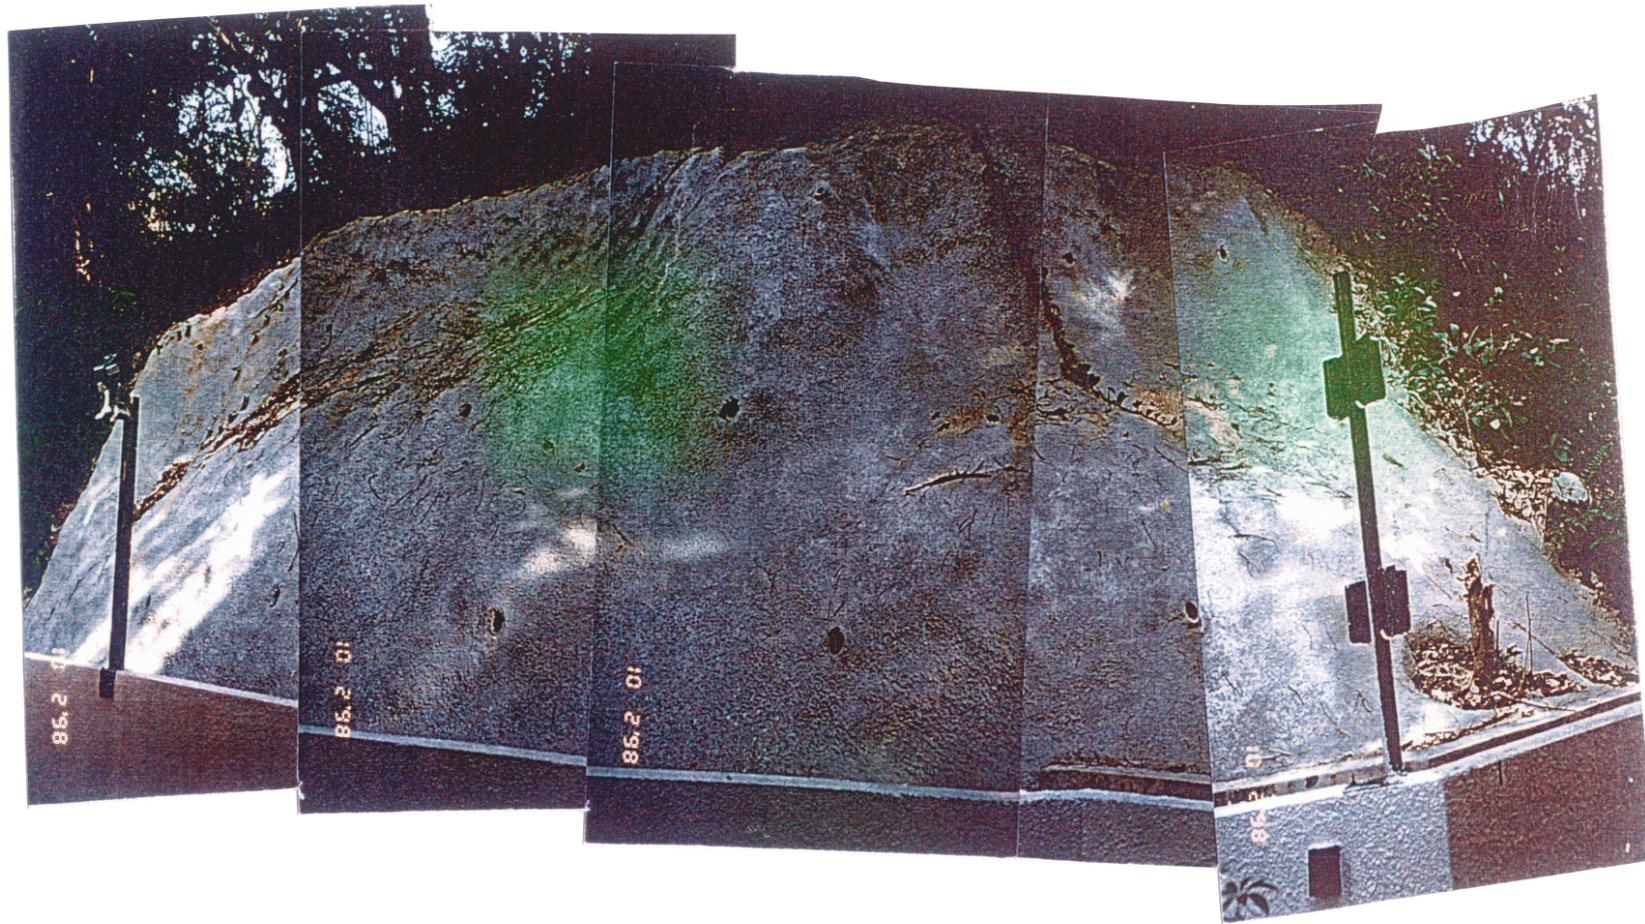
The morphology and geology of the three landslide scars suggest that they were shallow sliding failures predominantly within completely decomposed granite. The close correlation of the severe rainstorm on 4 June 1997 and the reported time of the failures indicate that they were probably triggered by rainfall.

Based on the field observations, there was no evidence of unusually weak materials, discontinuities or other adverse geological features. The failures were not typical of major washout incidents resulting from concentrated surface water flow nor was there any evidence of a general rise in the base groundwater table. Rainfall on 4 June 1997 was particularly severe and rainfall falling on the cut slope and surface run-off from the upslope area (as there was no surface drainage provision at the slope crest) were probably the principal sources of water. It is postulated that the most likely cause of failure was infiltration into the vegetated slope followed by downslope seepage flow (i.e. non-vertical) along preferential flowpaths resulting in the development of local seepage pressures in the near-surface soils.

Plate 2 - General View of Landslide A1 after Urgent Repair Works (Photograph Taken on 10 February 1998)

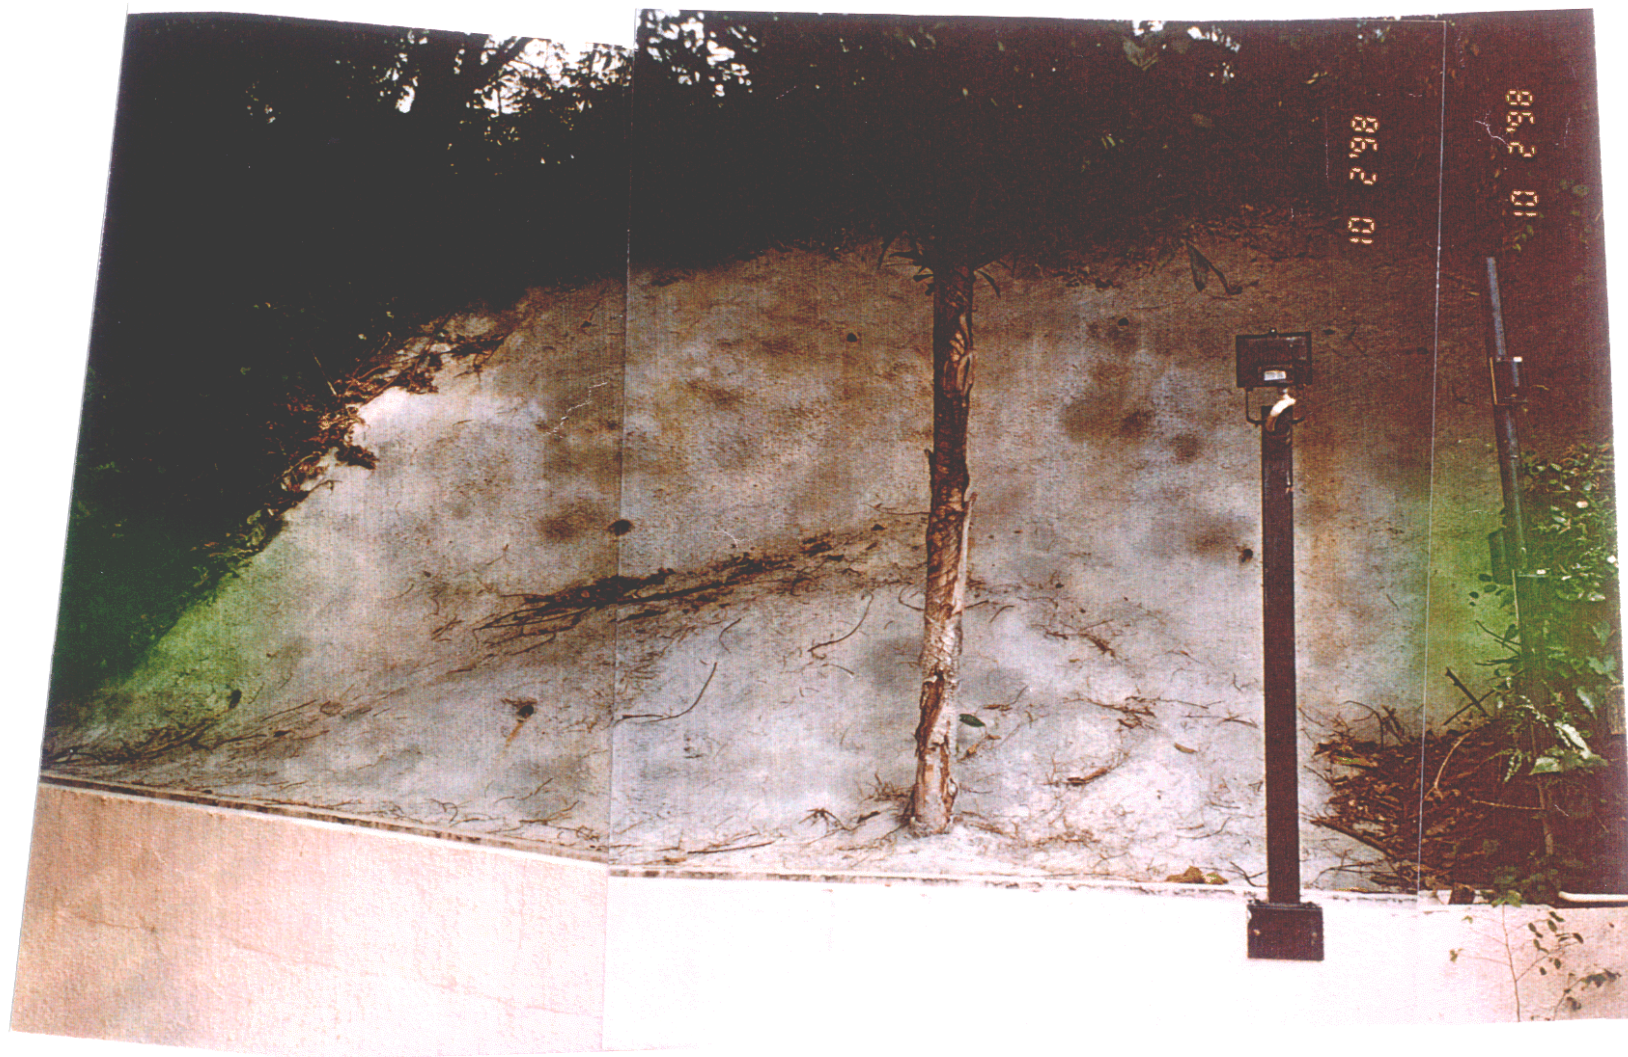
Landslides A2 and A3 were smaller (Plates 3 and 4). Landslide A2 was about 4 m wide, 2 m long and 0.5 m deep, and landslide A3 was about 2 m wide, 2 m long and 0.4 m deep (Plates 3 and 4). The total volume of these two landslides was about 4 m³. According to GEO's Incident Report prepared following an inspection on 4 June 1997, the debris was deposited at the toe of the retaining wall behind Nos. 2 and 3 Chung Shan Terrace. There is no record of groundwater seepage in the main scarps on the incident report. Application of shotcrete to the landslide scars as part of the urgent repair works prevented HAP preparing detailed descriptions of materials involved in the failures. The geology of the site, established from previous ground investigations (Figure 4) and observation of nearby exposures on the cut slope, suggests that the failures would have involved predominantly completely decomposed granite.

Plate 3 - General View of Landslide A2 after Urgent Repair Works (Photograph Taken on 10 February 1998)

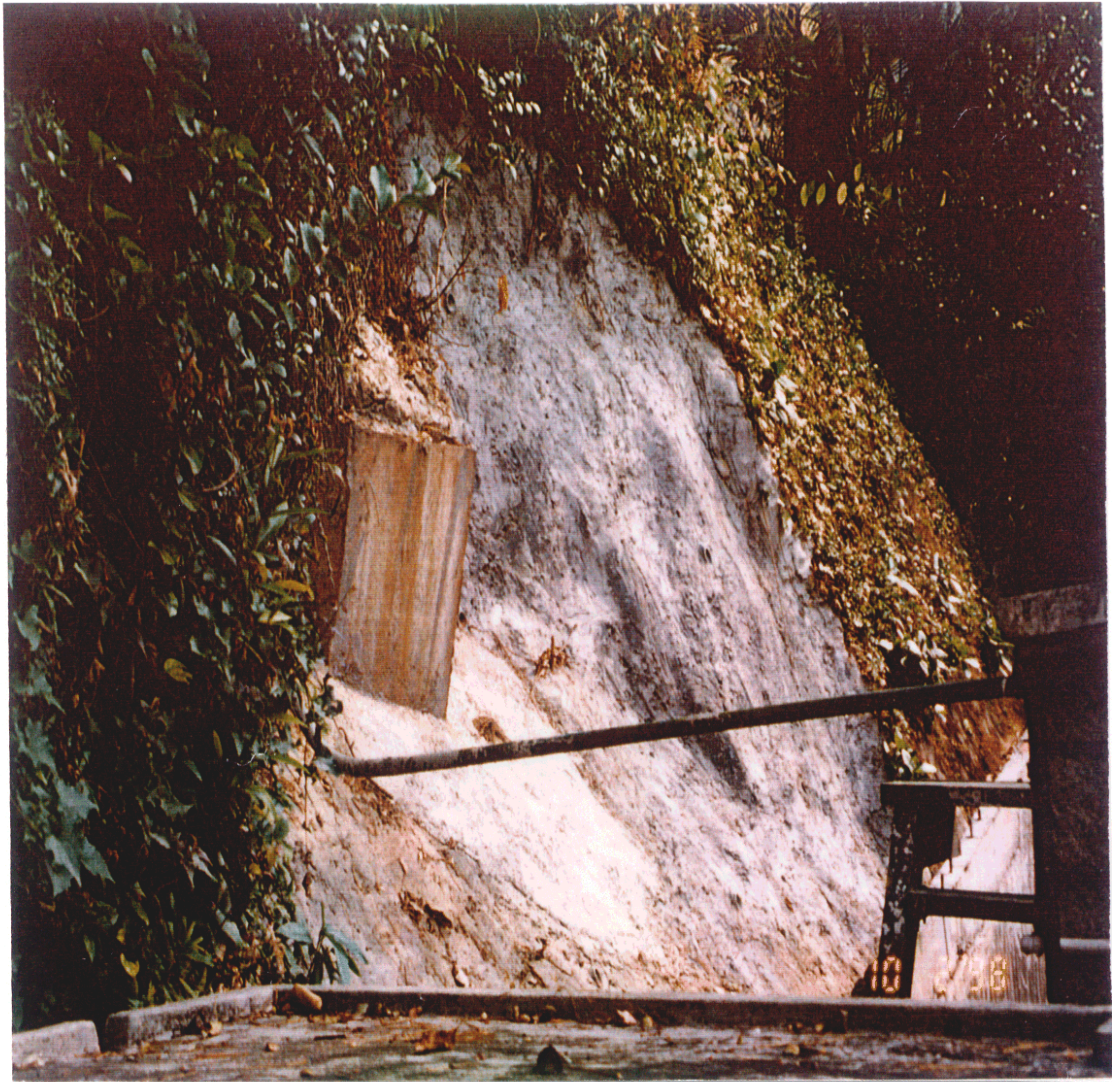
Plate 4 - General View of Landslide A3 after Urgent Repair Works
(Photograph Taken on 10 February 1998)

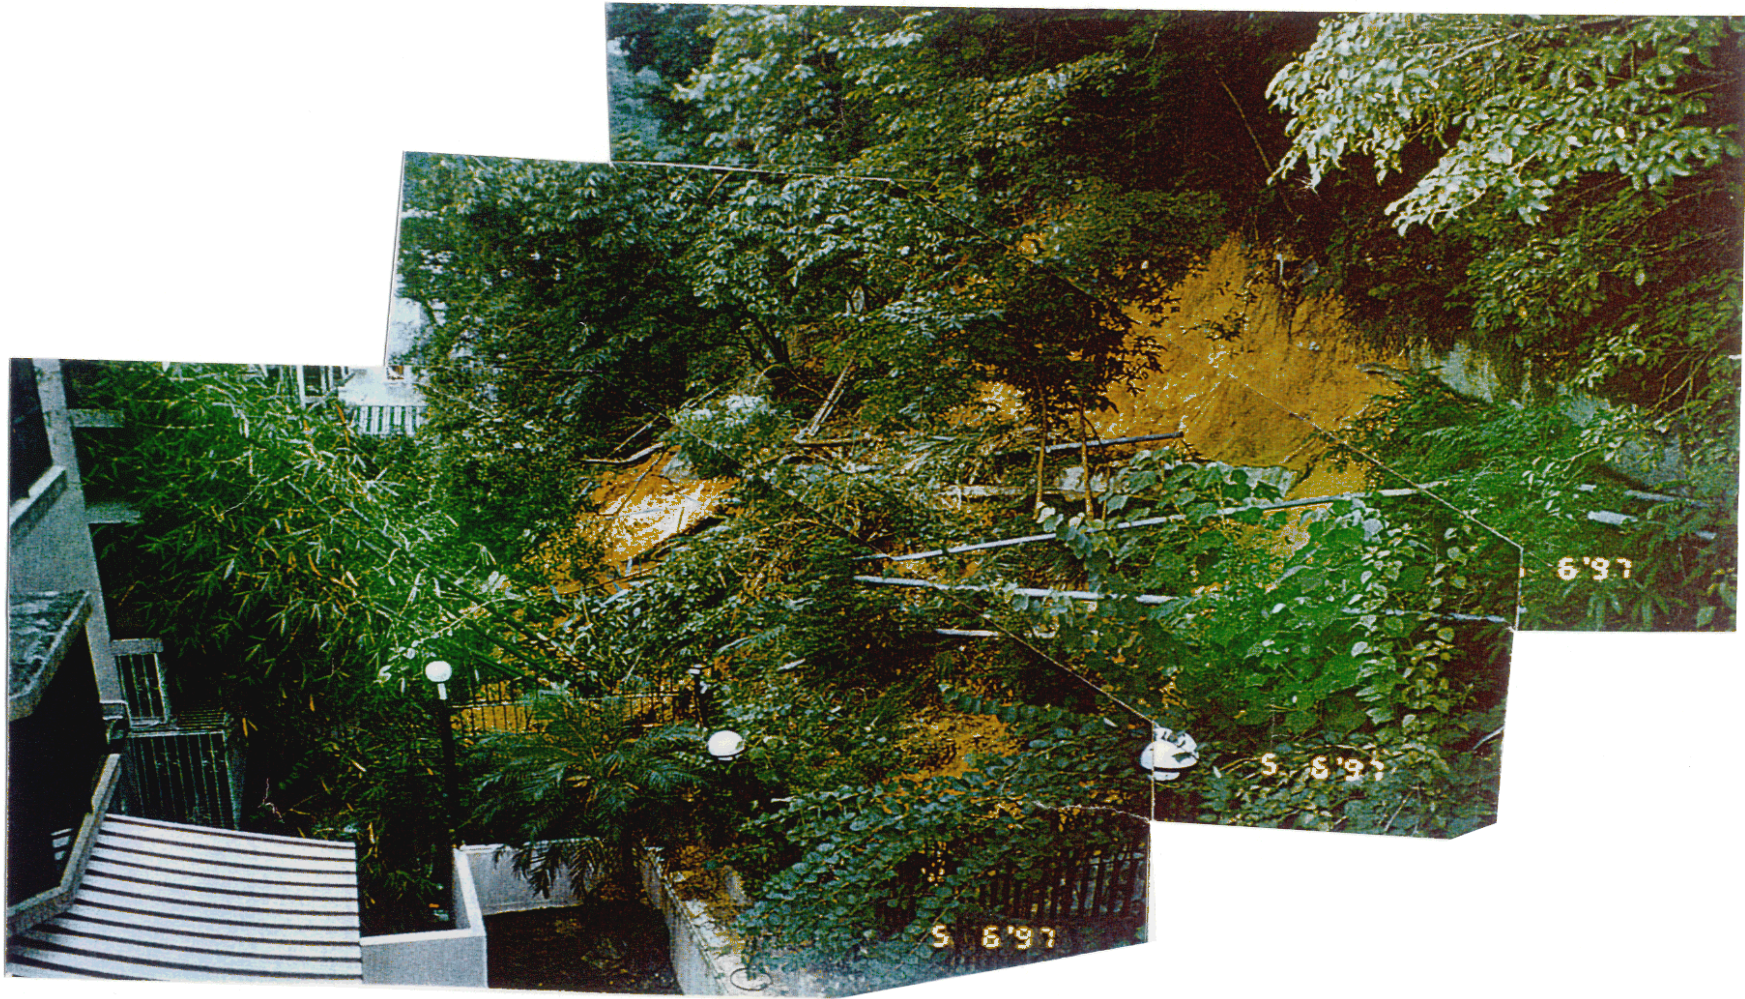
The morphology and geology of the landslide scar and debris suggest that the failure probably involved shallow sliding predominantly within completely decomposed granite. Landslide B occurred about 90 minutes after landslides A1 to A3, and was probably triggered by severe rainfall.

It is considered that the landslide was most probably caused by direct infiltration of rainwater into the predominantly unprotected cut slope followed by downslope seepage flow and the development of local seepage pressures in the near-surface soils.

Plate 5 - General View of Landslide B (Photograph Taken on 5 June 1997)

Following the landslides, BD implemented urgent repair works including removal of landslide debris, reinstatement of the slope drainage and protection of the landslide scars, at the recommendation of GEO. BD served a DH Order on the owners of Nos. 4 and 5 Chung Shan Terrace on 3 November 1997 at the recommendation of GEO.

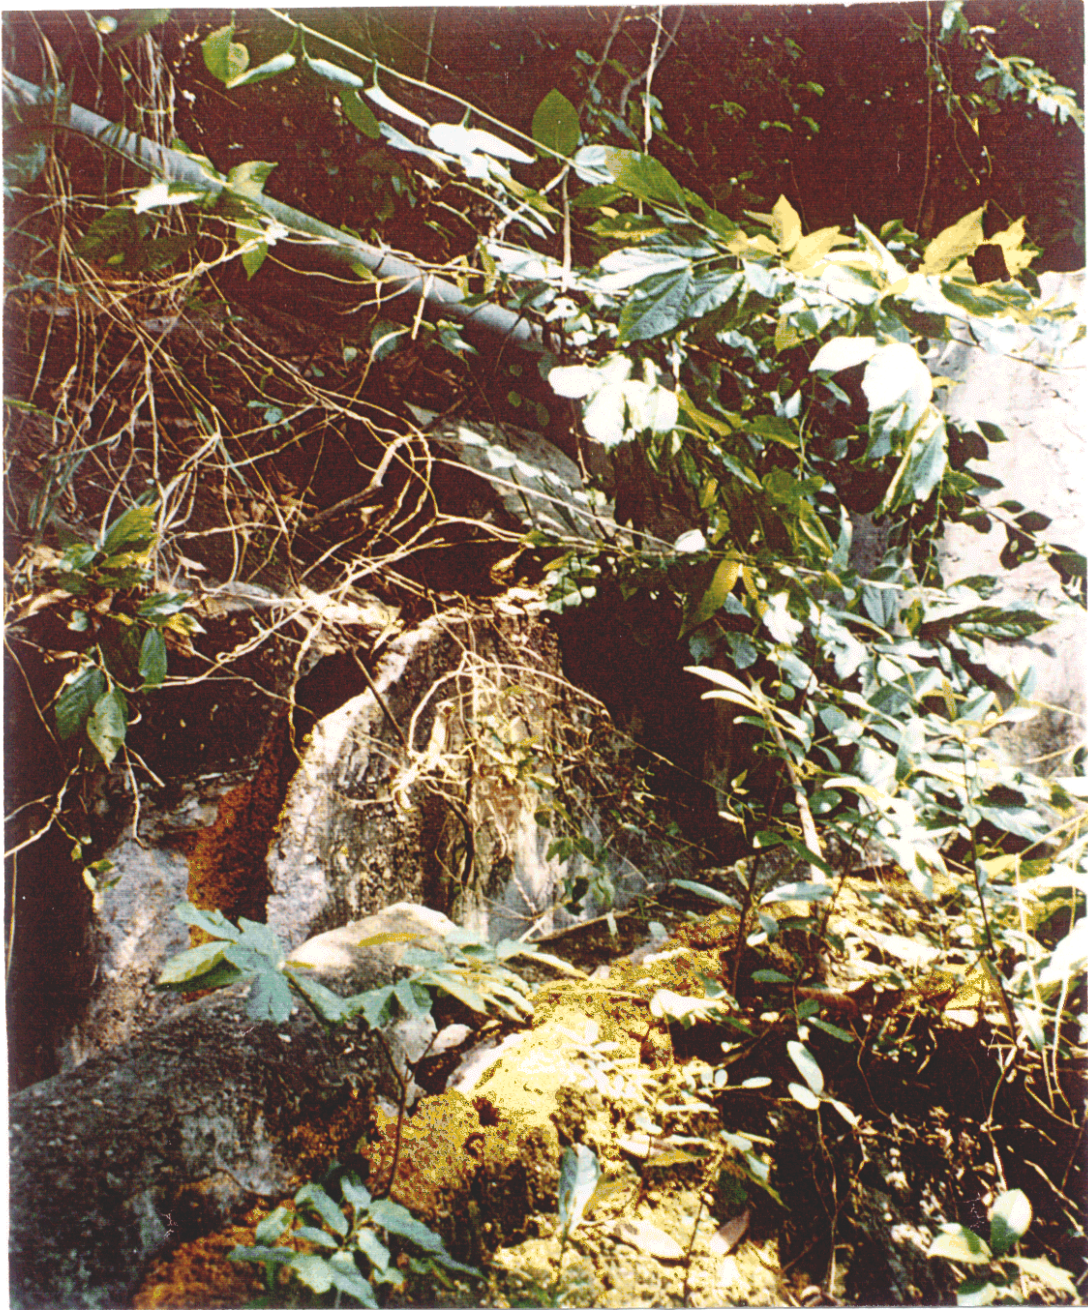
Plate 6 - Broken U-channel and Displaced Catchpit at Landslide B
(Photograph Taken on 5 June 1997)

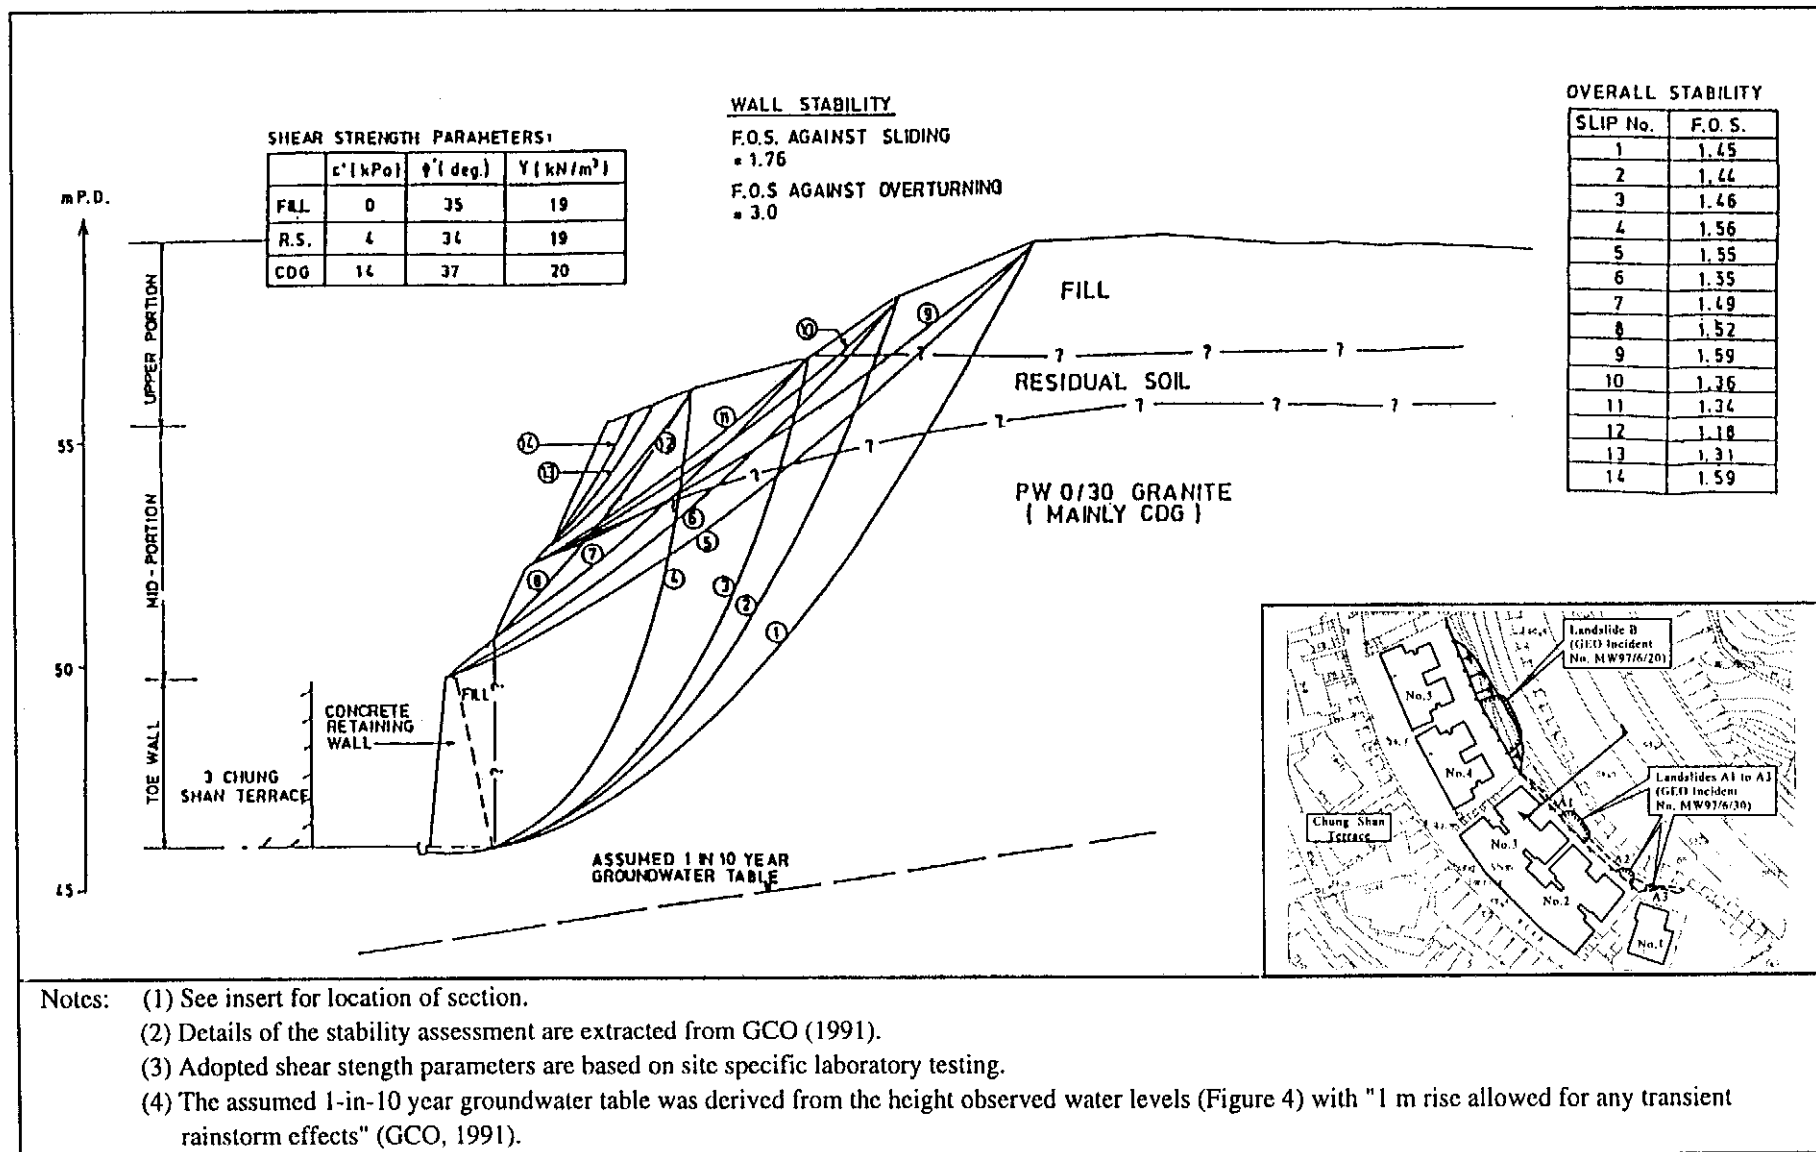
Figure A2 - Stability Assessment for the 1991 Stage 2 Study

The Stage 2 Study of the southern part of wall No. 11NW-A/R6, wall No. 11NW-A/R12 and the cut slope above included a stability assessment of a section about 5 m northwest of landslide A1, based on site-specific ground investigation that included boreholes (GCO, 1991). The location of the section together with the adopted geological model, assumptions and results of the assessment are summarised in Figure A2 of Appendix A.

The factor of safety of the potential failure surface, which most closely represents the rupture surface of landslide, A1 was about 1.5. It was also noted that "local slips in the residual soil" had a "marginally inadequate" factor of safety of 1.18. It was considered, however, that "the critical slip is quite small and shallow and (that) its failure would not affect the houses below". It was further noted that the stability of this part of the slope could "be maintained if adequate drainage is provided to minimise surface erosion and infiltration." The retaining walls were considered to have adequate factors of safety.

Following the Stage 2 Study, the BLD advised the owners of Nos. 2 and 3 Chung Shan Terrace in June 1992 to "provide (a) surface channel along (the) slope crest and behind the wall clear vegetation from the slope (and) protect the cleared slope surface with chunam plaster". The absence of surface protection and drainage on the slope, noted by HAP during the investigation of the landslides, suggests these works were not carried out before the 1997 failures occurred.
