**SECTION 3:
DETAILED STUDY OF
THE LANDSLIDES
AT KA TIN COURT,
SHATIN
ON 2 JULY 1997**

Halcrow Asia Partnership Ltd

**This report was originally produced in December 1998
as GEO Landslide Study Report No. LSR 24/98**

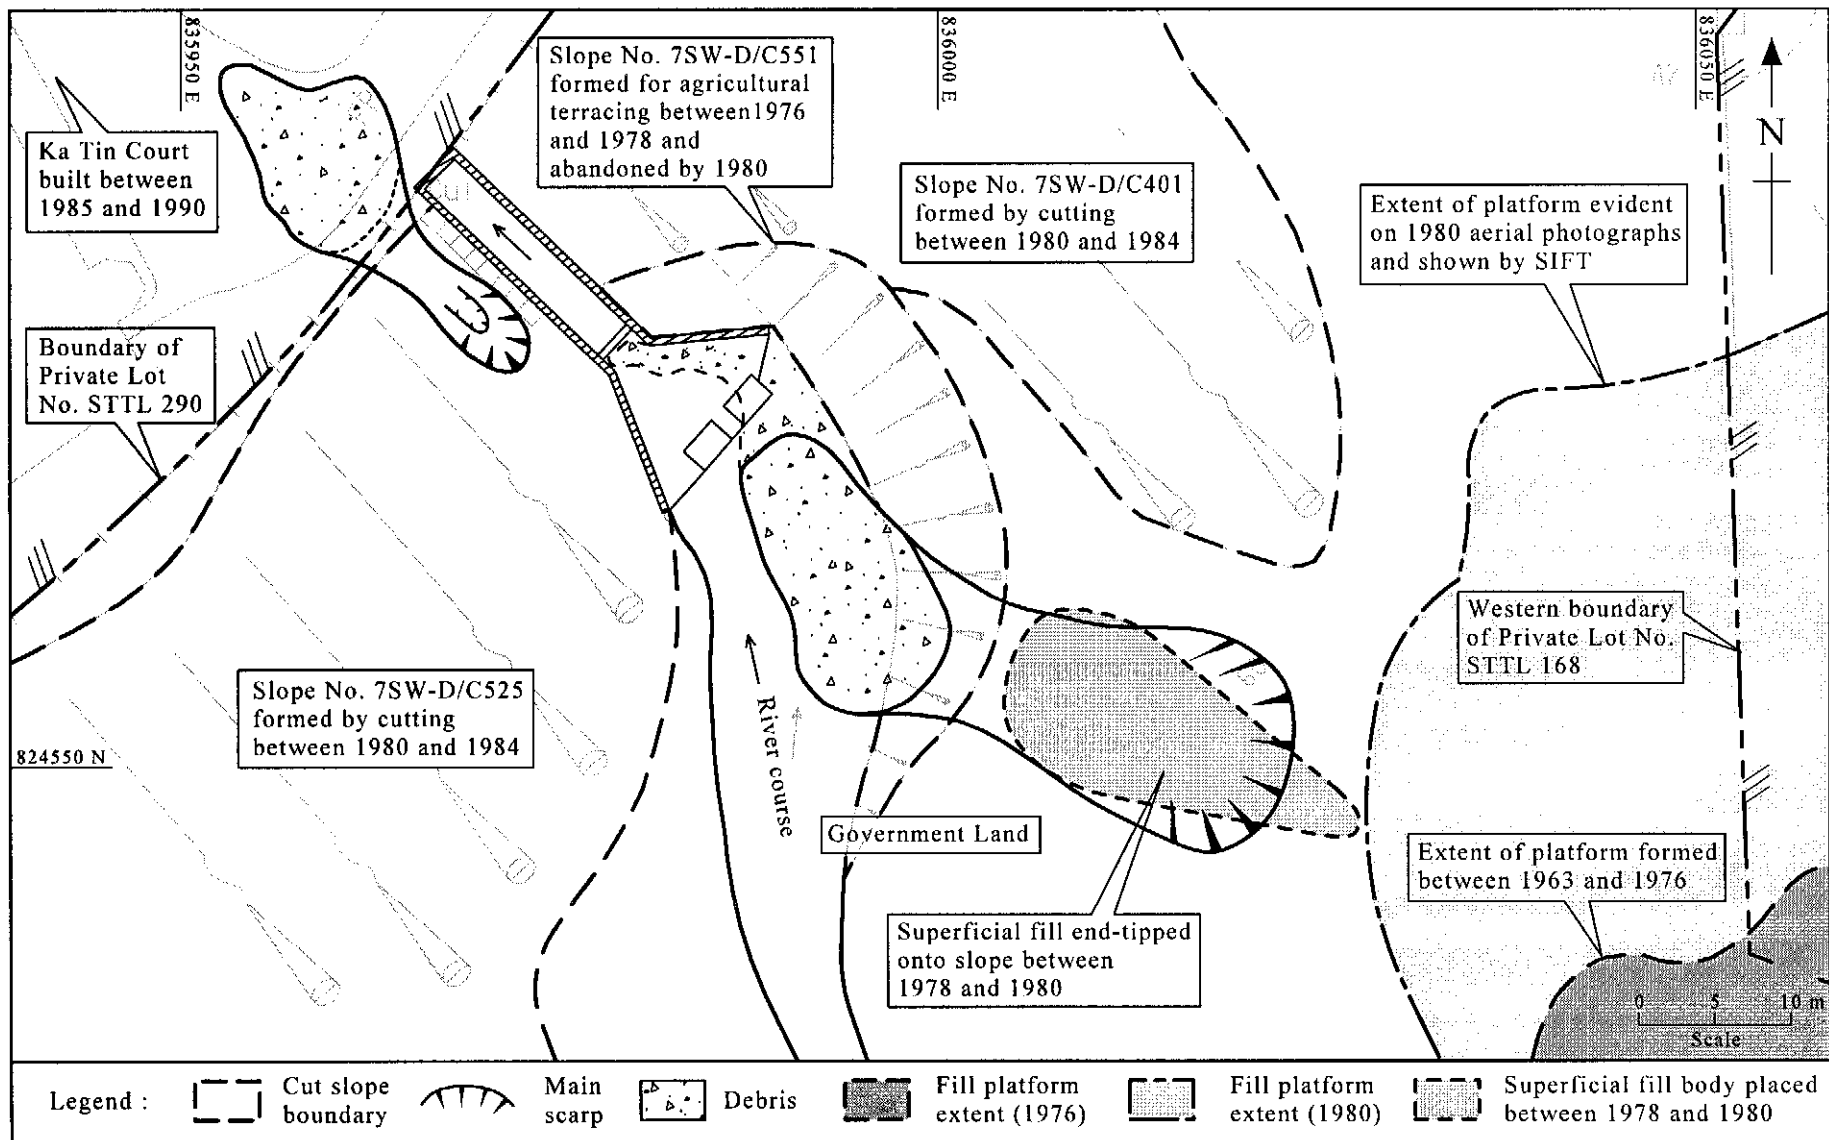
Figure 3 - Land Status and Site History

The morphology and observations made in and around the landslide scar suggest that the landslide probably involved sliding failure of the completely decomposed granite as well as the fill that had been placed on that part of the slope between 1978 and 1980 (Figure 3).

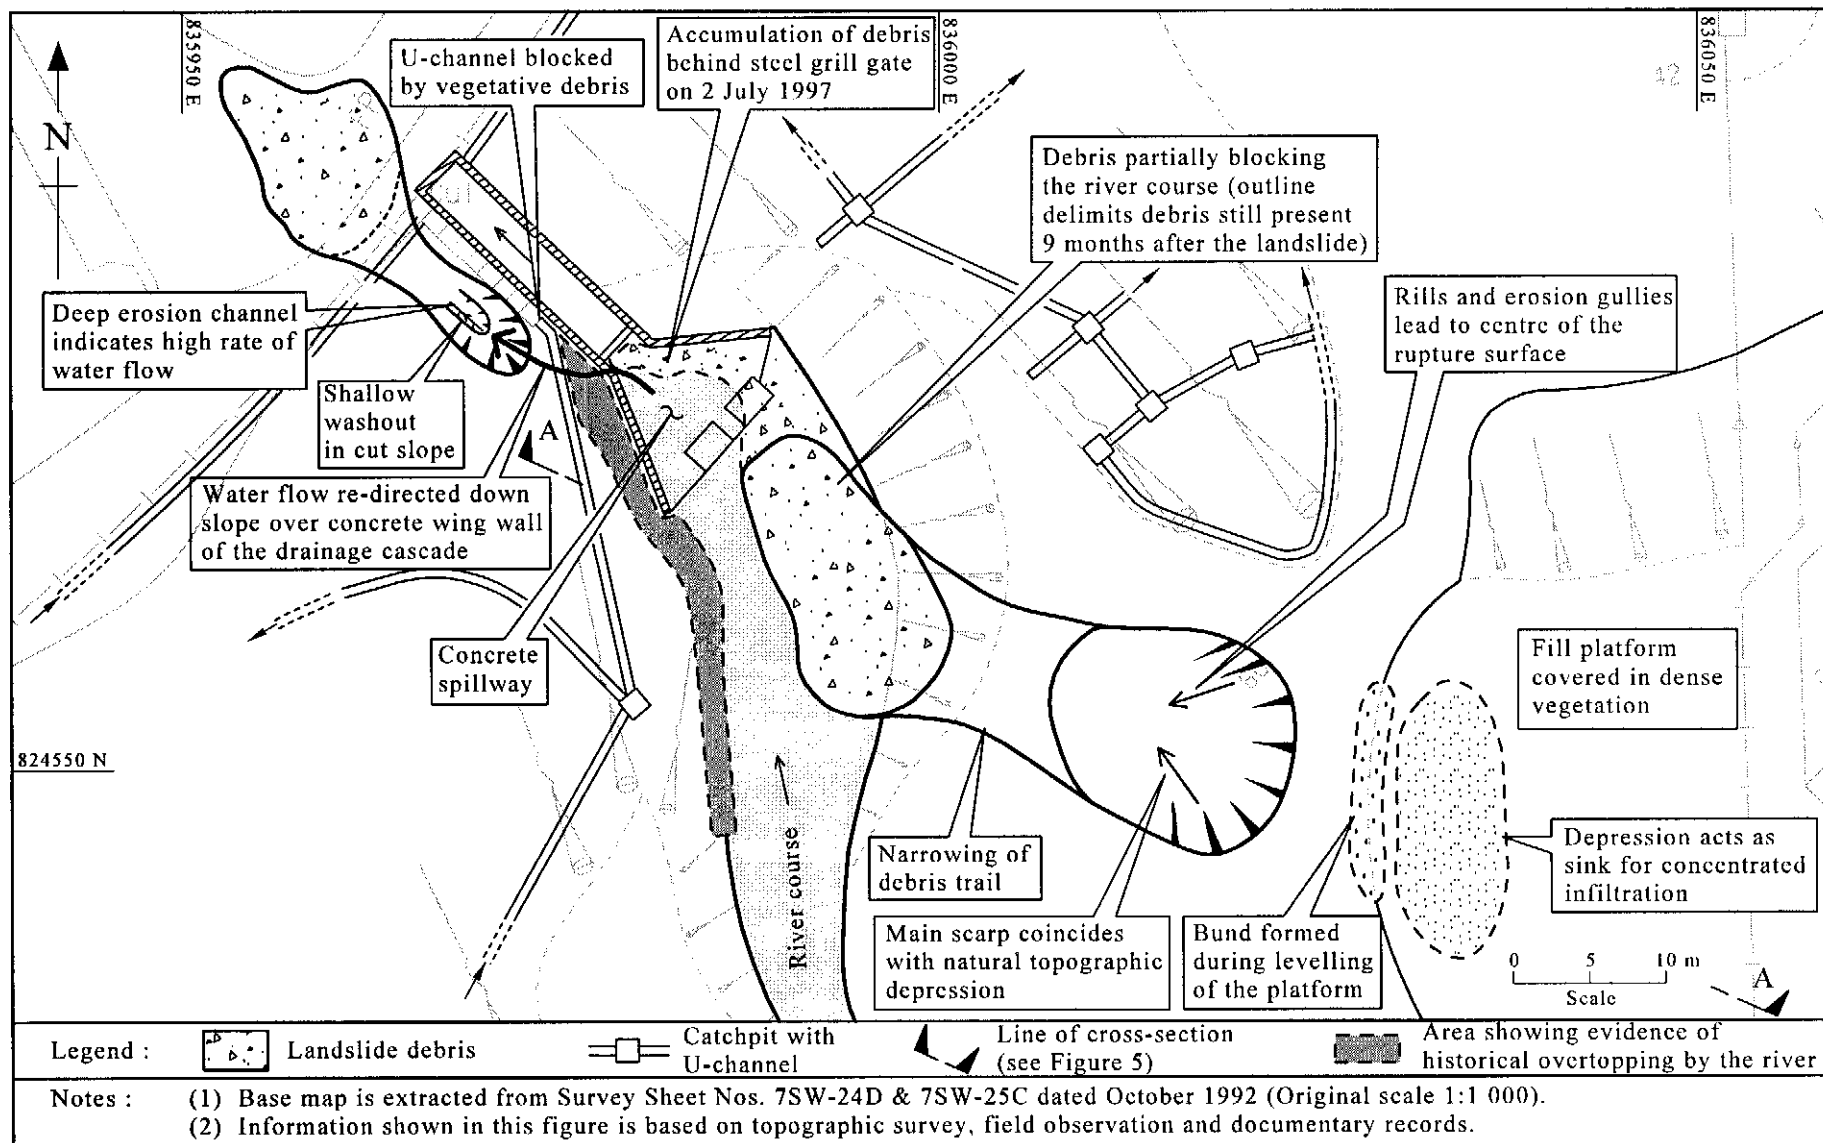
Figure 4 - Detailed Plan of the Landslide and Washout

HAP also observed that the fill platform above the crest of the landslide was overgrown and contained a hollow, about 17 m wide, 7 m long and up to 0.5 m deep (Figure 4). A bund of fill, about 0.3 m high, was also present beyond the crest of the valley-side slope, which was probably formed during the site formation work for the hospital platform (Figure 4). The hollow and bund together would have acted as a sink for water collection.

Debris from the landslide stripped material from the area lower down the valley-side slope and cut slope No. 7SW-D/C551 (Figure 4) and was deposited in the river bed at the toe. The river bed was found to be strewn with stream deposits including rounded boulders, typically between about 0.5 m and 1 m in diameter, that would have been present before the 2 July 1997 incident. The travel angle of the landslide debris was estimated to be about 30°, which is typical for rain-induced landslides in Hong Kong (Wong & Ho, 1996).

Localised erosion, stripping of vegetation and deposition of fines immediately upstream of the steel grill gate indicated that the river overtopped the concrete wing wall on the west side of the drainage cascade (Figure 4). There is also evidence that large areas of the west bank of the river have been affected by overtopping in the past (Figure 4).

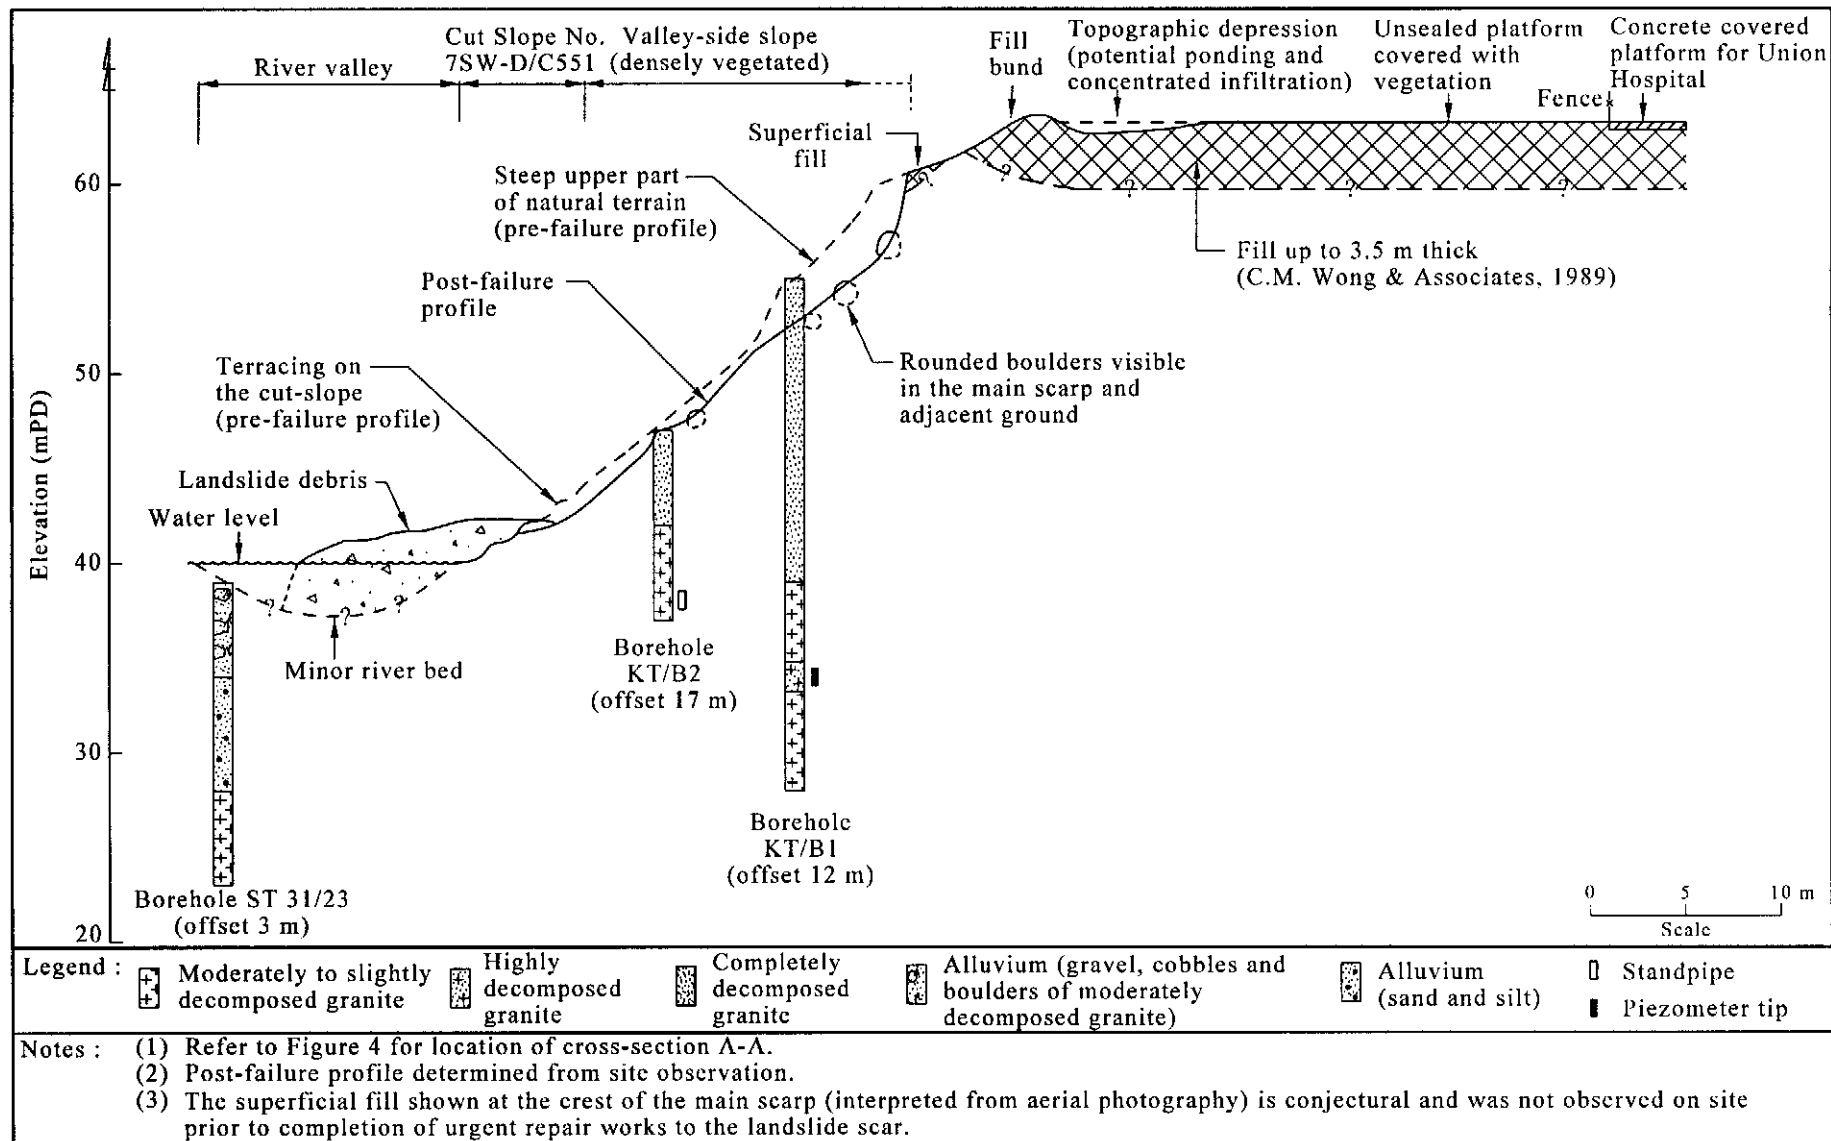
Figure 5 - Cross-section A - A through the Landslide

A piezometer was installed in borehole KT/B1 within the highly to moderately decomposed granite at about 33.5 mPD and a standpipe was installed in borehole KT/B2 in moderately to slightly decomposed granite near the base of the borehole (Figure 5). Water levels were recorded in the piezometer and standpipe at about 41 mPD and 38.5 mPD respectively during November 1996.

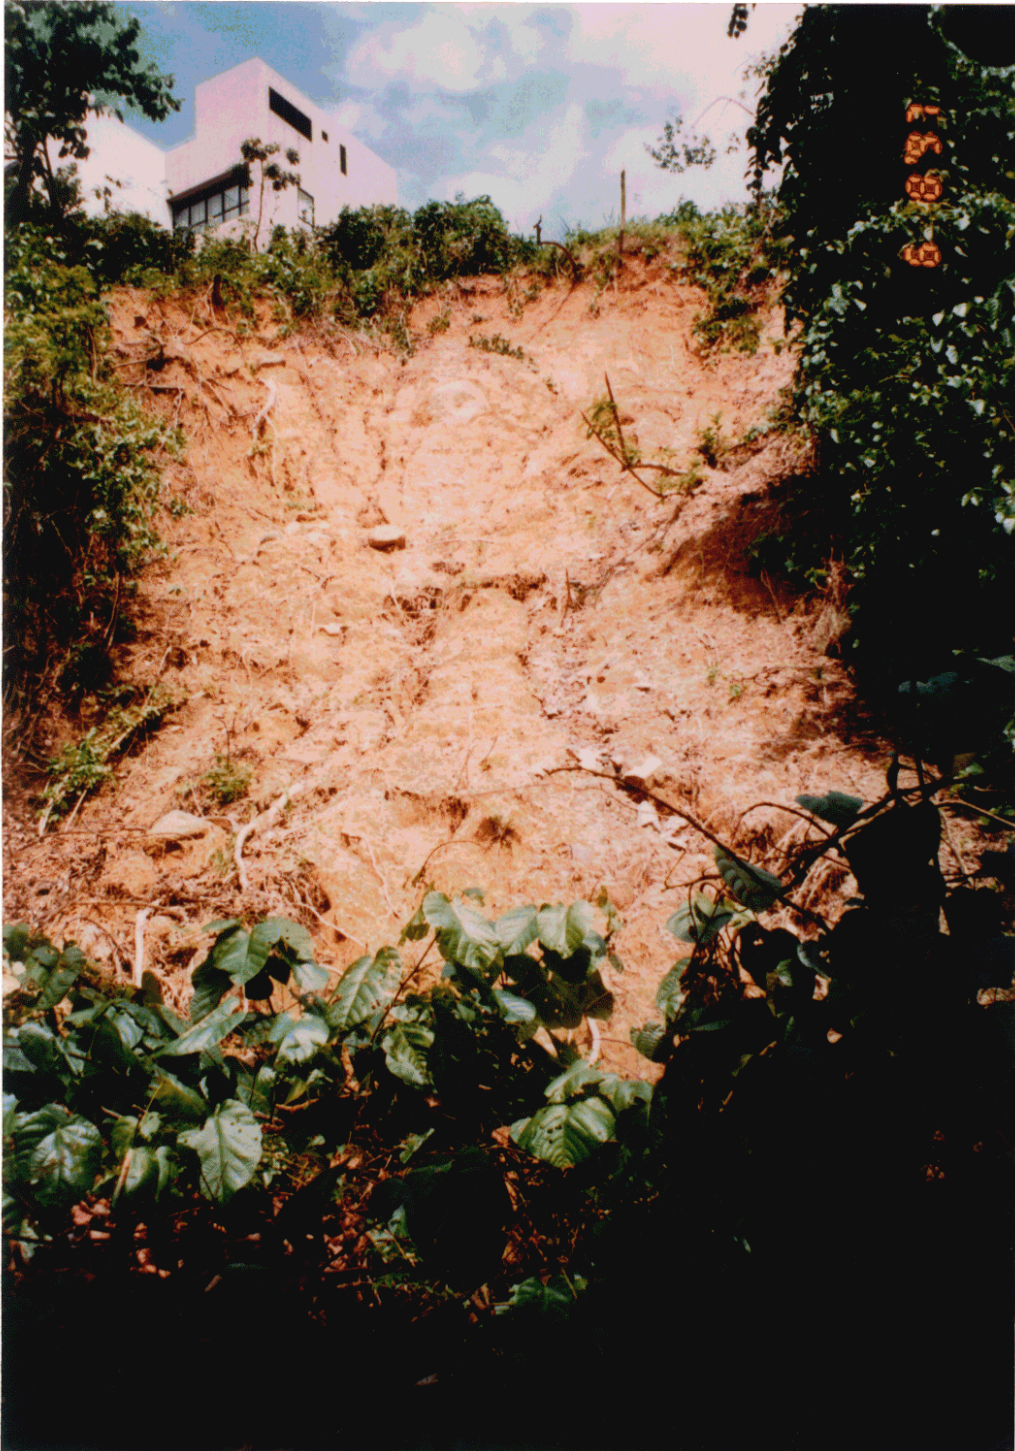
The landslide principally involved the failure of the partly-modified natural valley-side slope below the fill platform. The main scarp of the landslide was up to 10 m wide, 15 m in length and 2 m deep. The estimated volume of displaced material was 150 m³, excluding the material stripped from the valley-side slope (Section 2.1). The Incident Report prepared by the GEO following an inspection of the landslide on 5 July 1997 indicated that the failure occurred on "natural terrain" and involved "partially weathered rock". There was no record of groundwater seepage in the main scarp. HAP carried out a preliminary inspection of the landslide on 6 August 1997. During the inspection observations confirmed the presence of completely decomposed granite. No seepage of groundwater in the main scarp was observed at

Plate 1 - General View of the Landslide (Photograph Taken on 6 August 1997)

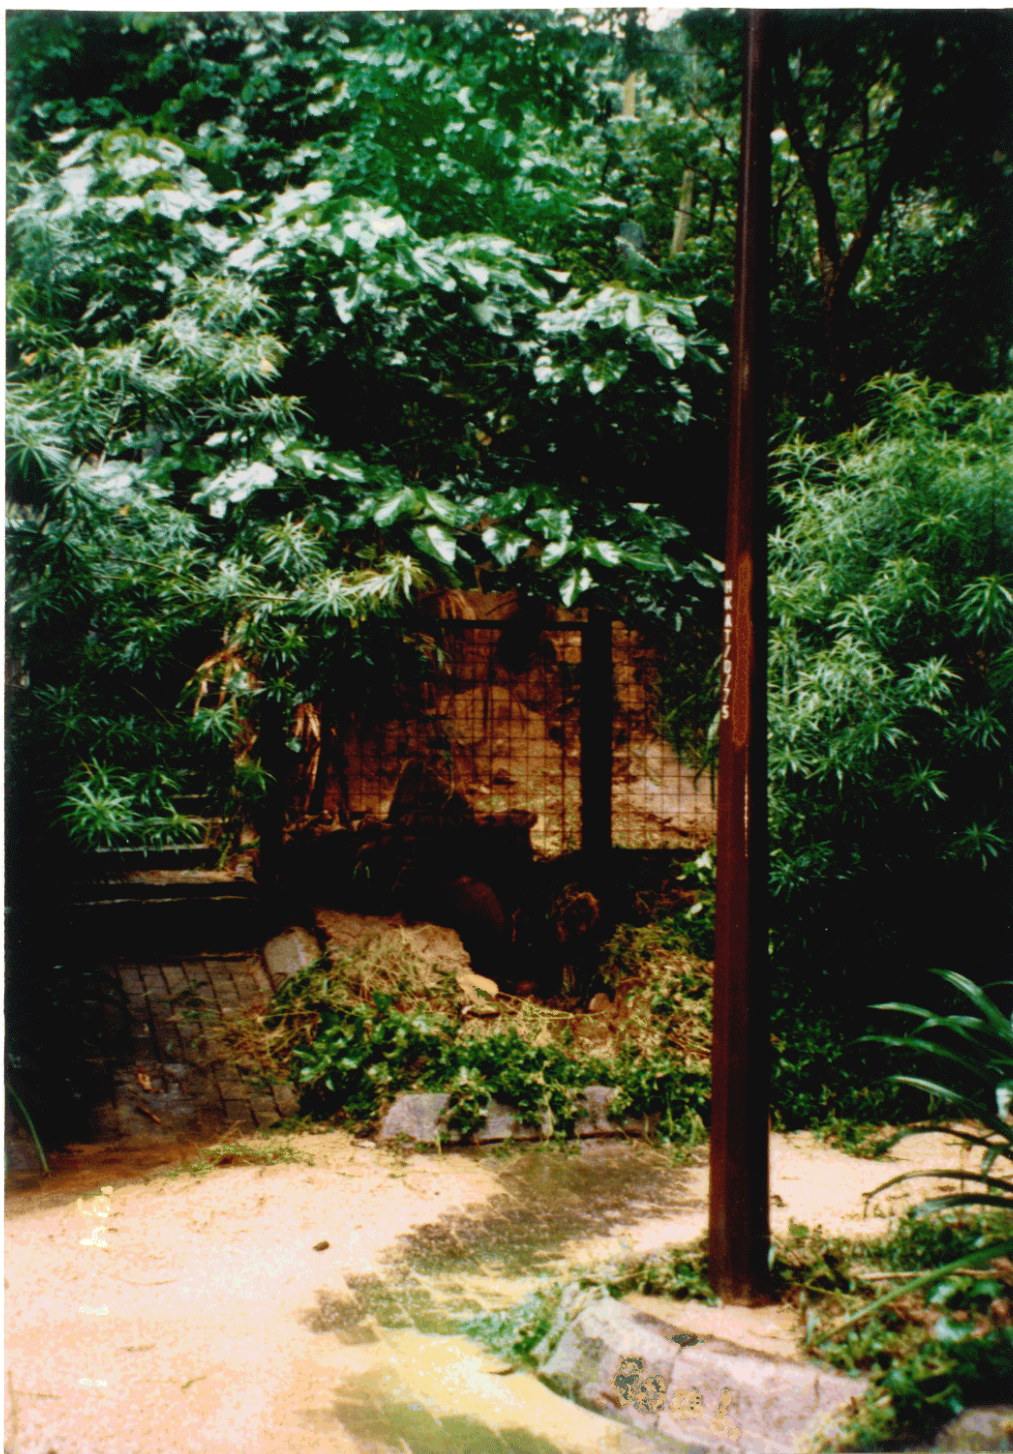
Plate 2 - General View of the Washout (Photograph Taken on 3 July 1997)

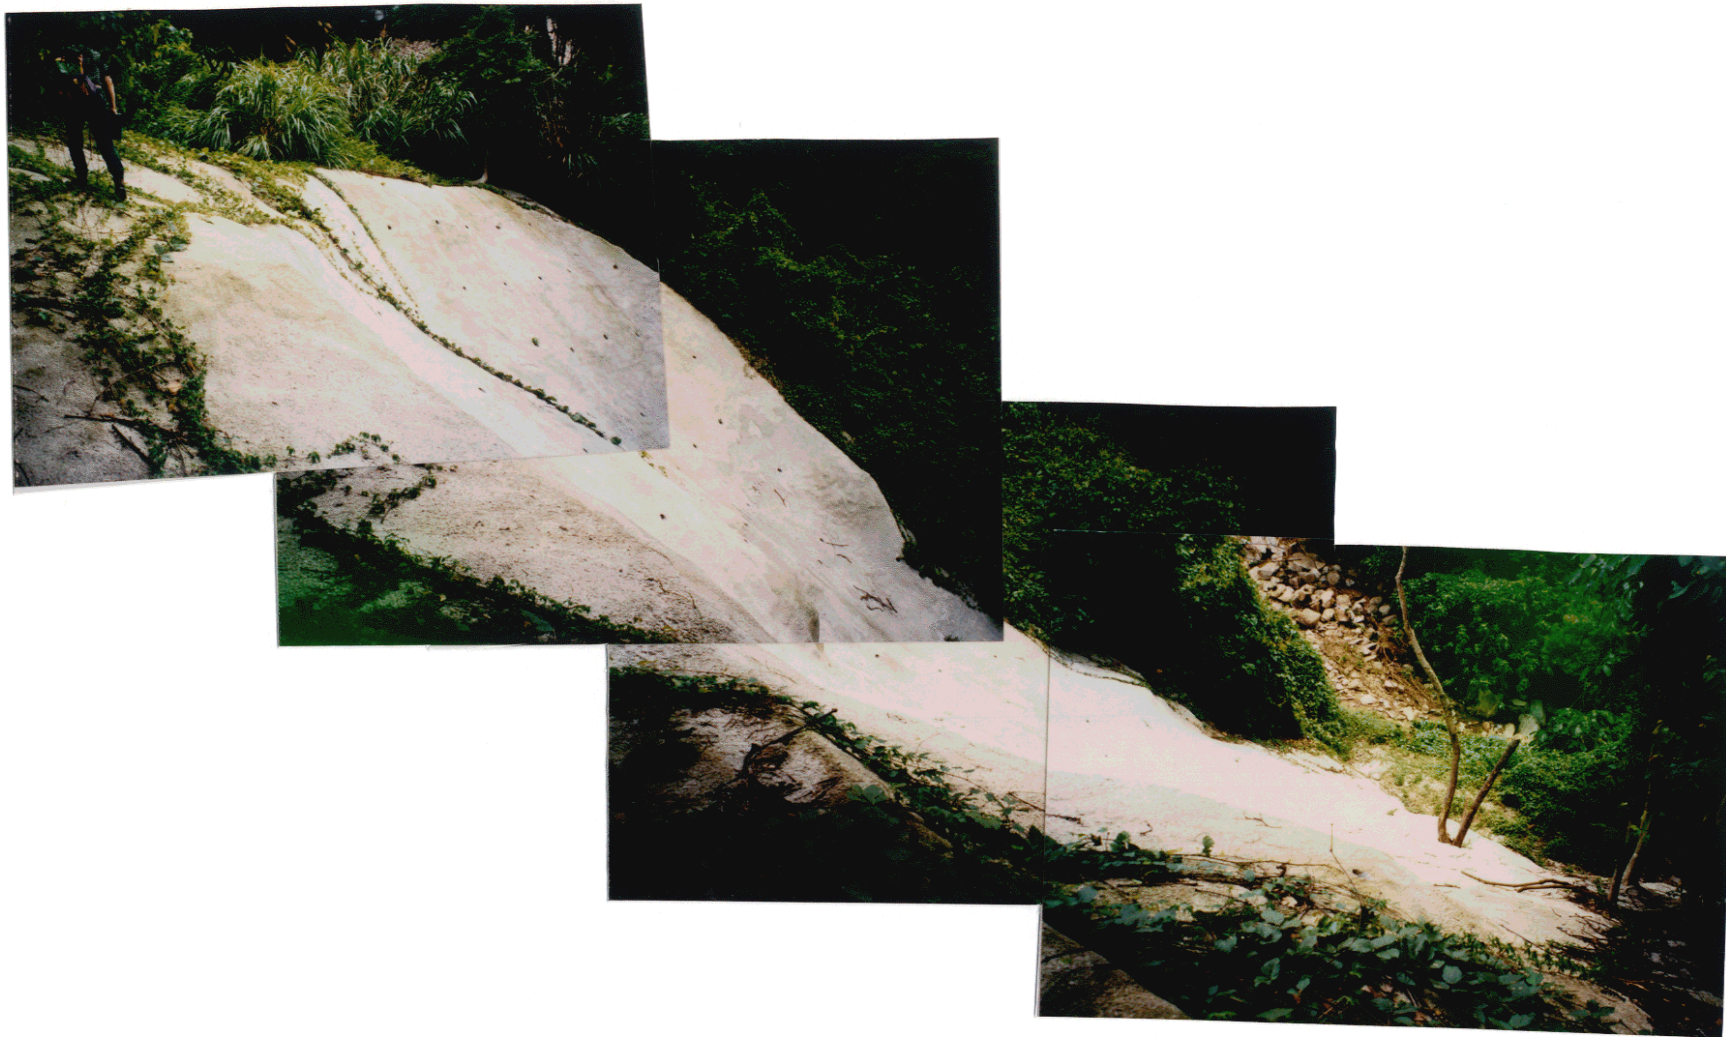
Plate 3 - View of the Landslide and Valley-Side Slope (Photograph Taken on 16 June 1998.
Note: the Valley-Side Slope is Locally Inclined at 50°)

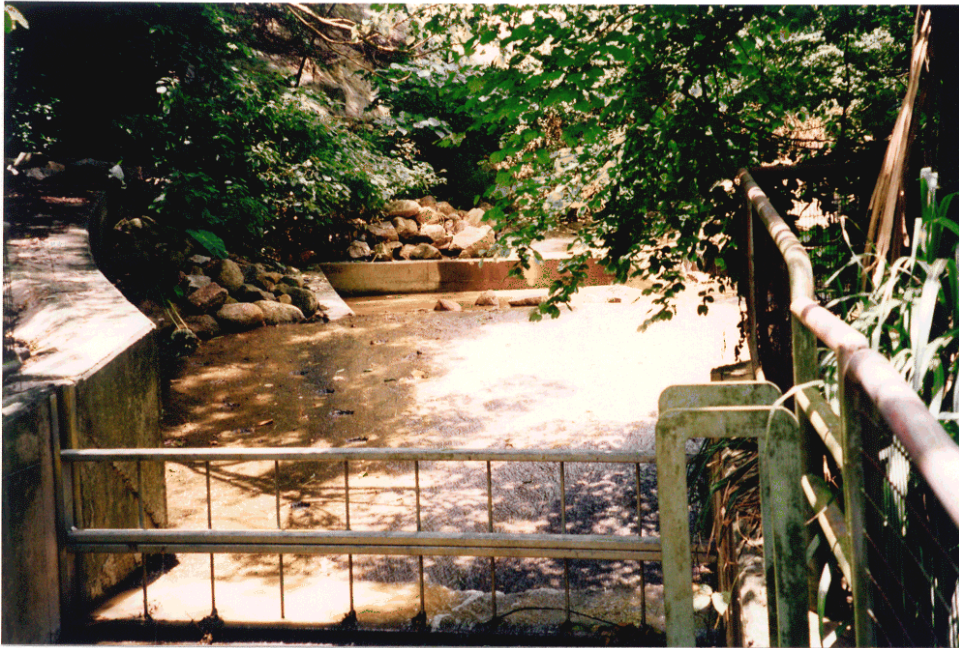
A steel grill gate across the entrance to the cascade was observed to be partly obstructed by landslide debris that included a significant proportion of vegetation. This material appeared to have been transported by water flow within the river course, that would have been relatively high in response to heavy rainfall in the area on 2 July 1997 (see Section 4).

Plate 4 - View of the Entrance to the Drainage Cascade, Showing the Steel Grill Gate (Photograph Taken on 16 June 1998)

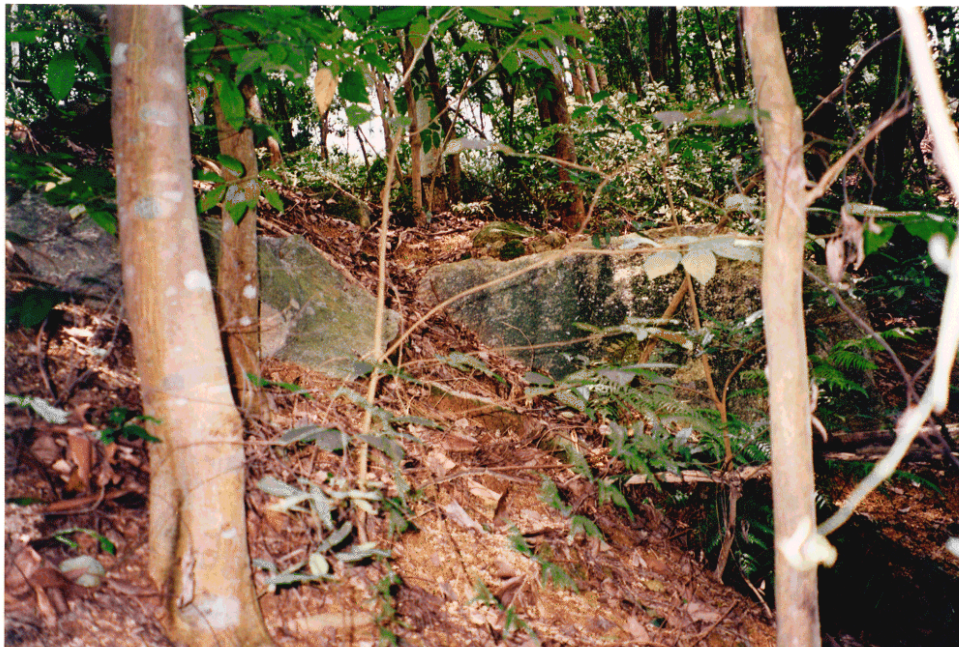
Field reconnaissance of the area surrounding the landslide scar carried out by HAP during the investigation, however, identified highly to completely decomposed, coarse-grained granite with some sub-angular to rounded boulders up to 1.5 m in diameter on the north side of the landslide (Plate 5). On the south side of the landslide, the geology comprised completely decomposed granite with some rounded, similarly sized boulders. The landslide scar was also observed to have occurred within a topographic depression on the valley-side slope, that would have directed surface water towards the landslide site.

Plate 5 - Boulders Set in a Matrix of Highly to Completely Decomposed Granite (Photograph Taken on 16 June 1998)

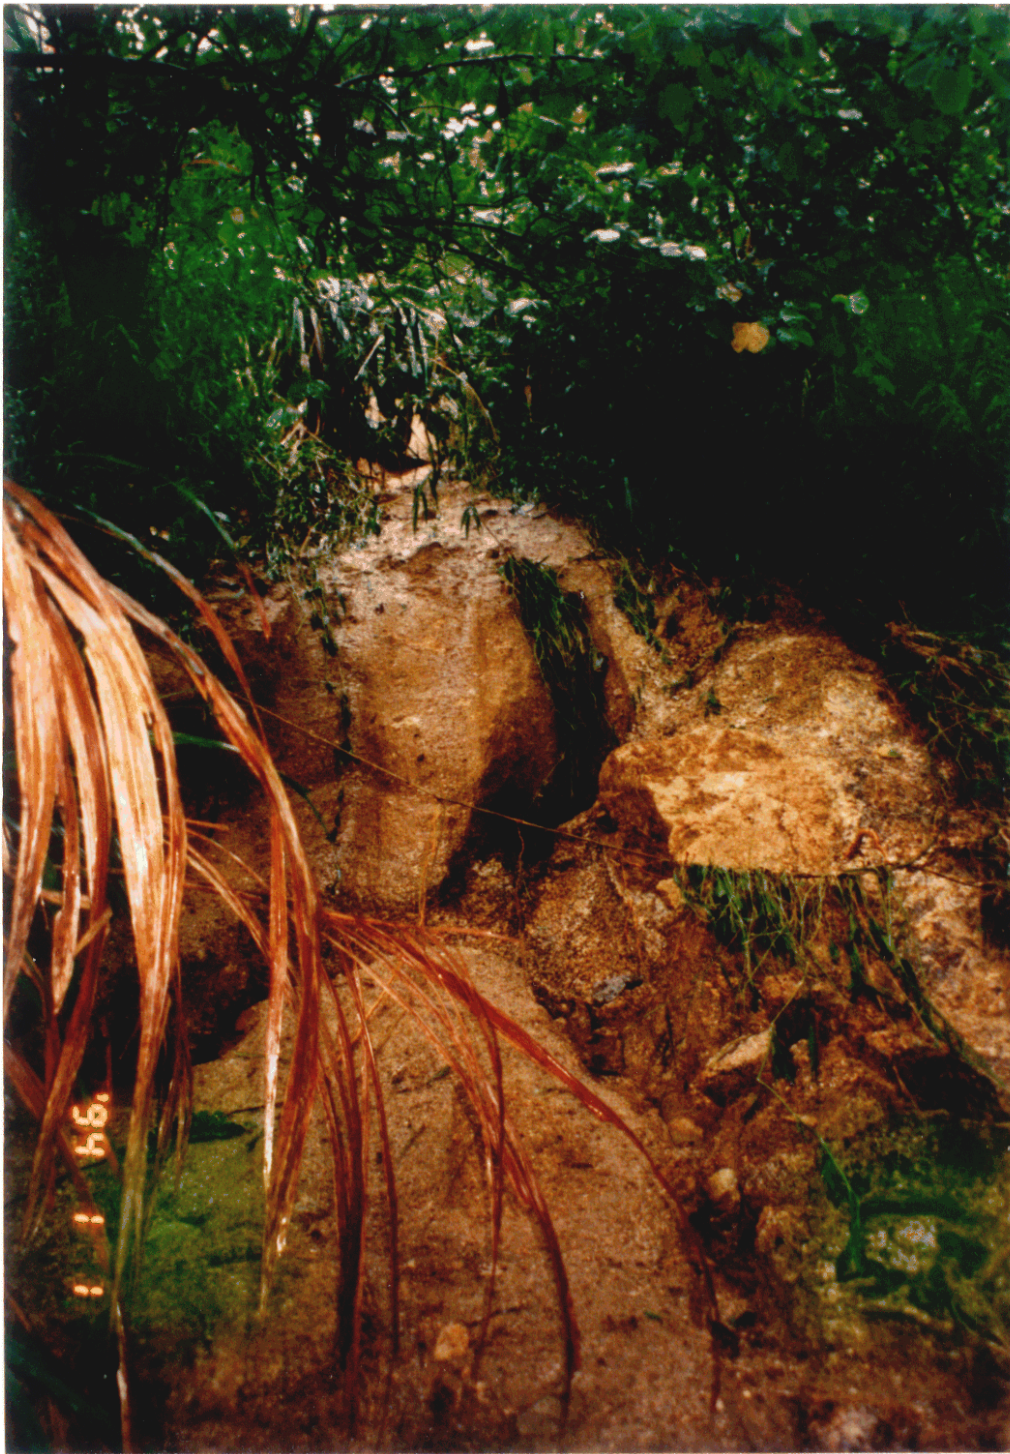
A 1 m-deep channel was observed to have been eroded on the unsealed cut slope (No. 7SW-D/C525) adjacent to the drainage cascade. This was caused by water that had overtopped the river course and flowed over the concrete wing wall of the drainage cascade and onto the cut slope, resulting in the washout into Ka Tin Court (Plate 6).

Plate 6 - Erosion Channel and Washout Scarp
(Photograph Taken on 3 July 1997)
