**SECTION 4  
DETAILED STUDY OF  
TWO FAILURES  
AT LI PO CHUN  
UNITED WORLD COLLEGE,  
WU KAI SHA  
ON 2 JULY 1997**

**Halcrow Asia Partnership Ltd**

**This report was originally produced in December 1998  
as GEO Landslide Study Report No. LSR 25/98**

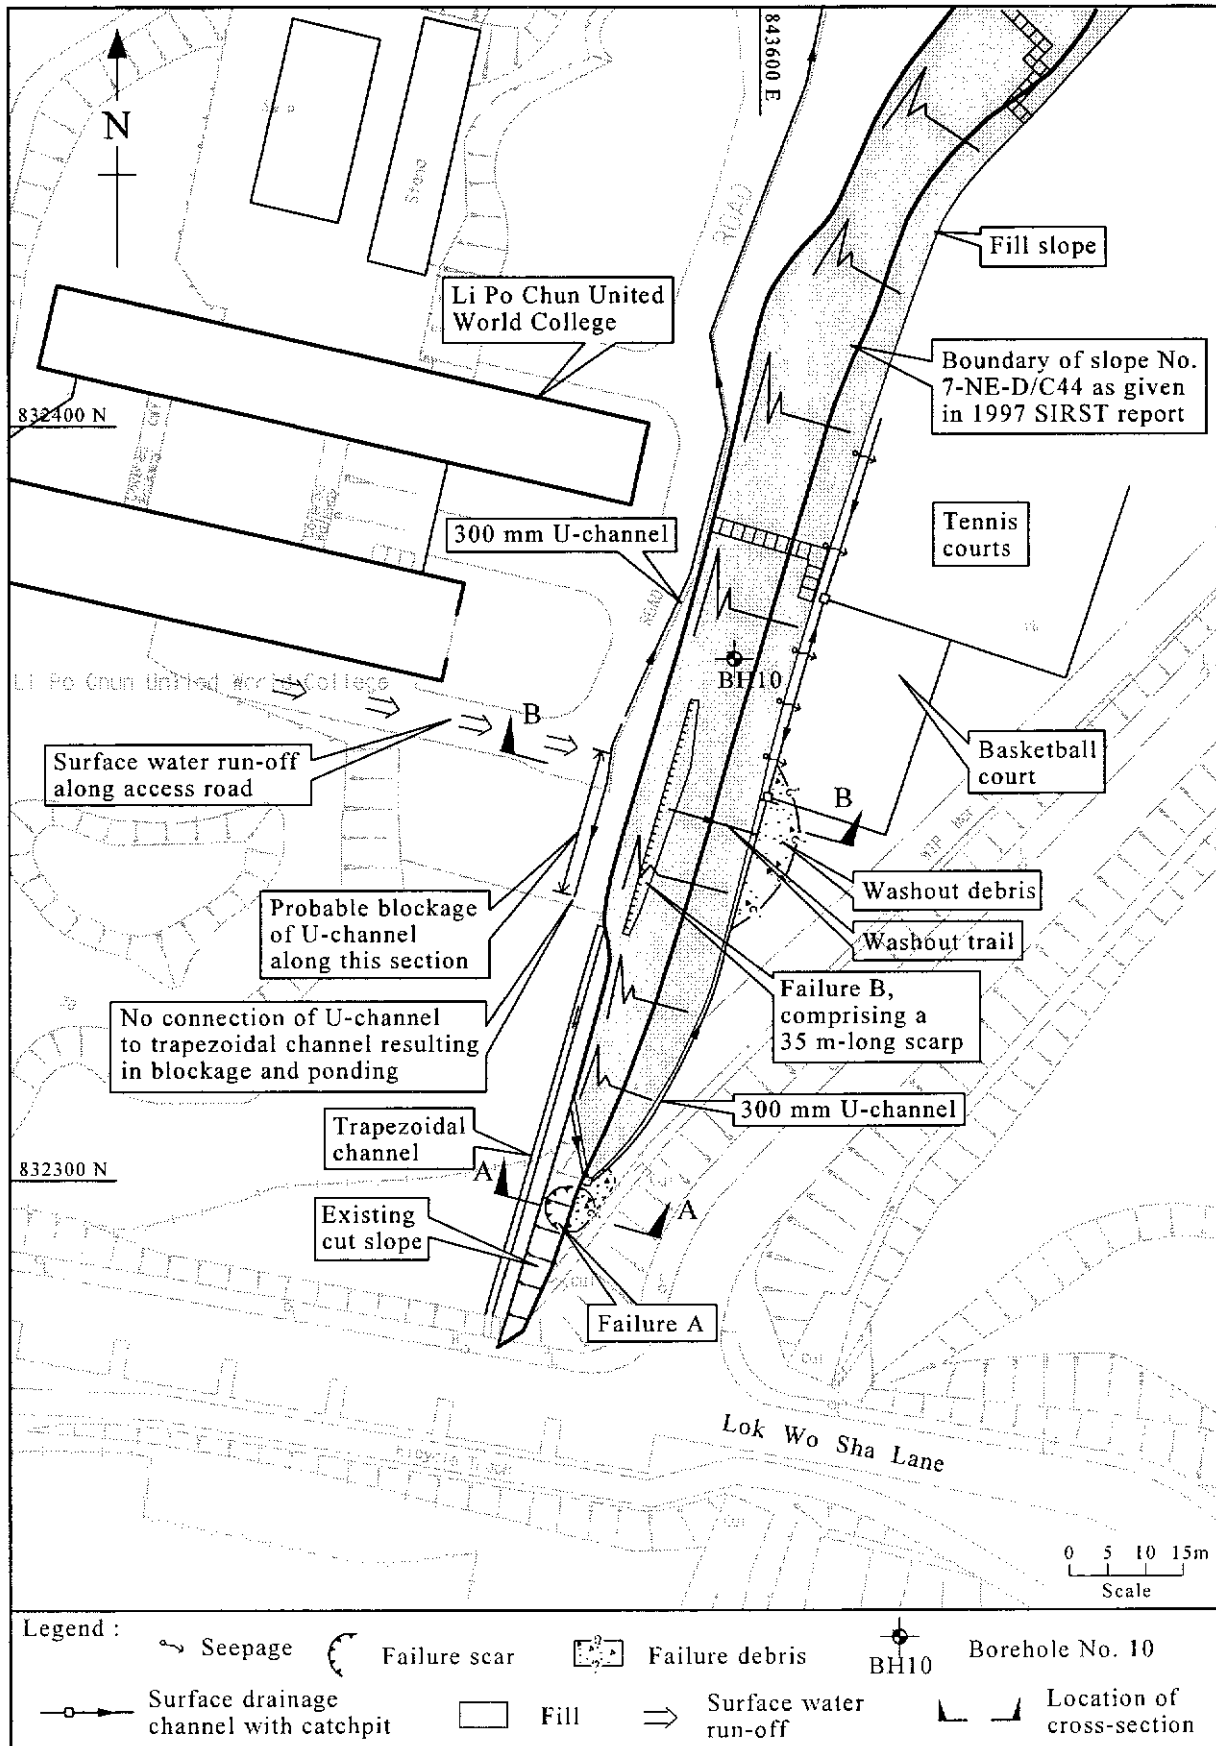
Figure 2 - Plan of the Failure Sites

The second failure (denoted 'B' in Figure 2), located to the east of an access road to Li Po Chun World College, occurred on an 8 m-high fill slope, which is inclined at about 30° to the horizontal and was constructed against an old cut slope in 1996. A basketball court and tennis courts are present at the toe of the fill slope.

The GEO Incident Report noted that the scarp for failure B was 6 m-long but according to information provided by the college, failure B consisted of a 35 m-long scarp at the crest of the fill slope near to its interface with the cut slope (Figure 2). The scarp was an approximately linear feature that ran parallel to the slope crest with a height of up to about 1 m. The face of the scarp was inclined at between about 45° and sub-vertical. Some time after the failure, it appears that secondary washout of the exposed fill occurred locally below the scarp, probably as a result of surface run-off. A narrow (less than 2 m wide), thin washout trail formed down the fill slope. The debris from the washout blocked the U-channel at the toe of the slope and a thin layer of debris accumulated on the adjacent open space (Plate 1). Based on the dimensions of the scarp, the estimated failure volume was about 25 m<sup>3</sup>.

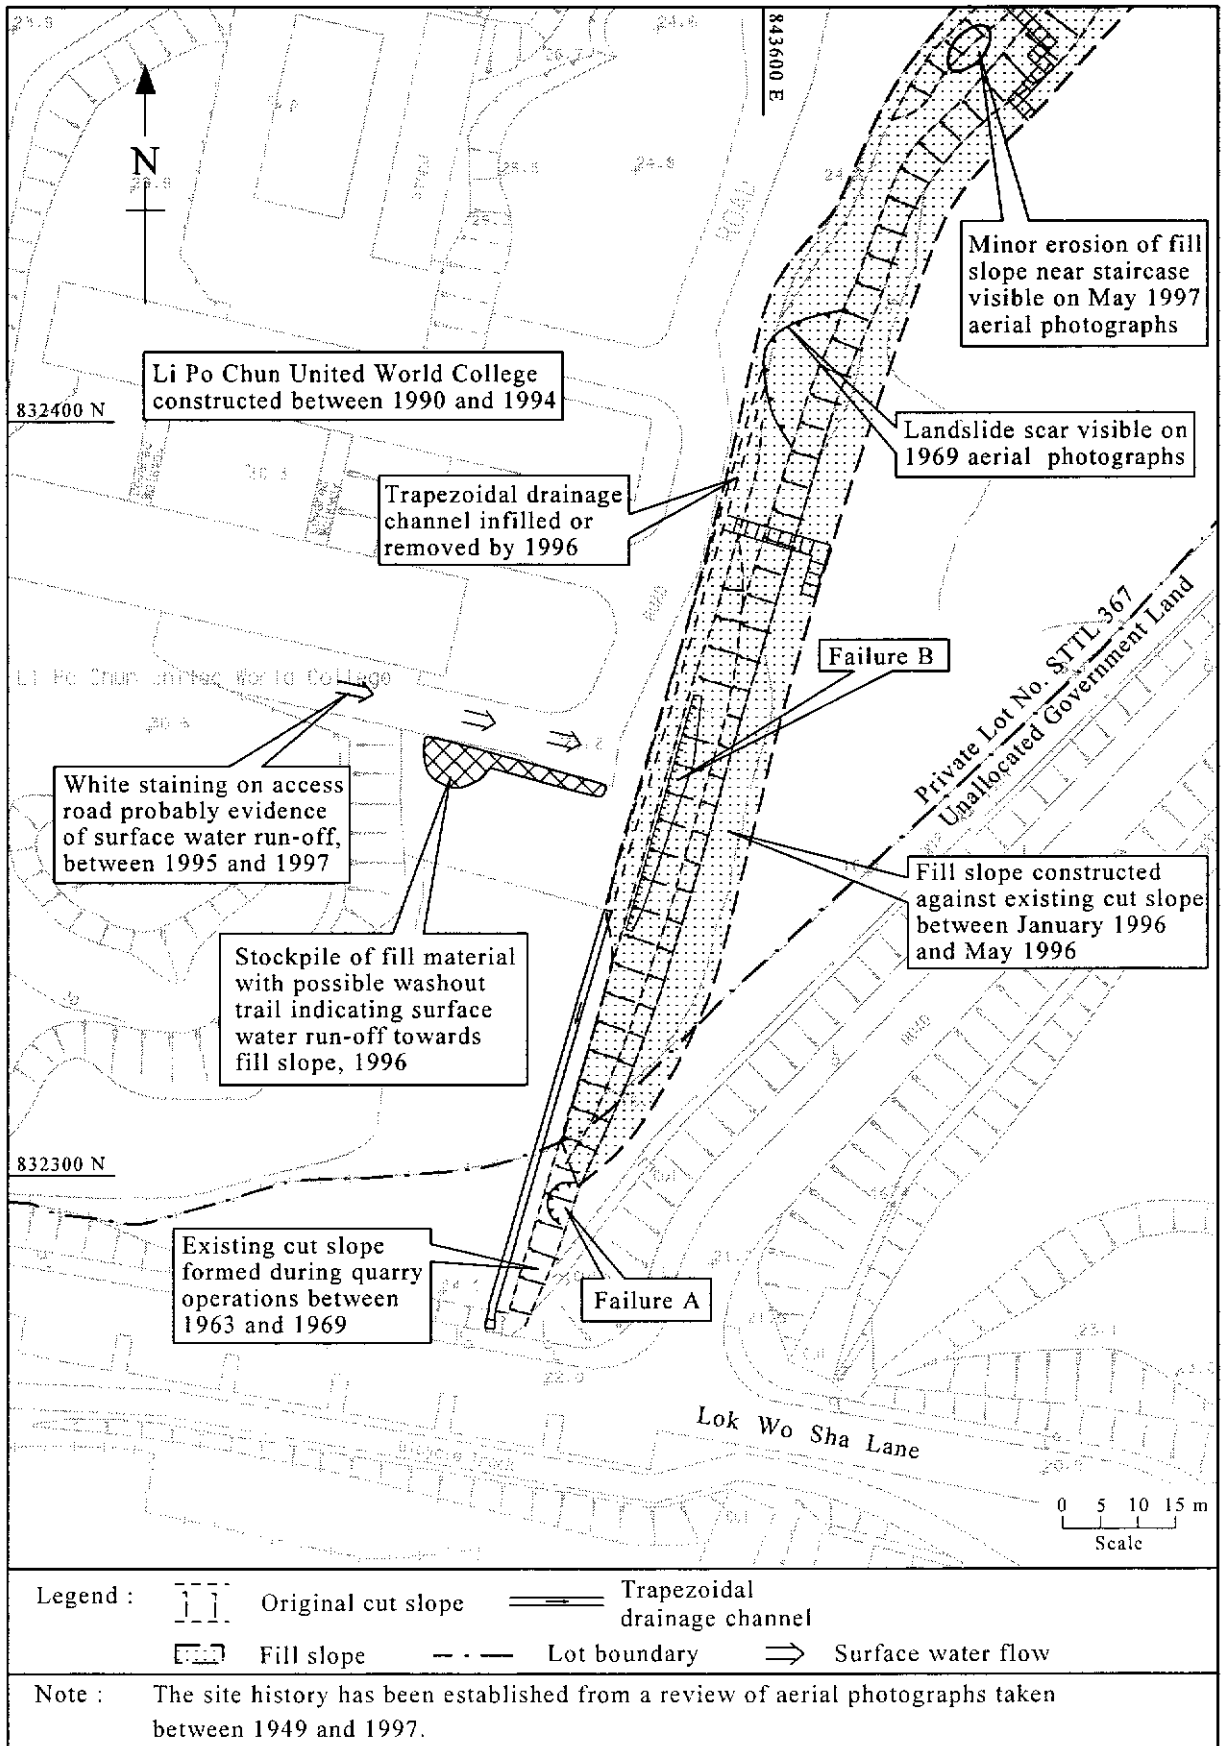
Figure 3 - Site History and Land Status

Aerial photographs taken in 1969 show that a large quarry was located at the site which modified the existing natural terrain and created the cut slope (Figure 3). At this time there was a trapezoidal drainage channel along the crest of the cut slope. This channel appears to have been either removed or infilled sometime before 1996. A fill slope was subsequently constructed against the cut slope, between January and May 1996, except for the southern-most 25 m-long section.

Aerial photographs taken in July 1995 show white staining on the access road above the location of failure B on the fill slope (Figure 3). It is considered likely that the staining resulted from surface water run-off down the access road.

A landslide was identified on the 1969 aerial photographs (Table 1) on the northern part of the original cut slope (Figure 3). The landslide scar was subsequently regraded and covered by the fill slope formed in 1996.

Minor erosion was observed near the northern part of the fill slope according to aerial photographs taken in May 1997 (Figure 3).

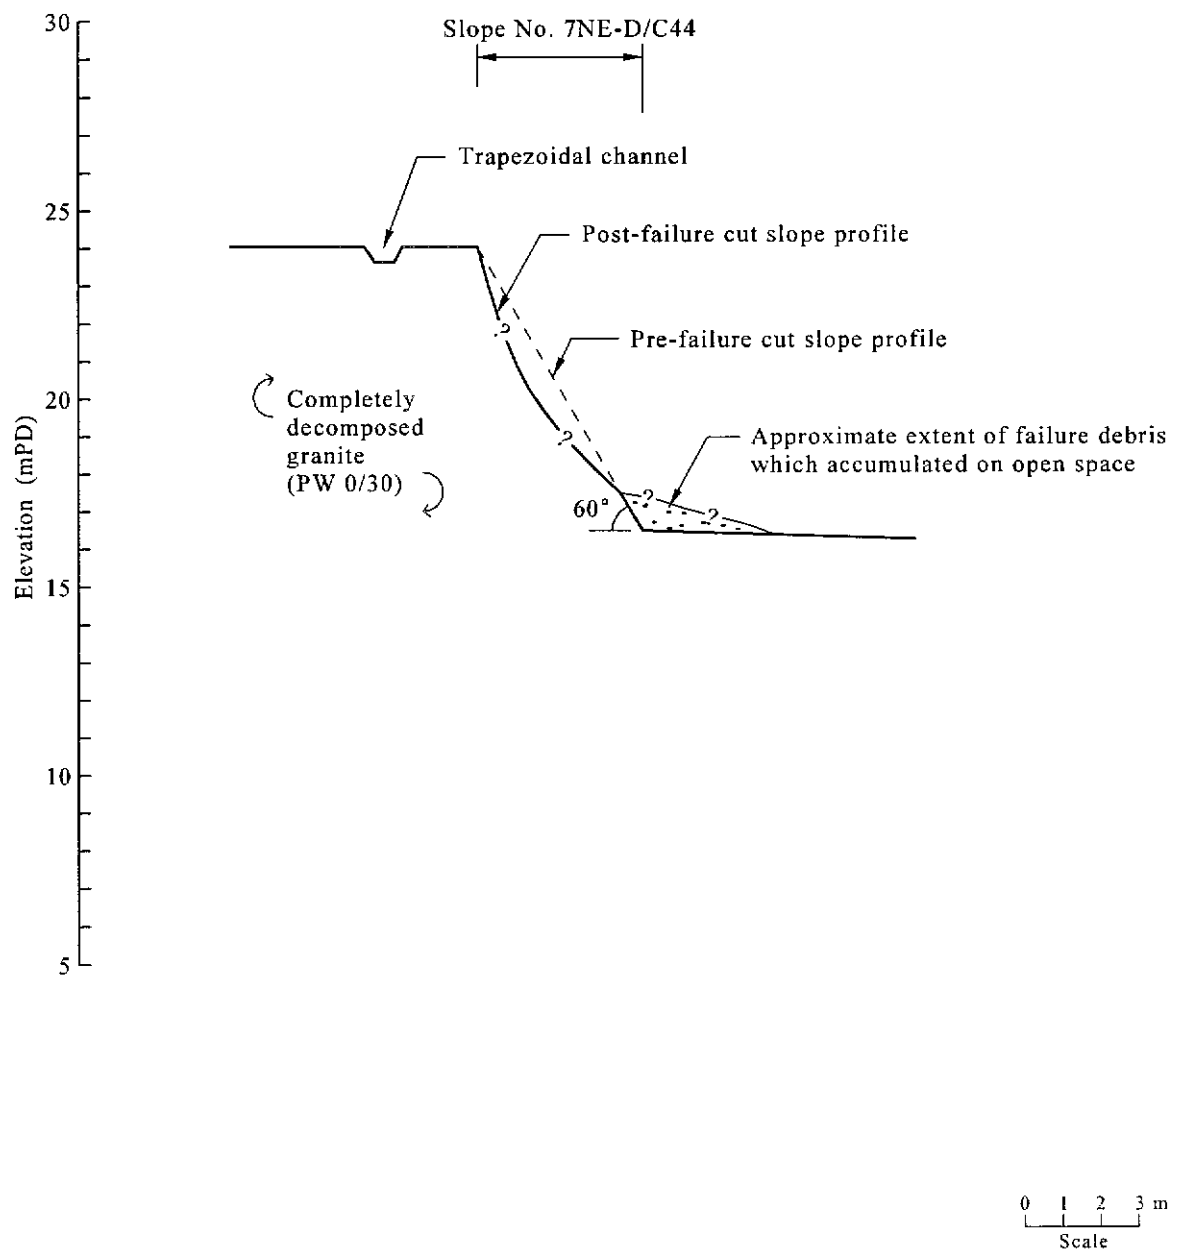
Figure 4 - Geological Cross-section A - A

At the location of failure A, adjacent surface exposures indicate that the cut slope comprised completely decomposed granite of mass weathering grade PW 0/30 (Figure 4).

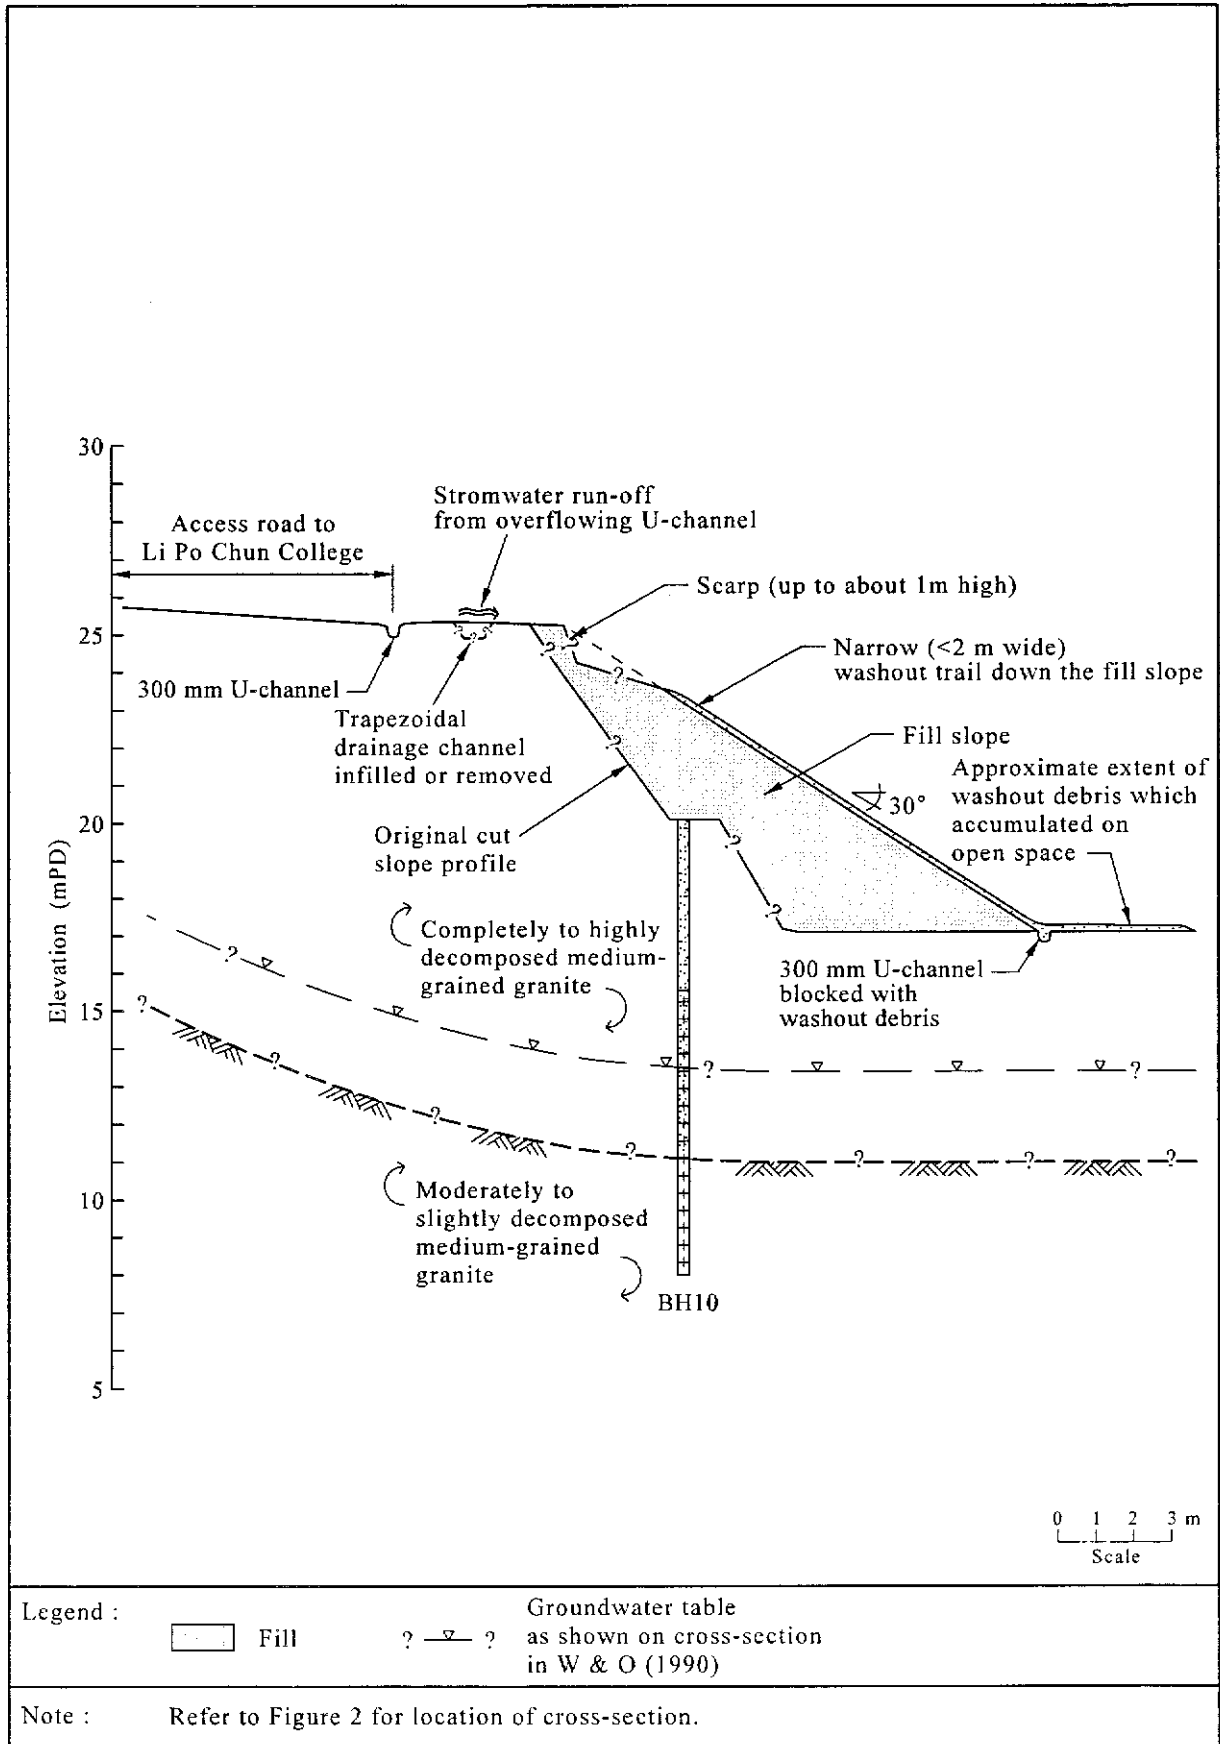
Figure 5 - Geological Cross-section B - B

A site investigation report by Lam Geotechnics Ltd (1990) included records of twelve boreholes drilled over the site of the proposed college development. Borehole No. BH10 was located about 20 m to the north of failure B (Figures 2 and 5). Groundwater assumed by W & O (1990) for the design was at a depth of about 4 m below the base of the newly-formed fill slope (Figure 5).

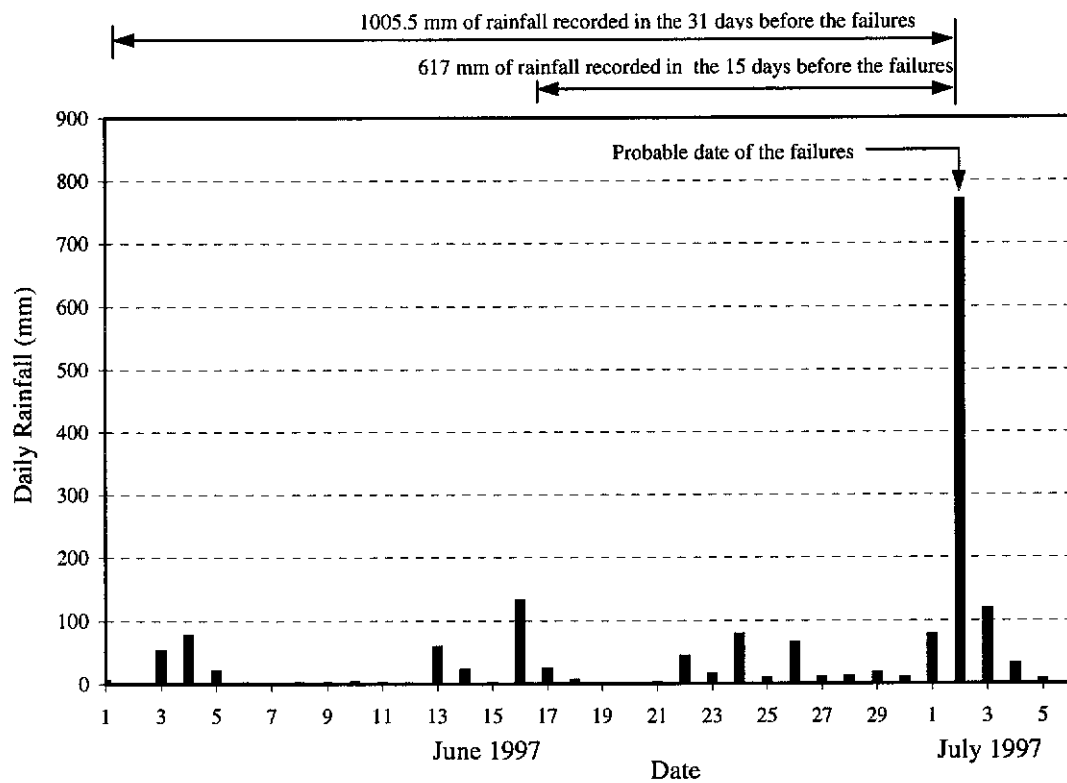
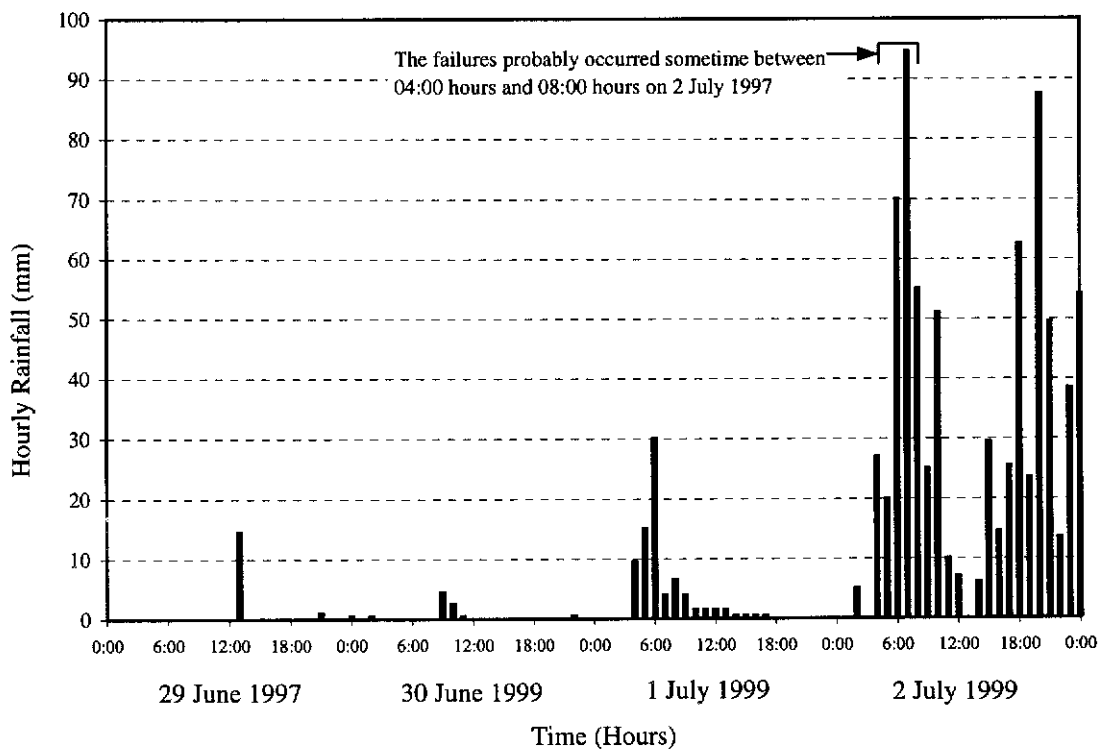
Figure 6 - Rainfall Recorded at GEO Raingauge No. N09

The nearest GEO automatic raingauge No. N09 is located at the Meteorology Laboratory at Chinese University, Sha Tin, about 4 km west of the site (Figure 7). The daily rainfall recorded between 1 June and 5 July 1997 is shown in Figure 6a. There was 1005.5 mm and 617 mm of rainfall in the 31 days and 15 days before the incidents respectively. The hourly rainfall between 29 June and 2 July 1997 is shown in Figure 6b. There was little rainfall between 18:00 hours on 1 July 1997 and 04:00 hours on 2 July 1997 which was followed by a severe rainstorm between about 04:00 hours and about 12:00 hours on 2 July 1997.

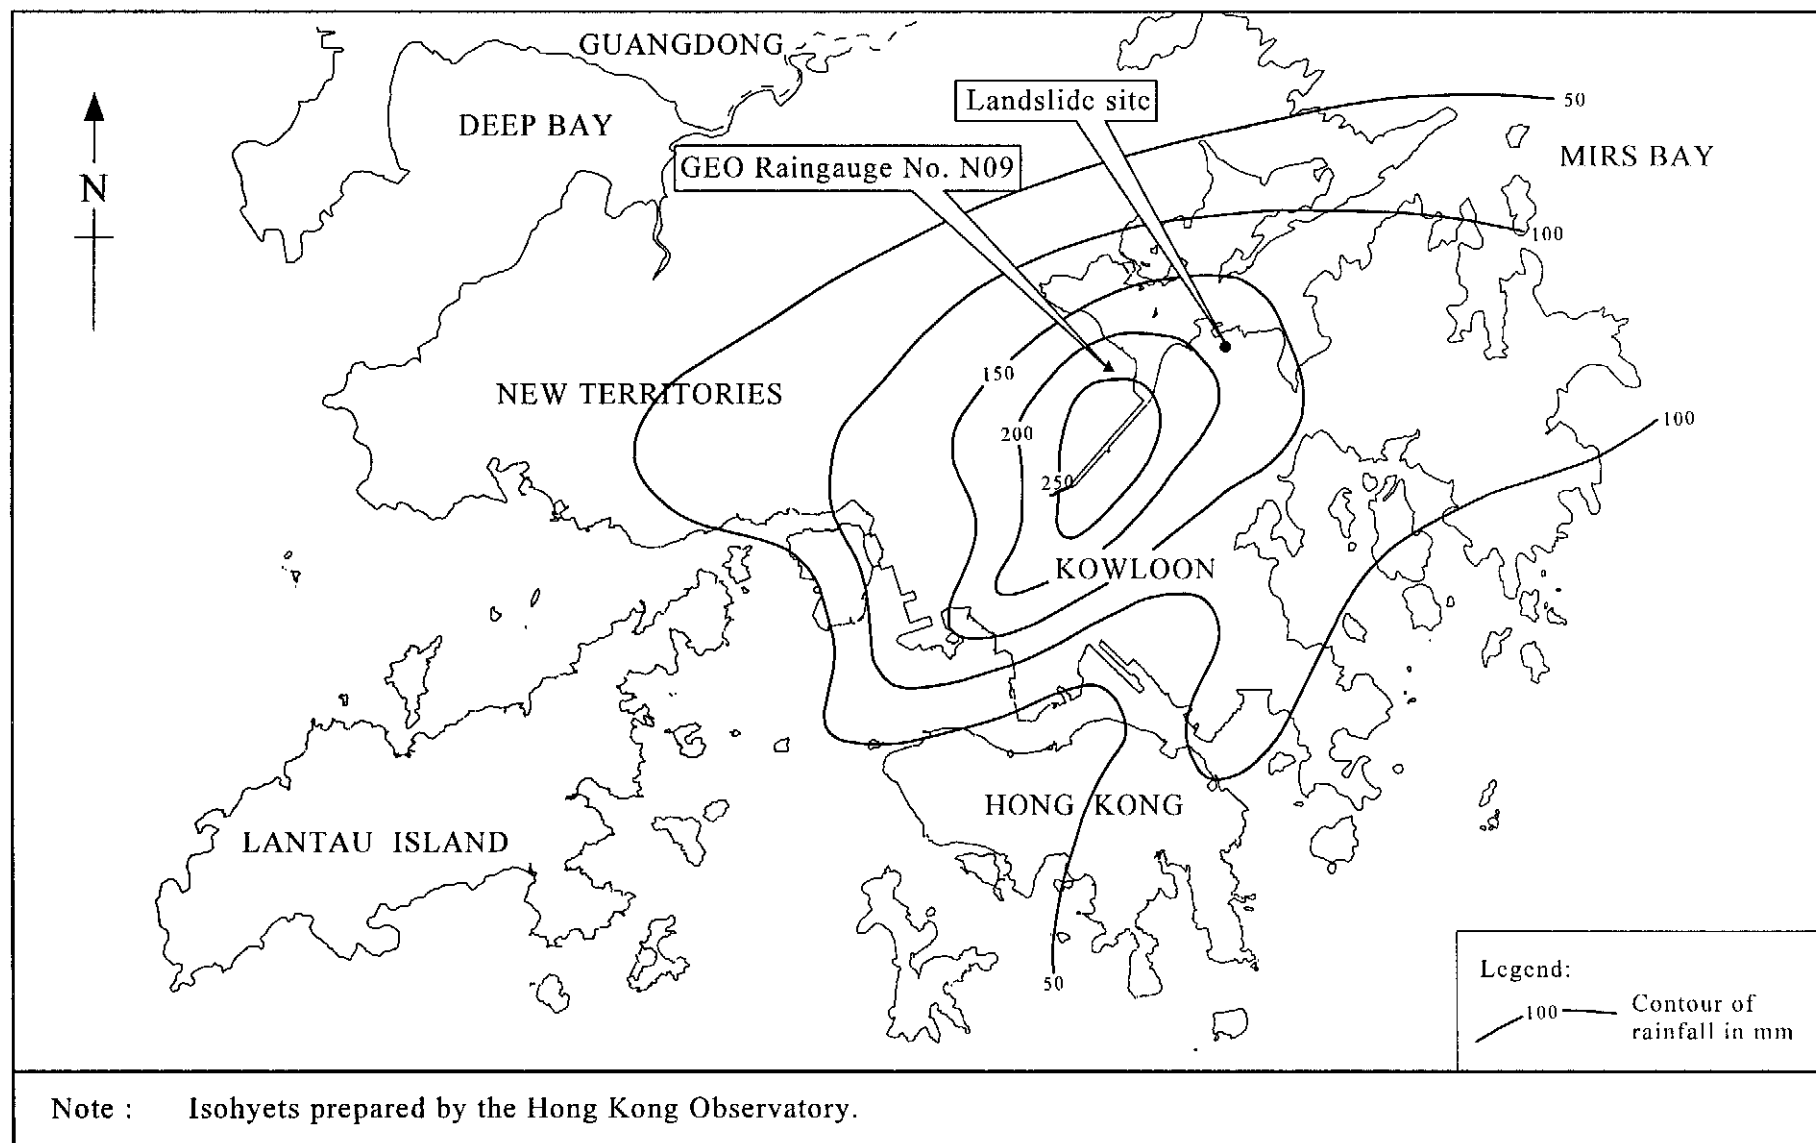
Figure 7 - Isohyets of Rainfall between 00:00 Hours and 08:00 Hours on 2 July 1997

An isohyet plot of rainfall recorded during the rainstorm between 00:00 hours and 08:00 hours on 2 July 1997 is given in Figure 7.

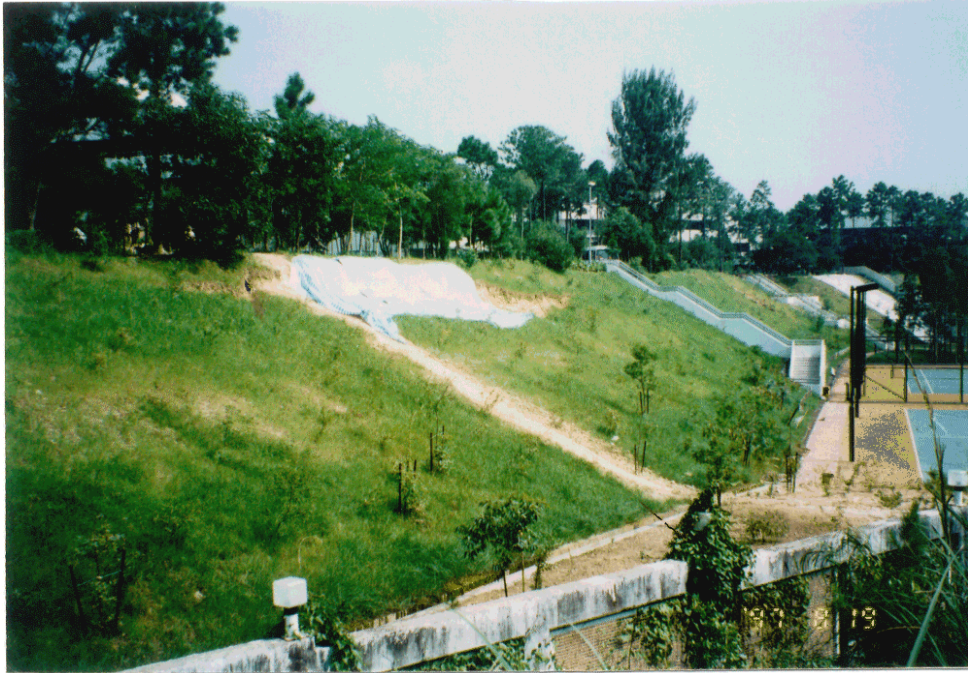
Failure B appears to have involved deformation near the crest of the fill slope and the development of 35 m-long scarp as a result of water ingress. The likely sources of water in the slope are:

- (a) stormwater run-off from the access road above the fill slope overflowing the crest U-channel, and
- (b) direct infiltration of rainfall into the slope.

Probable contributory factors to the failure could have been the presence of poorly compacted fill and inadequate surface drainage provision.

Plate 1 - View North Showing Failure B comprising 35 m-long Scarp on the Fill Slope (Photograph Taken on 19 August 1997)

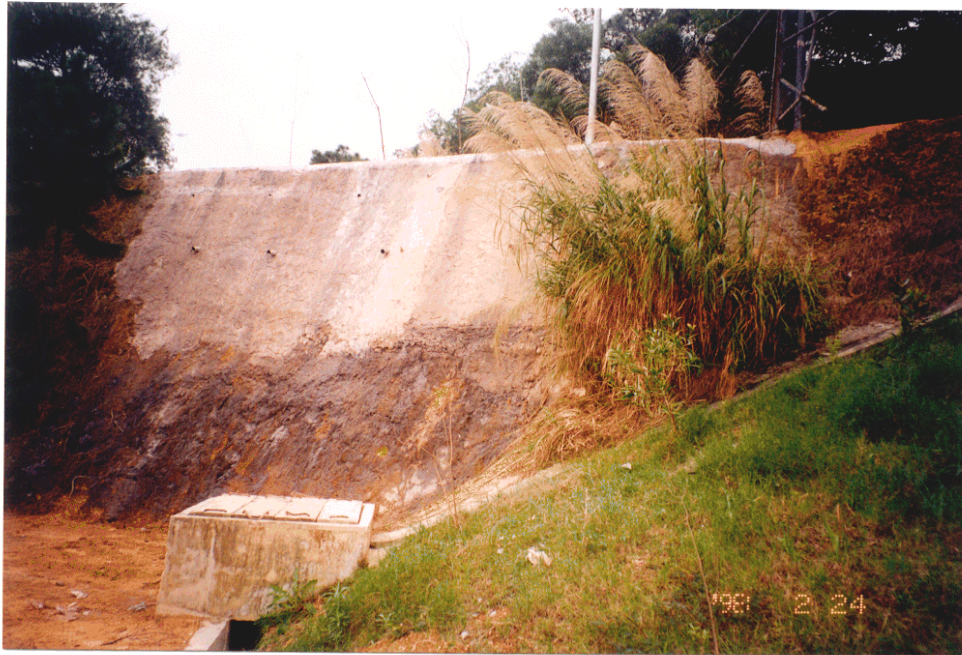
Plate 3 - Remedial Works at the Cut Slope  
(Photograph Taken on 24 February 1998)

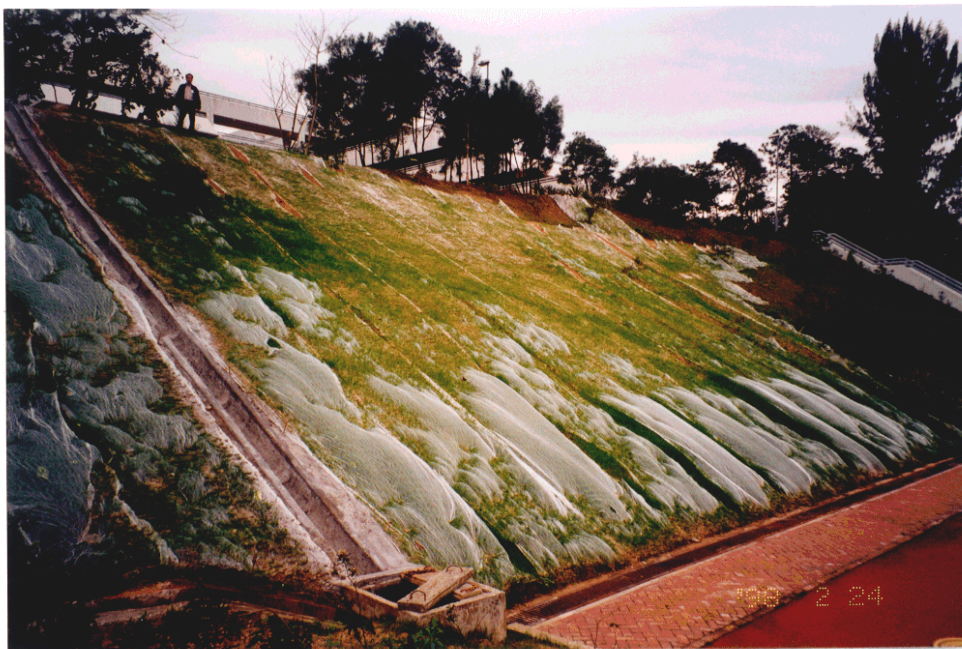
Plate 4 - Remedial Works at the Fill Slope  
(Photograph Taken on 24 February 1998)

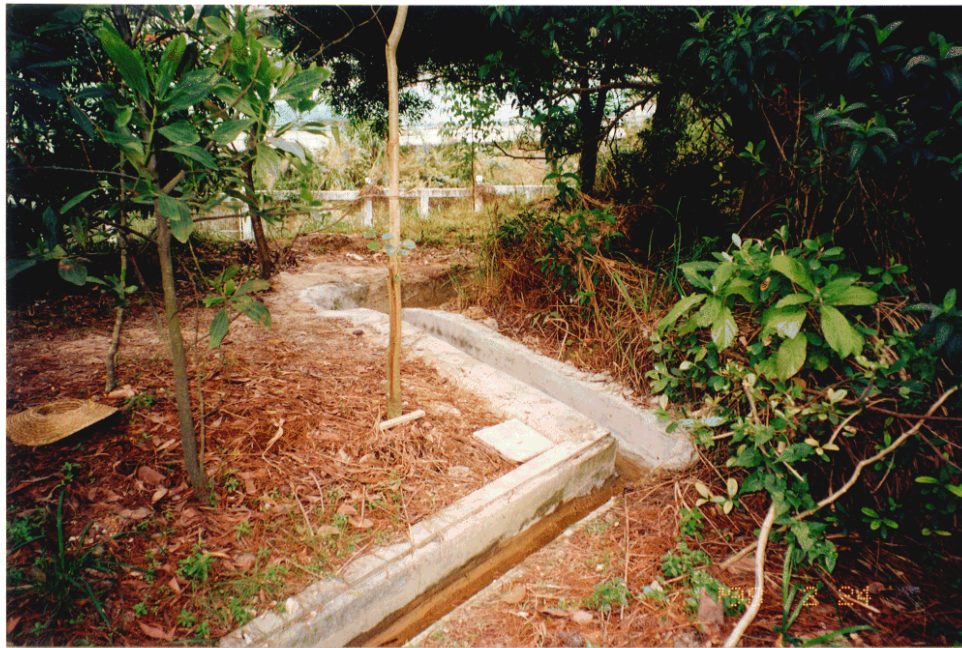
The general drainage layout plan for the college approved by BD in February 1992 shows a 300 mm U-channel connecting with the trapezoidal channel along the crest of the fill slope. At the time of inspection, the college caretaker informed HAP that this connecting U-channel was not present prior to the failure and had been constructed during the remedial works which were designed by W&O (Plate 5). The absence of the connecting U-channel could have promoted blockage and ponding of the crest U-channel.

Plate 5 - U-channel Constructed between the Existing  
Drainage Channels at the Crest of the Fill Slope  
During Remedial Works (Photograph Taken on  
24 February 1998)
