**INVESTIGATION OF SOME
SELECTED LANDSLIDE
INCIDENTS IN 1997
(VOLUME 6)**

GEO REPORT No. 92

**SECTION 1:
DETAILED STUDY OF THE
LANDSLIDES AT
NO. 7 KENG HAU ROAD
ON 4 JUNE 1997 AND
NO. 5 KENG HAU ROAD
ON 2 JULY 1997**

**This report was originally produced in May 1998
as GEO Landslide Study Report No. LSR 9/98**

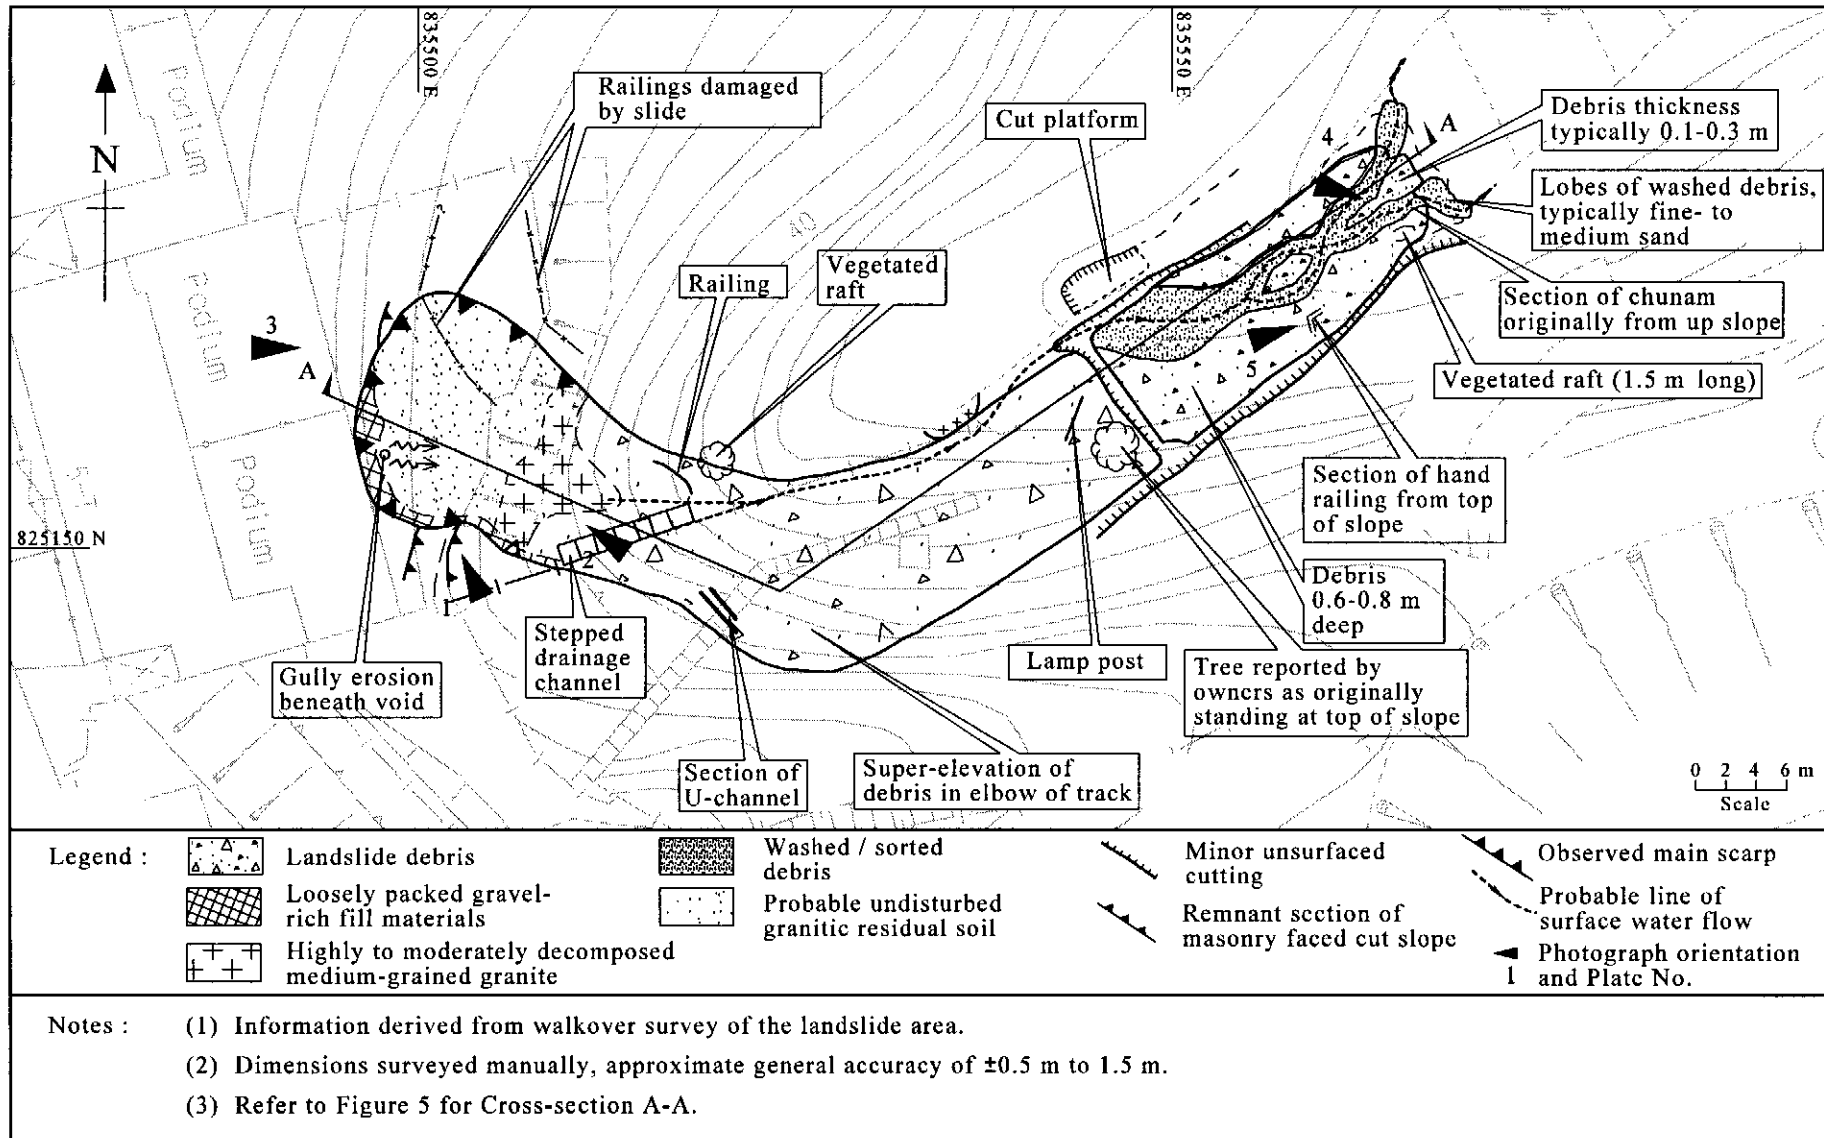
Figure 4 - Site Location Plan and Details of the Landslide of 4 June 1997

The failure undermined the southern section of the level platform adjacent to No. 7 Keng Hau Road, and formed a rupture surface between about 10 m and 12 m wide extending from the original toe of the cut slope to the eastern wall of the building podium (Plates 1 and 2). The maximum depth of failure was typically between 1.5 m and 2 m and the estimated volume of failure was 150 m³.

The landslide debris ran out down the slope and crossed the lower part of the stepped drainage channel that extended down the slope from near the south wall of No. 7 Keng Hau Road (Figure 4). The debris was deflected to the northeast by the opposing flank of the natural gully and came to rest on the low-lying cultivated area. The maximum horizontal travel distance was about 85 m. The travel angle of the debris, measured from the crest of the main scarp to the distal end of the main body of debris, was 19° (Figure 5). This angle is below the normal range for rain-induced failures in Hong Kong (Wong & Ho, 1996), indicating that the debris had relatively high mobility. The mobility of the debris was probably increased by stormwater flow discharged on to the slope from the main drainage channel near the toe of the main scarp.

The debris consisted mainly of pale orange, slightly clayey silty fine- to coarse-grained sand. Man-made artifacts including bricks, masonry, chunam and a section of hand railing, were found at the distal end of the debris track (Figure 4, Plates 4 and 5). A small tree originally located on the platform near the crest of the slope travelled about two-thirds of the way along the debris track.

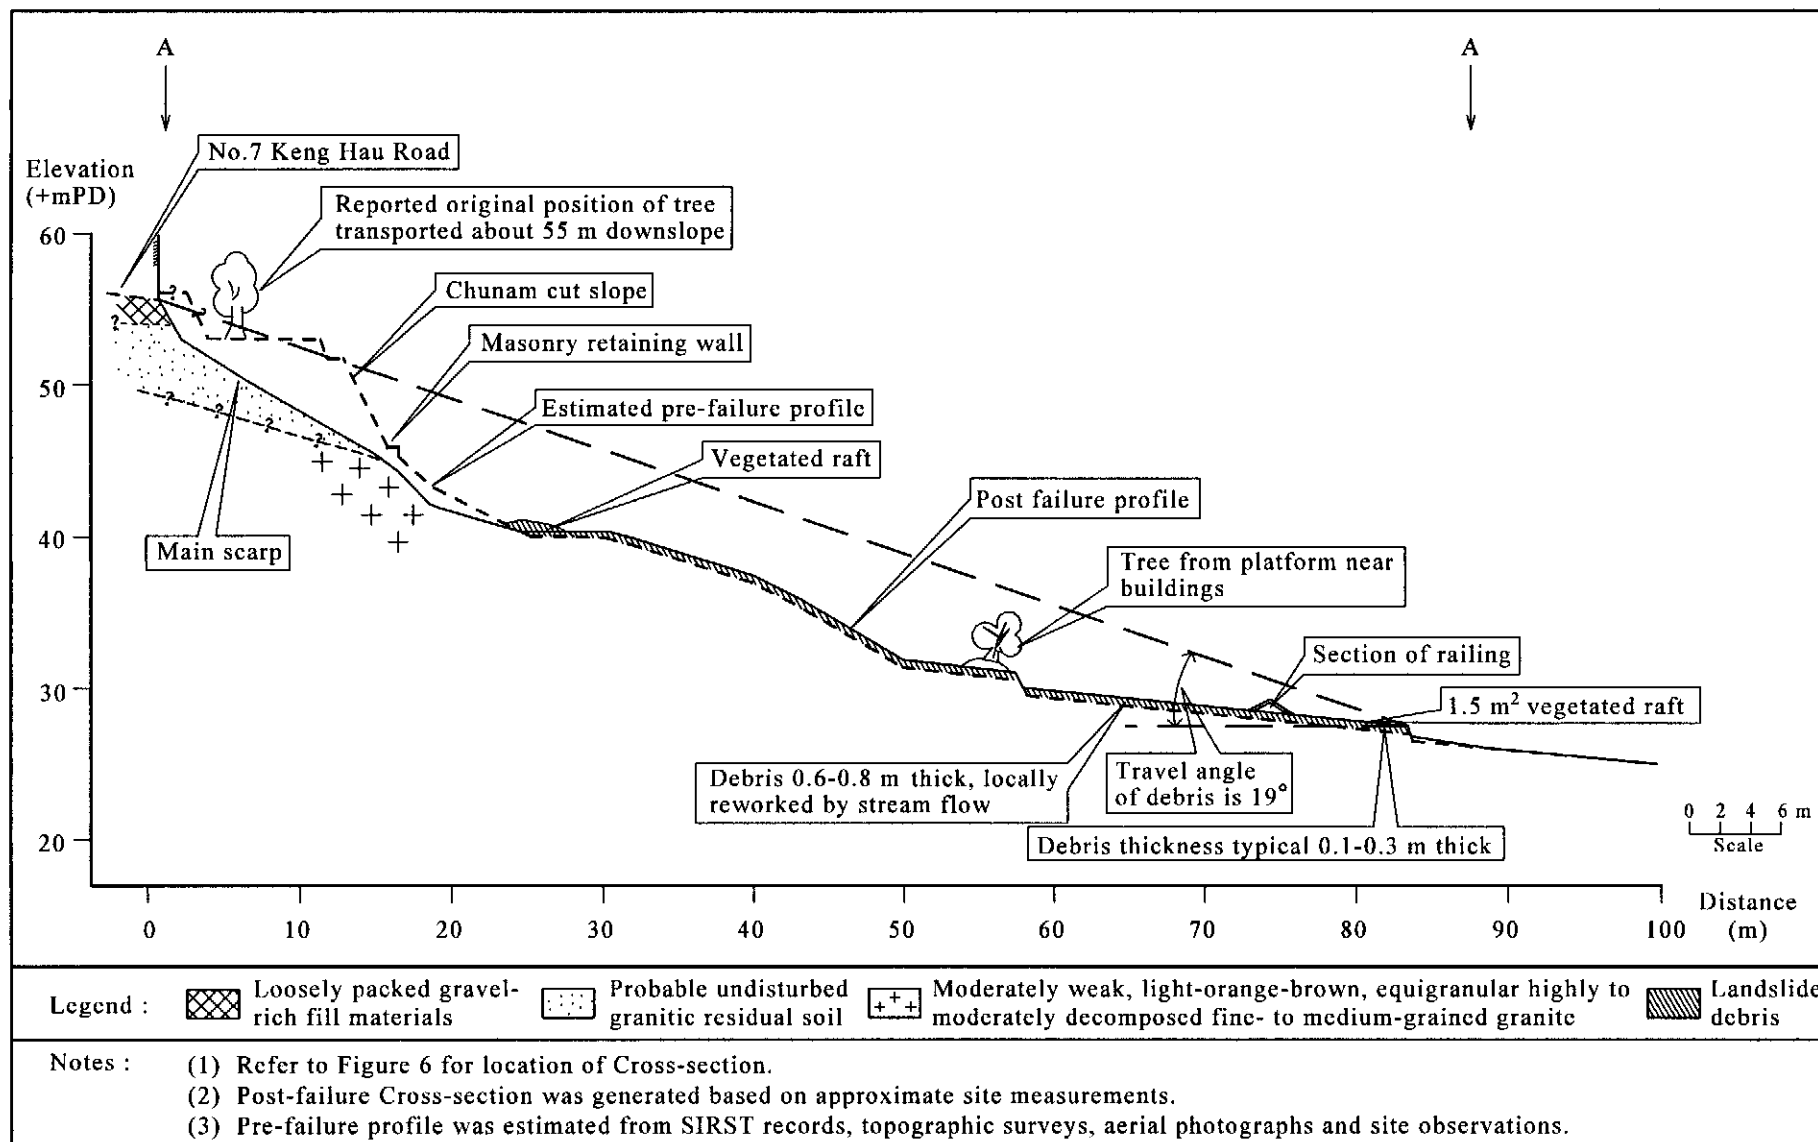
Figure 5 - Cross-section A-A Through the Landslide of 4 June 1997

Inspection of the main scarp identified about 0.5 m to 0.7 m of porous gravel-rich, granular fill overlying apparently undisturbed granitic residual soil (Figure 5). Highly to moderately decomposed fine- to medium-grained granite was exposed in the lower part of the rupture surface near the location of the chunamed section of slope prior to the failure. Variable, small thicknesses of fill were evident in association with the remaining sections of masonry walls and beneath the inclined channel along the southern margin of the first landslide (Figure 4).

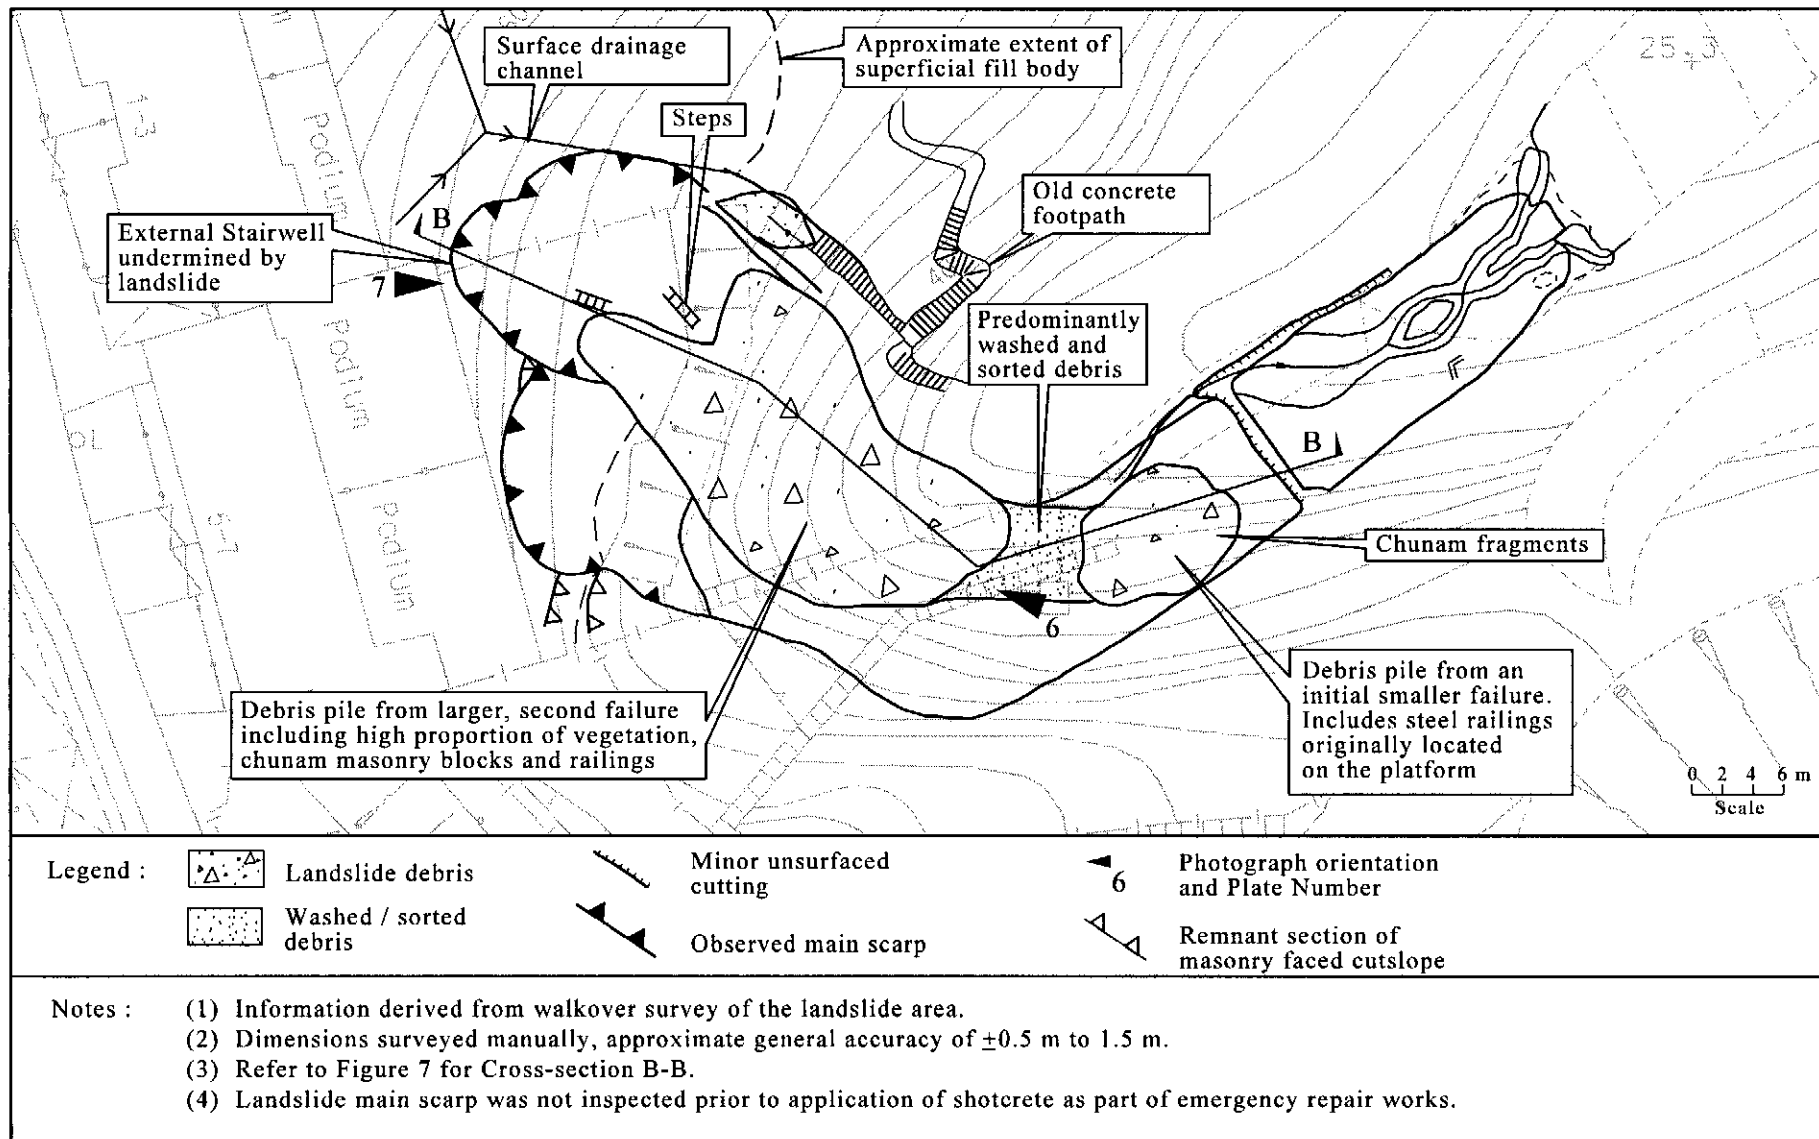
Figure 6 - Site Location Plan and Details of the Landslide of 2 July 1997

The second landslide was slightly larger than the first with an estimated volume of about 210 m³. The failure affected the remaining platform area adjacent to No. 5 Keng Hau Road and extended to the slope below Nos. 1 and 3 Keng Hau Road.

Two distinct failed masses were identified. The first, which had a volume of about 25 m³, travelled furthest from the rupture area. The debris mainly consisted of pale orange, slightly clayey, silty fine- to coarse-grained sand with occasional man-made artifacts including bricks, masonry and chunam fragments. The failure involved the cut slope and part of the platform at its crest. The material was wet and was deposited in the gully as a thin layer. The failure undermined the higher parts of the slope near No. 5 Keng Hau Road. The second, larger failed mass travelled between about 15 m and 40 m from the rupture zone. The proportion of man-made artifacts was significantly higher than that of the initial failed mass

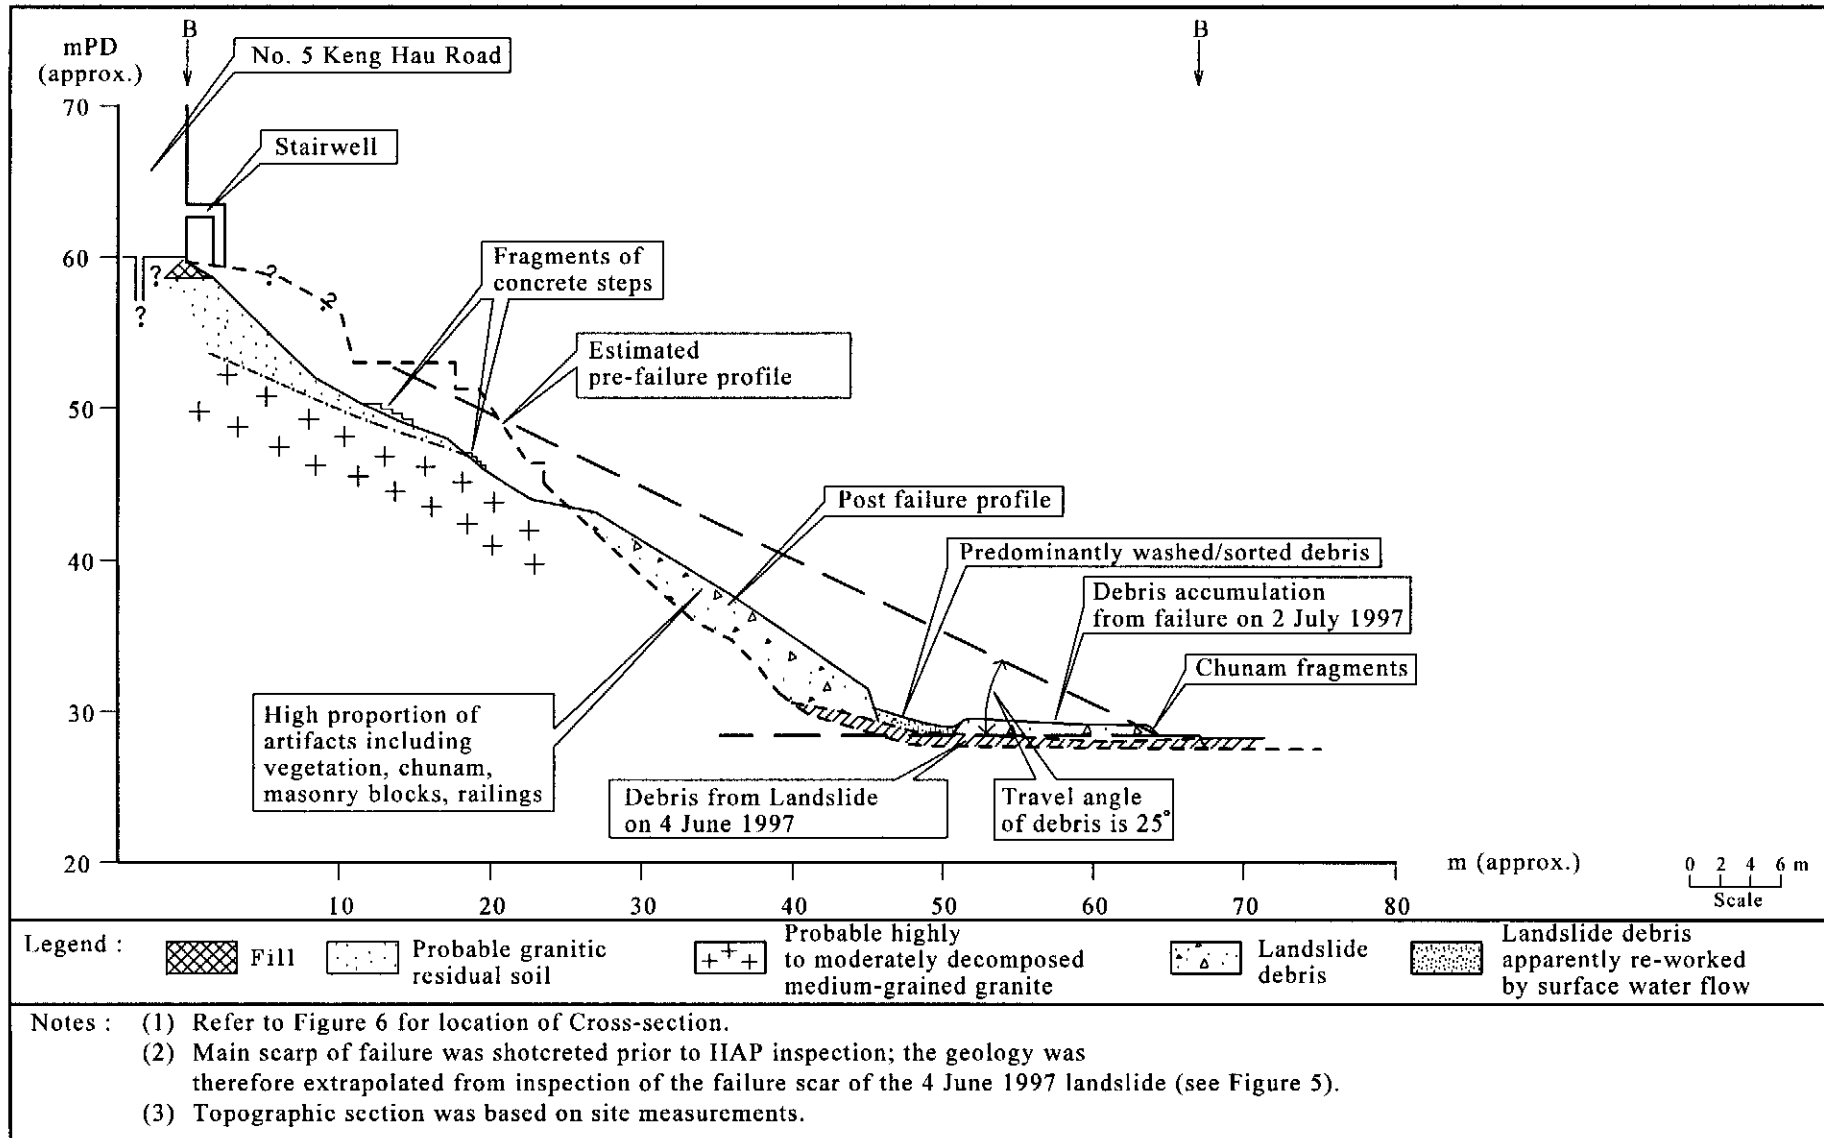
Figure 7 - Cross-section B-B Through the Landslide of 2 July 1997

The morphology of the main scarp suggests that the movements which undermined part of No. 5 Keng Hau Road may have involved a third retrogressive failure. The slide involved a comparatively small volume and travelled only a short distance. This is clear from the location of the concrete steps which were originally attached to the podium of No. 5 Keng Hau Road. These were displaced by only about 15 m during this phase of the landslide. Application of shotcrete soon after failure prevented detailed inspection of the main scarp by HAP. The failure affected the remaining part of the cut slope and platform and would probably have involved fill and residual soil as observed in the main scarp of the landslide of 4 June 1997.

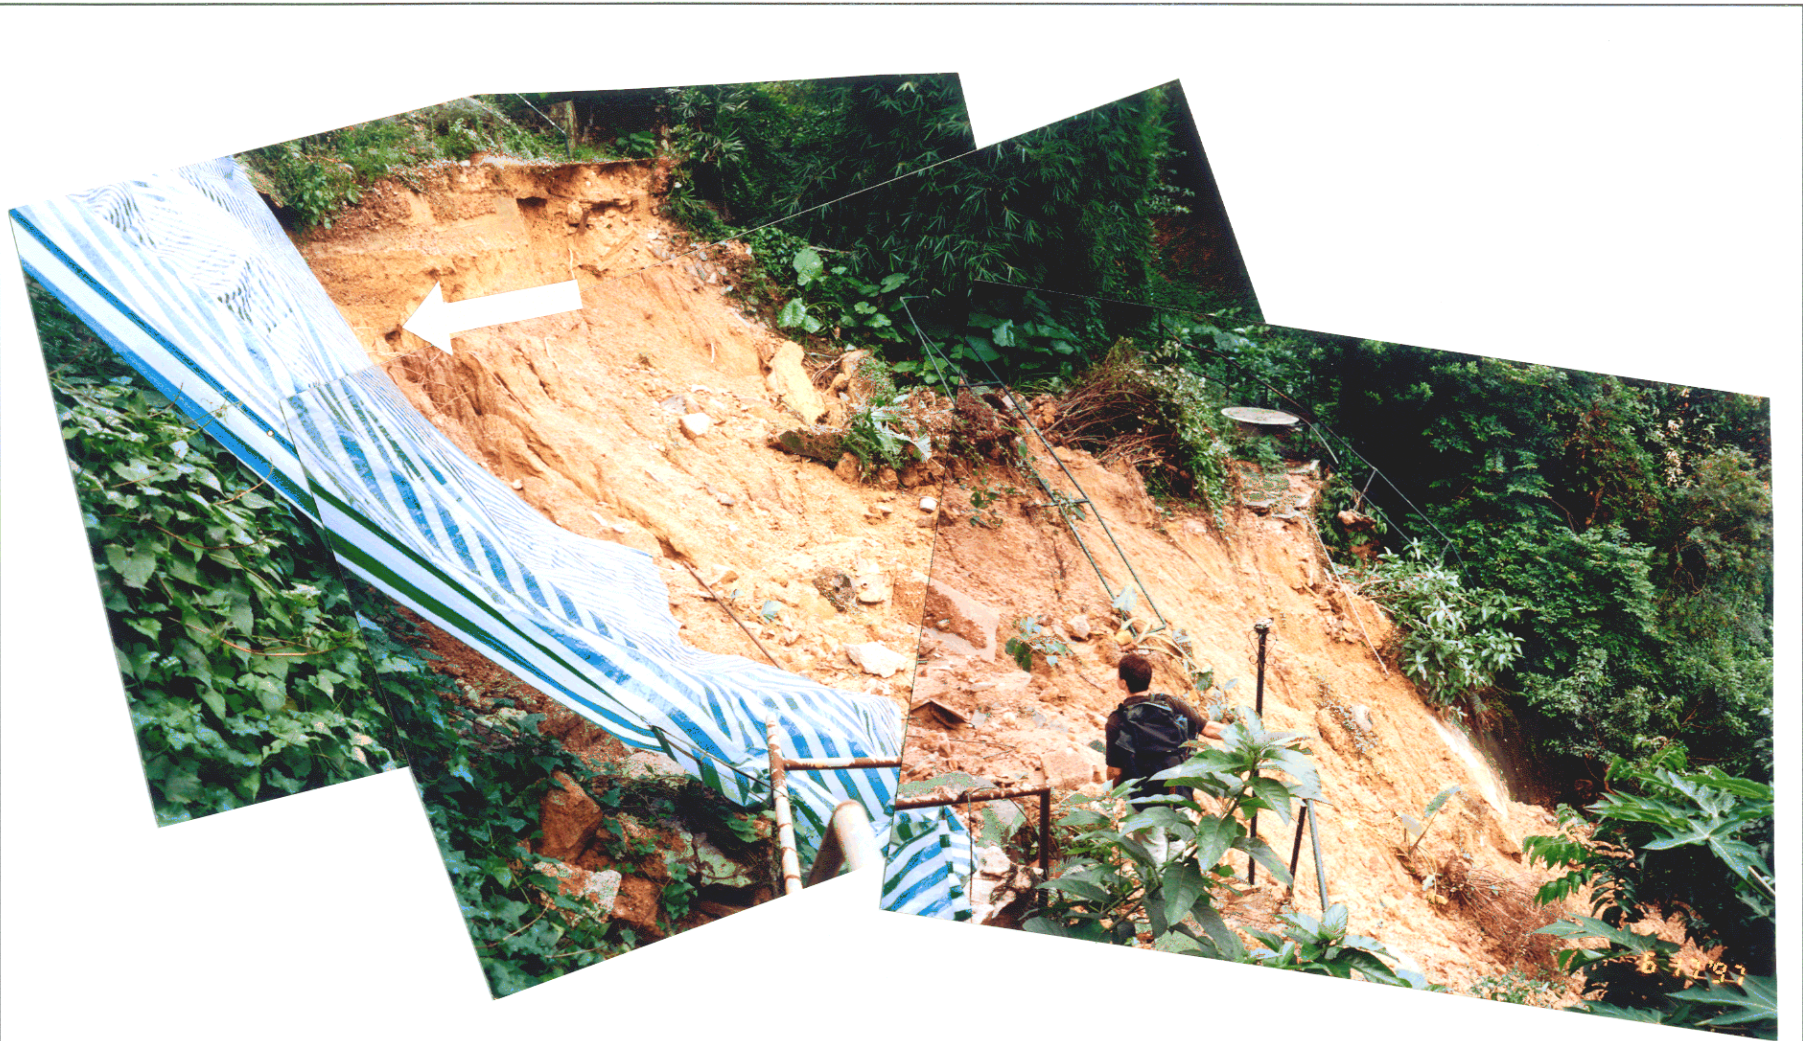
Groundwater was not observed during HAP's inspection of the landslide on 17 June 1997. However, minor erosion channels were observed below a void about 1 m below the central part of the main scarp, at the interpreted interface between the fill and in situ soil (Plate 1). It is possible that this feature is an erosion pipe associated with the throughflow of groundwater.

The presence of possible erosion pipes at the interface between the fill and residual soil indicates that throughflow of subsurface water into the landslide area may have occurred. The source of such water is, however, uncertain. The possibility that leakage of subsurface water-carrying installations associated with the buildings of No. 7 Keng Hau Road, or from the drainage system of Keng Hau Road itself, contributed to such flows cannot be discounted.

Plate 1 - Northern Flank of the Landslide of 4 June 1997 (Photograph Taken on 17 June 1997)
(Note the Possible Erosion Pipe, Indicated by the White Arrow, and the Associated Minor
Gullies, in the Upper Left Part of the Frame)

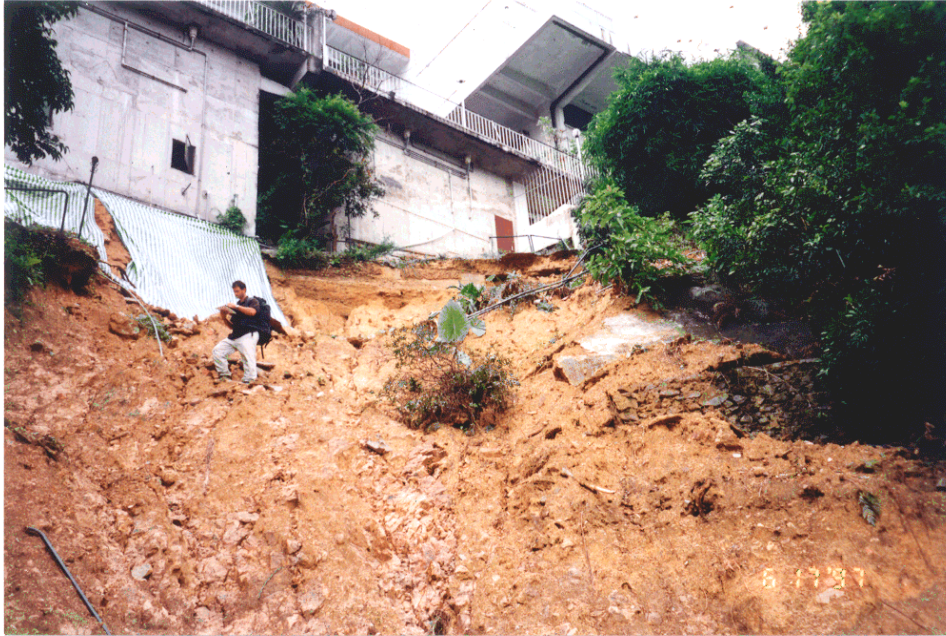
A number of plastic pipes with diameters between about 40 mm and 80 mm, and an out-fall pipe were attached to the podium immediately above the main scarp of the landslides (Plate 2). The pipes were associated with the overflow and filtration system of the swimming pool and periodically discharged water into the main drainage channel adjacent to No. 7 Keng Hau Road. No water was seen to be issuing from the out-fall pipe during inspections of the landslide by HAP for the present study.

The drain pipes attached to the front wall of the podium are associated with the overflow and filtration system of the swimming pool. According to the owner the swimming pool was empty at the time of the landslides and the pipes would not have been carrying water. No issue of water from the outfall pipe was observed during the investigation. It seems unlikely, therefore, that the pipes were a significant source of water.

Plate 2 - View of the Main Scarp of the Landslide of 4 June 1997
(Photograph Taken on 17 June 1997)
(Note the Plastic Pipes Attached to the Front Wall of the
Podia as Indicated by the White Arrow)

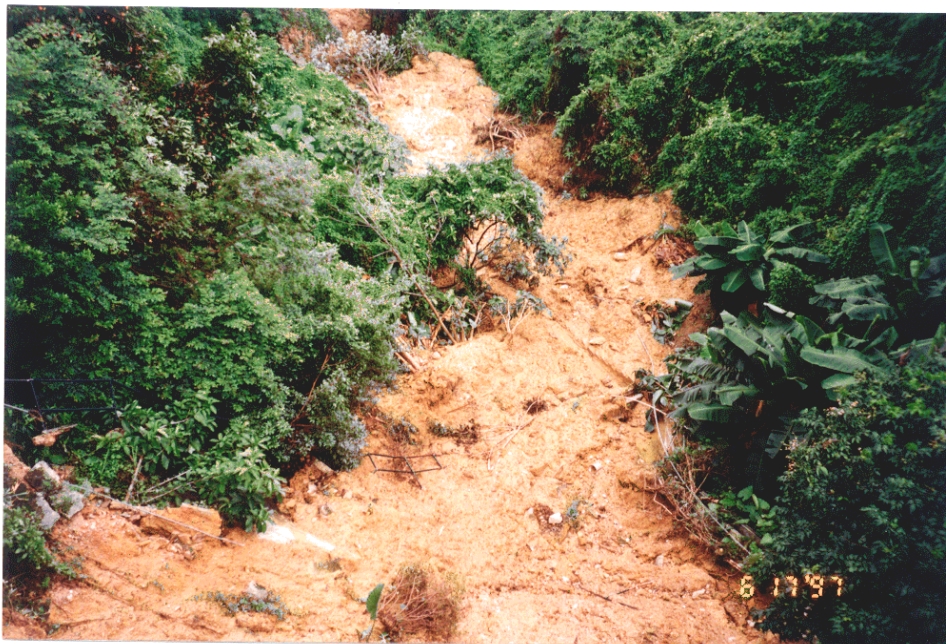
The width of the debris track was between 10 m and 12 m and super-elevation of debris by about 3 m was observed at the elbow of the track (Plate 3). The depth of debris varied between 0.6 m and 0.8 m near the rupture zone and between 0.1 m and 0.3 m at the distal end of the slide. The debris was very wet when examined 13 days after the failure and evidence of significant re-working by surface water was seen in the lower reaches of the debris track.

Plate 3 - View of the Track of the Landslide of 4 June 1997 (Photograph
Taken on 17 June 1997)
(Note Super-elevation of Debris on the Right Hand Side of the
Elbow in the Debris Track)

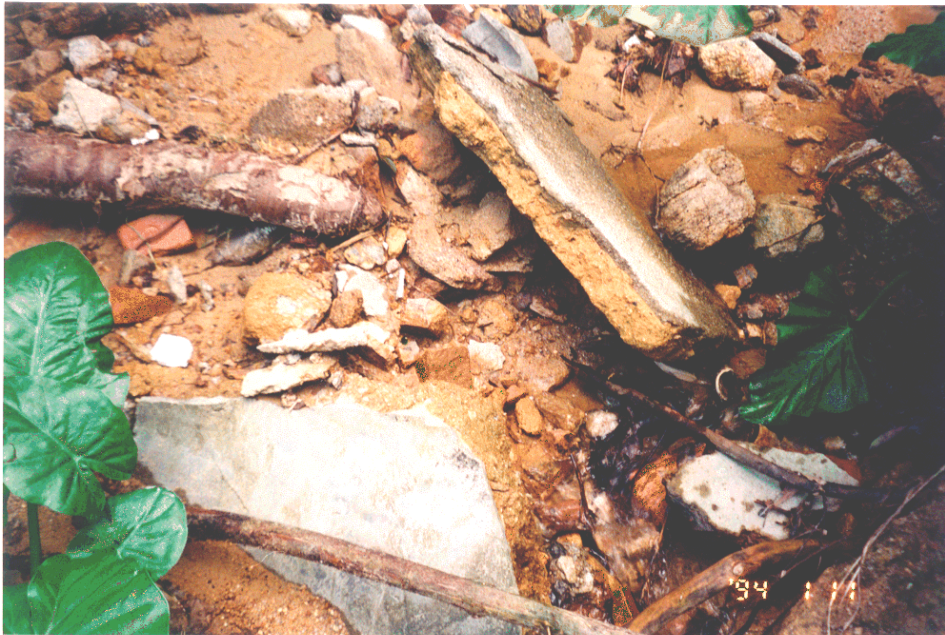
Plate 4 - Chunam Fragments Found at Toe of the Debris
(Photograph Taken on 17 June 1997)

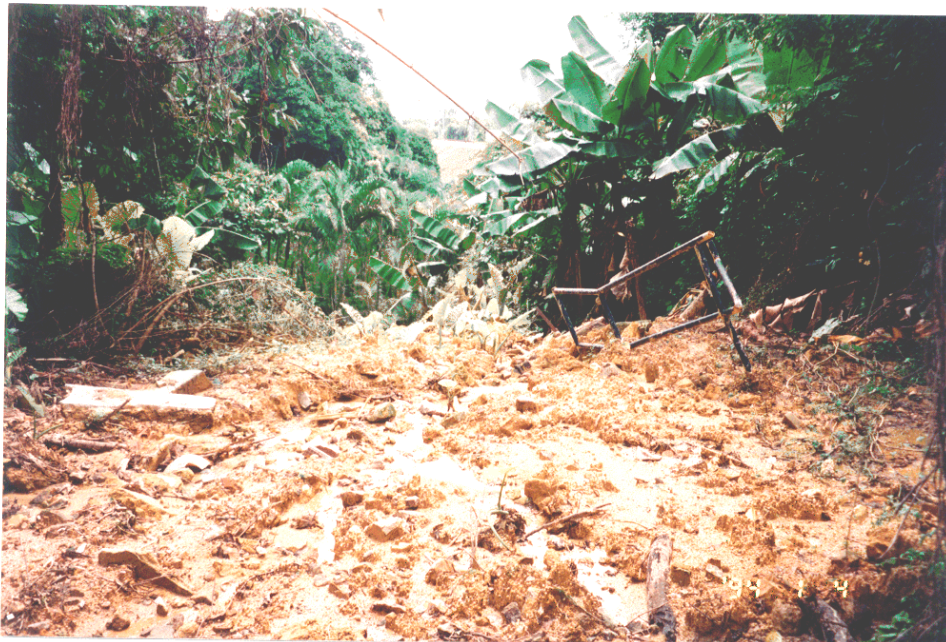
Plate 5 - Hand Railings Found Near the Toe of the Debris
(Photograph Taken on 17 June 1997)

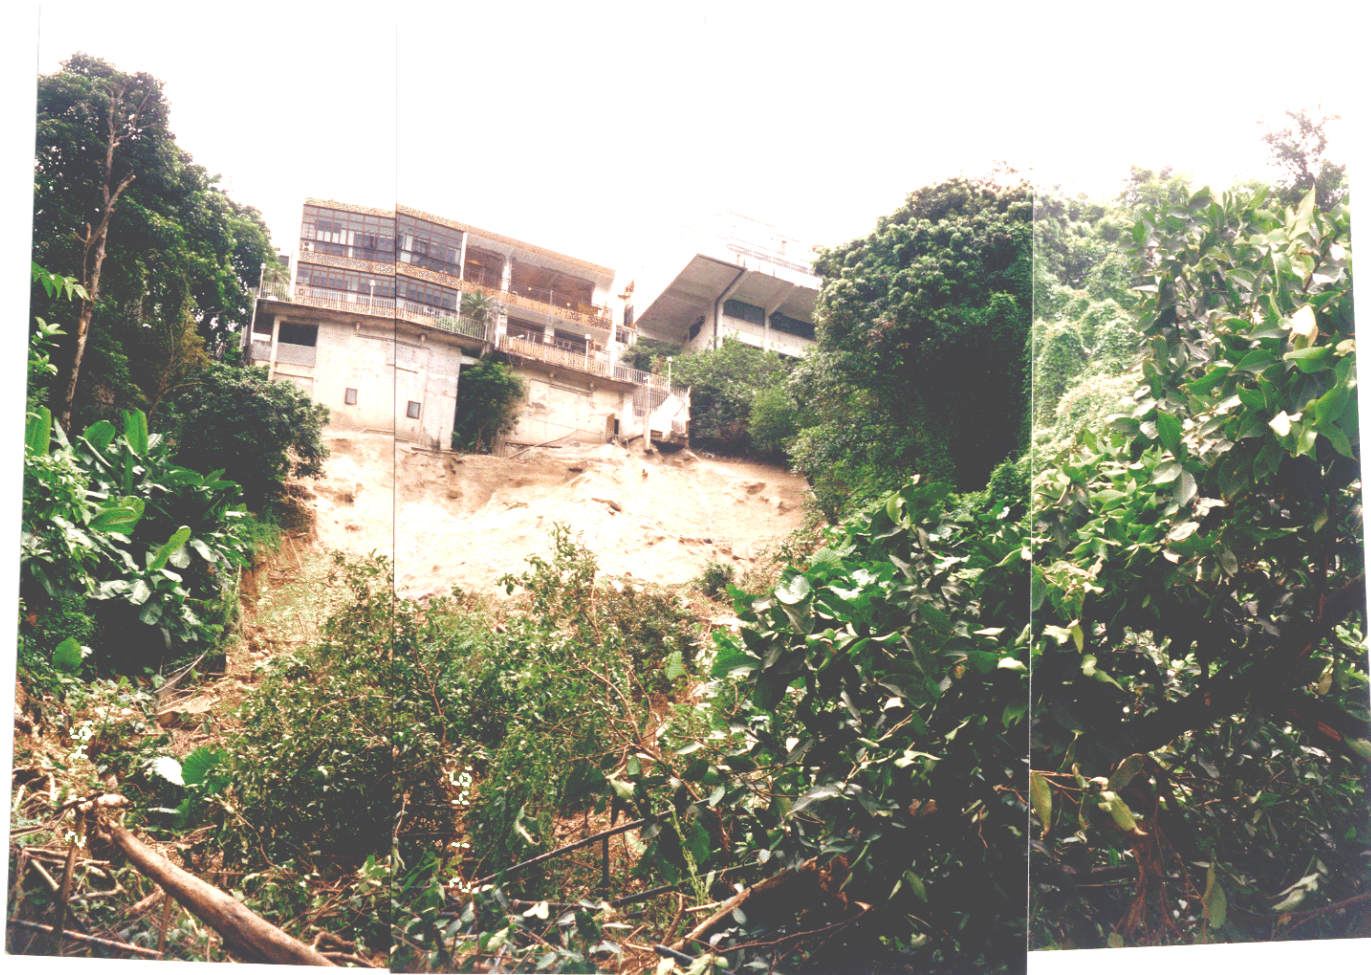
Plate 6 - Upslope View of the Landslide Scars (Photograph Taken on 11 July 1997)
(Note the Undermining of the Stairwell in the Centre of the Photograph)

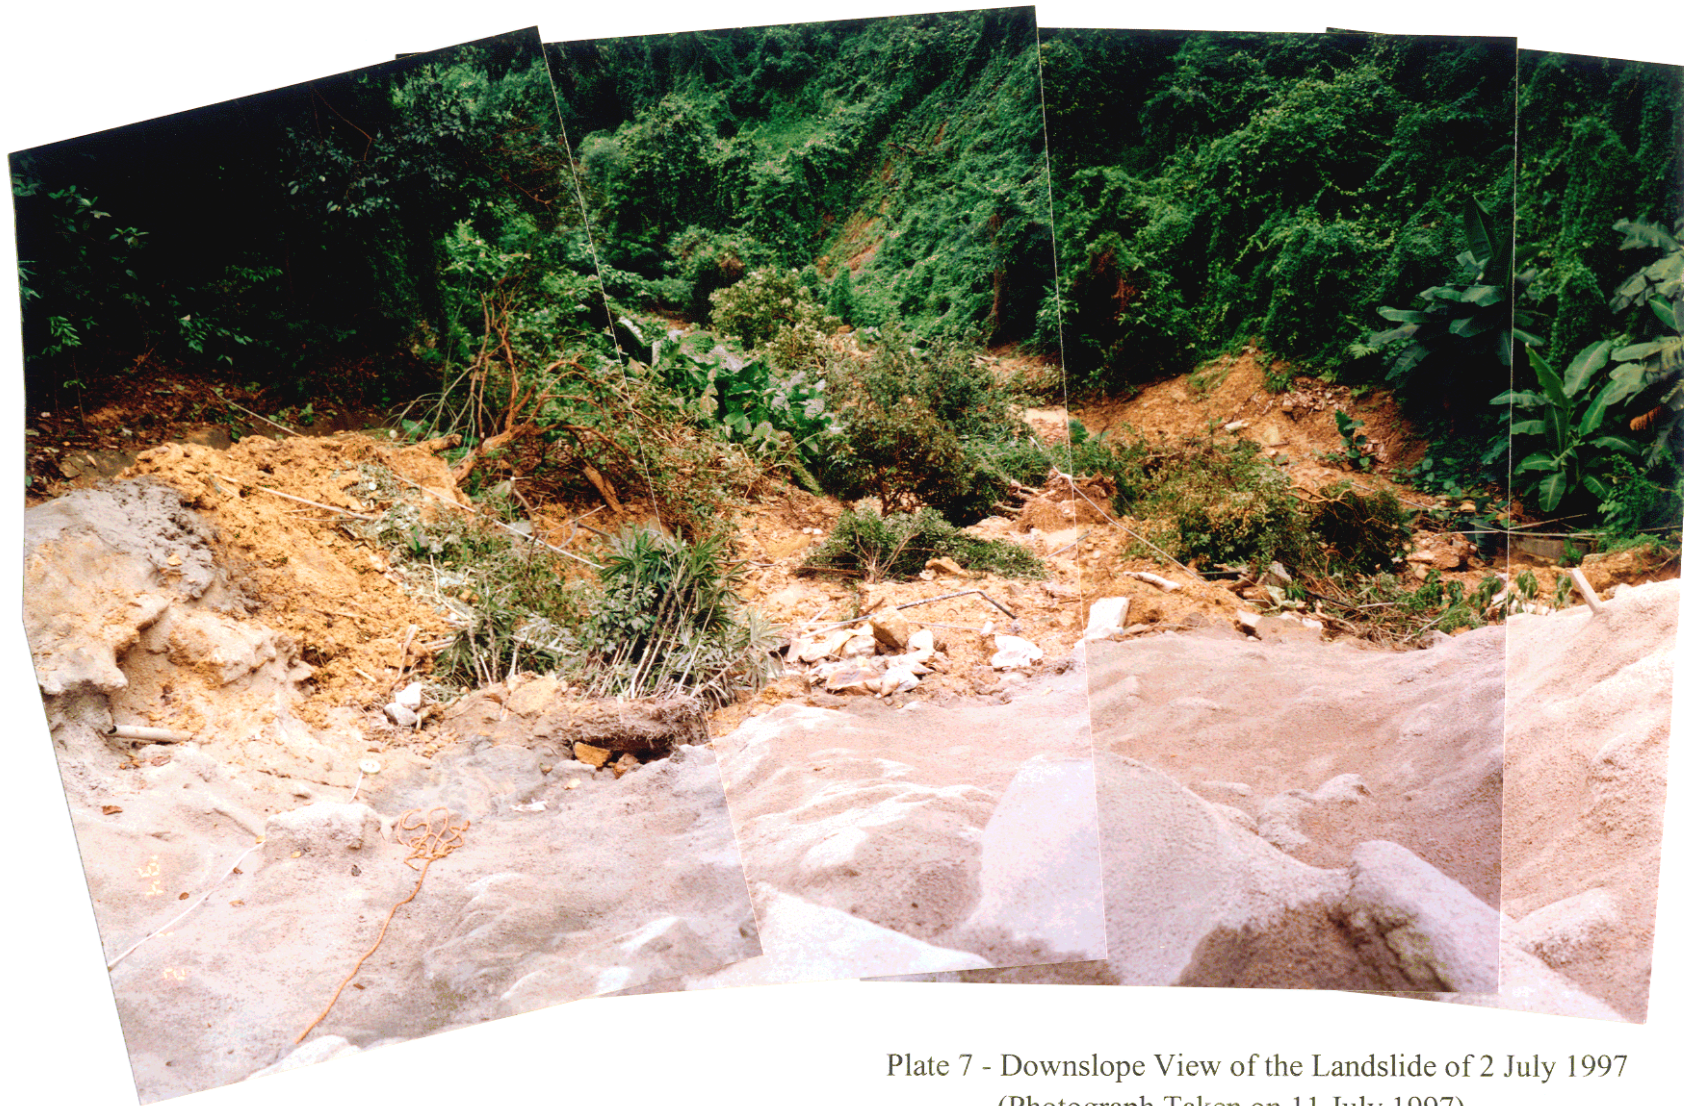
Plate 7 - Downslope View of the Landslide of 2 July 1997
(Photograph Taken on 11 July 1997)
