**SECTION 2:
DETAILED STUDY OF THE
LANDSLIDE AT
SHING MUN TUNNEL ROAD
ROUTE 5, TAI WAI
ON 2 JULY 1997**

Halcrow Asia Partnership Ltd

**This report was originally produced in December 1998
as GEO Landslide Study Report No. LSR 26/98**

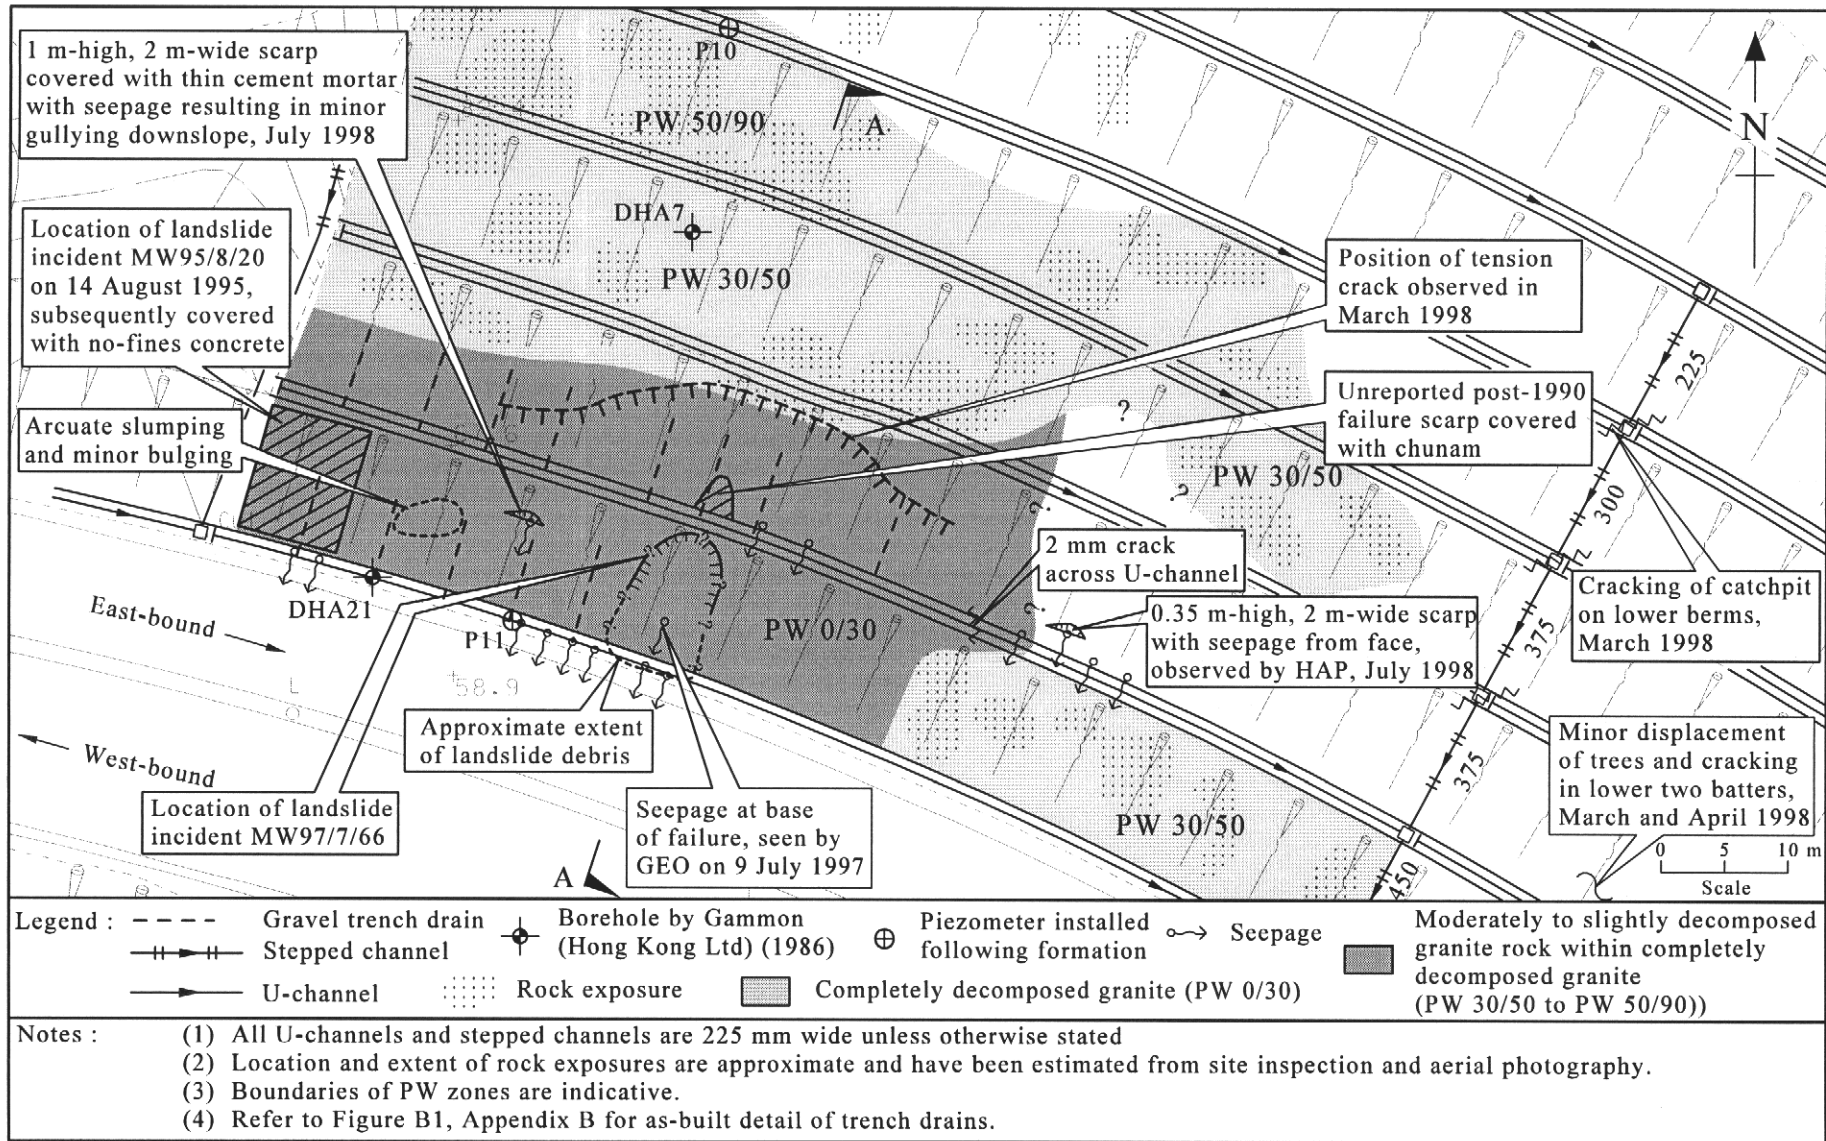
Figure 2 - Site Plan

The GEO and HyD jointly inspected the landslide on 9 July 1997. The landslide was located on the lowermost batter of the cut slope (Figure 2). The Incident Report prepared by the GEO indicated that the failure affected the upper 4 m of the batter and was 5 m wide and 1 m deep and that the estimated volume of landslide debris was 10 m³. A thin layer of debris covered the lower slope with further minor debris deposited on the verge of the east-bound carriageway of the Shing Mun Tunnel Road. Seepage from the base of the failure scar was also recorded during the inspection on 9 July 1997.

Seepages from several small scarps, the toes of the lower two batters, and the trench drains in the vicinity of the failure were also noted (Figures 2 and 5).

On the lower batter, about 15 m west of the 1997 landslide, signs of distress in the form of an area (about 25 m²) of minor bulging and slumping were noted (Figure 2).

During an inspection by HAP in March 1998, an arcuate open subvertical tension crack was identified on the second batter above the 1997 landslide and above the unreported failure in the second batter (Figure 2). The tension crack was 40 m long, 0.4 m wide and was open to a depth of at least 1.5 m. The weathered appearance of the tension crack and the presence of vegetation in it indicated that the feature had been present for some time. At the ends of the tension crack fresh soil scarps up to 0.1 m high and a fallen tree were observed, which suggest renewed movement and lateral extension of the crack. The central portion of the crack coincided with a steeply-dipping discontinuity within a localised exposure of moderately to slightly decomposed granite rock. Both ends of the crack had propagated through intact completely decomposed granite.

While inspecting the cut slope in March 1998, cracking of catchpits along a stepped channel was identified 50 m east of the 1997 landslide (Figure 2). In the lower two batters, to the east of the stepped channel, trees were displaced in a downslope direction.

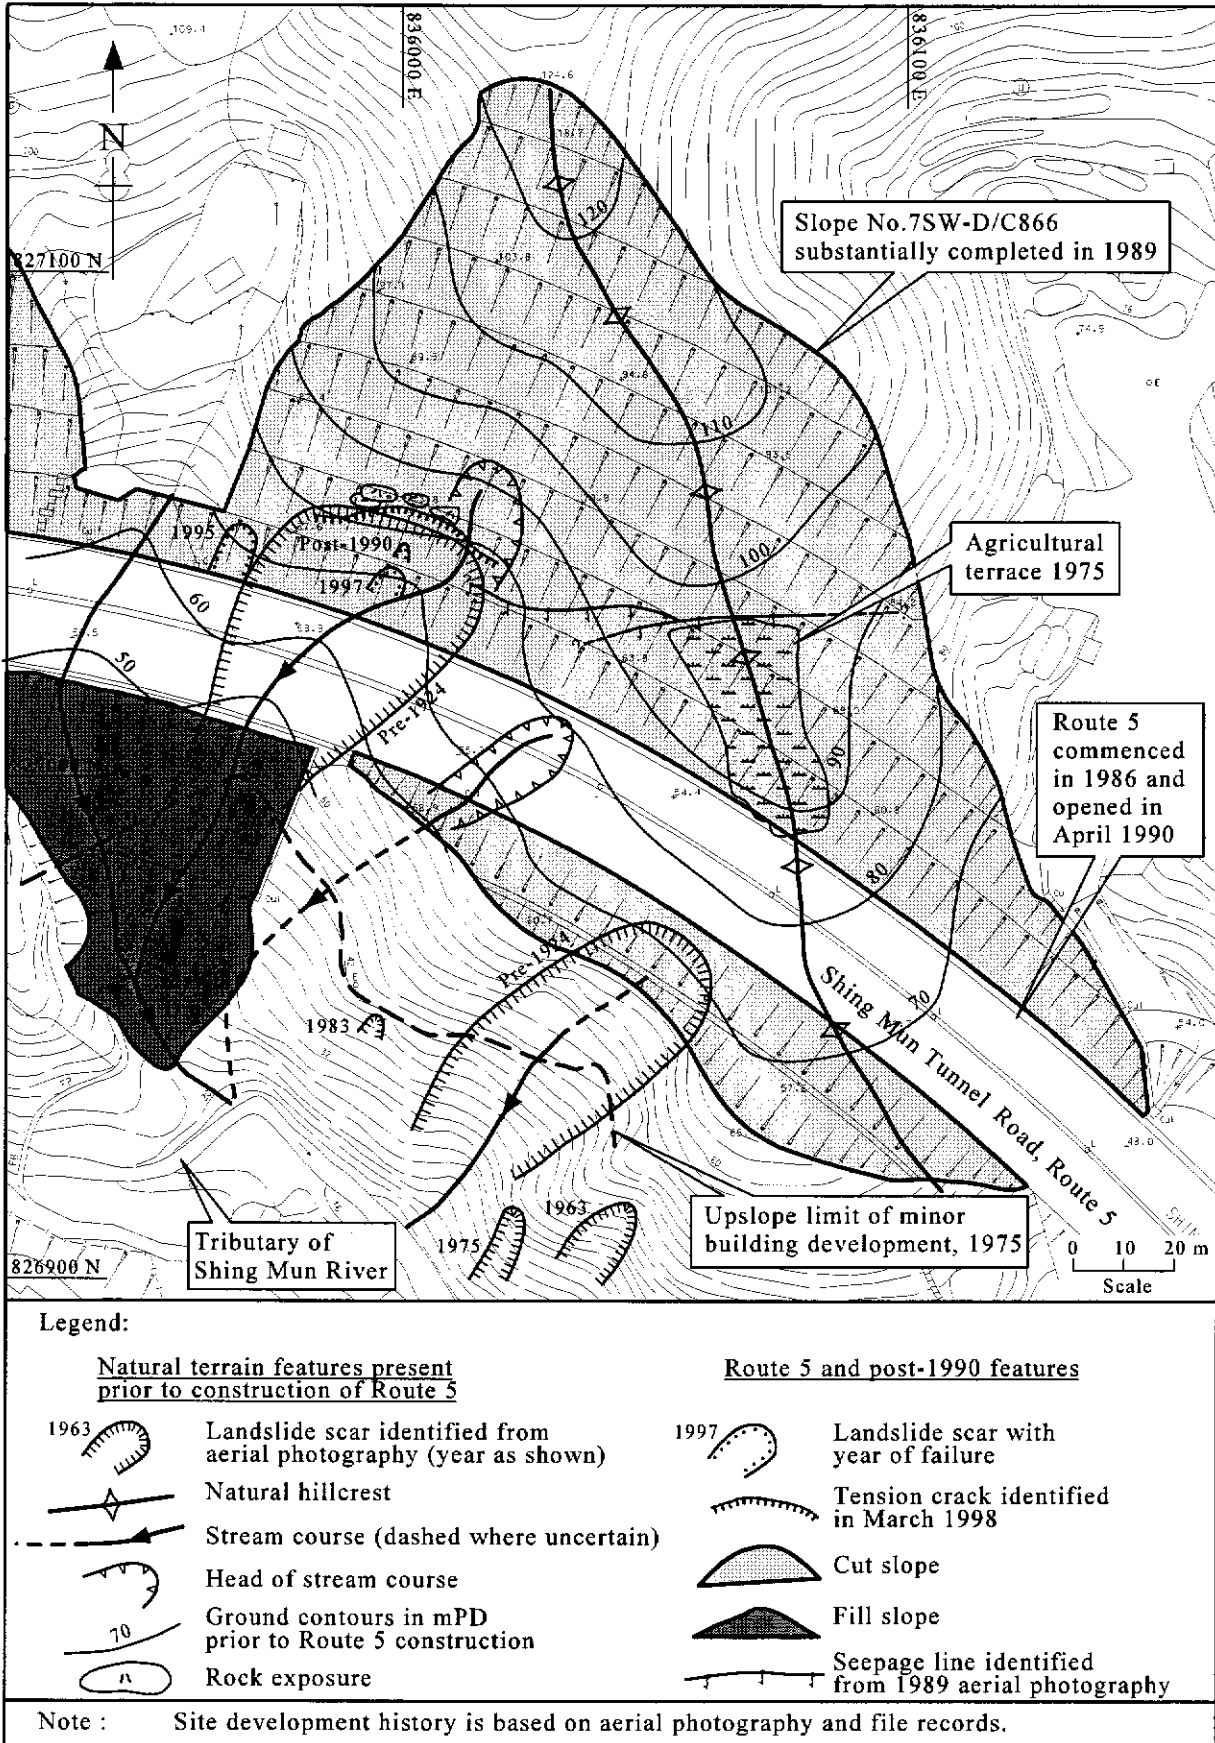
Figure 3 - Site Development History

In 1924, the aerial photographs show that the site was a vegetated natural hillside to the north of a tributary of the Shing Mun River (Figure 3). On these photographs two scarp features are visible on the lower hillside which probably indicate the presence of relict landslides. The southern-most scarp was about 30 m wide and extended upslope from the tributary at 20 mPD to about 70 mPD. On the northern part of the hillside a 40 m-wide depression was located downslope of an arcuate scarp with rock exposures at about 80 mPD. The arcuate scarp was located within the head of a pre-existing stream course.

On the 1989 aerial photographs (Table 2) evidence of a seepage line obliquely crossing the second to fourth batters (Figure 3) may be seen. The western end of the seepage line fades out just above the first batter about 20 m east of the 1997 landslide. The seepage line is possibly associated with the presence of a dyke.

On the 1924 aerial photographs two natural terrain landslides that predate 1924, are visible on the original hillside close to the 1997 landslide site (Figure 3). A further two smaller natural terrain landslides on the same hillside, to the south of the site, can be seen on

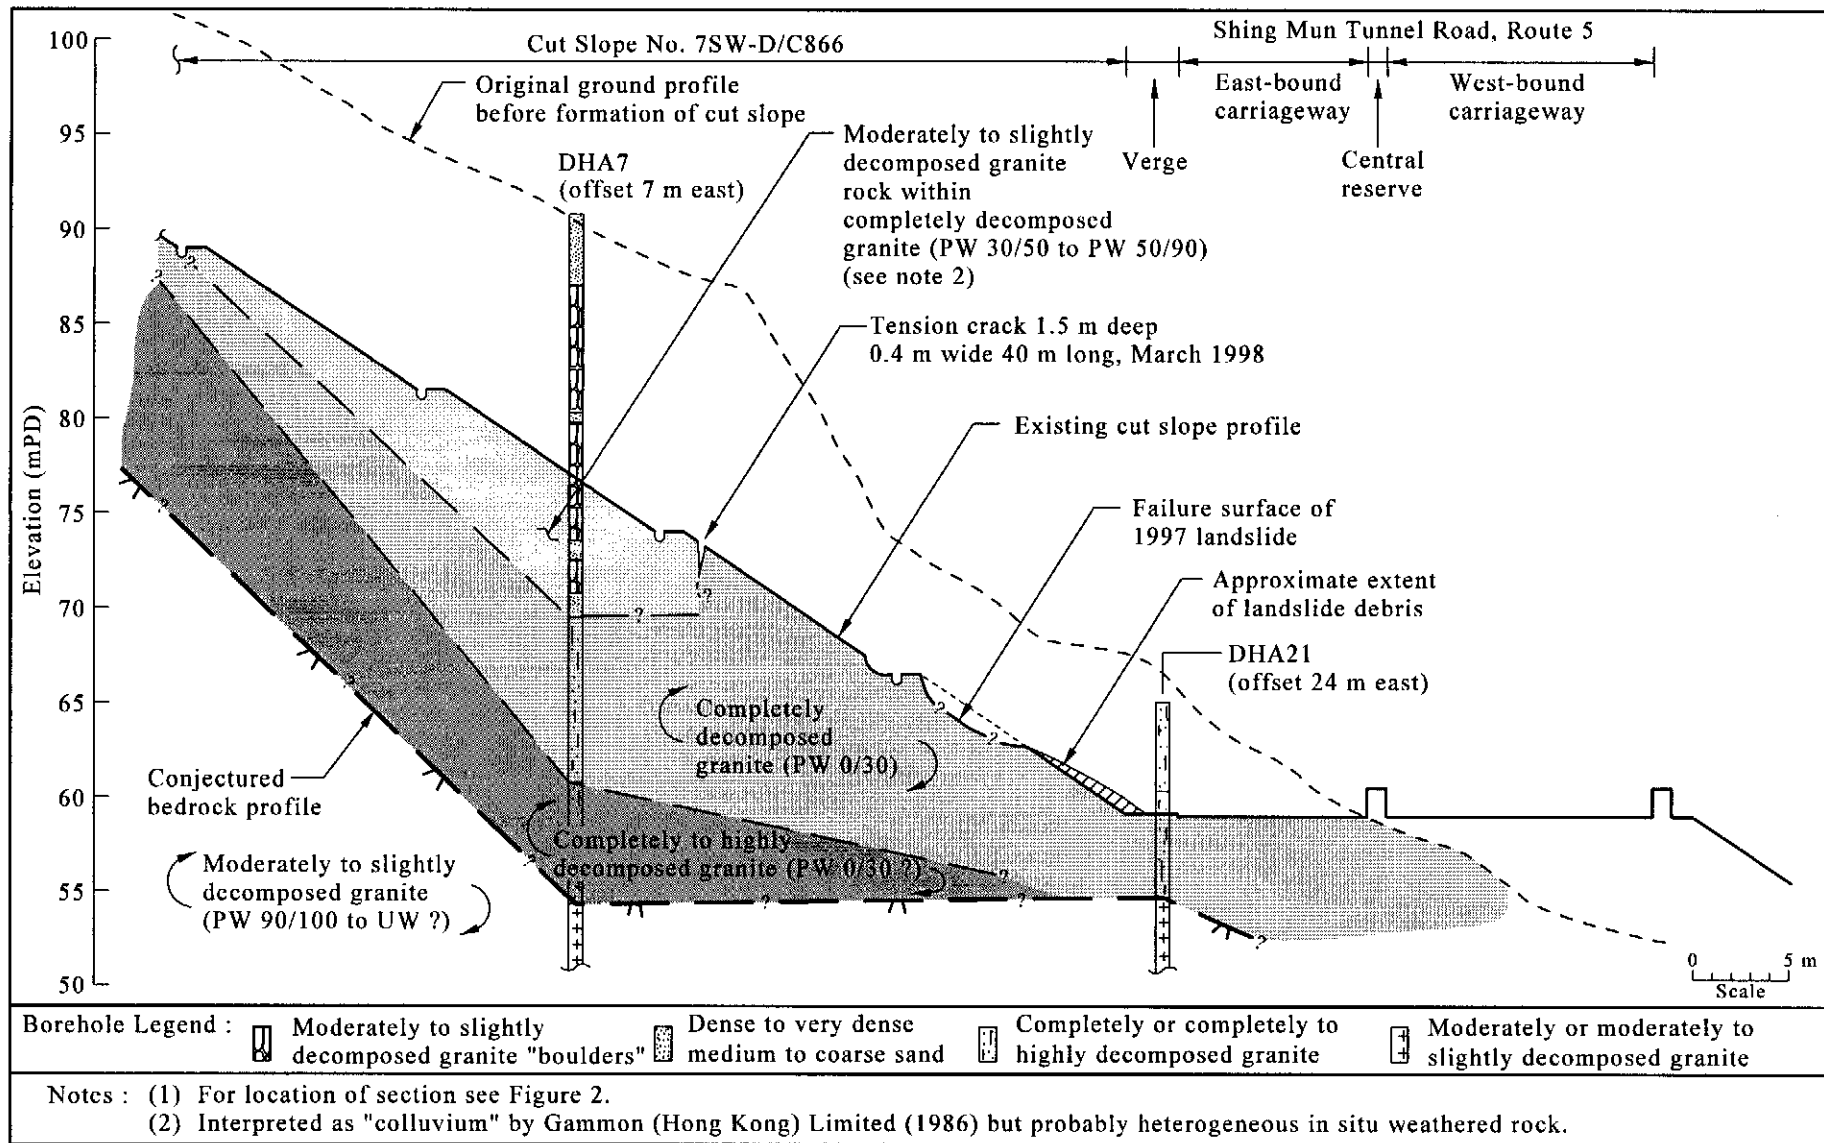
Figure 4 - Inferred Geological Cross-section A - A through the Landslide

A review of borehole data indicates that, in the vicinity of the 1997 landslide, the depth of weathering appears to be more pronounced, with a maximum of about 20 m (Figure 4). The greater depth of weathering coincides approximately with the former head of the stream course associated with earlier landsliding in the natural terrain (Section 2.2 and Figure 3).

affected the present cut slope given that much material (up to 15 m) was removed during slope formation. The probable pre-existing natural topography (Figure 4) suggests that the geometry of the relict landslide is unlikely to have extended much below the surface of the two lowermost batters of the cut slope and hence relict landsliding probably did not have a direct and significant effect. Notwithstanding this, the occurrence of a large-scale relict landslide highlights potential instability problems at the site and could provide an indication of inherent weakness of the terrain and/or unfavourable groundwater conditions. Such destabilising factors could still operate, to a certain extent, and affect the present distressed slope.

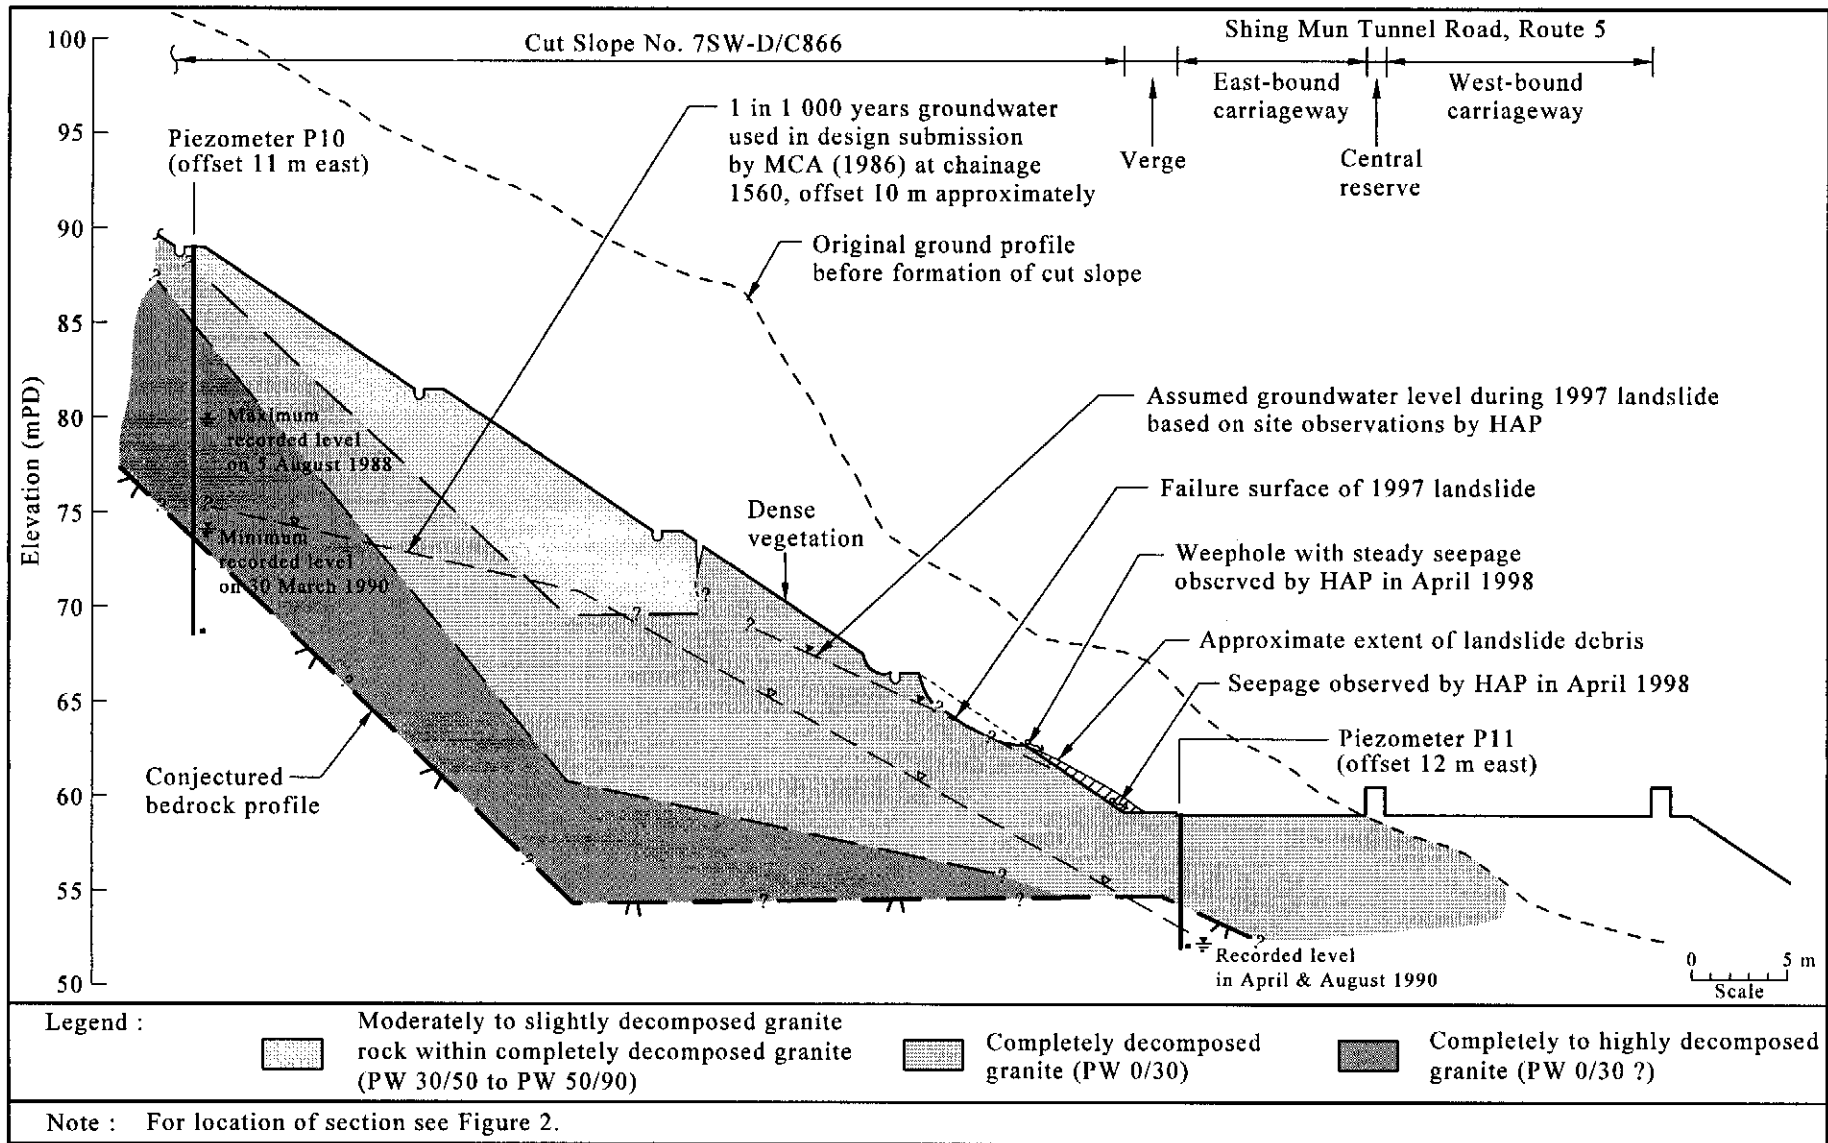
Figure 5 - Hydrogeological Cross-section A - A through the Landslide

Following formation of the cut slope, piezometers P10 and P11 were installed in the fourth berm and at the toe of the slope respectively (Figures 2 and 5). Between 1988 and 1990 intermittent monitoring of piezometer P10 recorded a 5.8 m range in water level. The highest water level recorded was 10.3 m below ground level (bgl) on 5 August 1988 following a period of heavy rainfall and the lowest water level was 16.1 m bgl on 30 March 1990. Monitoring records for piezometer P11 were only available for April and August 1990 which were relatively dry periods. The records showed fairly consistent water levels around 5.3 m bgl. Observations following the 1997 landslide appear to indicate a much higher water level in the lower part of the cut slope (see Section 3.2).

The groundwater regime in the weathering profile, particularly where the material has been subjected to displacement and disturbance, is likely to be complicated and highly variable, with infiltration and subsurface seepage through preferential flow paths and open cracks and joints. No post-failure groundwater monitoring was carried out but it is possible that the groundwater conditions could have been altered by the instability and hence may not be representative of that prevailing prior to the instability. Although there is much uncertainty regarding the precise groundwater model, there is however much evidence of high groundwater conditions within the two lowermost batters of this part of the slope, viz. piezometer monitoring records during the design and construction phases, presence of trench drains, and seepage observations during the detailed landslide study. A review of the piezometer data obtained during cut slope formation indicates that the highest reading of piezometer P10 in August 1988 was about 5 m higher than that assumed for the design of the slope (see Figure 5).

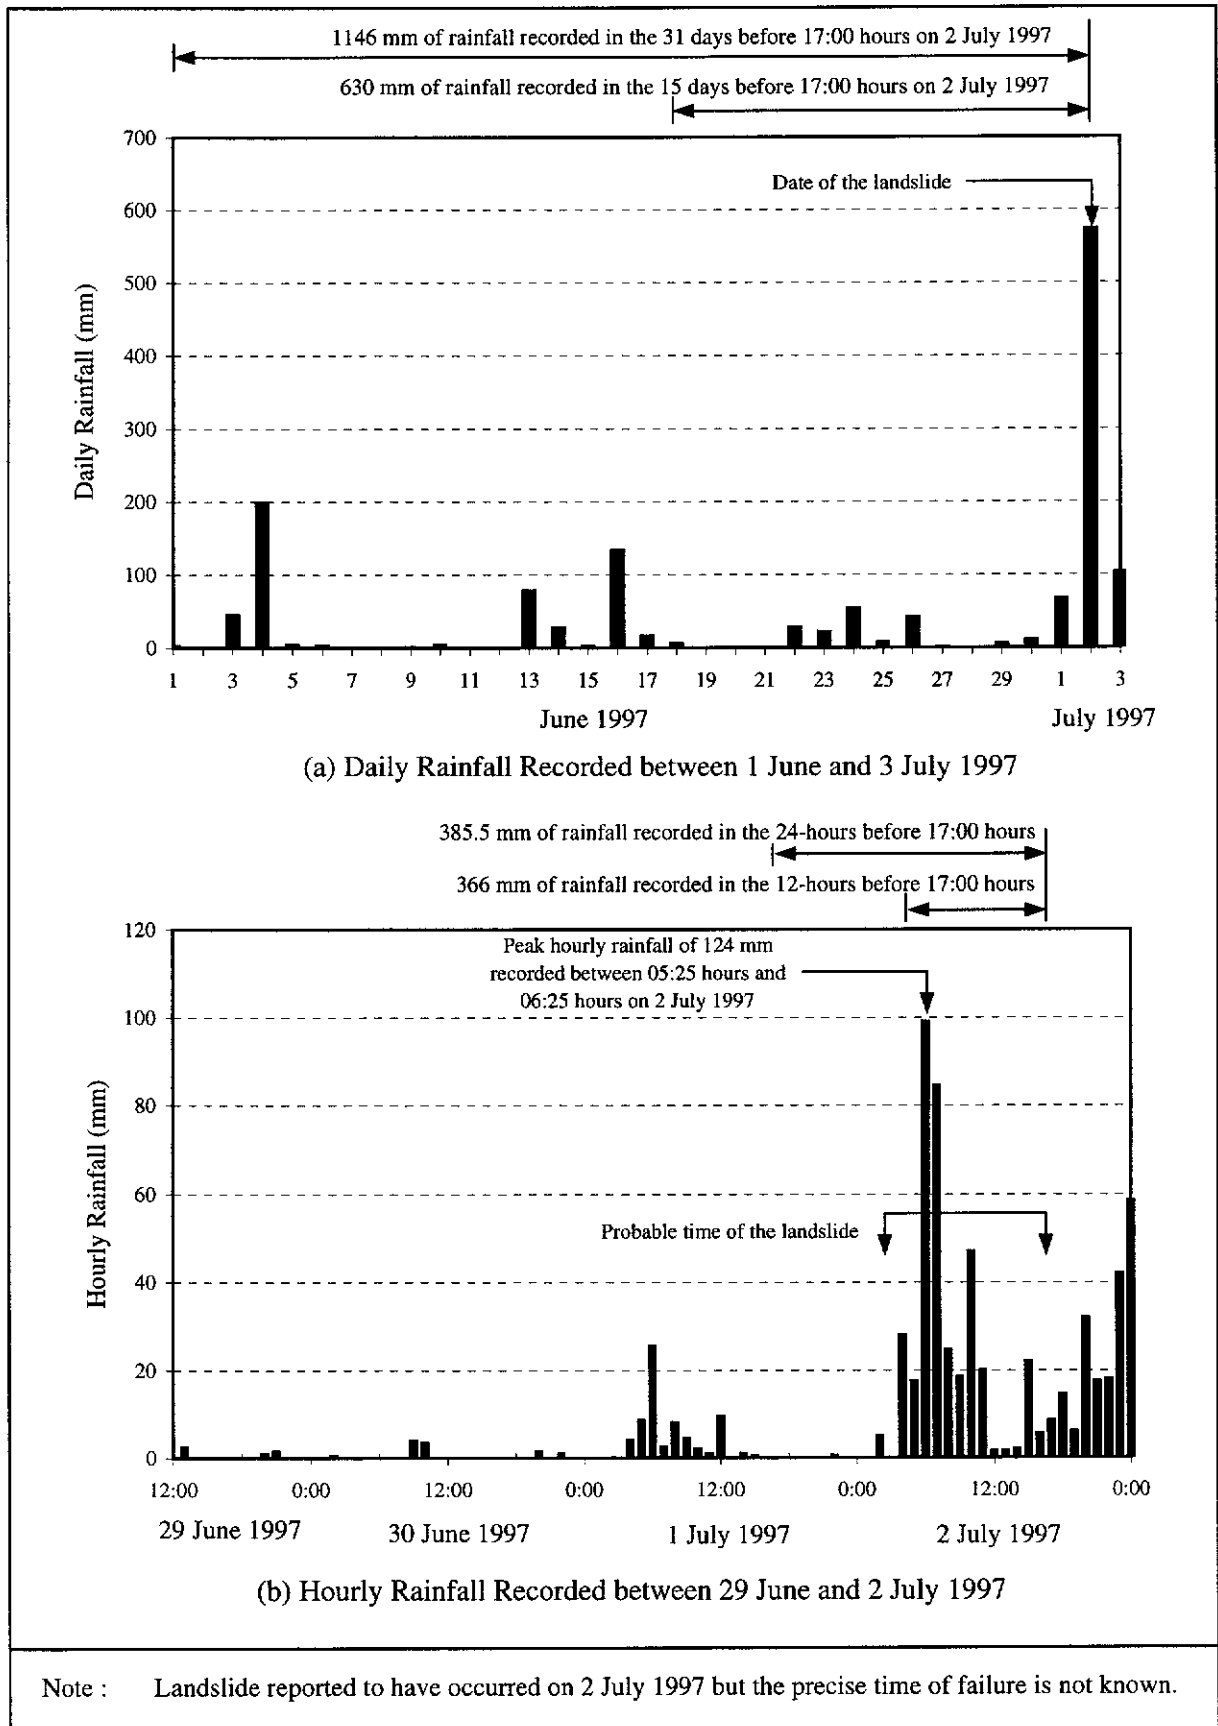
Figure 6 - Rainfall Records at GEO Raingauge No. N02

The daily rainfall recorded between 1 June 1997 and 3 July 1997 and hourly rainfall between 29 June and 2 July 1997 are shown in Figures 6a and 6b respectively. Intermittent rainfall commenced at about 01:00 hours on 2 July 1997 before intensifying between 05:00 hours and 06:00 hours on that morning. The peak hourly rainfall of 124 mm was recorded between 05:25 hours and 06:25 hours (Table 4). Rainfall of lower intensity continued for the rest of the day.

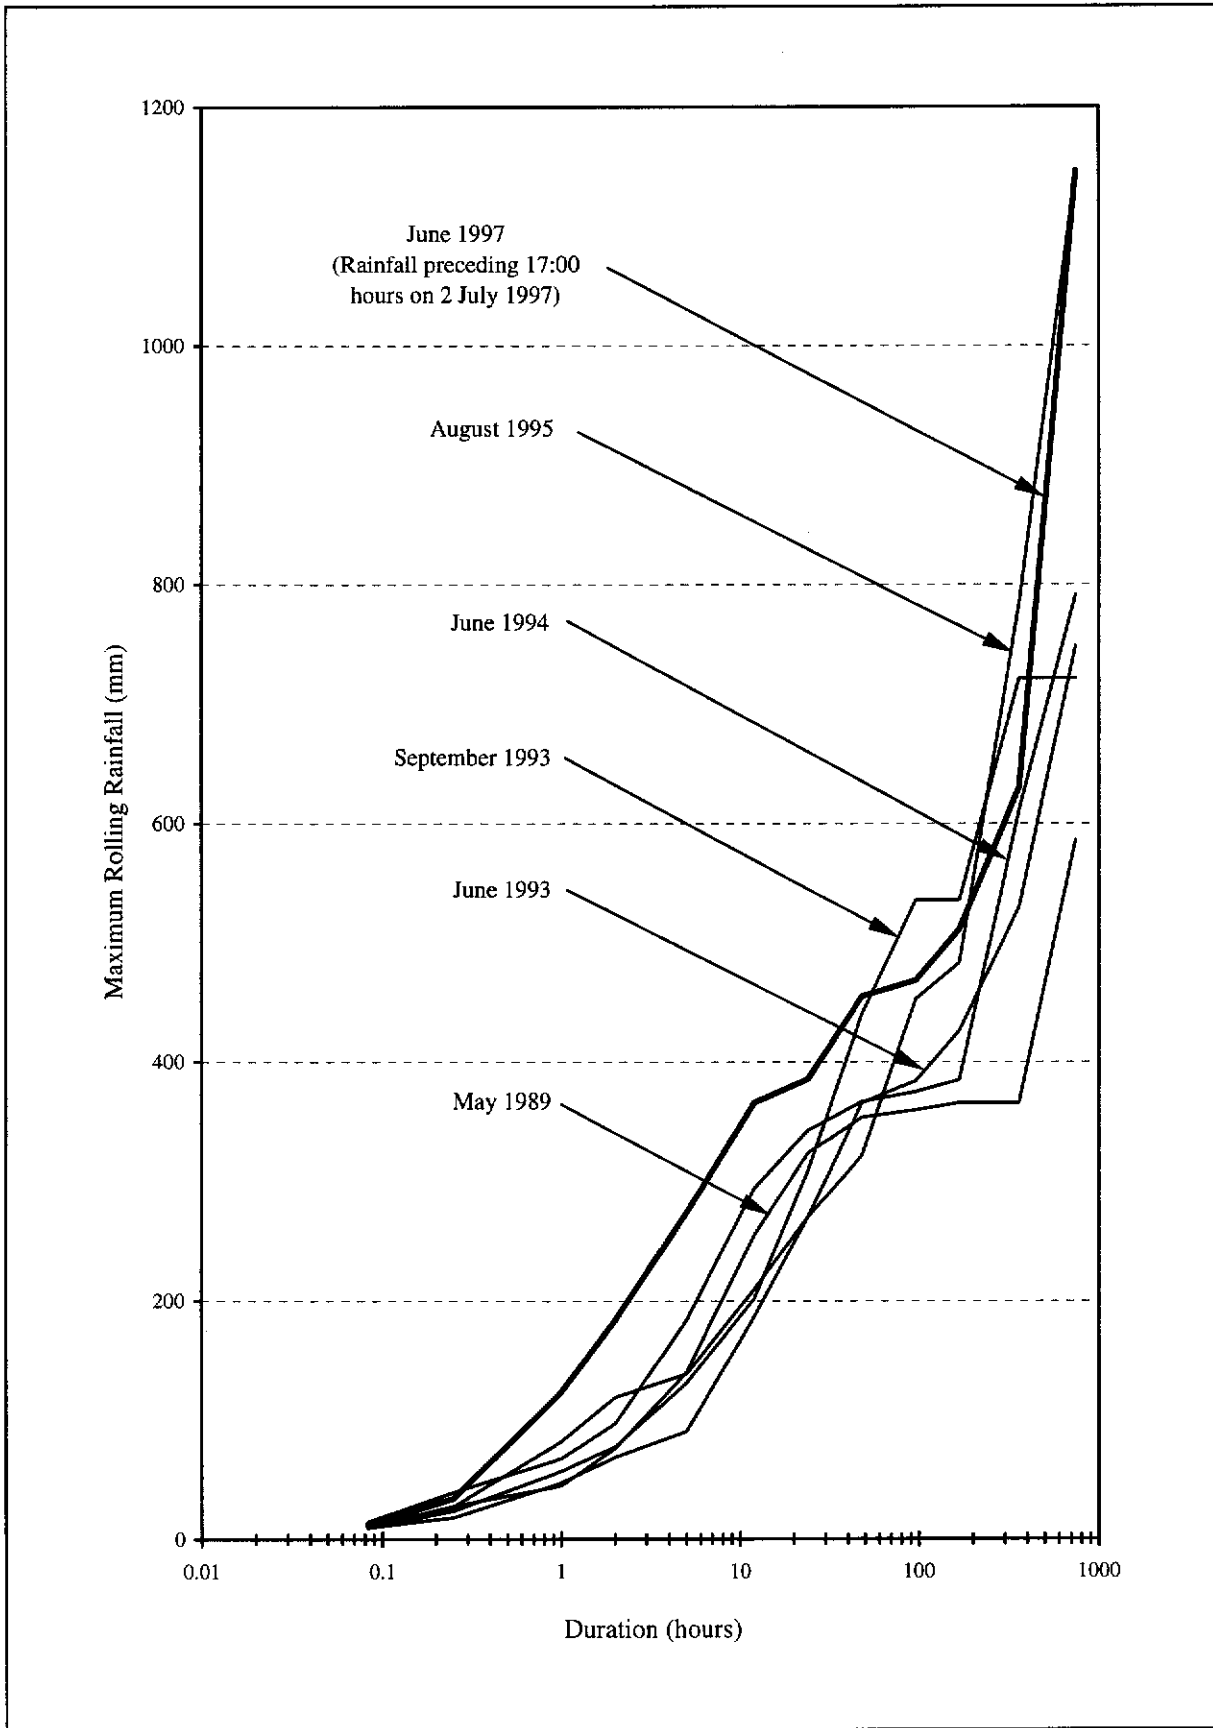
Figure 7 - Maximum Rolling Rainfall at GEO Raingauge No. N02 for Major Rainstorms

The maximum rolling rainfall for the rainstorm has been compared with selected past severe rainstorms recorded at raingauge No. N02 since the raingauge was installed in 1982 (Figure 7). The maximum rolling rainfall for the rainstorm of 2 July 1997 for durations between 15 minutes and 50 hours exceeds those of previous rainstorms recorded at the raingauge.

The detailed landslide study did not commence until early 1998 and the presence of the tension crack was not identified during the preliminary inspection made in July 1997. The timing of tension crack formation cannot be ascertained with confidence although its geometry in plan in relation to the location of 1997 failure would suggest that the tension crack may have been formed at the same time, in July 1997, during an intense rainstorm which was the most severe since slope formation for short to medium-duration rainfall (Figure 7).

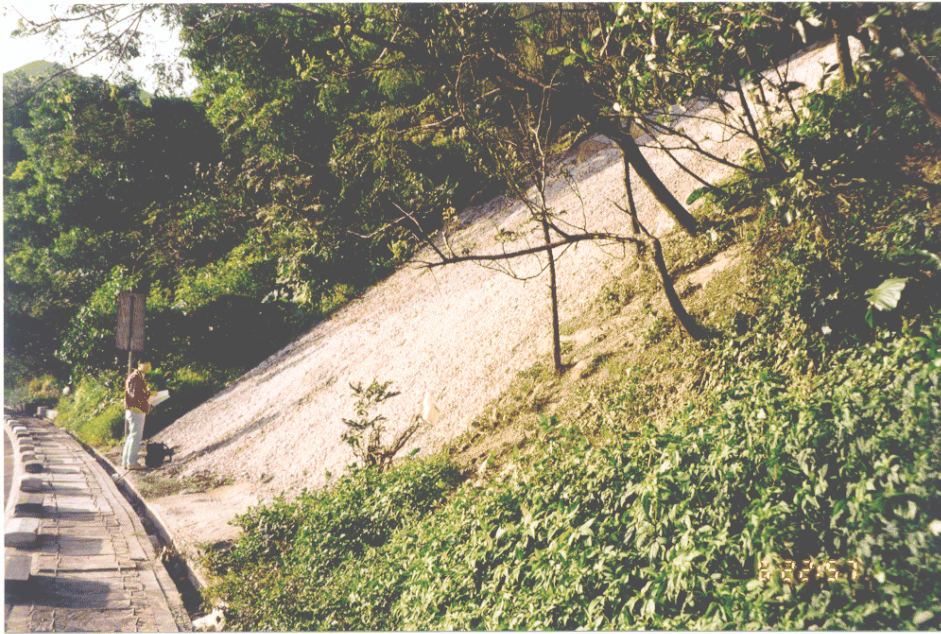
HAP carried out a number of inspections of the site between December 1997 and July 1998. The urgent repair works as specified above had been implemented. A steady seepage was noted from the drainage pipe installed in the failure scar during the urgent repair works.

Plate 1 - View of Incident No. MW97/7/66 after Urgent Repair Works (Photograph Taken on 4 December 1997)

The morphology of the failure scar suggests that the minor landslide was a shallow slide. The travel angle of the landslide debris was about 32°, as measured from the crest of the failure scar to the limit of debris run-out. This is within the typical range of 30° to 40° for rain-induced landslides in Hong Kong (Wong & Ho, 1996). After the landslide, GEO advised HyD to carry out urgent repair works which comprised the provision of a drainage pipe to collect seepage from the base of the failure scar, and reinstatement of the failed area with no-fines concrete.

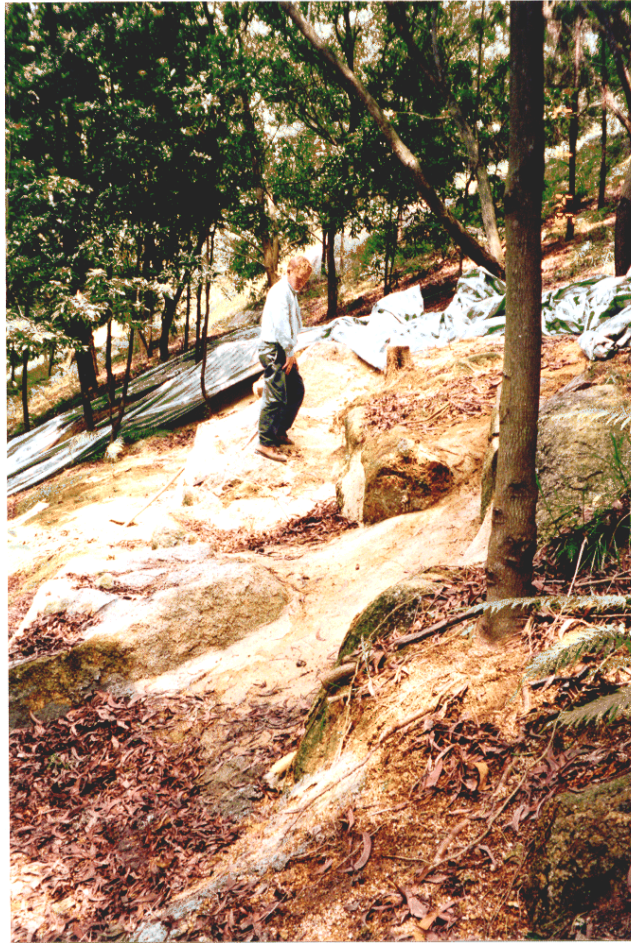
Plate 2 - Tension Crack Located on the Second Batter
(Photograph Taken on 15 September 1998)

Following inspection by HAP and GEO in April 1998, HyD was informed of the presence of the tension crack. At the recommendation of the GEO, HyD subsequently implemented urgent repair works which comprised vegetation clearance, infilling of the tension crack with compacted soil cement and covering with tarpaulin, and the placement of an oil drum safety barrier at the toe of the slope. The drainage pipe installed at the base of the 1997 failure scar was extended to direct water flow into the U-channel at the toe of the slope.

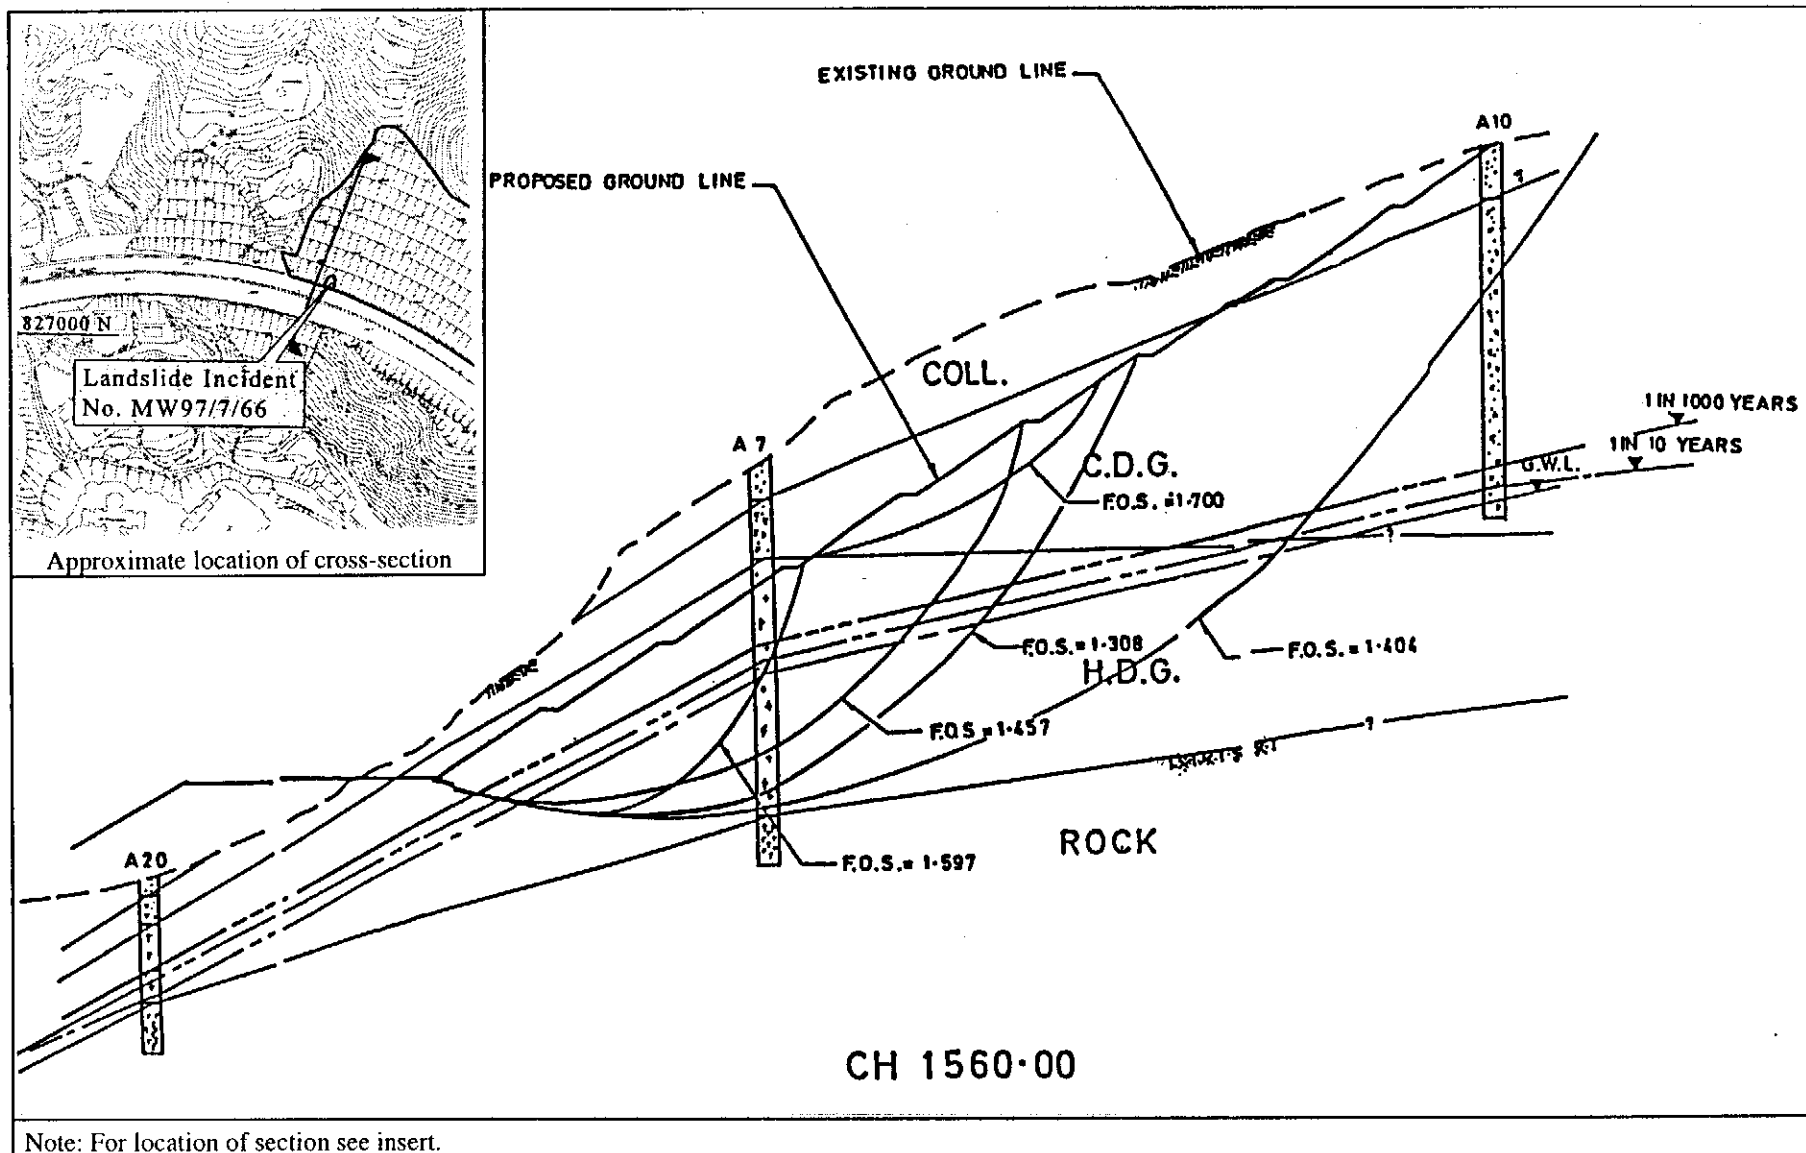
Figure B1 - Design Slope Stability Section X - X at Chainage 1560 (MCA, 1986)

Based on the above assumptions a stability assessment of the proposed cut slope was undertaken (Appendix B, Figure B1). The report stated that "For global stability at chainage 1560, the F.O.S. (factor of safety) corresponding to a 1 in 10 years and 1 in 1 000 years is 1.40 and 1.31 respectively".
