**SECTION 4:
DETAILED STUDY OF THE
LANDSLIDE AT
VILLE DE CASCADE,
FO TAN, SHATIN
ON 3 JULY 1997**

Halcrow Asia Partnership Ltd

**This report was originally produced in December 1998
as GEO Landslide Study Report No. LSR 29/98**

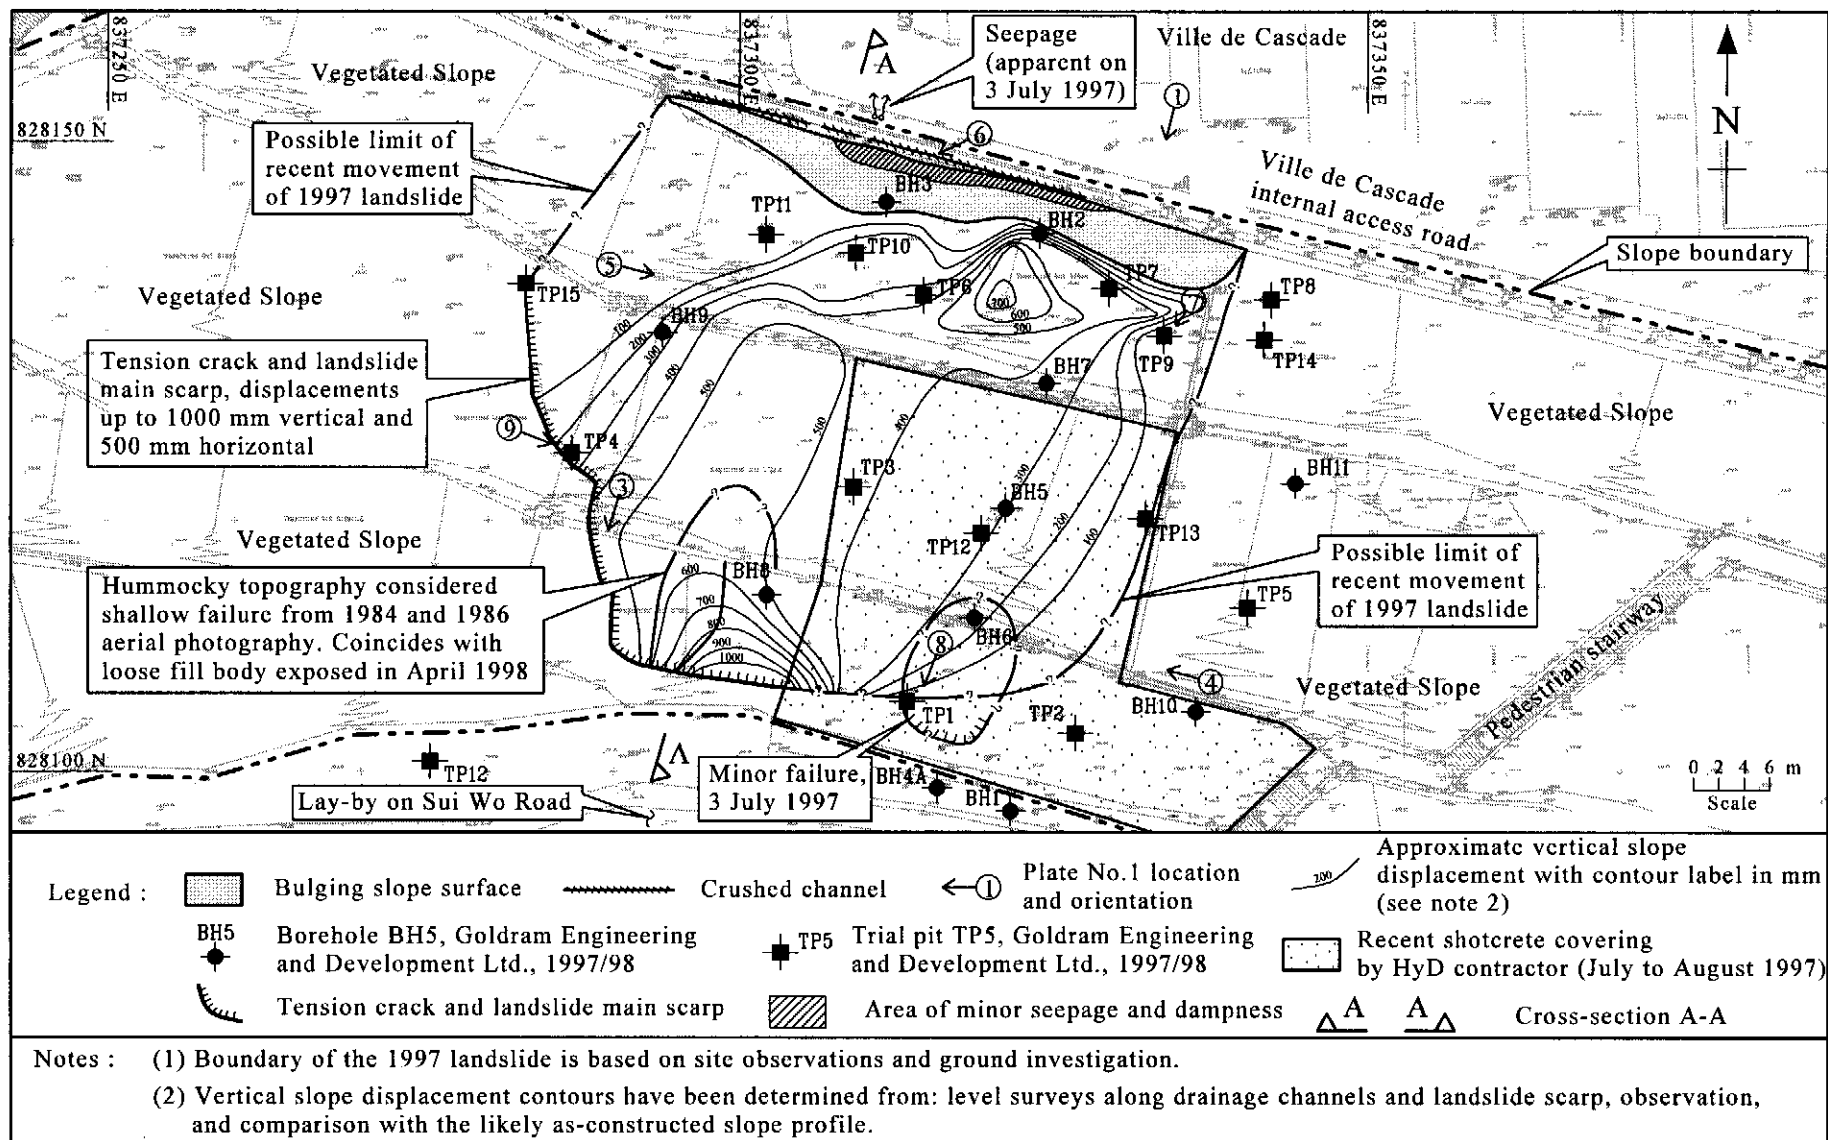
Figure 2 - Plan of the Landslide

The description of the landslide was based on walk-over surveys of the site by HAP and GEO and observations from trial pits during the ground investigation following the 1997 landslide. The observations (Figure 2) show an extensive area of displaced and cracked ground downslope and to the west of the minor failure of 3 July 1997, encompassing a slope area of about 2 500 m². If the failure surface extends to the base of the saprolite (see Sections 5.2 and 6), then the landslide volume is estimated to be up to about 10 000 m³.

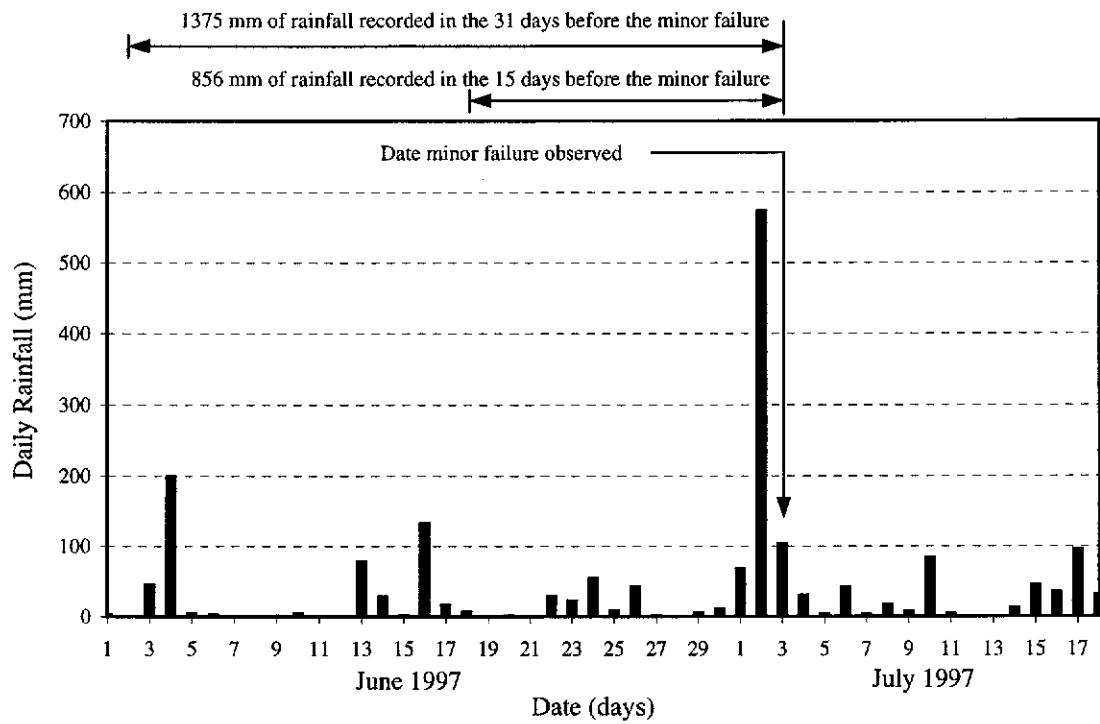
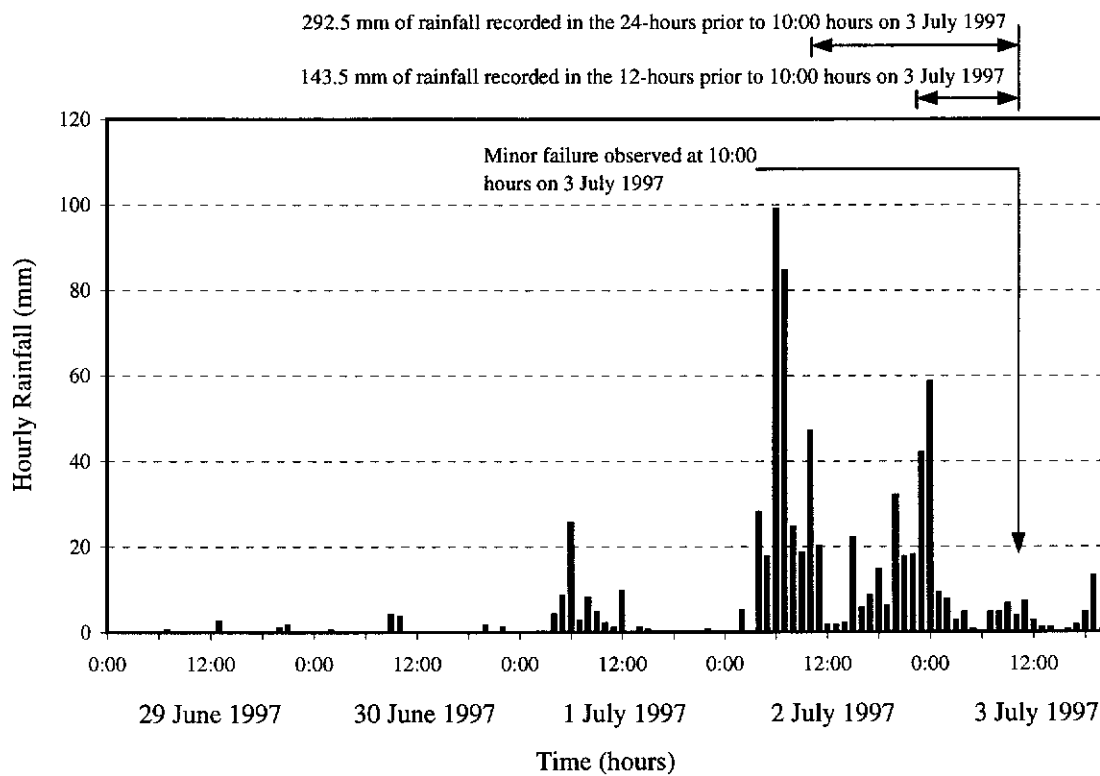
Figure 4 - Rainfall Recorded at GEO Raingauge No. N02

A total of 1375 mm of rainfall was recorded by raingauge No. N02 in the 31 days before the minor failure of 3 July 1997. The 12-hour and 24-hour rainfalls preceding the landslide are 143.5 mm and 292.5 mm respectively. The hourly rainfall preceding 3 July 1997 shows a prolonged period of rainfall starting at around 04:00 hours on 2 July 1997, and continuing up to the time the failure was first observed. The peak intensity of clock hourly rainfall occurred at between 05:00 hours to 06:00 hours on 2 July 1997 (Figure 4).

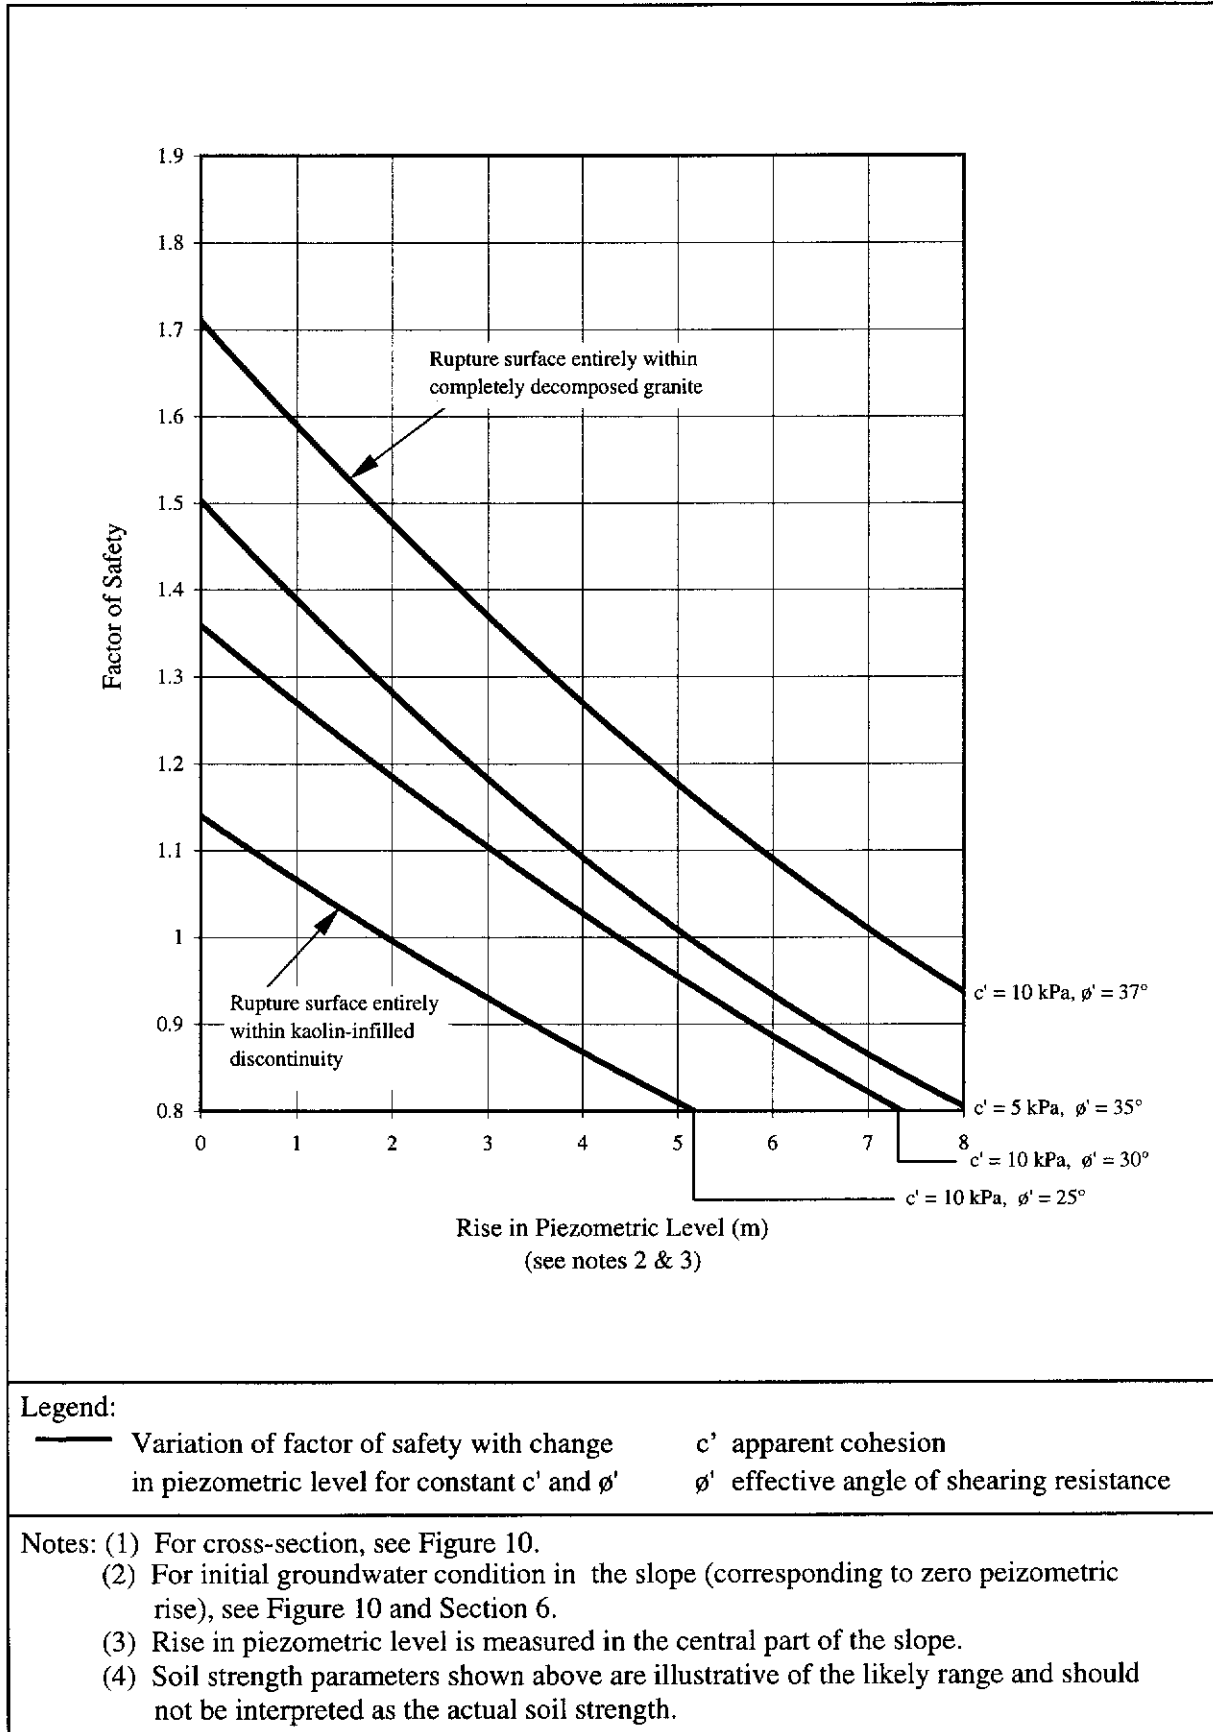
Figure 11 - Results of Theoretical Stability Analysis

For shear strength parameters that would apply for kaolin-infilled discontinuities ($c' = 10$ kPa and $\phi' = 25^\circ$), a piezometric rise of 2 m would have been required to reduce the factor of safety to unity (Figure 11). Limited groundwater monitoring between August 1980 and June 1981 has shown that the recorded piezometric level August 1980 was some 4 m above the dry season level. Given the severity of the rainstorm on 2 and 3 July 1997, it is probable that an even higher rise in the piezometric level could have occurred at the time of failure. For instance a rise of 5 m could have brought the slope into a state of limiting equilibrium with average operational shear strength parameters ($c' = 5$ kPa and $\phi' = 35^\circ$).

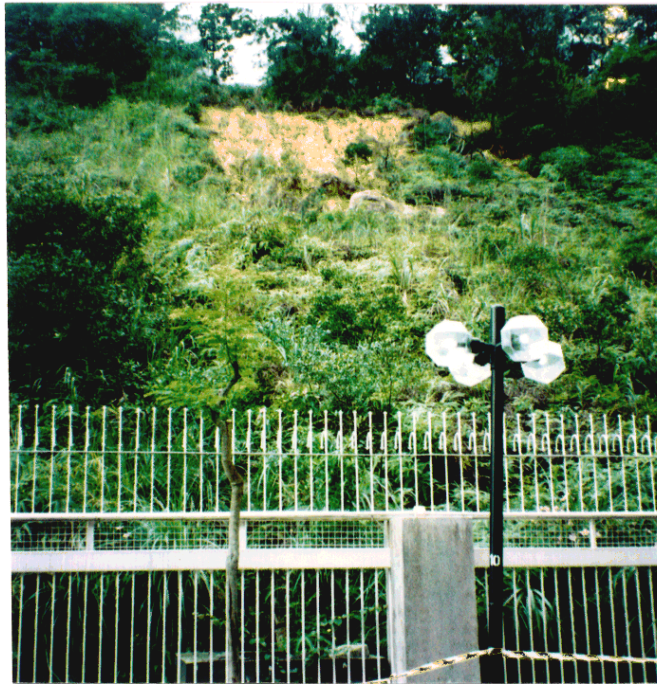
The minor failure of 3 July 1997 was apparently a shallow slide within principally very clayey and silty sand fill. The dimensions of the failure were estimated to be 5 m wide, 5 m long and up to 0.6 m deep, with a volume of about 15 m³. The failed material came to rest immediately downslope of the rupture surface (Figure 2 and Plate 1). The cause of the failure is not known, though surface water infiltration was indicated in the GEO Incident Report and localised loose fill deposits are known to exist in the vicinity (see below). It is also noted that the location of the toe of the rupture surface of the minor failure lies along an easterly extension of the main landslide scarp (Figure 2). It is possible that the minor failure was associated with the development of the main landslide scarp.

Plate 1 - View of Minor Failure (GEO Incident No. ME97/7/42) on
Slope No. 7SW-B/C123 (Photograph Taken on 7 July 1997)

The failure was reported to the GEO at 12:00 hours on 3 July 1997, who subsequently inspected the site on 7 July 1997 (Plate 1). At the time of the inspection the slope was densely vegetated and only limited access was possible. The GEO advised HyD to fence off the affected area, cover the failure scar with sheeting, remove loose soil debris, trim back the slope surface, provide a hard surface protection, and clear and repair surface channels, as necessary.

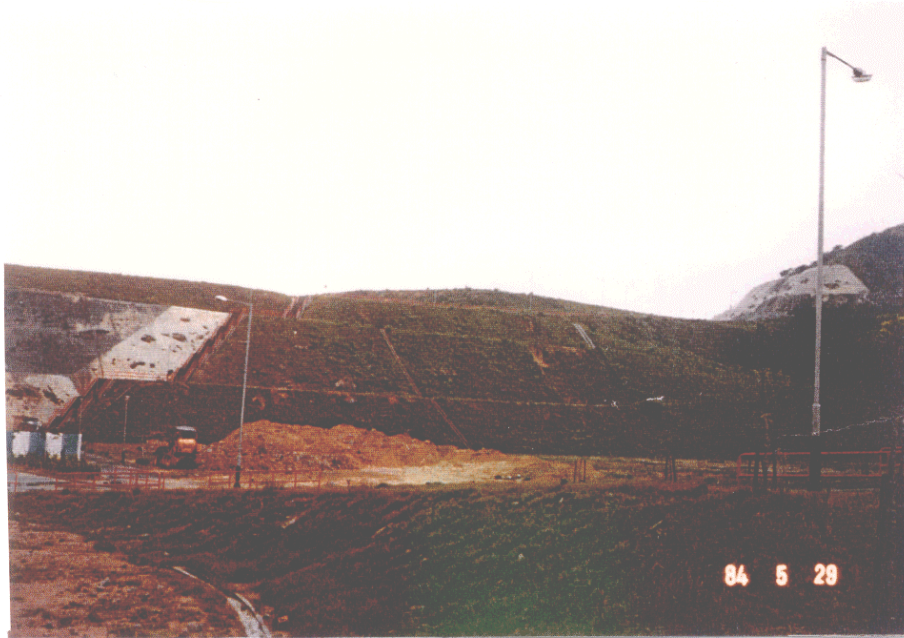
Plate 2 - View of Western Part of Slope No. 7SW-B/C123
(Photograph Taken on 29 May 1984)

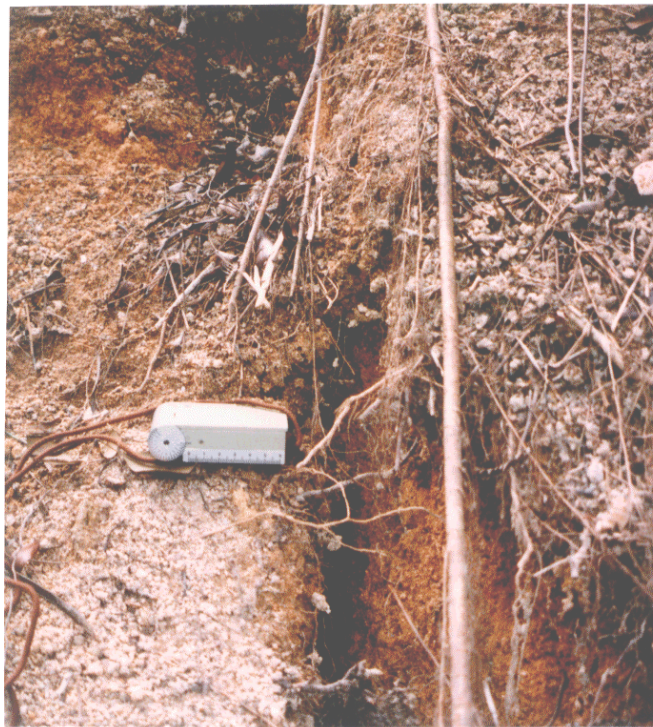
HAP noted that the scarp appeared predominantly fresh during the inspection on 7 November 1997 (Plate 3). However, it is uncertain whether there had been earlier movement along the scarp. Elsewhere, at the location where the scarp turns downslope, the ground surface is hummocky and lies within a depression (Figure 2). This area coincides with the 1984 and 1986 failures identified from interpretation of aerial photographs (Section 2.4). Subsequent excavation at this location in April 1998 for the LPM works revealed a local area of loose fill.

Although the tension crack was not identified for some 4 months after the reported landslide incident, its relatively fresh appearance suggests that it probably formed at the same time as the failure in July 1997, during a period of severe rainfall.

Plate 3 - View of Recent Displacement across Western Part of Tension
Crack (Photograph Taken on 2 February 1998)

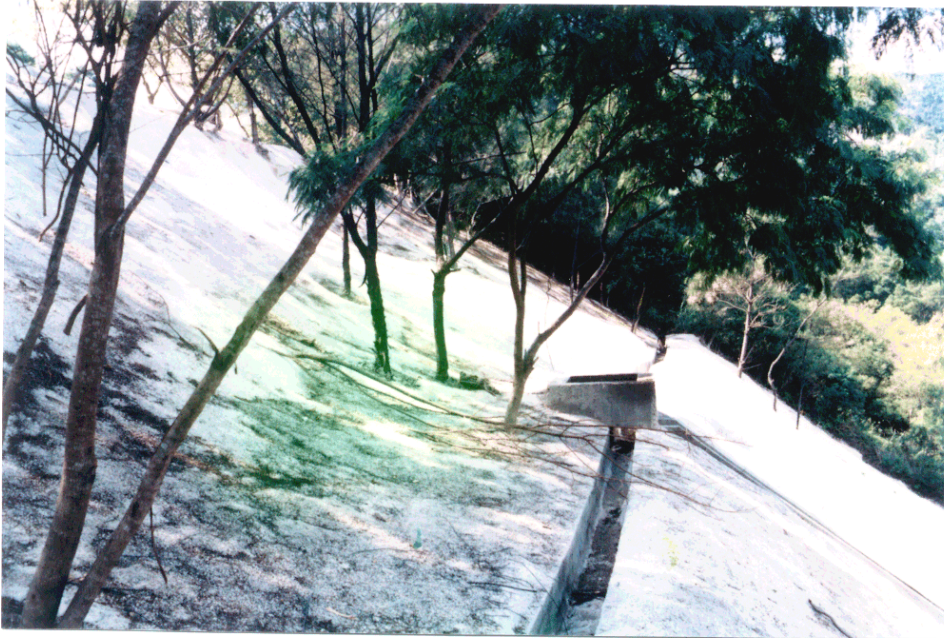
Plate 4 - Displacement of U-Channel, shown in Background along Upper Berm (Photograph Taken in November 1997)

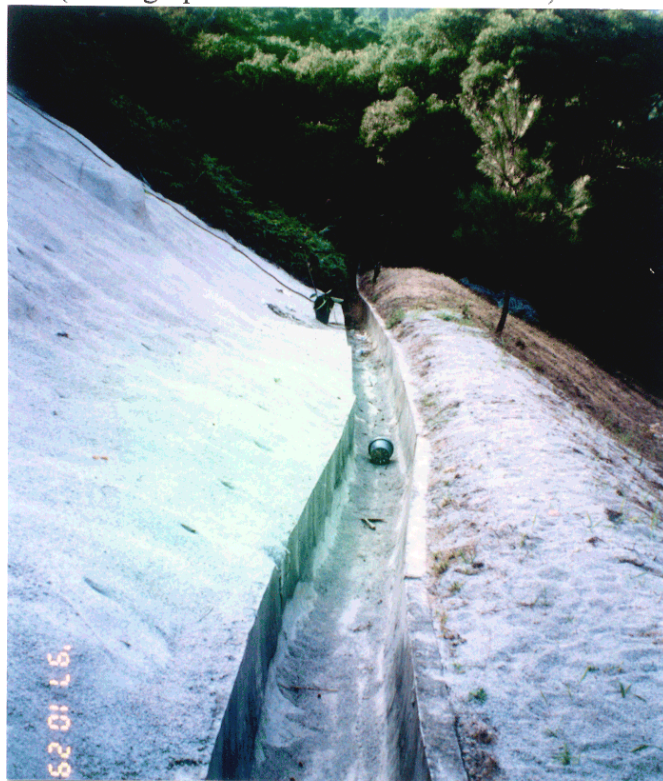
Plate 5 - Displacement of U-Channel along Lower Berm (Photograph Taken on 29 October 1997)

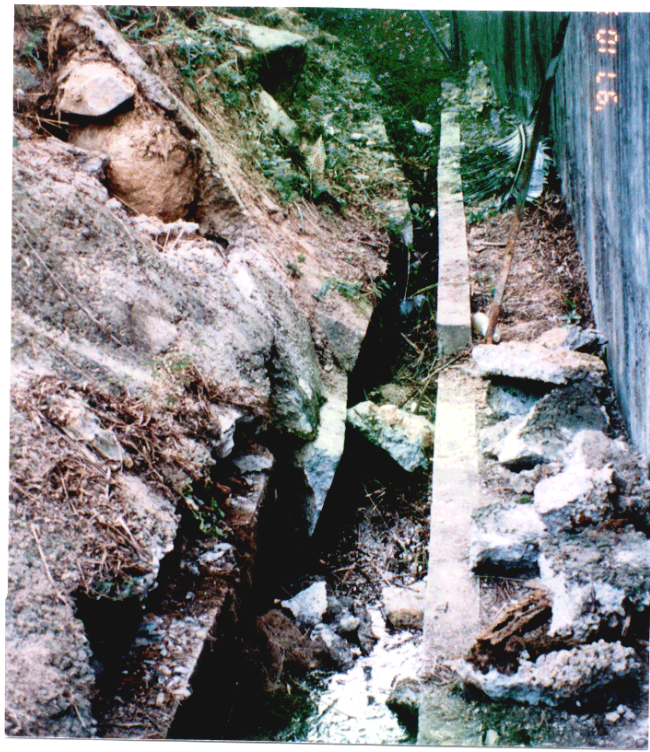
At the toe of the slope, bulging was evident over about a 30 m length that resulted in the crushing of the toe drain and small-scale collapses of soil (Plate 6). Upslope of the bulged area, the lower batter showed signs of disturbance with areas of subsidence and cracking up to 50 mm wide. Trial pits Nos. TP6, TP9, TP10 and TP11 excavated in the lower batter encountered sub-vertical open relict joints up to 120 mm wide. Within trial pit No. TP9, open joints partially infilled by the overlying fill were evident (Plate 7). A 2 m-high concrete wall along the toe of the slope and the paved area in Ville de Cascade showed no evidence of distress.

Plate 6 - Bulging and Collapse of Slope Toe (Photograph Taken on 30 October 1997)

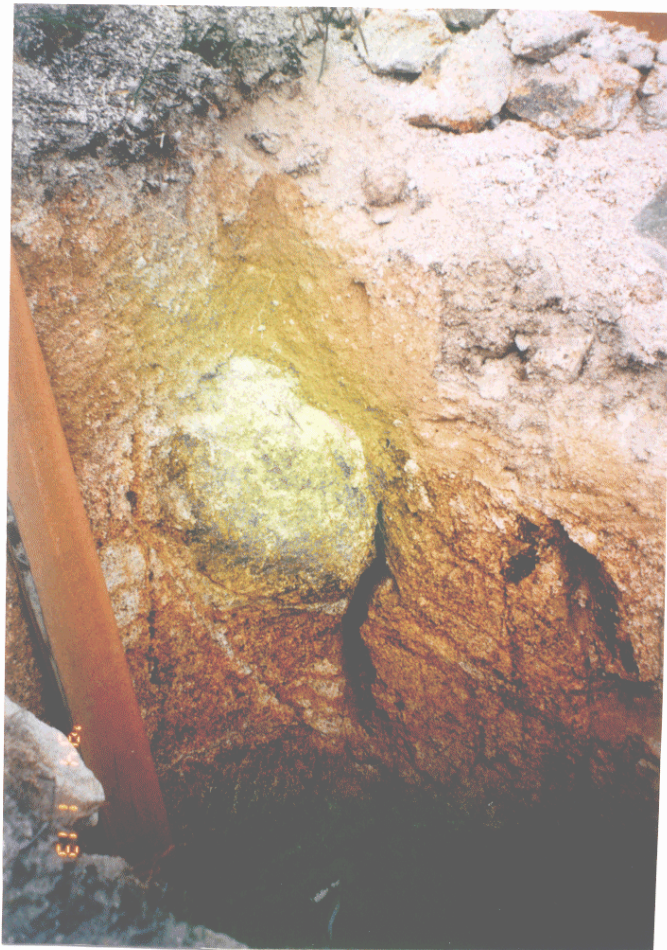
Plate 7 - Partially Infilled Open Joints within Trial Pit No. TP9
(Photograph Taken in November 1997)

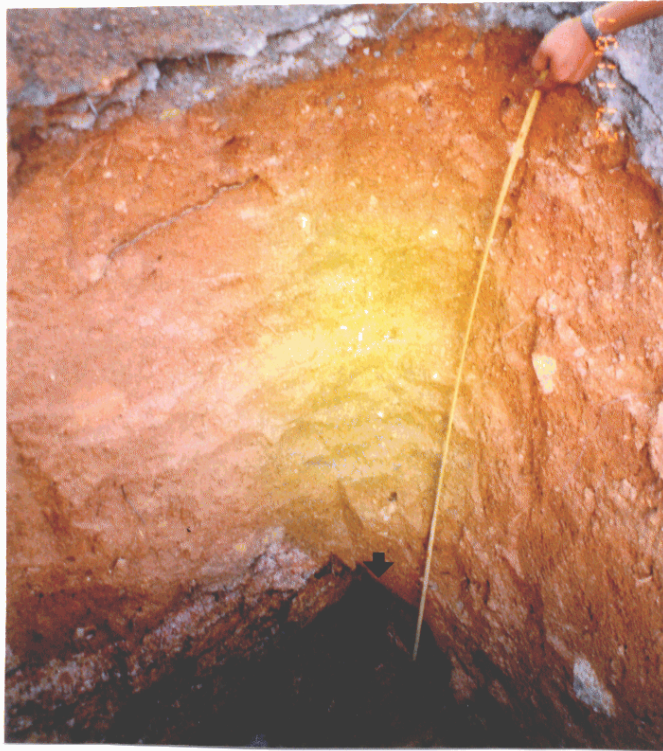
Plate 8 - Open Relict Joint about 80 mm Wide in Completely Decomposed Granite below Fill in Trial Pit No. TP1 (Photograph Taken on 27 November 1997)

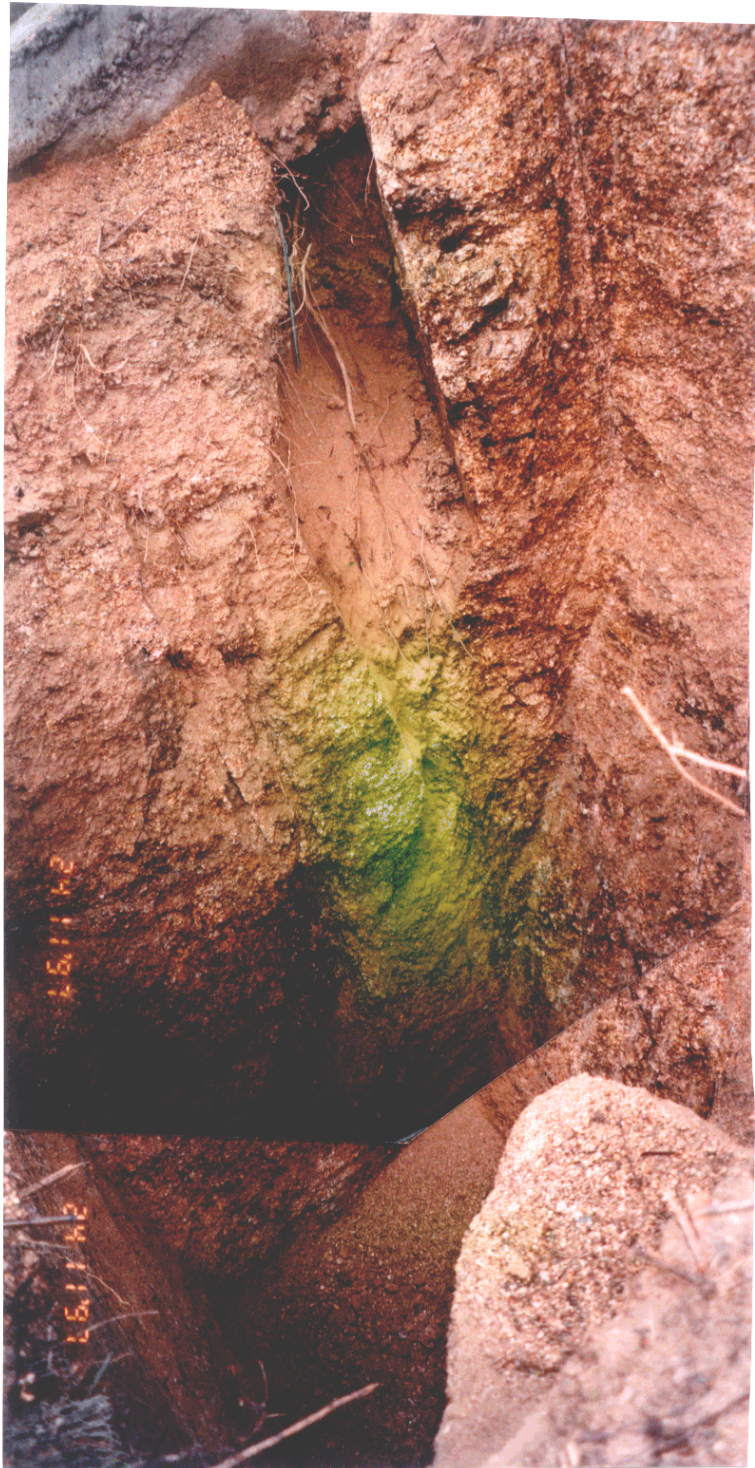
The western part of the landslide scarp, exposed in trial pit No. TP4, exploited a pre-existing relict joint in completely decomposed granite that was open to a depth of about 3 m below the ground surface (Plate 9). Displacement across the joint varied but was up to 400 mm horizontally and about 200 mm vertically. Trial pit No. TP15, located at the western end of the scarp, exposed a sub-vertical crack within the fill with a horizontal displacement of up to 20 mm. The crack extended about 0.8 m below the ground surface.

Plate 9 - Tension Crack Exploiting Pre-existing Relict Joint in Completely Decomposed Granite in Trial Pit No. TP4 (Photograph Taken on 24 November 1997)

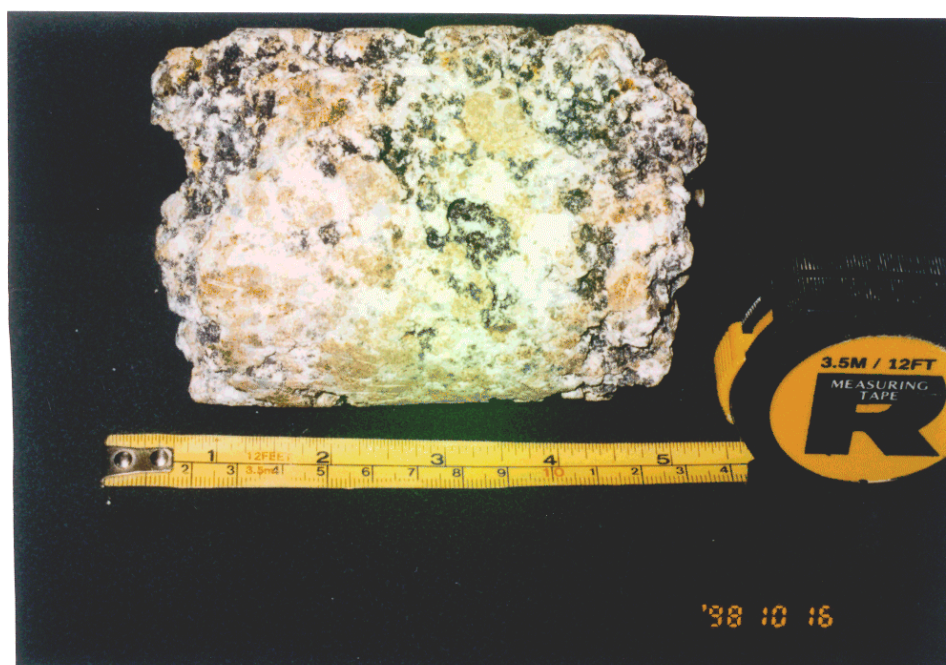
Plate 10 - View of Partial Mineral Dissolution in Moderately Decomposed Granite Retrieved from Borehole No. BH2 Between 3.3 m and 6.1 m Depth (Photograph Taken in October 1998)
